Inventory, Assessment, and Restoration Potential of Ephemeral Wetlands on FFWCC Wildlife Management Areas

Aucilla WMA Final Report

Submitted by: Rebecca P.M. Means¹, Ryan C. Means¹, Steven A. Johnson²

¹Coastal Plains Institute

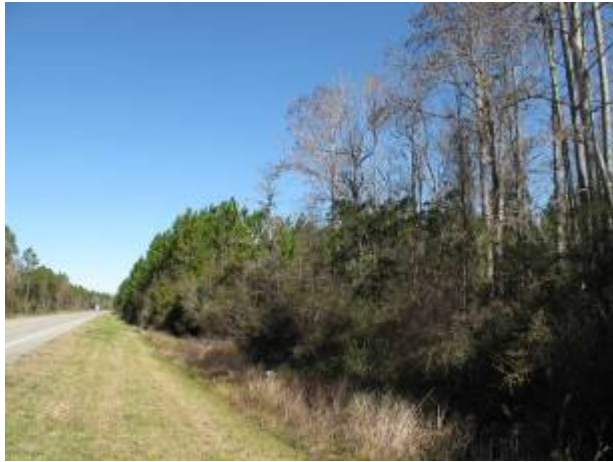
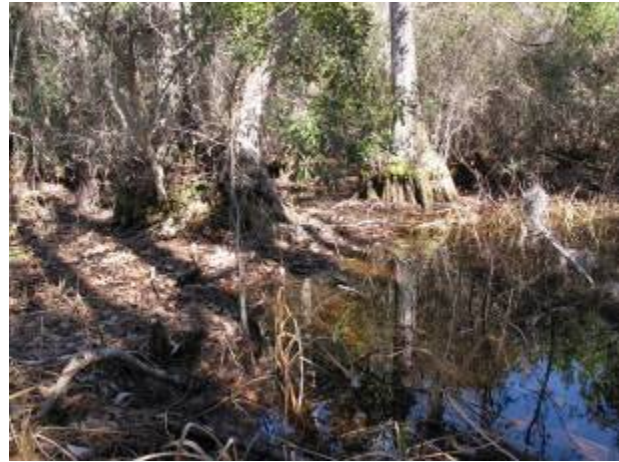
Wetland ID: 03-01

Description: This wetland is a 0.3 ha ephemeral mixed swamp. The presence of old cypress stumps provides evidence of historical logging. The cypress have regenerated and cover >75% of the wetland. The midstory is dominated by titi and wax myrtle, and covers 50- 75% of the wetland. Sawgrass grows in scattered patches, and covers 5-25% of the basin. A major road (SR 59) bisects this wetland. The western half of the wetland is on private land. The adjacent uplands are mesic flatwoods that were bedded and converted to a pine plantation. Upland restoration is in progress.

Wetland Concerns: Road, Woody encroachment

Restoration Action Recommended: In order to restore the hydrology of this wetland and the larger wetland system, the road would have to be removed. Recognizing that this road is now a permanent feature, we do not recommend any action relating to the road. The wetland could be monitored to ensure it is not affected by run-off or other impacts. Periodic fire in the wetland would reduce the encroaching woody vegetation and encourage the growth of the remnant herbaceous component.

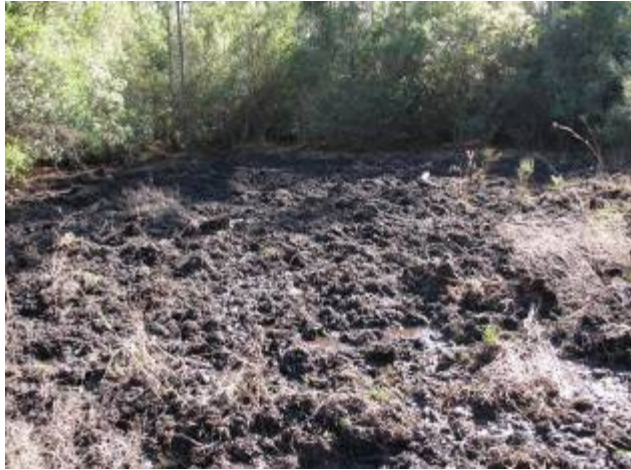
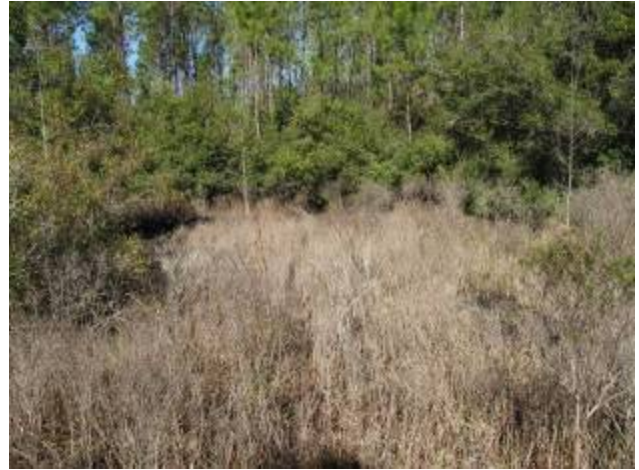
Wetland ID: 03-02

Description: This wetland is a 0.1 ha ephemeral marsh. There is no tree canopy or midstory cover. Sedges/grasses grow throughout the wetland, and cover >75% of the basin. The wetland would be in great condition except for the severe hog damage. The adjacent uplands are mesic flatwoods that were bedded and converted to a pine plantation. Upland restoration is in progress.

Wetland Concerns: Feral hog damage

Restoration Action Recommended: None

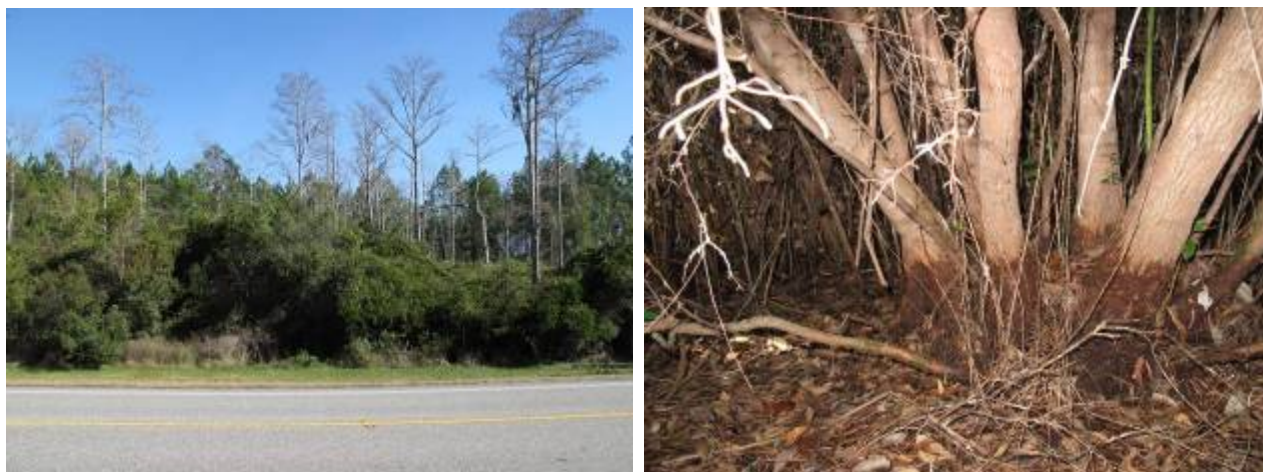
Wetland ID: 03-03

Description: This wetland is a 0.2 ha ephemeral mixed swamp. Cypress trees dominate the canopy, and cover 50-75% of the wetland. The midstory is dominated by titi, and covers >75% of the wetland. There is no herbaceous vegetation. The wetland is severely overgrown with encroaching shrubs, likely due to long-term fire suppression. A major road (SR 59) runs along the west side of the wetland. The adjacent uplands are mesic flatwoods that were bedded and converted to a pine plantation. The uplands were burned within the past year or two but the fire did not reach into the wetland. Upland restoration is in progress.

Wetland Concerns: Road, Woody encroachment

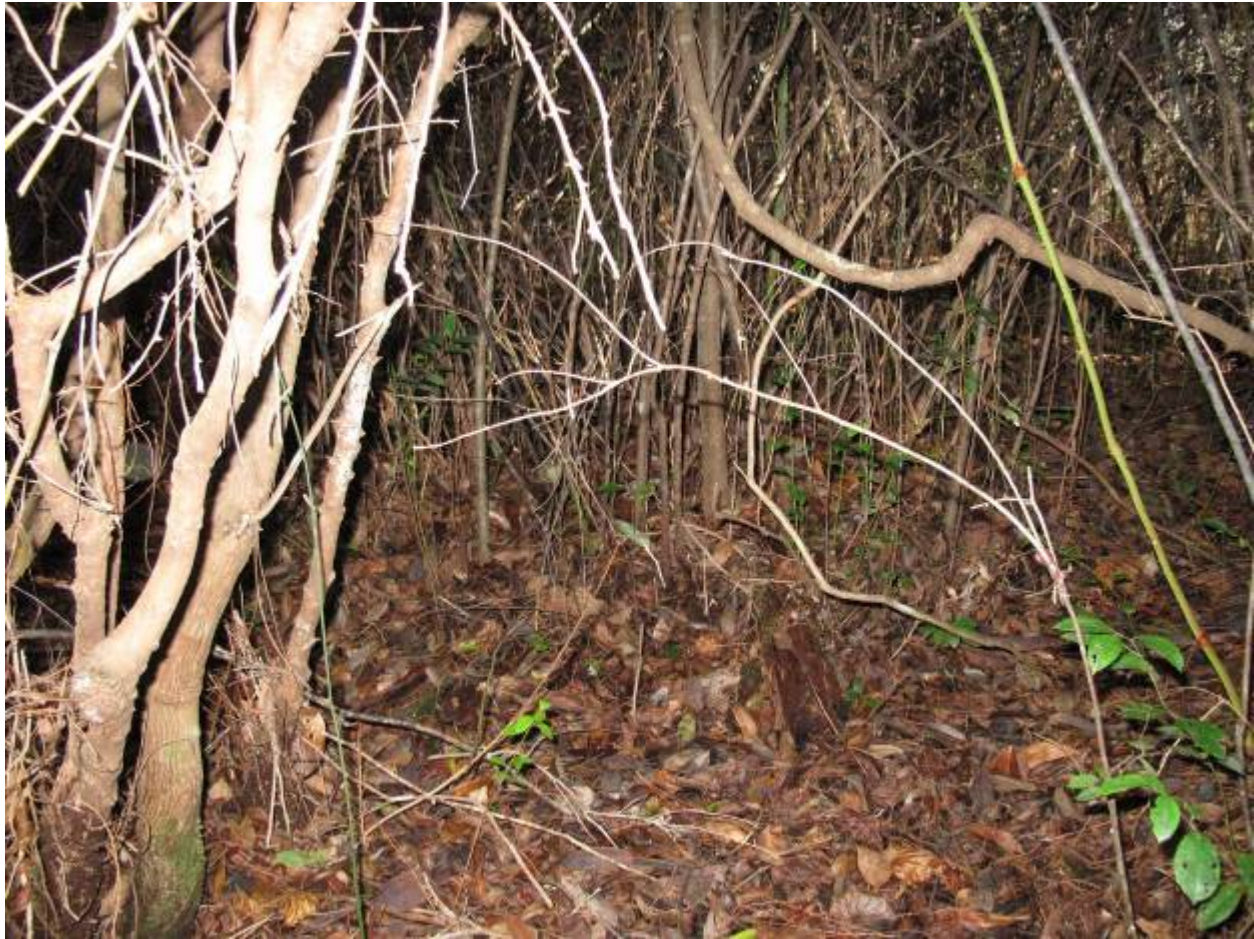
Wetland ID: 03-04

Description: This wetland is a 0.5 ha ephemeral shrub swamp. Cypress trees dominate the canopy, and cover 5-25% of the wetland. The midstory is dominated by dense titi, and covers >75% of the wetland. There is no herbaceous vegetation. Old stumps provide evidence that this wetland was once a cypress-dominated forested swamp. The adjacent uplands are mesic flatwoods that were bedded and converted to a pine plantation. The uplands were burned within the past year or two but the fire did not reach into the wetland. Upland restoration is in progress.

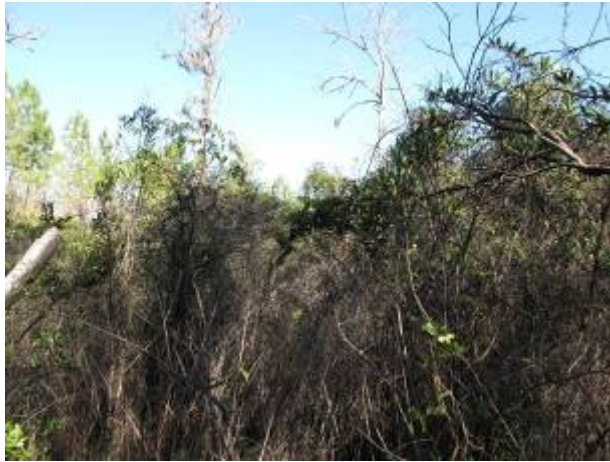
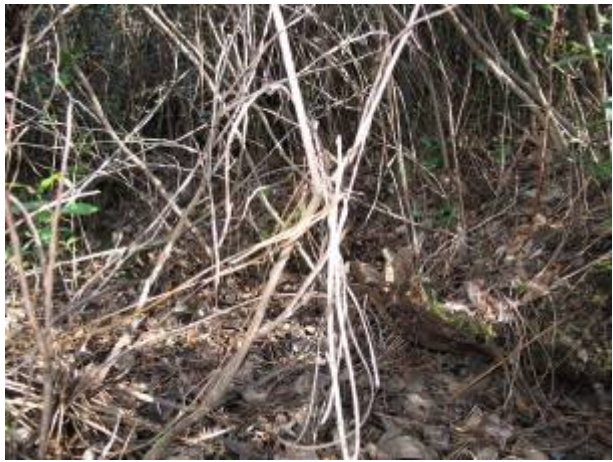
Wetland ID: 03-05

Description: This wetland is a 1.2 ha ephemeral shrub swamp. Cypress trees dominate the canopy, and cover 5-25% of the wetland. The midstory is dominated by dense titi, and covers >75% of the wetland. There is no herbaceous groundcover. Old stumps provide evidence that this wetland was once a cypress-dominated forested swamp. A thick wall of brush surrounds the wetland perimeter. The adjacent uplands are mesic flatwoods that were bedded and converted to a pine plantation. The uplands were burned within the past year or two but the fire did not reach into the wetland. Upland restoration is in progress.

Wetland Concerns: Woody encroachment

Restoration Action Recommended: Periodic fire in the wetland would reduce the dense titi and open the midstory.

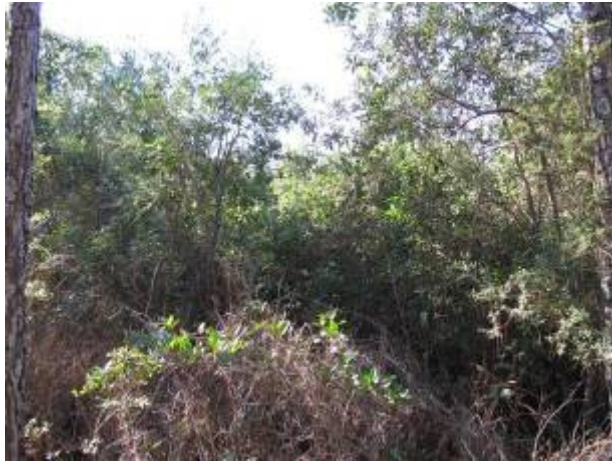
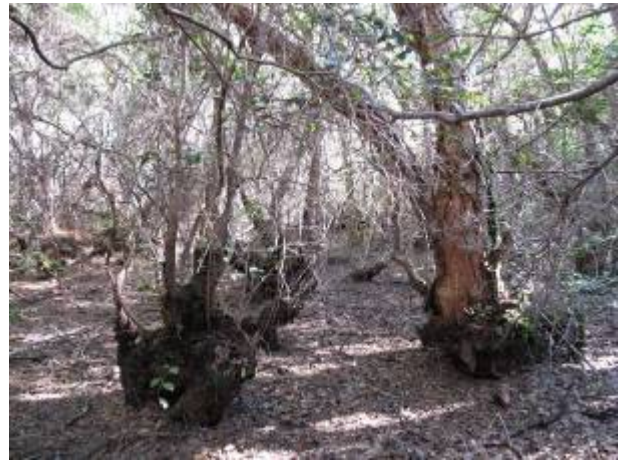
Wetland ID: 03-06

Description: This wetland is a 0.2 ha ephemeral shrub swamp. Cypress trees dominate the canopy, and cover 5-25% of the wetland. The midstory is dominated by titi and holly, and covers >75% of the wetland. There is no herbaceous vegetation. Old stumps provide evidence that this wetland was once a cypress-dominated forested swamp. A thick wall of brush surrounds the wetland perimeter. The adjacent uplands are mesic flatwoods that were bedded and converted to a pine plantation. The uplands were burned within the past year or two but the fire did not reach into the wetland. Upland restoration is in progress.

Wetland Concerns: Woody encroachment

Restoration Action Recommended: Periodic fire in the wetland would reduce the dense titi and open the midstory.

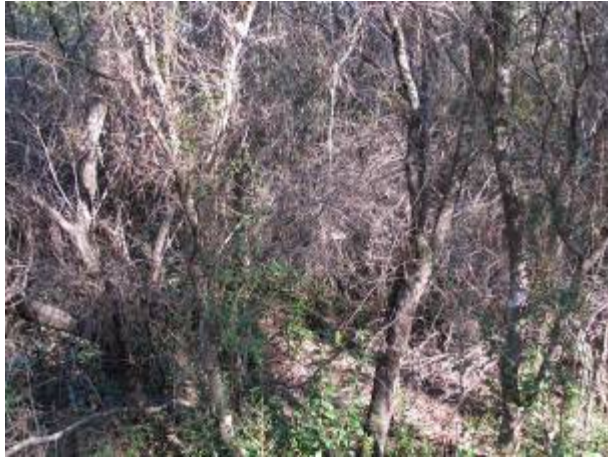
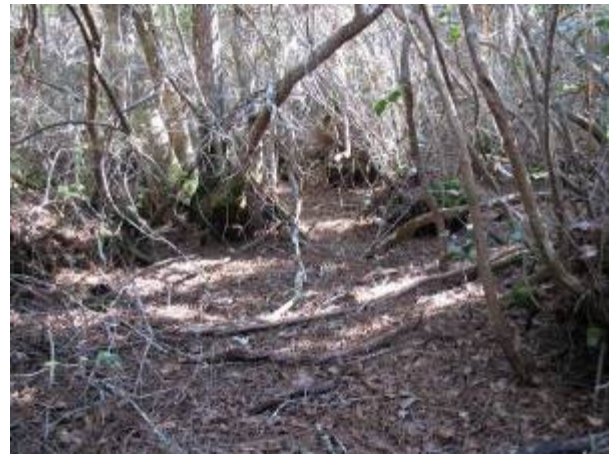
Wetland ID: 03-07

Description: This wetland is a 0.3 ha ephemeral shrub swamp. Cypress trees dominate the canopy, and cover 5-25% of the wetland. The midstory is dominated by titi, and covers >75% of the wetland. There is no herbaceous vegetation. Old stumps provide evidence that this wetland was once a cypress-dominated forested swamp. The adjacent uplands are mesic flatwoods that were bedded and converted to a pine plantation. The uplands were burned within the past year or two but the fire did not reach into the wetland. Upland restoration is in progress.

Wetland Concerns: Woody encroachment

Restoration Action Recommended: Periodic fire in the wetland would reduce the dense titi and open the midstory.

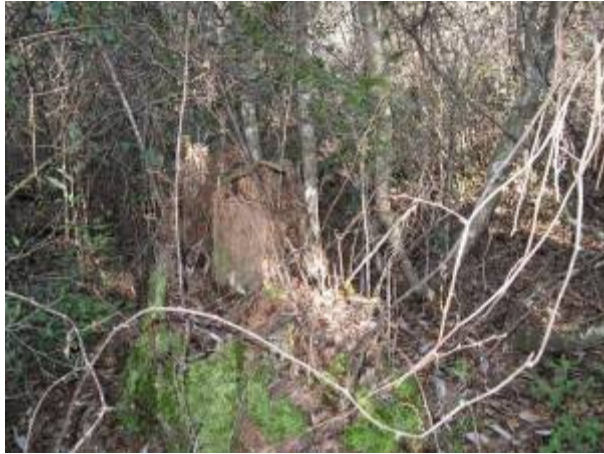
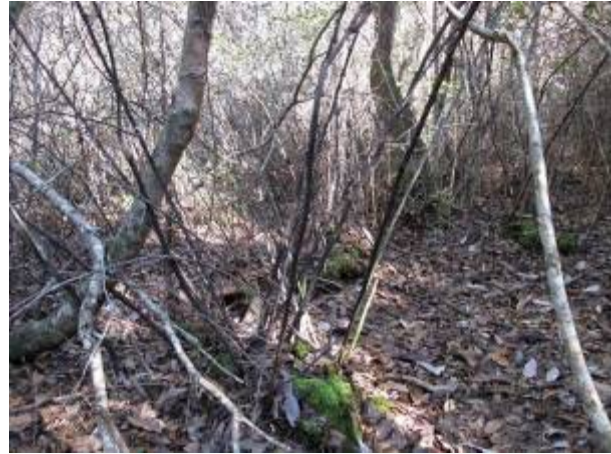
Wetland ID: 03-08

Description: This wetland is a 0.3 ha ephemeral shrub swamp. Cypress trees dominate the canopy, and cover 5-25% of the wetland. The midstory is dominated by titi and wax myrtle, and covers >75% of the wetland. There is no herbaceous vegetation. Old stumps provide evidence that this wetland was once a cypress-dominated forested swamp. The adjacent uplands are mesic flatwoods that were bedded and converted to a pine plantation. The uplands were burned within the past year or two but the fire did not reach into the wetland. Upland restoration is in progress.

Wetland Concerns: Woody encroachment

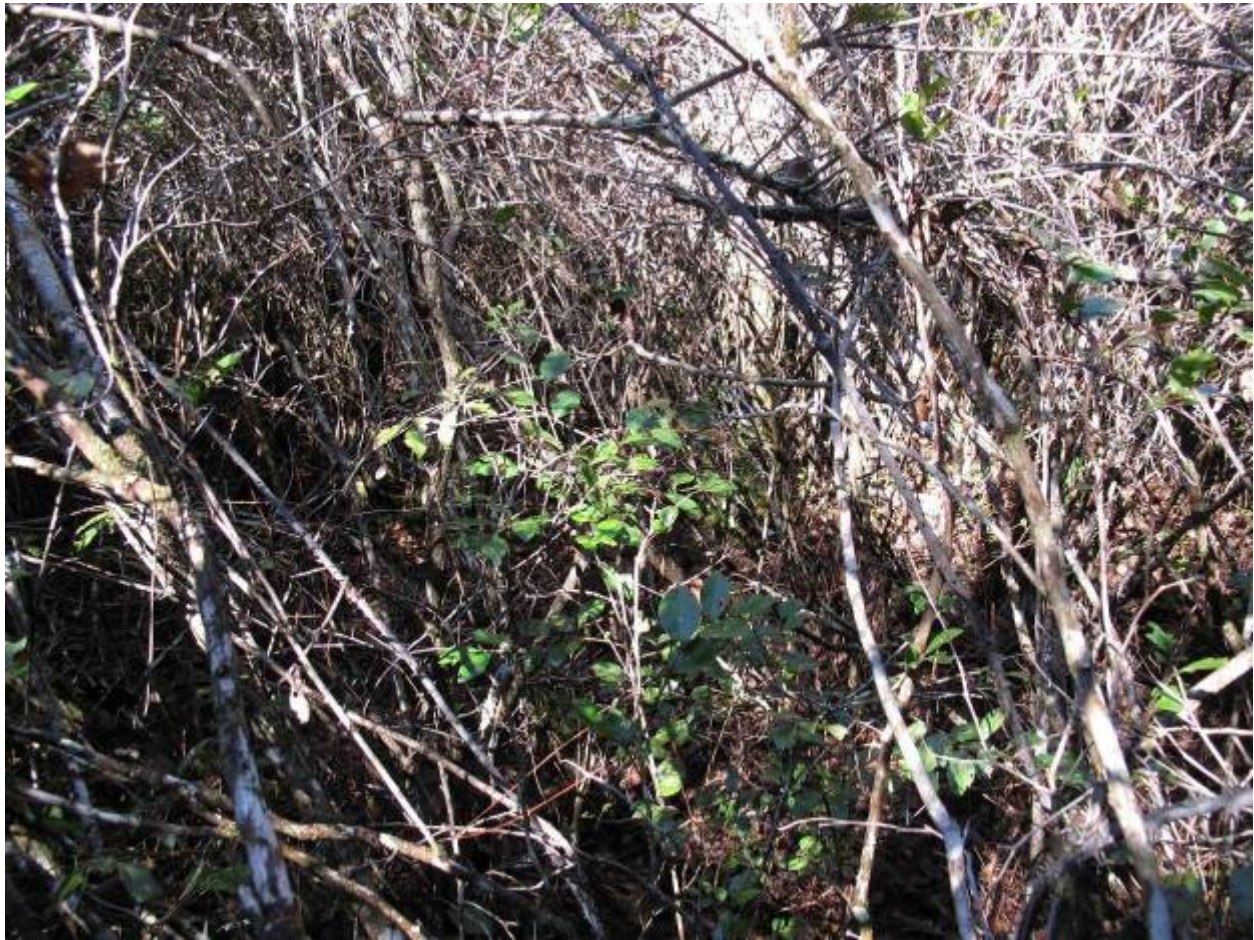
Wetland ID: 03-09

Description: This wetland is a 0.4 ha ephemeral shrub swamp. Cypress trees dominate the canopy, and cover 5-25% of the wetland. The midstory is dominated by fetterbush, and covers >75% of the wetland. There is no herbaceous vegetation. Old stumps provide evidence that this wetland was once a cypress-dominated forested swamp. A major road (SR 59) runs along the west side of the wetland. The adjacent uplands are mesic flatwoods that were bedded and converted to a pine plantation. The uplands were burned within the past year or two but the fire did not reach into the wetland. Upland restoration is in progress.

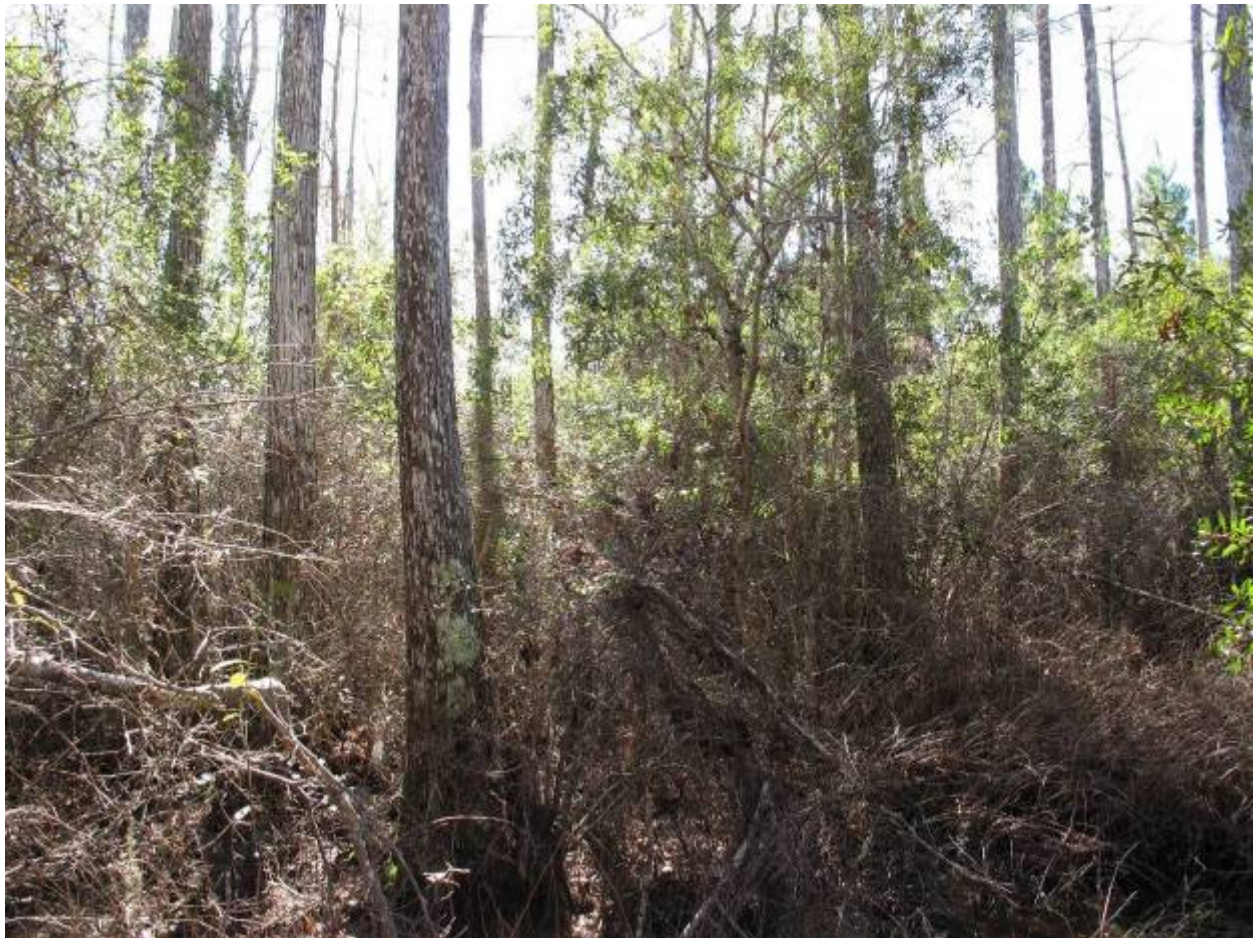
Wetland ID: 03-10

Description: This wetland is a 0.8 ha ephemeral mixed swamp. Cypress trees dominate the canopy, and cover >75% of the wetland. The midstory is dominated by wax myrtle and titi, and covers >75% of the wetland. There is no herbaceous vegetation. Old stumps provide evidence that cypress trees historically occupied the wetland. The adjacent uplands are mesic flatwoods that were bedded and converted to a pine plantation. The uplands were burned within the past year or two but the fire did not reach into the wetland. Upland restoration is in progress.

Wetland Concerns: Woody encroachment

Restoration Action Recommended: Periodic fire in the wetland would reduce the dense brush and open the midstory.

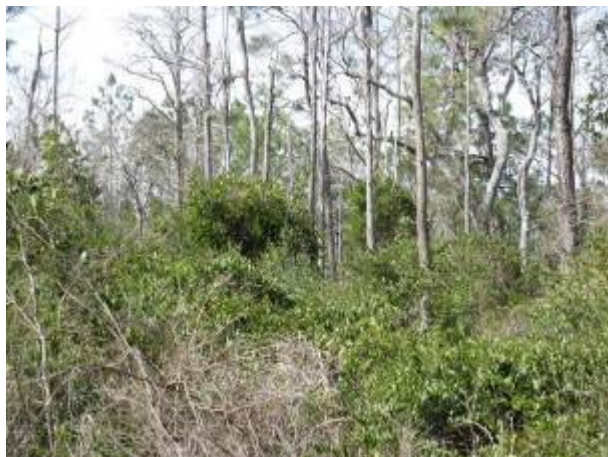
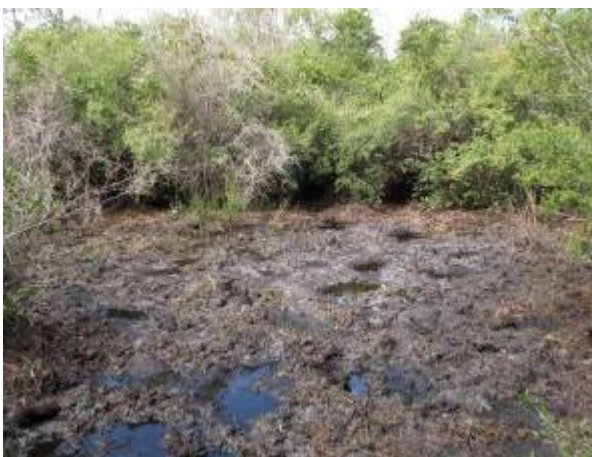
Wetland ID: 03-11

Description: This wetland is a 0.6 ha ephemeral shrub swamp. Cypress trees dominate the canopy, and cover 5-25% of the wetland. The midstory is dominated by titi, and covers >75% of the wetland. There is no herbaceous vegetation. There is an almost impenetrable shrub ring around the exterior of the wetland and the interior is also extremely thick. There is at least one substantial patch of feral hog damage. Old stumps provide evidence that cypress trees historically occupied the wetland. The adjacent uplands are mesic flatwoods that were bedded and converted to a pine plantation. The uplands were burned within the past year or two but the fire did not reach into the wetland. Upland restoration is in progress.

Wetland Concerns: Feral hog damage, Woody encroachment

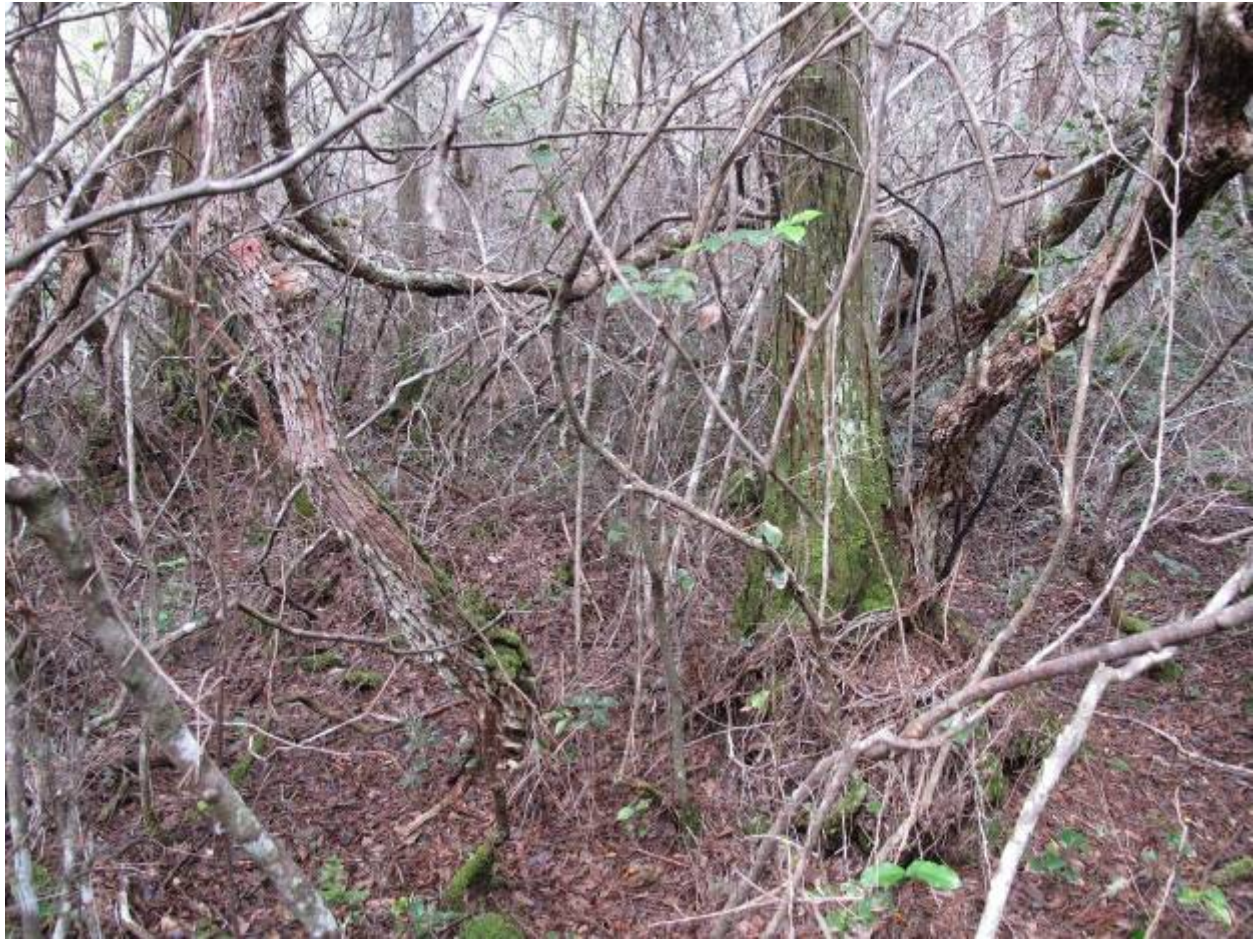
Wetland ID: 03-12

Description: This wetland is a 0.8 ha ephemeral shrub swamp. Cypress trees dominate the canopy, and cover 5-25% of the wetland. The midstory is dominated by titi, and covers >75% of the wetland. There is no herbaceous vegetation. A thick layer of duff covers the wetland floor. Old stumps provide evidence that cypress trees historically occupied the wetland. The adjacent uplands are mesic flatwoods that were bedded and converted to a pine plantation. The uplands were burned within the past year or two but the fire did not reach into the wetland. Upland restoration is in progress.

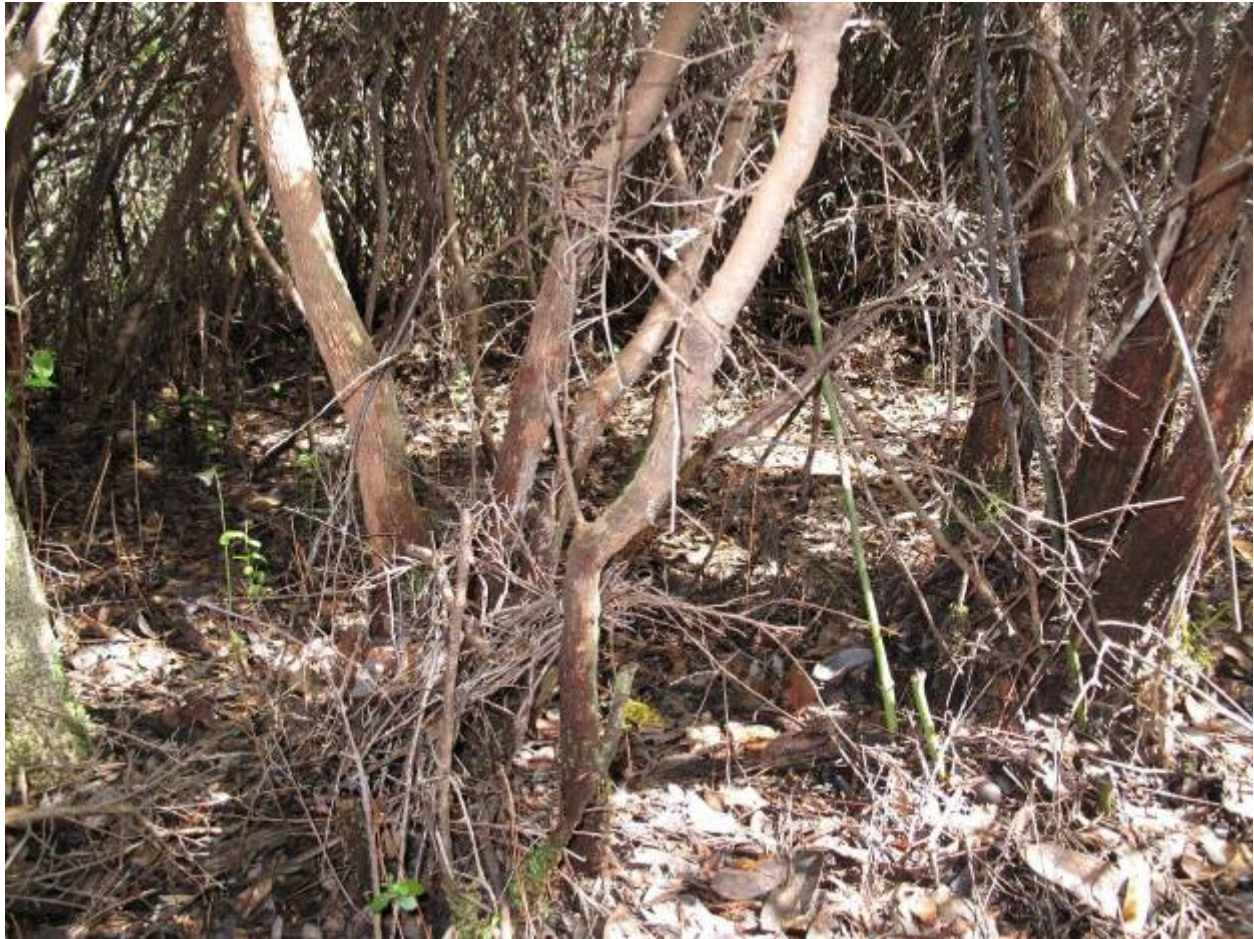
Wetland ID: 03-13

Description: This wetland is a 0.6 ha ephemeral shrub swamp. Cypress trees dominate the canopy, and cover 5-25% of the wetland. The midstory is dominated by titi, and covers >75% of the wetland. There is no herbaceous vegetation. A thick layer of duff covers the wetland floor. Old stumps provide evidence that cypress trees historically occupied the wetland. The adjacent uplands are mesic flatwoods that were bedded and converted to a pine plantation. The uplands were burned within the past year or two but the fire did not reach into the wetland. Upland restoration is in progress.

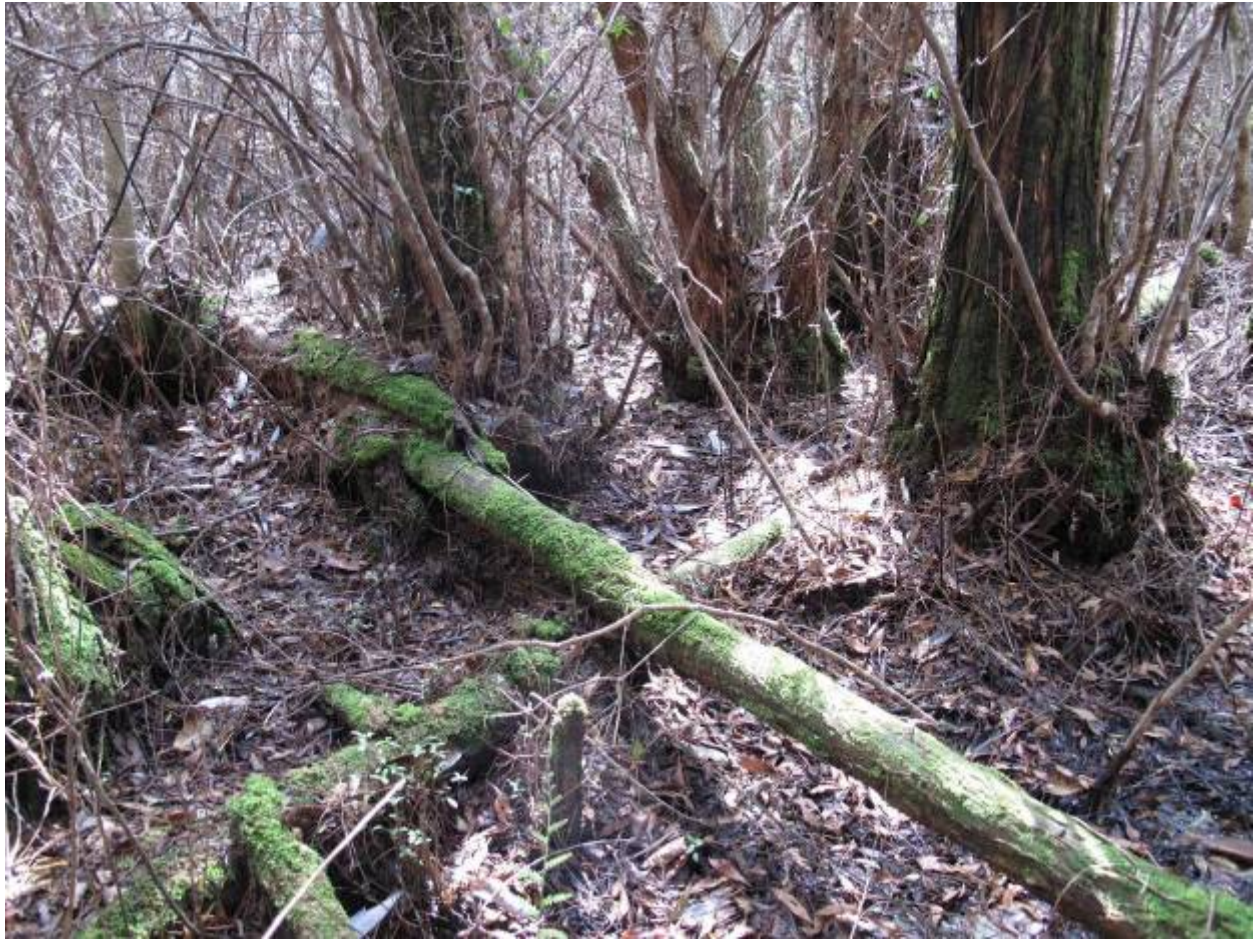
Wetland ID: 03-14

Description: This wetland is a 1.1 ha ephemeral shrub swamp. Cypress trees dominate the canopy, and cover 5-25% of the wetland. The midstory is dominated by titi, and covers >75% of the wetland. There is no herbaceous vegetation. A thick layer of duff covers the wetland floor. This wetland likely was part of a much larger, more permanent wetland system that was bisected by a road. The wetland currently is connected to deep ditches along Sawdust Pile Road. Old stumps provide evidence that cypress trees historically occupied the wetland. The adjacent uplands are mesic flatwoods that were bedded and converted to a pine plantation. The uplands were burned within the past year or two but the fire did not reach into the wetland. Upland restoration is in progress.

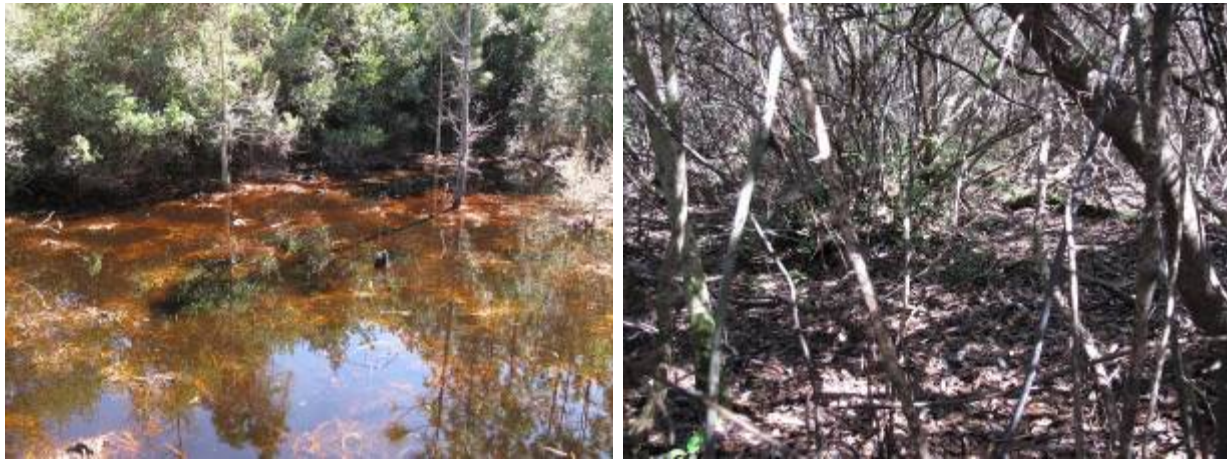
Wetland ID: 03-15

Description: This wetland is a 1.2 ha ephemeral shrub swamp. Cypress trees dominate the canopy, and cover 5-25% of the wetland. The midstory is dominated by titi, and covers >75% of the wetland. There is no herbaceous vegetation. The wetland has some feral hog damage on the west side. There is a push pile in the wetland interior, grown over with titi. Old stumps provide evidence that cypress trees historically occupied the wetland. The adjacent uplands are mesic flatwoods that were bedded and converted to a pine plantation. The uplands were burned within the past year or two but the fire did not reach into the wetland. Upland restoration is in progress.

Wetland Concerns: Feral hog damage, Push pile, Woody encroachment

Restoration Action Recommended: The push pile is not extensive enough to merit restoration action. Periodic fire in the wetland would reduce the dense titi and open the midstory.

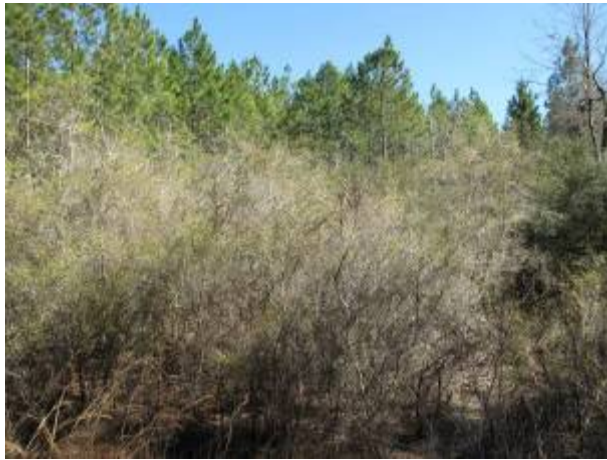
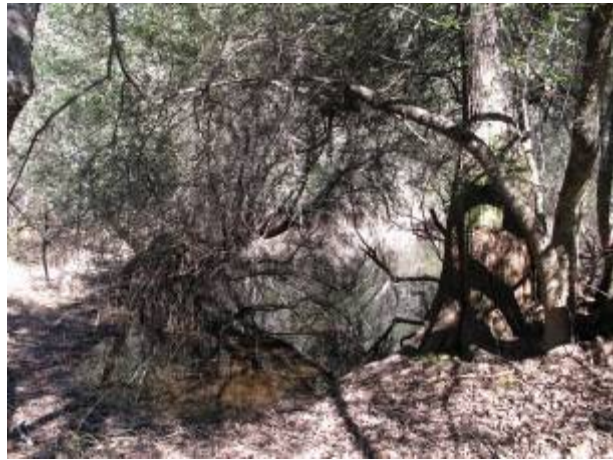
Wetland ID: 03-16

Description: This wetland is a 1.0 ha ephemeral shrub swamp. There is no tree canopy. Holly grows throughout the wetland, and covers 50-75% of the basin. There is no other dominant woody species. Sedges/grasses grow in scattered patches, and cover 5-25% of the basin. The adjacent uplands are mesic flatwoods that were bedded and converted to a pine plantation. The uplands were burned within the past year or two but the fire did not reach into the wetland. Upland restoration is in progress.

Wetland Concerns: None

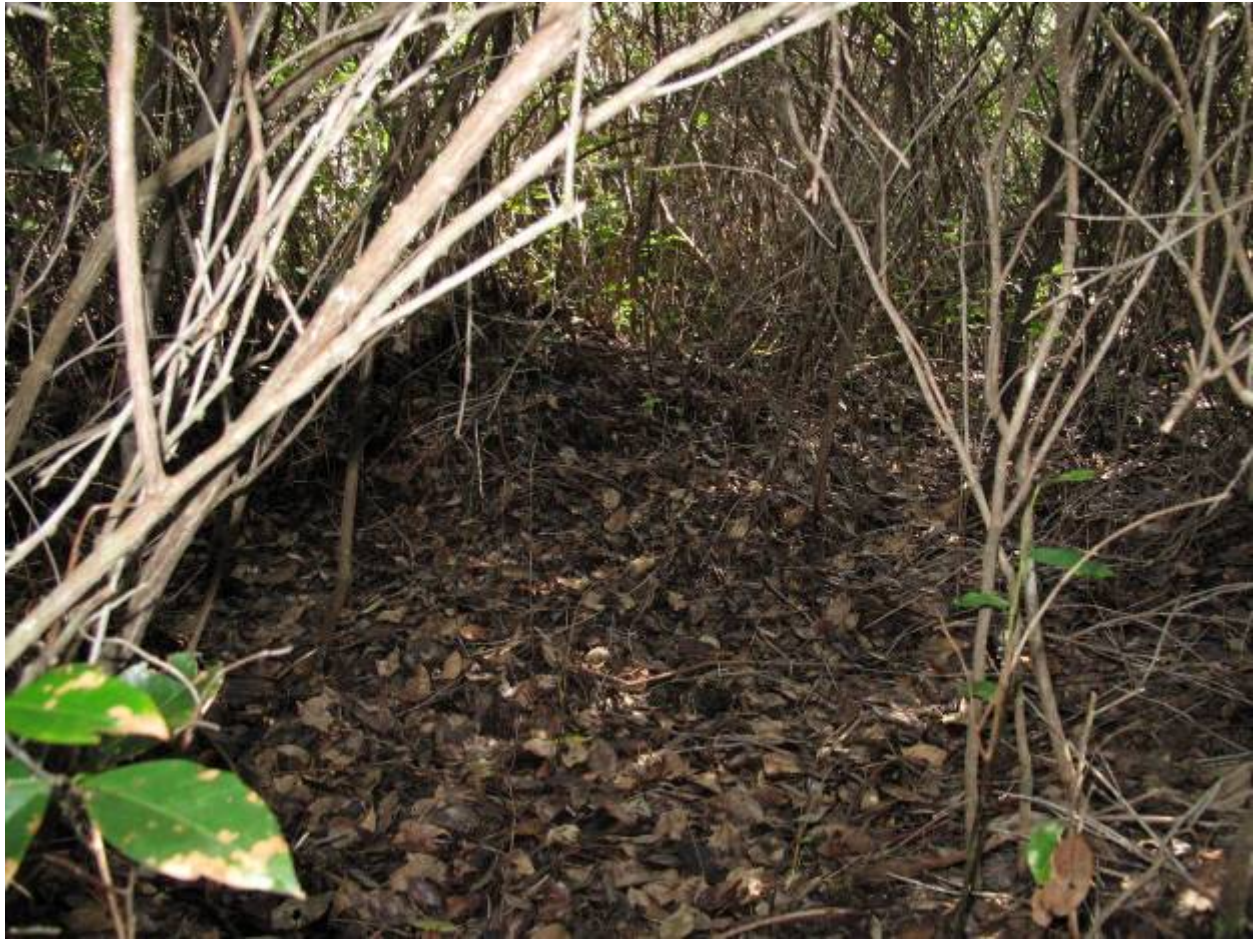
Wetland ID: 03-17

Description: This wetland is a 0.1 ha ephemeral shrub swamp. There is no tree canopy. Titi grows throughout the wetland, and covers >75% of the basin. There is no herbaceous vegetation and a thick, leafy duff layer is present. A push pile is in the center of the wetland, overgrown with titi. The adjacent uplands are mesic flatwoods that were bedded and converted to a pine plantation. The uplands were burned within the past year or two but the fire did not reach into the wetland. Upland restoration is in progress.

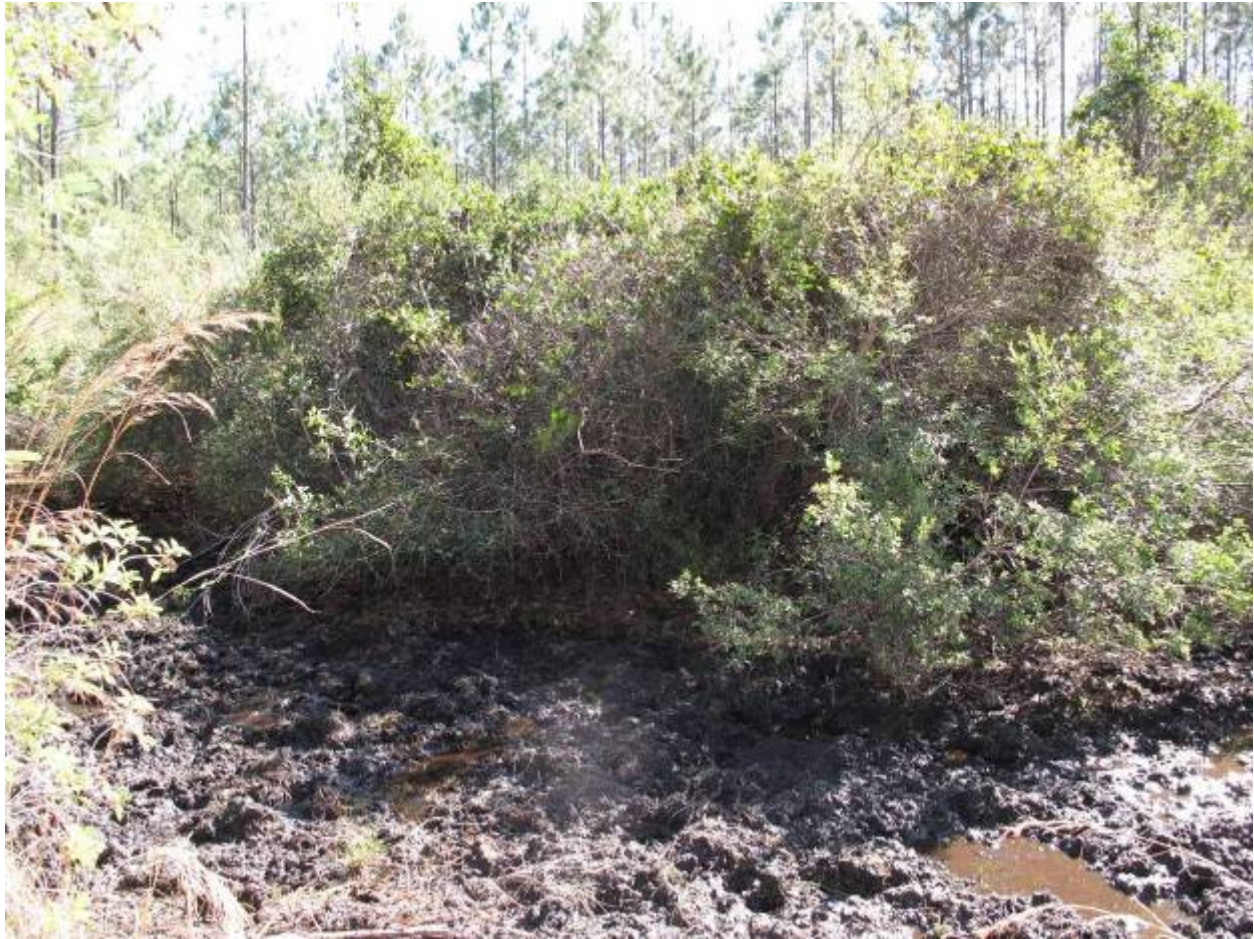
Wetland ID: 03-18

Description: This wetland is a 0.1 ha ephemeral shrub swamp. There is no tree canopy. Titi grows throughout the wetland, and cover 50-75% of the basin. There is no herbaceous vegetation, likely because of recent feral hog damage. There is a central push pile grown over with thick titi. It is uncertain whether this wetland was constructed as a result of push pile formation or if it was already a wetland before construction of the push pile. The uplands were burned within the past year or two but the fire did not reach into the wetland. The adjacent uplands are mesic flatwoods that were bedded and converted to a pine plantation. Upland restoration is in progress.

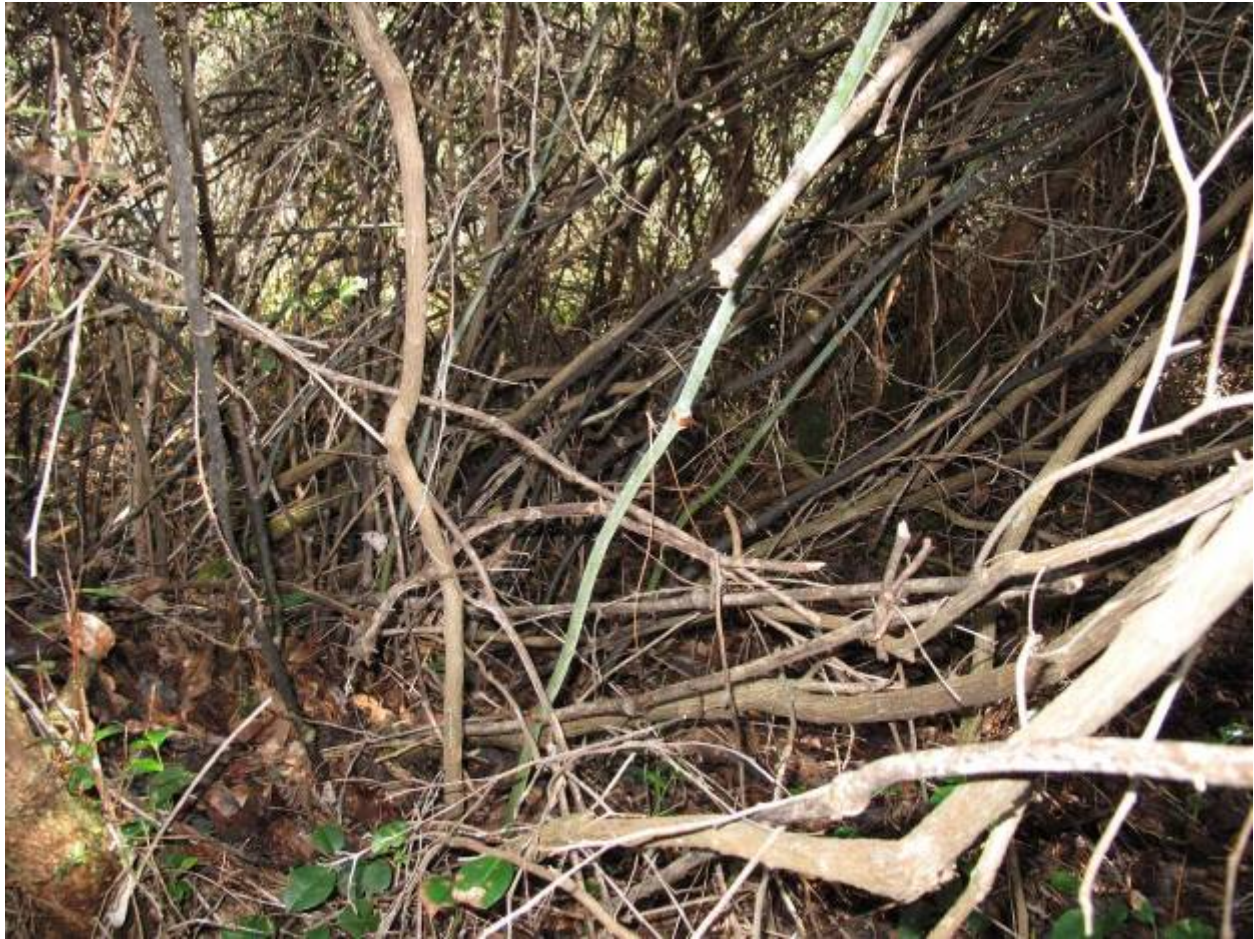
Wetland ID: 03-19

Description: This wetland is a 0.1 ha ephemeral shrub swamp. There is no tree canopy. Smilax-covered titi grows densely throughout the wetland, and covers >75% of the wetland. There is no herbaceous vegetation, and a very thick duff layer covers the wetland floor. The adjacent uplands are mesic flatwoods that were bedded and converted to a pine plantation. The uplands were burned within the past year or two but the fire did not reach into the wetland. Upland restoration is in progress.

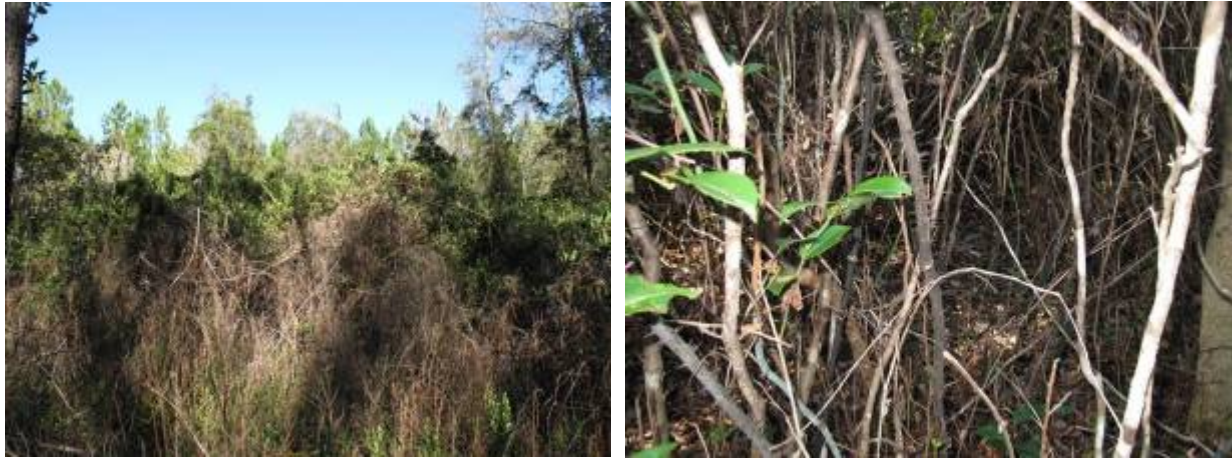
Wetland ID: 03-20

Description: This wetland is a 0.2 ha ephemeral shrub swamp. Gum trees dominant the canopy, and cover 5-25% of the wetland. The midstory is dominated by titi, and covers >75% of the wetland. There is no herbaceous vegetation. This wetland has an impenetrable wall of titi and smilax. The adjacent uplands are mesic flatwoods that were bedded and converted to a pine plantation. The uplands were burned within the past year or two but the fire did not reach into the wetland. Upland restoration is in progress.

Wetland Concerns: Woody encroachment

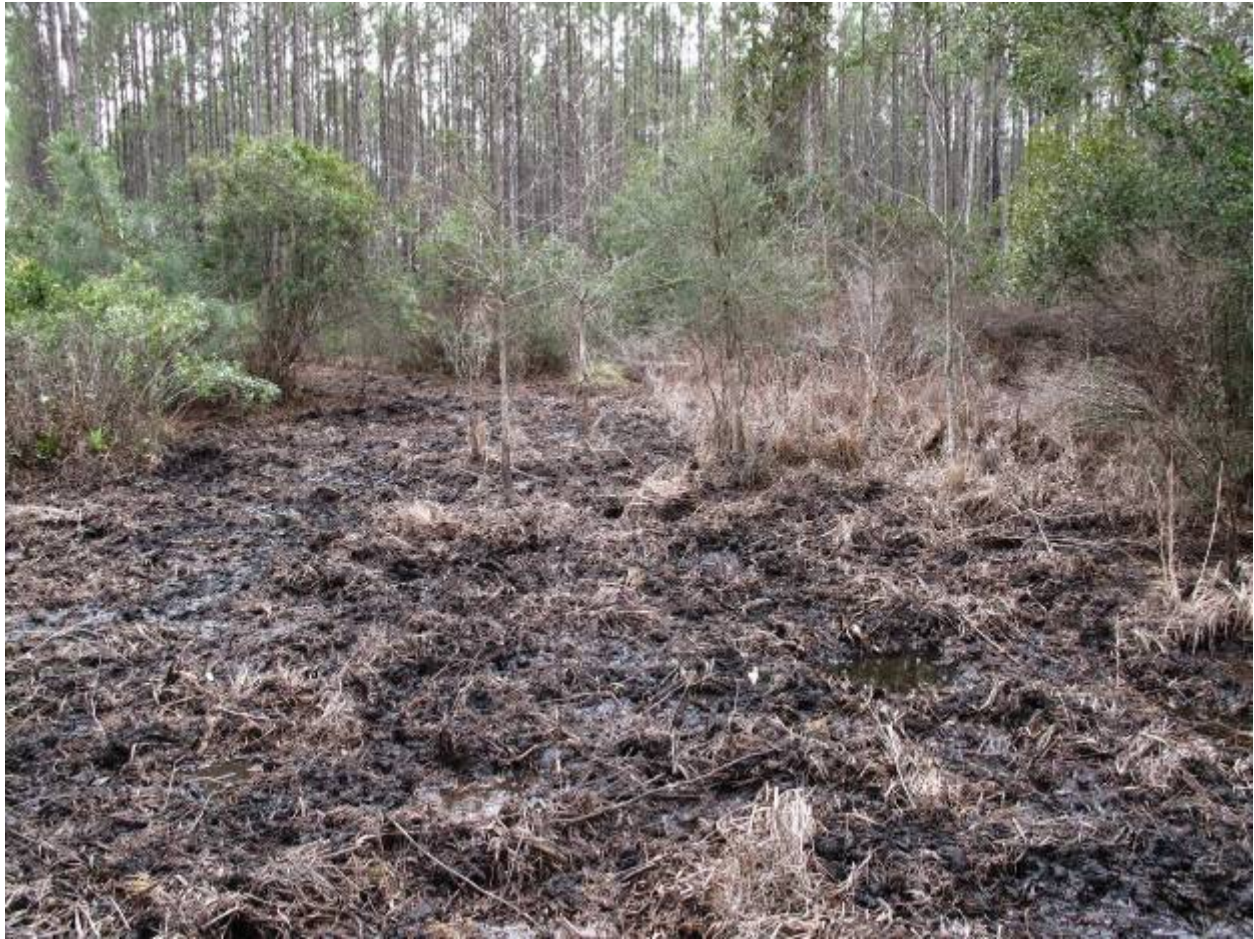
Description: This wetland is a 0.1 ha ephemeral marsh. There is no tree canopy. Wax myrtle and titi are the dominant woody vegetation, and cover 25-50% of the wetland. Sedges/grasses grow throughout the wetland, and cover 50-75% of the basin. There is a push pile in the center of the wetland that has grown over with titi. Feral hog damage is severe. The adjacent uplands are mesic flatwoods that were bedded and converted to a pine plantation. The uplands were burned within the past year or two but the fire did not reach into the wetland. Upland restoration is in progress.

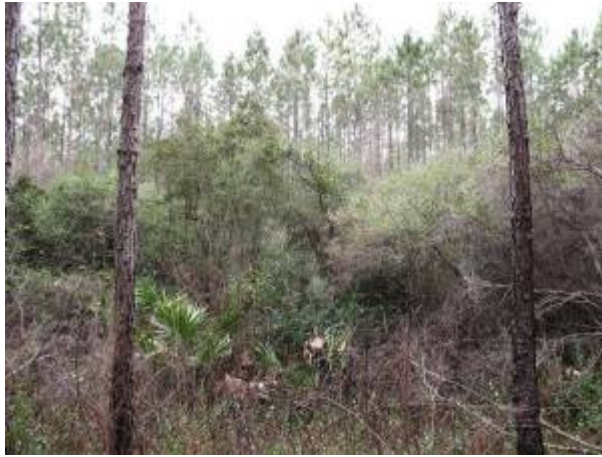
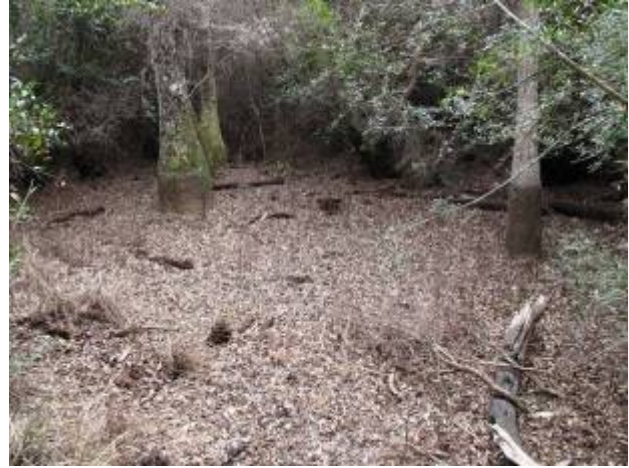
Wetland ID: 03-22

Description: This wetland is a 0.1 ha ephemeral shrub swamp. Gum trees dominate the canopy, and cover 5-25% of the wetland. The midstory is dominated by titi, and covers 50-75% of the wetland. There is no herbaceous vegetation. A dense shrub ring grows around the wetland perimeter. The adjacent uplands are mesic flatwoods that were bedded and converted to a pine plantation. The uplands were burned within the past year or two but the fire did not reach into the wetland. Upland restoration is in progress.

Wetland Concerns: Woody encroachment

Restoration Action Recommended: Periodic fire in the wetland would reduce the dense shrub ring.
