Inventory, Assessment, and Restoration Potential of Ephemeral Wetlands on FFWCC Wildlife Management Areas

Aucilla WMA Final Report

Submitted by: Rebecca P.M. Means¹, Ryan C. Means¹, Steven A. Johnson²

¹Coastal Plains Institute

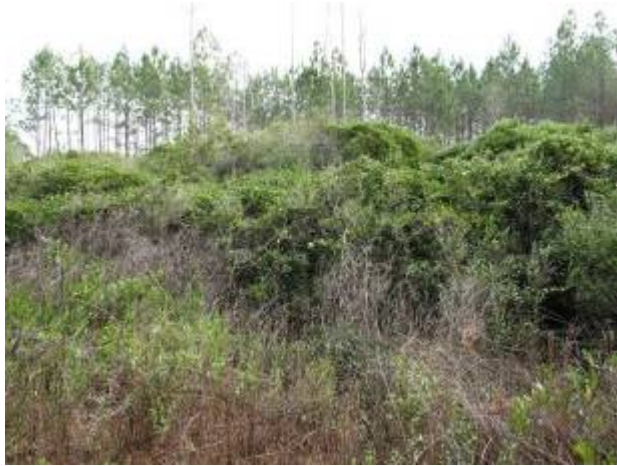
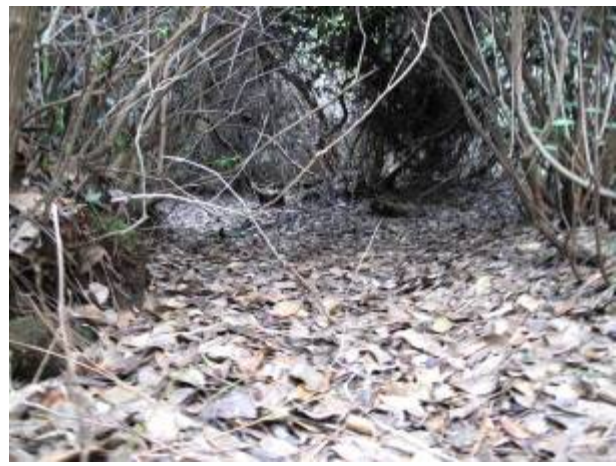
Wetland ID: 03-23

Description: This wetland is a 0.2 ha ephemeral shrub swamp. There is no tree canopy. Titi and fetterbush grow throughout the wetland, and cover >75% of the basin. There is no herbaceous vegetation. Old stumps provide evidence that this wetland was once a cypress-dominated forested swamp. The adjacent uplands are mesic flatwoods that were bedded and converted to a pine plantation. The uplands were burned within the past year or two but the fire did not reach into the wetland. Upland restoration is in progress.

Wetland Concerns: Woody encroachment

Restoration Action Recommended: Periodic fire in the wetland would reduce the dense titi and open the midstory.

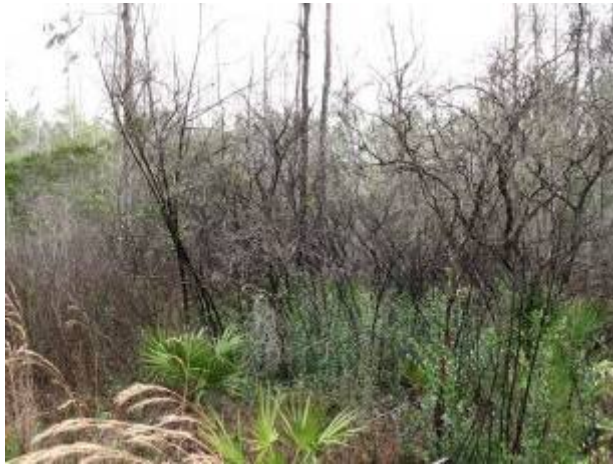
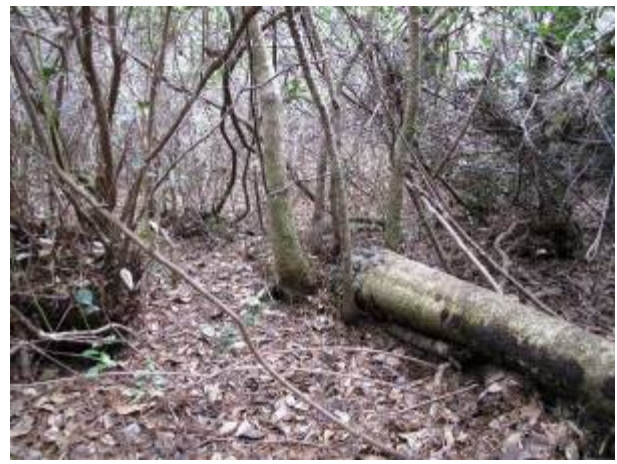
Wetland ID: 03-24

Description: This wetland is a 0.4 ha ephemeral mixed swamp. The presence of old cypress stumps provides evidence of historical logging. The cypress trees have regenerated and cover 50-75% of the wetland. The midstory is dominated by titi, and covers >75% of the wetland. There is no herbaceous vegetation. The adjacent uplands are mesic flatwoods that were bedded and converted to a pine plantation. The uplands were burned within the past year or two but the fire did not reach into the wetland. Upland restoration is in progress.

Wetland Concerns: Woody encroachment

Restoration Action Recommended: Periodic fire in the wetland would reduce the dense titi and open the midstory.

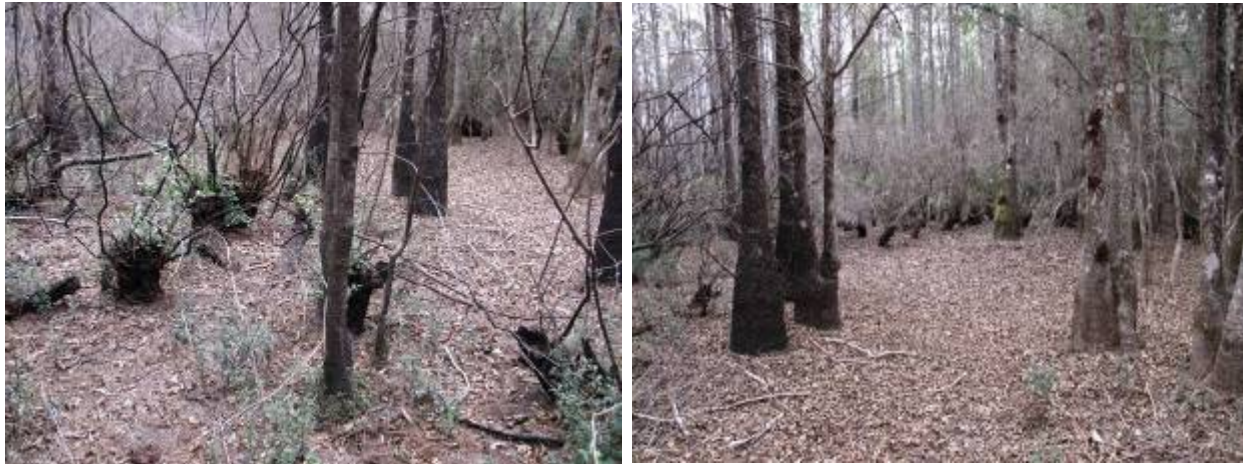
Wetland ID: 03-25

Description: This wetland is a 0.1 ha ephemeral mixed swamp. Gum trees dominant the canopy, and cover 50-75% of the wetland. The midstory is dominated by titi, fetterbush, and holly, and covers 50-75% of the wetland. There is no herbaceous vegetation. This wetland appears to be in excellent ecological condition. The uplands were burned within the past year or two and the dense shrubs that surrounded the wetland were killed by the fire. The adjacent uplands are mesic flatwoods that were bedded and converted to a pine plantation. Upland restoration is in progress.

Wetland Concerns: None

Restoration Action Recommended: None

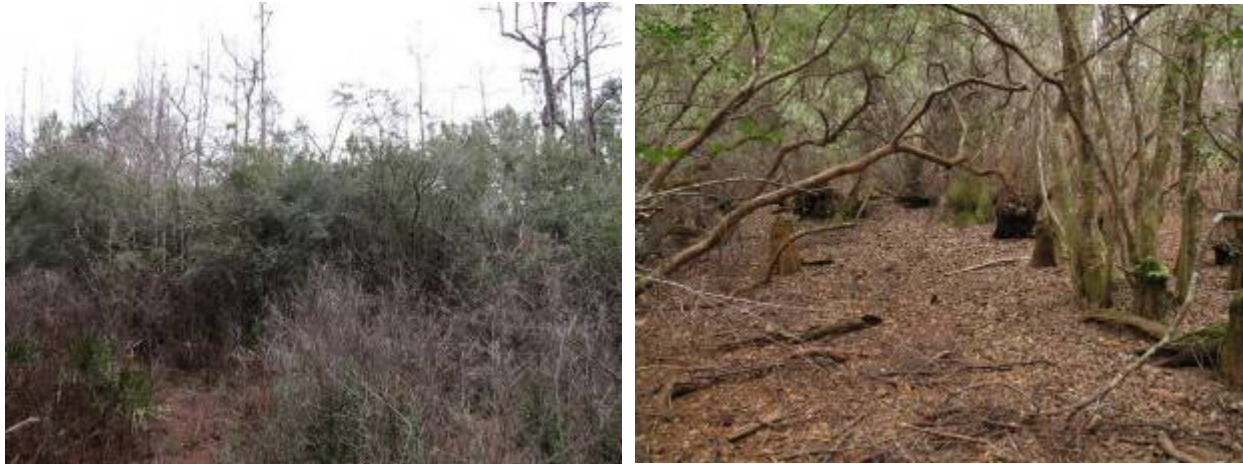
Wetland ID: 03-26

Description: This wetland is a 0.1 ha ephemeral mixed swamp. Cypress and gum trees dominant the canopy, and cover 50-75% of the wetland. The midstory is dominated by titi and holly, and covers >75% of the wetland. There is no herbaceous vegetation. The presence of old cypress stumps provides evidence of historical logging. The adjacent uplands are mesic flatwoods that were bedded and converted to a pine plantation. Upland restoration is in progress.

Wetland Concerns: Woody encroachment

Restoration Action Recommended: Periodic fire in the wetland would reduce the dense brush ring and open the midstory.

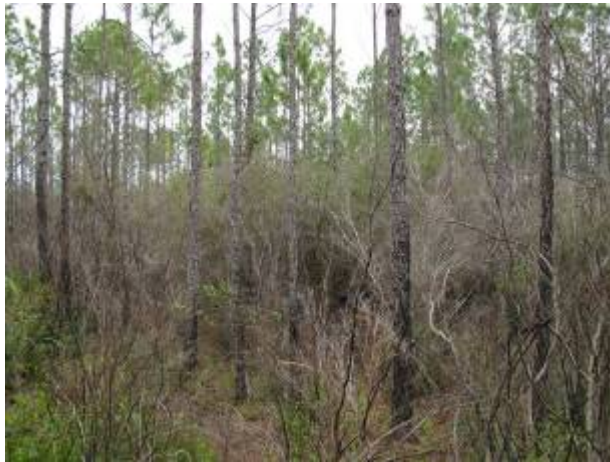
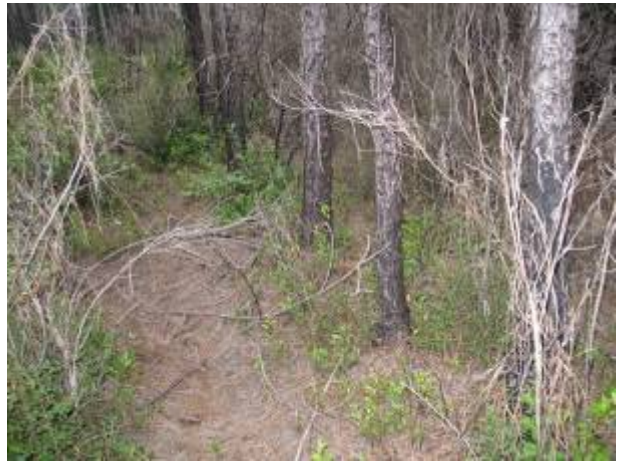
Wetland ID: 03-27

Description: This wetland is a <0.1 ha ephemeral mixed swamp. Pine trees dominant the canopy, and cover 25-50% of the wetland. The midstory is dominated by titi, and covers >75% of the wetland. There is no herbaceous vegetation. This small wetland was bedded and planted with pines. The adjacent uplands are mesic flatwoods that were bedded and converted to a pine plantation. Upland restoration is in progress.

Wetland Concerns: Bedding, Planted pine trees, Woody encroachment

Restoration Action Recommended: Remove the planted pine trees from the wetland interior. The bedding will erode over time. Periodic fire in the wetland would reduce the dense titi and open the midstory.

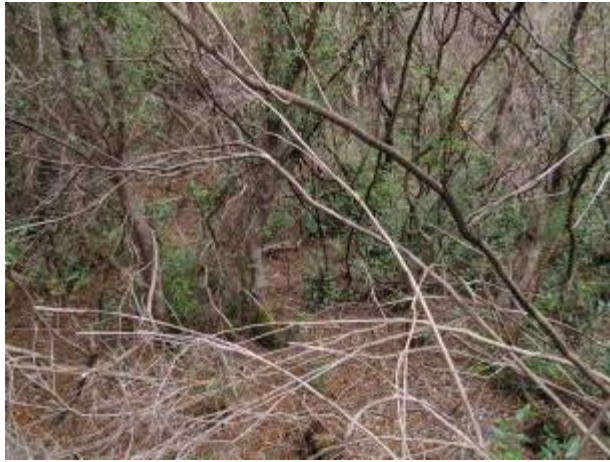
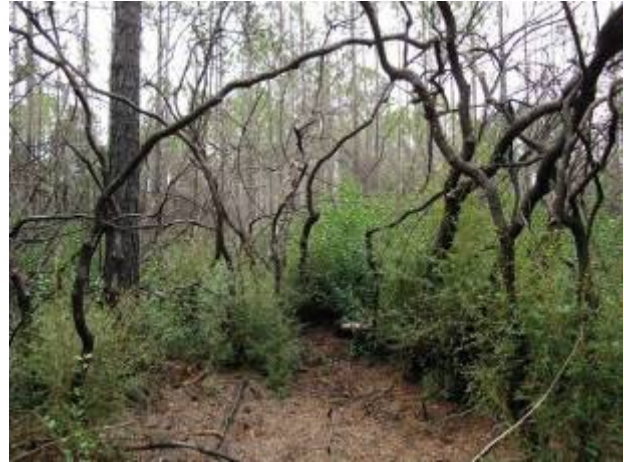
Wetland ID: 03-28

Description: This wetland is a 0.1 ha ephemeral mixed swamp. Gum and pine trees dominate the canopy, and cover 50-75% of the wetland. The midstory is dominated by titi, and covers 50-75% of the wetland. There is no herbaceous vegetation. At least one bedding row was constructed through the wetland. The uplands were burned within the past year or two. The fire burned into the wetland. Much of the titi burned although some remain. This is a good wetland to observe the positive effects of fire on titi reduction. The adjacent uplands are mesic flatwoods that were bedded and converted to a pine plantation. Upland restoration is in progress.

Wetland Concerns: Bedding, Planted pine trees, Woody encroachment

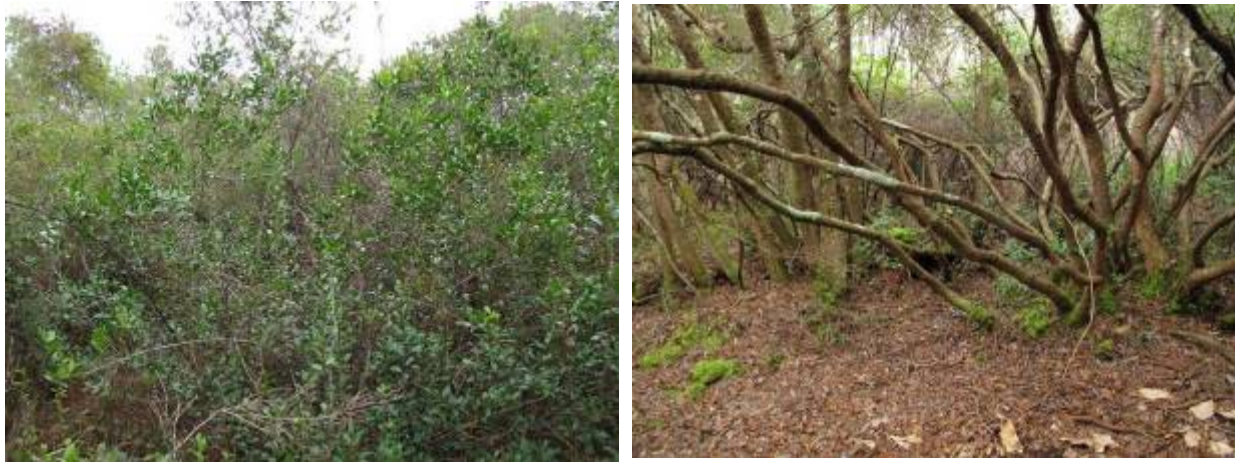
Wetland ID: 03-29

Description: This wetland is a 0.4 ha ephemeral shrub swamp. There is no tree canopy. Titi grows throughout the wetland, and covers >75% of the basin. There is no herbaceous vegetation. Old stumps provide evidence that this wetland was once a cypress-dominated forested swamp. The adjacent uplands are mesic flatwoods that were bedded and converted to a pine plantation. Upland restoration is in progress.

Wetland Concerns: Woody encroachment

Restoration Action Recommended: Periodic fire in the wetland would reduce the dense titi and open the midstory.

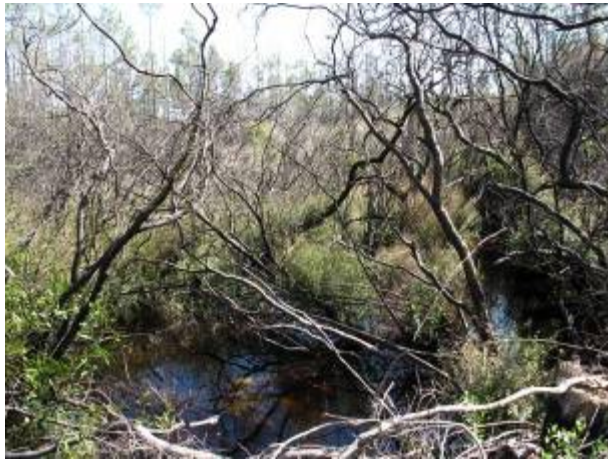
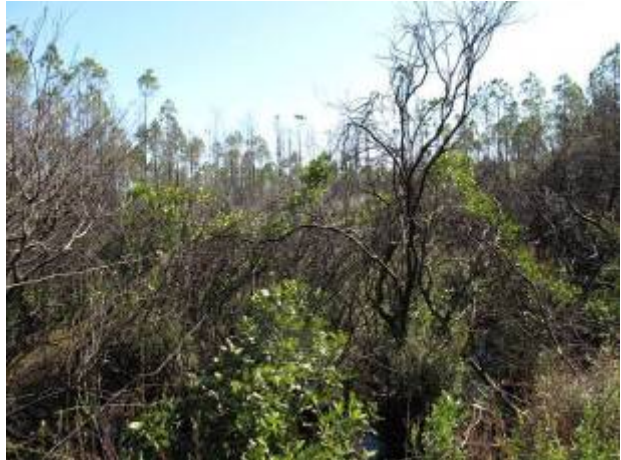
Wetland ID: 03-30

Description: This wetland is a 0.3 ha ephemeral shrub swamp. There is no tree canopy. Titi grows throughout the wetland, and covers 51- 75% of the basin. Sedges/grasses grow in scattered patches, and cover 5-25% of the basin. A recent fire penetrated into the wetland, reducing the peat and titi, and opening up the wetland. This is a good wetland to observe the positive effects of fire on titi reduction. Old stumps provide evidence that this wetland was once a cypress-dominated forested swamp. The adjacent uplands are mesic flatwoods that were bedded and converted to a pine plantation. Upland restoration is in progress.

Wetland Concerns: None

Restoration Action Recommended: None

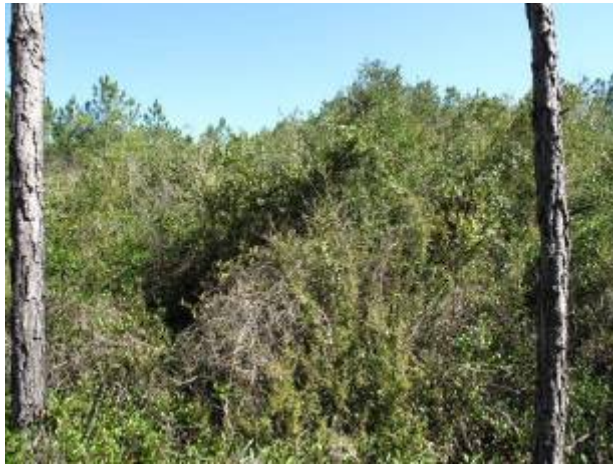
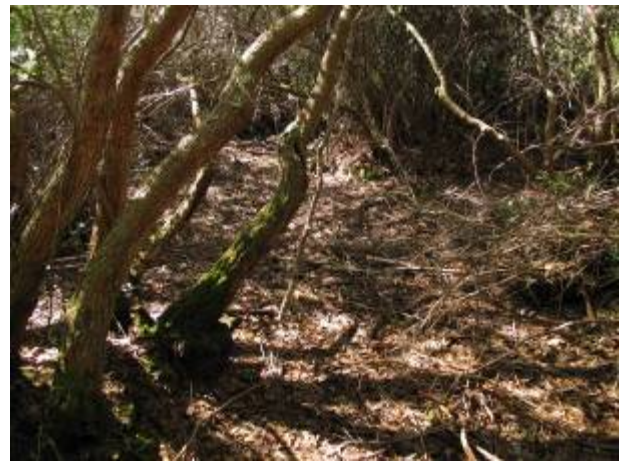
Wetland ID: 03-31

Description: This wetland is a 0.2 ha ephemeral shrub swamp. There is no tree canopy. Titi grows throughout the wetland, and covers >75% of the basin. There is no herbaceous vegetation. The uplands were burned within the past year or two but the fire did not penetrate this densely grown-up titi wetland. The adjacent uplands are mesic flatwoods that were bedded and converted to a pine plantation. Upland restoration is in progress.

Wetland Concerns: Woody encroachment

Restoration Action Recommended: Periodic fire in the wetland would reduce the dense titi and open the midstory.

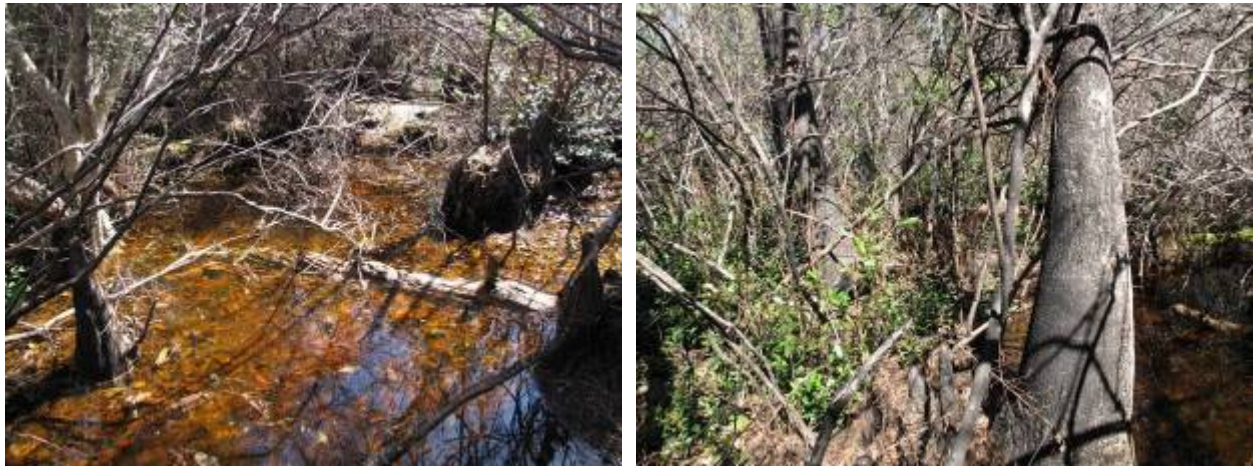
Wetland ID: 03-32

Description: This wetland is a 1.3 ha semi-permanent mixed swamp. Cypress and gum trees dominant the canopy, and cover 50-75% of the wetland. The midstory is dominated by titi, and covers >75% of the wetland. There is no herbaceous vegetation. The presence of old cypress stumps provides evidence of historical logging. A recent fire penetrated the wetland and burned much of the titi. The adjacent uplands are mesic flatwoods that were bedded and converted to a pine plantation. Upland restoration is in progress.

Wetland Concerns: None

Restoration Action Recommended: None

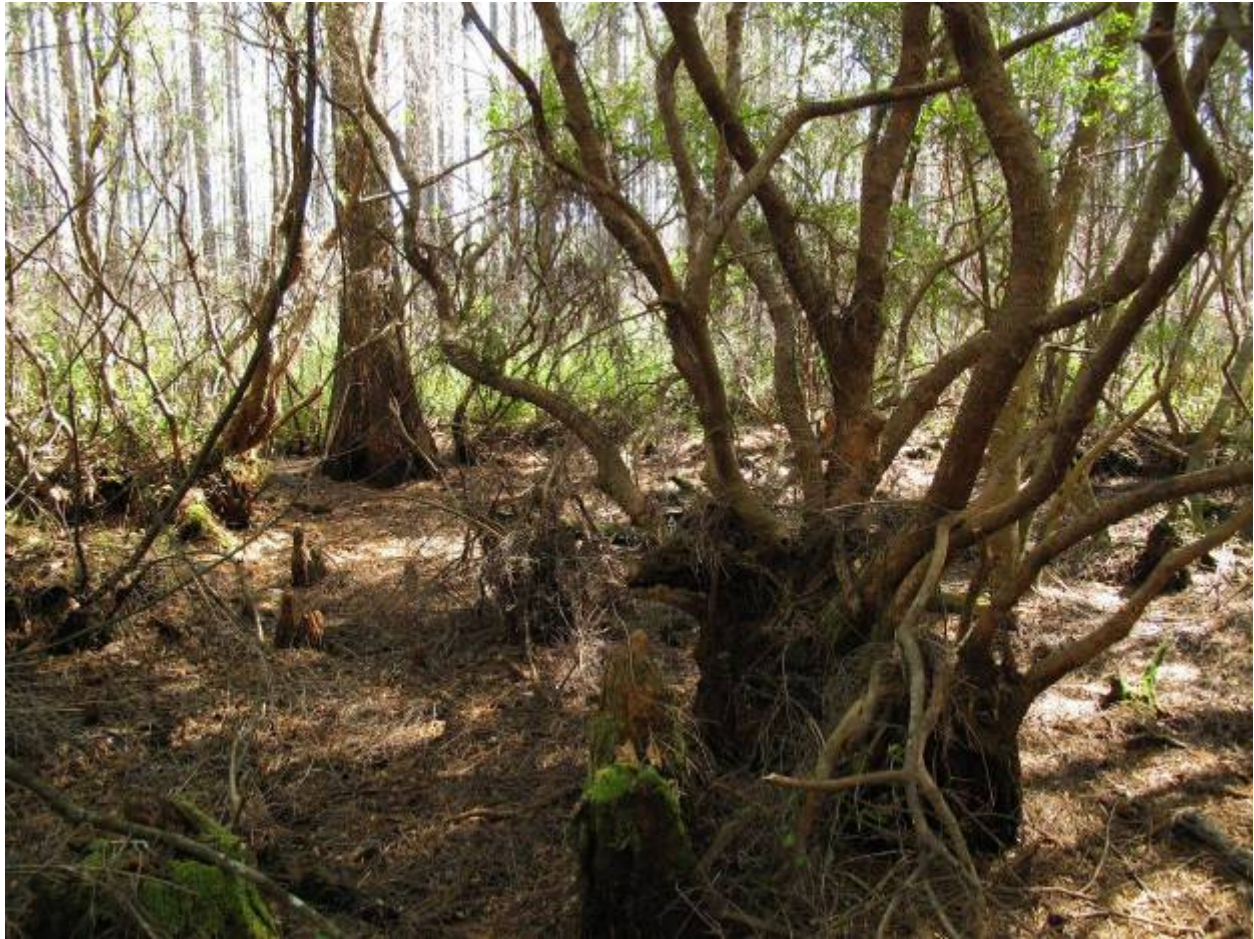
Description: This wetland is a 0.1 ha ephemeral shrub swamp. Cypress trees dominate the canopy, and cover 5-25% of the wetland. The midstory is dominated by titi, and covers >75% of the wetland. There is no herbaceous vegetation. Old stumps provide evidence that this wetland was once a cypress-dominated forested swamp. A recent fire penetrated the wetland and burned much of the titi. The adjacent uplands are mesic flatwoods that were bedded and converted to a pine plantation. Upland restoration is in progress.

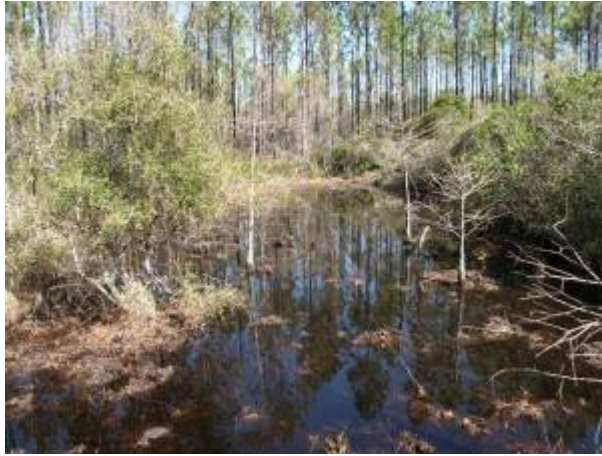
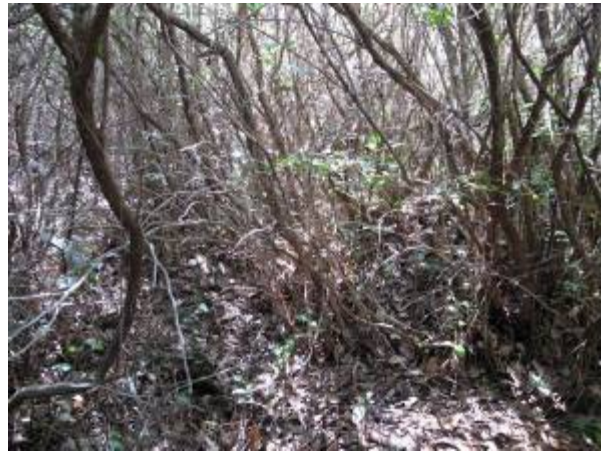
Wetland ID: 03-34

Description: This wetland is a 0.5 ha ephemeral shrub swamp. There is no tree canopy. Titi grows throughout the wetland, and covers >75% of the basin. Sedges/grasses grow in scattered patches, and cover 5-25% of the basin. Feral hogs created an open area on the north side of the wetland. Old stumps provide evidence that this wetland was once a cypress-dominated forested swamp. The adjacent uplands are mesic flatwoods that were bedded and converted to a pine plantation. The uplands were burned within the past year or two but the fire did not reach into the wetland. Upland restoration is in progress.

Wetland Concerns: Feral hog damage, Woody encroachment

Restoration Action Recommended: Periodic fire in the wetland would reduce the dense titi and open the midstory.

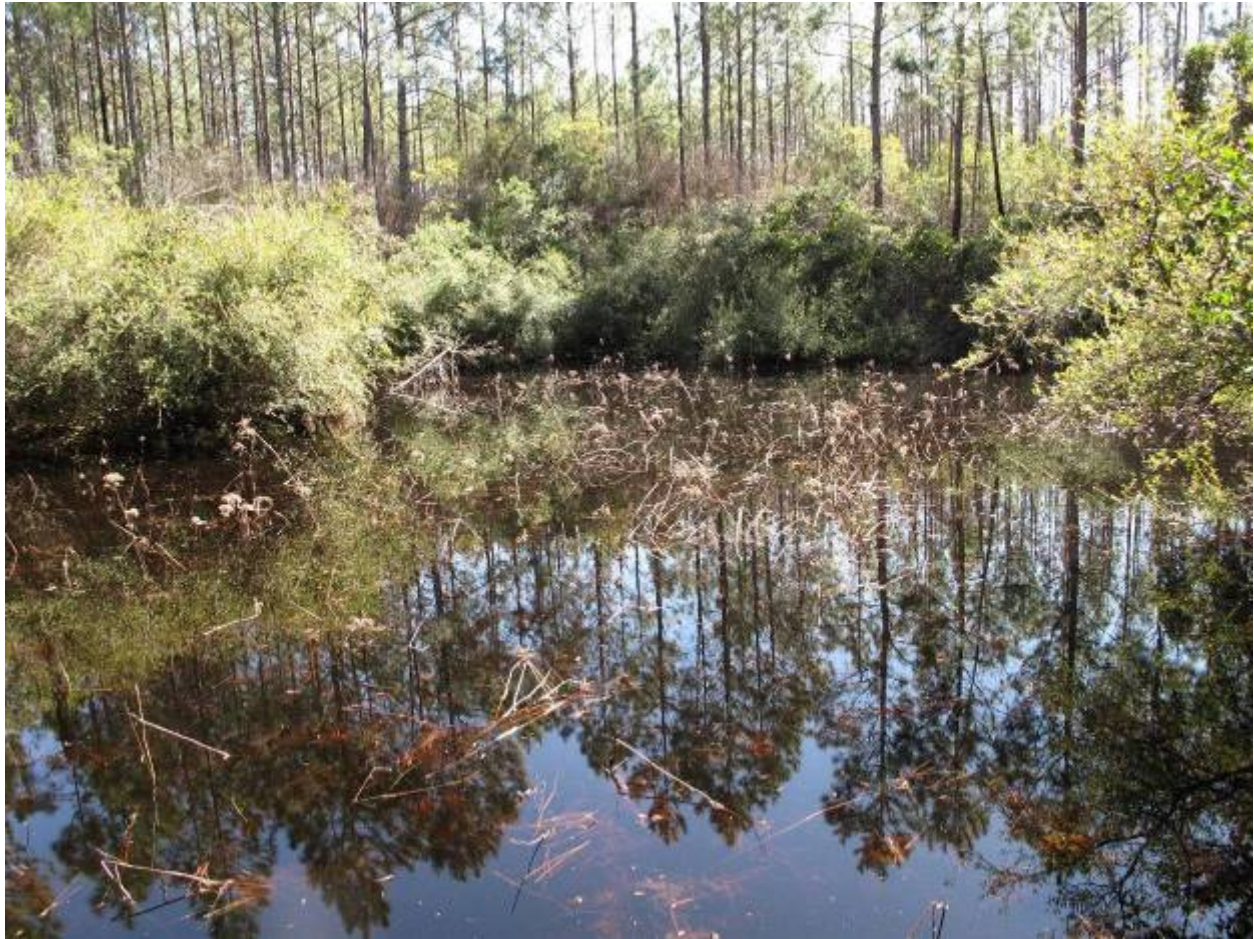
Description: This wetland is a 0.1 ha ephemeral marsh. There is no tree canopy. Titi grows around the wetland edge, and covers 5-25% of the wetland. Sedges/grasses grow in scattered patches, and cover 5-25% of the basin. Feral hogs have damaged the open wetland center. The uplands were burned within the past year or two and the fire burned much of the titi around the wetland edge. The adjacent uplands are mesic flatwoods that were bedded and converted to a pine plantation. Upland restoration is in progress.

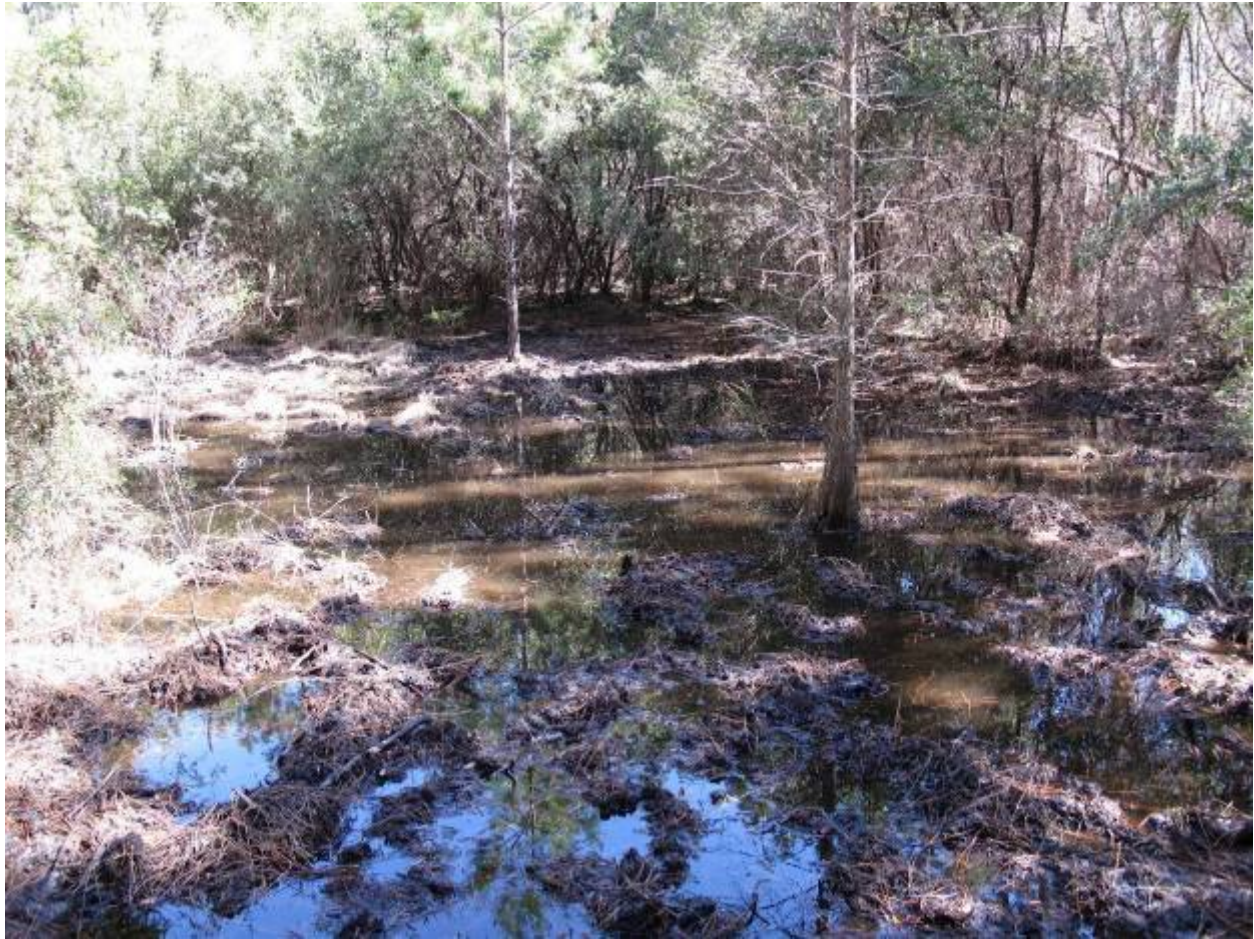
Description: This wetland is a <0.1 ha ephemeral marsh. There is no tree canopy. Titi is the dominant woody vegetation, and covers 5-25% of the wetland. Sedges/grasses grow in scattered patches, and cover 5-25% of the basin. Feral hog damage is extensive. Old stumps provide evidence that cypress trees historically occupied the wetland. The uplands were burned within the past year or two and the fire burned the ring of titi around the wetland edge. The adjacent uplands are mesic flatwoods that were bedded and converted to a pine plantation. Upland restoration is in progress.

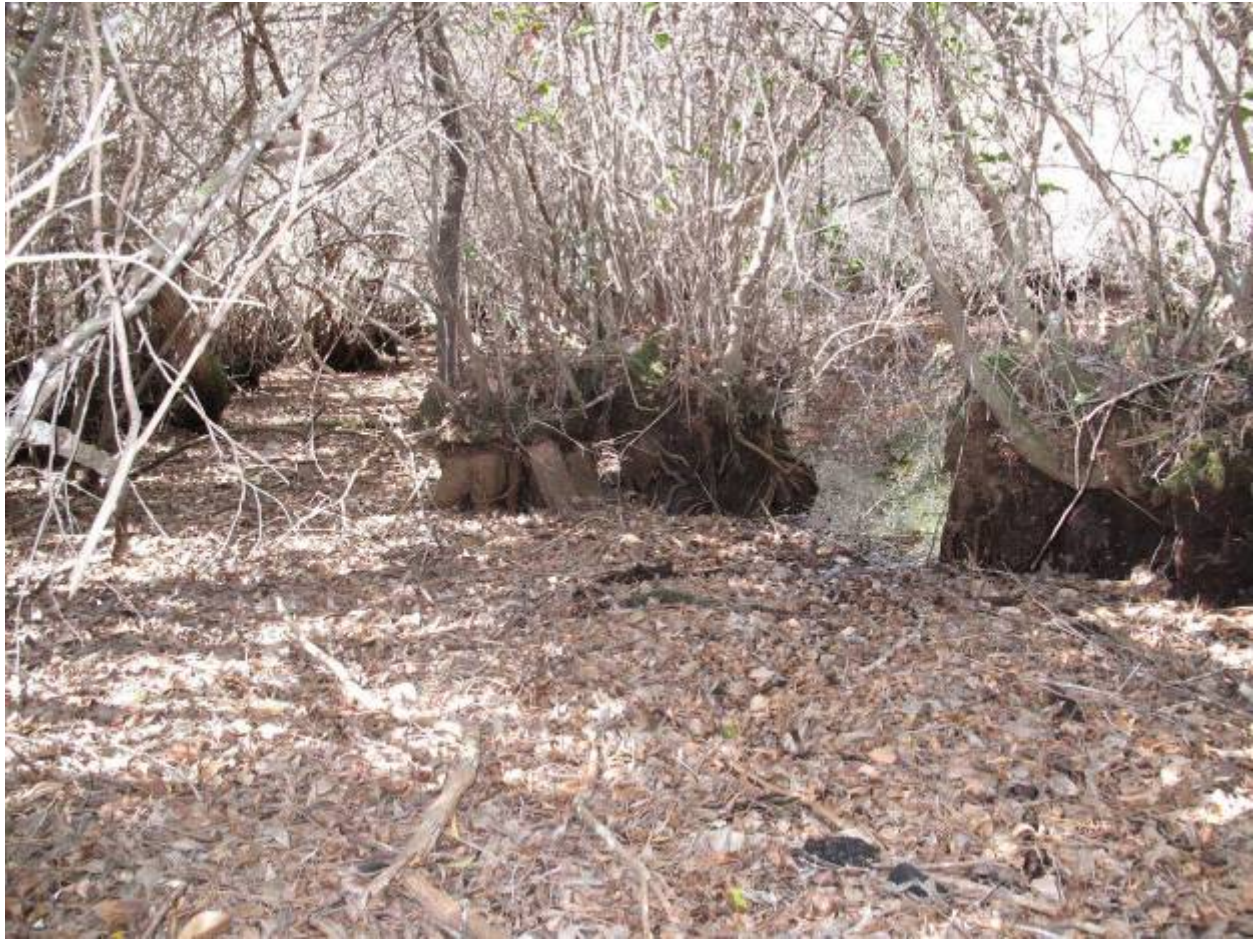
Description: This wetland is a 0.5 ha ephemeral shrub swamp. Cypress trees dominate the canopy, and cover 25-50% of the wetland. The midstory is dominated by titi, and covers >75% of the wetland. There is no herbaceous vegetation. Old stumps provide evidence that cypress trees historically occupied the wetland. The adjacent uplands are mesic flatwoods that were bedded and converted to a pine plantation. The uplands were burned within the past year or two but the fire did not reach into the wetland. Upland restoration is in progress.

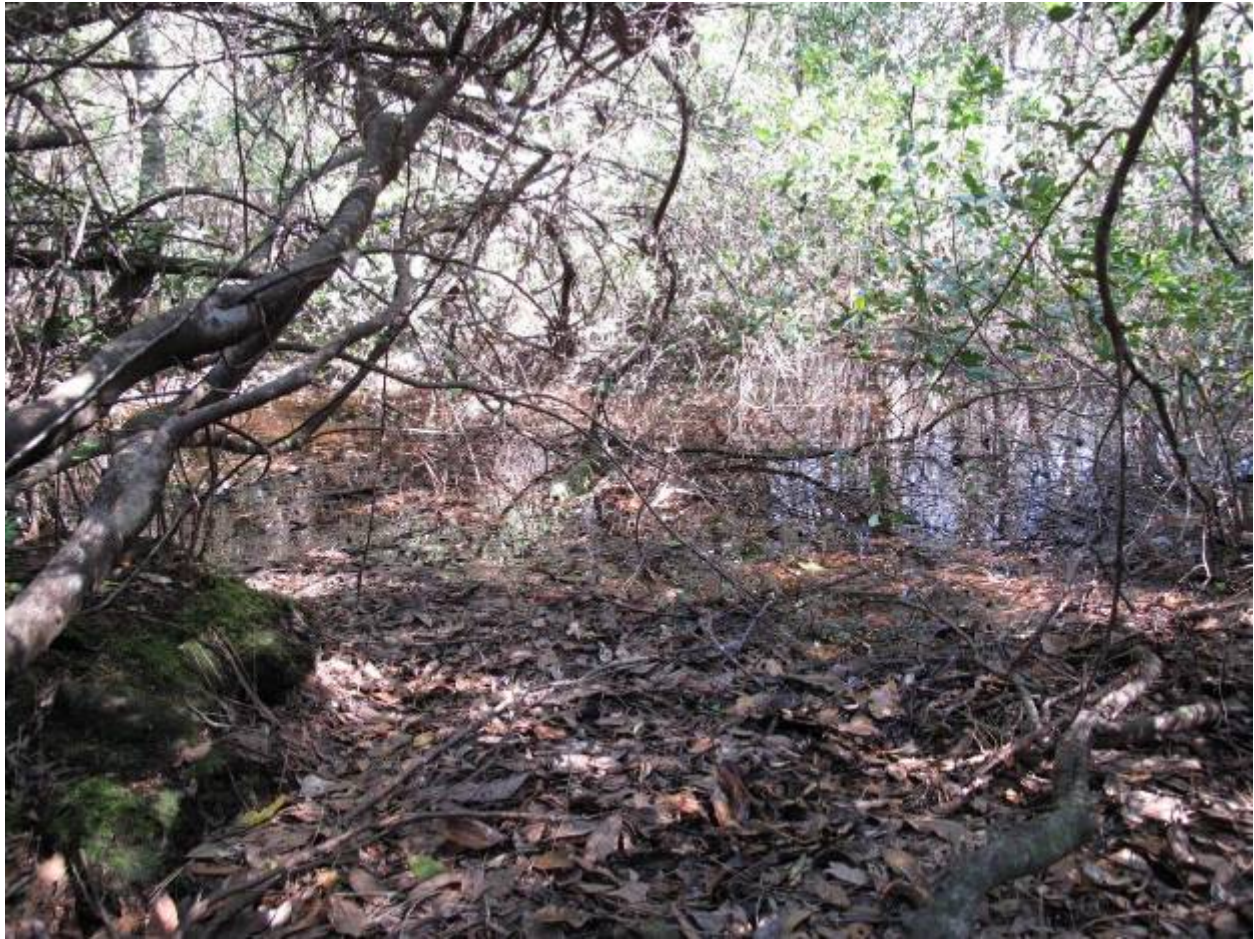
Description: This wetland is a 0.2 ha ephemeral shrub swamp. There is no tree canopy. Titi is the dominant woody vegetation, and covers >75% of the wetland. There is no herbaceous vegetation. A push pile or bedding row in the wetland center has thickly grown over with titi. The adjacent uplands are mesic flatwoods that were bedded and converted to a pine plantation. Upland restoration is in progress.

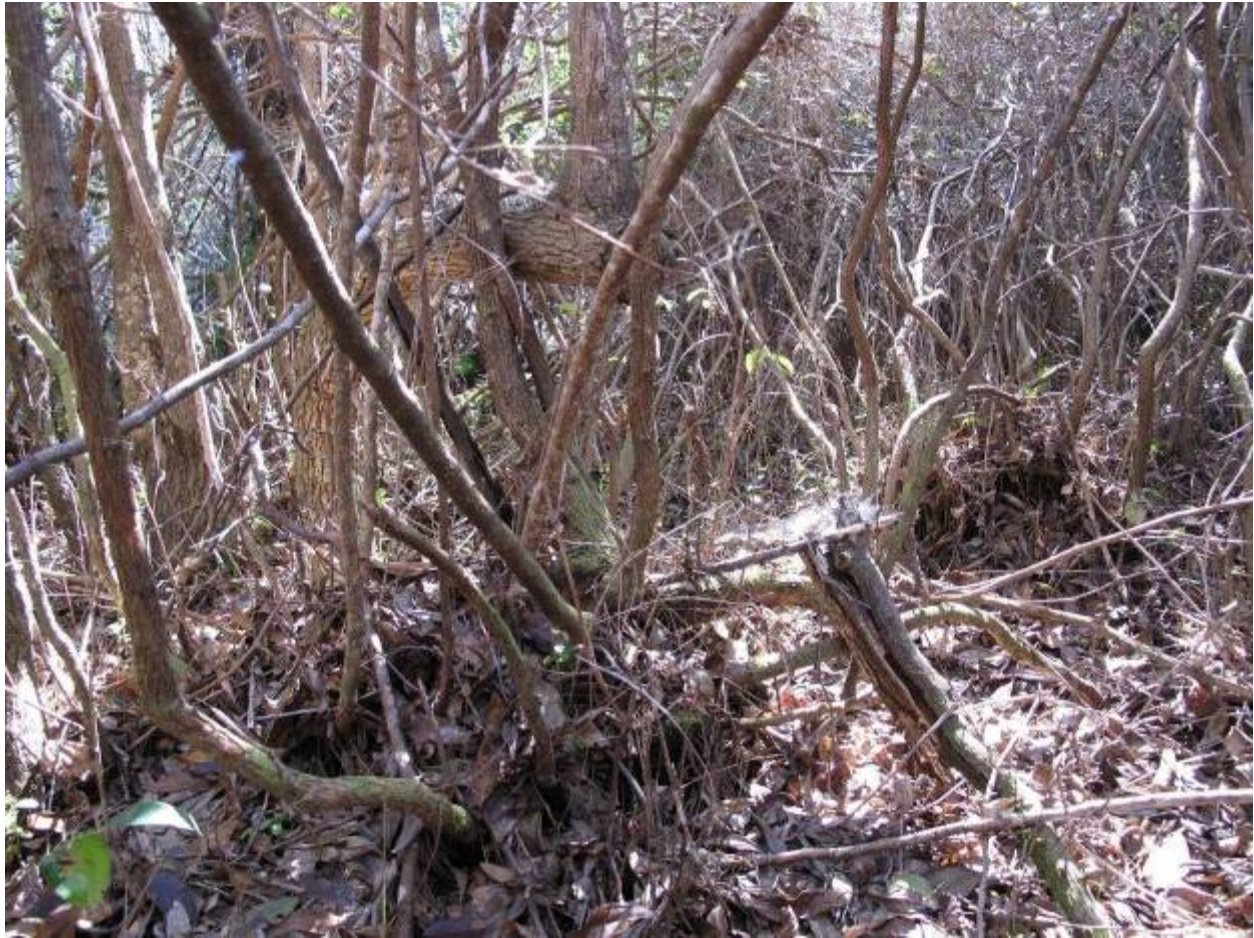
Wetland ID: 03-39

Description: This wetland is a 0.4 ha ephemeral shrub swamp. Cypress and gum trees dominate the canopy, and cover 5-25% of the wetland. The midstory is dominated by titi, and covers >75% of the wetland. There is no herbaceous vegetation. A thick, leafy duff layer covers the wetland floor. The adjacent uplands are mesic flatwoods that were bedded and converted to a pine plantation. The uplands were burned within the past year or two but the fire did not reach into the wetland. Upland restoration is in progress.

Wetland Concerns: Woody encroachment

Restoration Action Recommended: Periodic fire in the wetland would reduce the dense titi and open the midstory.

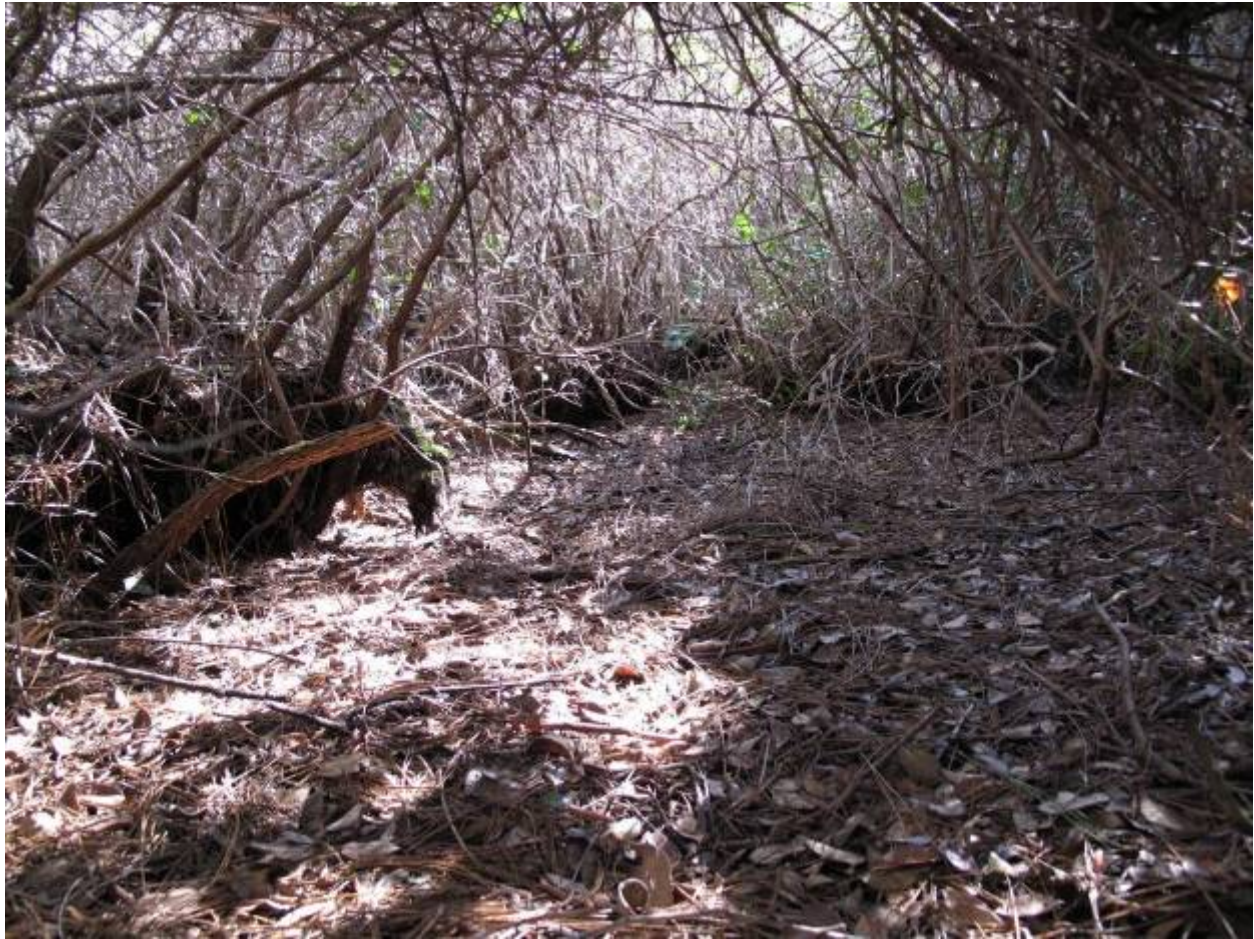
Description: This wetland is a 0.2 ha ephemeral shrub swamp. Cypress trees dominate the canopy, and cover 5-25% of the wetland. The midstory is dominated by titi, and covers >75% of the wetland. There is no herbaceous vegetation. A thick, leafy duff layer covers the wetland floor. The adjacent uplands are mesic flatwoods that were bedded and converted to a pine plantation. The uplands were burned within the past year or two but the fire did not reach into the wetland. Upland restoration is in progress.

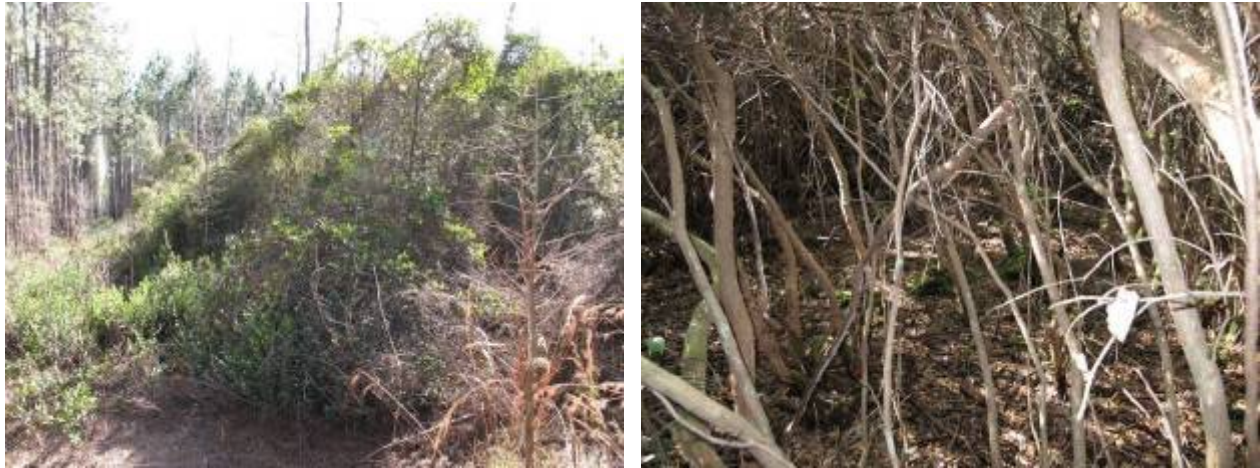
Wetland ID: 03-41

Description: This wetland is a 0.2 ha ephemeral shrub swamp. Cypress trees dominate the canopy, and cover 5-25% of the wetland. The midstory is dominated by titi, and covers >75% of the wetland. There is no herbaceous vegetation. The adjacent uplands are mesic flatwoods that were bedded and converted to a pine plantation. The uplands were burned within the past year or two but the fire did not reach into the wetland. Upland restoration is in progress.

Wetland Concerns: Woody encroachment

Restoration Action Recommended: Periodic fire in the wetland would reduce the dense titi and open the midstory.

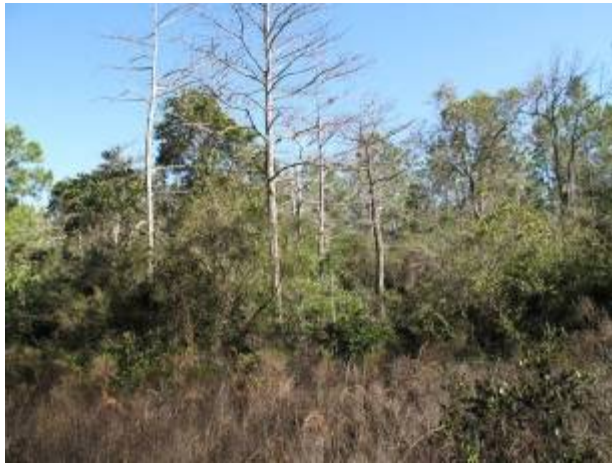
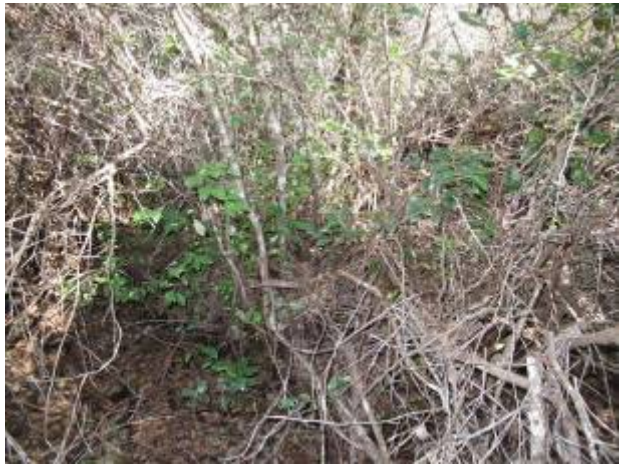
Wetland ID: 03-42

Description: This wetland is a 0.2 ha ephemeral shrub swam. Cypress trees dominate the canopy, and cover 25-50% of the wetland. The midstory is dominated by titi and fetterbush, and covers >75% of the wetland. There is no herbaceous vegetation. The adjacent uplands are mesic flatwoods that were bedded and converted to a pine plantation. The uplands were burned within the past year or two but the fire did not reach into the wetland. Upland restoration is in progress.

Wetland Concerns: Woody encroachment

Restoration Action Recommended: Periodic fire in the wetland would reduce the dense titi and open the midstory.

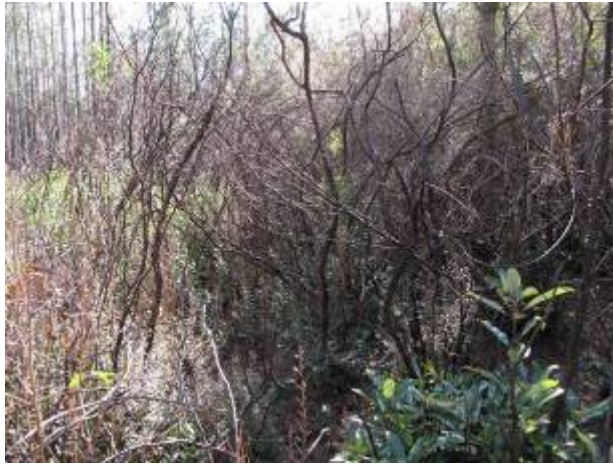
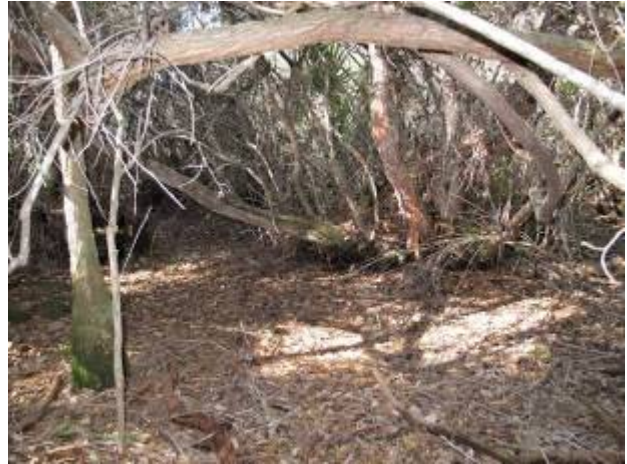
Wetland ID: 03-43

Description: This wetland is a 0.2 ha ephemeral shrub swamp. There is no tree canopy. Titi and holly are the dominant woody vegetation, and cover >75% of the wetland. There is no herbaceous vegetation. Old stumps provide evidence that cypress trees historically occupied the wetland. The uplands were burned within the past year or two. The fire reduced the brush around the perimeter but did not penetrate the wetland interior. The adjacent uplands are mesic flatwoods that were bedded and converted to a pine plantation. Upland restoration is in progress.

Wetland Concerns: Woody encroachment

Restoration Action Recommended: Periodic fire in the wetland would reduce the dense titi and open the midstory.

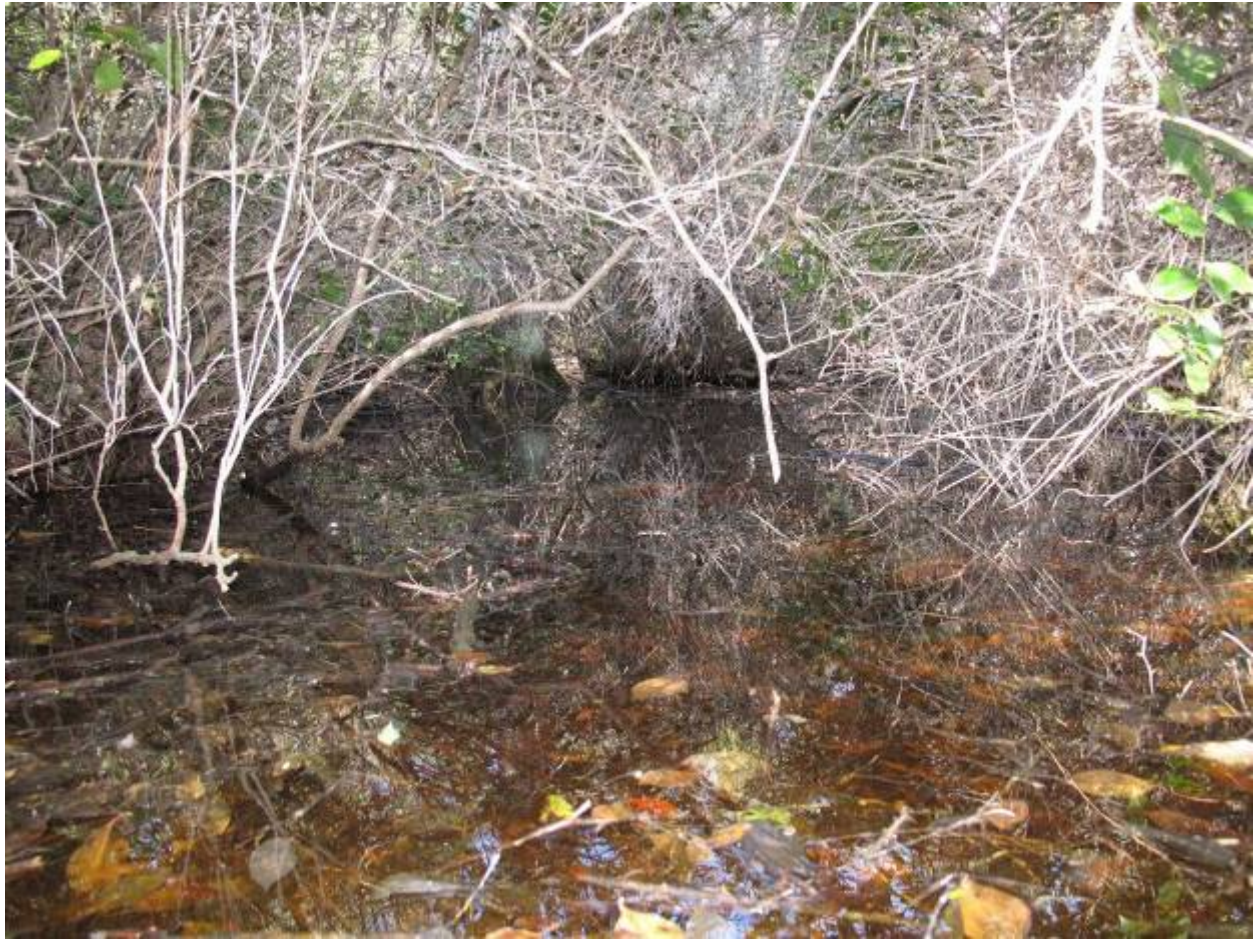
Description: This wetland is a 0.3 ha ephemeral shrub swamp. Cypress trees dominate the canopy, and cover 5-25% of the wetland. The midstory is dominated by titi, and covers >75% of the wetland. There is no herbaceous vegetation. Old stumps provide evidence that cypress trees historically occupied the wetland. The adjacent uplands are mesic flatwoods that were bedded and converted to a pine plantation. The uplands were burned within the past year or two but the fire did not reach into the wetland. Upland restoration is in progress.

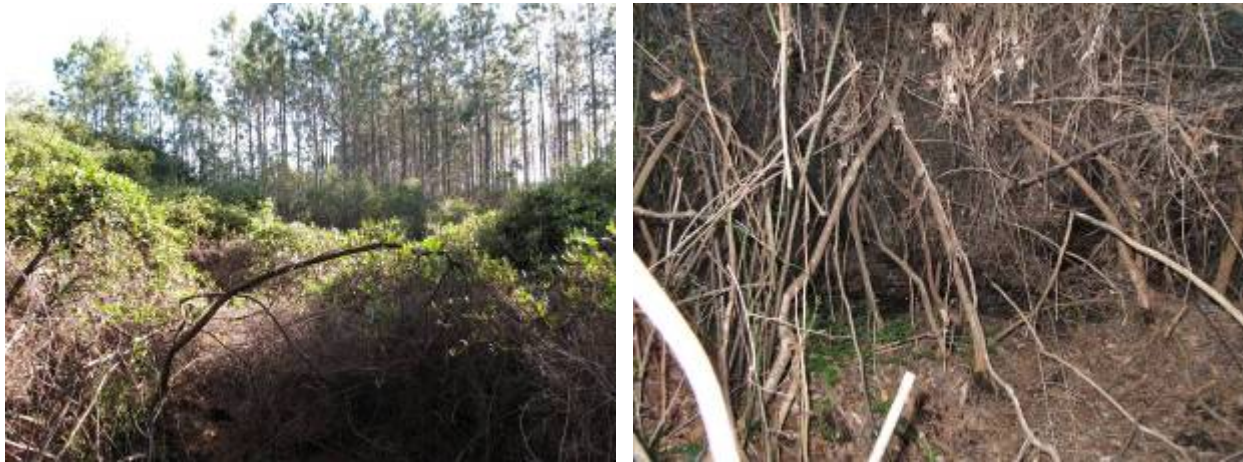
Wetland ID: 03-45

Description: This wetland is a 0.1 ha ephemeral shrub swamp. There is no tree canopy. Titi is the dominant woody vegetation, and covers >75% of the wetland. There is no herbaceous vegetation. The center of the wetland was deepened either by a peat fire or by past mechanical operations. Historic aerial photos suggest that this wetland may once have been a marsh. The uplands were burned within the past year or two but an impenetrable wall of titi and smilax still rings the wetland. The adjacent uplands are mesic flatwoods that were bedded and converted to a pine plantation. Upland restoration is in progress.

Wetland Concerns: Woody encroachment

Restoration Action Recommended: Encourage periodic fire in the wetland to reduce the dense titi.

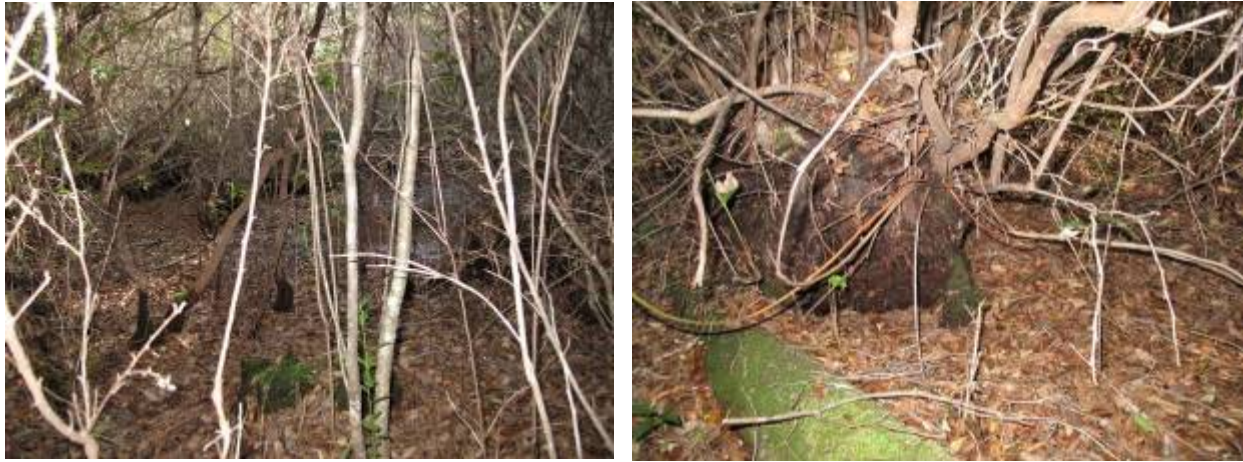
Wetland ID: 03-46

Description: This wetland is a 0.9 ha ephemeral shrub swamp. Cypress trees dominate the canopy, and cover 5-25% of the wetland. The midstory is dominated by titi, and covers >75% of the wetland. There is no herbaceous vegetation. A thick, leafy duff layer covers the wetland floor. This wetland likely was a cypress-dominated swamp that was logged and now is overgrown with titi. The adjacent uplands are mesic flatwoods that were bedded and converted to a pine plantation. Upland restoration is in progress.

Wetland Concerns: Woody encroachment

Restoration Action Recommended: Periodic fire in the wetland would reduce the dense titi and open the midstory.
