Inventory, Assessment, and Restoration Potential of Ephemeral Wetlands on FFWCC Wildlife Management Areas

Aucilla WMA Final Report

Submitted by: Rebecca P.M. Means¹, Ryan C. Means¹, Steven A. Johnson²

¹Coastal Plains Institute

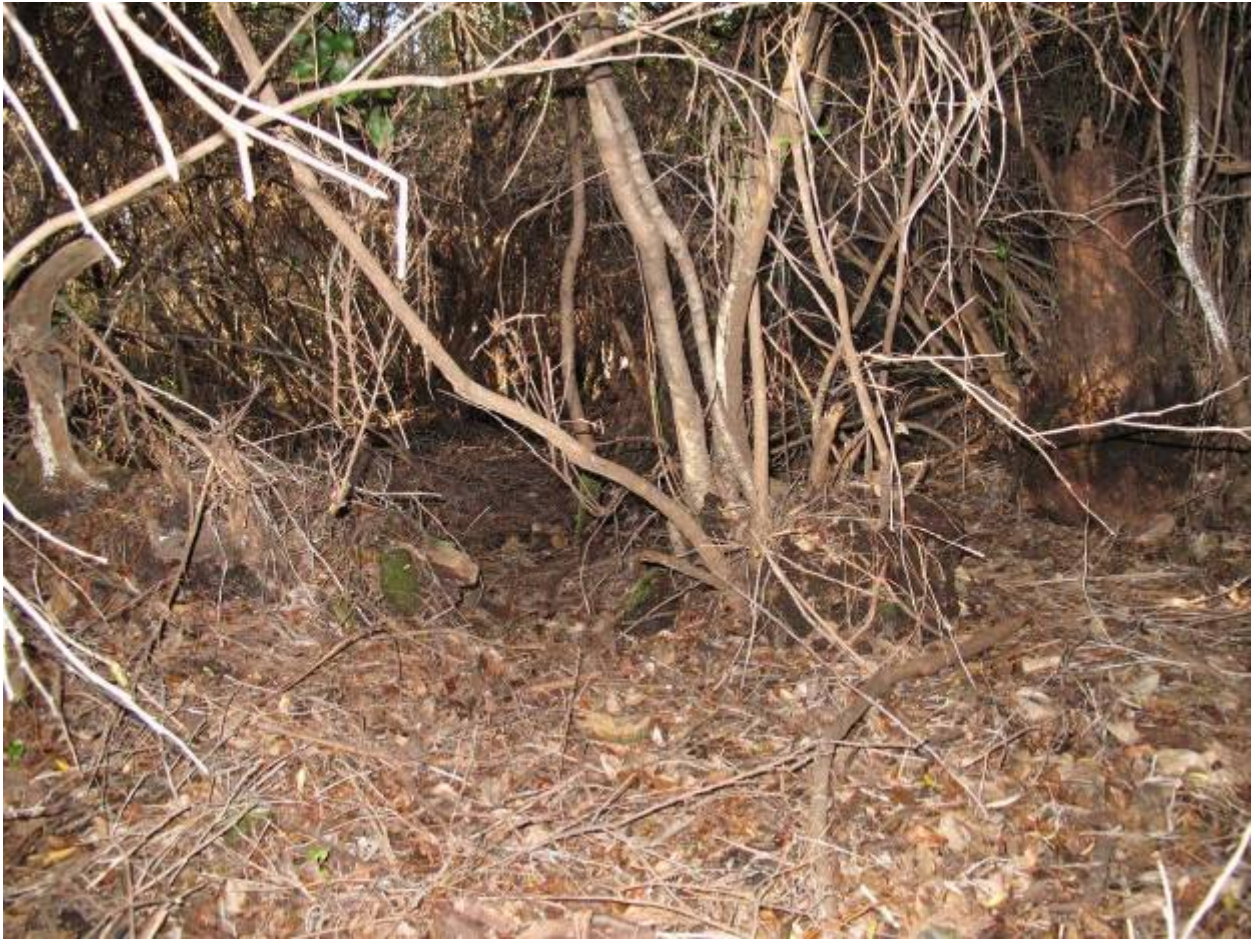
Wetland ID: 03-47

Description: This wetland is a 0.2 ha ephemeral shrub swamp. There is no tree canopy. Titi is the dominant woody vegetation, and covers >75% of the wetland. There is no herbaceous vegetation. A thick, leafy duff layer covers the wetland floor. Historic aerial photos suggest that this wetland was once a forested swamp. Cypress trees likely were logged from the wetland and titi were able to establish due to subsequent fire suppression. Although this MU burned recently, the uplands surrounding this wetland were not penetrated by fire. The adjacent uplands are mesic flatwoods that were bedded and converted to a pine plantation. Upland restoration is in progress.

Wetland Concerns: Woody encroachment

Restoration Action Recommended: Periodic fire in the wetland would reduce the dense titi and open the midstory.

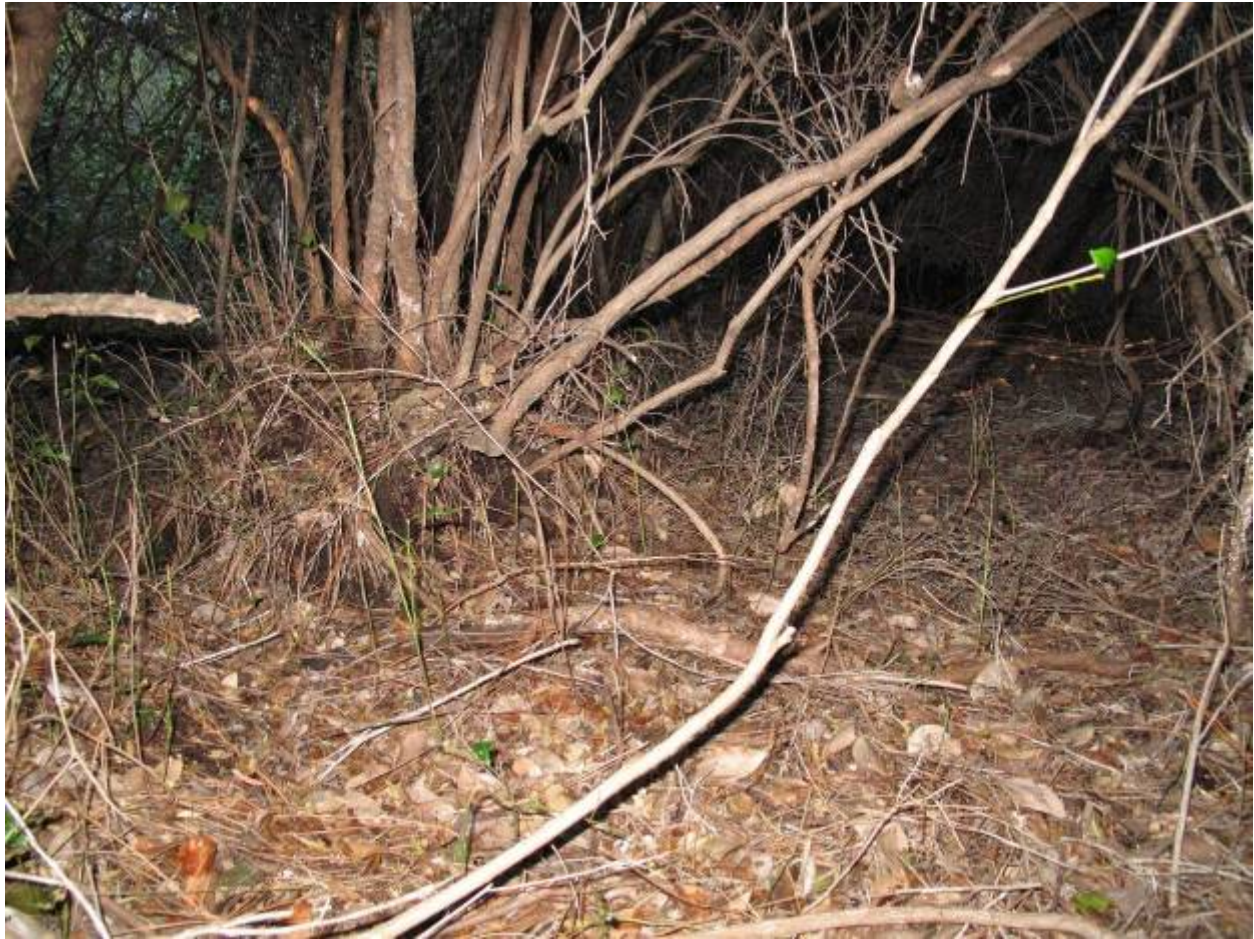
Description: This wetland is a 0.1 ha ephemeral shrub swamp. There is no tree canopy. Titi is the dominant woody vegetation, and covers >75% of the wetland. There is no herbaceous vegetation. A thick, leafy duff layer covers the wetland floor. Although this MU burned recently, the uplands surrounding this wetland were not penetrated by fire. The adjacent uplands are mesic flatwoods that were bedded and converted to a pine plantation. Upland restoration is in progress.

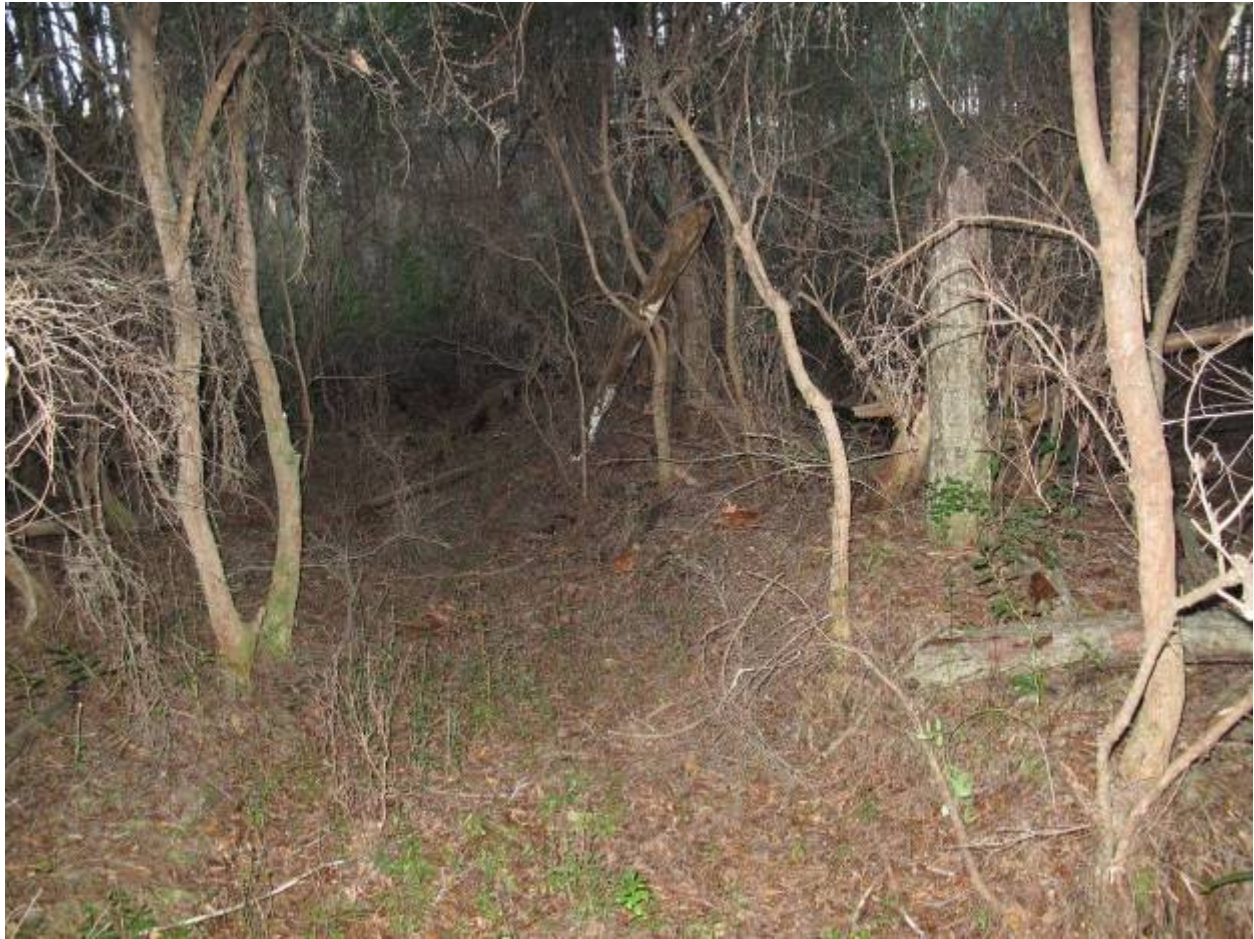
Description: This wetland is a 0.1 ha highly ephemeral shrub swamp. There is no tree canopy. Titi is the dominant woody vegetation, and covers >75% of the wetland. There is no herbaceous vegetation. Historic aerial photos suggest that this wetland once was a marsh. Pine trees were planted on bedded rows through the wetland interior. Although this MU burned recently, the uplands surrounding this wetland were not penetrated by fire. The adjacent uplands are mesic flatwoods that were bedded and converted to a pine plantation. Upland restoration is in progress.

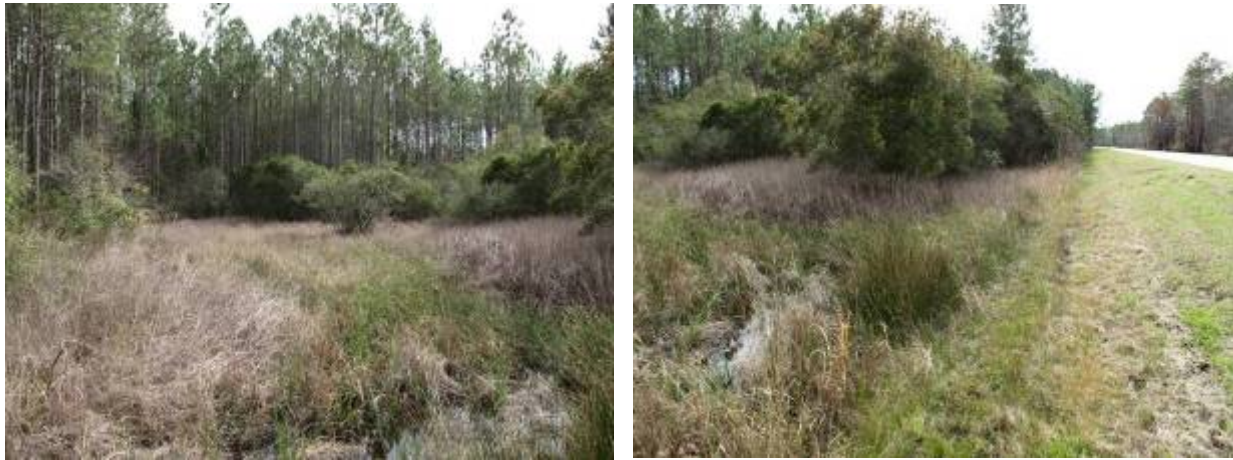
Wetland ID: 03-50

Description: This wetland is a 0.2 ha ephemeral marsh. There is no tree canopy. Titi is the dominant woody vegetation, and covers 25-50% of the wetland. Sedges/grasses grow throughout the wetland, and covers >75% of the basin. This marsh is not as severely encroached by woody shrubs as most of the wetlands in this MU; however, shrubs are beginning to establish. This wetland was once a part of a larger wetland system but was bisected by a major road (SR 59). Although this MU burned recently, the uplands surrounding this wetland were not penetrated by fire. The adjacent uplands are mesic flatwoods that were bedded and converted to a pine plantation. Upland restoration is in progress.

Wetland Concerns: Road, Woody encroachment

Restoration Action Recommended: In order to restore the hydrology of this wetland and the larger wetland system, the road would have to be removed. Recognizing that this road is now a permanent feature, we do not recommend any action relating to the road. The wetland could be monitored to ensure it is not affected by run-off or other impacts. We recommend the use of fire treatments here as soon as is feasible, before shrubby encroachment eliminates the marshy character of this wetland. .

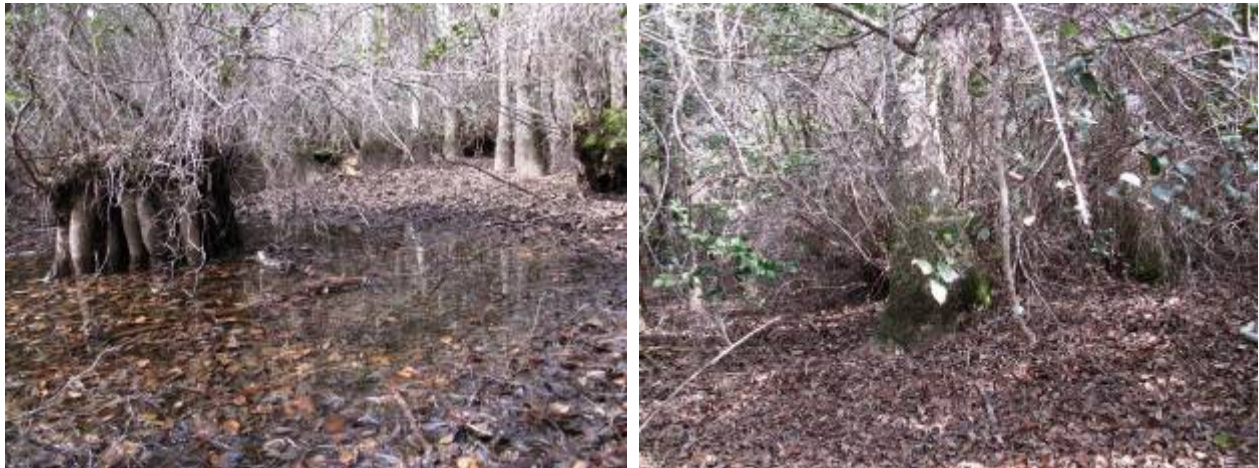
Wetland ID: 03-51

Description: This wetland is a 0.3 ha ephemeral mixed swamp, with two lobes. Gum trees dominate the canopy, and cover 50-75% of the wetland. The midstory is dominated by titi and fetterbush, and covers >75% of the wetland. There is no herbaceous vegetation. Although this MU burned recently, the uplands surrounding this wetland were not penetrated by fire. The adjacent uplands are mesic flatwoods that were bedded and converted to a pine plantation. Upland restoration is in progress.

Wetland Concerns: Woody encroachment

Restoration Action Recommended: Periodic fire in the wetland would reduce the dense titi and open the midstory.

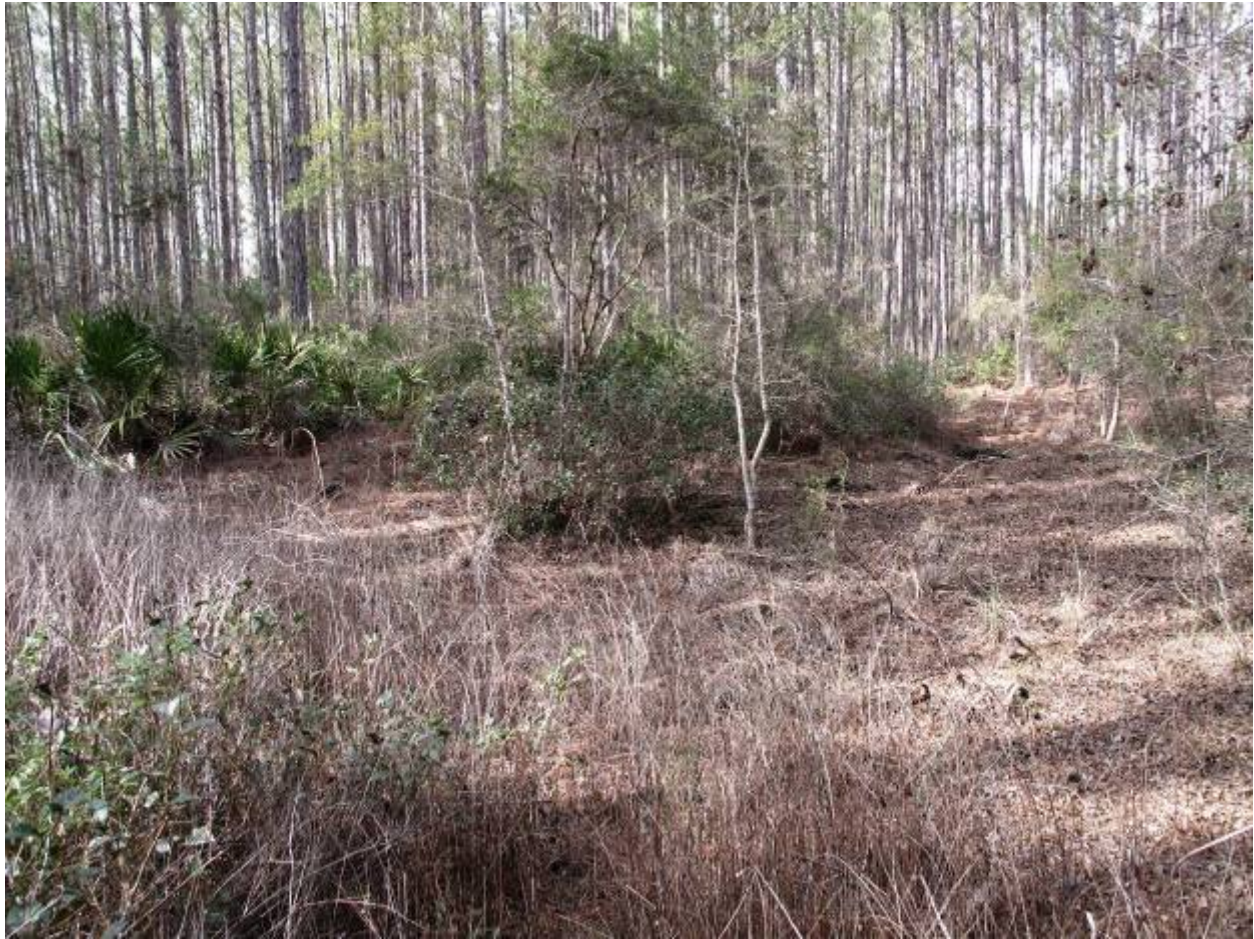
Description: This wetland is a <0.1 ha highly ephemeral marsh. There is no tree canopy. Fetterbush and holly are the dominant woody vegetation, and cover 5-25% of the wetland. Sedges/grasses grow throughout the wetland, and cover 25-50% of the basin. Although this MU burned recently, the uplands surrounding this wetland were not penetrated by fire. The adjacent uplands are mesic flatwoods that were bedded and converted to a pine plantation. Upland restoration is in progress.

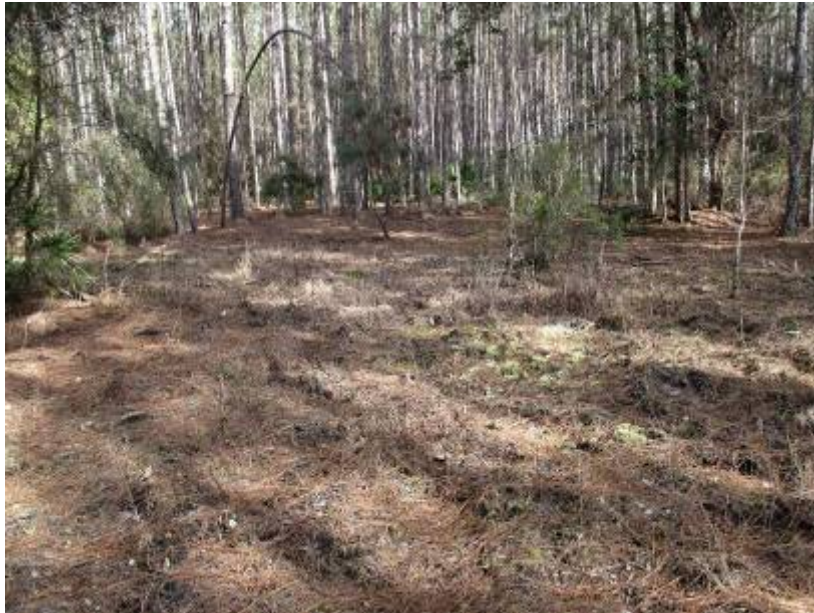
Wetland ID: 03-53

Description: This wetland is a <0.1 ha highly ephemeral marsh. Pine trees dominate the canopy, and cover 5-25% of the wetland. There is no midstory layer. Sedges/grasses grow throughout the wetland, and cover 25-50% of the basin. This small wetland was bedded and planted with pine trees. There is some feral hog damage in the wetland basin. Although this MU burned recently, the uplands surrounding this wetland were not penetrated by fire. The adjacent uplands are mesic flatwoods that were bedded and converted to a pine plantation. Upland restoration is in progress.

Wetland Concerns: Bedding, Feral hog damage, Planted pines

Restoration Action Recommended: The old bedding in this wetland is not severe and is showing signs of significant erosion. No action to remove the bedding is recommended; the bedding rows will erode over time. Remove the planted pine trees from the wetland interior.

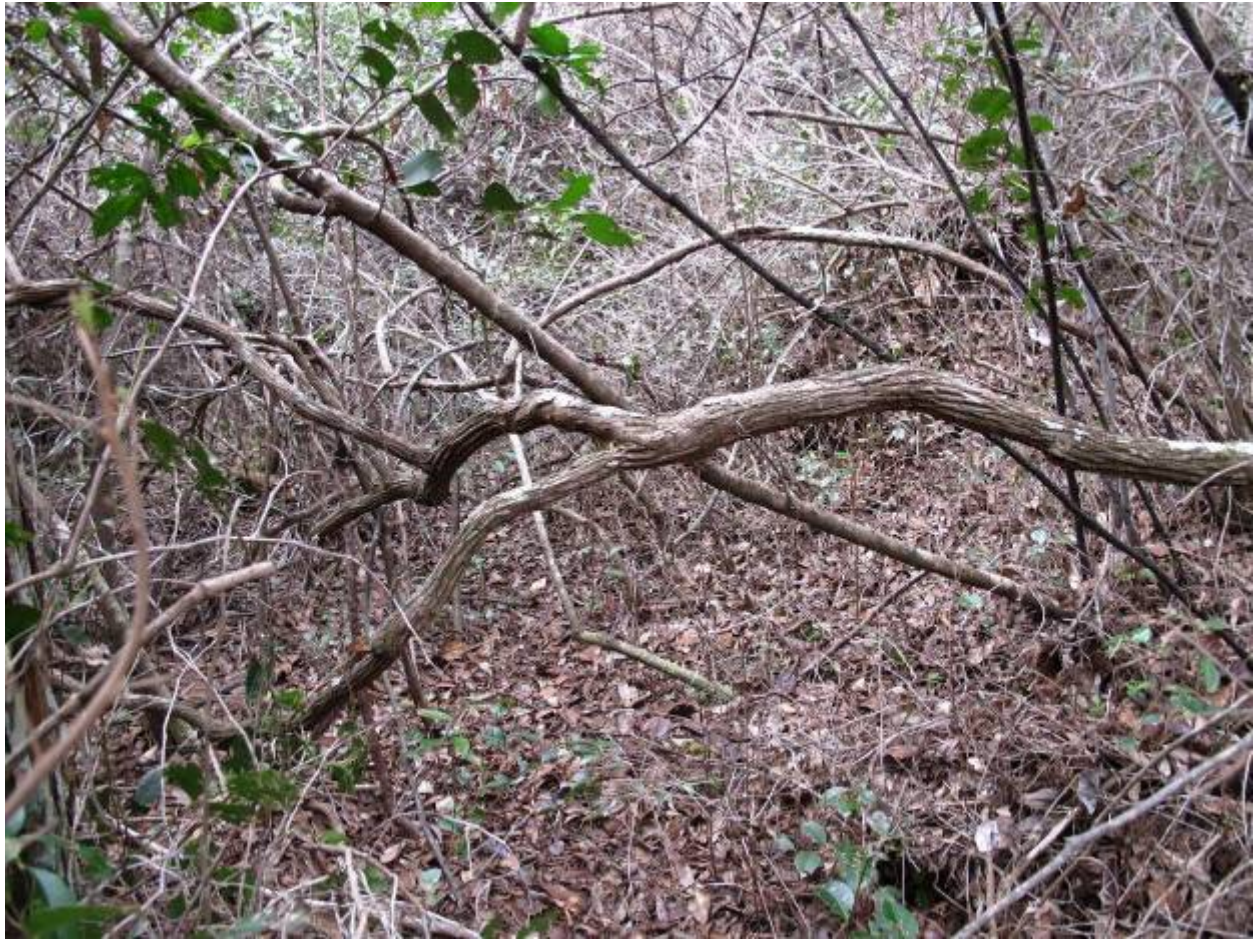
Description: This wetland is a 0.7 ha ephemeral mixed swamp. The presence of old cypress stumps provides evidence of historical logging. The cypress trees have regenerated and cover 50-75% of the wetland. The midstory is dominated by titi and fetterbush, and covers >75% of the wetland. There is no herbaceous vegetation. A thick, leafy duff layer covers the wetland floor. Although this MU burned recently, the uplands surrounding this wetland were not penetrated by fire. The adjacent uplands are mesic flatwoods that were bedded and converted to a pine plantation. Upland restoration is in progress.

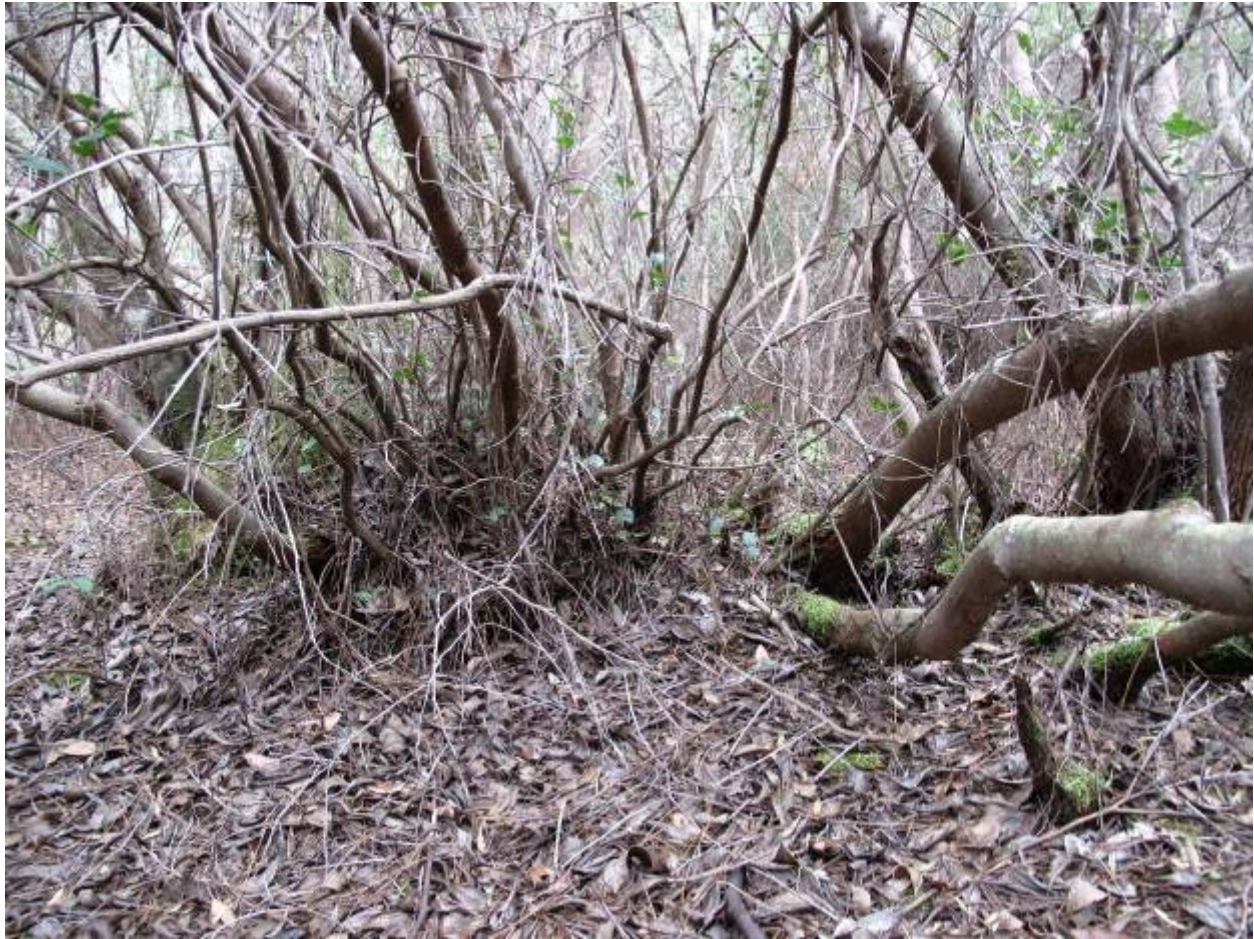
Description: This wetland is a 0.1 ha ephemeral shrub swamp. There is no tree canopy. Titi is the dominant woody vegetation, and covers >75% of the wetland. There is no herbaceous vegetation. Although this MU burned recently, the uplands surrounding this wetland were not penetrated by fire. The adjacent uplands are mesic flatwoods that were bedded and converted to a pine plantation. Upland restoration is in progress.

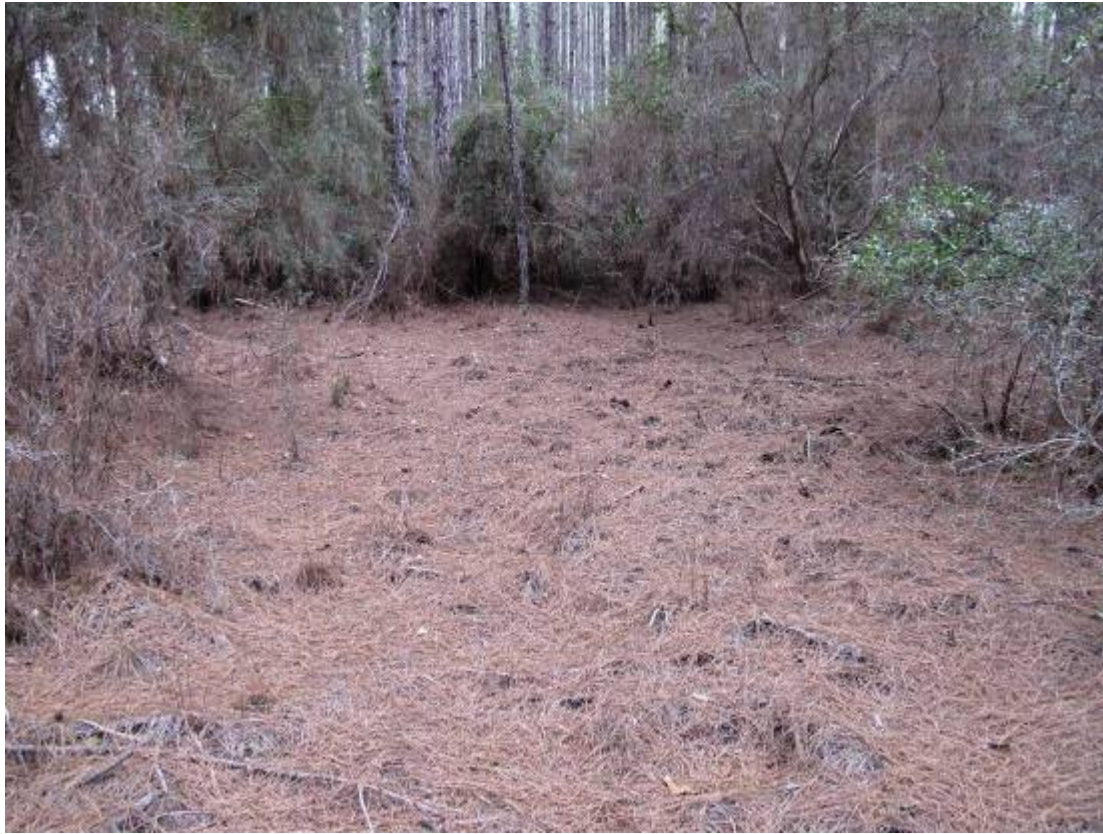
Wetland ID: 03-56

Description: This wetland is a <0.1 ha highly ephemeral altered wetland. Pine trees dominate the canopy, and cover 25-50% of the wetland. The midstory is dominated by wax myrtle, and covers 5-25% of the wetland. There is no herbaceous vegetation. A thick pine needle duff covers the wetland floor. This small wetland was bedded and planted with pine trees. Old feral hog damage is evident in the wetland. Although this MU burned recently, the uplands surrounding this wetland were not penetrated by fire. The adjacent uplands are mesic flatwoods that were bedded and converted to a pine plantation. Upland restoration is in progress.

Wetland Concerns: Bedding, Feral hog damage, Planted pines

Restoration Action Recommended: No action to remove the minor bedding is recommended; the bedding rows will erode over time. Remove the planted pine trees from the wetland interior.

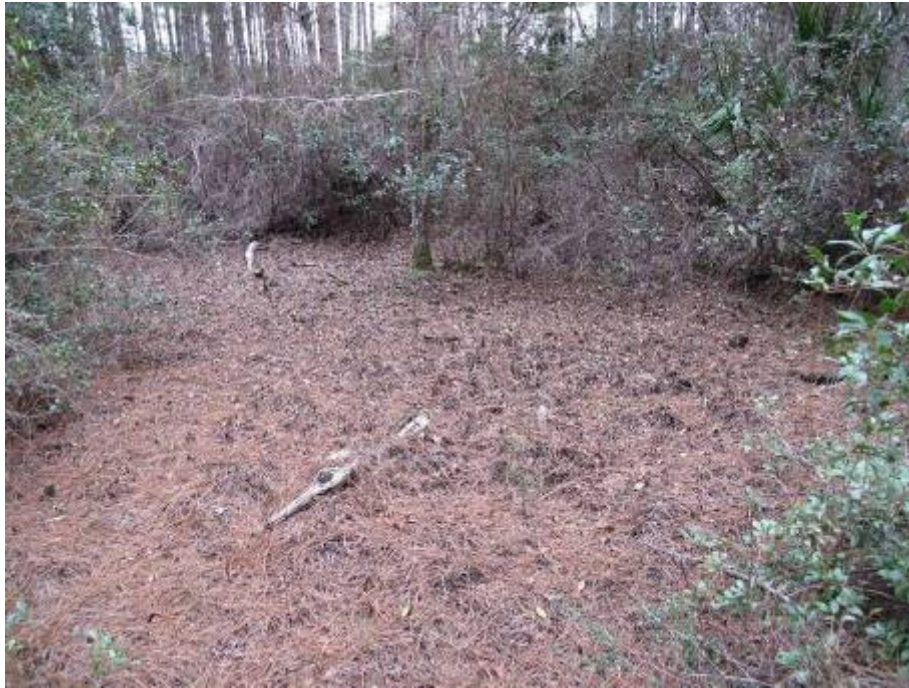
Wetland ID: 03-57

Description: This wetland is a <0.1 ha highly ephemeral altered wetland. Gum and pine trees dominate the canopy, and cover 5-25% of the wetland. The midstory is dominated by fetterbush, and covers 5-25% of the wetland. There is no herbaceous vegetation. There is a thick needle duff layer that covers the wetland floor. This wetland may have been a small marsh but feral hog damage and the shade from planted pine trees around the perimeter have eliminated potential herbaceous vegetation. Although this MU burned recently, the uplands surrounding this wetland were not penetrated by fire. The adjacent uplands are mesic flatwoods that were bedded and converted to a pine plantation. Upland restoration is in progress.

Wetland Concerns: Bedding, Feral hog damage, Planted pines

Restoration Action Recommended: No action to remove the minor bedding is recommended; the bedding rows will erode over time. Remove the planted pine trees from the wetland interior.

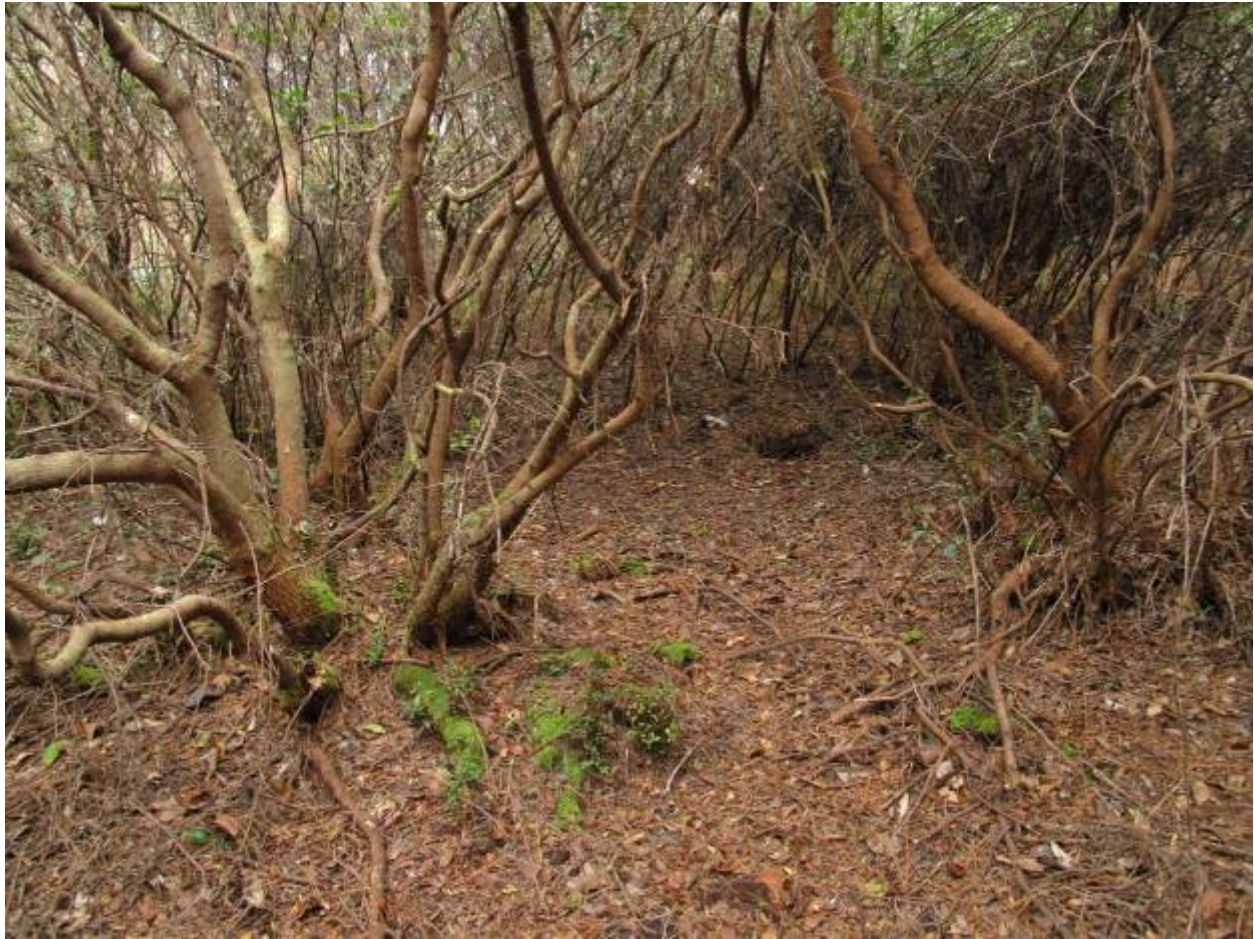
Description: This wetland is a 0.1 ha ephemeral shrub swamp. There is no tree canopy. Titi is the dominant woody vegetation, and covers >75% of the wetland. There is no herbaceous vegetation. There is a thick, leafy duff layer that covers the wetland floor. Although this MU burned recently, the uplands surrounding this wetland were not penetrated by fire. The adjacent uplands are mesic flatwoods that were bedded and converted to a pine plantation. Upland restoration is in progress.

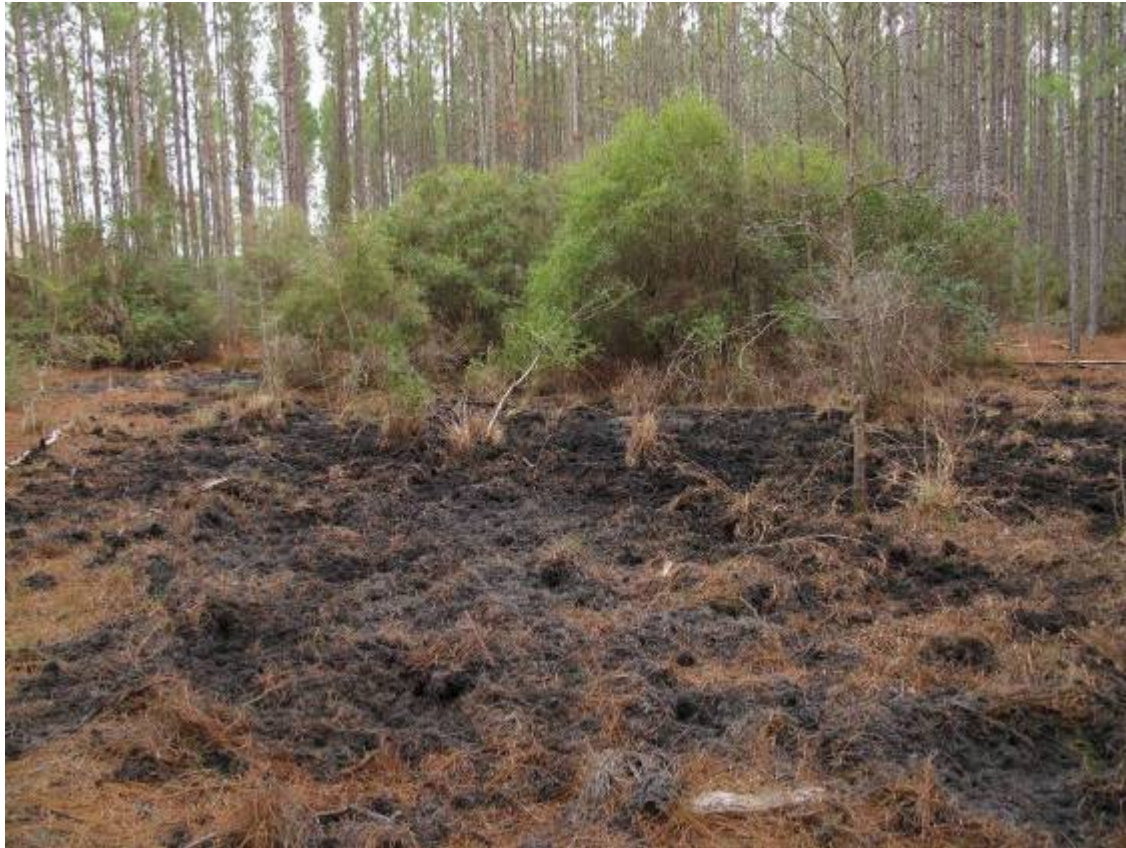
Wetland ID: 03-59

Description: This wetland is a 0.1 ha ephemeral marsh. Pine trees dominate the canopy, and cover 5-25% of the wetland. The midstory is dominated by titi, and covers 5-25% of the wetland. Sedges/grasses grow sparse in the wetland, and cover 5-25% of the basin. Recent feral hog damage is severe. Bedding rows with planted pines run up to the wetland perimeter. Although this MU burned recently, the uplands surrounding this wetland were not penetrated by fire. The adjacent uplands are mesic flatwoods that were bedded and converted to a pine plantation. Upland restoration is in progress.

Wetland Concerns: Feral hog damage

Restoration Action Recommended: None

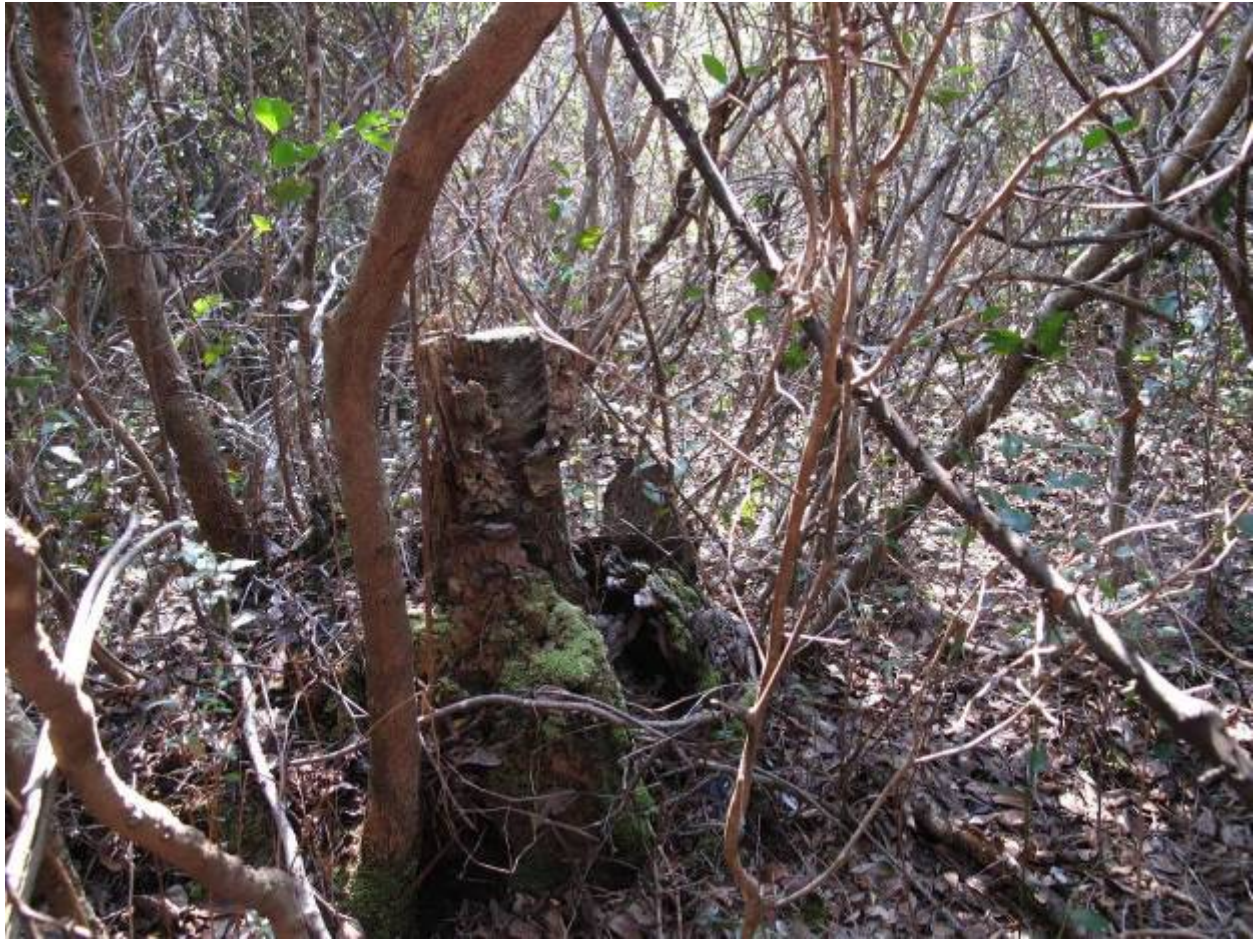
Description: This wetland is a 0.5 ha ephemeral shrub swamp. There is no tree canopy. Titi is the dominant woody vegetation, and covers >75% of the wetland. There is no herbaceous vegetation. This large, two-lobed wetland is extremely brushy, and has a thick duff layer and covers the floor. Interestingly, an old, cat-faced pine stump was encountered within the wetland perimeter, which indicates that the area was used for turpentine during the naval stores industry of the 19th and 20th centuries. The presence of old cypress stumps also provides evidence of historical logging. Although this MU burned recently, the uplands surrounding this wetland were not penetrated by fire. The adjacent uplands are mesic flatwoods that were bedded and converted to a pine plantation. Upland restoration is in progress.

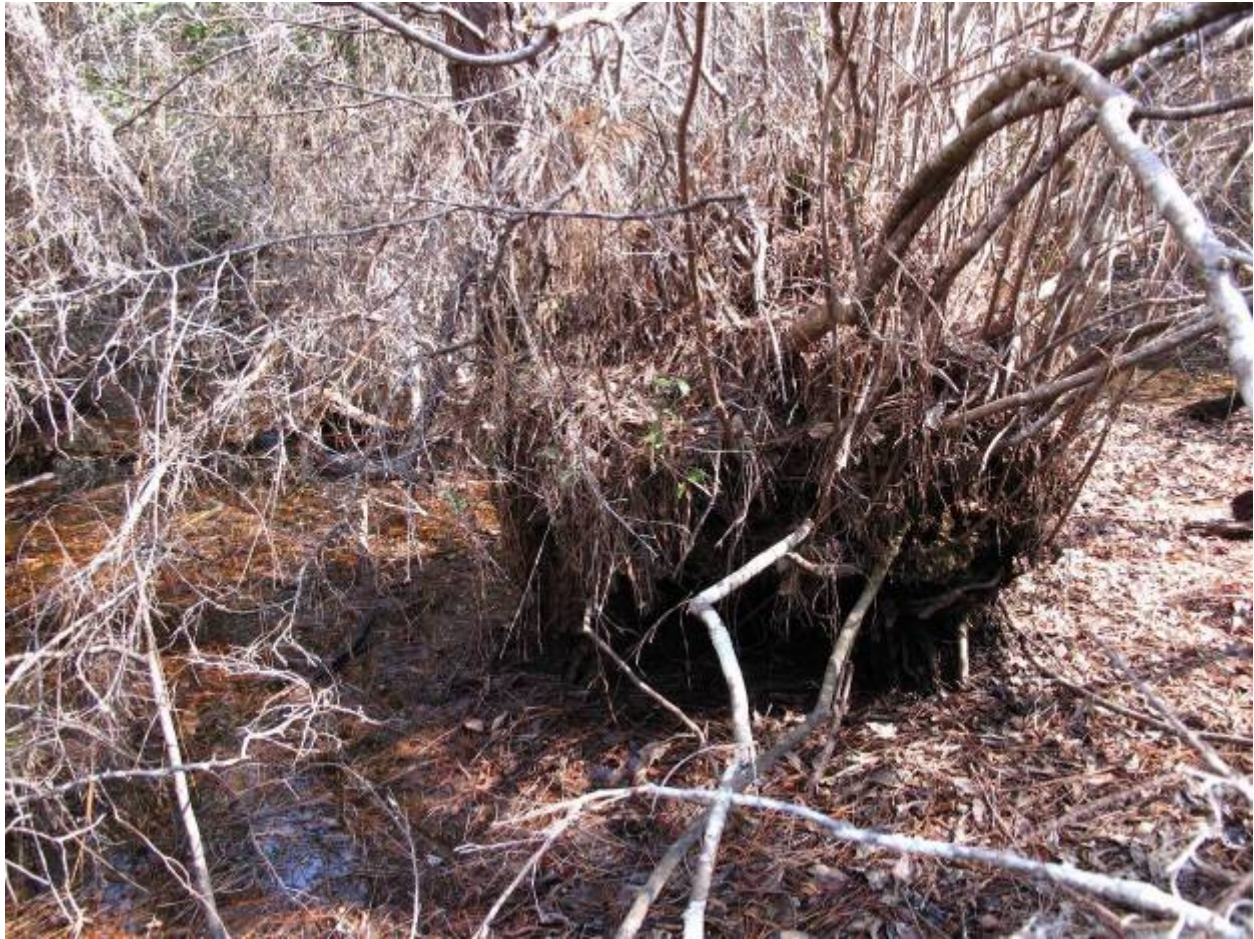
Description: This wetland is a 0.2 ha ephemeral mixed swamp. Cypress and gum trees dominate the canopy, and cover >75% of the wetland. The midstory is dominated by titi and fetterbush, and covers >75% of the wetland. There is no herbaceous vegetation. There is a thick, leafy duff layer covering the wetland floor. Although this MU burned recently, the uplands surrounding this wetland were not penetrated by fire. The adjacent uplands are mesic flatwoods that were bedded and converted to a pine plantation. Upland restoration is in progress.

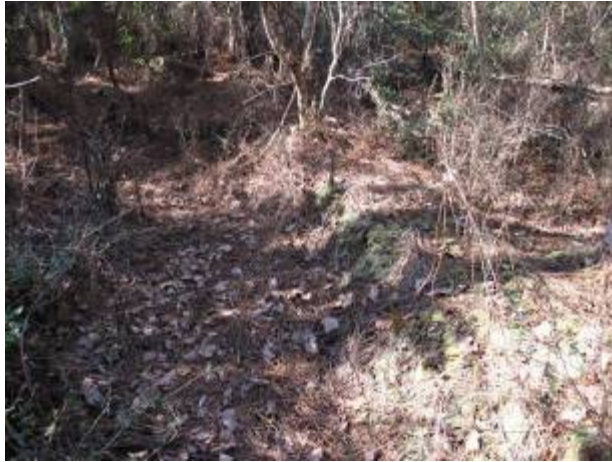
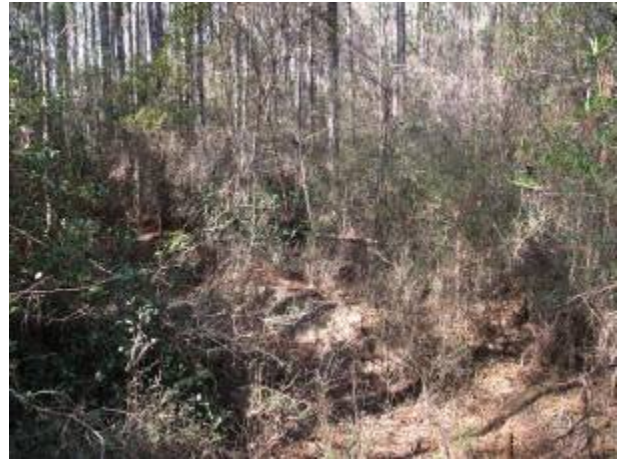
Wetland ID: 03-62

Description: This wetland is a <0.1 ha highly ephemeral altered wetland. The hydrology of this wetland was severely altered when it was bedded for a pine plantation. There is no tree canopy. Titi is the dominant woody vegetation, and covers 50-75% of the wetland. There is no herbaceous vegetation. A thick duff layer covers the wetland floor. Although this MU burned recently, the uplands surrounding this wetland were not penetrated by fire. The adjacent uplands are mesic flatwoods that were bedded and converted to a pine plantation. Upland restoration is in progress.

Wetland Concerns: Bedding, Woody encroachment

Restoration Action Recommended: Due to the already altered state of this wetland, we recommend mechanically removing the bedding rows and simultaneously remove or thin titi. Return periodic fire to the wetland to prevent further titi encroachment.

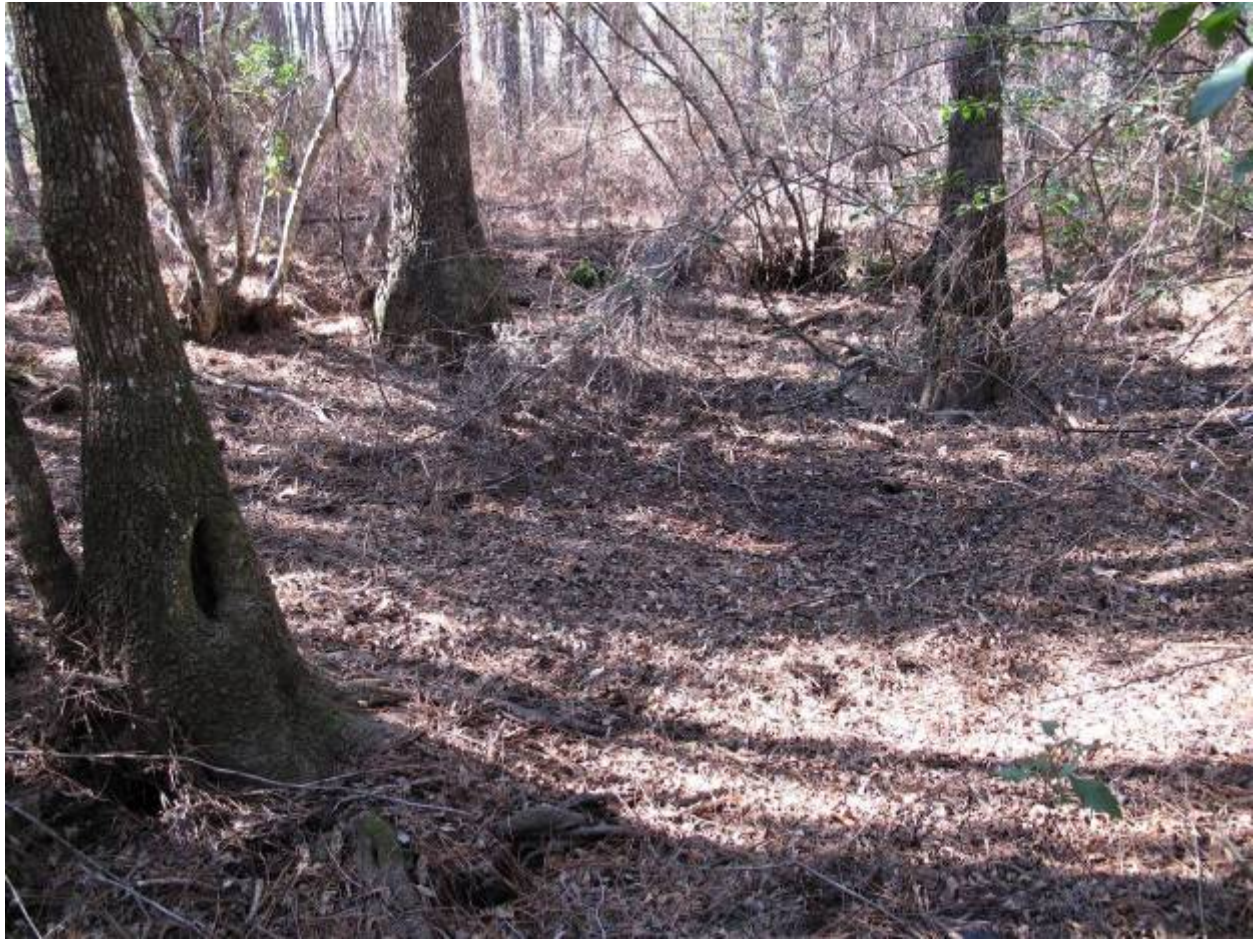
Description: This wetland is a <0.1 ha ephemeral forested swamp. Gum trees dominate the canopy, and cover >75% of the wetland. The midstory is dominated by fetterbush, and covers 5-25% of the wetland. There is no herbaceous vegetation. There is a thick, leafy duff layer covering the wetland floor. Overall, this wetland appears to be ecologically healthy, despite being embedded within a fire-suppressed landscape. Although this MU burned recently, the uplands surrounding this wetland were not penetrated by fire. The adjacent uplands are mesic flatwoods that were bedded and converted to a pine plantation. Upland restoration is in progress.

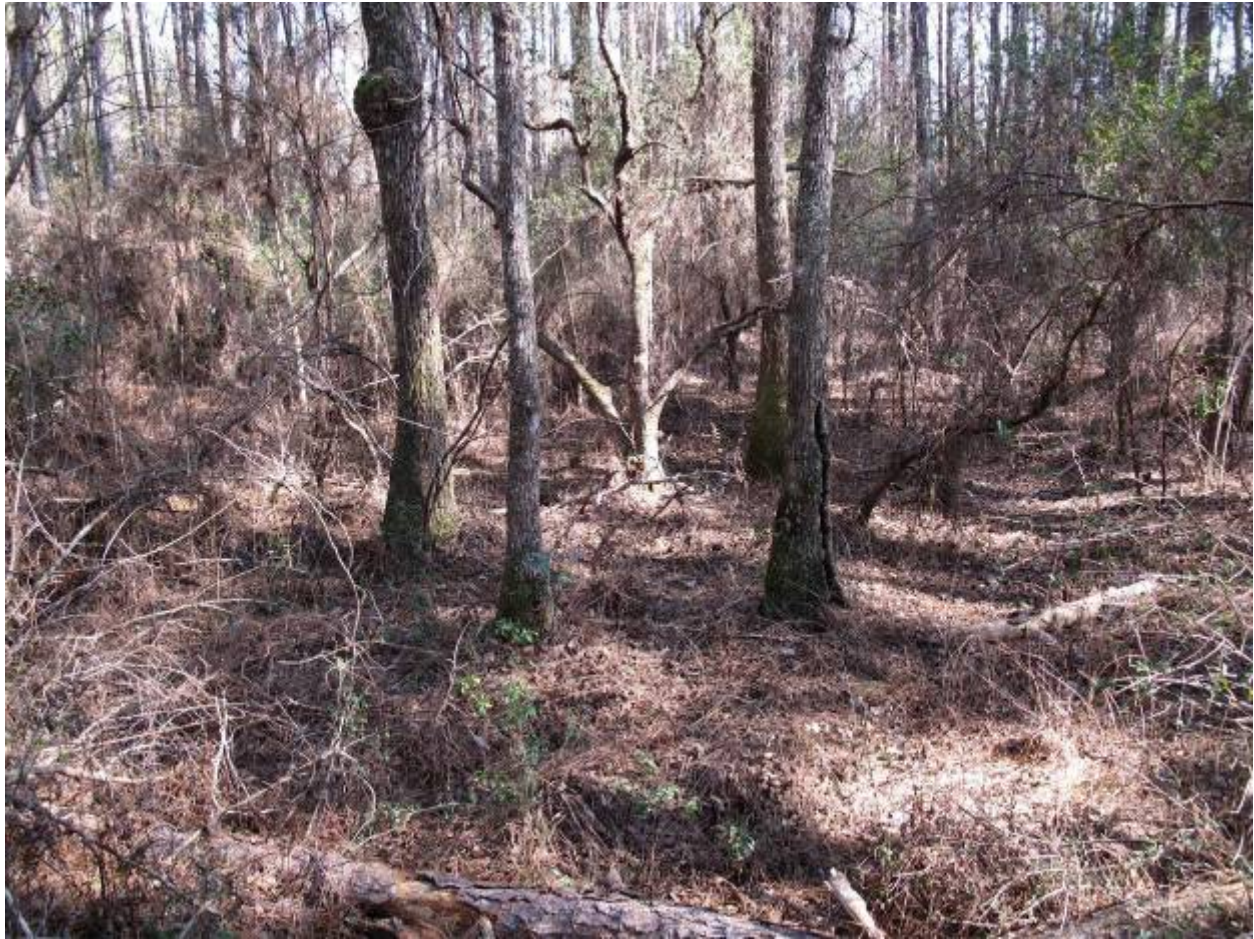
Description: This wetland is a <0.1 ha ephemeral forested swamp. Gum trees dominate the canopy, and cover >75% of the wetland. The midstory is dominated by titi, and covers 25-50% of the wetland. There is no herbaceous vegetation. This gum pond has a thick duff layer and old bedding rows through the interior. Although this MU burned recently, the uplands surrounding this wetland were not penetrated by fire. The adjacent uplands are mesic flatwoods that were bedded and converted to a pine plantation. Upland restoration is in progress.

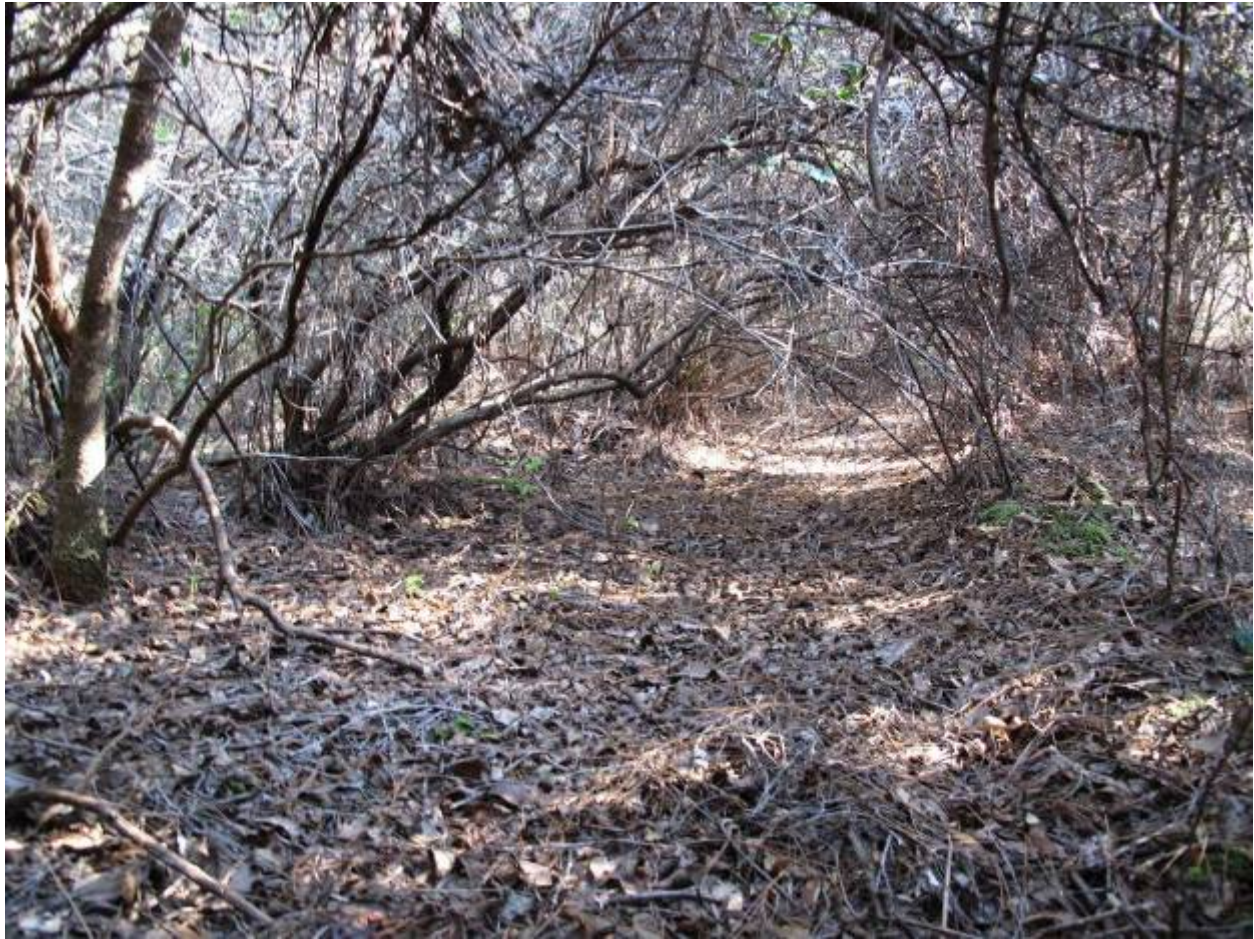
Wetland ID: 03-65

Description: This wetland is a 0.1 ha ephemeral shrub swamp. There is no tree canopy. Titi and fetterbush are the dominant woody vegetation, and cover >75% of the wetland. There is no herbaceous vegetation. Bedding rows run through the interior of the wetland. Historic aerial photos suggest that this wetland once was a marsh or a more open wetland. The uplands were burned within the past year or two but the fire did not burn the thick wall of fetterbush ringing the wetland nor the dense titi in the interior. The adjacent uplands are mesic flatwoods that were bedded and converted to a pine plantation. Upland restoration is in progress.

Wetland Concerns: Bedding, Woody encroachment

Restoration Action Recommended: Encourage periodic fire in the wetland to reduce the dense titi.
