Inventory, Assessment, and Restoration Potential of Ephemeral Wetlands on FFWCC Wildlife Management Areas

Aucilla WMA Final Report

Submitted by: Rebecca P.M. Means¹, Ryan C. Means¹, Steven A. Johnson²

¹Coastal Plains Institute

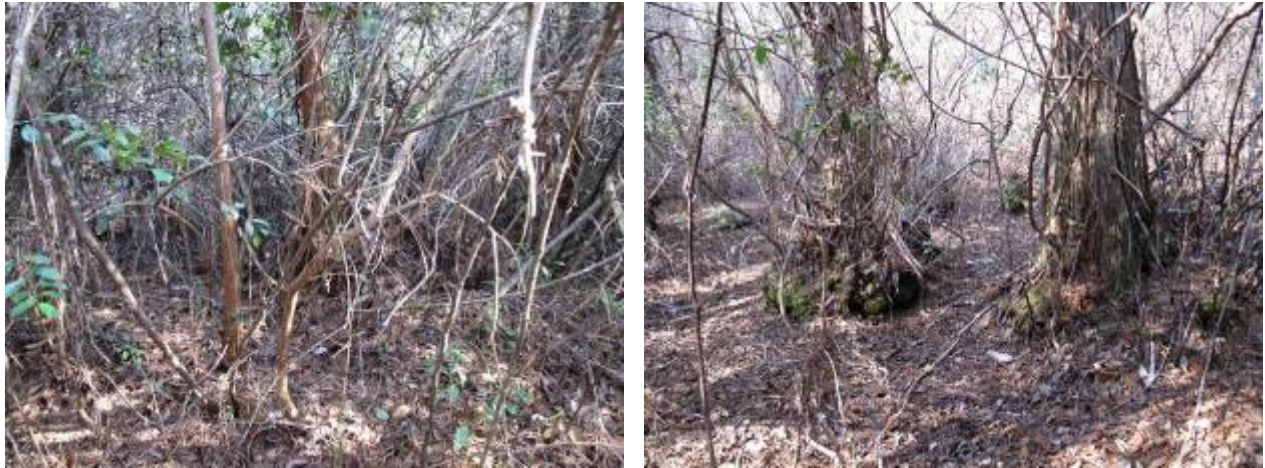
Wetland ID: 03-66

Description: This wetland is a 0.4 ha ephemeral mixed swamp. The presence of old cypress stumps provides evidence of historical logging. The cypress trees have regenerated and cover 50-75% of the wetland. The midstory is dominated by titi, and covers >75% of the wetland. There is no herbaceous vegetation. A thick duff layer covers the wetland floor. A major road (SR 59) bisects the northwest side of the wetland, creating 2 separate wetlands. The adjacent uplands are mesic flatwoods that were bedded and converted to a pine plantation. The uplands were burned within the past year or two but the fire did not reach into the wetland. Upland restoration is in progress.

Wetland Concerns: Road, Woody encroachment

Restoration Action Recommended: In order to restore the hydrology of this wetland and the larger wetland system, the road would have to be removed. Recognizing that this road is now a permanent fixture, we do not recommend any action relating to the road. The wetland could be monitored to ensure it is not affected by run-off or other impacts. Periodic fire in the wetland would reduce the dense titi and thick duff.

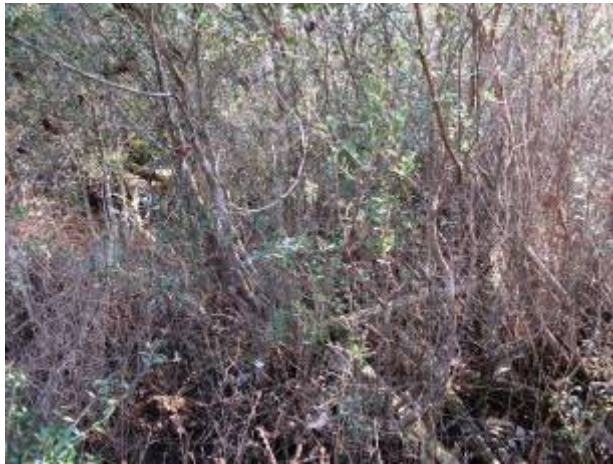
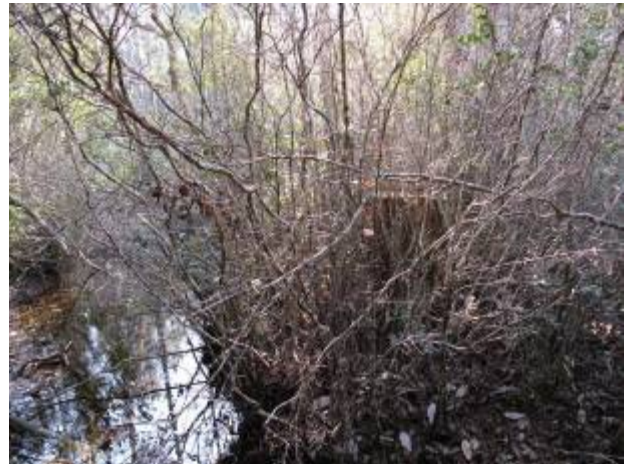
Wetland ID: 03-67

Description: This wetland is a 0.5 ha semi-permanent shrub swamp. The presence of old cypress stumps provides evidence of historical logging. The cypress trees are regenerating and cover 25-50% of the wetland. The midstory is dominated by titi, and covers >75% of the wetland. There is no herbaceous vegetation. The adjacent uplands are mesic flatwoods that were bedded and converted to a pine plantation. The uplands were burned within the past year or two but the fire did not reach into the wetland. Upland restoration is in progress.

Wetland Concerns: Woody encroachment

Restoration Action Recommended: Periodic fire in the wetland would reduce the dense titi and open the midstory.

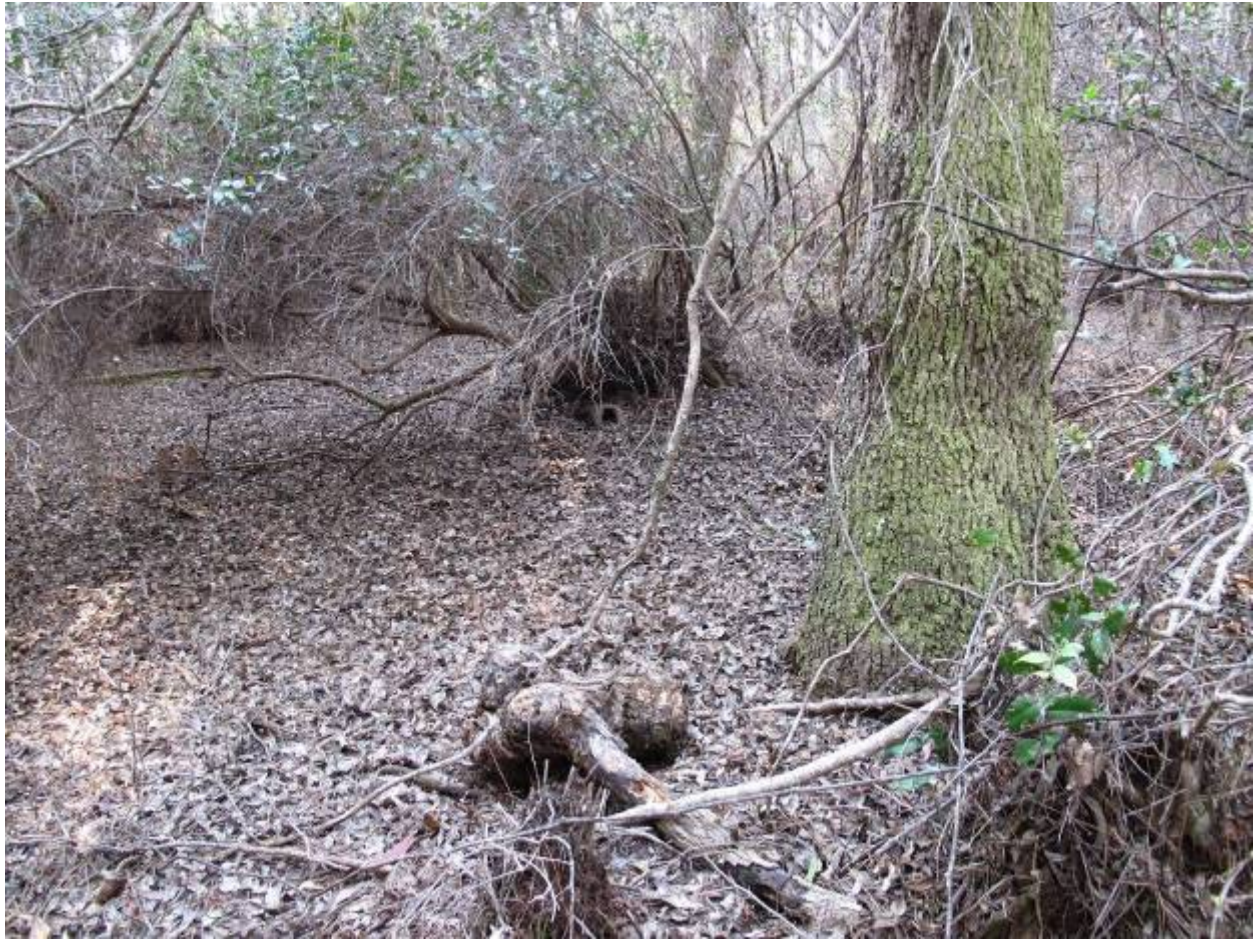
Wetland ID: 03-68

Description: This wetland is a 0.1 ha ephemeral shrub swamp. Gum trees dominate the canopy, and cover 5-25% of the wetland. The midstory is dominated by titi, and covers 50-75% of the wetland. There is no herbaceous vegetation. This small, circular sink depression pond is surrounded by a dense ring of titi. The uplands were burned within the past few years but the fire did not reach into the wetland. The adjacent uplands are mesic flatwoods that were bedded and converted to a pine plantation. Upland restoration is in progress.

Wetland Concerns: Woody encroachment

Restoration Action Recommended: Periodic fire would reduce the dense brush ring.

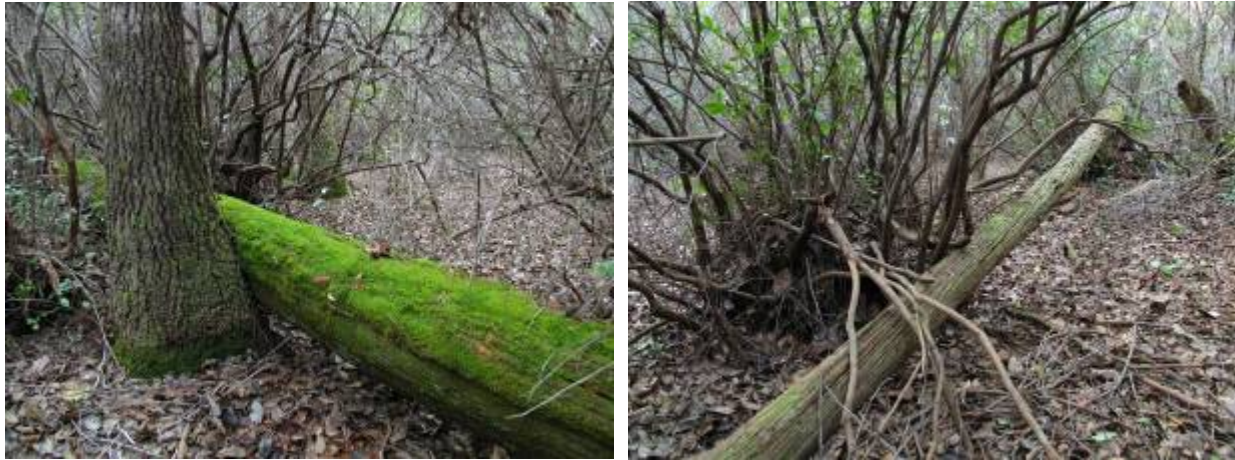
Wetland ID: 03-69

Description: This wetland is a 0.3 ha ephemeral shrub swamp. Cypress and gum trees dominate the canopy, and cover 25-50% of the wetland. The midstory is dominated by titi and fetterbush, and covers >75% of the wetland. There is no herbaceous vegetation. Old stumps and historical aerial photos provide evidence this wetland was once a forested swamp. The uplands were burned within the past few years but the fire did not reach into the wetland. The adjacent uplands are mesic flatwoods that were bedded and converted to a pine plantation. Upland restoration is in progress.

Wetland Concerns: Woody encroachment

Restoration Action Recommended: Periodic fire in the wetland would reduce the dense titi and open the midstory.

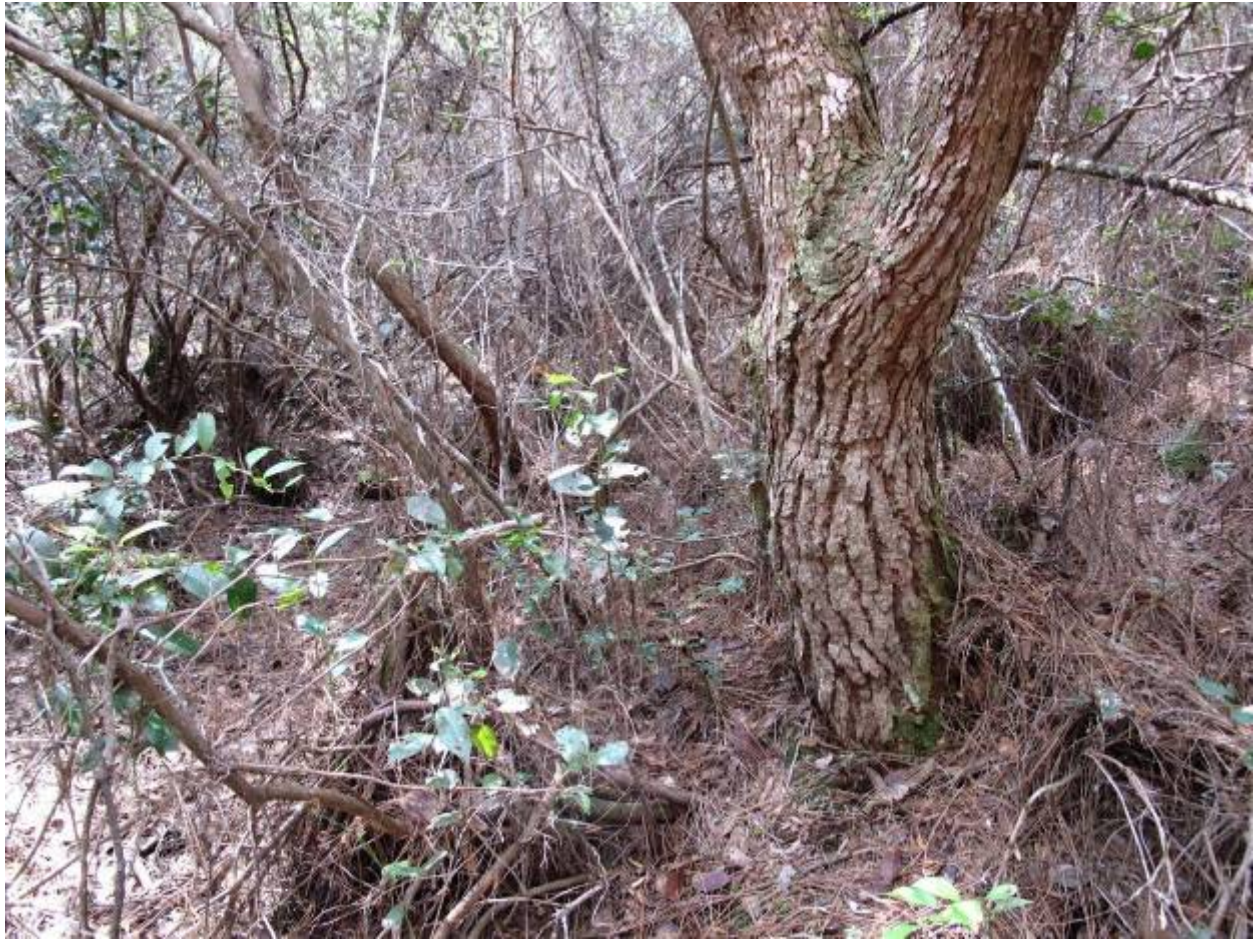
Wetland ID: 03-70

Description: This wetland is a 0.6 ha ephemeral mixed swamp. Cypress and pine trees dominate the canopy, and cover 50-75% of the wetland. The midstory is dominated by titi, and covers >75% of the wetland. There is no herbaceous vegetation. A very thick duff layer blankets the wetland floor. Old stumps and historical aerial photos provide evidence this wetland was once a forested swamp. Although this MU burned recently, the uplands surrounding this wetland were not penetrated by fire. The adjacent uplands are mesic flatwoods that were bedded and converted to a pine plantation. Upland restoration is in progress.

Wetland Concerns: Woody encroachment

Restoration Action Recommended: Periodic fire in the wetland would reduce the dense titi and thick duff.

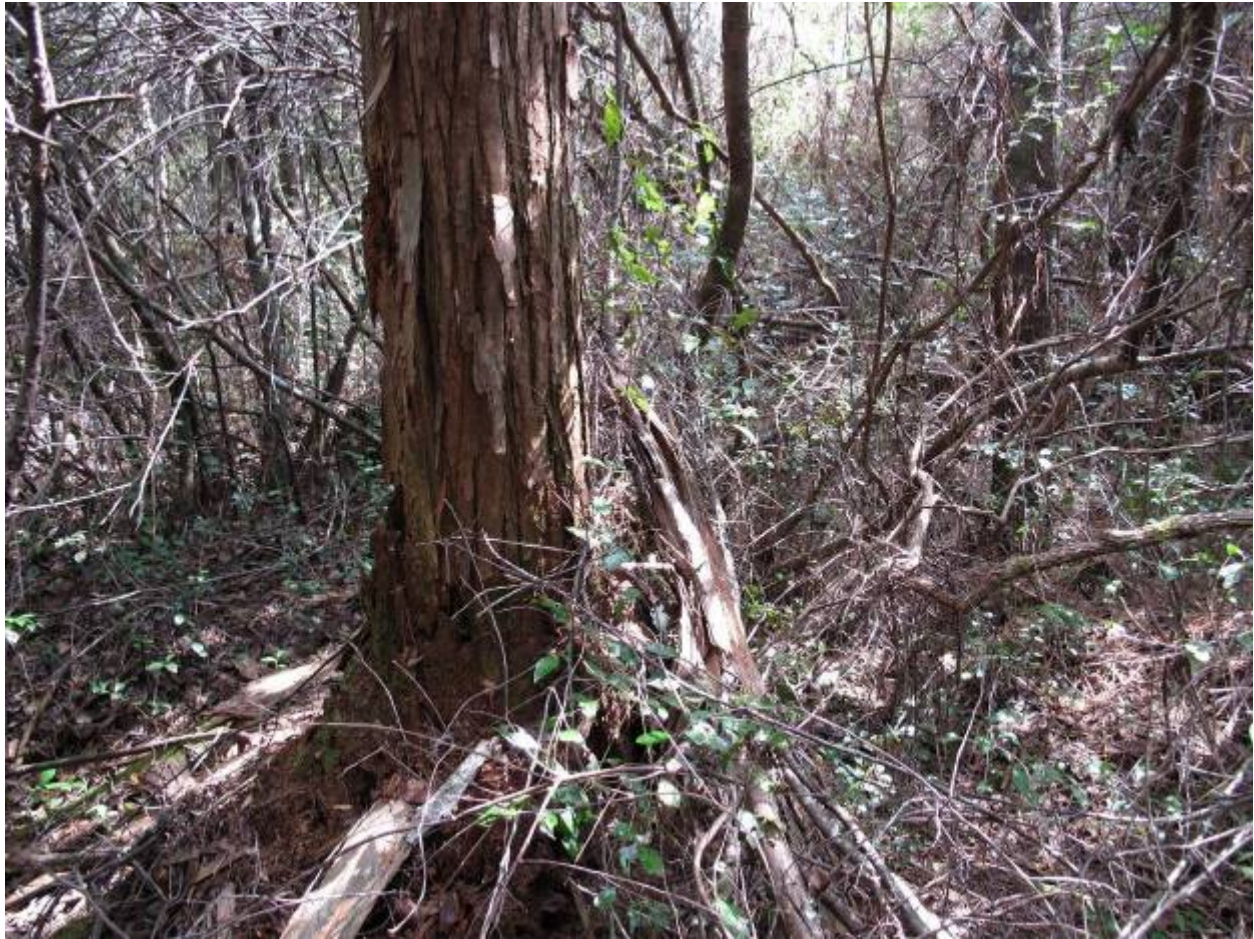
Wetland ID: 03-71

Description: This wetland is a 0.3 ha ephemeral shrub swamp. Cypress trees dominate the canopy, and cover 25-50% of the wetland. The midstory is dominated by titi, and covers >75% of the wetland. There is no herbaceous vegetation. A very thick duff layer covers the wetland floor. The north side is bedded through the wetland. Although this MU burned recently, the uplands surrounding this wetland were not penetrated by fire. The adjacent uplands are mesic flatwoods that were bedded and converted to a pine plantation. Upland restoration is in progress.

Wetland Concerns: Bedding, Woody encroachment

Restoration Action Recommended: No action to remove the minor bedding is recommended; the bedding rows will erode over time. Periodic fire in the wetland would reduce the dense titi and thick duff.

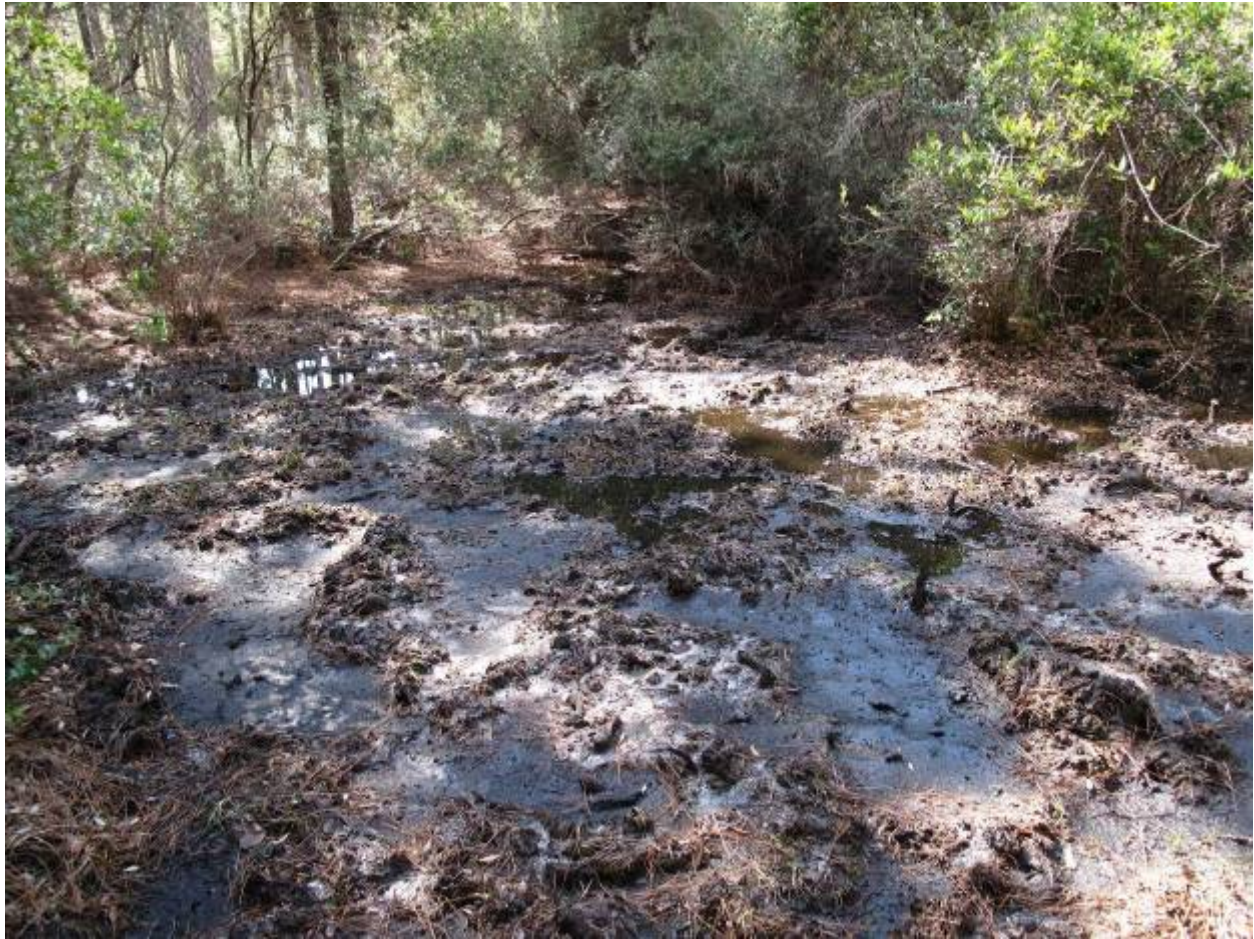
Wetland ID: 03-72

Description: This wetland is a 0.1 ha ephemeral marsh. There is no tree canopy. Titi forms a ring around the wetland edge, and covers 5-25% of the wetland. Sedges/grasses grow sparsely in the wetland, and cover 5-25% of the basin. This small wetland has been severely damaged by feral hogs. Although this MU burned recently, the uplands surrounding this wetland were not penetrated by fire. The adjacent uplands are mesic flatwoods that were bedded and converted to a pine plantation. Upland restoration is in progress.

Wetland Concerns: Feral hog damage, Woody encroachment

Restoration Action Recommended: Periodic fire would reduce the titi ring and prevent further encroachment.

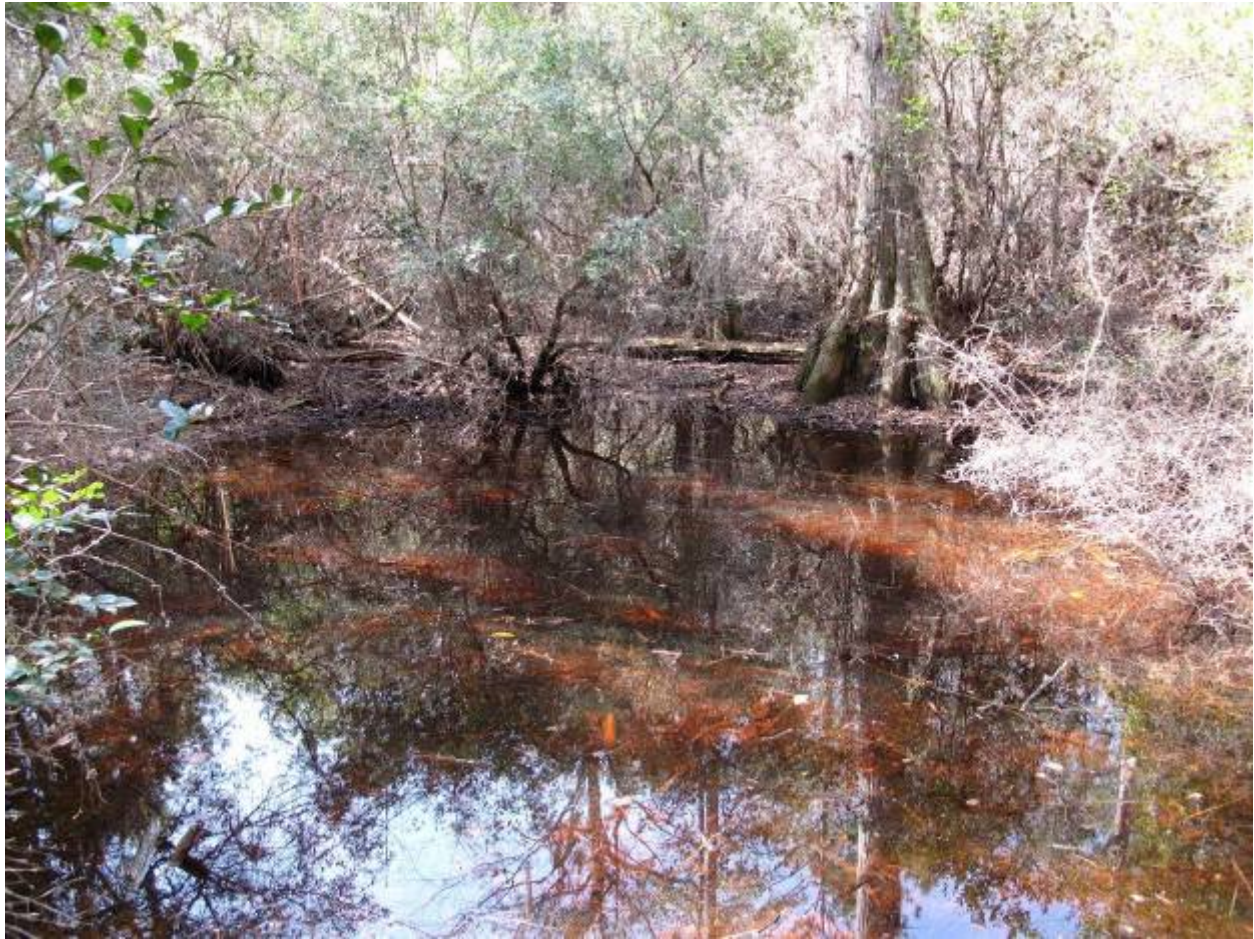
Wetland ID: 03-73

Description: This wetland is a 0.1 ha semi-permanent mixed swamp. The outer edge of the wetland is ringed with cypress trees and titi. The woody vegetation covers 50-75% of the wetland. There is no herbaceous vegetation and the wetland has a fairly thick duff layer. Although this MU burned recently, the uplands surrounding this wetland were not penetrated by fire. The adjacent uplands are mesic flatwoods that were bedded and converted to a pine plantation. Upland restoration is in progress.

Wetland Concerns: Woody encroachment

Restoration Action Recommended: Periodic fire in the wetland would reduce the dense titi ring.

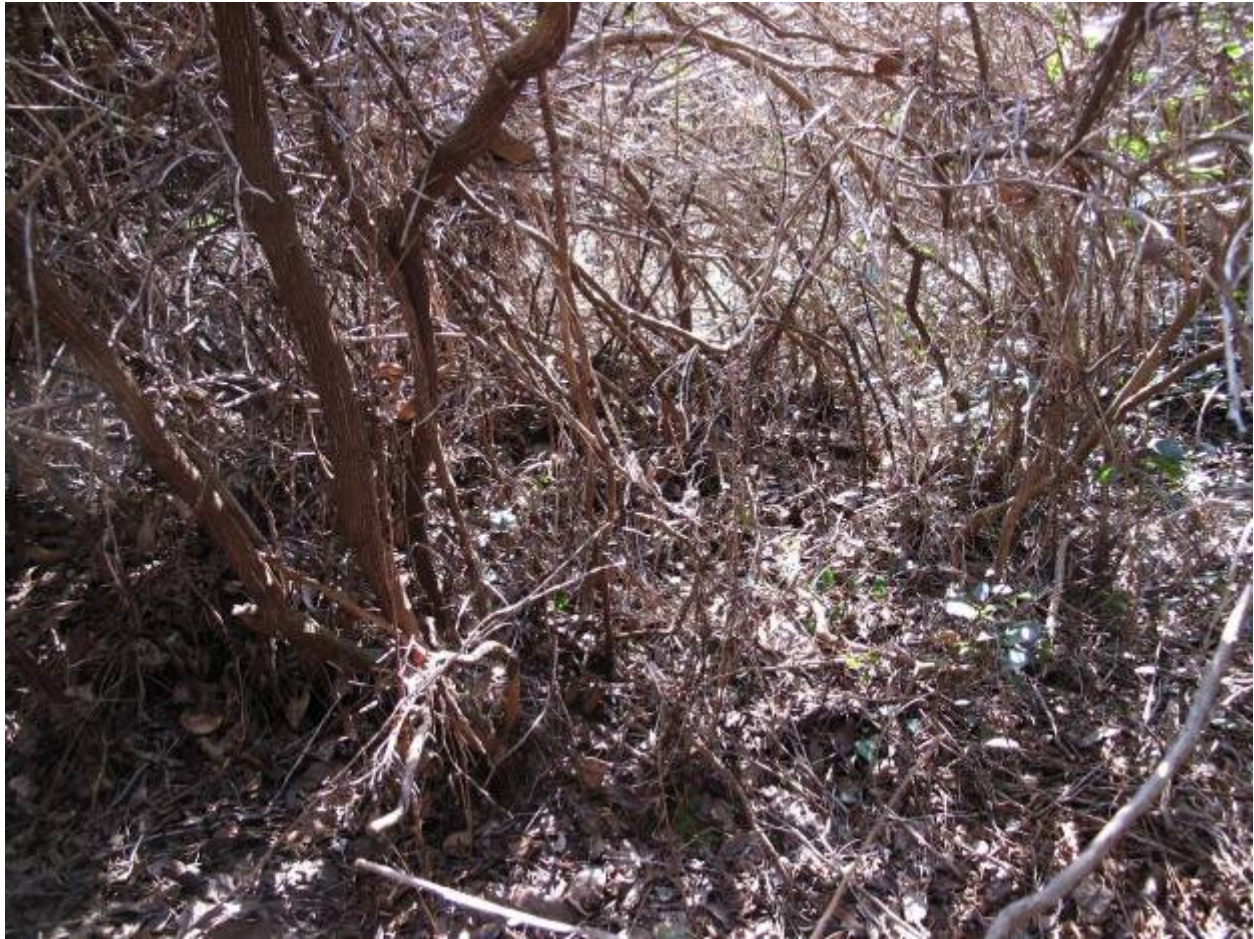
Wetland ID: 03-74

Description: This wetland is a 0.1 ha ephemeral shrub swamp. There is no tree canopy. Titi is the dominant woody vegetation, and covers >75% of the wetland. There is no herbaceous vegetation. A thick layer of duff covers the wetland floor. Historical aerial photos suggest this wetland (along with 03-75 and 03-76) was part of a larger, more open wetland system before pine plantation conversion. Although this MU burned recently, the uplands surrounding this wetland were not penetrated by fire. The adjacent uplands are mesic flatwoods that were bedded and converted to a pine plantation. Upland restoration is in progress.

Wetland Concerns: Woody encroachment

Restoration Action Recommended: Encourage periodic fire in the wetland to reduce the dense titi.

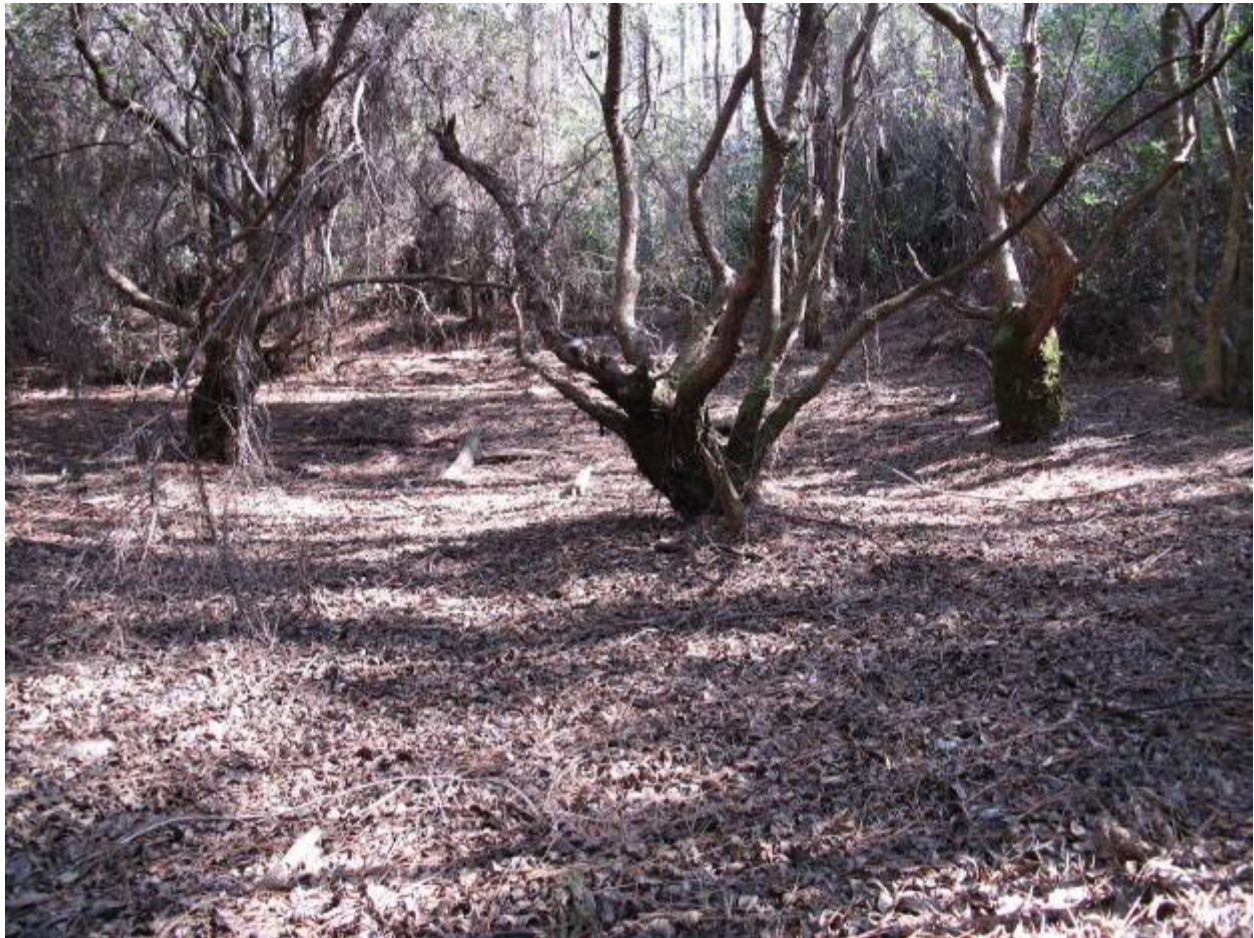
Wetland ID: 03-75

Description: This wetland is a <0.1 ha ephemeral shrub swamp. There is no tree canopy. Titi and holly are the dominant woody vegetation, and cover >75% of the wetland. There is no herbaceous vegetation. A thick duff layer covers the wetland floor. This relatively open sink depressional pond has a ring of brush around the edge. Historical aerial photos suggest this wetland (along with 03-74 and 03-76) was part of a larger, more open wetland system before pine plantation conversion. Although this MU burned recently, the uplands surrounding this wetland were not penetrated by fire. The adjacent uplands are mesic flatwoods that were bedded and converted to a pine plantation. Upland restoration is in progress.

Wetland Concerns: Woody encroachment

Restoration Action Recommended: Encourage periodic fire in the wetland to reduce the dense brush.

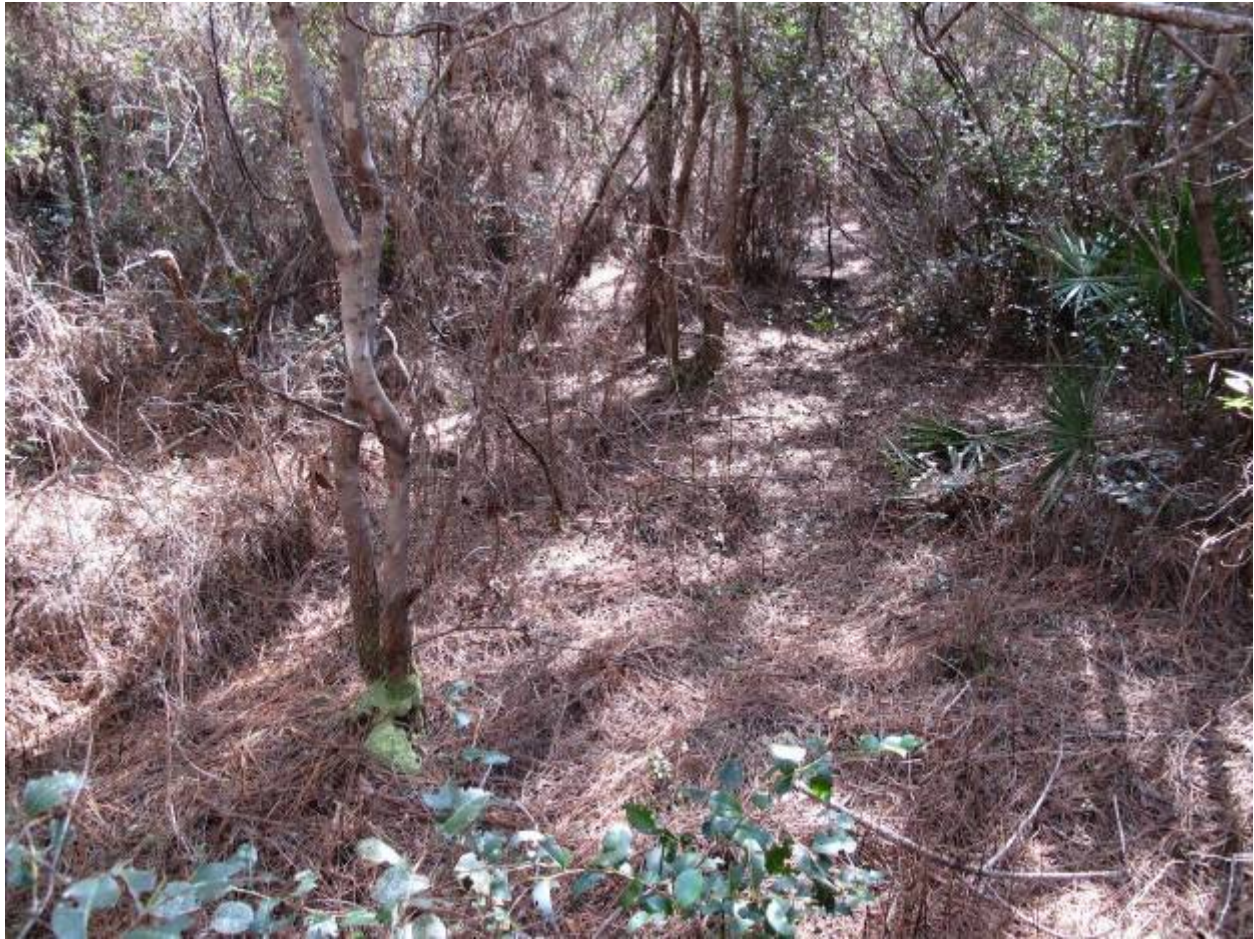
Wetland ID: 03-76

Description: This wetland is a <0.1 ha highly ephemeral shrub swamp. Pine trees were planted on bedding rows through the wetland. The tree canopy covers 5-25% of the wetland. The midstory is dominated by titi, and covers >75% of the wetland. There is no herbaceous vegetation and a thick layer of duff covers the wetland floor. Historical aerial photos suggest this wetland (along with 03-74 and 03-75) was part of a larger, more open wetland system before pine plantation conversion. Although this MU burned recently, the uplands surrounding this wetland were not penetrated by fire. The adjacent uplands are mesic flatwoods that were bedded and converted to a pine plantation. Upland restoration is in progress.

Wetland Concerns: Bedding, Planted pine trees, Woody encroachment

Restoration Action Recommended: Encourage periodic fire in the wetland to reduce the dense titi.

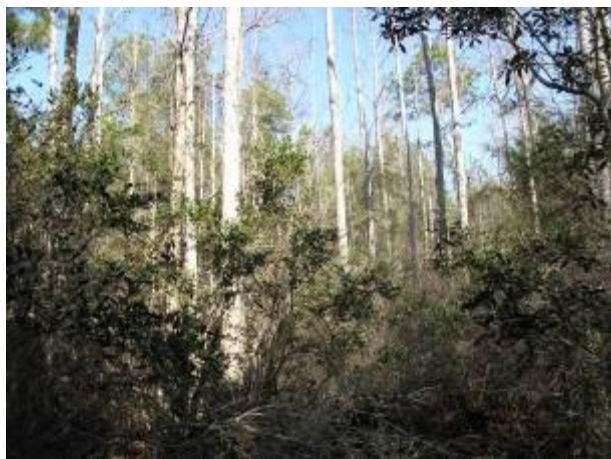
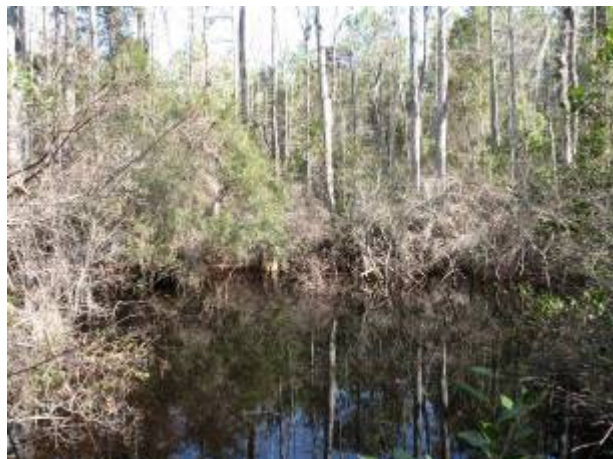
Wetland ID: 03-77

Description: This wetland is a 1.1 ha semi-permanent mixed swamp. The presence of old cypress stumps provides evidence of historical logging. The cypress trees have regenerated and cover 50-75% of the wetland. The midstory is dominated by titi, fetterbush, and wax myrtle, and covers >75% of the wetland. There is no herbaceous vegetation. Dense brush forms a ring around the wetland perimeter. Although this MU burned recently, the uplands surrounding this wetland were not penetrated by fire. The adjacent uplands are mesic flatwoods that were bedded and converted to a pine plantation. Upland restoration is in progress.

Wetland Concerns: Woody encroachment

Restoration Action Recommended: Periodic fire in the wetland would reduce the dense brush ring and open the midstory.

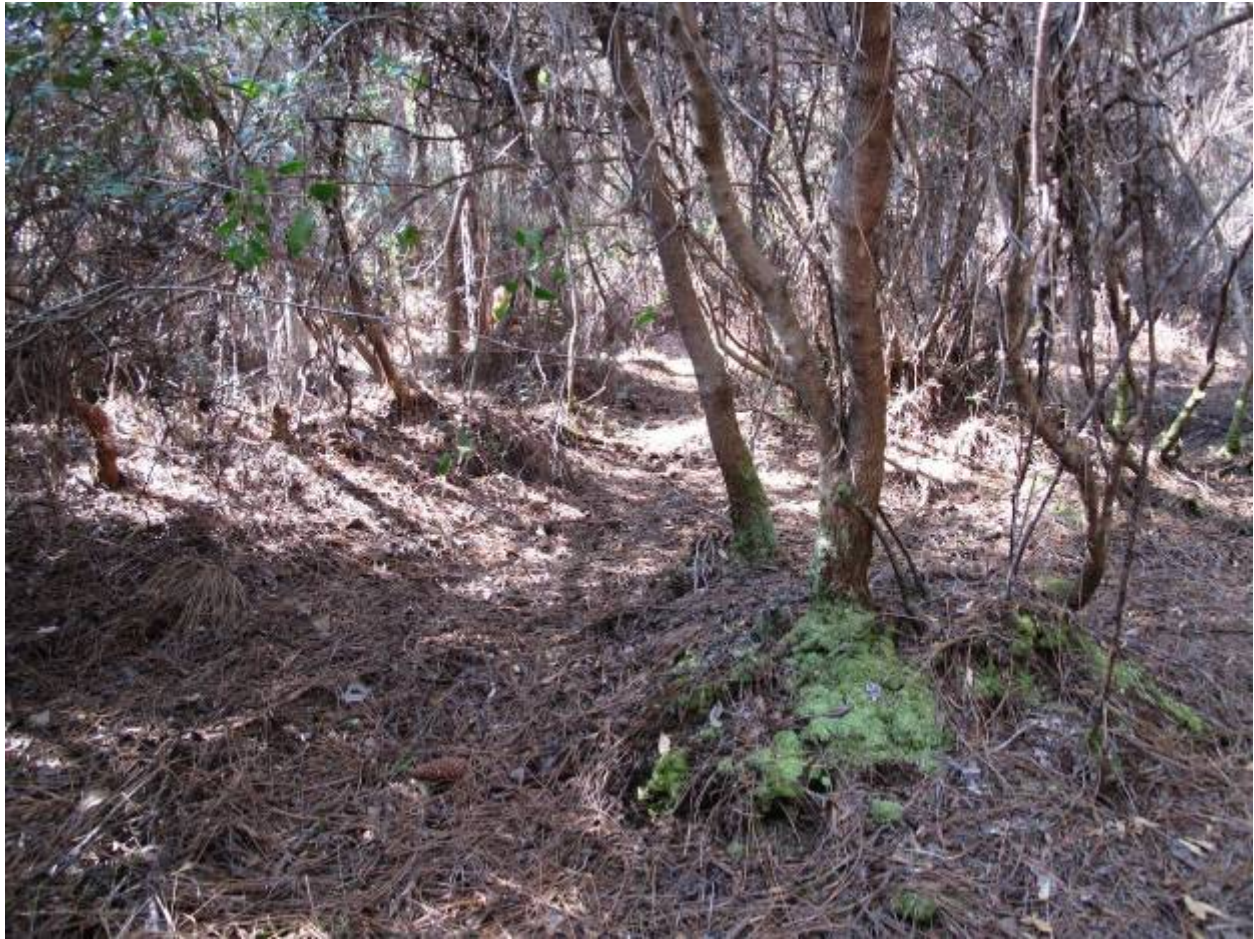
Wetland ID: 03-78

Description: This wetland is a <0.1 ha highly ephemeral shrub swamp. There is no tree canopy. Titi is the dominant woody vegetation, and covers 50-75% of the wetland. There is no herbaceous vegetation. Bedding rows were constructed into the wetland edge. Although this MU burned recently, the uplands surrounding this wetland were not penetrated by fire. The adjacent uplands are mesic flatwoods that were bedded and converted to a pine plantation. Upland restoration is in progress.

Wetland Concerns: Bedding, Woody encroachment

Restoration Action Recommended: No action to remove the bedding is recommended; the bedding rows will erode over time. Periodic fire in the wetland would reduce the brush.

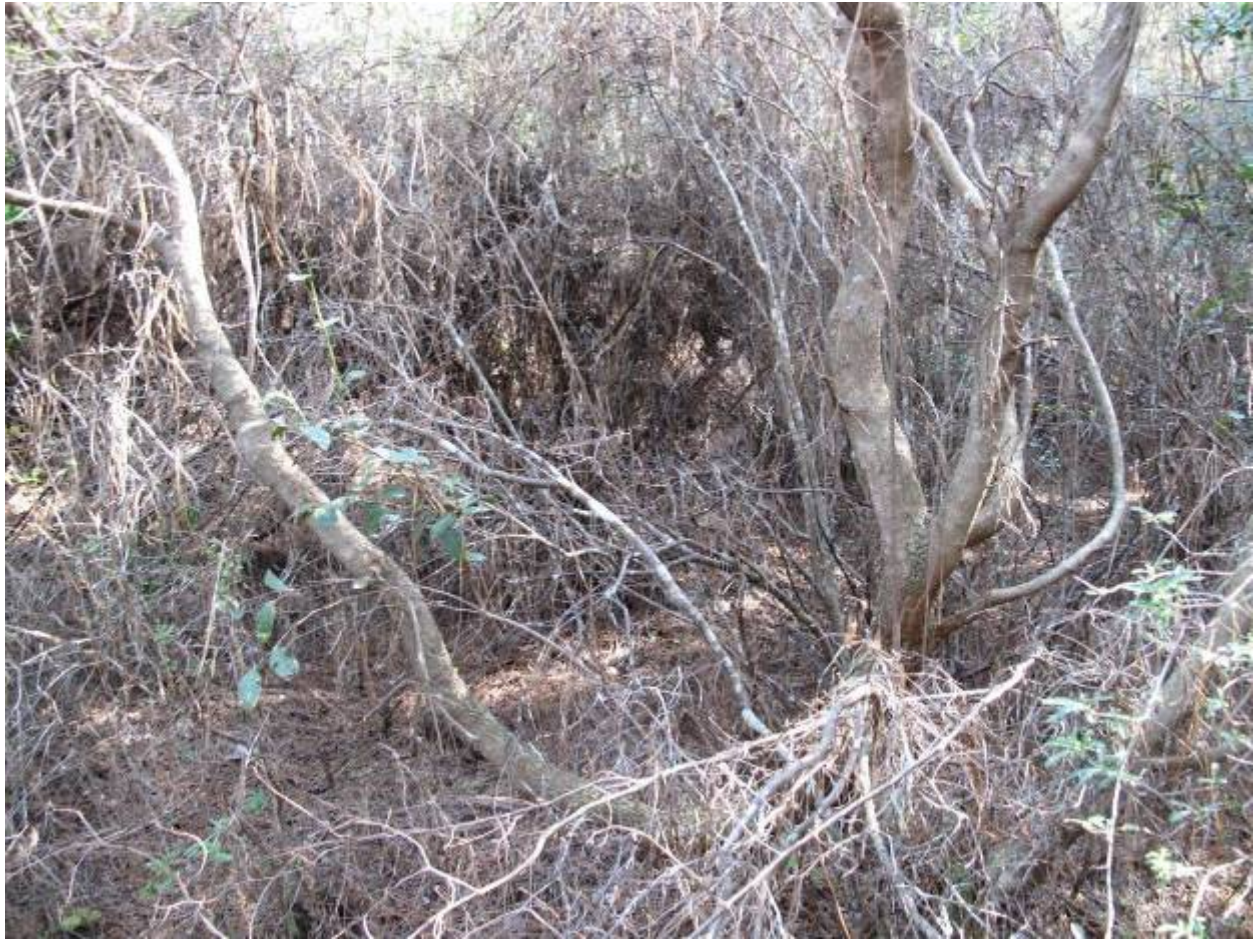
Wetland ID: 03-79

Description: This wetland is a <0.1 ha highly ephemeral shrub swamp. There is no tree canopy. Titi is the dominant woody vegetation, and covers 50-75% of the wetland. There is no herbaceous vegetation and there is a thick duff layer covering the wetland floor. This small wetland has old feral hog damage and bedding around the edges. Although this MU burned recently, the uplands surrounding this wetland were not penetrated by fire. The adjacent uplands are mesic flatwoods that were bedded and converted to a pine plantation. Upland restoration is in progress.

Wetland Concerns: Feral hog damage, Woody encroachment

Restoration Action Recommended: Periodic fire in the wetland would reduce the brush.

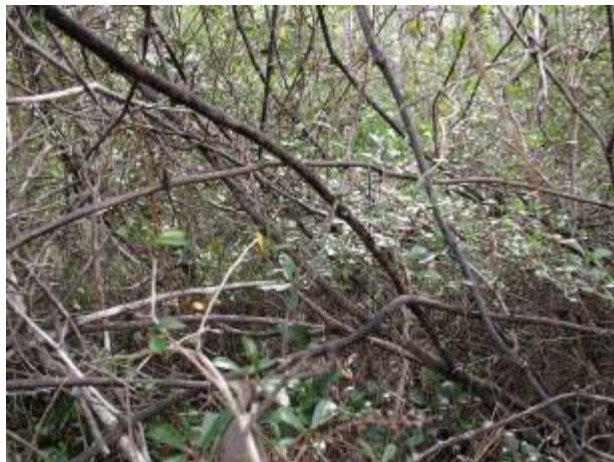
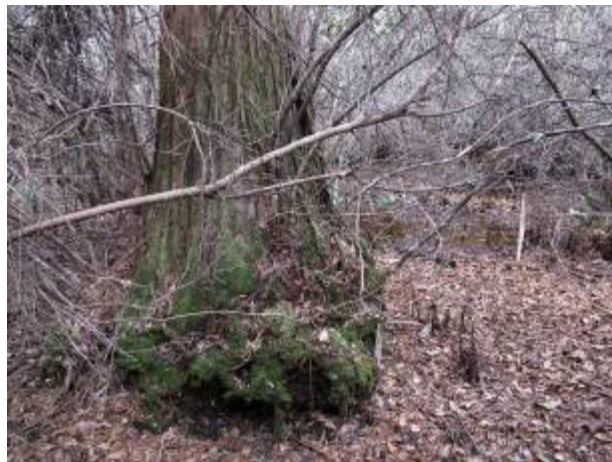
Wetland ID: 03-80

Description: This wetland is a 0.4 ha ephemeral mixed swamp. The presence of old cypress stumps provides evidence of historical logging. The cypress trees are regenerating and cover 25-50% of the wetland. The midstory is dominated by titi, and covers >75% of the wetland. There is no herbaceous vegetation. This wetland is nearly impenetrable around the perimeter and there is thick duff and shrub canopy in the interior. Although this MU burned recently, the uplands surrounding this wetland were not penetrated by fire. The adjacent uplands are mesic flatwoods that were bedded and converted to a pine plantation. Upland restoration is in progress.

Wetland Concerns: Woody encroachment

Restoration Action Recommended: Periodic fire in the wetland would reduce the dense titi and thick duff.

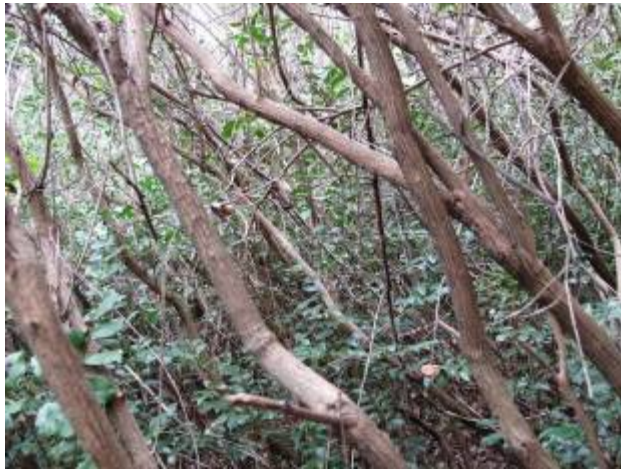
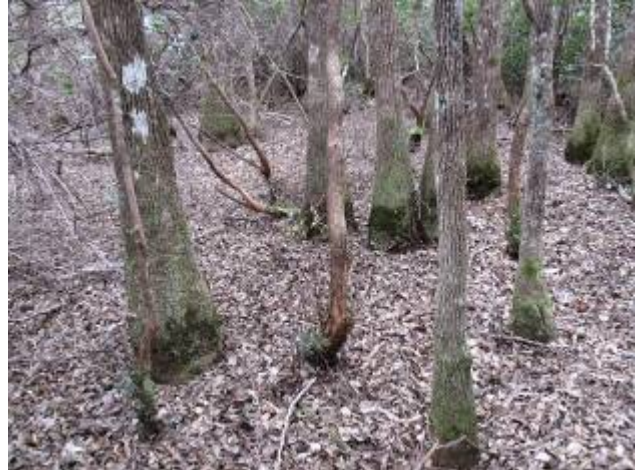
Wetland ID: 03-81

Description: This wetland is a <0.1 ha ephemeral mixed swamp. Gum trees dominate the canopy, and cover >75% of the wetland. The midstory is dominated by titi, and covers 50-75% of the wetland. There is no herbaceous vegetation. This wetland appears to be a former gum swamp that was encroached by titi. Although this MU burned recently, the uplands surrounding this wetland were not penetrated by fire. The adjacent uplands are mesic flatwoods that were bedded and converted to a pine plantation. Upland restoration is in progress.

Wetland Concerns: Woody encroachment

Restoration Action Recommended: Periodic fire in the wetland would reduce the titi and open the midstory.

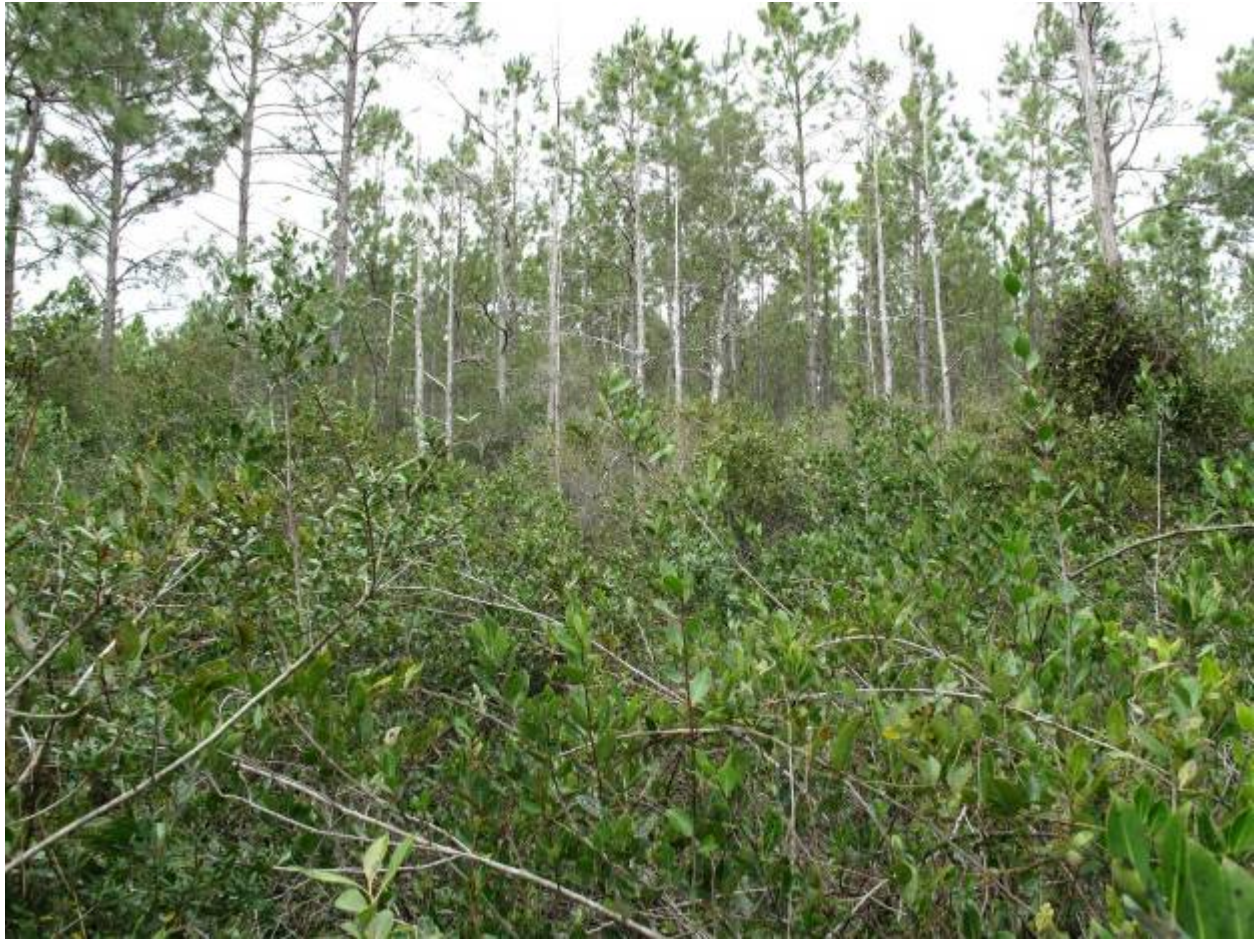
Description: This wetland is a 0.3 ha ephemeral shrub swamp. Cypress trees dominate the canopy, and cover 5-25% of the wetland. The midstory is dominated by titi, galberry, and smilax, covers >75% of the wetland. There is no herbaceous vegetation. This pond has an impenetrable wall of brush and smilax around the perimeter. Although this MU burned recently, the uplands surrounding this wetland were not penetrated by fire. The adjacent uplands are mesic flatwoods that were bedded and converted to a pine plantation. Upland restoration is in progress.

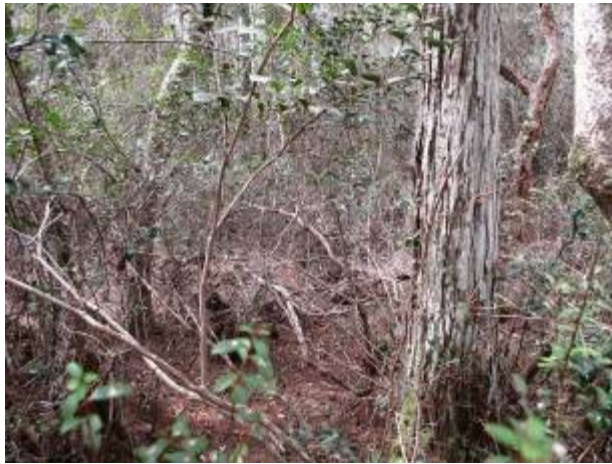
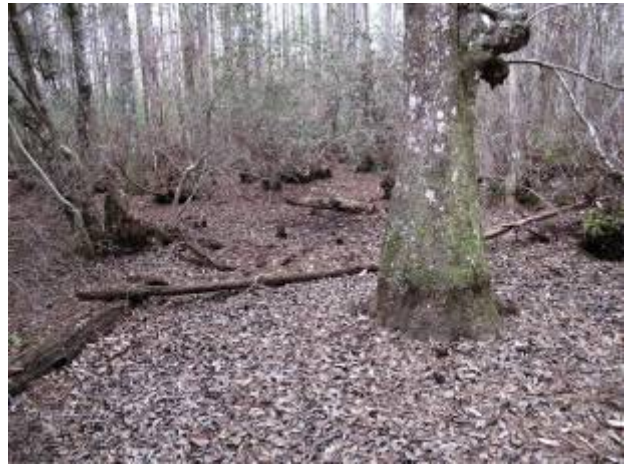
Wetland ID: 03-83

Description: This wetland is a 0.1 ha ephemeral mixed swamp. Cypress and gum trees dominate the canopy, and cover >75% of the wetland. The midstory is dominated by titi, and covers >75% of the wetland. There is no herbaceous vegetation. The presence of old cypress stumps provides evidence of historical logging. This wetland is densely ringed with brush but more open in the interior. Although this MU burned recently, the uplands surrounding this wetland were not penetrated by fire. The adjacent uplands are mesic flatwoods that were bedded and converted to a pine plantation. Upland restoration is in progress.

Wetland Concerns: Woody encroachment

Restoration Action Recommended: Periodic fire in the wetland would reduce the thick brush ring.

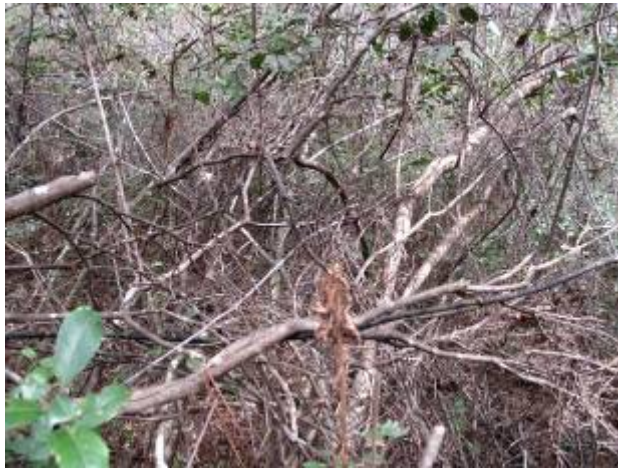
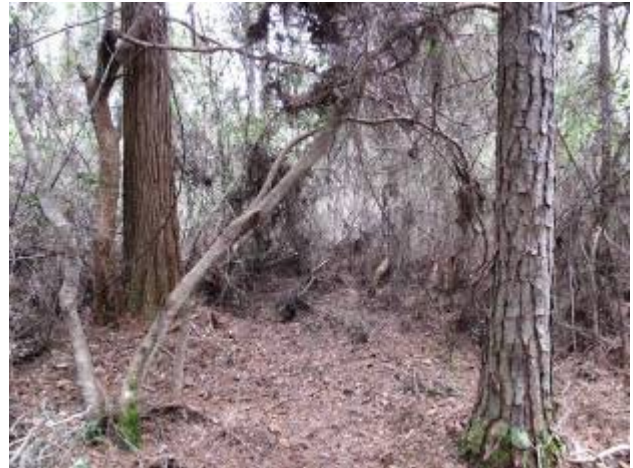
Wetland ID: 03-84

Description: This wetland is a <0.1 ha ephemeral mixed swamp. Cypress and gum trees dominate the canopy, and cover 50-75% of the wetland. The midstory is dominated by titi, and covers >75% of the wetland. There is no herbaceous vegetation and there is a thick duff layer covering the wetland floor. This wetland has a dense brush ring around the perimeter, an open center, and signs of old bedding. Although this MU burned recently, the uplands surrounding this wetland were not penetrated by fire. The adjacent uplands are mesic flatwoods that were bedded and converted to a pine plantation. Upland restoration is in progress.

Wetland Concerns: Bedding, Woody encroachment

Restoration Action Recommended: No action to remove the minor bedding is recommended; the bedding rows will erode over time. The dense titi ring could be reduced through the use of periodic fire.
