Inventory, Assessment, and Restoration Potential of Ephemeral Wetlands on FFWCC Wildlife Management Areas

Aucilla WMA Final Report

Submitted by: Rebecca P.M. Means¹, Ryan C. Means¹, Steven A. Johnson²

¹Coastal Plains Institute

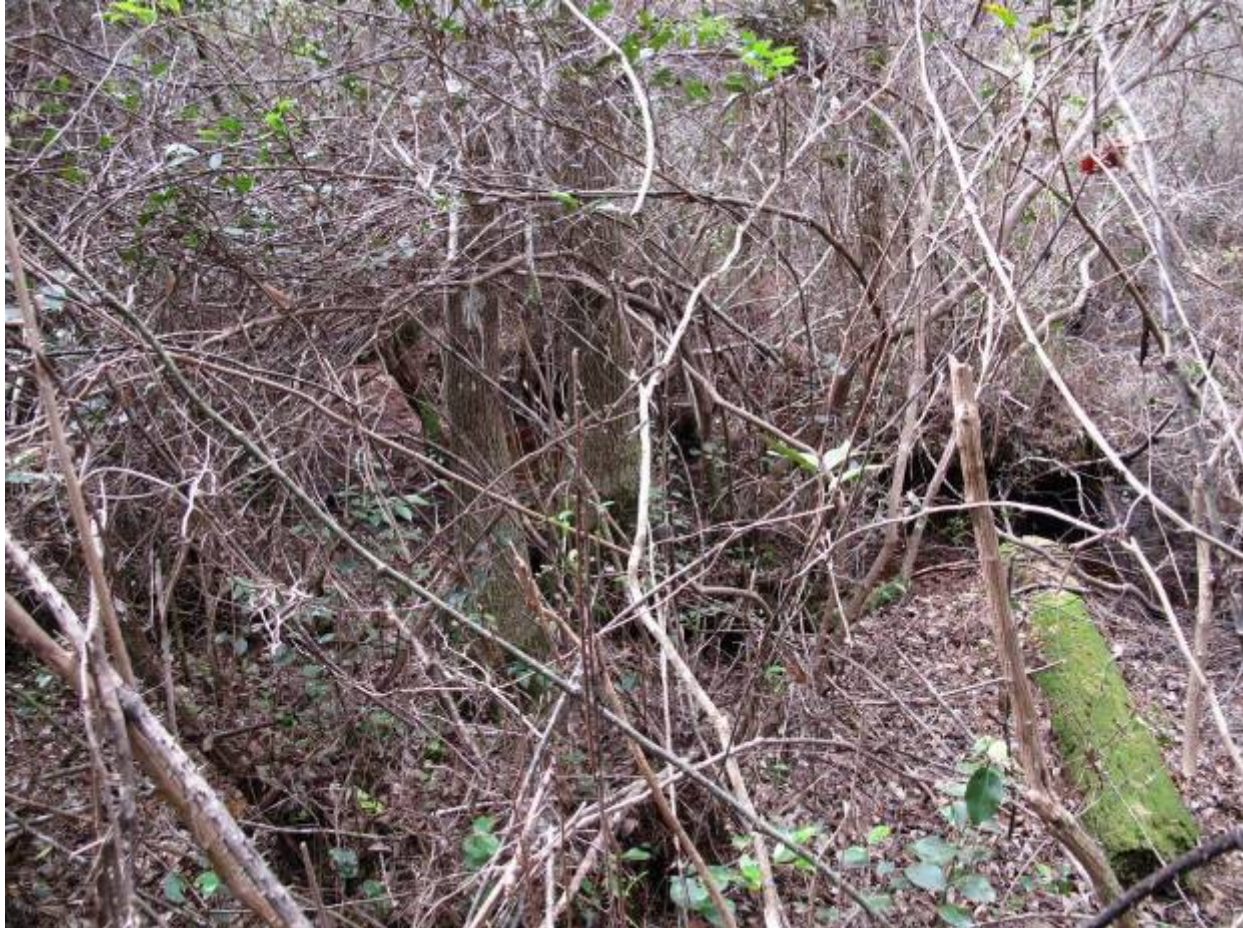
Wetland ID: 03-85

Description: This wetland is a 0.3 ha semi-permanent mixed swamp. Cypress and gum trees dominate the canopy, and cover 50-75% of the wetland. The midstory is dominated by titi, and covers >75% of the wetland. There is no herbaceous vegetation. Dense brush grows throughout this wetland and there are many large, old cypress stumps. Although this MU burned recently, the uplands surrounding this wetland were not penetrated by fire. The adjacent uplands are mesic flatwoods that were bedded and converted to a pine plantation. Upland restoration is in progress.

Wetland Concerns: Woody encroachment

Restoration Action Recommended: Periodic fire in the wetland would reduce the dense titi and open the midstory.

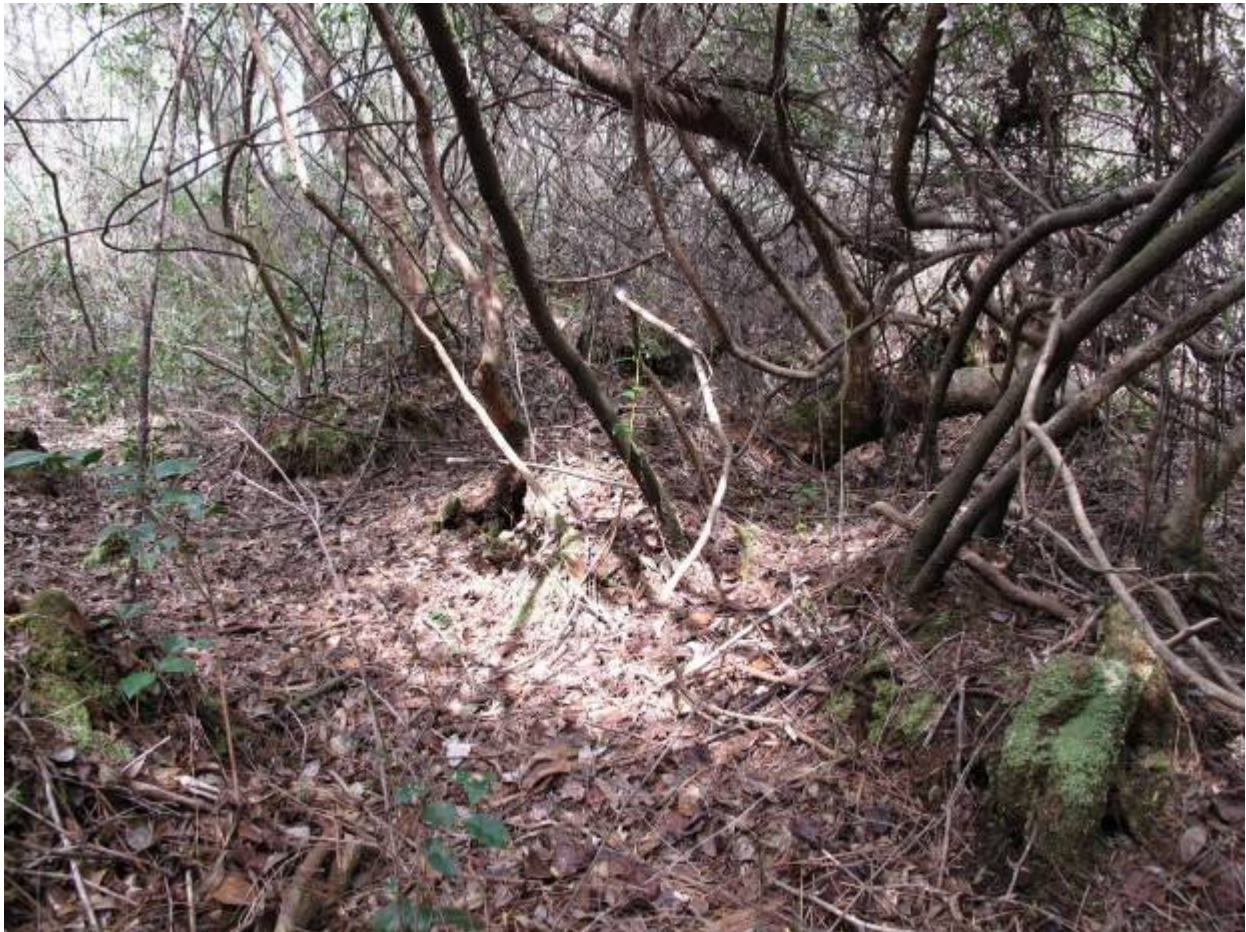
Wetland ID: 03-86

Description: This wetland is a 0.1 ha ephemeral shrub swamp. Cypress and gum trees dominate the canopy, and cover 25-50% of the wetland. The midstory is dominated by titi, and covers >75% of the wetland. There is no herbaceous vegetation. A thick duff layer covers the wetland floor. Dense shrubs have grown over old and weathered push piles in the wetland. Although this MU burned recently, the uplands surrounding this wetland were not penetrated by fire. The adjacent uplands are mesic flatwoods that were bedded and converted to a pine plantation. Upland restoration is in progress.

Wetland Concerns: Push piles, Woody encroachment

Restoration Action Recommended: The push pile is already eroding and weathering. Encourage periodic fire in the wetland to reduce the dense titi and thick duff.

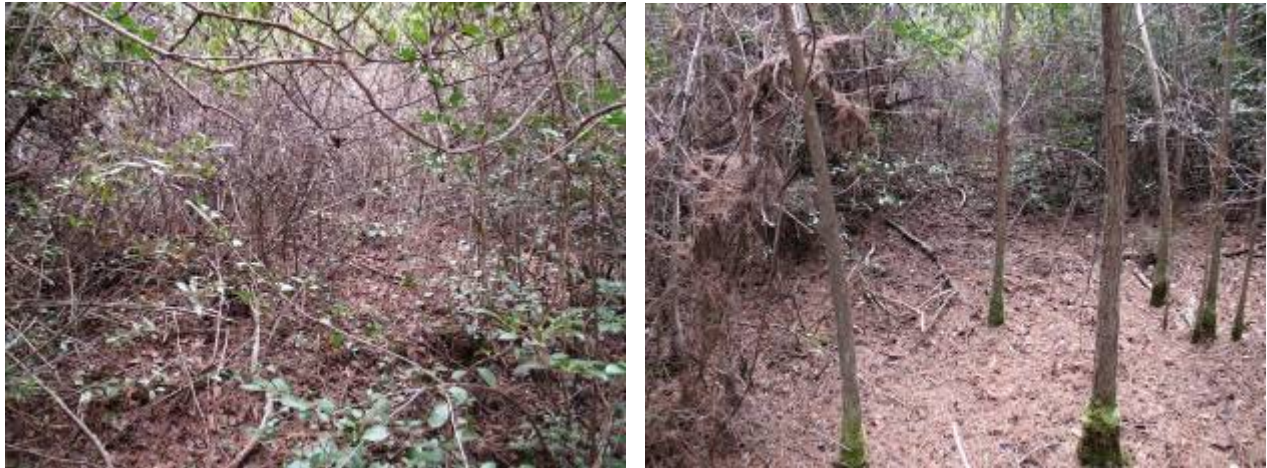
Wetland ID: 03-87

Description: This wetland is a 0.1 ha highly ephemeral shrub swamp. There is no tree canopy. Titi is the dominant woody vegetation, and covers >75% of the wetland. There is no herbaceous vegetation. This small shrub pond has at least one push pile in the center that has grown over with vegetation. Although this MU burned recently, the uplands surrounding this wetland were not penetrated by fire. The adjacent uplands are mesic flatwoods that were bedded and converted to a pine plantation. Upland restoration is in progress.

Wetland Concerns: Push piles, Woody encroachment

Restoration Action Recommended: Mechanically remove the push pile and simultaneously uproot the titi established on the push pile. This process should be completed when the wetland is completely dry and progress monitored. Return periodic fire to the wetland to prevent further titi encroachment.

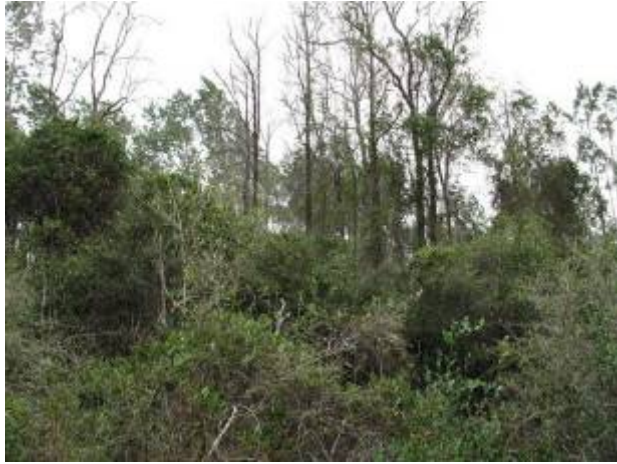
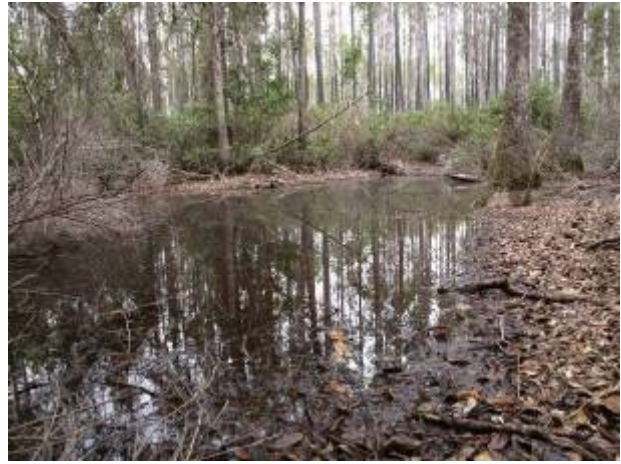
Wetland ID: 03-88

Description: This wetland is a 0.1 ha ephemeral mixed swamp. Gum trees dominate the canopy, and cover 50-75% of the wetland. The midstory is dominated by titi, and covers 50-75% of the wetland. There is no herbaceous vegetation. This pond has an open center but is surrounded by a ring of dense brush. Bedding rows were constructed in the wetland edges. Although this MU burned recently, the uplands surrounding this wetland were not penetrated by fire. The adjacent uplands are mesic flatwoods that were bedded and converted to a pine plantation. Upland restoration is in progress.

Wetland Concerns: Bedding, Woody encroachment

Restoration Action Recommended: No action to remove the minor bedding is recommended; the bedding rows will erode over time. Periodic fire would reduce the thick brush ring.

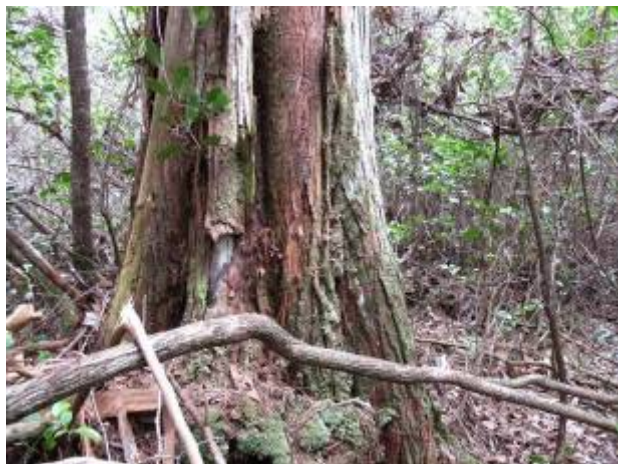
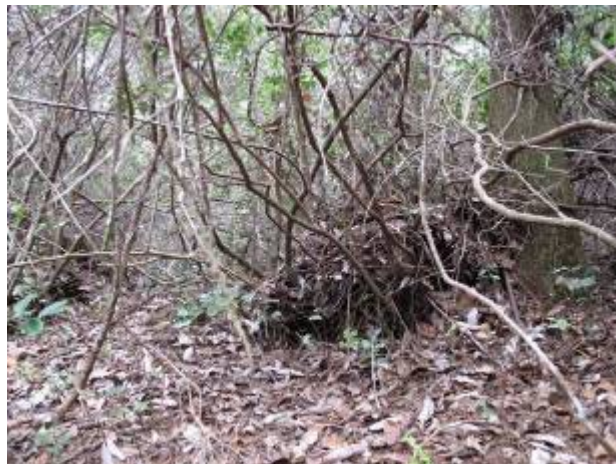
Wetland ID: 03-89

Description: This wetland is a 0.4 ha ephemeral shrub swamp. Cypress and gum trees dominate the canopy, and cover 25-50% of the wetland. The midstory is dominated by titi, and covers >75% of the wetland. There is no herbaceous vegetation. This rather big, circular wetland has extremely dense brush and a thick duff layer. The presence of old cypress stumps provides evidence of historical logging. Although this MU burned recently, the uplands surrounding this wetland were not penetrated by fire. The adjacent uplands are mesic flatwoods that were bedded and converted to a pine plantation. Upland restoration is in progress.

Wetland Concerns: Woody encroachment

Restoration Action Recommended: Periodic fire in the wetland would reduce the dense titi and thick duff.

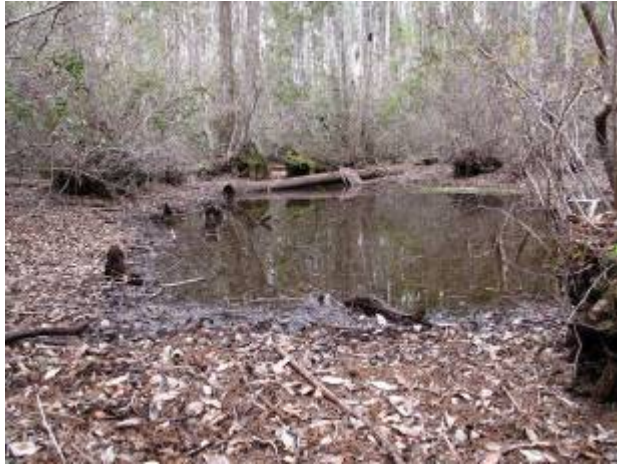
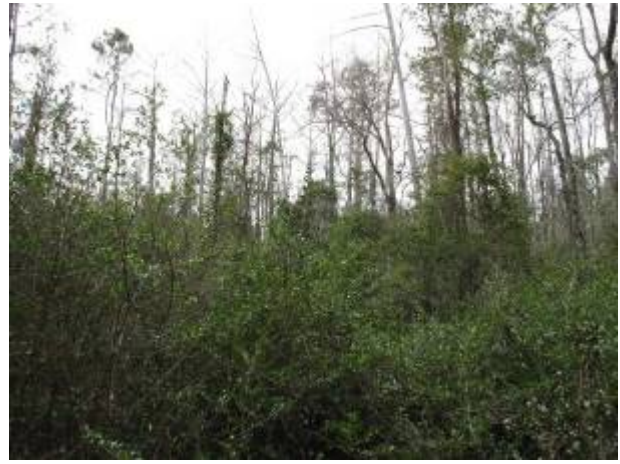
Wetland ID: 03-90

Description: This wetland is a 0.5 ha semi-permanent mixed swamp. Cypress and gum trees dominate the canopy, and cover >75% of the wetland. The midstory is dominated by titi, and covers 50-75% of the wetland. There is no herbaceous vegetation. This large wetland is fairly healthy but has a dense ring of brush and a thick duff layer. The presence of old cypress stumps provides evidence of historical logging. Although this MU burned recently, the uplands surrounding this wetland were not penetrated by fire. The adjacent uplands are mesic flatwoods that were bedded and converted to a pine plantation. Upland restoration is in progress.

Wetland Concerns: Woody encroachment

Restoration Action Recommended: Periodic fire in the wetland would reduce the dense titi ring and thick duff.

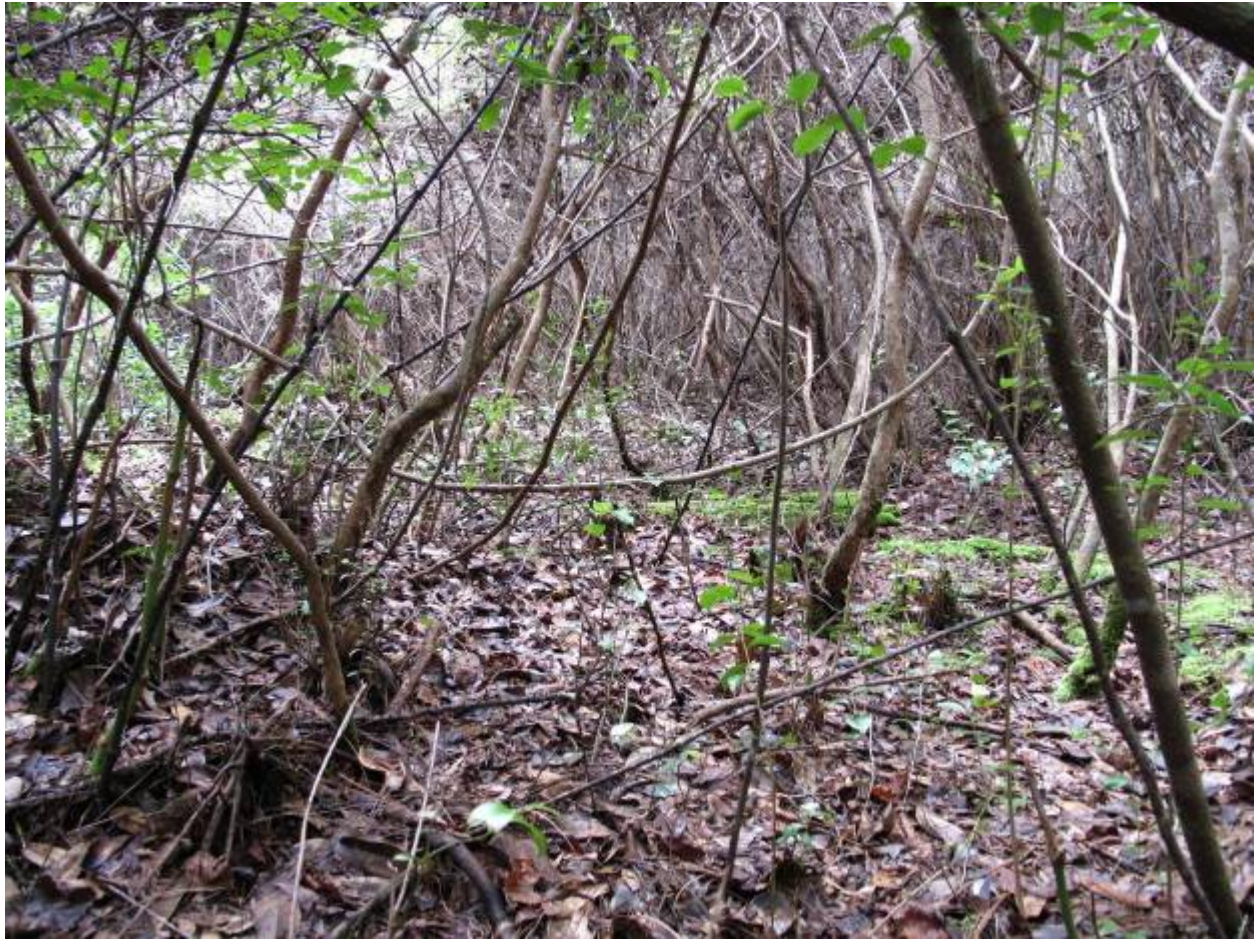
Description: This wetland is a 0.2 ha ephemeral shrub swamp. There is no tree canopy. Fetterbush is the dominant woody vegetation, and covers >75% of the wetland. There is no herbaceous vegetation. This circular pond has thick brush and duff. Old stumps provide evidence that cypress trees historically occupied the wetland. Although this MU burned recently, the uplands surrounding this wetland were not penetrated by fire. The adjacent uplands are mesic flatwoods that were bedded and converted to a pine plantation. Upland restoration is in progress.

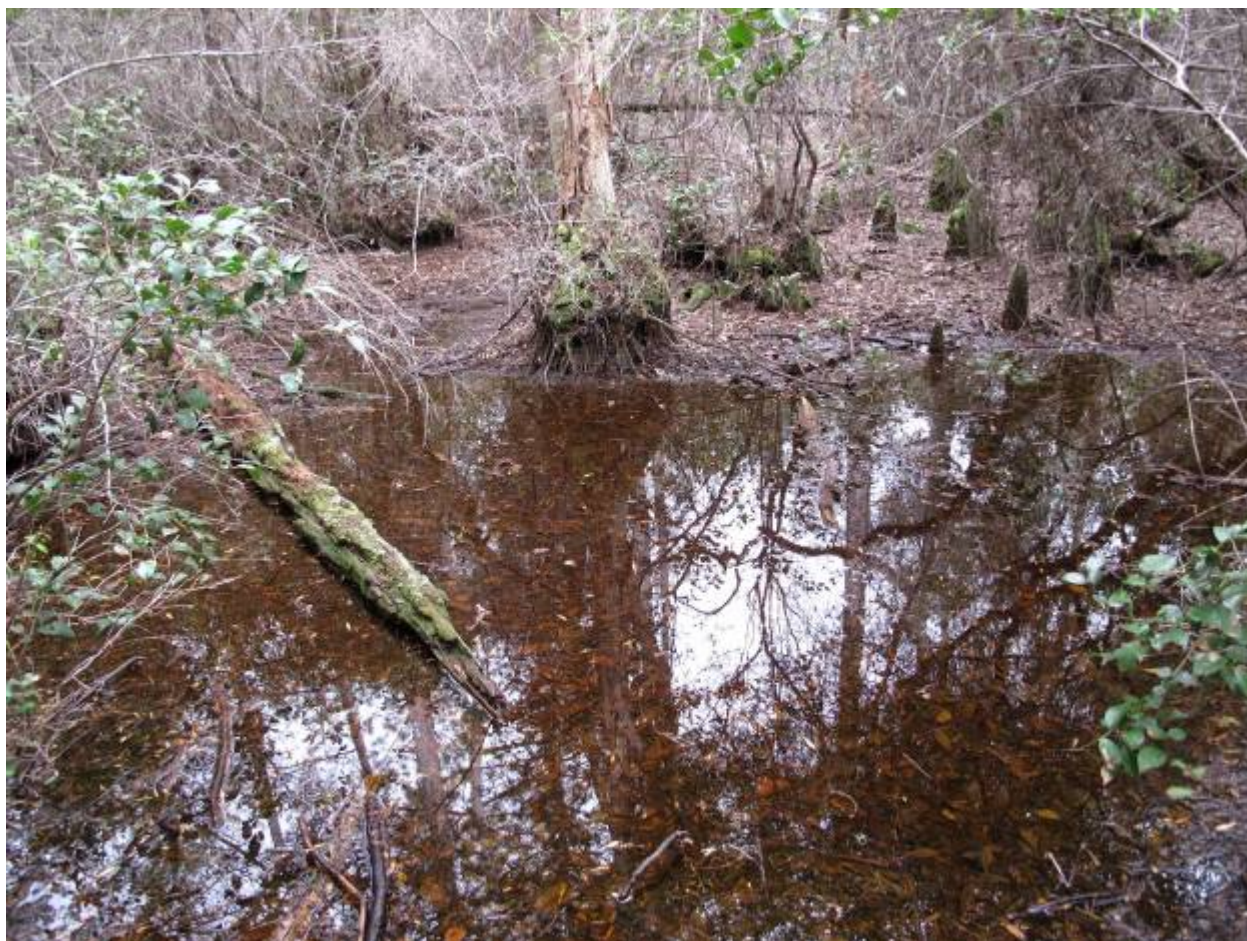
Wetland ID: 03-92

Description: This wetland is a 0.4 ha ephemeral mixed swamp. The presence of old cypress stumps provides evidence of historical logging. The cypress trees have regenerated and cover 50-75% of the wetland. The midstory is dominated by titi, and covers >75% of the wetland. There is no herbaceous ground cover. The wetland is surrounded by a dense ring of brush. Although this MU burned recently, the uplands surrounding this wetland were not penetrated by fire. The adjacent uplands are mesic flatwoods that were bedded and converted to a pine plantation. Upland restoration is in progress.

Wetland Concerns: Woody encroachment

Restoration Action Recommended: Periodic fire in the wetland would reduce the dense titi ring.

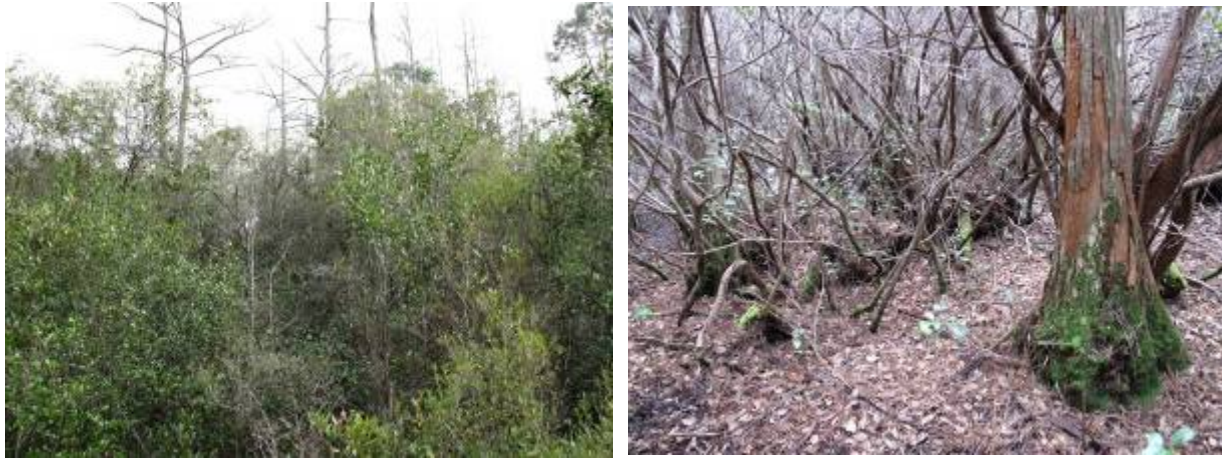
Wetland ID: 03-93

Description: This wetland is a 0.6 ha ephemeral mixed swamp. The presence of old cypress stumps provides evidence of historical logging. The cypress trees have regenerated and cover 50-75% of the wetland. The midstory is dominated by titi, and covers >75% of the wetland. There is no herbaceous vegetation. This fairly large wetland is extremely brushy throughout and has a thick layer of duff. Although this MU burned recently, the uplands surrounding this wetland were not penetrated by fire. The adjacent uplands are mesic flatwoods that were bedded and converted to a pine plantation. Upland restoration is in progress.

Wetland Concerns: Woody encroachment

Restoration Action Recommended: Periodic fire in the wetland would reduce the dense titi and thick duff.

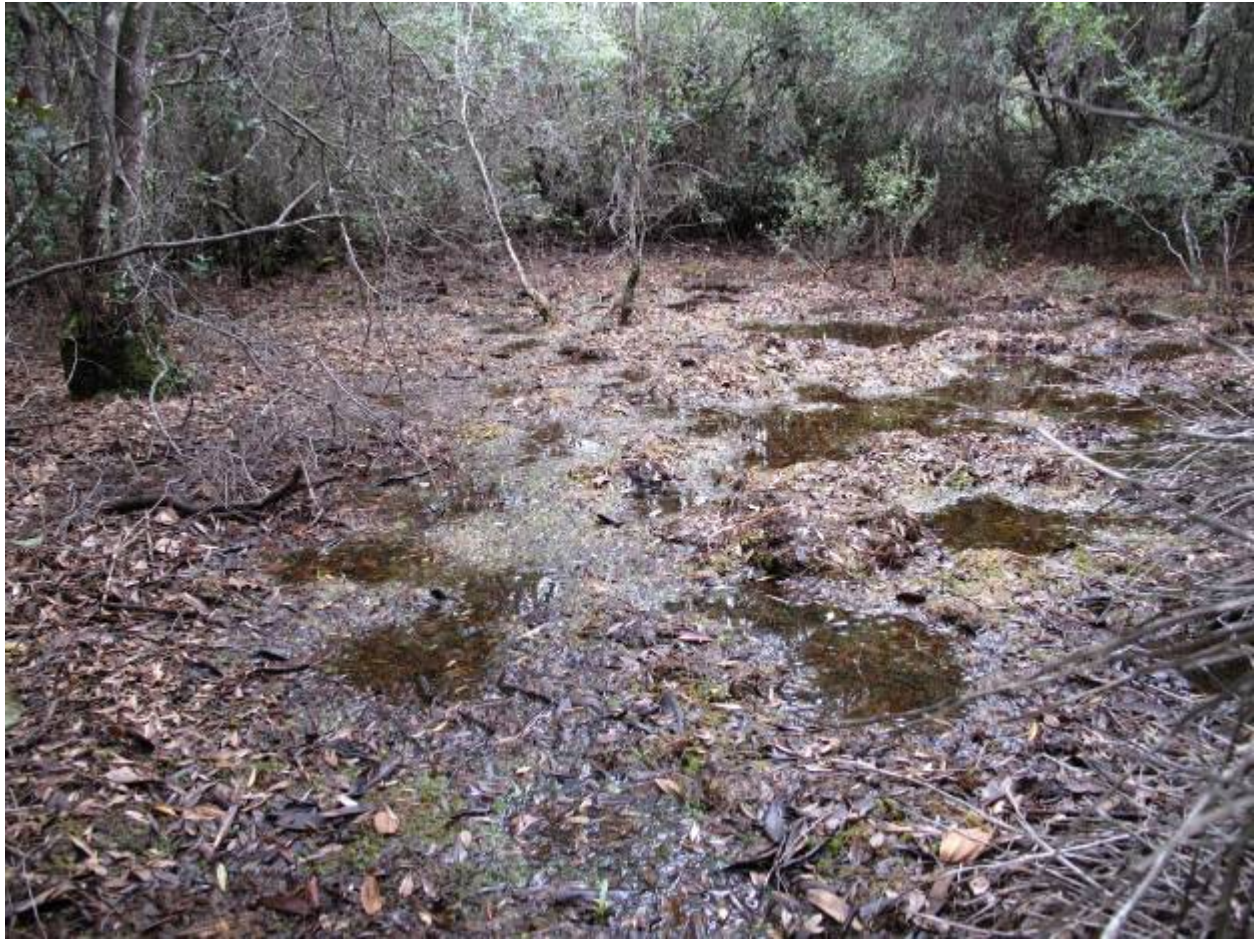
Wetland ID: 03-94

Description: This wetland is a 0.1 ha ephemeral shrub swamp. There is no tree canopy. Titi is the dominant woody vegetation, and covers >75% of the wetland. There is no herbaceous vegetation. This wetland has a dense ring of brush and a slightly open interior where old feral hog damage is evident. Although this MU burned recently, the uplands surrounding this wetland were not penetrated by fire. The adjacent uplands are mesic flatwoods that were bedded and converted to a pine plantation. Upland restoration is in progress.

Wetland Concerns: Feral hog damage, Woody encroachment

Restoration Action Recommended: Periodic fire in the wetland would reduce the dense titi ring.

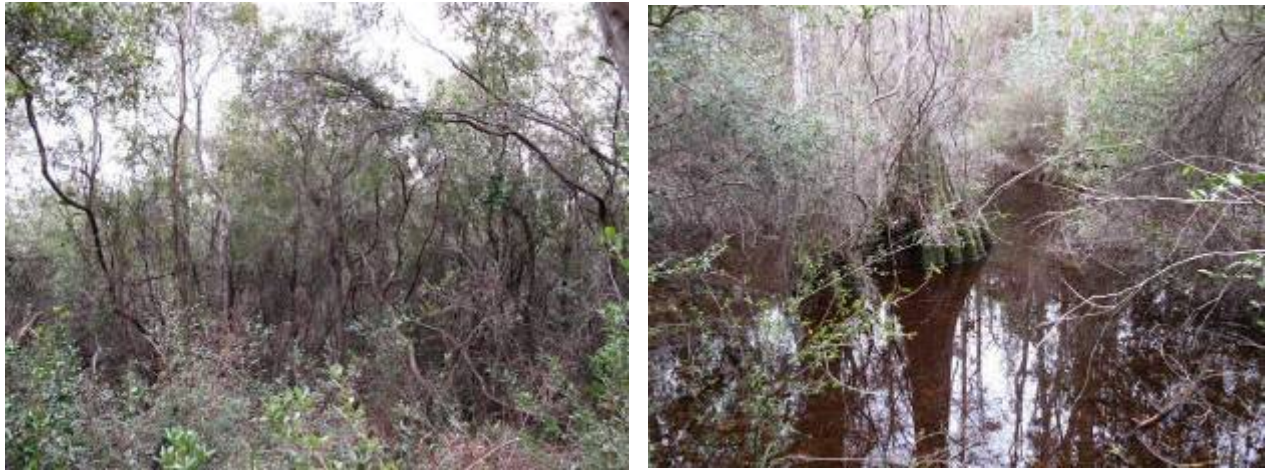
Wetland ID: 03-95

Description: This wetland is a 0.8 ha semi-permanent mixed swamp. Cypress trees dominate the canopy, and cover >75% of the wetland. The midstory is dominated by titi, and covers >75% of the wetland. There is no herbaceous vegetation. This large, circular wetland has a dense ring of brush and extremely thick duff. The presence of old cypress stumps provides evidence of historical logging. Although this MU burned recently, the uplands surrounding this wetland were not penetrated by fire. The adjacent uplands are mesic flatwoods that were bedded and converted to a pine plantation. Upland restoration is in progress.

Wetland Concerns: Woody encroachment

Restoration Action Recommended: Periodic fire in the wetland would reduce the dense titi and thick duff.

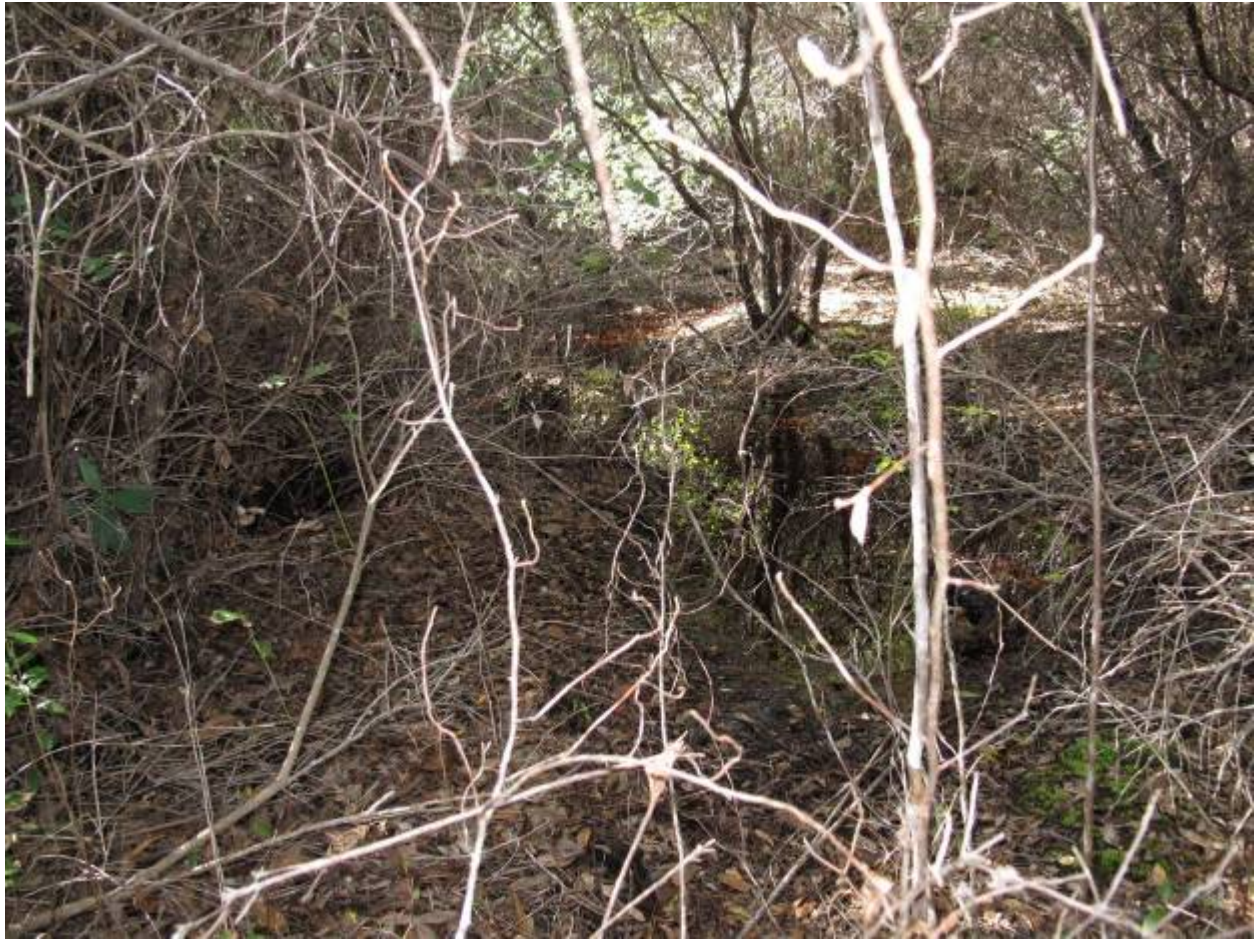
Description: This wetland is a 0.2 ha semi-permanent shrub swamp. It is difficult to discern whether this shrub wetland is a push pile turned wetland or a wetland covered by push piles. There is no tree canopy. Titi is the dominant woody vegetation, and covers >75% of the wetland. There is no herbaceous vegetation. The wetland is covered by push piles. Many push piles are grown over with titi. Deep gouges in the wetland have standing water. Although this MU burned recently, the uplands surrounding this wetland were not penetrated by fire. The adjacent uplands are mesic flatwoods that were bedded and converted to a pine plantation. Upland restoration is in progress.

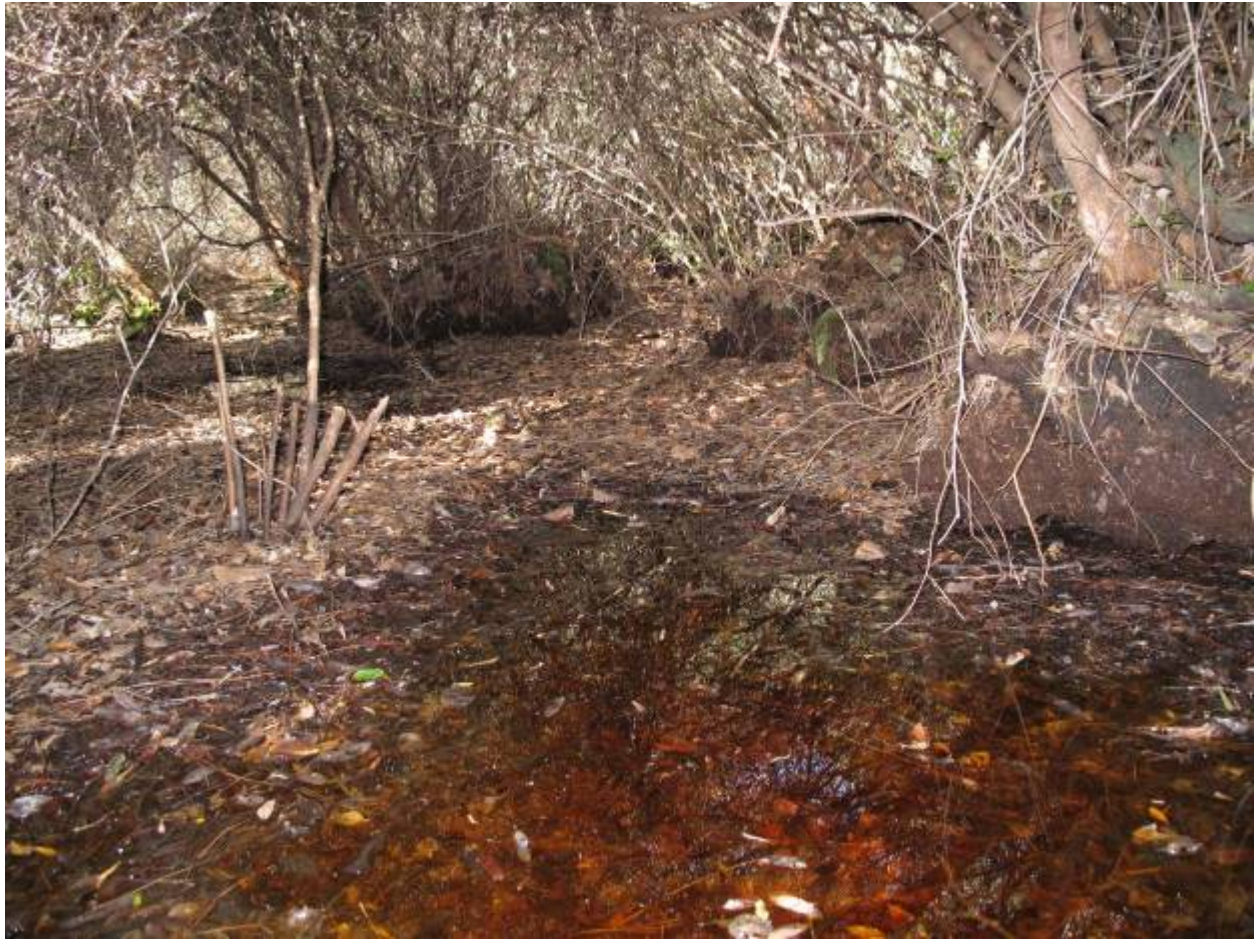
Wetland ID: 03-97

Description: This wetland is a 0.1 ha ephemeral shrub swamp. There is no tree canopy. Titi is the dominant woody vegetation, and covers >75% of the wetland. There is no herbaceous vegetation. There are many large hummocks and at least one push pile in the wetland. Although this MU burned recently, the uplands surrounding this wetland were not penetrated by fire. The adjacent uplands are mesic flatwoods that were bedded and converted to a pine plantation. Upland restoration is in progress.

Wetland Concerns: Push piles, Woody encroachment

Restoration Action Recommended: Mechanically remove the push pile and simultaneously uproot the titi and hummocks. This process should be completed when the wetland is completely dry and progress monitored. Return periodic fire to the wetland to prevent further titi encroachment.

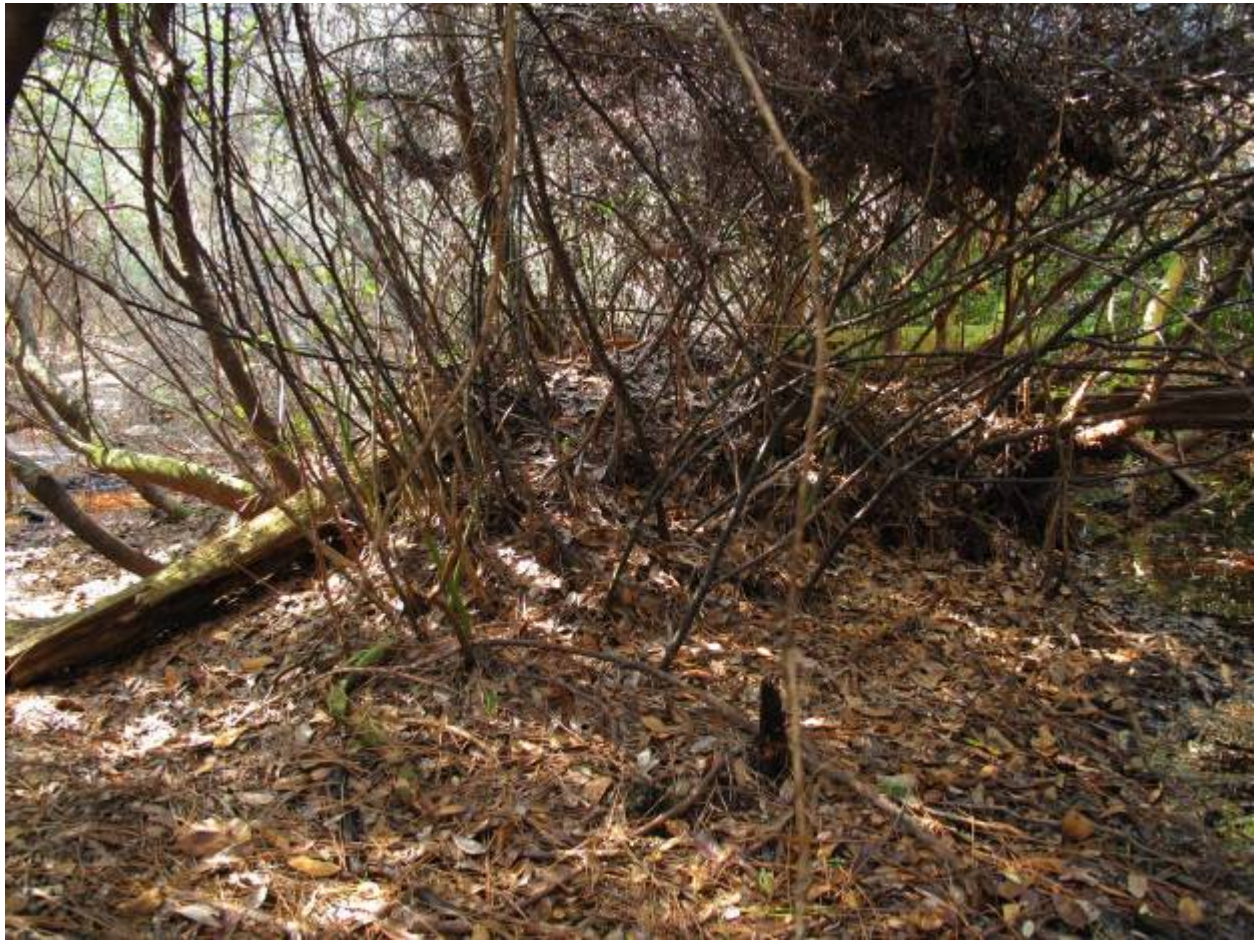
Description: This wetland is a 0.1 ha semi-permanent shrub swamp. There is no tree canopy. Titi is the dominant woody vegetation, and covers >75% of the wetland. There is no herbaceous vegetation. This extremely brushy wetland has large hummocks, push piles, and deep gouge holes. Although this MU burned recently, the uplands surrounding this wetland were not penetrated by fire. The adjacent uplands are mesic flatwoods that were bedded and converted to a pine plantation. Upland restoration is in progress.

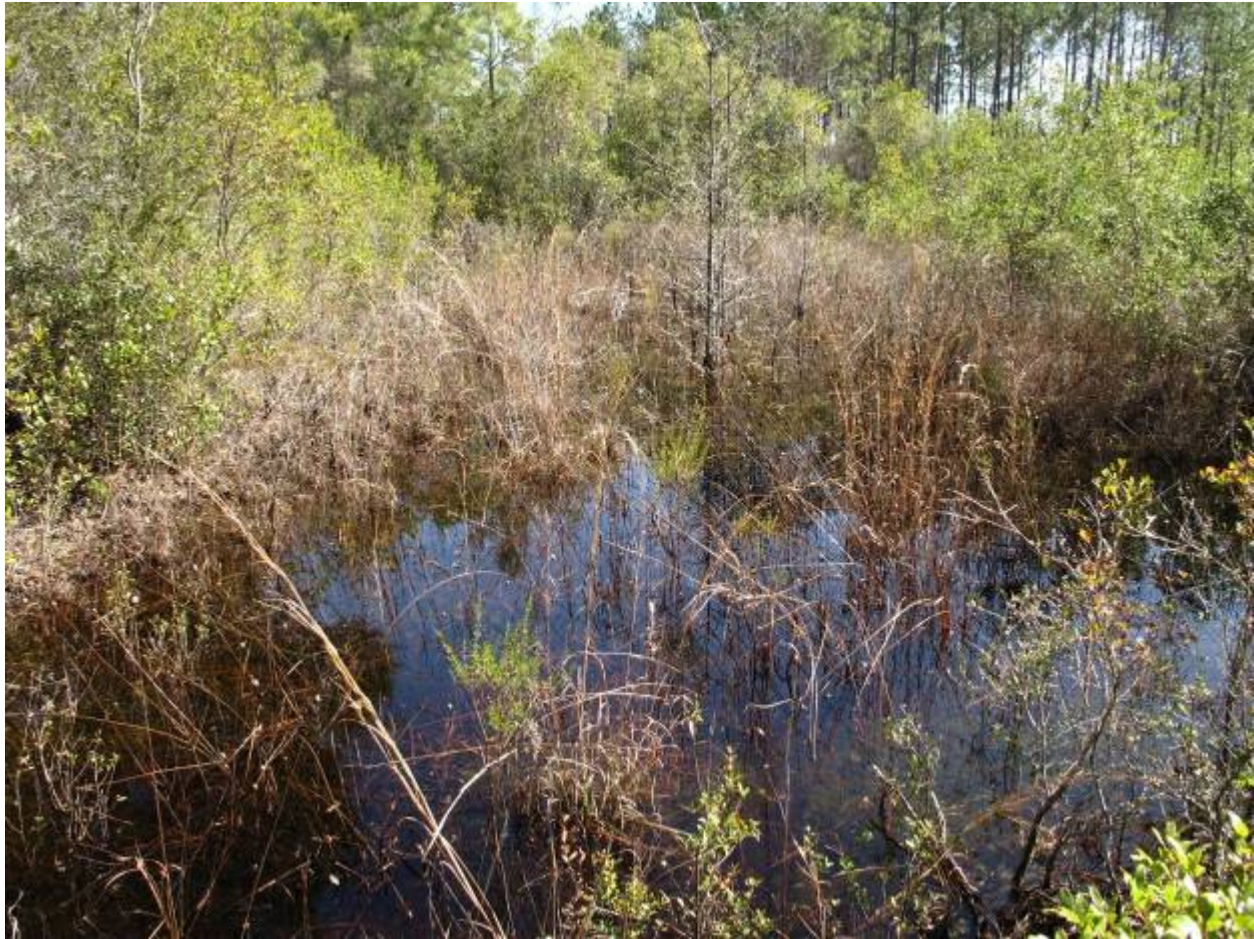
Wetland ID: 03-99

Description: This wetland is a 0.2 ha ephemeral marsh. There is no tree canopy. Titi is encroaching from the wetland perimeter, and covers 25-50% of the wetland. Sedges/grasses and *Sphagnum* grow in scattered patches, and cover 25-50% of the basin. There are 2 large push piles in the wetland basin with adjacent deep ruts. One push pile is over 2 m tall. This wetland may have been formed when the push piles were constructed but it is now functioning as an ephemeral wetland. We were unable to discern from historic aerial photos whether this wetland existed in 1949. Two dirt roads flank the wetland on the east and south sides. Although this MU burned recently, the uplands surrounding this wetland were not penetrated by fire. The adjacent uplands are mesic flatwoods that were bedded and converted to a pine plantation. Upland restoration is in progress.

Wetland Concerns: Push piles, Road, Vehicular damage, Woody encroachment

Restoration Action Recommended: Mechanically remove the push pile when the wetland is completely dry. Reintroducing periodic fire to the wetland basin will prevent further titi encroachment.

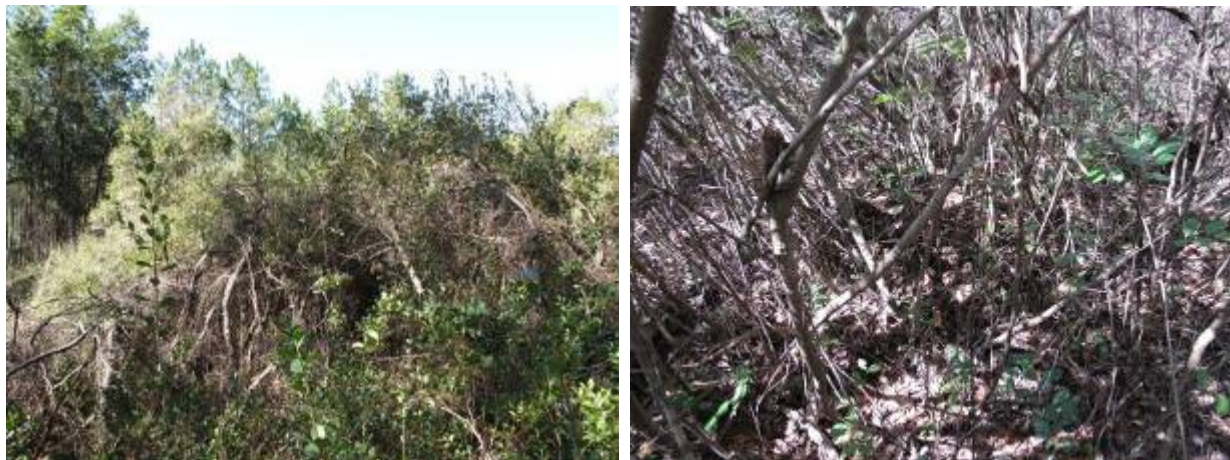
Wetland ID: 03-100

Description: This wetland is a 0.2 ha highly ephemeral shrub swamp. There is no tree canopy. Titi is the dominant woody vegetation, and covers >75% of the wetland. There is no herbaceous vegetation. There are small push piles or large hummocks in the wetland basin. Old stumps provide evidence that cypress trees historically occupied the wetland. The uplands were burned within the past several years but the fire did not reach into the wetland. The adjacent uplands are mesic flatwoods that were bedded and converted to a pine plantation. Upland restoration is in progress.

Wetland Concerns: Push piles, Woody encroachment

Restoration Action Recommended: Periodic fire in the wetland would reduce the dense titi and hummocks and open the midstory.

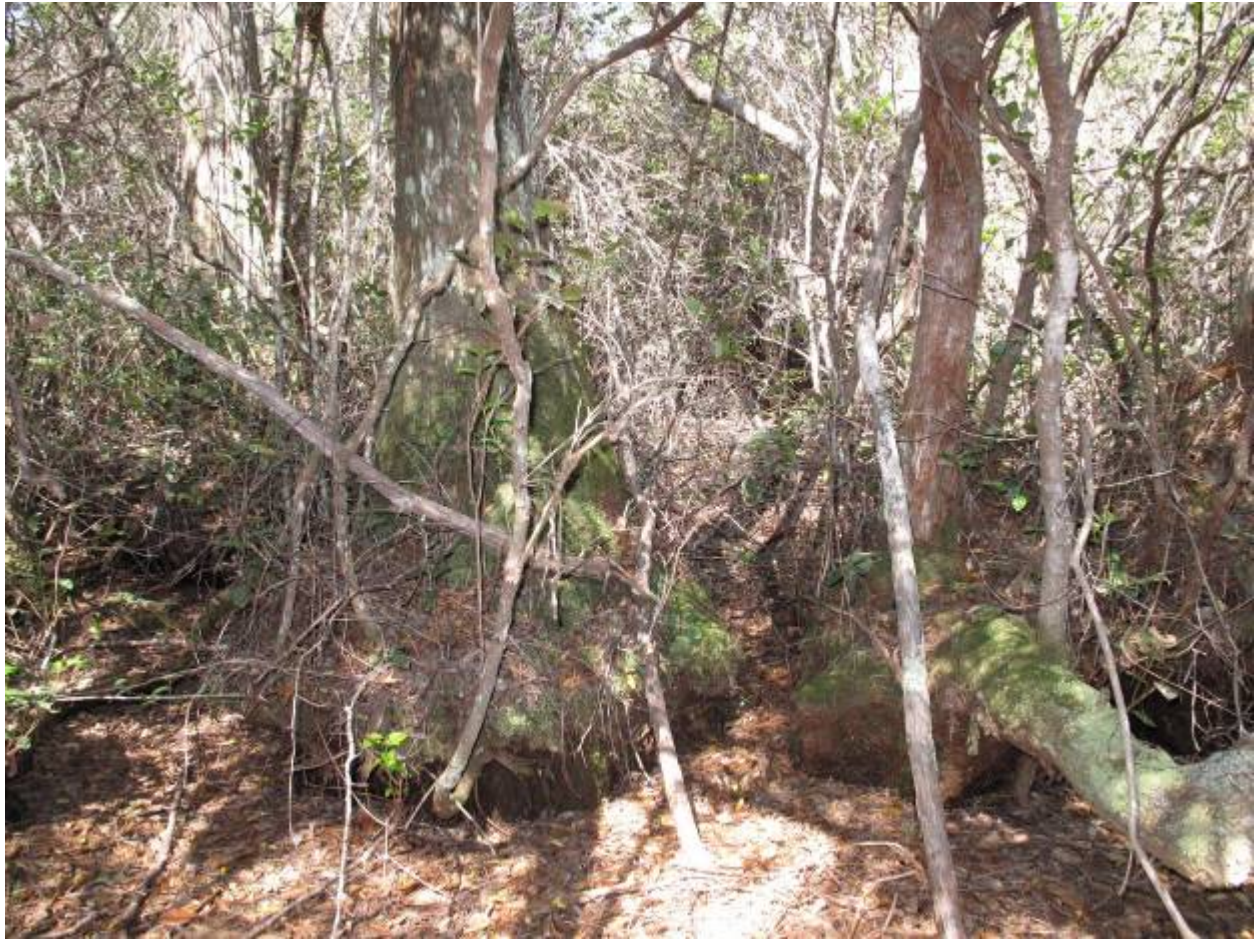
Description: This wetland is a 0.8 ha ephemeral shrub swamp. The presence of old cypress stumps provides evidence of historical logging. The cypress trees are regenerating and cover 25-50% of the wetland. The midstory is dominated by titi, and covers >75% of the wetland. There is no herbaceous vegetation. A thick duff layer covers the wetland floor. Although this MU burned recently, the uplands surrounding this wetland were not penetrated by fire. The adjacent uplands are mesic flatwoods that were bedded and converted to a pine plantation. Upland restoration is in progress.

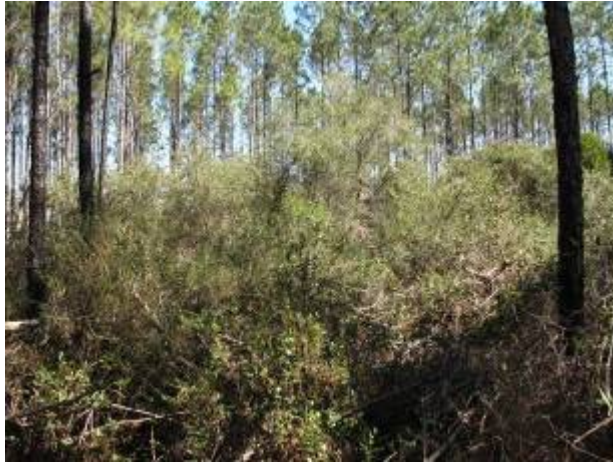
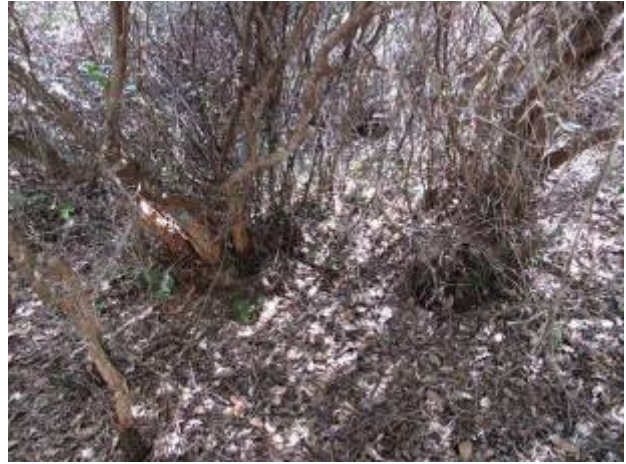
Wetland ID: 03-102

Description: This wetland is a 0.1 ha ephemeral shrub swamp. There is no tree canopy. Titi is the dominant woody vegetation, and covers >75% of the wetland. There is no herbaceous vegetation. The wetland burned a few years ago and the fire killed some of the titi around the perimeter. Titi remains thick in the wetland center. Historic aerial photos suggest that this wetland once was a marsh. The adjacent uplands are mesic flatwoods that were bedded and converted to a pine plantation. Upland restoration is in progress.

Wetland Concerns: Woody encroachment

Restoration Action Recommended: Continue providing periodic fire to reduce the dense titi in the wetland interior.

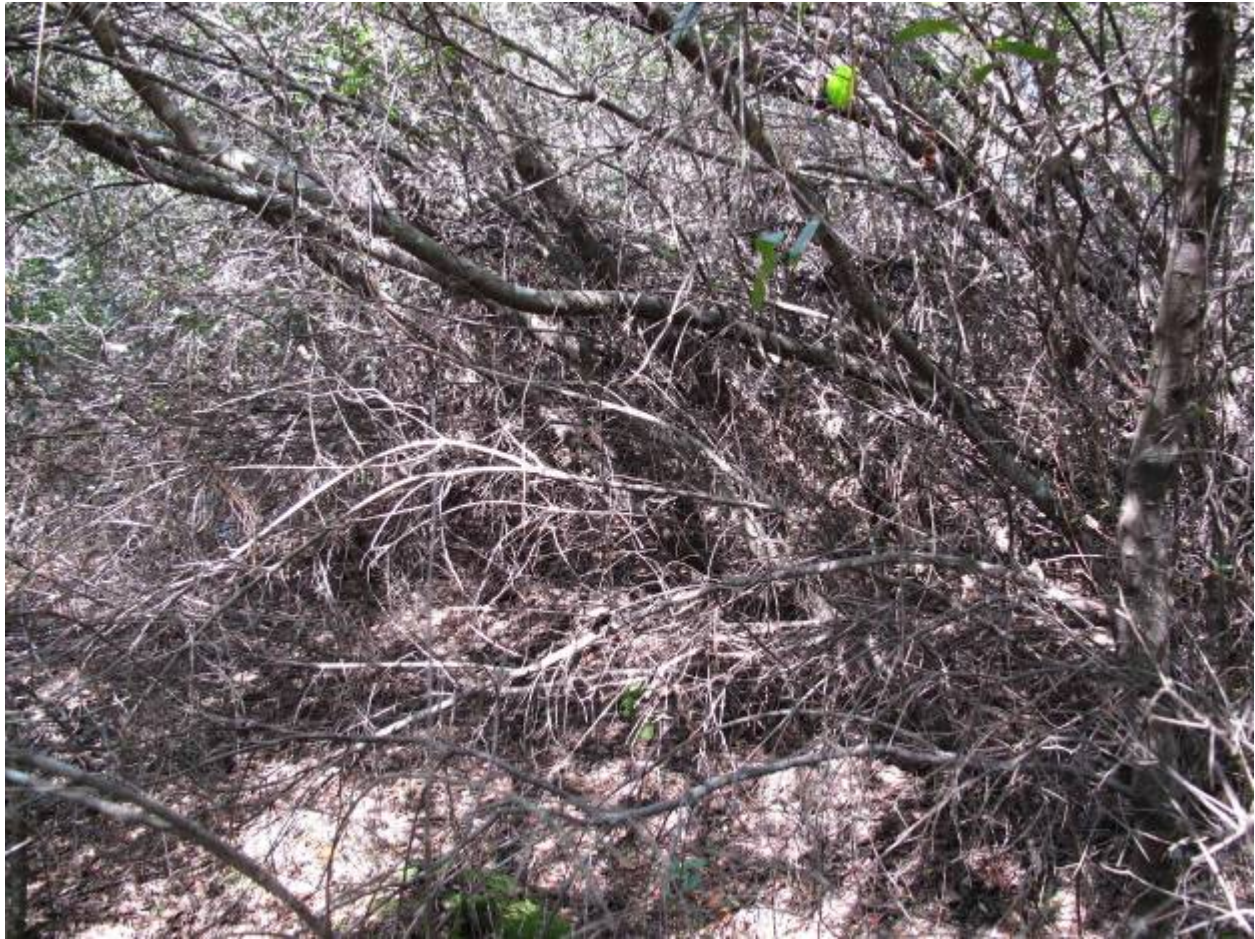
Description: This wetland is a 0.1 ha ephemeral shrub swamp. There is no tree canopy. Titi is the dominant woody vegetation, and covers >75% of the wetland. There is no herbaceous vegetation. This wetland was once part of a larger system but was bisected by Nasty Block Road. The bedding in the wetland is old and eroded. The wetland burned several years ago and killed some of the titi. The adjacent uplands are mesic flatwoods that were bedded and converted to a pine plantation. Upland restoration is in progress.

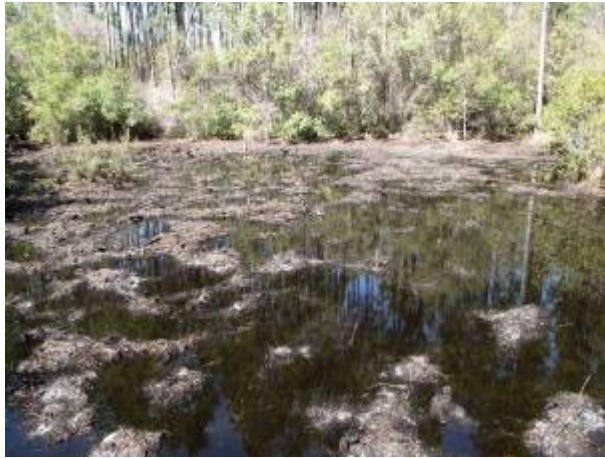
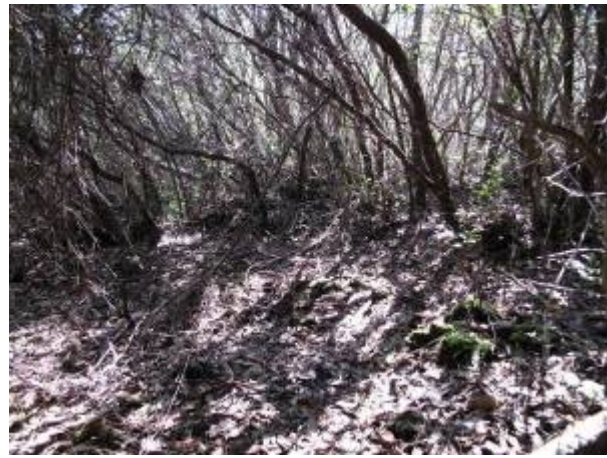
Wetland ID: 03-104

Description: This wetland is a 1.8 ha semi-permanent shrub swamp. The presence of old cypress stumps as well as historical aerial photos provide evidence of historical logging. The cypress trees are regenerating and cover 5-25% of the wetland. The midstory is dominated by titi, and covers >75% of the wetland. There is no herbaceous vegetation. There is a thick duff layer covering the wetland floor. This large wetland has an open section on the northeast side with severe feral hog damage. Although this MU burned recently, the uplands surrounding this wetland were not penetrated by fire. The adjacent uplands are mesic flatwoods that were bedded and converted to a pine plantation. Upland restoration is in progress.

Wetland Concerns: Feral hog damage, Woody encroachment

Restoration Action Recommended: Periodic fire in the wetland would reduce the dense titi and open the midstory.
