Inventory, Assessment, and Restoration Potential of Ephemeral Wetlands on FFWCC Wildlife Management Areas

Aucilla WMA Final Report

Submitted by: Rebecca P.M. Means¹, Ryan C. Means¹, Steven A. Johnson²

¹Coastal Plains Institute

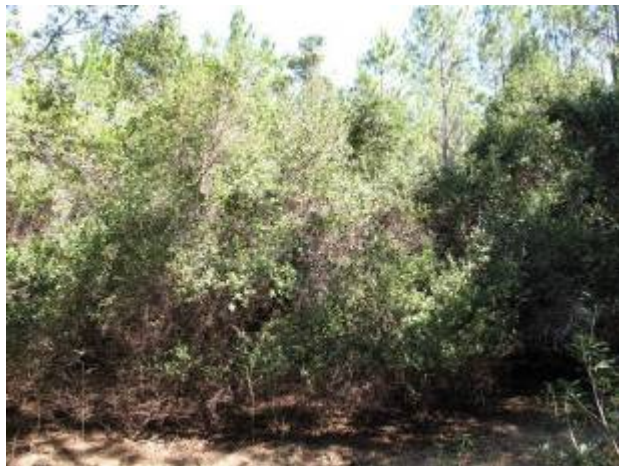
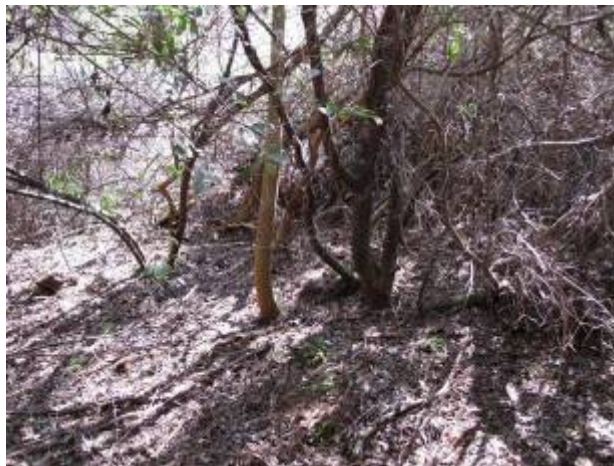
Wetland ID: 03-105

Description: This wetland is a 0.1 ha highly ephemeral shrub swamp. There is no tree canopy. Titi is the dominant woody vegetation, and covers >75% of the wetland. Sedges/grasses grow in scattered patches, and cover 5-25% of the basin. A 1 m tall push pile in the center of the wetland has grown over with titi. There is a marshy spot and minor bedding on the west side of the wetland. The adjacent uplands are mesic flatwoods that were bedded and converted to a pine plantation. Upland restoration is in progress.

Wetland Concerns: Bedding, Push piles, Woody encroachment

Restoration Action Recommended: Mechanically remove the push pile and simultaneously uproot the titi established on the push pile. This process should be completed when the wetland is completely dry and progress monitored. Return periodic fire to the wetland to prevent further titi encroachment.

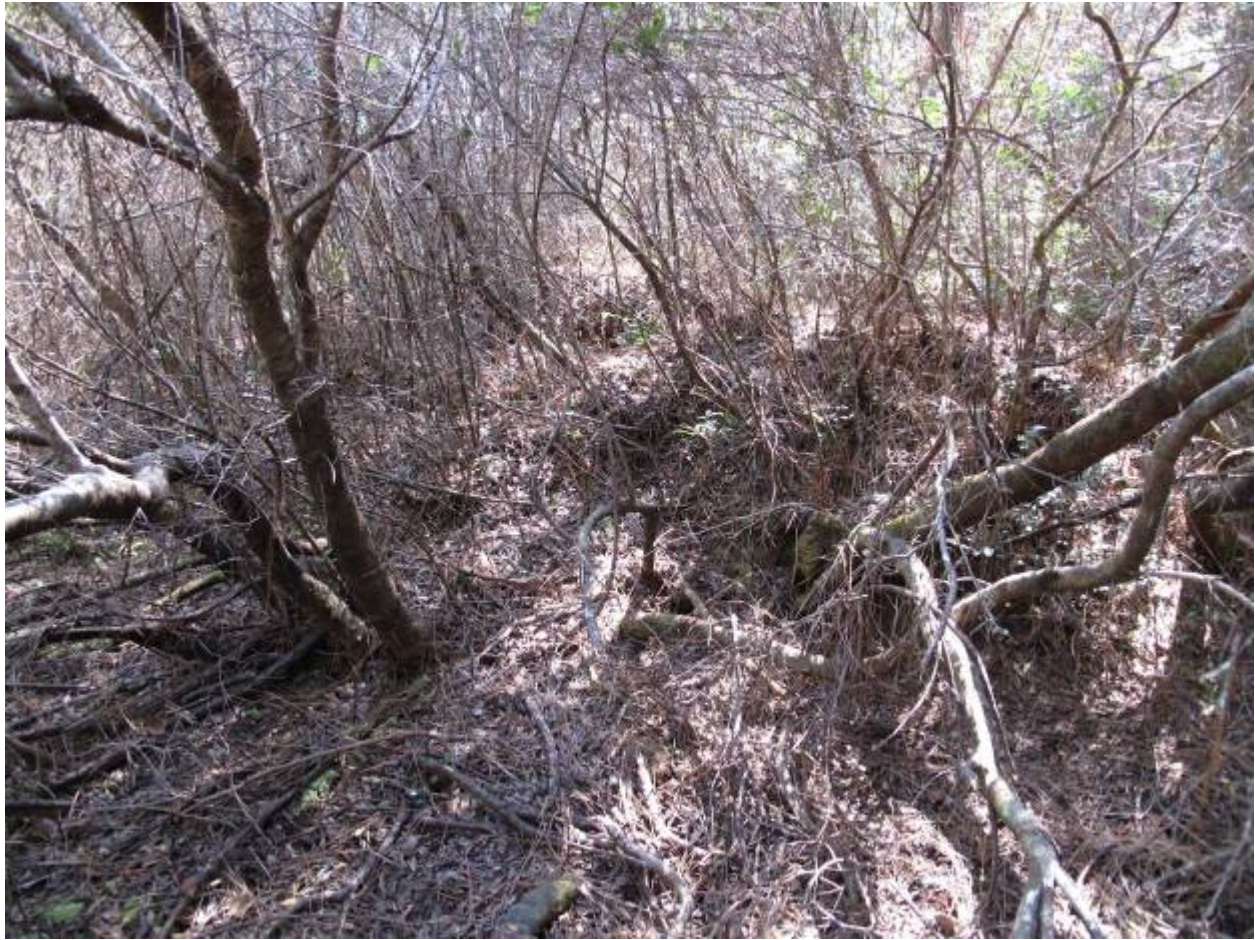
Description: This wetland is a <0.1 ha highly ephemeral shrub swamp. It is a rectangular wetland that appears to have formed in a bulldozer scrape and is now functioning as an ephemeral wetland. There is no tree canopy. Titi is the dominant woody vegetation, and covers 50-75% of the wetland. *Sphagnum* grows in scattered patches, and covers 5-25% of the basin. There is a push pile on the south side of the wetland. The adjacent uplands are mesic flatwoods that were bedded and converted to a pine plantation. Upland restoration is in progress.

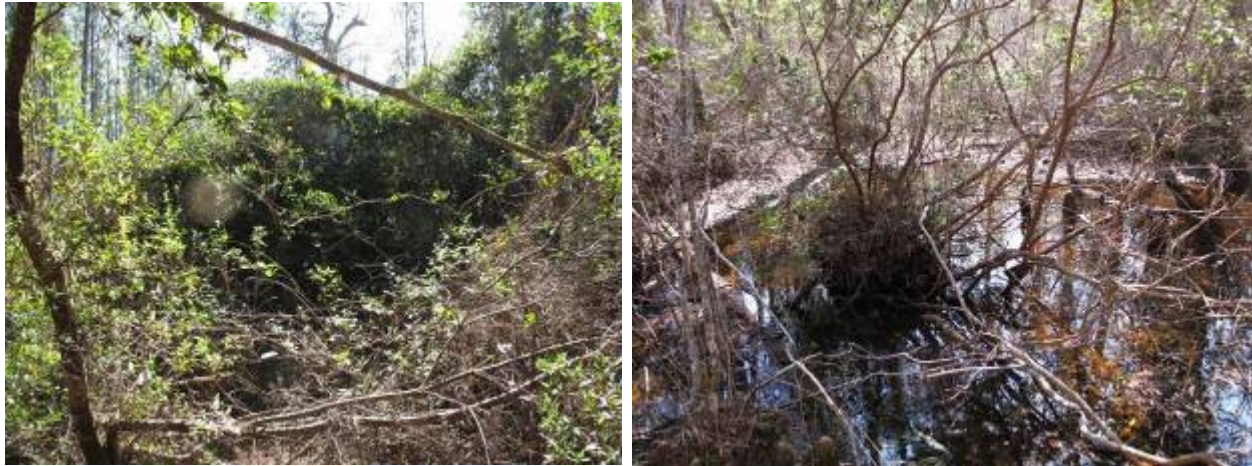
Wetland ID: 03-107

Description: This wetland is a 0.7 ha semi-permanent mixed swamp. Cypress and gum trees dominate the canopy, and cover >75% of the wetland. The midstory is dominated by wax myrtle, fetterbush, and titi, and covers >75% of the wetland. There is no herbaceous vegetation. A thick duff layer covers the wetland floor. The presence of old cypress stumps provides evidence of historical logging. The adjacent uplands are mesic flatwoods that were bedded and converted to a pine plantation. Upland restoration is in progress.

Wetland Concerns: Woody encroachment

Restoration Action Recommended: Periodic fire in the wetland would reduce the dense titi and open the midstory.

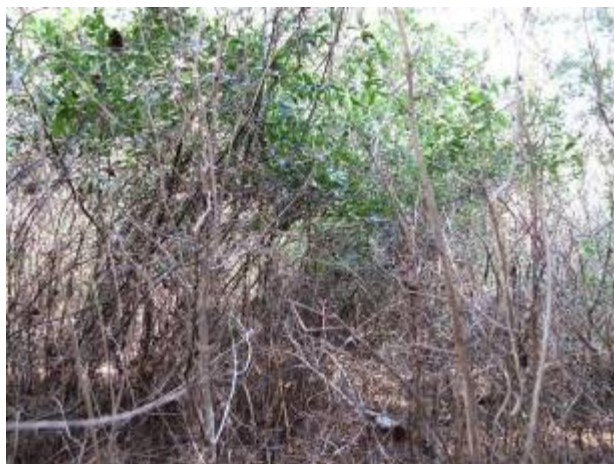
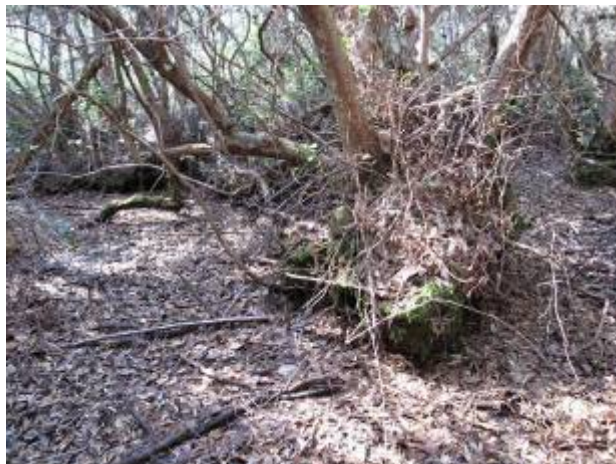
Wetland ID: 03-108

Description: This wetland is a 0.6 ha ephemeral shrub swamp. The presence of old cypress stumps provides evidence of historical logging. The cypress trees are regenerating and cover 25-50% of the wetland. The midstory is dominated by titi, and covers >75% of the wetland. There is no herbaceous vegetation. This wetland has thick brush, large hummocks, and what appear to be old push piles. The adjacent uplands are mesic flatwoods that were bedded and converted to a pine plantation. Upland restoration is in progress.

Wetland Concerns: Push piles, Woody encroachment

Restoration Action Recommended: The push pile is not extensive enough to merit restoration action. The process of erosion will eliminate this push pile over time. Periodic fire in the wetland would reduce the dense titi and open the midstory.

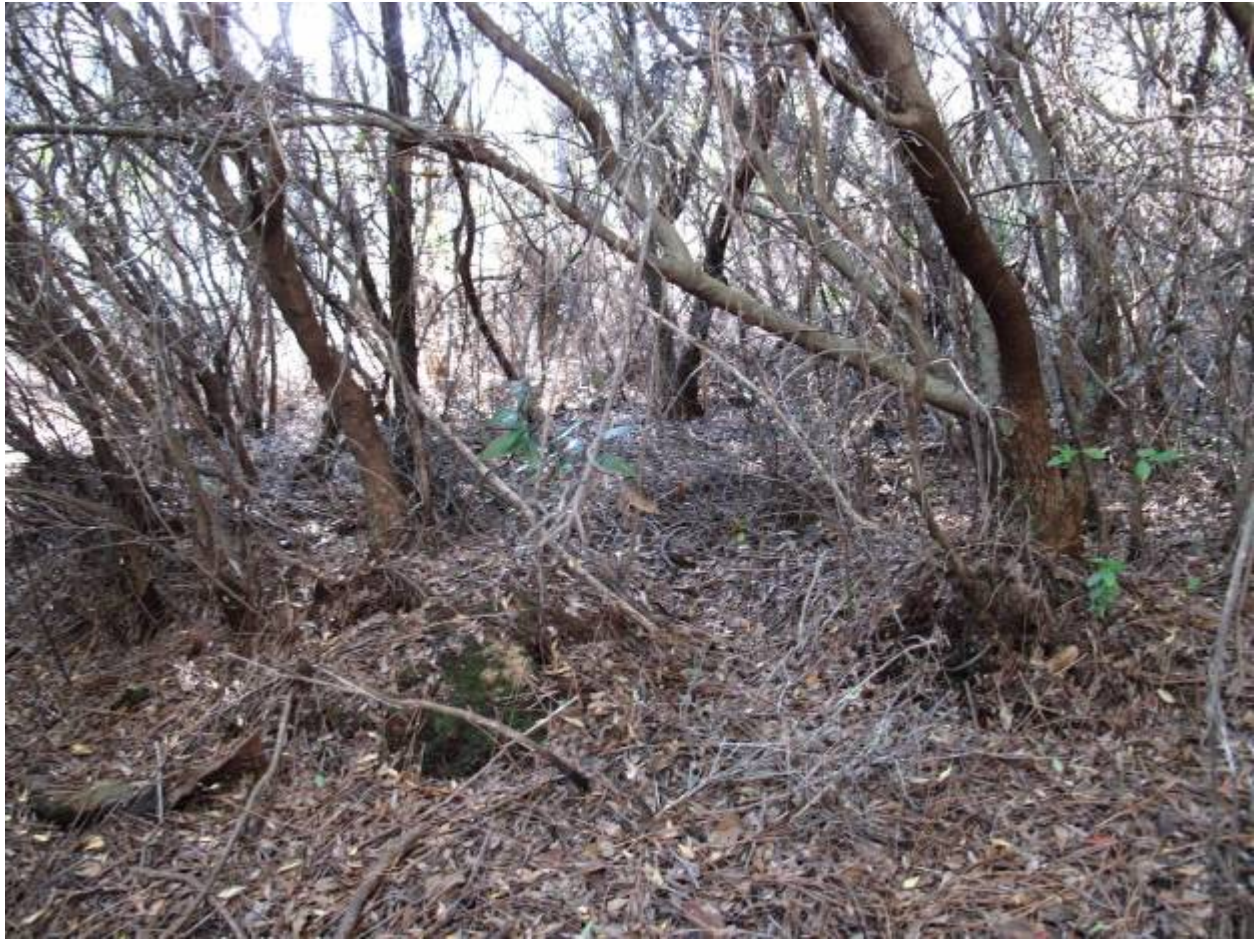
Wetland ID: 03-109

Description: This wetland is a 0.2 ha ephemeral shrub swamp. Pine trees dominate the canopy, and cover 5-25% of the wetland. The midstory is dominated by titi, and covers >75% of the wetland. There is no herbaceous vegetation. A thick duff layer covers the wetland floor. This wetland was bedded and pine trees were planted around the edges. The adjacent uplands are mesic flatwoods that were bedded and converted to a pine plantation. Upland restoration is in progress.

Wetland Concerns: Bedding, Planted pines, Woody encroachment

Restoration Action Recommended: Allow bedding rows to erode over time, remove any planted pine trees in the wetland basin, and reintroduce periodic fire to reduce the dense titi.

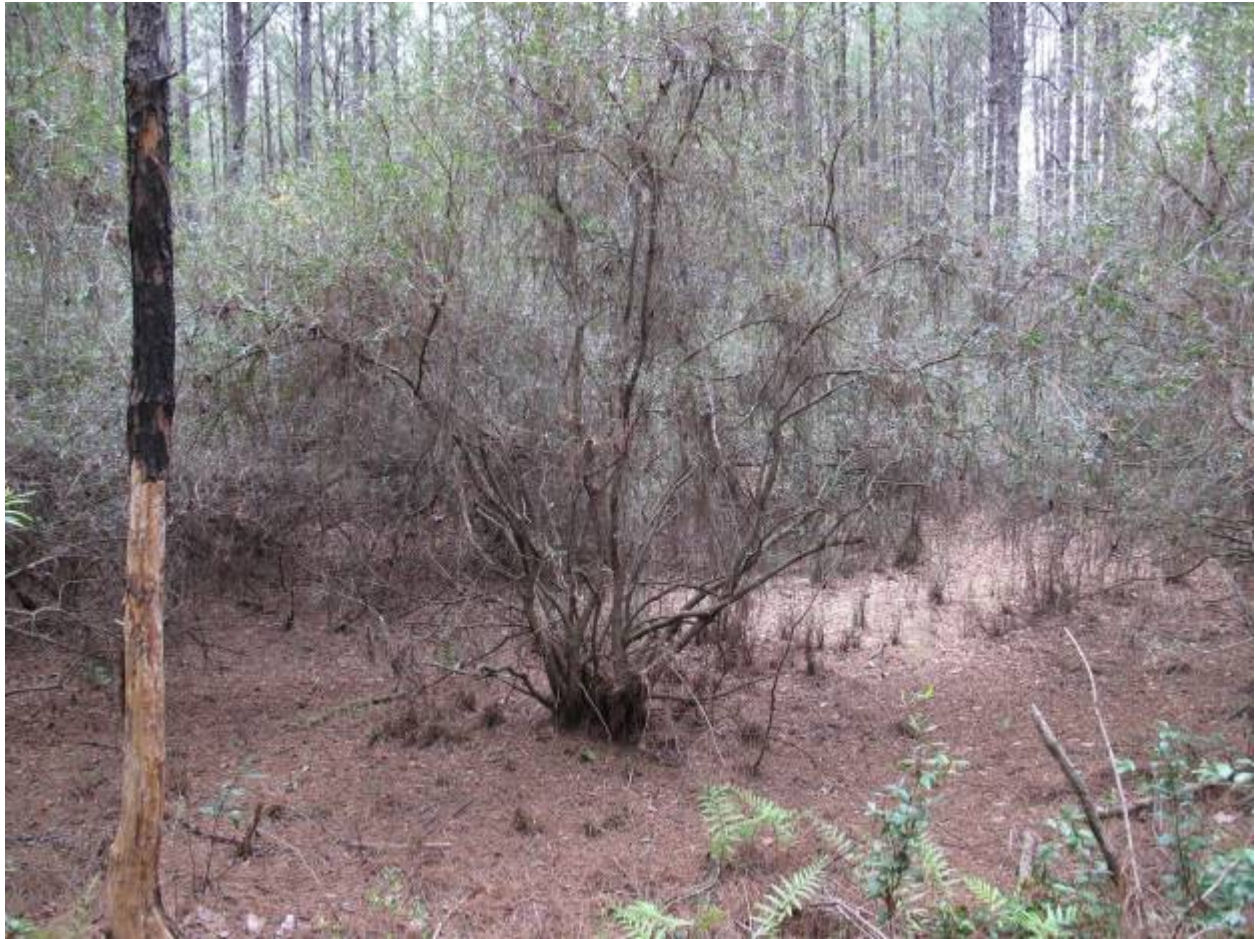
Description: This wetland is a <0.1 ha ephemeral shrub swamp. There is no tree canopy. Titi is the dominant woody vegetation, and covers 50-75% of the wetland. There is no herbaceous vegetation. This small, circular depression is a very nice example of an ephemeral shrub swamp. Historical aerial photos however suggest this wetland may have been a marsh. The adjacent uplands are mesic flatwoods that were bedded and converted to a pine plantation. Upland restoration is in progress.

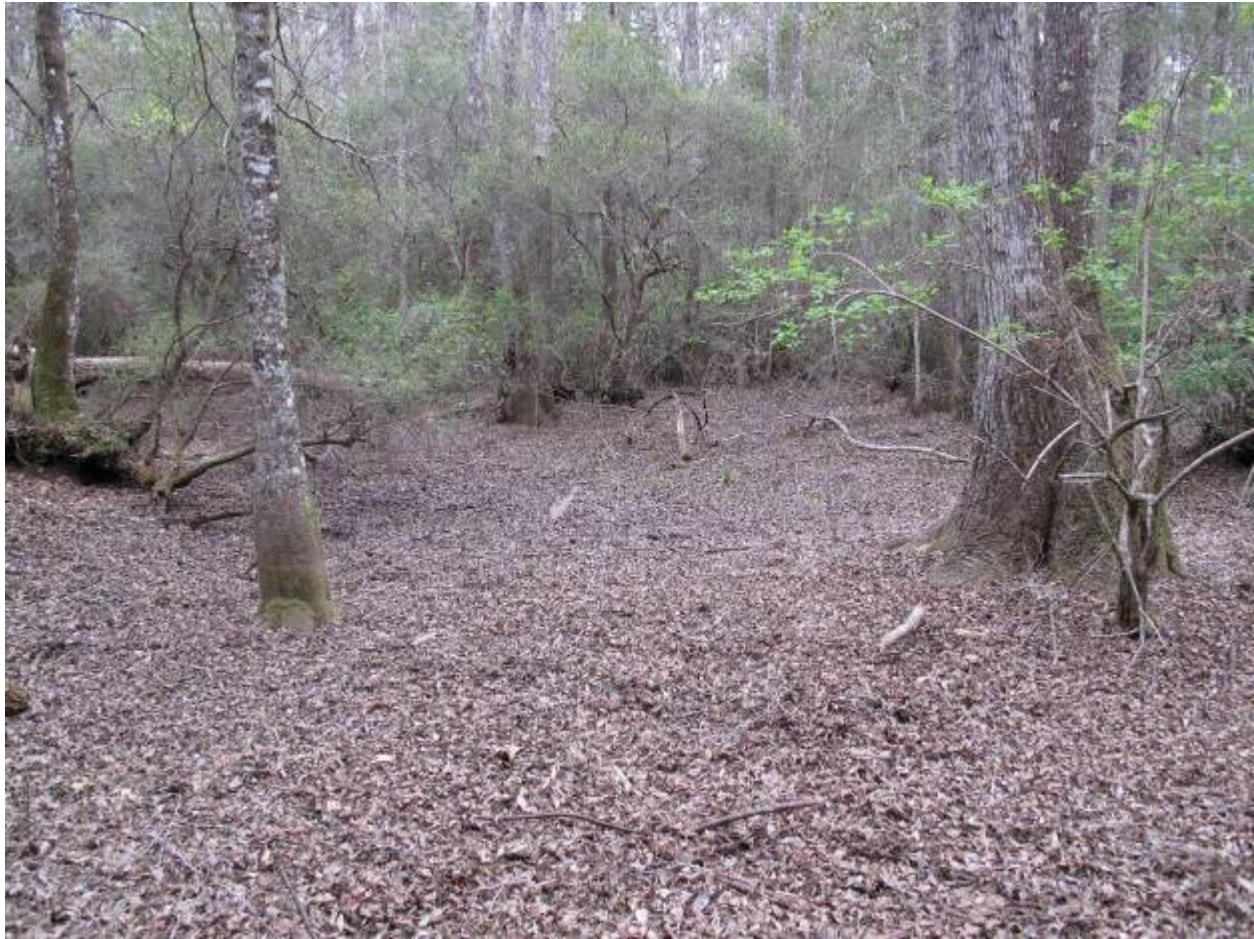
Wetland ID: 04-02

Description: This wetland is a 0.4 ha ephemeral mixed swamp. Gum trees dominate the canopy, and cover 50-75% of the wetland. The midstory is dominated by titi, and covers 50-75% of the wetland. There is no herbaceous vegetation. The wetland interior is predominantly open with widely scattered trees and shrubs. This wetland is an excellent example of a mixed swamp. The adjacent uplands are mesic flatwoods that were bedded and converted to a pine plantation. Upland restoration is in progress.

Wetland Concerns: None

Restoration Action Recommended: None

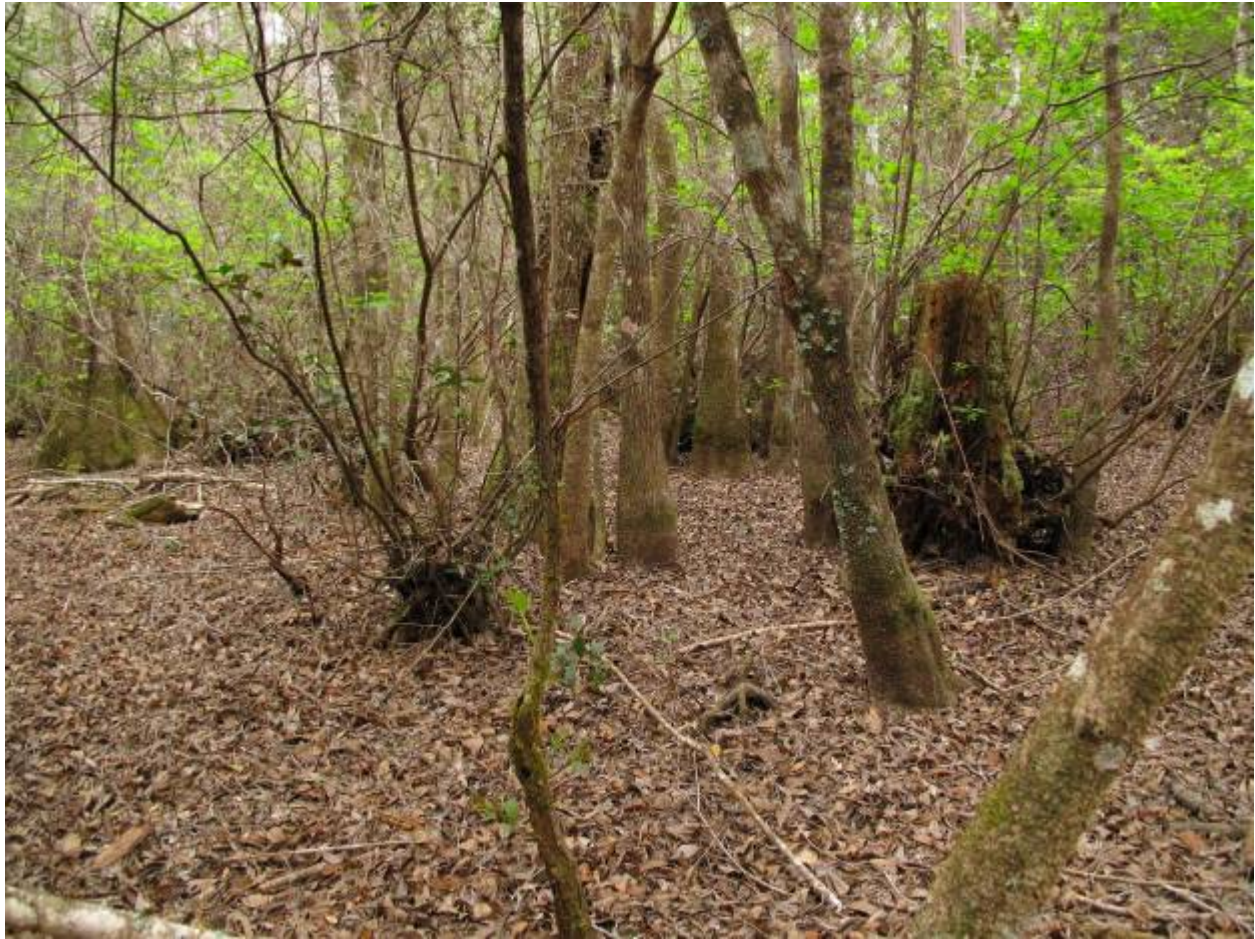
Description: This wetland is a 0.4 ha ephemeral mixed swamp. Gum trees dominate the wetland canopy, and cover >75% of the wetland. The midstory is dominated by titi, fetterbush, and holly, and covers >75% of the wetland. There is no herbaceous vegetation. This former cypress swamp was logged and colonized by gum trees and shrubs. The brush is not too dense however and the swamp is in fairly good condition. The adjacent uplands are mesic flatwoods that were bedded and converted to a pine plantation. Upland restoration is in progress.

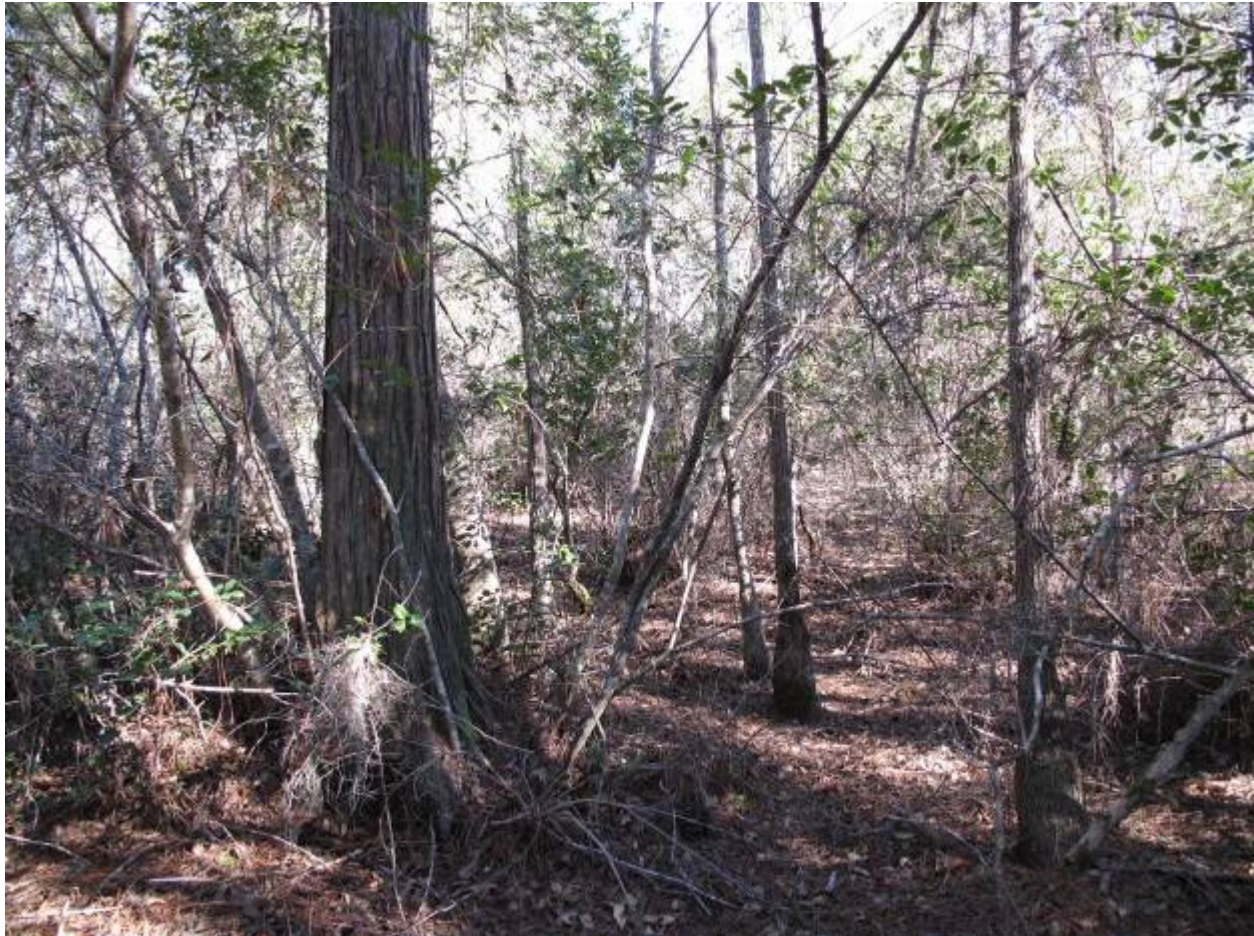
Wetland ID: 07-01

Description: This wetland is a 0.2 ha ephemeral mixed swamp. Cypress trees dominant the wetland canopy, and cover 25-50% of the wetland. The midstory is dominated by titi and holly, and covers >75% of the wetland. The wetland basin is covered in leaf litter and there is little to no herbaceous cover. The adjacent uplands are mesic flatwoods that were bedded and converted to a pine plantation. Upland restoration is in progress.

Wetland Concerns: Woody encroachment

Restoration Action Recommended: Periodic fire in the wetland would reduce the dense brush and open the midstory.

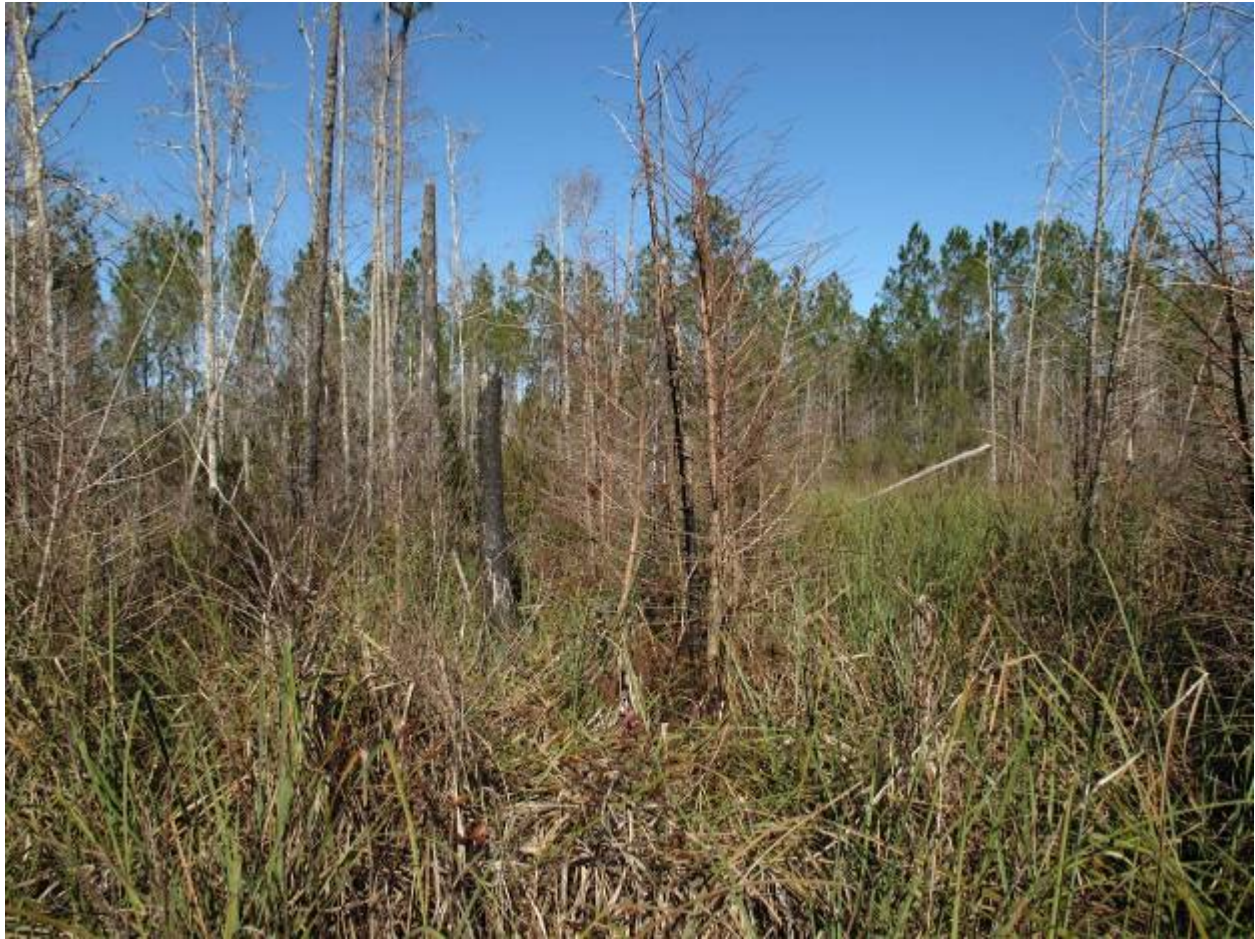
Description: This wetland is a 1.1 ha ephemeral marsh. Cypress trees dominate the canopy, and cover 5-25% of the wetland. Titi and wax myrtle form a ring around the wetland edge, and cover 5-25% of the basin. Sawgrass grows throughout the wetland, and covers >75% of the basin. The wetland appears to have burned fairly recently. The adjacent uplands are mesic flatwoods that were bedded and converted to a pine plantation. Upland restoration is in progress.

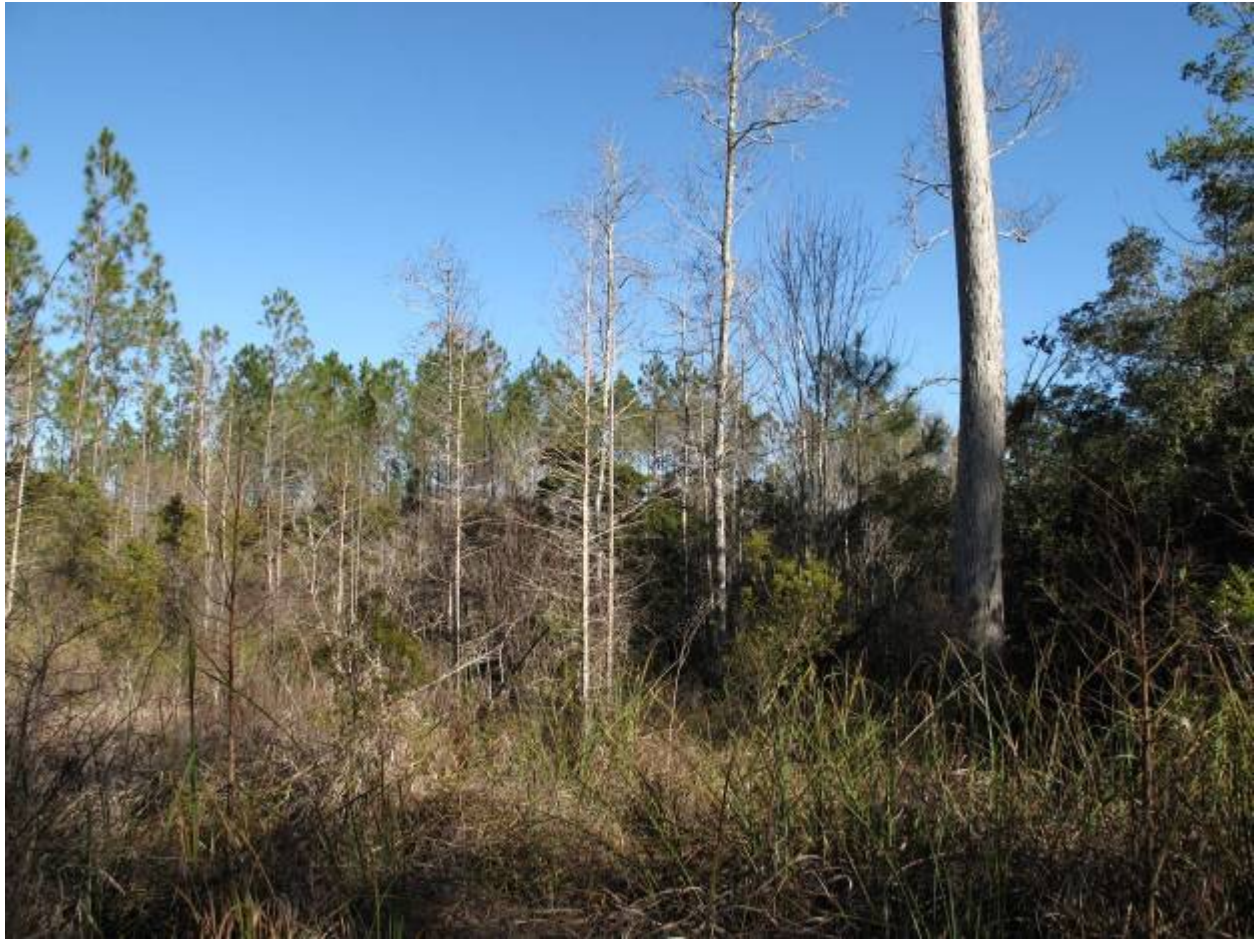
Wetland ID: 07-03

Description: This wetland is a 0.5 ha ephemeral marsh. The presence of old cypress stumps provides evidence of historical logging. The cypress trees are regenerating and cover 5-25% of the wetland. The midstory is dominated by titi and wax myrtle, and covers 25-50% of the wetland. Sawgrass grows throughout the wetland, and covers 50-75% of the basin. This wetland appears to be a marsh in the process of succeeding to a mixed cypress and shrub swamp. The adjacent uplands are mesic flatwoods that were bedded and converted to a pine plantation. Upland restoration is in progress.

Wetland Concerns: Woody encroachment

Restoration Action Recommended: Encourage periodic fire to reduce the encroaching shrubs.

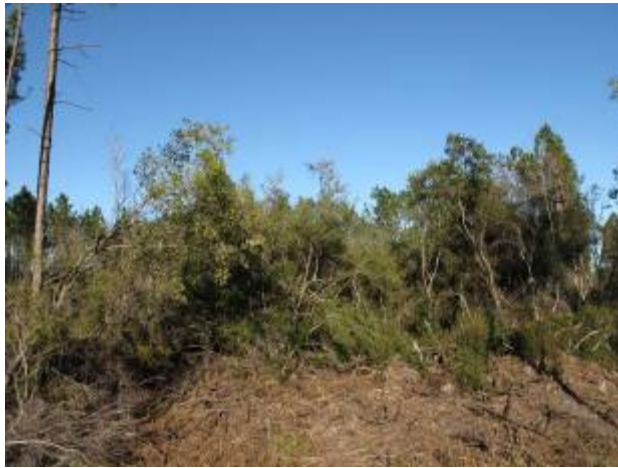
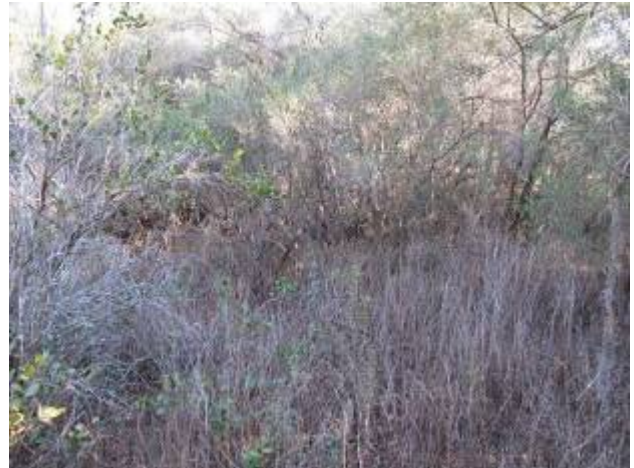
Wetland ID: 07-04

Description: This wetland is a 0.3 ha ephemeral shrub swamp. Cypress trees dominate the canopy, and cover 5-25% of the wetland. The midstory is dominated by titi, and covers >75% of the wetland. Ferns grow in scattered patches, and cover 5-25% of the basin. The adjacent uplands are mesic flatwoods that were bedded and converted to a pine plantation. Upland restoration is in progress.

Wetland Concerns: Woody encroachment

Restoration Action Recommended: Periodic fire in the wetland would reduce the dense titi and open the midstory.

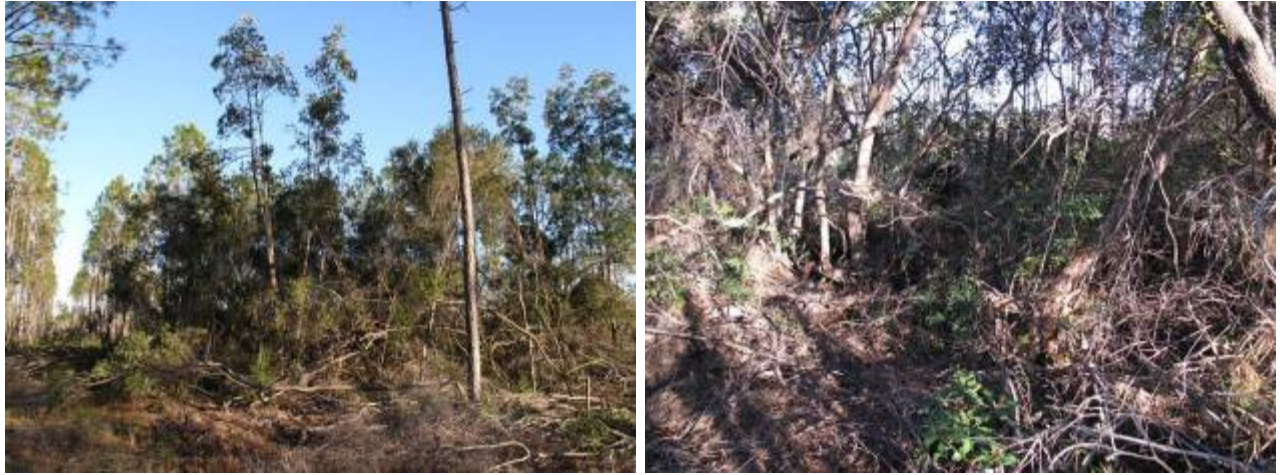
Wetland ID: 07-05

Description: This wetland is a 0.1 ha ephemeral shrub swamp. There is little to no canopy cover. The midstory is dominated by titi, and covers >75% of the wetland. There is no herbaceous vegetation. A recent thinning operation pushed slash debris into the wetland. The adjacent uplands are mesic flatwoods that were bedded and converted to a pine plantation. Upland restoration is in progress.

Wetland Concerns: Slash, Woody encroachment

Restoration Action Recommended: Periodic fire would reduce the slash and the dense titi.

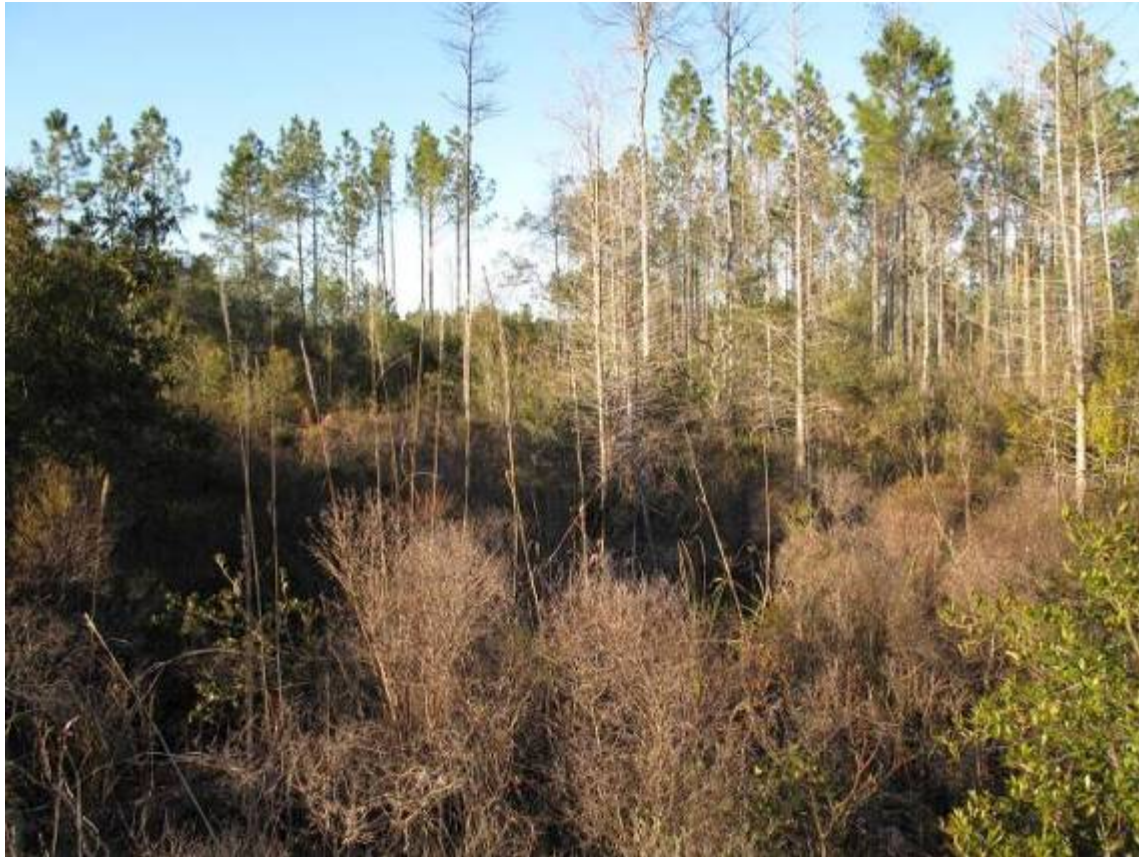
Wetland ID: 07-06

Description: This wetland is a 0.8 ha ephemeral marsh. The presence of old cypress stumps provides evidence of historical logging. The cypress trees are regenerating and cover 5-25% of the wetland. The midstory is dominated by titi, wax myrtle, and *Hypericum*, and covers 50-75% of the wetland. Sedges/grasses and sawgrass grow throughout the wetland, and cover 50-75% of the basin. Old ruts are widespread, likely from former timber operations. The adjacent uplands are mesic flatwoods that were bedded and converted to a pine plantation. Upland restoration is in progress.

Wetland Concerns: Vehicular damage, Woody encroachment

Restoration Action Recommended: Allow the ruts to heal over time. To prevent future damage, operate machinery only when wetland is completely dry. Evidence of historical logging signifies that this wetland may once have been a cypress swamp. Historical aerial photos depict a marsh-like wetland with scattered trees in the basin. These photos may have been taken after cypress trees were logged from the wetland. Regardless of the original condition of this wetland, periodic fire will prevent the shrubs from establishing and allow this wetland to continue as a marsh if desired or succeed to a cypress swamp.

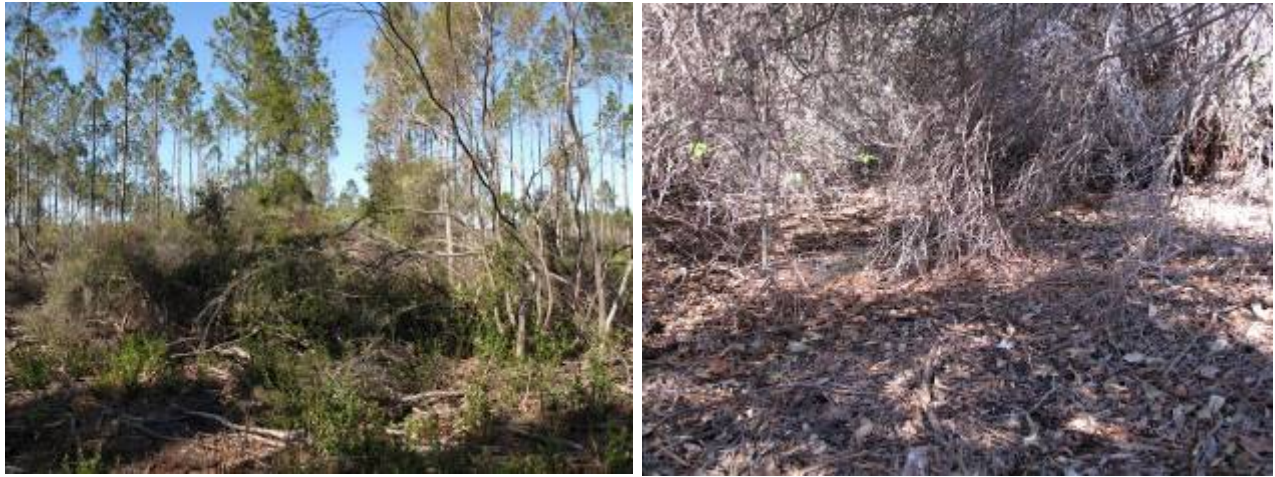
Wetland ID: 07-07

Description: This wetland is a 0.1 ha ephemeral shrub swamp. There is little to no canopy cover. The midstory is dominated by titi, and covers 50-75% of the wetland. There is no herbaceous cover. Ruts were created around the wetland, likely during recent thinning operations. The adjacent uplands are mesic flatwoods that were bedded and converted to a pine plantation. Upland restoration is in progress.

Wetland Concerns: Vehicular damage, Woody encroachment

Restoration Action Recommended: Allow the ruts to heal over time. To prevent future damage, operate machinery only when wetland is completely dry. Smaller wetlands may need to be flagged to alert operators of the wetland's existence. Return periodic fire into the wetland to reduce the dense titi.

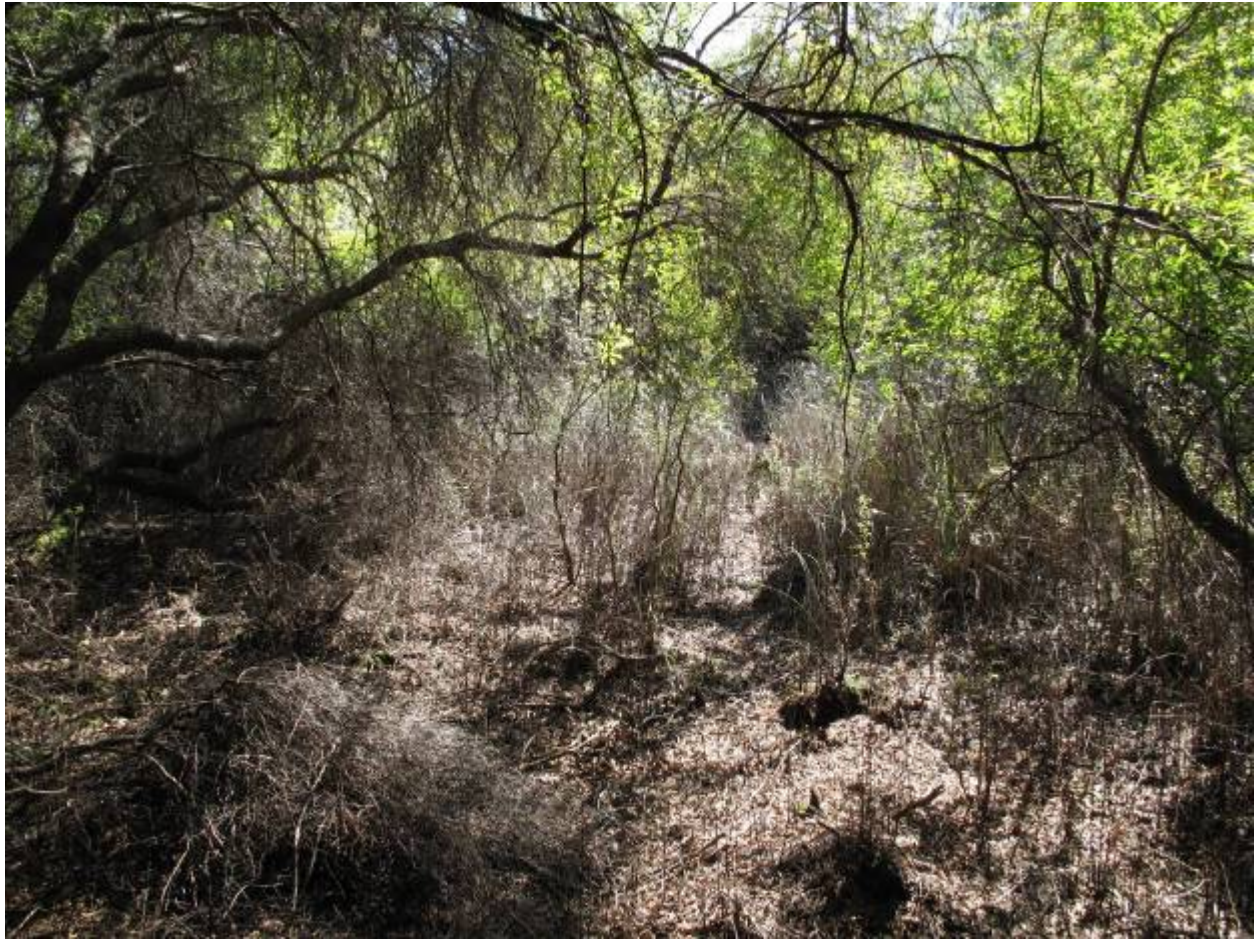
Wetland ID: 07-08

Description: This wetland is a 0.3 ha ephemeral shrub swamp. There is little to no canopy cover. The midstory is dominated by titi, and covers >75% of the wetland. Fern grows in scattered patches, and covers 5-25% of the basin. While this wetland has a dense titi midstory, the understory is fairly open. The adjacent uplands are mesic flatwoods that were bedded and converted to a pine plantation. Upland restoration is in progress.

Wetland Concerns: Woody encroachment

Restoration Action Recommended: Periodic fire in the wetland would reduce the dense titi and open the midstory.

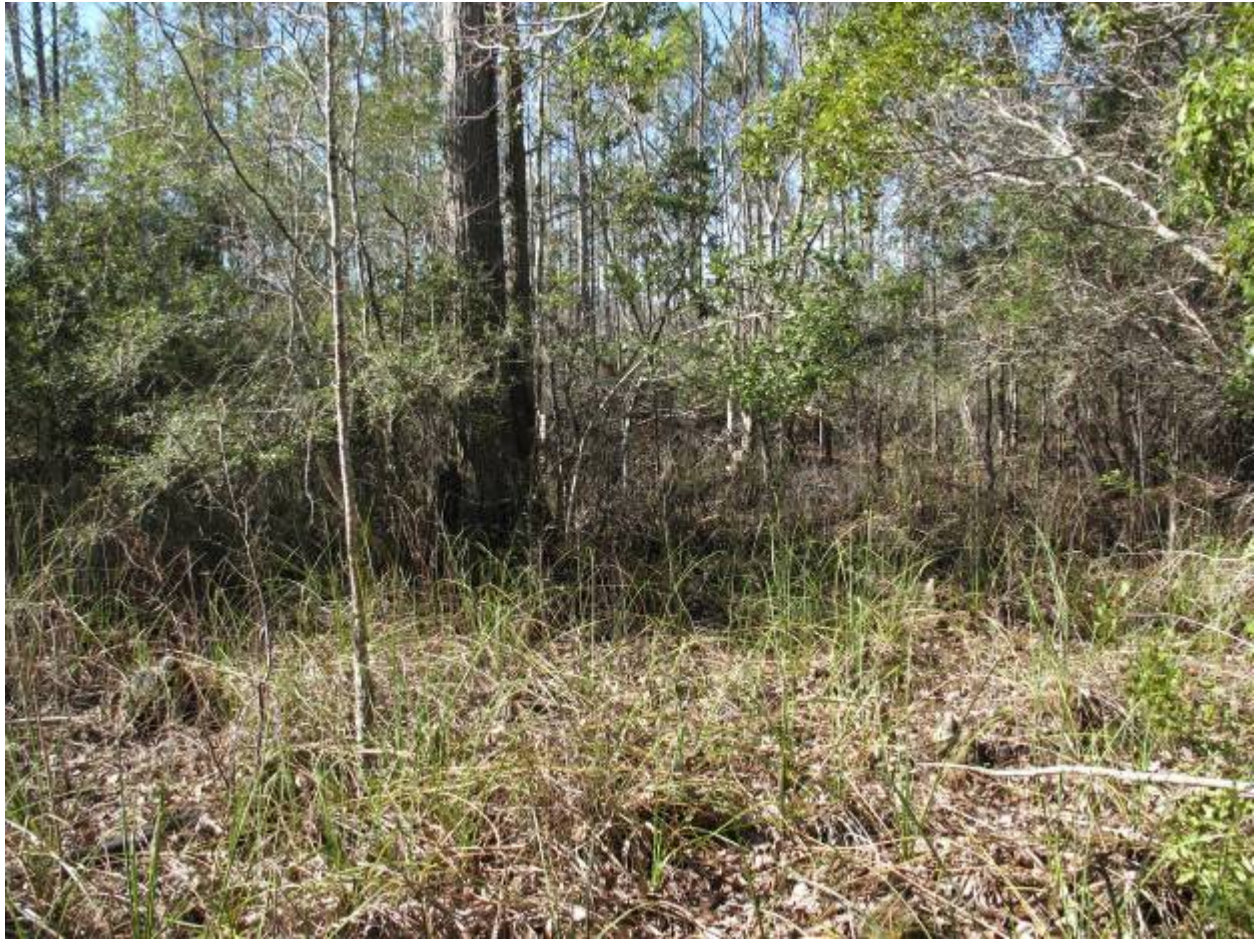
Wetland ID: 07-09

Description: This wetland is a 0.1 ha ephemeral mixed swamp. The presence of old cypress stumps provides evidence of historical logging. The cypress trees are regenerating and cover 25-50% of the wetland. The midstory is dominated by wax myrtle, and covers 50-75% of the wetland. Sawgrass grows in scattered patches, and covers 5-25% of the basin. The adjacent uplands are mesic flatwoods that were bedded and converted to a pine plantation. Upland restoration is in progress.

Wetland Concerns: Woody encroachment

Restoration Action Recommended: Return periodic fire into the wetland to prevent further shrub encroachment.

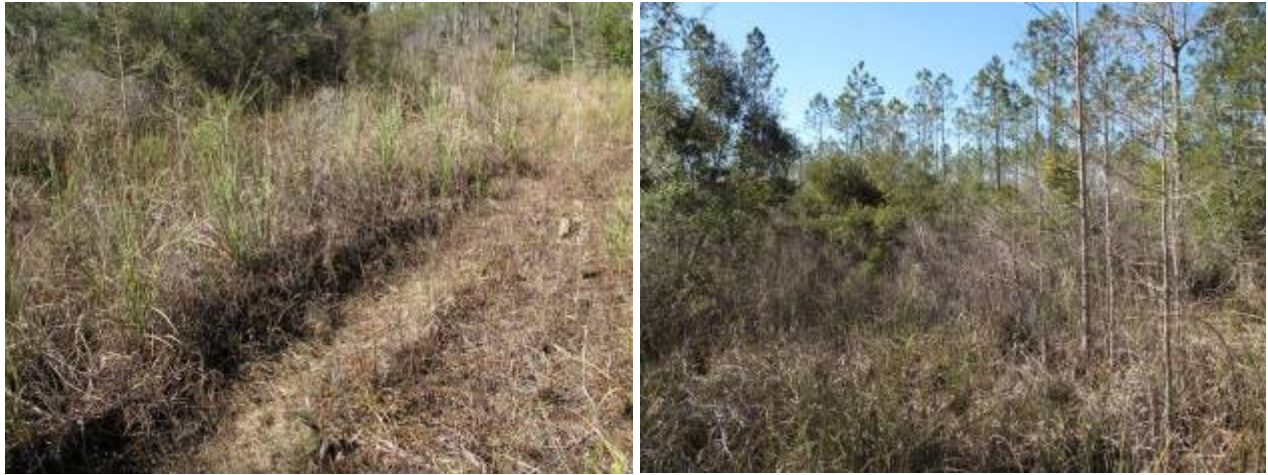
Wetland ID: 07-10

Description: This wetland is a 0.2 ha ephemeral marsh. There is little to no canopy cover. The midstory is dominated by titi, wax myrtle, and *Hypericum*, and covers 25-50% of the wetland. Sawgrass grows throughout the wetland, and covers >75% of the basin. While predominantly a marsh, shrubs are encroaching into the wetland. Old ruts are still evident in the wetland basin. The adjacent uplands are mesic flatwoods that were bedded and converted to a pine plantation. Upland restoration is in progress.

Wetland Concerns: Vehicular damage, Woody encroachment

Restoration Action Recommended: The ruts should erode over time. If the ruts were a result of management operation, ensure future activity occurs only when the wetland is completely dry. Smaller wetlands may need to be flagged to alert operators of the wetland's existence. Return periodic fire into the wetland to prevent further shrub encroachment.

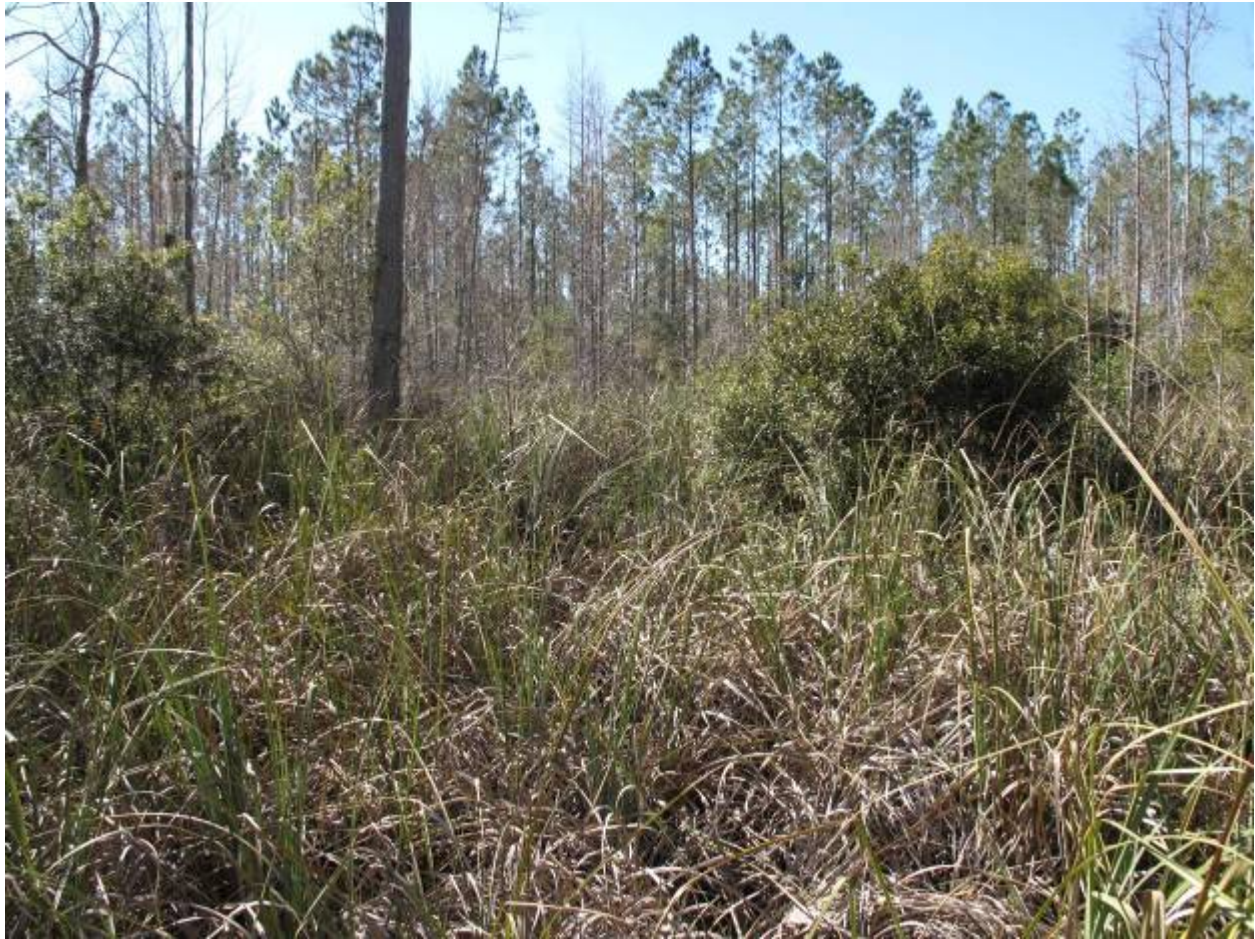
Description: This wetland is a 0.6 ha ephemeral marsh. Cypress trees dominate the canopy, and cover 5-25% of the wetland. Wax myrtle is encroaching into the wetland, and covers 5-25% of the basin. Sawgrass grows throughout the wetland, and covers >75% of the basin. The adjacent uplands are mesic flatwoods that were bedded and converted to a pine plantation. Upland restoration is in progress.

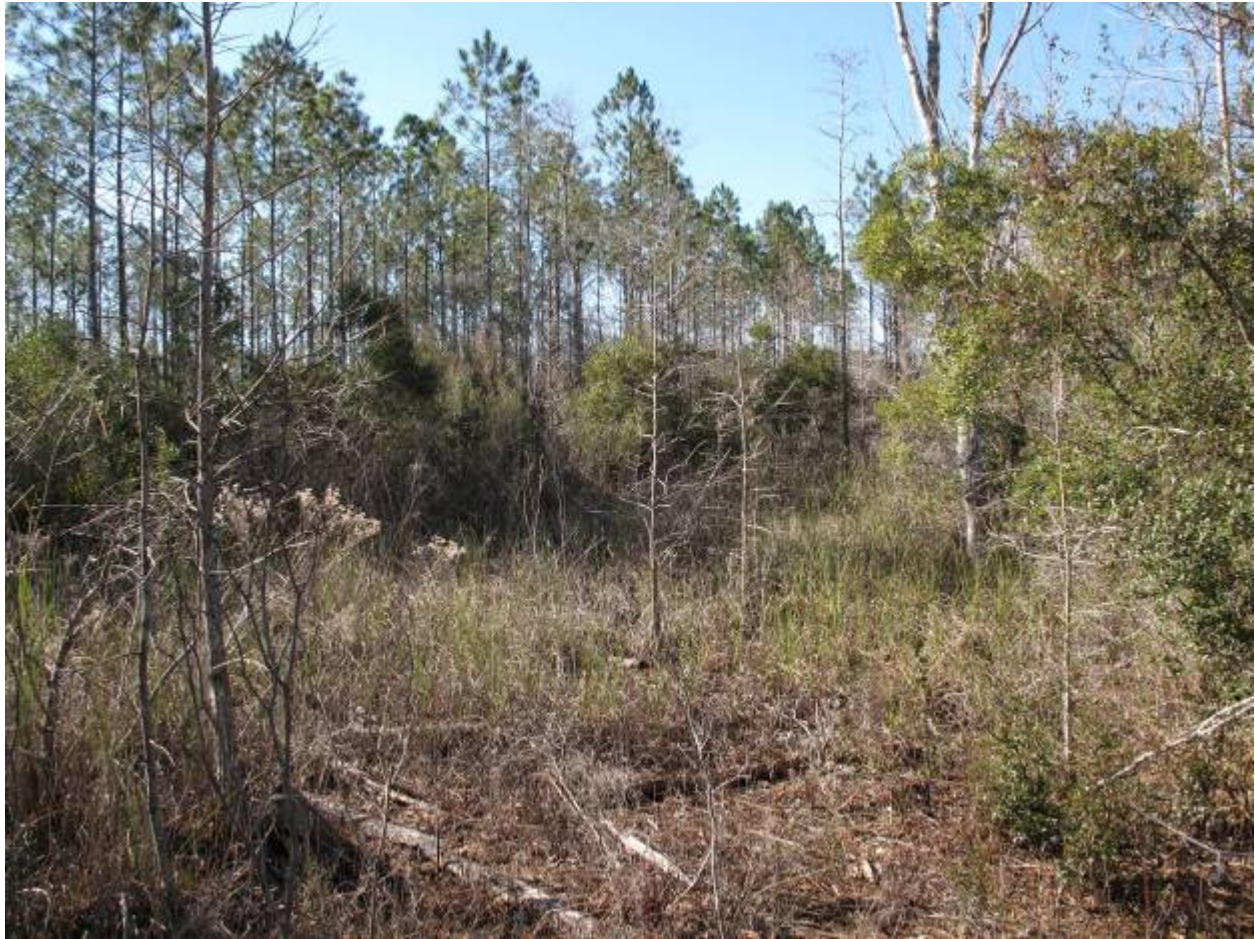
Description: This wetland is a 0.3 ha ephemeral marsh. Cypress trees dominate the canopy, and cover 5-25% of the wetland. Wax myrtle is encroaching into the wetland, and covers 5-25% of the basin. Sawgrass grows throughout the wetland, and covers 50-75% of the basin. The adjacent uplands are mesic flatwoods that were bedded and converted to a pine plantation. Upland restoration is in progress.
