Inventory, Assessment, and Restoration Potential of Ephemeral Wetlands on FFWCC Wildlife Management Areas

Aucilla WMA Final Report

Submitted by: Rebecca P.M. Means¹, Ryan C. Means¹, Steven A. Johnson²

¹Coastal Plains Institute

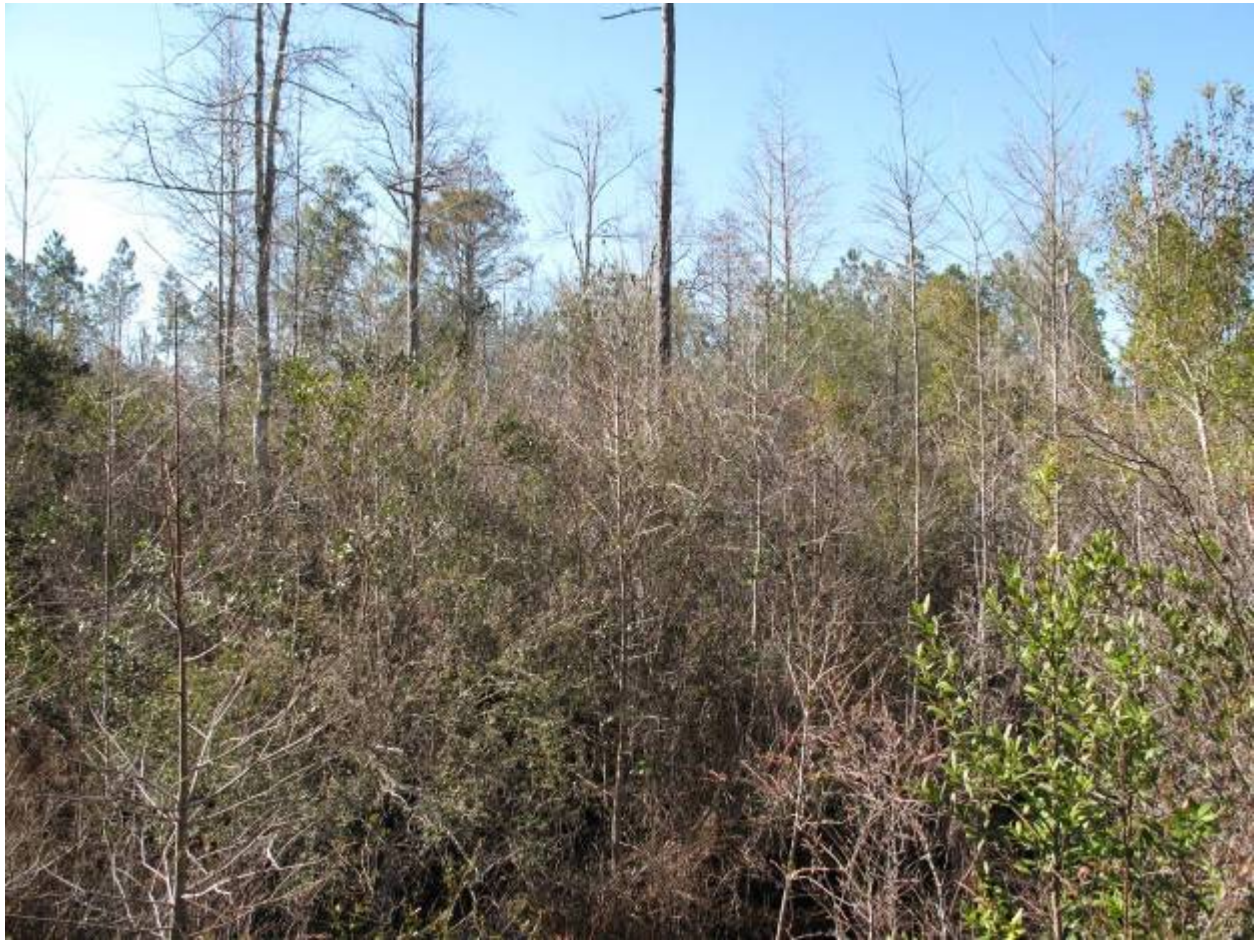
Description: This wetland is a 0.7 ha semi-permanent shrub swamp. Cypress trees dominate the canopy, and cover 5-25% of the wetland. The midstory is dominated by titi and wax myrtle, and covers >75% of the wetland. There is little to no herbaceous cover. Many old cypress stumps and old logging ruts provide evidence of historical logging in the wetland. The adjacent uplands are mesic flatwoods that were bedded and converted to a pine plantation. Upland restoration is in progress.

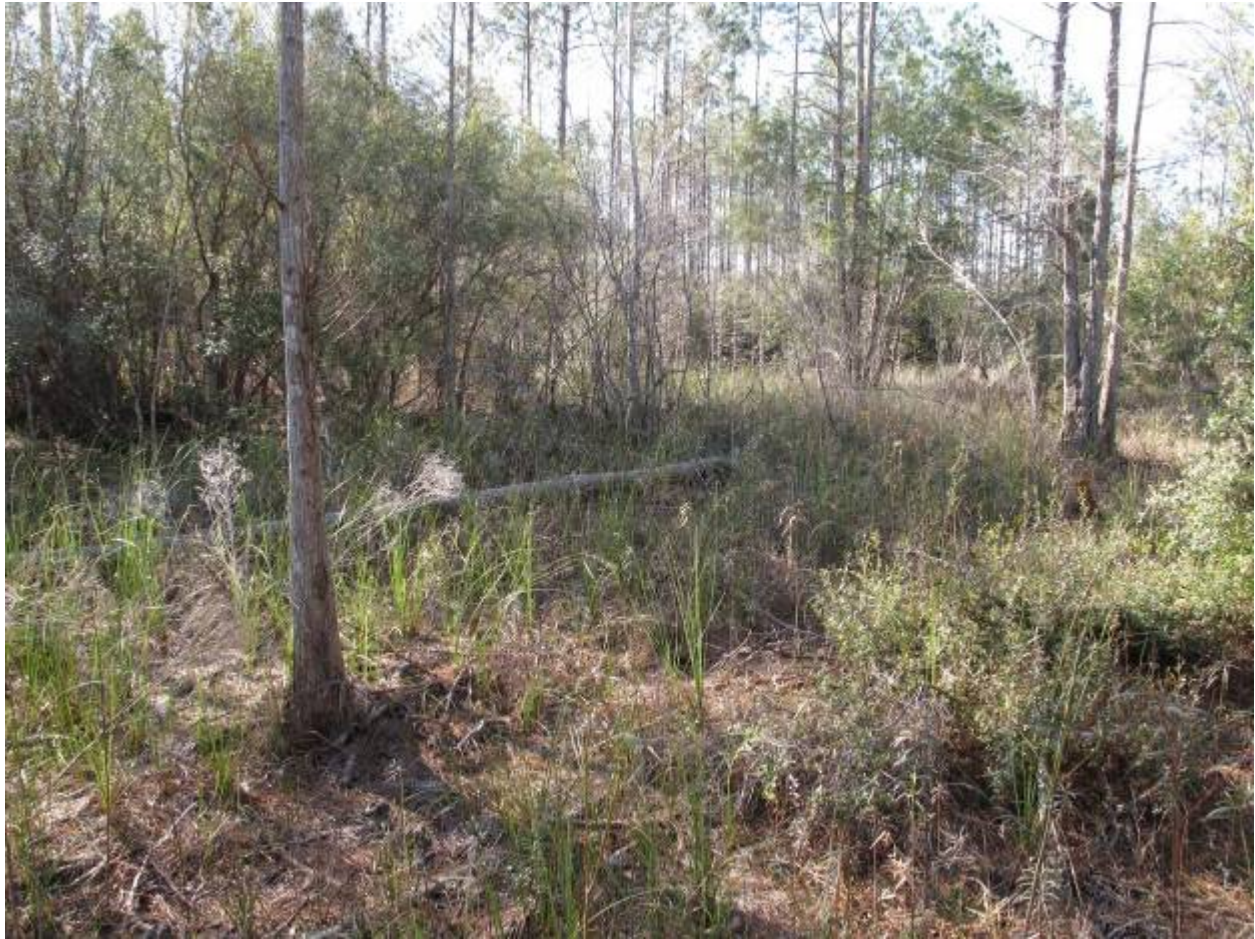
Description: This wetland is a 0.1 ha ephemeral marsh. Cypress trees dominate the canopy, and cover 5-25% of the wetland. Titi grows in a ring around the wetland edge, and covers 5-25% of the wetland. Sawgrass grows throughout the wetland, and covers 50-75% of the basin. There is evidence of old bedding in the wetland basin. The adjacent uplands are mesic flatwoods that were bedded and converted to a pine plantation. Upland restoration is in progress.

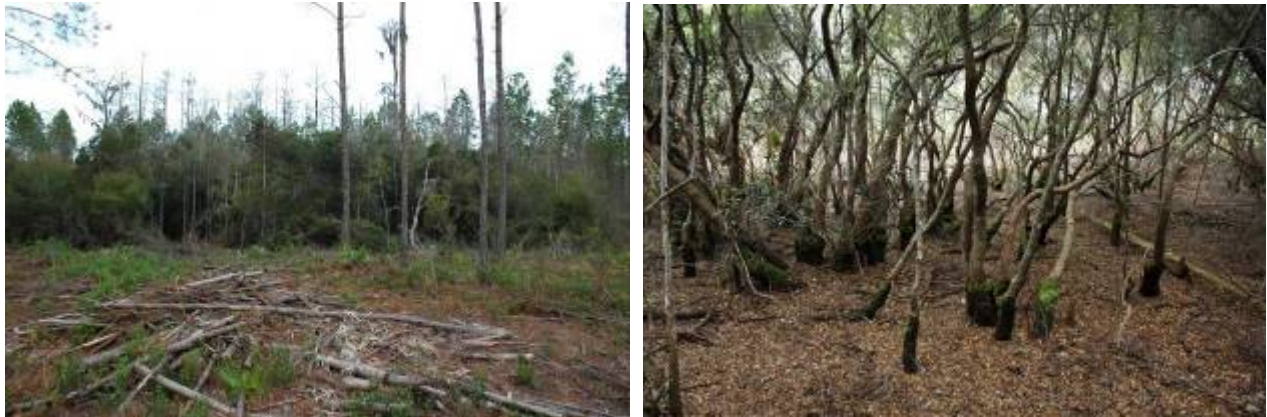
Wetland ID: 10-01

Description: This wetland is a 0.3 ha ephemeral mixed swamp. Cypress trees dominate the canopy, and cover 5-25% of the wetland. The midstory is dominated by titi and fetterbush, and covers >75% of the wetland. There is no herbaceous ground cover. The wetland appears to be an old cypress dome that was logged and colonized by titi. The adjacent uplands are mesic flatwoods that were bedded and converted to a pine plantation. Upland restoration is in progress.

Wetland Concerns: Woody encroachment

Restoration Action Recommended: Periodic fire in the wetland would reduce the dense titi and open the midstory.

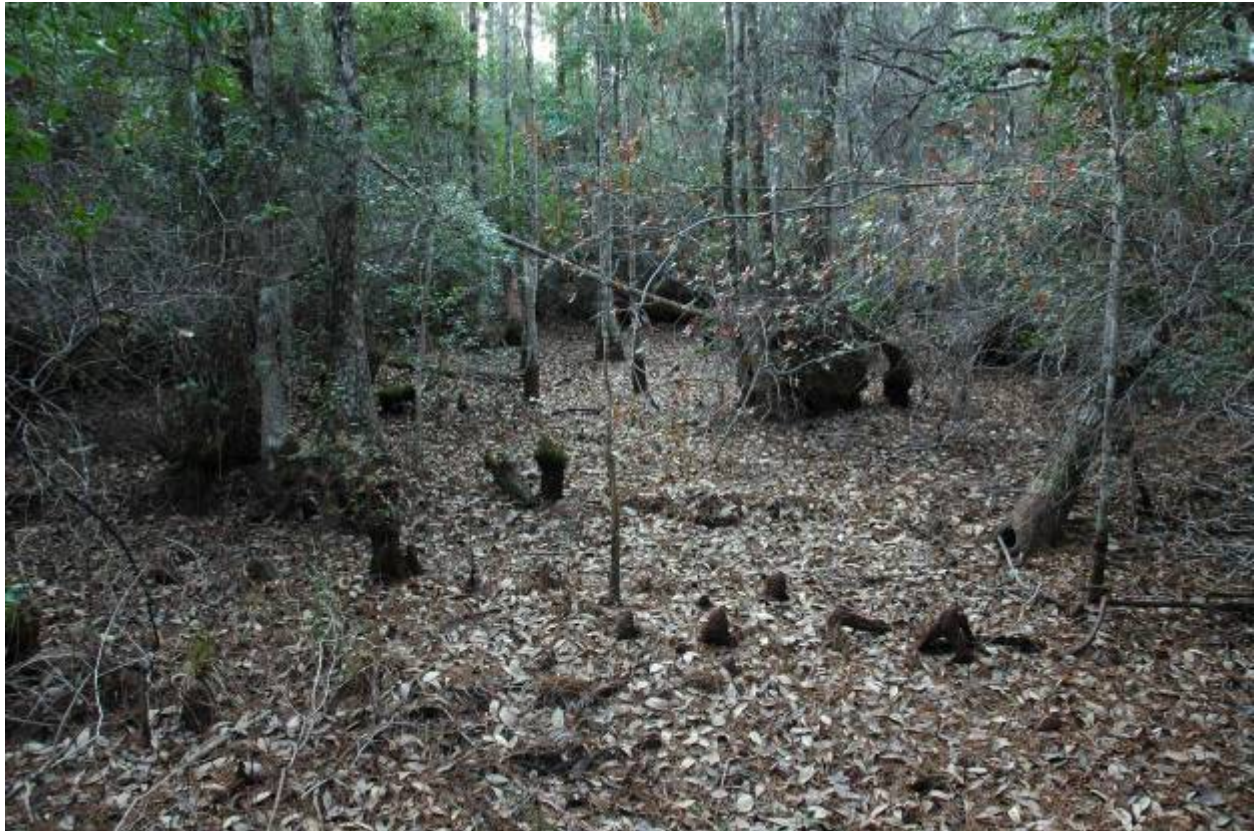
Wetland ID: 10-02

Description: This wetland is a 0.3 ha ephemeral mixed swamp. Gum and cypress trees dominate the canopy, and cover 50-75% of the wetland. The midstory is dominated by titi, fetterbush, and myrtle-leaf holly, and covers >75% of the wetland. There is no herbaceous ground cover. This wetland appears to be an old cypress dome that was logged and colonized by both gum and cypress trees. Pine trees planted through the edge of the wetland recently were removed. There is a gouge on the western edge of the wetland, likely a result of recent pine tree removal activity. The adjacent uplands are mesic flatwoods that were bedded and converted to a pine plantation. Upland restoration is in progress.

Wetland Concerns: Vehicular damage, Woody encroachment

Restoration Action Recommended: Allow the rut to heal over time. To avoid future damage, operate machinery only when wetland is completely dry. Smaller wetlands may need to be flagged to alert operators of the wetland's existence. Periodic fire in the wetland would reduce the dense titi and open the midstory.

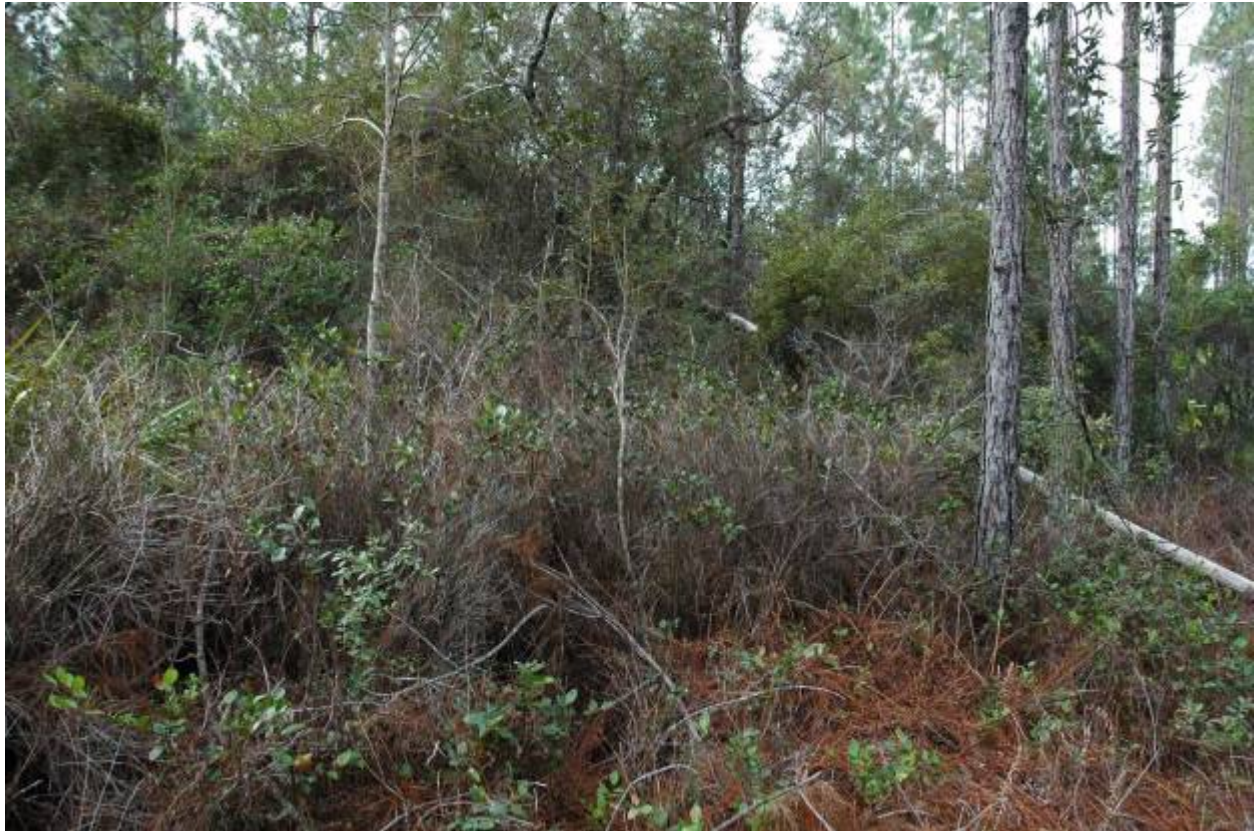
Wetland ID: 10-03

Description: This wetland is a 0.1 ha highly ephemeral mixed swamp. Cypress and pine trees dominant the canopy, and cover 25-50% of the wetland. The midstory is dominated by wax myrtle, myrtle-leaved holly, and fetterbush, and covers >75% of the wetland. There is no herbaceous ground cover. A former small, shallow cypress dome, this wetland was bedded and now has thick shrubs and planted pines through the center. The hydrology of this wetland has been altered as a result of the bedding rows. The adjacent uplands are mesic flatwoods that were bedded and converted to a pine plantation. Upland restoration is in progress.

Wetland Concerns: Bedding, Planted pine trees, Woody encroachment

Restoration Action Recommended: Remove planted pines from wetland interior. Provide periodic fire in the wetland to reduce the dense brush.

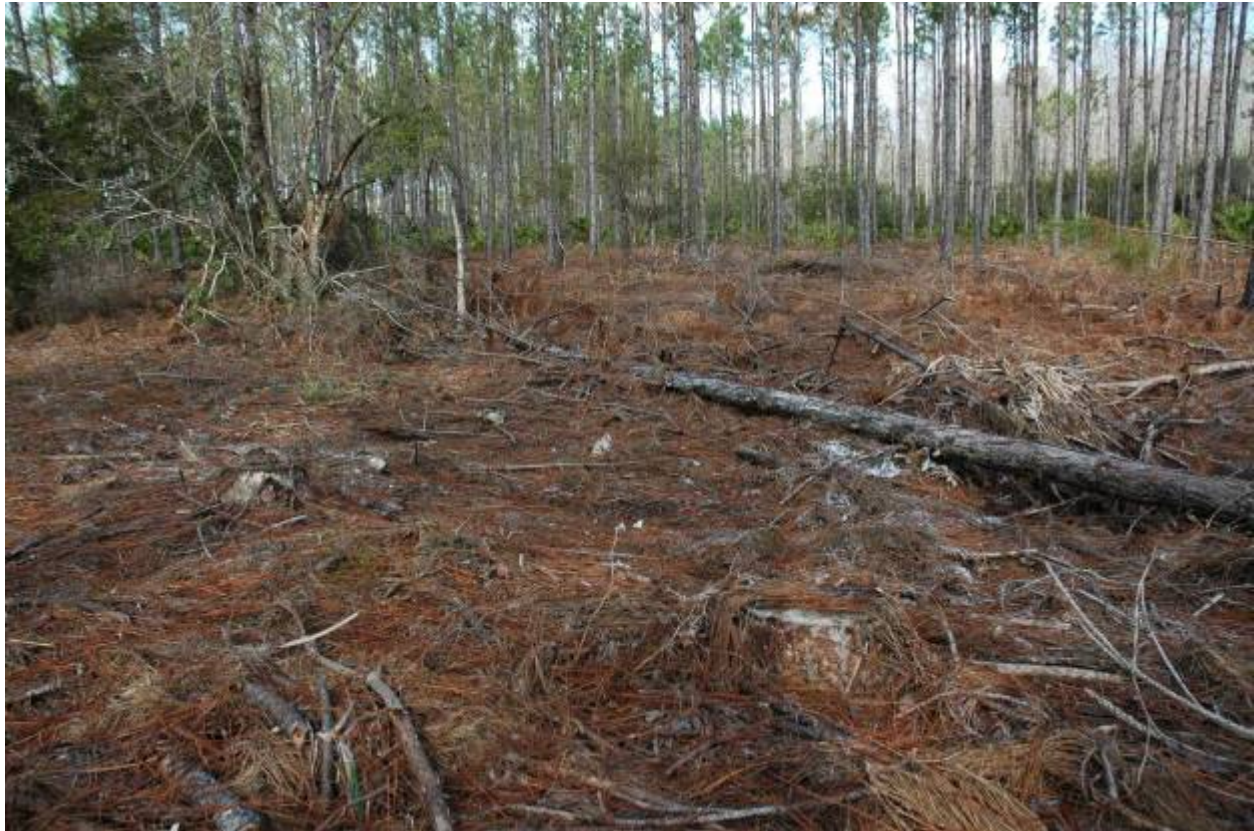
Wetland ID: 10-04

Description: This wetland is a <0.1 ha highly ephemeral, severely altered, wetland. It is a very small depressional wetland that likely was not noticed by machine operators during recent thinning/logging. The wetland was cleared of virtually all vegetation. There is no remaining canopy or midstory cover and no herbaceous ground cover. Pines, planted on bedding rows through the wetland, were recently logged. The depression is filled with pine needles and slash piles. The adjacent uplands are mesic flatwoods that were bedded and converted to a pine plantation. Upland restoration is in progress.

Wetland Concerns: Slash

Restoration Action Recommended: If this vegetation clearing was not intentional, we recommend flagging wetlands in the future to alert operators of a wetland's existence. This wetland will be a great experimental site to monitor how a wetland responds to complete vegetation clearing. Fire should be reintroduced into the system in order to clear out needle duff and slash piles. If fire does not eliminate the slash, mechanical treatment may be necessary.

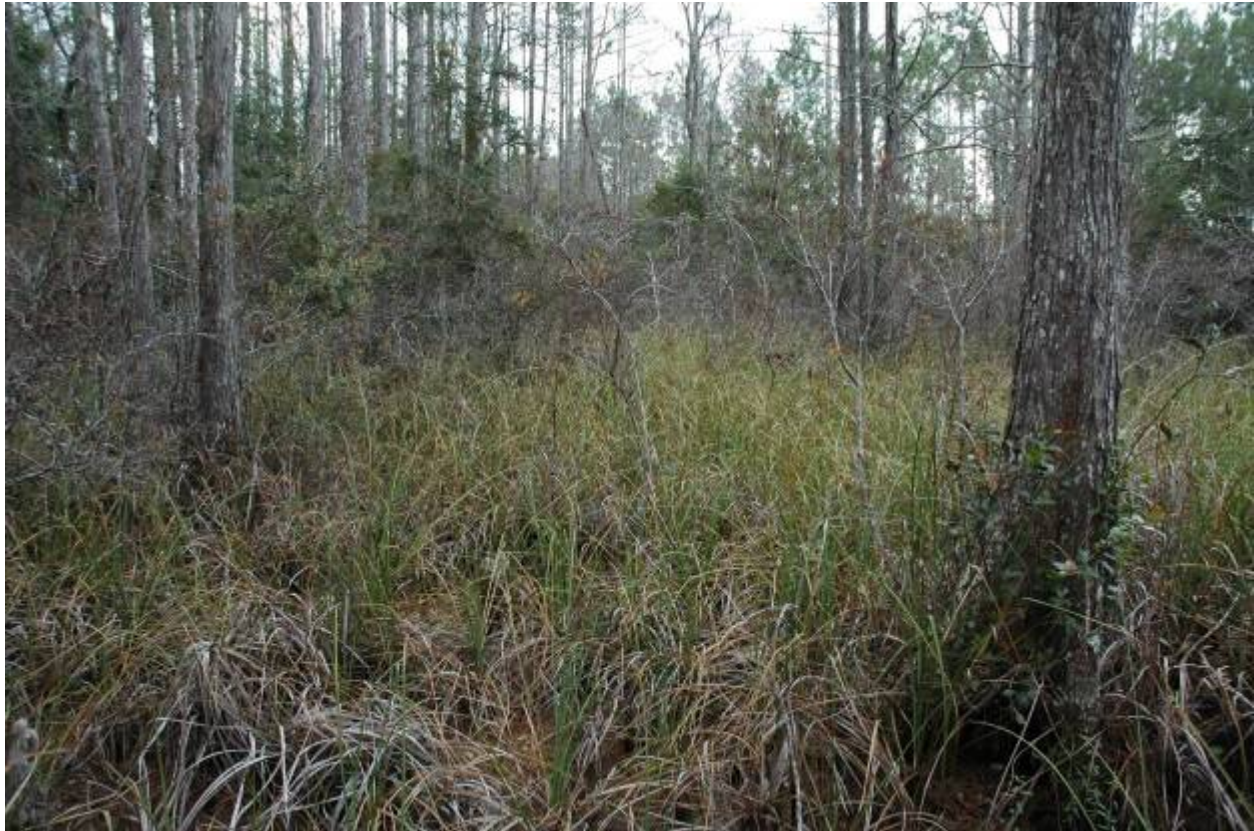
Wetland ID: 10-05

Description: This wetland is a 1.2 ha ephemeral mixed swamp. Cypress trees dominate the canopy, and cover 50-75% of the wetland. The midstory is dominated by titi and holly, and covers 50-75% of the wetland. Sawgrass grows in scattered patches, and covers 25-50% of the wetland. The wetland is ringed in brush, beyond which was cleared to expose mineral soil and encourage the growth of herbaceous vegetation. This wetland likely once was a more open sawgrass marsh. Long-term fire suppression of the surrounding landscape allowed for the encroachment of trees and shrubs. The adjacent uplands are mesic flatwoods that were bedded and converted to a pine plantation. Upland restoration is in progress.

Wetland Concerns: Woody encroachment

Restoration Action Recommended: Monitor the wetland, fire may need to be intentionally set in the wetland basin if the bare ground creates a fire break during an upland burn. Return periodic fire into the wetland to reduce the dense brush ring and prevent further shrub encroachment.

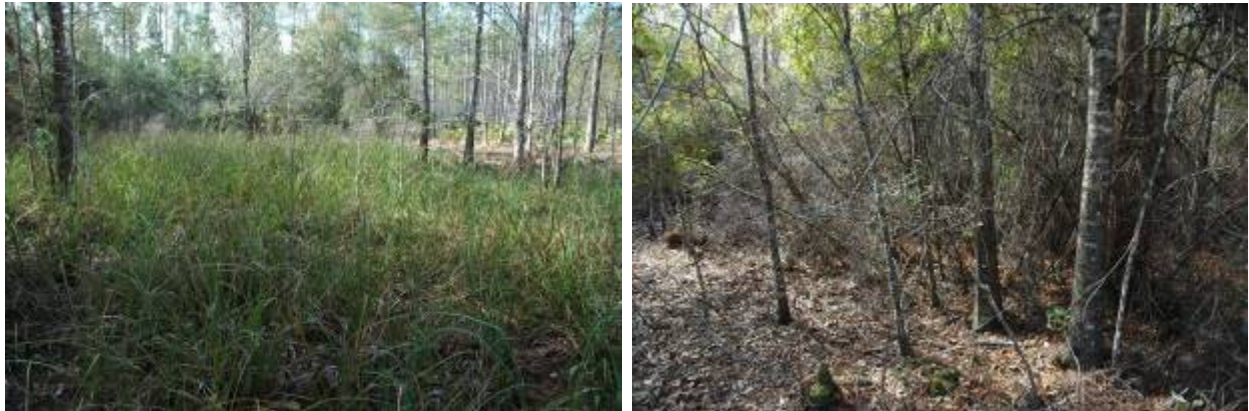
Wetland ID: 10-06

Description: This wetland is a 0.5 ha ephemeral forested swamp. Cypress and pine trees dominant the canopy, and covers 50-75% of the wetland. The midstory is dominated by wax myrtle and water oak, and covers 50-75% of the wetland. Sawgrass grows throughout the wetland, and covers 25-50% of the basin. The east side of the swamp is a thicket of brush. The adjacent uplands are mesic flatwoods that were bedded and converted to a pine plantation. Upland restoration is in progress.

Wetland Concerns: Woody encroachment

Restoration Action Recommended: The dense brush on the east side could be reduced through the use of periodic fire.

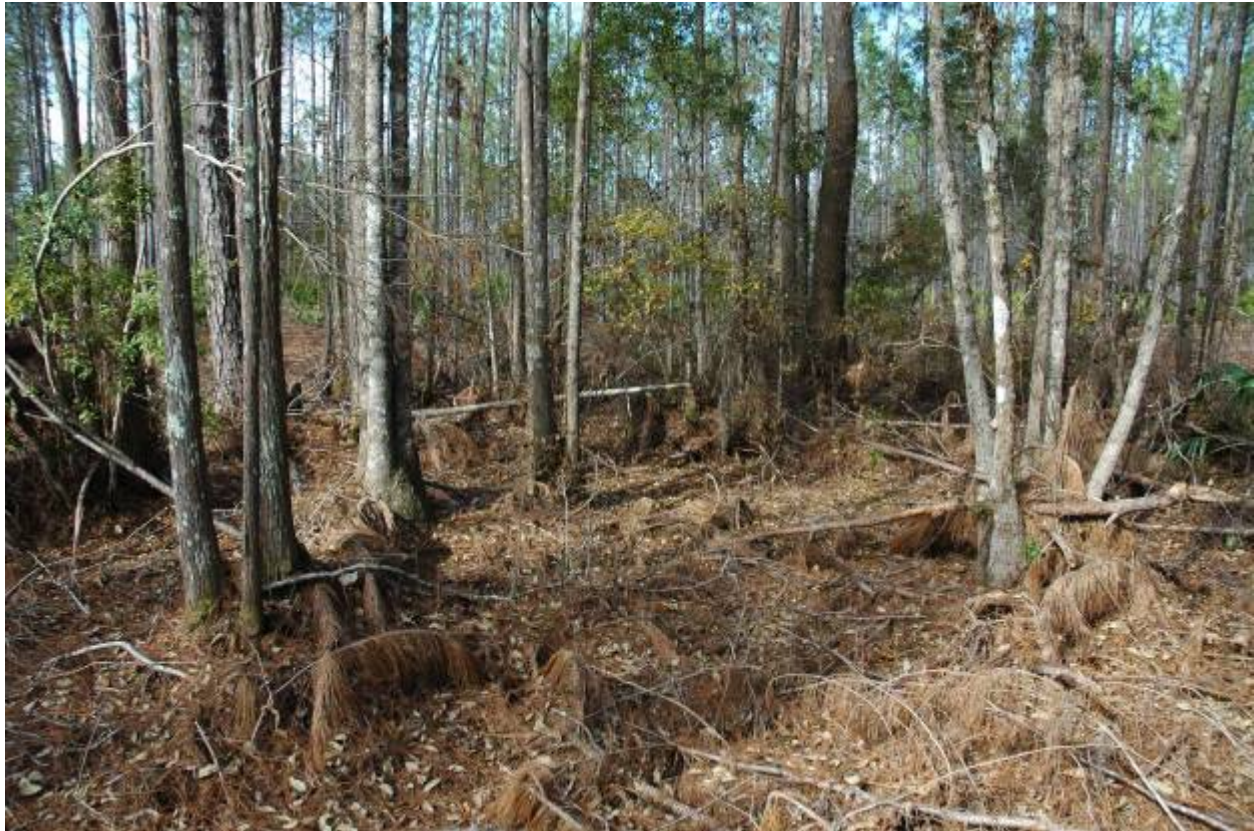
Wetland ID: 10-07

Description: This wetland is a 0.1 ha highly ephemeral forested swamp. Cypress and gum trees dominant the canopy, and covers >75% of the wetland. The midstory is dominated by holly and wax myrtle, and covers 5-25% of the wetland. There is no herbaceous ground cover. Slash was pushed into the wetland during recent thinning activities. The adjacent uplands are mesic flatwoods that were bedded and converted to a pine plantation. Upland restoration is in progress.

Wetland Concerns: Slash

Restoration Action Recommended: Encourage fire in the wetland basin to eliminate the slash.

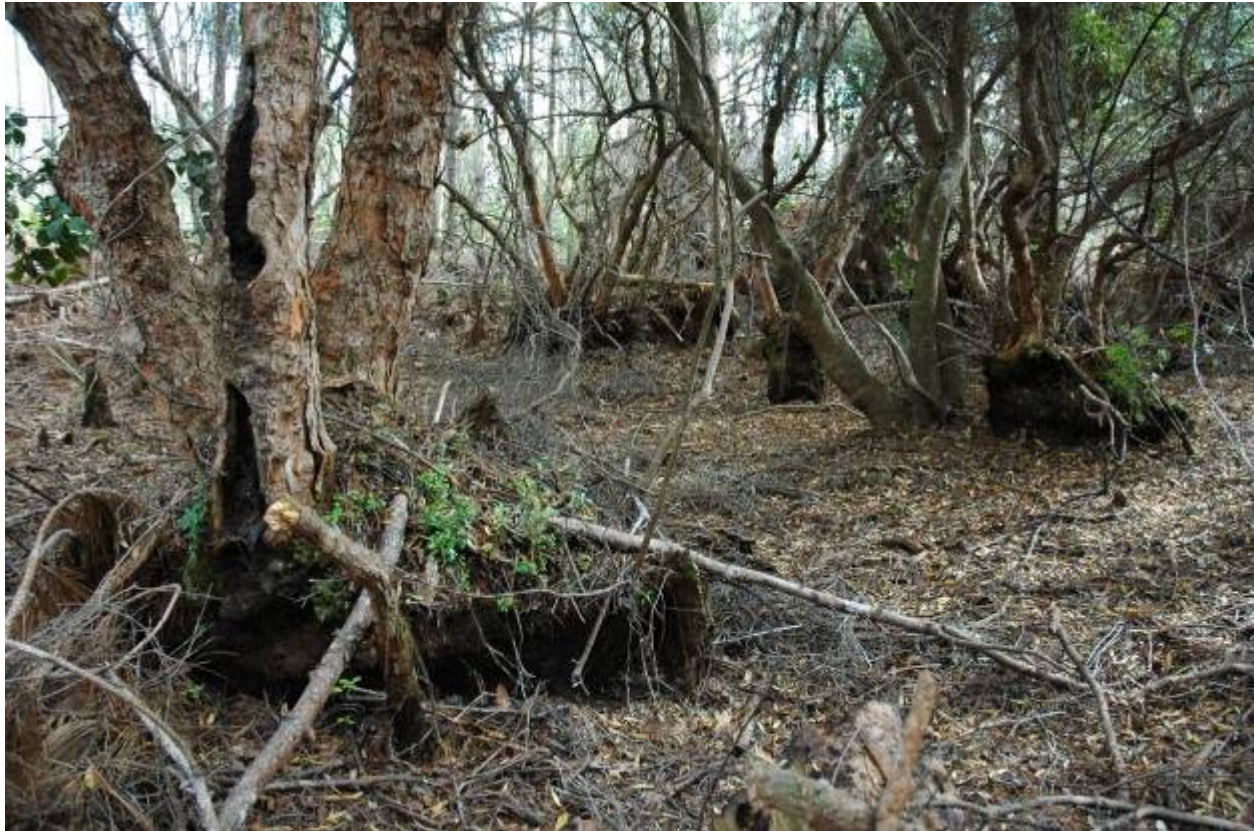
Wetland ID: 10-08

Description: This wetland is a 0.1 ha highly ephemeral shrub swamp. Water oak and cypress trees dominant the canopy, and cover 5-25% of the wetland. The midstory is dominated by titi, and covers >75% of the wetland. There is no herbaceous ground cover. This wetland appears to be a former cypress dome that was logged and colonized by titi. There are slash piles in the wetland from recent thinning activities. The adjacent uplands are mesic flatwoods that were bedded and converted to a pine plantation. Upland restoration is in progress.

Wetland Concerns: Slash, Woody encroachment

Restoration Action Recommended: The slash and dense titi could be reduced through the use of periodic fire.

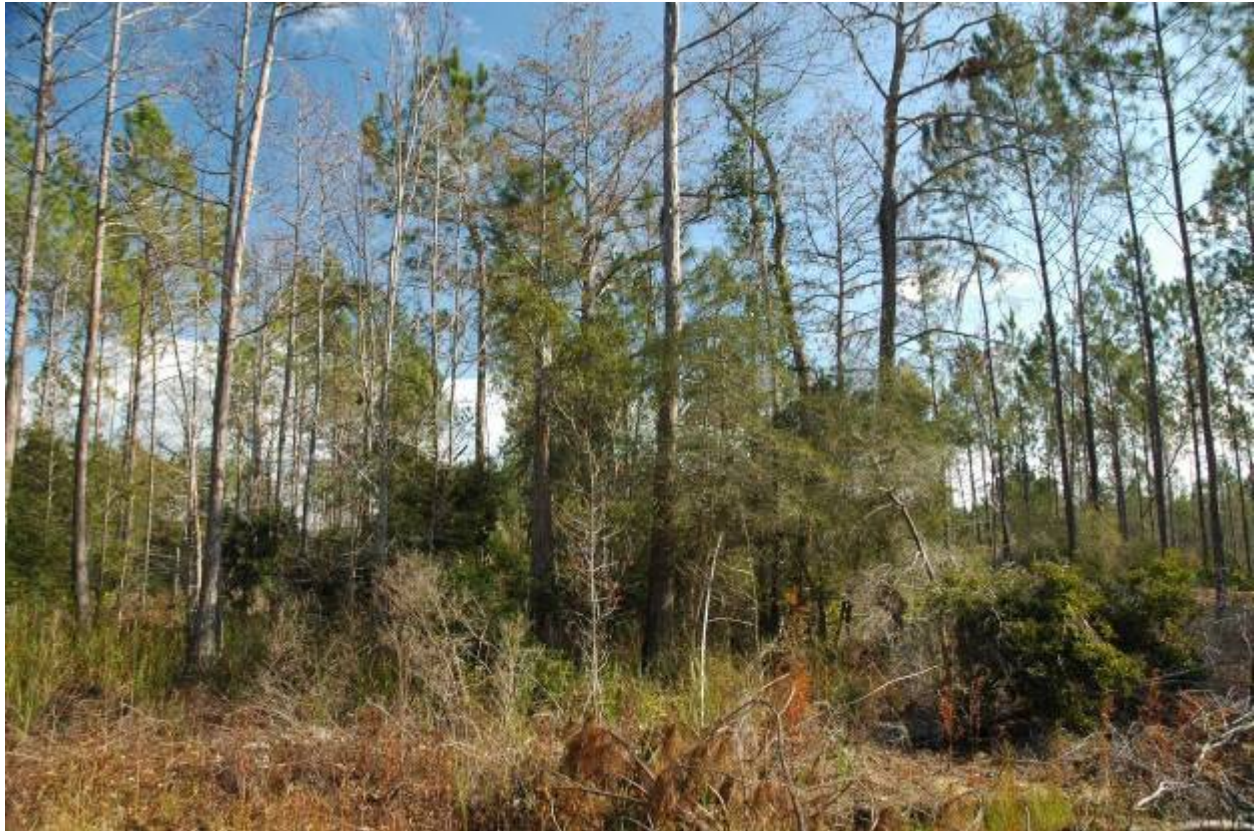
Wetland ID: 10-09

Description: This wetland is a 0.1 ha ephemeral mixed swamp. Cypress trees dominate the canopy, and cover 25-50% of the wetland. The midstory is dominated by wax myrtle, and covers 50-75% of the wetland. Grass and sawgrass grow throughout the wetland, and cover 50-75% of the basin. Pine trees were planted on bedding rows up to and slightly into the wetland. The trees were recently removed. There are slash piles in the wetland from the recent logging operations. The adjacent uplands are mesic flatwoods that were bedded and converted to a pine plantation. Upland restoration is in progress.

Wetland Concerns: Bedding, Slash, Woody encroachment

Restoration Action Recommended: No action to remove the bedding is recommended; the bedding rows will erode over time. Reintroduce fire into the wetland to reduce the slash piles and to prevent the shrubs from becoming too dense.

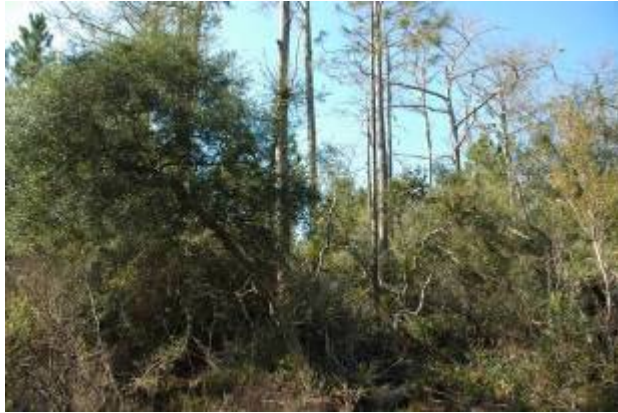
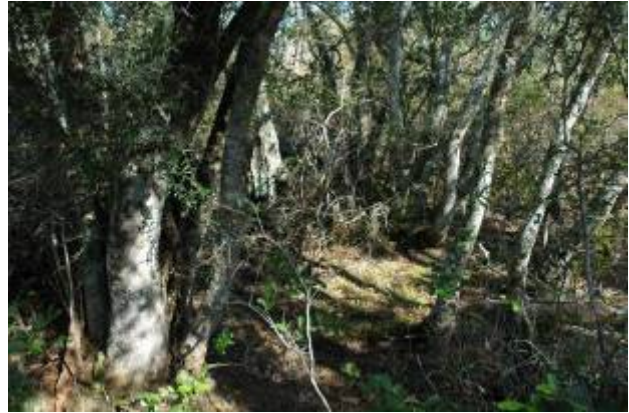
Wetland ID: 10-10

Description: This wetland is a 0.2 ha ephemeral mixed swamp. Cypress trees dominate the canopy, and cover 25-50% of the wetland. The midstory is dominated by holly and fetterbush, and covers >75% of the wetland. *Sphagnum* and grasses grow in scattered patches, and cover 5-25% of the basin. There are slash piles in the wetland. The adjacent uplands are mesic flatwoods that were bedded and converted to a pine plantation. Upland restoration is in progress.

Wetland Concerns: Slash, Woody encroachment

Restoration Action Recommended: Reintroduce periodic fire to eliminate the slash and reduce the dense shrubs.

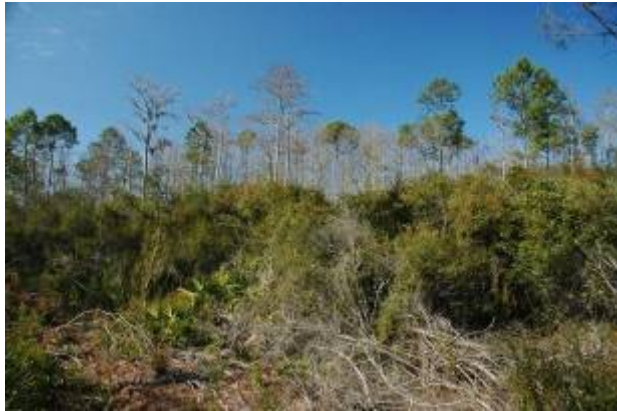
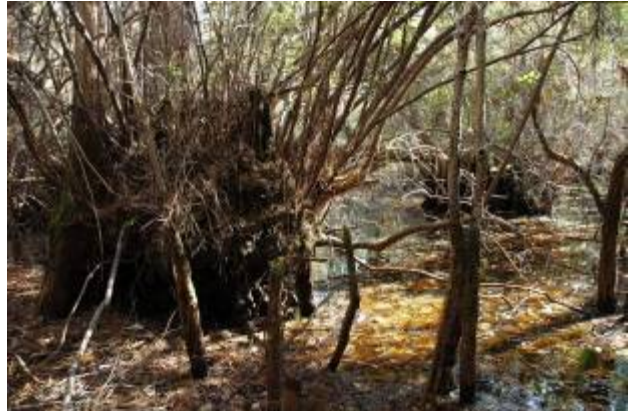
Wetland ID: 10-11

Description: This wetland is a 2.8 ha ephemeral mixed swamp. Cypress trees dominate the canopy, and cover 50-75% of the wetland. The midstory is dominated by titi and fetterbush, and covers >75% of the wetland. There is no herbaceous vegetation. The wetland is surrounded by an almost impenetrable ring of brush. There are slash piles around the wetland edges. The adjacent uplands are mesic flatwoods that were bedded and converted to a pine plantation. Upland restoration is in progress.

Wetland Concerns: Slash, Woody encroachment

Restoration Action Recommended: Encourage periodic fire to eliminate the slash and reduce the dense shrub ring.

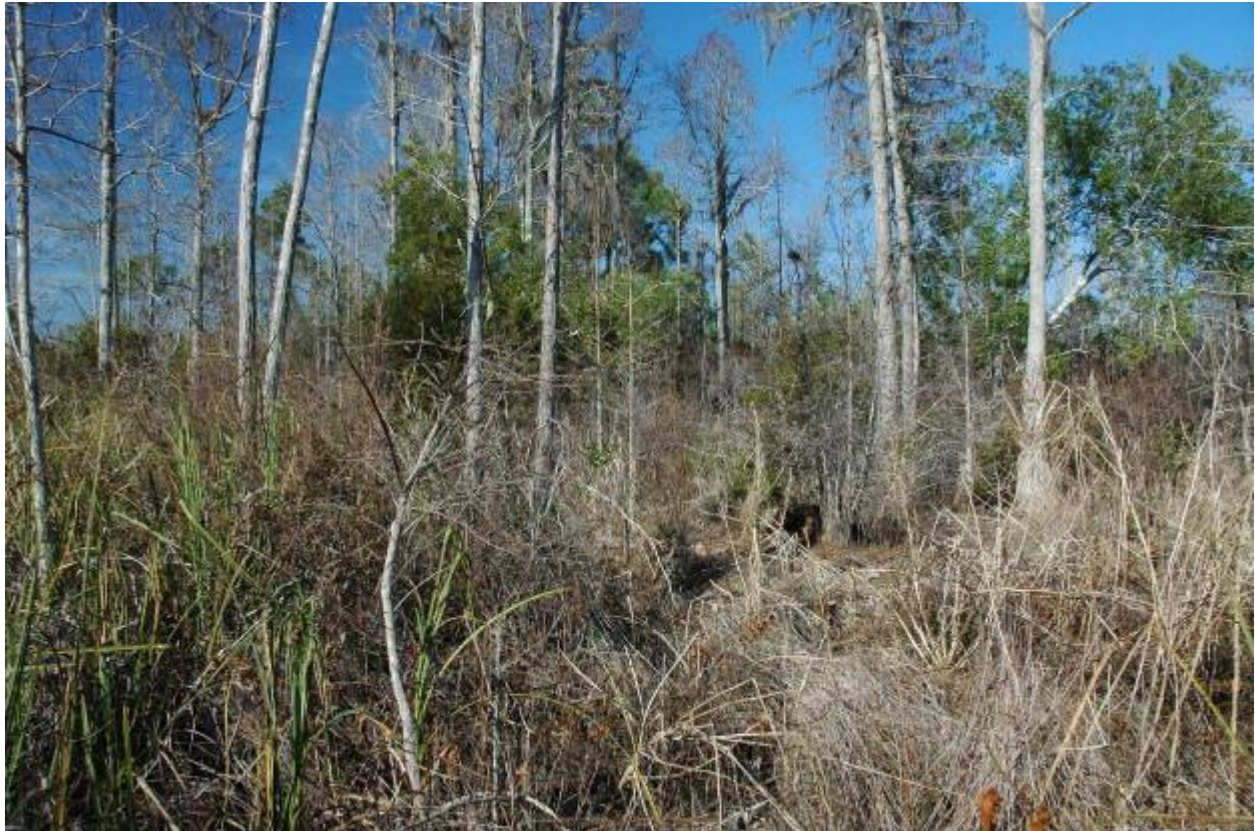
Wetland ID: 10-12

Description: This wetland is a 1.8 ha ephemeral mixed swamp. The presence of old cypress stumps provides evidence of historical logging. The cypress trees are regenerating and cover 25-50% of the wetland. The midstory is dominated by wax myrtle and buttonbush, and covers 25-50% of the wetland. Sawgrass grows in scattered patches, and covers 25-50% of the basin. Old gouges from machinery are still evident. There is a small amount of slash in the wetland. The adjacent uplands are mesic flatwoods that were bedded and converted to a pine plantation. Upland restoration is in progress.

Wetland Concerns: Slash, Vehicular damage

Restoration Action Recommended: Periodic fire will eliminate the slash and prevent the midstory from becoming too dense. No action is recommended for the old vehicular tracks in wetland, the tracks will erode over time.

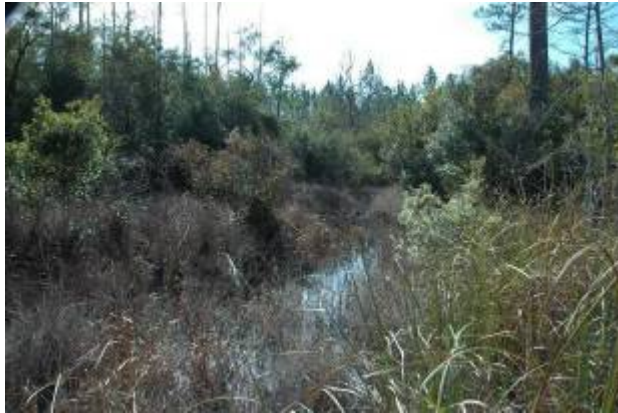
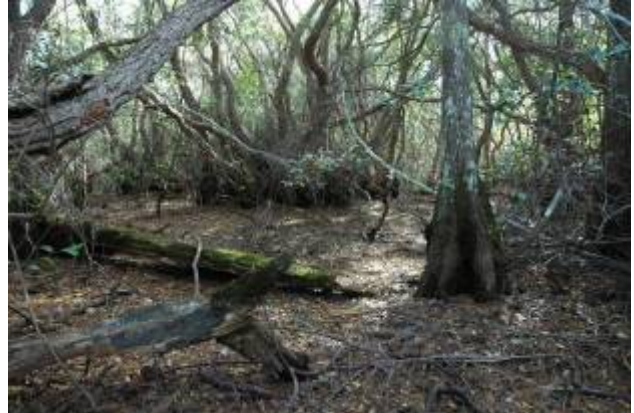
Wetland ID: 10-13

Description: This wetland is a 0.6 ha ephemeral mixed swamp. The presence of old cypress stumps provides evidence of historical logging. The cypress trees are regenerating and cover 5-25% of the wetland. The midstory is a mixture of various shrubs including titi, holly, fetterbush, and wax myrtle, and covers 50-75% of the wetland. Sawgrass grows in scattered patches, and covers 50-75% of the basin. Gouges from machinery are still evident and there are slash piles around the wetland. What appears to be a logging track runs alongside the wetland. The adjacent uplands are mesic flatwoods that were bedded and converted to a pine plantation. Upland restoration is in progress.

Wetland Concerns: Slash, Vehicular damage, Woody encroachment

Restoration Action Recommended: If the track is necessary to maintain, re-route away from the wetland. Fire may need to be intentionally set in the wetland basin if the logging track creates a fire break during an upland burn. Periodic fire will eliminate the slash and reduce the dense midstory. No action is recommended for the old vehicular tracks in wetland, the gouges will erode and re-vegetate over time.

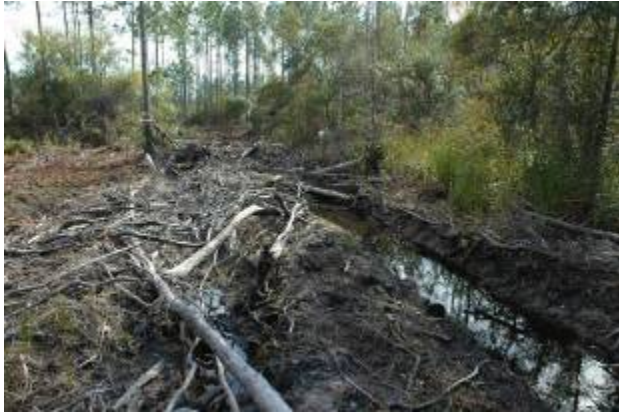
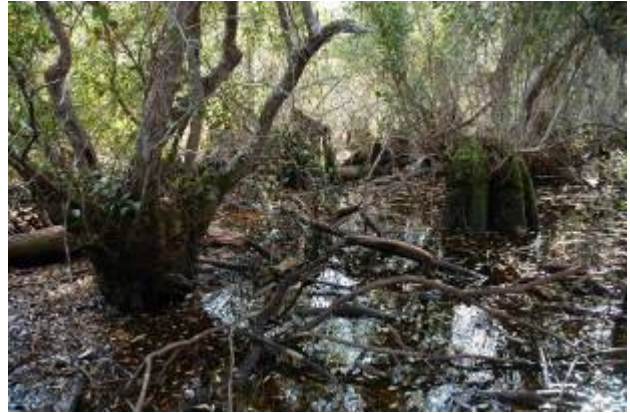
Wetland ID: 10-14

Description: This wetland is a 0.5 ha ephemeral mixed swamp. Cypress trees dominate the canopy, and cover 25-50% of the wetland. The midstory is dominated by holly, fetterbush, and titi, and covers >75% of the wetland. Sawgrass grows in scattered patches, and covers 25-50% of the wetland. Deep gouges on the east side likely occurred during recent thinning operations. Fish were present in the ruts on the day of our visit. There are piles of slash around the wetland. The adjacent uplands are mesic flatwoods that were bedded and converted to a pine plantation. Upland restoration is in progress.

Wetland Concerns: Slash, Vehicular damage, Woody encroachment

Restoration Action Recommended: Reintroduce periodic fire to eliminate slash and reduce the dense midstory. To prevent future damage, machinery should be operated around wetlands only when the wetland is completely dry.

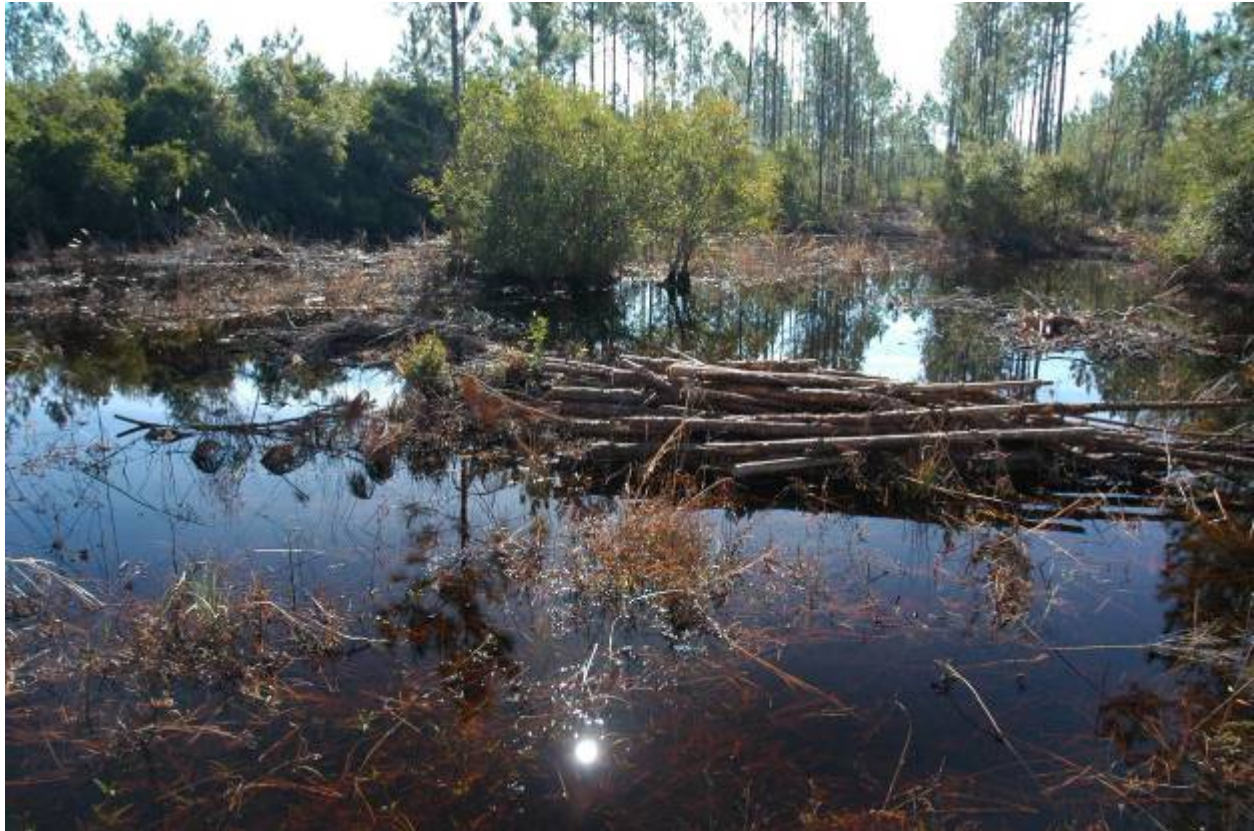
Wetland ID: 10-15

Description: This wetland is a 0.2 ha ephemeral shrub swamp. There is no tree canopy. Wax myrtle, fetterbush, and titi are the dominant woody vegetation, and cover 25-50% of the wetland. Grasses grow in scattered patches, and covers 5-25% of the wetland. Remnants of old bedding rows are still apparent through the wetland interior. Brush, and possibly pine trees, recently were removed from the wetland. A slash pile remains in the wetland interior. The adjacent uplands are mesic flatwoods that were bedded and converted to a pine plantation. Upland restoration is in progress.

Wetland Concerns: Bedding, Slash, Vehicular damage

Restoration Action Recommended: Reintroduce periodic fire to the wetland to eliminate slash and allow this wetland to re-establish. If the next fire does not reduce the slash pile in the wetland, mechanical treatment may be necessary. With the return of fire, this wetland may become a marsh/shrub swamp. To prevent future damage, operate machinery only when wetland is completely dry. Smaller wetlands may need to be flagged to alert operators of the wetland's existence.

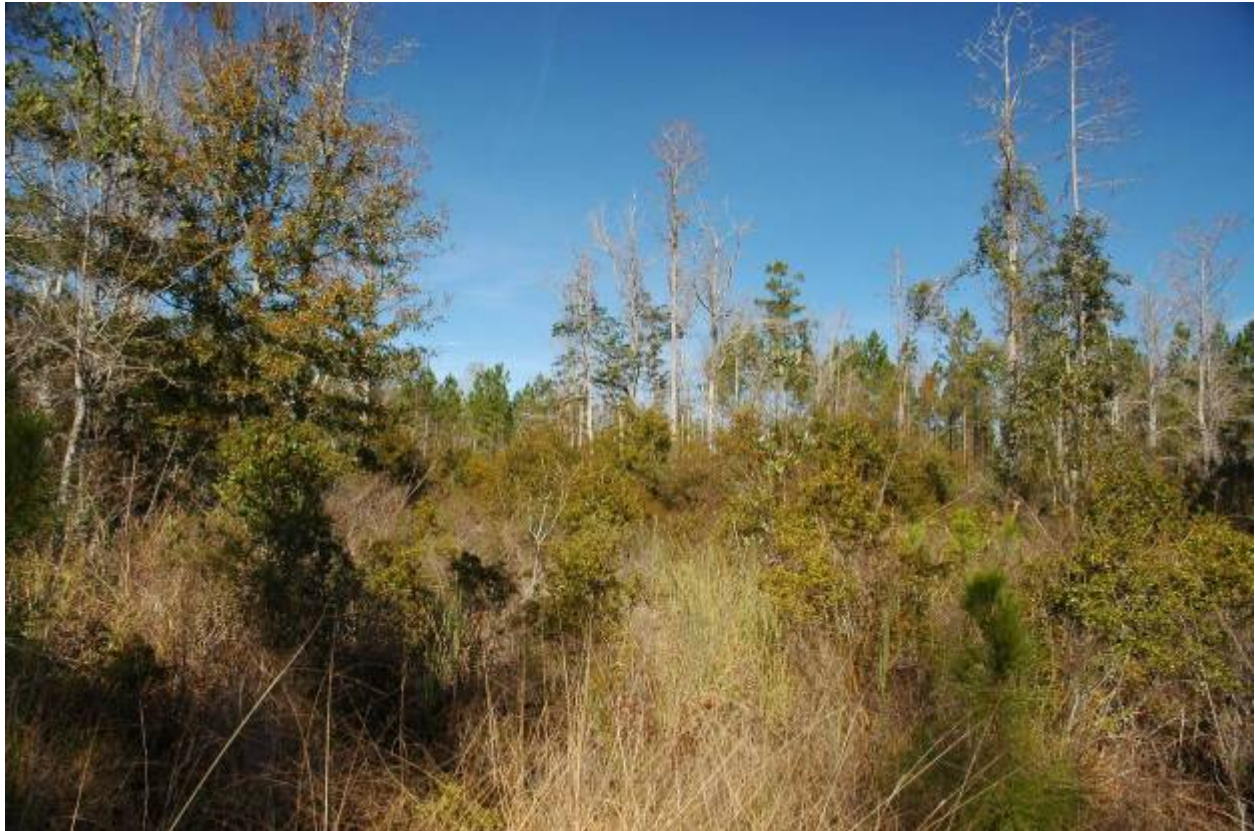
Wetland ID: 10-16

Description: This wetland is a 0.9 ha ephemeral marsh. Cypress and sweet bay magnolia trees dominate the canopy, and cover 5-25% of the wetland. The midstory is dominated by wax myrtle, and covers 25-50% of the wetland. Grasses and sawgrass grow throughout the wetland, and cover >75% of the basin. Old bedding rows and mechanical tracks are still evident in the wetland. There is a drainage ditch associated with the wetland. The presence of old cypress stumps provides evidence of historical logging. The adjacent uplands are mesic flatwoods that were bedded and converted to a pine plantation. Upland restoration is in progress.

Wetland Concerns: Ditching, Slash piles, Vehicular damage, Woody encroachment

Restoration Action Recommended: Plug the drainage ditch. Encourage fire in the wetland to eliminated the slash and prevent further shrub encroachment. Allow old bedding and machine gouges to erode over time.

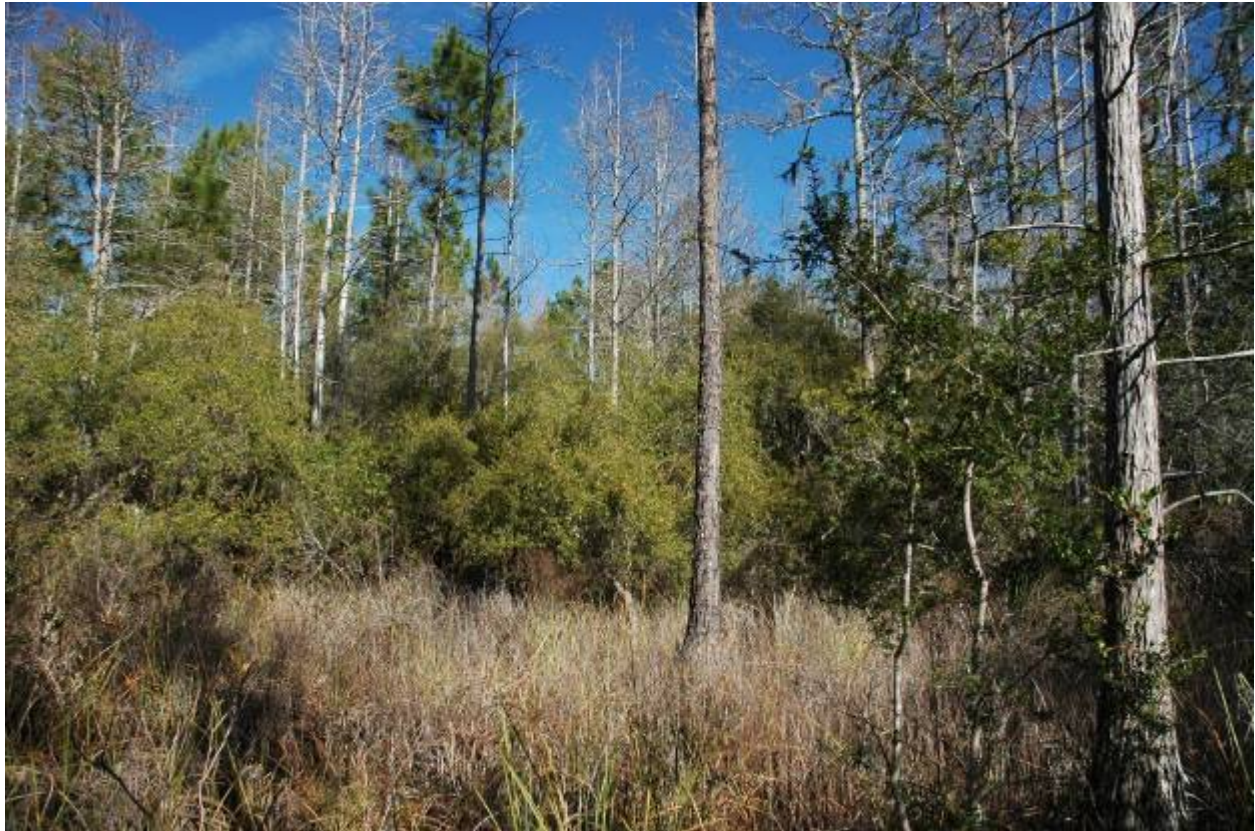
Wetland ID: 10-17

Description: This wetland is a 1.1 ha ephemeral marsh and mixed swamp. Cypress and pine trees dominant the canopy, and cover 25-50% of the wetland. The midstory is dominated by wax myrtle and titi, and covers 50-75% of the wetland. Sawgrass grows throughout the wetland, and covers 50-75% of the basin. The wetland floor is very spongy from a build up of peat. The presence of old cypress stumps provides evidence of historical logging. The adjacent uplands are mesic flatwoods that were bedded and converted to a pine plantation. Upland restoration is in progress.

Wetland Concerns: Woody encroachment

Restoration Action Recommended: Periodic fire in the wetland basin would reduce the brush and expose some of the peat to oxidation.

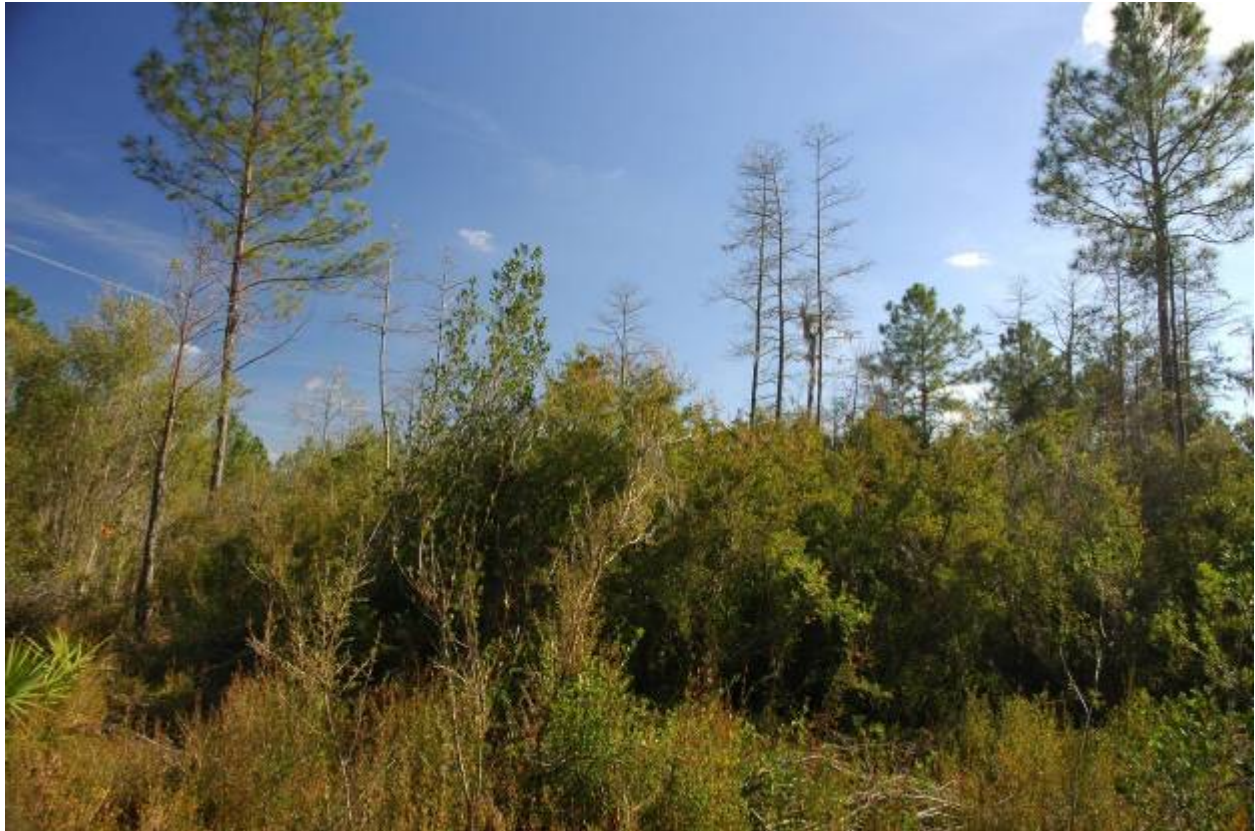
Wetland ID: 10-18

Description: This wetland is a 1.0 ha ephemeral shrub swamp. The presence of old cypress stumps provides evidence of historical logging. The cypress trees are generating and cover 5-25% of the wetland. The midstory is dominated by titi, and covers >75% of the wetland. Sawgrass grows sparsely throughout the wetland, and covers 5-25% of the basin. Old bedding rows are still evident in the wetland as are machinery tracks, presumably from past logging operations. The adjacent uplands are mesic flatwoods that were bedded and converted to a pine plantation. Upland restoration is in progress.

Wetland Concerns: Bedding, Vehicular damage, Woody encroachment

Restoration Action Recommended: No action to remove the bedding is recommended; the bedding rows will erode over time. Allow the tracks to heal over time. To avoid future damage, operate machinery only when wetland is completely dry. Periodic fire in the wetland would reduce the dense titi and open the midstory.
