Inventory, Assessment, and Restoration Potential of Ephemeral Wetlands on FFWCC Wildlife Management Areas

Aucilla WMA Final Report

Submitted by: Rebecca P.M. Means¹, Ryan C. Means¹, Steven A. Johnson²

¹Coastal Plains Institute

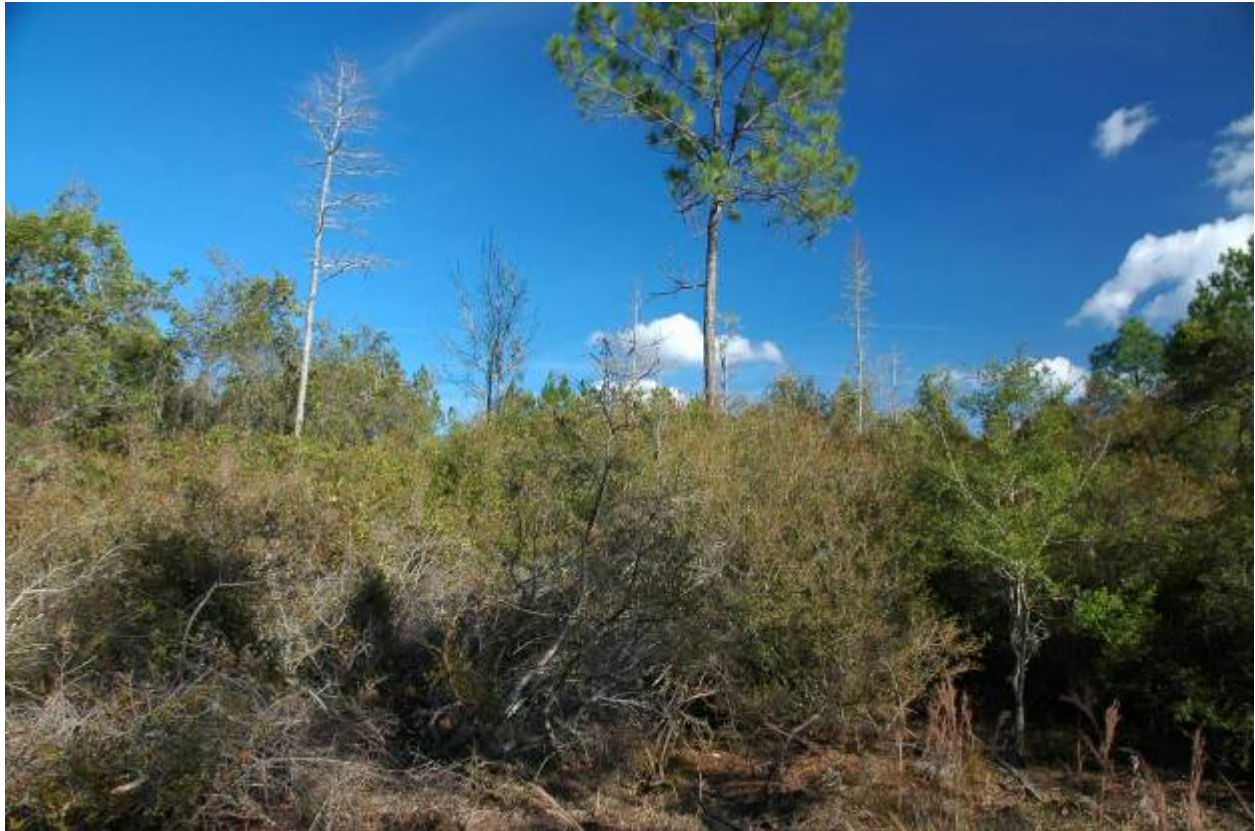
Wetland ID: 10-19

Description: This wetland is a 1.6 ha ephemeral shrub swamp. There is no tree canopy. Titi is the dominant woody vegetation, and covers >75% of the wetland. There is no herbaceous vegetation. Brush has been removed around the edge of the wetland. The adjacent uplands are mesic flatwoods that were bedded and converted to a pine plantation. Upland restoration is in progress.

Wetland Concerns: Woody encroachment

Restoration Action Recommended: Periodic fire in the wetland would reduce the dense titi

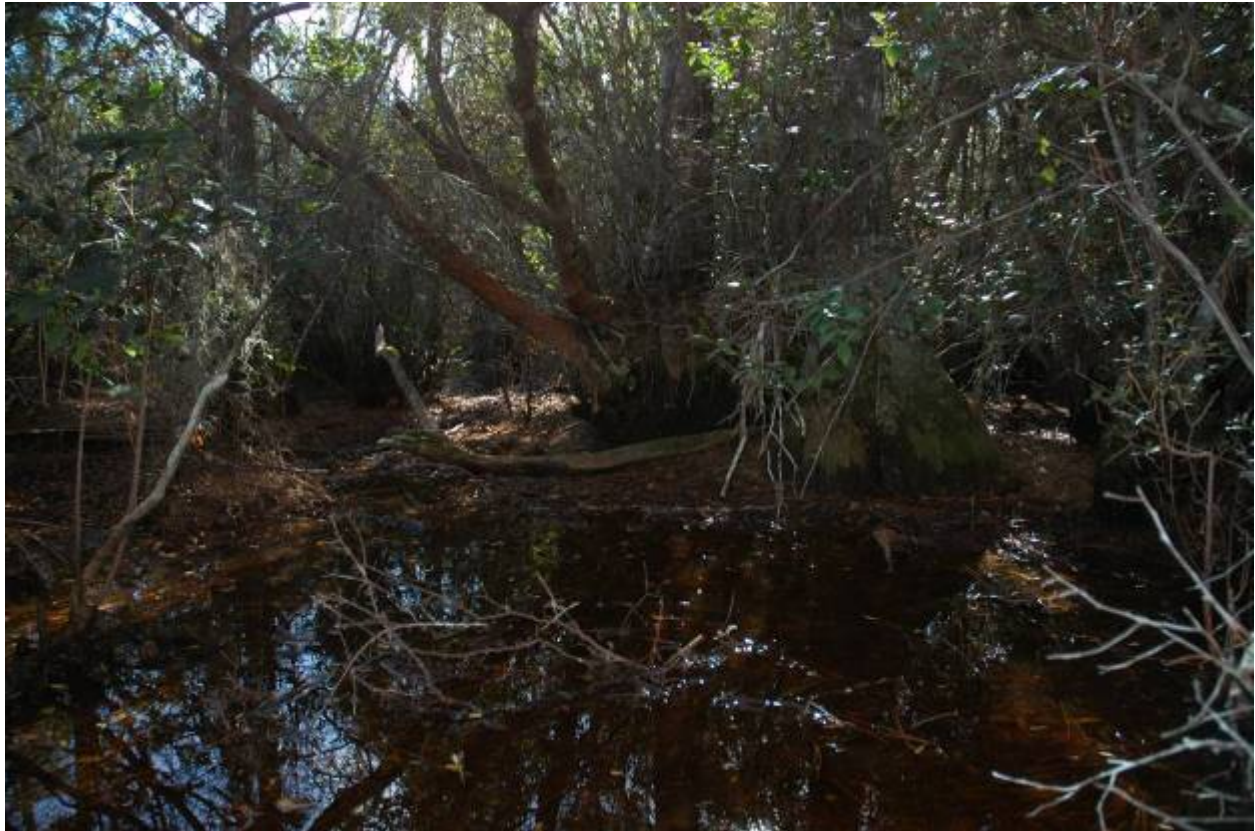
Wetland ID: 10-20

Description: This wetland is a 1.1 ha ephemeral shrub swamp. Cypress and pine trees dominant the canopy, and cover 5-25% of the wetland. The midstory is dominated by titi and fetterbush, and covers >75% of the wetland. There is no herbaceous vegetation, and peat has built up in the wetland center. Old machinery tracks have created a small opening in the wetland. The adjacent uplands are mesic flatwoods that were bedded and converted to a pine plantation. Upland restoration is in progress.

Wetland Concerns: Vehicular damage, Woody encroachment

Restoration Action Recommended: Allow the rut to heal over time. To avoid future damage, operate machinery only when wetland is completely dry. Periodic fire in the wetland would reduce the dense titi and expose peat to oxidation.

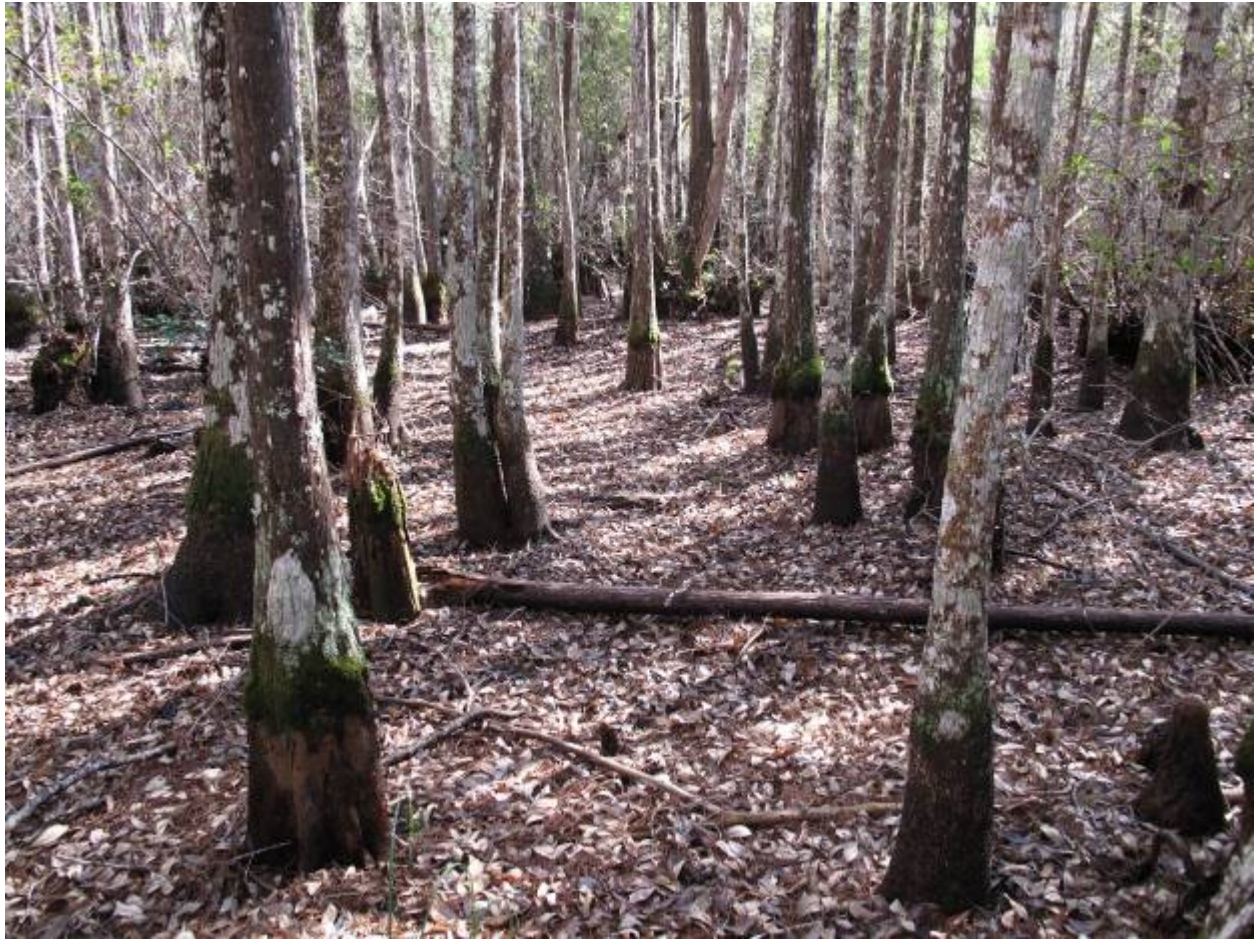
Wetland ID: 10-21

Description: This wetland is a 0.9 ha ephemeral forested swamp. Cypress and gum trees dominate the canopy, and cover >75% of the wetland. The midstory is dominated by holly, and covers 25-50% of the wetland. There is no herbaceous vegetation, and a thick layer of duff covers the wetland floor. The presence of old cypress stumps provides evidence of historical logging. A major road (SR 59) runs along the west side of the wetland. Before the road was built, this wetland was part of a larger wetland system. The adjacent uplands are mesic flatwoods that were bedded and converted to a pine plantation. Upland restoration is in progress.

Wetland Concerns: Road

Restoration Action Recommended: In order to restore the hydrology of this wetland and the larger wetland system, the road would have to be removed. Recognizing that this road is now a permanent part of the landscape, we do not recommend any action relating to the road. The wetland could be monitored to ensure it is not affected by run-off or other impacts.

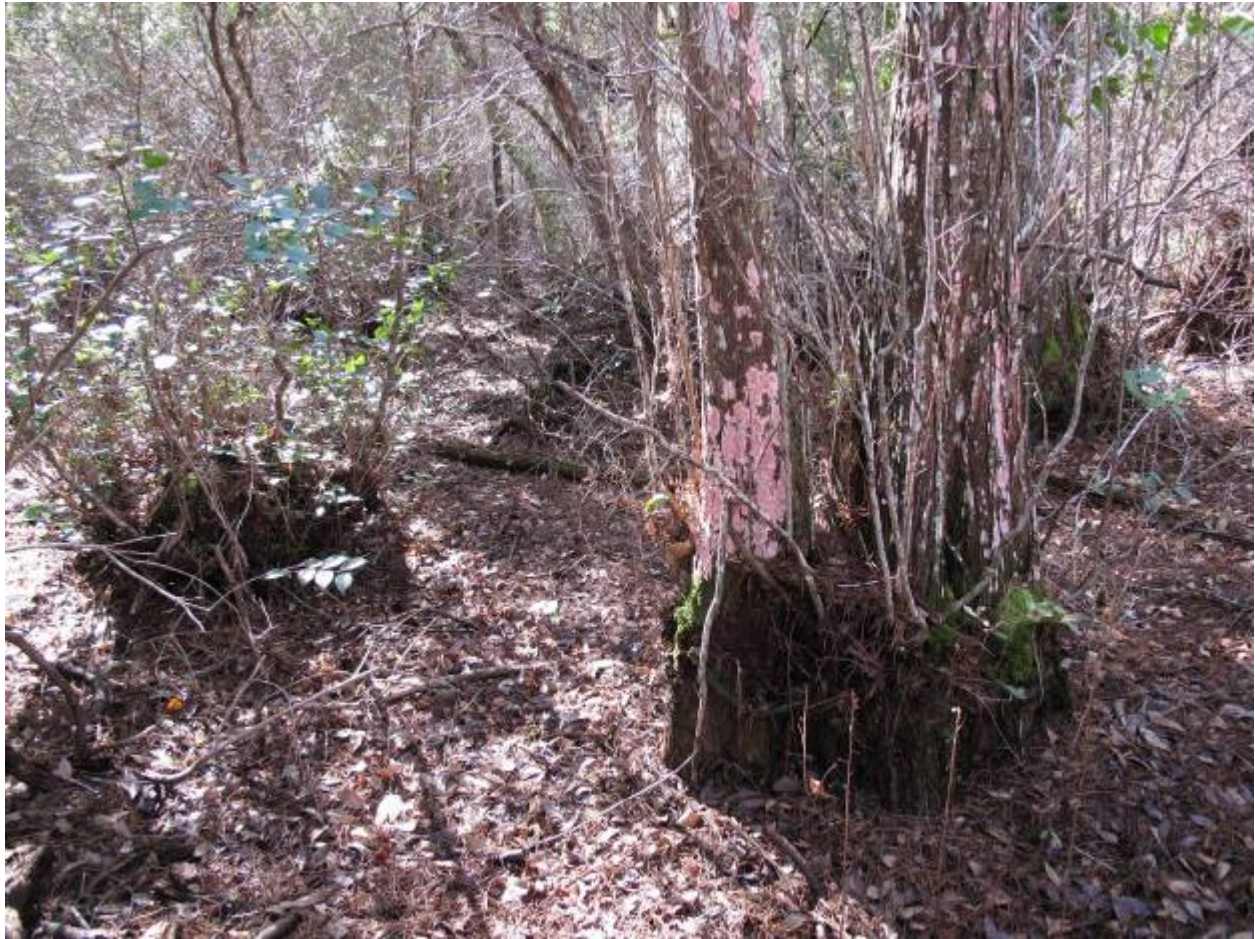
Description: This wetland is a 0.6 ha ephemeral mixed swamp. The presence of old cypress stumps provides evidence of historical logging. The cypress trees have regenerate and cover 50-75% of the wetland. The midstory is dominated by titi, and covers >75% of the wetland. There is no herbaceous vegetation, and a thick layer of duff covers the wetland floor. The adjacent uplands are mesic flatwoods that were bedded and converted to a pine plantation. Upland restoration is in progress.

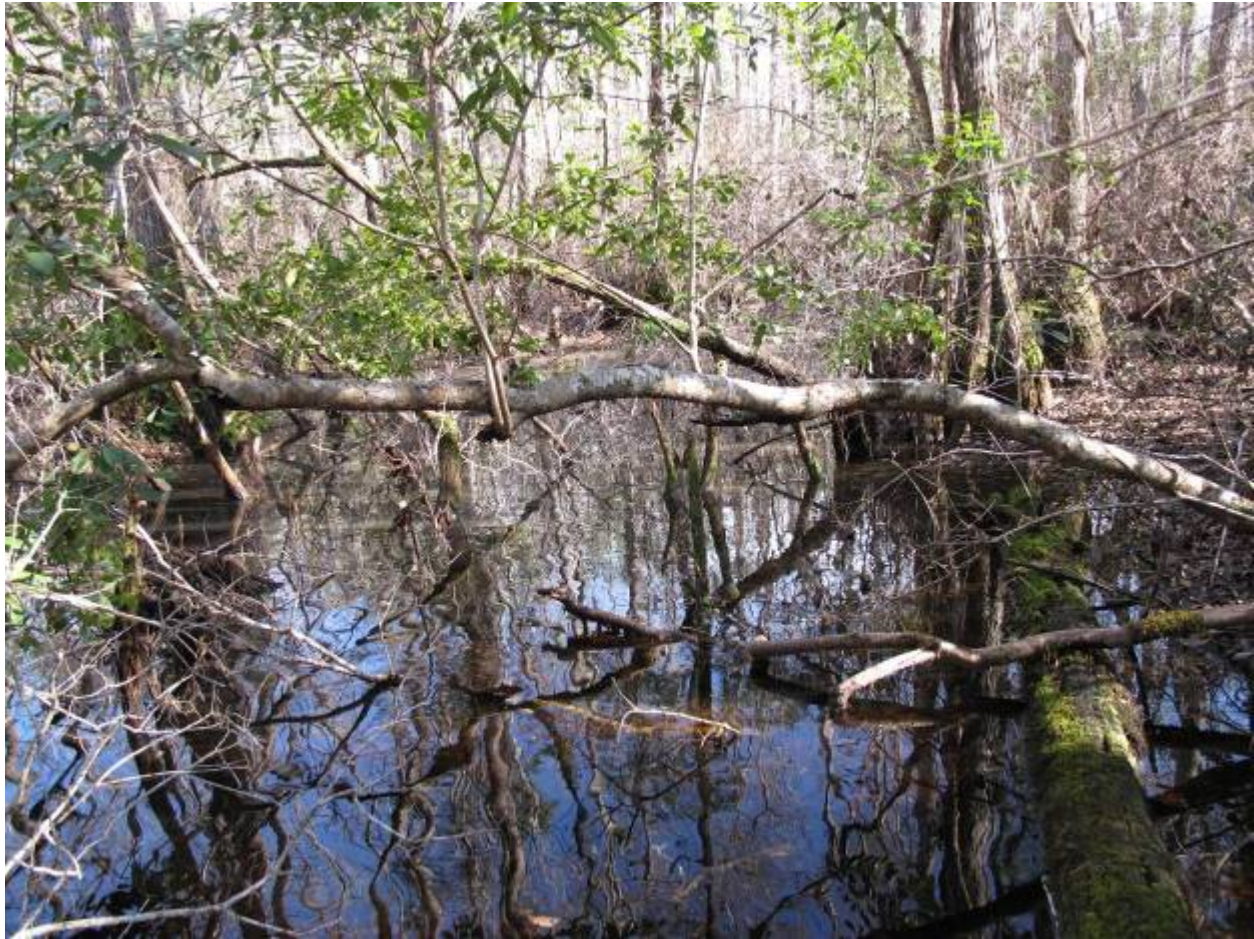
Wetland ID: 10-23

Description: This wetland is a 1.8 ha semi-permanent mixed swamp. Cypress and gum trees dominant the canopy, and cover >75% of the wetland. The midstory is dominated by wax myrtle, titi, and holly, and covers 50-75% of the wetland. There is no herbaceous vegetation. The presence of old cypress stumps provides evidence of historical logging. The adjacent uplands are mesic flatwoods that were bedded and converted to a pine plantation. Upland restoration is in progress.

Wetland Concerns: Woody encroachment

Restoration Action Recommended: Periodic fire in the wetland would reduce the dense shrubs and open the midstory.

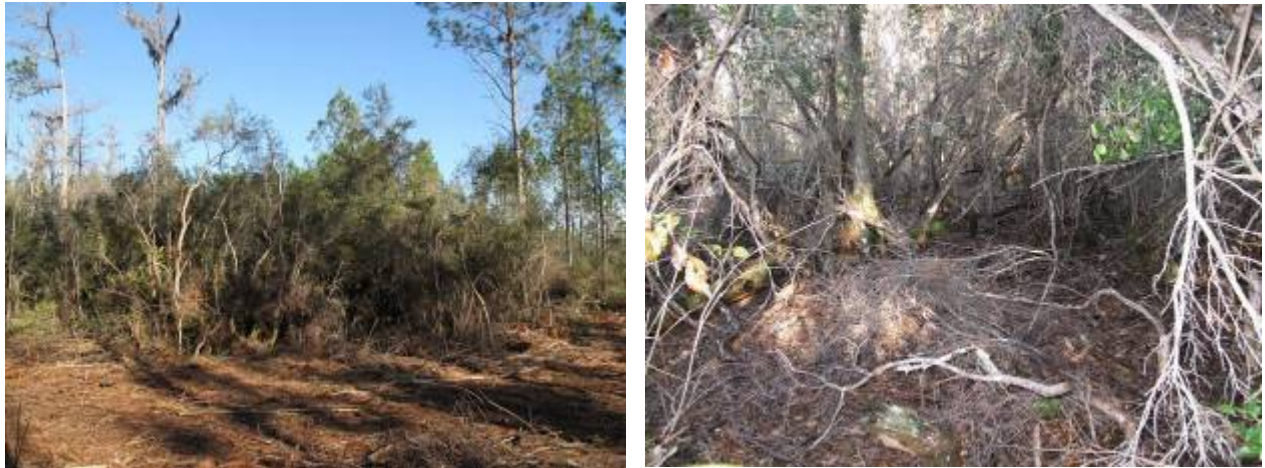
Wetland ID: 10-24

Description: This wetland is a 0.4 ha ephemeral shrub swamp. The presence of old cypress stumps provides evidence of historical logging. The cypress trees are regenerating and cover 5-25% of the wetland. The midstory is dominated by titi, and covers >75% of the wetland. There is no herbaceous vegetation. The area surrounding the wetland was recently cleared of vegetation and some vehicular tracks remain. The adjacent uplands are mesic flatwoods that were bedded and converted to a pine plantation. Upland restoration is in progress.

Wetland Concerns: Woody encroachment

Restoration Action Recommended: Periodic fire in the wetland would reduce the dense titi and open the midstory.

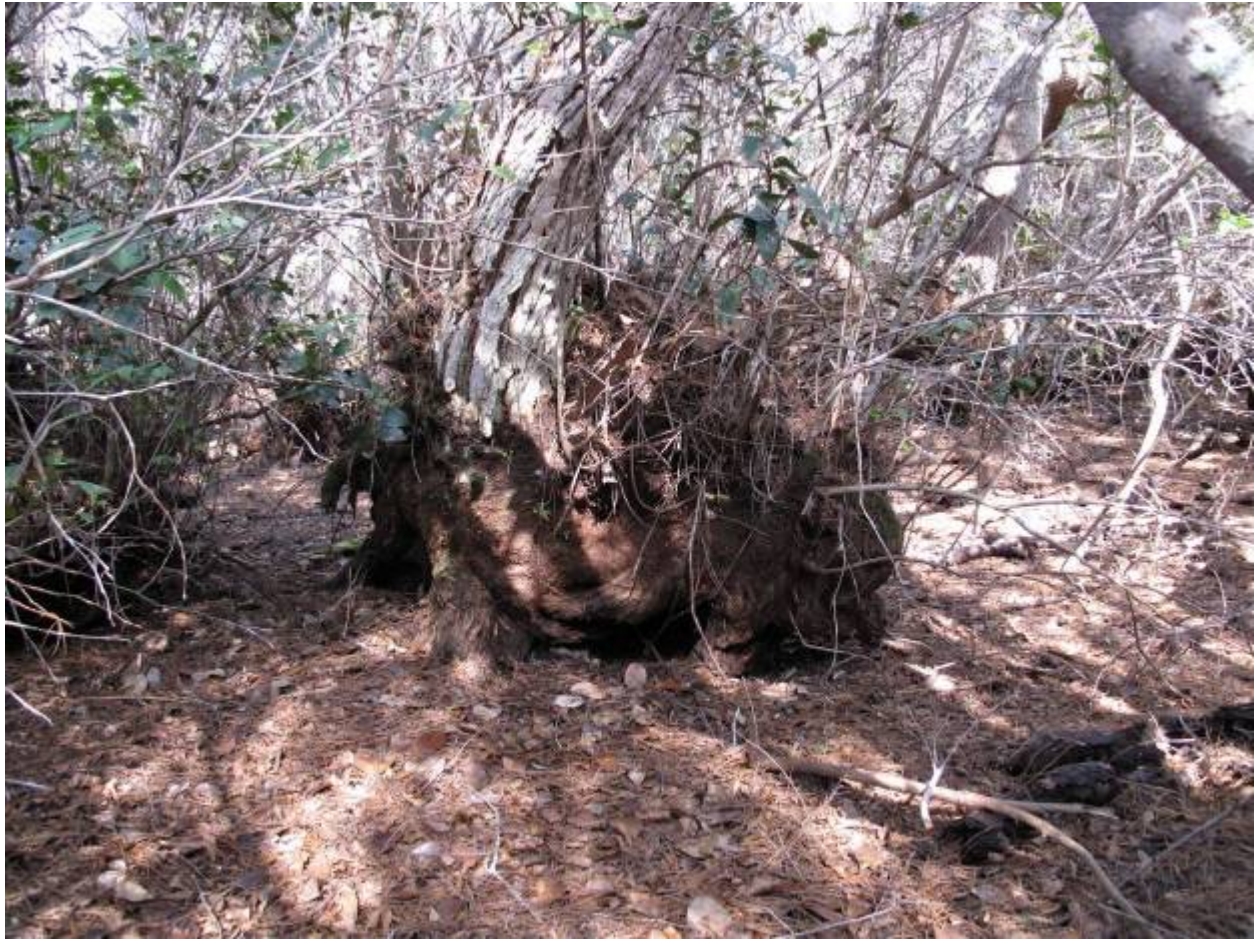
Wetland ID: 10-25

Description: This wetland is a 0.4 ha ephemeral mixed swamp. The presence of old cypress stumps provides evidence of historical logging. The cypress trees are regenerating and cover 5-25% of the wetland. The midstory is dominated by holly and titi, and covers >75% of the wetland. There is no herbaceous vegetation, and a thick duff layer covers the wetland floor. A major road (SR 59) runs along the west side of the wetland. The adjacent uplands are mesic flatwoods that were bedded and converted to a pine plantation. Upland restoration is in progress.

Wetland Concerns: Road, Woody encroachment

Restoration Action Recommended: In order to restore the hydrology of this wetland and the larger wetland system, the road would have to be removed. Recognizing that this road is now a permanent attribute to the property, we do not recommend any action relating to the road. The wetland could be monitored to ensure it is not affected by run-off or other impacts. Periodic fire in the wetland would reduce the dense titi, open the midstory, and allow the regeneration of this cypress swamp

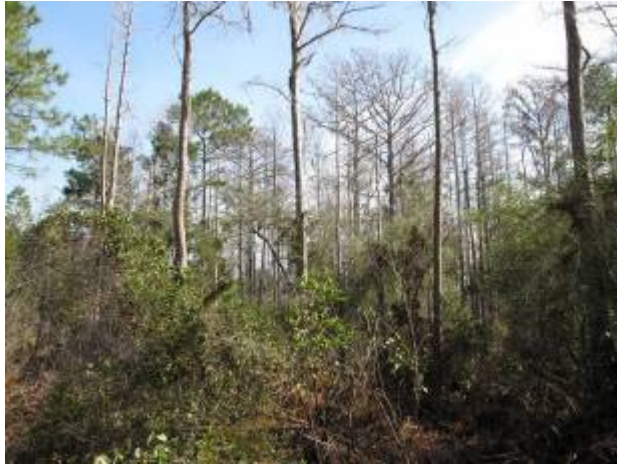
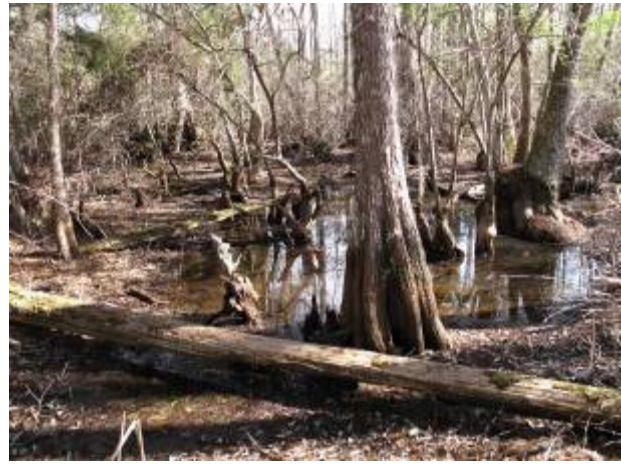
Wetland ID: 10-26

Description: This wetland is a 1.1 ha semi-permanent mixed swamp. It has a dense brush ring but a more open interior. Cypress trees dominate the canopy, and cover 50-75% of the wetland. The midstory is dominated by holly and titi, and covers 50-75% of the wetland. There is no herbaceous vegetation. The presence of old cypress stumps provides evidence of historical logging. The adjacent uplands are mesic flatwoods that were bedded and converted to a pine plantation. Upland restoration is in progress.

Wetland Concerns: Woody encroachment

Restoration Action Recommended: Periodic fire would reduce the dense brush ring and prevent further shrub encroachment.

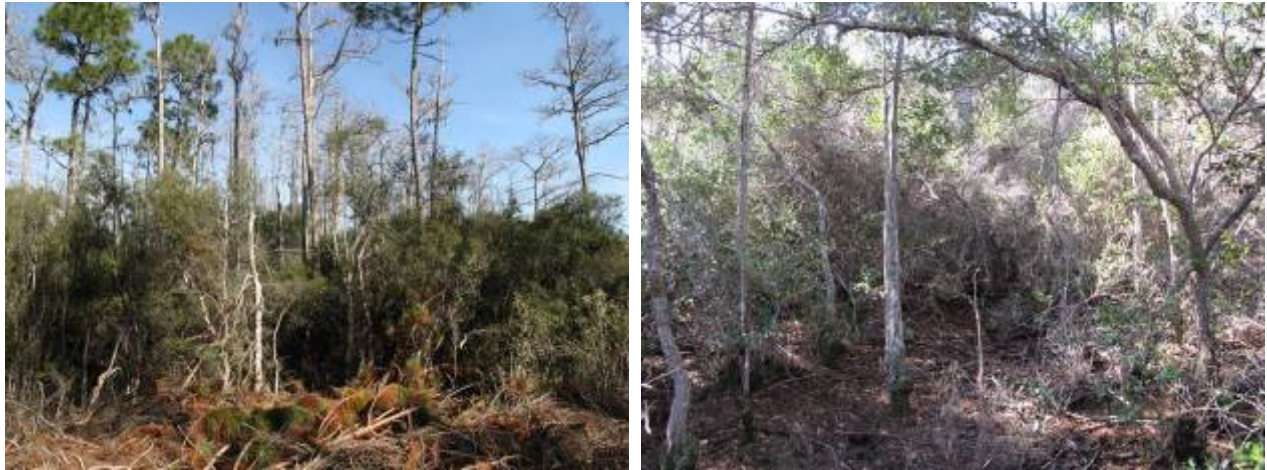
Wetland ID: 10-27

Description: This wetland is a 0.7 ha semi-permanent mixed swamp. Cypress trees dominate the canopy, and cover 50-75% of the wetland. The midstory is dominated by holly and titi, and covers >75% of the wetland. There is no herbaceous vegetation. The presence of old cypress stumps provides evidence of historical logging. The adjacent uplands are mesic flatwoods that were bedded and converted to a pine plantation. Upland restoration is in progress.

Wetland Concerns: Woody encroachment

Restoration Action Recommended: Periodic fire in the wetland would reduce the thick brush and open the midstory.

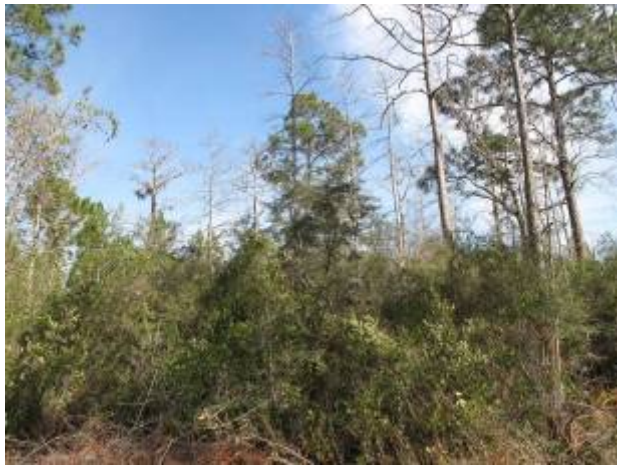
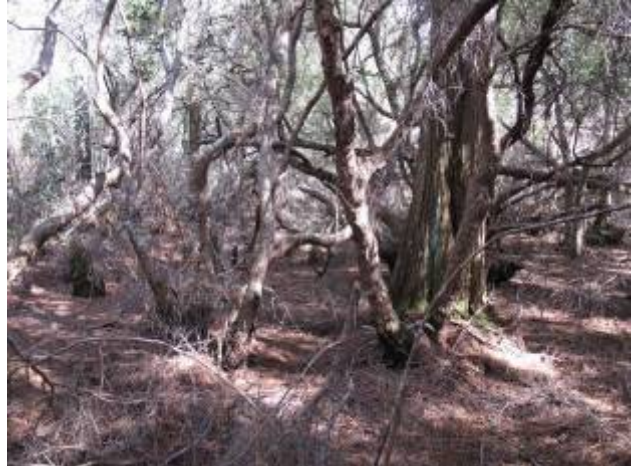
Wetland ID: 10-28

Description: This wetland is a 0.3 ha ephemeral mixed swamp. Cypress trees dominate the canopy, and cover 25-50% of the wetland. The midstory is dominated by titi, and covers >75% of the wetland. There is no herbaceous vegetation. The titi growing in this wetland are very large and the wetland is open underneath. The presence of old cypress stumps provides evidence of historical logging. The adjacent uplands are mesic flatwoods that were bedded and converted to a pine plantation. Upland restoration is in progress.

Wetland Concerns: Woody encroachment

Restoration Action Recommended: Periodic fire in the wetland would reduce the dense titi and open the midstory.

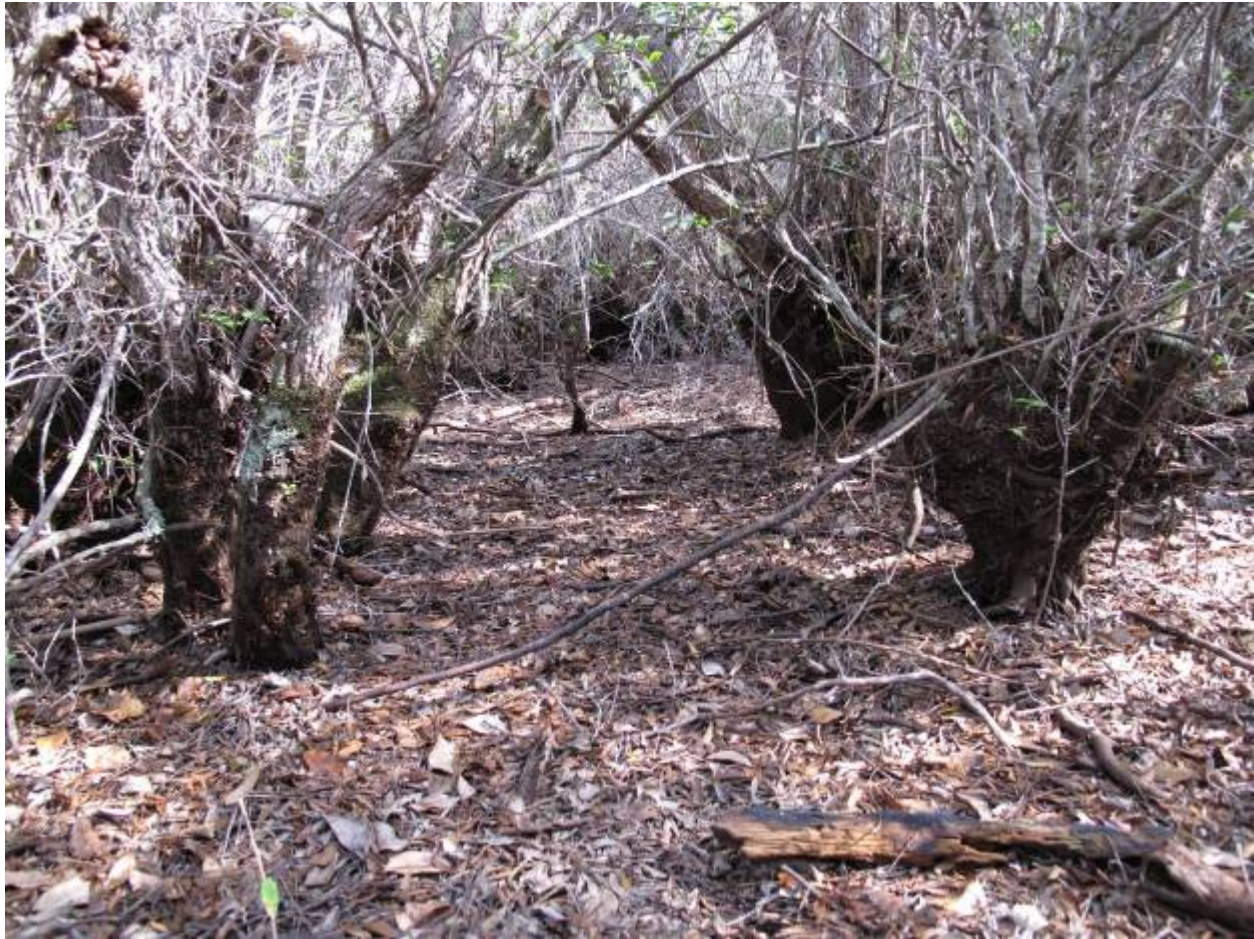
Wetland ID: 10-29

Description: This wetland is a 0.9 ha ephemeral shrub swamp. The presence of old cypress stumps provides evidence of historical logging. The cypress trees are regenerating and cover 5-25% of the wetland. The midstory is dominated by holly and titi, and covers >75% of the wetland. There is no herbaceous vegetation. The adjacent uplands are mesic flatwoods that were bedded and converted to a pine plantation. Upland restoration is in progress.

Wetland Concerns: Woody encroachment

Restoration Action Recommended: Periodic fire in the wetland would reduce the dense shrub and open the midstory.

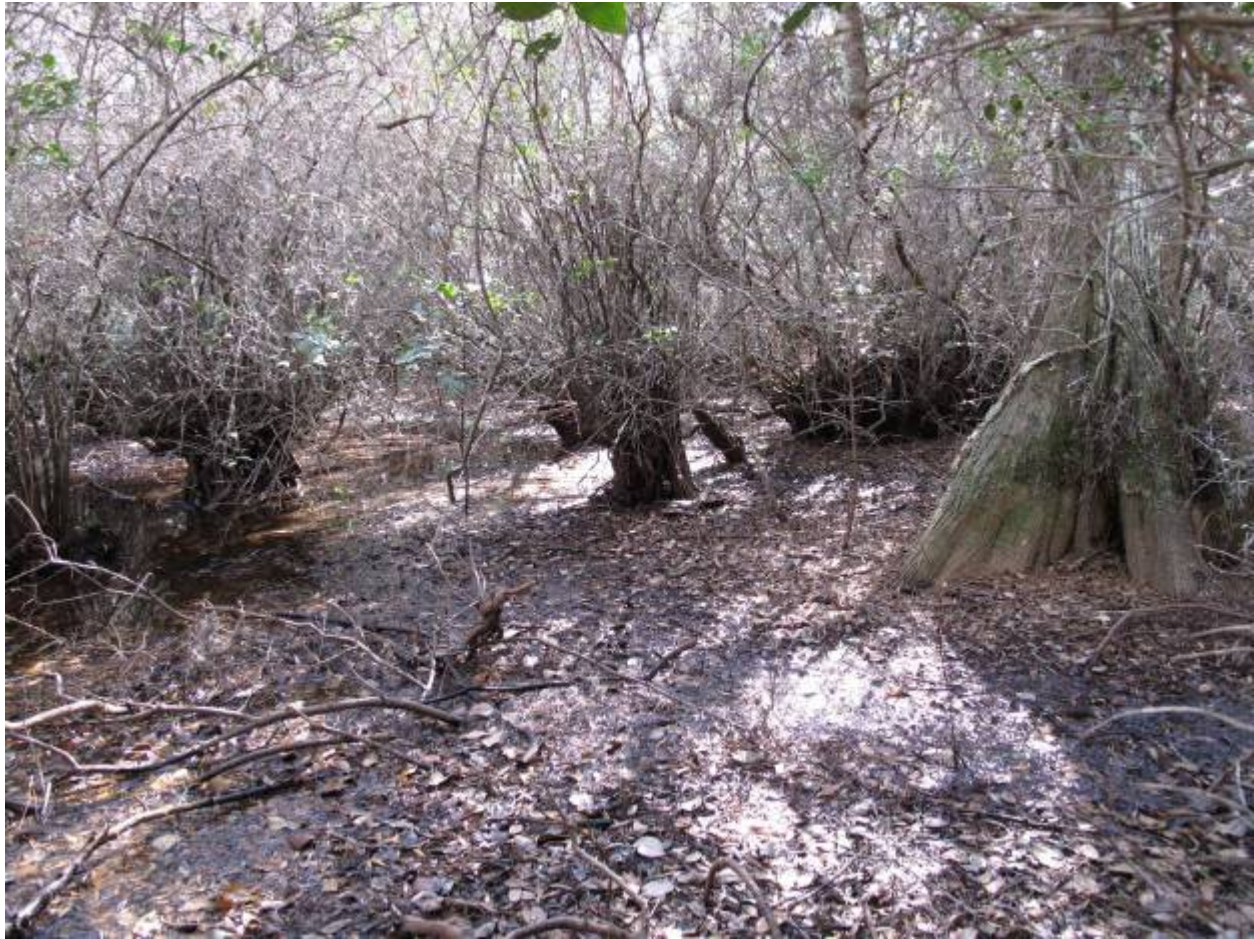
Wetland ID: 10-30

Description: This wetland is a 0.3 ha semi-permanent shrub swamp. The presence of old cypress stumps provides evidence of historical logging. The cypress trees are regenerating and cover 5-25% of the wetland. The midstory is dominated by titi, and covers >75% of the wetland. There is no herbaceous vegetation. The adjacent uplands are mesic flatwoods that were bedded and converted to a pine plantation. Upland restoration is in progress.

Wetland Concerns: Woody encroachment

Restoration Action Recommended: Periodic fire in the wetland would reduce the dense titi and open the midstory.

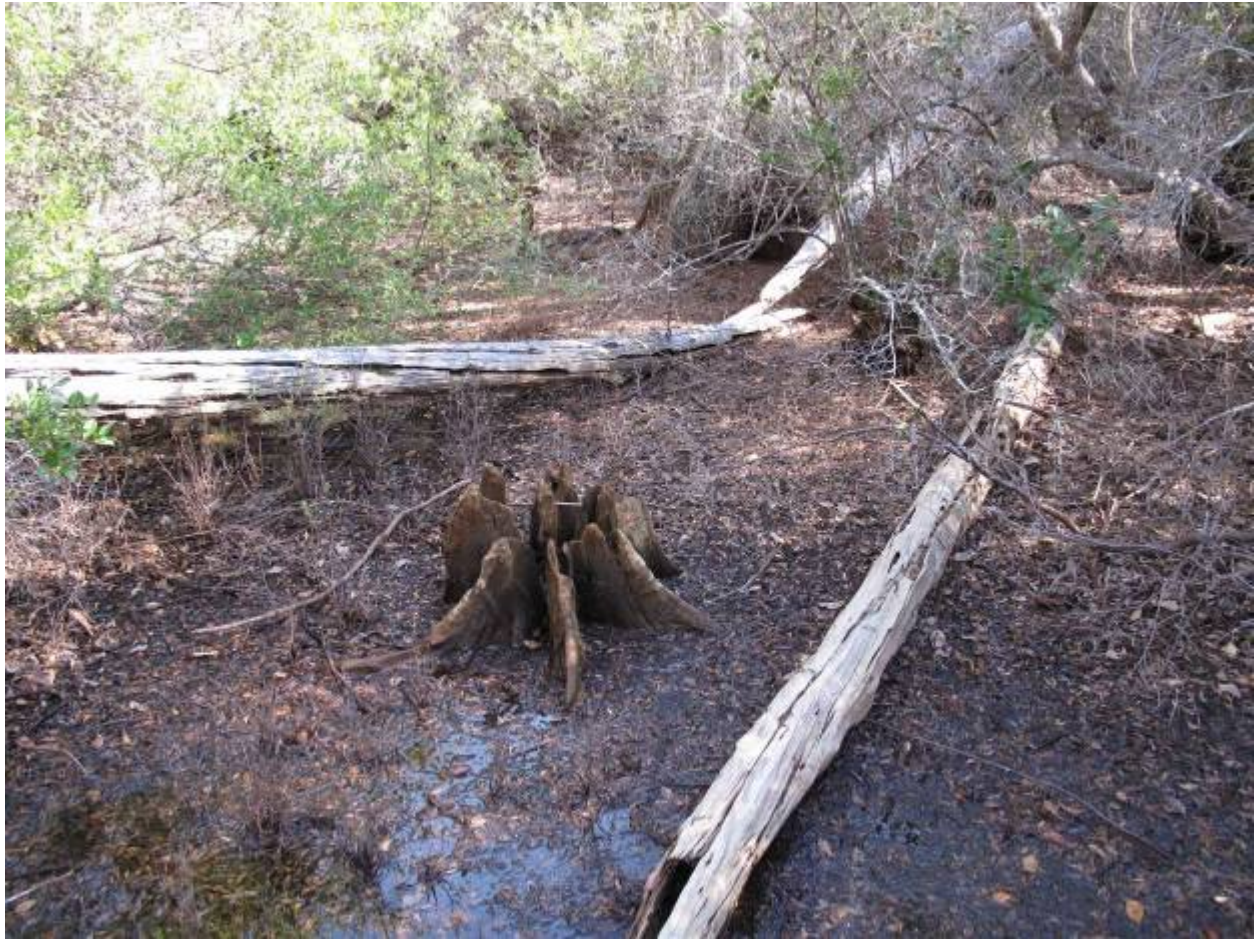
Wetland ID: 10-31

Description: This wetland is a 0.5 ha ephemeral shrub swamp. There is no tree canopy. Titi is the dominant woody vegetation, and covers >75% of the wetland. There is no herbaceous vegetation. Old stumps provide evidence that cypress trees historically occupied the wetland. The adjacent uplands are mesic flatwoods that were bedded and converted to a pine plantation. Upland restoration is in progress.

Wetland Concerns: Woody encroachment

Restoration Action Recommended: Periodic fire in the wetland would reduce the dense titi and open the midstory.

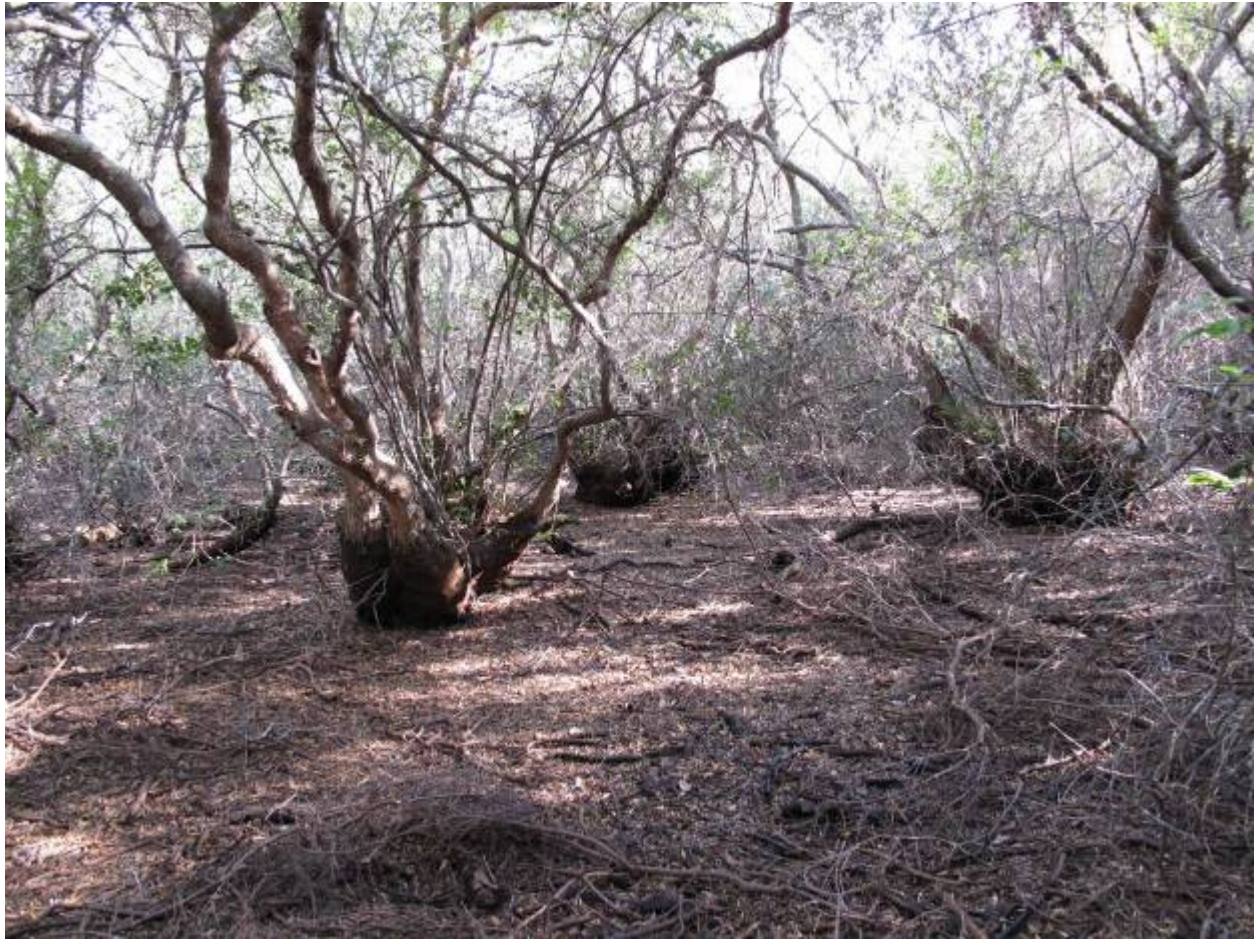
Description: This wetland is a 0.3 ha ephemeral shrub swamp. There is no tree canopy. Titi grows on hummocks, and covers >75% of the wetland. There is no herbaceous vegetation. Old stumps provide evidence that cypress trees historically occupied the wetland. The adjacent uplands are mesic flatwoods that were bedded and converted to a pine plantation. Upland restoration is in progress.

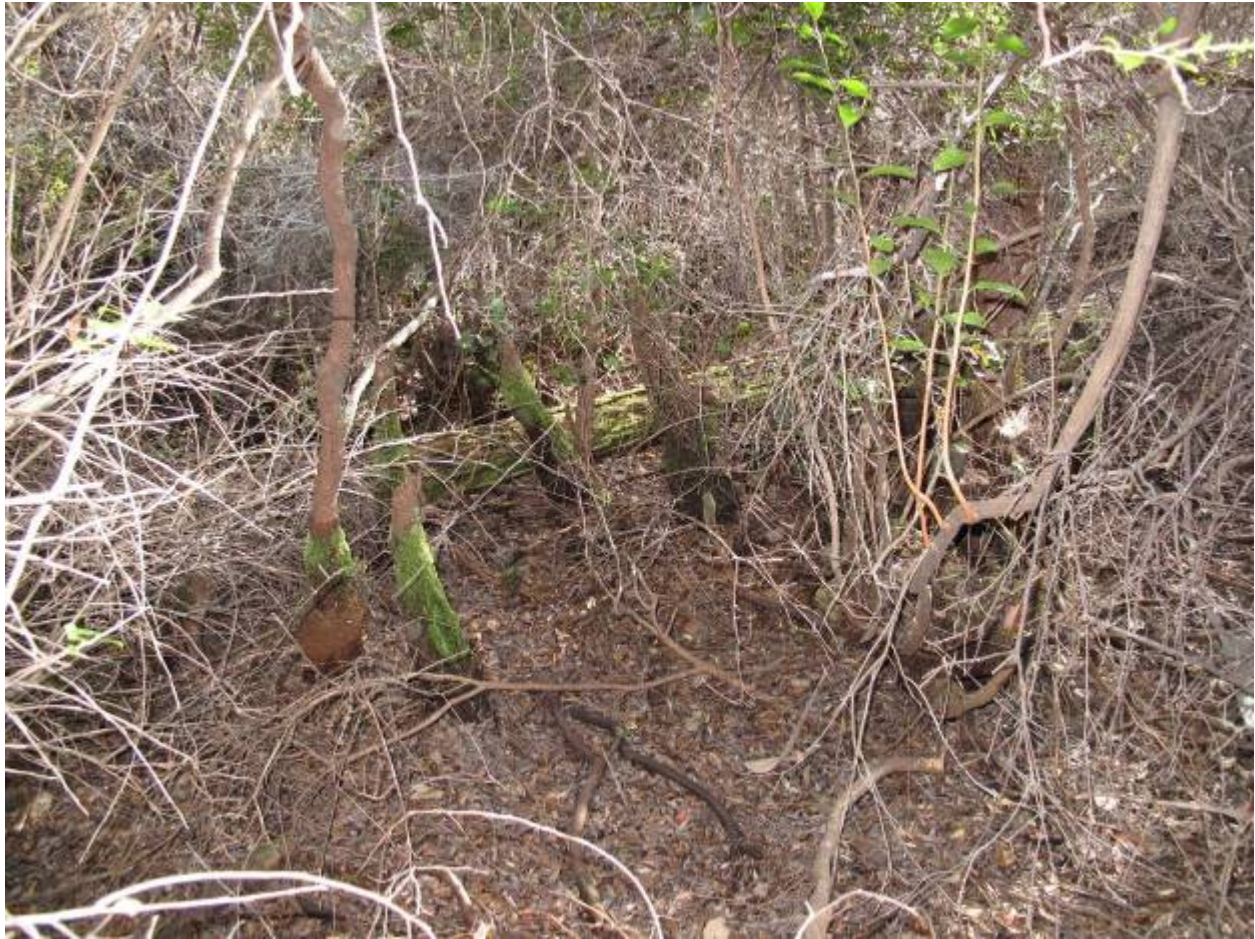
Description: This wetland is a 0.4 ha ephemeral shrub swamp. Titi is the dominant woody vegetation, and covers >75% of the wetland. There is no herbaceous vegetation, and a thick duff layer covers the wetland floor. Old stumps provide evidence that cypress trees historically occupied the wetland. The adjacent uplands are mesic flatwoods that were bedded and converted to a pine plantation. Upland restoration is in progress.

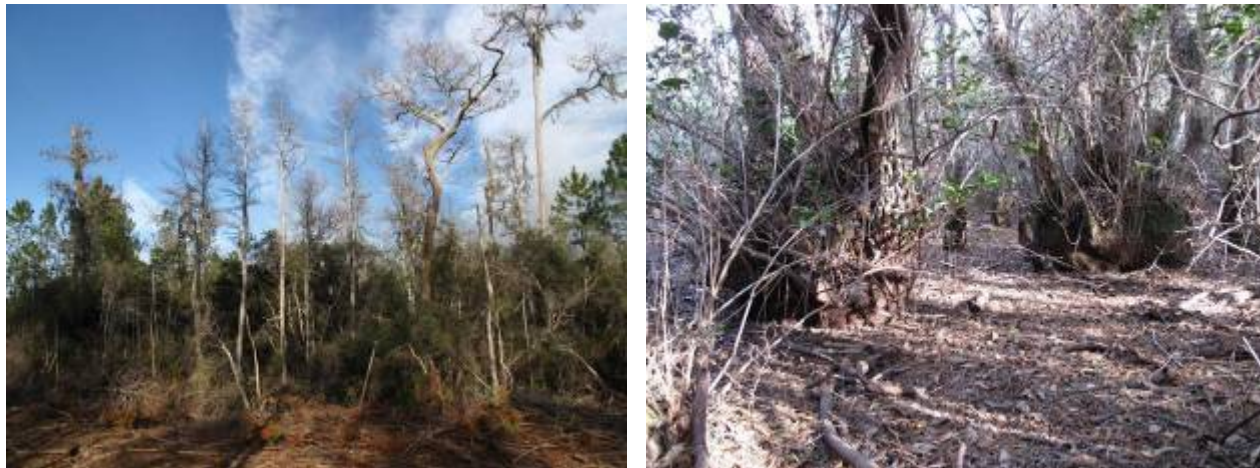
Wetland ID: 10-34

Description: This wetland is a 0.7 ha ephemeral shrub swamp. The presence of old cypress stumps provides evidence of historical logging. The cypress trees are regenerating and cover 5-25% of the wetland. The midstory is dominated by titi, and covers >75% of the wetland. There is no herbaceous vegetation. There are slash and push piles on the west side of the wetland. The adjacent uplands are mesic flatwoods that were bedded and converted to a pine plantation. Upland restoration is in progress.

Wetland Concerns: Slash, Push piles, Woody encroachment

Restoration Action Recommended: The push piles are not extensive enough to merit restoration action. The process of erosion will eliminate these push piles over time. Periodic fire in the wetland would eliminate the slash piles and reduce the dense titi.

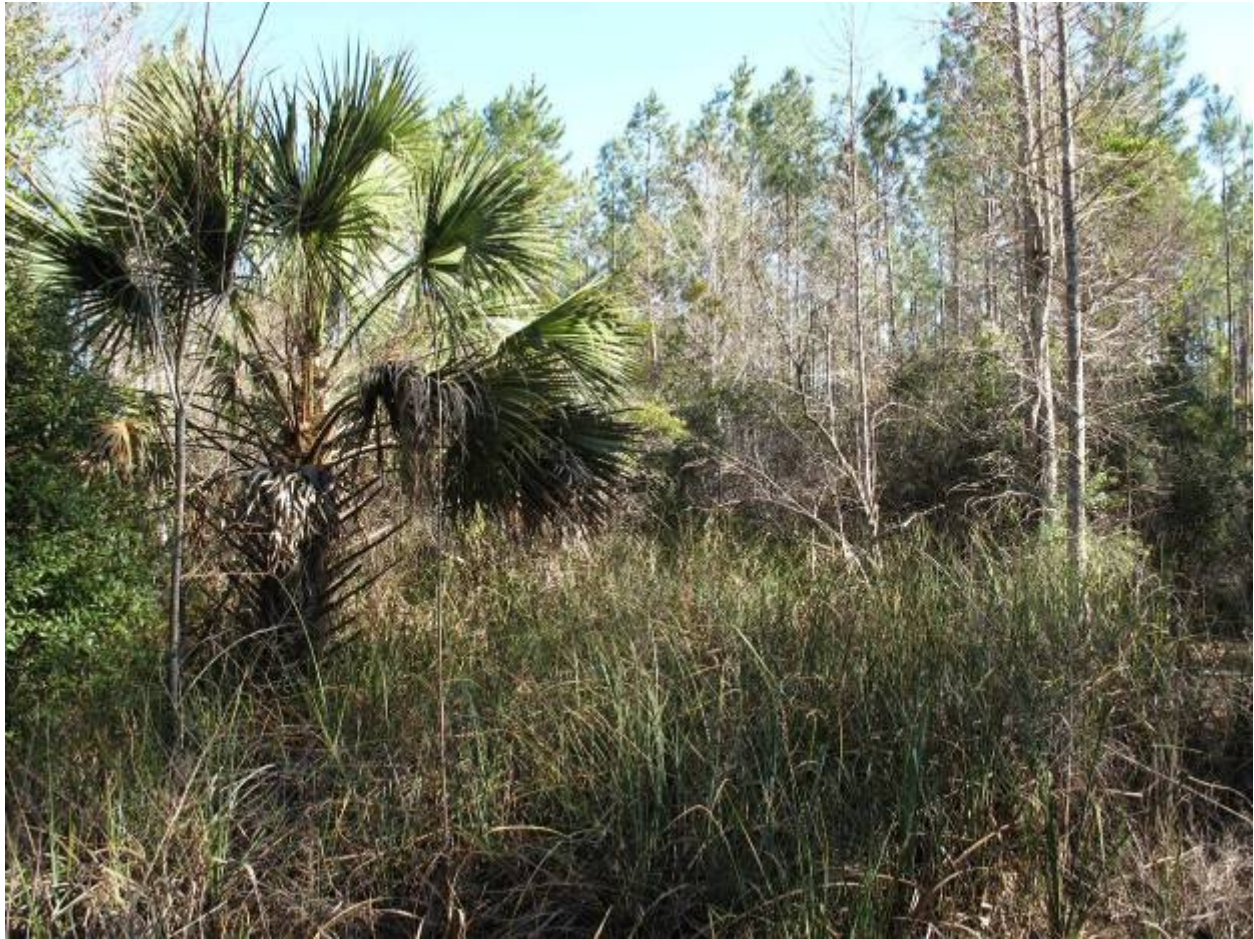
Wetland ID: 10-35

Description: This wetland is a 0.1 ha ephemeral marsh. There is no tree canopy. Wax myrtle is the dominant woody vegetation, and covers 50- 75% of the wetland. Sawgrass grows throughout the wetland, and covers 50-75% of the basin. The adjacent uplands are mesic flatwoods that were bedded and converted to a pine plantation. Upland restoration is in progress.

Wetland Concerns: Woody encroachment

Restoration Action Recommended: Periodic fire in the wetland basin would prevent further shrub encroachment.

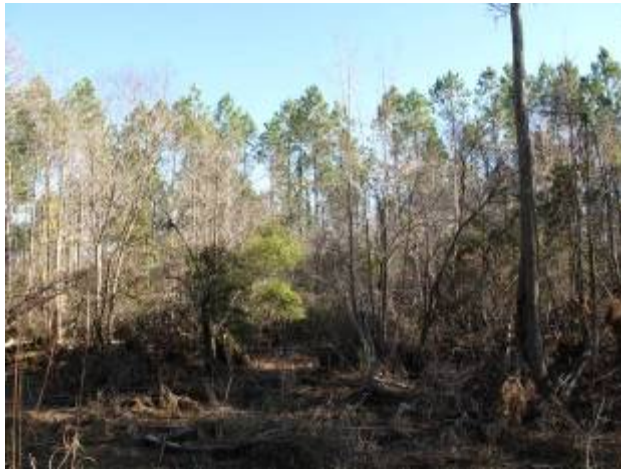
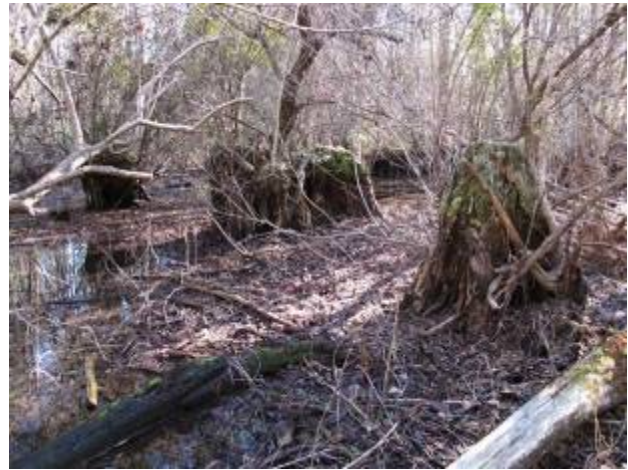
Wetland ID: 10-36

Description: This wetland is a 0.3 ha ephemeral shrub swamp. There is no tree canopy. Wax myrtle and buttonbush are the dominant woody vegetation, and cover 50-75% of the wetland. Sawgrass grows in scattered patches, and covers 5-25% of the basin. Old stumps provide evidence that cypress trees historically occupied the wetland. The adjacent uplands are mesic flatwoods that were bedded and converted to a pine plantation. Upland restoration is in progress.

Wetland Concerns: Woody encroachment

Restoration Action Recommended: Periodic fire in the wetland basin would prevent further shrub encroachment.

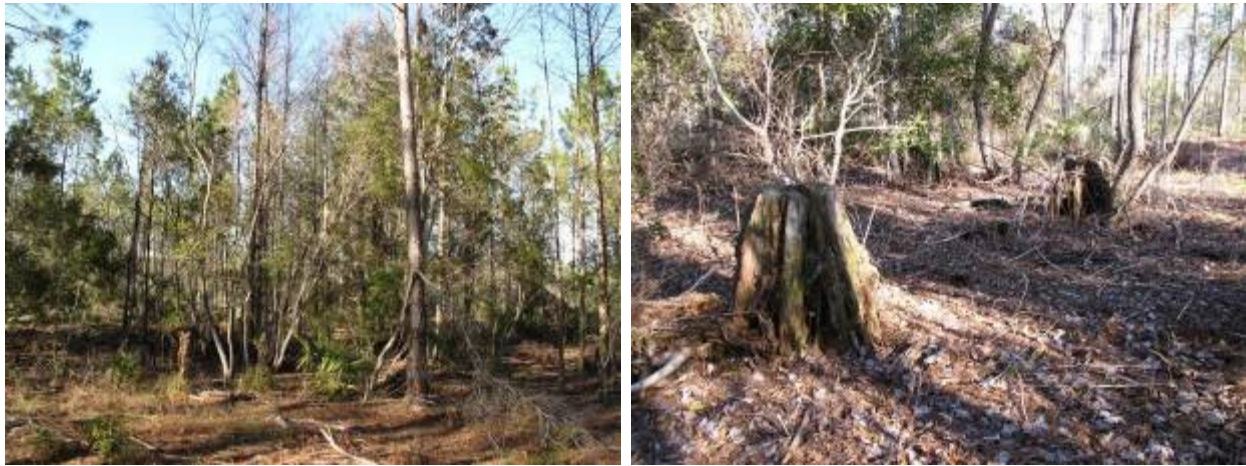
Wetland ID: 10-37

Description: This wetland is a 0.1 ha ephemeral forested swamp. The presence of old cypress stumps provides evidence of historical logging. The cypress trees have regenerated and cover >75% of the wetland. The midstory is dominated by wax myrtle, and covers 5-25% of the wetland. There is no herbaceous vegetation, and a thick duff layer covers the wetland floor. The adjacent uplands are mesic flatwoods that were bedded and converted to a pine plantation. Upland restoration is in progress.

Wetland Concerns: None

Restoration Action Recommended: Periodic fire in the wetland would prevent shrubs from encroaching.

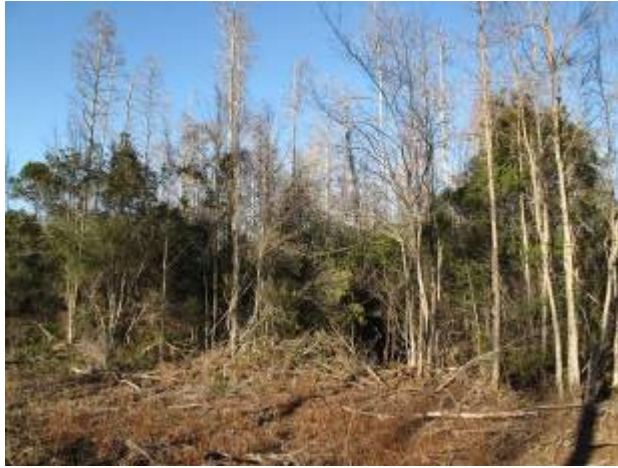
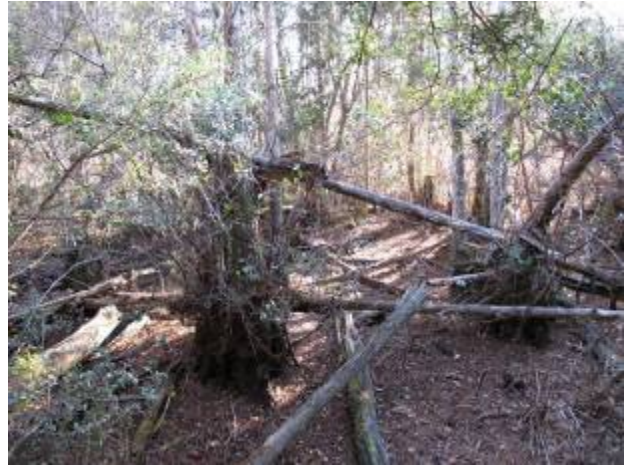
Wetland ID: 10-38

Description: This wetland is a 0.9 ha ephemeral mixed swamp. Cypress trees dominate the canopy, and cover 50-75% of the wetland. The midstory is dominated by titi and wax myrtle, and covers >75% of the wetland. There is no herbaceous vegetation. Old cypress stumps throughout the wetland provide evidence of historic logging. The wetland was likely a cypress dome that was logged and colonized by shrubs. The adjacent uplands are mesic flatwoods that were bedded and converted to a pine plantation. Upland restoration is in progress.

Wetland Concerns: Woody encroachment

Restoration Action Recommended: Periodic fire in the wetland would reduce the dense brush and open the midstory.
