Inventory, Assessment, and Restoration Potential of Ephemeral Wetlands on FFWCC Wildlife Management Areas

Aucilla WMA Final Report

Submitted by: Rebecca P.M. Means¹, Ryan C. Means¹, Steven A. Johnson²

¹Coastal Plains Institute

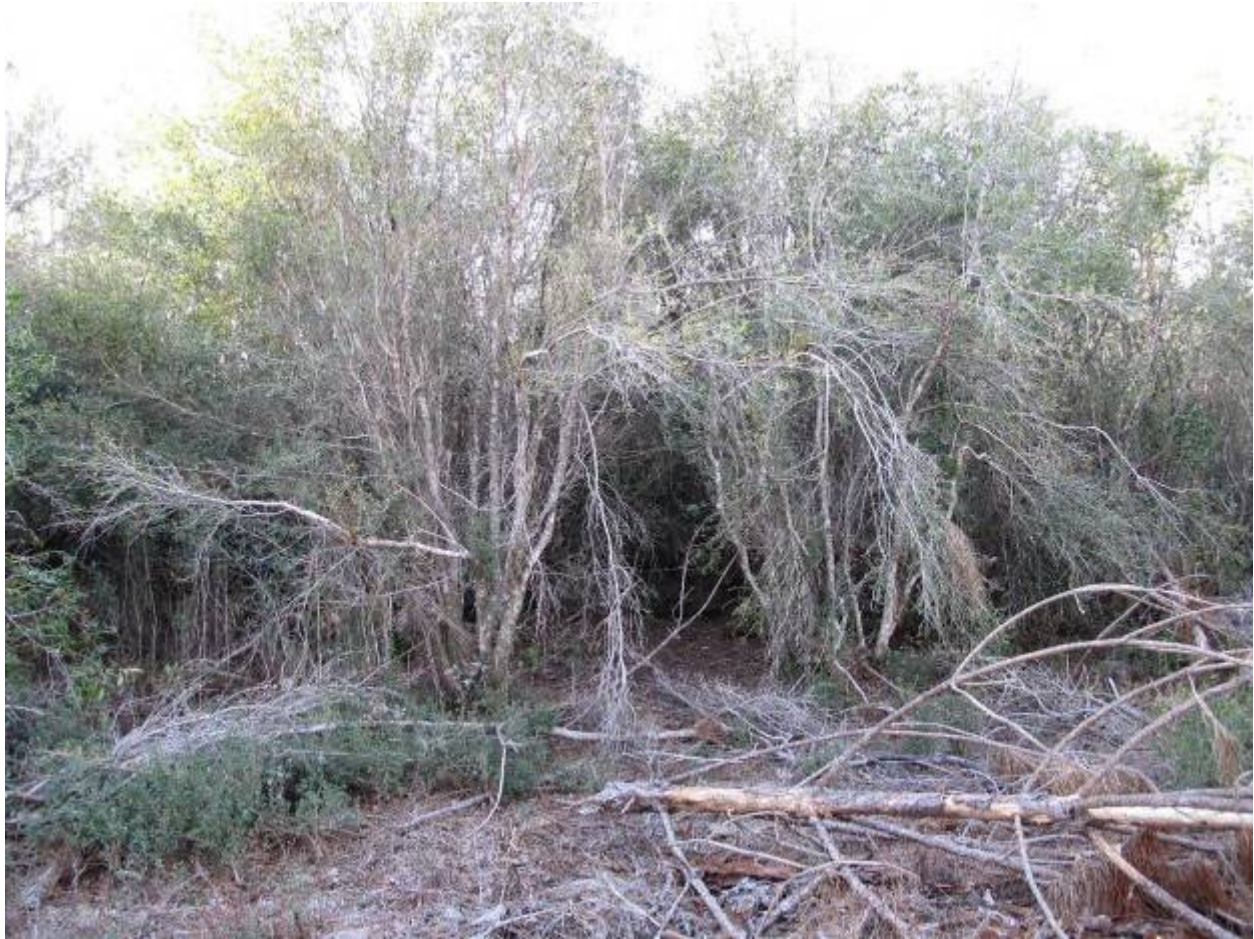
Wetland ID: 10-39

Description: This wetland is a 0.3 ha ephemeral shrub swamp. There is no tree canopy. Titi is the dominant woody vegetation, and covers >75% of the wetland. There is no herbaceous vegetation. Ruts along the wetland edge are likely a result of thinning machinery close to the wetland while there was still standing water or the wetland soils were too saturated. Old stumps provide evidence that cypress trees historically occupied the wetland. The adjacent uplands are mesic flatwoods that were bedded and converted to a pine plantation. Upland restoration is in progress.

Wetland Concerns: Vehicular damage, Woody encroachment

Restoration Action Recommended: To avoid future damage, operate machinery only when wetland is completely dry. Periodic fire in the wetland would reduce the dense titi and open the midstory.

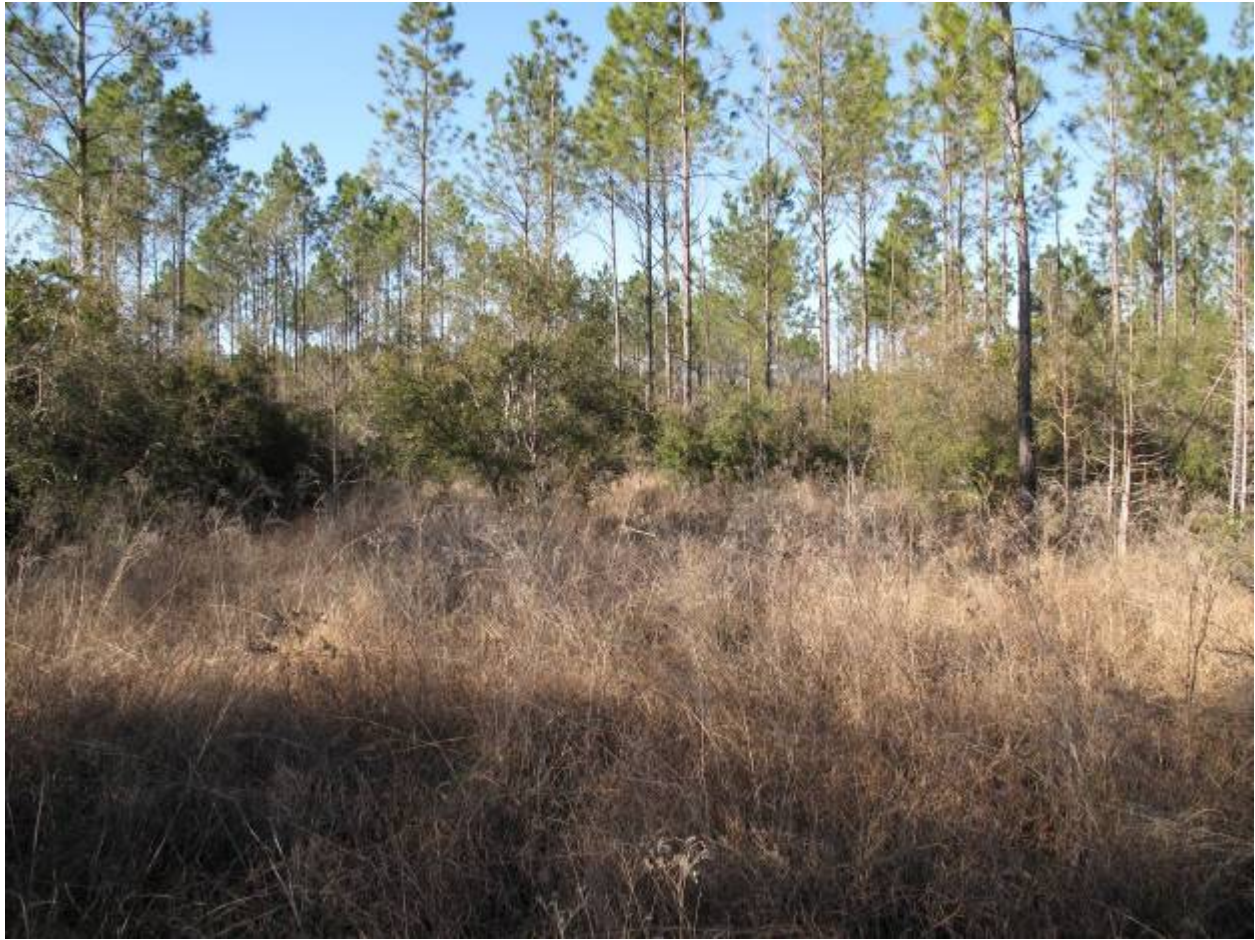
Description: This wetland is a 0.1 ha ephemeral marsh. There is no tree canopy. A ring of titi around the wetland edge covers 5-25% of the wetland. Sedges/grasses grow throughout the wetland, and cover 50-75% of the basin. The adjacent uplands are mesic flatwoods that were bedded and converted to a pine plantation. Upland restoration is in progress.

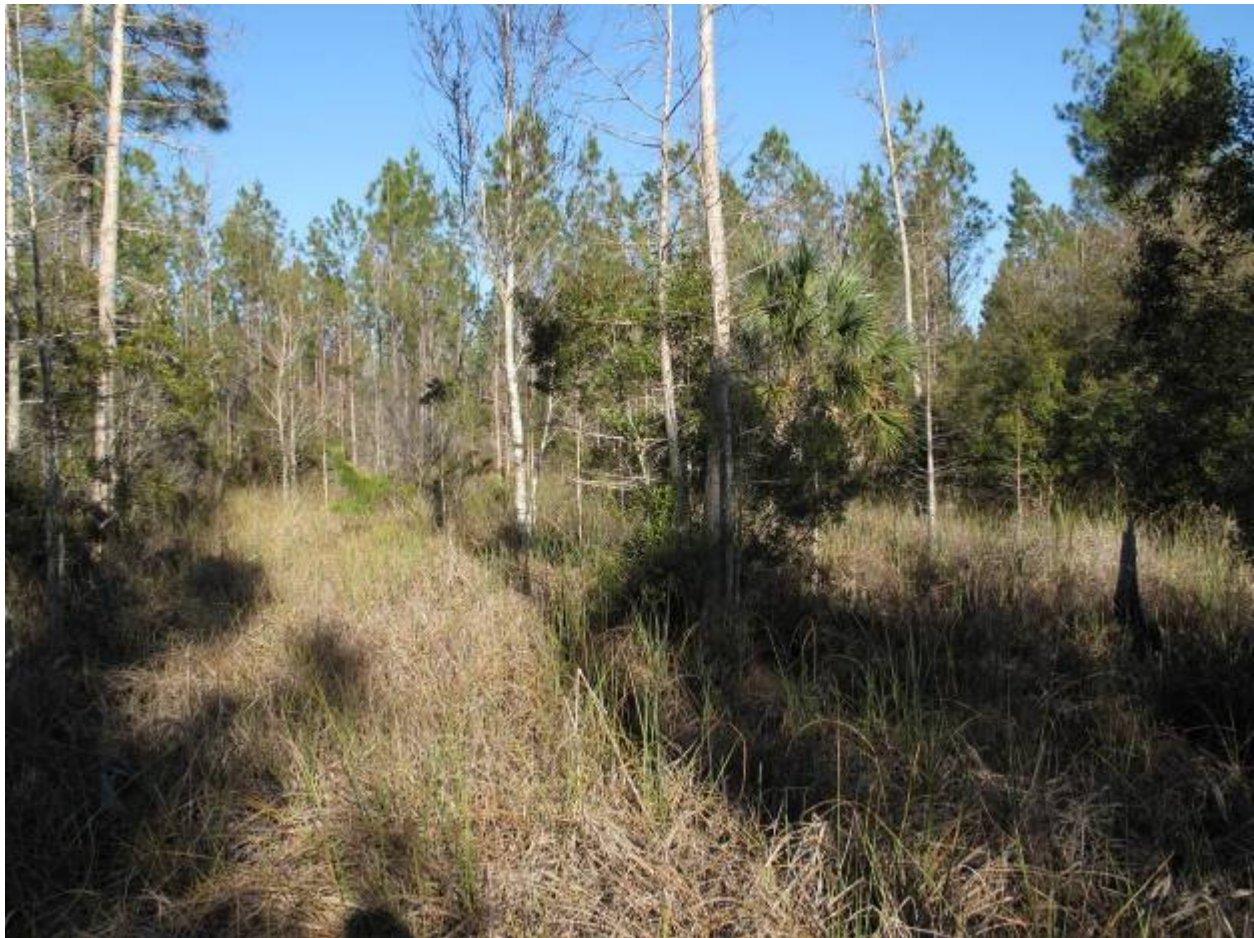
Wetland ID: 12-02

Description: This wetland is a 0.4 ha ephemeral marsh. Cypress trees dominate the canopy, and cover 5-25% of the wetland. The midstory is dominated by titi and wax myrtle, and covers 25-50% of the wetland. Sawgrass grows throughout the wetland, and covers >75% of the basin. The adjacent uplands are mesic flatwoods that were bedded and converted to a pine plantation. Upland restoration is in progress.

Wetland Concerns: Woody encroachment

Restoration Action Recommended: Periodic fire would reduce the shrubs and prevent further shrub encroachment.

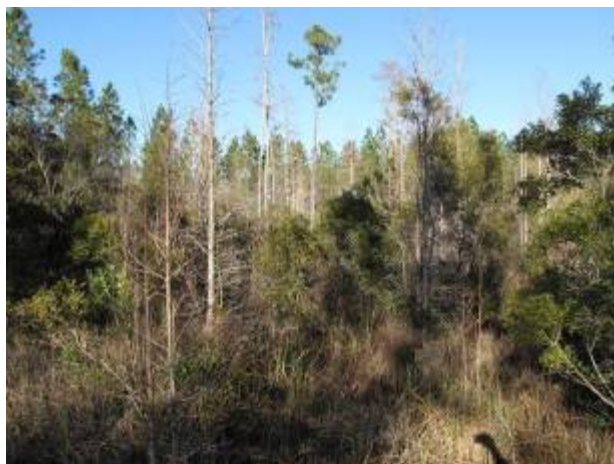
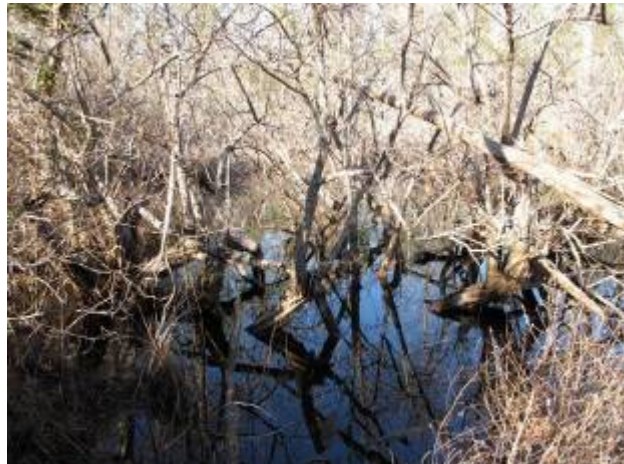
Wetland ID: 12-03

Description: This wetland is a 0.5 ha ephemeral marsh. The presence of old cypress stumps provides evidence of historical logging. The cypress trees are regenerating and cover 5-25% of the wetland. The midstory is dominated by buttonbush and wax myrtle, and covers 50-75% of the wetland. Sedges/grasses grow throughout the wetland, and cover 50- 75% of the basin. This wetland likely was a cypress dome and now is a marsh with heavy shrub encroachment. The adjacent uplands are mesic flatwoods that were bedded and converted to a pine plantation. Upland restoration is in progress.

Wetland Concerns: Woody encroachment

Restoration Action Recommended: Periodic fire in the wetland basin would prevent further shrub encroachment.

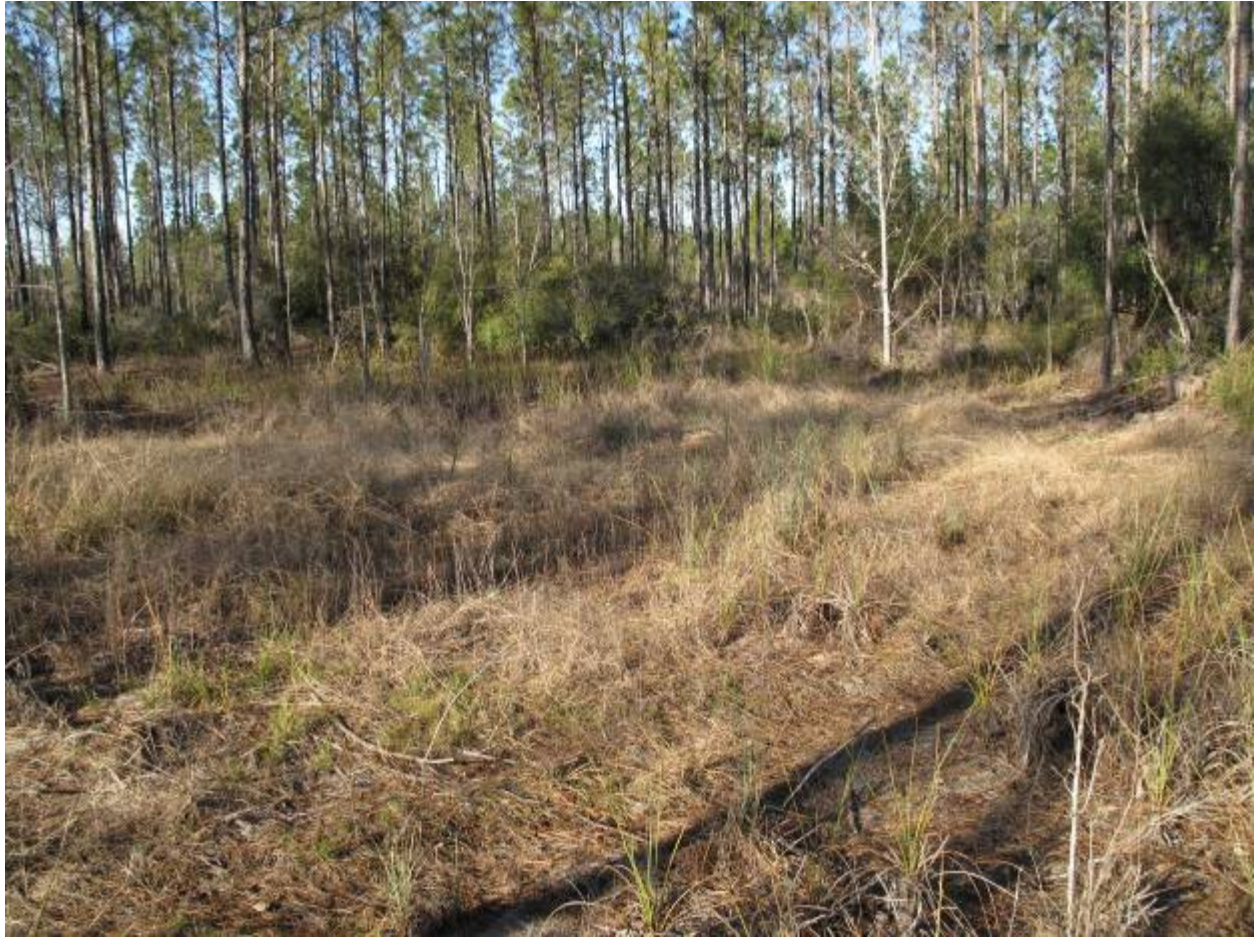
Wetland ID: 12-04

Description: This wetland is a 0.1 ha ephemeral marsh. Pine trees dominate the canopy, and cover 5-25% of the wetland. There is no midstory cover. Sedges/grasses grow throughout the wetland, and cover >75% of the basin. Bedding rows with planted pine trees were constructed through the wetland. The adjacent uplands are mesic flatwoods that were bedded and converted to a pine plantation. Upland restoration is in progress.

Wetland Concerns: Bedding, Planted pines

Restoration Action Recommended: The planted pine trees could be removed from the wetland interior. The bedding should erode with time. Provide periodic fire for ecological maintenance.

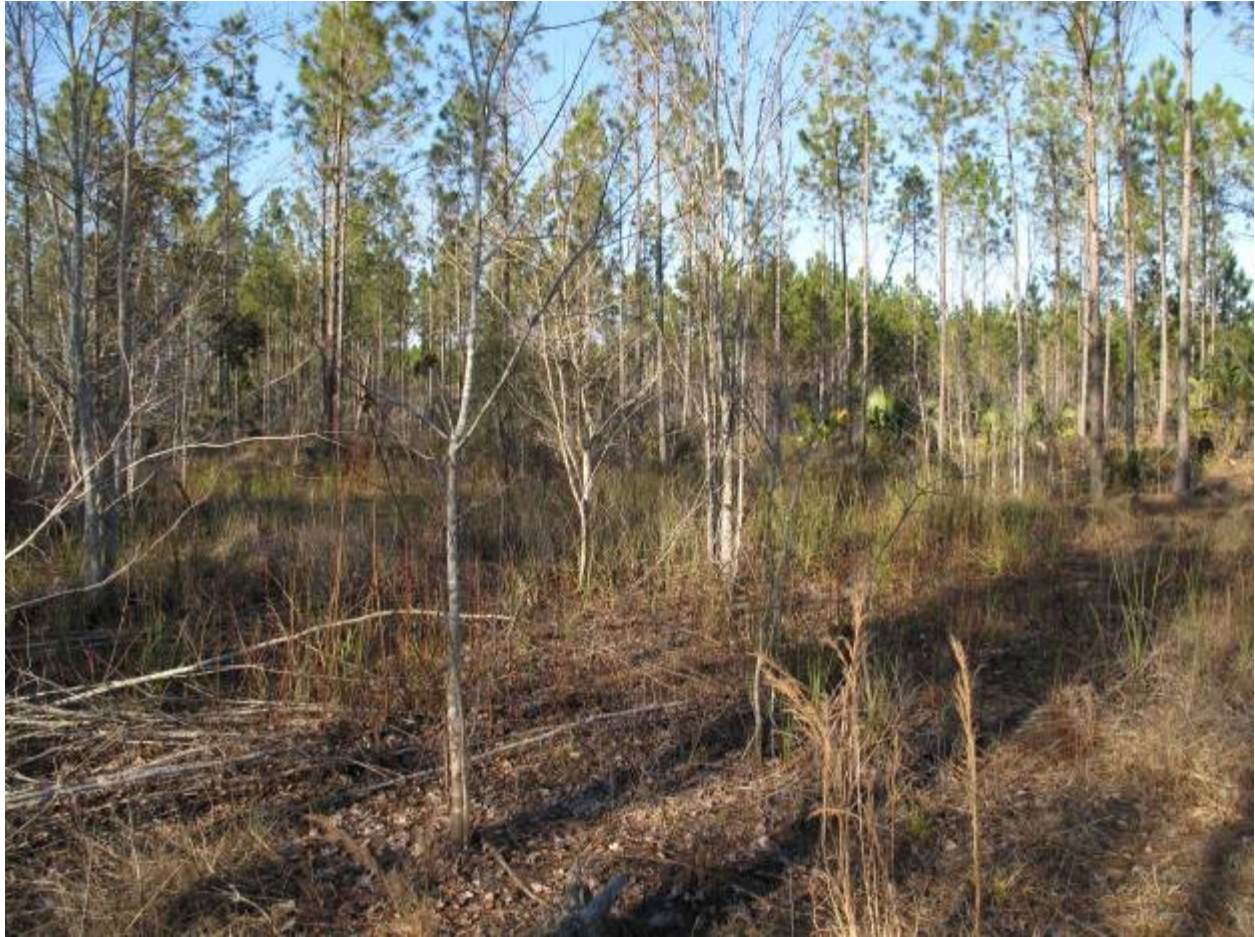
Wetland ID: 12-05

Description: This wetland is a <0.1 ha ephemeral marsh. Pine trees dominate the canopy, and cover 5-25% of the wetland. The subcanopy is dominated by young gum and maple trees, and covers 5-25% of the wetland. Sawgrass grows throughout the wetland, and covers 25-50% of the basin. Bedding rows with planted pine trees were constructed through the wetland. The adjacent uplands are mesic flatwoods that were bedded and converted to a pine plantation. Upland restoration is in progress.

Wetland Concerns: Bedding, Planted pines

Restoration Action Recommended: The planted pine trees could be removed from the wetland interior. The bedding should erode with time. Provide periodic fire for ecological maintenance.

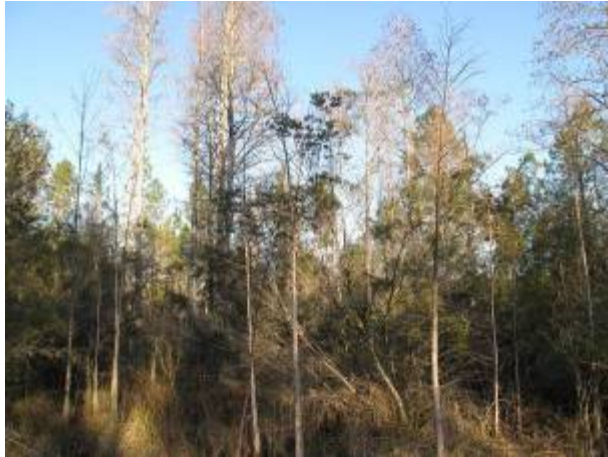
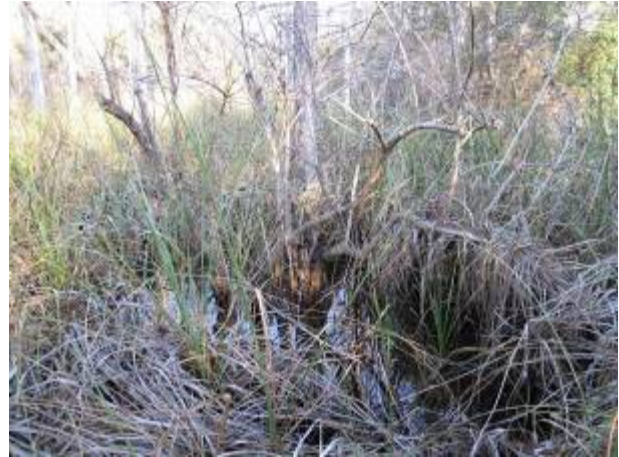
Wetland ID: 12-06

Description: This wetland is a 0.1 ha ephemeral marsh. Cypress trees dominate the canopy, and cover 25-50% of the wetland. The midstory is dominated by wax myrtle and titi, and covers 25-50% of the wetland. Sawgrass grows dense throughout the wetland, and covers >75% of the basin. The adjacent uplands are mesic flatwoods that were bedded and converted to a pine plantation. Upland restoration is in progress.

Wetland Concerns: Woody encroachment

Restoration Action Recommended: Periodic fire would reduce shrub encroachment and open up the wetland.

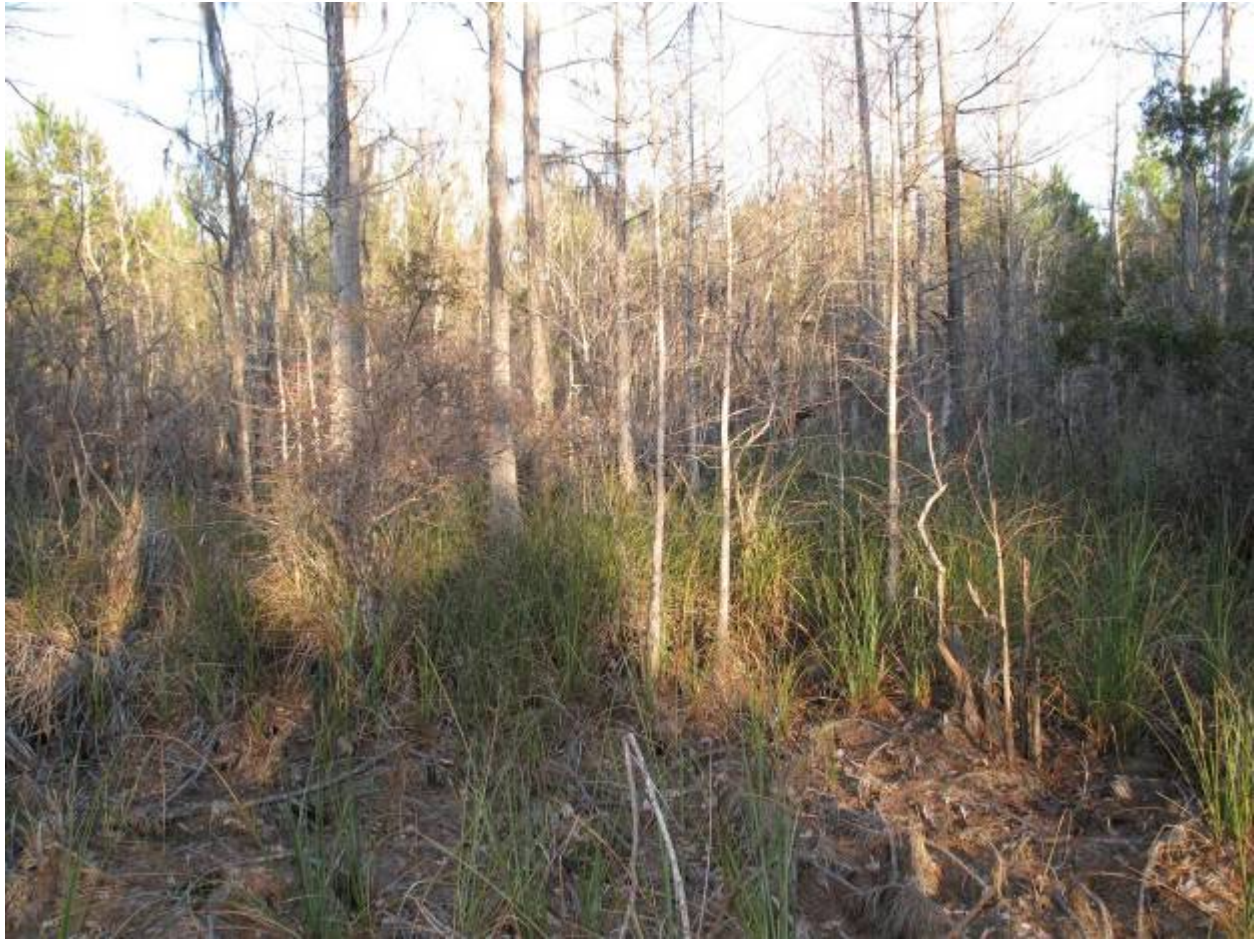
Description: This wetland is a 0.3 ha semi-permanent mixed swamp. Cypress trees dominate the canopy, and cover 50-75% of the wetland. The midstory is dominated by wax myrtle and buttonbush, and covers 50-75% of the wetland. Sawgrass grows in scattered patches, and covers 25-50% of the basin. The adjacent uplands are mesic flatwoods that were bedded and converted to a pine plantation. Upland restoration is in progress.

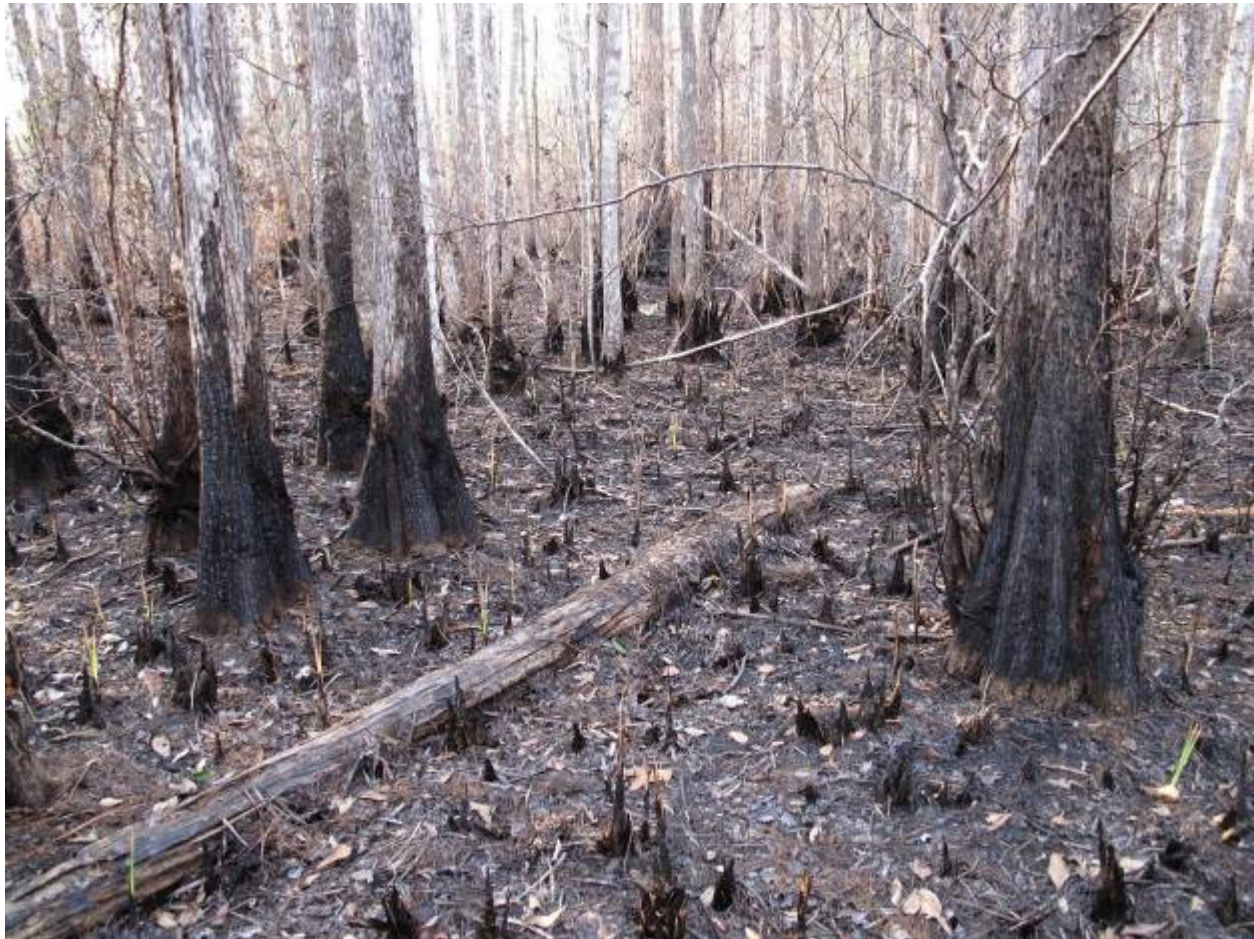
Wetland ID: 12-08

Description: This wetland is a 0.3 ha ephemeral forested swamp. Cypress trees dominate the canopy, and cover >75% of the wetland. The midstory is dominated by wax myrtle and titi, and covers 25-50% of the wetland. Sawgrass grows throughout the wetland, and covers 5-25% of the basin. A fire recently burned all the way through the wetland. The adjacent uplands are mesic flatwoods that were bedded and converted to a pine plantation. Upland restoration is in progress.

Wetland Concerns: None

Restoration Action Recommended: None

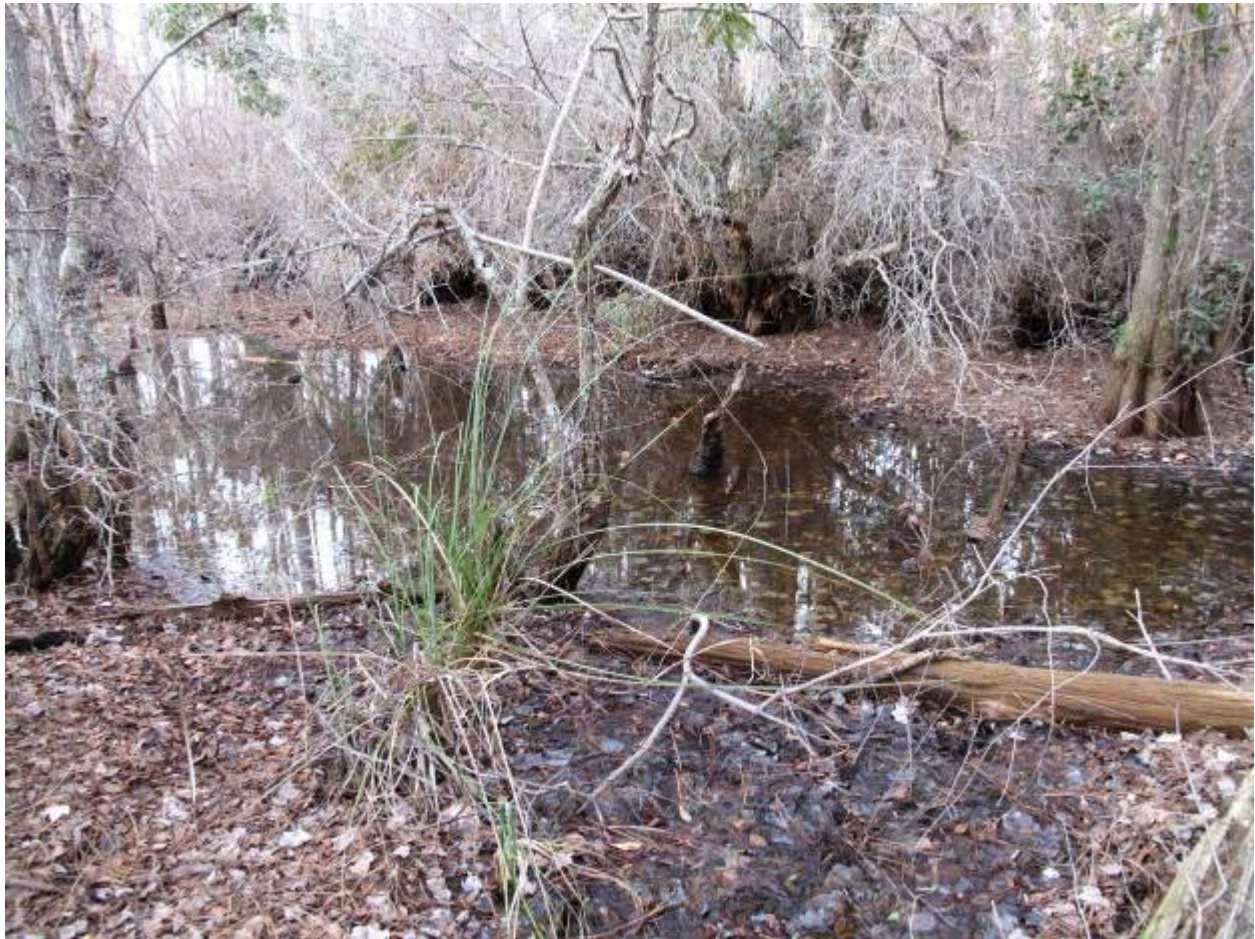
Description: This wetland is a <0.1 ha ephemeral forested swamp. Cypress trees dominate the canopy, and cover >75% of the wetland. The midstory is dominated by wax myrtle and titi, and covers 50-75% of the wetland. There is no herbaceous vegetation. A fire recently burned all the way through the wetland. There is a push pile in the wetland on the east side. The adjacent uplands are mesic flatwoods that were bedded and converted to a pine plantation. Upland restoration is in progress.

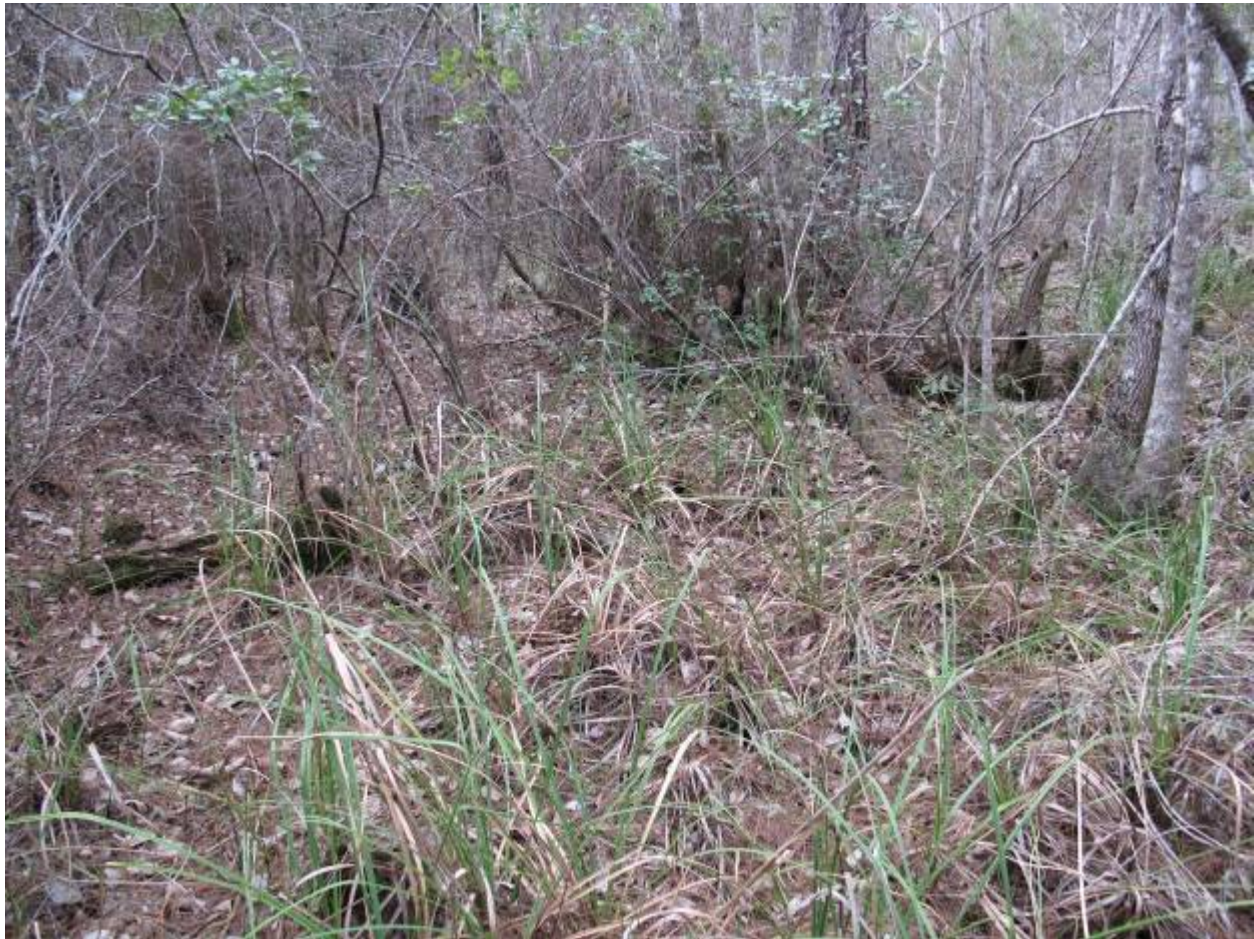
Wetland ID: 12-10

Description: This wetland is a 0.2 ha ephemeral mixed swamp. Cypress and gum trees dominate the canopy, and cover >75% of the wetland. The midstory is dominated by wax myrtle, and covers 50-75% of the wetland. Sawgrass grows in scattered patches, and covers 5-25% of the wetland. A thick brush ring surrounds the wetland. The adjacent uplands are mesic flatwoods that were bedded and converted to a pine plantation. Upland restoration is in progress.

Wetland Concerns: Woody encroachment

Restoration Action Recommended: Periodic fire in the wetland basin would reduce the ring of thick woody vegetation around the wetland edge.

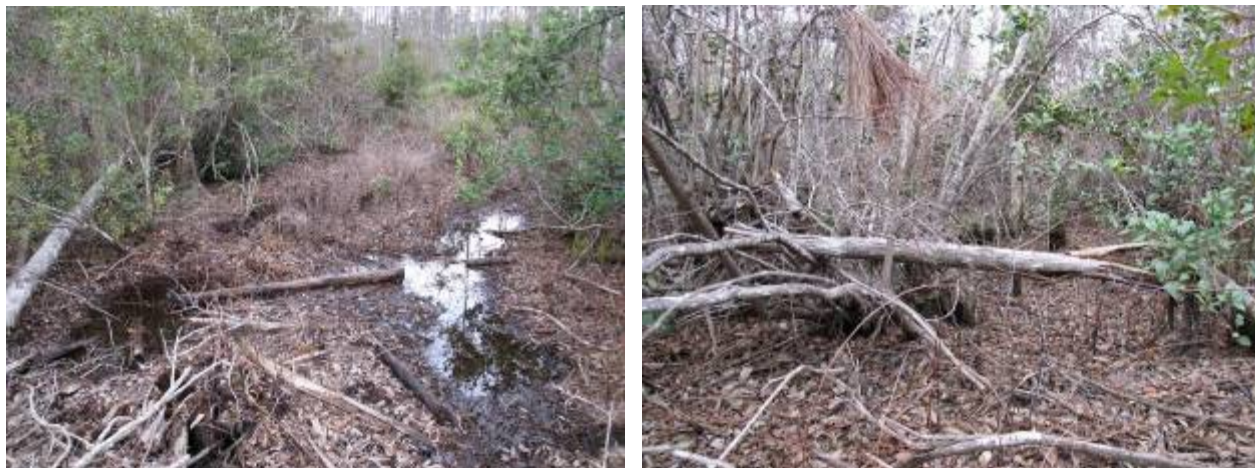
Wetland ID: 12-11

Description: This wetland is a 0.2 ha ephemeral mixed swamp. Cypress and gum trees dominate the canopy, and cover 50-75% of the wetland. The midstory is dominated by wax myrtle and fetterbush, and covers 50-75% of the wetland. Fern grow throughout the wetland, and cover 5-25% of the basin. Large machinery tracks run through the center of the wetland. Grade 17, a dirt road, runs along the north side of the wetland. The adjacent uplands are mesic flatwoods that were bedded and converted to a pine plantation. Upland restoration is in progress.

Wetland Concerns: Road, Slash, Vehicular damage, Woody encroachment

Restoration Action Recommended: In order to restore the hydrology of this wetland and the larger wetland system, the road would have to be removed. Recognizing that this road is now a permanent attribute to the property, we do not recommend any action relating to the road. Encourage fire to burn in the wetland to reduce the slash piles and dense brush. The vehicular ruts should fill in with vegetation over time. To avoid future damage, operate machinery only when wetland is completely dry.

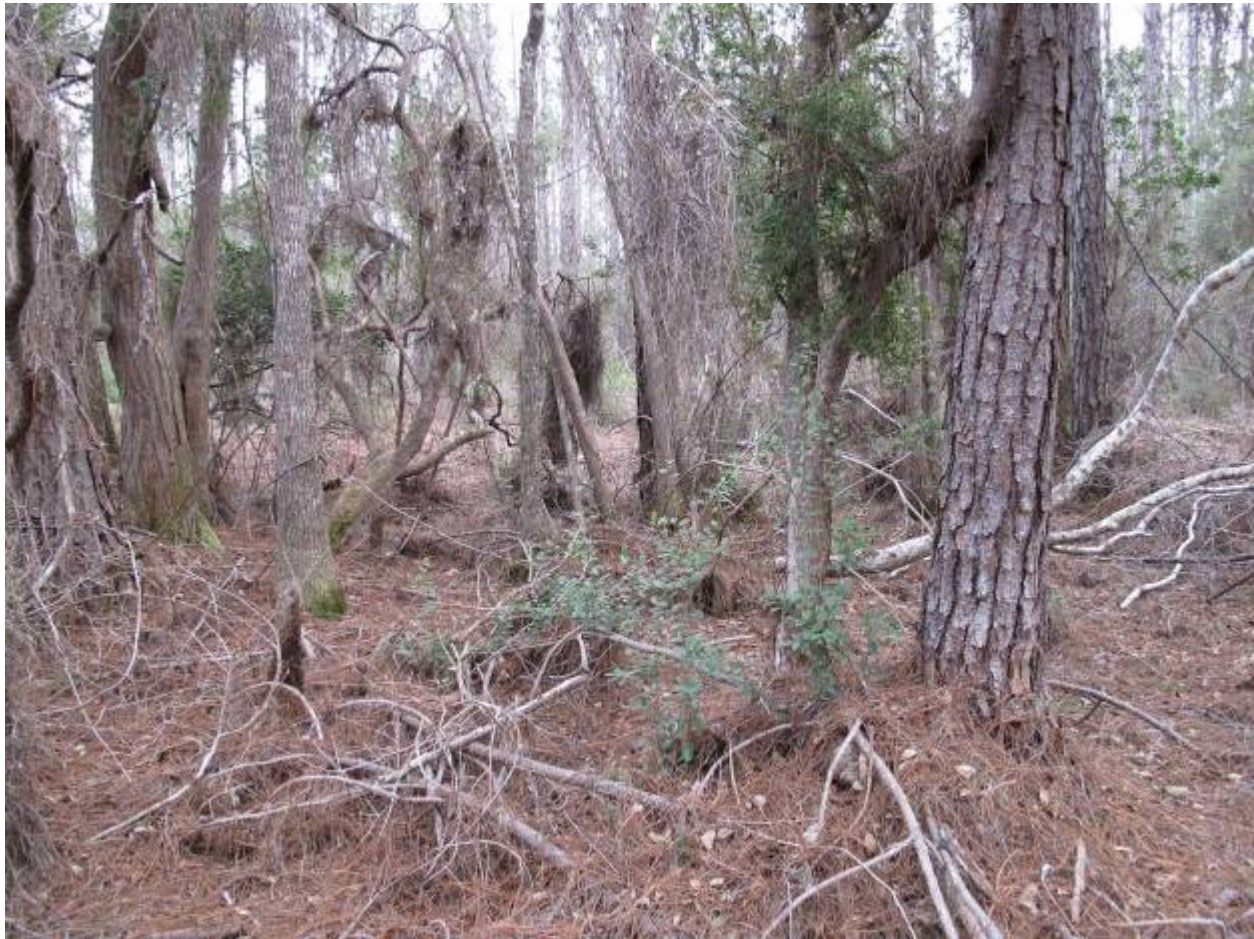
Wetland ID: 12-12

Description: This wetland is a <0.1 ha ephemeral forested swamp. Cypress and pine trees dominate the canopy, and cover >75% of the wetland. The midstory is dominated by gallberry and holly, and covers 25-50% of the wetland. There is no herbaceous vegetation and the wetland basin has a thick layer of needle duff. Pine trees were planted on bedded rows through the wetland interior. The adjacent uplands are mesic flatwoods that were bedded and converted to a pine plantation. Upland restoration is in progress.

Wetland Concerns: Bedding, Planted pines

Restoration Action Recommended: No action to remove the bedding is recommended; the bedding rows will erode over time. Remove the planted pine trees from the wetland interior. Provide periodic fire for ecological maintenance.

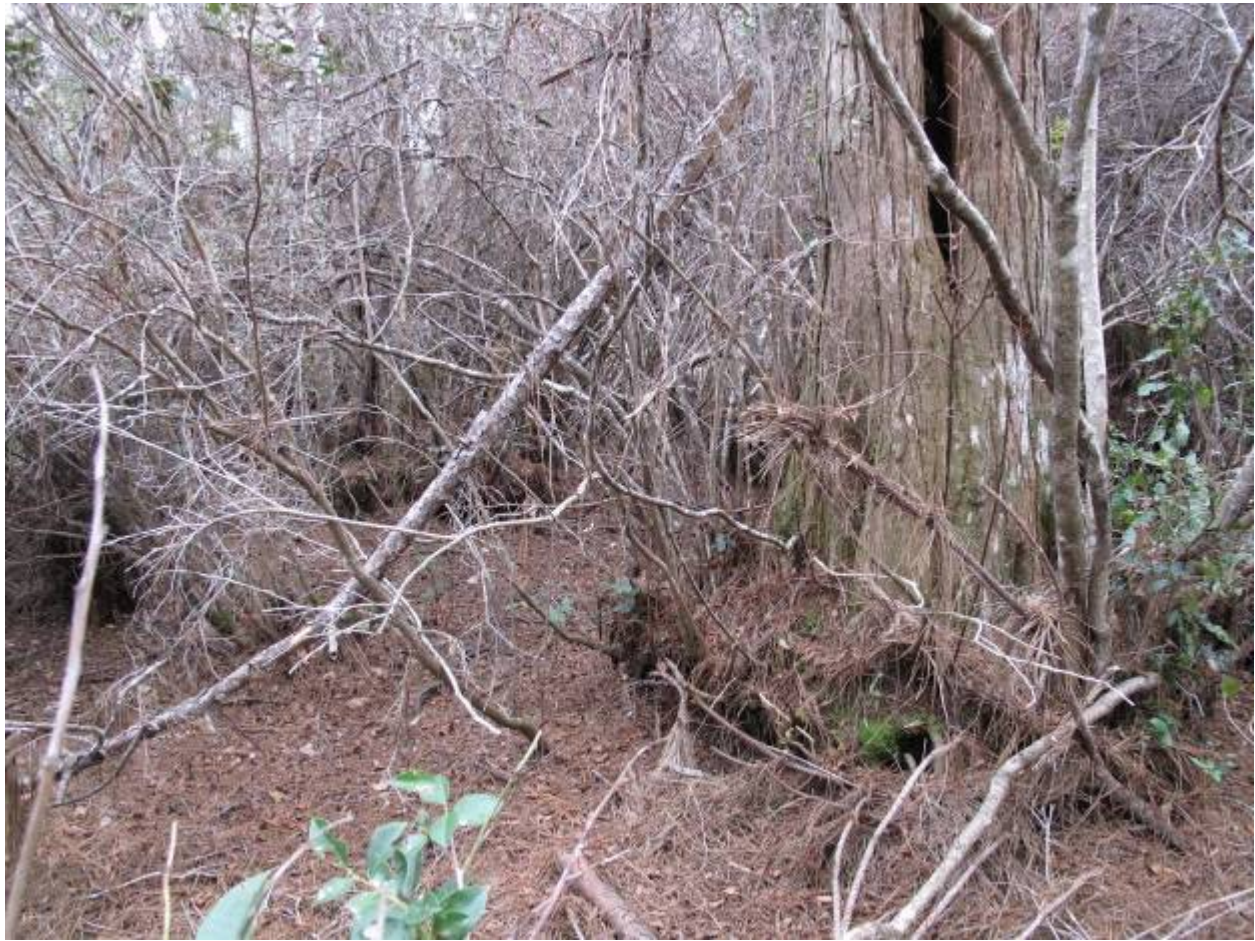
Description: This wetland is a 0.1 ha ephemeral mixed swamp. Cypress and pine trees dominate the canopy, and cover >75% of the wetland. The midstory is dominated by wax myrtle, fetterbush, and titi, and covers >75% of the wetland. There is no herbaceous vegetation but the wetland basin has a thick layer of pine needle duff. Pine trees were planted on bedded rows through the wetland interior. The adjacent uplands are mesic flatwoods that were bedded and converted to a pine plantation. Upland restoration is in progress.

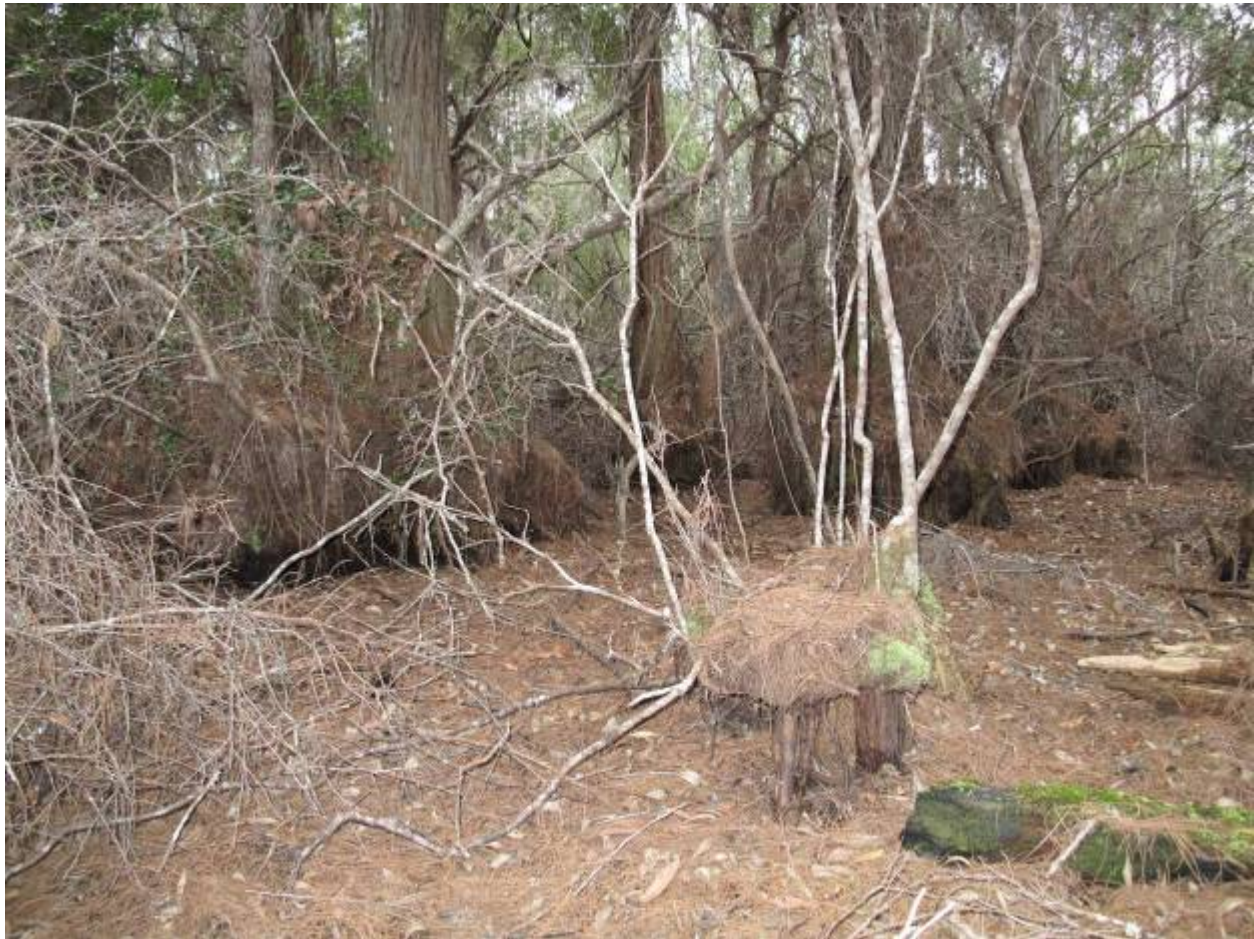
Wetland ID: 12-14

Description: This wetland is a 0.1 ha ephemeral mixed swamp. Cypress and pine trees dominate the canopy, and cover >75% of the wetland. The midstory is dominated by a mixture of wax myrtle, fetterbush, holly and titi, and covers >75% of the wetland. There is no herbaceous vegetation but the wetland basin is has a thick layer of pine needle duff. Pine trees were planted on bedded rows through the wetland interior. The adjacent uplands are mesic flatwoods that were bedded and converted to a pine plantation. Upland restoration is in progress.

Wetland Concerns: Bedding, Planted pines, Slash, Woody encroachment

Restoration Action Recommended: No action to remove the bedding is recommended; the bedding rows will erode over time. Remove the planted pine trees from the wetland interior. Periodic fire would eliminate the slash and reduce the thick pine duff and dense woody vegetation.

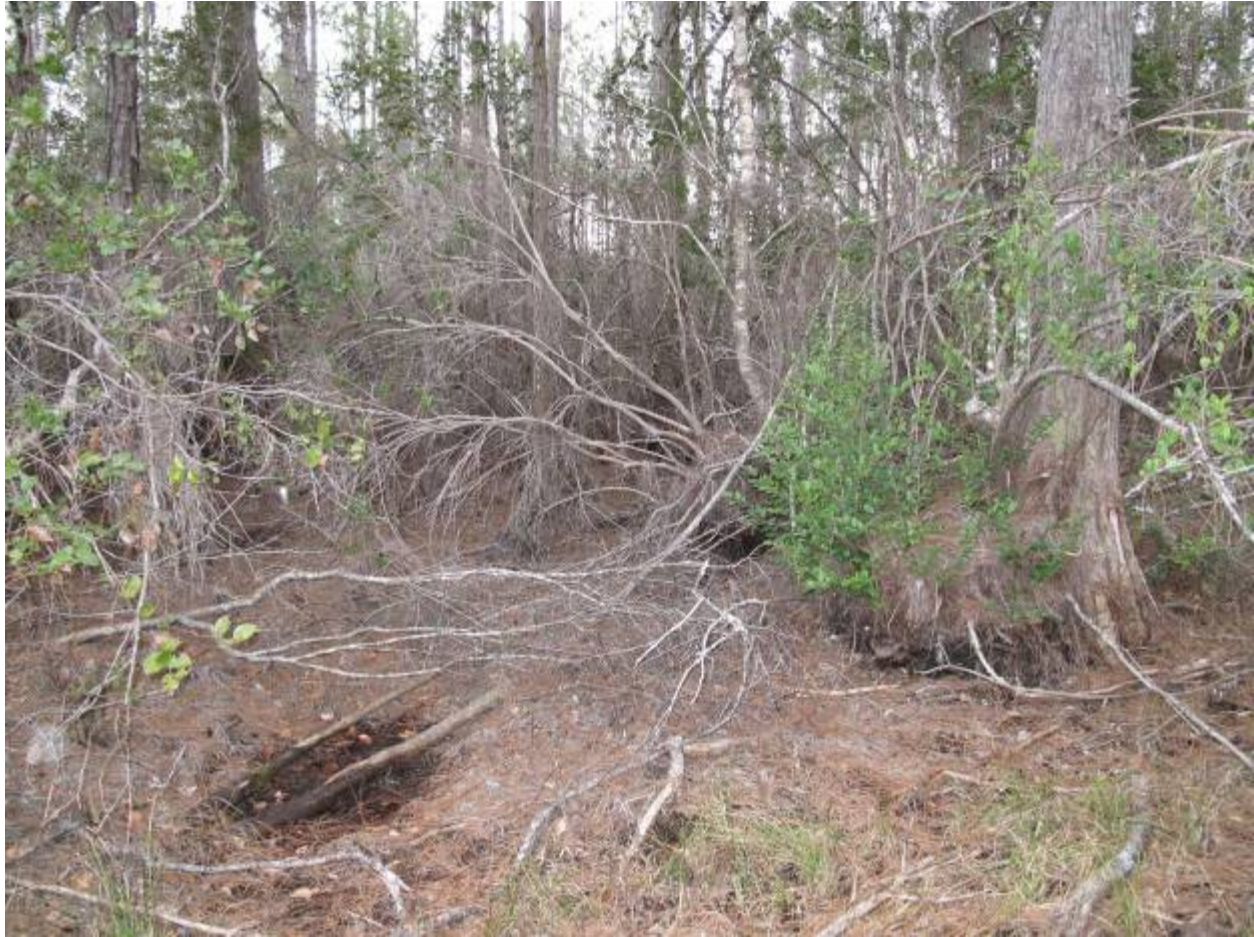
Wetland ID: 12-15

Description: This wetland is a <0.1 ha ephemeral mixed swamp. Cypress trees dominate the canopy, and cover 50- 75% of the wetland. The midstory is dominated by a mixture of wax myrtle, fetterbush, holly, and titi, and covers 50-75% of the wetland. There is no herbaceous vegetation but the wetland basin has a thick layer of pine needle duff. Pine trees were planted on bedded rows through the wetland interior. The adjacent uplands are mesic flatwoods that were bedded and converted to a pine plantation. Upland restoration is in progress.

Wetland Concerns: Bedding, Planted pines, Slash, Woody encroachment

Restoration Action Recommended: No action to remove the bedding is recommended; the bedding rows will erode over time. Remove the planted pine trees from the wetland interior. Periodic fire would eliminate the slash and reduce the thick pine duff and dense woody vegetation.

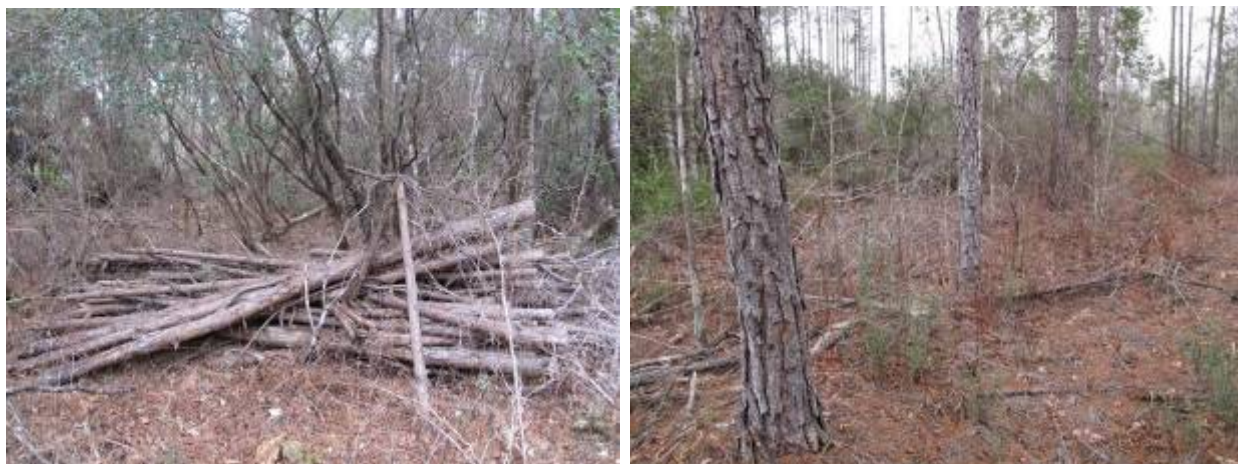
Wetland ID: 12-16

Description: This wetland is a <0.1 ha ephemeral mixed swamp. Cypress and pine trees dominate the canopy, and cover 25-50% of the wetland. The midstory is dominated by fetterbush and titi, and covers 25-50% of the wetland. There is no herbaceous vegetation. Heavy machinery left gouges through the wetland and a slash pile was left in the wetland. Pine trees were planted on bedded rows through the wetland interior. The adjacent uplands are mesic flatwoods that were bedded and converted to a pine plantation. Upland restoration is in progress.

Wetland Concerns: Bedding, Planted pines, Slash, Vehicular damage, Woody encroachment

Restoration Action Recommended: No action to remove the bedding is recommended; the bedding rows will erode over time. Remove the planted pine trees from the wetland interior. Periodic fire would eliminate the slash and reduce the thick pine duff and dense woody vegetation. Allow the gouges to heal over time. To avoid future damage, operate machinery only when wetland is completely dry. Smaller wetlands may need to be flagged to alert operators of the wetland's existence.

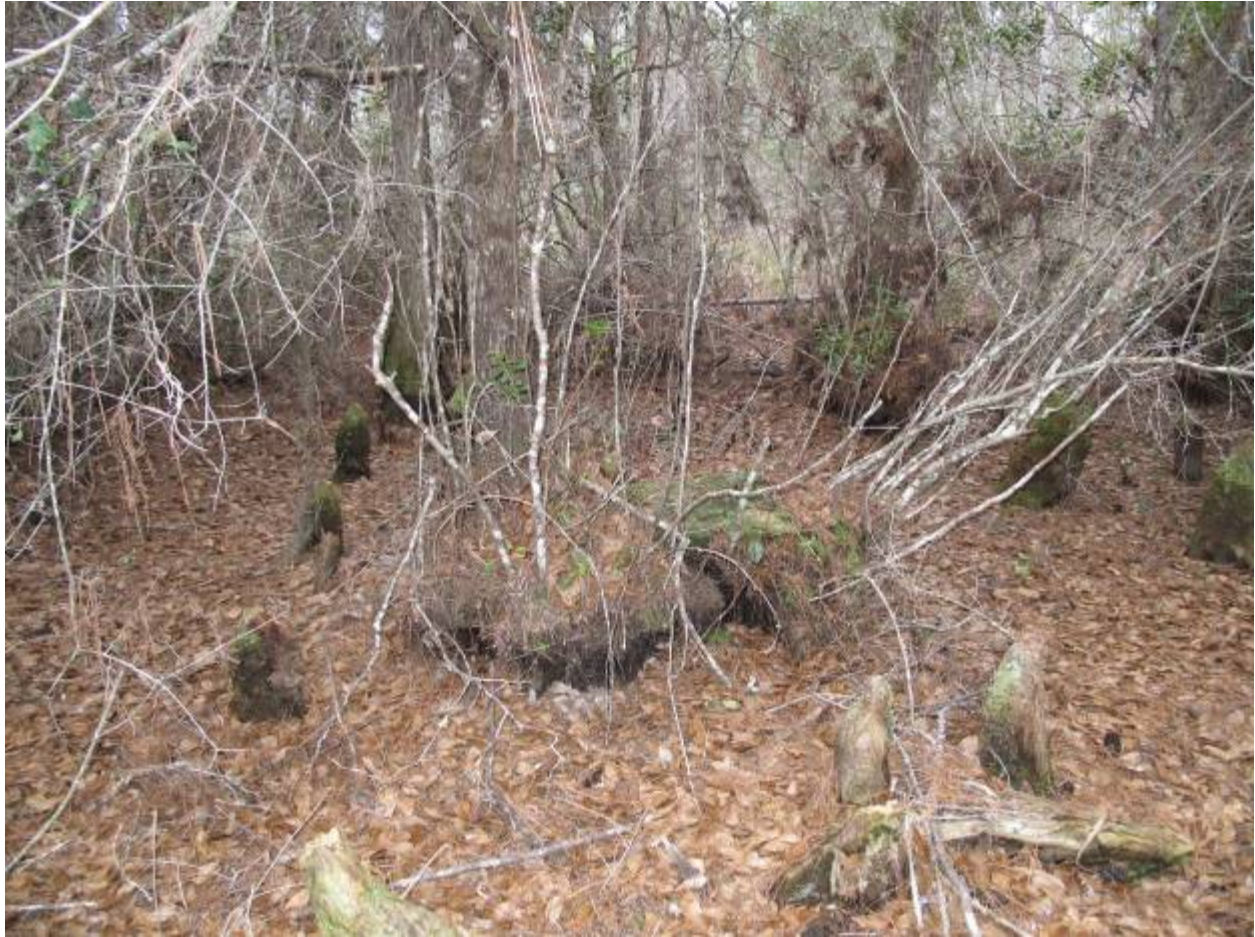
Wetland ID: 12-17

Description: This wetland is a 0.3 ha ephemeral mixed swamp. Cypress and pine trees dominate the canopy, and cover 50-75% of the wetland. The midstory is dominated by holly, fetterbush, and titi, and covers 50-75% of the wetland. Sawgrass grows in scattered patches, and covers 5-25% of the basin. Pine trees were planted on bedded rows through the wetland. The pine trees were thinned and slight vehicular tracks remain from a recent thinning operation. The adjacent uplands are mesic flatwoods that were bedded and converted to a pine plantation. Upland restoration is in progress.

Wetland Concerns: Bedding, Woody encroachment

Restoration Action Recommended: No action to remove the bedding is recommended; the bedding rows will erode over time. Periodic fire should reduce the thick duff and woody vegetation.
