Inventory, Assessment, and Restoration Potential of Ephemeral Wetlands on FFWCC Wildlife Management Areas

Aucilla WMA Final Report

Submitted by: Rebecca P.M. Means¹, Ryan C. Means¹, Steven A. Johnson²

¹Coastal Plains Institute

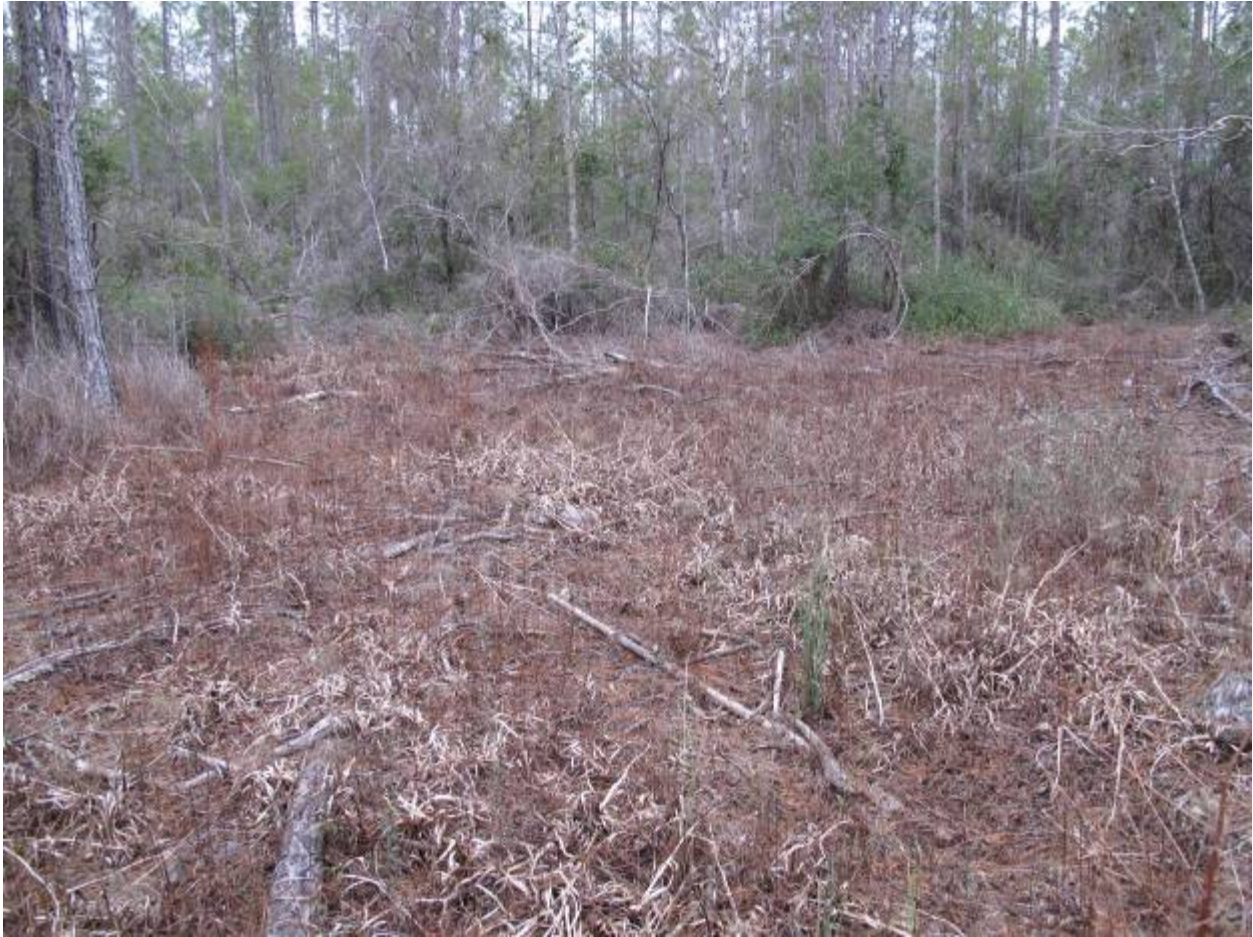
Wetland ID: 12-18

Description: This wetland is a 0.1 ha ephemeral marsh. Cypress and pine trees dominate the canopy, and cover 5-25% of the wetland. The midstory is dominated by fetterbush and titi, and covers 5-25% of the wetland. Redroot grows throughout the wetland, and covers 25-50% of the basin. Pine trees were planted on bedding rows through the wetland. Recent mechanical activity removed brush and pine trees from the wetland interior. Some slash remains in the wetland. The adjacent uplands are mesic flatwoods that were bedded and converted to a pine plantation. Upland restoration is in progress.

Wetland Concerns: Bedding, Slash

Restoration Action Recommended: No action to remove the bedding is recommended; the bedding rows will erode over time. Encourage fire to burn in the wetland to reduce the slash piles and prevent shrub encroachment.

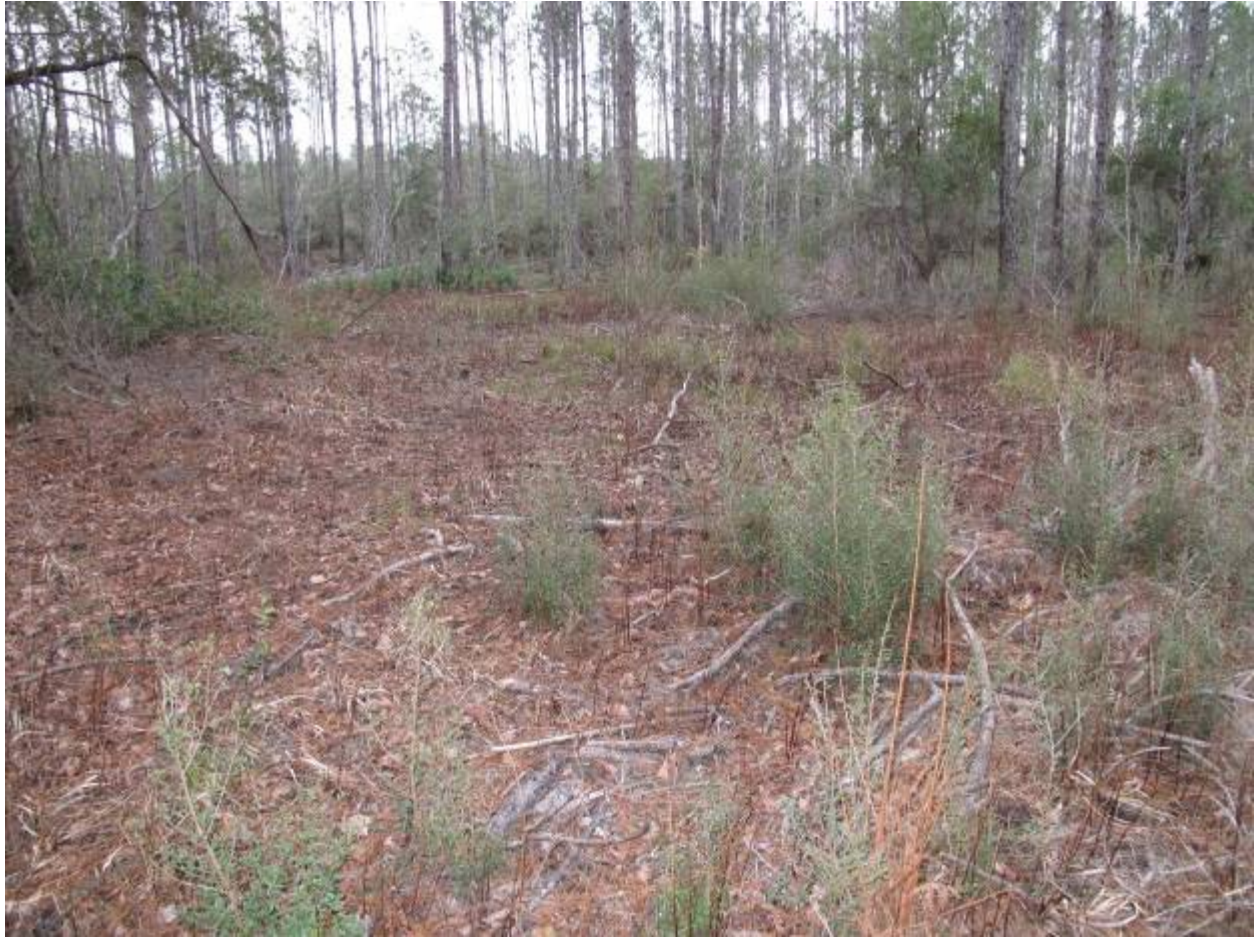
Wetland ID: 12-19

Description: This wetland is a 0.2 ha ephemeral mixed swamp. Cypress and pine trees dominate the canopy, and cover 25-50% of the wetland. The midstory is dominated by wax myrtle and titi, and covers 25-50% of the wetland. Sedges/grasses and redroot grow in scattered patches, and cover 5-25% of the wetland. Pine trees were planted on bedded rows through the wetland interior. The pine trees were recently mechanically removed when the wetland was dry but the bedding remains. Historical evidence suggests this wetland was a forested swamp prior to pine plantation conversion. The adjacent uplands are mesic flatwoods that were bedded and converted to a pine plantation. Upland restoration is in progress.

Wetland Concerns: Bedding, Woody encroachment

Restoration Action Recommended: No action to remove the bedding is recommended; the bedding rows will erode over time. Periodic fire in the wetland would reduce the patches of dense woody vegetation.

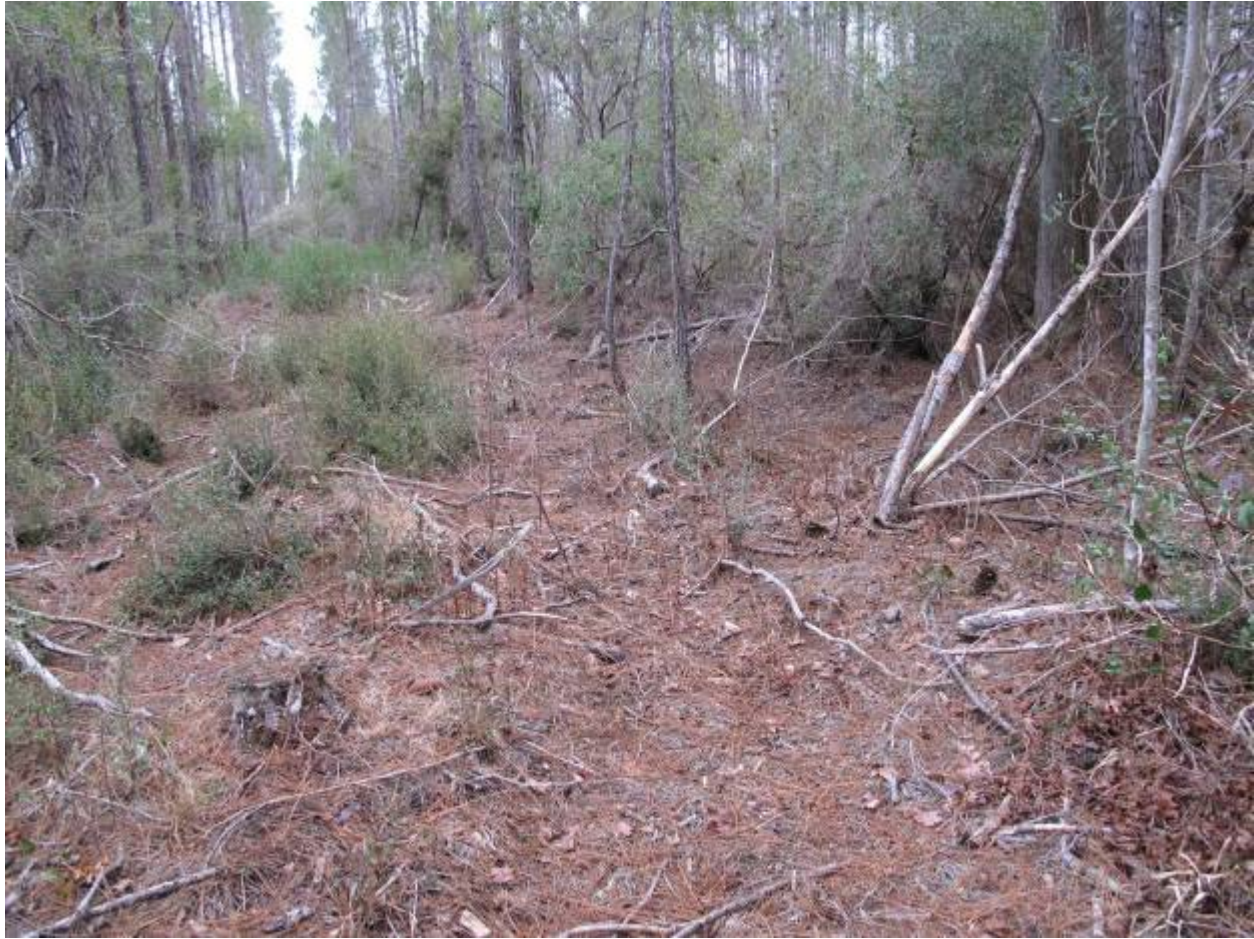
Wetland ID: 12-20

Description: This wetland is a <0.1 ha ephemeral mixed swamp. Cypress and pine trees dominate the canopy, and cover >75% of the wetland. The midstory is dominated by holly and titi, and covers 50-75% of the wetland. There is no herbaceous vegetation but the wetland basin has a thick layer of pine needle duff. Old bedding rows run through the wetland. The pines that were planted on the beds recently were mechanically removed. The adjacent uplands are mesic flatwoods that were bedded and converted to a pine plantation. Upland restoration is in progress.

Wetland Concerns: Bedding, Slash, Woody encroachment

Restoration Action Recommended: No action to remove the bedding is recommended; the bedding rows will erode over time. Encourage fire to burn in the wetland to eliminate the slash, reduce the needle duff, and prevent further shrub encroachment.

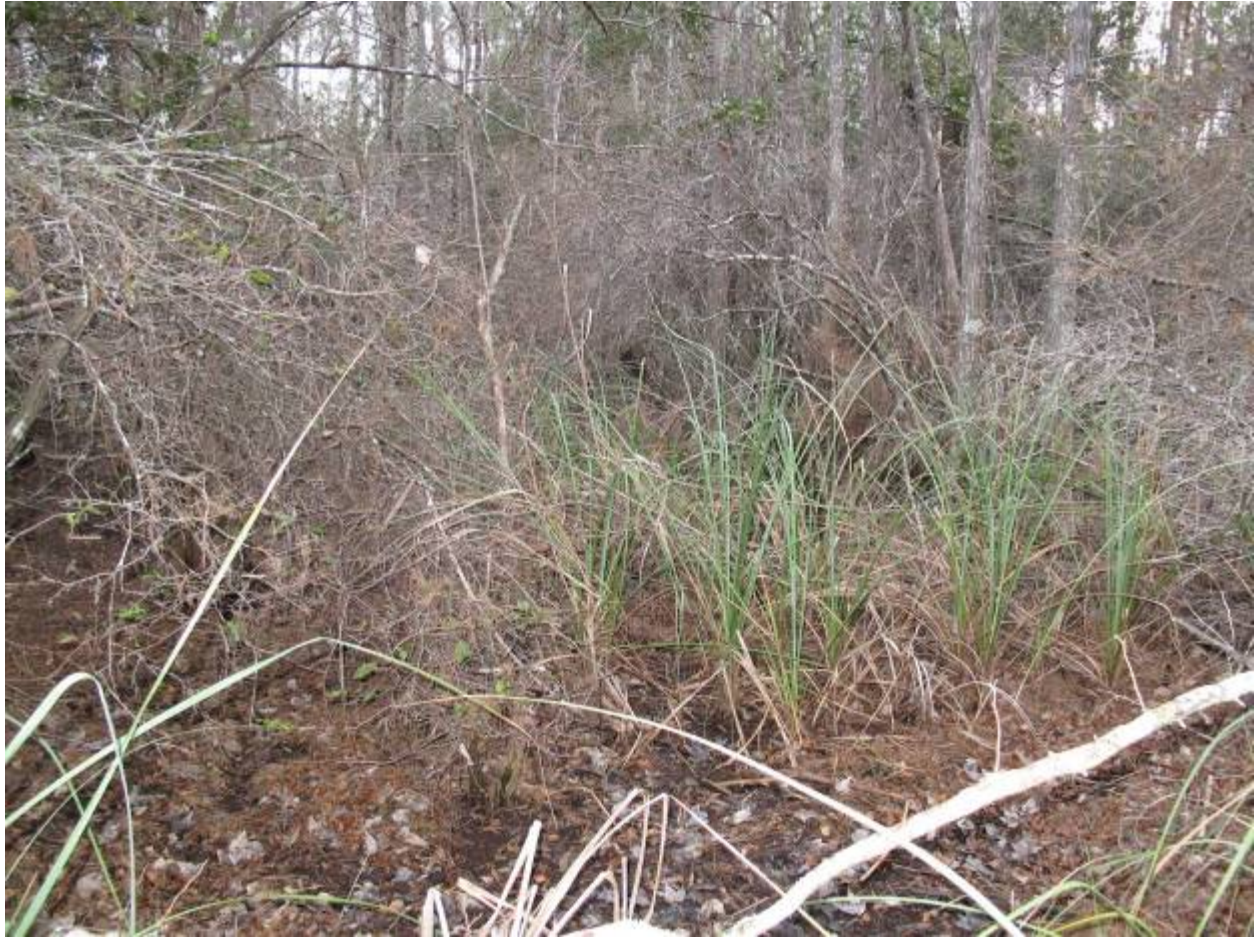
Wetland ID: 12-21

Description: This wetland is a 0.1 ha ephemeral mixed swamp. Cypress trees dominate the canopy, and cover >75% of the wetland. The midstory is dominated by wax myrtle, fetterbush, and titi, and covers 50-75% of the wetland. Sawgrass grows in scattered patches, and covers 5-25% of the basin. Old bedding rows run through the wetland perimeter. The pines that were planted in the beds recently were mechanically removed. The adjacent uplands are mesic flatwoods that were bedded and converted to a pine plantation. Upland restoration is in progress.

Wetland Concerns: Bedding, Woody encroachment

Restoration Action Recommended: No action to remove the bedding is recommended; the bedding rows will erode over time. Periodic fire in the wetland basin would reduce the thick duff and woody vegetation.

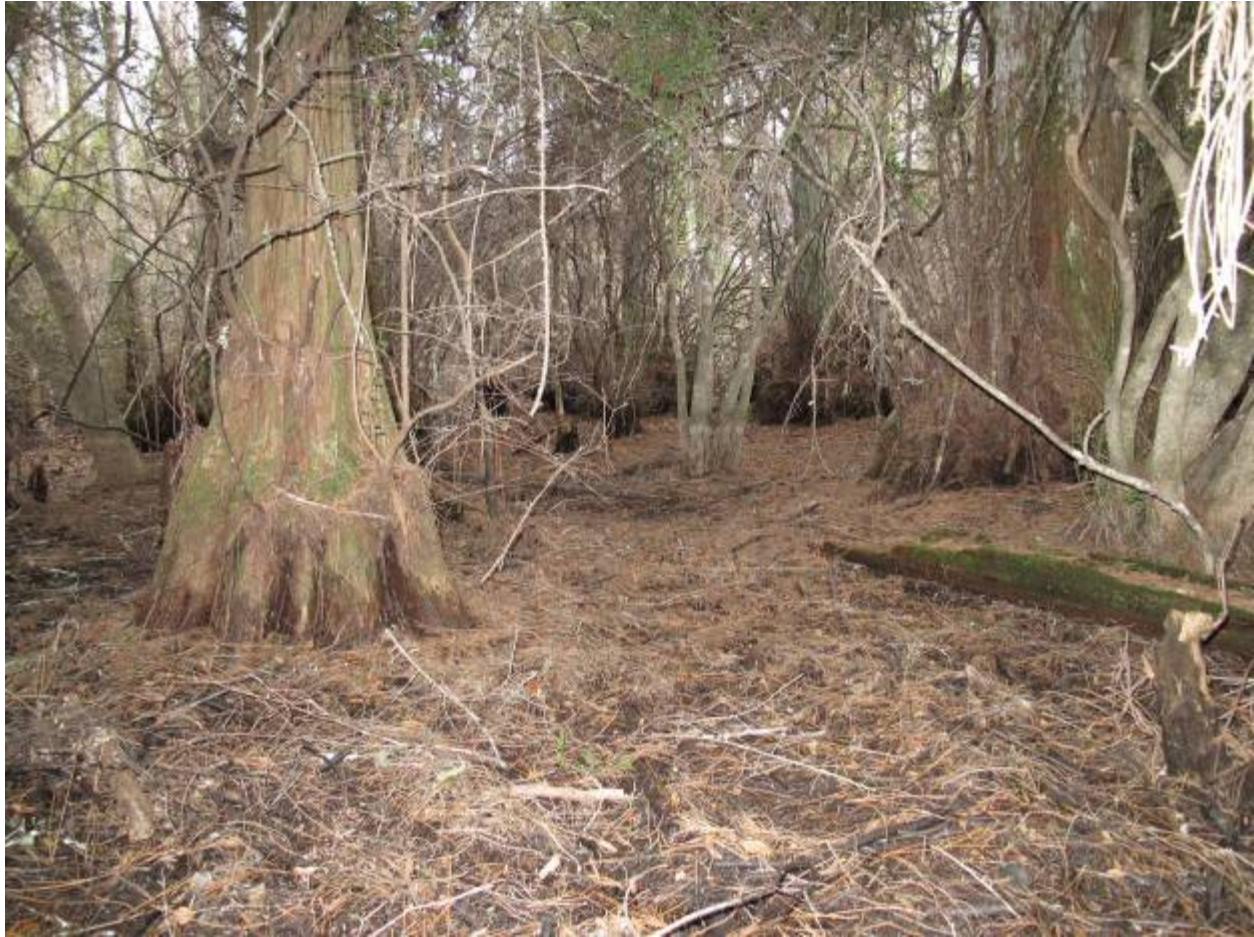
Wetland ID: 12-22

Description: This wetland is a 0.1 ha ephemeral mixed swamp. Cypress and pine trees dominate the canopy, and cover >75% of the wetland. The midstory is dominated by fetterbush and holly, and covers 50-75% of the wetland. There is no herbaceous vegetation. Old bedding rows run through the wetland perimeter. The adjacent uplands are mesic flatwoods that were bedded and converted to a pine plantation. Upland restoration is in progress.

Wetland Concerns: Bedding, Slash, Woody encroachment

Restoration Action Recommended: No action to remove the bedding is recommended; the bedding rows will erode over time. Encourage fire to burn in the wetland to eliminate the slash and prevent further shrub encroachment.

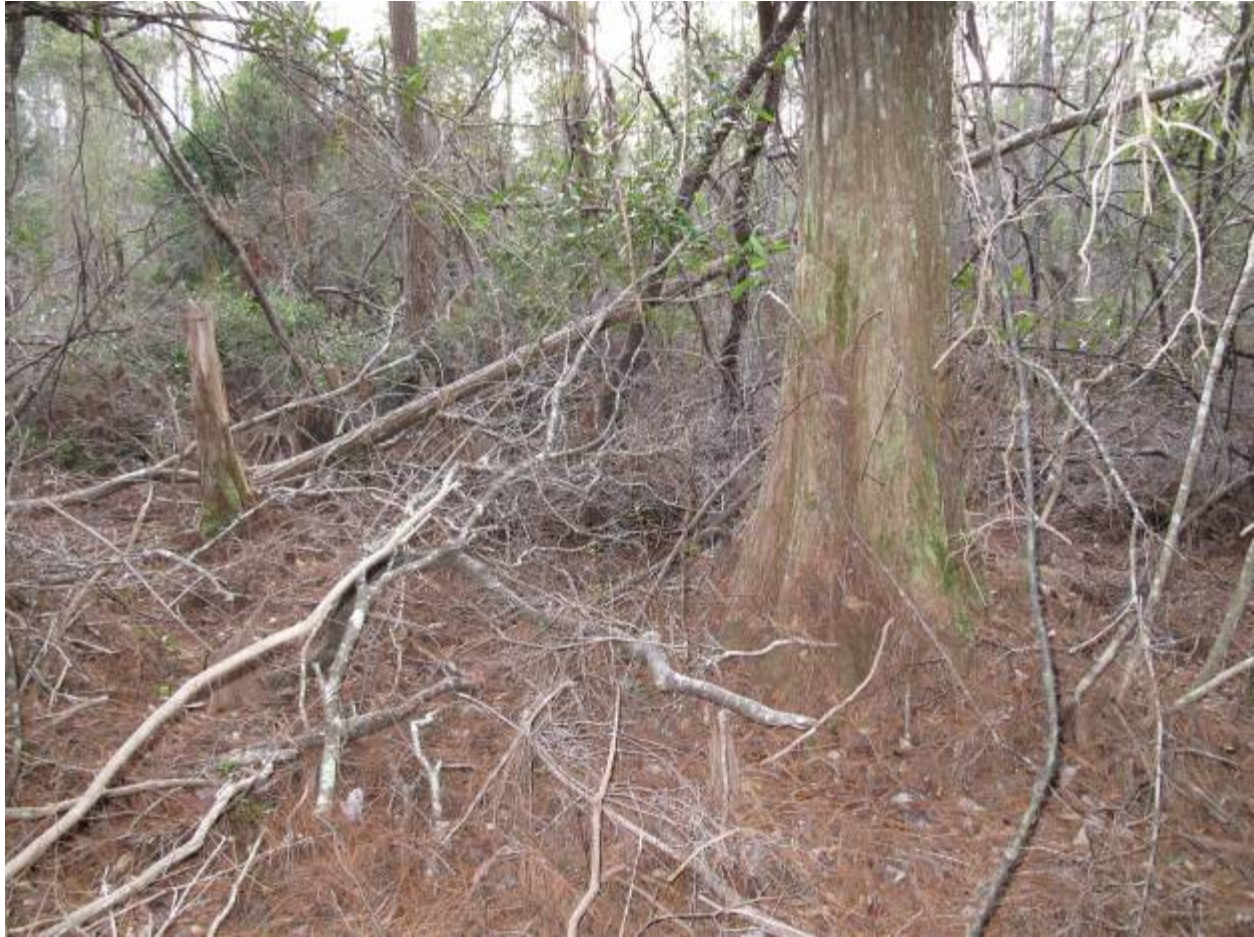
Wetland ID: 12-23

Description: This wetland is a 0.2 ha ephemeral mixed swamp. Cypress and pine trees dominate the canopy, and cover >75% of the wetland. The midstory is dominated by wax myrtle, and covers 50-75% of the wetland. There is no herbaceous vegetation but the wetland basin has a thick layer of pine needle duff. The adjacent uplands are mesic flatwoods that were bedded and converted to a pine plantation. Upland restoration is in progress.

Wetland Concerns: Slash, Woody encroachment

Restoration Action Recommended: Encourage fire to burn in the wetland to reduce the thick needle duff and eliminate the slash piles.

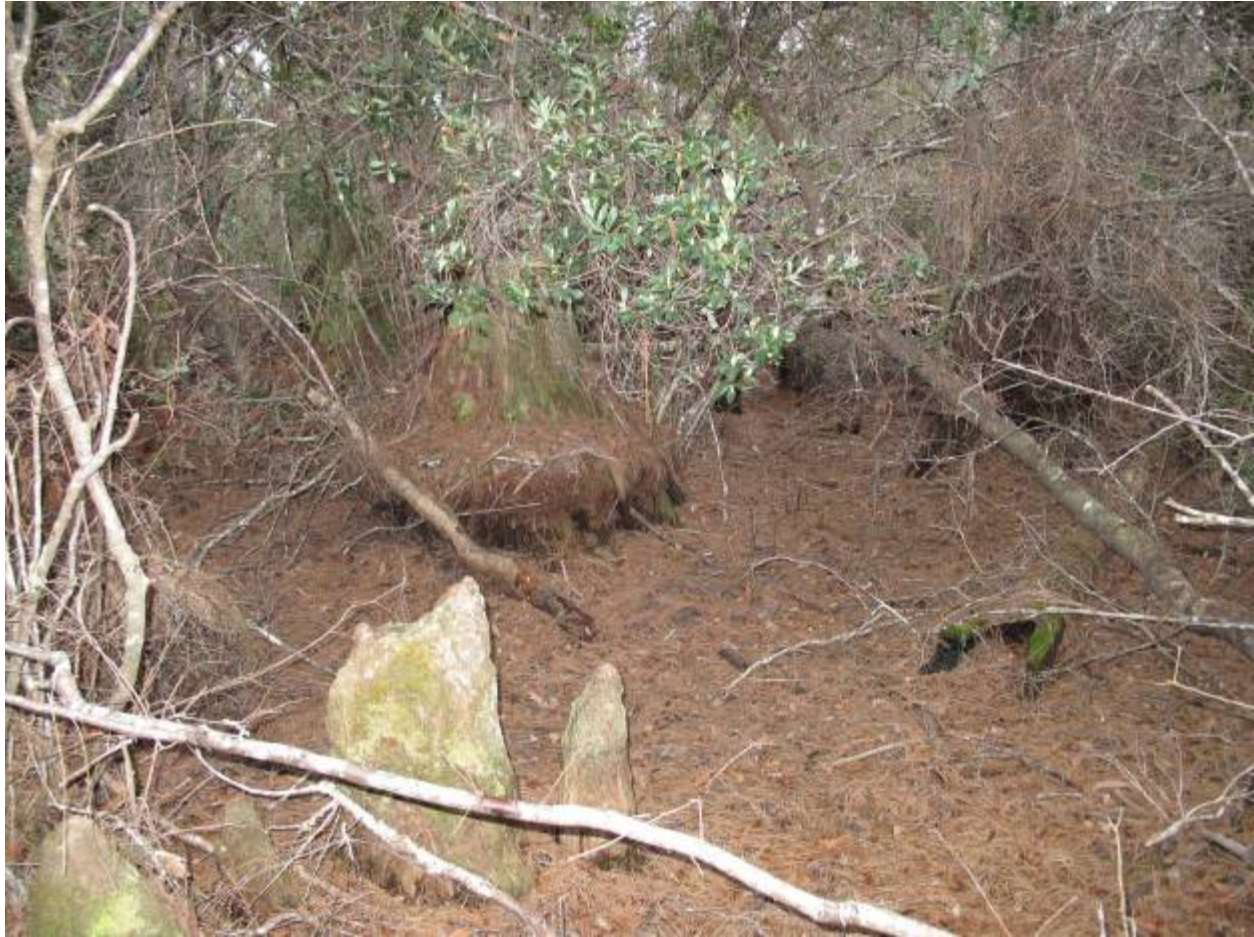
Wetland ID: 12-24

Description: This wetland is a 0.1 ha ephemeral mixed swamp. Cypress and pine trees dominate the canopy, and cover 50-75% of the wetland. The midstory is dominated by wax myrtle and holly, and covers 50-75% of the wetland. There is no herbaceous vegetation but the wetland basin has a thick layer of pine needle duff. There is a minor amount of slash in the wetland. The adjacent uplands are mesic flatwoods that were bedded and converted to a pine plantation. Upland restoration is in progress.

Wetland Concerns: Woody encroachment

Restoration Action Recommended: Encourage fire to burn in the wetland reduce the thick needle duff, eliminate the slash, and prevent further shrub encroachment.

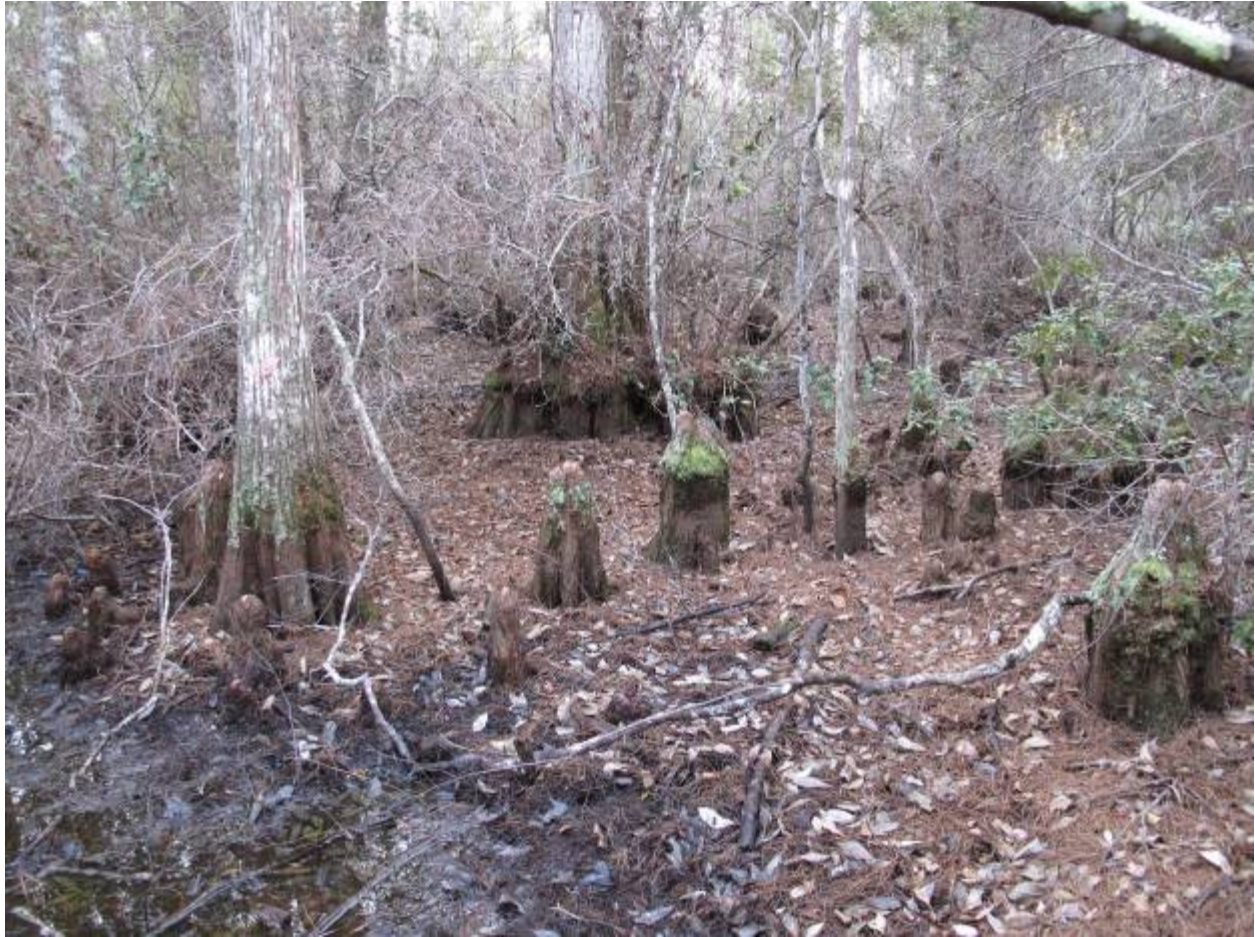
Wetland ID: 12-25

Description: This wetland is a 0.5 ha ephemeral mixed swamp. Cypress trees dominate the canopy, and cover >75% of the wetland. The midstory is dominated by a mixture of titi, fetterbush, holly, and wax myrtle, and covers 50-75% of the wetland. There is no herbaceous vegetation. A small amount of slash is piled around the perimeter of the wetland. The adjacent uplands are mesic flatwoods that were bedded and converted to a pine plantation. Upland restoration is in progress.

Wetland Concerns: Woody encroachment

Restoration Action Recommended: Encourage fire to burn in the wetland to eliminate the slash and reduce the woody brush.

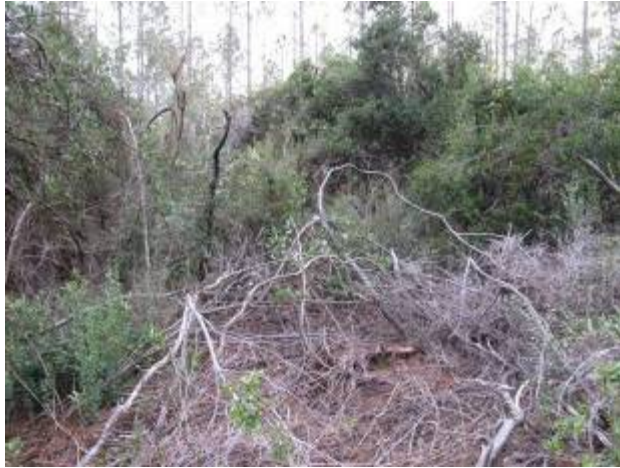
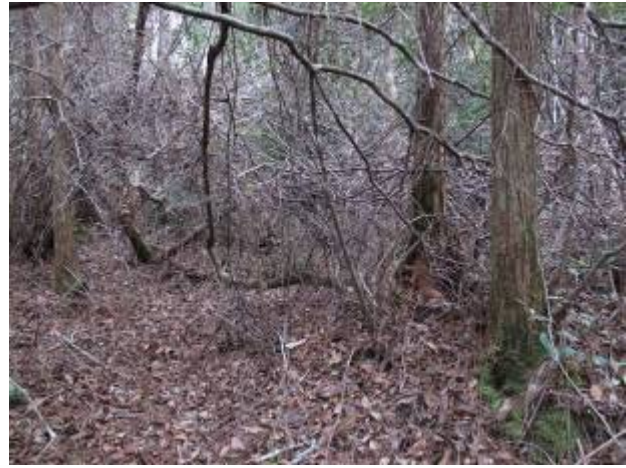
Wetland ID: 12-26

Description: This wetland is a 0.2 ha ephemeral shrub swamp. Cypress trees dominate the canopy, and cover 5-25% of the wetland. The midstory is dominated by titi, and covers >75% of the wetland. There is no herbaceous vegetation. There is some slash in the wetland. The adjacent uplands are mesic flatwoods that were bedded and converted to a pine plantation. Upland restoration is in progress.

Wetland Concerns: Slash, Woody encroachment

Restoration Action Recommended: Encourage fire to burn in the wetland to eliminate the slash and reduce the dense titi.

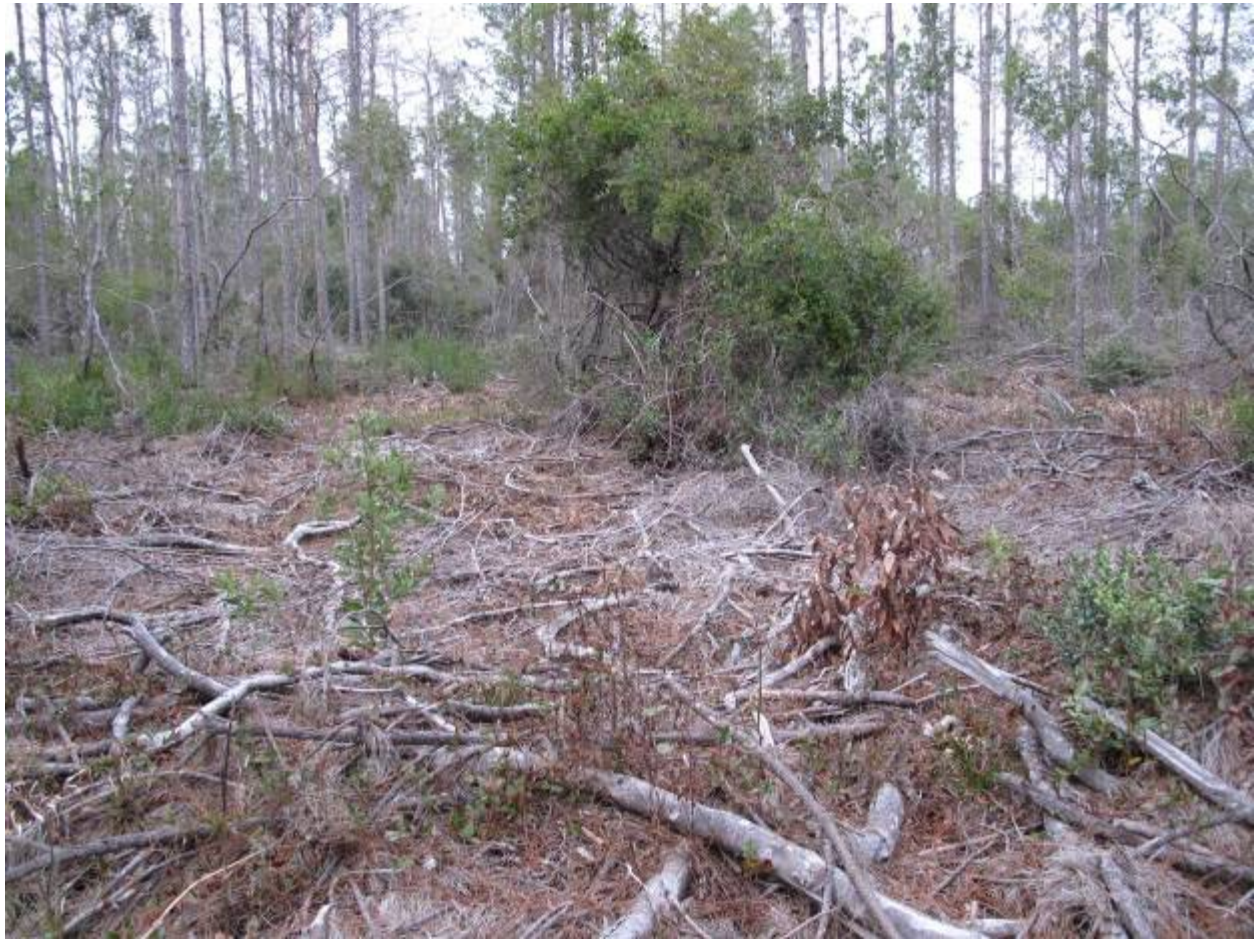
Wetland ID: 12-27

Description: This wetland is a <0.1 ha ephemeral altered wetland. All vegetation was removed from this wetland during a recent thinning operation. Evidence of bedding rows remain and slash is scattered throughout the wetland interior. Historical photos suggest this wetland was part of a larger forested swamp system. The adjacent uplands are mesic flatwoods that were bedded and converted to a pine plantation. Upland restoration is in progress.

Wetland Concerns: Bedding, Slash

Restoration Action Recommended: Encourage fire to burn through the wetland to eliminate the slash, encourage herbaceous vegetation to return, and prevent encroachment of a dense midstory. We suggest monitoring this wetland over time to learn how it responds to complete vegetation removal.

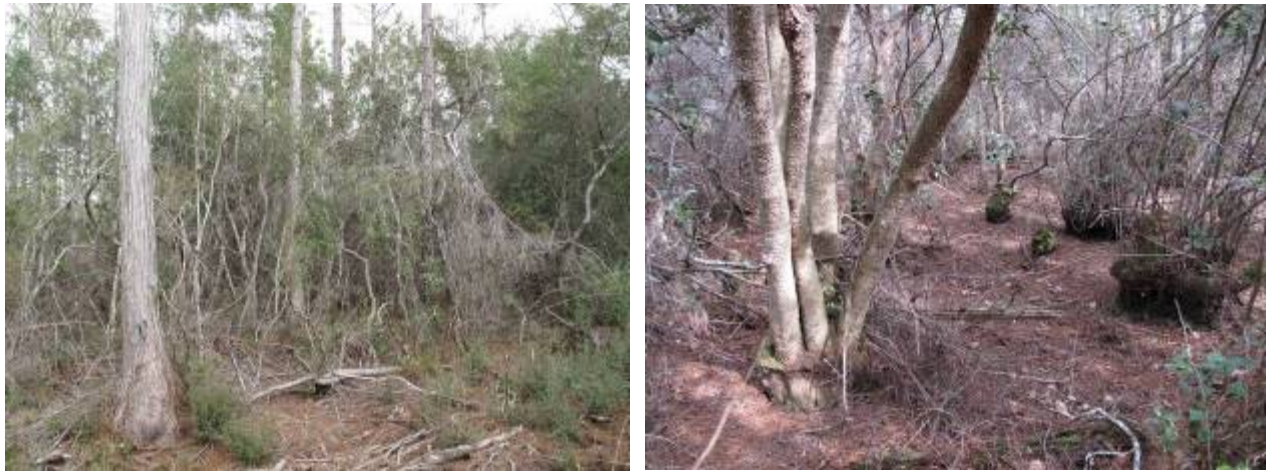
Wetland ID: 12-28

Description: This wetland is a 0.1 ha ephemeral mixed swamp. Cypress trees dominate the canopy, and cover 50-75% of the wetland. The midstory is dominated by holly and fetterbush, and covers >75% of the wetland. There is no herbaceous vegetation and the wetland basin has a thick layer of needle duff. The adjacent uplands are mesic flatwoods that were bedded and converted to a pine plantation. Upland restoration is in progress.

Wetland Concerns: Woody encroachment

Restoration Action Recommended: Encourage periodic fire in the wetland to reduce the dense shrubs and thick needle duff.

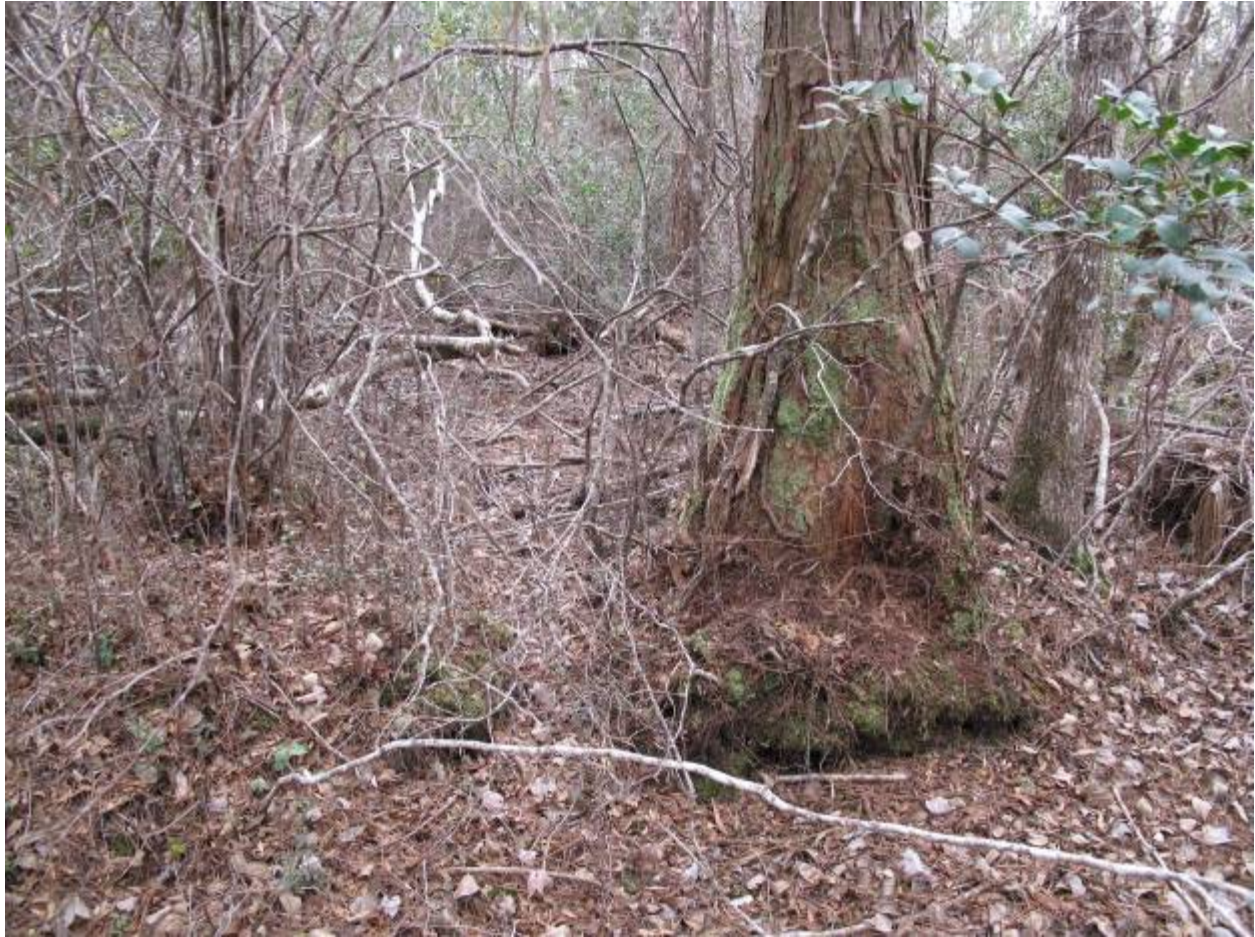
Wetland ID: 12-29

Description: This wetland is a 0.2 ha ephemeral mixed swamp. Cypress and pine trees dominate the canopy, and cover 50-75% of the wetland. The midstory is dominated by wax myrtle and fetterbush, and covers >75% of the wetland. Sawgrass grows in scattered patches, and covers 5-25% of the basin. There is a thick duff layer in the wetland. The adjacent uplands are mesic flatwoods that were bedded and converted to a pine plantation. Upland restoration is in progress.

Wetland Concerns: Woody encroachment

Restoration Action Recommended: Encourage periodic fire in the wetland to reduce the dense shrubs and thick needle duff.

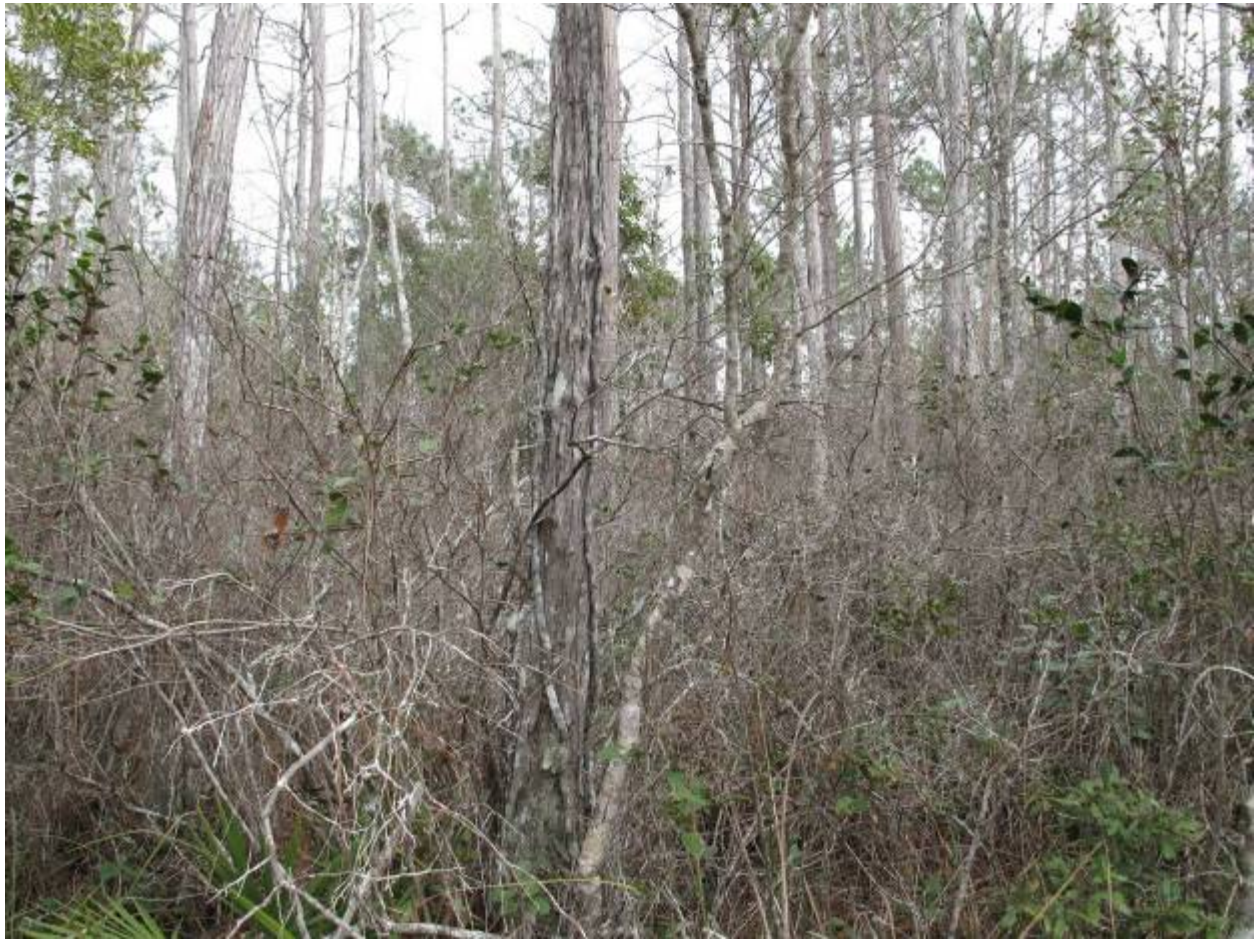
Wetland ID: 12-30

Description: This wetland is a 0.6 ha ephemeral mixed swamp. Cypress trees dominate the canopy, and cover 50- 75% of the wetland. The midstory is dominated by wax myrtle, titi, and fetterbush, and covers >75% of the wetland. Sawgrass grows in scattered patches, and covers 5-25% of the basin. A minor amount of slash is piled around the wetland edges. The adjacent uplands are mesic flatwoods that were bedded and converted to a pine plantation. Upland restoration is in progress.

Wetland Concerns: Woody encroachment

Restoration Action Recommended: Periodic fire in the wetland basin would reduce the thick shrubs and eliminate the slash.

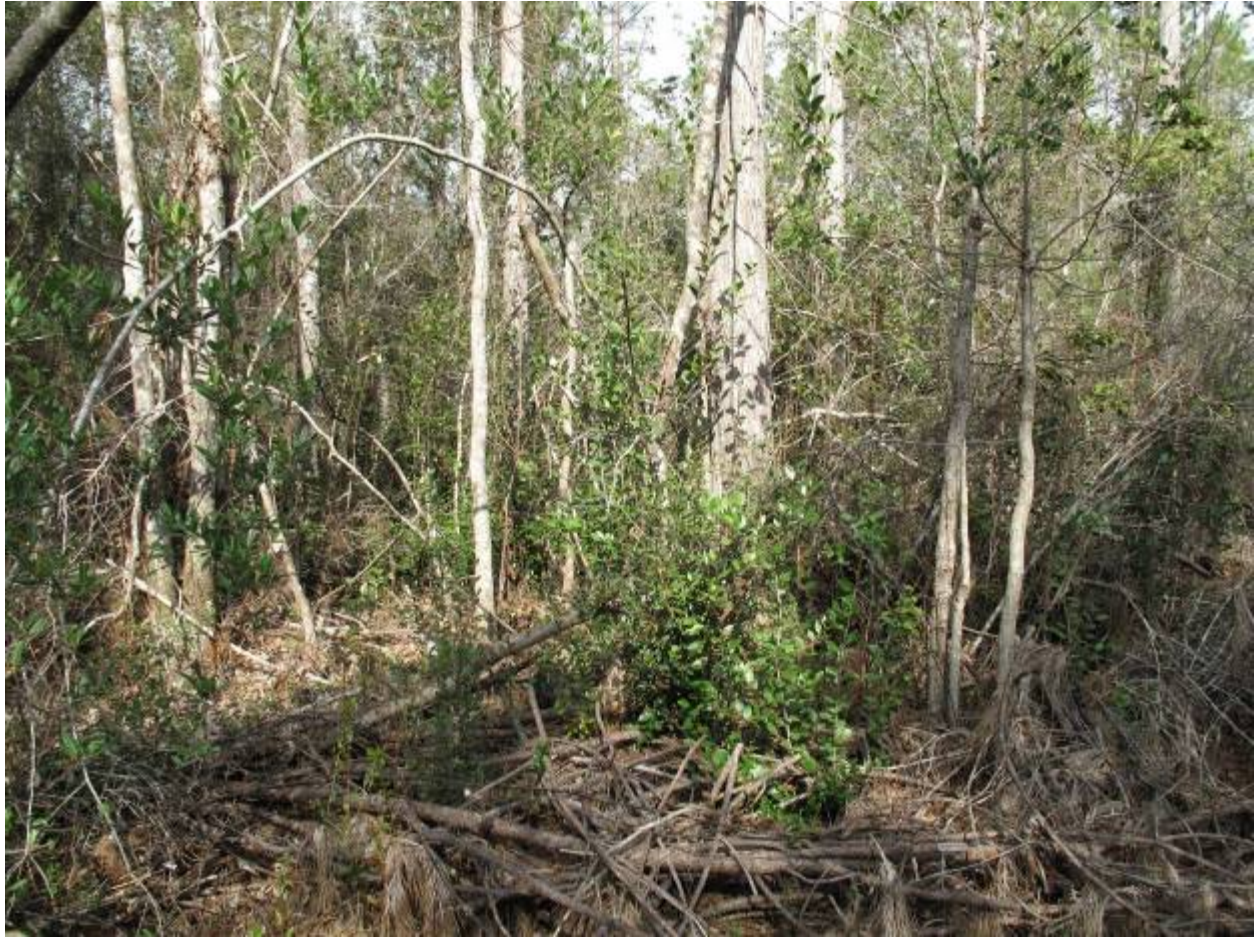
Wetland ID: 12-31

Description: This wetland is a 0.1 ha ephemeral mixed swamp. Cypress trees dominate the canopy, and cover 50-75% of the wetland. The midstory is dominated by wax myrtle, titi, and holly, and covers 50-75% of the wetland. There is no herbaceous vegetation. There is slash piled throughout the wetland. The adjacent uplands are mesic flatwoods that were bedded and converted to a pine plantation. Upland restoration is in progress.

Wetland Concerns: Slash, Woody encroachment

Restoration Action Recommended: Periodic fire in the wetland basin would reduce the thick shrubs and eliminate the slash piles.

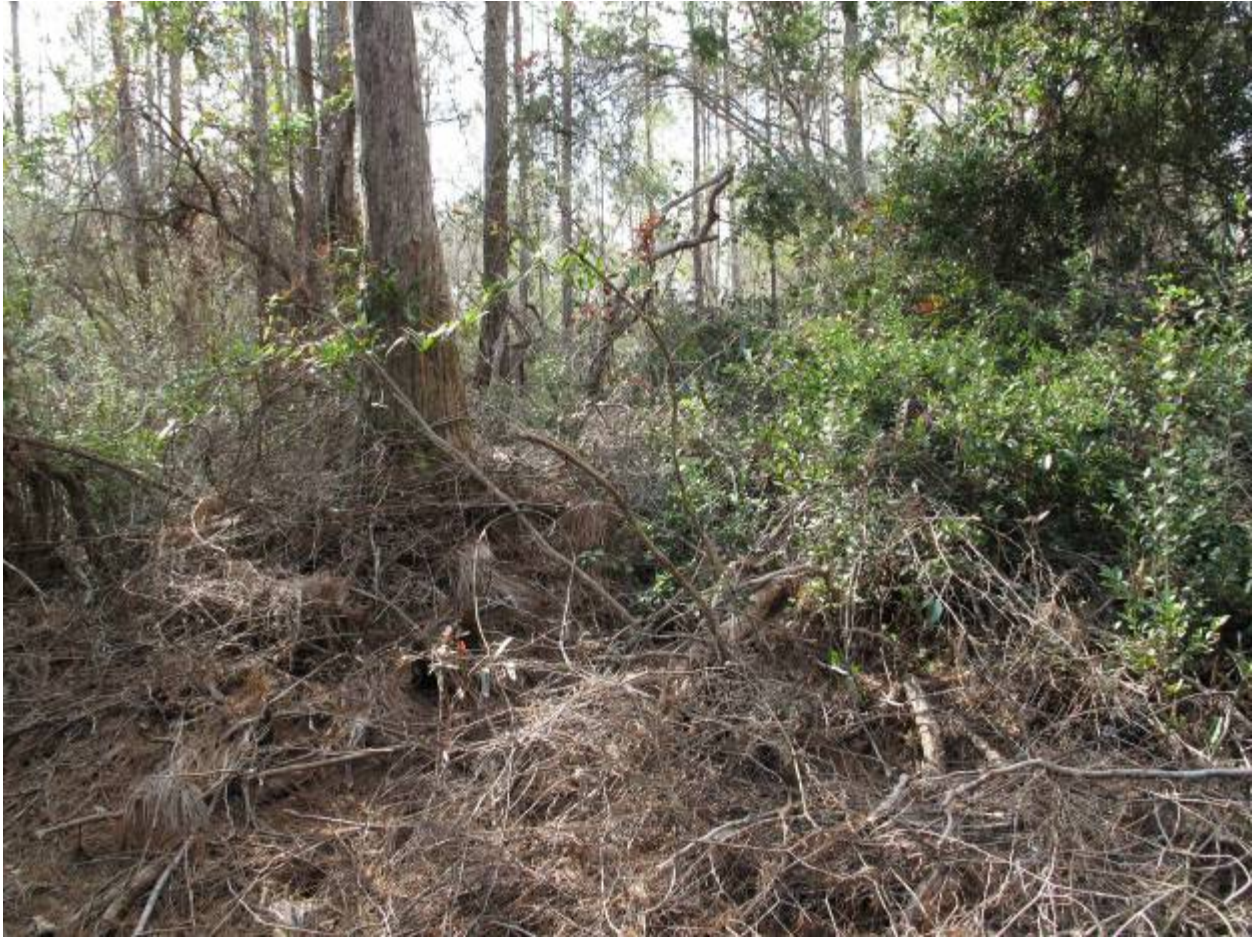
Wetland ID: 12-32

Description: This wetland is a 0.1 ha ephemeral mixed swamp. Cypress trees dominate the canopy, and cover 50-75% of the wetland. The midstory is dominated by titi and holly, and covers 50-75% of the wetland. There is no herbaceous vegetation. There is slash throughout the wetland. The adjacent uplands are mesic flatwoods that were bedded and converted to a pine plantation. Upland restoration is in progress.

Wetland Concerns: Slash, Woody encroachment

Restoration Action Recommended: Periodic fire in the wetland basin would reduce the thick titi and eliminate the slash piles.

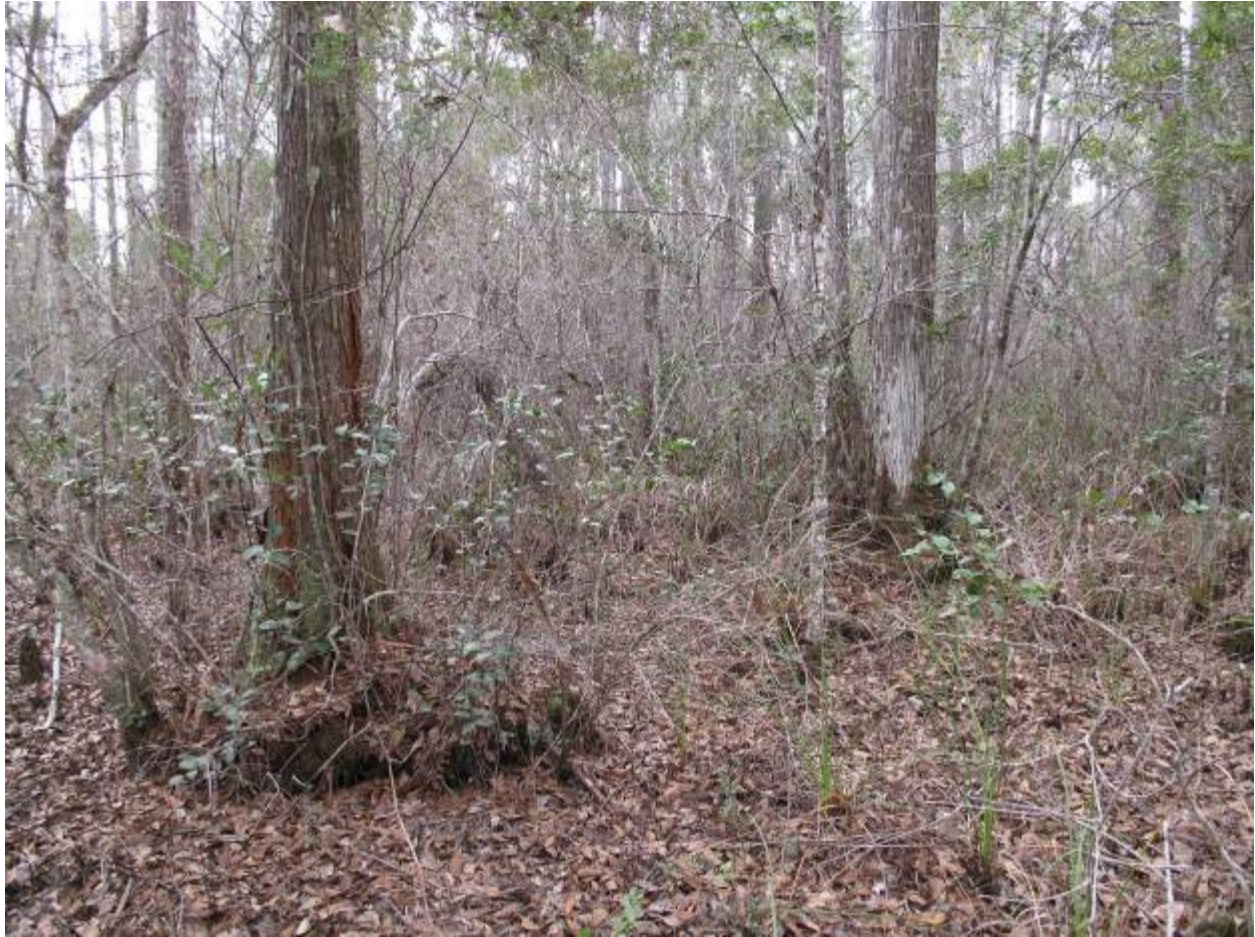
Wetland ID: 12-33

Description: This wetland is a 0.5 ha ephemeral forested swamp. Cypress and gum trees dominate the canopy, and cover >75% of the wetland. The midstory is dominated by wax myrtle, titi, and holly, and covers 25-50% of the wetland. Sawgrass grows in scattered patches, and covers 5-25% of the basin. There are minor amounts of slash around the wetland edges. The adjacent uplands are mesic flatwoods that were bedded and converted to a pine plantation. Upland restoration is in progress.

Wetland Concerns: Woody encroachment

Restoration Action Recommended: Periodic fire in the wetland will prevent shrub encroachment.

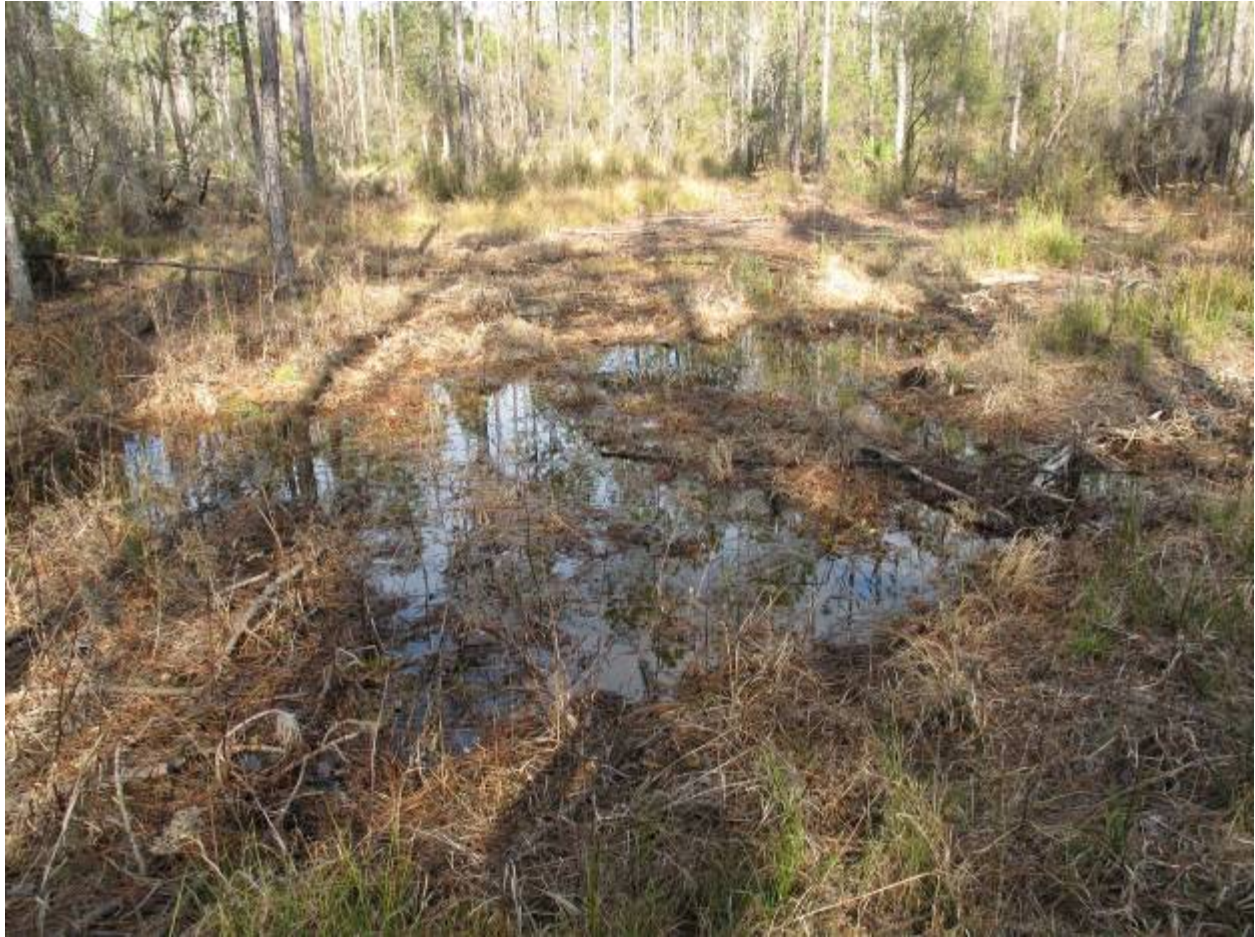
Wetland ID: 12-34

Description: This wetland is a <0.1 ha ephemeral marsh. Pine trees dominate the canopy, and cover 5-25% of the wetland. There is no midstory layer. Sedges/grasses grow throughout the wetland, and cover 50-75% of the basin. Pine trees were planted on bedded rows through the wetland. The pine trees were recently removed and a minor amount of slash remains. The adjacent uplands are mesic flatwoods that were bedded and converted to a pine plantation. Upland restoration is in progress.

Wetland Concerns: Bedding

Restoration Action Recommended: No action to remove the bedding is recommended; the bedding rows will erode over time. Use fire in the wetland basin to maintain the marsh and eliminate the slash.
