Inventory, Assessment, and Restoration Potential of Ephemeral Wetlands on FFWCC Wildlife Management Areas

Aucilla WMA Final Report

Submitted by: Rebecca P.M. Means¹, Ryan C. Means¹, Steven A. Johnson²

¹Coastal Plains Institute

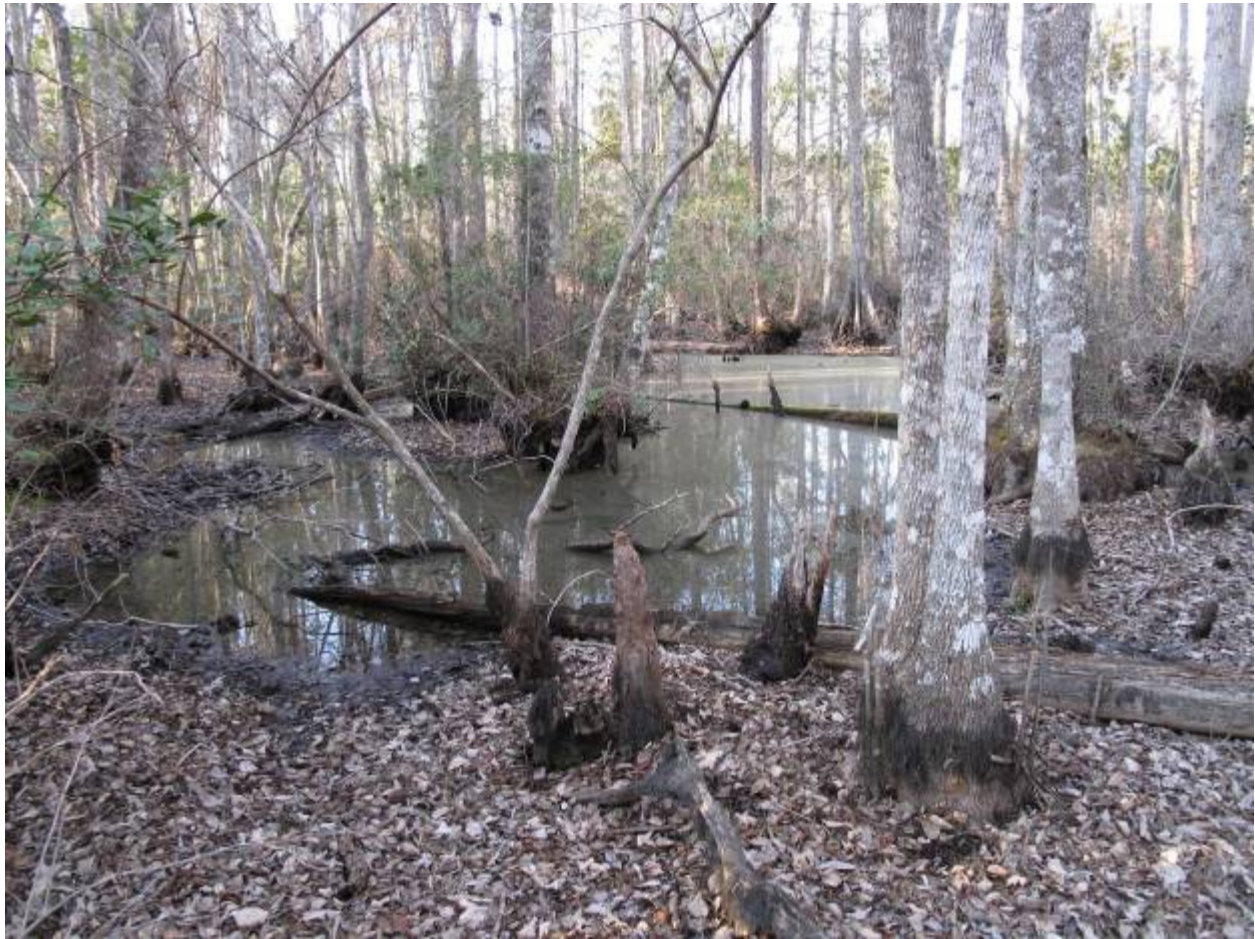
Wetland ID: 12-35

Description: This wetland is a 0.8 ha semi-permanent forested swamp. Cypress and gum trees dominate the canopy, and cover >75% of the wetland. Wax myrtle, fetterbush, and holly, and grow in a ring around the wetland, and cover 25-50% of the basin. There is no herbaceous vegetation. The adjacent uplands are mesic flatwoods that were bedded and converted to a pine plantation. Upland restoration is in progress.

Wetland Concerns: Woody encroachment

Restoration Action Recommended: Periodic fire would reduce the thick ring of shrub around the wetland edge.

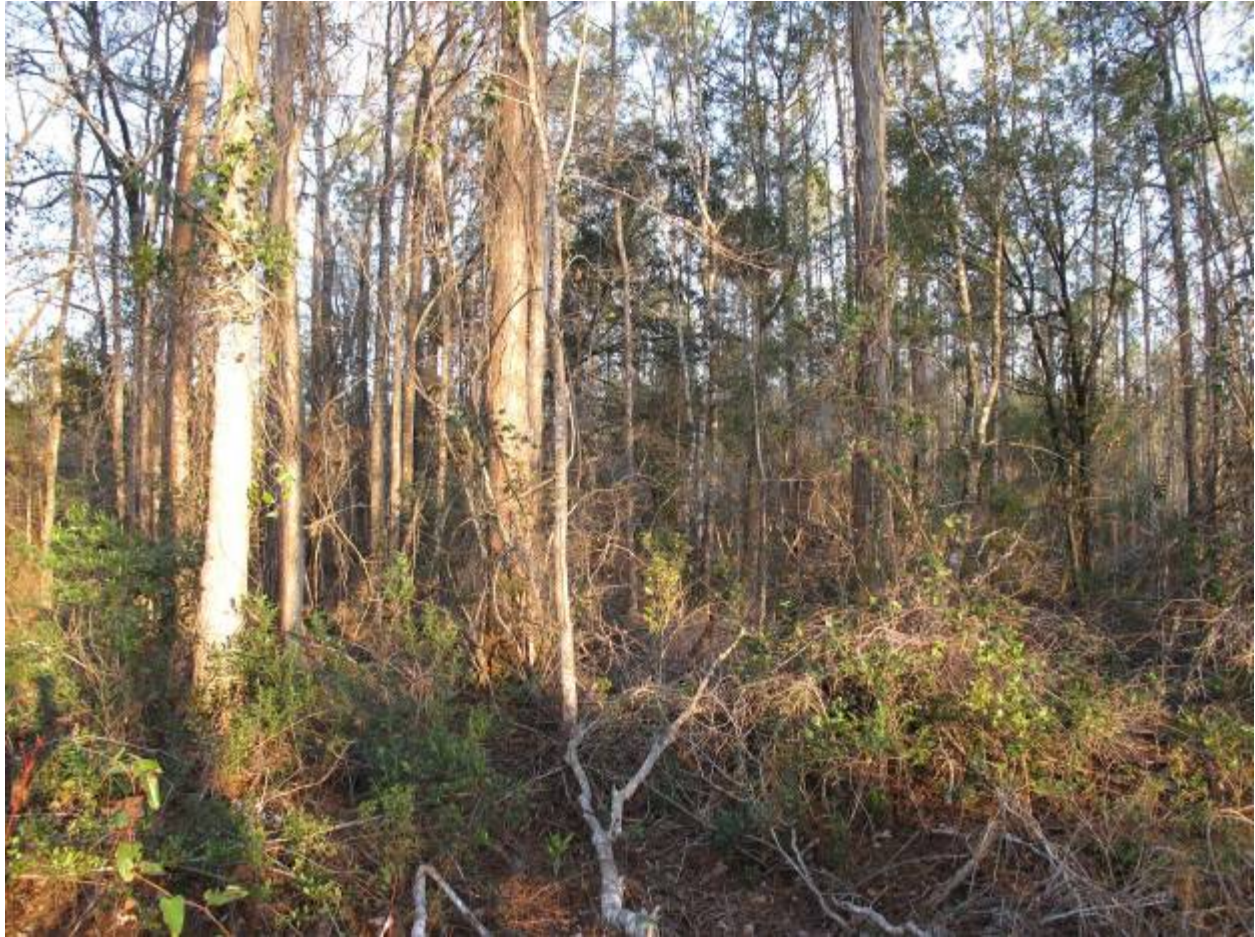
Wetland ID: 12-36

Description: This wetland is a 0.1 ha ephemeral forested swamp. Cypress and gum trees dominate the canopy, and covers >75% of the wetland. The midstory is dominated by wax myrtle, and covers 25-50% of the wetland. There is no herbaceous vegetation. There is some slash in the wetland. A road (Grade 17) with a ditch runs along the north side of the wetland. The adjacent uplands are mesic flatwoods that were bedded and converted to a pine plantation. Upland restoration is in progress.

Wetland Concerns: Bedding, Road, Slash, Woody encroachment

Restoration Action Recommended: No action to remove the bedding is recommended; the bedding rows will erode over time. In order to restore the hydrology of this wetland and the larger wetland system, the road would have to be removed. Recognizing that this road is now a permanent attribute to the property, we do not recommend any action relating to the road or roadside ditches. Provide periodic fire to eliminate the slash and prevent further shrub encroachment.

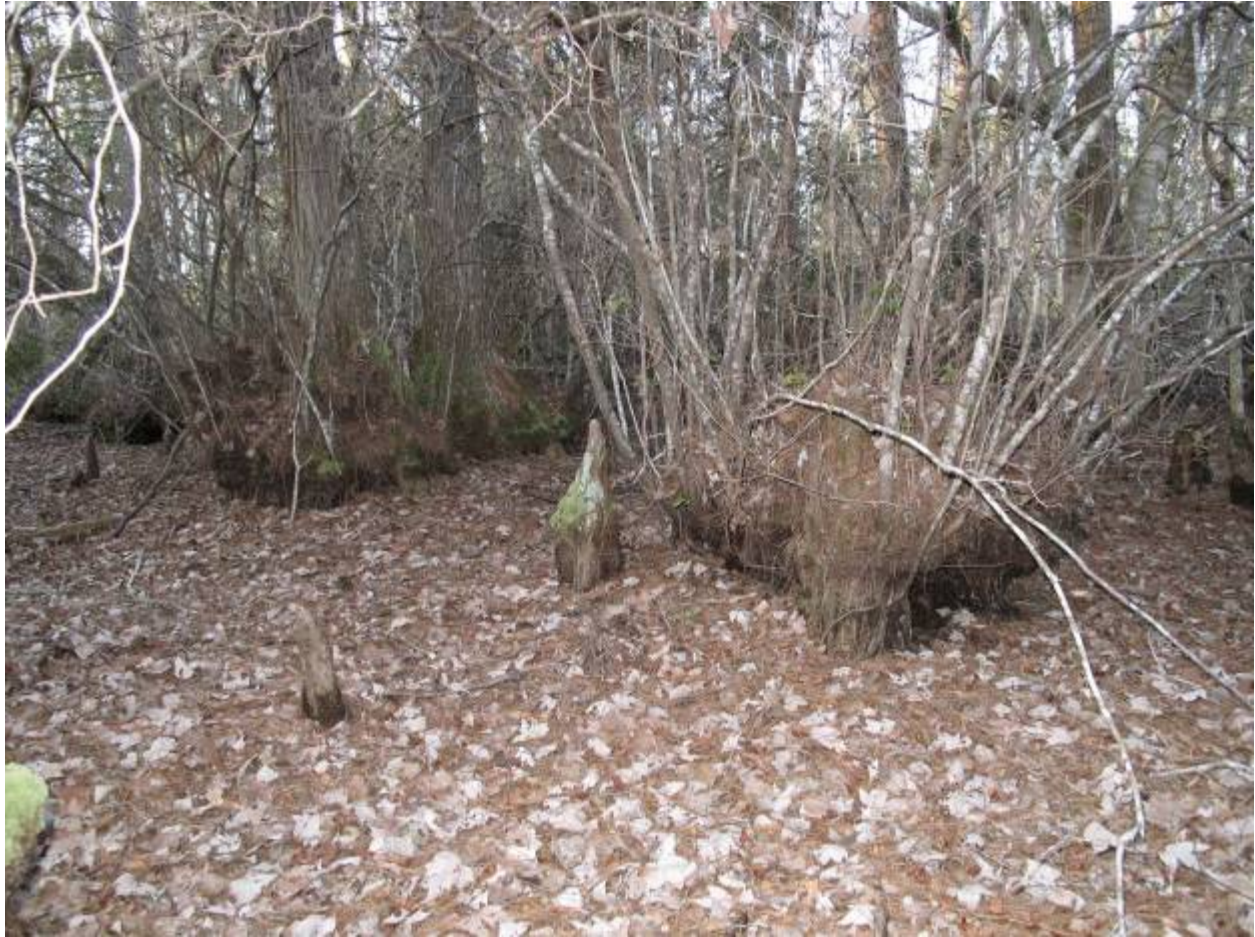
Wetland ID: 12-37

Description: This wetland is a 0.1 ha ephemeral mixed swamp. Cypress trees dominate the canopy, and cover >75% of the wetland. The midstory is a mixture of wax myrtle, fetterbush, titi, and holly, and covers 50-75% of the wetland. There is no herbaceous vegetation and there is a thick duff layer covering the wetland floor. There is a push pile on the south side of the wetland and slash in the wetland. The adjacent uplands are mesic flatwoods that were bedded and converted to a pine plantation. Upland restoration is in progress.

Wetland Concerns: Push pile, Slash, Woody encroachment

Restoration Action Recommended: Provide periodic fire to eliminate the slash and prevent further shrub encroachment. Allow the push pile to erode over time.

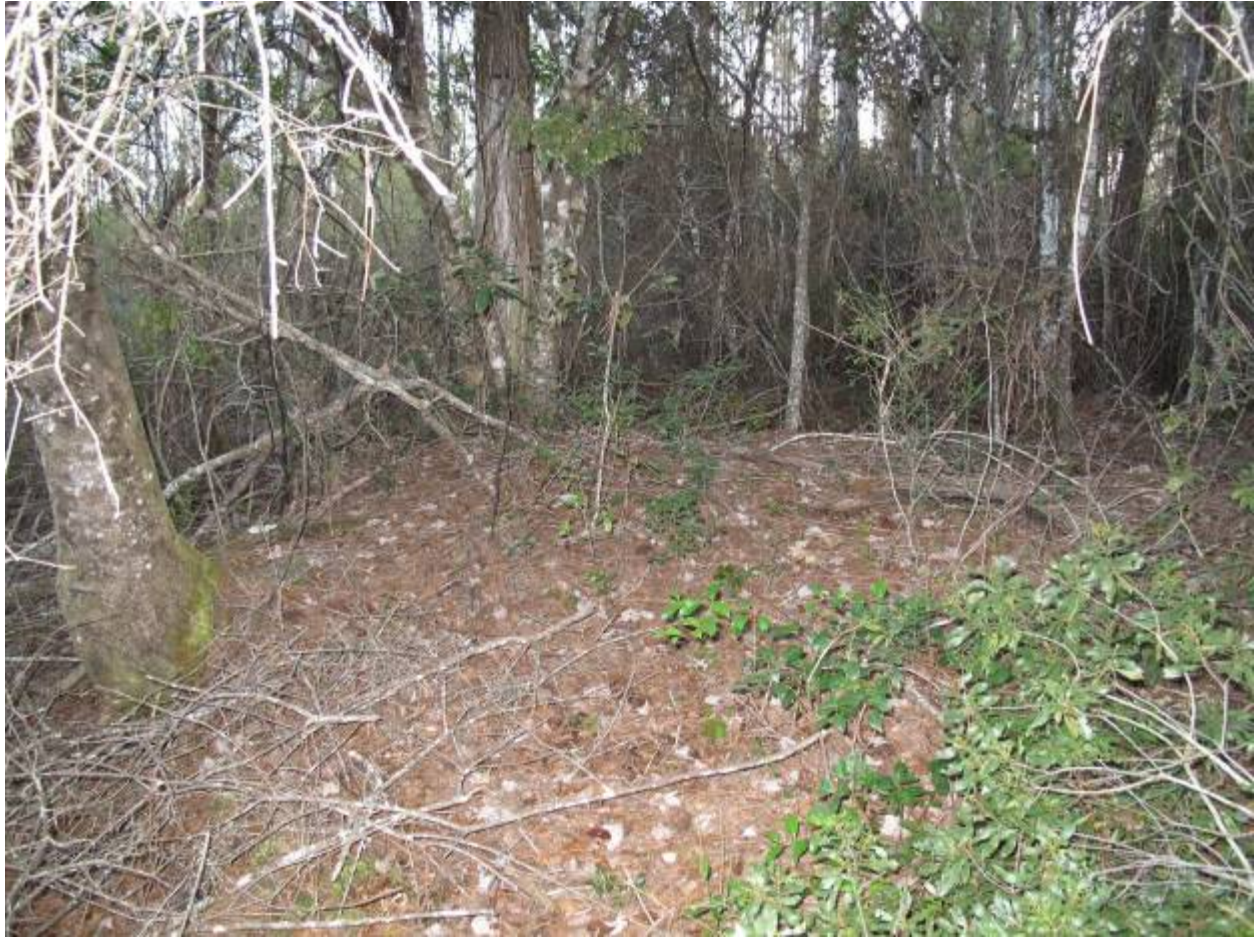
Wetland ID: 12-38

Description: This wetland is a 0.1 ha ephemeral mixed swamp. Cypress and pine trees dominate the canopy, and cover >75% of the wetland. The midstory is dominated by titi and fetterbush, and covers 50-75% of the wetland. There is no herbaceous vegetation, and the wetland floor has a thick layer of needle duff. This small wetland was severely disturbed by bedding (and subsequent planted pines) and push piles. The adjacent uplands are mesic flatwoods that were bedded and converted to a pine plantation. Upland restoration is in progress.

Wetland Concerns: Bedding, Planted pines, Push piles, Woody encroachment

Restoration Action Recommended: Mechanically remove the push pile and simultaneously uproot the titi established on the push pile. This process should be completed when the wetland is completely dry and progress monitored. While this process is occurring, the bedding rows and planted pines could be removed from the wetland interior as well. Return periodic fire to the wetland to prevent further titi encroachment.

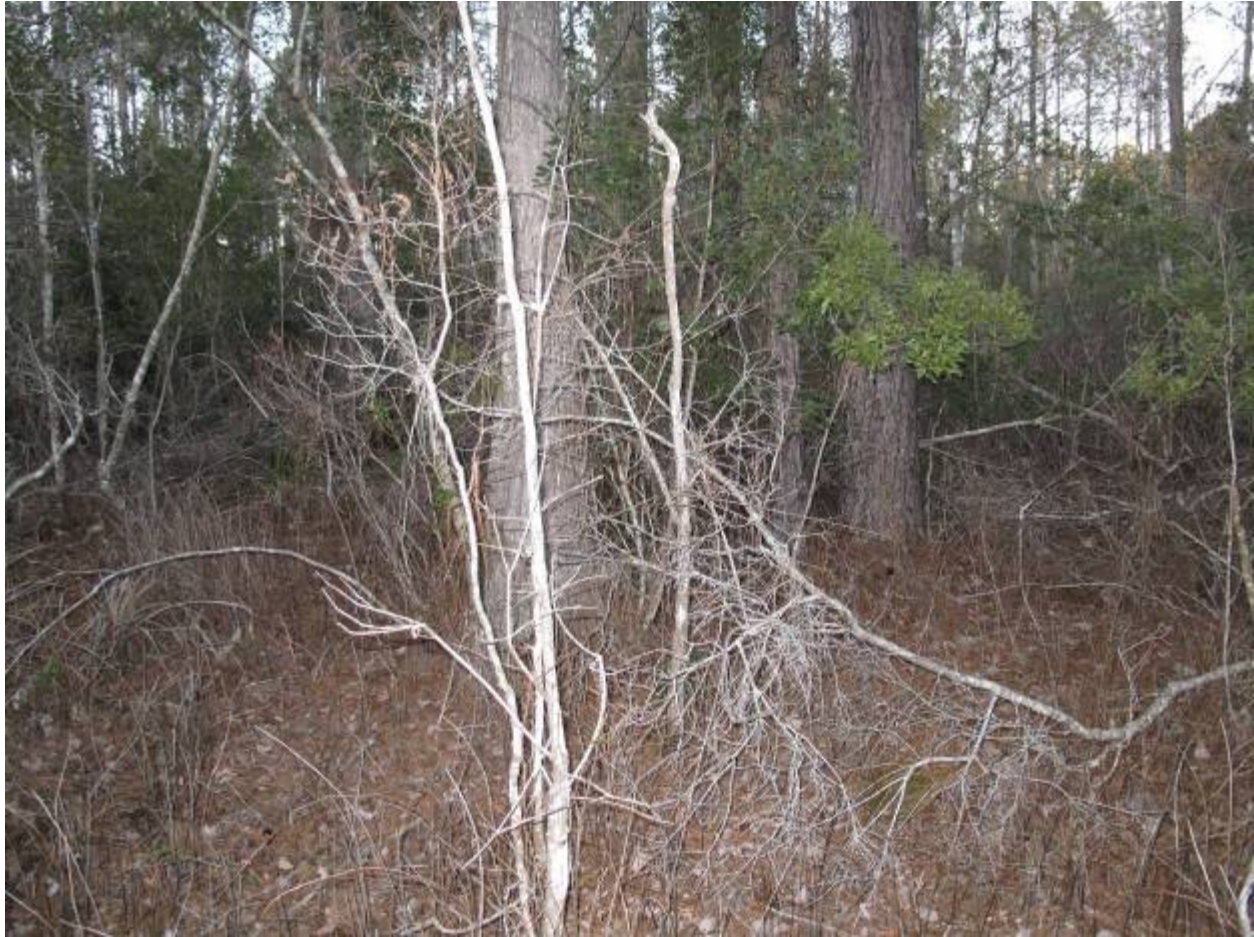
Wetland ID: 12-39

Description: This wetland is a 0.4 ha ephemeral mixed swamp. Cypress and pine trees dominate the canopy, and cover 25-50% of the wetland. The midstory is dominated by wax myrtle and titi, and covers 50-75% of the wetland. Fern grow throughout the wetland, and cover 5-25% of the basin. The presence of old cypress stumps provides evidence of historical logging. An old vehicular gouge runs through the center of the wetland, likely a result of past logging operations. The adjacent uplands are mesic flatwoods that were bedded and converted to a pine plantation. Upland restoration is in progress.

Wetland Concerns: Vehicular damage, Woody encroachment

Restoration Action Recommended: Periodic fire in the wetland would prevent further shrub encroachment. The vehicle damage will erode over time. To avoid future damage, operate machinery only when wetland is completely dry.

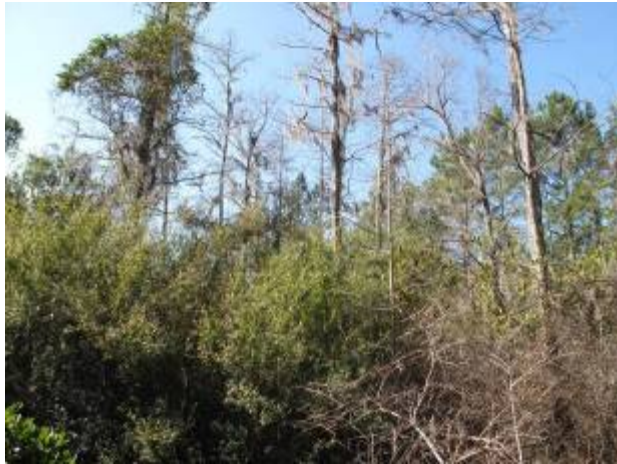
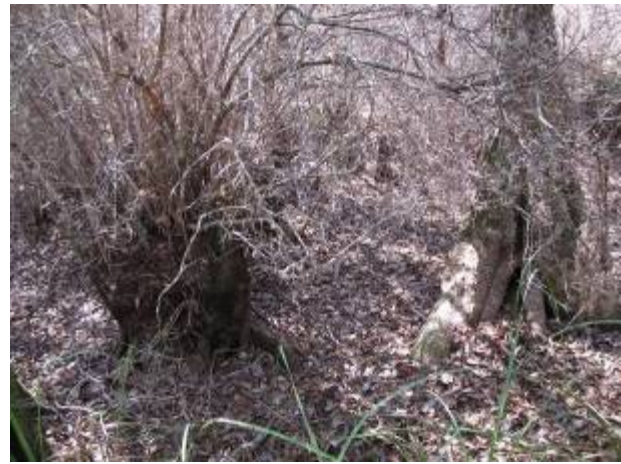
Wetland ID: 12-40

Description: This wetland is a 1.0 ha ephemeral mixed swamp. The presence of old cypress stumps provides evidence of historical logging. The cypress trees have regenerated and cover 50-75% of the wetland. The midstory is dominated by titi, and covers >75% of the wetland. There is no herbaceous vegetation. The area was burned a few days prior to our visit but the fire did not burn through the wetland. The adjacent uplands are mesic flatwoods that were bedded and converted to a pine plantation. Upland restoration is in progress.

Wetland Concerns: Woody encroachment

Restoration Action Recommended: Encourage fire to burn into the wetland basin to reduce the dense titi.

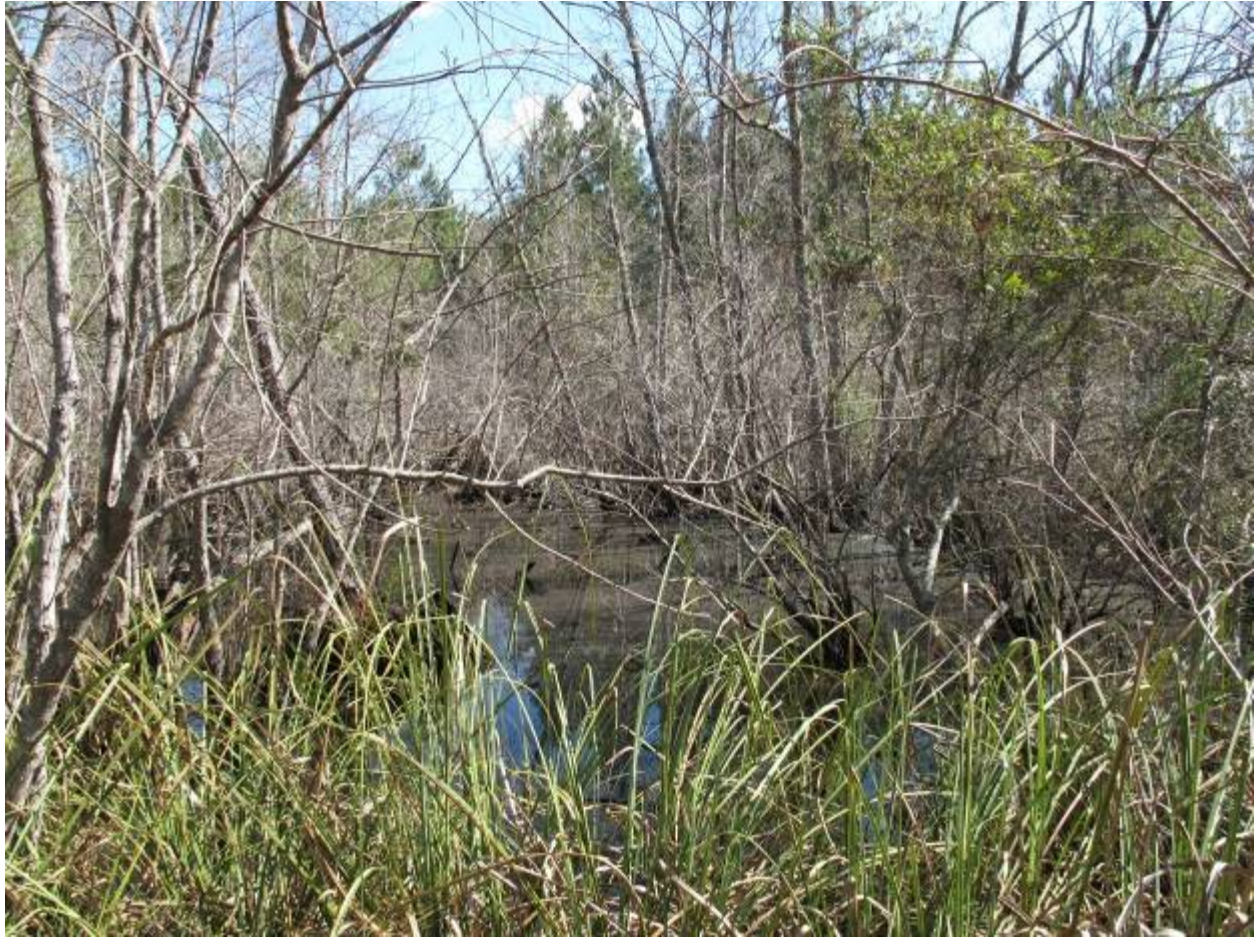
Wetland ID: 12-41

Description: This wetland is a 0.3 ha semi-permanent marsh. Gum trees dominate the canopy, and covers 5-25% of the wetland. The midstory is dominated by willow and buttonbush, and covers 25-50% of the wetland. Sawgrass grows throughout the wetland, and covers >75% of the basin. This thick sawgrass wetland has a deeper, open water center. The area was burned a few days prior to our visit but the fire did not burn through the wetland. The adjacent uplands are mesic flatwoods that were bedded and converted to a pine plantation. Upland restoration is in progress.

Wetland Concerns: Woody encroachment

Restoration Action Recommended: Monitor the wetland and ensure it burns the next time the wetland is dry. The wetland may need to be custom-burned in the future. Due to its longer hydroperiod, the fire periodicity of this wetland is significantly longer than that of most area ephemeral wetlands. Woody encroachment is not a problem yet but easily could become one if the wetland does not burn during the next few upland burns.

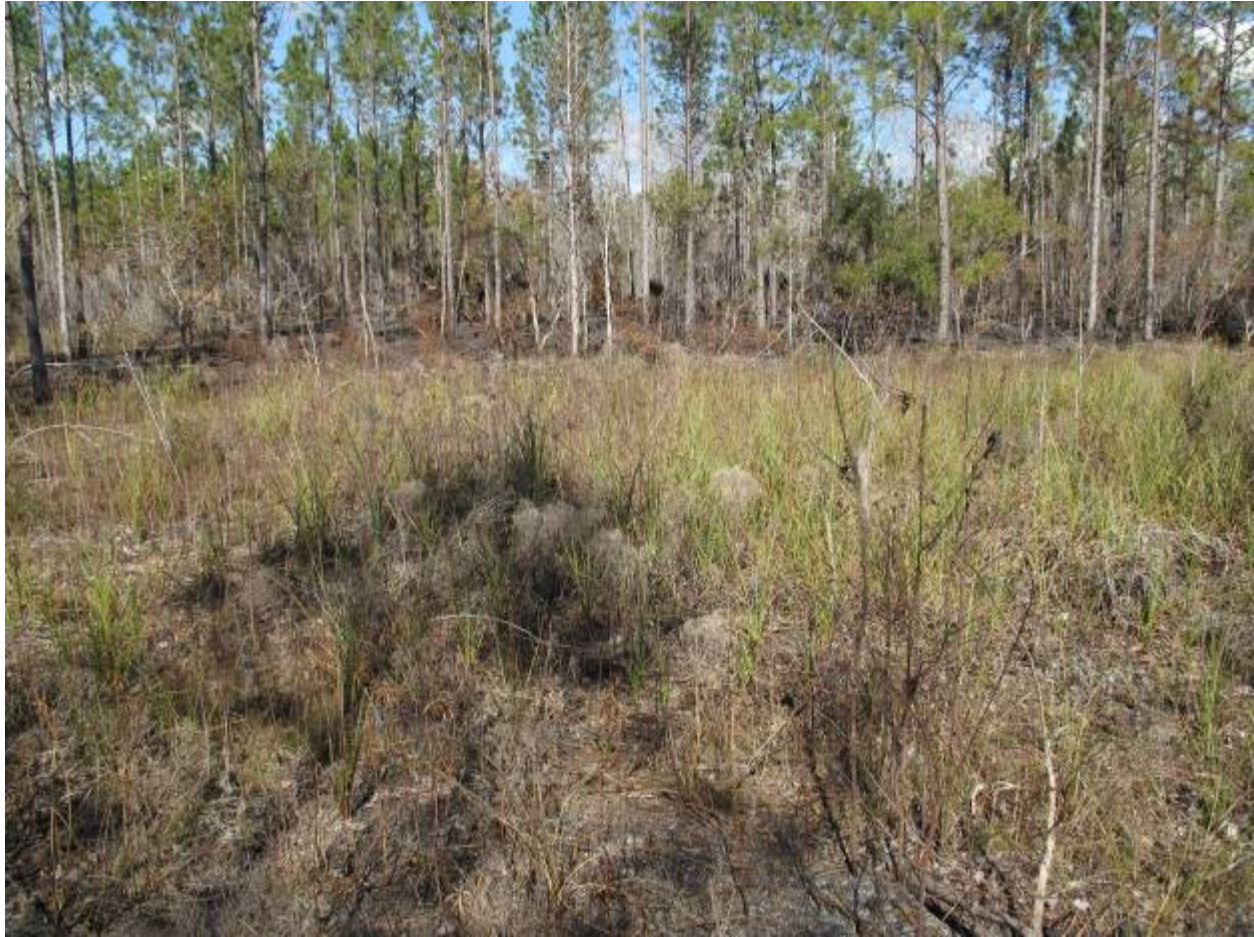
Wetland ID: 12-42

Description: This wetland is a 0.1 ha highly ephemeral marsh. There is no canopy or midstory cover. Sedges/grasses and sawgrass grow throughout the wetland, and cover >75% of the basin. This wetland was bedded at one time but the bedding has since mostly eroded. The area was burned a few days prior to our visit but the fire did not burn through the wetland. The adjacent uplands are mesic flatwoods that were bedded and converted to a pine plantation. Upland restoration is in progress.

Wetland Concerns: None

Restoration Action Recommended: None

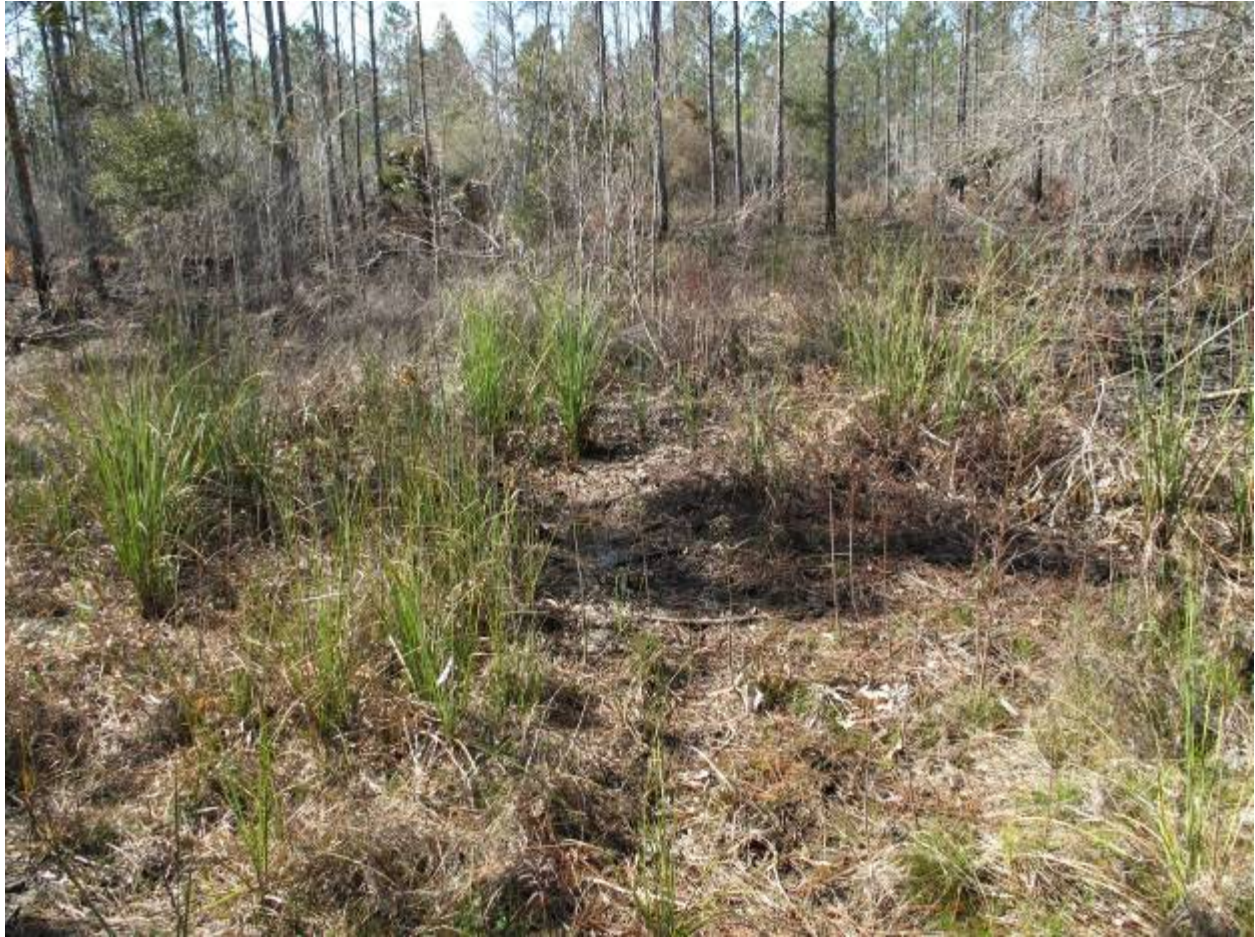
Wetland ID: 12-43

Description: This wetland is a 0.1 ha highly ephemeral marsh. Laurel oak and maple trees grow on a push pile in the wetland, and cover 5-25% of the basin. The midstory is dominated by wax myrtle, and covers 5-25% of the wetland. Sedges/grasses and sawgrass grow throughout the wetland, and cover >75% of the basin. This wetland was altered by bedding and a push pile in the center. The area was burned a few days prior to our visit and the fire burned through half the marsh. The adjacent uplands are mesic flatwoods that were bedded and converted to a pine plantation. Upland restoration is in progress.

Wetland Concerns: Bedding, Push piles

Restoration Action Recommended: Manage this wetland with periodic fire and allow bedding and push pile to erode over time.

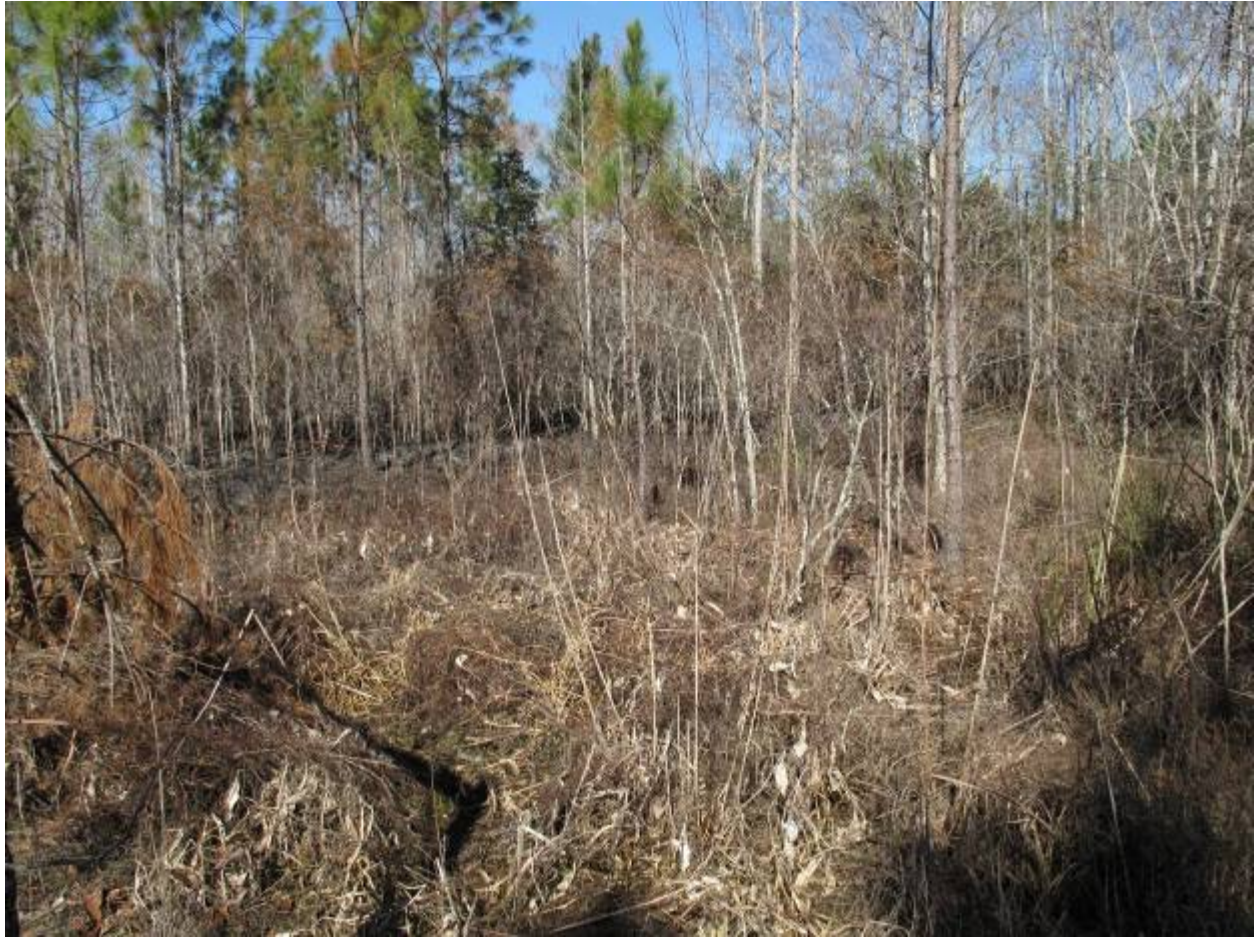
Wetland ID: 12-44

Description: This wetland is a 0.1 ha highly ephemeral marsh. There is no tree canopy. Buttonbush is the dominant woody vegetation, and covers 5-25% of the wetland. Sedges/grasses grow throughout the wetland, and cover >75% of the basin. Old bedding rows run through the wetland. The area was burned a few days prior to our visit and the fire burned into the wetland edges. The adjacent uplands are mesic flatwoods that were bedded and converted to a pine plantation. Upland restoration is in progress.

Wetland Concerns: Bedding

Restoration Action Recommended: Manage this wetland with periodic fire and allow bedding to erode over time.

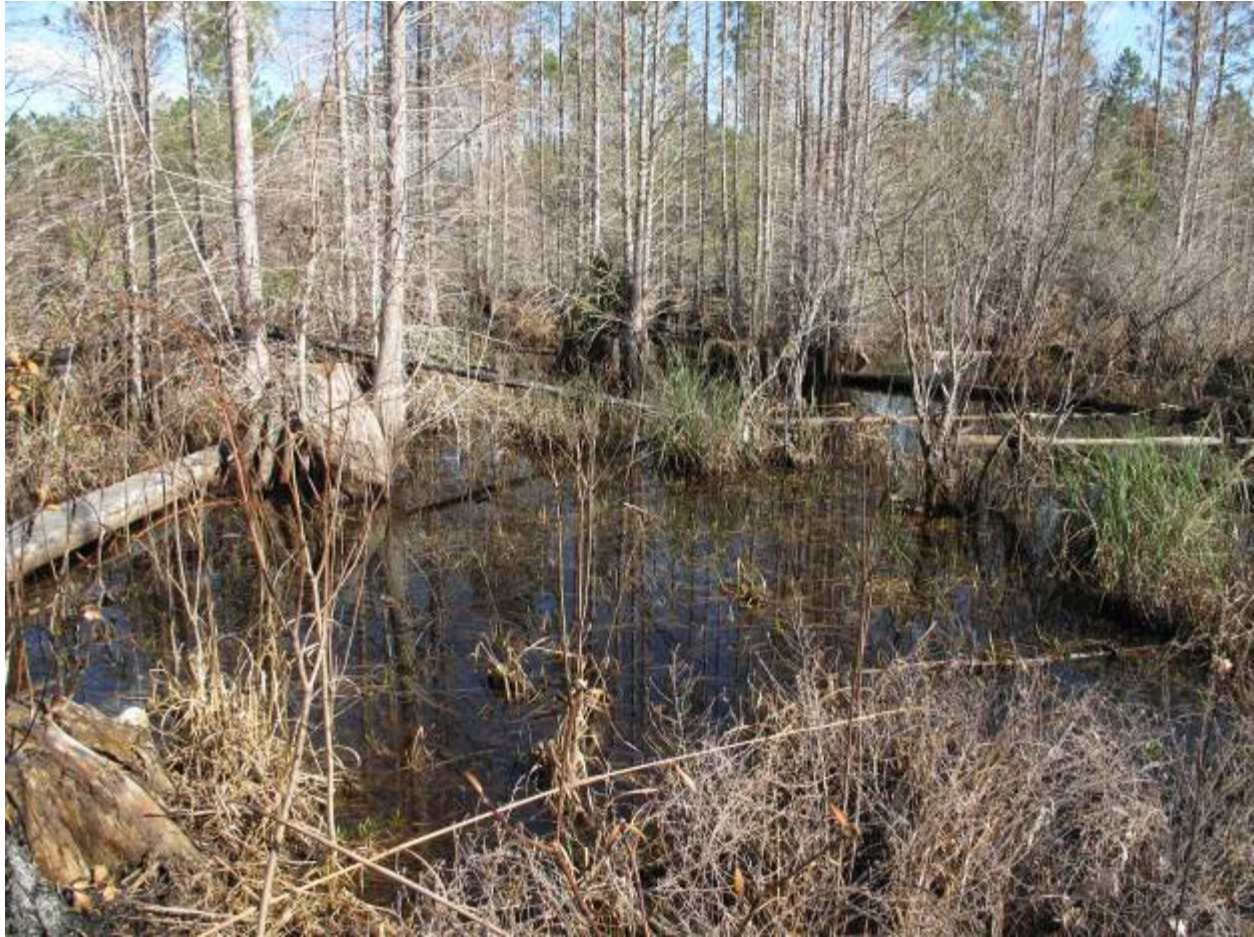
Wetland ID: 12-45

Description: This wetland is a 0.2 ha semi-permanent marsh. Cypress trees dominate the canopy, and cover 5-25% of the wetland. The midstory is dominated by wax myrtle, and covers 5-25% of the wetland. Sawgrass grows throughout the wetland, and covers 50-75% of the basin. This wetland was once a cypress swamp and has many old cypress stumps. The area was burned a few days prior to our visit but the fire did not burn through the wetland, because the wetland was hydrated. The adjacent uplands are mesic flatwoods that were bedded and converted to a pine plantation. Upland restoration is in progress.

Wetland Concerns: None

Restoration Action Recommended: None

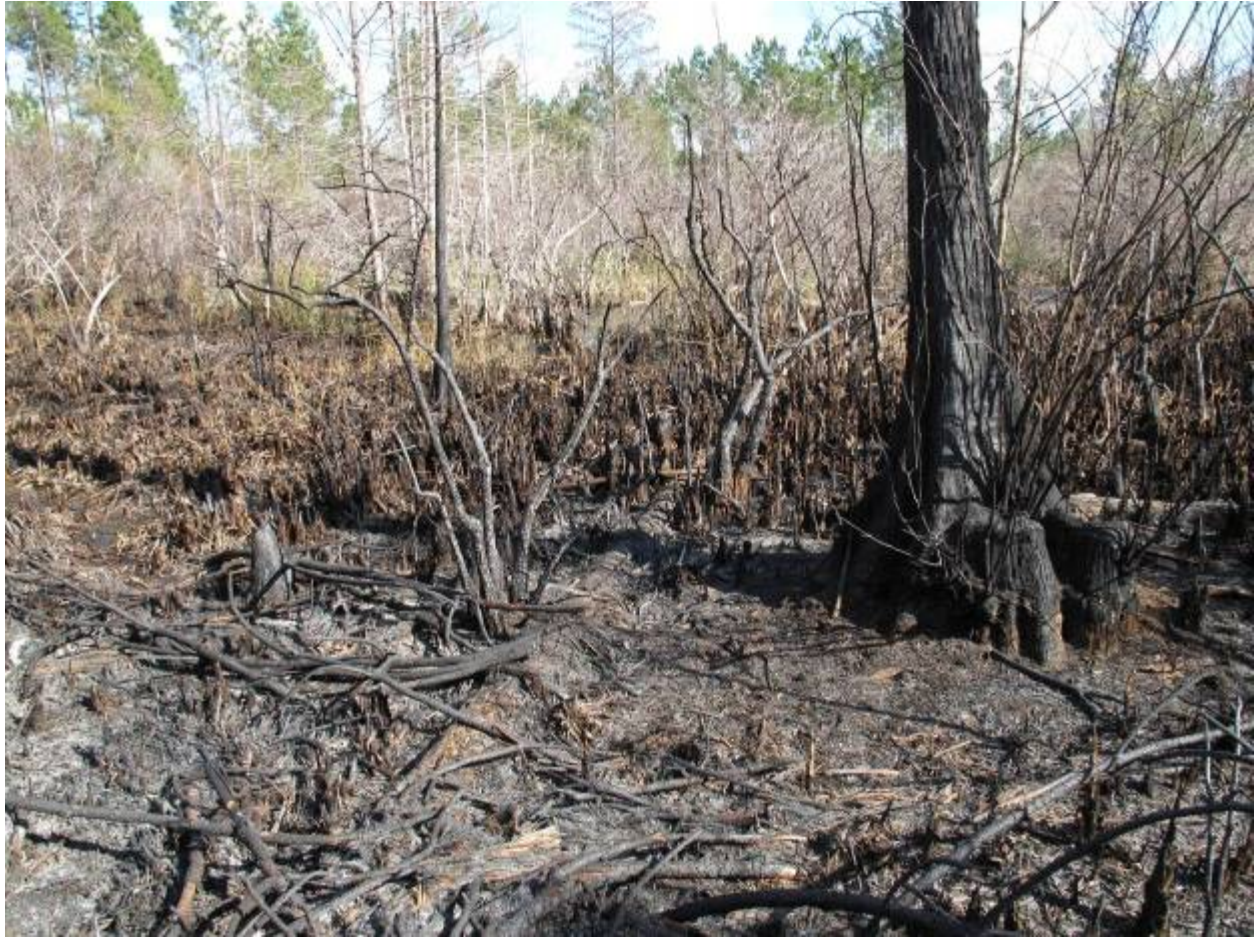
Wetland ID: 12-46

Description: This wetland is a 0.7 ha semi-permanent marsh. There is no tree canopy. Buttonbush is the dominant woody vegetation, and covers 50-75% of the wetland. Sawgrass grows throughout the wetland, and covers >75% of the basin. The presence of old cypress stumps provides evidence of historical logging. The area was burned a few days prior to our visit and the fire burned through most of the wetland. The fire burned at the surface, but did not penetrate underlying damp peat. The adjacent uplands are mesic flatwoods that were bedded and converted to a pine plantation. Upland restoration is in progress.

Wetland Concerns: None

Restoration Action Recommended: None

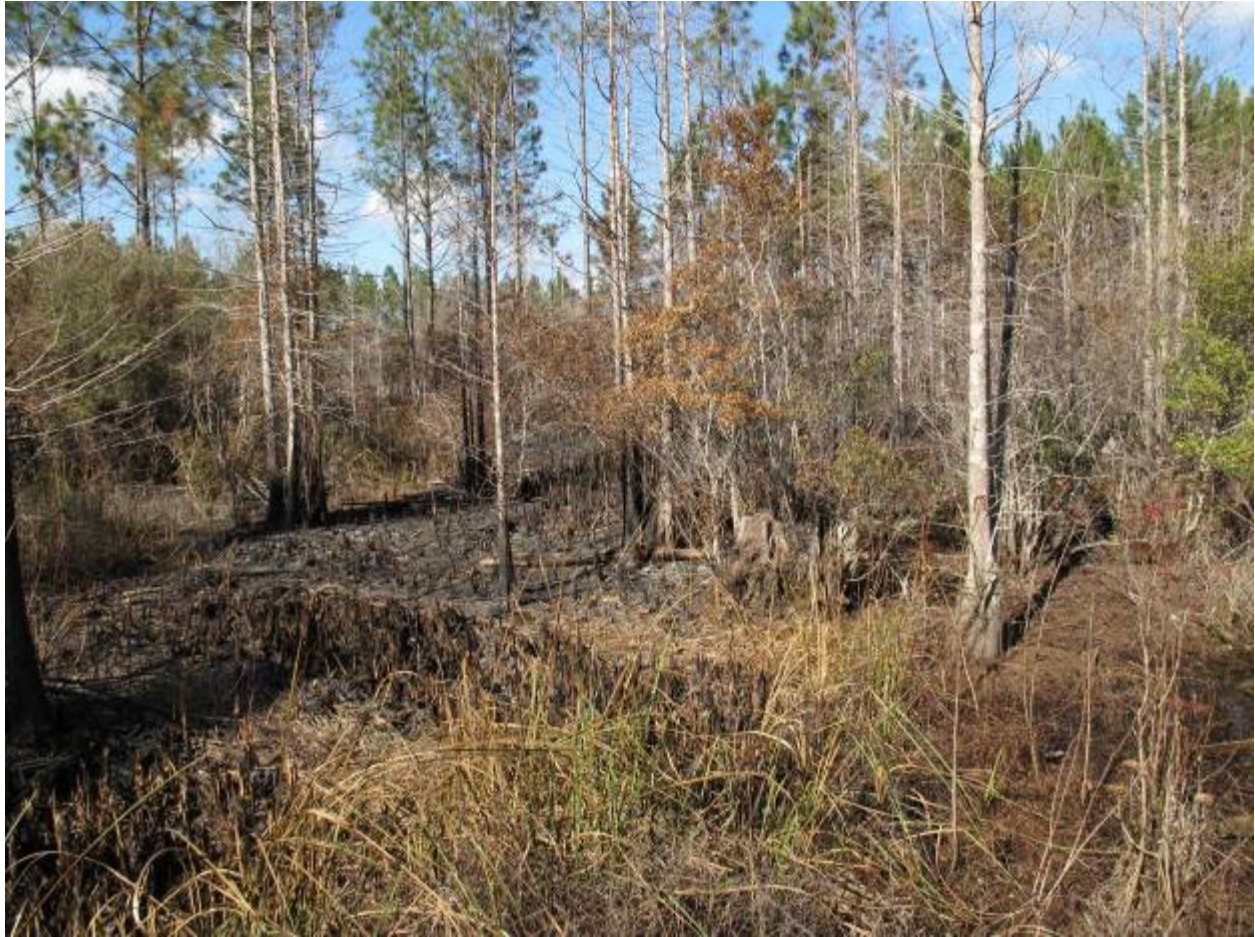
Wetland ID: 12-47

Description: This wetland is a 0.2 ha ephemeral marsh. Cypress trees dominate the canopy, and cover 5-25% of the wetland. The midstory is dominated by wax myrtle, and covers 5-25% of the wetland. Sawgrass grows throughout the wetland, and covers >75% of the basin. Young cypress trees are sprouting from old, logged stumps. The area was burned a few days prior to our visit and the fire partially burned through the wetland. The fire burned at the wetland surface but did not penetrate into the damp peat. The adjacent uplands are mesic flatwoods that were bedded and converted to a pine plantation. Upland restoration is in progress.

Wetland Concerns: None

Restoration Action Recommended: None

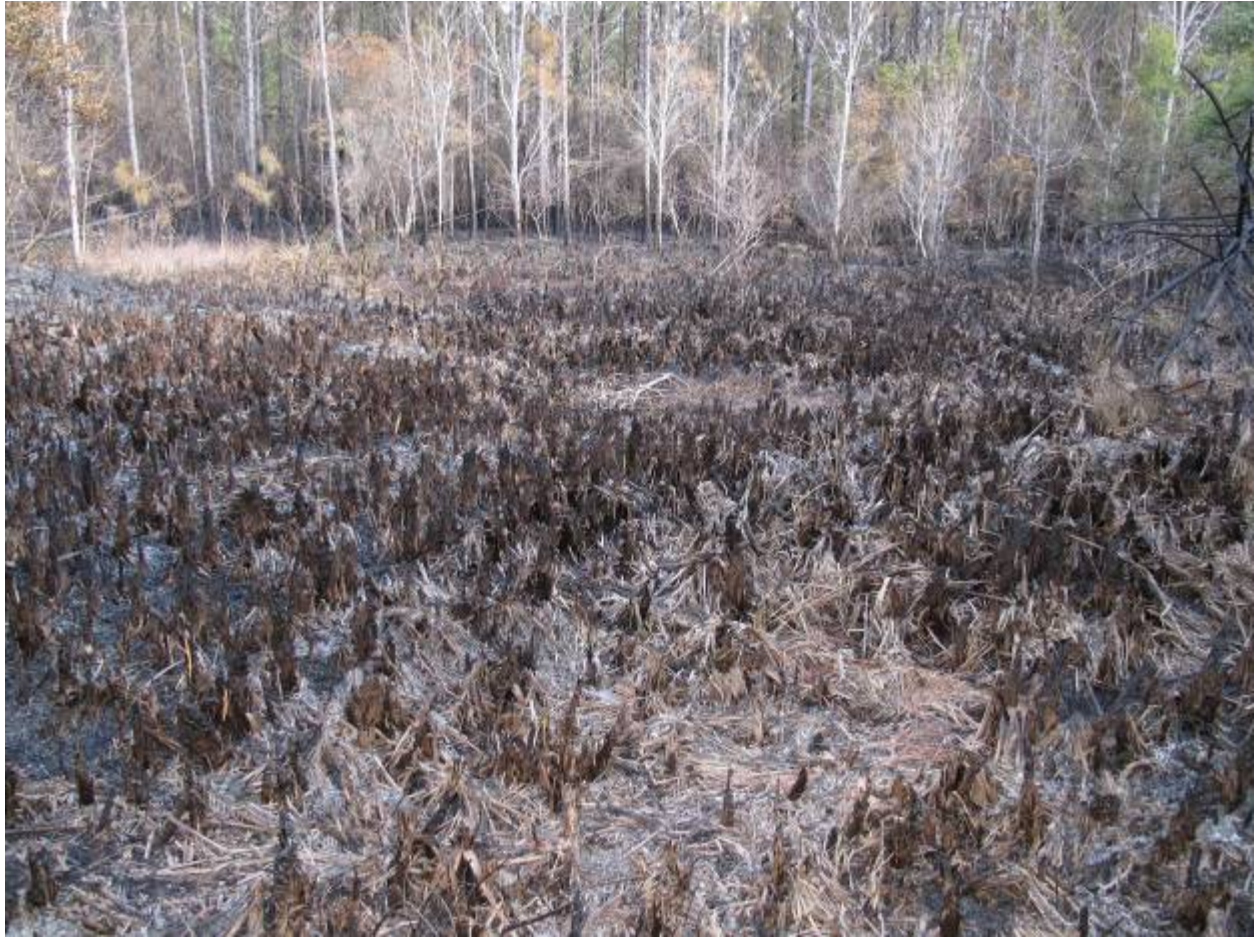
Wetland ID: 12-48

Description: This wetland is a 0.1 ha ephemeral marsh. There is no canopy or midstory cover. Sawgrass grows throughout the wetland, and covers >75% of the basin. Old bedding rows that were constructed through the wetland have partly eroded. The area was burned a few days prior to our visit and the fire burned completely through the wetland. The fire burned at the wetland surface but did not penetrate into the damp peat. The adjacent uplands are mesic flatwoods that were bedded and converted to a pine plantation. Upland restoration is in progress.

Wetland Concerns: None

Restoration Action Recommended: None

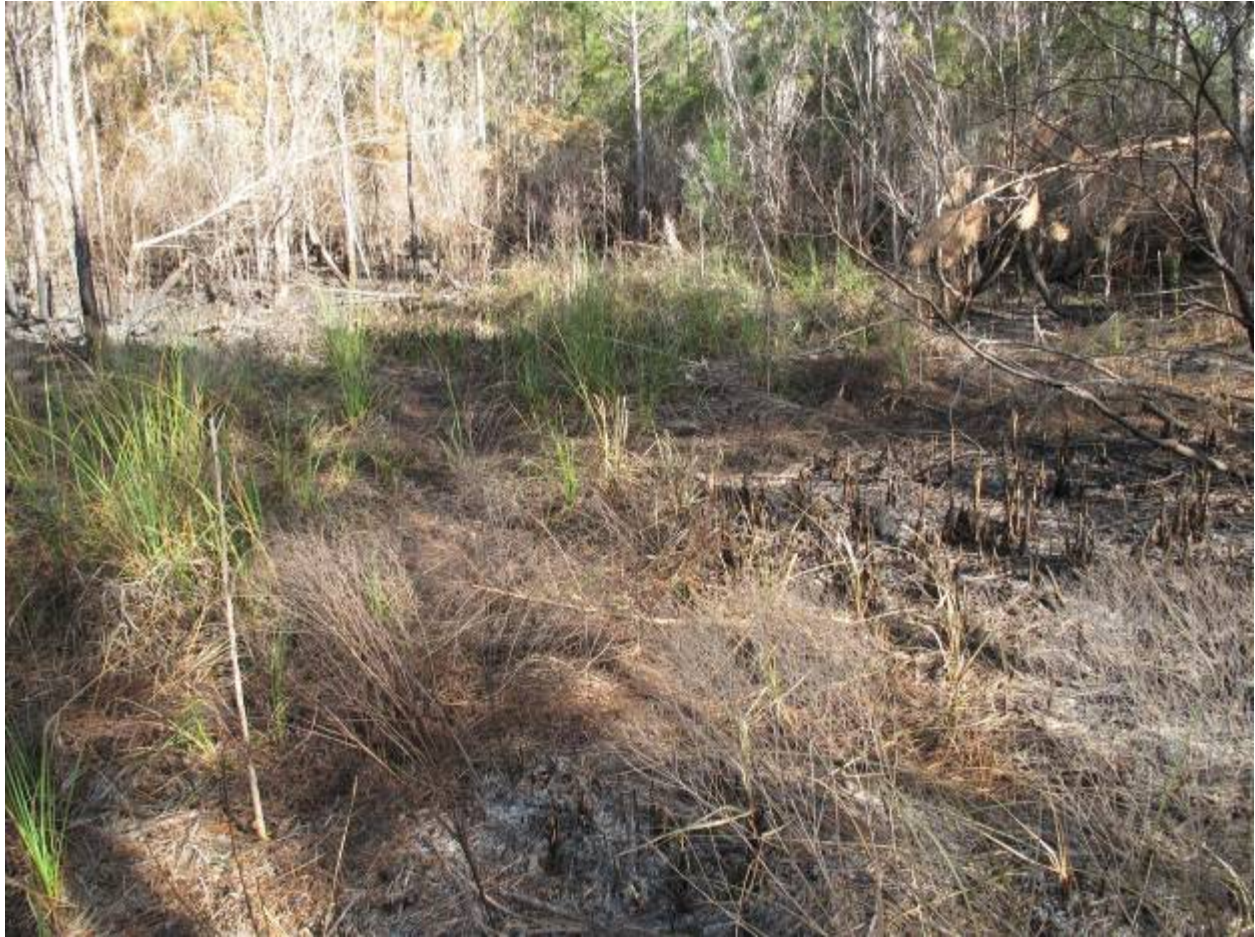
Wetland ID: 12-49

Description: This wetland is a 0.1 ha ephemeral marsh. Pine trees dominate the canopy, and cover 5-25% of the wetland. There is no mid-story cover. Sawgrass grows throughout the wetland, and covers >75% of the basin. Pine trees were planted on bedded rows through the wetland. The area was burned a few days prior to our visit and the fire partially burned through the wetland. The fire burned at the wetland surface but did not penetrate into the damp peat. The adjacent uplands are mesic flatwoods that were bedded and converted to a pine plantation. Upland restoration is in progress.

Wetland Concerns: Bedding, Planted pines

Restoration Action Recommended: No action to remove the bedding is recommended; the bedding rows will erode over time. Remove the planted pine trees from the wetland interior.

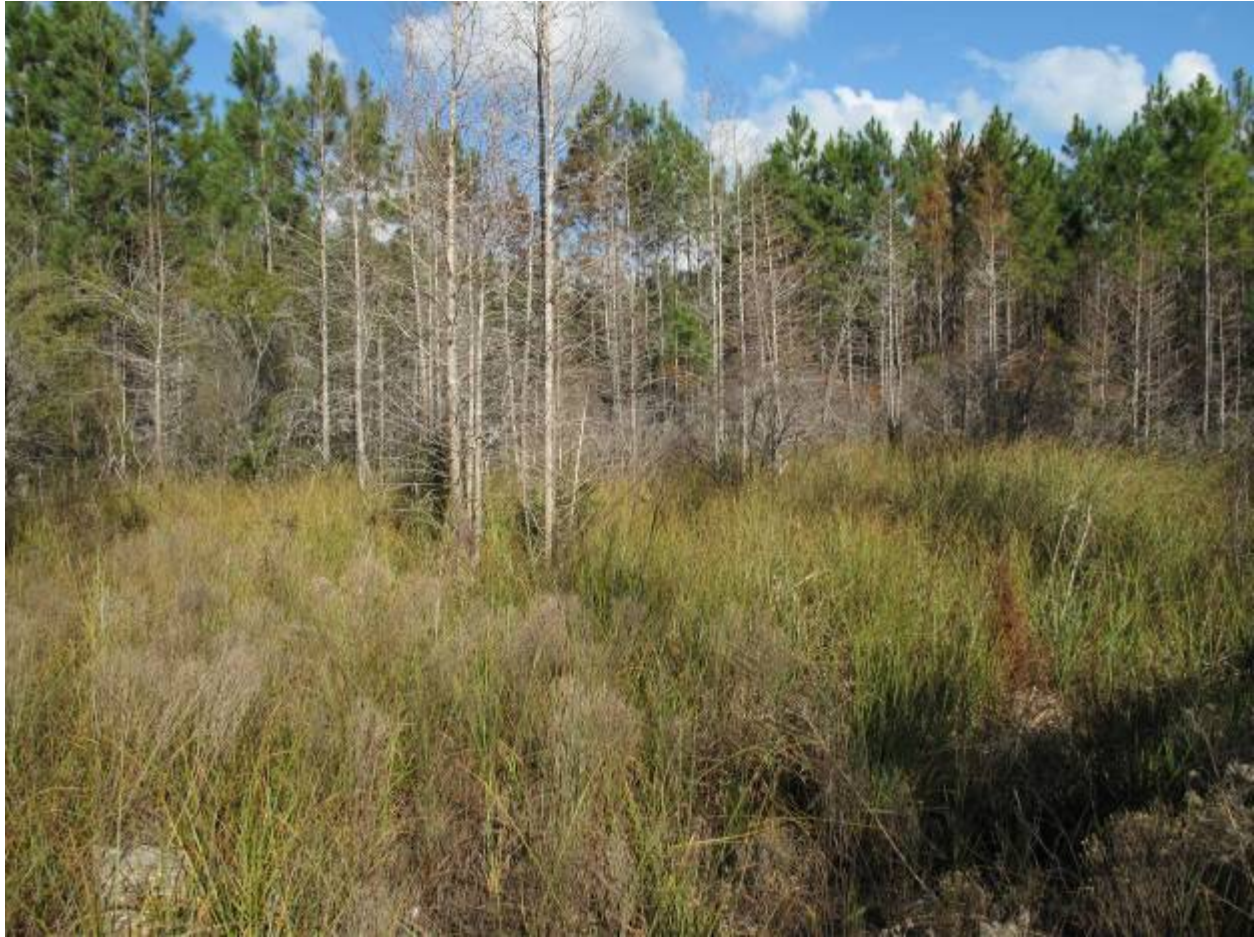
Wetland ID: 12-50

Description: This wetland is a 0.2 ha ephemeral marsh. There is no significant tree canopy. Wax myrtle is the dominant woody vegetation, and covers 5-25% of the wetland. Sawgrass grows throughout the wetland, and covers >75% of the basin. The area was burned a few days prior to our visit and the fire burned around the wetland edges. The adjacent uplands are mesic flatwoods that were bedded and converted to a pine plantation. Upland restoration is in progress.

Wetland Concerns: None

Restoration Action Recommended: None
