Inventory, Assessment, and Restoration Potential of Ephemeral Wetlands on FFWCC Wildlife Management Areas

Aucilla WMA Final Report

Submitted by: Rebecca P.M. Means¹, Ryan C. Means¹, Steven A. Johnson²

¹Coastal Plains Institute

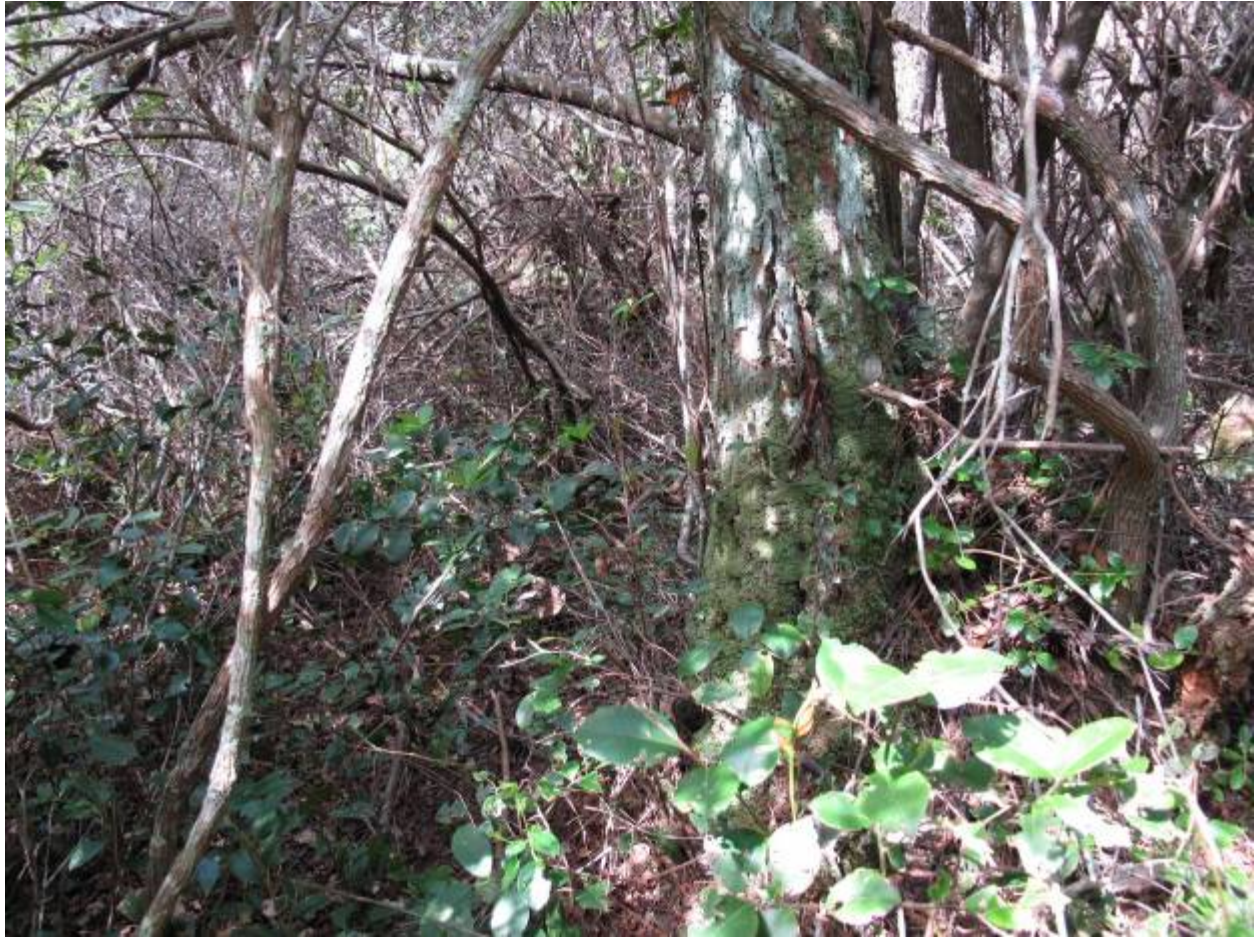
Wetland ID: 13-01

Description: This wetland is a 0.4 ha ephemeral shrub swamp. Cypress trees dominate the canopy, and cover 5-25% of the wetland. The midstory is dominated by titi and fetterbush, and covers >75% of the wetland. There is no herbaceous vegetation, and the wetland floor is covered with a layer of thick duff. Hummocks have formed around old, logged cypress stumps. The north side of the wetland is connected to a ditch along Sawdust Pile Road. This wetland likely was part of a larger wetland system but was bisected during road construction. The adjacent uplands are mesic flatwoods that were bedded and converted to a pine plantation. Upland restoration is in progress.

Wetland Concerns: Road, Roadside ditch, Woody encroachment

Restoration Action Recommended: In order to restore the hydrology of this wetland and the larger wetland system, the road would have to be removed. Recognizing that this road is now a permanent attribute to the property, we do not recommend any action relating to the road or roadside ditches. Periodic fire in the wetland would reduce the dense titi and thick duff.

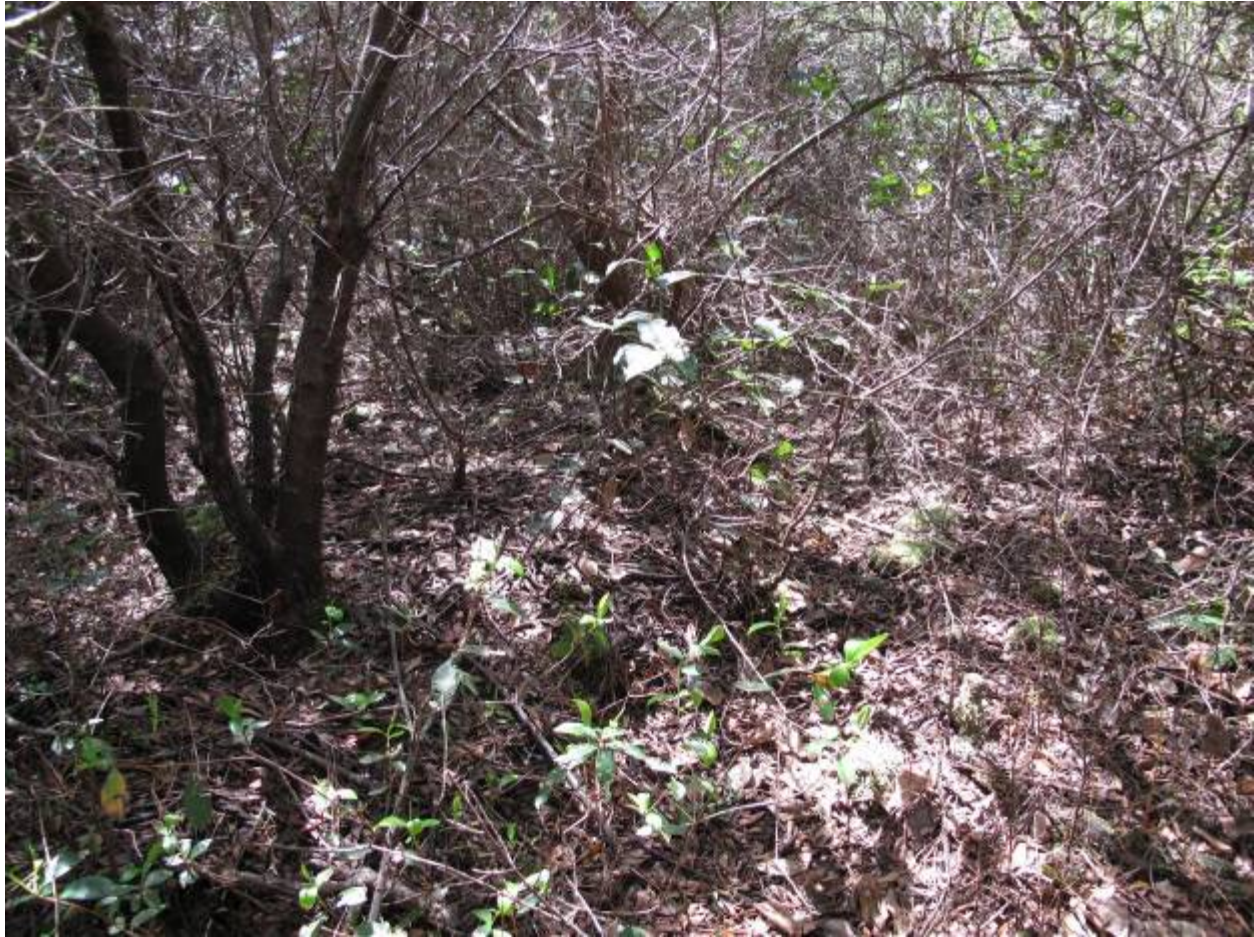
Wetland ID: 13-02

Description: This wetland is a 0.1 ha highly ephemeral shrub swamp. Pine trees were planted on bedded rows through the wetland. The bedding is eroded and only a few pine trees remain, providing <5% cover. Titi is the dominant woody vegetation, and covers >75% of the wetland. There is no herbaceous vegetation and a thick duff layer covers the wetland floor. Feral hog damage is minor. The adjacent uplands are mesic flatwoods that were bedded and converted to a pine plantation. Upland restoration is in progress.

Wetland Concerns: Bedding, Feral hog damage, Planted pine trees, Woody encroachment,

Restoration Action Recommended: The bedding rows will erode over time. The remaining planted pine trees could be removed from the wetland interior. Periodic fire would reduce the dense titi and thick duff layer. .

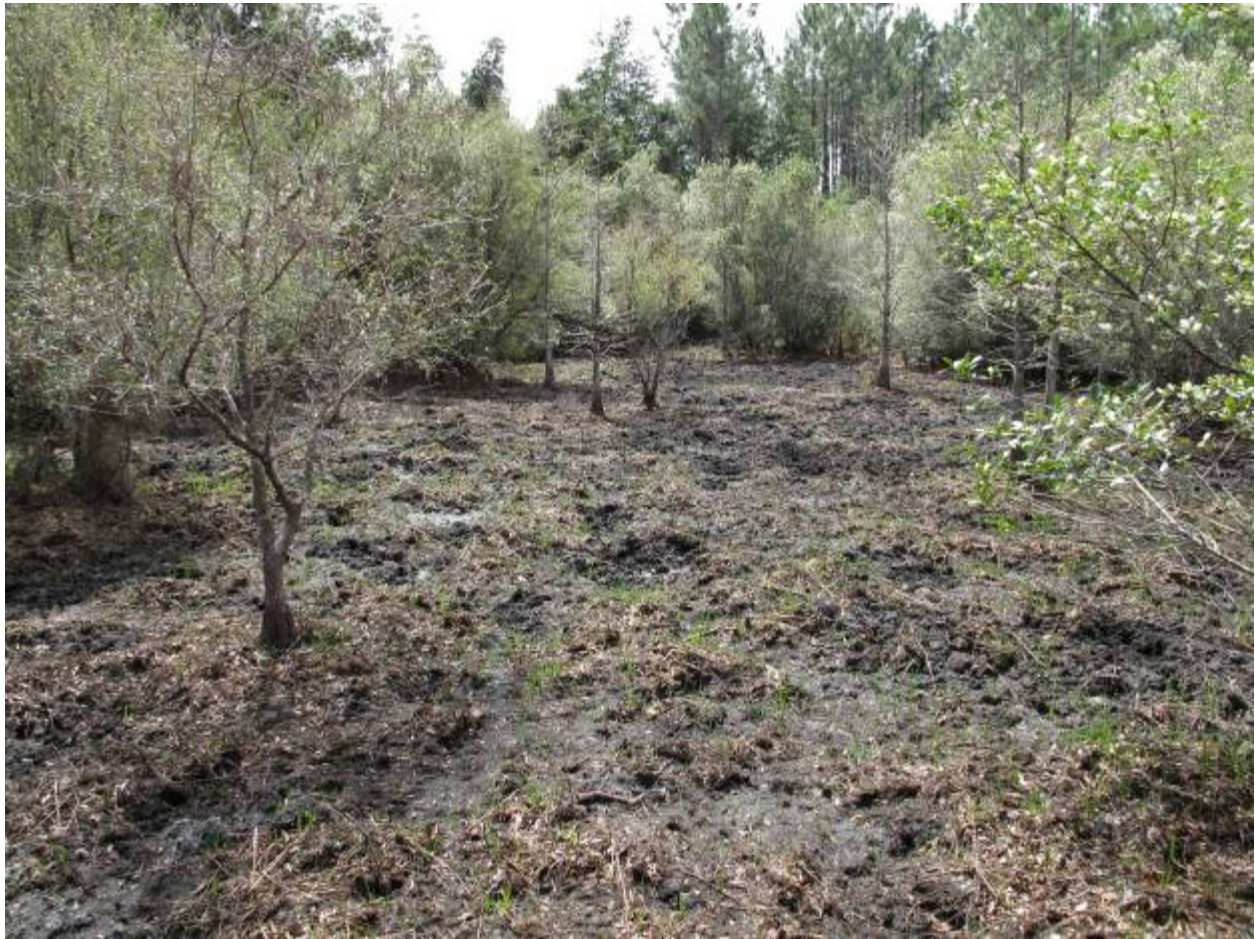
Wetland ID: 13-03

Description: This wetland is a 0.2 ha ephemeral shrub swamp. There is no tree canopy. Titi grows in a ring around the wetland, and covers 25-50% of the wetland. Sedges/grasses and red root grow in scattered patches, and covers 5-25% of the basin. The wetland has an open center as a result of recent feral hog rooting. The adjacent uplands are mesic flatwoods that were bedded and converted to a pine plantation. Upland restoration is in progress.

Wetland Concerns: Feral hog damage, Woody encroachment

Restoration Action Recommended: Provide periodic fire to the wetland to prevent encroachment of titi brush ring.

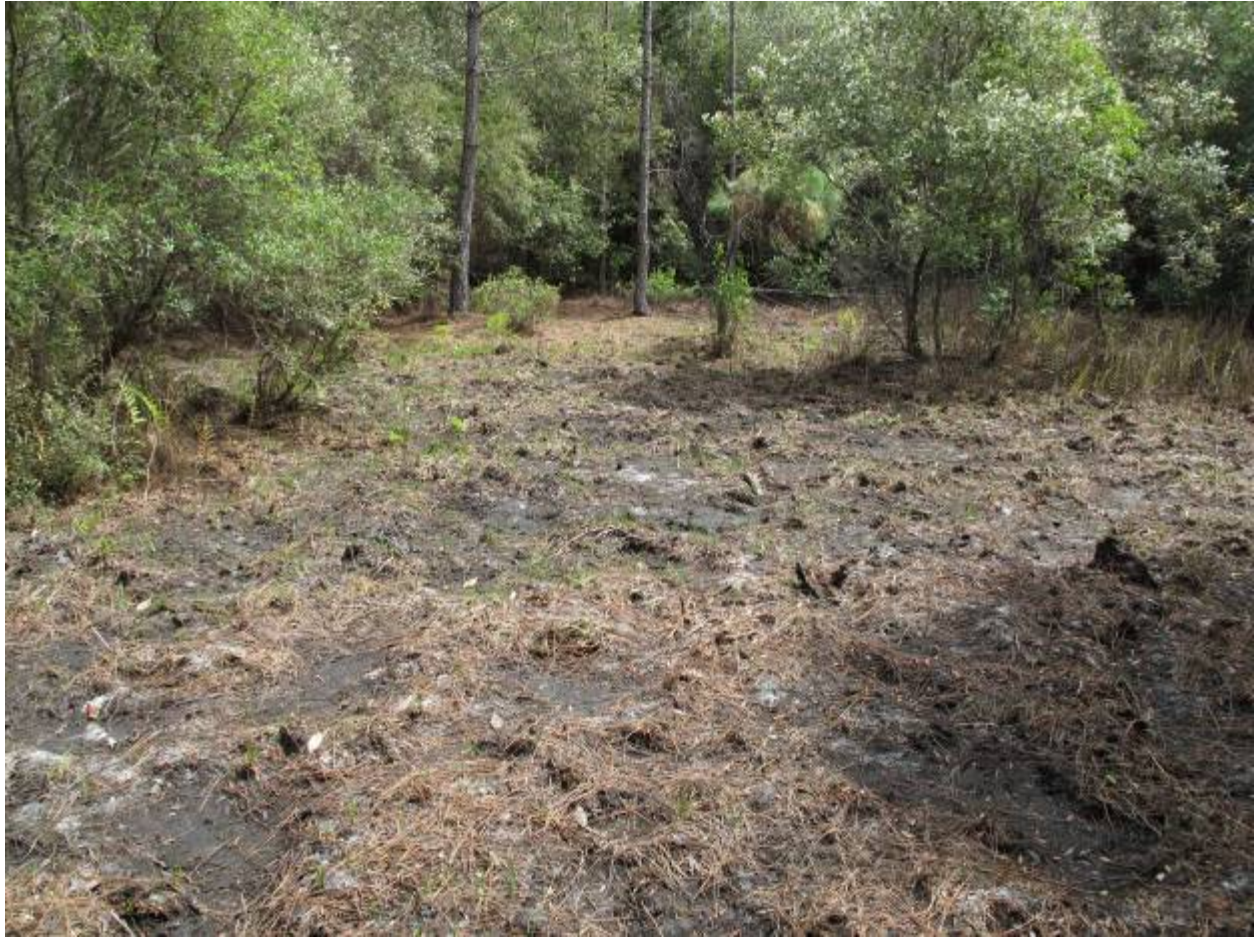
Wetland ID: 13-04

Description: This wetland is a 0.1 ha ephemeral marsh. There is no tree canopy. Titi grows in a dense ring around the wetland, and covers 5-25% of the basin. Sedges/grasses and fern grow in scattered patches, and covers 5-25% of the basin. Feral hog damage is extensive. The adjacent uplands are mesic flatwoods that were bedded and converted to a pine plantation. Upland restoration is in progress.

Wetland Concerns: Feral hog damage

Restoration Action Recommended: Periodic fire in the wetland basin would prevent further titi ring encroachment.

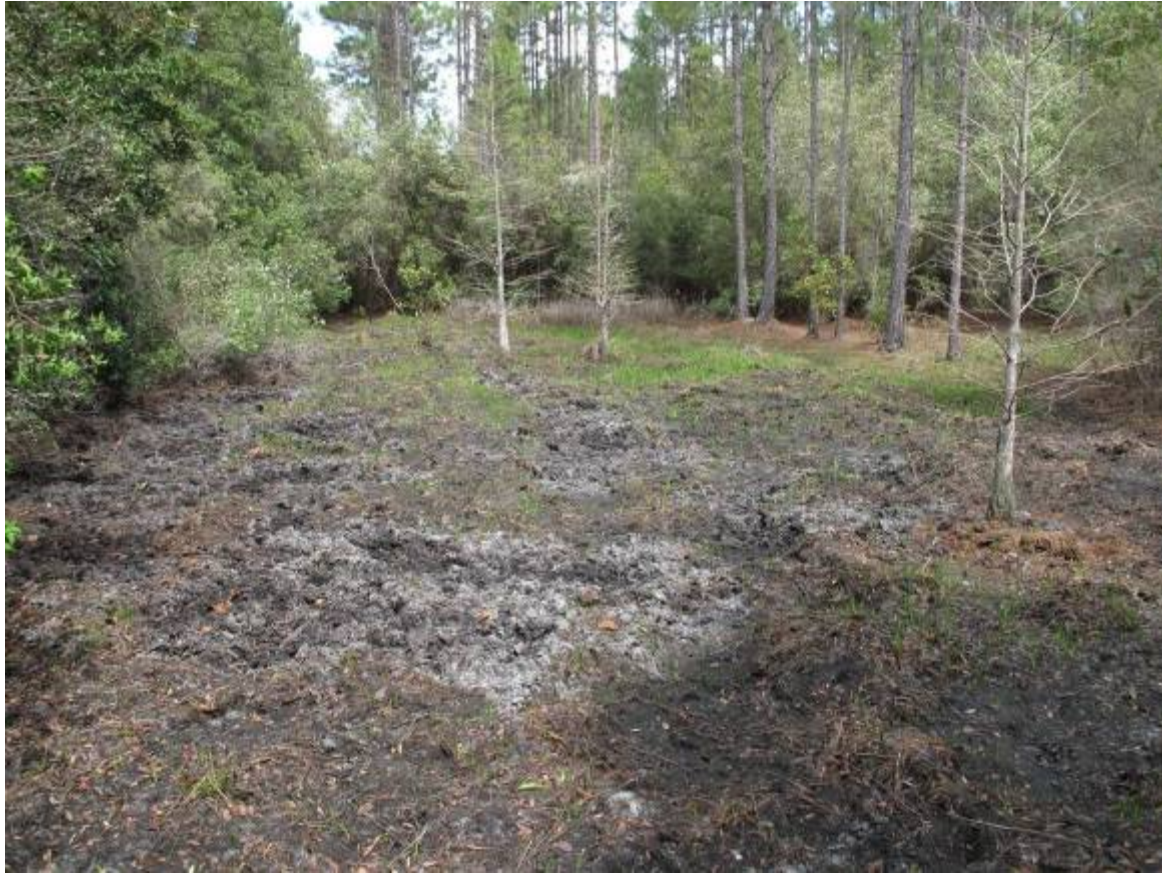
Wetland ID: 13-05

Description: This wetland is a 0.1 ha ephemeral marsh. There is no significant tree canopy. Titi grows in a dense ring around the wetland, and covers 5-25% of the basin. Sedges/grasses and red root grow in scattered patches, and cover 5-25% of the basin. The wetland has an open center, a result of feral hog rooting. Pine trees were planted on bedded rows in the north end of the wetland. The adjacent uplands are mesic flatwoods that were bedded and converted to a pine plantation. Upland restoration is in progress.

Wetland Concerns: Bedding, Feral hog damage, Planted pines

Restoration Action Recommended: No action to remove the bedding is recommended; the bedding rows will erode over time. Remove the planted pine trees from the wetland interior. Periodic fire in the wetland would prevent the brush ring from encroaching further.

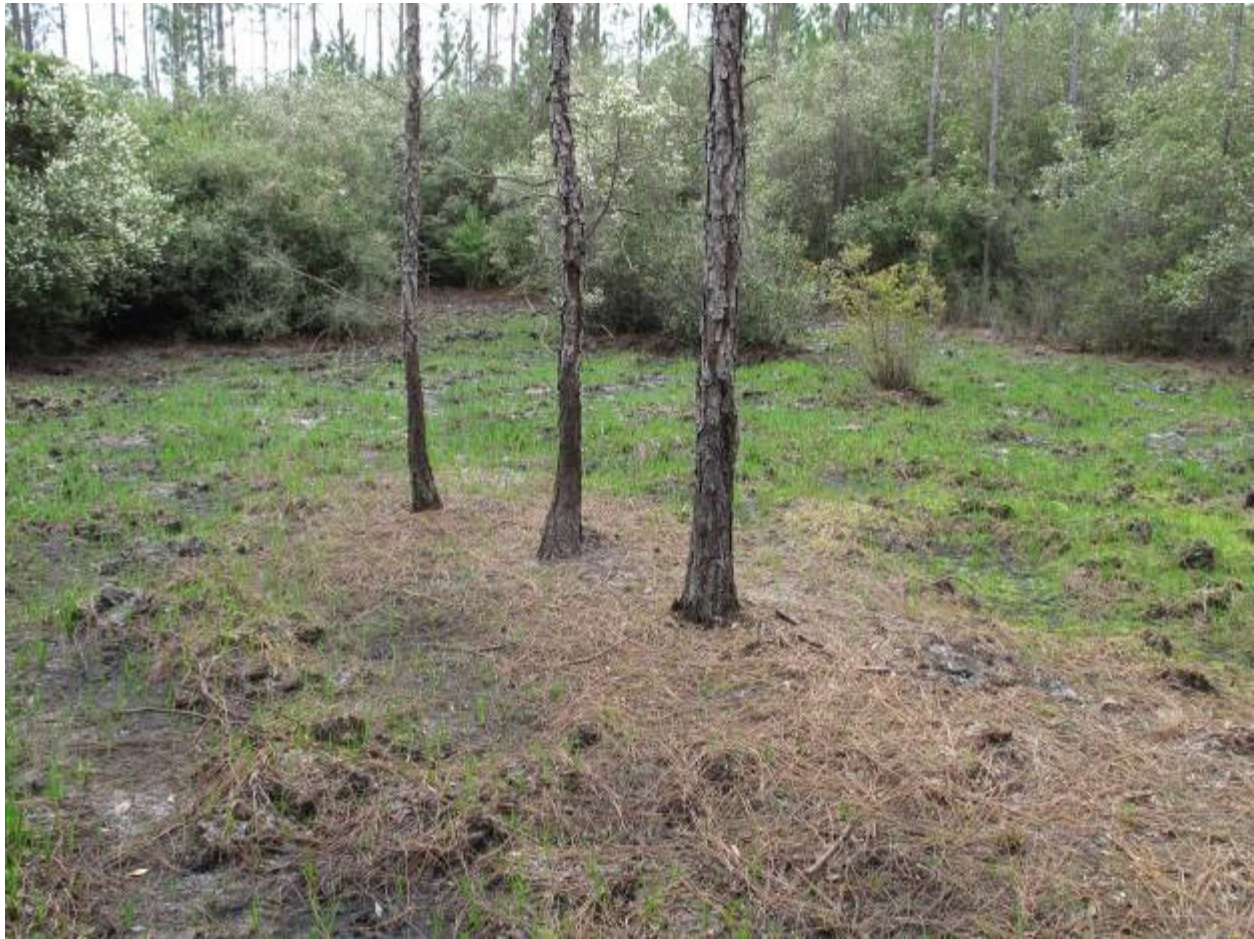
Wetland ID: 13-06

Description: This wetland is a 0.1 ha ephemeral marsh. Pine trees were planted on bedded rows through the wetland. A few pine trees remain but there is no significant tree canopy. Titi grows around the wetland edges, and covers 5-25% of the wetland. Sedges/grasses and red root grow in scattered patches, and cover 25-50% of the basin. Feral hogs have rooted extensively in the wetland. The adjacent uplands are mesic flatwoods that were bedded and converted to a pine plantation. Upland restoration is in progress.

Wetland Concerns: Bedding, Feral hog damage, Planted pine trees

Restoration Action Recommended: No action to remove the bedding is recommended; the bedding rows will erode over time. Remove the planted pine trees from the wetland interior.

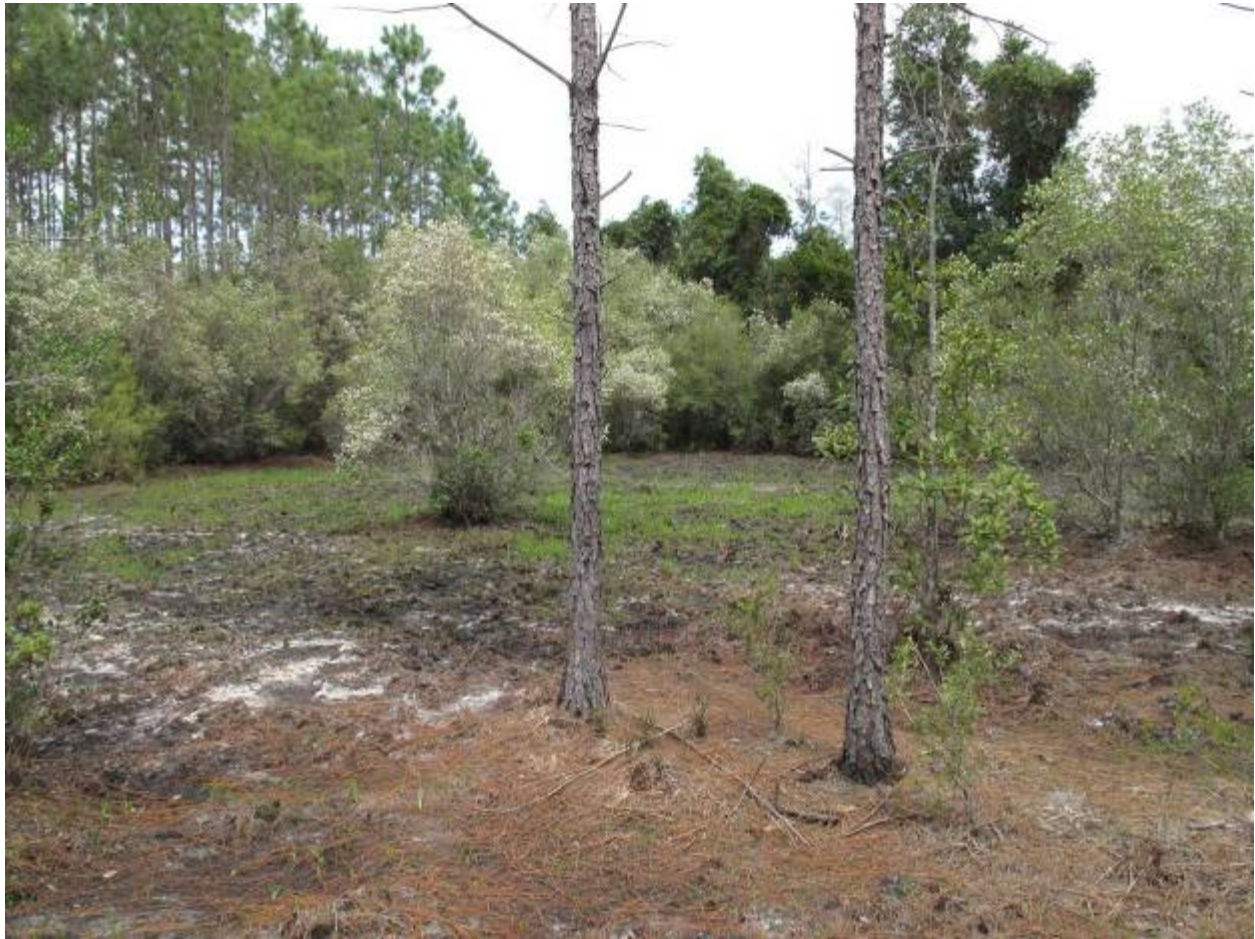
Wetland ID: 13-07

Description: This wetland is a 0.1 ha ephemeral marsh. Pine trees were planted on bedded rows through the wetland. A few pine trees remain but there is no significant tree canopy. There is no significant midstory cover. Sedges/grasses and red root grow throughout the wetland, and cover 5-25% of the basin. Feral hog damage is extensive. Titi grows dense around the wetland. The adjacent uplands are mesic flatwoods that were bedded and converted to a pine plantation. Upland restoration is in progress.

Wetland Concerns: Bedding, Feral hog damage, Planted pine trees

Restoration Action Recommended: No action to remove the bedding is recommended; the bedding rows will erode over time. Remove the planted pine trees from the wetland interior.

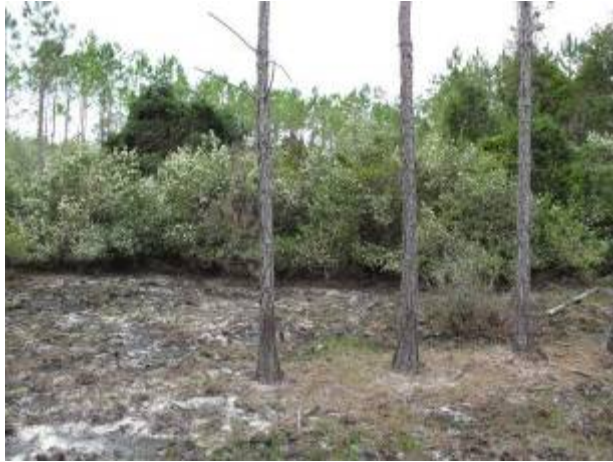
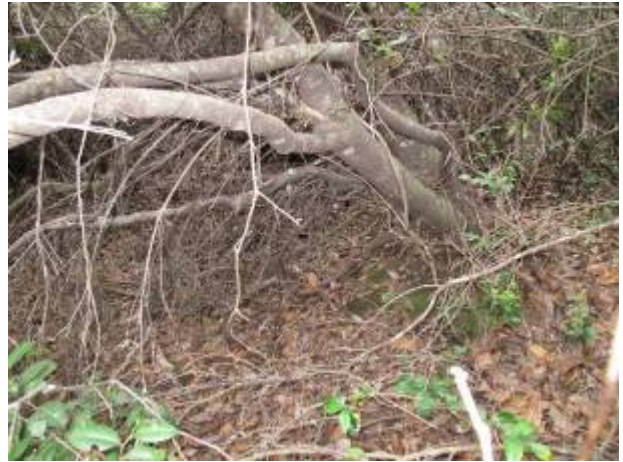
Wetland ID: 13-08

Description: This wetland is a 0.1 ha ephemeral shrub swamp. There is no significant tree canopy. Titi is the dominant woody vegetation, and covers 50-75% of the wetland. Red root grows in a ring around the edge of the wetland, and covers 5-25% of the basin. This pond almost joins wetland 13-07 but is separated by a row of pines. There is a titi-covered push pile in the wetland center. Feral hog damage is limited to the wetland edge. Pine trees were planted on bedding rows through the wetland. Most of the bedding has eroded and only a few pine trees remain. The adjacent uplands are mesic flatwoods that were bedded and converted to a pine plantation. Upland restoration is in progress.

Wetland Concerns: Bedding, Feral hog damage, Planted pine trees, Push pile

Restoration Action Recommended: This wetland is a good candidate for a mechanical push pile/titi and bedding removal. Remove pine trees from wetland interior as well. Encourage periodic fire to burn through the wetland.

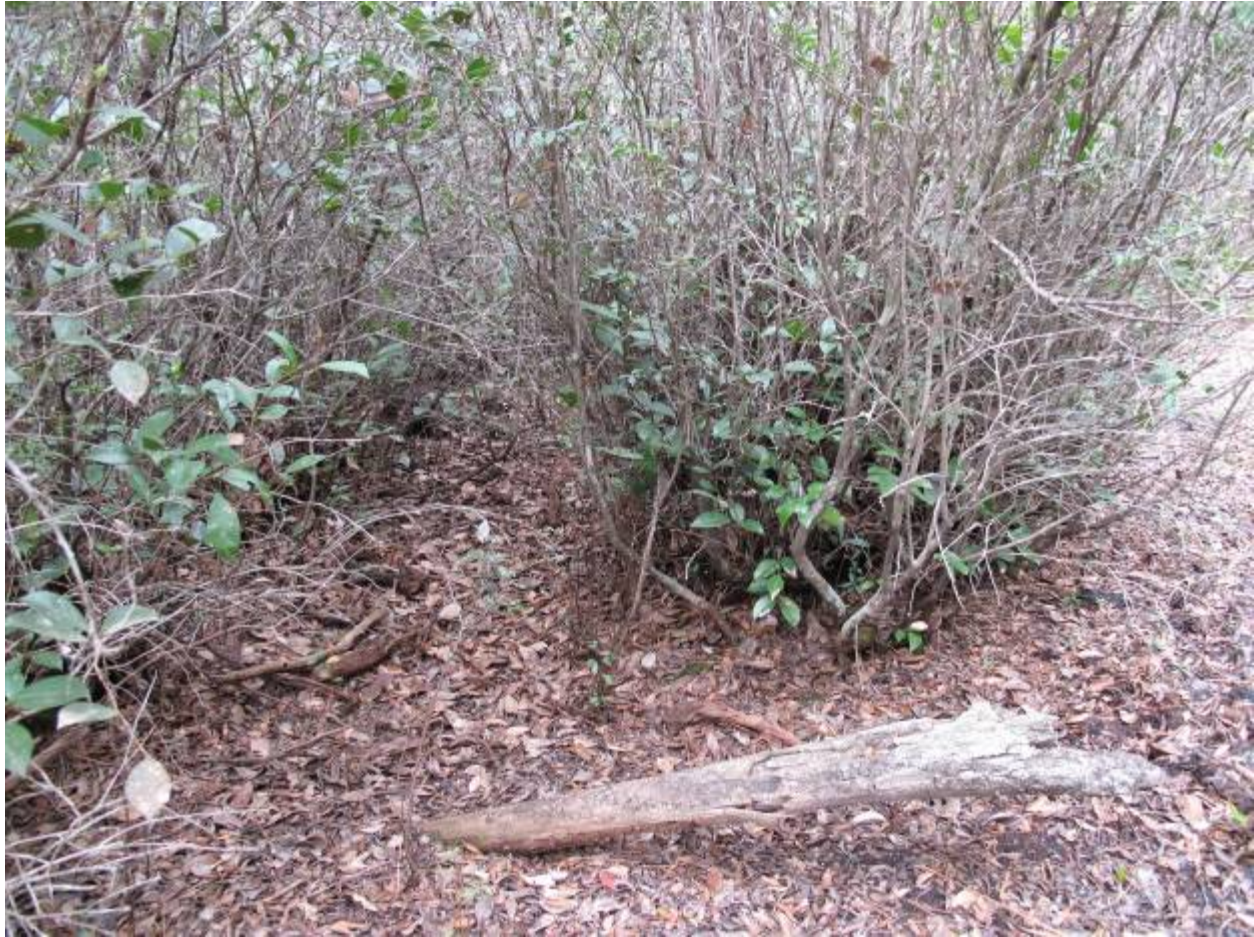
Wetland ID: 13-09

Description: This wetland is a 0.5 ha ephemeral shrub swamp. There is no significant tree canopy cover. Titi and fetterbush are the dominant woody vegetation, and cover >75% of the wetland. There is no herbaceous vegetation. This wetland was likely a cypress swamp that was logged and colonized by shrubs. A few cypress trees remain in the wetland. The adjacent uplands are mesic flatwoods that were bedded and converted to a pine plantation. Upland restoration is in progress.

Wetland Concerns: Woody encroachment

Restoration Action Recommended Periodic fire in the wetland would reduce the dense titi and open the midstory.

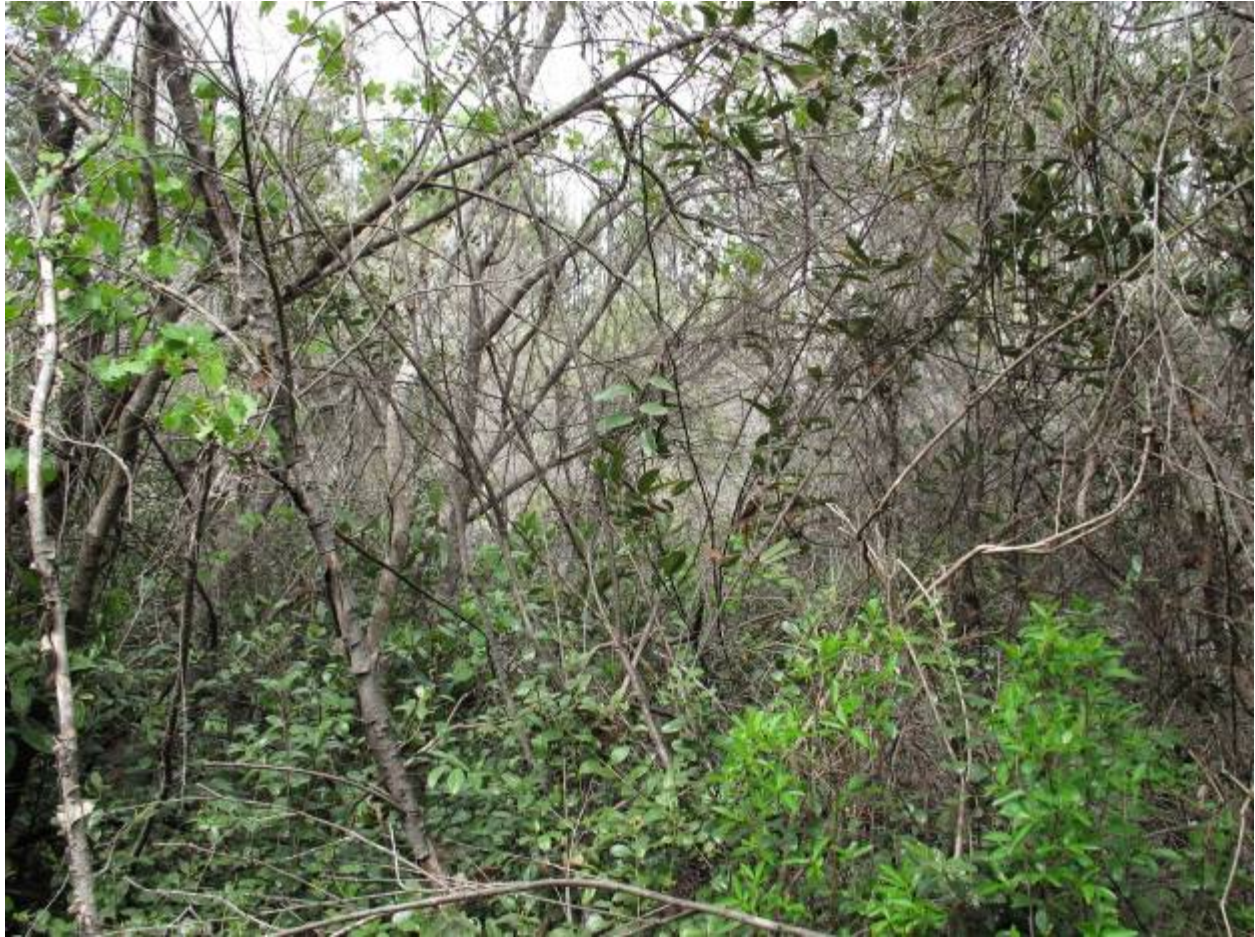
Wetland ID: 13-10

Description: This wetland is a 0.2 ha ephemeral shrub swamp. There is no tree canopy cover. Titi is the dominant woody vegetation, and covers >75% of the wetland. There is no herbaceous vegetation. There are 1 m tall push piles on the south side of the wetland. A fire burned through the wetland a few years ago, reducing the brush. The adjacent uplands are mesic flatwoods that were bedded and converted to a pine plantation. Upland restoration is in progress.

Wetland Concerns: Push piles

Restoration Action Recommended: The push piles could be flattened and titi thinned when the wetland is completely dry.

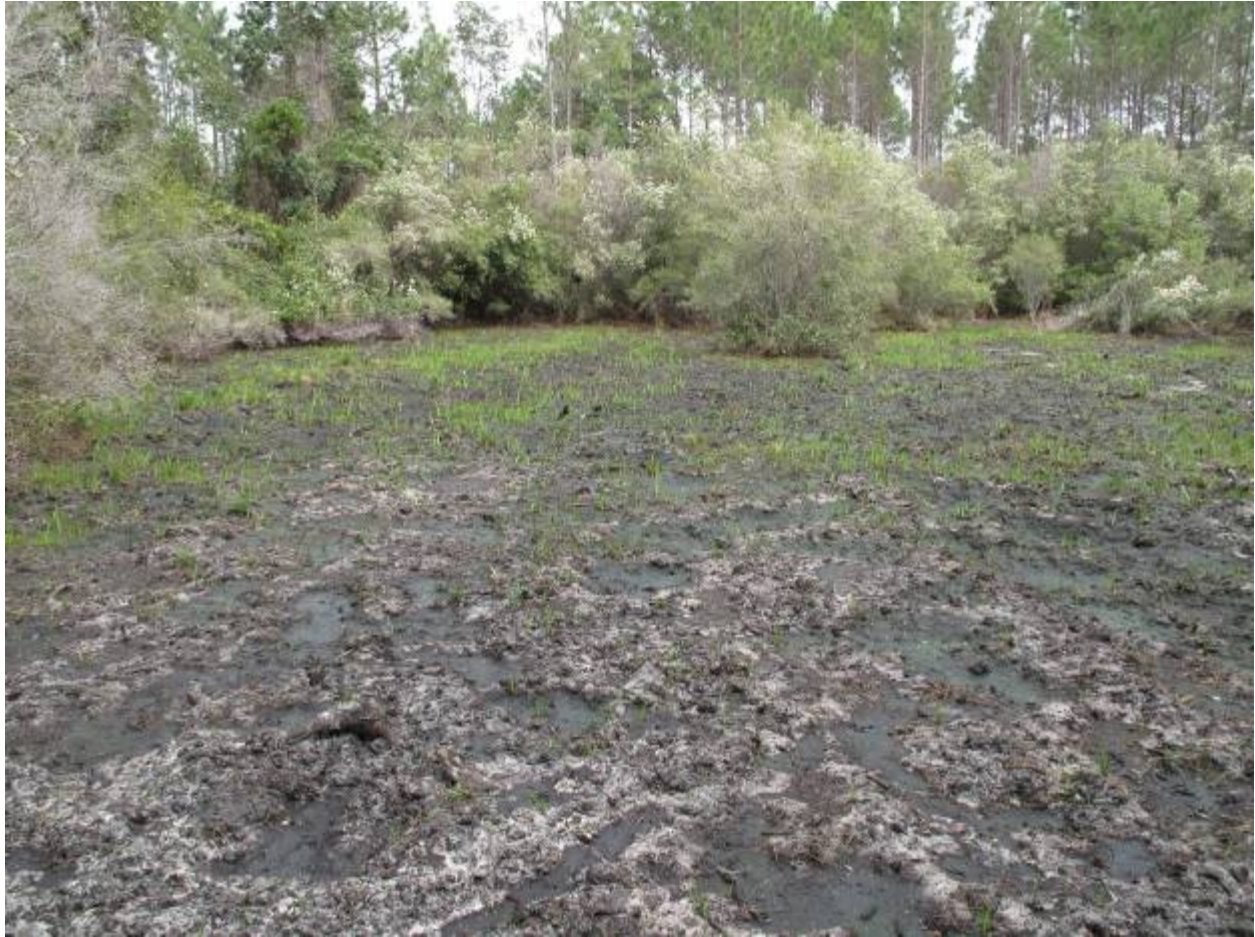
Wetland ID: 13-11

Description: This wetland is a 0.1 ha ephemeral marsh. There is no tree canopy or midstory cover. Sedges/grasses and red root grow throughout the wetland, and cover 5-25% of the basin. Feral hog damage is extensive in the wetland but herbaceous vegetation is now growing back. The adjacent uplands are mesic flatwoods that were bedded and converted to a pine plantation. Upland restoration is in progress.

Wetland Concerns: Feral hog damage

Restoration Action Recommended: None

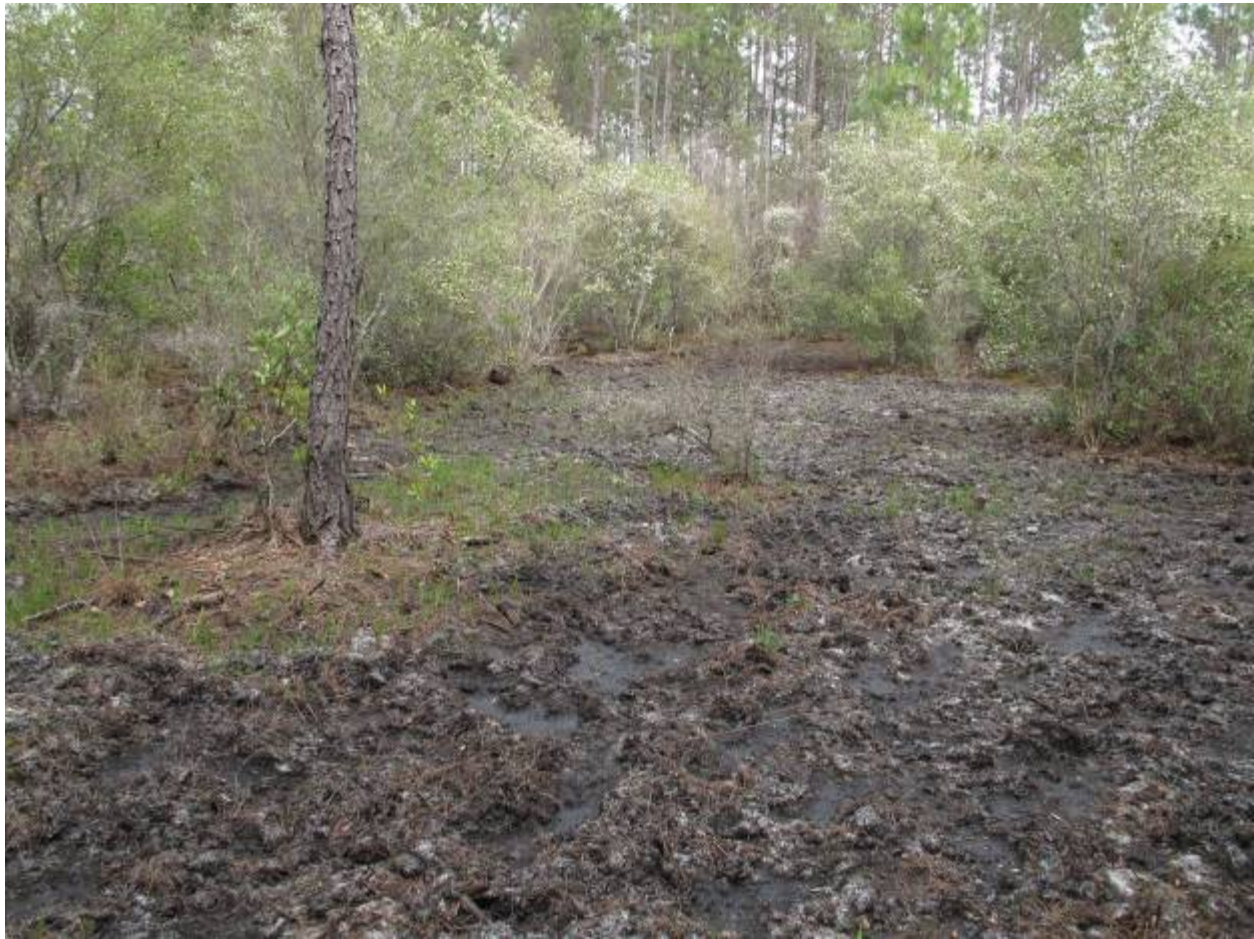
Wetland ID: 13-12

Description: This wetland is a 0.1 ha ephemeral marsh. There is no tree canopy cover. Titi is the dominant woody vegetation, and covers 5-25% of the wetland. Sedges/grasses grow sparsely in the wetland, and cover 5-25% of the basin. Feral hog damage is extensive. Old bedding rows that were constructed through the wetland have mostly eroded. The adjacent uplands are mesic flatwoods that were bedded and converted to a pine plantation. Upland restoration is in progress.

Wetland Concerns: Feral hog damage

Restoration Action Recommended: Periodic fire will prevent titi encroachment.

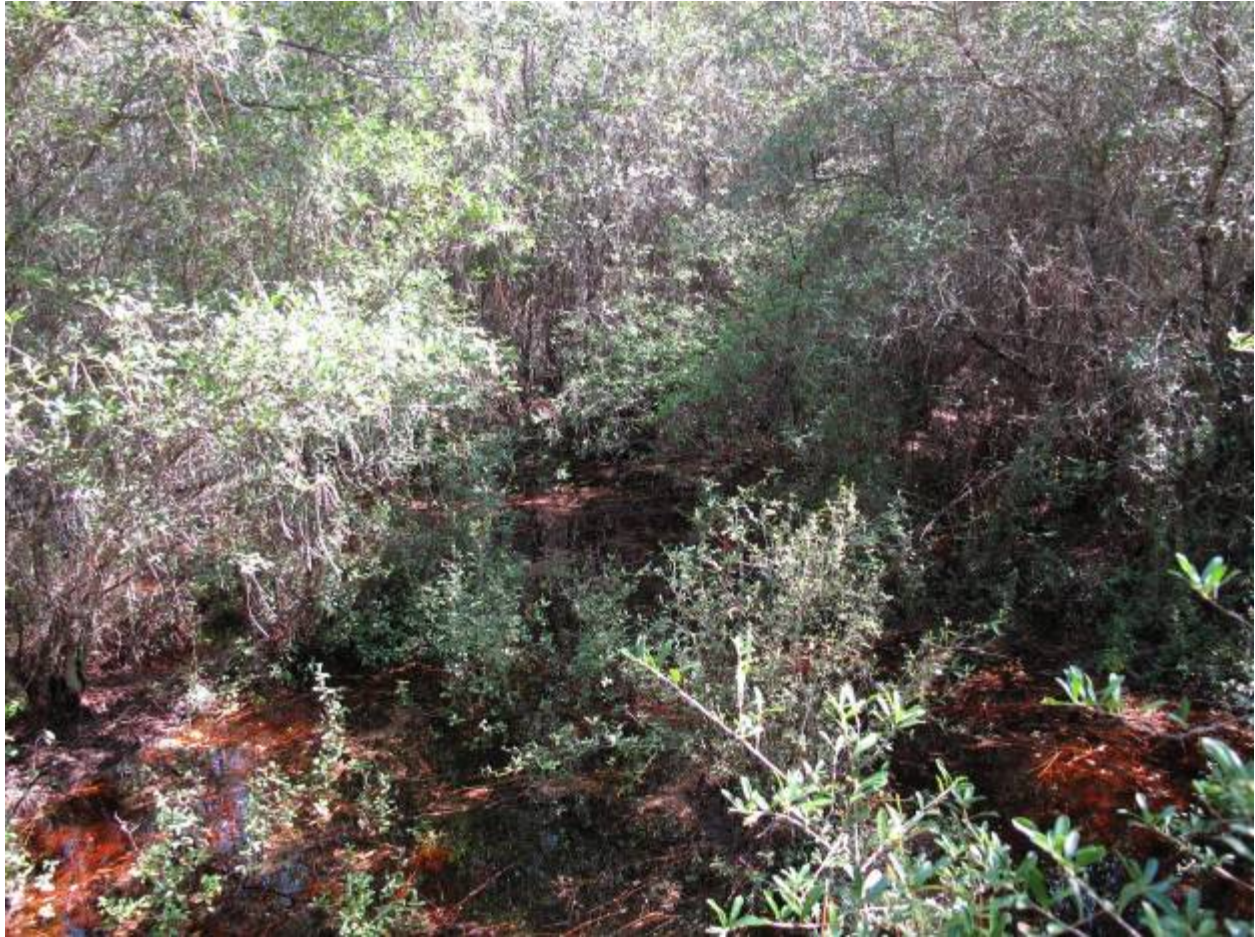
Wetland ID: 13-13

Description: This wetland is a 0.1 ha ephemeral shrub swamp. Pine trees dominate the canopy, and cover 5-25% of the wetland. The midstory is dominated by titi, and covers >75% of the wetland. There is no herbaceous vegetation. Pine trees were planted on bedded rows through the wetland. The adjacent uplands are mesic flatwoods that were bedded and converted to a pine plantation. Upland restoration is in progress.

Wetland Concerns: Bedding, Planted pine trees, Woody encroachment,

Restoration Action Recommended: No action to remove the bedding is recommended; the bedding rows will erode over time. Remove the planted pine trees from the wetland interior. Encourage periodic fire in the wetland to reduce the thick titi.

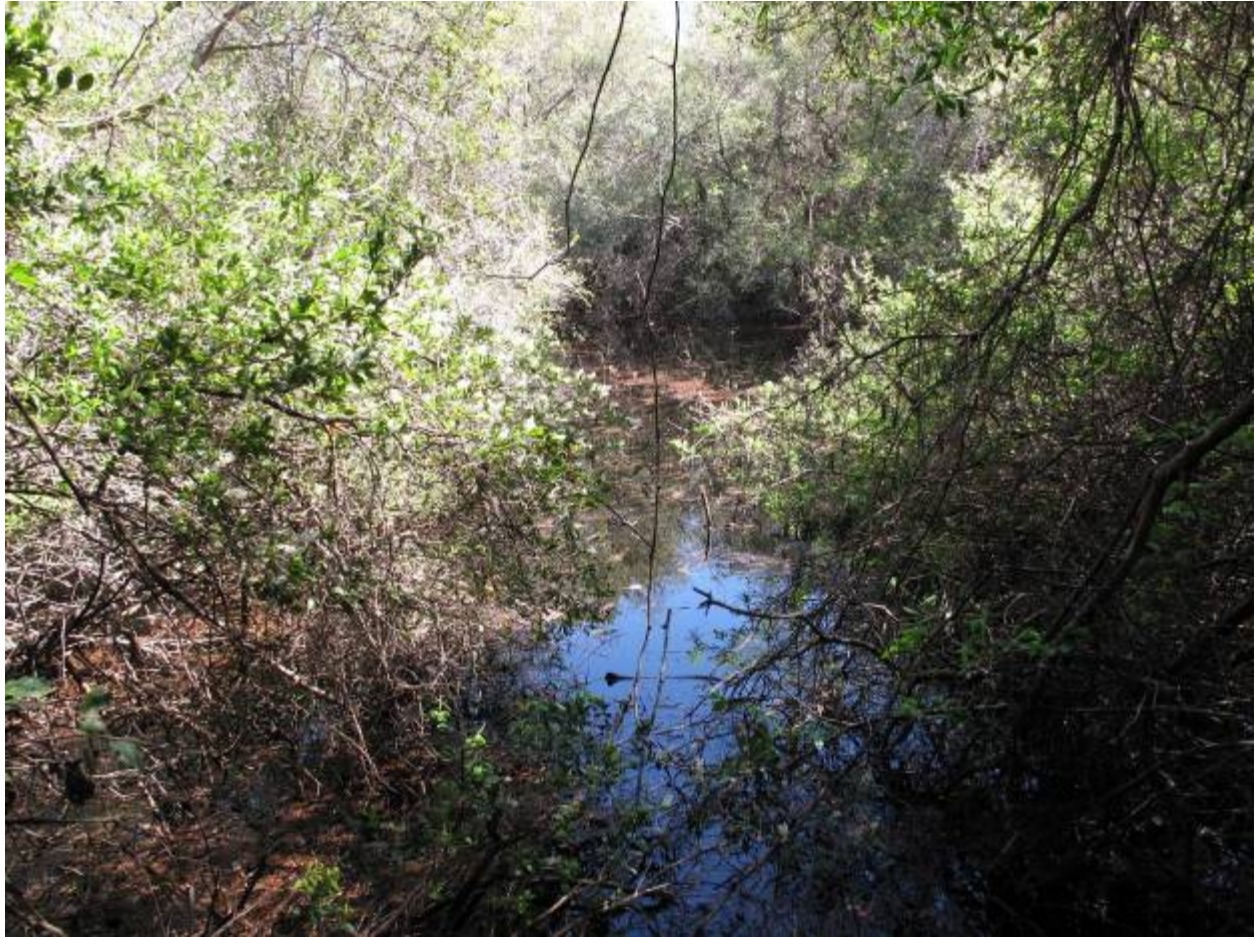
Wetland ID: 13-14

Description: This wetland is a 0.4 ha ephemeral shrub swamp. There is no tree canopy cover. Titi is the dominant woody vegetation, and covers >75% of the wetland. There is no herbaceous vegetation. This wetland was most likely a former cypress swamp. The cypress trees were logged and hummocks have developed around the old stumps. These hummocks now support large titi shrubs. An old, eroded wind row runs through the western edge of the wetland. The adjacent uplands are mesic flatwoods that were bedded and converted to a pine plantation. Upland restoration is in progress.

Wetland Concerns: Woody encroachment, Windrow

Restoration Action Recommended: The windrow and hummocks could be flattened and the titi either removed or thinned when the wetland is completely dry. Encourage periodic fire through the wetland.

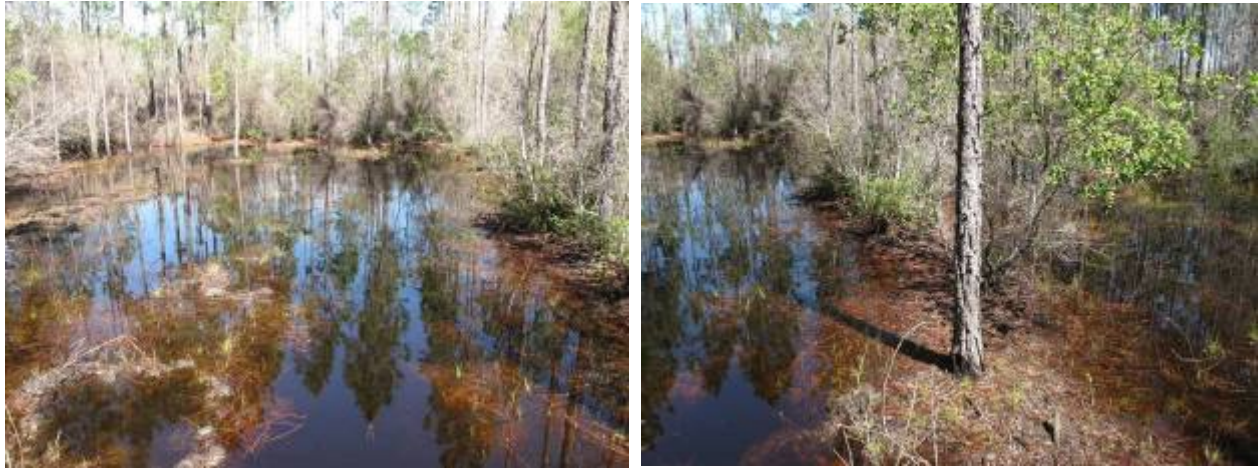
Wetland ID: 13-15

Description: This wetland is a 0.1 ha ephemeral marsh. Pine trees dominate the canopy, and cover 5-25% of the wetland. Titi grows dense around the wetland edge, and covers 5-25% of the wetland. Sedges/grasses are sparsely distributed, and cover 5-25% of the basin. Pine trees and titi grow on the bedding rows through the wetland. A fire burned through the wetland a few years ago, reducing the brush. The wetland was inundated on the day of our visit. We suspect there is extensive hog rooting beneath the water. The adjacent uplands are mesic flatwoods that were bedded and converted to a pine plantation. Upland restoration is in progress.

Wetland Concerns: Bedding, Feral hog damage, Planted pines

Restoration Action Recommended: No action to remove the bedding is recommended; the bedding rows will erode over time. Remove the planted pine trees from the wetland interior.

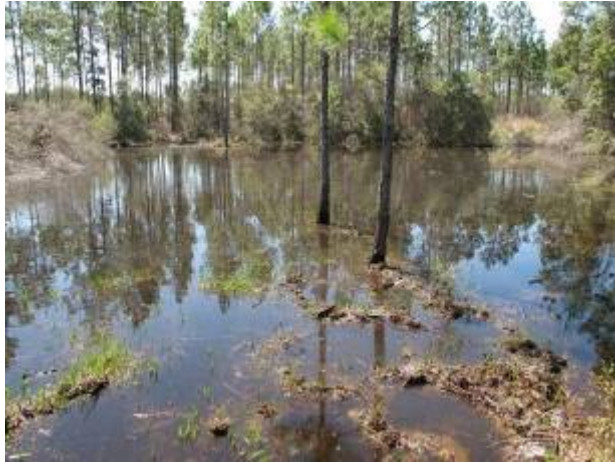
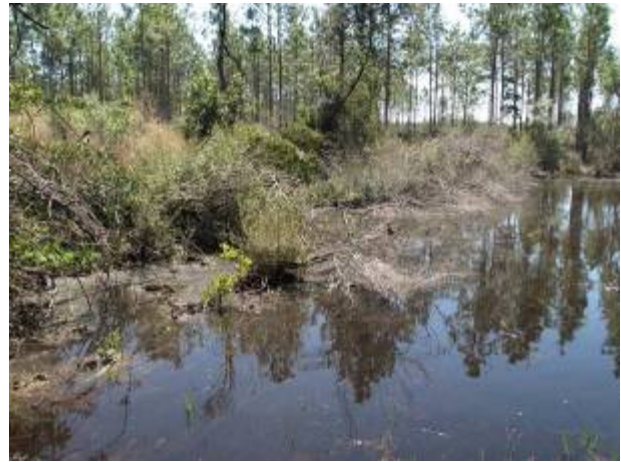
Wetland ID: 13-16

Description: This wetland is a 0.1 ha ephemeral marsh. There is no canopy or midstory cover. Sedges/grasses are sparsely distributed, and cover 5-25% of the basin. Feral hog damage is extensive. Bedding rows were constructed through the center of the wetland and now are eroding. A windrow along the east side of the wetland bisects what would be one, large wetland and creates a cluster of smaller ones (this wetland, 13-17, and 13-20). There is another windrow on the west side of the wetland. The adjacent uplands are mesic flatwoods that were bedded and converted to a pine plantation. Upland restoration is in progress.

Wetland Concerns: Bedding, Feral hog damage, Planted pine trees, Windrow

Restoration Action Recommended: When the wetland is completely dry, flatten the windrow in the vicinity of the wetland. In addition to altering wetland hydrology, windrows could act as a barrier to small animal migration and dispersal. Once the windrow is eliminated, the cluster of ponds will reconnect to form one, large wetland. Remove planted pine trees from wetland interior. Encourage periodic fire to this wetland to restore the herbaceous vegetation.

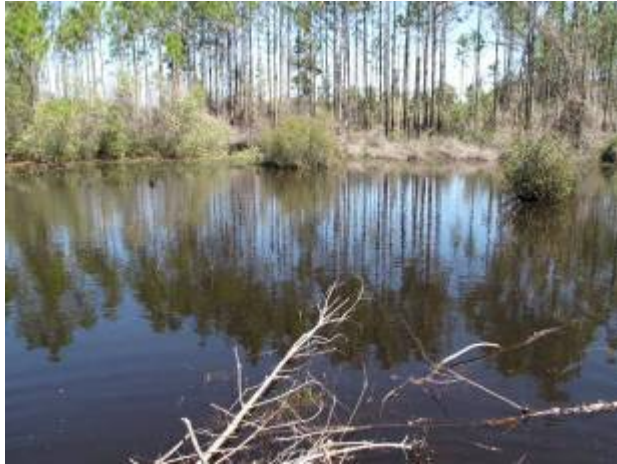
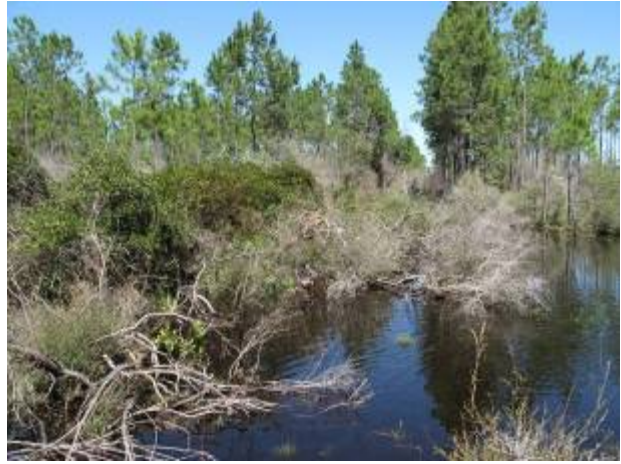
Wetland ID: 13-17

Description: This wetland is a 0.2 ha ephemeral marsh. There is no canopy or midstory cover. Sedges/grasses are sparsely distributed, and cover 5-25% of the basin. Feral hog damage is extensive. A windrow along the west side of the wetland bisects what would be one, large wetland and creates a cluster of smaller ones (this wetland, 13-16, and 13-20). There is also a windrow on the east side of the wetland. The adjacent uplands are mesic flatwoods that were bedded and converted to a pine plantation. Upland restoration is in progress.

Wetland Concerns: Feral hog damage, Windrow

Restoration Action Recommended: When the wetland is completely dry, flatten the windrow in the vicinity of the wetland. In addition to altering wetland hydrology, windrows could act as a barrier to small animal migration and dispersal. Once the windrow is eliminated, the cluster of ponds will reconnect to form one, large wetland. Encourage periodic fire to this wetland to restore the herbaceous vegetation.

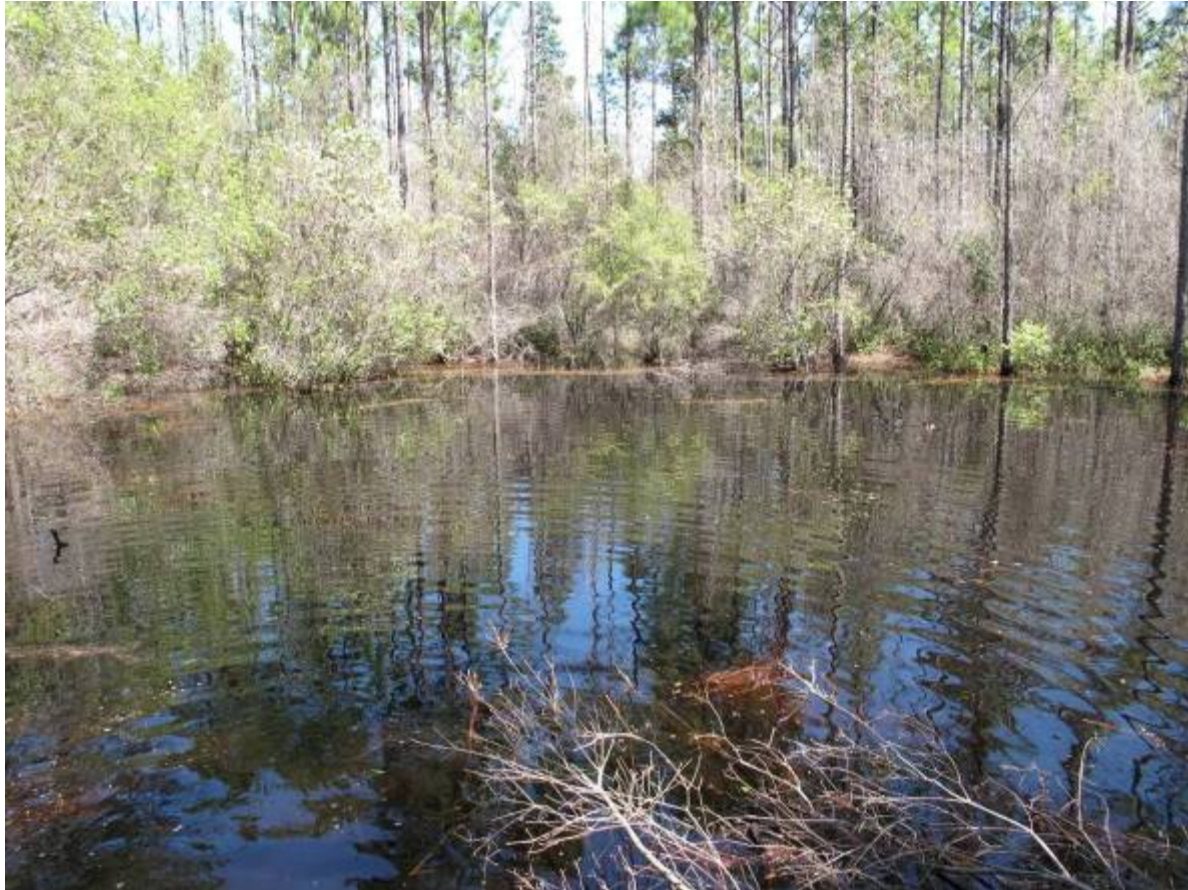
Wetland ID: 13-18

Description: This wetland is a <0.1 ha ephemeral marsh. There is no canopy or midstory cover and no herbaceous vegetation. This small open wetland was inundated with water on the day of our visit. We suspect there is extensive feral hog rooting beneath the water. A windrow spans along the western edge and there are eroding bedding rows around the wetland edge. The adjacent uplands are mesic flatwoods that were bedded and converted to a pine plantation. Upland restoration is in progress.

Wetland Concerns: Bedding, Feral hog damage, Windrow

Restoration Action Recommended: No action to remove the bedding is recommended; the bedding rows will erode over time. When the wetland is completely dry, flatten the windrow in the vicinity of the wetland. In addition to altering wetland hydrology, windrows could act as a barrier to small animal migration and dispersal. Encourage periodic fire to this wetland to restore the herbaceous vegetation.
