Inventory, Assessment, and Restoration Potential of Ephemeral Wetlands on FFWCC Wildlife Management Areas

Aucilla WMA Final Report

Submitted by: Rebecca P.M. Means¹, Ryan C. Means¹, Steven A. Johnson²

¹Coastal Plains Institute

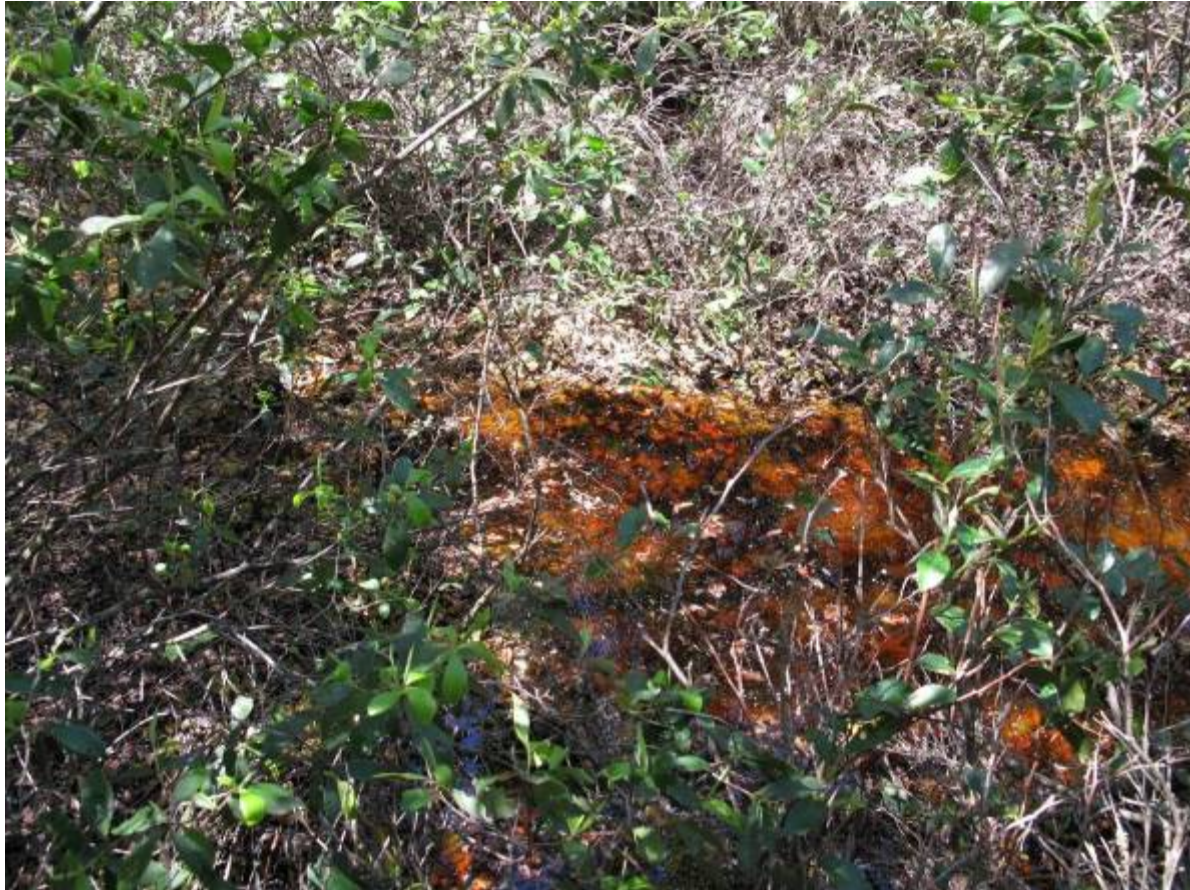
Wetland ID: 13-19

Description: This wetland is a 0.2 ha ephemeral shrub swamp. There is no tree canopy. Titi is the dominant woody vegetation, and covers >75% of the wetland. *Sphagnum* grows sparsely, and covers 5-25% of the basin. Feral hogs have rooted an open area on the south end of the wetland. There are windrows on the west and east sides. The adjacent uplands are mesic flatwoods that were bedded and converted to a pine plantation. Upland restoration is in progress.

Wetland Concerns: Feral hog damage, Windrow, Woody encroachment

Restoration Action Recommended: When the wetland is completely dry, flatten the windrow in the vicinity of the wetland and thin the dense titi. In addition to altering wetland hydrology, windrows could act as a barrier to small animal migration and dispersal. Encourage periodic fire to this wetland to reduce the dense titi.

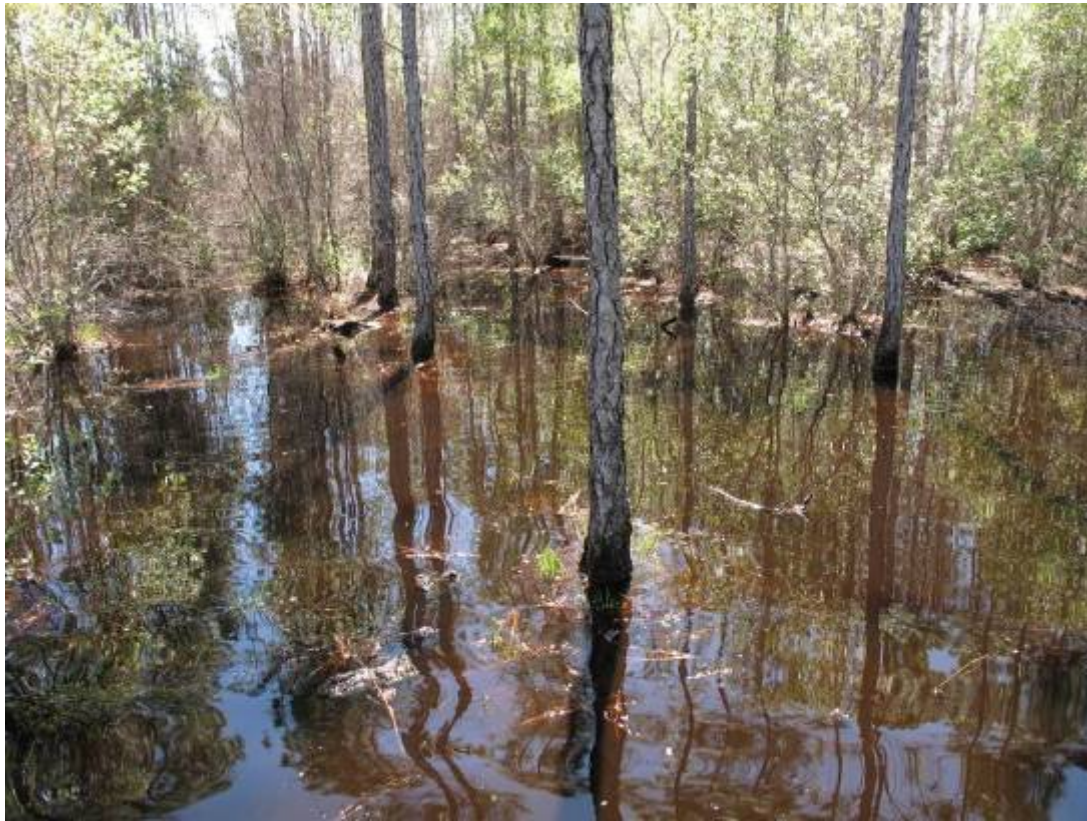
Wetland ID: 13-20

Description: This wetland is a 0.1 ha ephemeral marsh. Pine trees grow on bedding rows through the wetland. The tree canopy covers 5-25% of the wetland. The midstory is dominated by titi, and covers 5-25% of the wetland. A windrow along the east side bisects what would be one, large wetland and creates a cluster of smaller ones (this wetland, 13-16, and 13-17). There is also an old windrow on the west side of the wetland. There is feral hog damage in the wetland. The adjacent uplands are mesic flatwoods that were bedded and converted to a pine plantation. Upland restoration is in progress.

Wetland Concerns: Bedding, Feral hog damage, Planted pine trees, Windrow

Restoration Action Recommended: Remove planted pine trees from wetland interior. When the wetland is completely dry, flatten the bedding rows and windrow. In addition to altering wetland hydrology, windrows could act as a barrier to small animal migration and dispersal. Once the windrow is eliminated, the cluster of ponds will reconnect to form one, large wetland. Encourage periodic fire to this wetland to restore the herbaceous vegetation.

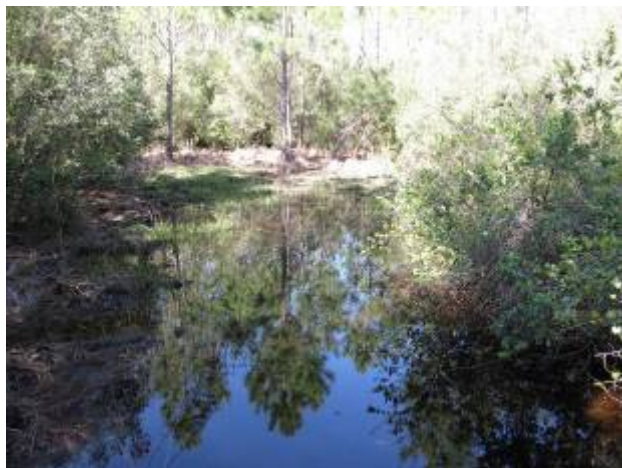
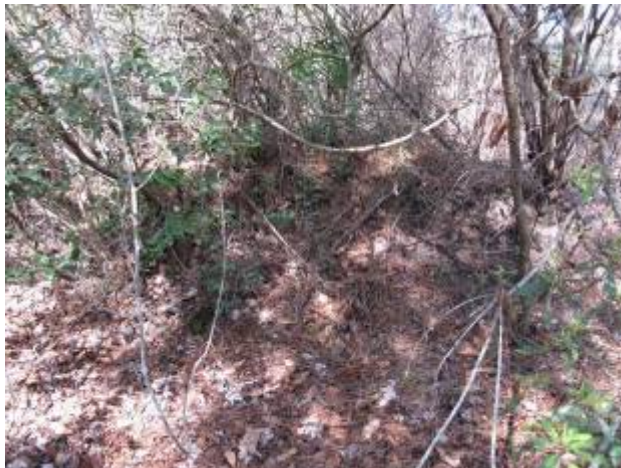
Wetland ID: 19-01

Description: This wetland is a 0.1 ha ephemeral, altered wetland. It is either a wetland with a big, central push pile or the mechanical activity involved with forming the push pile created a semicircular arc of wetland. There is no tree canopy cover. Titi is the dominant woody vegetation, and covers 50-75% of the wetland. Redroot grows in scattered patches, and covers 5-25% of the basin. The adjacent uplands are mesic flatwoods that were bedded and converted to a pine plantation. Upland restoration is in progress.

Wetland Concerns: Feral hog damage, Push pile

Restoration Action Recommended: Mechanically remove the push pile and simultaneously uproot the titi established on the push pile. This process should be completed when the wetland is completely dry and progress monitored. Return periodic fire to the wetland to prevent further titi encroachment.

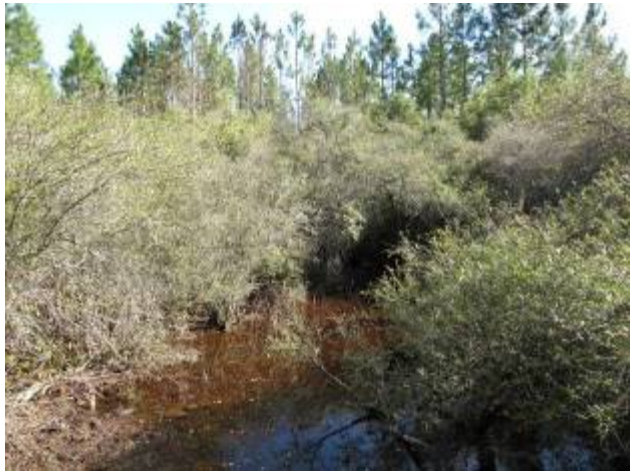
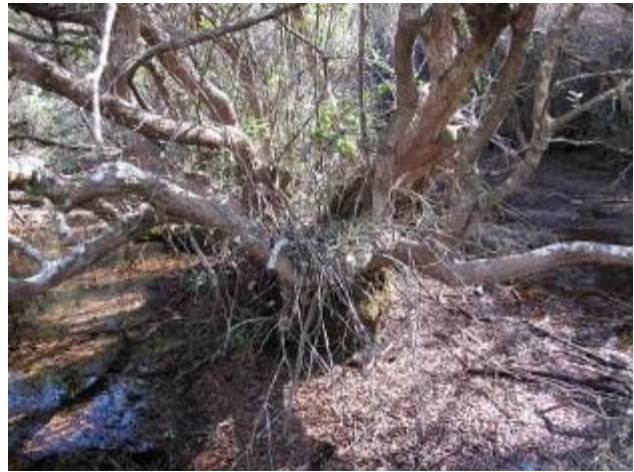
Wetland ID: 19-02

Description: This wetland is a 0.2 ha ephemeral shrub swamp. There is no tree canopy cover. Large titi grow on hummocks in the wetland and cover >75% of the wetland. The hummocks may have grown around old cypress stumps. There is no herbaceous vegetation. This wetland has dense brush around the edge with a more open center. This wetland was likely part of a larger wetland system before the landscape was altered by pine plantation. The adjacent uplands are mesic flatwoods that were bedded and converted to a pine plantation. Upland restoration is in progress.

Wetland Concerns: Woody encroachment

Restoration Action Recommended: The dense titi could be reduced through the use of periodic fire..

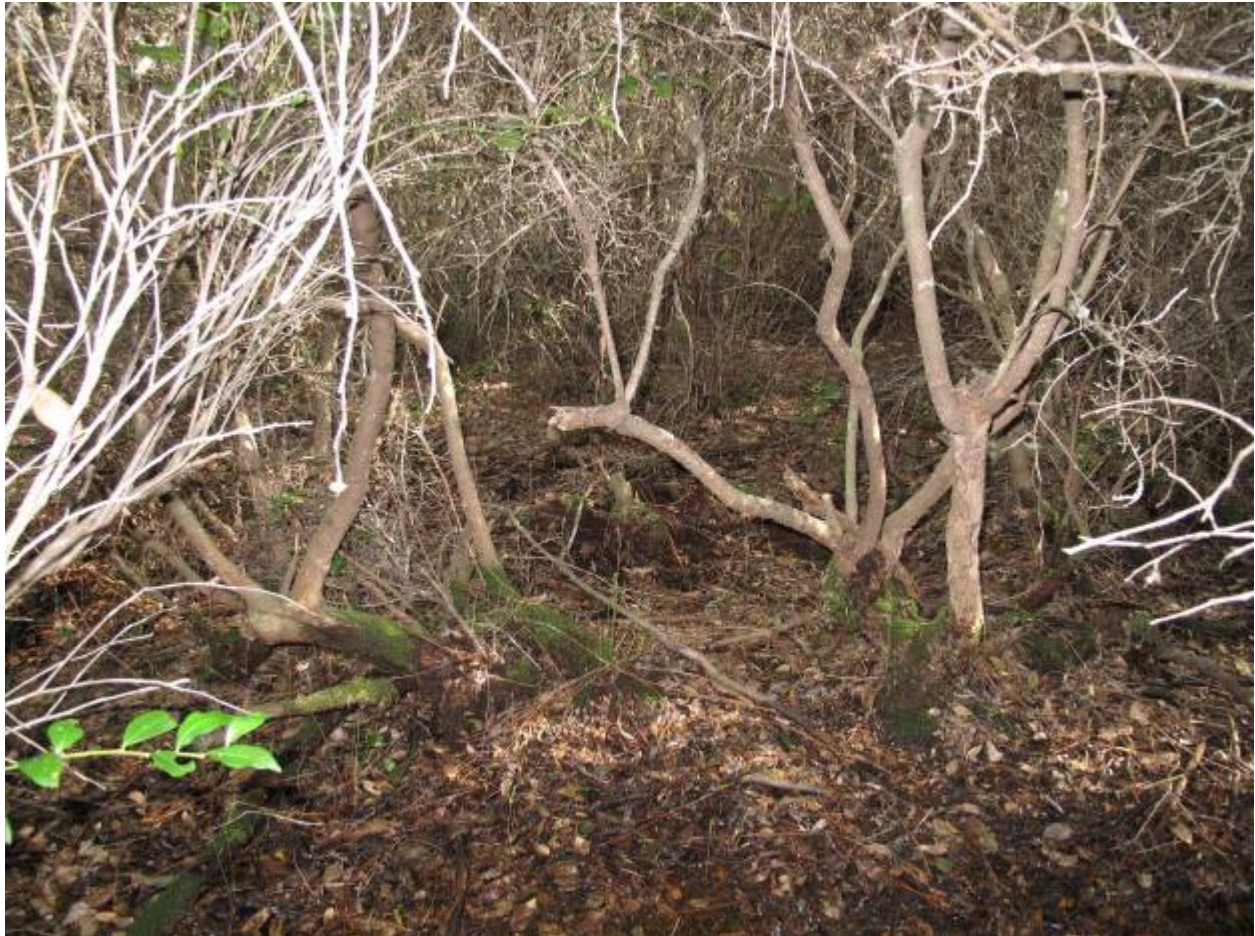
Wetland ID: 19-03

Description: This wetland is a <0.1 ha ephemeral shrub swamp. There is no tree canopy cover. Titi is the dominant woody vegetation, and covers >75% of the wetland. There is no herbaceous vegetation. This small, circular wetland has some small, natural hummocks and extremely dense brush. This wetland was likely part of a larger wetland system before the landscape was altered by pine plantation. The adjacent uplands are mesic flatwoods that were bedded and converted to a pine plantation. Upland restoration is planned.

Wetland Concerns: Woody encroachment

Restoration Action Recommended: Encourage periodic fire in the wetland to reduce the dense titi.

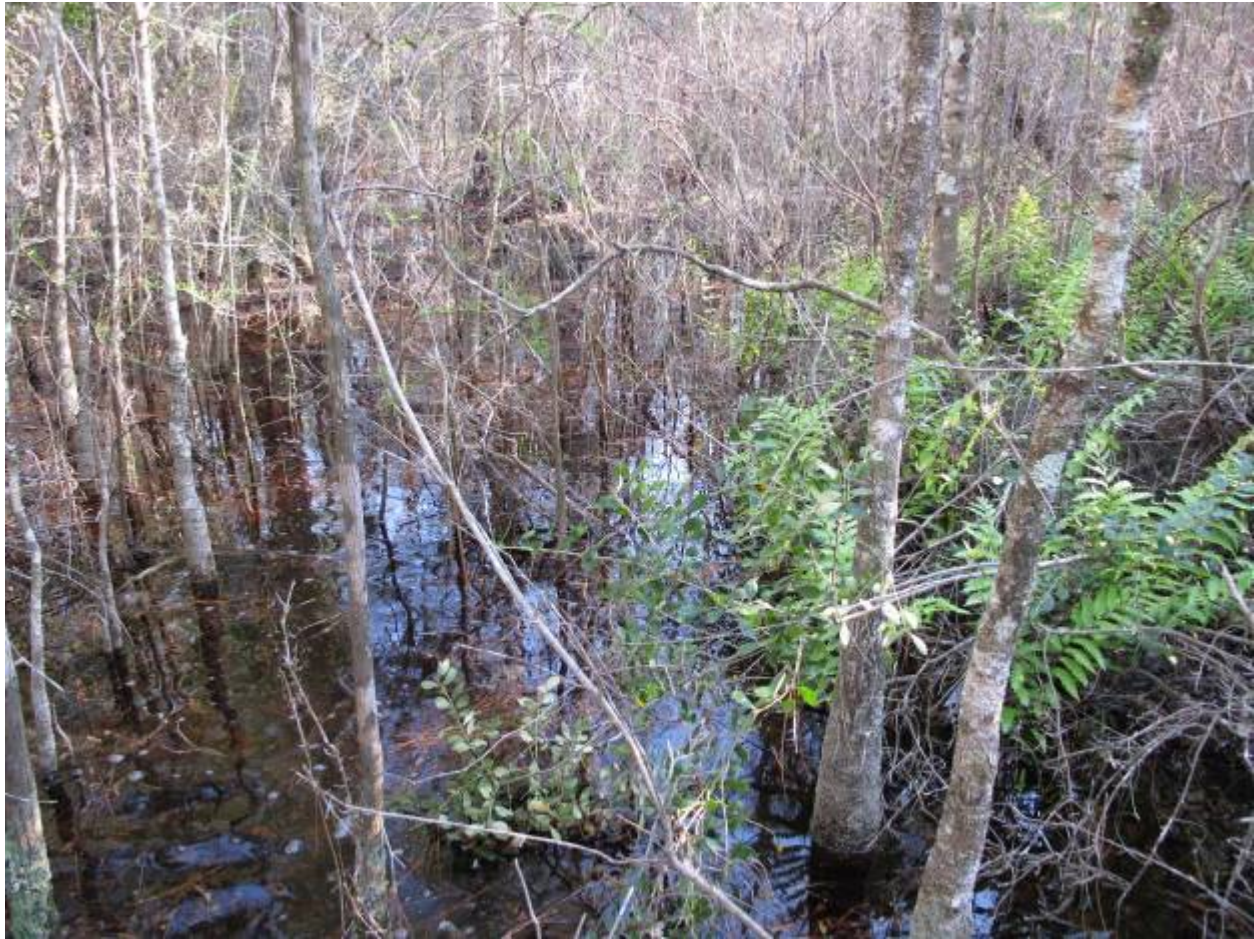
Wetland ID: 19-04

Description: This wetland is a 0.1 ha ephemeral forested swamp. Cypress and holly trees dominate the canopy, and cover 50-75% of the wetland. The midstory is dominated by titi and holly, and covers 25-50% of the wetland. Fern grow in scattered patches, and cover 5-25% of the basin. There is a small (<1 m high) push pile in the wetland center. A recent fire burned through the entire wetland. This wetland was likely part of a larger wetland system before the landscape was altered by pine plantation. The adjacent uplands are mesic flatwoods that were bedded and converted to a pine plantation. Upland restoration is in progress.

Wetland Concerns: Push pile

Restoration Action Recommended: The push pile is not extensive enough to merit restoration action. Encourage periodic fire in the wetland to prevent titi encroachment.

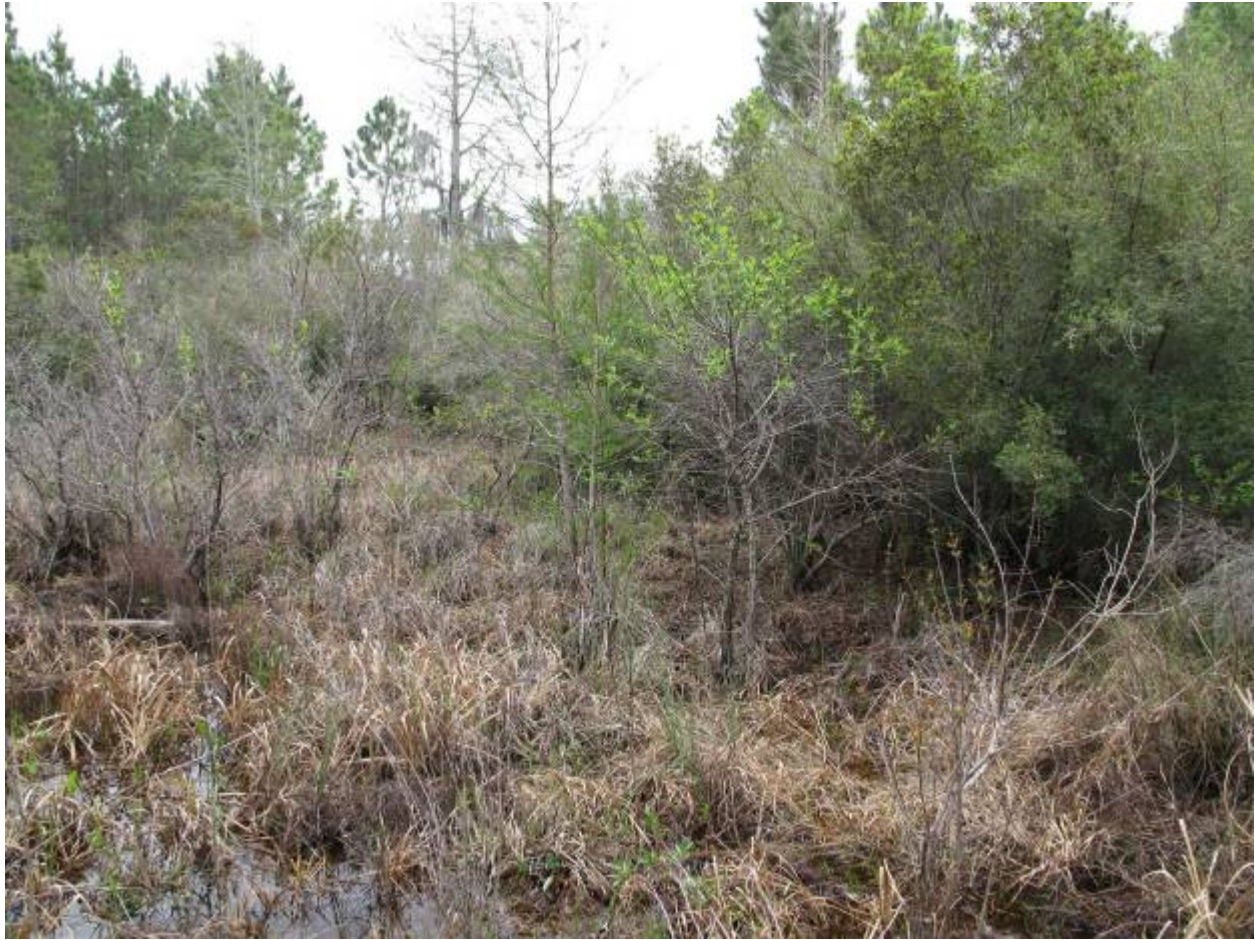
Wetland ID: 19-05

Description: This wetland is a 0.1 ha ephemeral marsh. There is no tree canopy cover. Titi and buttonbush are the dominant woody vegetation, and cover 25-50% of the wetland. A diverse array of sedges/grasses grow throughout the wetland, and cover >75% of the basin. Grade 19 ½ and an accompanying ditch run along the north side of the wetland. The road likely bisected this wetland, separating it from the larger wetland system to the north. The uplands were burned recently, but the fire did not burn into the wetland. The adjacent uplands are mesic flatwoods that were bedded and converted to a pine plantation. Upland restoration is in progress.

Wetland Concerns: Road, Roadside ditch

Restoration Action Recommended: In order to restore the hydrology of this wetland and the larger wetland system, the road would have to be removed. Recognizing that this road is now a permanent attribute to the property, we do not recommend any action relating to the road or roadside ditches.

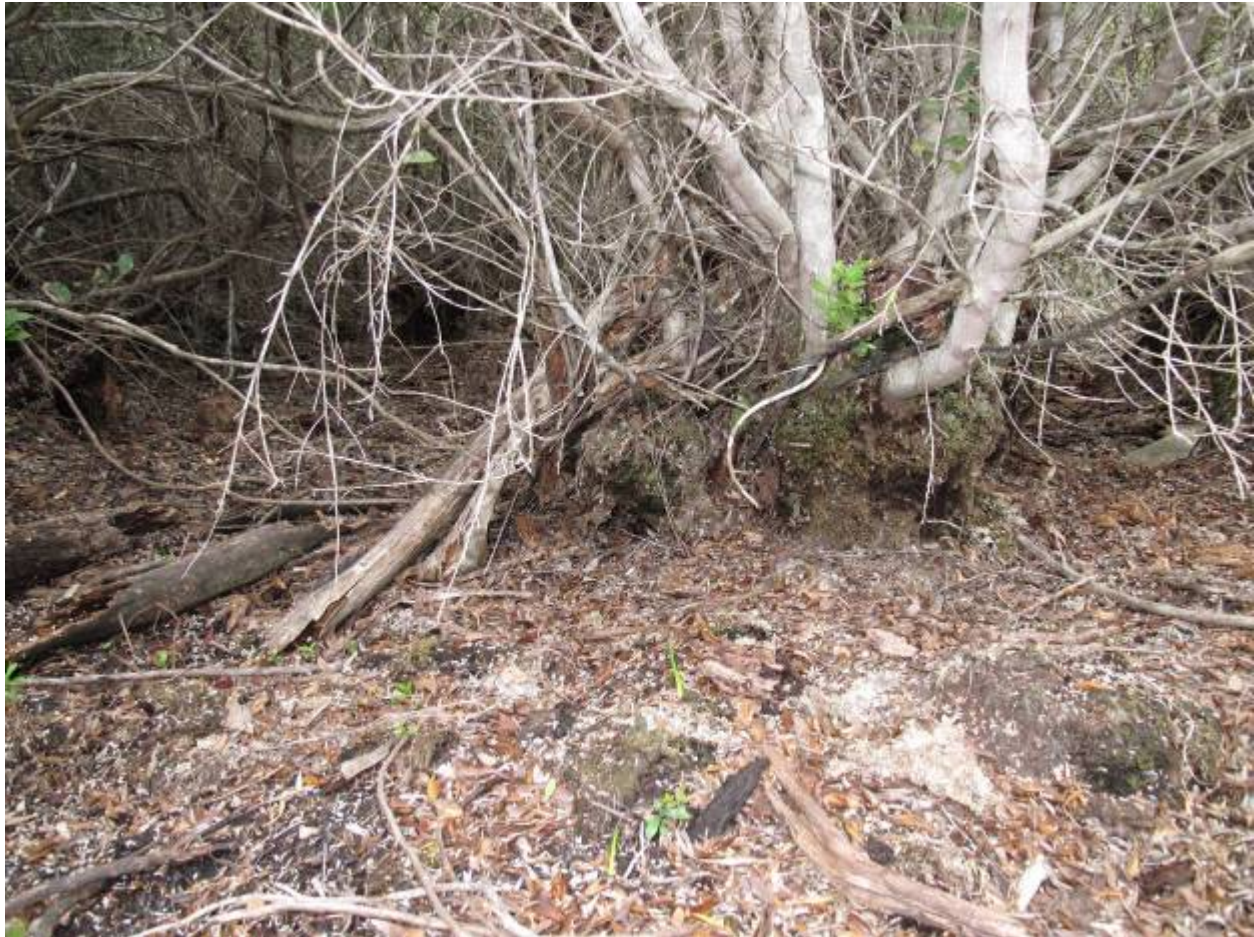
Wetland ID: 19-06

Description: This wetland is a 0.2 ha ephemeral shrub swamp. There is no tree canopy cover. Titi is the dominant woody vegetation, and covers 50-75% of the wetland. Large hummocks have grown up around the titi. Sedges/grasses grow in scattered patches, and cover 5-25% of the basin. It is unclear from historical aerial photos whether this wetland previously was a marsh or did not exist at all prior to pine plantation conversion. The adjacent uplands are mesic flatwoods that were bedded and converted to a pine plantation. Upland restoration is in progress.

Wetland Concerns: Woody encroachment

Restoration Action Recommended: Reduce the titi through use of periodic fire. If fire alone does not reduce the titi and hummocks, consider mechanical treatments.

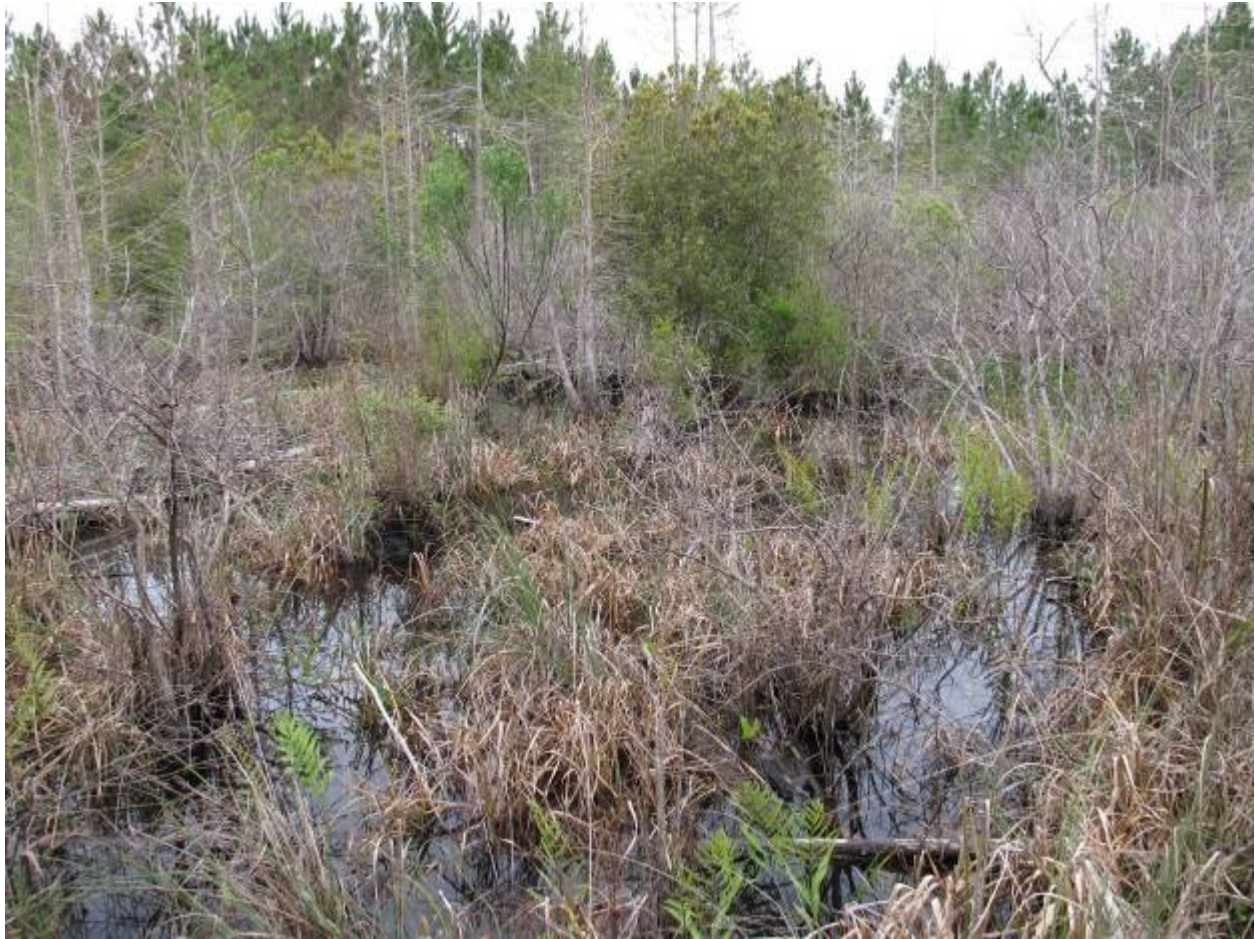
Wetland ID: 19-07

Description: This wetland is a 0.3 ha ephemeral marsh. Cypress trees dominate the canopy, and cover 5-25% of the wetland. The midstory is dominated by titi and wax myrtle, and covers 25-50% of the wetland. Sedges/grasses and sawgrass grow throughout the wetland, and cover 50-75% of the basin. This former cypress swamp was logged and now is a marsh with many young and regenerating cypress trees. The adjacent uplands are mesic flatwoods that were bedded and converted to a pine plantation. Upland restoration is in progress.

Wetland Concerns: None

Restoration Action Recommended: None

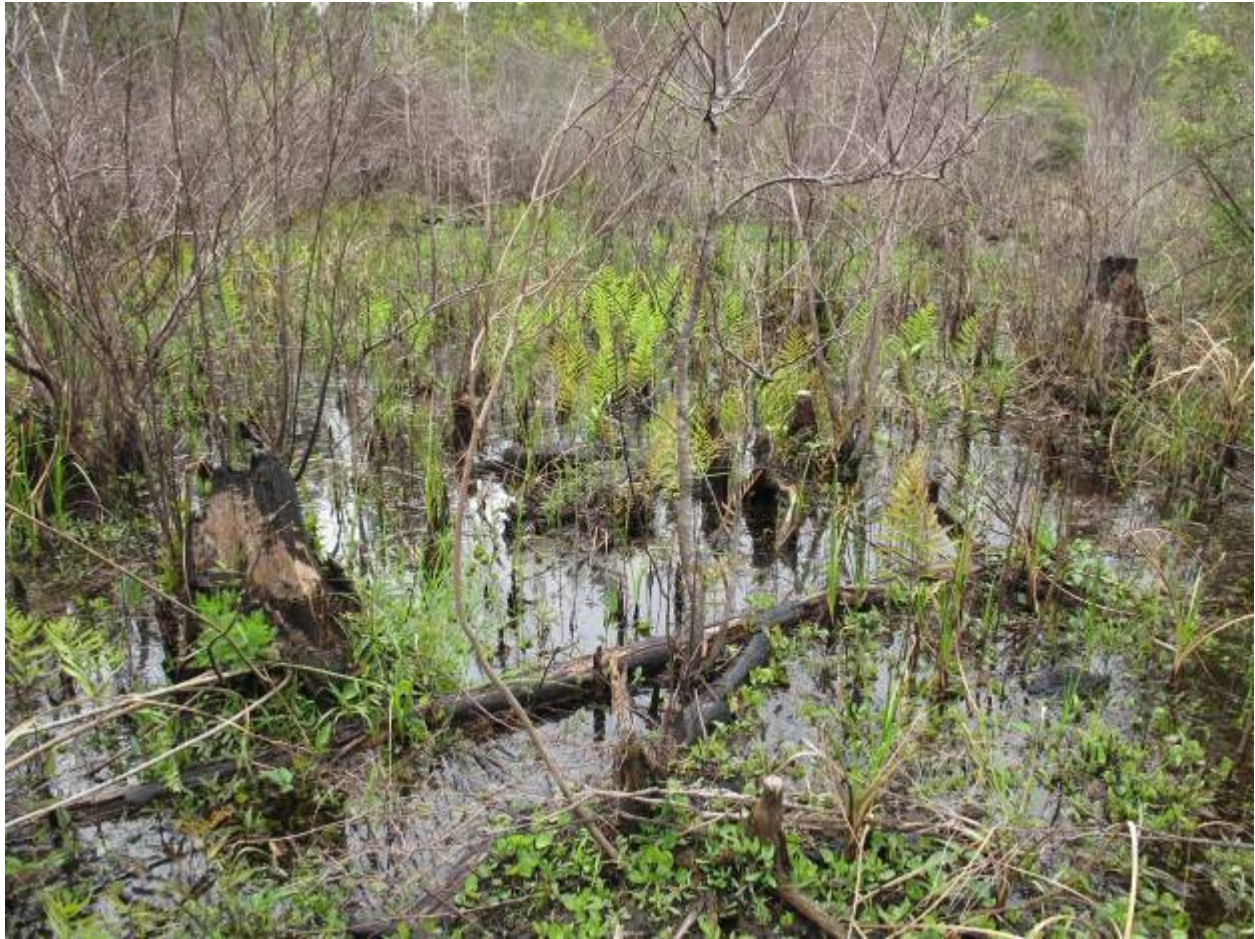
Wetland ID: 19-08

Description: This wetland is a 0.4 ha ephemeral marsh. There is no tree canopy cover. Wax myrtle and buttonbush are the dominant woody vegetation, and cover 5-25% of the wetland. Sedges/grasses and sawgrass grow throughout the wetland, and cover >75% of the basin. This former cypress wetland was logged and is now a marsh with a high diversity of herbaceous vegetation. A recent fire burned through the wetland. Old, eroding bedding rows are still evident along some of the wetland edges. The adjacent uplands are mesic flatwoods that were bedded and converted to a pine plantation. Upland restoration is in progress.

Wetland Concerns: None

Restoration Action Recommended: None

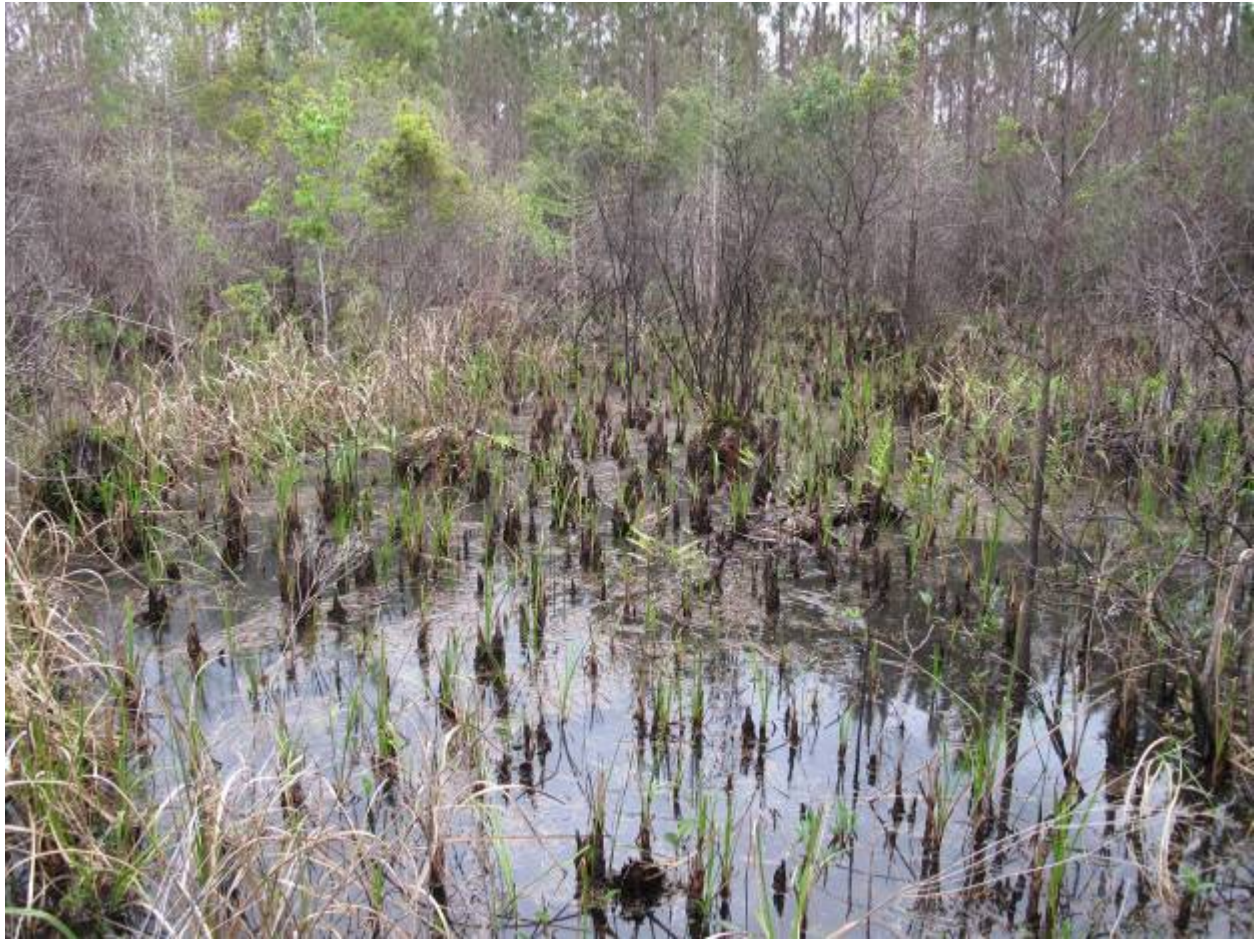
Wetland ID: 19-09

Description: This wetland is a 0.1 ha ephemeral marsh. There is no tree canopy cover. Wax myrtle and buttonbush are the dominant woody vegetation, and cover 25-50% of the wetland. Sedges/grasses, and sawgrass grow throughout the wetland, and covers 50-75% of the basin. This former cypress wetland was logged and is now a marsh with a high diversity of herbaceous vegetation. A recent fire burned through half of the wetland. The wetland appears to be an archaeological chert quarry site as there is exposed, beaten chert boulders and debitage. The adjacent uplands are mesic flatwoods that were bedded and converted to a pine plantation. Upland restoration is in progress.

Wetland Concerns: None

Restoration Action Recommended: None

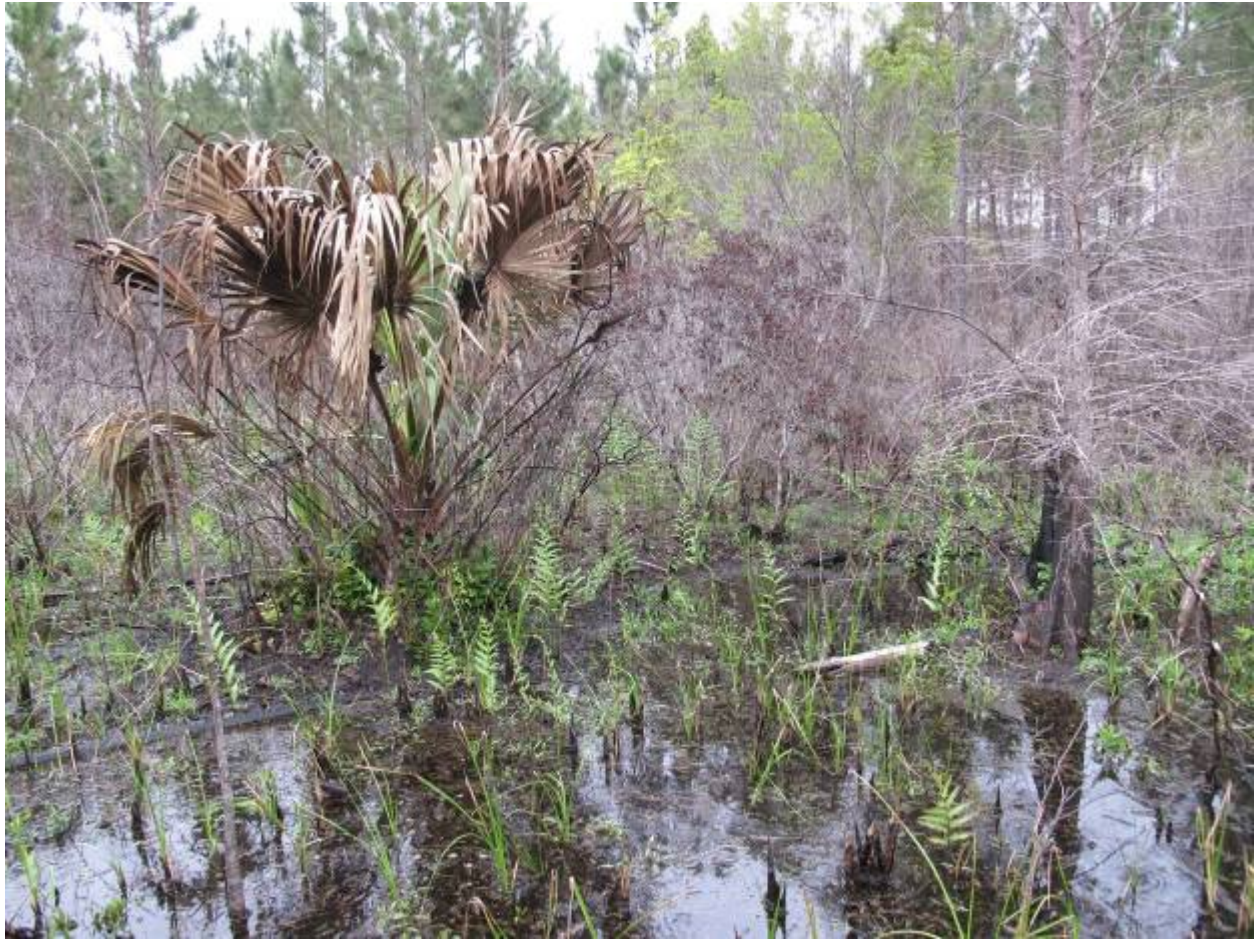
Wetland ID: 19-10

Description: This wetland is a 0.1 ha ephemeral marsh. There is no tree canopy cover. Wax myrtle and buttonbush are the dominant woody vegetation, and cover 5-25% of the wetland. Sedges/grasses and fern grow throughout the wetland, and cover 50-75% of the basin. A recent fire burned all the way through the wetland, and eliminated many shrubs. The adjacent uplands are mesic flatwoods that were bedded and converted to a pine plantation. Upland restoration is in progress.

Wetland Concerns: None

Restoration Action Recommended: None

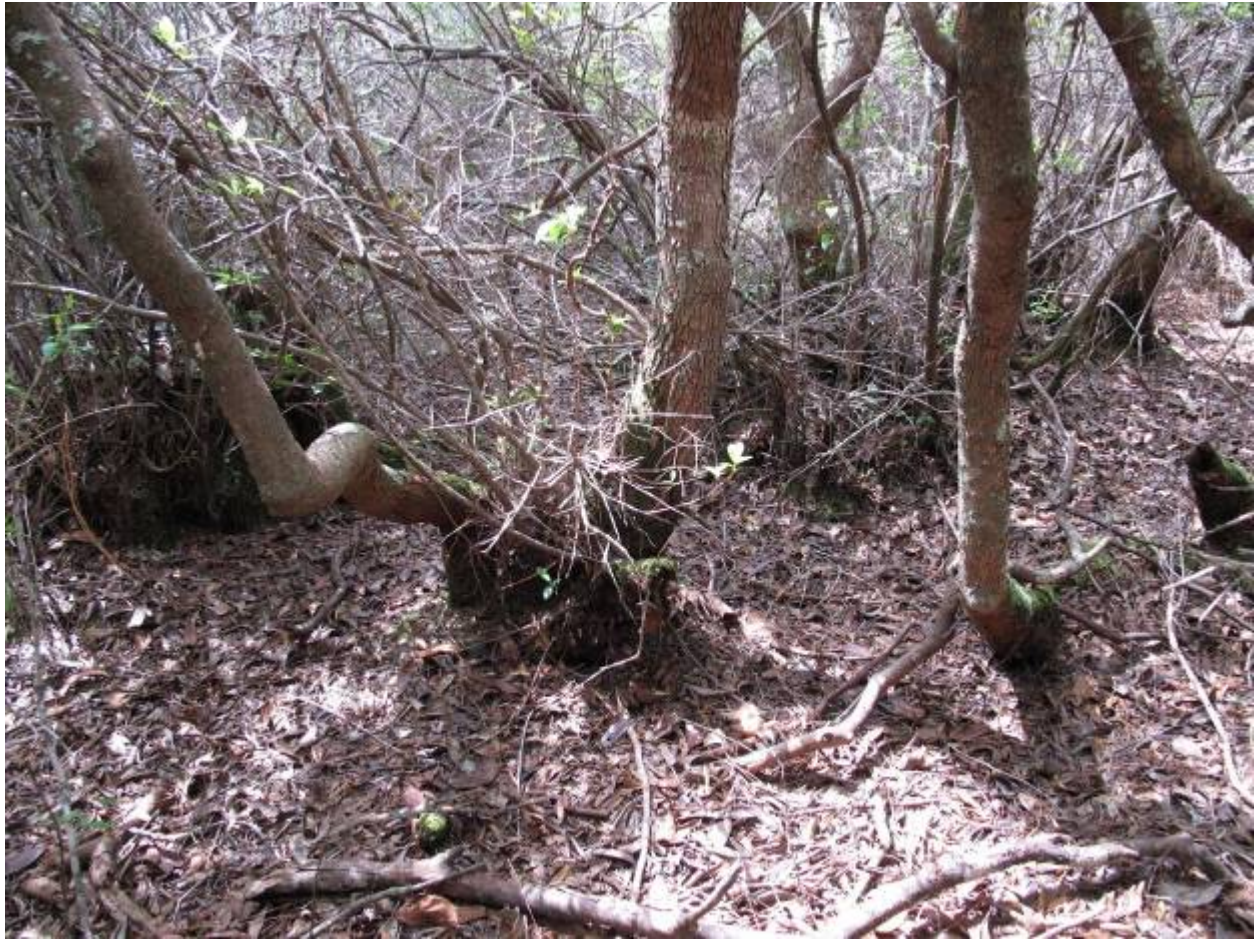
Wetland ID: 20-01

Description: This wetland is a 0.1 ha ephemeral shrub swamp. There is no tree canopy cover. Titi is the dominant woody vegetation, and covers >75% of the wetland. There is no herbaceous vegetation, and a thick layer of duff covers the wetland floor. A dirt road (Firebreak 14) and accompanying ditch run along the wetland's western edge. Historical aerial photos suggest this swamp was a much more open wetland. The adjacent uplands are mesic flatwoods that were bedded and converted to a pine plantation. Upland restoration is in progress.

Wetland Concerns: Road, Roadside ditch, Woody encroachment

Restoration Action Recommended: In order to restore the hydrology of this wetland and the larger wetland system, the road would have to be removed. Recognizing that this road is now a permanent attribute to the property, we do not recommend any action relating to the road or roadside ditches. Encourage periodic fire in the wetland to reduce the dense titi and thick duff.

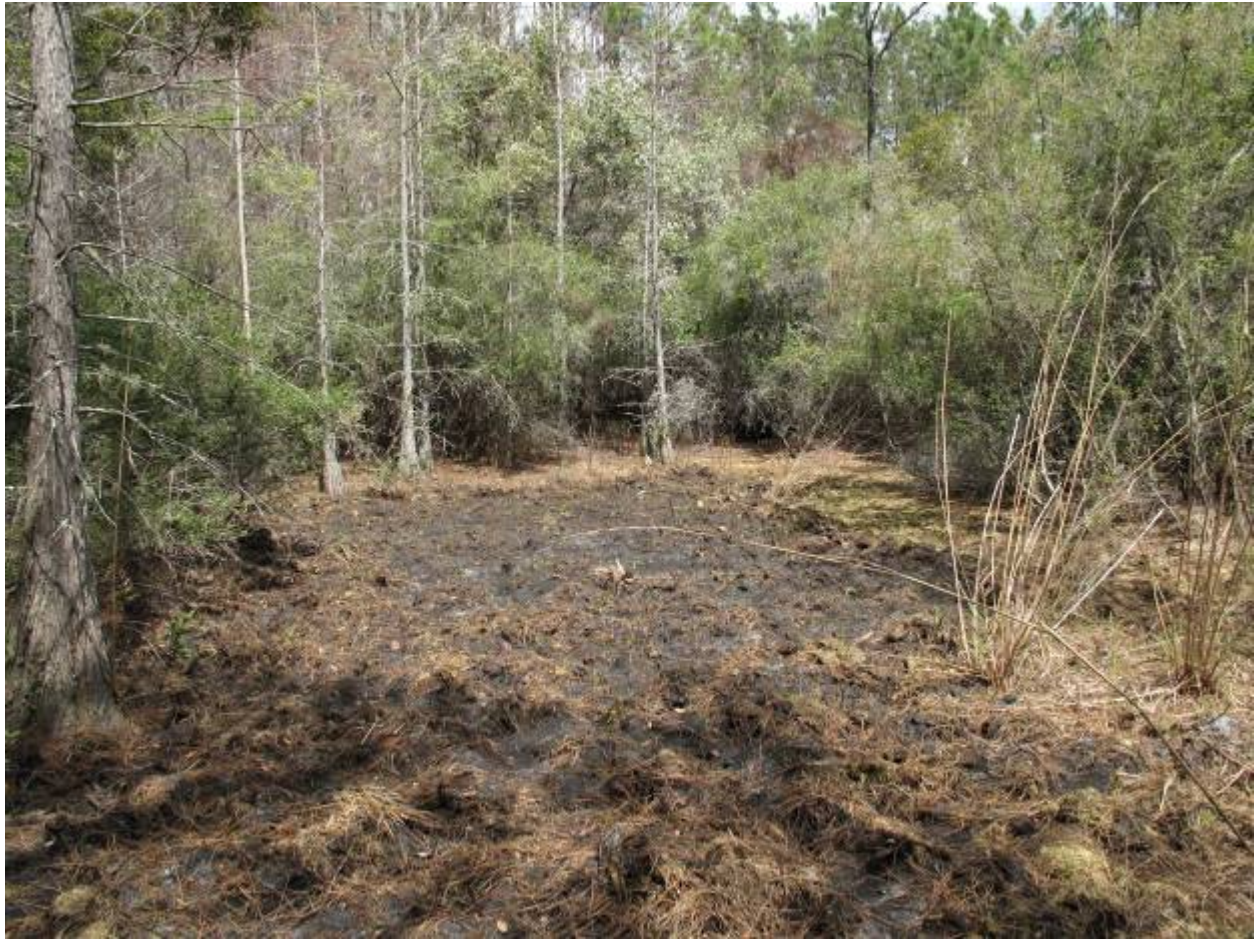
Wetland ID: 20-02

Description: This wetland is a 1.2 ha ephemeral shrub swamp. There is no tree canopy cover. Titi and fetterbush are the dominant woody vegetation, and cover >75% of the wetland. There is no herbaceous vegetation. This wetland has dense brush except for an open section on the west side, a result of feral hog rooting. Historical aerial photos suggest this swamp was a much more open wetland. The adjacent uplands are mesic flatwoods that were bedded and converted to a pine plantation. Upland restoration is in progress.

Wetland Concerns: Feral hog damage, Woody encroachment

Restoration Action Recommended: Encourage periodic fire in the wetland to reduce the dense brush.

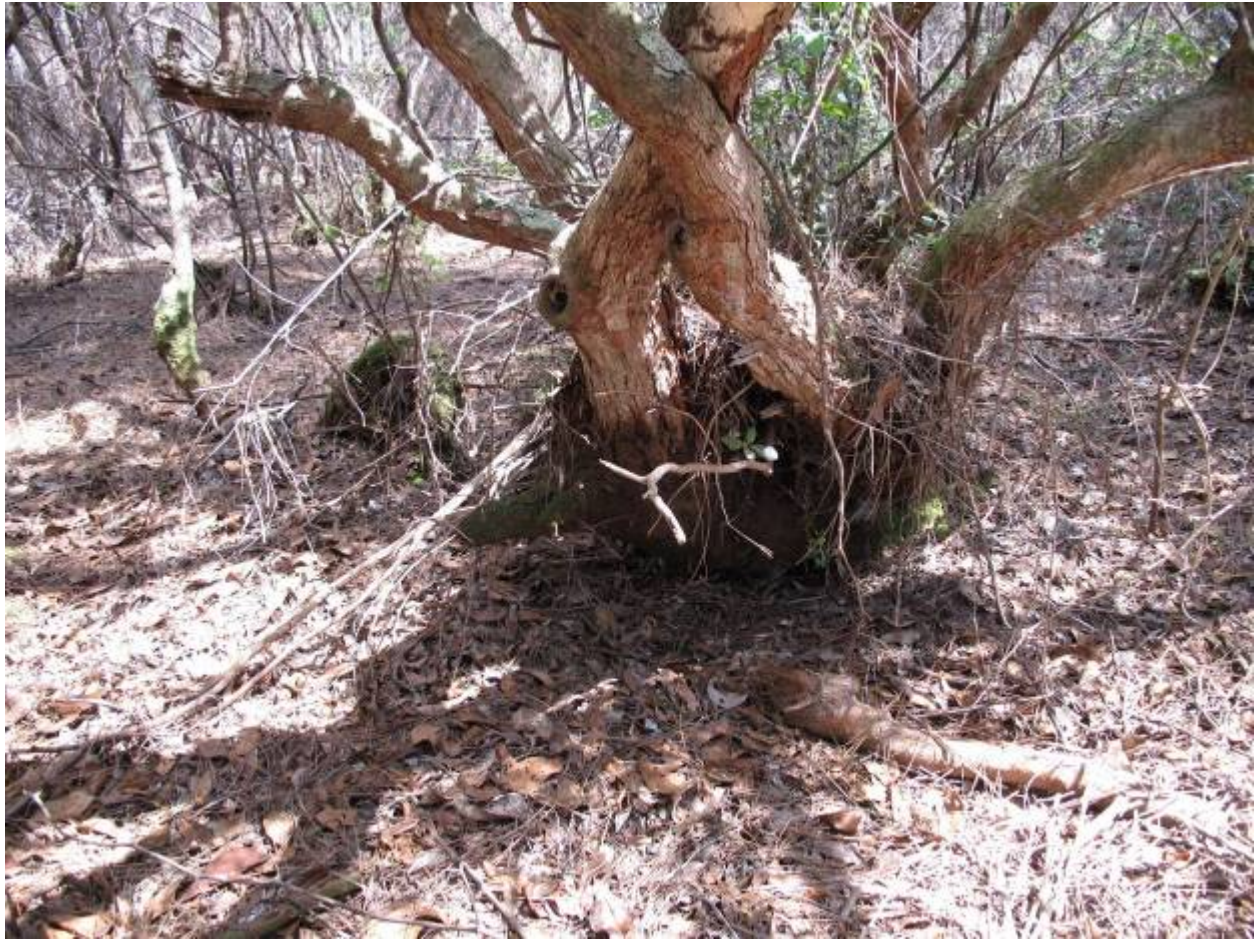
Wetland ID: 20-03

Description: This wetland is a <0.1 ha ephemeral shrub swamp. There is no tree canopy cover. Titi is the dominant woody vegetation, and covers >75% of the wetland. There is no herbaceous vegetation and there is a thick duff layer covering the wetland floor. A recent fire burned into the wetland edges. The adjacent uplands are mesic flatwoods that were bedded and converted to a pine plantation. Upland restoration is in progress.

Wetland Concerns: Woody encroachment

Restoration Action Recommended: Encourage periodic fire in the wetland to reduce the dense titi and thick duff layer.

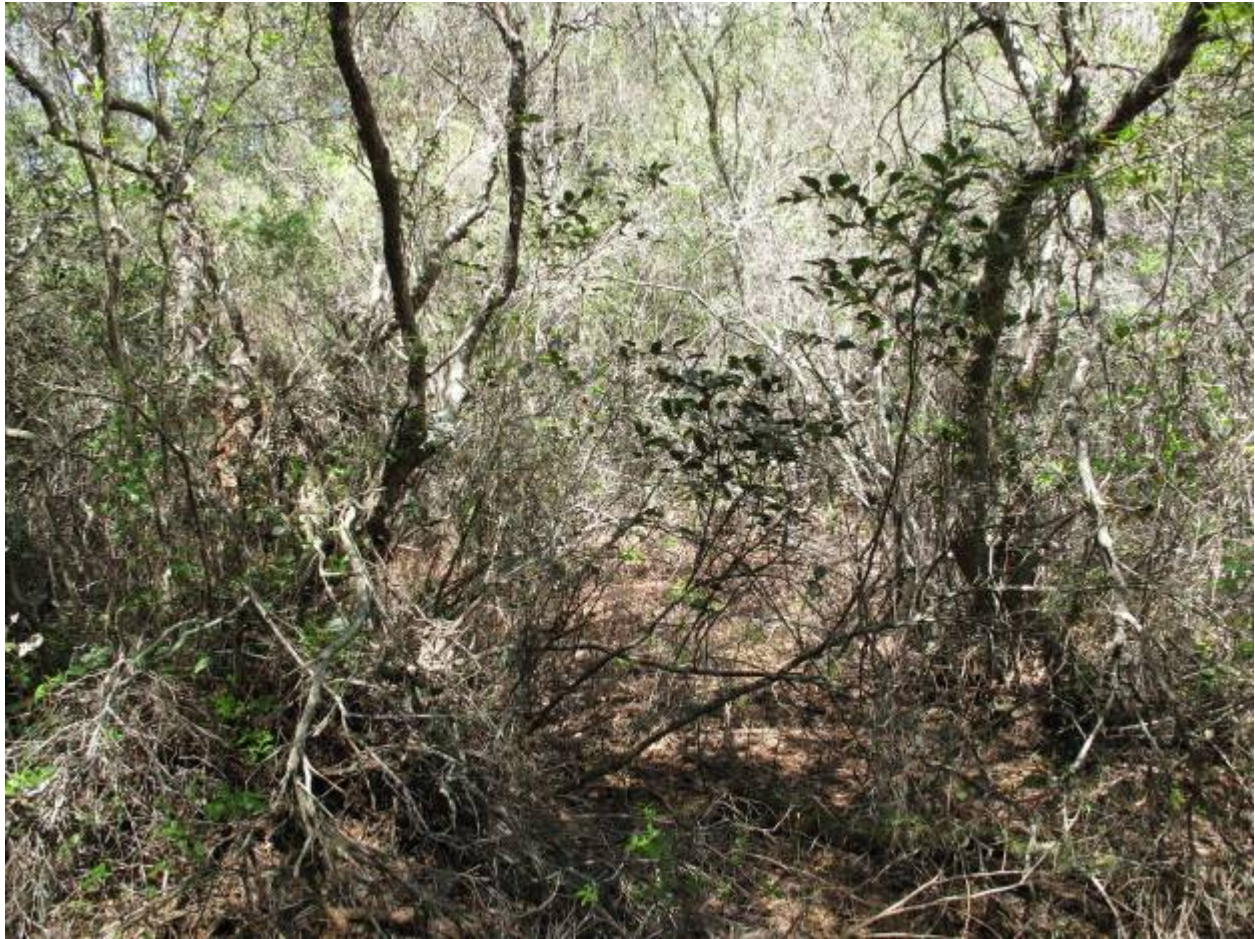
Wetland ID: 20-04

Description: This wetland is a 0.2 ha ephemeral shrub swamp. Titi and a few pine trees are growing on large hummocks in the wetland. There is no significant tree canopy cover. Titi covers >75% of the wetland. *Sphagnum* grows in scattered patches, and covers 5-25% of the basin. Historic aerial photos suggest this wetland, along with 20-05, once was part of a larger wetland system. The adjacent uplands are mesic flatwoods that were bedded and converted to a pine plantation. Upland restoration is in progress.

Wetland Concerns: Woody encroachment

Restoration Action Recommended: Encourage periodic fire in the wetland to reduce the dense titi.

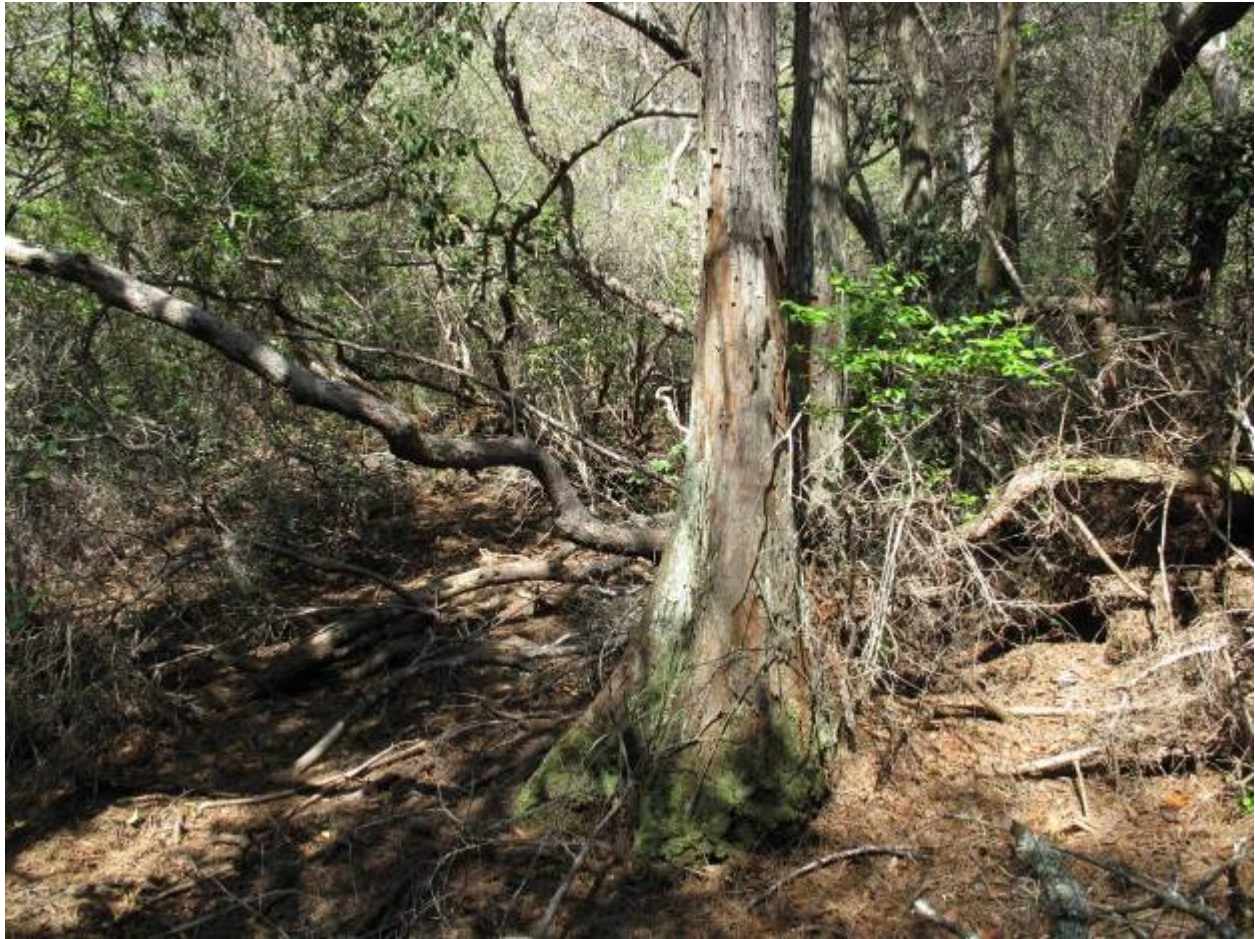
Wetland ID: 20-05

Description: This wetland is a 0.7 ha ephemeral shrub swamp. This former cypress swamp was logged and colonized by titi. Cypress trees dominate the canopy, and cover 5-25% of the wetland. The midstory is dominated by titi, and covers >75% of the wetland. There is no herbaceous vegetation. Hummocks have formed around the cypress stumps. There is a thick duff layer covering the wetland floor. Historic aerial photos suggest this wetland, along with 20-04, once was part of a larger wetland system. The adjacent uplands are mesic flatwoods that were bedded and converted to a pine plantation. Upland restoration is in progress.

Wetland Concerns: Woody encroachment

Restoration Action Recommended: The dense titi and hummocks could be reduced through the use of periodic fire.
