Inventory, Assessment, and Restoration Potential of Ephemeral Wetlands on FFWCC Wildlife Management Areas

Aucilla WMA Final Report

Submitted by: Rebecca P.M. Means¹, Ryan C. Means¹, Steven A. Johnson²

¹Coastal Plains Institute

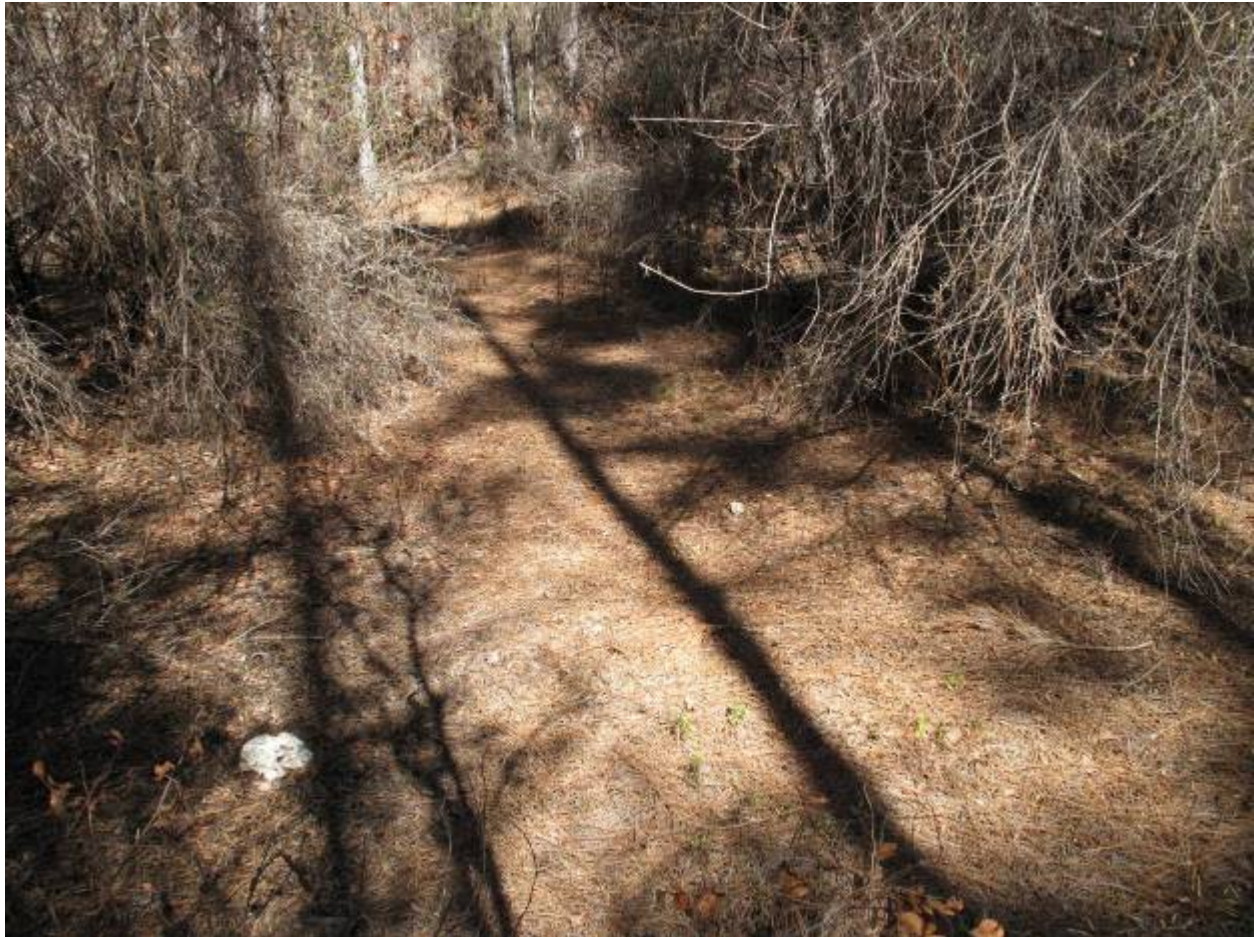
Wetland ID: 20-06

Description: This wetland is a <0.1 ha highly ephemeral shrub swamp. Planted pines grow on bedded rows into the wetland edge. The tree canopy covers 5-25% of the wetland. The midstory is dominated by titi, and covers 50-75% of the wetland. There is no herbaceous vegetation; the wetland has a pine needle-covered floor. A recent fire burned into the wetland depression. Historical aerial photos suggest this wetland was either non-existent or was a small marsh. The adjacent uplands are mesic flatwoods that were bedded and converted to a pine plantation. Upland restoration is in progress.

Wetland Concerns: Bedding, Planted pines, Woody encroachment

Restoration Action Recommended: No action to remove the bedding is recommended; the bedding rows will erode over time. Remove planted pine trees from the interior edge of the wetland. Encourage periodic fire to reduce the dense titi.

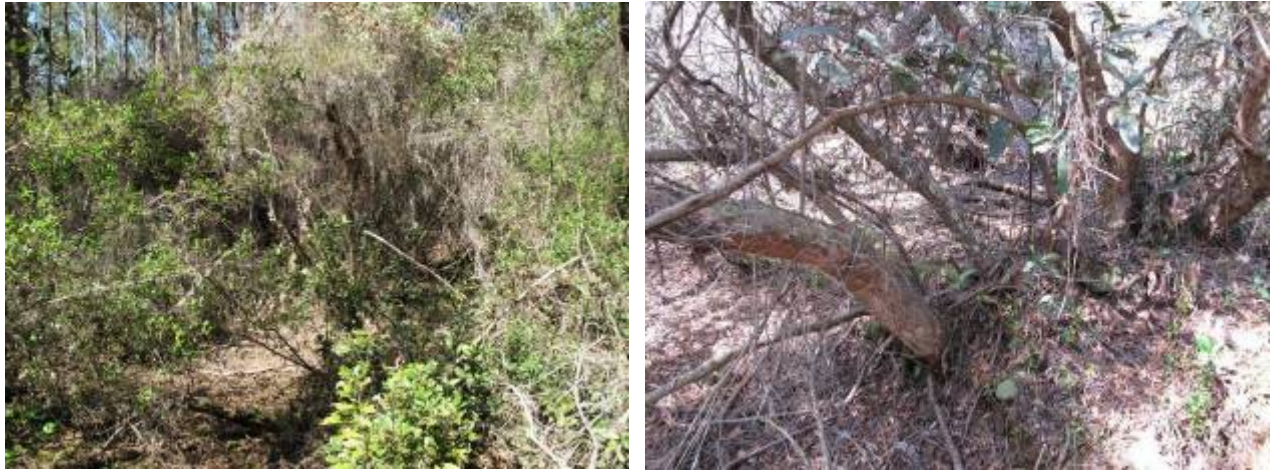
Wetland ID: 20-07

Description: This wetland is a <0.1 ha ephemeral shrub swamp. There is no tree canopy cover. Titi is the dominant woody vegetation, and covers 50-75% of the wetland. There is no herbaceous vegetation, and a thick layer of duff covers the wetland floor. There are some hummocks in the wetland. The adjacent uplands are mesic flatwoods that were bedded and converted to a pine plantation. Upland restoration is in progress.

Wetland Concerns: Woody encroachment

Restoration Action Recommended: Encourage periodic fire in the wetland to reduce the dense titi, the hummocks, and the thick duff layer.

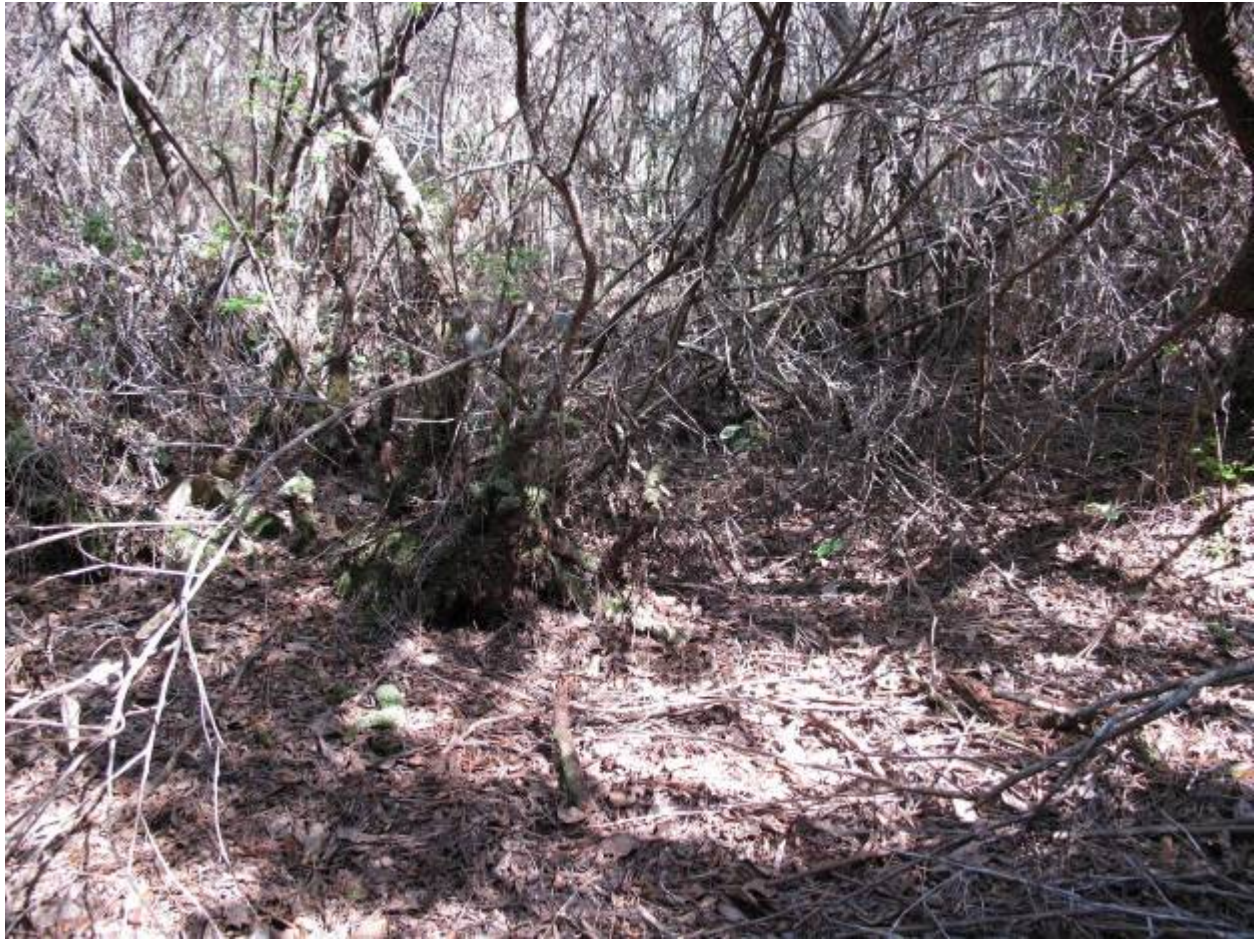
Wetland ID: 20-08

Description: This wetland is a <0.1 ha ephemeral shrub swamp. There is no tree canopy cover. Titi grows densely on small hummocks within the wetland. The titi covers >75% of the wetland. There is no herbaceous vegetation, and a thick layer of duff covers the wetland floor. Feral hog damage is light and restricted to the wetland edges. The adjacent uplands are mesic flatwoods that were bedded and converted to a pine plantation. Upland restoration is in progress.

Wetland Concerns: Feral hog damage, Woody encroachment

Restoration Action Recommended: Periodic fire in the wetland would reduce the dense titi and thick duff layer.

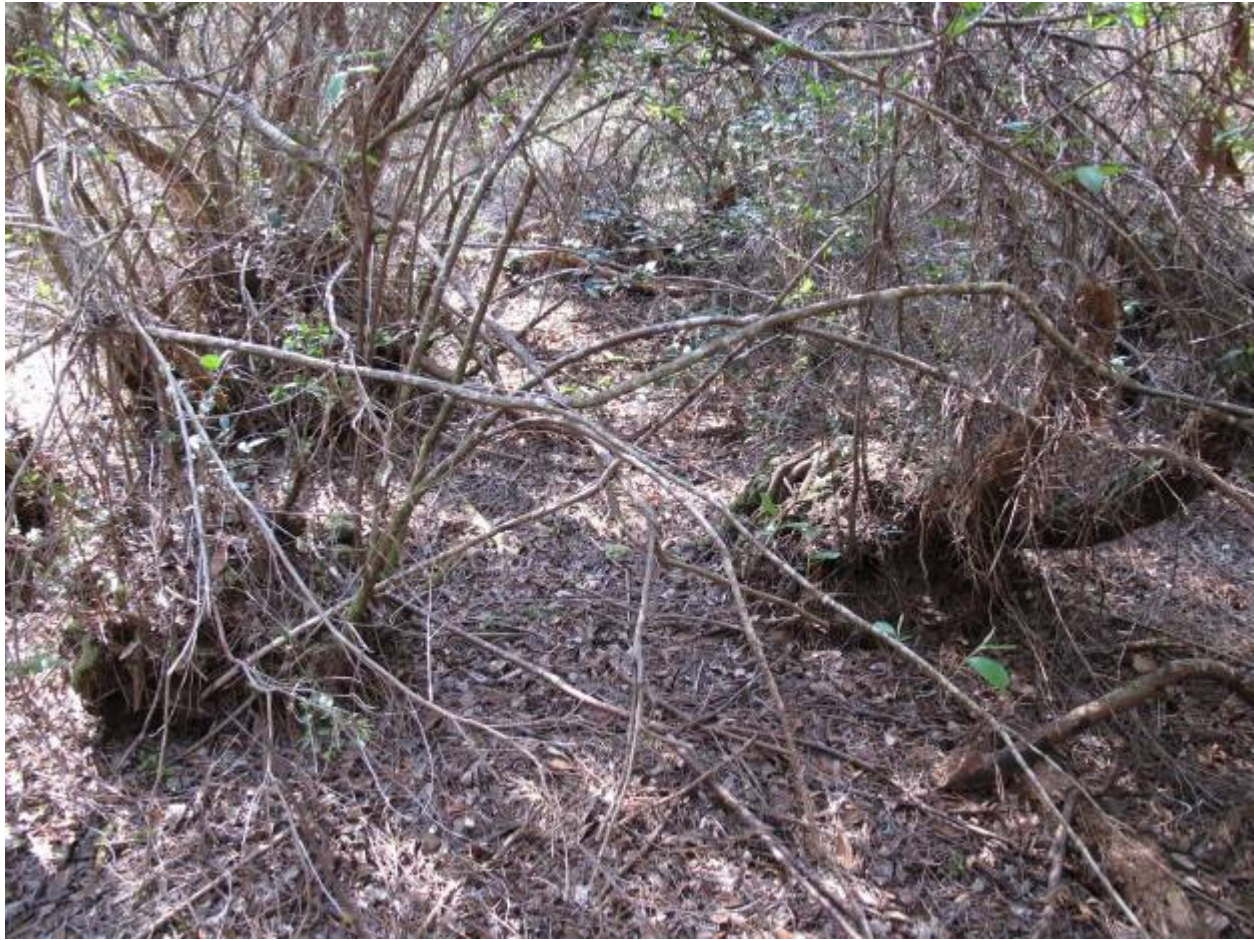
Wetland ID: 20-09

Description: This wetland is a <0.1 ha ephemeral shrub swamp. Gum trees dominate the canopy, and cover 5-25% of the wetland. Titi grow on large hummocks in the wetland, and cover >75% of the basin. There is no herbaceous vegetation, and a thick duff layer covers the wetland floor. The adjacent uplands are mesic flatwoods that were bedded and converted to a pine plantation. Upland restoration is in progress.

Wetland Concerns: Woody encroachment

Restoration Action Recommended: Periodic fire in the wetland would reduce the dense titi, the hummocks, and the thick duff layer.

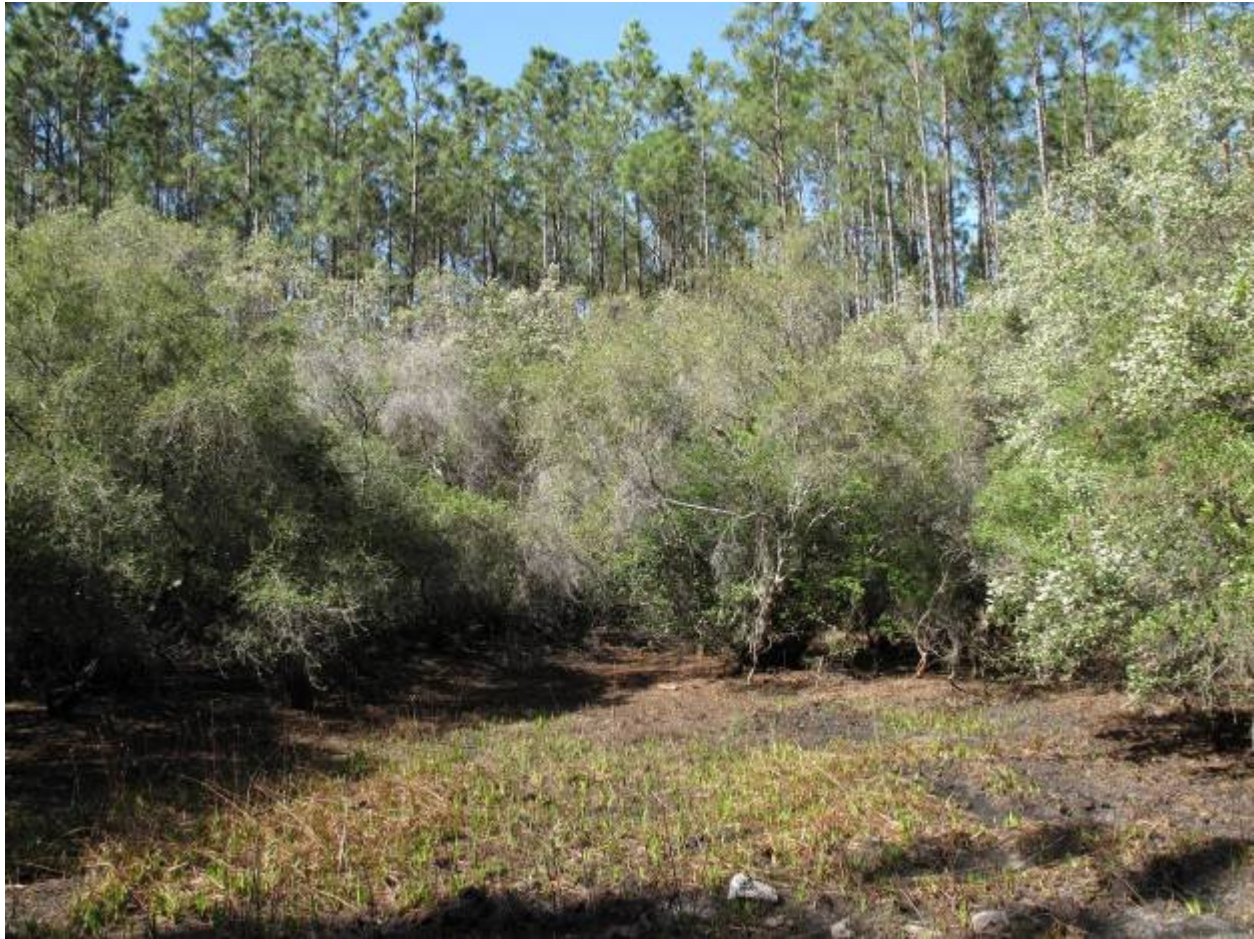
Wetland ID: 20-10

Description: This wetland is a 0.1 ha ephemeral marsh. There is no tree canopy cover. Titi grow on large hummocks around the wetland, and cover 5-25% of the wetland. Sedges/grasses and redroot grow throughout the wetland, and cover 25-50% of the basin. There is feral hog damage in the wetland center. The wetland appears to be a prehistoric archaeological chert quarry site. Chert boulders and abundant lithic debitage are exposed at the surface. The adjacent uplands are mesic flatwoods that were bedded and converted to a pine plantation. Upland restoration is in progress.

Wetland Concerns: Feral hog damage, Woody encroachment

Restoration Action Recommended: Encourage periodic fire in the wetland to reduce the dense titi ring and prevent further encroachment. Because this wetland appears to be an archaeological site, we recommend either not using any heavy, soil-disturbing machinery in this wetland or conferring with the Florida Division of Historical Resources.

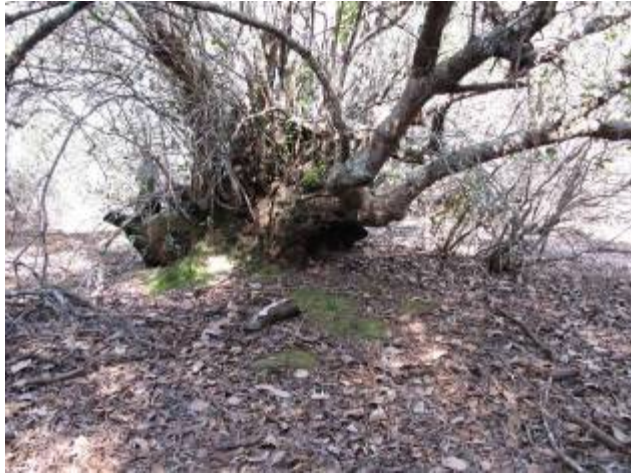
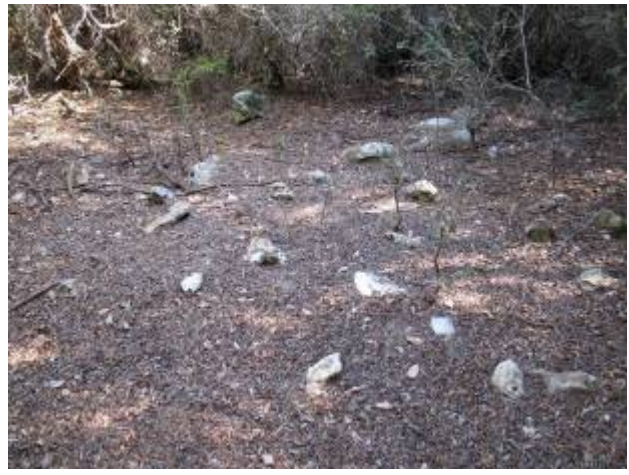
Wetland ID: 20-11

Description: This wetland is a 0.1 ha ephemeral shrub swamp. There is no tree canopy cover. Titi grows densely in and around the wetland, and covers >75% of the wetland. There is no herbaceous vegetation. The wetland appears to be a prehistoric archaeological chert quarry site. Chert boulders and abundant lithic debitage are exposed at the surface. The adjacent uplands are mesic flatwoods that were bedded and converted to a pine plantation. Upland restoration is in progress.

Wetland Concerns: Woody encroachment

Restoration Action Recommended: Encourage periodic fire in the wetland to reduce the dense titi. Because this wetland appears to be an archaeological site, we recommend either not using any heavy, soil-disturbing machinery in this wetland or conferring with the Florida Division of Historical Resources.

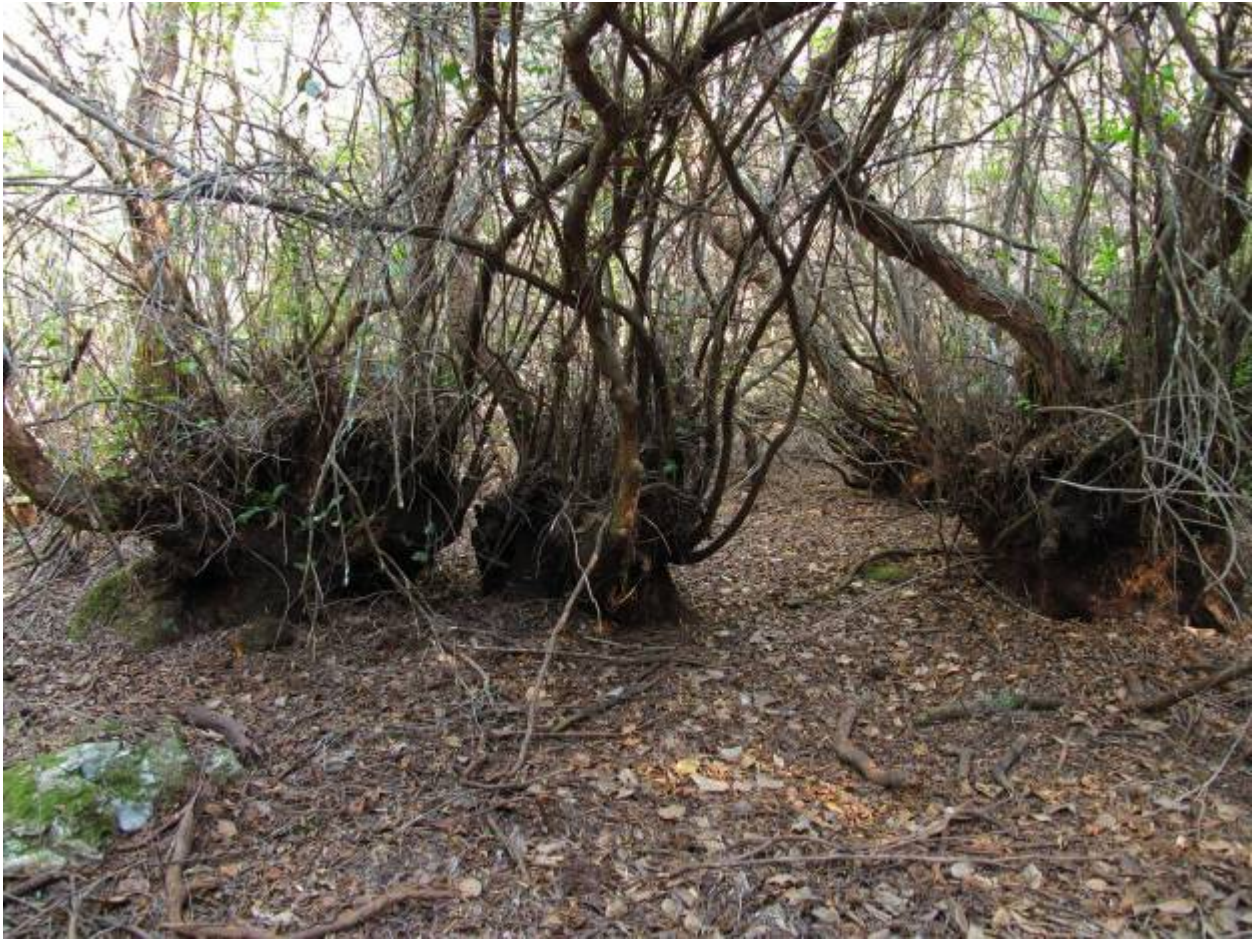
Wetland ID: 20-12

Description: This wetland is a 0.1 ha ephemeral shrub swamp. There is no tree canopy cover. Titi is the dominant woody vegetation, and covers >75% of the wetland. There is no herbaceous vegetation. There is feral hog damage in the wetland center. The wetland appears to be a prehistoric archaeological chert quarry site. Chert boulders and abundant lithic debitage are exposed at the surface. The adjacent uplands are mesic flatwoods that were bedded and converted to a pine plantation. Upland restoration is in progress.

Wetland Concerns: Feral hog damage, Woody encroachment

Restoration Action Recommended: Encourage periodic fire in the wetland to reduce the dense brush. Because this wetland appears to be an archaeological site, we recommend either not using any heavy, soil-disturbing machinery in this wetland or conferring with the Florida Division of Historical Resources.

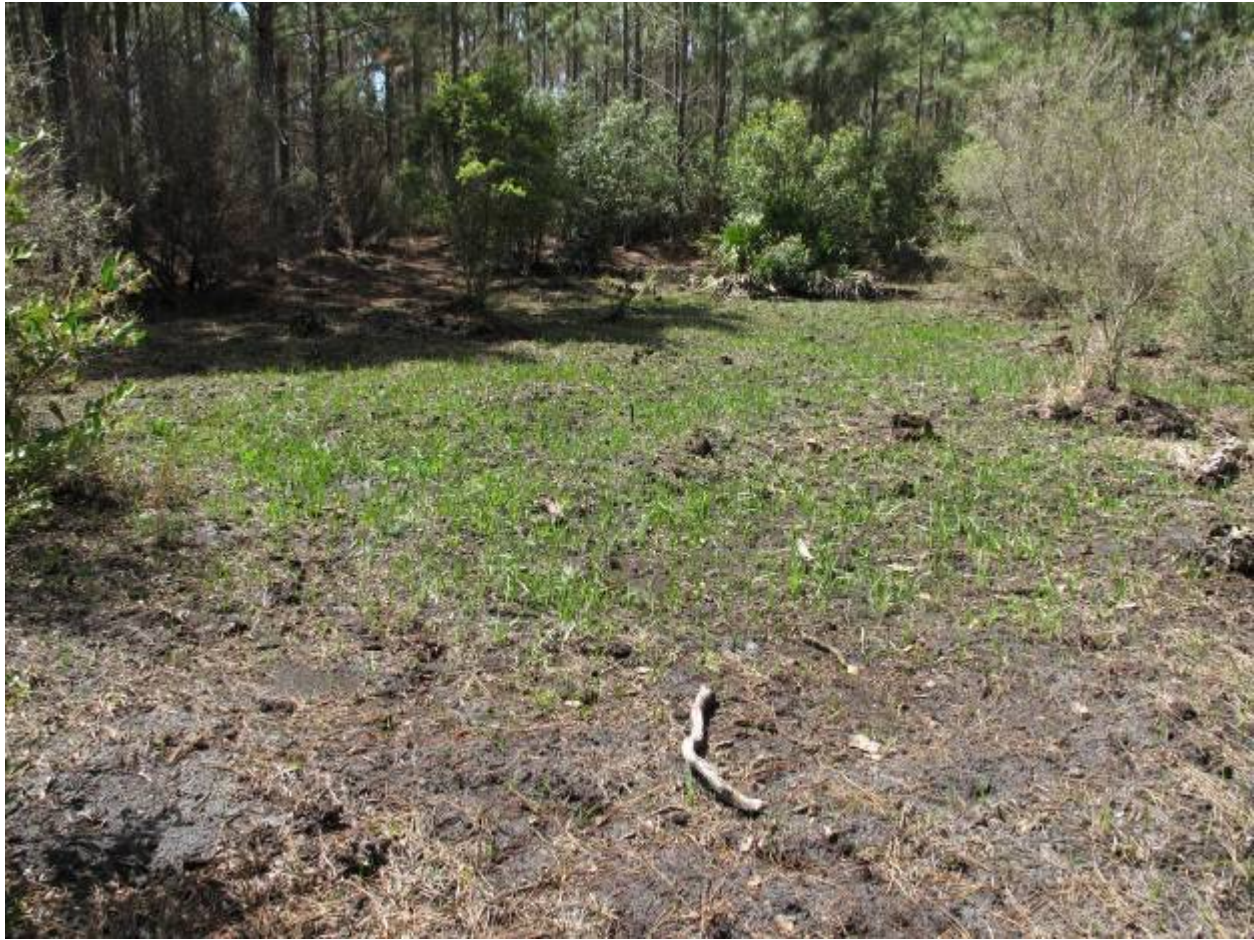
Wetland ID: 20-13

Description: This wetland is a 0.1 ha highly ephemeral marsh. There is no tree canopy cover. Titi is the dominant woody vegetation, and covers 5-25% of the wetland. Redroot grows throughout the wetland, and covers 25-50% of the basin. A recent fire burned all the way through the wetland basin. Old bedding rows are almost completely eroded. Feral hog damage is evident in the wetland but is not severe. The adjacent uplands are mesic flatwoods that were bedded and converted to a pine plantation. Upland restoration is in progress.

Wetland Concerns: Feral hog damage

Restoration Action Recommended: None

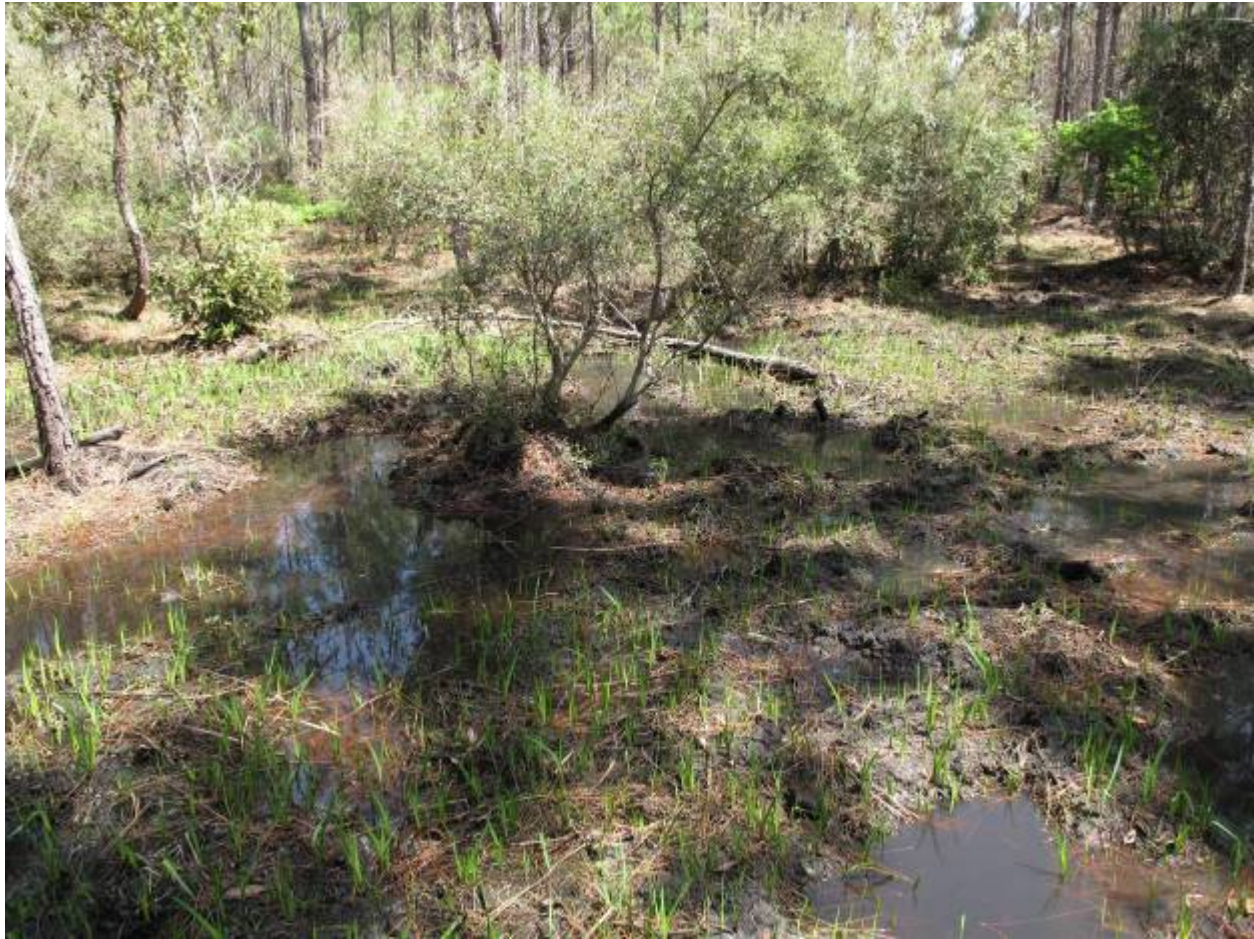
Wetland ID: 20-14

Description: This wetland is a <0.1 ha ephemeral marsh. Pine trees grow on bedded rows through the wetland. The tree canopy covers 5-25% of the wetland. The midstory is dominated by titi, and covers 5-25% of the wetland. Redroot grows throughout the wetland, and covers 25-50% of the basin. Feral hog damage is severe. A recent fire burned all the way through the wetland. Historical aerial photos suggest this wetland (along with 20-15, 20-20, and possibly others) was part of a larger wetland system before pine plantation conversion. The adjacent uplands are mesic flatwoods that were bedded and converted to a pine plantation. Upland restoration is in progress.

Wetland Concerns: Bedding, Feral hog damage, Planted pine trees

Restoration Action Recommended: No action to remove the bedding is recommended; the bedding rows will erode over time. Remove the planted pine trees from the wetland interior.

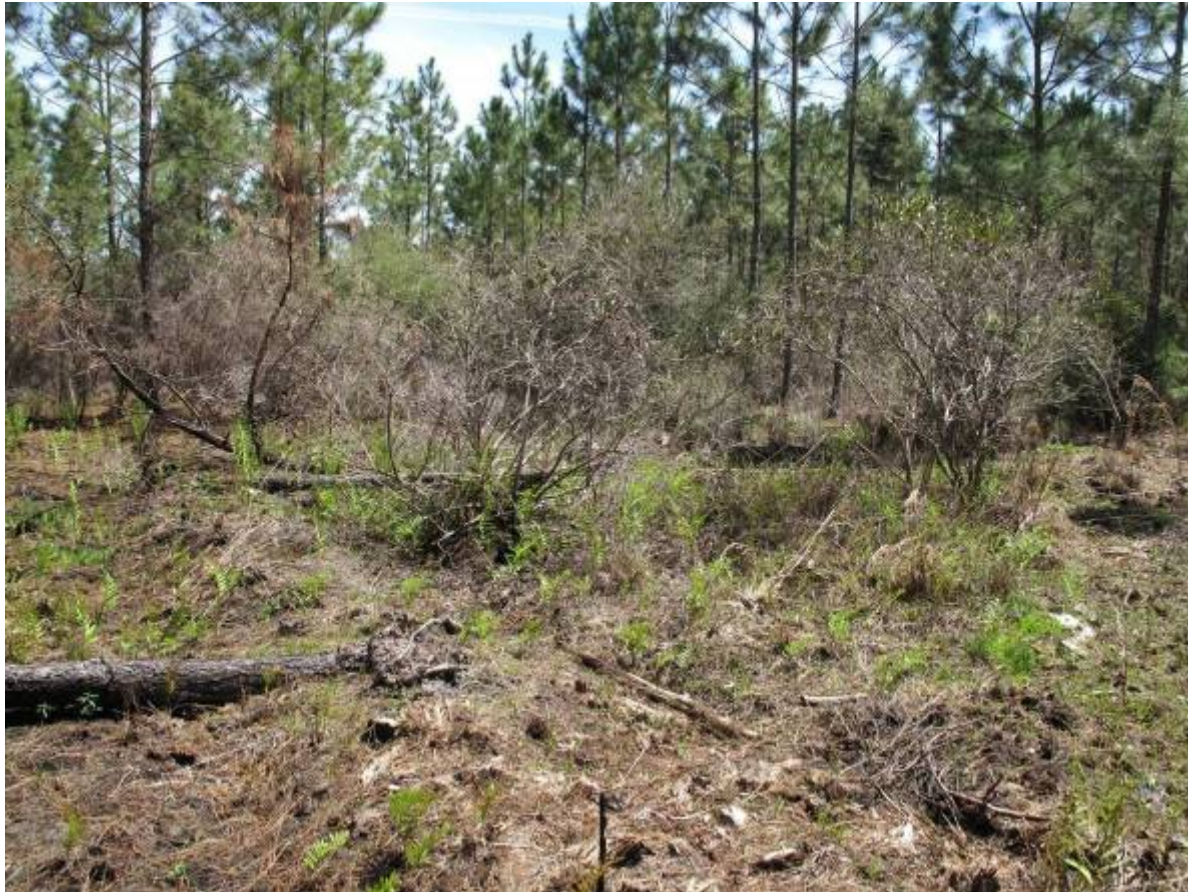
Wetland ID: 20-15

Description: This wetland is a <0.1 ha highly ephemeral marsh. There is no tree canopy cover. Titi and buttonbush are the dominant woody vegetation, and cover 5-25% of the wetland. Grass, fern, and redroot grow throughout the wetland, and cover 25-50% of the basin. This small pond has extensive bedding and feral hog damage. It appears to be a prehistoric archaeological chert quarry site as evidenced by chert boulders and debitage. A fire recently burned through the wetland basin. Historical aerial photos suggest this wetland (along with 20-14, 20-20, and possibly others) was part of a larger wetland system before pine plantation conversion. The adjacent uplands are mesic flatwoods that were bedded and converted to a pine plantation. Upland restoration is in progress.

Wetland Concerns: Bedding, Feral hog damage

Restoration Action Recommended: Because this wetland already is extensively damaged by feral hogs, we recommend mechanically removing the bedding rows and encouraging periodic fire in the wetland. However, it appears to be an archaeological site so we recommend using caution with machinery here and also conferring with the Florida Division of Historical Resources.

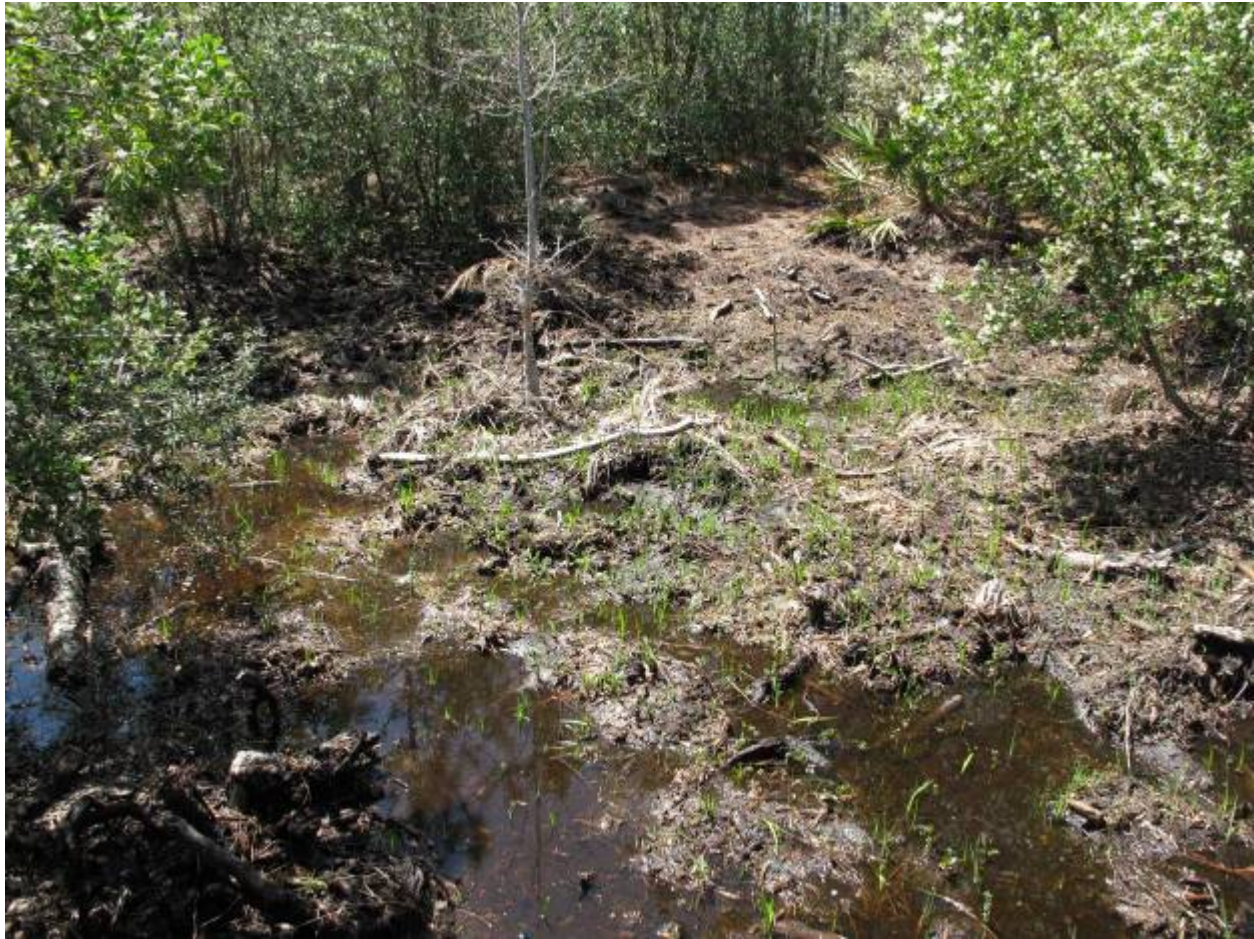
Wetland ID: 20-16

Description: This wetland is a 1.0 ha semi-permanent shrub swamp. The presence of old cypress stumps provides evidence of historical logging. The cypress trees are regenerating and cover 5-25% of the wetland. The midstory is dominated by titi, and covers >75% of the wetland. There is no herbaceous vegetation. Hummocks have formed around old cypress stumps. There is feral hog damage in the wetland center. The adjacent uplands are mesic flatwoods that were bedded and converted to a pine plantation. Upland restoration is in progress.

Wetland Concerns: Feral hog damage, Woody encroachment

Restoration Action Recommended: Encourage periodic fire in the wetland to reduce the dense titi and open the midstory.

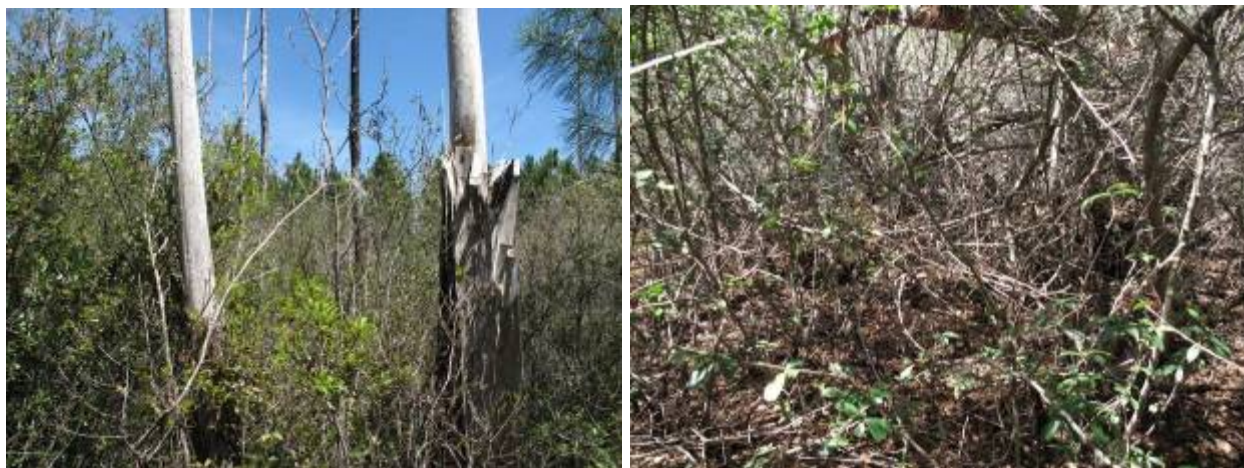
Wetland ID: 20-17

Description: This wetland is a 0.2 ha ephemeral shrub swamp. There is no tree canopy cover. Titi is the dominant woody vegetation, and covers >75% of the wetland. There is no herbaceous vegetation. Old stumps provide evidence that cypress trees historically occupied the wetland. A hot fire reduced the duff and killed many regenerating cypress trees. Dense titi remains. Historical aerial photos suggest this wetland (along with 20-18 and 20-19) was part of a larger wetland system before pine plantation conversion. The adjacent uplands are mesic flatwoods that were bedded and converted to a pine plantation. Upland restoration is in progress.

Wetland Concerns: Woody encroachment

Restoration Action Recommended: Return periodic fire into the wetland to reduce the dense titi.

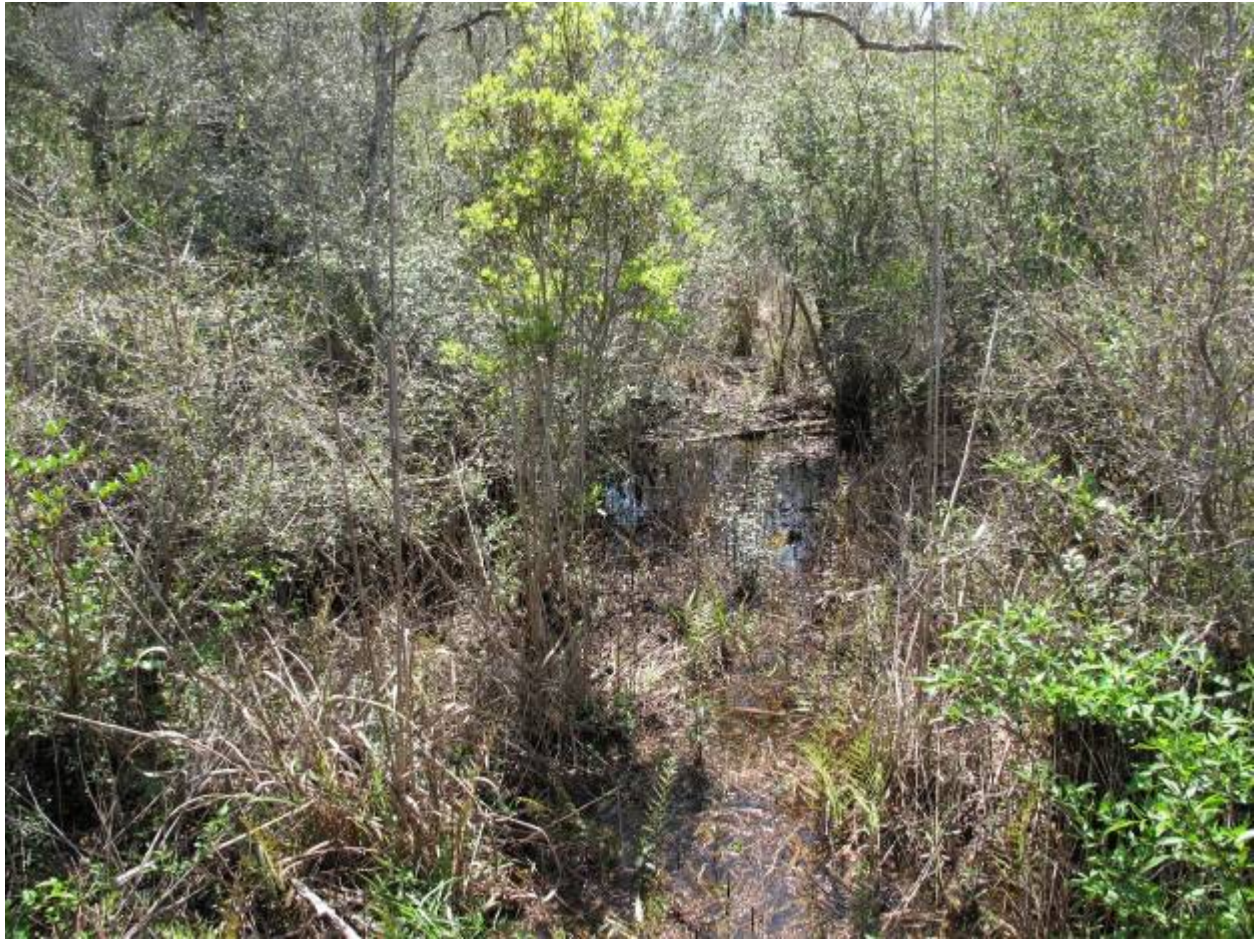
Wetland ID: 20-18

Description: This wetland is a 0.2 ha ephemeral shrub swamp. There is no tree canopy cover. Titi is the dominant woody vegetation, and covers 50-75% of the wetland. Sedges/grasses and fern grow throughout the wetland, and cover 5-25% of the basin. The vegetation in the wetland is diverse. Old stumps provide evidence that cypress trees historically occupied the wetland. Hummocks in the wetland are probably a result of cypress stumps. There are some old bedding rows on the south side of the wetland. A fire burned the wetland about 5-10 years ago, reducing the duff and shrubs. Historical aerial photos suggest this wetland (along with 20-17 and 20-19) was part of a larger wetland system before pine plantation conversion. The adjacent uplands are mesic flatwoods that were bedded and converted to a pine plantation. Upland restoration is in progress.

Wetland Concerns: None

Restoration Action Recommended: The wetland is currently functioning as a healthy shrub swamp with diverse vegetation. If WMA personnel wish to restore this wetland back to a cypress swamp, a hot fire is needed to kill the titi and more frequent fire periodicity would be needed to prevent titi from encroaching.

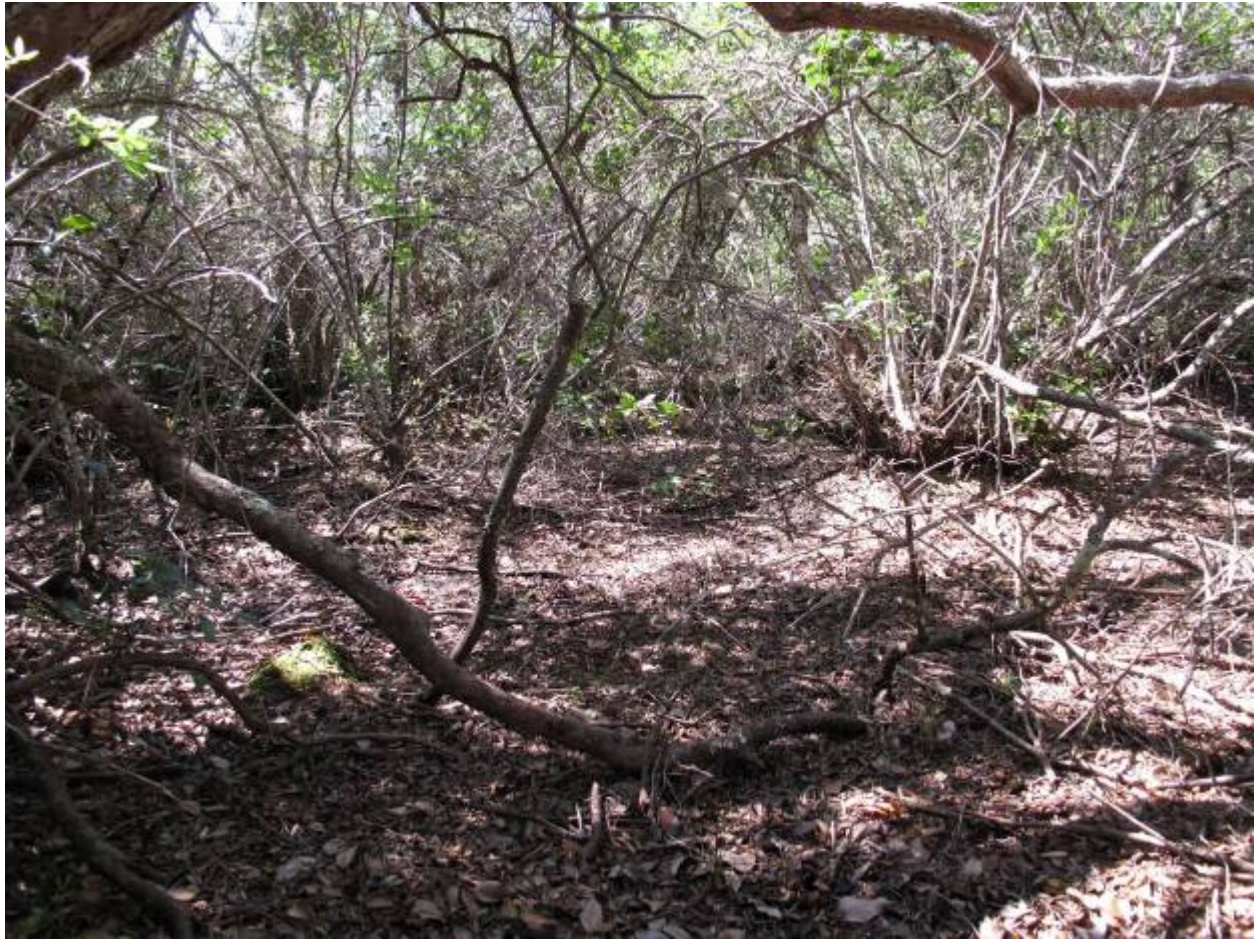
Wetland ID: 20-19

Description: This wetland is a 0.1 ha ephemeral shrub swamp. There is no tree canopy cover. Titi is the dominant woody vegetation, and covers >75% of the wetland. There is no herbaceous vegetation, and a thick duff layer covers the wetland. Old stumps provide evidence that cypress trees historically occupied the wetland. Large hummocks, probably evolved from the cypress stumps, support dense growths of titi. Feral hogs have created open areas in the wetland. Historical aerial photos suggest this wetland (along with 20-17, 20-18) was part of a larger wetland system before pine plantation conversion. The adjacent uplands are mesic flatwoods that were bedded and converted to a pine plantation. Upland restoration is in progress.

Wetland Concerns: Feral hog damage, Woody encroachment

Restoration Action Recommended: Periodic fire in the wetland should reduce the large hummocks and thin the dense titi.

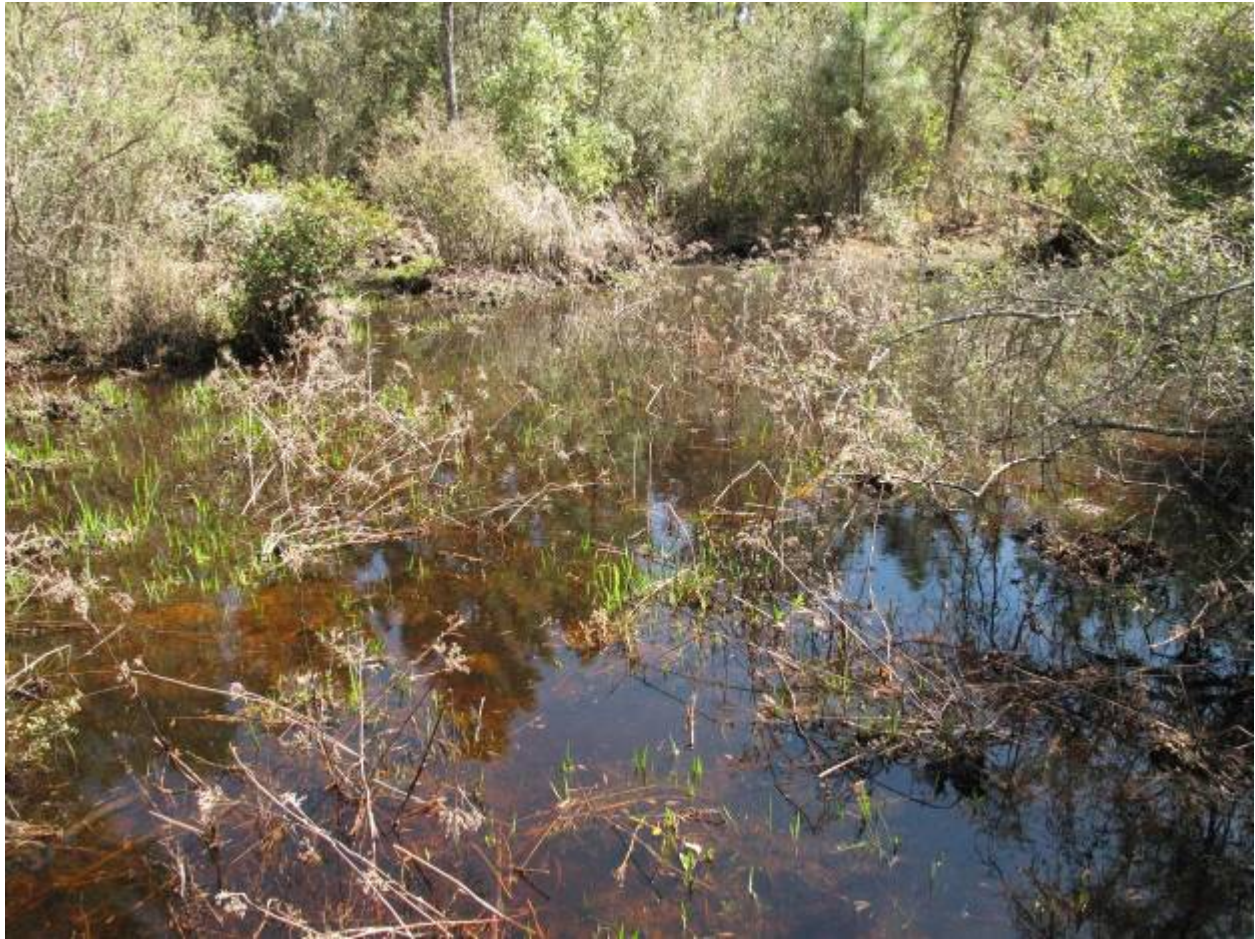
Wetland ID: 20-20

Description: This wetland is a 0.1 ha ephemeral shrub swamp. There is no tree canopy cover. Titi grows densely on hummocks, and covers >75% of the wetland. There is no herbaceous vegetation. The wetland has a few open patches created by feral hogs. Bedding rows are still evident around the wetland edges. Historical aerial photos suggest this wetland (along with 20-14, 20-15, and possibly others) was part of a larger wetland system before pine plantation conversion. The adjacent uplands are mesic flatwoods that were bedded and converted to a pine plantation. Upland restoration is in progress.

Wetland Concerns: Bedding, Feral hog damage, Woody encroachment

Restoration Action Recommended: Periodic fire in the wetland should reduce the hummocks and thin the dense titi.

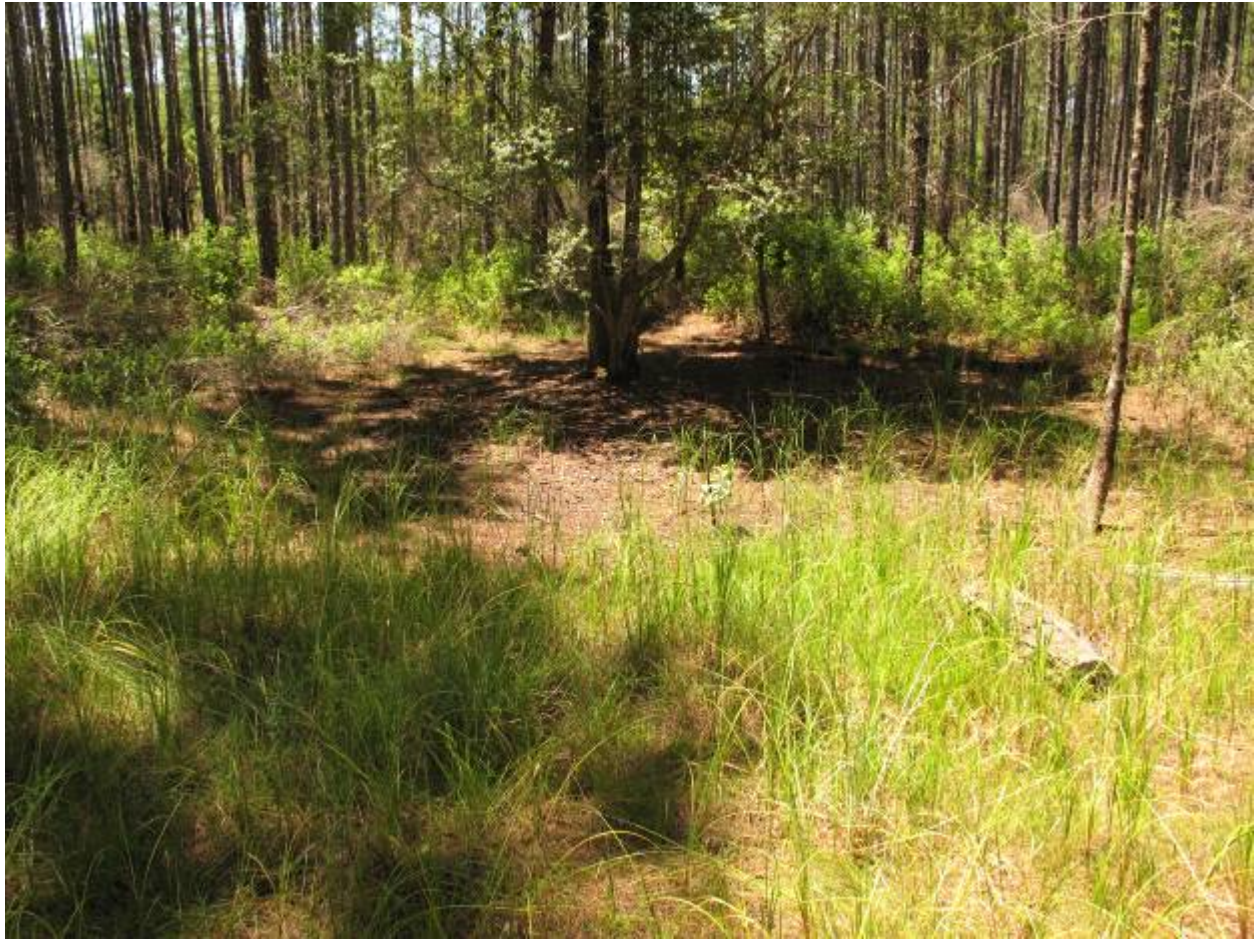
Wetland ID: 28-01

Description: This wetland is a <0.1 ha ephemeral marsh. A large gum tree and a holly tree grow in the wetland center, and cover 25-50% of the wetland. Sawgrass grows in scattered patches, and covers 25-50% of the basin. There are some old, eroding bedding rows still evident in the wetland. The adjacent uplands are mesic flatwoods that were bedded and converted to a pine plantation. Upland restoration is in progress.

Wetland Concerns: None

Restoration Action Recommended: None

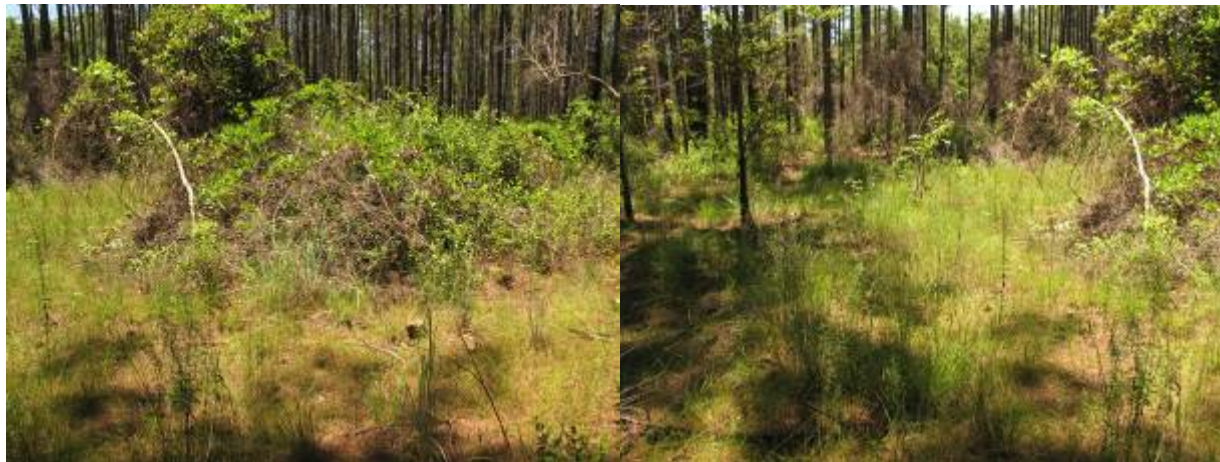
Wetland ID: 28-02

Description: This wetland is a <0.1 ha ephemeral marsh. Pine trees were planted on bedding rows through the wetland. A few pine trees remain in the north end of the wetland, and cover 5-25% of the basin. There is a *Smilax* thicket in the center of the wetland that covers 5-25% of the basin. Sedges/grasses grow throughout the wetland, and cover 50-75% of the basin. A recent fire burned through the wetland, killing much of the encroaching woody vegetation. The adjacent uplands are mesic flatwoods that were bedded and converted to a pine plantation. Upland restoration is in progress.

Wetland Concerns: Bedding, Planted pines, Woody encroachment

Restoration Action Recommended: No action to remove the bedding is recommended; the bedding rows will erode over time. Remove the 3-5 large pine trees that are in the north end of the wetland. Continue managing this wetland with fire to prevent further woody encroachment.

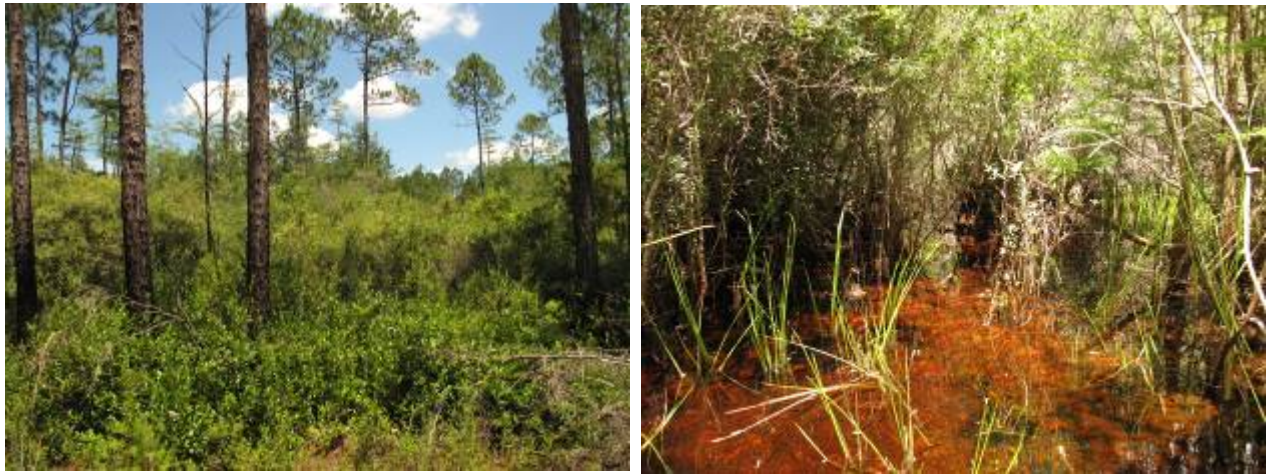
Wetland ID: 28-03

Description: This wetland is a 1.0 ha ephemeral shrub swamp. Cypress and pine trees dominate the canopy, and cover 5-25% of the wetland. The midstory is dominated by titi, and covers >75% of the wetland. Sedges/grasses grow in scattered patches, and cover 5-25% of the wetland. Hummocks in the wetland likely formed around old tree stumps. The adjacent uplands are mesic flatwoods that were bedded and converted to a pine plantation. Upland restoration is in progress.

Wetland Concerns: Woody encroachment

Restoration Action Recommended: Encourage periodic fire in the wetland to reduce the dense titi.
