Inventory, Assessment, and Restoration Potential of Ephemeral Wetlands on FFWCC Wildlife Management Areas

Aucilla WMA Final Report

Submitted by: Rebecca P.M. Means¹, Ryan C. Means¹, Steven A. Johnson²

¹Coastal Plains Institute

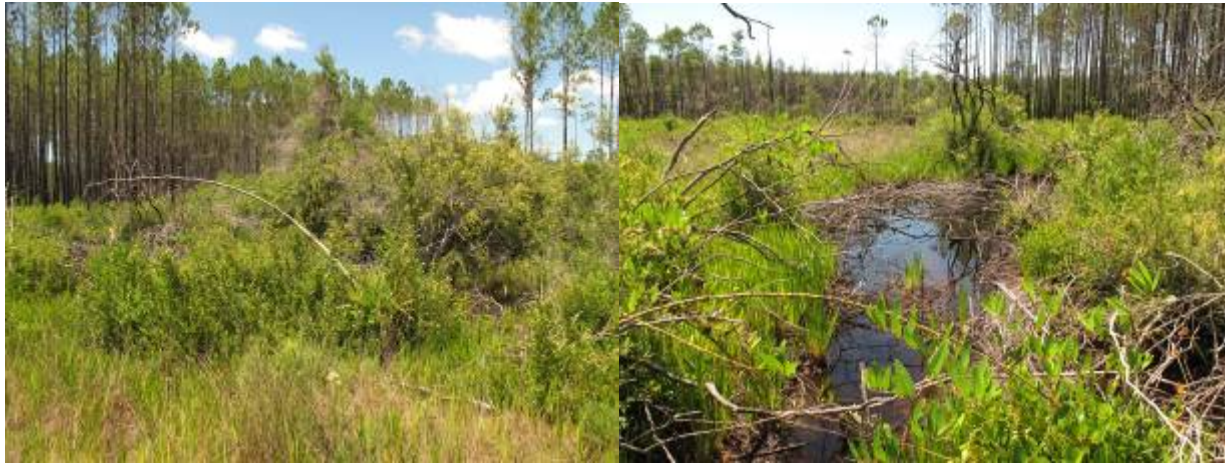
Wetland ID: 28-04

Description: This wetland is a 0.1 ha ephemeral shrub swamp. There is no tree canopy. Titi is the dominant woody vegetation, and covers 50-75% of the wetland. *Sphagnum* and redroot grow in scattered patches, and cover 5-25% of the wetland. Feral hog damage is old. The adjacent uplands are mesic flatwoods that were bedded and converted to a pine plantation. Upland restoration is in progress.

Wetland Concerns: Feral hog damage, Woody encroachment

Restoration Action Recommended: Encourage periodic fire in the wetland to reduce the dense brush.

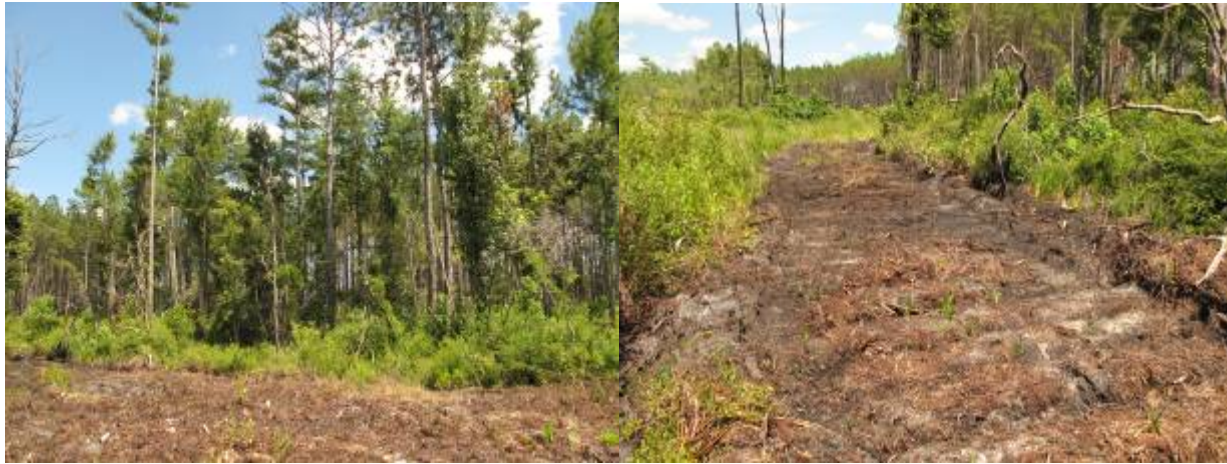
Wetland ID: 28-05

Description: This wetland is a 0.1 ha ephemeral mixed swamp. Cypress and gum trees dominate the canopy, and cover >75% of the wetland. The midstory is dominated by titi, and covers 50-75% of the wetland. There is no herbaceous vegetation. There is a vehicular/machine track through the north end of the wetland, likely a result of recent upland restoration activities. This wetland was impacted by woody encroachment until a recent fire burned through the wetland and killed much of the titi. The wetland is now in fire-maintenance condition. The adjacent uplands are mesic flatwoods that were bedded and converted to a pine plantation. Upland restoration is in progress.

Wetland Concerns: None

Restoration Action Recommended: None

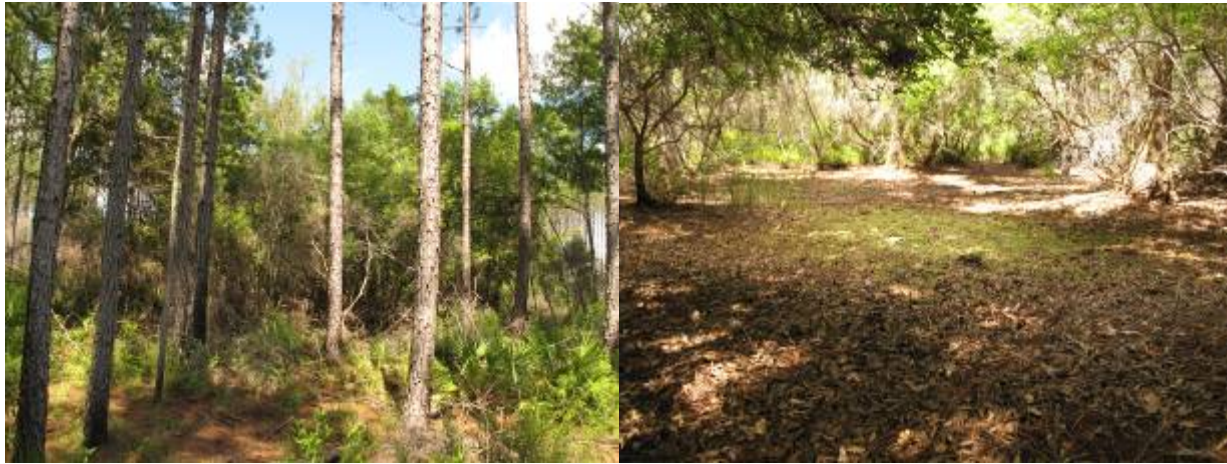
Wetland ID: 28-06

Description: This wetland is a 0.1 ha ephemeral mixed swamp. Gum trees dominate the canopy, and cover 50-75% of the wetland. The midstory is dominated by titi, and covers >75% of the wetland. There is no herbaceous vegetation. The wetland appears to be in fire-maintenance condition and is a good example of a mixed swamp. The adjacent uplands are mesic flatwoods that were bedded and converted to a pine plantation. Upland restoration is in progress.

Wetland Concerns: None

Restoration Action Recommended: None

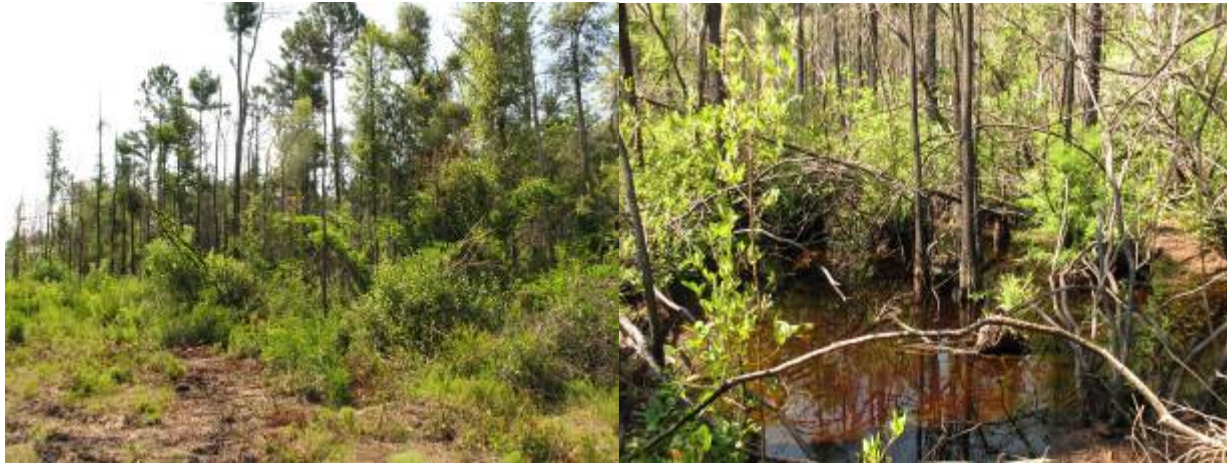
Wetland ID: 28-07

Description: This wetland is a 0.4 ha ephemeral mixed swamp. Cypress and pine trees dominate the canopy, and cover 50-75% of the wetland. The midstory is dominated by titi, and covers 50-75% of the wetland. There is no herbaceous vegetation. This wetland was impacted by woody encroachment until a recent fire burned through the wetland and left many dead titi and cypress snags. The wetland is now in fire-maintenance condition. Deep needle and leaf duff remains on the wetland floor. The adjacent uplands are mesic flatwoods that were bedded and converted to a pine plantation. Upland restoration is in progress.

Wetland Concerns: None

Restoration Action Recommended: None

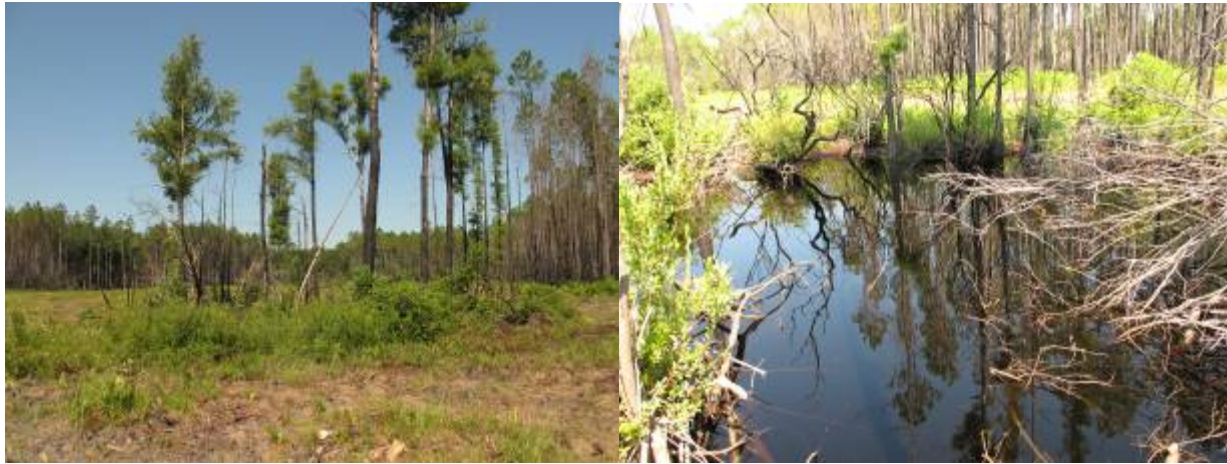
Wetland ID: 28-08

Description: This wetland is a <0.1 ha ephemeral mixed swamp. Cypress trees dominate the canopy, and cover 25-50% of the wetland. The midstory is dominated by titi, and covers 50-75% of the wetland. There is no herbaceous vegetation. This wetland was impacted by woody encroachment until a recent fire burned through the wetland and left many dead titi and cypress snags. A dense ring of brush surrounding the wetland was also killed. The wetland is now in fire-maintenance condition. The adjacent uplands are mesic flatwoods that were bedded and converted to a pine plantation. Upland restoration is in progress.

Wetland Concerns: None

Restoration Action Recommended: None

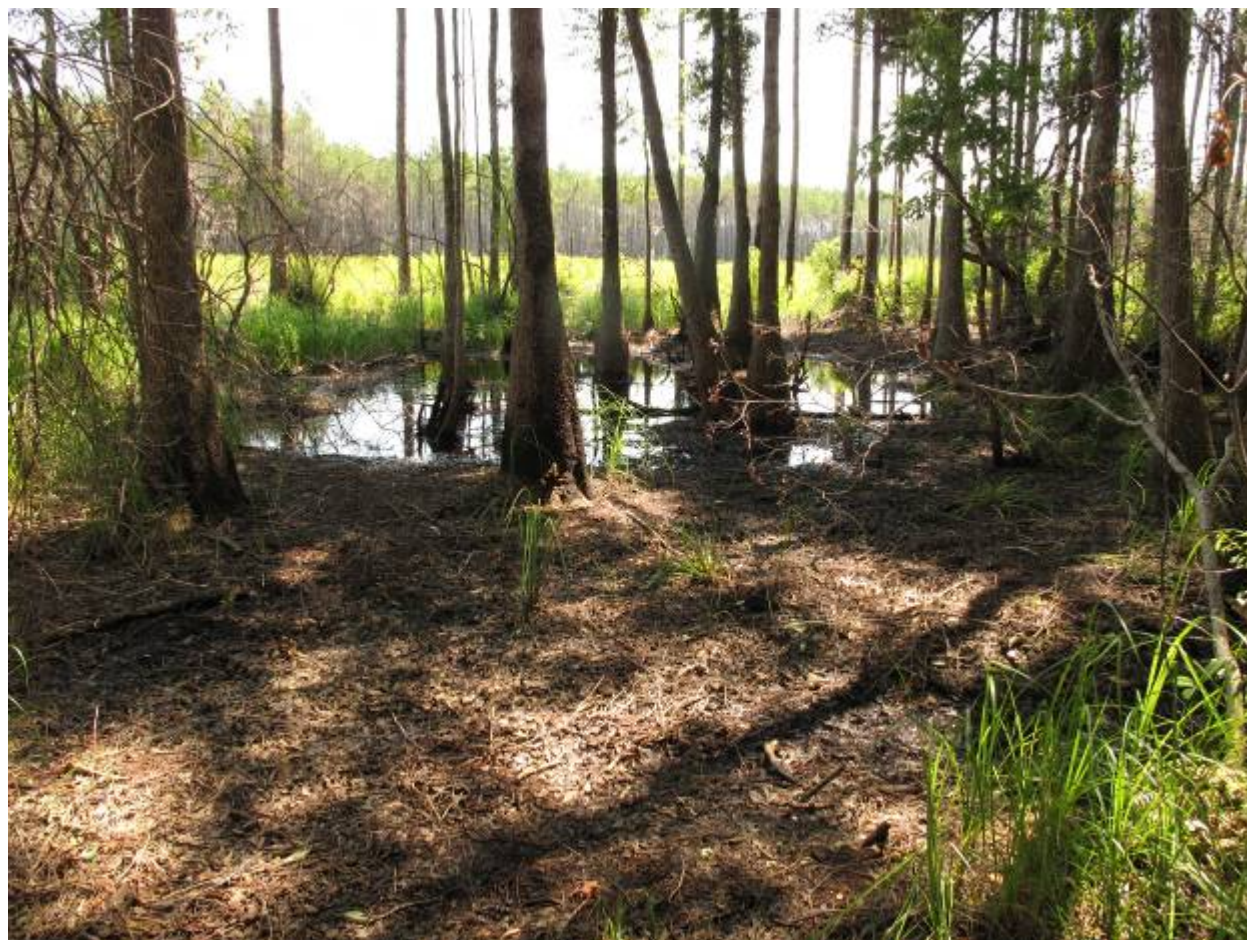
Wetland ID: 28-09

Description: This wetland is a 0.1 ha ephemeral forested swamp. Gum trees dominate the canopy, and cover >75% of the wetland. The midstory is dominated by titi, and covers 25-50% of the wetland. Sawgrass grows in scattered patches, and covers 5-25% of the wetland. This wetland was impacted by woody encroachment until a recent fire burned through the wetland and left many dead titi and cypress snags. The wetland is now in fire-maintenance condition. The adjacent uplands are mesic flatwoods that were bedded and converted to a pine plantation. Upland restoration is in progress.

Wetland Concerns: None

Restoration Action Recommended: None

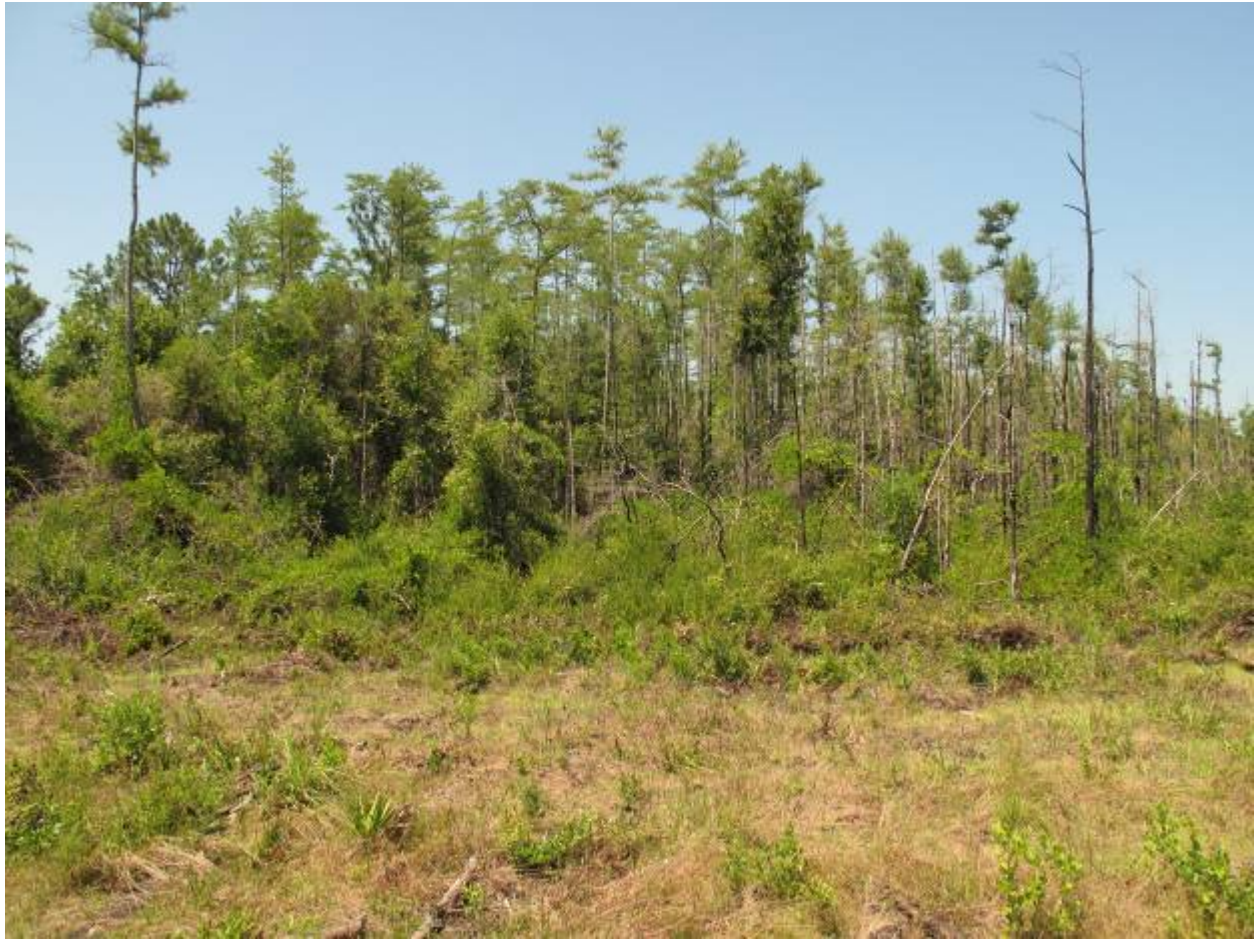
Wetland ID: 28-10

Description: This wetland is a 2.2 ha ephemeral mixed swamp. Cypress trees dominate the canopy, and cover 50-75% of the wetland. The midstory is dominated by titi, and covers >75% of the wetland. There is no herbaceous vegetation. A recent fire burned to the wetland edges and killed some perimeter woody vegetation. The wetland is still extremely brushy and virtually impenetrable. The adjacent uplands are mesic flatwoods that were bedded and converted to a pine plantation. Upland restoration is in progress.

Wetland Concerns: Woody encroachment

Restoration Action Recommended: Encourage periodic fire in the wetland to reduce the dense titi.

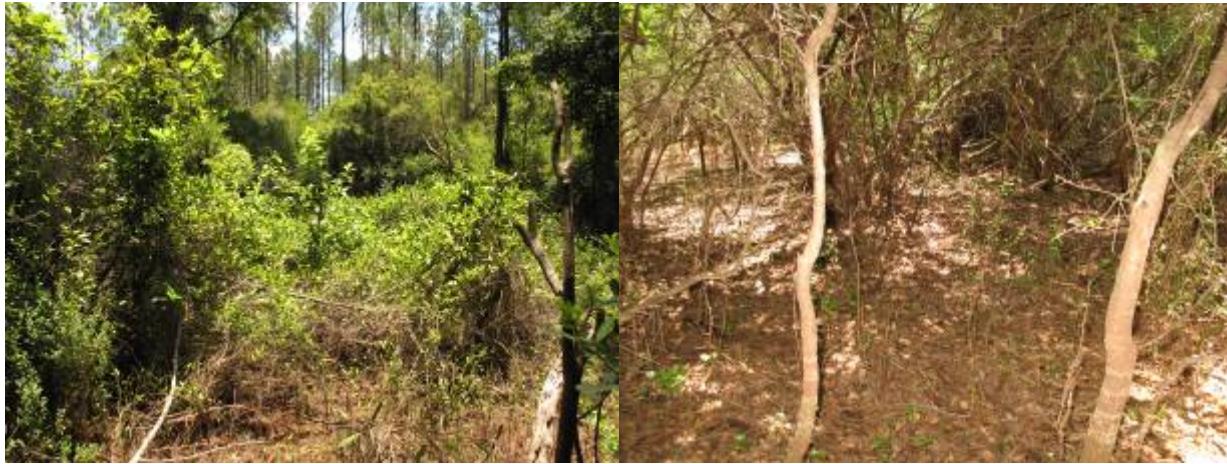
Wetland ID: 29-01

Description: This wetland is a 0.4 ha ephemeral shrub and forested swamp. The north end of the wetland is a healthy gum and pine tree swamp with an open understory and a leaf-covered floor. The south end of the wetland is a titi thicket. Gum and pine trees cover 25-50% of the wetland basin, titi covers 25-50% of the wetland. Fire has burned through the wetland and has reduced some of the woody encroachment. Sawgrass grows in scattered patches, and covers 5-25% of the wetland. Old, eroding bedding rows are still evident in the wetland. The adjacent uplands are mesic flatwoods that were bedded and converted to a pine plantation. Upland restoration is in progress.

Wetland Concerns: Bedding, Woody encroachment

Restoration Action Recommended: No action to remove the bedding is recommended; the bedding rows will erode over time. Encourage periodic fire in the wetland to reduce the dense titi.

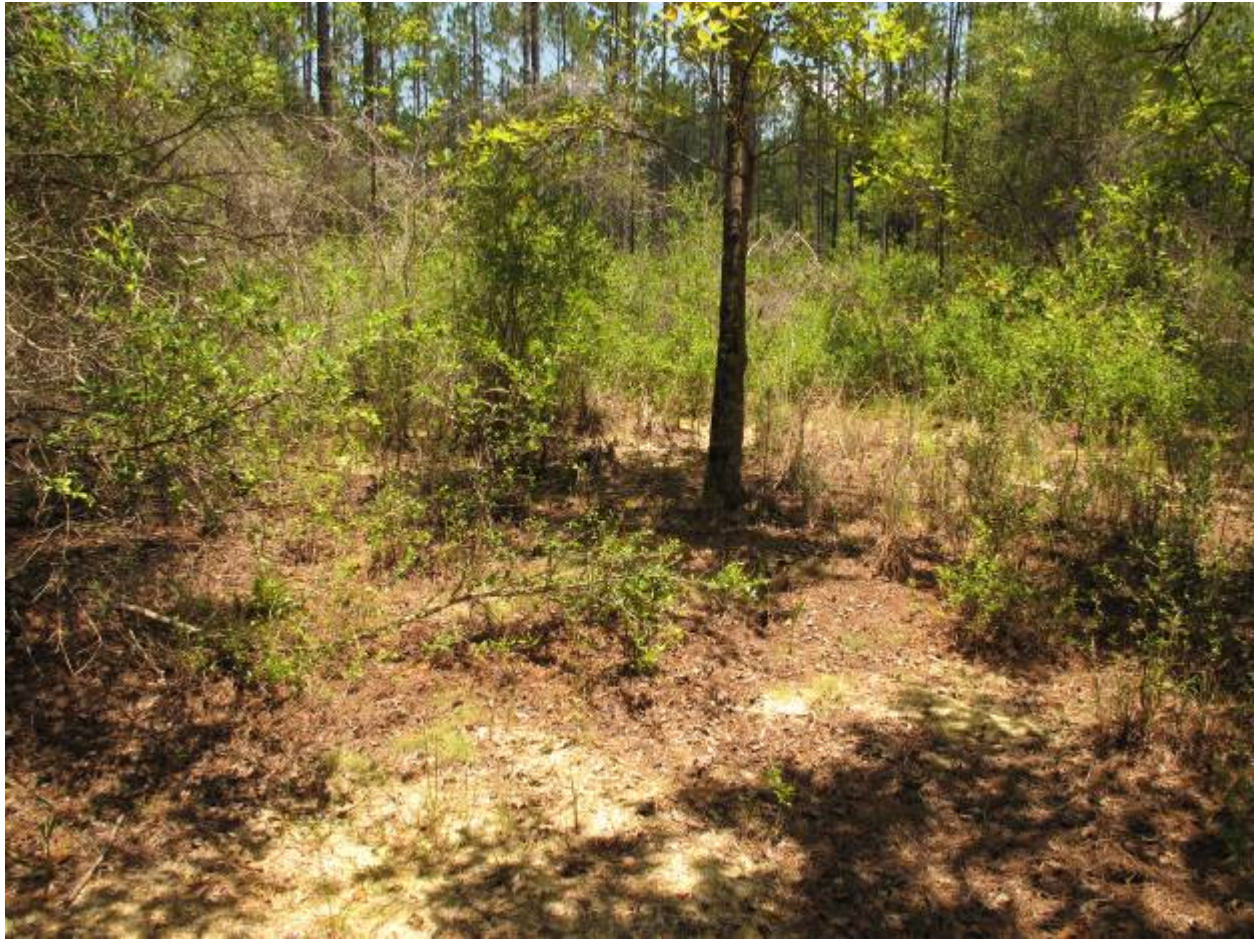
Wetland ID: 29-02

Description: This wetland is a <0.1 ha ephemeral shrub swamp. There is no tree canopy. Titi is the dominant woody vegetation, and covers >75% of the wetland. Sedges/grasses and *Sphagnum* grow in a marshy area in the wetland center, and cover 5-25% of the basin. There is a large push pile in the southwest corner of the wetland on which a large titi grows. There are old, eroding bedding rows in the wetland. The adjacent uplands are mesic flatwoods that were bedded and converted to a pine plantation. Upland restoration is in progress.

Wetland Concerns: Push pile, Woody encroachment

Restoration Action Recommended: Mechanically remove the bedding and push pile and simultaneously uproot the titi established on the push pile. This process should be completed when the wetland is completely dry and progress monitored. Return periodic fire to the wetland to prevent further titi encroachment.

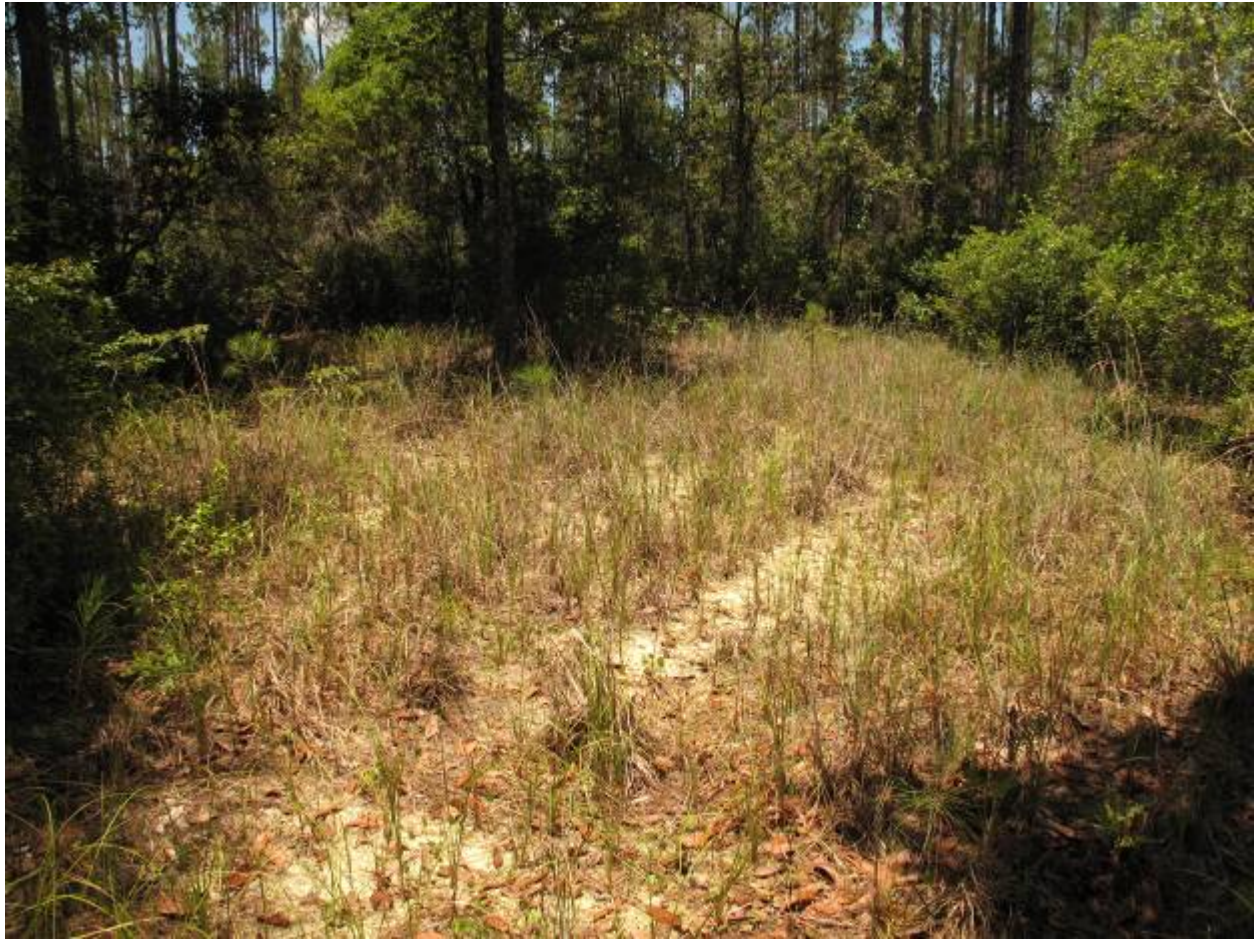
Wetland ID: 29-03

Description: This wetland is a 0.1 ha ephemeral mix of a marsh and a mixed swamp. There are open, marsh-like patches mixed with clumps of shrub and gum trees. Gum trees dominate the canopy, and cover 25-50% of the wetland. The midstory is dominated by titi and wax myrtle, and covers 25-50% of the wetland. Sawgrass grows in scattered patches, and covers 25-50% of the wetland. The adjacent uplands are mesic flatwoods that were bedded and converted to a pine plantation. Upland restoration is in progress.

Wetland Concerns: Woody encroachment

Restoration Action Recommended: Manage with periodic fire to prevent further woody encroachment.

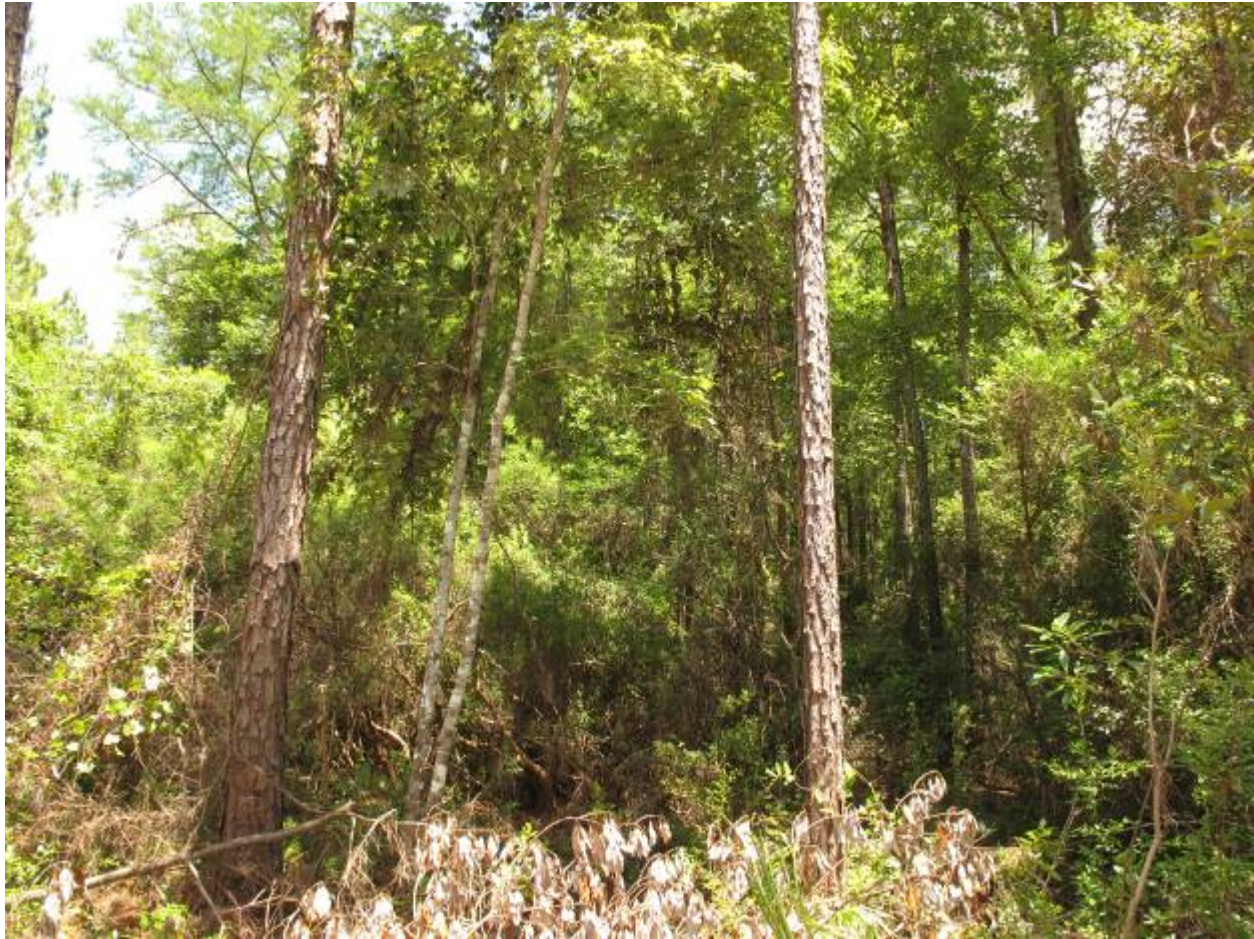
Wetland ID: 29-04

Description: This wetland is a 0.3 ha ephemeral mixed swamp. Gum and cypress trees dominate the canopy, and cover >75% of the wetland. The midstory is dominated by titi, and covers >75% of the wetland. There is no herbaceous vegetation. The wetland does not appear to have burned in a long time. The adjacent uplands are mesic flatwoods that were bedded and converted to a pine plantation. Upland restoration is in progress.

Wetland Concerns: Woody encroachment

Restoration Action Recommended: Encourage periodic fire in the wetland to reduce the dense titi.

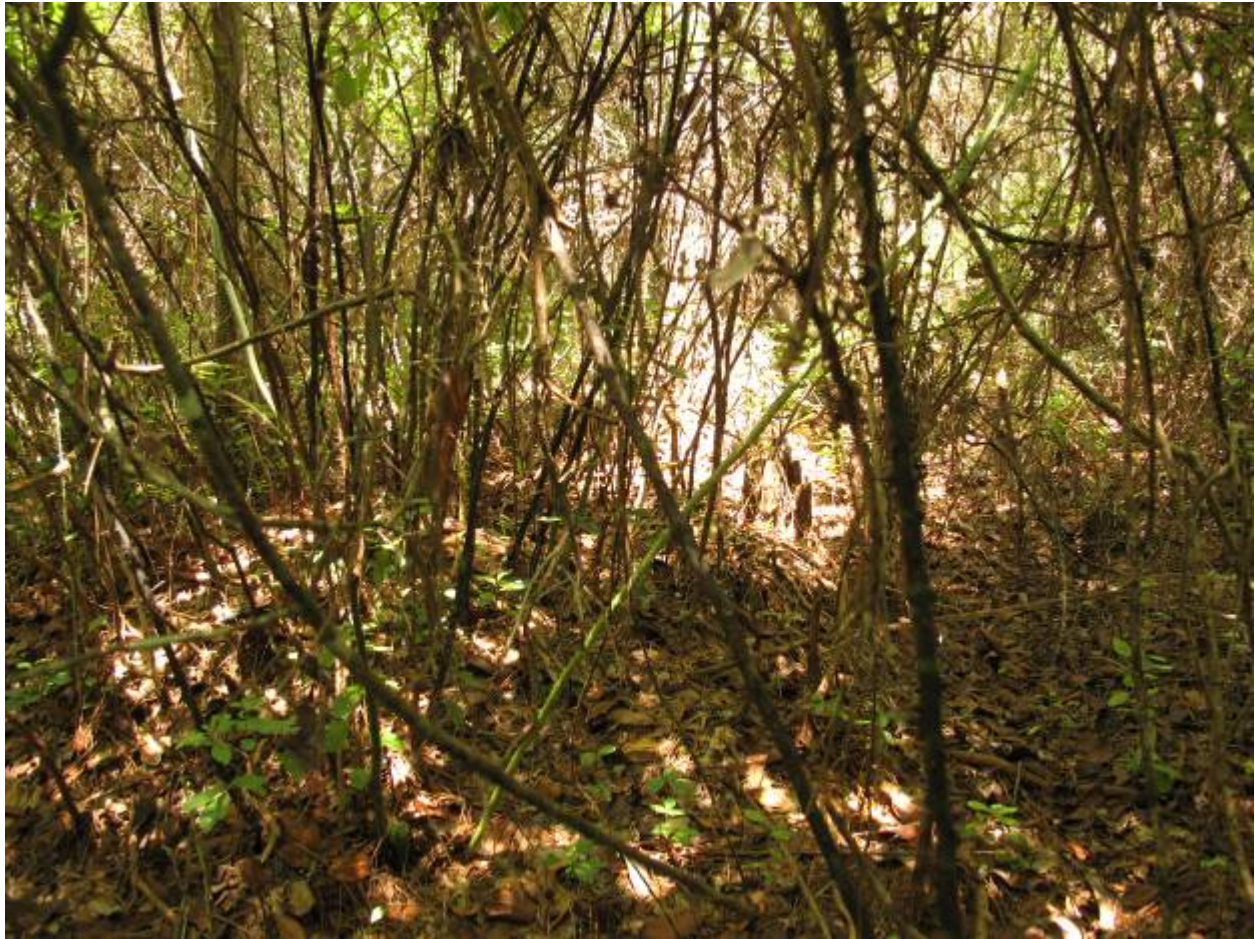
Wetland ID: 29-05

Description: This wetland is a 0.2 ha ephemeral shrub swamp. Pine and cypress trees dominate the canopy, and cover 5-25% of the wetland. The midstory is dominated by titi, and covers >75% of the wetland. There is no herbaceous vegetation. The wetland does not appear to have burned in a long time. The adjacent uplands are mesic flatwoods that were bedded and converted to a pine plantation. The uplands do not appear to have burned in a long time.

Wetland Concerns: Woody encroachment

Restoration Action Recommended: Encourage periodic fire in the wetland to reduce the dense titi.

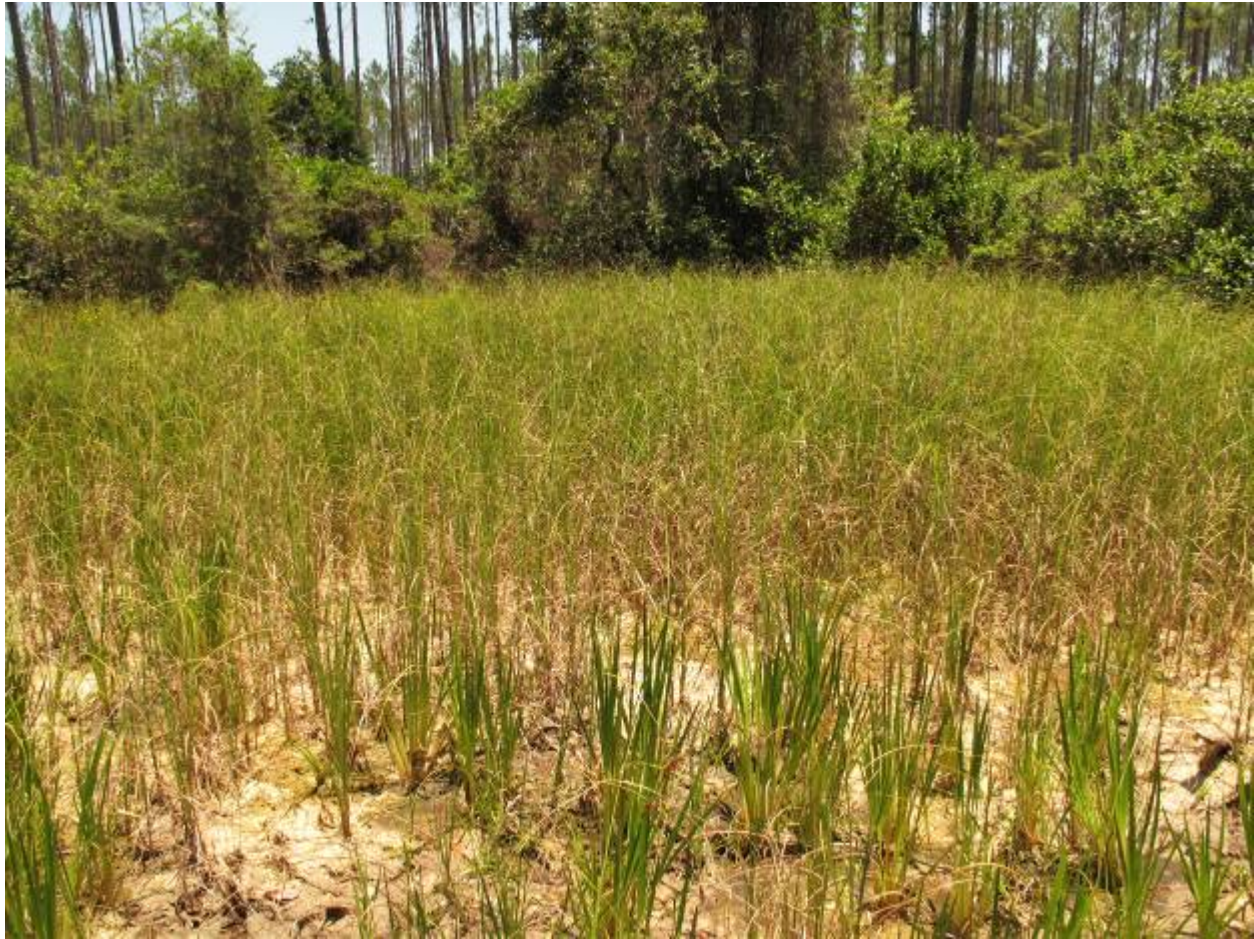
Wetland ID: 29-06

Description: This wetland is a 0.1 ha ephemeral marsh. There is no tree canopy. Fetterbush grows in a dense ring around the wetland, and covers 25-50% of the basin. Sawgrass and *Sphagnum* grow in the wetland center, and cover 50-75% of the basin. The adjacent uplands are mesic flatwoods that were bedded and converted to a pine plantation. Upland restoration is in progress.

Wetland Concerns: Woody encroachment

Restoration Action Recommended: Return periodic fire into the wetland to reduce the dense brush ring and prevent further shrub encroachment.

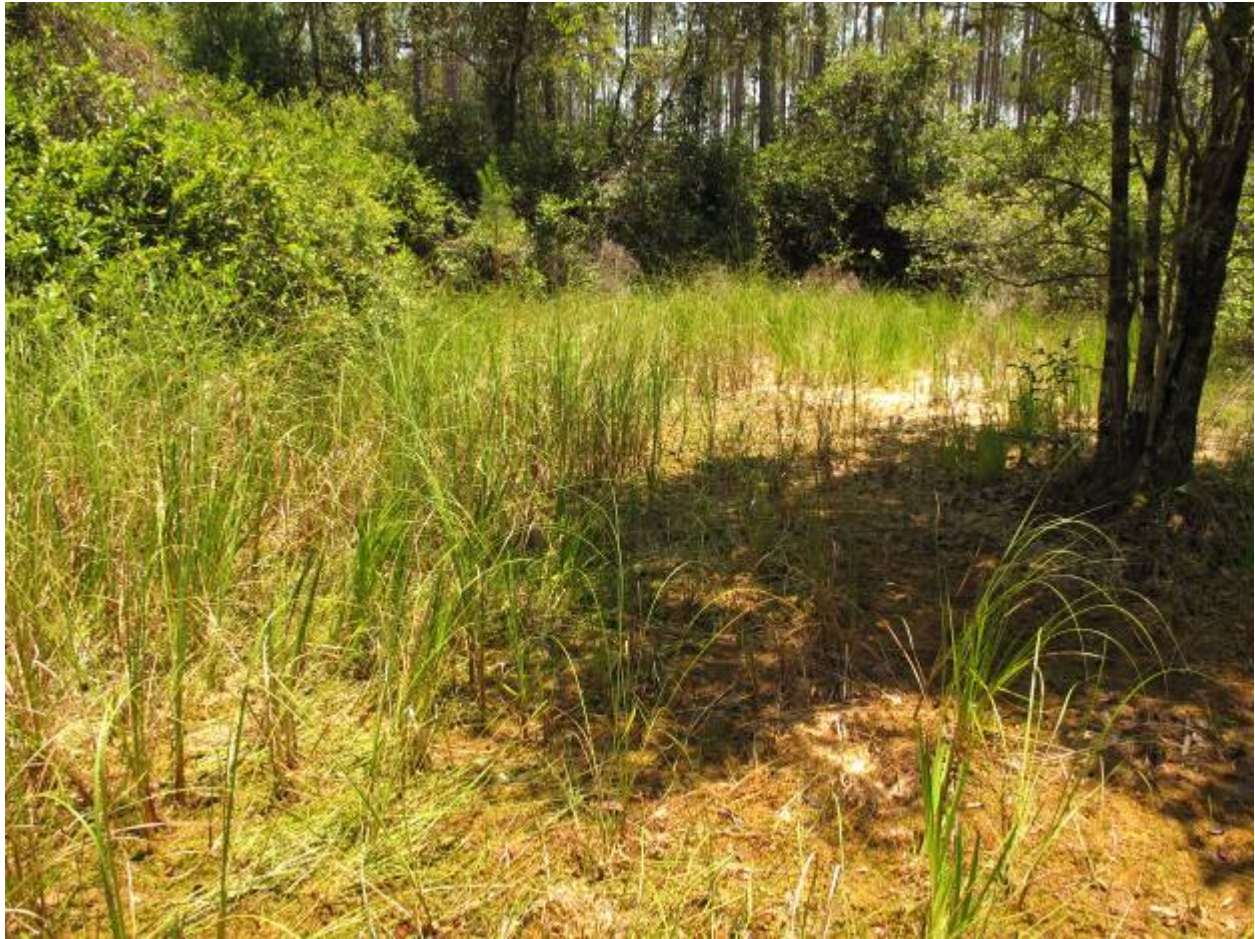
Wetland ID: 29-07

Description: This wetland is a 0.1 ha ephemeral marsh. There is no tree canopy. Fetterbush is encroaching into the wetland, and covers 25-50% of the basin. Sawgrass and *Sphagnum* grow in the wetland center, and cover 50-75% of the basin. The adjacent uplands are mesic flatwoods that were bedded and converted to a pine plantation. Upland restoration is in progress.

Wetland Concerns: Woody encroachment

Restoration Action Recommended: Manage with periodic fire to reduce the encroaching woody vegetation.

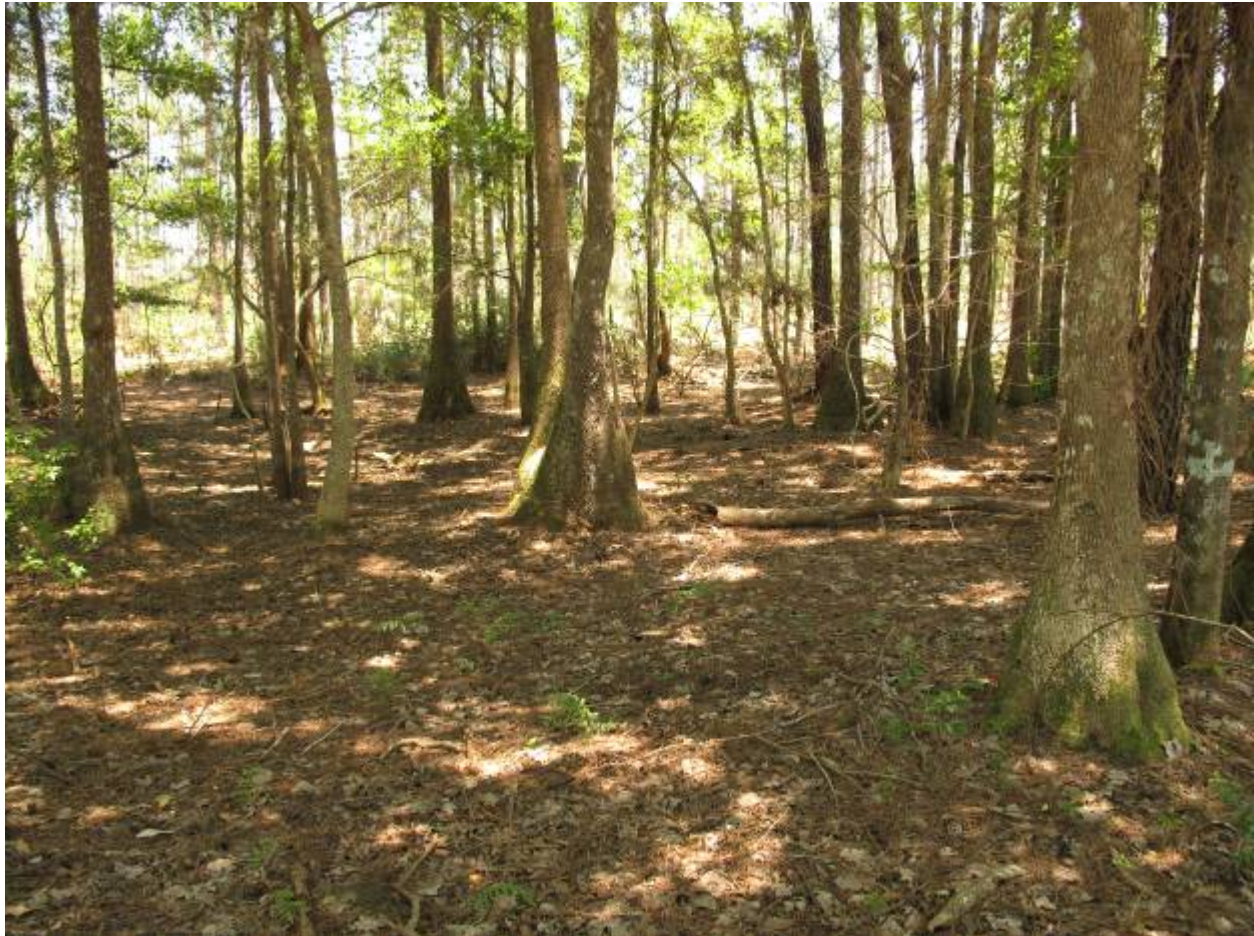
Wetland ID: 29-08

Description: This wetland is a 0.1 ha ephemeral forested swamp. Gum and pine trees dominate the canopy, and cover >75% of the wetland. There is no midstory or herbaceous vegetation. This wetland appears to be healthy and in fire-maintenance condition. The adjacent uplands are mesic flatwoods that were bedded and converted to a pine plantation. Upland restoration is in progress.

Wetland Concerns: None

Restoration Action Recommended: None

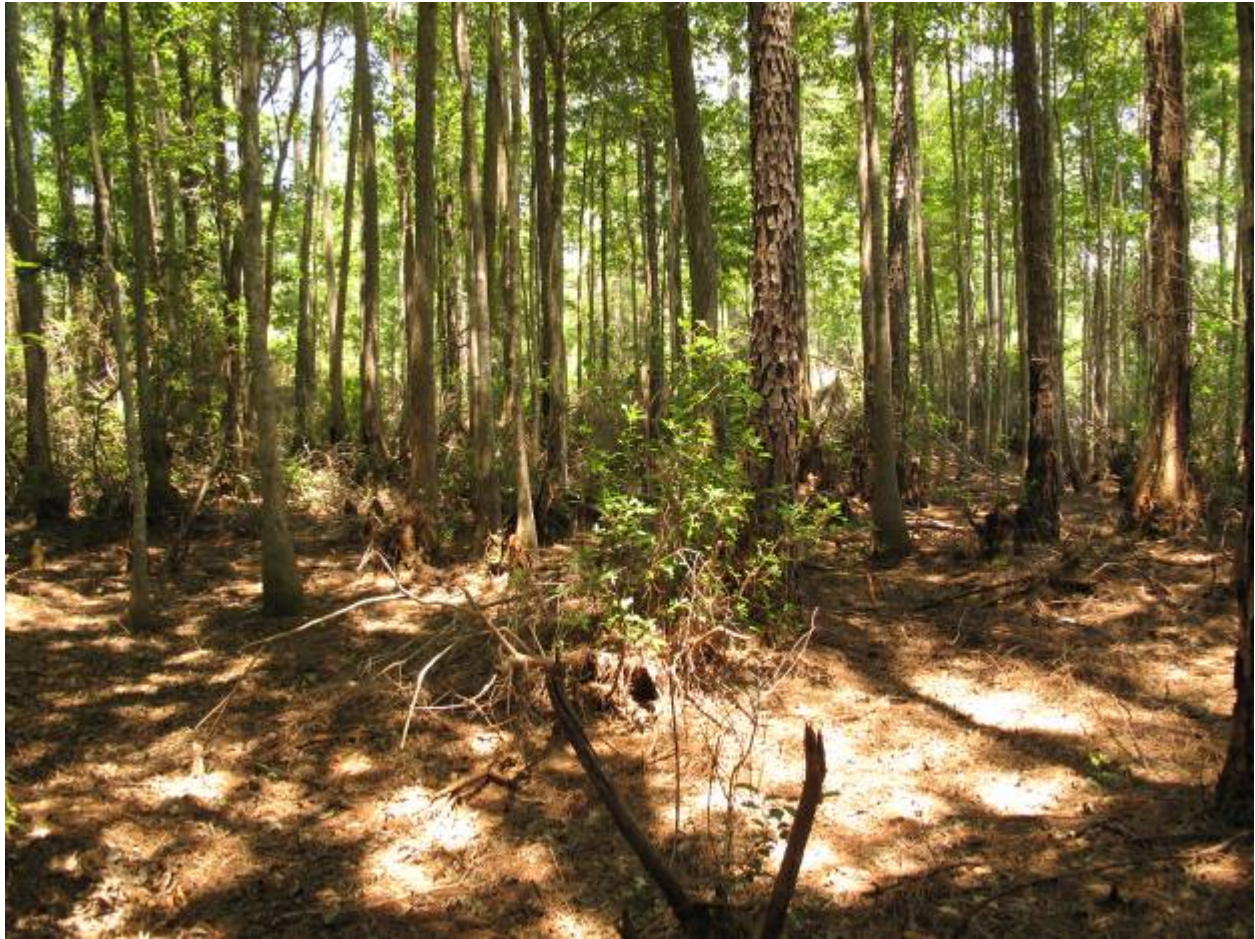
Wetland ID: 29-09

Description: This wetland is a 0.8 ha ephemeral forested swamp. Cypress, gum and pine trees dominate the canopy, and cover >75% of the wetland. The midstory is dominated by titi, wax myrtle, and fetterbush and covers 5-25% of the wetland. There is no herbaceous vegetation. A recent fire burned through the outer half of the wetland. The adjacent uplands are mesic flatwoods that were bedded and converted to a pine plantation. Upland restoration is in progress.

Wetland Concerns: None

Restoration Action Recommended: None

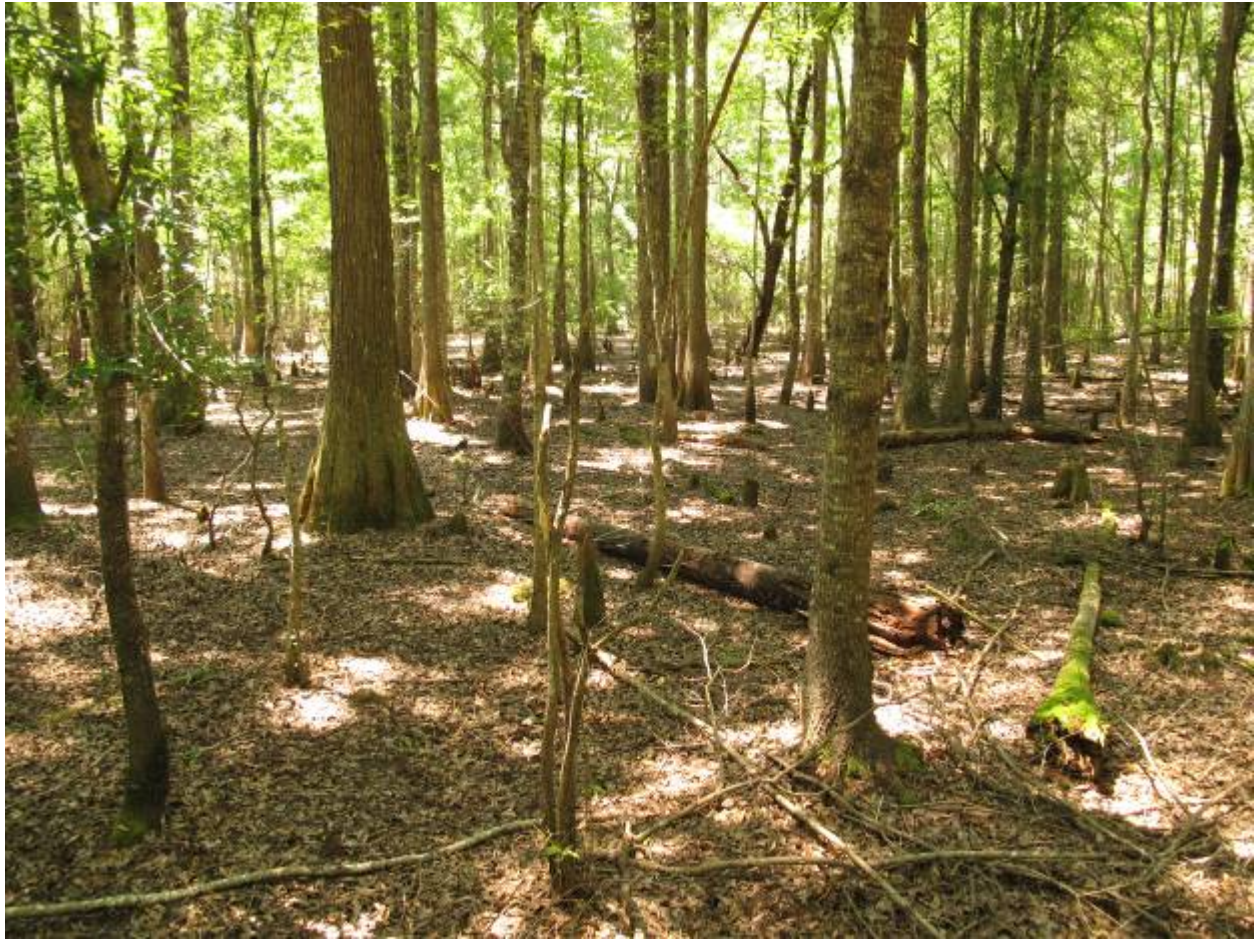
Wetland ID: 29-10

Description: This wetland is a 0.5 ha ephemeral forested swamp. Cypress and gum trees dominate the canopy, and cover >75% of the wetland. There is no midstory layer or herbaceous vegetation. This wetland appears to be healthy and in fire-maintenance condition. The adjacent uplands are mesic flatwoods that were bedded and converted to a pine plantation. Upland restoration is in progress.

Wetland Concerns: None

Restoration Action Recommended: None
