# **Inventory, Assessment, and Restoration Potential of Ephemeral Wetlands on FFWCC Wildlife Management Areas**

**Caravelle Ranch WMA Final Report**

November 2008

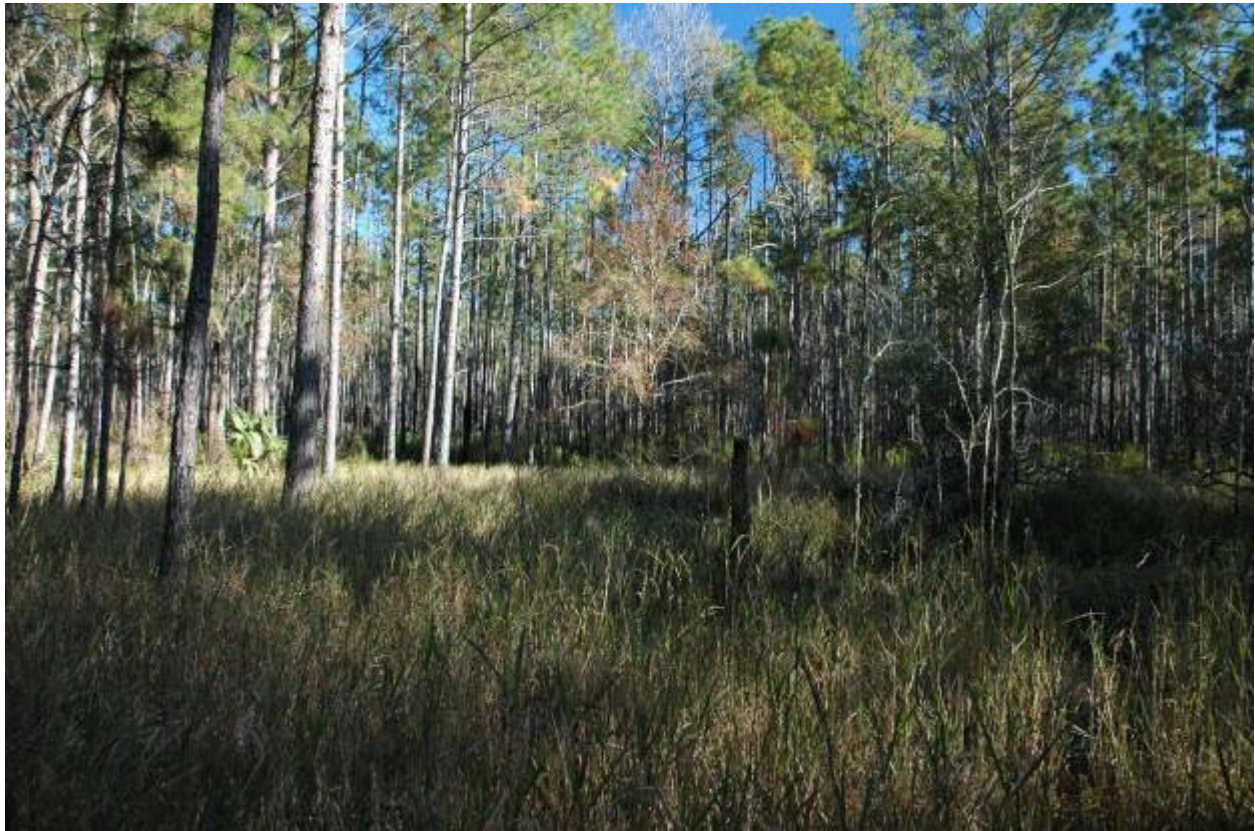
**Wetland ID: 08-01**

**Description:** This wetland is a 0.1 ha highly ephemeral marsh. A few large slash pine trees have established in the wetland interior. The tree canopy covers 5-25% of the wetland basin. There is no midstory cover. Maidencane densely grows throughout the wetland, and covers >75% of the wetland basin. The encroaching pine trees and dense maidencane likely are a result of a lack of fire in the wetland. The adjacent uplands are mesic flatwoods that are managed with prescribed fire.

**Wetland Concern(s):** Herbaceous density, Woody encroachment

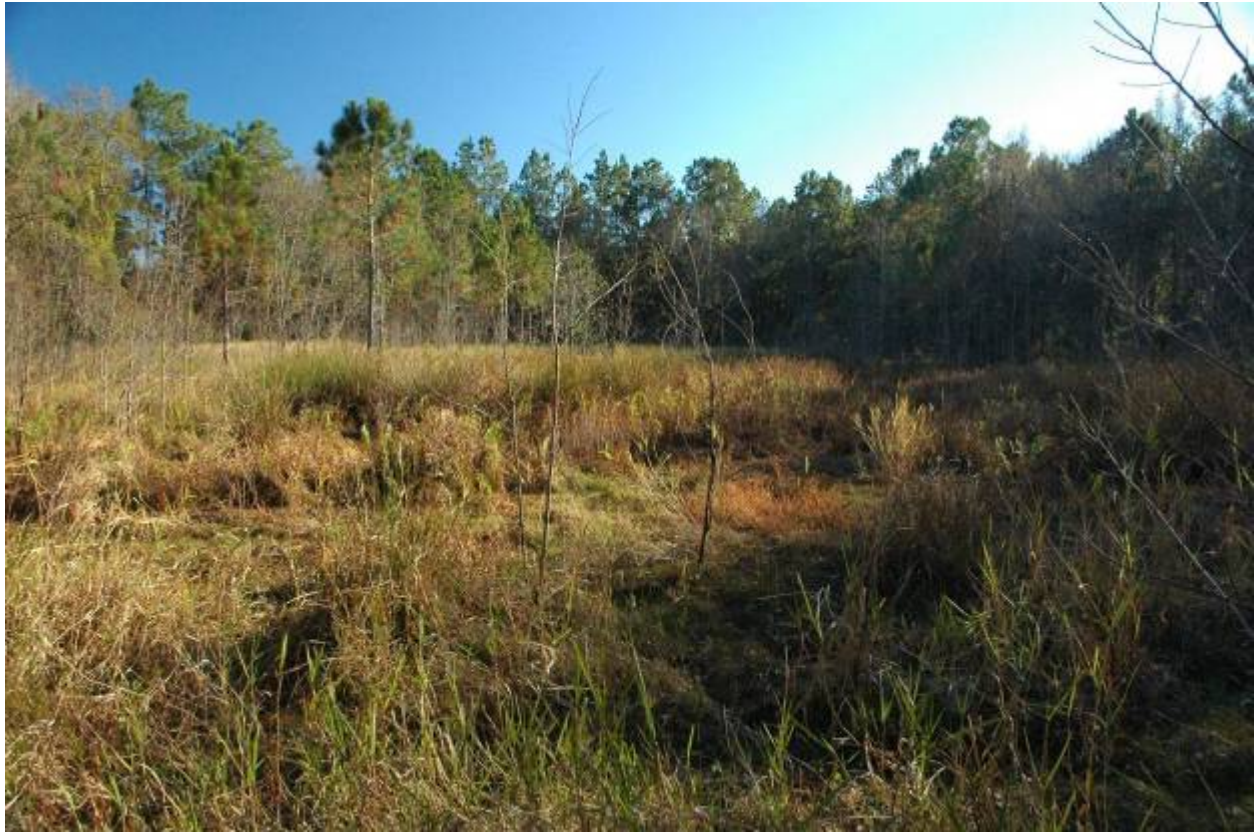
**Wetland ID: 09-01**

**Description:** This wetland is a 0.6 ha ephemeral marsh. There is no tree canopy or midstory cover. A diverse array of maidencane, sedges/grasses, and emergent vegetation grow throughout the wetland, and cover >75% of the basin. The adjacent uplands were ditched, drained, and logged to provide grazing habitat for cattle. The uplands currently are an oldfield community.

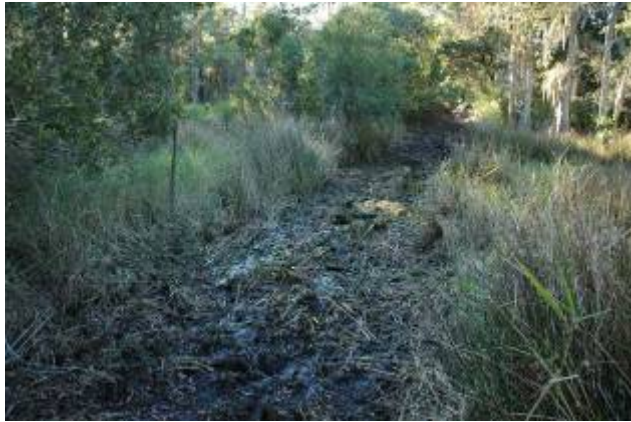
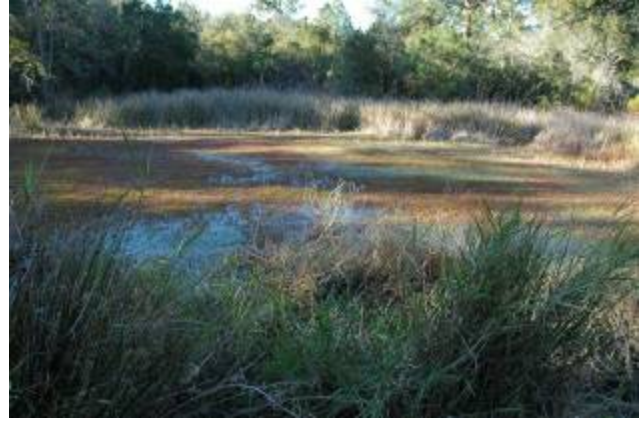
**Wetland ID: 09-02**

**Description:** This wetland is a 0.1 ha ephemeral marsh. There is no tree canopy or midstory cover. Sedges/ grasses grow throughout the wetland, and cover >75% of the basin. A MU boundary/fireline bisects the south end of the wetland. The boundary line separates properties managed by 2 public agencies. There is a road on the other side of the fireline with associated ditches. The adjacent uplands were ditched, drained, and logged to provide grazing habitat for cattle. The uplands currently are an oldfield community.

**Wetland Concern(s):** MU boundary/fireline, Road, Roadside ditch, Upland condition

**Restoration Action Recommended:** Re-route the MU boundary/fireline into the uplands and out of the wetland if feasible. If the road cannot be re-routed, fill the roadside ditch where it is adjacent to the wetland. In order to restore the full ecological function of this wetland, the uplands would need to be restored.

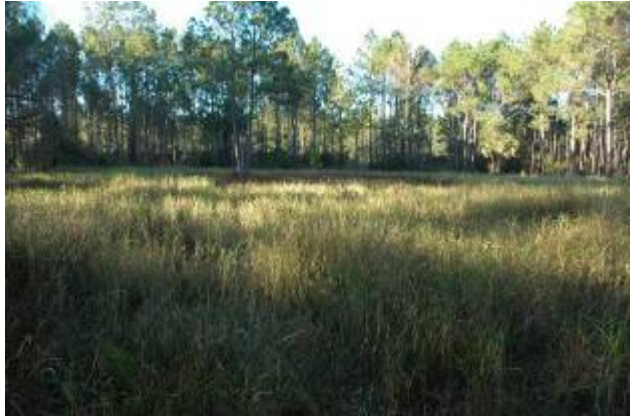
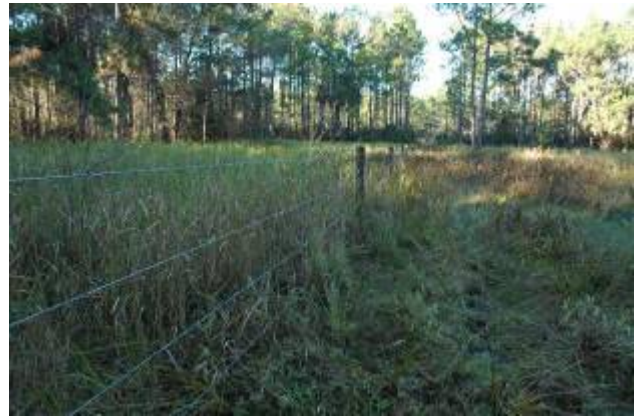
**Wetland ID: 09-03**

**Description:** This wetland is a 0.3 ha ephemeral marsh. There is no tree canopy or midstory cover. Maidencane grows thick throughout the wetland, and covers >75% of the basin. A private property boundary fence bisects the middle of the wetland. The adjacent uplands were ditched, drained, and logged to provide grazing habitat for cattle. The uplands currently are an oldfield community.

**Wetland Concern(s):** Herbaceous density, Upland condition

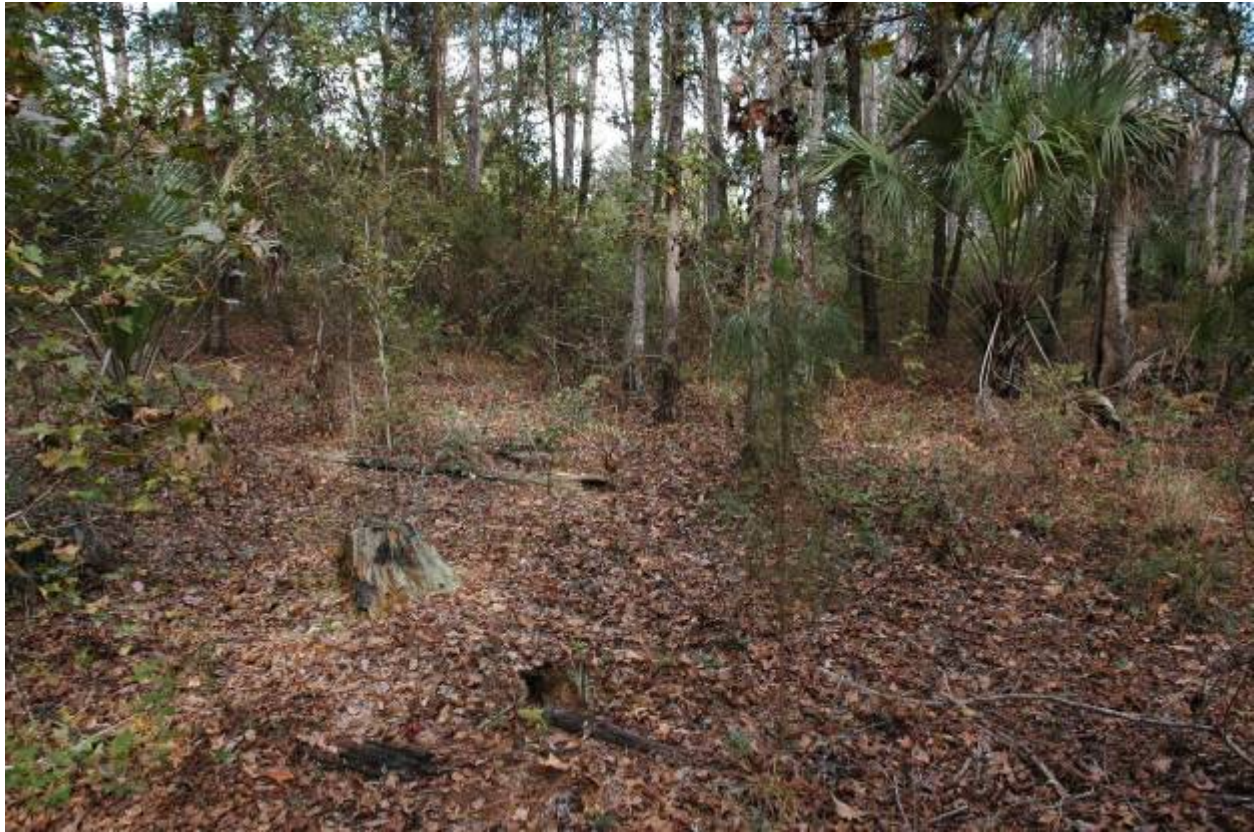
**Description:** This former wetland is a 2.4 ha highly ephemeral forested swamp. It was logged and has since succeeded to a hardwood forest, likely due to ditching and the historic draining of the property. Maple, pine, sweet gum, and oak trees cover >75% of the area and smilax grows over most vegetation. Herbaceous cover is sparse. The adjacent uplands were ditched, drained, and logged to provide grazing habitat for cattle. The uplands currently are oldfield and food plot communities.

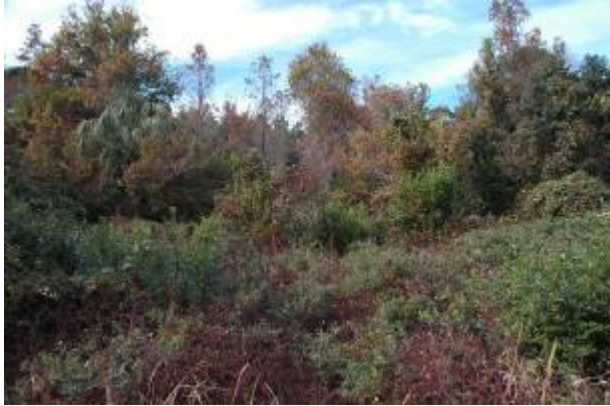
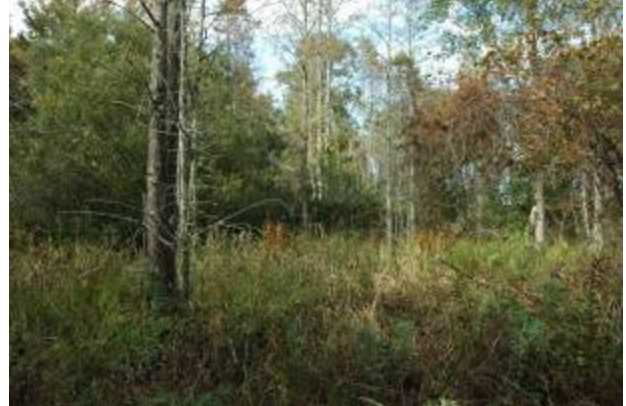
**Wetland ID: 11-02**

**Description:** This wetland is a 1.0 ha highly ephemeral mixed swamp. Cypress trees dominate the canopy, and cover 25-50% of the wetland. The midstory is dominated by wax myrtle, fetterbush, and buttonbush, and covers 25-50% of the wetland. Maidencane and fern grow throughout the wetland, and cover >75% of the basin. The wetland is surrounded by almost impenetrable grapevine and blackberry covered vegetation. The adjacent uplands were ditched, drained, and logged to provide grazing habitat for cattle. The uplands currently are oldfield and food plot communities.

**Wetland Concern(s):** Woody encroachment, Upland condition

**Restoration Action Recommended:** The thick brush ring surrounding this wetland needs to be thinned. Periodic fire in and around the wetland should reduce the dense woody vegetation, but this wetland also is a good candidate for experimental, mechanical brush ring removal. In order to restore the full ecological function of this wetland, the uplands would need to be restored.

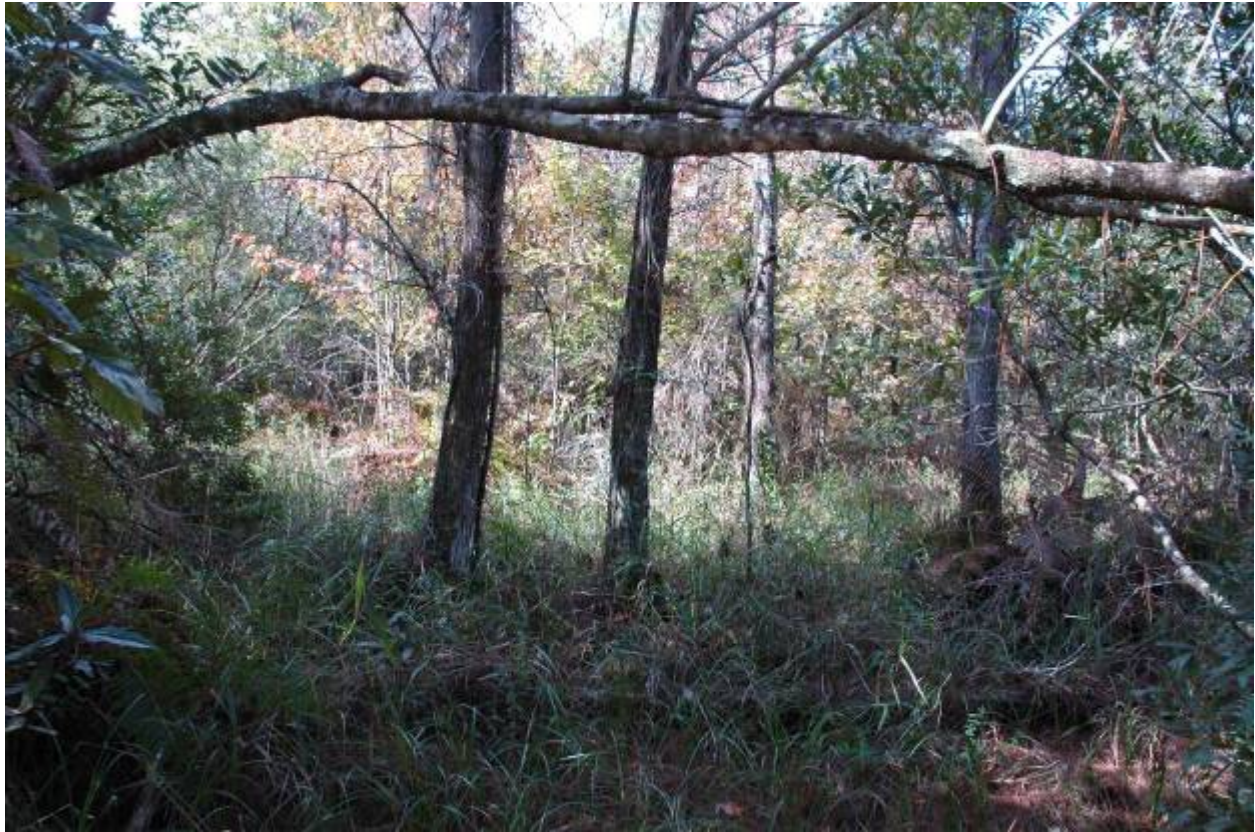
**Description:** This wetland is a 0.5 ha highly ephemeral forested swamp. Cypress, gum, and bay trees dominate the canopy, and cover >75% of the wetland. The midstory is dominated by wax myrtle, and covers 25-50% of the wetland. Maidencane and sedges/grasses grow throughout the wetland, and cover >75% of the basin. This wetland was most likely a cypress dome before the cypress trees were logged. The wetland is surrounded by a dense thicket. The adjacent uplands were ditched, drained, and logged to provide grazing habitat for cattle. The uplands currently are an oldfield community.

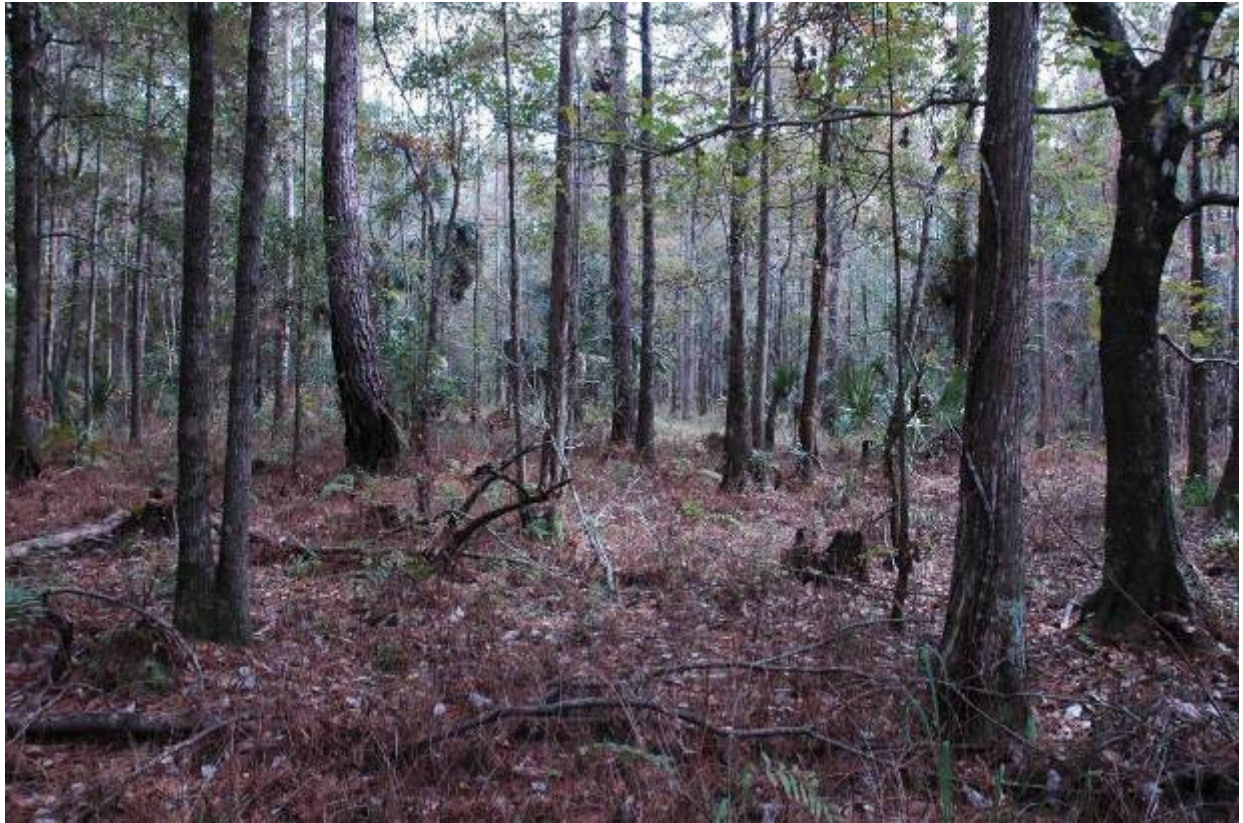
**Wetland ID: 12-02**

**Description:** This wetland is a 0.8 ha highly ephemeral forested swamp. Gum and pine trees dominate the canopy, and cover > 75% of the wetland. The midstory is dominated by wax myrtle, and covers 5-25% of the wetland. Maidencane and fern grow in scattered patches, and cover 25-50% of the wetland basin. Historically, this wetland likely was a cypress dome. The cypress were logged, the uplands drained for cattle grazing, and the resulting desiccation allowed gum and pine trees to colonize. On its current tract, the wetland will succeed to a hardwood forest and no longer function as a wetland. The wetland is ringed in thick brush. The adjacent uplands were ditched, drained, and logged to provide grazing habitat for cattle. The uplands currently are an oldfield community.

**Wetland Concern(s):** Upland condition

**Restoration Action Recommended:** In order to restore the full ecological function of this wetland, the uplands would need to be restored.

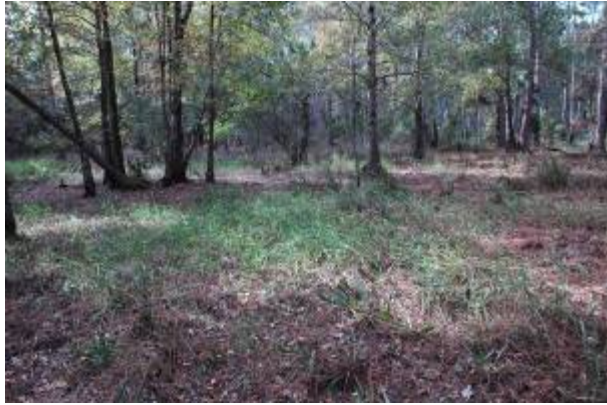
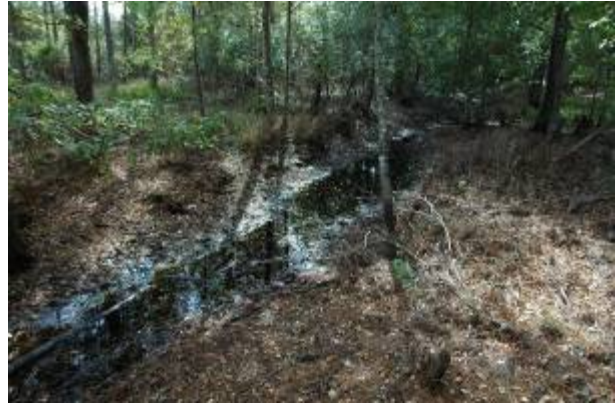
**Wetland ID: 12-03a**

**Description:** This wetland is a 0.3 ha highly ephemeral forested swamp. Gum, maple, and pine trees dominate the canopy, and cover 51- 75% of the wetland basin. The midstory is dominated by wax myrtle, and cover 5-25% of the wetland. Sedges/grasses and fern grow in scattered patches, and cover 50-75% of the basin. This swamp is located on the northeastern end of what historically was a 300m long, continuous cypress wetland strand and that now is separated into 3 wetlands. The wetland is ringed in thick brush. There are ditches on the east and south sides of the wetland. This wetland likely was a cypress swamp. The cypress were logged, the uplands drained for cattle grazing, and the resulting desiccation allowed gum and pine to colonize. The uplands currently are an oldfield community.

**Wetland Concern(s):** Ditching, Upland condition

**Restoration Action Recommended:** Fill the ditches to restore the wetland's hydrology. In order to restore the full ecological function of this wetland, the uplands would need to be restored.

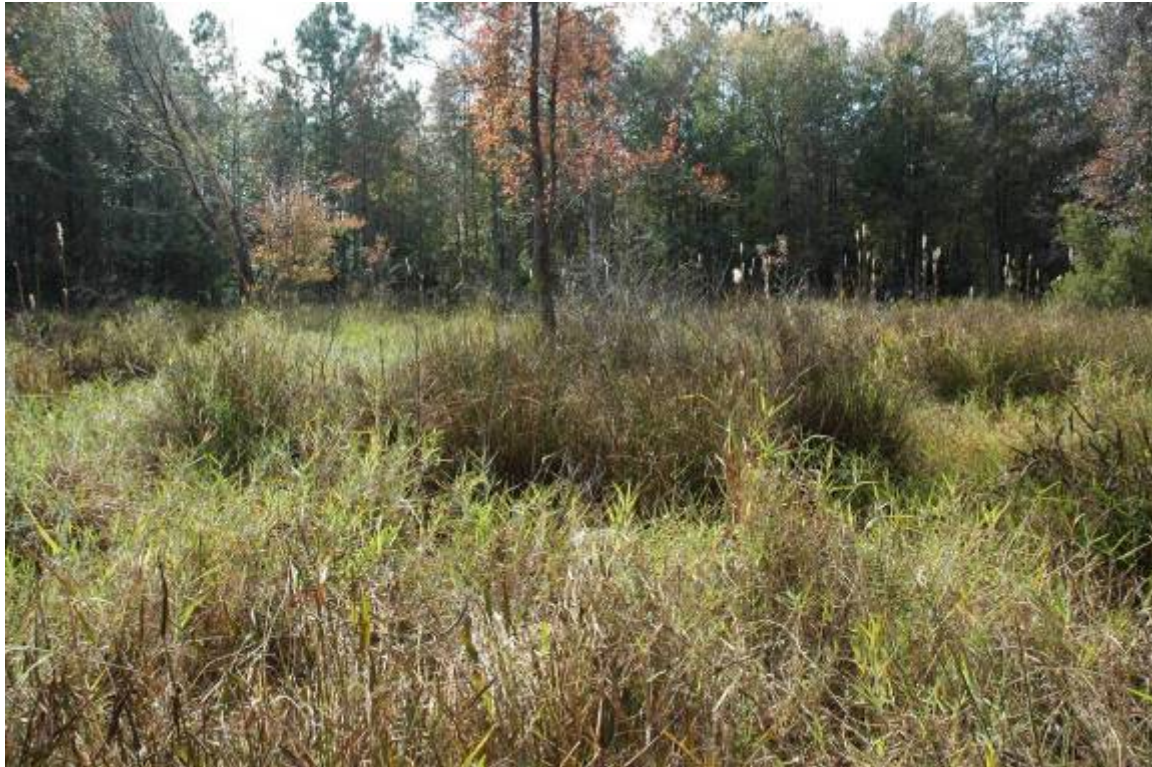
**Wetland ID: 12-03b**

**Description:** This wetland is a 0.4 ha ephemeral marsh. There is no tree canopy or midstory cover. Maidencane, rush, and pickerelweed grow throughout the wetland, and cover >75% of the basin. This wetland is located in the center of what historically was a 300m long, continuous cypress wetland strand and that now is separated into 3 wetlands. The cypress were logged, the uplands drained for cattle grazing, and presently the area is open and herbaceous. The uplands currently are an oldfield community.

**Wetland Concern(s):** Herbaceous density, Upland condition

**Restoration Action Recommended:** This wetland is the most functional part of the 3-part wetland system. Monitor herbaceous density; provide custom burn treatments if needed. In order to restore the full ecological function of this wetland, the uplands would need to be restored.

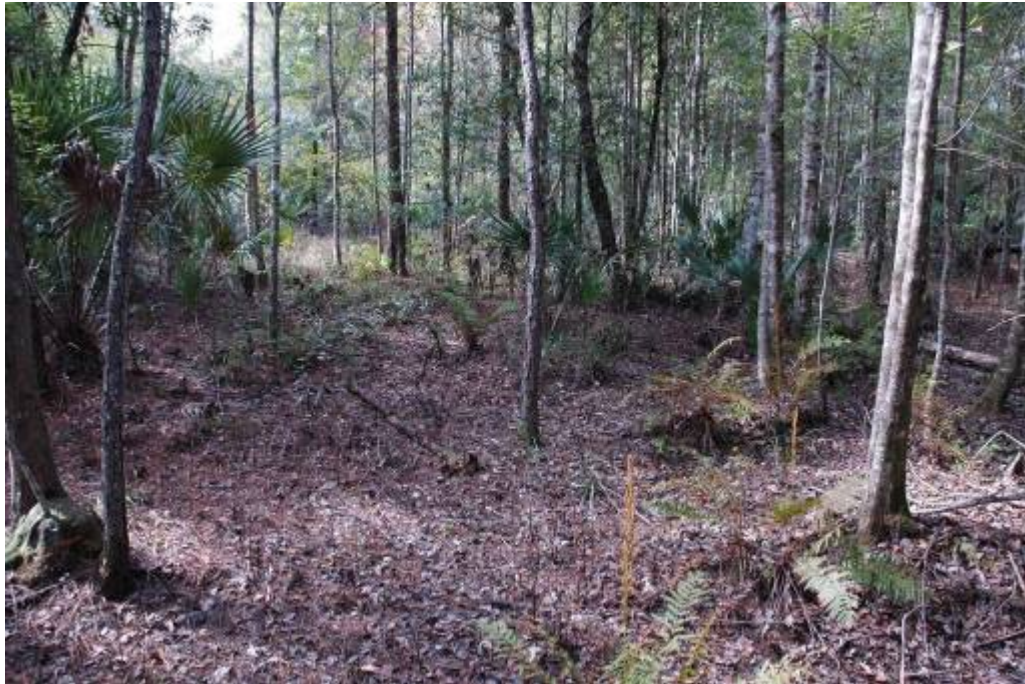
**Wetland ID: 12-03c**

**Description:** This wetland is a 0.7 ha ephemeral forested swamp. Maple and gum trees dominate the canopy, and cover >75% of the wetland. The midstory is dominated by wax myrtle and palm, and covers 5-25% of the wetland. Grasses and fern grow in scattered patches, and cover 25-50% of the basin. This wetland is located on the southwestern side of what historically was a 300m long, continuous cypress wetland strand and that now is separated into 3 wetlands. The cypress were logged, the uplands drained for cattle grazing, and the resulting desiccation allowed hardwoods and pine trees to colonize. The uplands currently are an oldfield community.

**Wetland Concern(s):** Upland condition

**Restoration Action Recommended:** Monitor herbaceous density; provide custom burn treatments if needed. In order to restore the full ecological function of this wetland, the uplands would need to be restored.

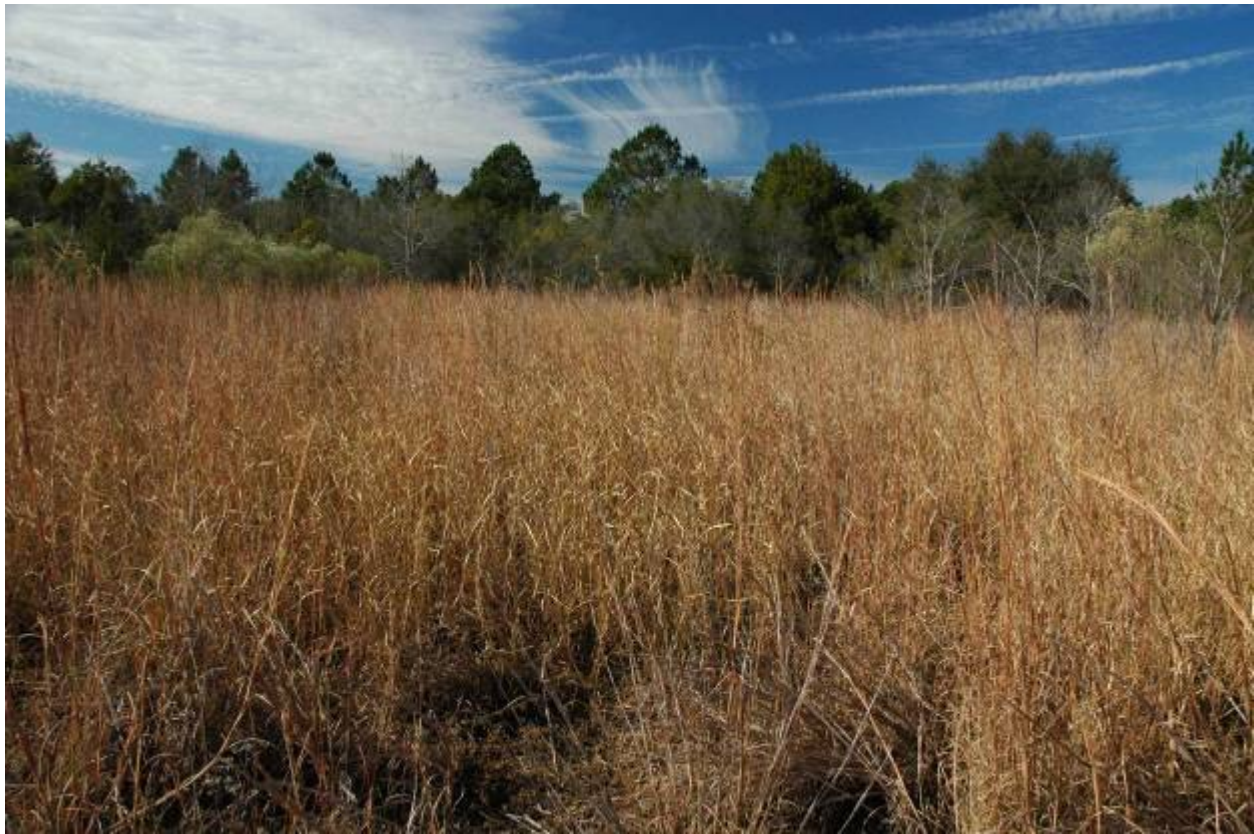
**Description:** This wetland is a 0.3 ha ephemeral marsh. There is no tree canopy cover. The midstory is dominated by wax myrtle and *Baccharis*, and covers 5-25% of the wetland. Maidencane and broomsedge grow throughout the wetland, and cover >75% of the basin. The adjacent uplands were ditched, drained, and logged to provide grazing habitat for cattle. The uplands currently are an oldfield community.

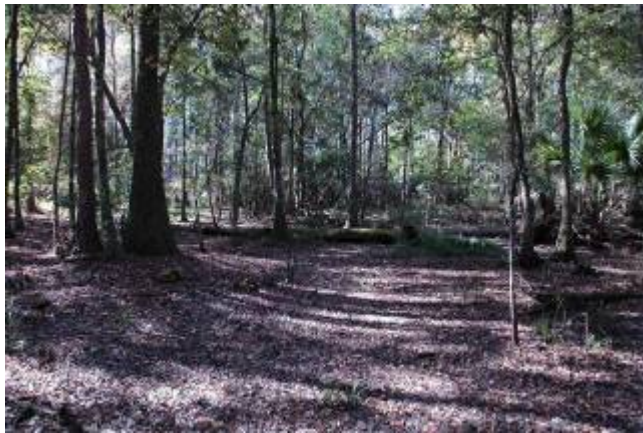
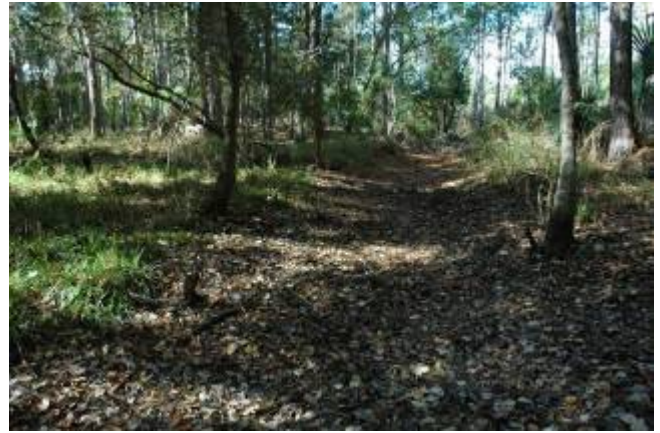
**Wetland ID: 15-02**

**Description:** This wetland is a 0.4 ha ephemeral forested swamp. Gum trees dominate the canopy, and cover >75% of the wetland. There is little midstory cover. Grasses and fern are sparse in the wetland, and cover 5-25% of the basin. The wetland floor is covered in leaf and pine litter. An old ditch appears to be eroded enough that it does not drain the wetland. Our site visit occurred during a drier period so this should be verified during the rainy season. A virtually impenetrable thicket of shrub, blackberry, and smilax ring the pond. The adjacent uplands were ditched, drained, and logged to provide grazing habitat for cattle. The uplands currently are an oldfield community.

**Wetland Concern(s):** Ditching, Upland condition, Woody encroachment

**Restoration Action Recommended:** In order to restore the full ecological function of this wetland, the uplands would need to be restored.

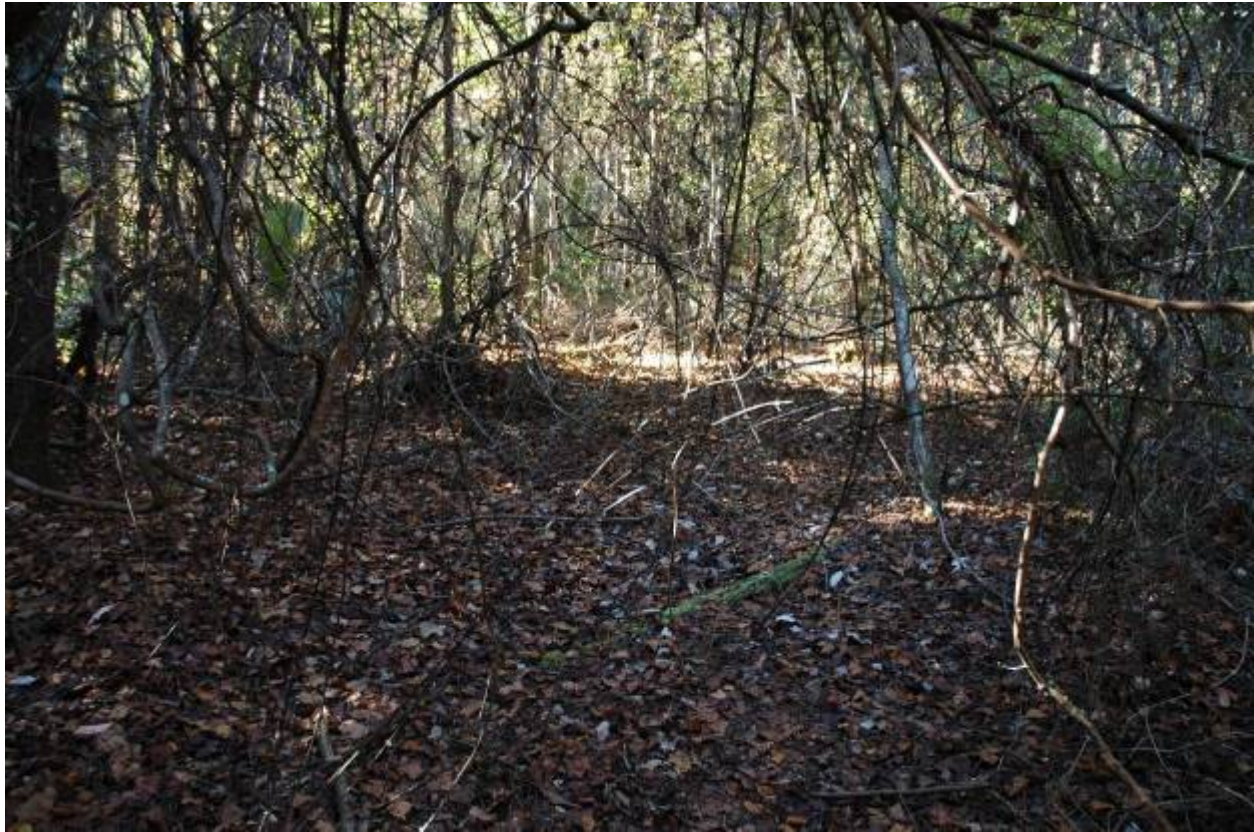
**Description:** This wetland is a 0.6 ha highly ephemeral forested swamp. Bay and palm trees dominate the canopy, cover >75% of the wetland. The midstory is dominated by wax myrtle, and covers 50-75% of the wetland. Muscadine grape densely covers vegetation. The wetland ground surface is predominately covered in leaf litter with very little herbaceous cover. The adjacent uplands were ditched, drained, and logged to provide grazing habitat for cattle. The uplands currently are mesic flatwoods.

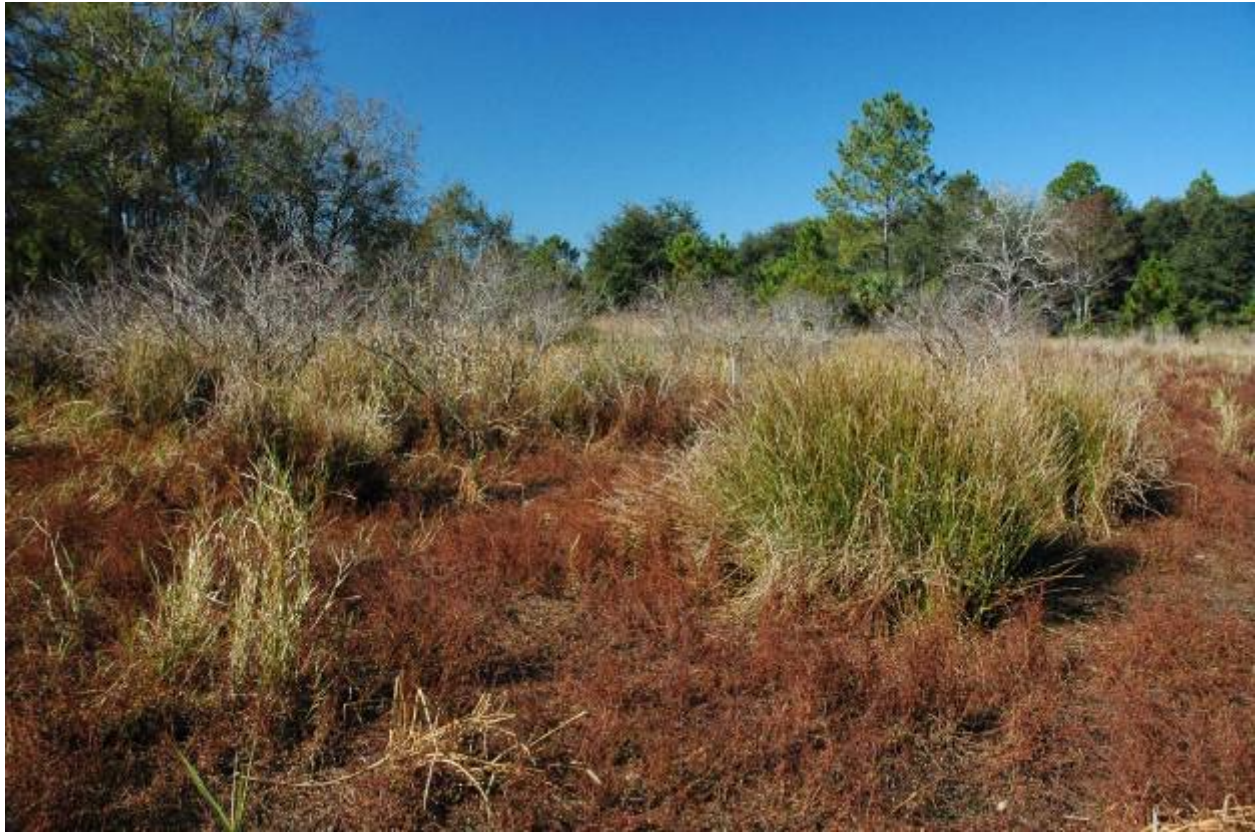
**Description:** This wetland is a 0.7 ha ephemeral marsh. There is no tree canopy cover. The midstory is dominated by buttonbush, and covers 5-25% of the wetland. Maidencane, smartweed, and rush grow throughout the wetland, and cover >75% of the basin. An old ditch runs up to a berm 90m to the south of the wetland. The ditch was filled adjacent to the wetland and no longer appears to be functioning. The adjacent uplands were ditched, drained, and logged to provide grazing habitat for cattle. The uplands currently are pasture and oldfield communities.

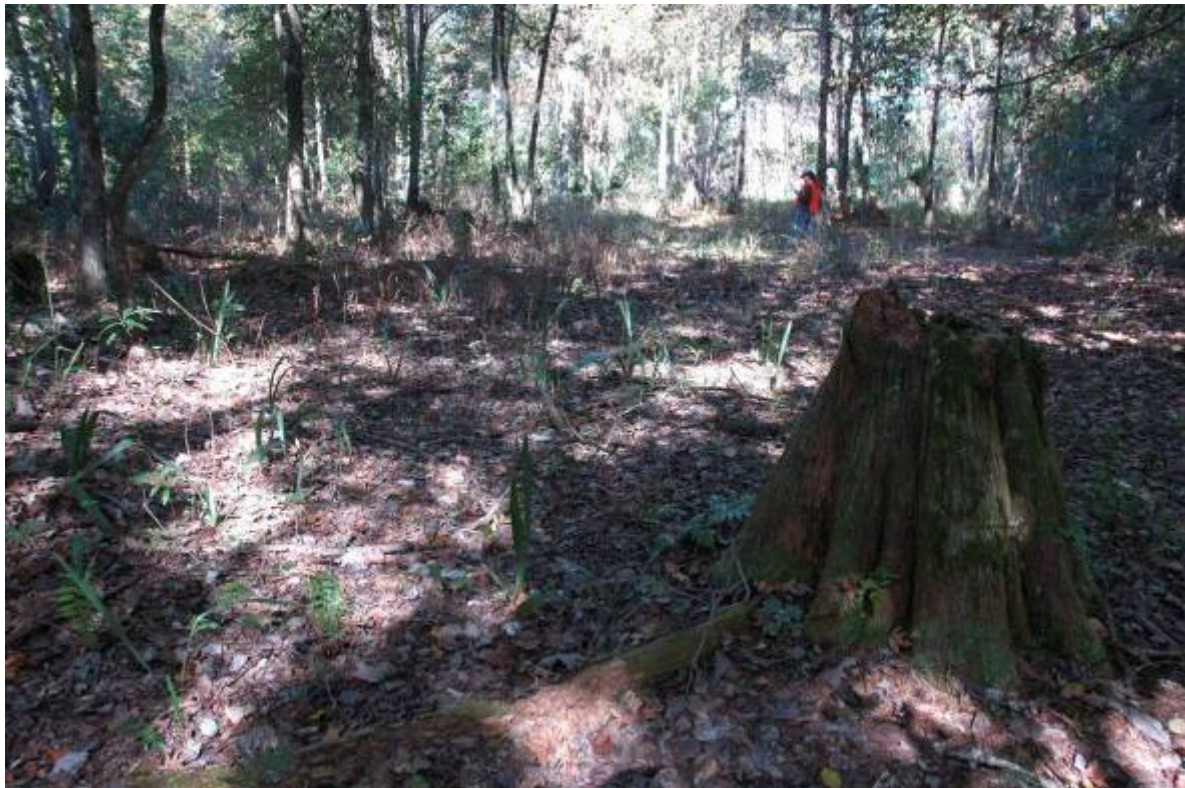
**Wetland ID: 24-02**

**Description:** This wetland is a 1.4 ha highly ephemeral forested swamp. This wetland likely was a cypress dome. The cypress were logged, the uplands drained for cattle grazing, and the resulting desiccation allowed gum trees to colonize. Gum trees dominate the canopy, and cover >75% of the wetland. There is little to no midstory cover. Maidencane and rush grow throughout, and cover 50-75% of the basin. A ditch and fireline encircle 3/4 of the pond. The adjacent uplands were ditched, drained, and logged to provide grazing habitat for cattle. The uplands currently are pasture and oldfield communities.

**Wetland Concern(s):** Ditching, Fireline, Upland condition

**Restoration Action Recommended:** Monitor herbaceous density; provide custom burn treatments if needed. In order to restore the full ecological function of this wetland, the uplands would need to be restored.

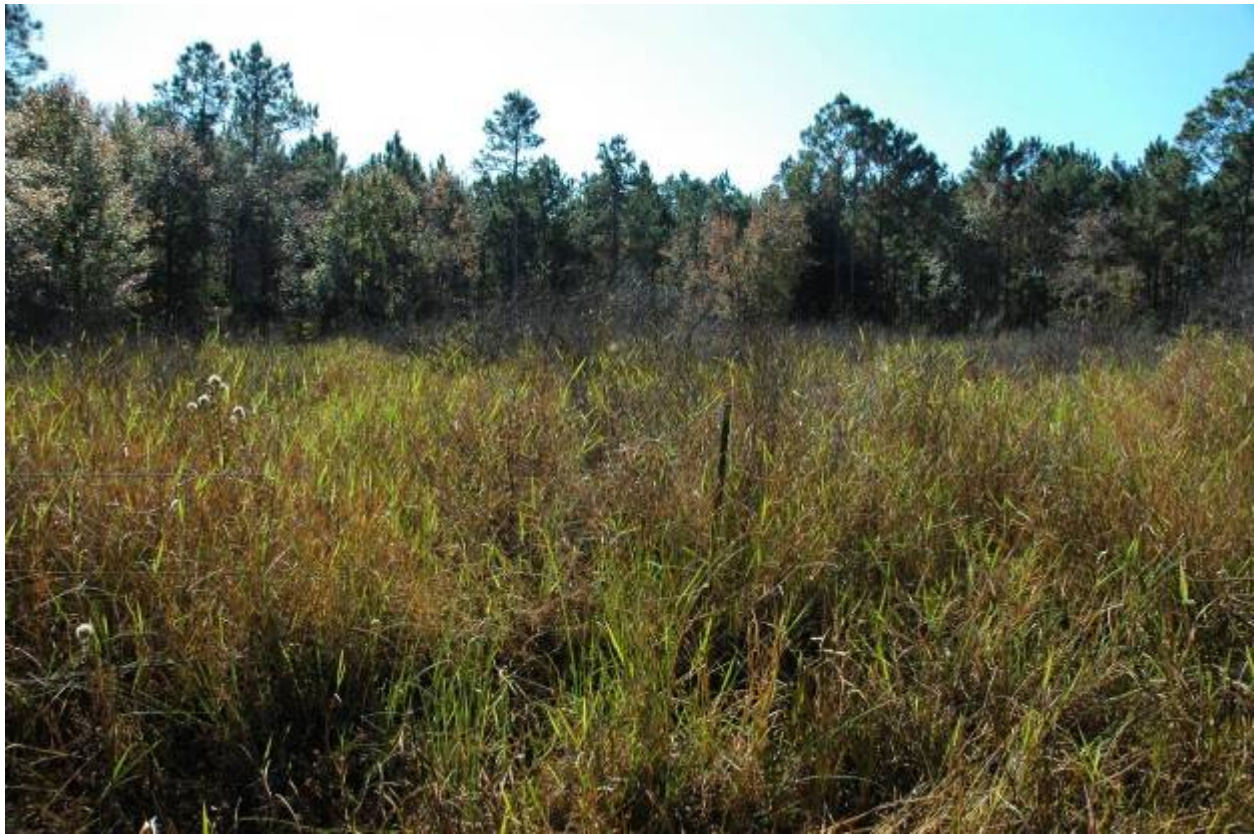
**Description:** This wetland is a 0.7 ha ephemeral marsh. There is no tree canopy cover. The midstory is dominated by buttonbush, and covers 5-25% of the wetland. Maidencane and rush densely grow throughout the wetland, and cover >75% of the basin. A barbed wire fence runs through the center of the wetland. There is some evidence of cattle traffic. The adjacent uplands were ditched, drained, and logged to provide grazing habitat for cattle. The uplands currently are pasture and oldfield communities.

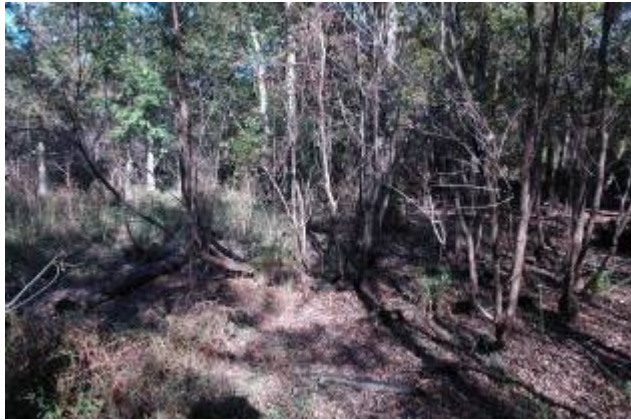
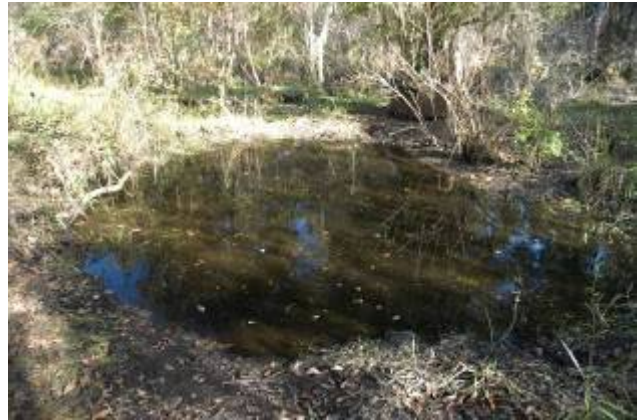
**Wetland ID: 24-04**

**Description:** This wetland is a 0.6 ha ephemeral forested swamp. Gum and maple trees dominate the canopy, and cover 50-75% of the wetland. The midstory is dominated by wax myrtle and willow, and covers 50-75% of the wetland. Maidencane and smartweed grow in scattered patches, and cover 25-50% of the basin. The wetland is ringed in thick brush. An old barbed wire fence runs through the wetland. The adjacent uplands were ditched, drained, and logged to provide grazing habitat for cattle. The uplands currently are grazed oldfield, planted pine, and mesic flatwoods communities.

**Wetland Concern(s):** Upland condition, Woody encroachment

**Restoration Action Recommended:** The almost impenetrable thick brush surrounding this wetland needs to be thinned. Periodic fire should reduce the dense woody vegetation, but this wetland also is a good candidate for experimental, mechanical brush ring removal. In order to restore the full ecological function of this wetland, the uplands would need to be restored.

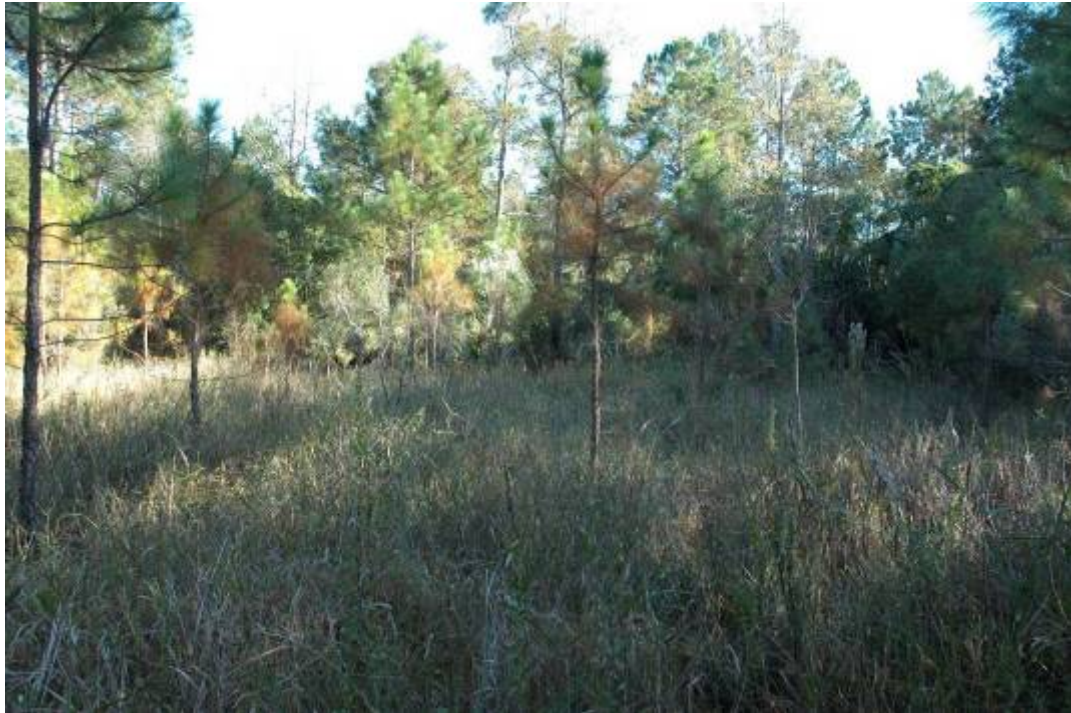
**Wetland ID: 24-05**

**Description:** This wetland is a 0.1 ha highly ephemeral marsh. There is no tree canopy or midstory cover. Small pine trees are encroaching into the wetland, but cover <5% of the basin. Maidencane grows throughout the wetland, and covers >75% of the basin. The wetland is ringed in a brushy thicket. There is a ditch/fireline along the north side of the wetland. The adjacent uplands were ditched, drained, and logged to provide grazing habitat for cattle. The uplands currently are pasture and mesic flatwoods communities.

**Wetland Concern(s):** Ditching, Fireline, Upland condition, Woody encroachment

**Restoration Action Recommended:** In order to restore the full ecological function of this wetland, the uplands would need to be restored.

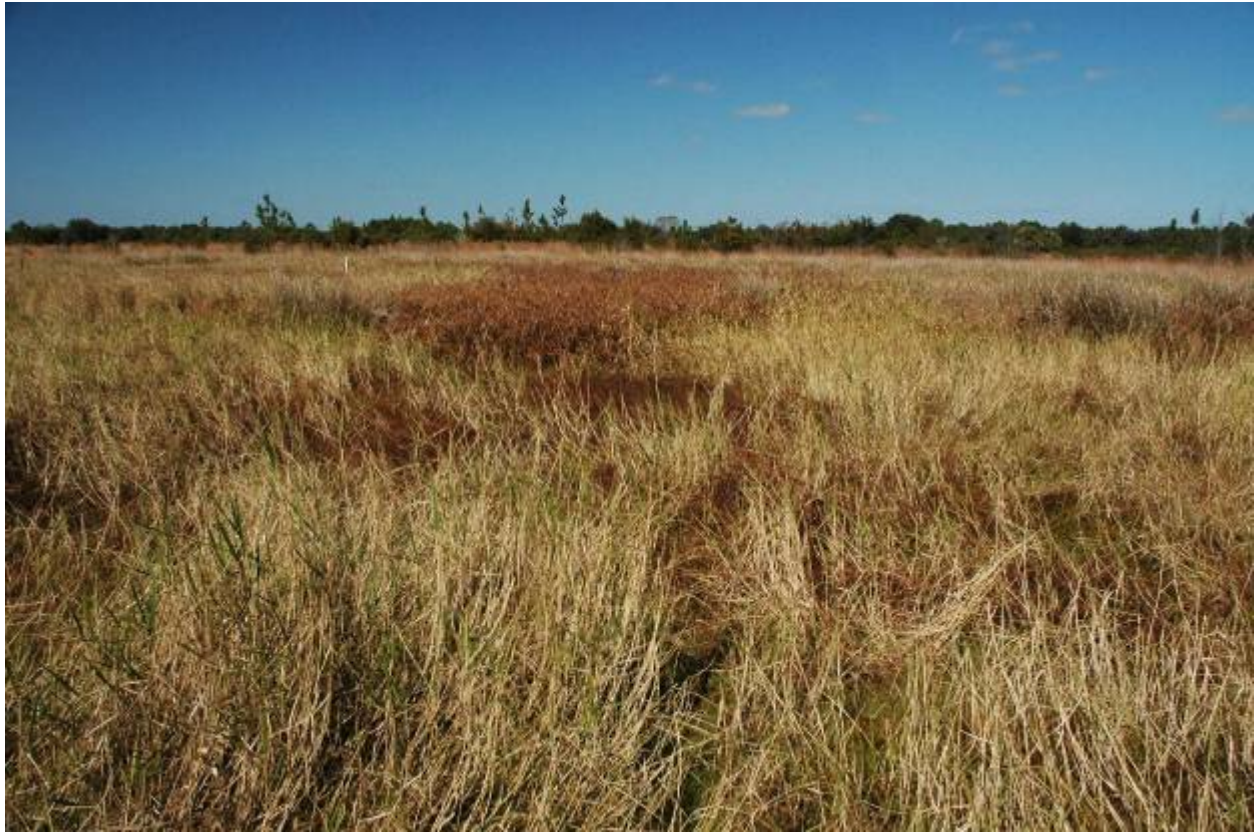
**Description:** This wetland is a 0.8 ha ephemeral marsh. There is no tree canopy or midstory cover. Maidencane grows throughout the wetland, and covers >75% of the basin. A portion of the wetland is enclosed by a rectangular barbed wire fence. There is evidence of cattle in the wetland. The adjacent uplands were ditched, drained, and logged to provide grazing habitat for cattle. The uplands currently are a pasture community.

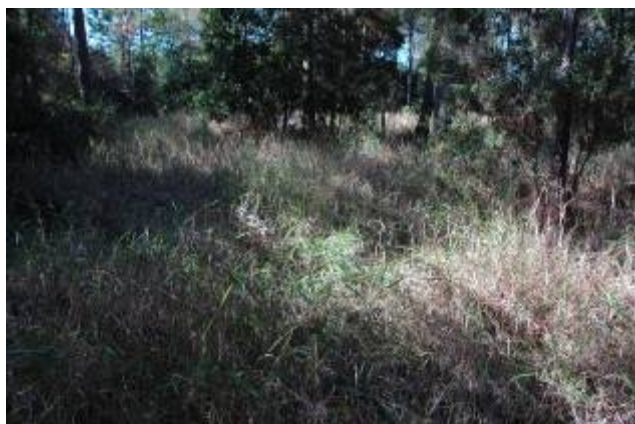
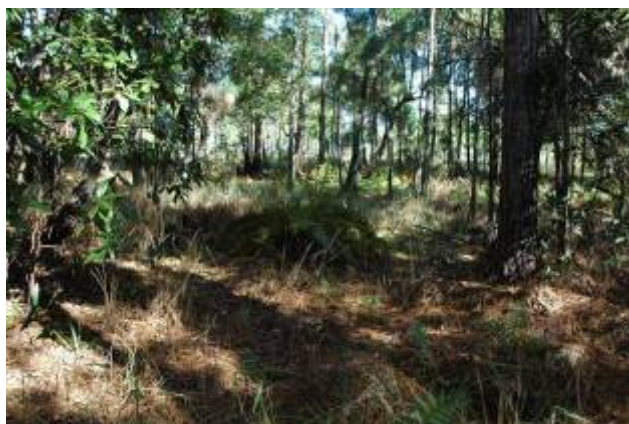
**Wetland ID: 26-01**

**Description:** This wetland is a 0.5 ha ephemeral forested swamp. Gum and pine trees dominate the canopy, and cover >75% of the wetland. The midstory is comprised of various shrubs, and covers 25-50% of the wetland. Maidencane, *Sphagnum*, and fern grow throughout the wetland, and cover 50-75% of the basin. A ditch drains the wetland to the south and the wetland shows effects of long-term desiccation. The adjacent uplands were ditched, drained, and logged to provide grazing habitat for cattle. The uplands are a mix of pasture, food plot, and planted longleaf pine communities.

**Wetland Concern(s):** Ditching, Upland condition

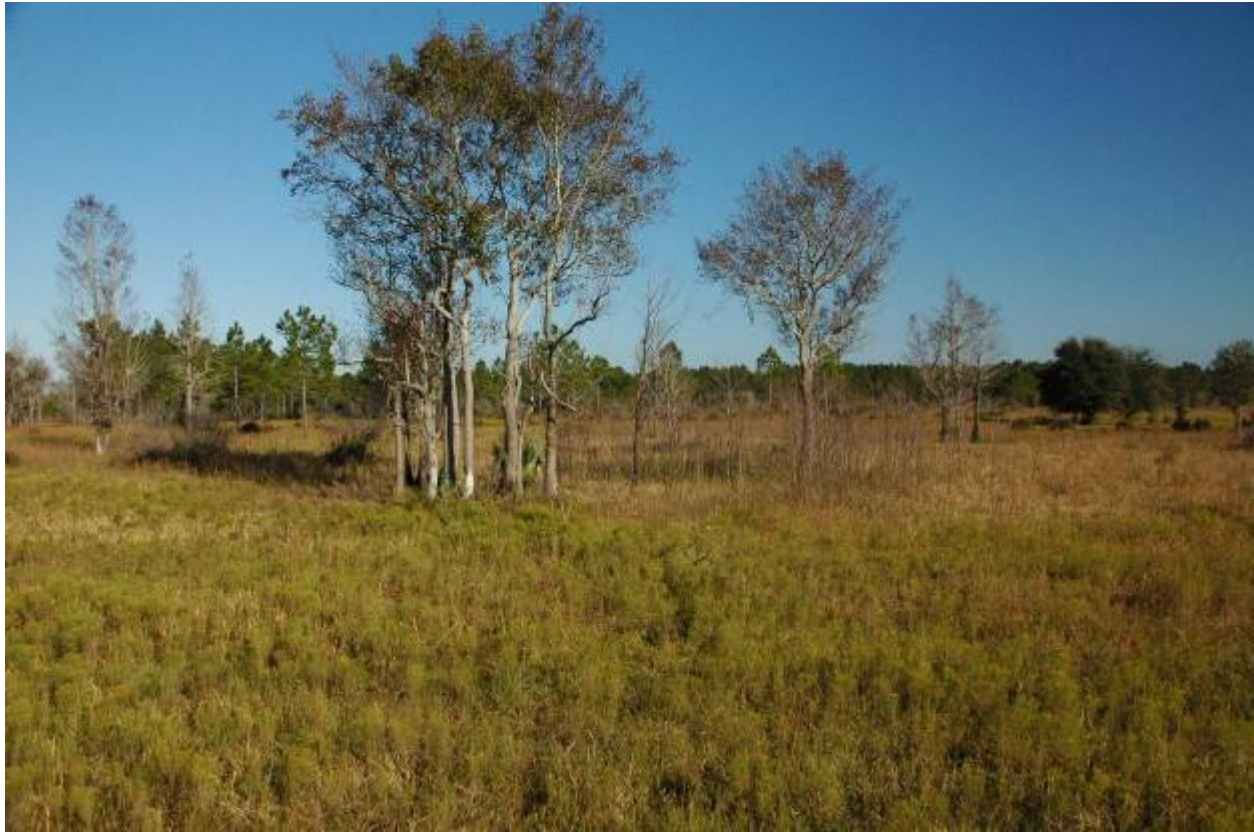
**Description:** This wetland is a 0.2 ha highly ephemeral marsh. Several gum trees ring the pond edge and a few saplings are growing in the pond center. The trees provide <5% cover. There is no midstory cover. Maidencane and rush are grow throughout the wetland, and cover >75% of the basin. The adjacent uplands were ditched, drained, and logged to provide grazing habitat for cattle. The uplands currently are a pasture community.
