# **Inventory, Assessment, and Restoration Potential of Ephemeral Wetlands on FFWCC Wildlife Management Areas**

**Caravelle Ranch WMA Final Report**

November 2008

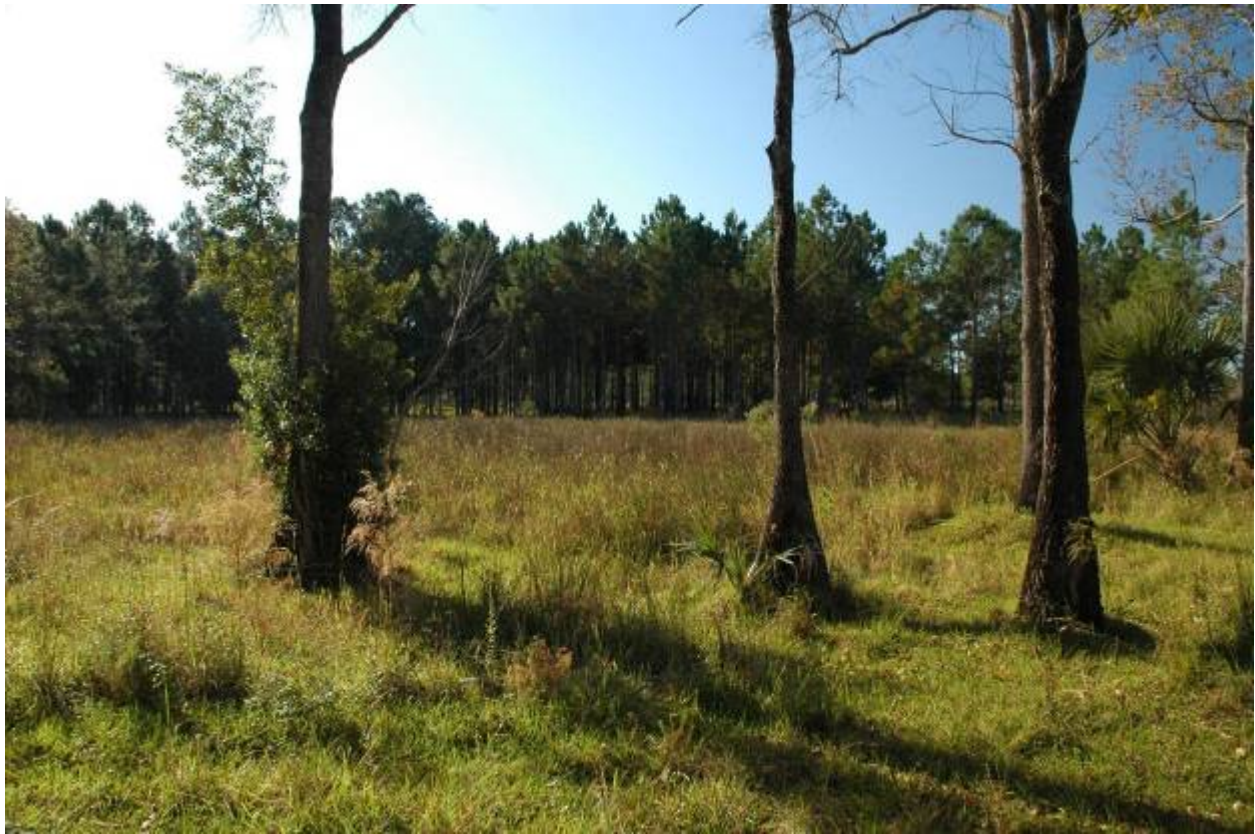
**Description:** This wetland is a 0.3 ha ephemeral marsh. A few gum trees grow around the wetland edge, but cover <5% of the wetland. There is no midstory cover. Maidencane and rush grow throughout the wetland, and cover >75% of the basin. The adjacent uplands were ditched, drained, and logged to provide grazing habitat for cattle. The uplands currently are a pasture community.

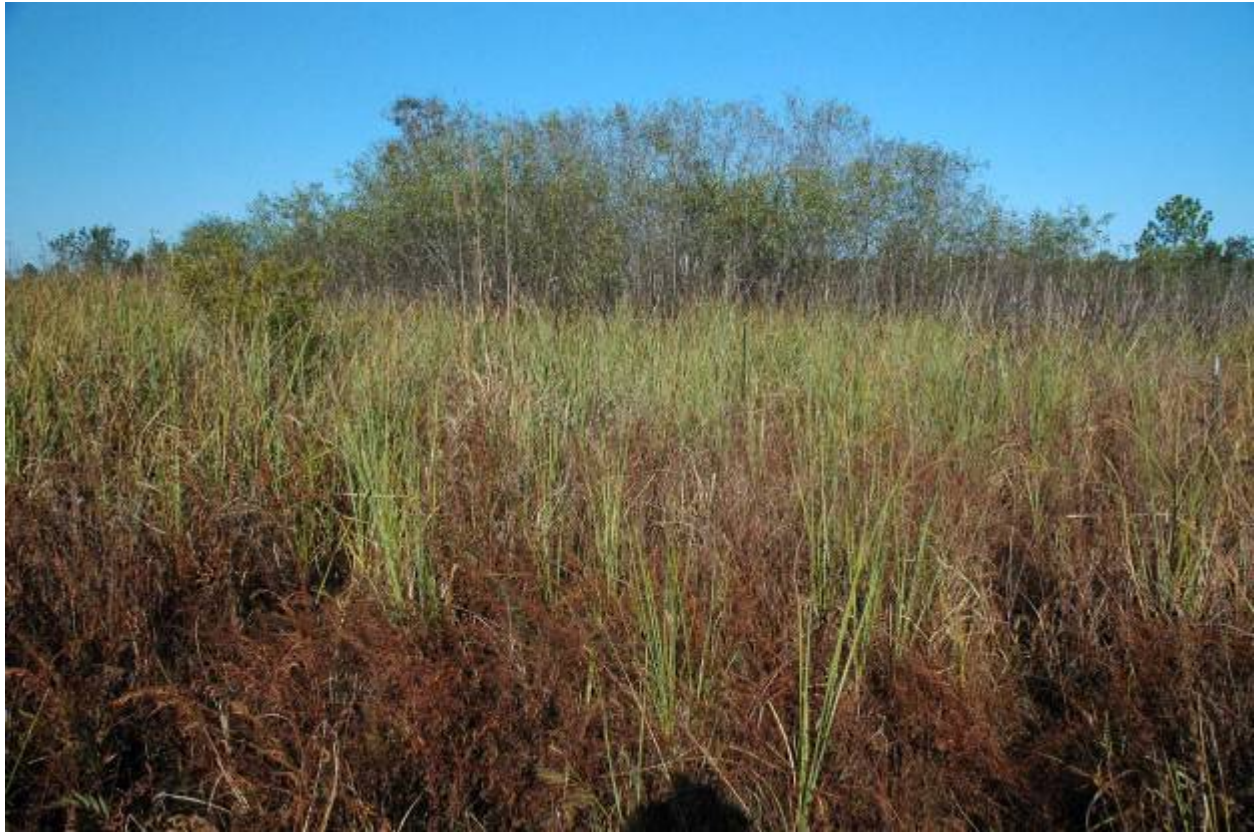
**Description:** This wetland is a 0.3 ha ephemeral. There is no tree canopy. A clump of willow shrubs grow in the wetland center, and covers 5-25% of the basin. Sawgrass and fern grow throughout the wetland, and cover >75% of the basin. There is evidence of cattle grazing in the wetland. The adjacent uplands were ditched, drained, and logged to provide grazing habitat for cattle. The uplands currently are a pasture community.

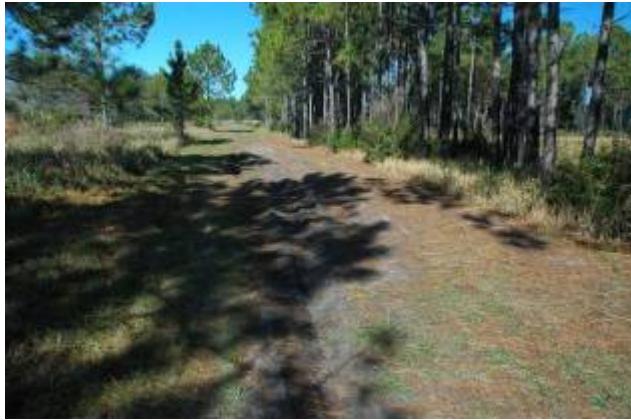
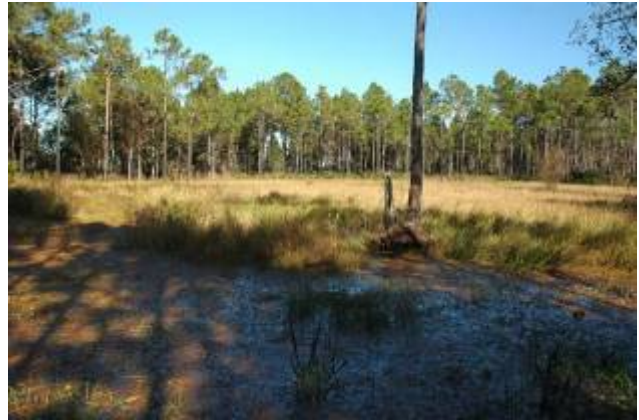
**Wetland ID: 33-01**

**Description:** This wetland is a 0.6 ha ephemeral marsh. There is no tree canopy or midstory cover. Maidencane grows throughout the wetland, and covers >75% of the basin. A dike road bisects the west end of the pond. The adjacent uplands were ditched, drained, and logged to provide grazing habitat for cattle. The uplands currently are pasture and mesic flatwoods communities.

**Wetland Concern(s):** Road, Upland condition

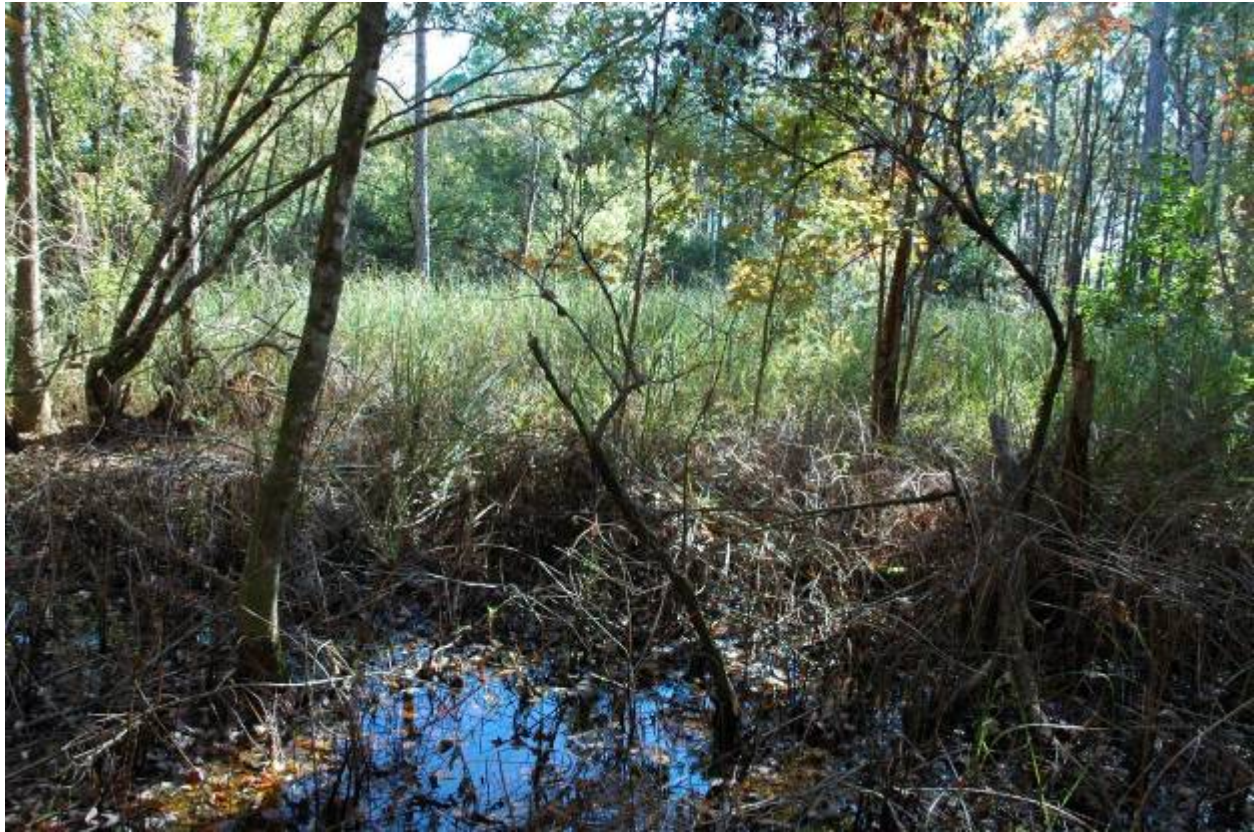
**Description:** This wetland is a 1.3 ha ephemeral forested swamp. Maple, gum and pine trees dominate the canopy, and cover >75% of the wetland. The midstory is dominated by fetterbush and *Vaccinium*, and covers 5-25% of the wetland. Sawgrass grows in scattered patches, and covers 5-25% of the basin. Thick brush surrounds the wetland. The adjacent uplands were ditched, drained, and logged to provide grazing habitat for cattle. The uplands currently are grazed, mesic flatwoods.

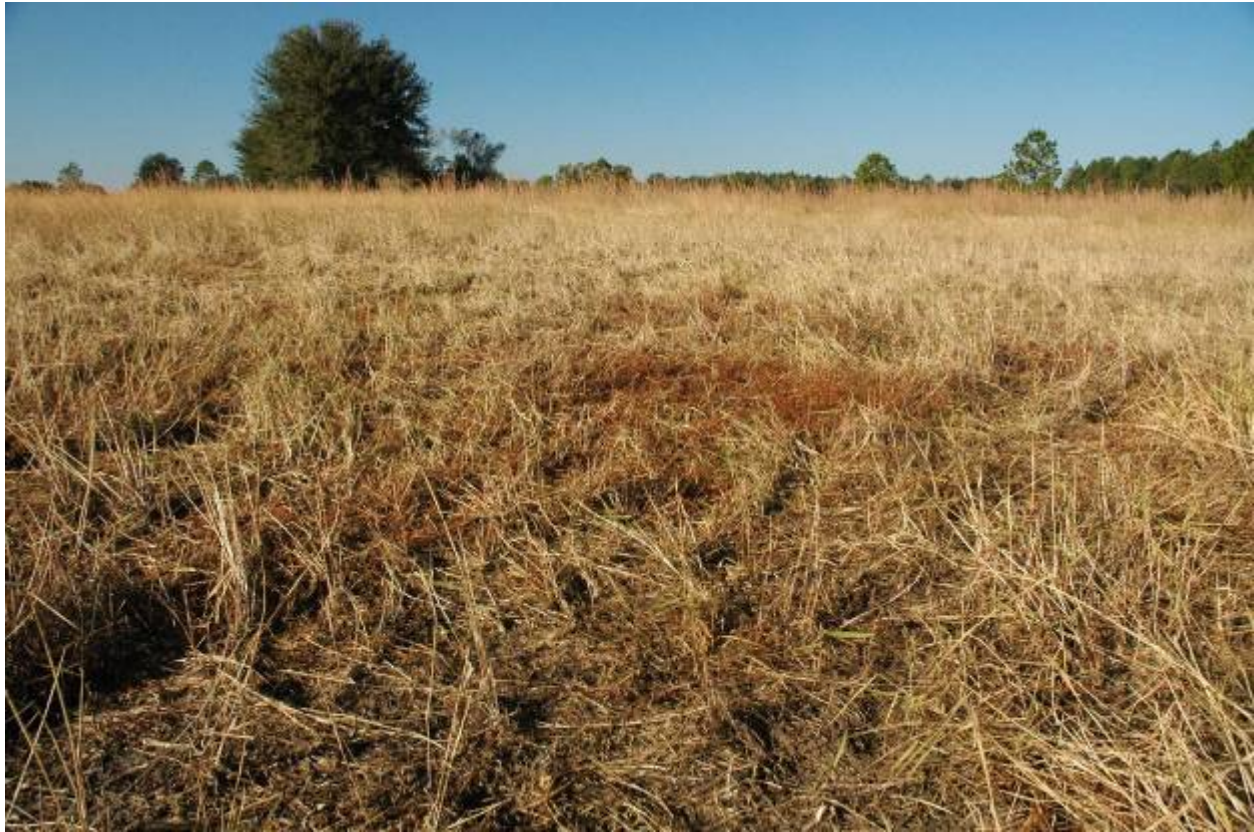
**Description:** This wetland is a 0.7 ha highly ephemeral marsh. There is no tree canopy or midstory cover. Maidencane and smartweed grow throughout the wetland, and cover >75% of the basin. There is evidence of grazing in the wetland. The adjacent uplands were ditched, drained, and logged to provide grazing habitat for cattle. The uplands currently are a pasture community.

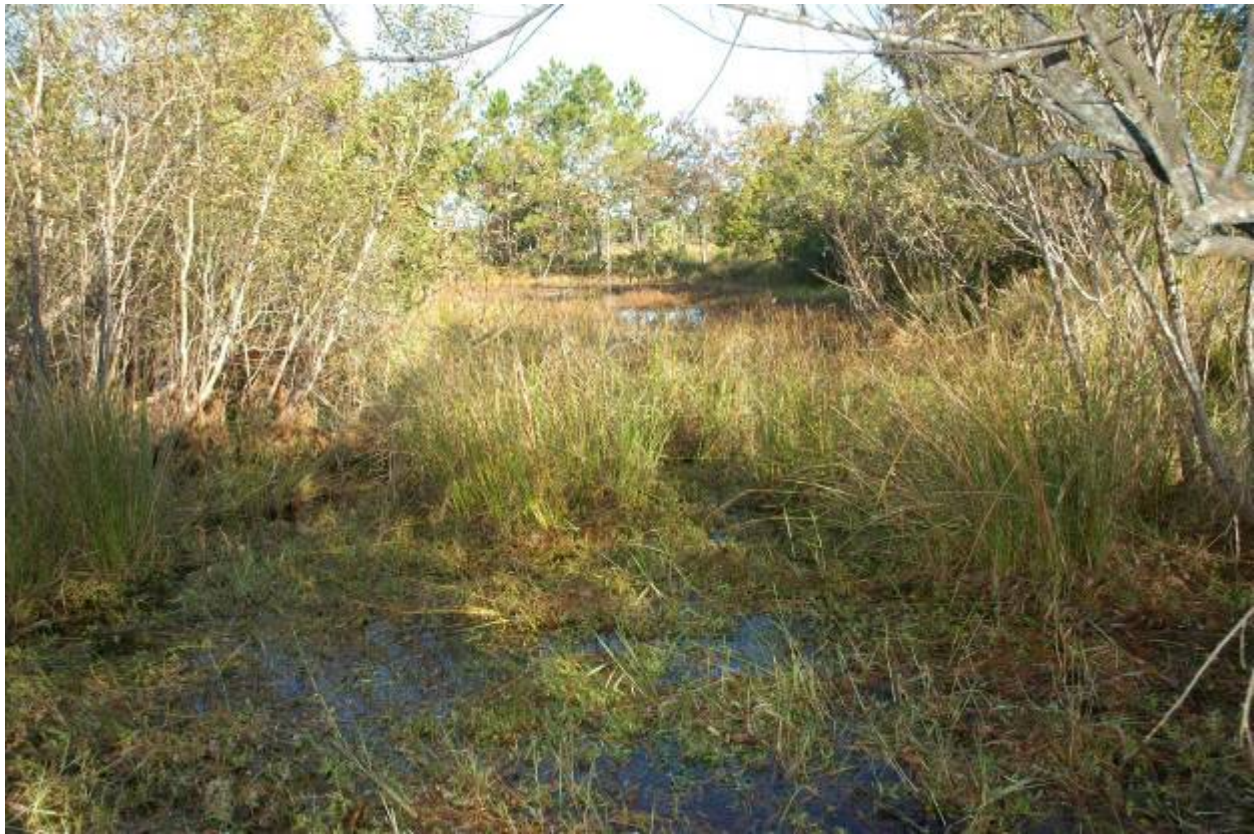
**Description:** This wetland is a 0.6 ha ephemeral mixed swamp. Pine trees dominate the canopy, and cover 5-25% of the wetland. The midstory is dominated by wax myrtle and willow, and covers 25-50% of the wetland. Maidencane and rush grow throughout the wetland, and cover >75% of the basin. This wetland is either man-made or man-enhanced and there is a berm on the east side. We saw cattle in the wetland basin on the day of our visit. The adjacent uplands were ditched, drained, and logged to provide grazing habitat for cattle. The uplands currently are a pasture community.

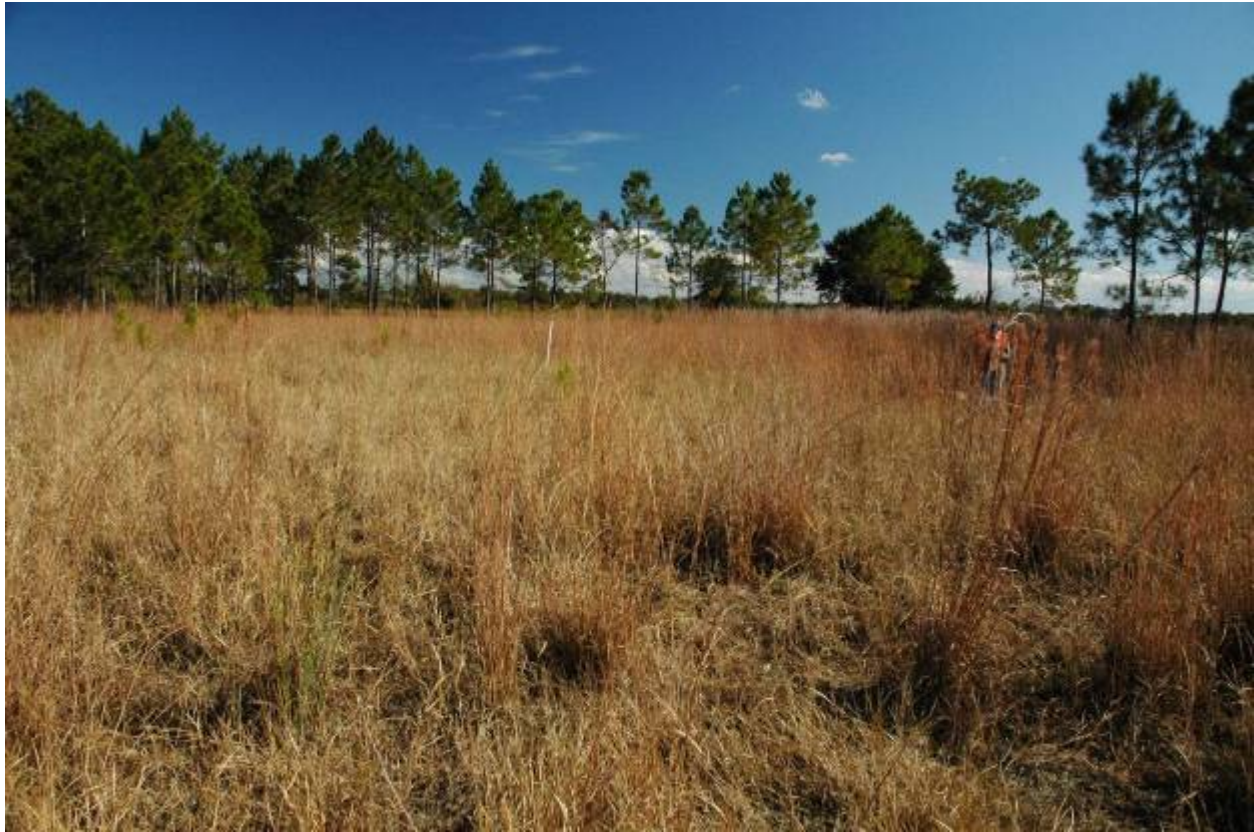
**Description:** This wetland is a 0.2 ha highly ephemeral marsh. There is no tree canopy or midstory cover. Maidencane and broomsedge grow throughout the wetland, and cover >75% of the basin. A MU boundary/dirt road runs along the north end of the wetland. Cattle trails lead into and around the pond. The adjacent uplands were ditched, drained, and logged to provide grazing habitat for cattle. The uplands currently are a pasture community.

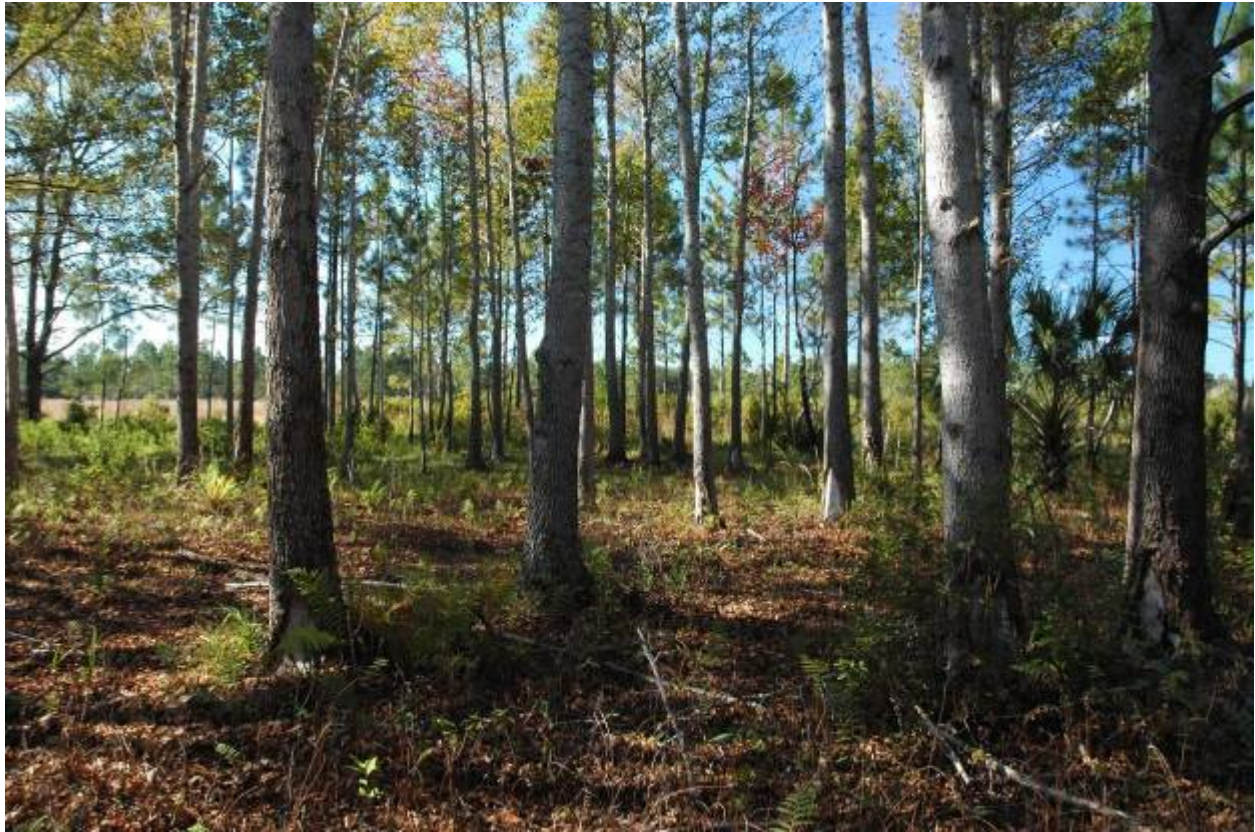
**Description:** This wetland is a 0.4 ha highly ephemeral forested swamp. Gum trees dominate the canopy, and cover >75% of the wetland. There is minimal midstory cover. Grasses and ferns grow throughout the wetland, cover >75% of the basin. Historically, a ditch drained the wetland and desiccated the swamp. The ditch has been filled in an effort to restore the wetland's hydrology. Cattle trails lead into and around the wetland. The adjacent uplands were ditched, drained, and logged to provide grazing habitat for cattle. The uplands currently are a pasture community.

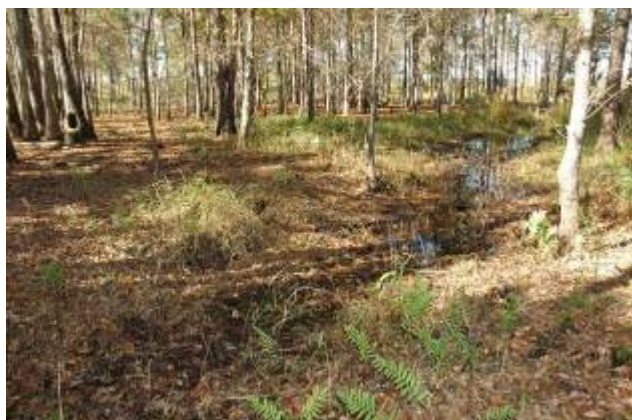
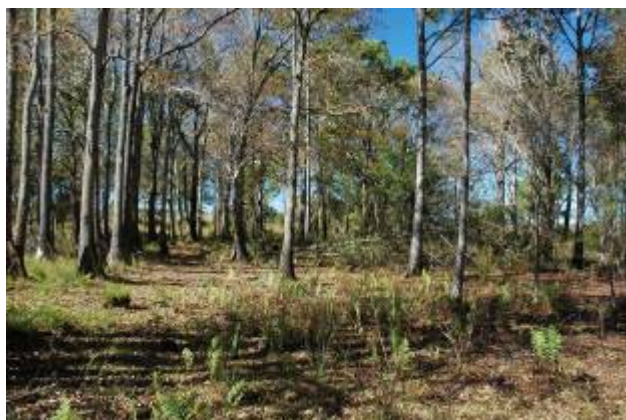
**Wetland ID: 35-02**

**Description:** This wetland is a 0.6 ha highly ephemeral forested swamp. Gum and pine trees dominate the canopy, and cover >75% of the wetland. There is minimal midstory cover. Maidencane, grasses, and ferns grow in scattered patches, and cover 25-50% of the basin. Historically, a ditch drained the wetland and desiccated the swamp. The ditch has been filled in an effort to restore the wetland's hydrology. Cattle trails lead into and around the wetland. The adjacent uplands were ditched, drained, and logged to provide grazing habitat for cattle. The uplands currently are a pasture community.

**Wetland Concern(s):** Cattle, Upland condition

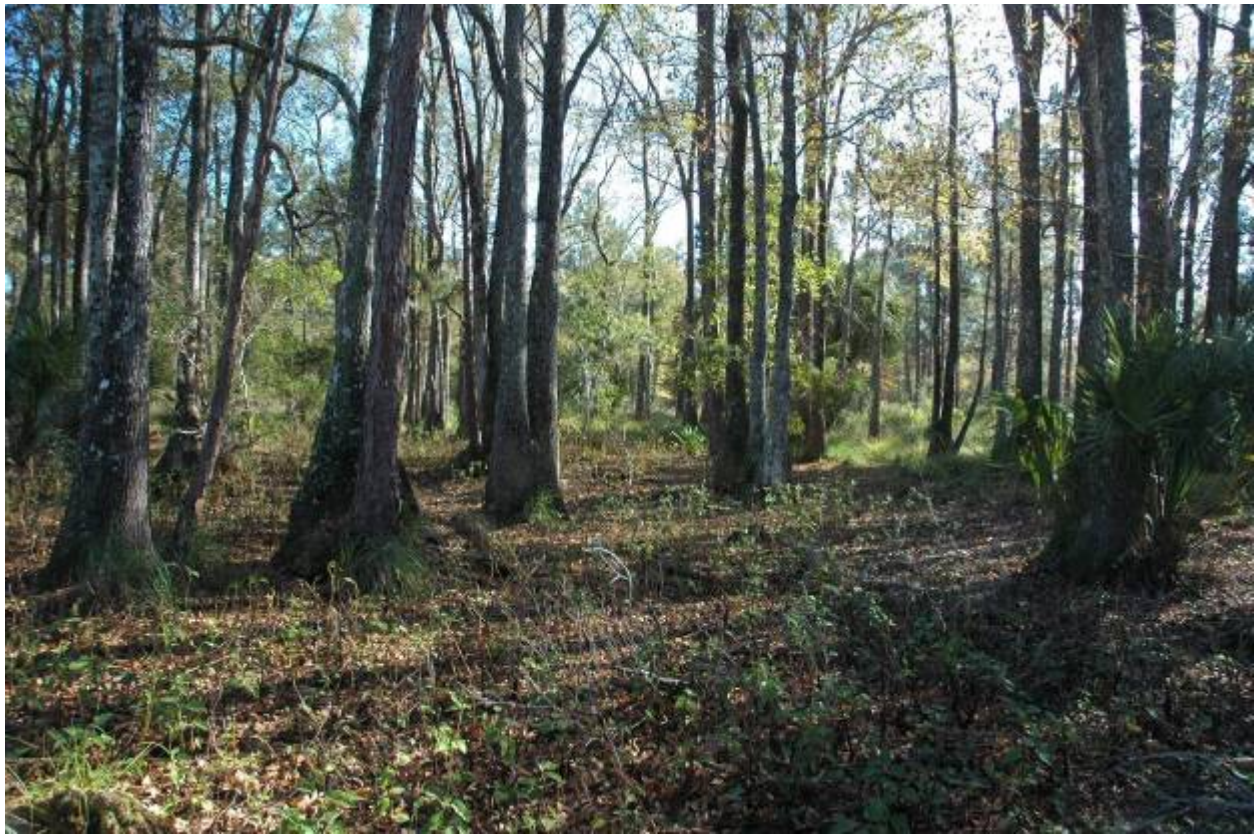
**Description:** This wetland is a 0.3 ha ephemeral forested swamp. Black gum trees dominate the canopy and a few large pine trees grow in the wetland center. The tree canopy covers >75% of the wetland. There is minimal midstory cover. Grasses and lizard's tail ring the wetland edge, and cover 25-50% of the basin. The adjacent uplands have been ditched, drained, and logged to provide grazing habitat for cattle. The uplands currently are pasture, food plot, and river bottomland communities.

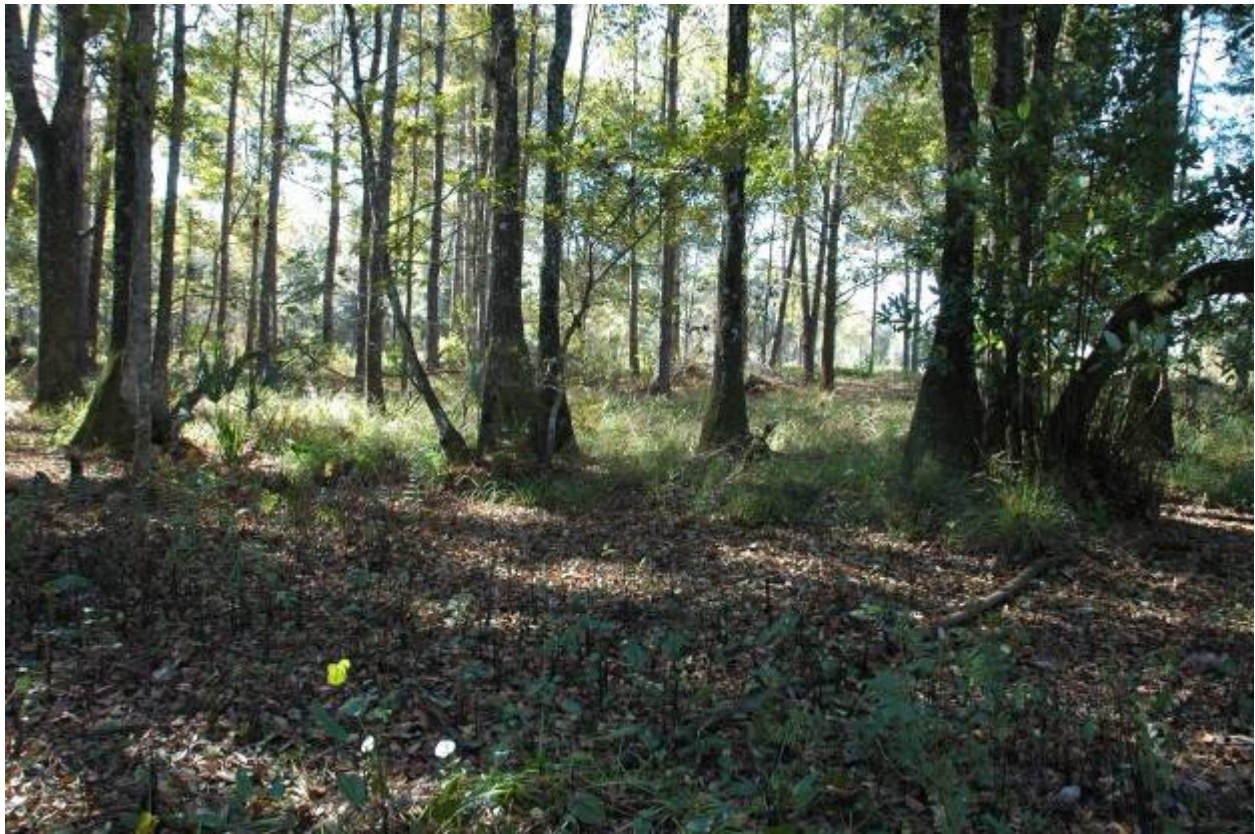
**Description:** This wetland is a 0.2 ha ephemeral forested swamp. Black gum trees dominate the canopy, and cover 25-50% of the wetland. There is no midstory cover. Maidencane, grasses, and lizardtail grow throughout the wetland, and cover 50-75% of the basin. The adjacent uplands have been ditched, drained, and logged to provide grazing habitat for cattle. The uplands currently are pasture and river bottomland communities.

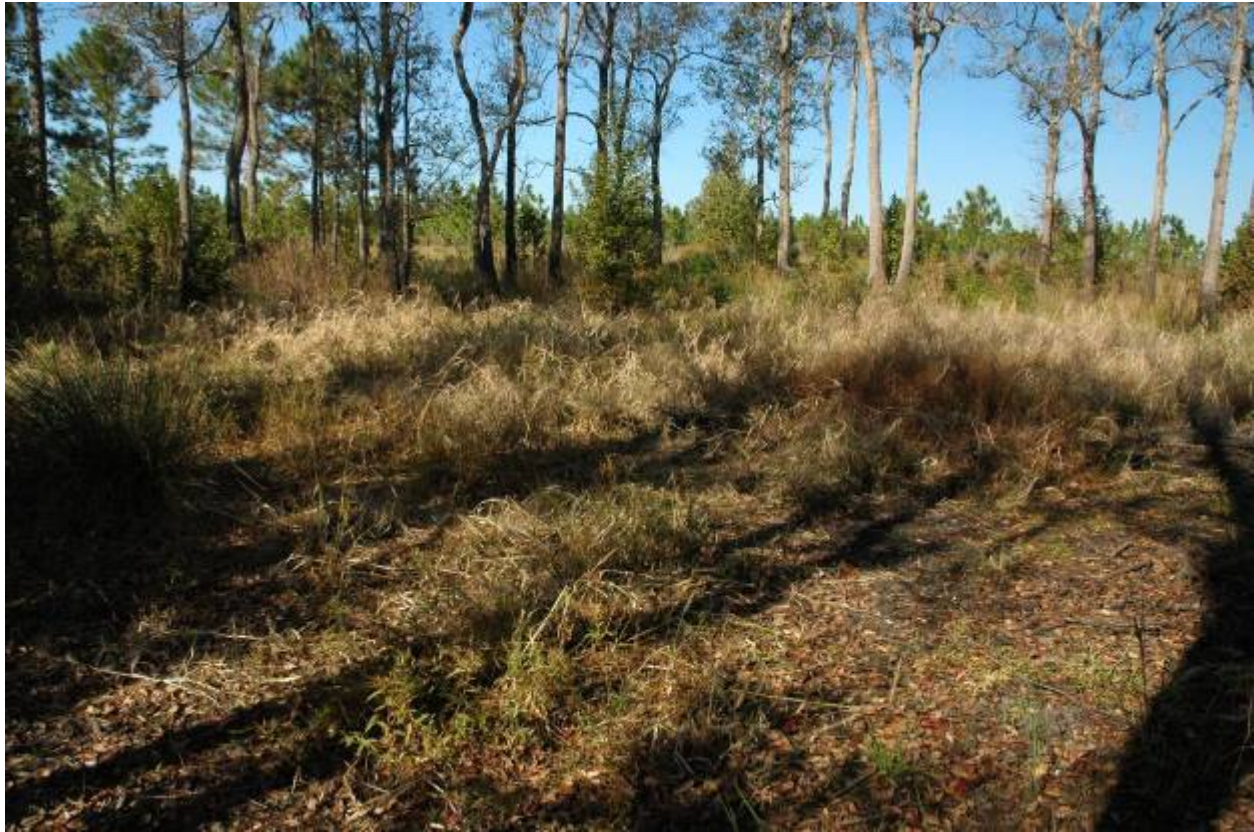
**Description:** This wetland is a 0.2 ha highly ephemeral forested swamp. Black gum trees dominate the canopy, and cover 5-25% of the wetland. Shrubs were mechanically removed from the west side of the wetland. There is minimal midstory cover. Maidencane and smartweed grow throughout the wetland, and cover >75% of the basin. The adjacent uplands have been ditched, drained, and logged to provide grazing habitat for cattle. The uplands currently are grazed oldfield and food plot communities.

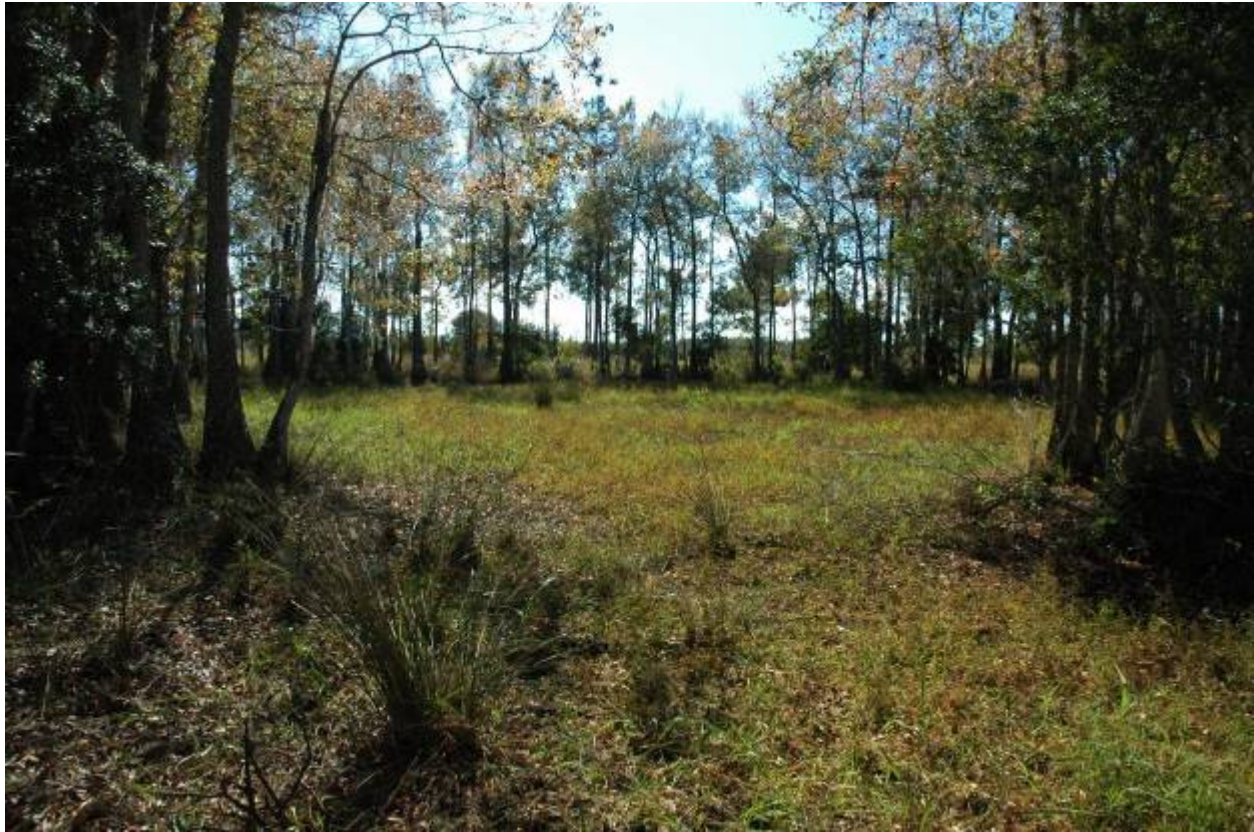
**Description:** This wetland is a 0.4 ha ephemeral marsh. Black gum trees grow in a ring around the wetland edge, and cover 25-50% of the wetland. There is no midstory cover. Maidencane, grasses, and smartweed grow throughout the wetland, and cover >75% of the basin. The adjacent uplands have been ditched, drained, and logged to provide grazing habitat for cattle. The uplands currently are pasture and food plot communities.

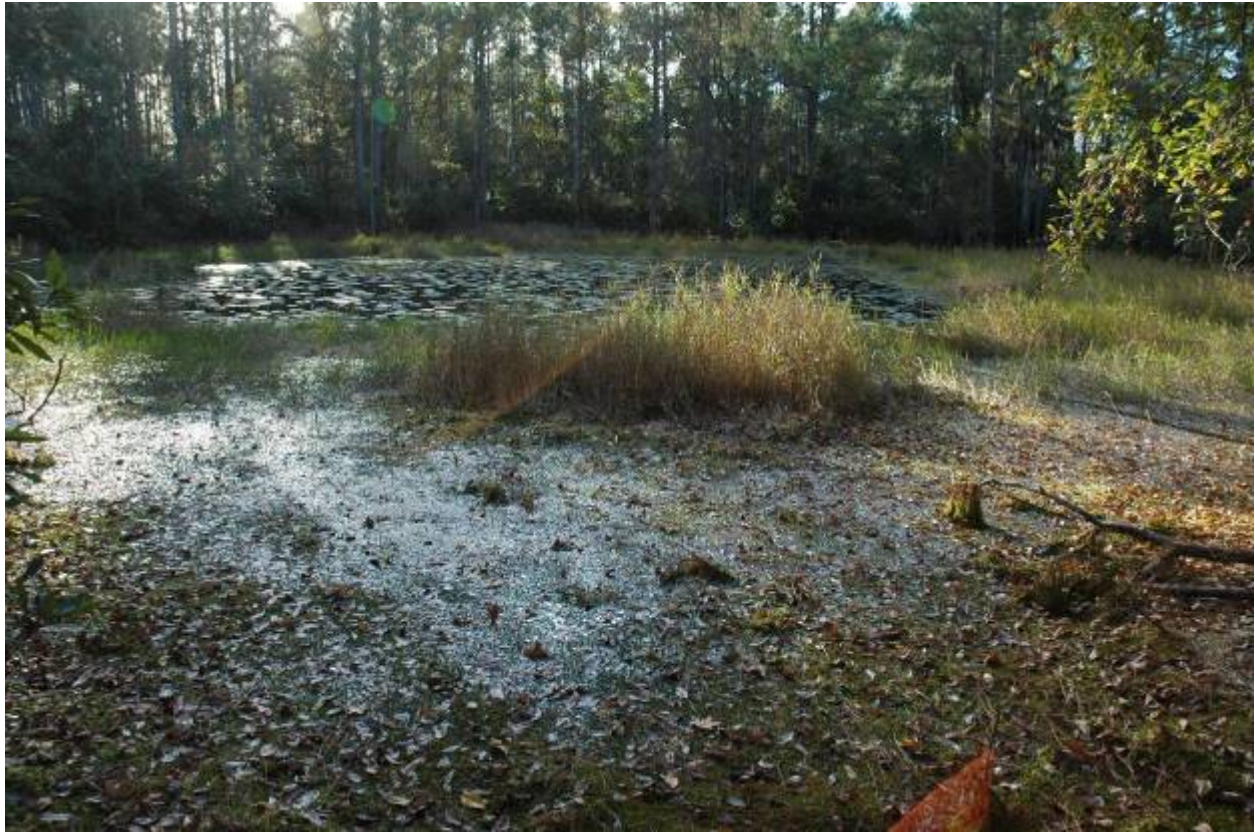
**Description:** This wetland is a 0.2 ha semi-permanent man-made marsh. There is no tree canopy or midstory cover. Maidencane and *Sphagnum* grow in a ring the edge of the wetland, and cover 50-75% of the basin. The wetland has an open water center with lily pads. A 2 m tall earthen berm surrounds the wetland. The adjacent uplands are fire-suppressed mesic flatwoods.

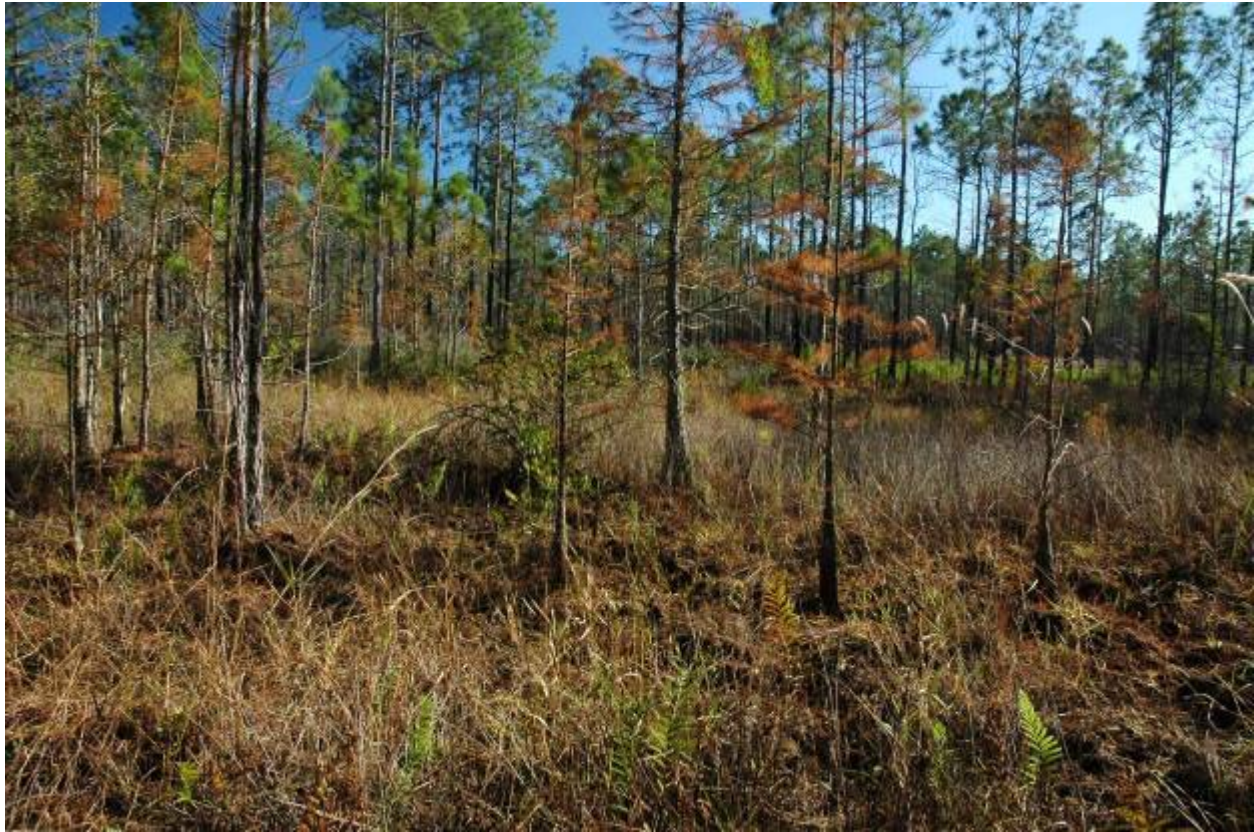
**Description:** This wetland is a 0.3 ha highly ephemeral forested swamp. Young cypress and pine trees cover >75% of the wetland. Grasses and fern grow throughout the wetland, and cover >75% of the wetland basin. An MU boundary/fireline runs along the northwest side of the wetland. There is a ditched canal along the opposite side of the fireline (i.e. not proximal to the wetland). Feral hog damage is minimal. The adjacent uplands are mesic flatwoods that are managed with prescribed fire.

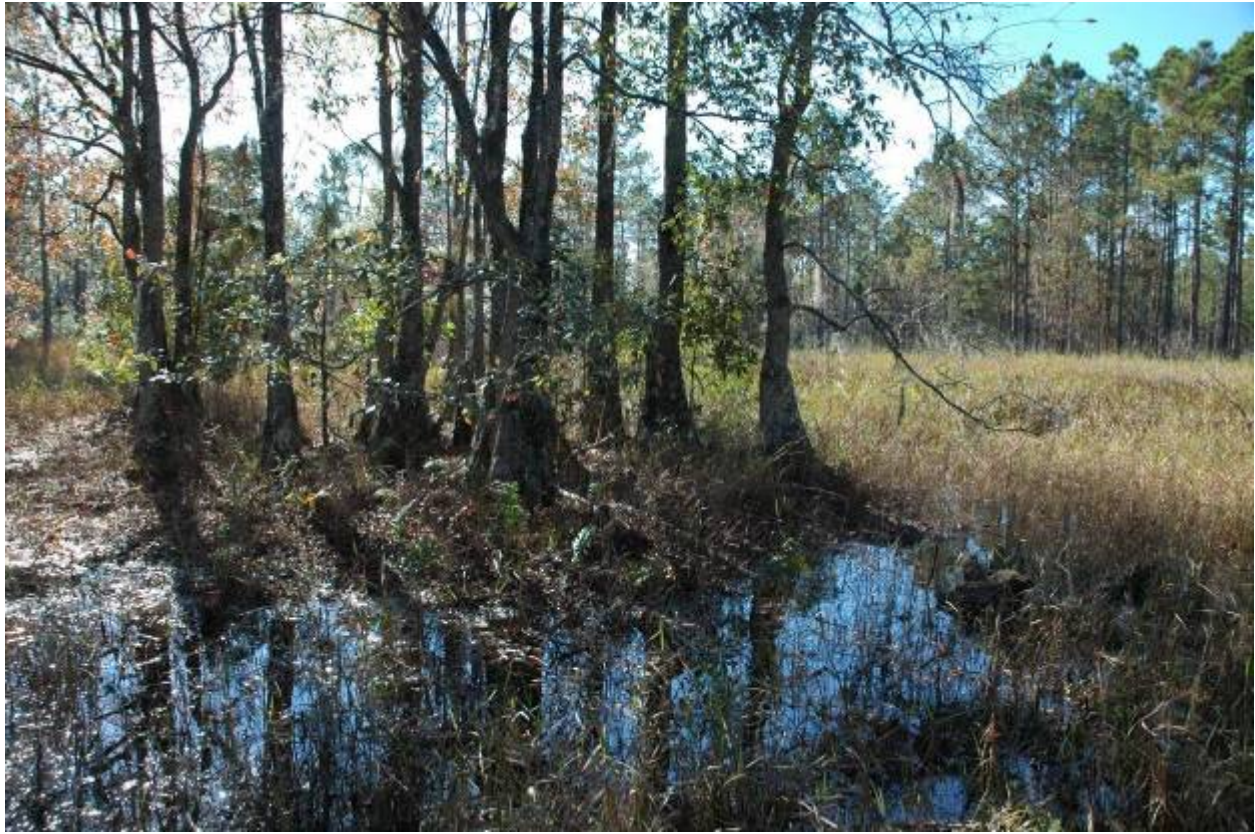
**Description:** This wetland is a 0.3 ha ephemeral marsh. A cluster of gum and pine trees cover 5-25% of the wetland. There is no midstory cover. There are thick patches of maidencane throughout the wetland. The herbaceous vegetation covers >75% of the basin. A major road (SR 19) is located on the east side of the wetland. The adjacent uplands are mesic flatwoods that are managed with prescribed fire.

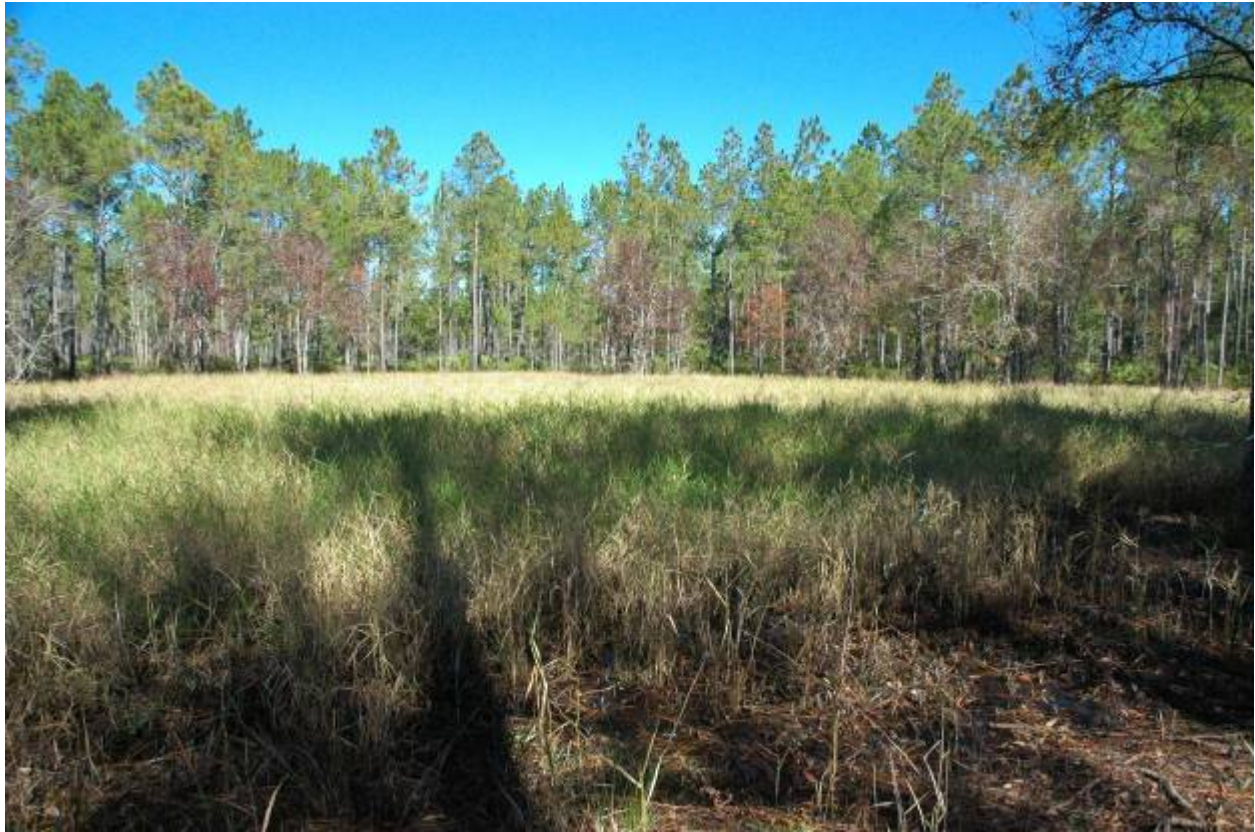
**Description:** This wetland is a 0.4 ha ephemeral marsh. There is no tree canopy or midstory cover. Maidencane grows thick throughout the wetland, and covers >75% of the basin. Feral hog damage is present, but not severe. The adjacent uplands are mesic flatwoods that are managed with prescribed fire.

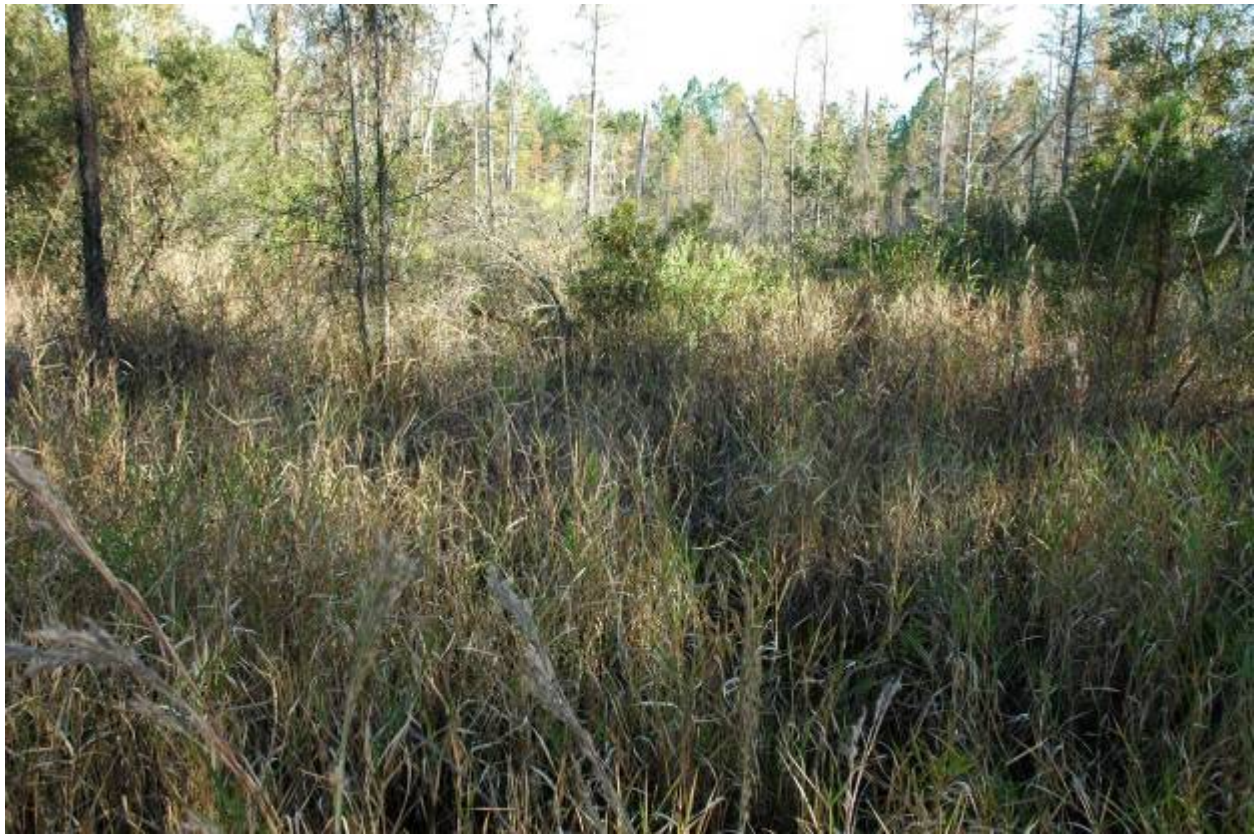
**Description:** This wetland is a 1.0 ha ephemeral mixed swamp. Cypress trees dominate the canopy, and cover 5-25% of the wetland. The midstory is dominated by wax myrtle, fetterbush, and buttonbush, and covers 25-50% of the wetland. Maidencane grows thick throughout the wetland, and covers >75% of the basin. The adjacent uplands are mesic flatwoods. The topography is undulating with old, but deep, plowlines created by the Florida Department of Forestry.

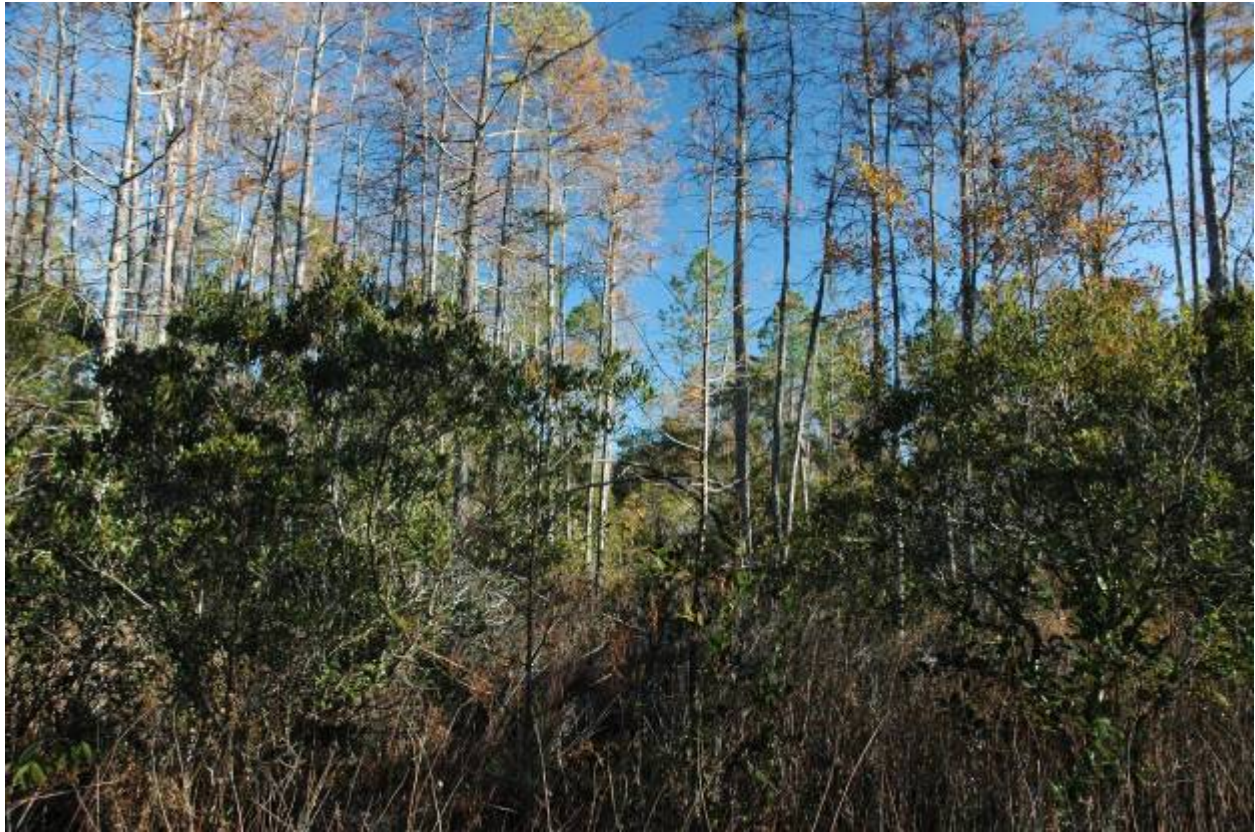
**Description:** This wetland is a 1.2 ha ephemeral mixed swamp. Cypress trees dominate the canopy, and cover 25-50% of the wetland. The midstory is dominated by wax myrtle and fetterbush, and covers 50-75% of the wetland. Sphagnum, grasses, and ferns are extensive throughout, cover >75% of the basin. Dense shrubs ring the outer edge of the wetland. The adjacent uplands are mesic flatwoods. The topography is undulating with old, but deep, plowlines created by the Florida Department of Forestry.

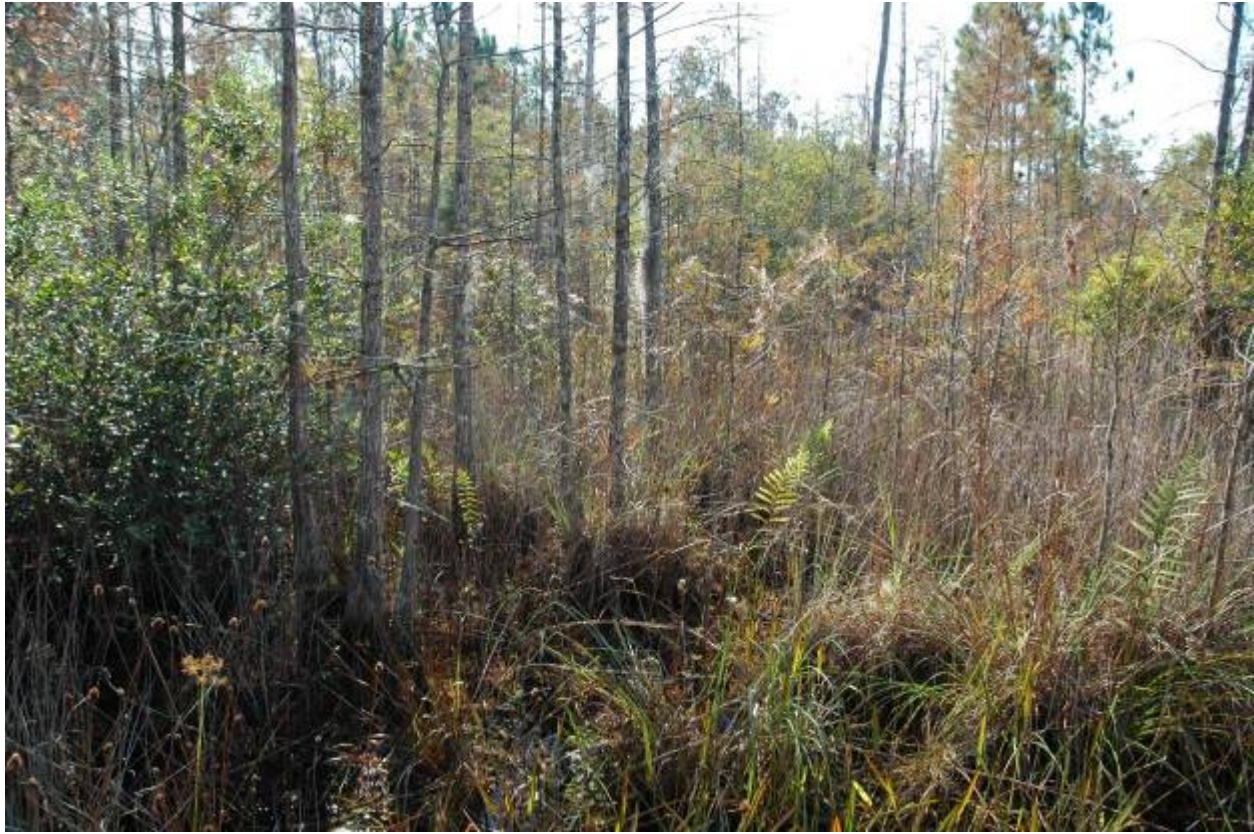
**Description:** This wetland is a 1.9 ha ephemeral mixed swamp. Cypress trees dominate the canopy, and cover 25-50% of the wetland. The midstory is dominated by wax myrtle and fetterbush, and covers 50-75% of the wetland. Maidencane, sphagnum, and fern grow throughout the wetland, and cover >75% of the basin. The adjacent uplands are mesic flatwoods.
