# **Inventory, Assessment, and Restoration Potential of Ephemeral Wetlands on FFWCC Wildlife Management Areas**

**Caravelle Ranch WMA Final Report**

November 2008

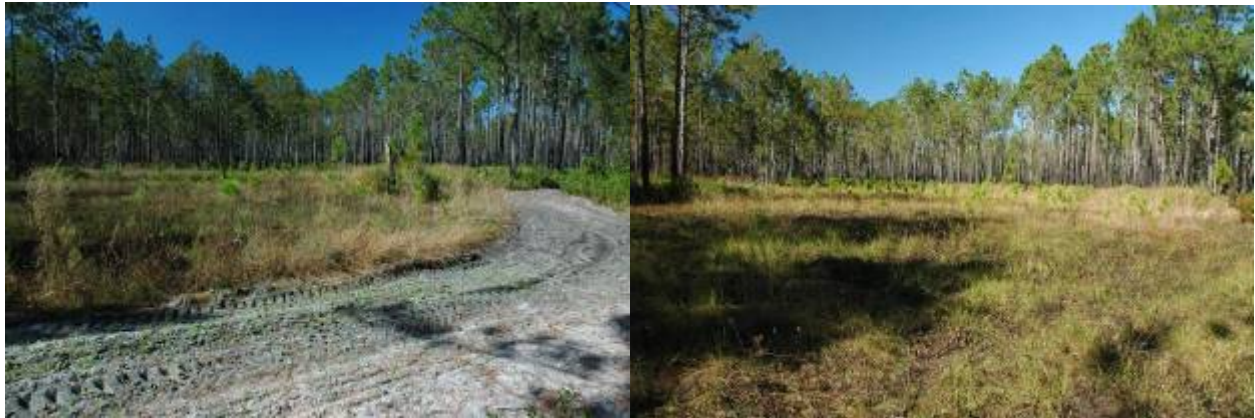
**Wetland ID: 61-01**

**Description:** This wetland is a 0.3 ha highly ephemeral marsh. Slash pine trees are beginning to colonize the wetland basin. There is no tree canopy or midstory cover. Maidencane, grasses, and sedges grow throughout the wetland, cover >75% of the basin. An MU boundary/fireline runs along the east edge of the wetland. Feral hog damage is extensive. Push piles are present along the western edge of the wetland. The adjacent uplands are mesic flatwoods. The topography is undulating with old, but deep, plowlines created by the Florida Department of Forestry.

**Wetland Concern(s):** Feral hog damage, MU boundary/fireline, Push piles, Woody encroachment

**Restoration Action Recommended:** Monitor this wetland to ensure more damage does not occur in the future. This wetland is part of a cluster of wetlands impacted by feral hog damage. If feral hog activity continues to be a problem in this area, this wetland would be a candidate for more aggressive action. Re-route the fireline into the uplands and away from the wetland. Hand-chop pines out of the wetland if inundation or fire does not kill them within the next year or two. The push piles are not extensive but they could be flattened to restore more natural conditions to the wetland.

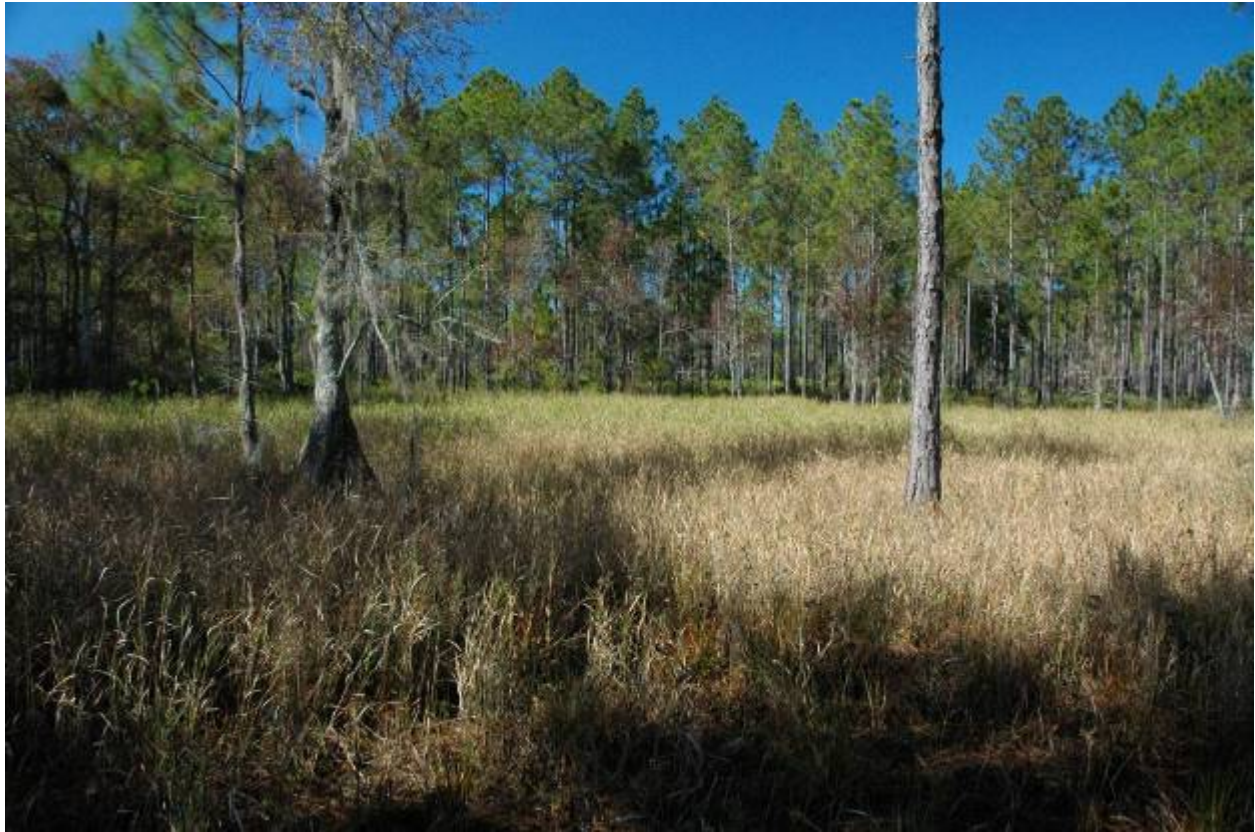
**Description:** This wetland is a 0.3 ha ephemeral marsh. There is no tree canopy or midstory cover. Maidencane grows throughout the wetland, and covers >75% of the basin. Feral hog damage is present, but not severe. The adjacent uplands are mesic flatwoods. The topography is undulating with old, but deep, plowlines created by the Florida Department of Forestry.

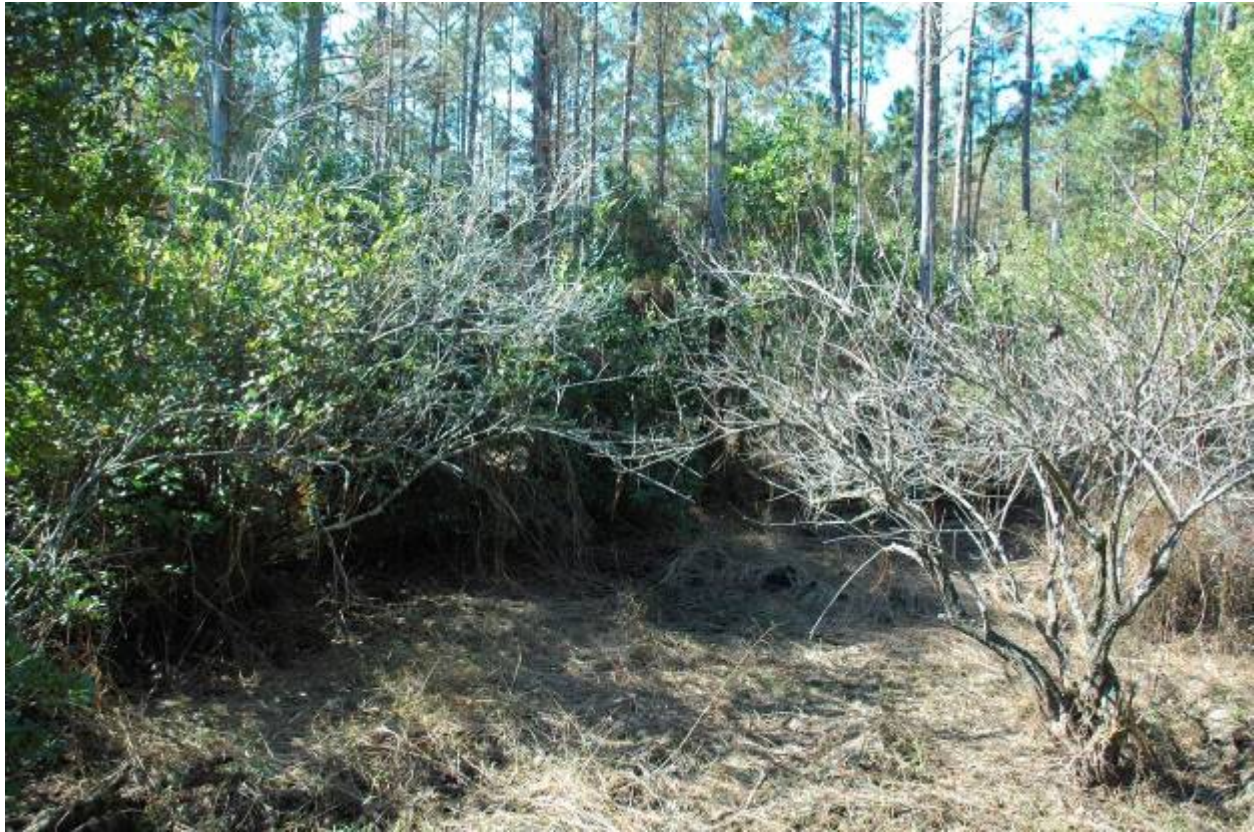
**Description:** This wetland is a 0.5 ha highly ephemeral mixed swamp. Cypress trees dominate the canopy, and cover 5-25% of the wetland. The midstory is dominated by fetterbush, wax myrtle, and buttonbush, and covers 50-75% of the wetland. Sedges/grasses and fern grow in scattered patches, and cover 25-50% of the wetland basin. This wetland appears to be suffering from long-term dryness due to drought and/or land use practices. The adjacent uplands are mesic flatwoods and a food plot.

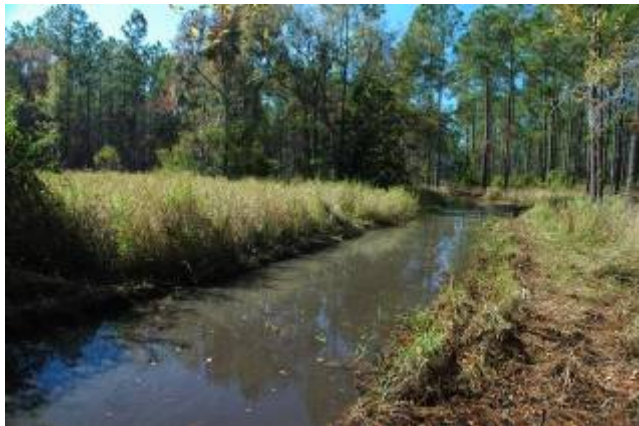
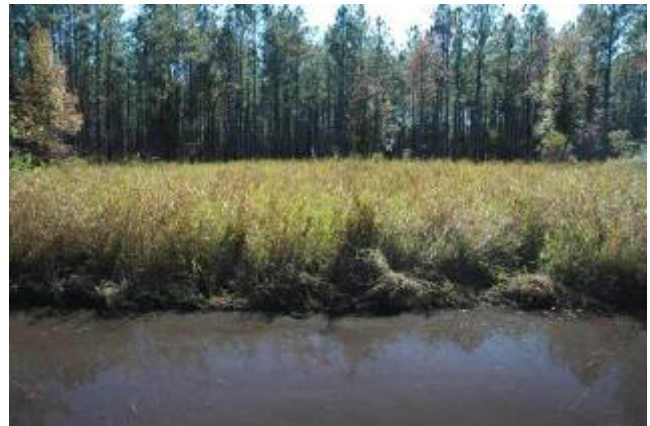
**Wetland ID: 63-01**

**Description:** This wetland is a 0.2 ha ephemeral marsh. Gum and pine trees dominate the canopy and cover 5-25% of the wetland. There is no midstory cover. Maidencane grows throughout the wetland, and covers >75% of the basin. A property boundary fireline bisects the northern edge of the wetland. The adjacent uplands are mesic flatwoods that are managed with prescribed fire.

**Wetland Concern(s):** Herbaceous density, Property boundary/fireline

**Restoration Action Recommended:** Periodic fire within the wetland basin should reduce the thick maidencane and encourage the growth of other species. If possible, re-route the property boundary into the uplands and away from the wetland.

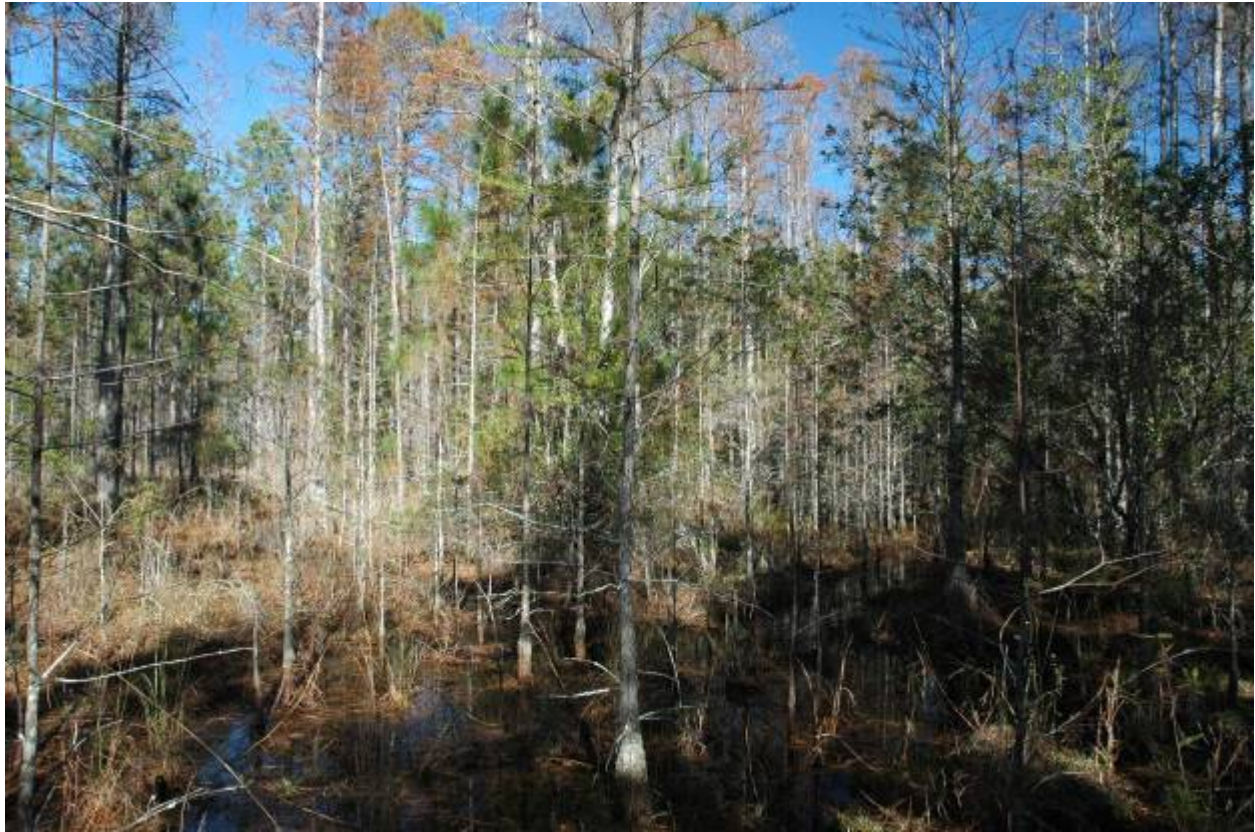
**Description:** This wetland is a 0.9 ha ephemeral forested swamp. Cypress and pine trees dominate the canopy, and cover 50-75% of the wetland. The midstory is dominated by wax myrtle, and covers 5-25% of the wetland. Maidencane and other grasses grow throughout the wetland, and cover 25-50% of the basin. The adjacent uplands are mesic flatwoods that are managed with prescribed fire.

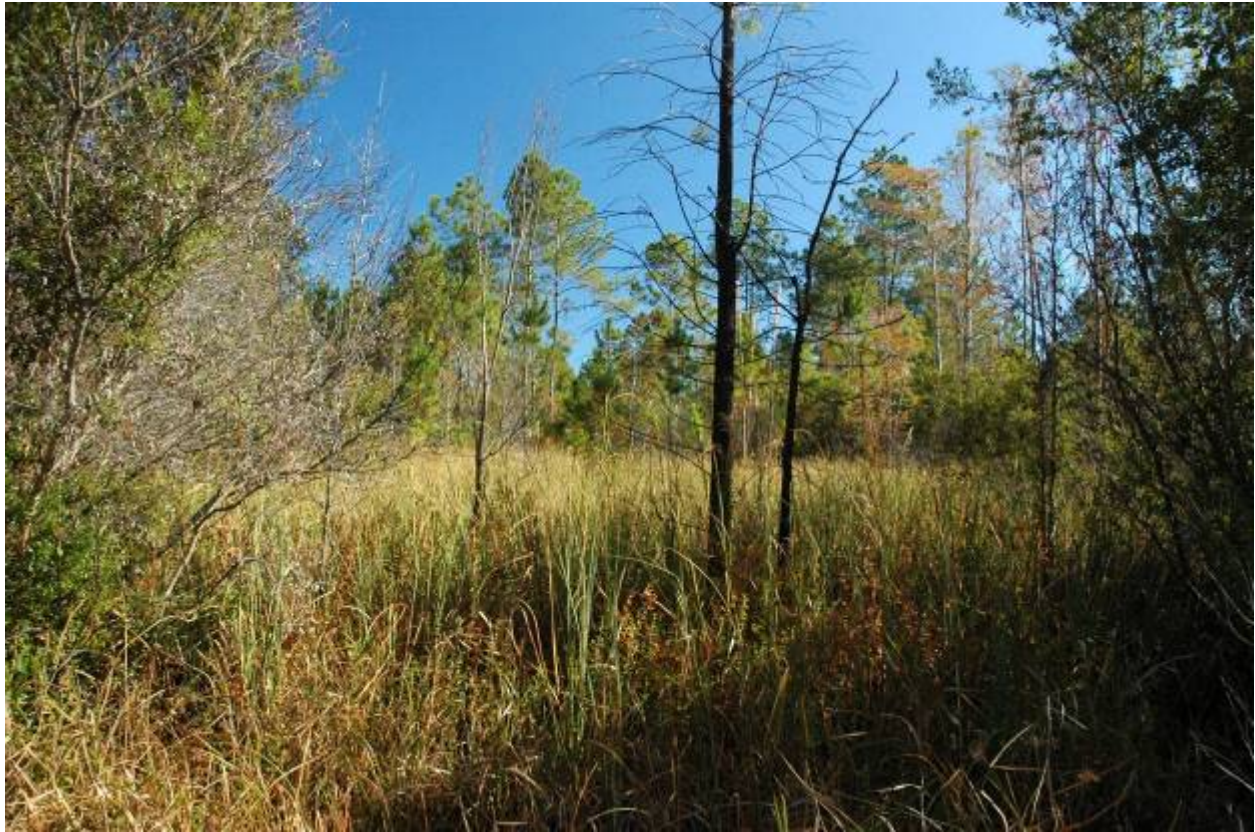
**Description:** This wetland is a 1.7 ha ephemeral marsh. Cypress and pine trees grow around the wetland edge, and cover 25-50% of the basin. The midstory is dominated by wax myrtle and fetterbush, and covers 25-50% of the wetland. Maidencane and sawgrass grow throughout the wetland, and cover >75% of the basin. A drainage ditch on the west side of the wetland has allowed upland woody plants to encroach into the wetland. The adjacent uplands are mesic flatwoods with thickly stocked pine trees.

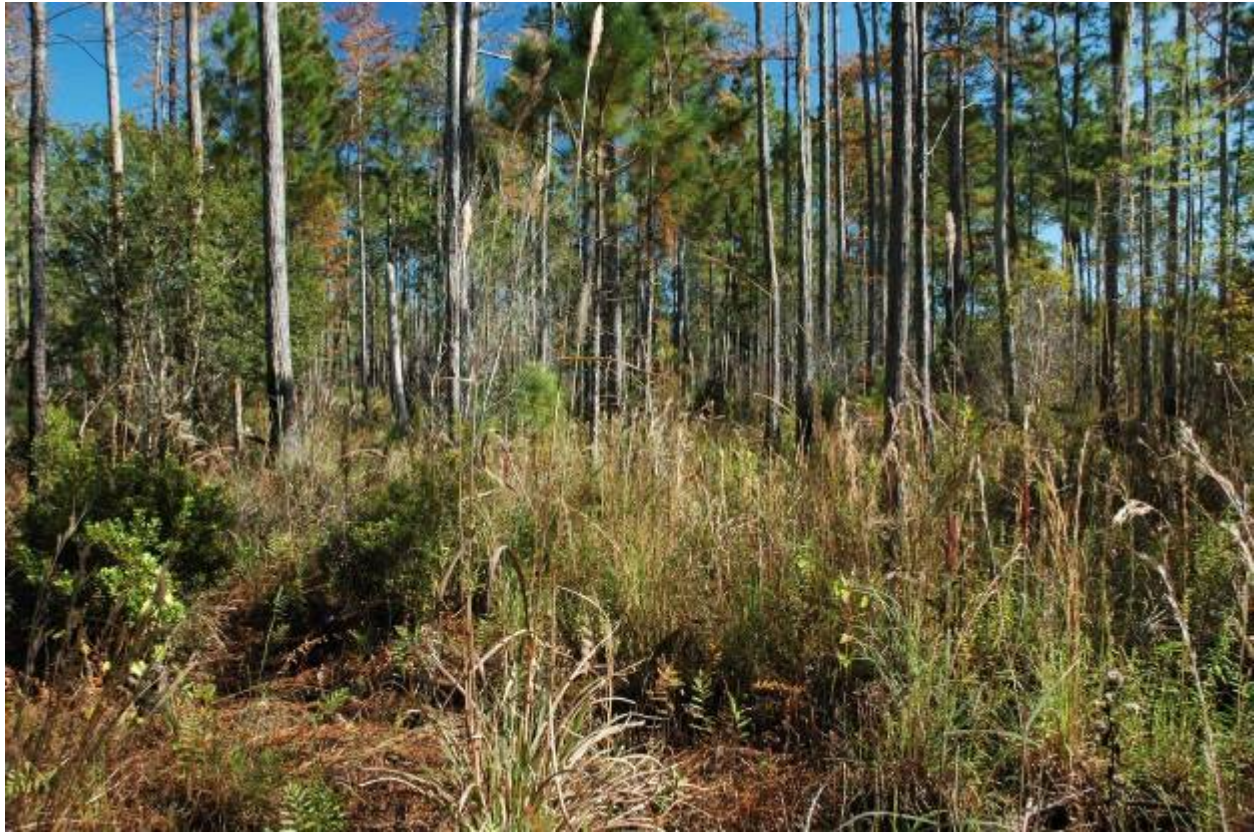
**Description:** This wetland is a 0.5 ha highly ephemeral mixed swamp. Cypress and large slash pine trees dominate the canopy, and cover 50-75% of the wetland. The midstory is dominated by wax myrtle, and covers 25-50% of the wetland. Sedges and grasses grow throughout the wetland, and cover >75% of the basin. The adjacent uplands are mesic flatwoods that are managed with prescribed fire.

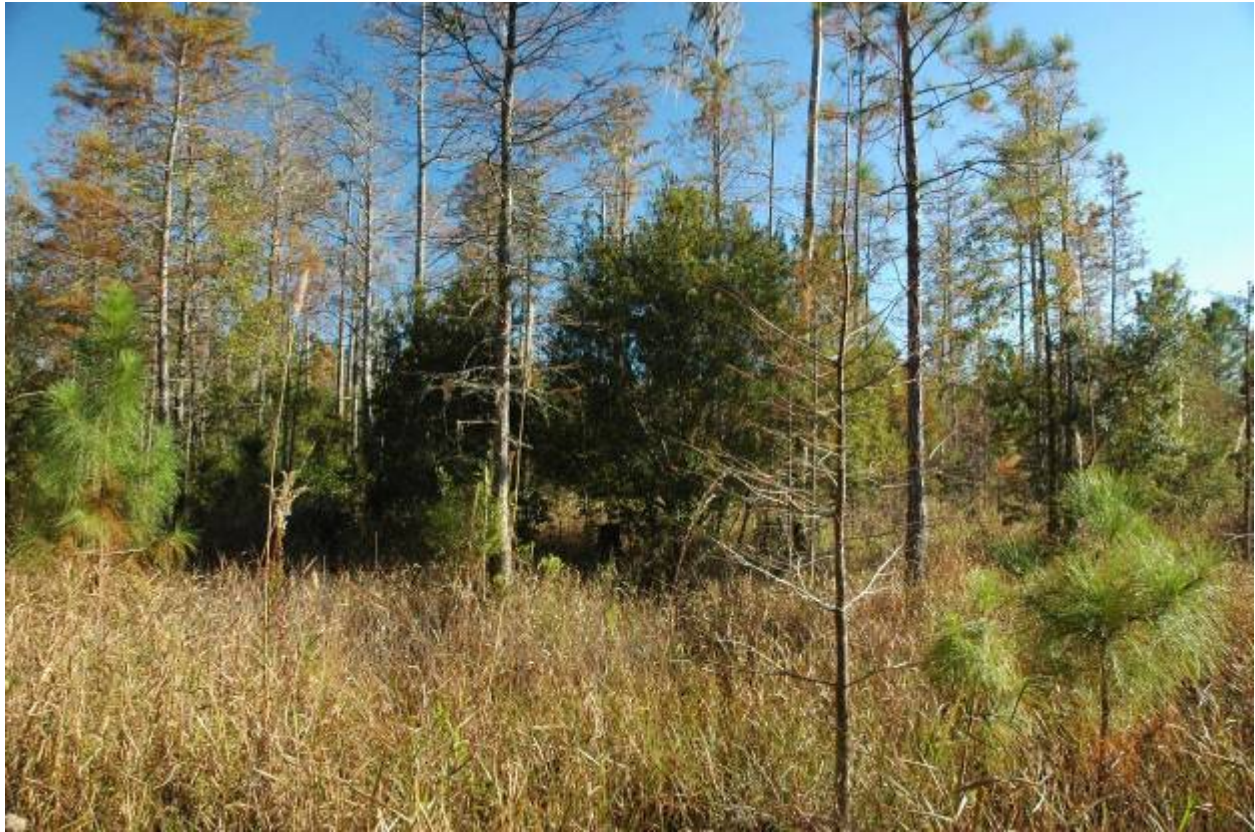
**Description:** This wetland is a 2.0 ha ephemeral mixed swamp. Cypress trees dominate the canopy, and cover 25-50% of the wetland. The midstory is dominated by wax myrtle, and covers 25-50% of the wetland. A few pine trees are beginning to colonize the wetland basin. Maidencane grows thick throughout the wetland, and covers >75% of the basin. The adjacent uplands are mesic flatwoods that are managed with prescribed fire.

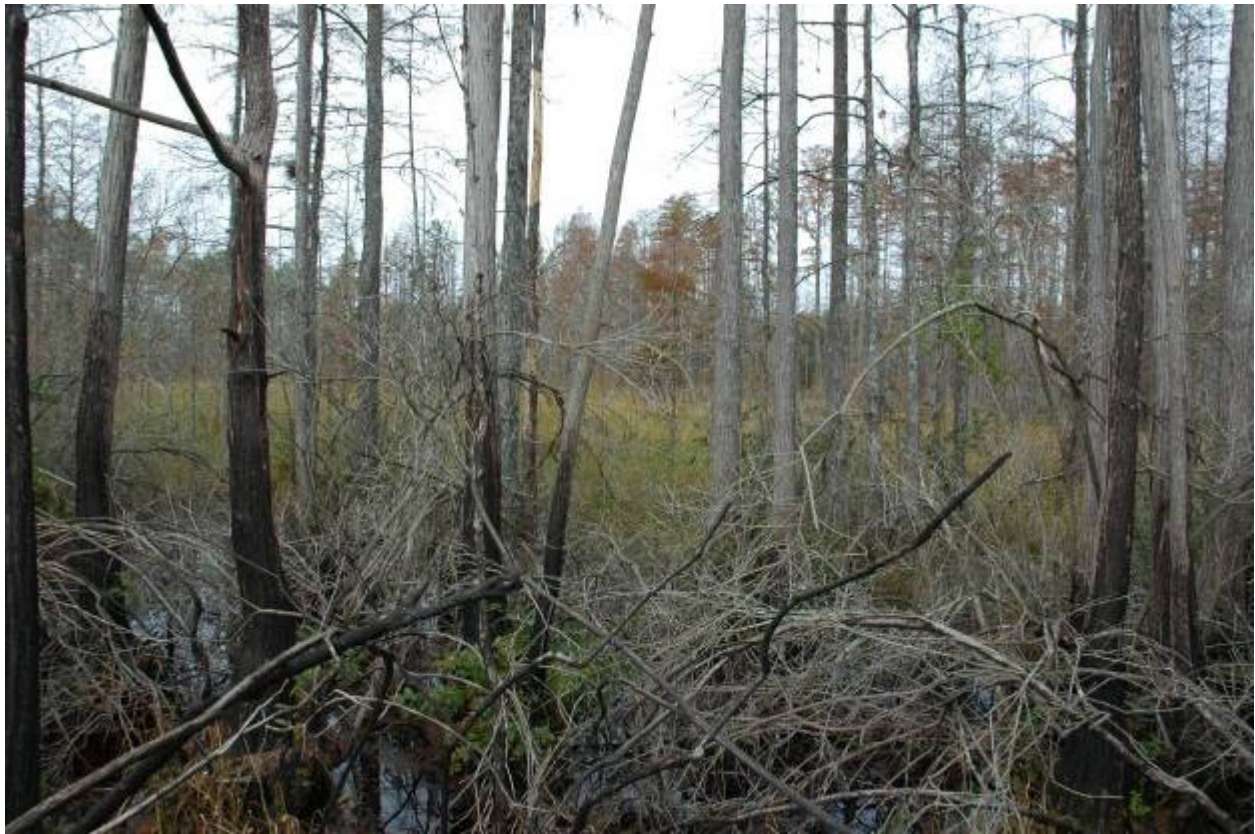
**Description:** This wetland is a 1.2 ha semi-permanent marsh. It has an open, herbaceous center and is ringed with cypress and other woody vegetation. Cypress trees cover 25-50% of the basin. The midstory is dominated by fetterbush, gallberry, and *Smilax*, and covers 5-25% of the wetland. Fern grow throughout the wetland, and cover >75% of the basin. Snags stand along the east side of the wetland. A wildfire burned through this management unit in August of 2006, and completely removed encroaching woody vegetation from the wetland. The adjacent uplands are mesic flatwoods.

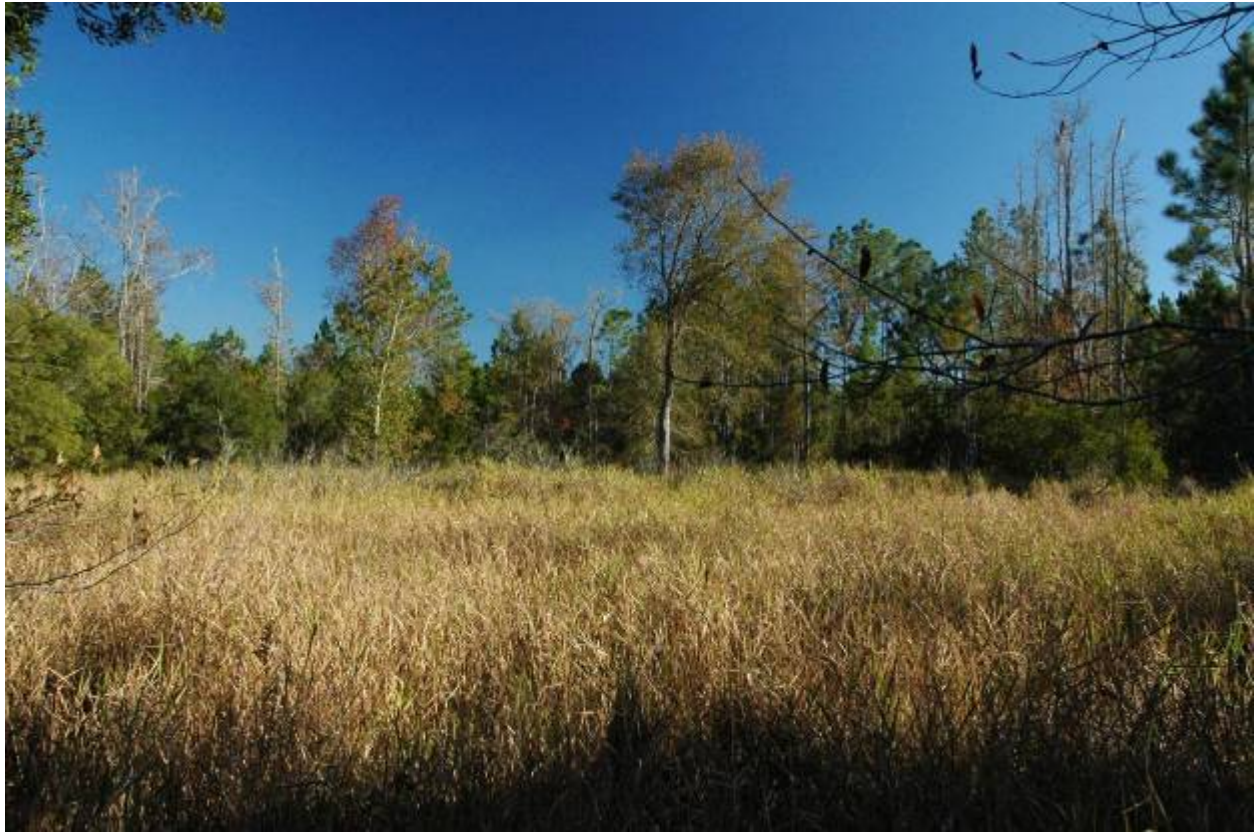
**Description:** This wetland is a 0.7 ha ephemeral marsh. There is no tree canopy cover. Wax myrtle grows in a ring around the wetland center, and covers 5-25% of the wetland. Maidencane grows throughout the wetland, and covers >75% of the basin. The adjacent uplands are wet flatwoods with densely stocked pine trees.

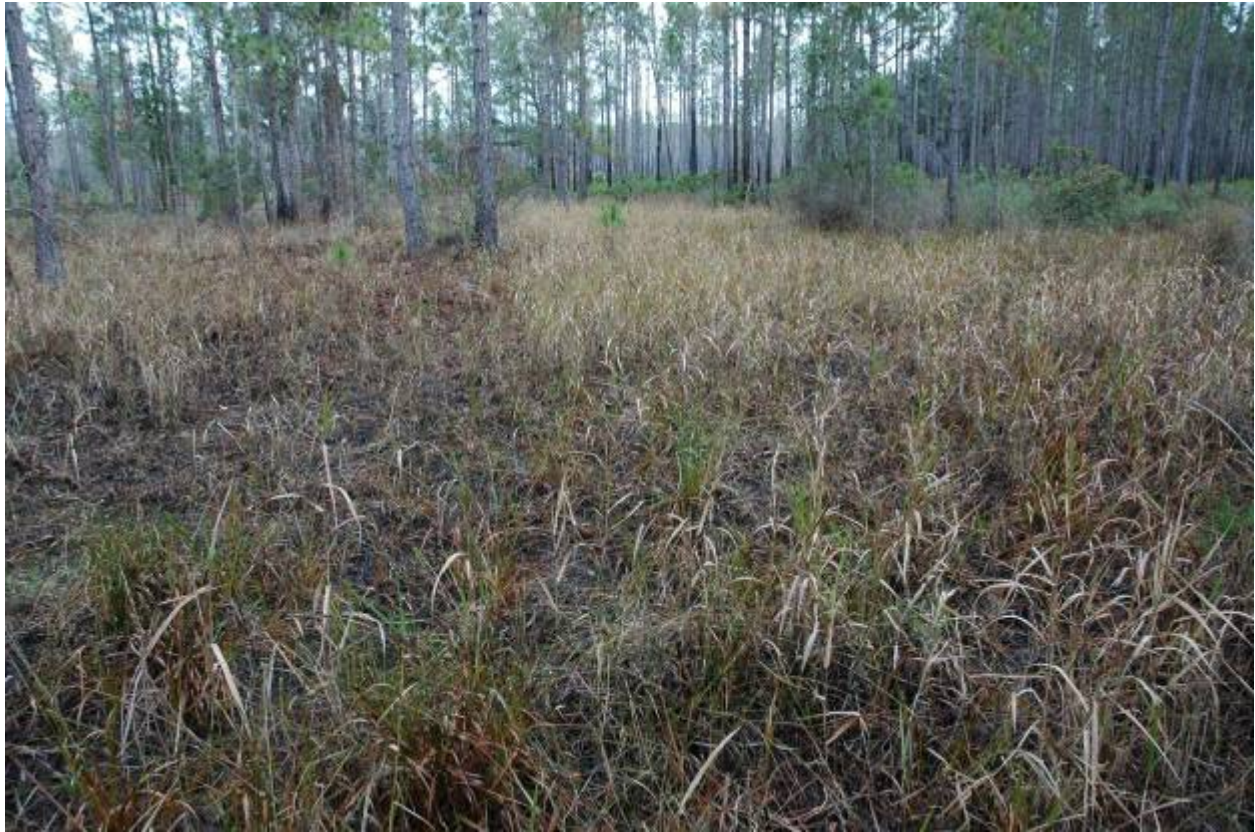
**Description:** This wetland is a 0.2 ha ephemeral marsh. Pine trees grow around the wetland edge, and cover 5-25% of the basin. There is no midstory cover. Maidencane and other grasses grow throughout the wetland, and cover >75% of the basin. A MU boundary/fireline bisects the north side of the wetland and another MU boundary/fireline flanks the east side. Old feral hog damage is evident in the wetland. The adjacent wetlands are mesic flatwoods.

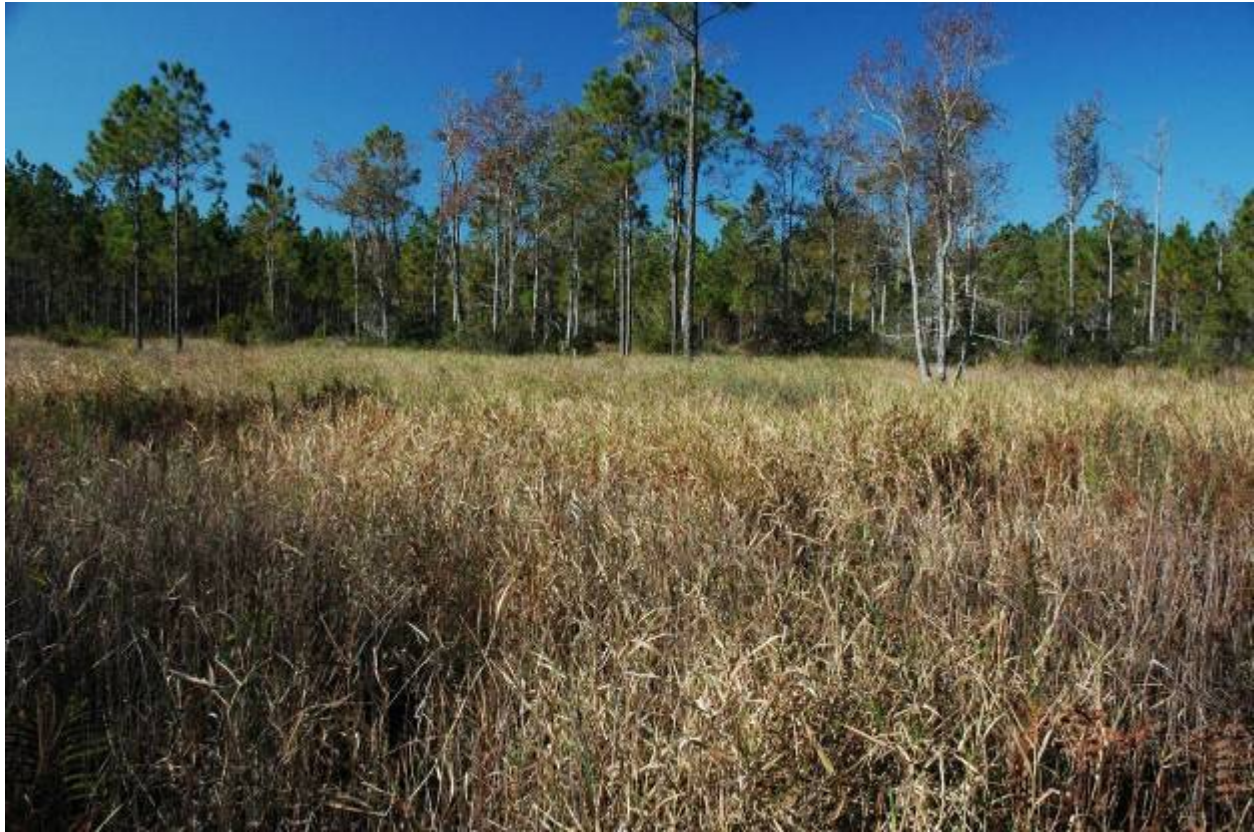
**Description:** This wetland is a 0.4 ha ephemeral marsh. Gum and pine trees grow around the edge of the wetland, and cover 5-25% of the wetland. The midstory is dominated by wax myrtle, and covers 5-25% of the wetland. Maidencane and fern grow throughout the wetland, and cover >75% of the basin. Old stumps in the adjacent wet flat provide evidence of historical logging. The adjacent uplands are a mix of mesic and wet flatwoods.

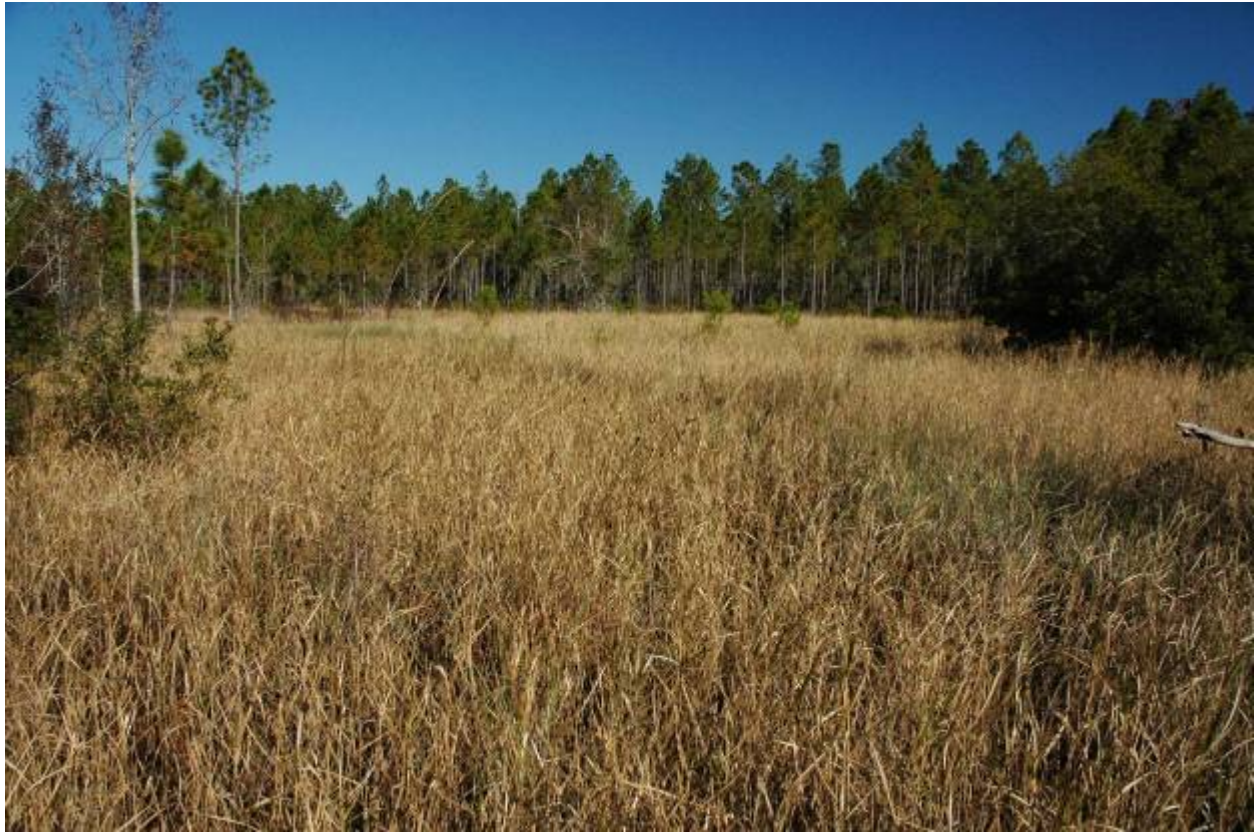
**Description:** This wetland is a 0.2 ha ephemeral marsh. There is no significant tree canopy or midstory cover, although a few young pine trees grow scattered in the wetland basin. Maidencane grows thick throughout the wetland, and covers >75% of the basin. Old stumps in the adjacent wet flat provide evidence of historical logging. The adjacent uplands are a mix of mesic and wet flatwoods.

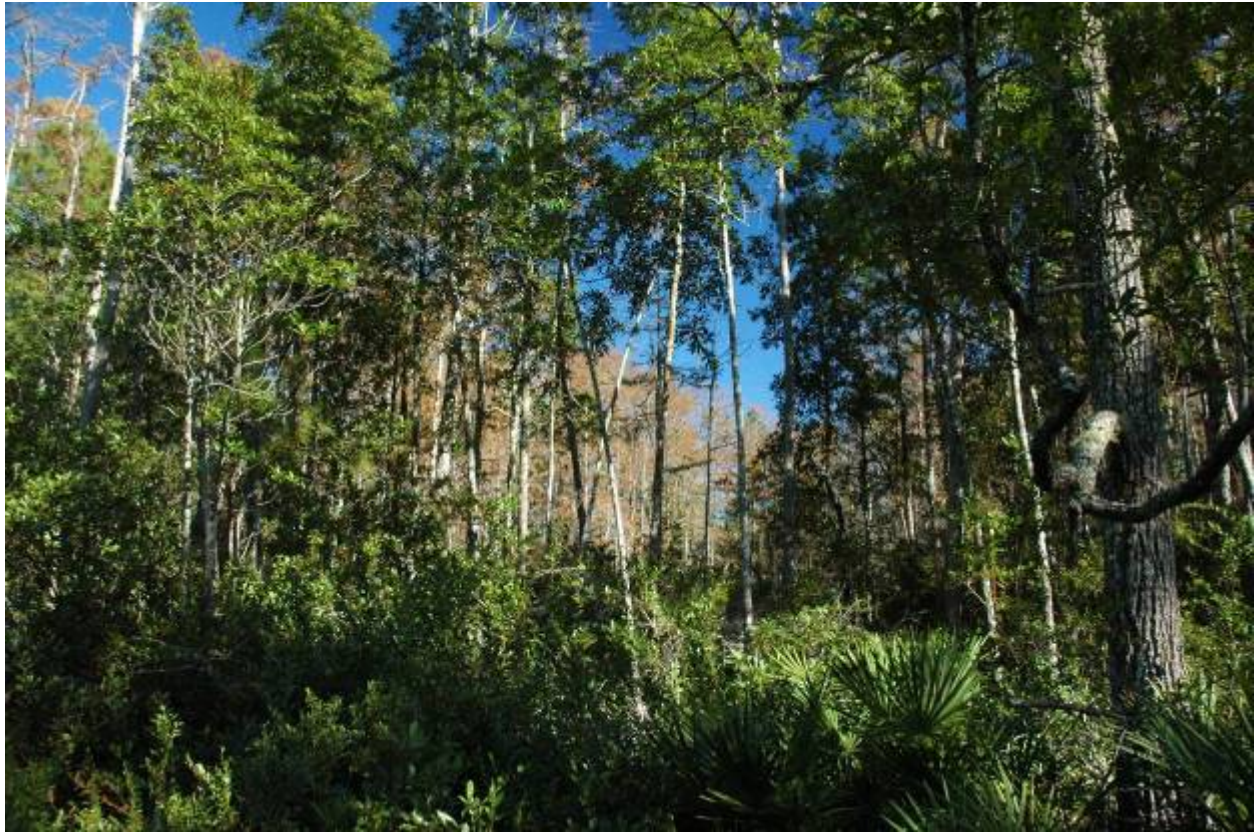
**Description:** This wetland is a 1.5 ha semi-permanent mixed swamp. Cypress, bay, and pine trees dominate the canopy, and cover >75% of the wetland. The midstory is dominated by fetterbush and bay saplings, and covers >75% of the wetland. There is sparse herbaceous cover. An MU boundary/fireline bisects the northwest side of the wetland. The adjacent uplands are mesic flatwoods. The topography is undulating with old, but deep, plowlines created by the Florida Department of Forestry.

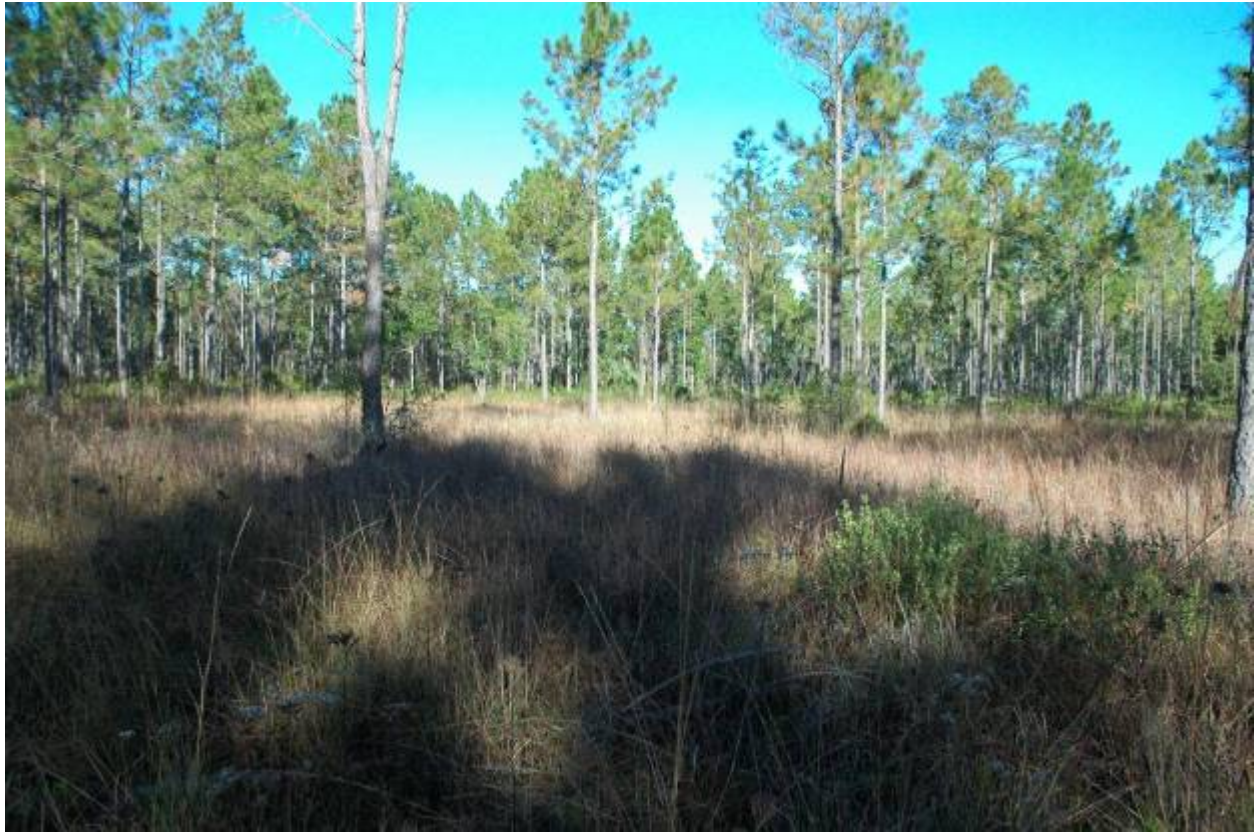
**Description:** This wetland is a 0.3 ha highly ephemeral marsh. A few large slash pines are growing within the wetland, but prove <5% canopy cover. There is no midstory cover. Sedges, grasses, and ferns are extensive throughout, and cover >75% of the wetland basin. The adjacent uplands are mesic flatwoods that are managed with prescribed fire.

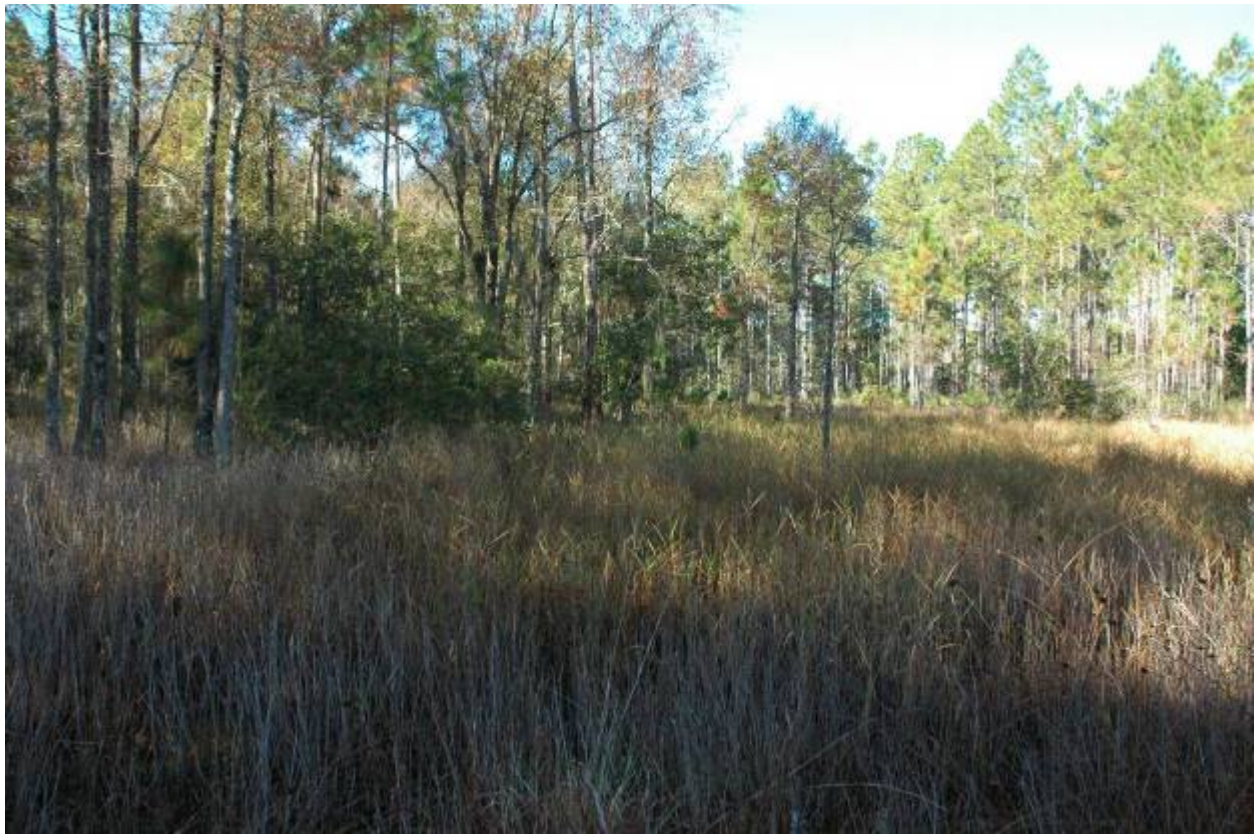
**Description:** This wetland is a 0.4 ha ephemeral marsh. Black gum trees ring the wetland edge, and cover 25-50% of the wetland. The midstory is dominated by wax myrtle, and covers 5-25% of the wetland. Maidencane, sphagnum, and fern grow throughout the wetland, and cover >75% of the basin. An old ditch is located in the uplands on the north side. The adjacent uplands are mesic flatwoods that are managed with prescribed fire.

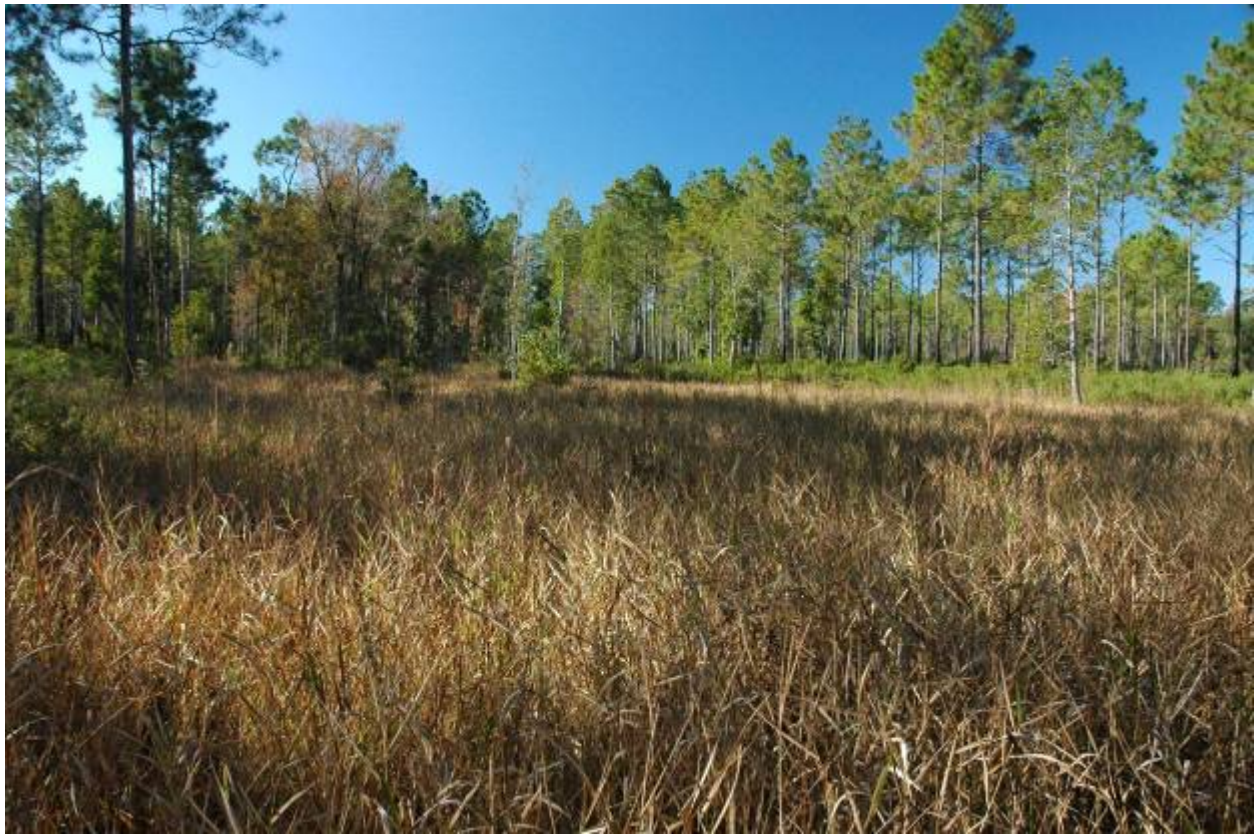
**Description:** This wetland is a 0.5 ha ephemeral marsh. Gum and pine trees dominate the canopy, and cover 5-25% of the wetland. There is no midstory layer. Maidencane grows throughout the wetland, and covers >75% of the basin. The adjacent uplands are mesic flatwoods that are managed with prescribed fire.

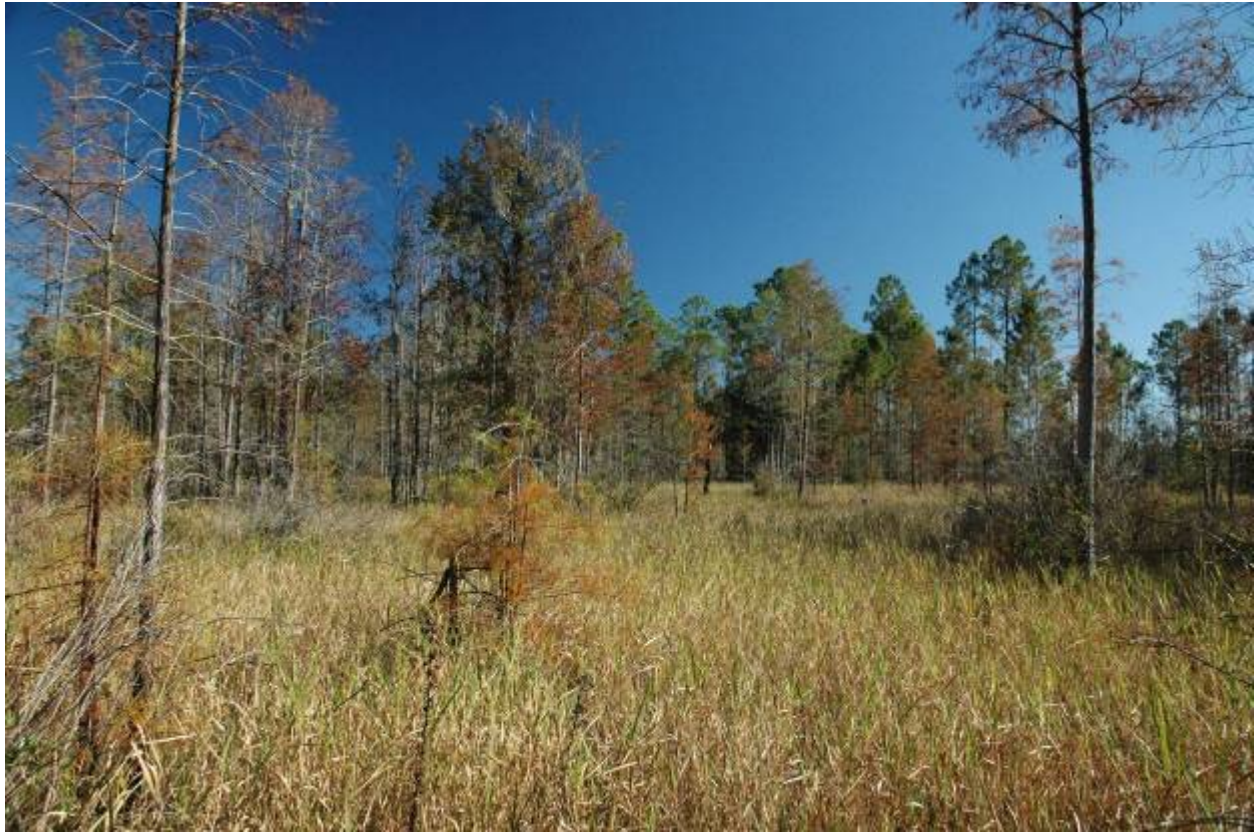
**Description:** This wetland is a 0.8 ha ephemeral marsh. Cypress and pine trees dominate the canopy, and cover 5-25% of the wetland. There is no midstory cover. Maidencane grows throughout the wetland, and covers >75% of the basin. There is light feral hog damage around the wetland edge. We observed mechanical restoration activity in the uplands that extended to the wetland edge. The adjacent uplands are mesic flatwoods that are managed with mechanical treatment and prescribed fire.

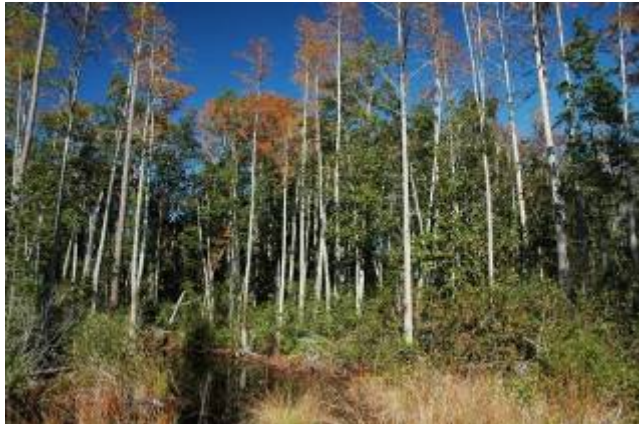
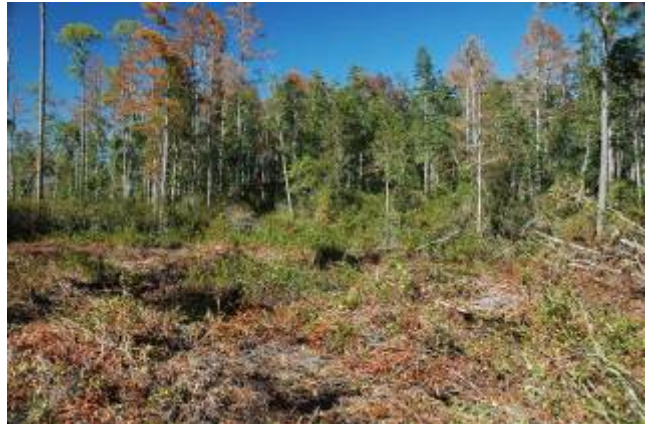
**Wetland ID: 73-02**

**Description:** This wetland is a 4.5 ha semi-permanent mixed swamp. Cypress and bay trees dominate the canopy, and cover >75% of the wetland. The midstory is dominated by fetterbush, and covers >75% of the wetland. There is little to no herbaceous vegetation. Recent restoration activity was conducted in the uplands and up to wetland edge to rehabilitate a large fireline constructed by Florida Department of Forestry during the 2006 wildfire. It appears the wetland was not completely dry and there are ruts and deep holes surrounding the wetland. The adjacent uplands are mesic flatwoods that are managed with mechanical treatment and prescribed fire.

**Wetland Concern(s):** Vehicular damage, Woody encroachment

**Restoration Action Recommended:** The ruts and deep holes will heal over time. Periodic fires should reduce the thick shrub layer.

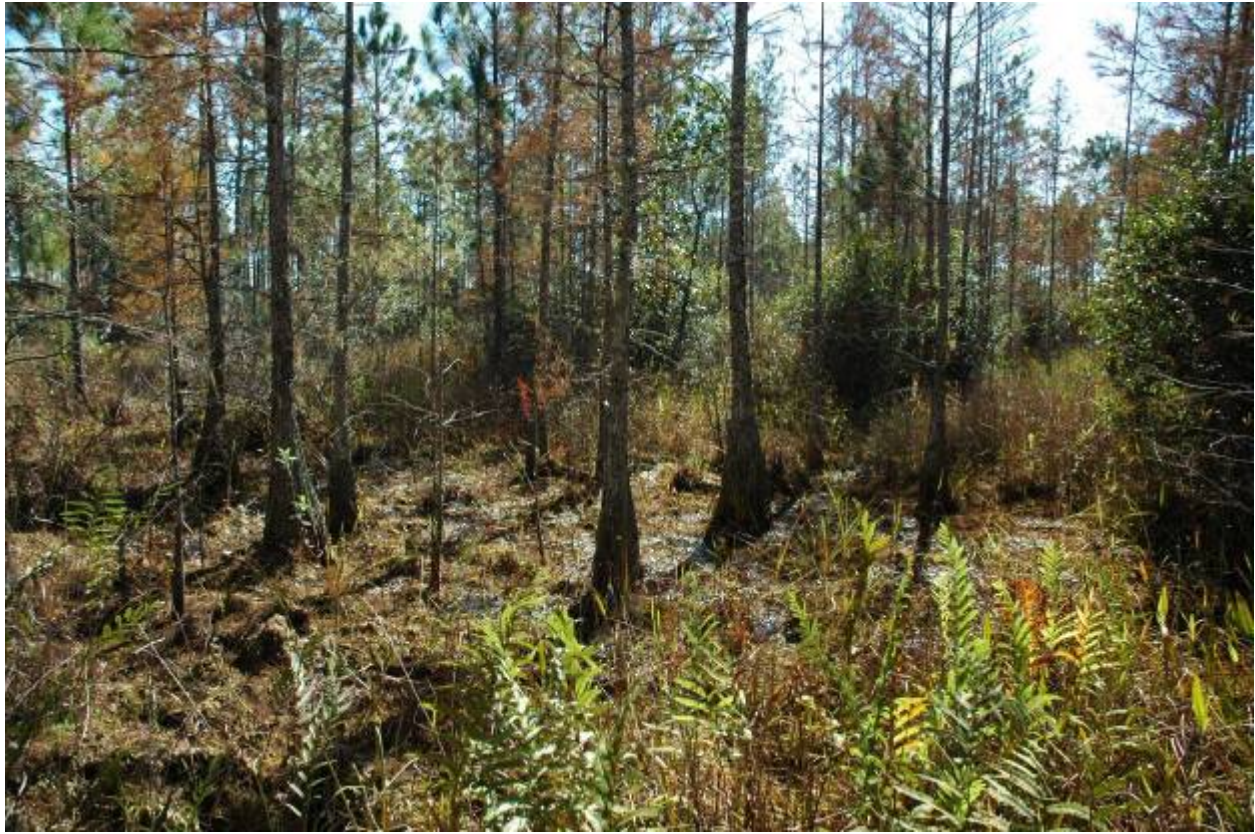
**Description:** This wetland is a 0.7 ha ephemeral forested swamp. Cypress and pine trees dominate the canopy, and cover 25-50% of the wetland. The midstory is dominated by fetterbush and wax myrtle, and covers 5-25% of the wetland. Maidencane, *Sphagnum*, and fern grow throughout the wetland, and cover >75% of the basin. The adjacent uplands are mesic flatwoods.
