# **Inventory, Assessment, and Restoration Potential of Ephemeral Wetlands on FFWCC Wildlife Management Areas**

**Caravelle Ranch WMA Final Report**

November 2008

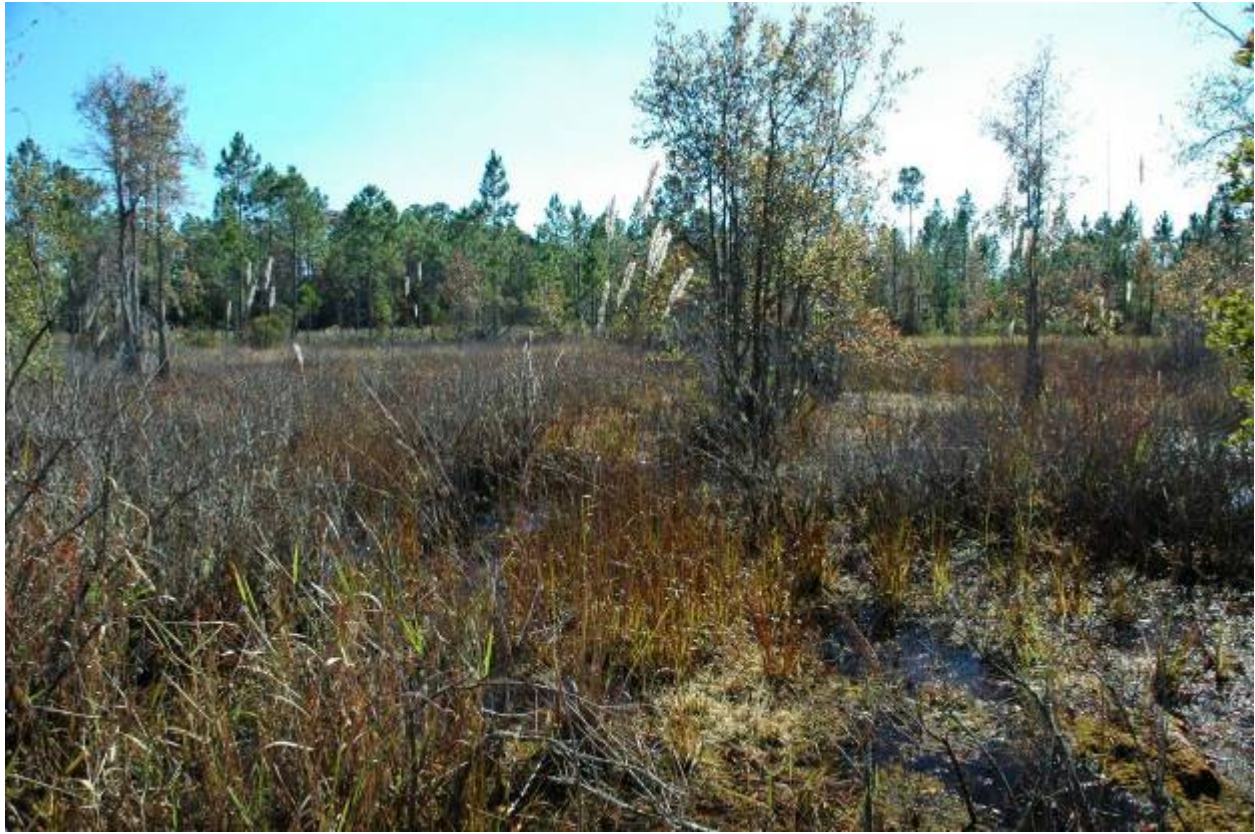
**Description:** This wetland is a 1.0 ha ephemeral marsh. There is no tree canopy or midstory cover. Maidencane grows throughout the wetland, and covers >75% of the basin. The adjacent uplands are mesic flatwoods.

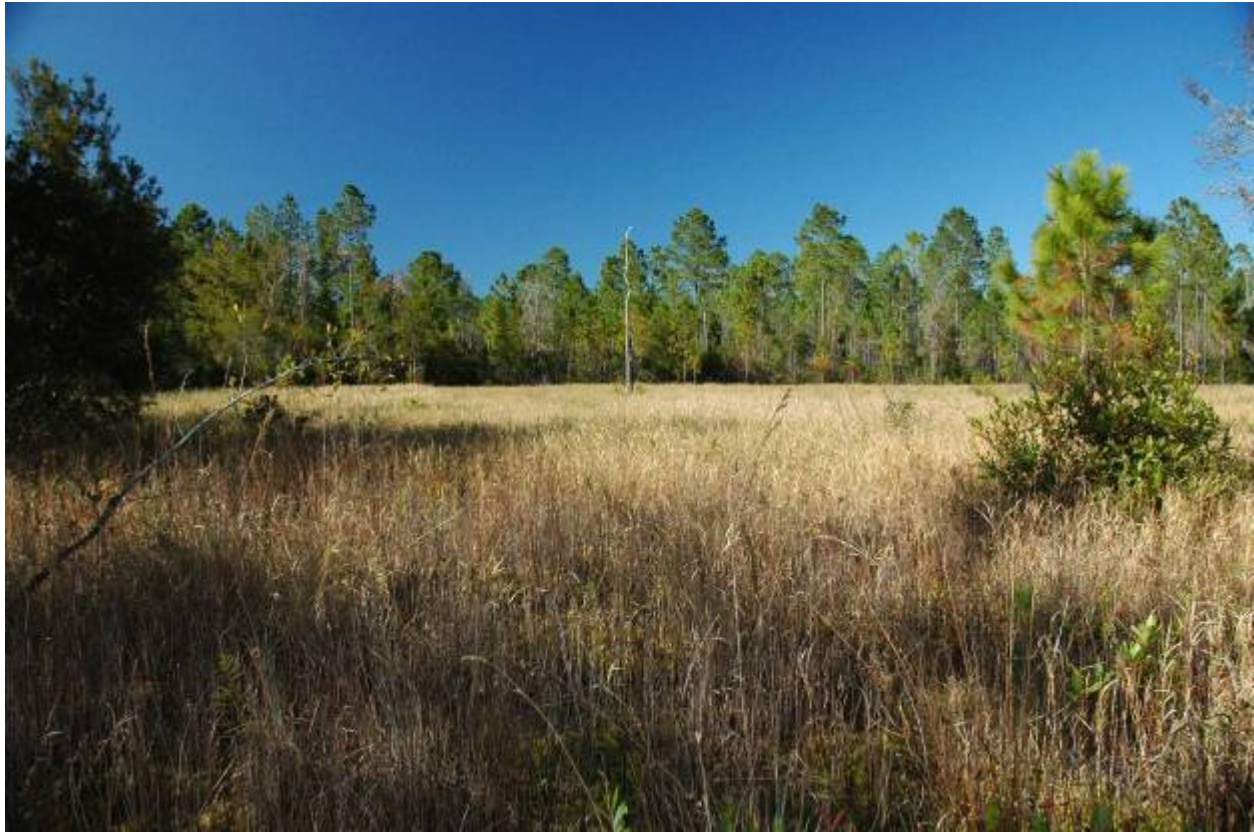
**Description:** This wetland is a 1.1 ha ephemeral marsh. There is no tree canopy. A thick patch of shrubs grows on the south and southwest periphery of the wetland, but covers <5% of the wetland. Maidencane grows thick throughout the wetland, and covers >75% of the basin. The adjacent uplands are mesic flatwoods.

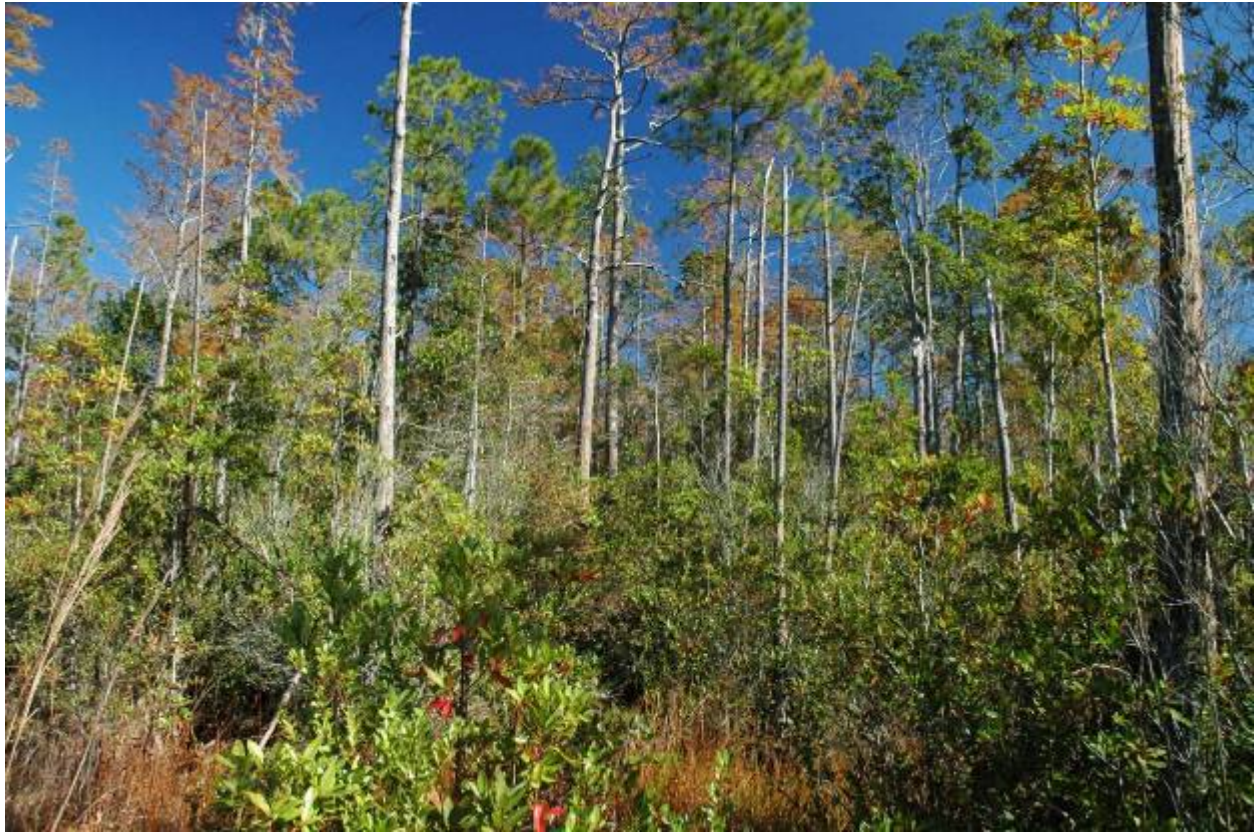
**Description:** This wetland is a 6.3 ha semi-permanent mixed swamp. Cypress and pine trees dominate the canopy, and cover >75% of the wetland. The midstory is dominated by fetterbush, and covers >75% of the wetland. Sedges and grasses grow in scattered patches, and cover 5-25% of the wetland basin. The brush surrounding this wetland is tall and very thick. The adjacent uplands are mesic flatwoods. The topography is undulating with old plowlines created by the Florida Department of Forestry.

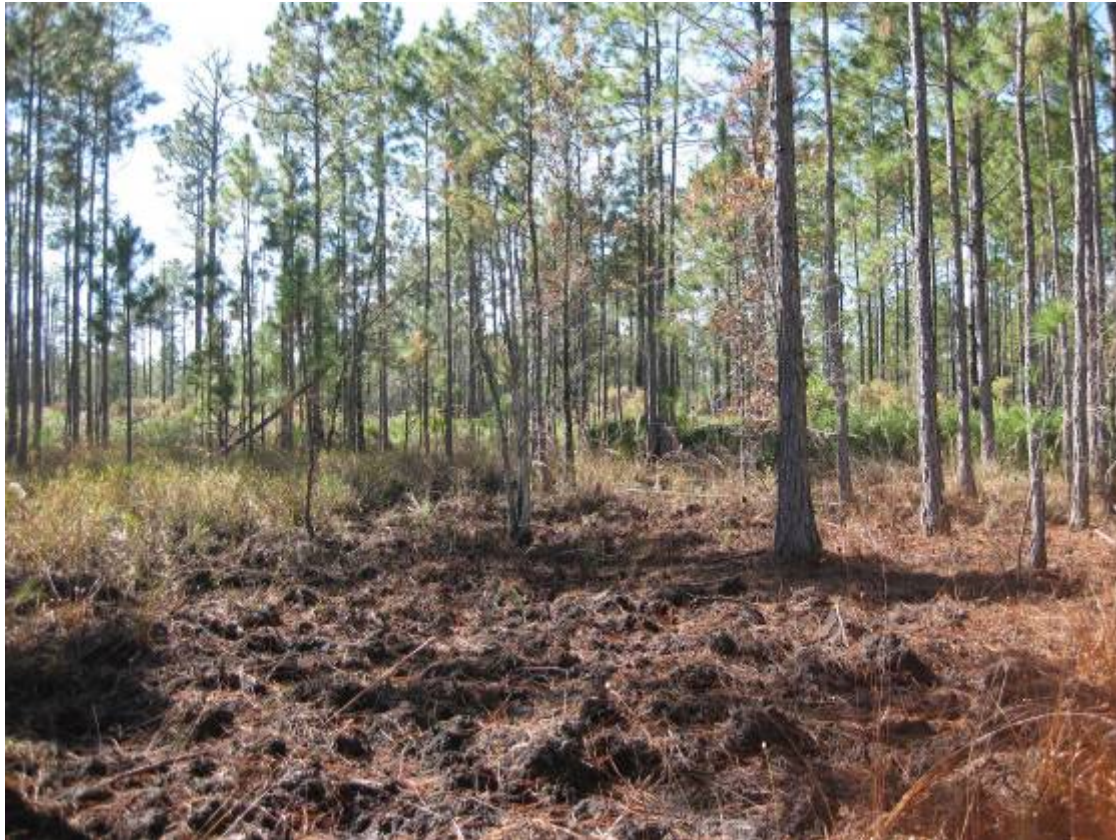
**Wetland ID: 76-01**

**Description:** This wetland is a 0.1 ha highly ephemeral marsh. Slash pines have established in the wetland, and cover 25-50% of the basin. There is no midstory layer. Maidencane and redroot grow throughout the wetland, and covers 25-50% of the wetland basin. Feral hog damage is severe and mostly concentrated through the center of the wetland. The adjacent uplands are mesic flatwoods. The topography is undulating with old plowlines created by the Florida Department of Forestry.

**Wetland Concern(s):** Feral hog damage, Woody encroachment

**Restoration Action Recommended:** This wetland is part of a cluster of wetlands impacted by severe feral hog damage and should be considered for more aggressive action. Remove pine trees from the wetland interior.

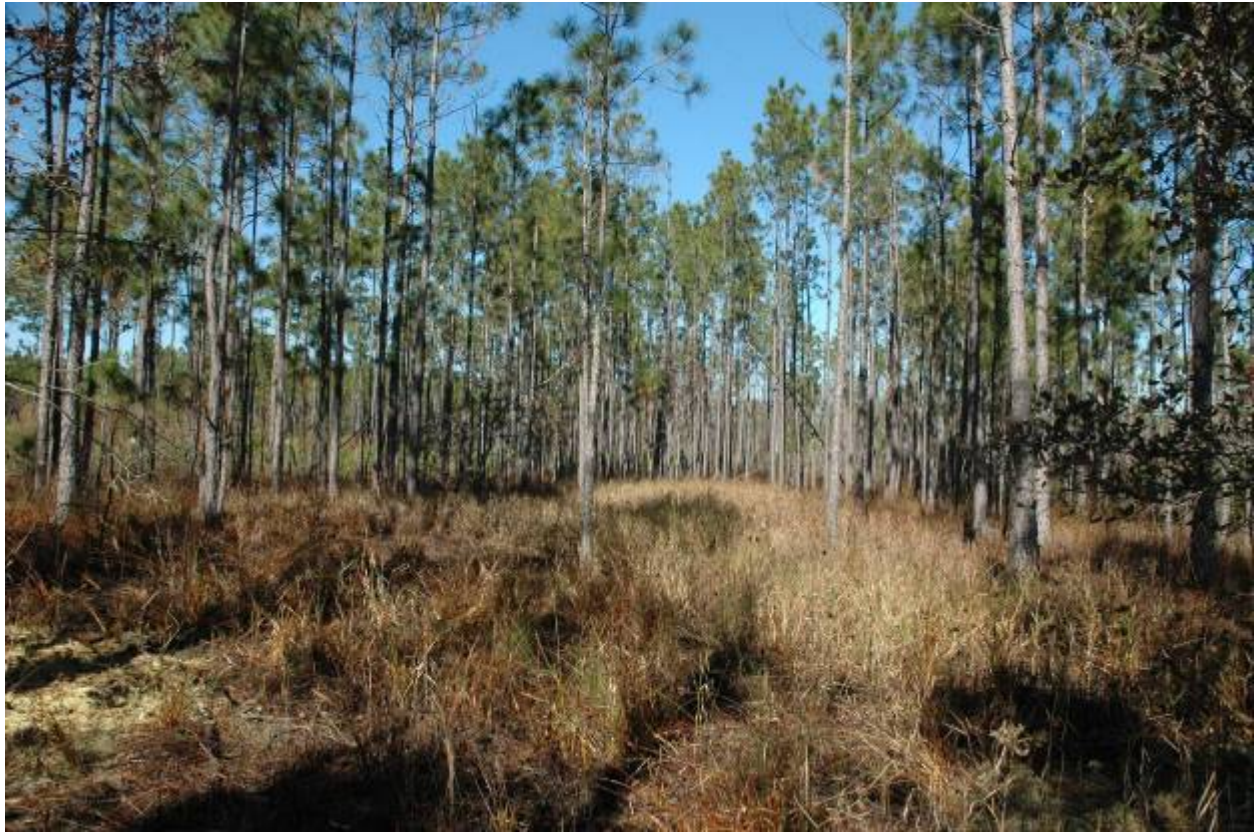
**Wetland ID: 76-02**

**Description:** This wetland is a 0.2 ha highly ephemeral marsh. Slash pine trees have established in the wetland, and cover 25-50% of the wetland. There is no midstory layer. Maidencane and *Sphagnum* grow throughout, and cover >75% of the wetland basin. Old and new feral hog damage is evident. The adjacent uplands are mesic flatwoods. The topography is undulating with old plowlines created by the Florida Department of Forestry.

**Wetland Concern(s):** Feral hog damage, Woody encroachment

**Restoration Action Recommended:** This wetland is part of a cluster of wetlands impacted by severe feral hog damage and should be considered for more aggressive action. Remove pine trees from the wetland interior.

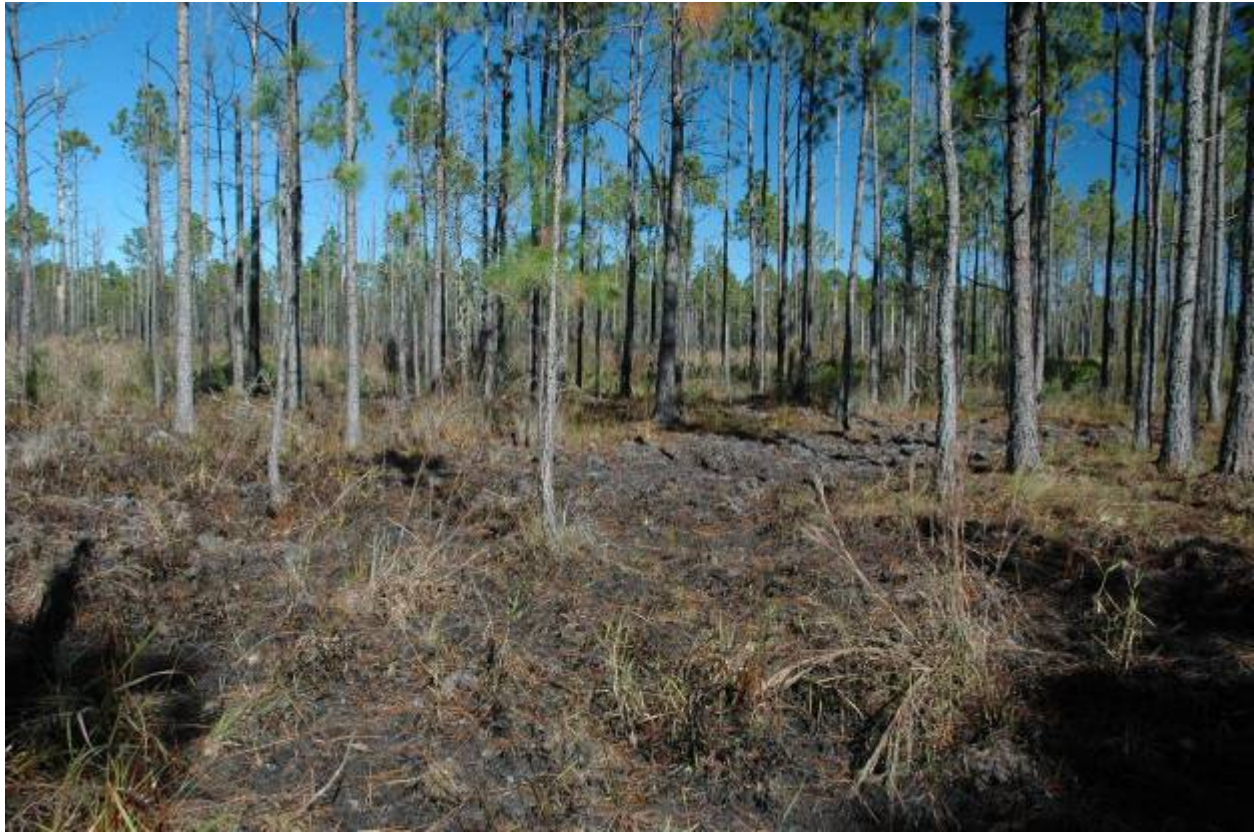
**Wetland ID: 76-03**

**Description:** This wetland is a 01. ha highly ephemeral marsh. Slash pine trees have established in the wetland, and cover 25-50% of the wetland. There is no midstory layer. Redroot and *Xyris* grow throughout the wetland, and cover 50-75% of the basin. The feral hog damage is severe and distributed throughout the wetland. The adjacent uplands are mesic flatwoods. The topography is undulating with old plowlines created by the Florida Department of Forestry.

**Wetland Concern(s):** Feral hog damage, Woody encroachment

**Restoration Action Recommended:** This wetland is part of a cluster of wetlands impacted by severe feral hog damage and should be considered for more aggressive action. Remove pine trees from the wetland interior.

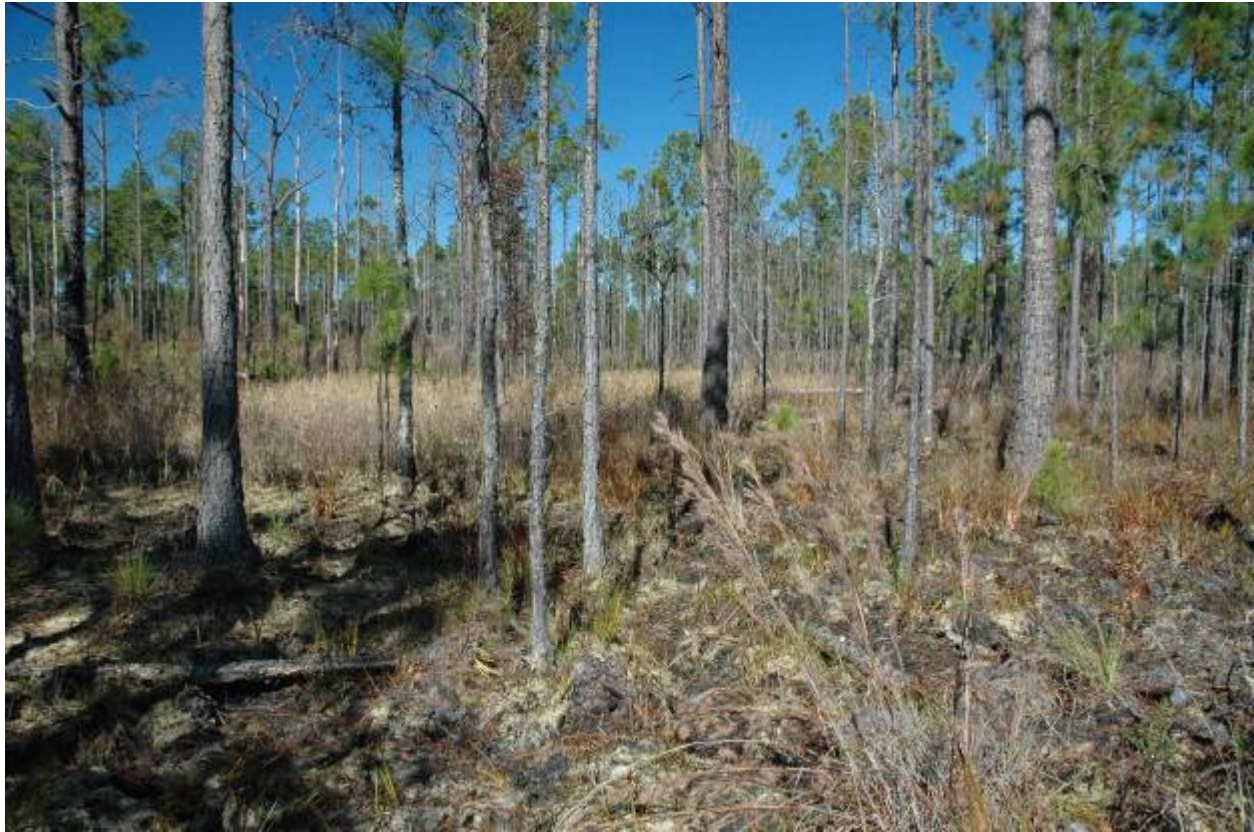
**Wetland ID: 76-04**

**Description:** This wetland is a 0.1 ha highly ephemeral marsh. Slash pine trees have established in the wetland, and cover 5-25% of the wetland. There is no midstory layer. Maidencane, *Sphagnum*, and redroot grow throughout the wetland, and cover 50-75% of the basin. Feral hog damage is distributed throughout the wetland. The adjacent uplands are mesic flatwoods. The topography is undulating with old plowlines created by the Florida Department of Forestry.

**Wetland Concern(s):** Feral hog damage, Woody encroachment

**Restoration Action Recommended:** This wetland is part of a cluster of wetlands impacted by severe feral hog damage and should be considered for more aggressive action. Remove pine trees from the wetland interior.

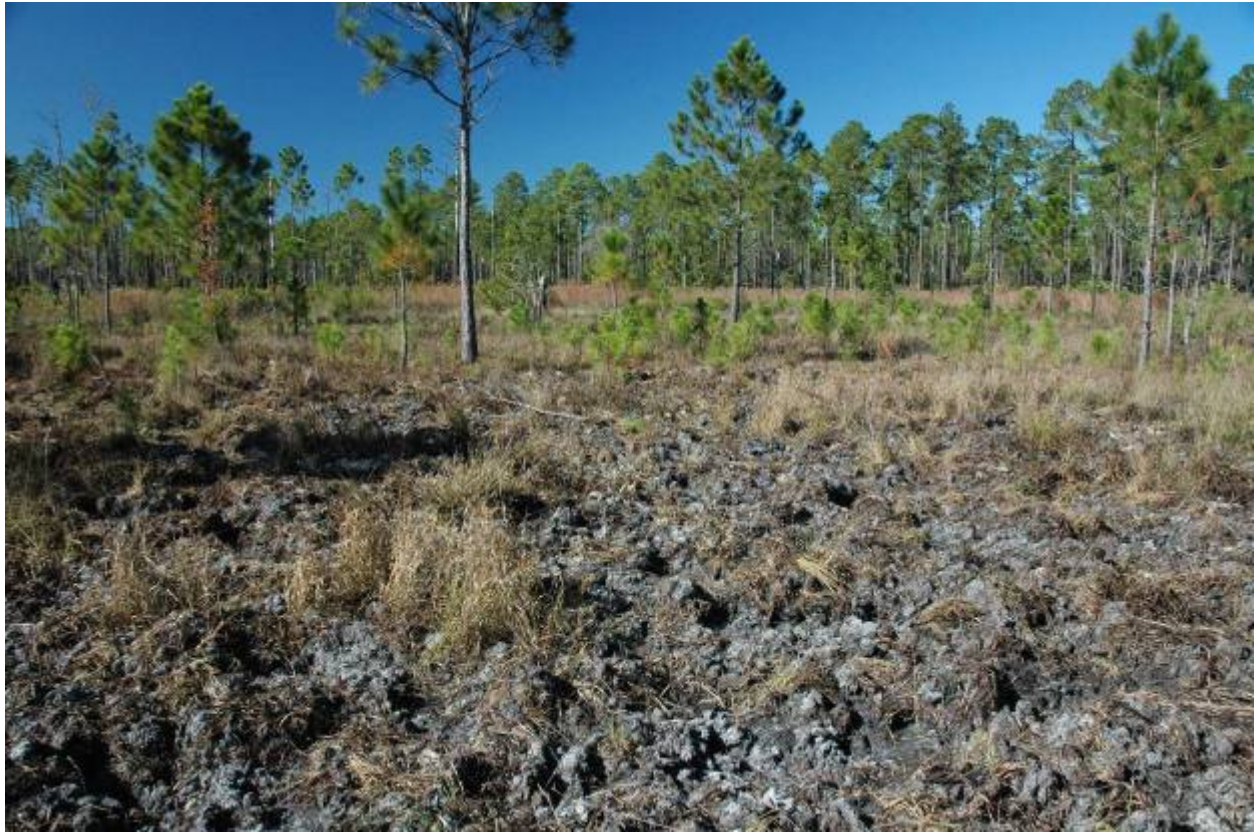
**Wetland ID: 76-05**

**Description:** This wetland is a 0.4 ha highly ephemeral marsh. A few slash pines have established in the wetland, but provide less than 5% canopy cover. There is no midstory layer. Slash pine seedlings are beginning to establish in the wetland basin. *Sphagnum*, sedges, grasses, and redroot grow throughout the wetland, and cover 50-75% of the basin. The feral hog damage is severe and is distributed throughout the wetland. The adjacent uplands are mesic flatwoods. The topography is undulating with old plowlines created by the Florida Department of Forestry.

**Wetland Concern(s):** Feral hog damage, Woody encroachment

**Restoration Action Needed:** This wetland is part of a cluster of wetlands impacted by severe feral hog damage and should be considered for more aggressive action. Monitor the encroaching pine seedlings to ensure they do not get established. Pine saplings can be hand-chopped if needed in the future.

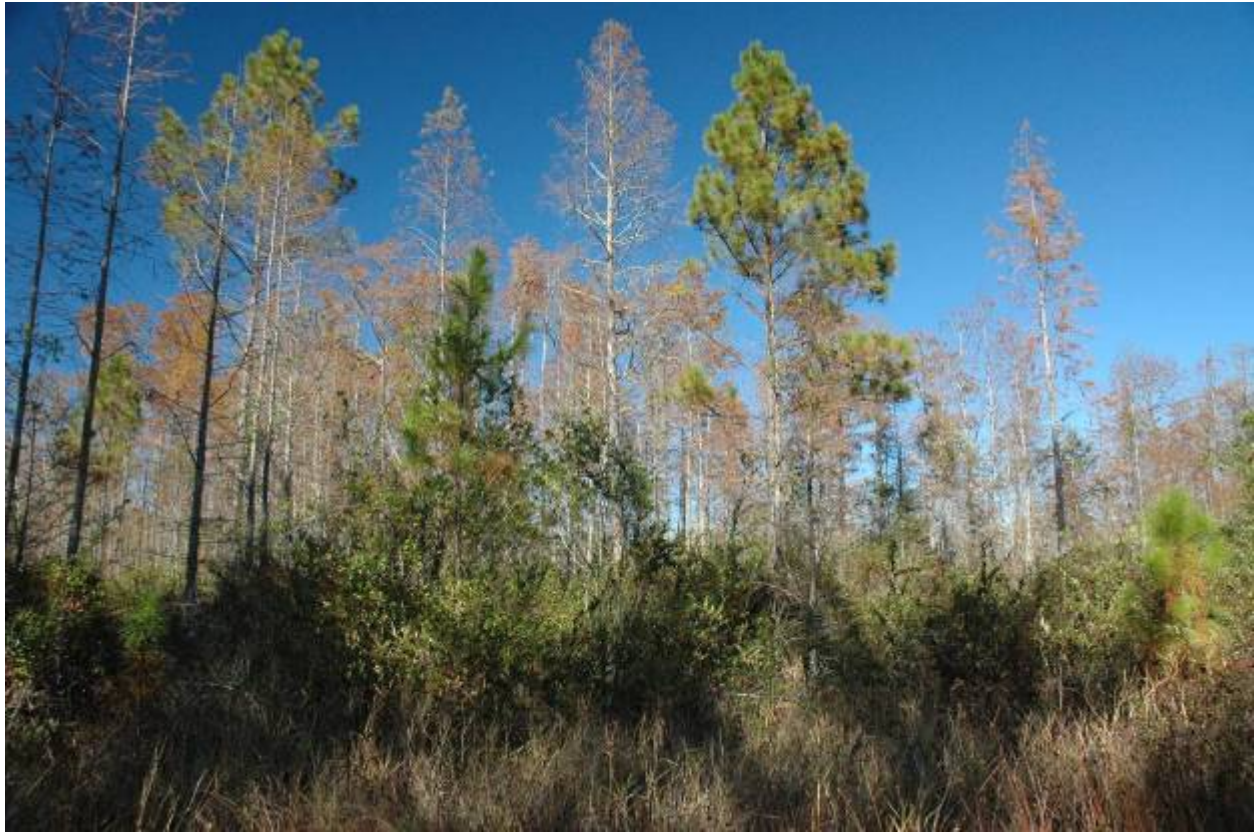
**Wetland ID: 76-06**

**Description:** This wetland is a 1.1 ha semi-permanent mixed swamp surrounded by mesic flatwoods. Cypress trees dominate the canopy, and cover 50-75% of the wetland basin. The midstory is dominated by fetterbush and smilax, and covers 50-75% of the wetland. Maidencane is sparse, and covers 5-25% of the wetland basin. An old fireline encircles the pond. The adjacent uplands are mesic flatwoods.

**Wetland Concern(s):** Fireline

**Restoration Action Recommended:** Allow vegetation to reestablish in the old fire break and monitor the wetland to ensure it regularly burns. When burning this management unit, custom burning of the wetland basin and vegetation surrounding the basin may be needed if the old fire break acts as a barrier.

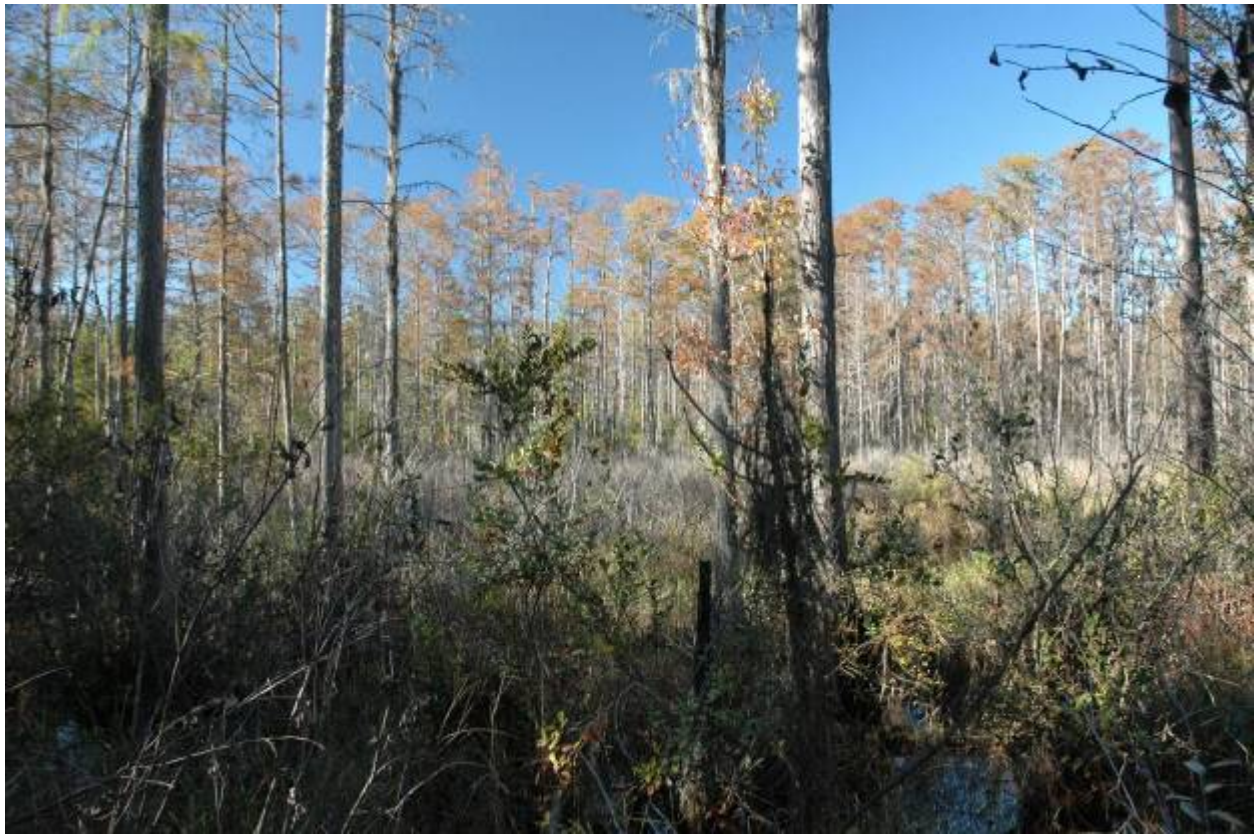
**Wetland ID: 76-07**

**Description:** This wetland is a 1.6 ha semi-permanent forested swamp. Cypress trees grow in a ring around an herbaceous marsh center. The tree canopy covers 25-50% of the wetland basin. Fetterbush and wax myrtle grow in a ring around the wetland, and cover 5-25% of the wetland. Maidencane grows throughout the wetland, and covers 50-75% of the basin. The adjacent uplands are mesic flatwoods.

**Wetland Concern(s):** None

**Restoration Action Recommended:** None

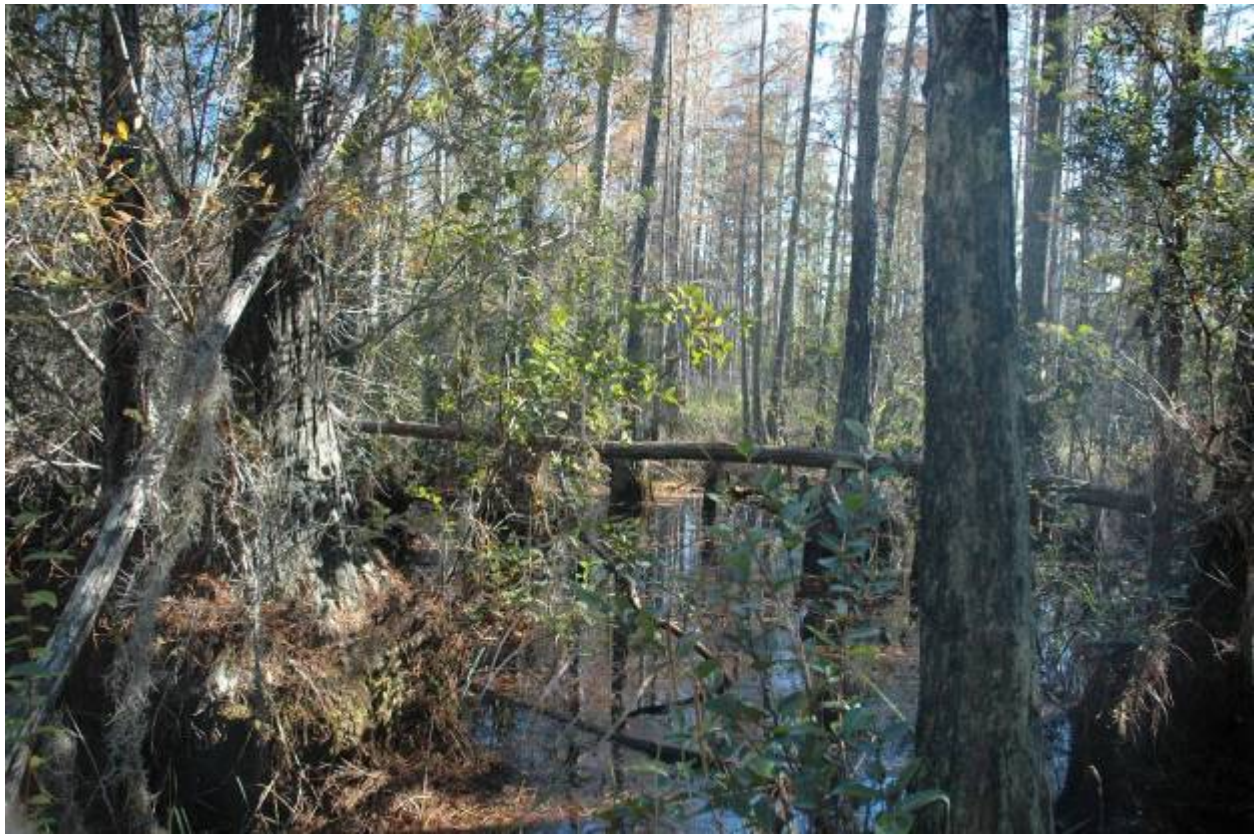
**Wetland ID: 77-01**

**Description:** This wetland is 0.7 ha semi-permanent mixed swamp. Cypress trees dominate the canopy, and cover 50-75% of the wetland. The midstory is dominated by wax myrtle and fetterbush, and covers 25-50% of the wetland. Maidencane grows in scattered patches and covers 5-25% of the wetland basin. This cypress dome is ringed with a thick shrub layer. The adjacent uplands are mesic flatwoods.

**Wetland Concern(s):** Woody encroachment

**Restoration Action Recommended:** Periodic, growing-season burns around the edge of the wetland should reduce the thick shrub layer.

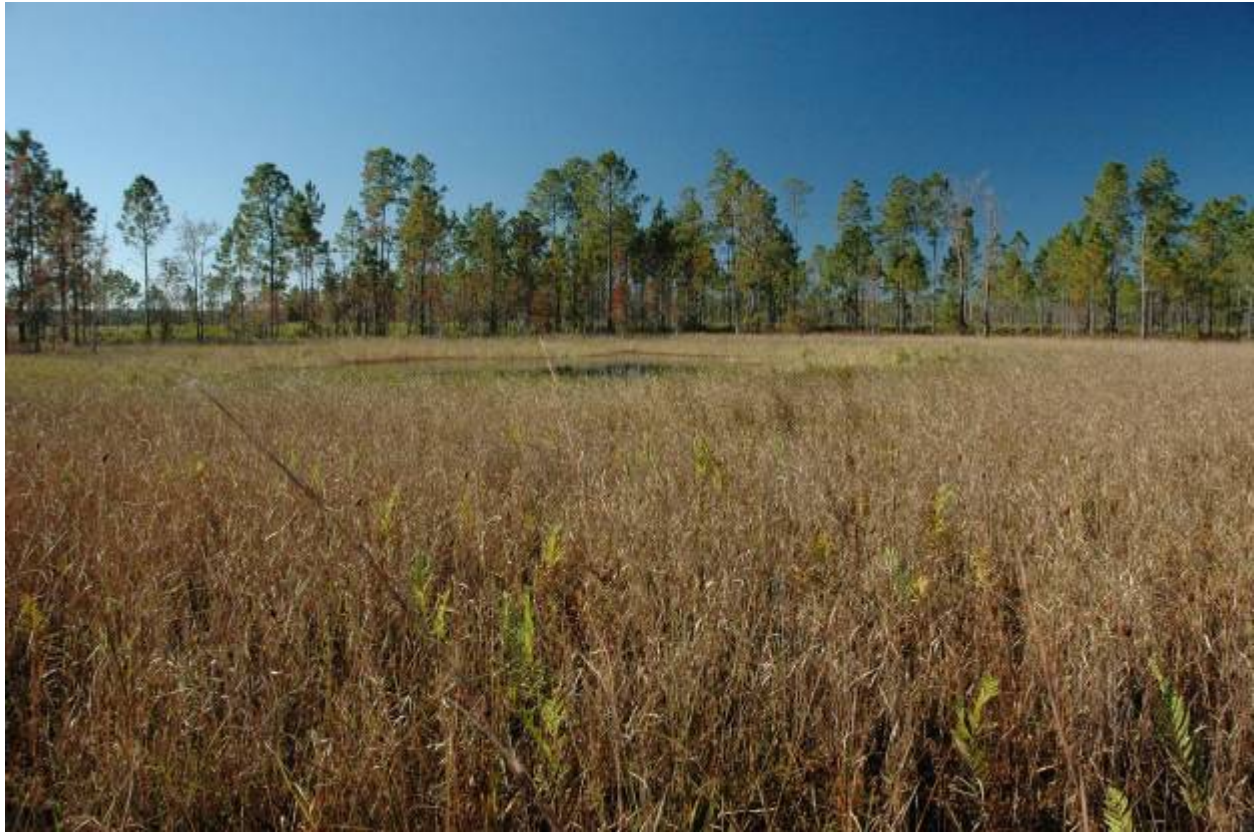
**Wetland ID: 77-02**

**Description:** This wetland is 0.9 ha ephemeral marsh. There is no tree canopy or midstory cover. Maidencane grows in a ring around the open-water center, and covers 50-75% of the wetland basin. Feral hog damage is minor and concentrated around the wetland edge. The adjacent uplands are scrubby flatwoods.

**Wetland Concern(s):** Feral hog damage

**Restoration Action Recommended:** This wetland is part of a cluster of wetlands impacted to varying degrees by feral hog damage. These wetlands should be monitored for changes in feral hog activity. If damage becomes more severe or more widespread, the area should be considered for more aggressive action.

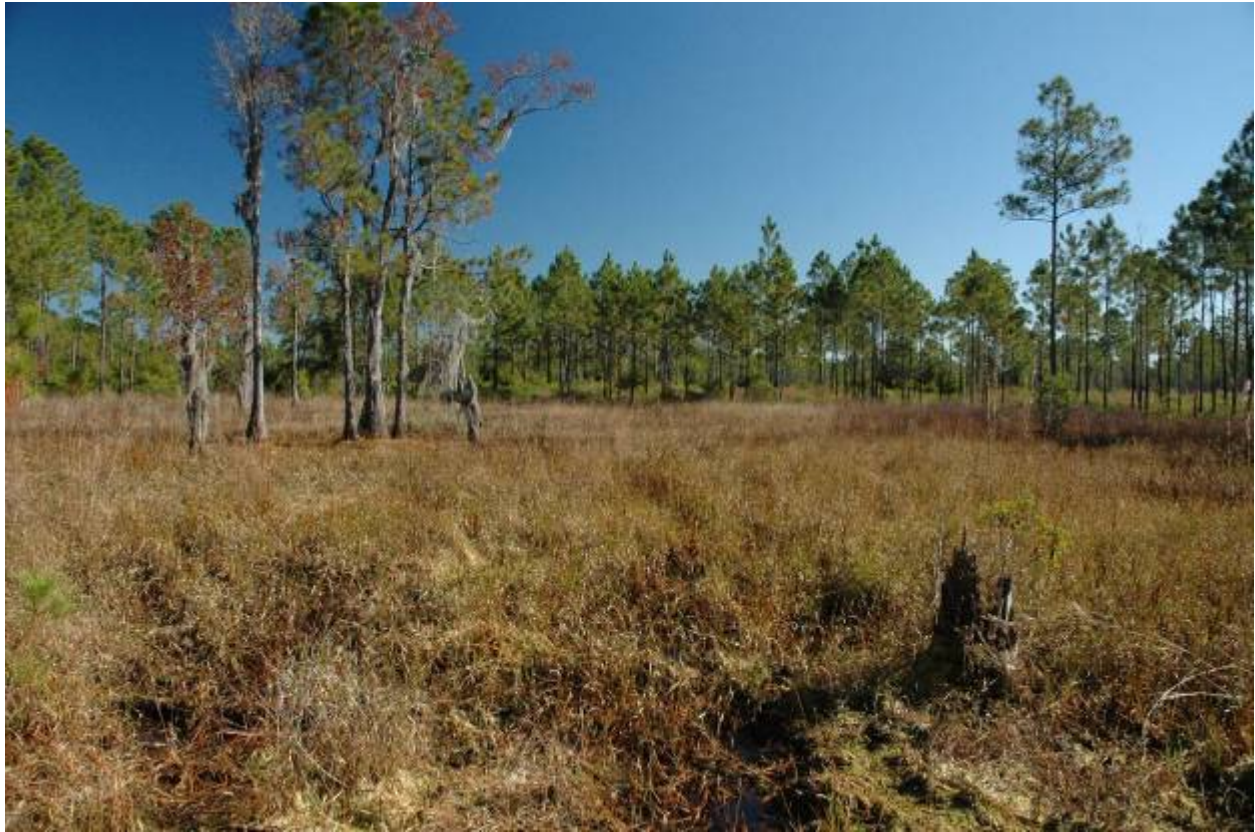
**Wetland ID: 77-03**

**Description:** This wetland is a 0.4 ha highly ephemeral marsh. There is no tree canopy or midstory cover. Maidencane and other grasses grow throughout the wetland, and cover >75% of the basin. Vegetation is now growing in old feral hog ruts and rootings. The adjacent uplands are a mix of mesic and scrubby flatwoods. The topography is undulating with old plowlines created by the Florida Department of Forestry.

**Wetland Concern(s):** Feral hog damage

**Restoration Action Recommended:** This wetland is part of a cluster of wetlands impacted to varying degrees by feral hog damage. These wetlands should be monitored for changes in feral hog activity. If damage becomes more severe or more widespread, the area should be considered for more aggressive action.

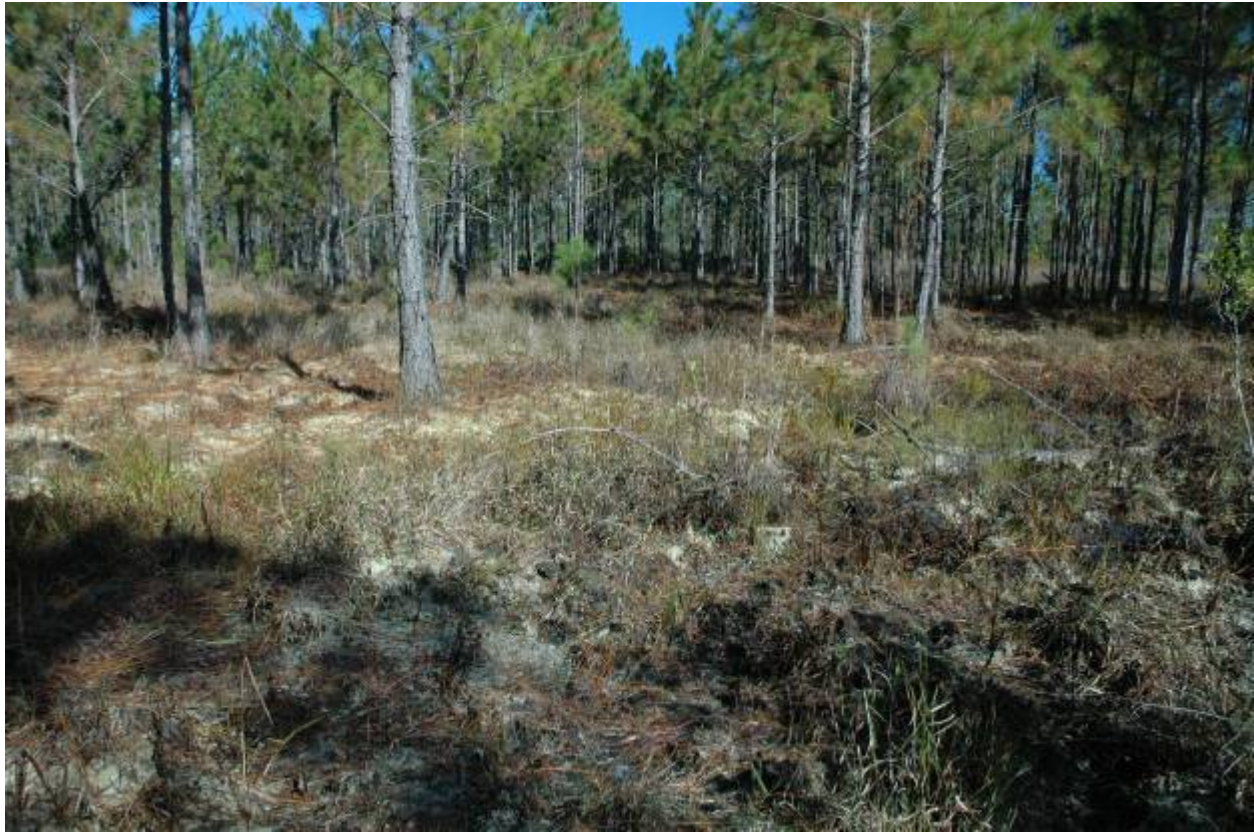
**Wetland ID: 77-04**

**Description:** This wetland is a 0.9 ha highly ephemeral marsh. Slash pine trees dominate the canopy, and cover 5-25% of the wetland. There is no midstory cover. Maidencane, *Sphagnum*, and redroot grow throughout the wetland, and cover >75% of the basin. Old feral hog damage is extensive throughout the wetland, although vegetation has recovered. The adjacent uplands are a mix of mesic and scrubby flatwoods. The topography is undulating with old plowlines created by the Florida Department of Forestry.

**Wetland Concern(s):** Feral hog damage

**Restoration Action Recommended:** This wetland is part of a cluster of wetlands impacted to varying degrees by feral hog damage. These wetlands should be monitored for changes in feral hog activity. If damage becomes more severe or more widespread, the area should be considered for more aggressive action.

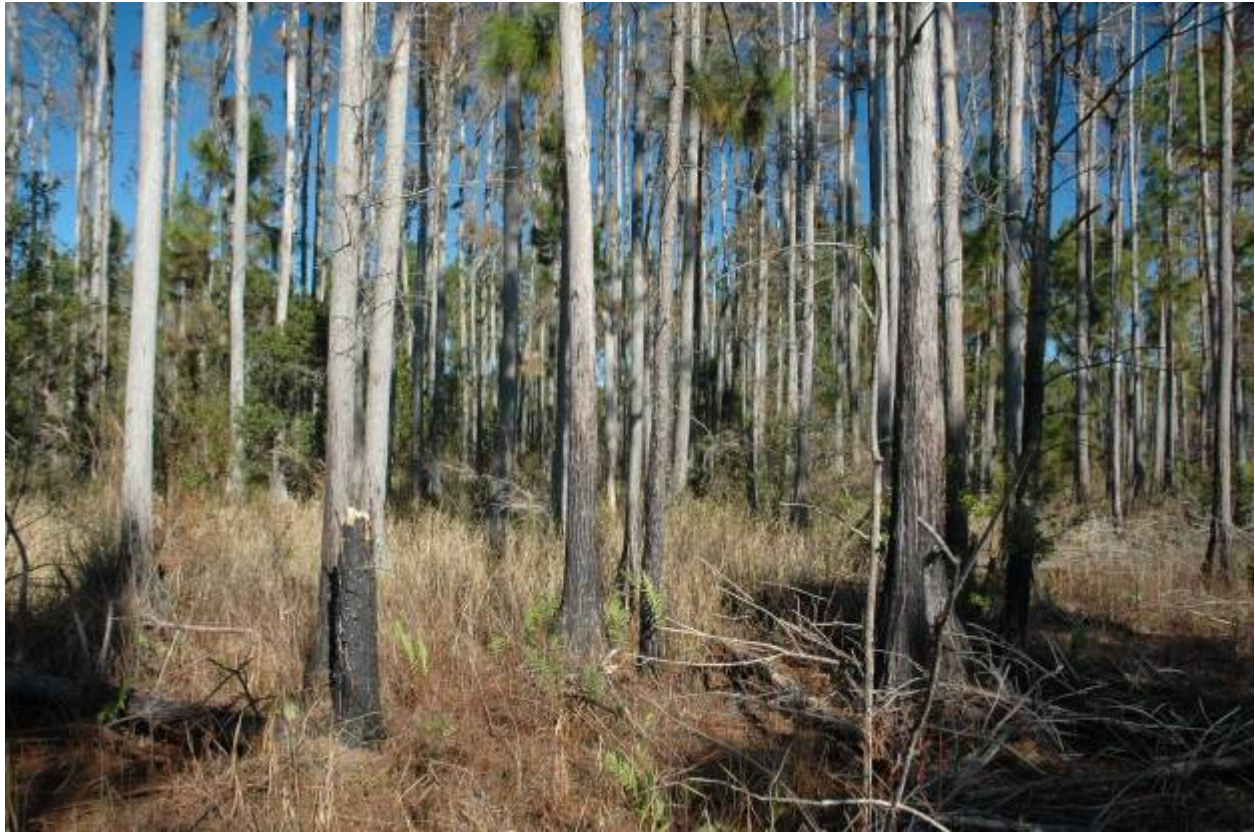
**Wetland ID: 77-05**

**Description:** This wetland is a 0.3 ha ephemeral forested swamp. Cypress trees dominate the canopy, and cover 50-75% of the wetland. The midstory is dominated by wax myrtle, and covers 5-25% of the wetland. Maidencane grows throughout the wetland, and covers >75% of the basin. The adjacent uplands are scrubby flatwoods. The topography is undulating with old plowlines created by the Florida Department of Forestry.

**Wetland Concern(s):** None

**Restoration Action Recommended:** None

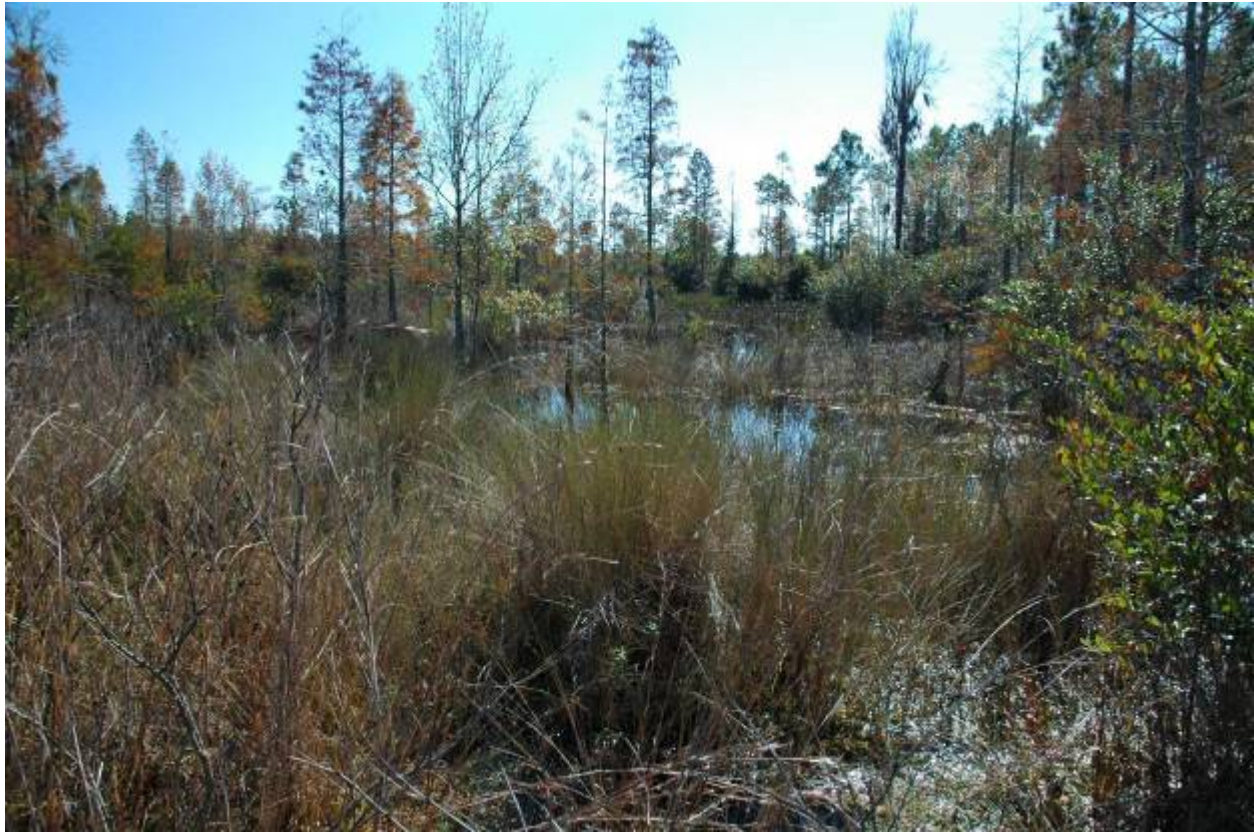
**Wetland ID: 78-01**

**Description:** This wetland is 1.3 ha semi-permanent mixed swamp. Cypress trees dominate the canopy, and cover 25-50% of the wetland. The midstory is dominated by wax myrtle and fetterbush, and covers 25-50% of the wetland. Sedges, grasses, and pickerel weed grow throughout the wetland, and cover 50-75% of the basin. Cypress stumps indicate historical logging within the wetland. A minimal amount of feral hog damage is present. This cypress pond has a high diversity of herbaceous and woody vegetation, especially on the east side of the pond. The adjacent uplands are scrubby flatwoods. The topography is undulating with old plowlines created by the Florida Department of Forestry.

**Wetland Concern(s):** Feral hog damage

**Restoration Action Recommended:** This wetland is part of a cluster of wetlands impacted to varying degrees by feral hog damage. These wetlands should be monitored for changes in feral hog activity. If damage becomes more severe or more widespread, the area should be considered for more aggressive action.

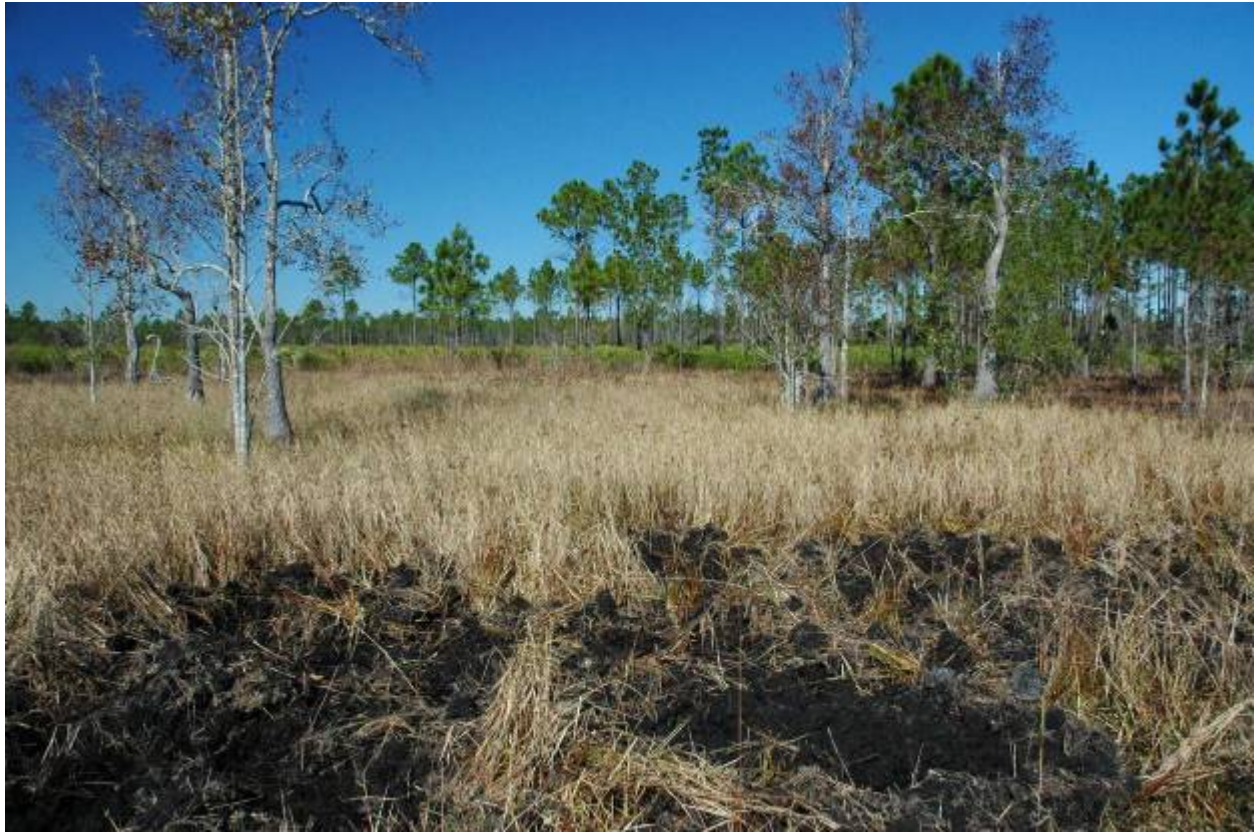
**Wetland ID: 78-02**

**Description:** This wetland is a 0.6 ha highly ephemeral marsh. There is minimal canopy cover and no midstory cover. Maidencane, other grasses, and *Sphagnum* grow throughout the wetland, and cover >75% of the basin. Feral hog damage is severe. The adjacent uplands are scrubby flatwoods. The topography is undulating with old plowlines created by the Florida Department of Forestry.

**Wetland Concern(s):** Feral hog damage

**Restoration Action Recommended:** This wetland is part of a cluster of wetlands impacted to varying degrees by feral hog damage. These wetlands should be monitored for changes in feral hog activity. If damage becomes more severe or more widespread, the area should be considered for more aggressive action.

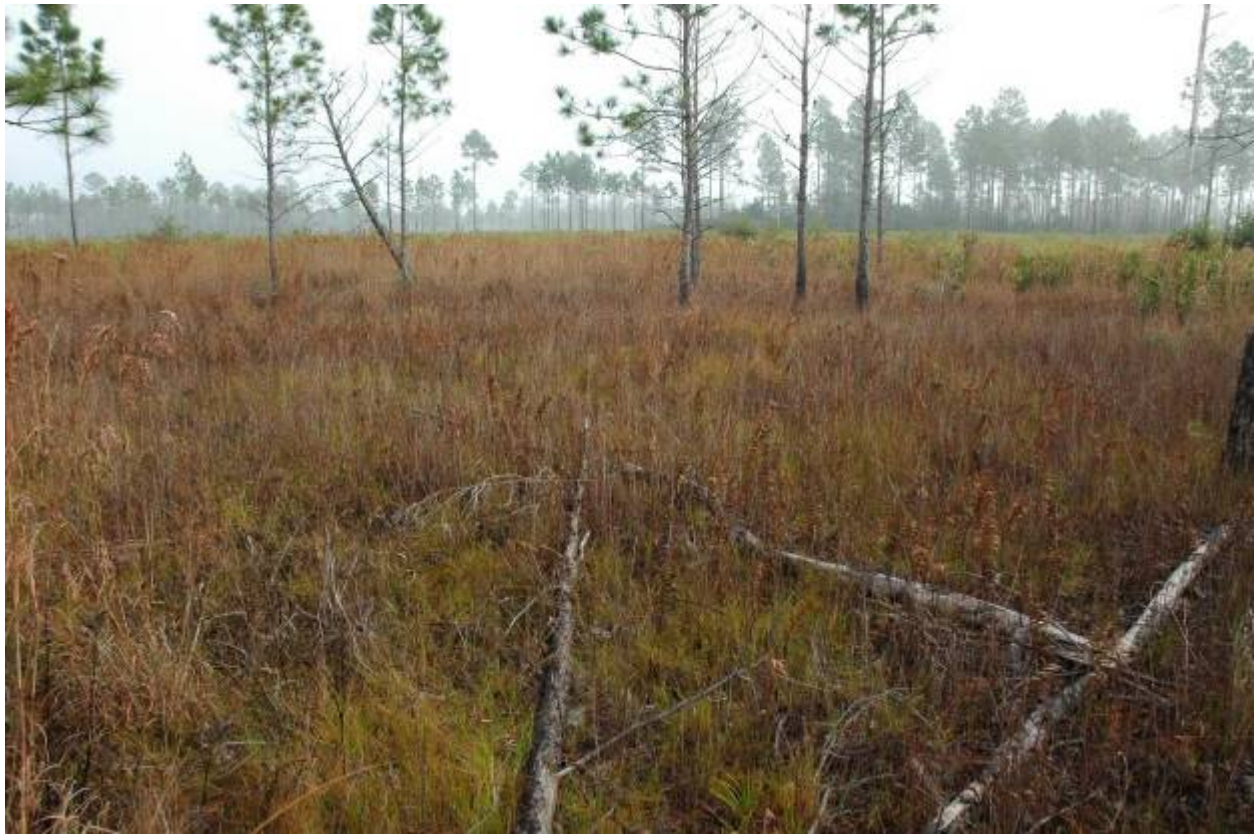
**Wetland ID: 78-03**

**Description:** This wetland is a 0.1 ha highly ephemeral marsh. There is no tree canopy or midstory cover. Grasses and ferns grow throughout the wetland, and cover >75% of the basin. Feral hog damage is minor. The adjacent uplands are mesic flatwoods.

**Wetland Concern(s):** Feral hog damage

**Restoration Action Recommended:** This wetland is part of a cluster of wetlands impacted to varying degrees by feral hog damage. These wetlands should be monitored for changes in feral hog activity. If damage becomes more severe or more widespread, the area should be considered for more aggressive action.
