# **Inventory, Assessment, and Restoration Potential of Ephemeral Wetlands on FFWCC Wildlife Management Areas**

**Caravelle Ranch WMA Final Report**

November 2008

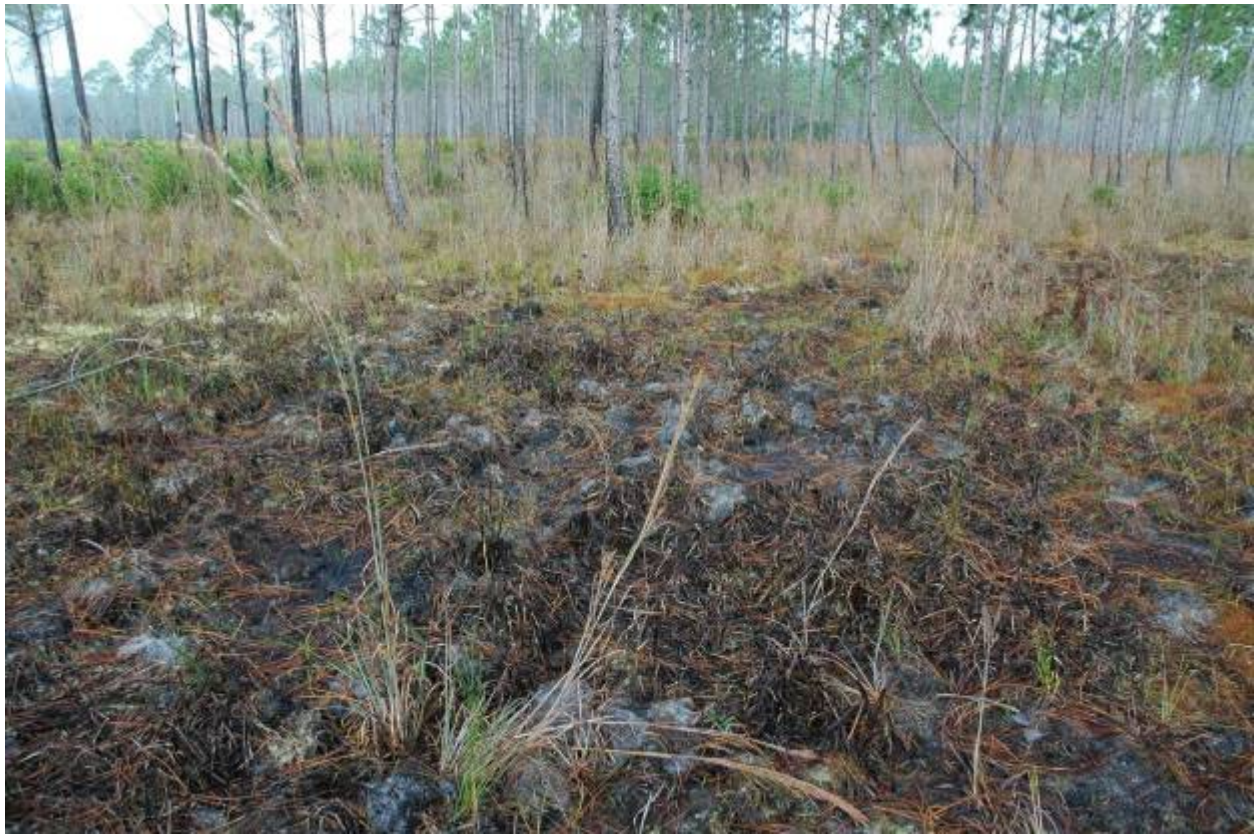
**Wetland ID: 78-04**

**Description:** This wetland is a 1.1 ha highly ephemeral marsh. Slash pine trees cover 25-50% of the wetland. There is no midstory layer. *Sphagnum*, grasses, and redroot grow throughout the wetland, and cover >75% of the basin. Old and new feral hog damage is evident and severe to moderate in extent. The adjacent uplands are scrubby flatwoods.

**Wetland Concern(s):** Feral hog damage

**Restoration Action Recommended:** This wetland is part of a cluster of wetlands impacted to varying degrees by feral hog damage. These wetlands should be monitored for changes in feral hog activity. If damage becomes more severe or more widespread, the area should be considered for more aggressive action. The pine trees could be removed from the wetland interior.

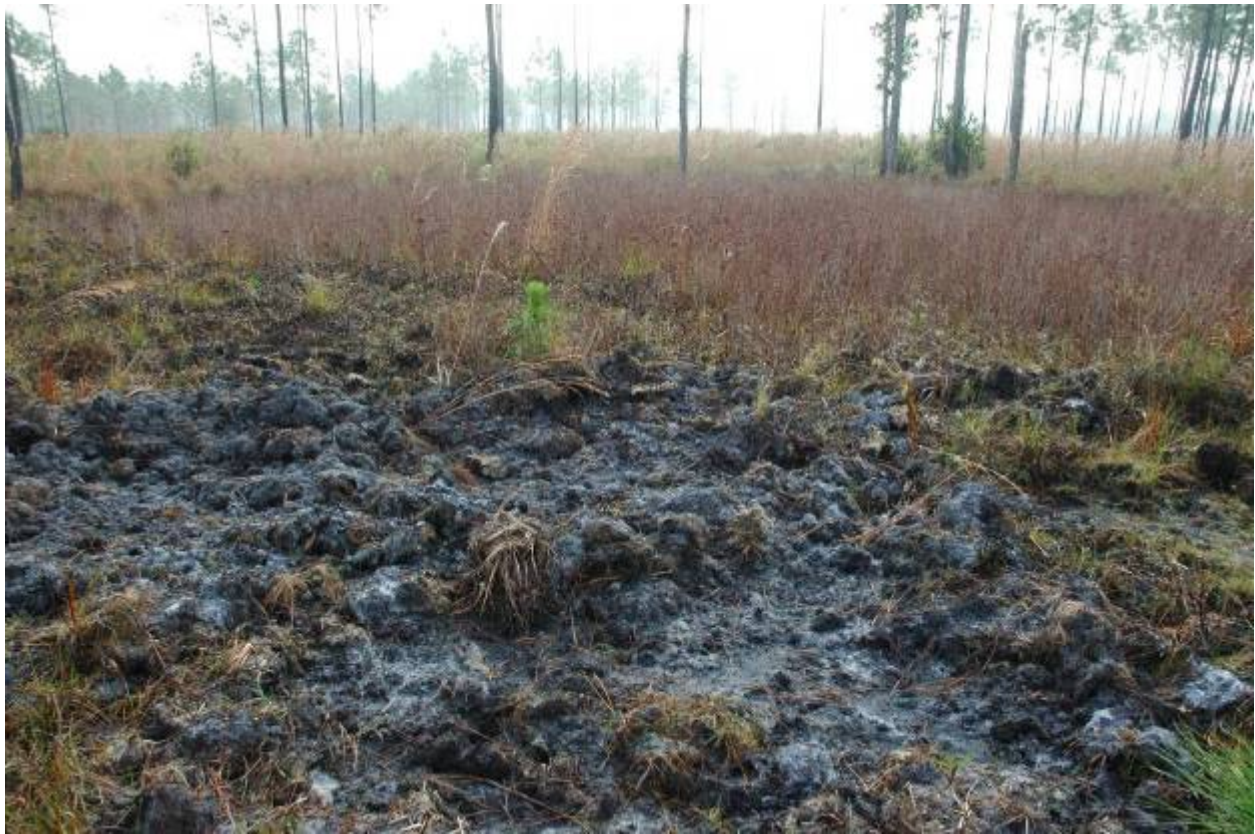
**Wetland ID: 78-05**

**Description:** This wetland is a 0.2 ha highly ephemeral marsh. There is no tree canopy or midstory cover. *Sphagnum* and ferns grow throughout the wetland, and cover >75% of the basin. Feral hog damage is deep and extensive. The adjacent uplands are scrubby flatwoods.

**Wetland Concern(s):** Feral hog damage

**Restoration Action Recommended:** This wetland is part of a cluster of wetlands impacted to varying degrees by feral hog damage. These wetlands should be monitored for changes in feral hog activity. If damage becomes more severe or more widespread, the area should be considered for more aggressive action.

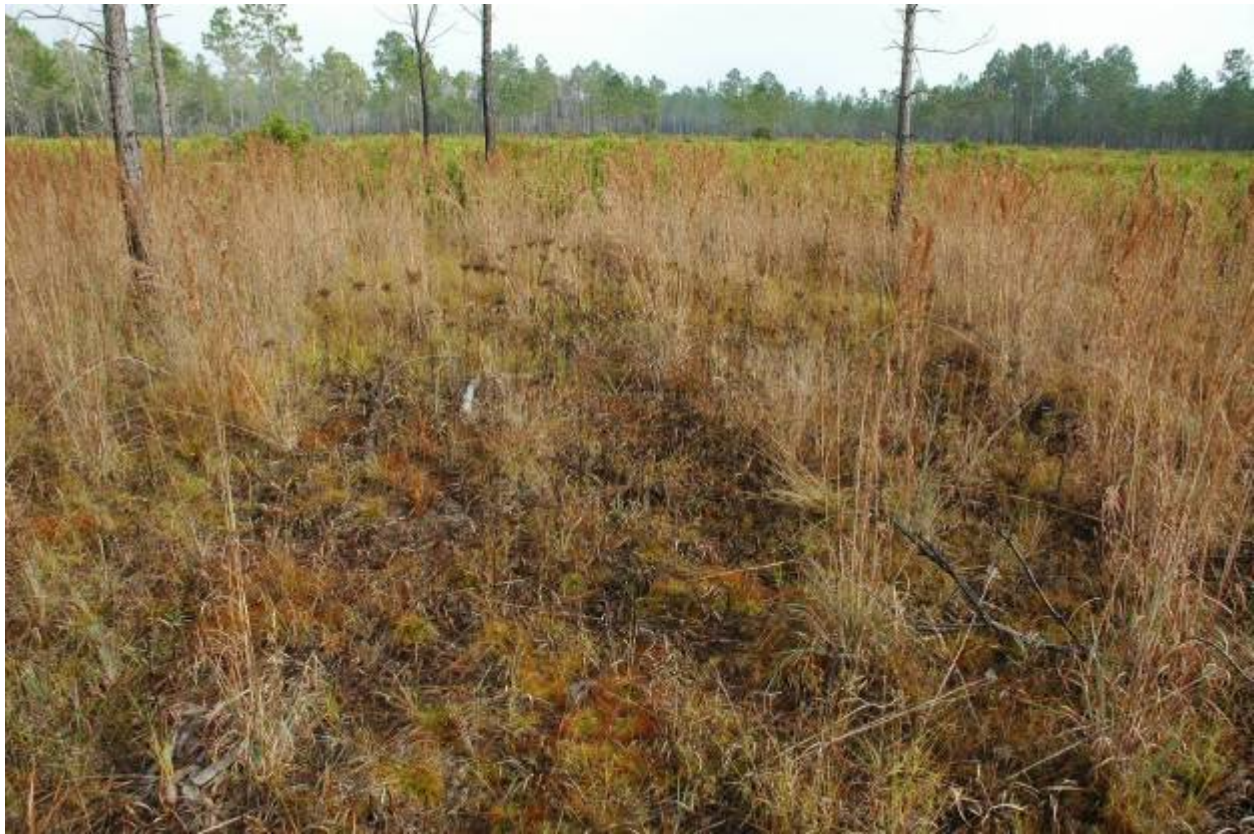
**Wetland ID: 78-06**

**Description:** This wetland is a <0.1 ha highly ephemeral marsh. There is no tree canopy or midstory cover. Grasses and redroot grow throughout the wetland, and cover >75% of the basin. Vegetation is now growing in old feral hog ruts and rootings. The adjacent uplands are scrubby flatwoods.

**Wetland Concern(s):** Feral hog damage

**Restoration Action Recommended:** This wetland is part of a cluster of wetlands impacted to varying degrees by feral hog damage. These wetlands should be monitored for changes in feral hog activity. If damage becomes more severe or more widespread, the area should be considered for more aggressive action.

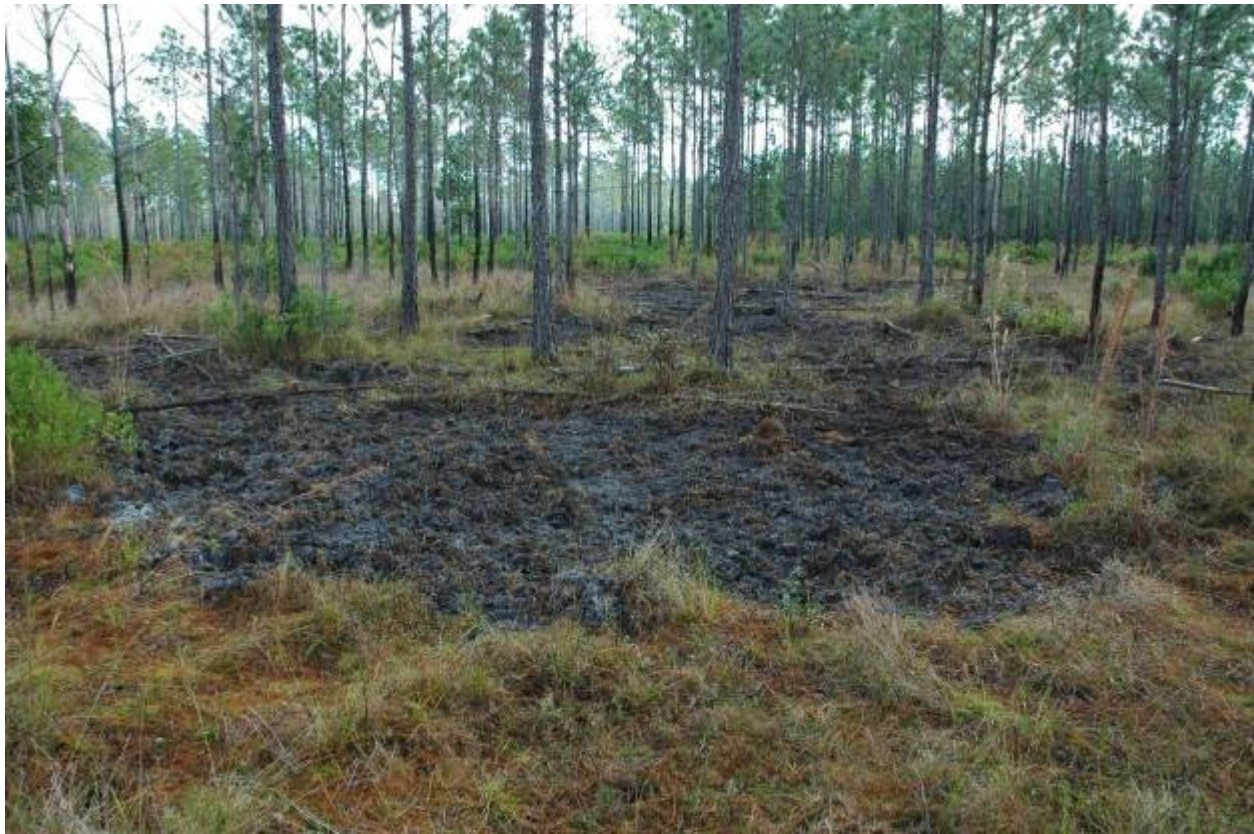
**Wetland ID: 78-07**

**Description:** This wetland is a 0.2 ha highly ephemeral marsh. Slash pine trees cover 25-50% of the wetland. The midstory is dominated by gallberry, and covers 5-25% of the wetland. Grasses and fern grow throughout the wetland, and cover 50-75% of the basin. Feral hog damage eliminated the vegetation in the center of the wetland. The adjacent uplands are wet flatwoods.

**Wetland Concern(s):** Feral hog damage

**Restoration Action Needed:** This wetland is part of a cluster of wetlands impacted to varying degrees by feral hog damage. These wetlands should be monitored for changes in feral hog activity. If damage becomes more severe or more widespread, the area should be considered for more aggressive action.

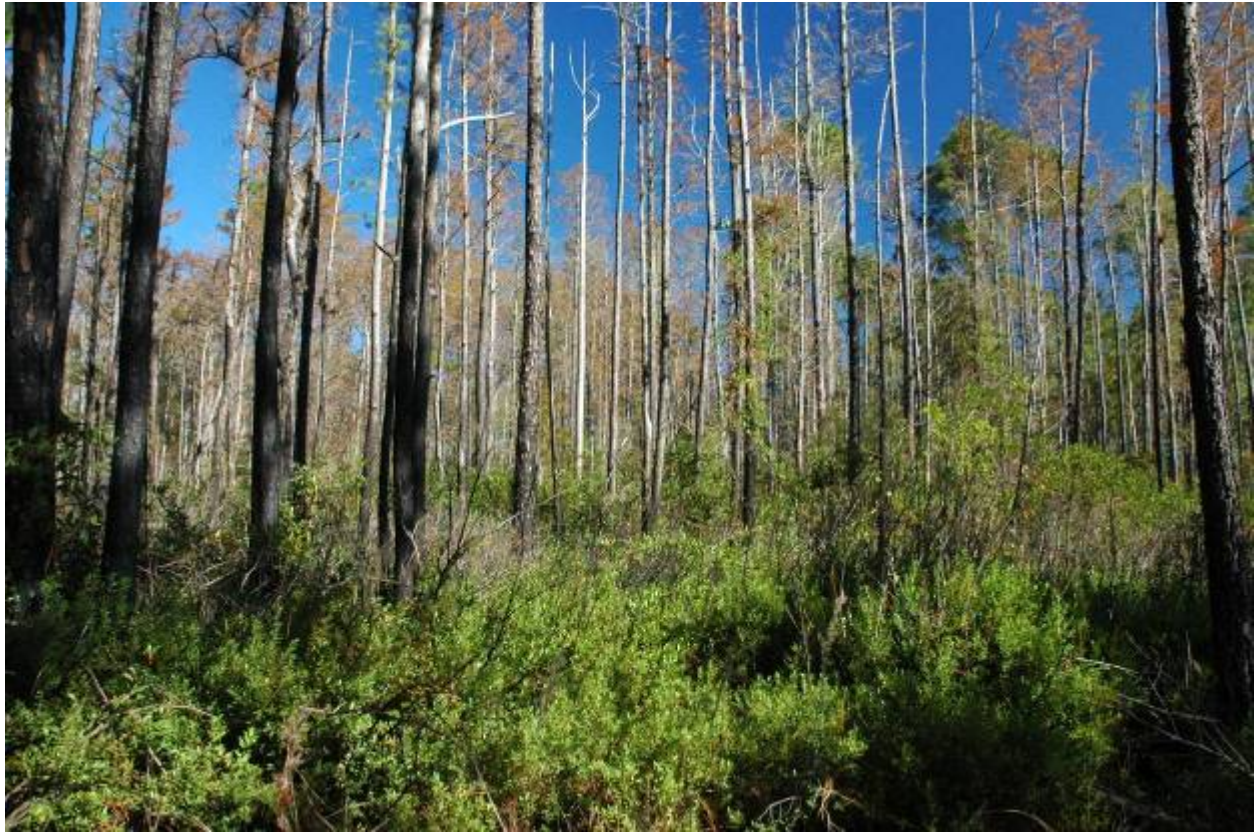
**Wetland ID: 80-01**

**Description:** This wetland is a 0.7 ha semi-permanent mixed swamp. Cypress trees dominate the canopy, and cover 50-75% of the wetland. The dense midstory layer is dominated by fetterbush and smilax, and covers >75% of the wetland. There is no herbaceous cover. The adjacent uplands are wet flatwoods with thick underbrush. The topography is undulating with old plowlines created by the Florida Department of Forestry.

**Wetland Concern(s):** Woody encroachment

**Restoration Action Recommended:** Although this wetland was recently burned, the shrub layer remains tall and dense. Periodic fire should reduce this thick midstory layer.

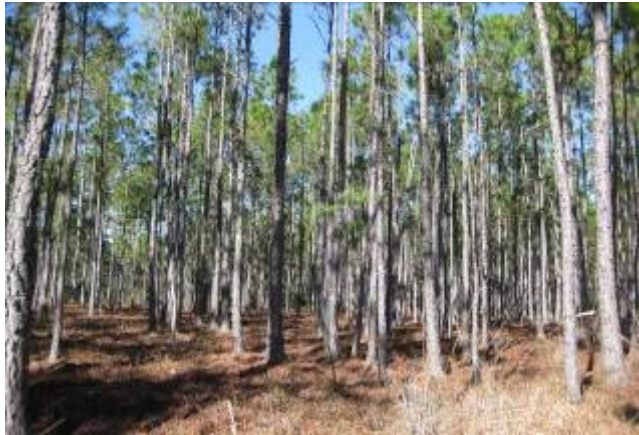
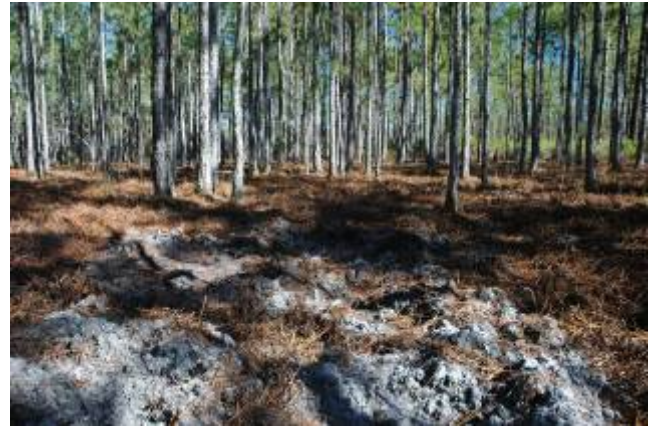
**Wetland ID: 80-02**

**Description:** This wetland is a 0.2 ha highly ephemeral wetland. Slash pine trees dominate the canopy, and cover 50-75% of the basin. There is no midstory layer. *Sphagnum* and redroot grow throughout the wetland, and cover >75% of the basin. Old and new feral hog damage covers the entire wetland basin. The adjacent uplands are mesic flatwoods.

**Wetland Concern(s):** Feral hog damage, Woody encroachment

**Restoration Action Recommended:** Both feral hogs and the pine canopy are excluding herbaceous vegetation growth. This wetland is part of a cluster of wetlands impacted by severe feral hog damage and should be considered for more aggressive action. The pine trees around the wetland could be thinned during the next upland thinning operation.

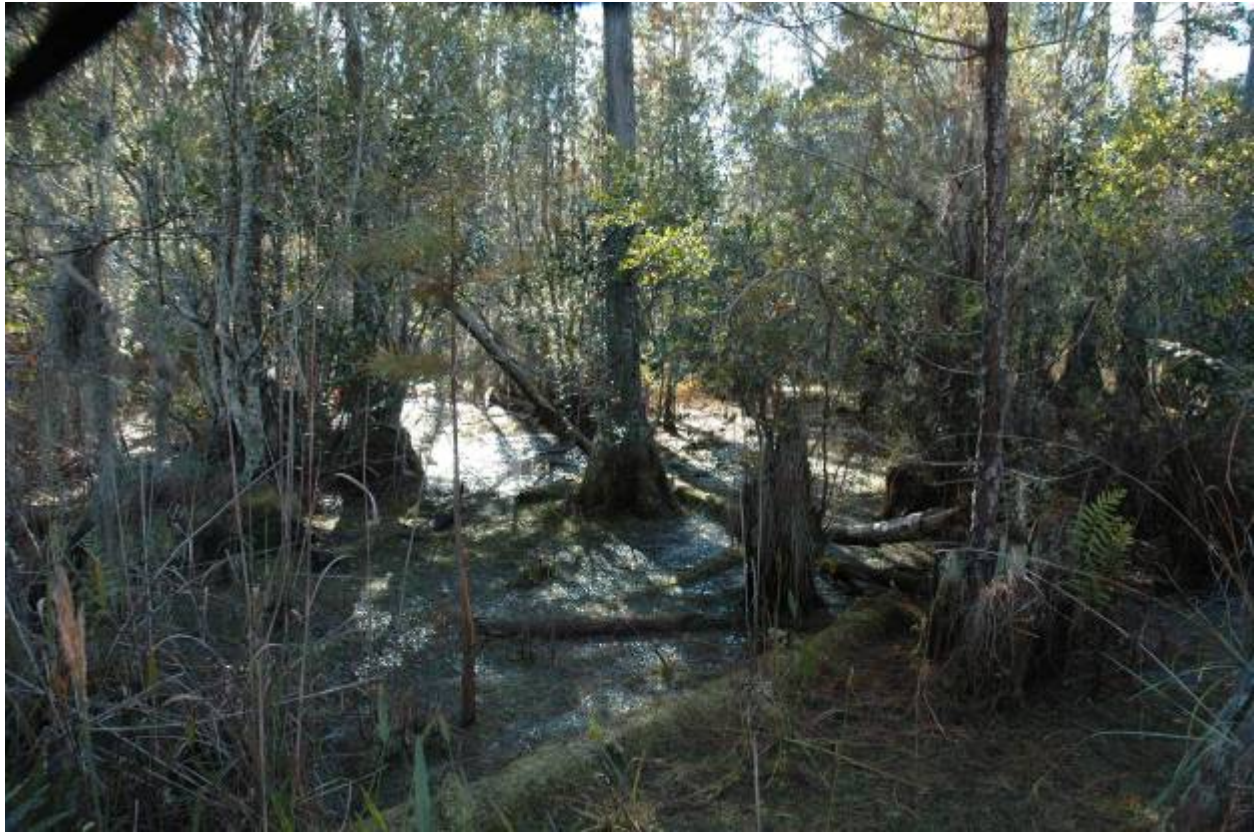
**Wetland ID: 80-03**

**Description:** This wetland is a 0.4 ha ephemeral mixed swamp. Cypress trees dominate the canopy, and cover 25-50% of the wetland. The midstory is dominated by fetterbush and wax myrtle, and covers 25-50% of the wetland. *Sphagnum*, fern, and pickerelweed grow throughout the wetland, and cover >75% of the basin. Thick shrubs encircle the edges of the wetland. The adjacent uplands are mesic flatwoods.

**Wetland Concern(s):** Woody encroachment

**Restoration Action Recommended:** Periodic fire, particularly around the wetland edge, would reduce the thick shrub layer.

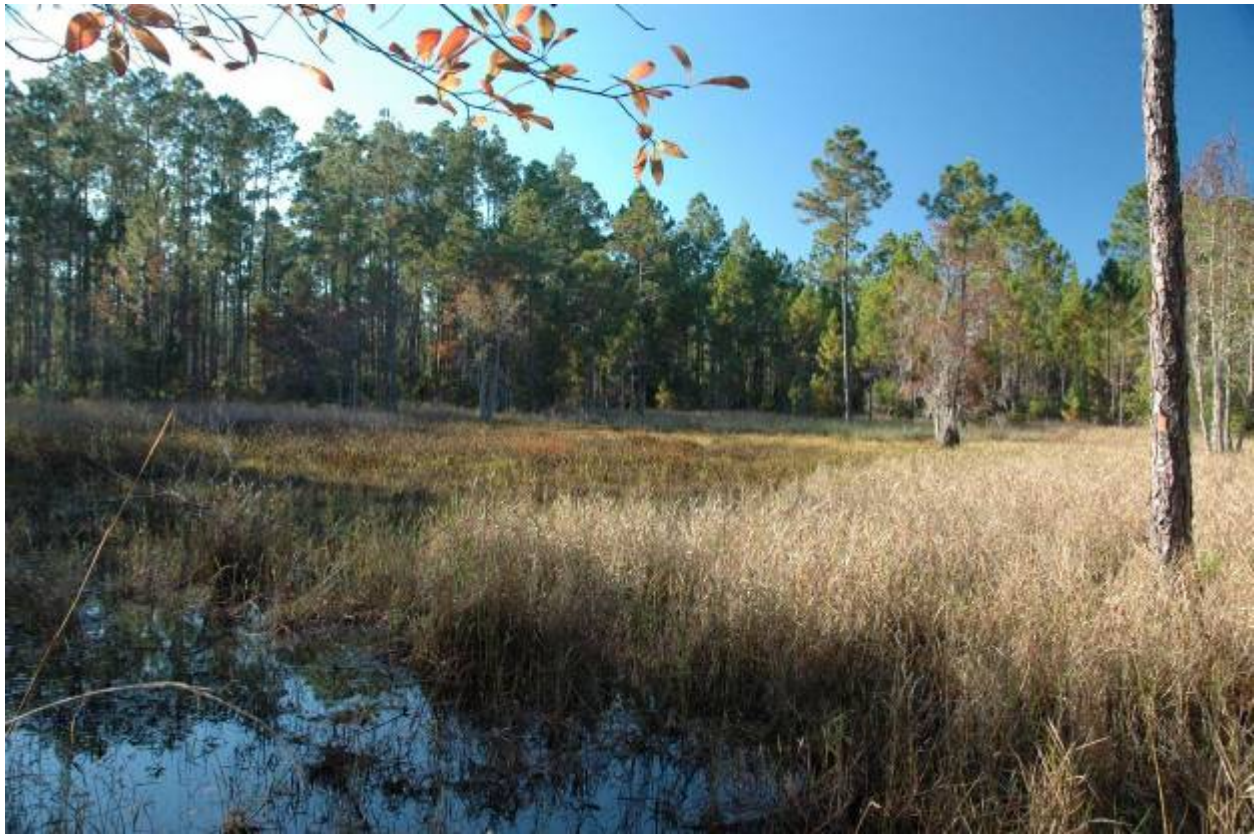
**Wetland ID: 80-04**

**Description:** This wetland is a 0.6 ha ephemeral marsh. There is no tree canopy or midstory layer. Maidencane grows throughout the wetland, and covers >75% of the basin. The adjacent uplands are mesic flatwoods.

**Wetland Concern(s):** None

**Restoration Action Recommended:** None
