Inventory, Assessment, and Restoration Potential of Ephemeral Wetlands on FFWCC Wildlife Management Areas

Chassahowitzka WMA Final Report

Submitted by: Rebecca P.M. Means¹, Ryan C. Means¹, Steven A. Johnson²

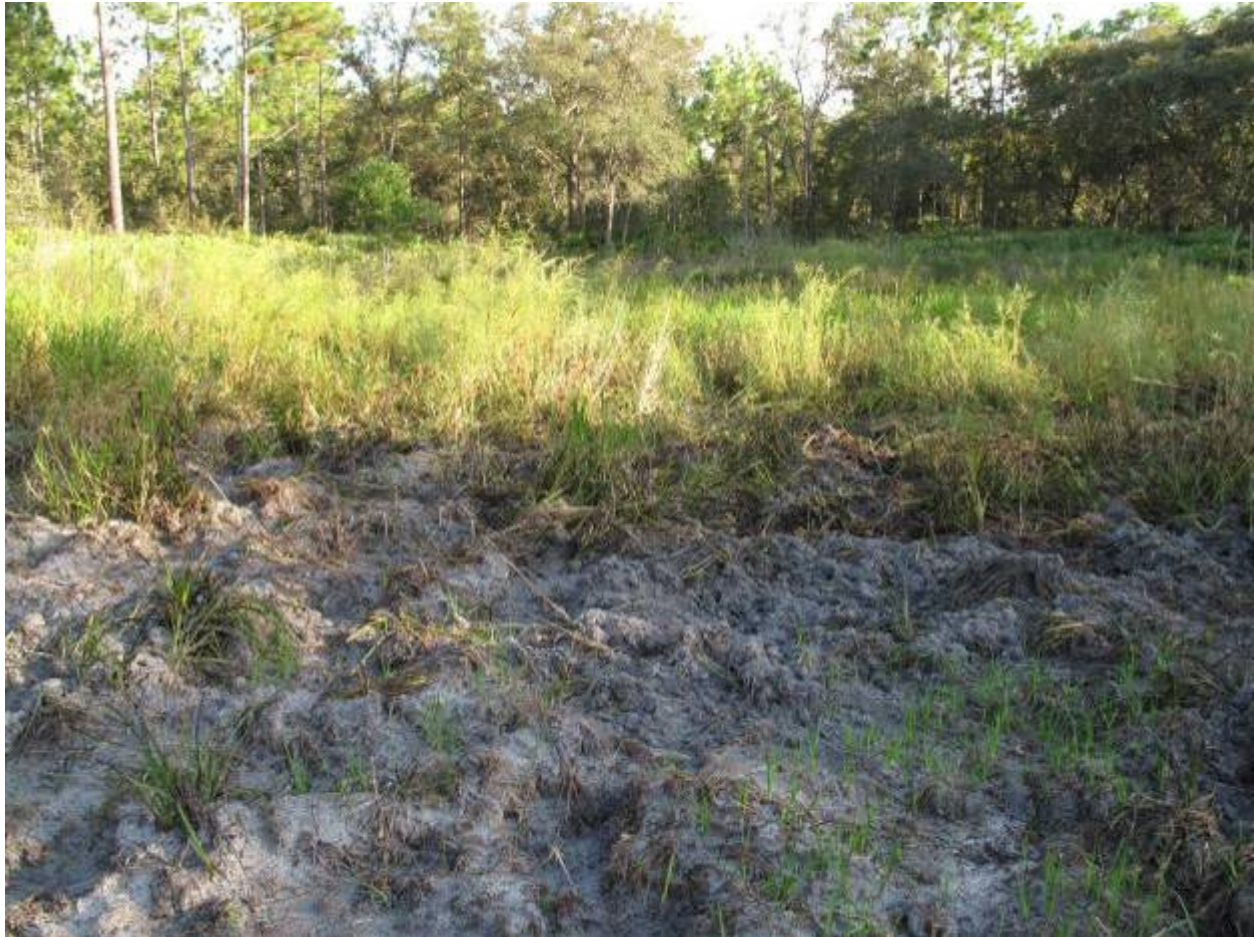
Wetland ID: 02A-01

Description: This wetland is a 0.2 ha ephemeral marsh. Slash pine trees are beginning to encroach into the wetland basin on the west side but cover <5% of the wetland. There is no canopy or midstory cover. Sedges/grasses, maidencane, and redroot grow throughout the wetland, and cover 50-75% of the basin. The wetland has severe feral hog damage. This wetland is a potential striped newt breeding pond. The adjacent uplands are sandhill. The sandhills appear to have been fire suppressed but now are managed with prescribed fire.

Wetland Concerns: Feral hog damage

Restoration Action Recommended: Because of the widespread damage to ephemeral wetlands on CWMA, we recommend aggressive action to reduce the overall numbers of feral hogs on the property.

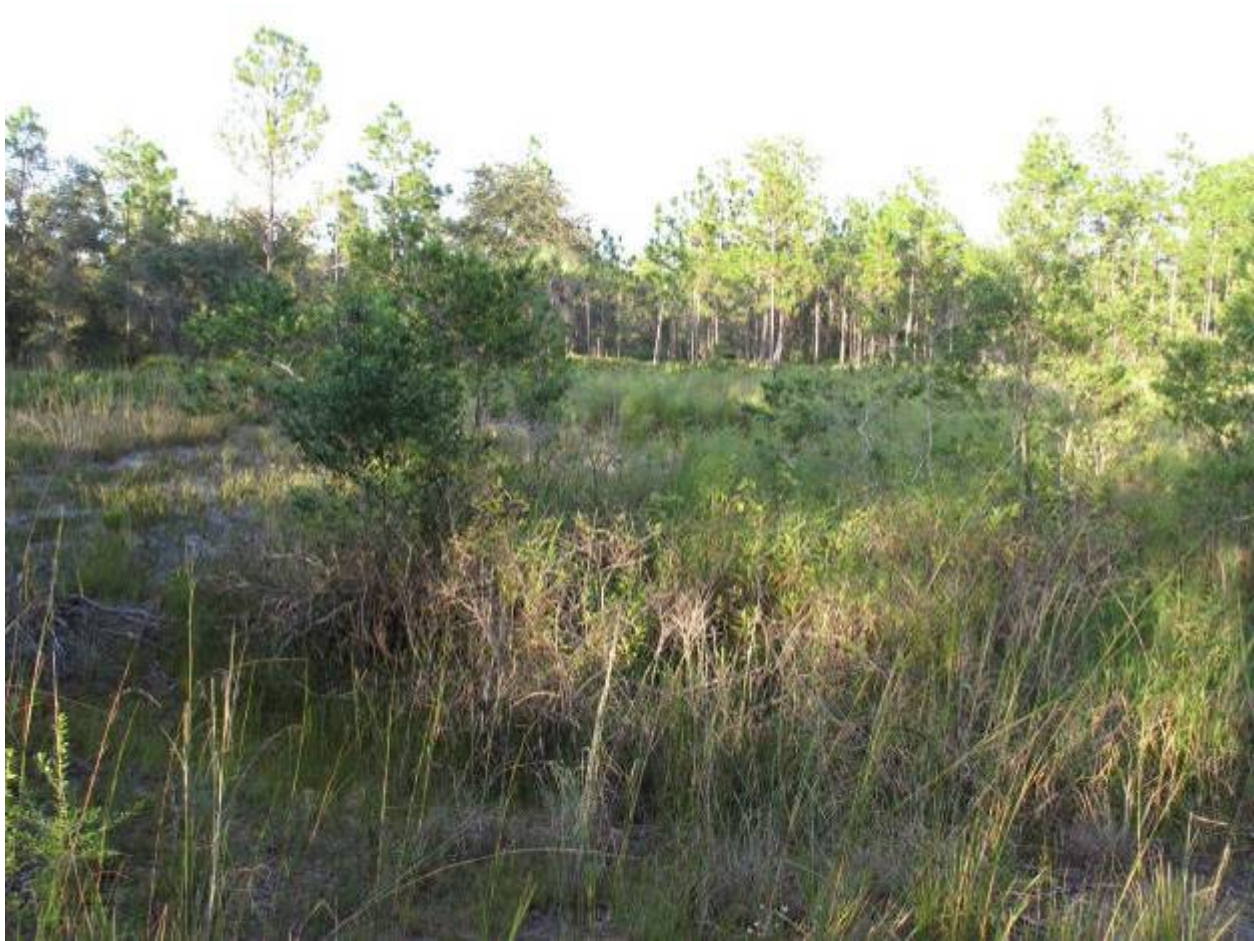
Description: This wetland is a 0.2 ha ephemeral marsh. There is no tree canopy. Dog fennel, buttonbush, and holly are the dominant woody vegetation, and cover 25-50% of the wetland. Sedges/grasses, maidencane, and redroot are distributed throughout the wetland, and cover 50-75% of the basin. This depression marsh has a deeper, sinkhole depression on the west side. Shrubs have established due to the naturally long hydroperiod of this deep depression. The wetland has extensive feral hog damage. This wetland is a potential striped newt breeding pond. The adjacent uplands are sandhill. The sandhills appear to have been fire suppressed but now are managed with prescribed fire.

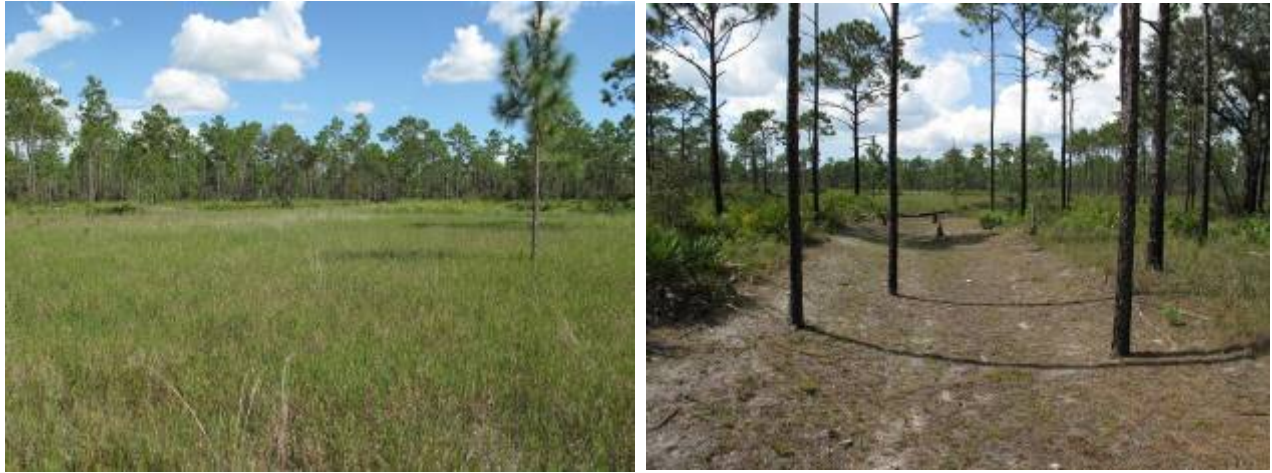
Wetland ID: 03A-01

Description: This wetland is a 0.3 ha ephemeral marsh. There is no canopy or midstory cover. Maidencane grows throughout the wetland, and covers >75% of the basin. The wetland has minor, old feral hog damage. This wetland will connect with wetland 03A-02 during periods of high water. There is a ditch on the eastern side of the wetland that drains to/from the adjacent highway (US 19). This wetland is in fire maintenance condition and is a potential striped newt breeding pond. The adjacent uplands are sandhill. The sandhills appear to have been fire suppressed but now are managed with prescribed fire. This wetland provides a nice example of how fire-management maintains low to moderate maidencane density.

Wetland Disturbance: Feral hog damage, Ditching

Restoration Action Recommended: Because of the widespread damage to ephemeral wetlands on CWMA, we recommend aggressive action to reduce the overall numbers of feral hogs on the property. Fill the ditch to break connectivity with the wetland. Alternatively, the ditch could be plugged and vegetation allowed to regenerate.

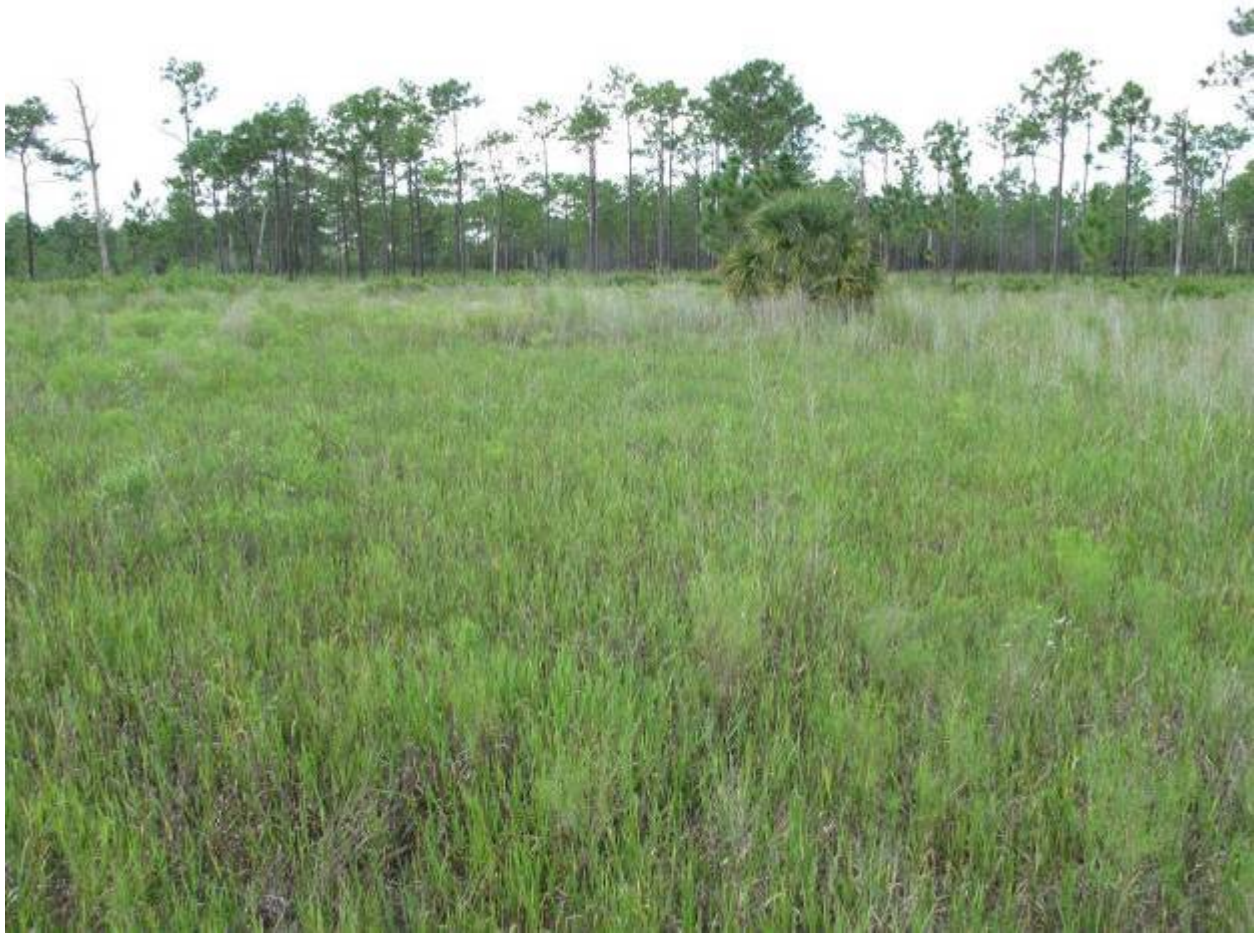
Wetland ID: 03A-02

Description: This wetland is a 0.4 ha ephemeral marsh. There is no canopy or midstory cover. Maidencane grows throughout the wetland, and covers >75% of the basin. The wetland has old feral hog damage. This wetland will connect with wetland 03A-01 during periods of high water. Due to the connectedness of these two wetlands, the ditch that drains to or from wetland 03A-01 will also affect this wetland. This wetland is in fire maintenance condition and is a potential striped newt breeding pond. The adjacent uplands are sandhill. The sandhills appear to have been fire suppressed but now are managed with prescribed fire.

Wetland Disturbance: Feral hog damage, Ditching

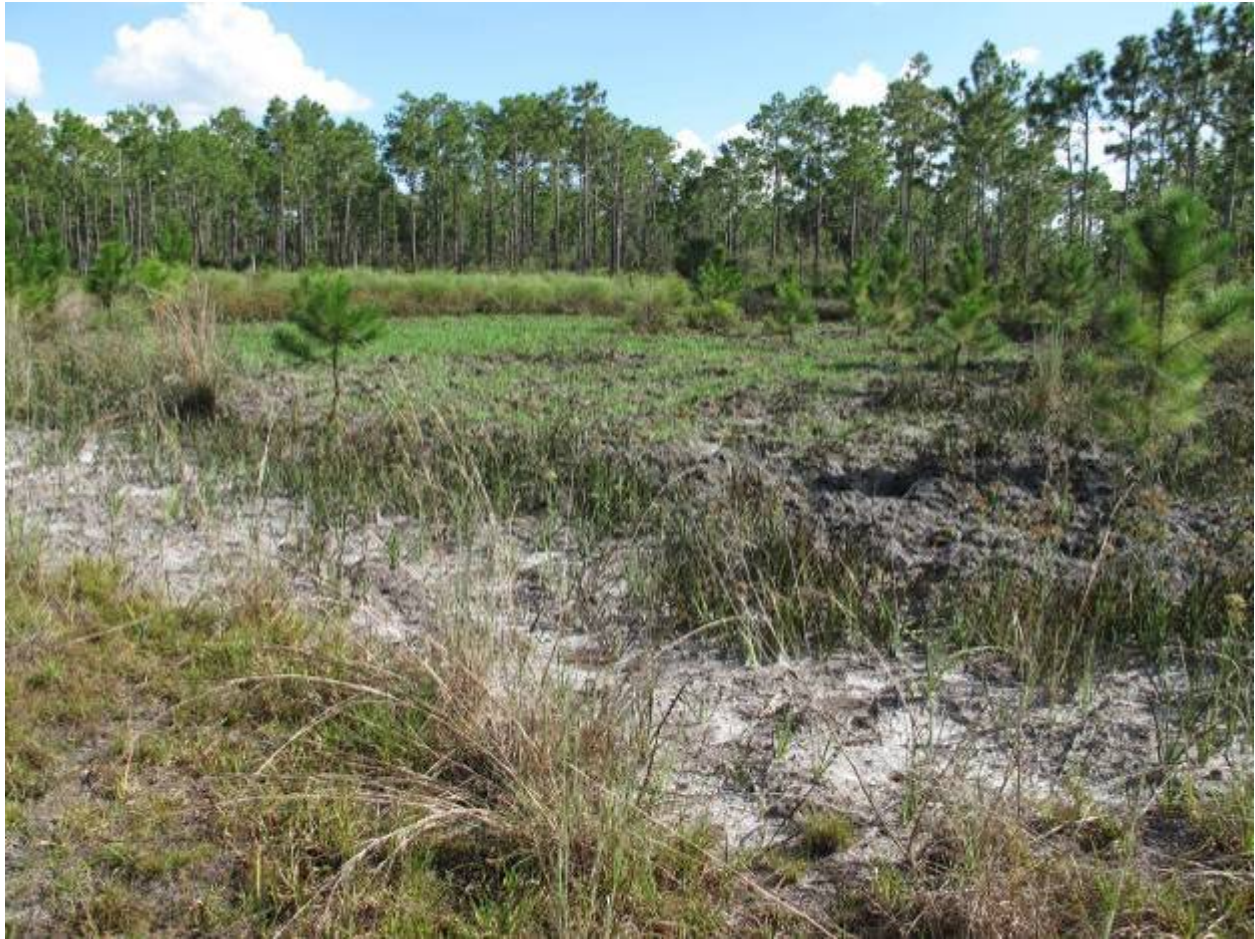
Description: This wetland is a 0.4 ha ephemeral marsh. There is no tree canopy. Small pine trees are encroaching into the wetland, and cover 5-25% of the basin. Redroot grows throughout the wetland, and covers 50-75% of the basin. Feral hogs have caused extensive damage throughout the wetland. This wetland is a potential striped newt breeding pond. The adjacent uplands are sandhill. The sandhills appear to have been fire suppressed but now are managed with prescribed fire.

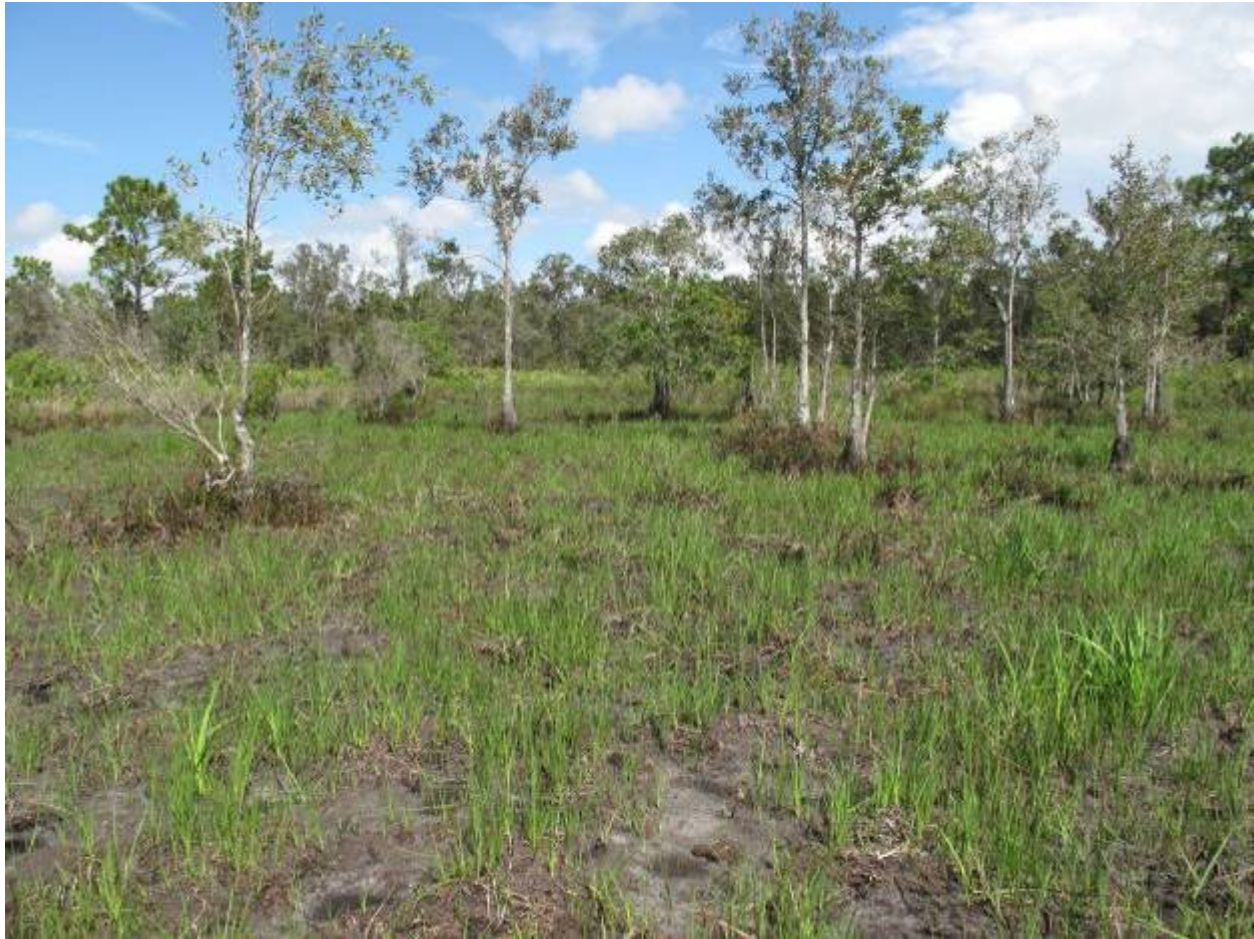
Description: This wetland is a 1.9 ha ephemeral marsh. Gum trees dominate the canopy, and cover 5-25% of the wetland basin. The midstory is dominated by wax myrtle, and covers 5-25% of the wetland basin. Redroot grows throughout the wetland, and covers 50-75% of the basin. The wetland has severe feral hog damage. The wetland provides an excellent example of a marsh encroached by trees from the adjacent swamp. This wetland is a potential striped newt breeding pond. The adjacent uplands are sandhill and currently are managed with prescribed fire and mechanical vegetation removal.

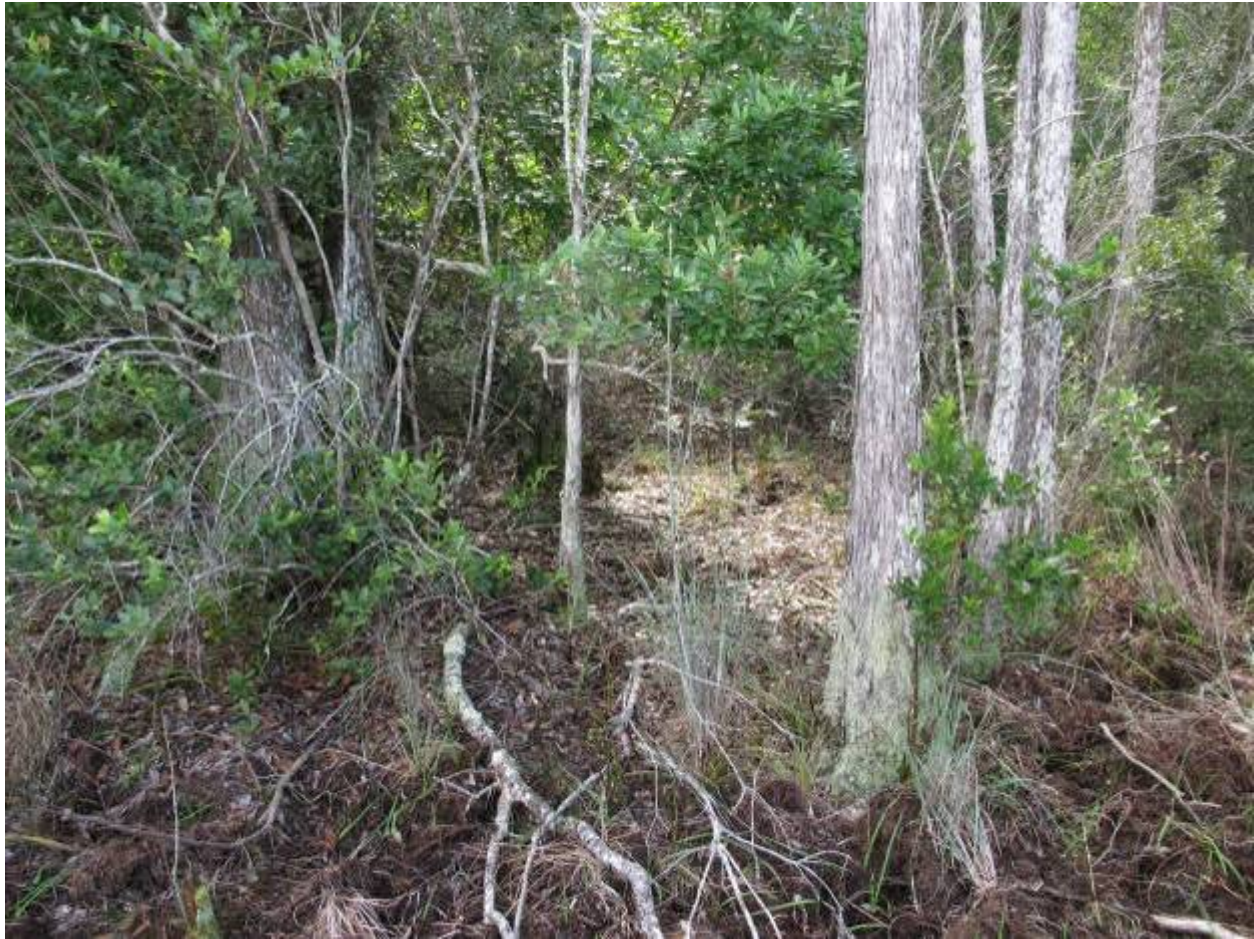
Description: This wetland is a 0.5 ha ephemeral mixed swamp. Cypress trees dominate the canopy, and cover 50-75% of the wetland basin. The midstory is dominated by wax myrtle, fetterbush, and holly, and covers 50-75% of the wetland basin. Sedges/grasses and fern grow in scattered patches, and cover 25-50% of the wetland. The wetland has both old and new feral hog damage. The adjacent uplands are sandhill and currently are managed with prescribed fire and mechanical vegetation removal.

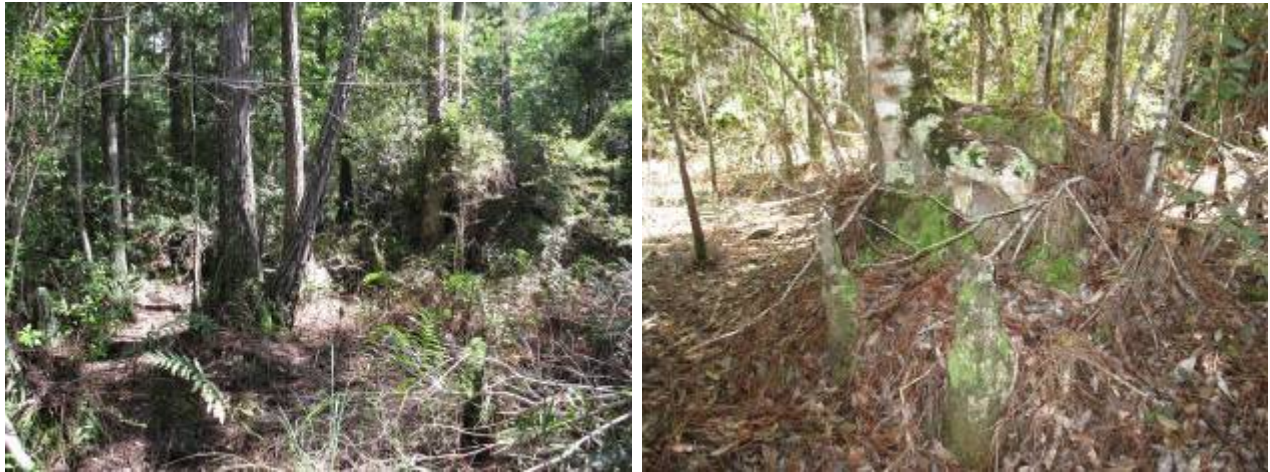
Wetland ID: 04A-03

Description: This wetland is a 0.7 ha ephemeral mixed swamp. Cypress trees dominate the canopy, and covers 50-75% of the wetland basin. The midstory is dominated by wax myrtle and holly, and covers >75% of the wetland basin. Fern grow in scattered patches, and cover 5-25% of the wetland. A thick duff layer covers the wetland floor. Old stumps provide evidence of historic logging within the wetland. The wetland has both old and new feral hog damage. The adjacent uplands are sandhill and currently are managed with prescribed fire and mechanical vegetation removal.

Wetland Disturbance: Feral hog damage, Woody encroachment

Restoration Action Recommended: Because of the widespread damage to ephemeral wetlands on CWMA, we recommend aggressive action to reduce the overall numbers of feral hogs on the property. Encourage periodic fire in the wetland to reduce the shrubs.

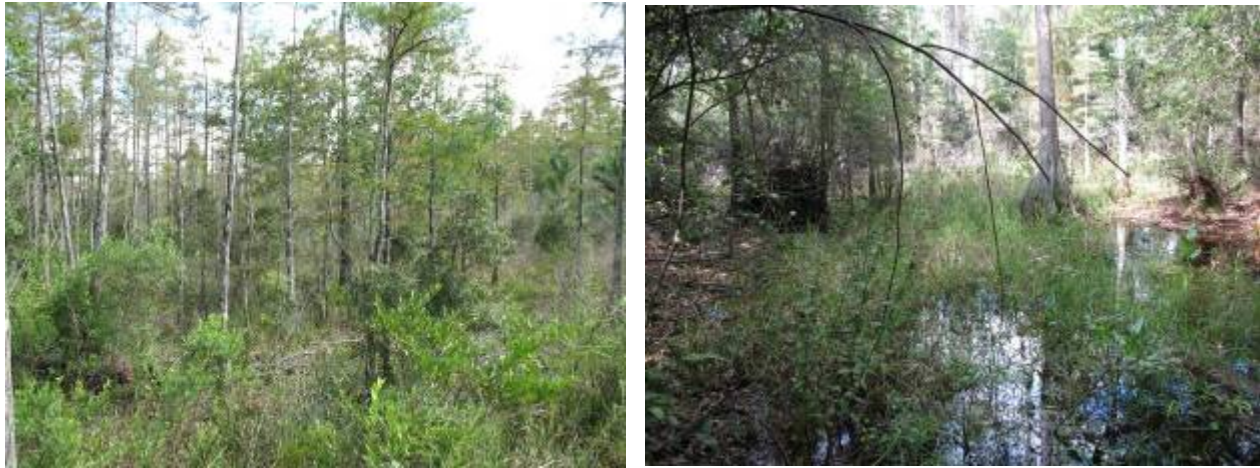
Wetland ID: 04A-04

Description: This wetland is a 2.0 ha semi-permanent mixed swamp. Cypress trees dominate the canopy, and covers 50-75% of the wetland basin. The midstory is dominated by wax myrtle, fetterbush, and holly, and covers 50-75% of the wetland basin. Sedges/grasses and maidencane grow in a ring around the wetland, and cover 25-50% of the basin. The edge of the swamp is marsh with small and widely scattered cypress trees; the center is deeper and has a denser canopy. Large stumps provide evidence of historic logging within the wetland. The wetland has both old and new feral hog damage. The adjacent uplands are sandhill and currently are managed with prescribed fire and mechanical vegetation removal.

Wetland Disturbance: Feral hog damage, Woody encroachment

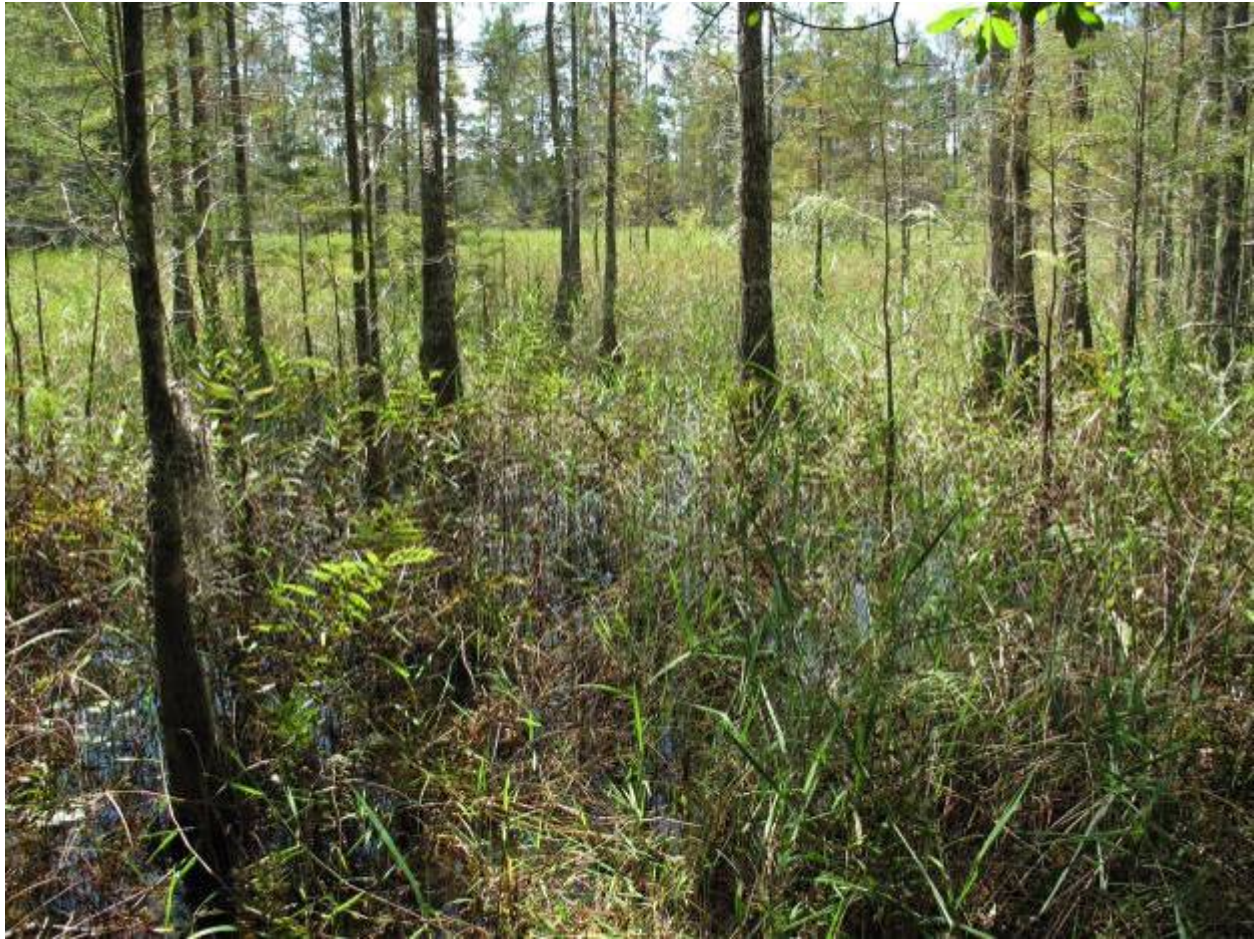
Description: This 1.5 ha semi-permanent wetland is ringed with cypress trees and shrubs, with a deeper, marsh interior. Cypress trees cover 25-50% of the wetland basin. The midstory is dominated by wax myrtle, fetterbush, and holly, and covers 25-50% of the wetland basin. Maidencane grows throughout the wetland, and covers 50-75% of the basin. Old stumps around the perimeter cypress ring provide evidence of historic logging within the wetland. Young cypress trees are colonizing the wetland center. A recent fire burned into the wetland edge. The adjacent uplands are sandhills and currently are managed with prescribed fire and mechanical vegetation removal.

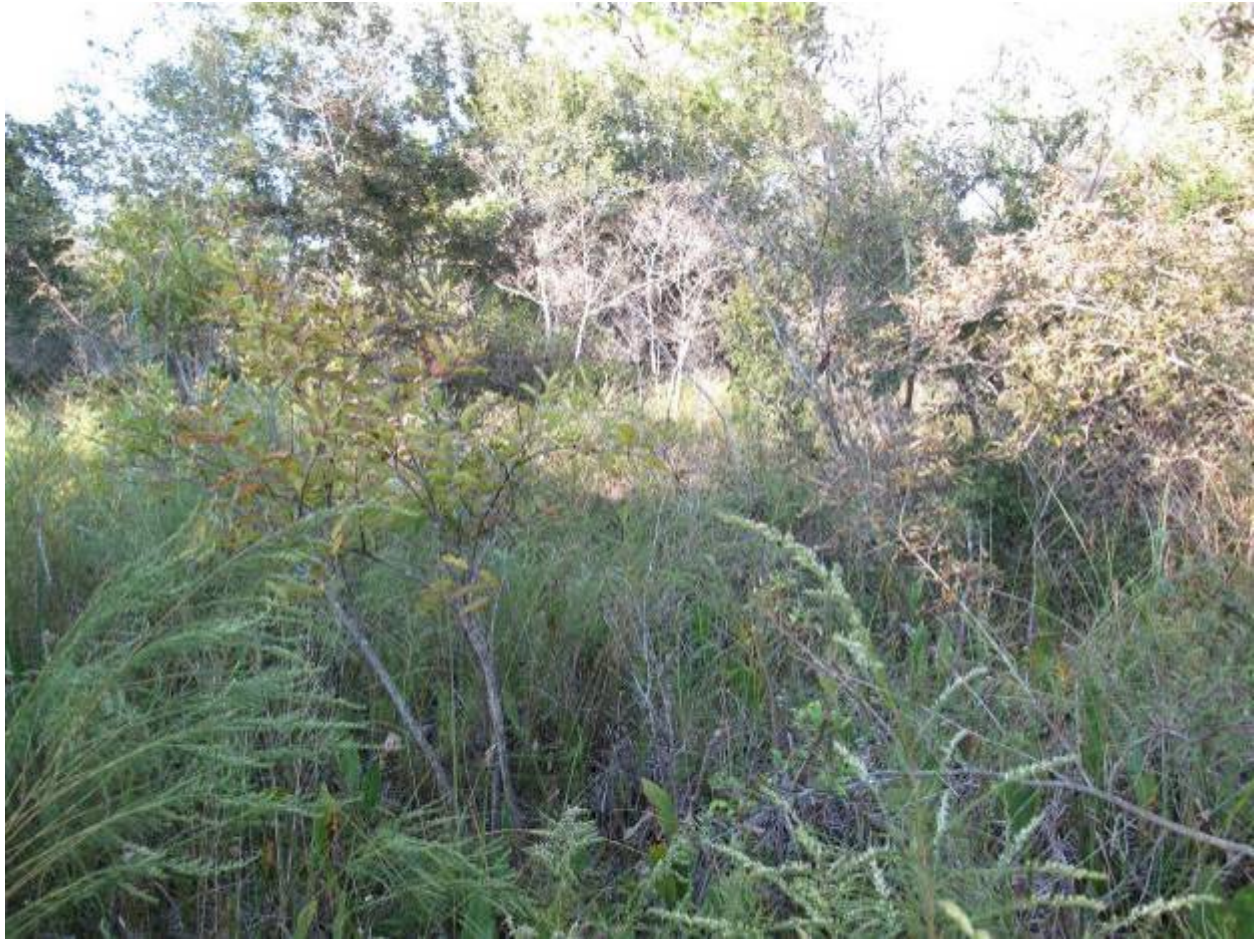
Description: This wetland is a 0.5 ha ephemeral shrub swamp. Maple trees dominate the canopy, and cover 5-25% of the wetland basin. The midstory is dominated by wax myrtle, willow, and buttonbush, and covers 50-75% of the wetland basin. Sedges/grasses, sawgrass, and emergent vegetation grow throughout the wetland, and cover >75% of the basin. This wetland was likely once a marsh but has succeeded to a shrub swamp. There is a thick duff layer. The adjacent uplands are sandhill. The sandhills appear to have been fire suppressed but now are managed with prescribed fire.

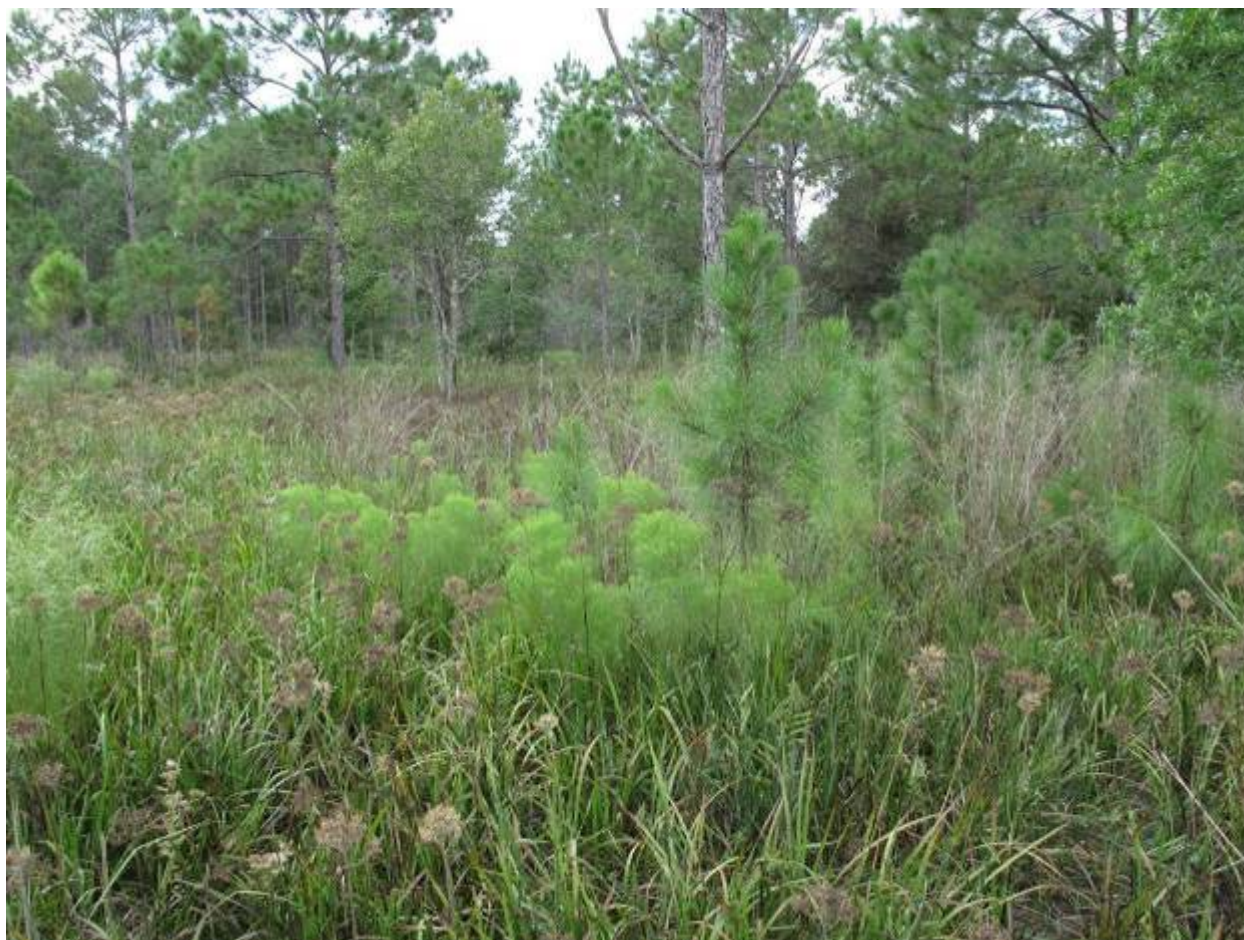
Wetland ID: 07A-02

Description: This wetland is a 0.2 ha ephemeral marsh. Pine trees dominate the canopy, and cover 5-25% of the wetland basin. The midstory is dominated by small pine trees, and covers 5-25% of the wetland basin. Fern and redroot grow throughout the wetland, and cover >75% of the basin. Some pine trees and hardwoods are encroaching into the wetland basin. The wetland has both old and new feral hog damage. This wetland is a potential striped newt breeding pond. The adjacent uplands are sandhill. The sandhills appear to have been fire suppressed but now are managed with prescribed fire.

Wetland Disturbance: Feral hog damage, Woody encroachment

Restoration Action Recommended: Because of the widespread damage to ephemeral wetlands on CWMA, we recommend aggressive action to reduce the overall numbers of feral hogs on the property. If the next fire or inundation does not kill the encroaching small pine trees, they should be removed from the wetland.

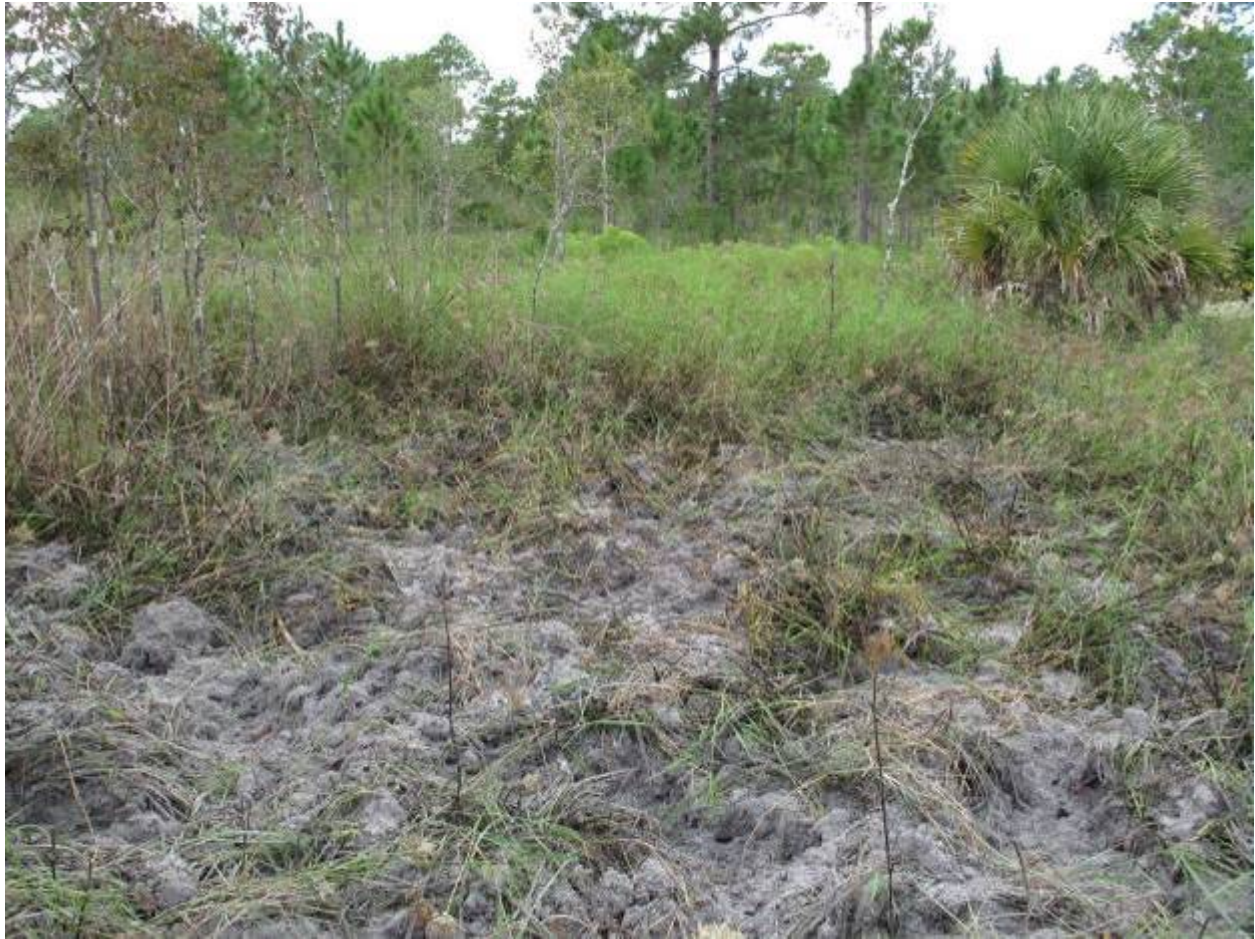
Description: This wetland is a 0.4 ha ephemeral marsh. There is no tree canopy. Small pine trees are encroaching into the wetland, and cover 5-25% of the basin. Maidencane and redroot grow throughout the wetland, and cover >75% of the basin. The wetland has new feral hog damage. This wetland is a potential striped newt breeding pond. The adjacent uplands are sandhill. The sandhills appear to have been fire suppressed but now are managed with prescribed fire.

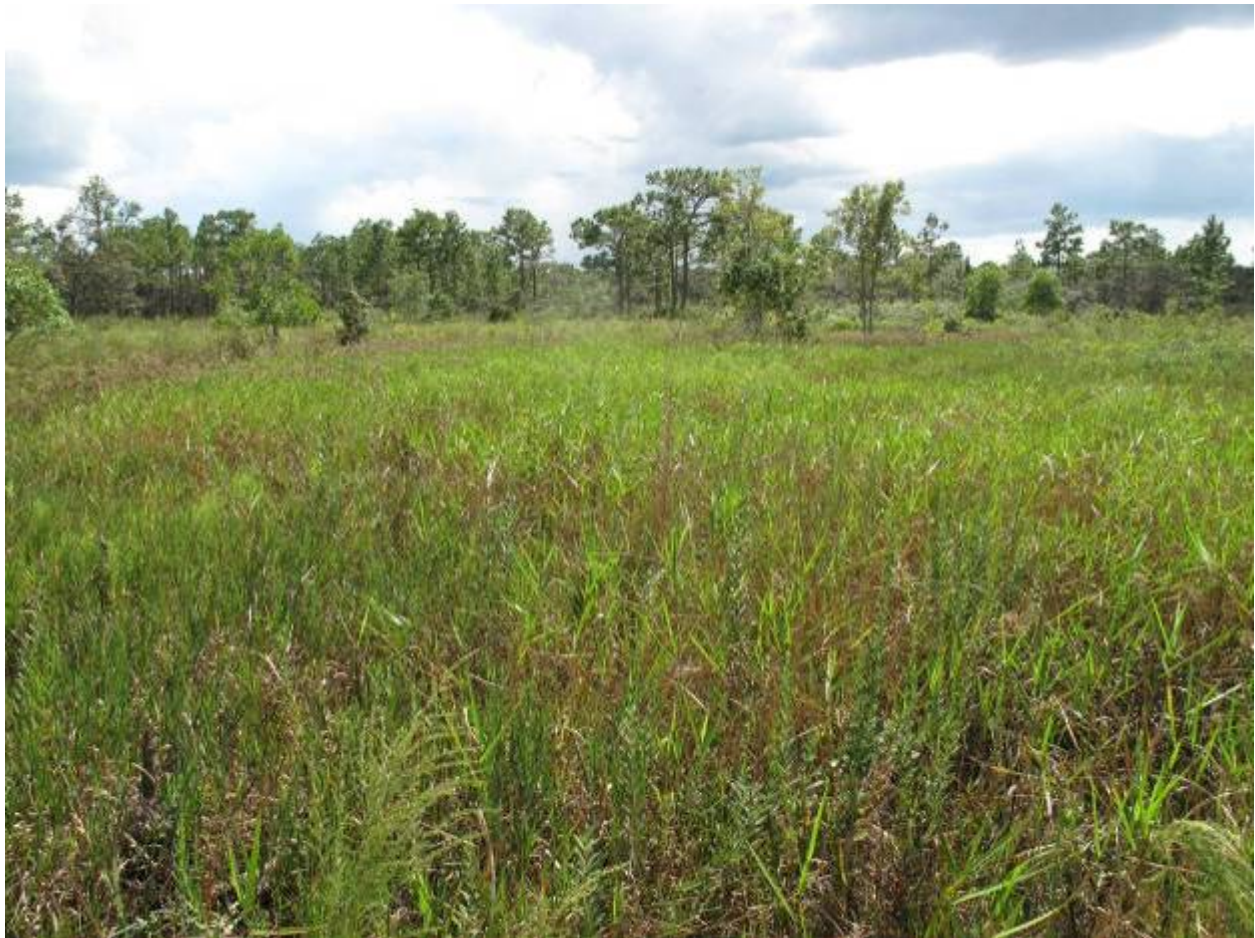
Wetland ID: 07A-04

Description: This wetland is a 1.1 ha ephemeral marsh. There is no canopy or midstory cover. Maidencane grows throughout the wetland, and covers >75% of the basin. The wetland has old feral hog damage. This wetland is in fire maintenance condition and is a potential striped newt breeding pond. The adjacent uplands are sandhill. The sandhills appear to have been fire suppressed but now are managed with prescribed fire.

Wetland Disturbance: Feral hog damage

Restoration Action Recommended: Because of the widespread damage to ephemeral wetlands on CWMA, we recommend aggressive action to reduce the overall numbers of feral hogs on the property.

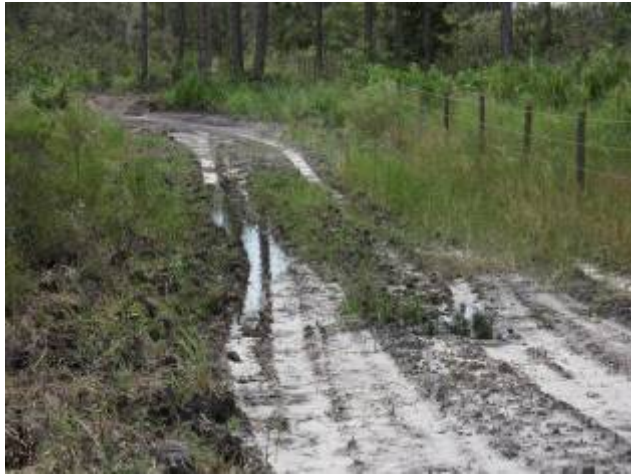
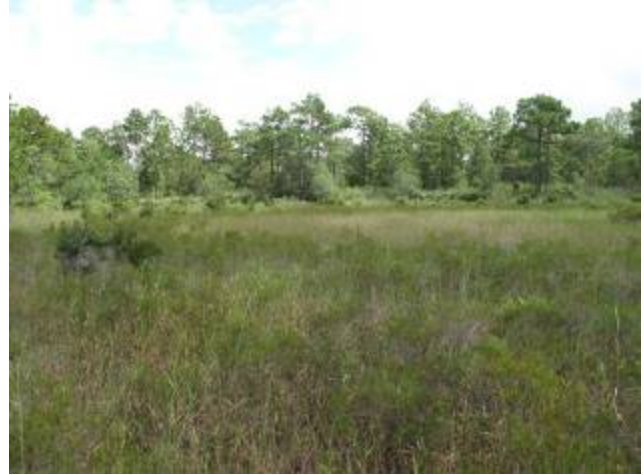
Wetland ID: 08A-01

Description: This wetland is a 0.8 ha ephemeral marsh with a deep center. There is no tree canopy. Wax myrtle are encroaching into the wetland, and cover 5-25% of the basin. Maidencane grows throughout the wetland, and covers >75% of the basin. A fireline/property boundary bisects the western wetland edge. Approximately 10% of this wetland is privately owned. This wetland is a potential striped newt breeding pond. The adjacent uplands are sandhill and are managed with mechanical treatments.

Wetland Disturbance: Fireline, Woody encroachment

Restoration Action Recommended: Because the fireline represents a private property boundary, it is unlikely that fireline can be moved. Maintain the fireline when the wetland is dry to prevent establishment of ruts. Encourage periodic fire in the wetland to prevent further encroachment of woody vegetation

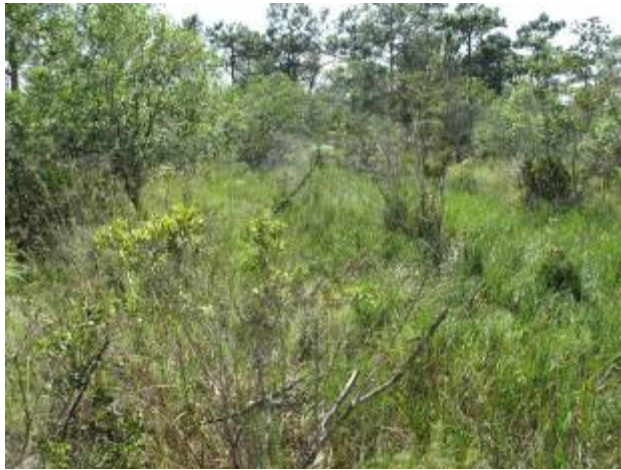
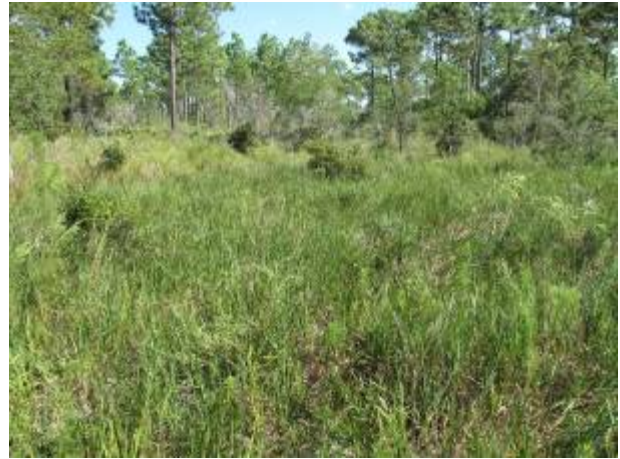
Wetland ID: 08A-02

Description: This wetland is a 0.2 ha ephemeral marsh. Holly trees dominate the canopy, and cover 5-25% of the wetland basin. The midstory is dominated by wax myrtle and holly, and covers 5-25% of the wetland. Maidencane grows throughout the wetland, and covers >75% of the basin. A few trees and some shrubs are encroaching into the wetland basin. The wetland has relatively light feral hog damage. This wetland is a potential striped newt breeding pond. The adjacent sandhills appear to be fire-suppressed and currently are managed with mechanical treatments.

Wetland Disturbance: Feral hog damage, Woody encroachment

Restoration Action Recommended: Because of the widespread damage to ephemeral wetlands on CWMA, we recommend aggressive action to reduce the overall numbers of feral hogs on the property. Encourage periodic fire in the wetland to prevent further encroachment of woody vegetation.

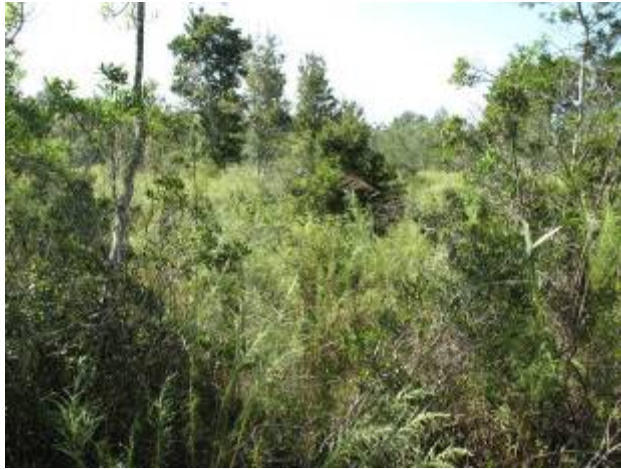
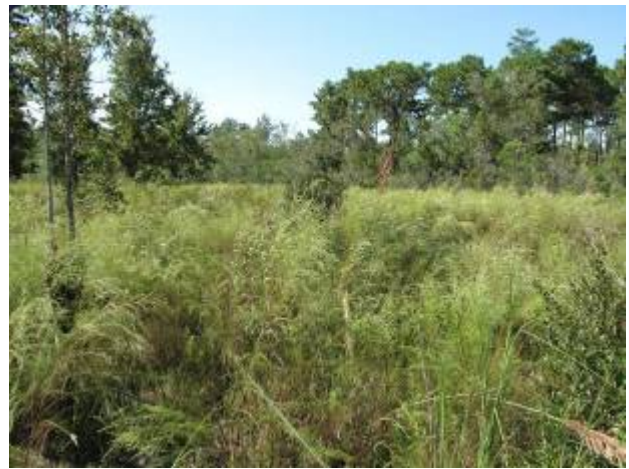
Wetland ID: 08A-03

Description: This wetland is a 0.7 ha ephemeral marsh. Maple trees dominate the canopy, and cover 5-25% of the wetland basin. The midstory is dominated by wax myrtle, holly, dog fennel, and small bay and maple trees, and covers 50-75% of the wetland. Maidencane, sedges/grasses, and emergent vegetation grow throughout the wetland, and cover >75% of the basin. A dense brush ring surrounds the wetland and a stand of maples grow in the wetland center. The wetland has severe feral hog damage. This wetland is a potential striped newt breeding pond but is in danger of succeeding to a shrub swamp. The adjacent sandhills appear to be fire-suppressed and currently are managed with mechanical treatments.

Wetland Disturbance: Feral hog damage, Woody encroachment

Restoration Action Recommended: Because of the widespread damage to ephemeral wetlands on CWMA, we recommend aggressive action to reduce the overall numbers of feral hogs on the property. Remove large maple trees from the wetland interior. Encourage periodic fire in the wetland. Monitor this wetland to ensure encroaching woody vegetation is eliminated with the next fire or inundation. If they become established, the encroaching vegetation will need to be removed from the wetland.

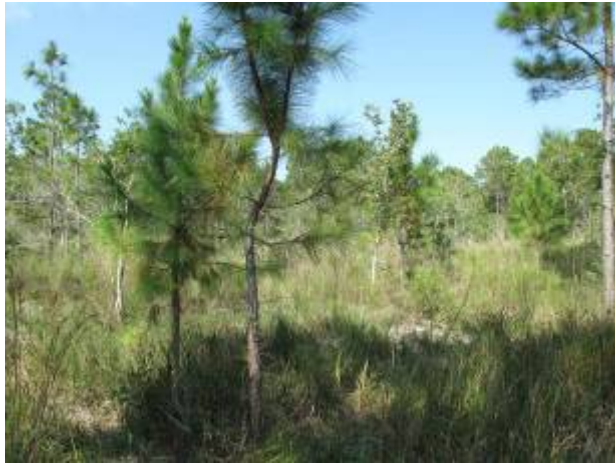
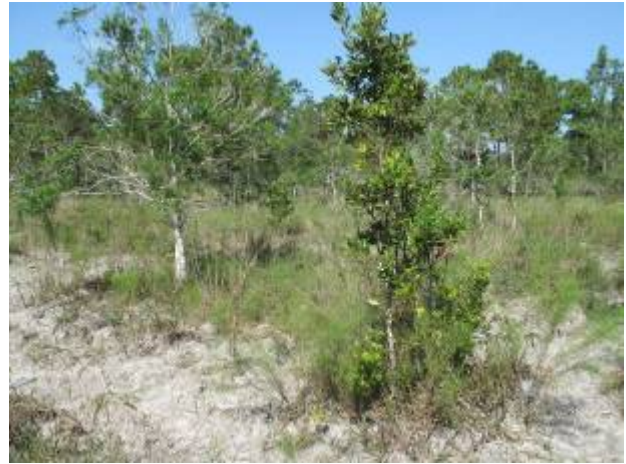
Wetland ID: 08A-04

Description: This wetland is a 0.6 ha ephemeral marsh. There is no tree canopy. Wax myrtle, holly, small pine trees, and dog fennel are encroaching into the wetland, and 25-50% of the wetland. Maidencane and sedges/grasses grow throughout the wetland, and cover >75% of the basin. There is severe and deep feral hog damage in the wetland. This marsh likely connects with wetland 03A-02 during periods of high water. This wetland is a potential striped newt breeding pond. The adjacent sandhills appear to be fire-suppressed and currently are managed with mechanical treatments.

Wetland Disturbance: Feral hog damage, Woody encroachment

Restoration Action Recommended: Because of the widespread damage to ephemeral wetlands on CWMA, we recommend aggressive action to reduce the overall numbers of feral hogs on the property. Encourage periodic fire in the wetland. Monitor this wetland to ensure encroaching woody vegetation is eliminated with the next fire or inundation. If they become established, the encroaching vegetation will need to be removed from the wetland.

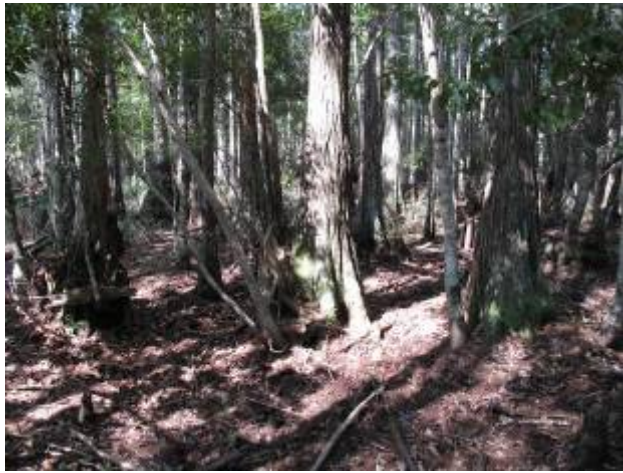
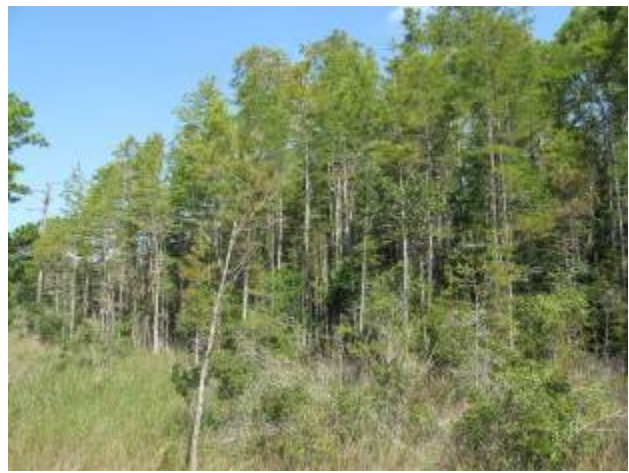
Wetland ID: 08A-05

Description: This wetland is a 1.1 ha ephemeral mixed swamp. Cypress trees dominate the canopy, and cover 50-75% of the wetland basin. The midstory is dominated by wax myrtle, holly, and fetterbush, and covers 50-75% of the wetland. Maidencane, sedges/grasses, and sawgrass grow in scattered patches, covering 25-50% of the wetland. The wetland has a forested center with a more open, marsh-like perimeter. The interior of the wetland has a thick layer of duff. Old stumps provide evidence of historic logging. The wetland has minor feral hog damage. This wetland will connect to a larger swamp strand system on the south side in times of high water. The adjacent sandhills appear to be fire-suppressed and currently are managed with mechanical treatments.

Wetland Disturbance: Feral hog damage, Woody encroachment
