Inventory, Assessment, and Restoration Potential of Ephemeral Wetlands on FFWCC Wildlife Management Areas

Chassahowitzka WMA Final Report

Submitted by: Rebecca P.M. Means¹, Ryan C. Means¹, Steven A. Johnson²

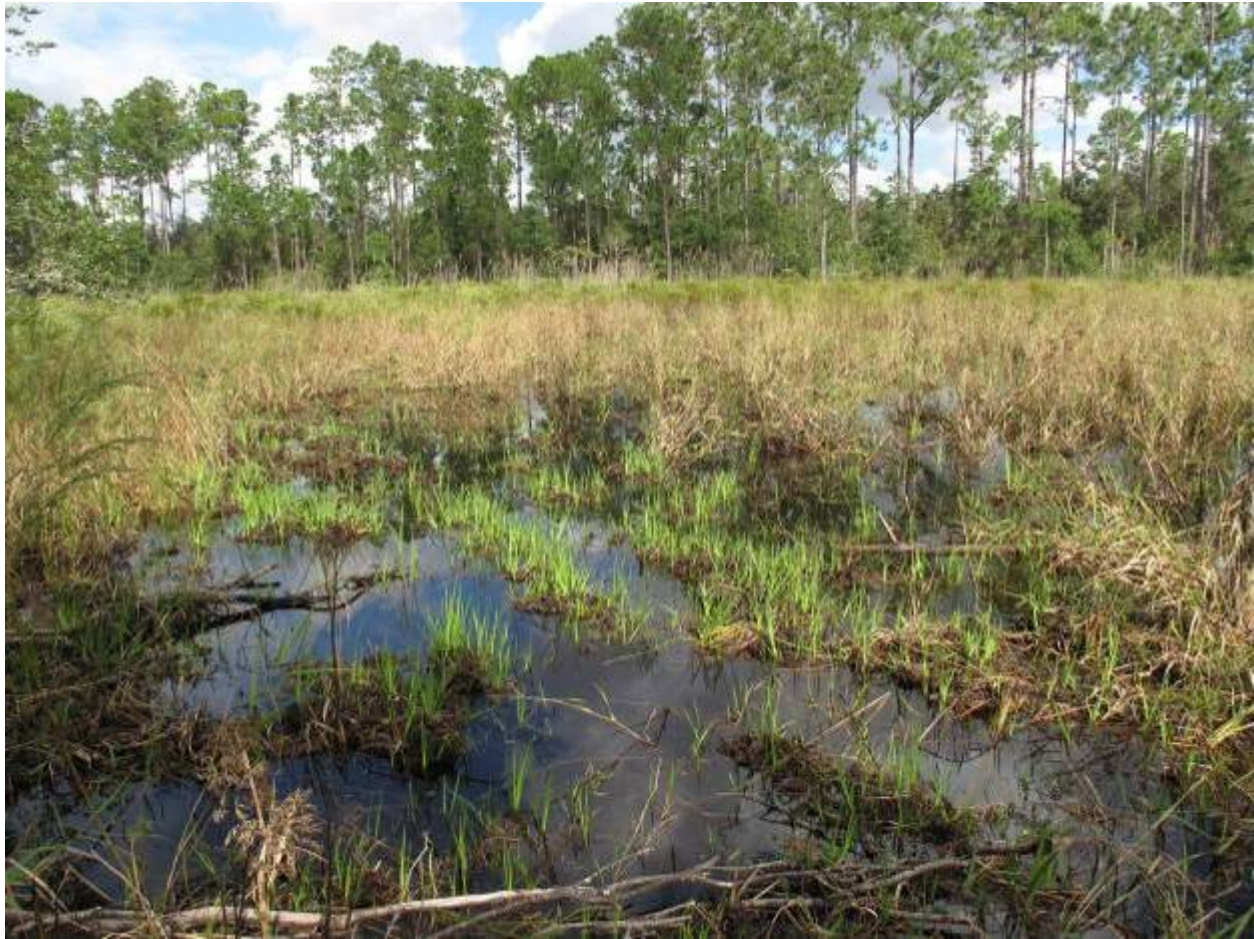
Description: This wetland is a 0.9 ha ephemeral marsh. Pine trees grow in a dense ring around the wetland, and cover 5-25% of the basin. The midstory is dominated by wax myrtle and holly, and covers 5-25% of the wetland. Maidencane and redroot grow throughout the wetland, and cover >75% of the basin. The wetland has extensive feral hog damage. This wetland is a potential striped newt breeding pond. The adjacent sandhills appear to be fire-suppressed and currently are managed with mechanical treatments.

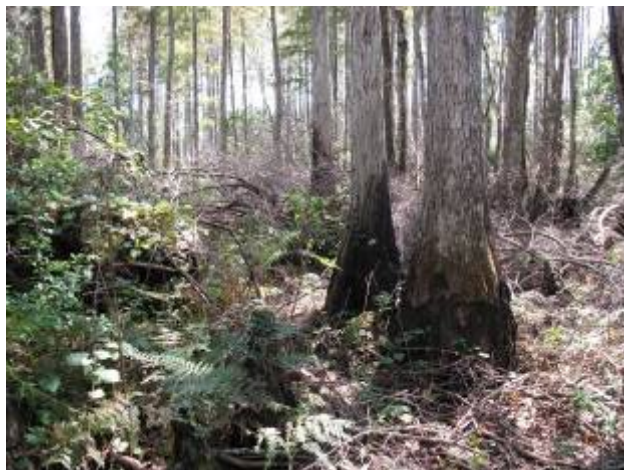
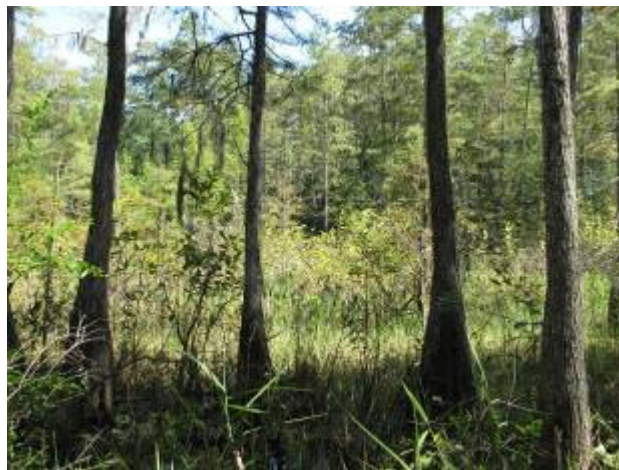
Wetland ID: 09A-02

Description: This wetland is a 2.4 ha semi-permanent forested swamp. Cypress trees dominate the canopy, and cover 50-75% of the wetland basin. The midstory is dominated by wax myrtle, buttonbush, fetterbush, and holly, and covers 25-50% of the wetland. Maidencane, sedges/grasses, and emergent vegetation grow in scattered patches, and cover 25-50% of the wetland. The wetland has a deeper and more marsh-like interior. Old stumps provide evidence of historic logging within the wetland. The wetland has both new and old feral hog damage. This wetland is in fire maintenance condition. The adjacent uplands are mesic flatwoods and sandhills, a portion of which is a pine plantation. The uplands appear to be fire-suppressed and currently are managed with mechanical treatments.

Wetland Disturbance: Feral hog damage

Restoration Action Recommended: Because of the widespread damage to ephemeral wetlands on CWMA, we recommend aggressive action to reduce the overall numbers of feral hogs on the property.

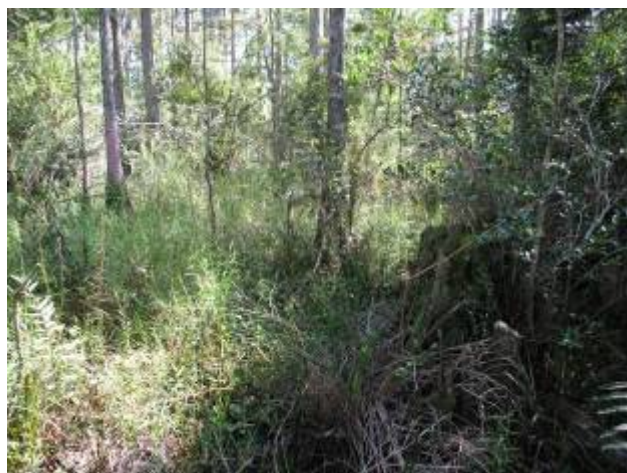
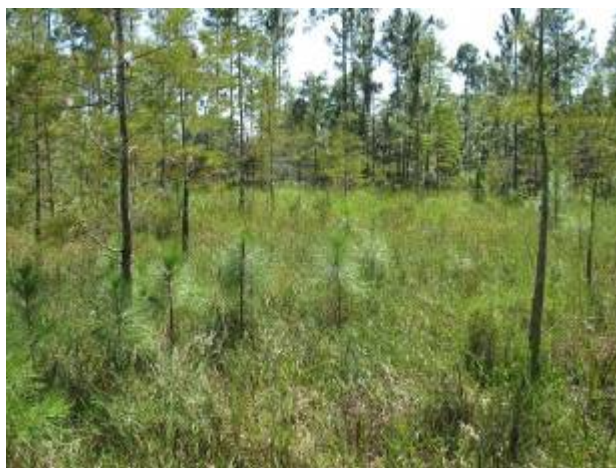
Wetland ID: 09A-03

Description: This wetland is a 1.2 ha ephemeral mixed swamp. Cypress trees dominate the canopy, and cover 50-75% of the wetland basin. The midstory is dominated by wax myrtle and holly, and covers 50-75% of the wetland. Maidencane and sedges/grasses grow throughout, covering 50-75% of the wetland. This wetland is primarily a mixed swamp with young cypress trees and a marsh-like section on the western side. Old stumps in the wetland's center provide evidence of historic logging within the wetland. The wetland has both new and old feral hog damage. The adjacent uplands are sandhills that were planted into a pine plantation. The uplands appear to be fire-suppressed and currently are managed with mechanical treatments.

Wetland Disturbance: Feral hog damage, Woody encroachment

Restoration Action Recommended: Because of the widespread damage to ephemeral wetlands on CWMA, we recommend aggressive action to reduce the overall numbers of feral hogs on the property. Remove the planted and encroaching pine trees from the wetland interior.

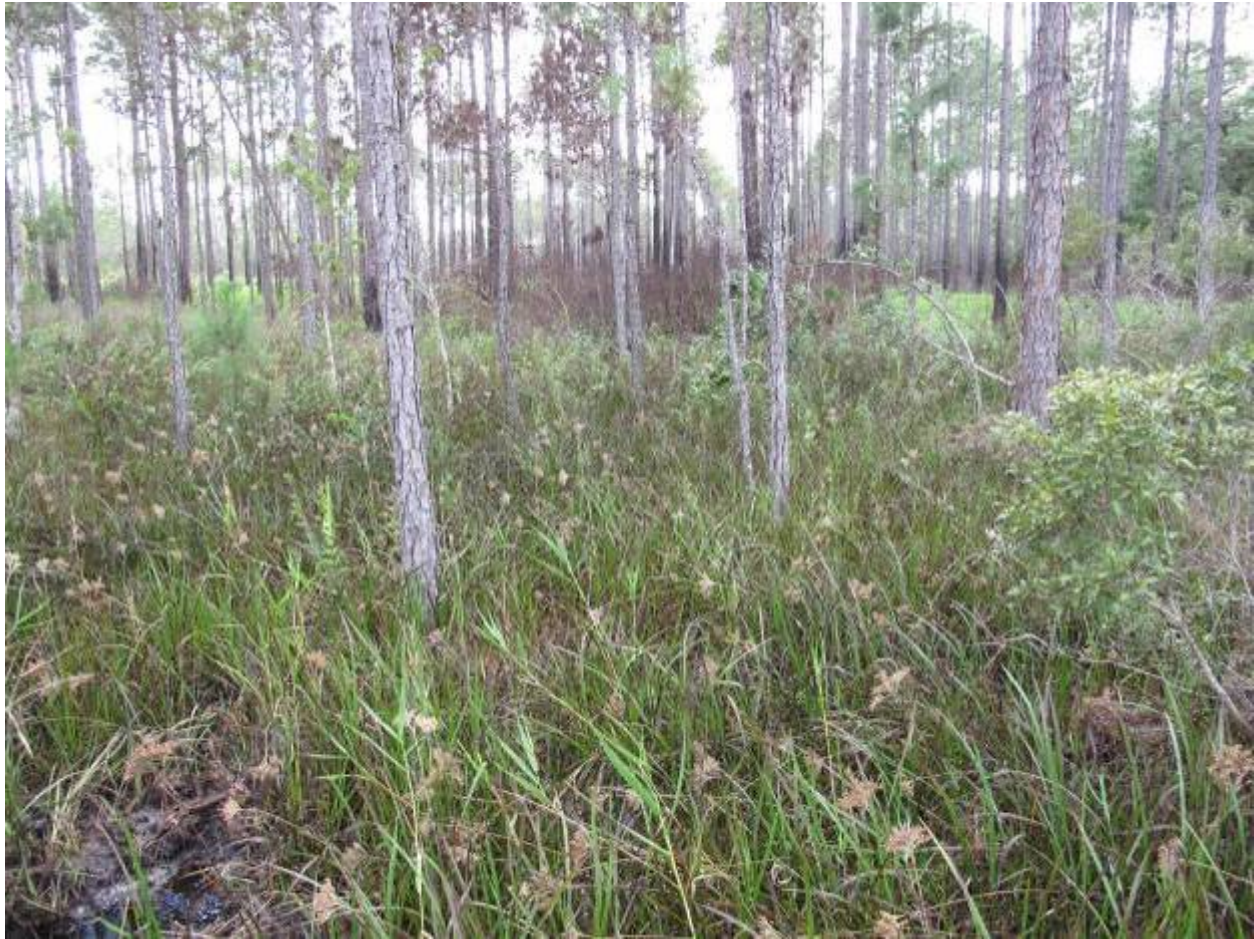
Description: This wetland is a 0.1 ha ephemeral marsh. Slash pine trees were planted through the wetland and also are encroaching from the edges. The tree canopy covers 25-50% of the wetland basin. The midstory is dominated by wax myrtle, holly, and young maples, and covers 5-25% of the wetland. Redroot grows throughout, covering >75% of the wetland. The wetland has extensive, but recovering, feral hog damage. A recent fire burned into the edge of the wetland. The adjacent uplands are mesic flatwoods that were converted to a pine plantation. The uplands have been thinned and burned to restore them to a more open flatwoods community.

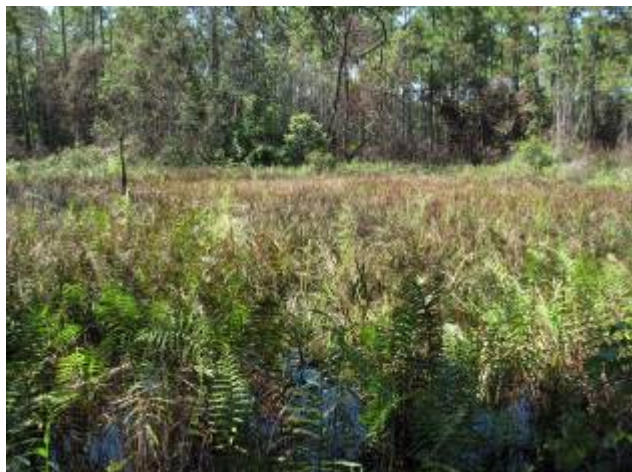
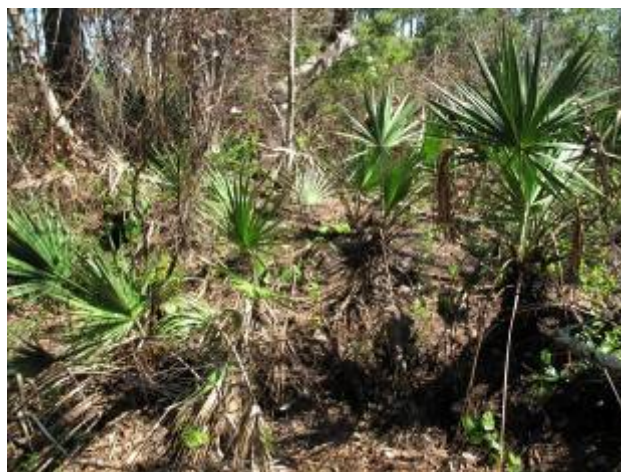
Wetland ID: 10A-02

Description: This wetland is a 0.2 ha semi-permanent marsh. There is no tree canopy. Wax myrtle, fetterbush, and loblolly bay grow in a ring around the wetland, and cover 5-25% of the wetland basin. Sedges/grasses, fern, and redroot grow throughout the wetland, and cover >75% of the basin. An almost 1m tall berm nearly surrounds the wetland. A recent fire killed some of the shrubs around the wetland. The wetland has old feral hog damage that is recovering well. The adjacent uplands are mesic flatwoods that were converted to a pine plantation. The uplands have been thinned and burned to restore them to a more open flatwoods community.

Wetland Disturbance: Berm, Feral hog damage, Woody encroachment

Restoration Action Recommended: Remove the berm and simultaneously thin the dense brush ring. Continue to encourage fire in the wetland basin to prevent encroachment of woody vegetation. Because of the widespread damage to ephemeral wetlands on CWMA, we recommend aggressive action to reduce the overall numbers of feral hogs on the property.

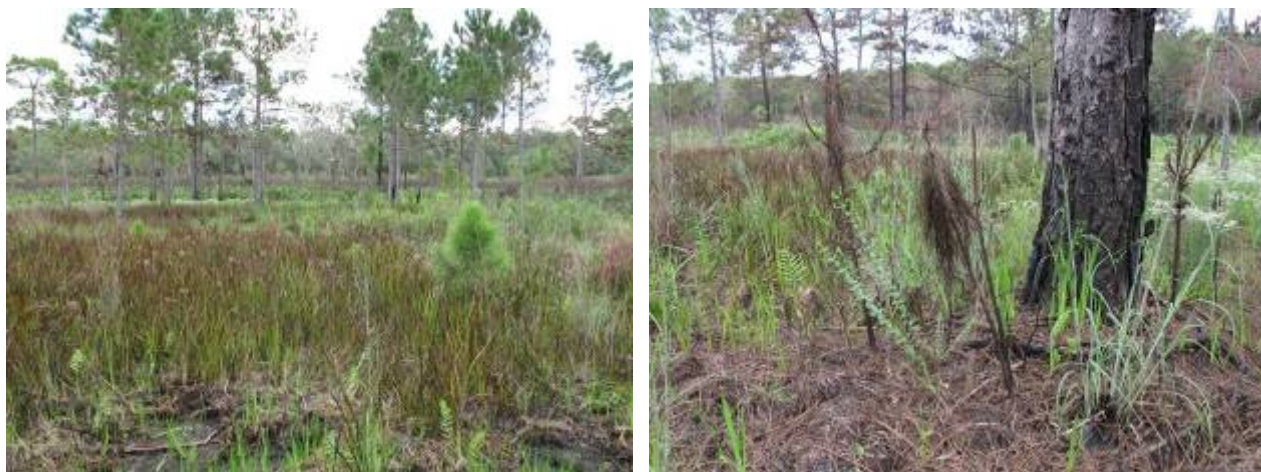
Wetland ID: 12A-01

Description: This wetland is a 0.2 ha ephemeral marsh. Slash pine trees cover 5-25% of the wetland basin. There is no midstory cover. Redroot grows throughout the wetland, and covers >75% of the basin. A recent fire killed the smaller pine trees that had encroached into the wetland basin; larger pine trees still remain. The wetland has severe feral hog damage. The adjacent uplands are sandhill. The sandhills appear to have been fire suppressed but now are managed with prescribed fire.

Wetland Disturbance: Feral hog damage, Woody encroachment

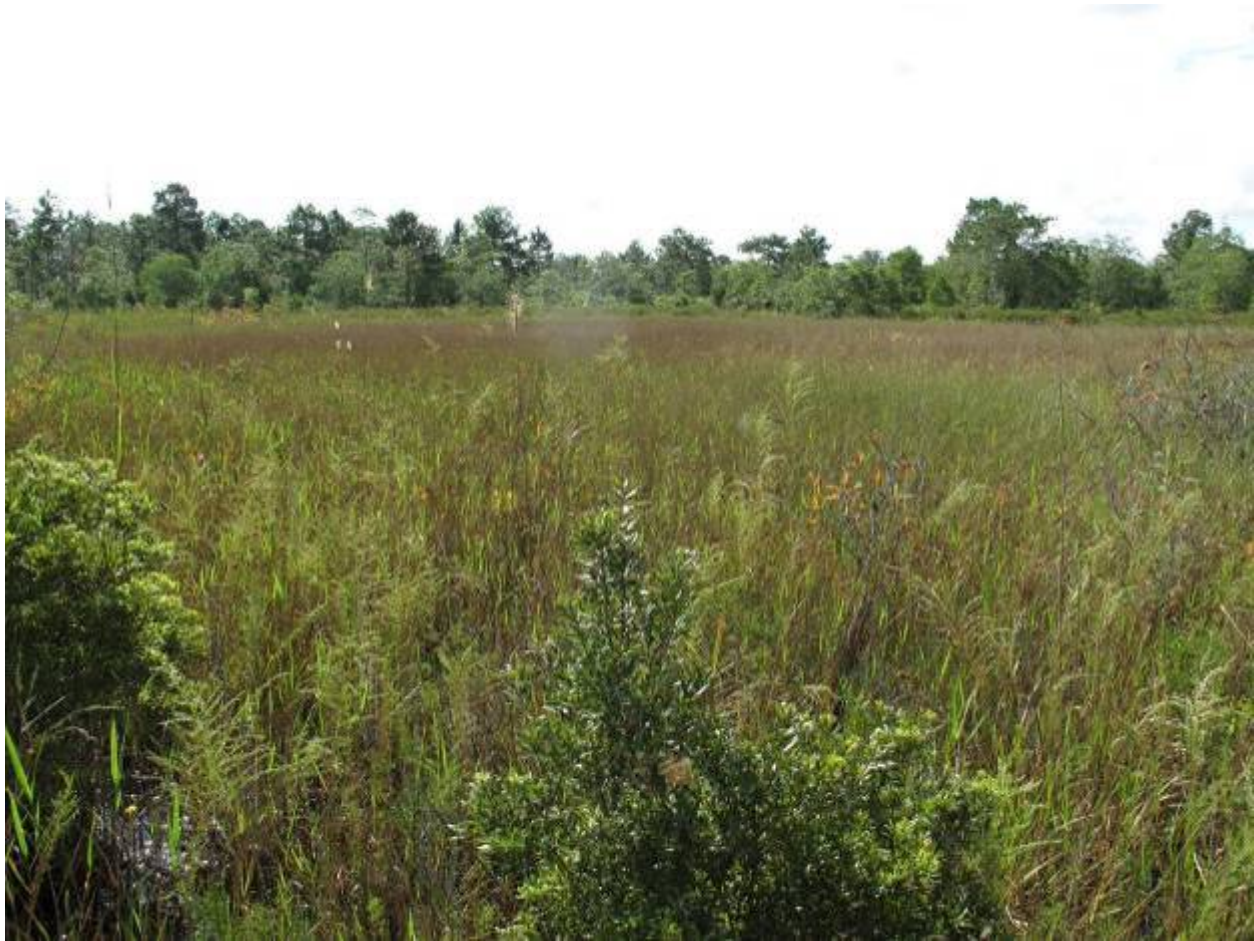
Description: This wetland is a 1.0 ha ephemeral marsh. There is no tree canopy. Wax myrtle, buttonbush, and *Hypericum* grow in a ring around the wetland, and cover 5-25% of the basin. A diverse array of maidencane and sedges/grasses grow throughout the wetland, and cover >75% of the basin. The wetland has minor feral hog damage. A ditch enters the wetland on the north side and exits on the south side. This wetland is a potential striped newt breeding pond. The adjacent uplands are sandhill. The sandhills appear to have been fire suppressed but now are managed with prescribed fire.

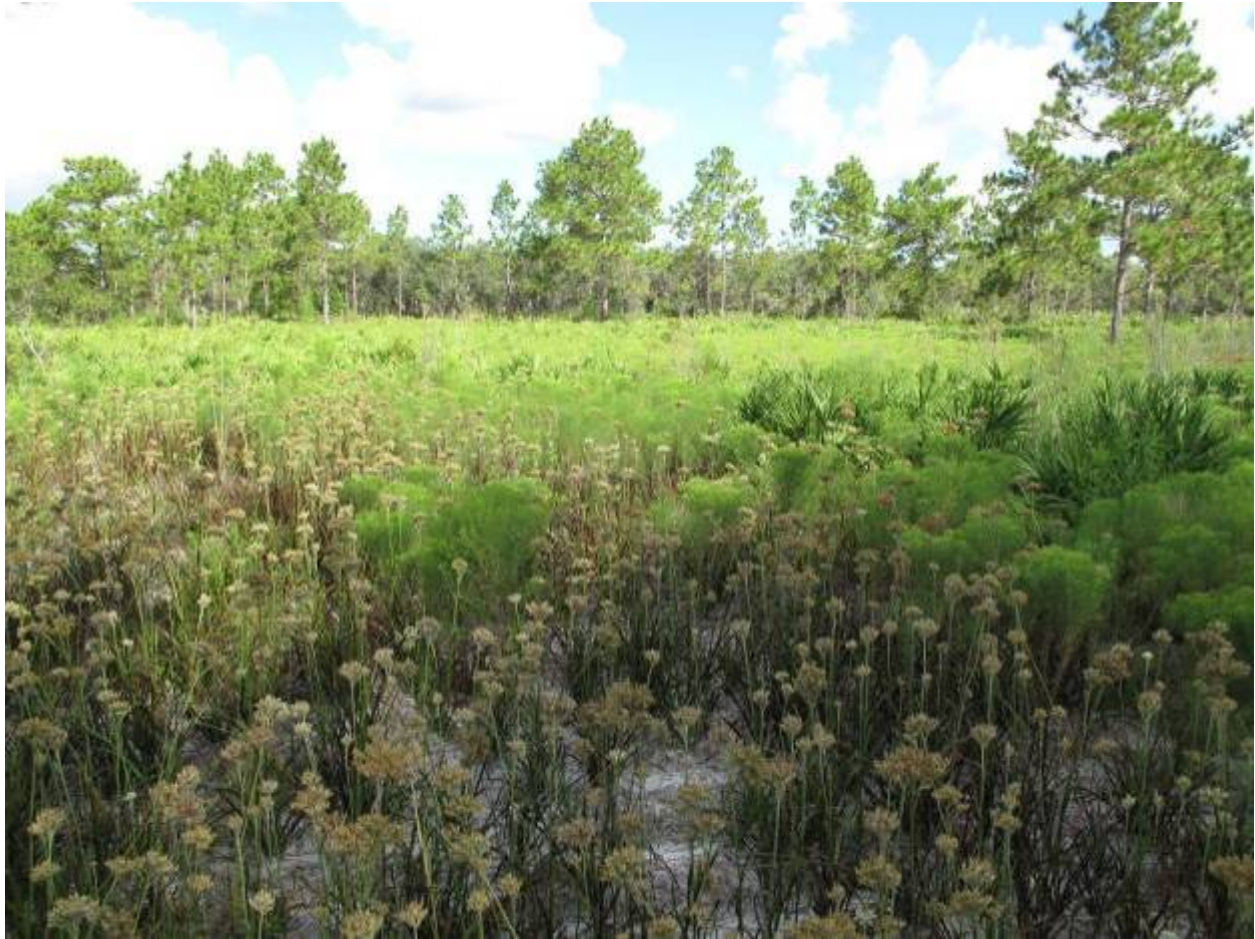
Description: This wetland is a 0.2 ha highly ephemeral marsh. There is no tree canopy. Dog fennel covers 25-50% of the wetland. Saw palmetto grows on the higher islands within the wetland basin. Redroot grows throughout the wetland, and covers >75% of the basin. The wetland has severe hog damage; the hog rootings now are growing with herbaceous vegetation. The adjacent uplands are mesic flatwoods. The uplands appear to have been fire suppressed but now are receiving prescribed fire.

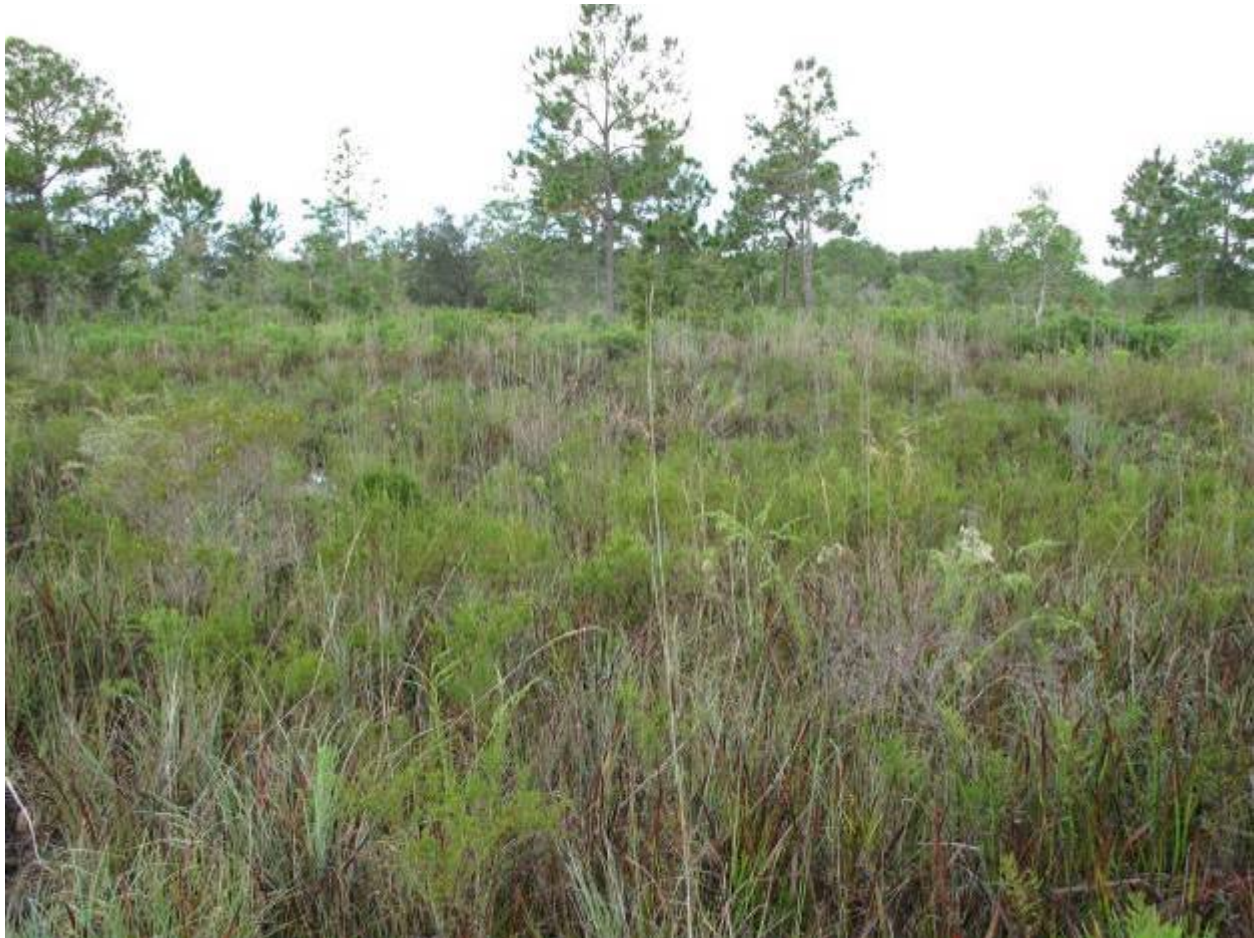
Wetland ID: 14A-03

Description: This wetland is a 0.2 ha ephemeral marsh. There is no tree canopy. *Hypericum* covers 5-25% of the wetland. Sedges/grasses grow throughout the wetland, and cover >75% of the basin. This wetland has severe feral hog damage. The adjacent uplands are mesic flatwoods. The uplands appear to have been fire suppressed but now are receiving prescribed fire.

Wetland Disturbance: Feral hog damage

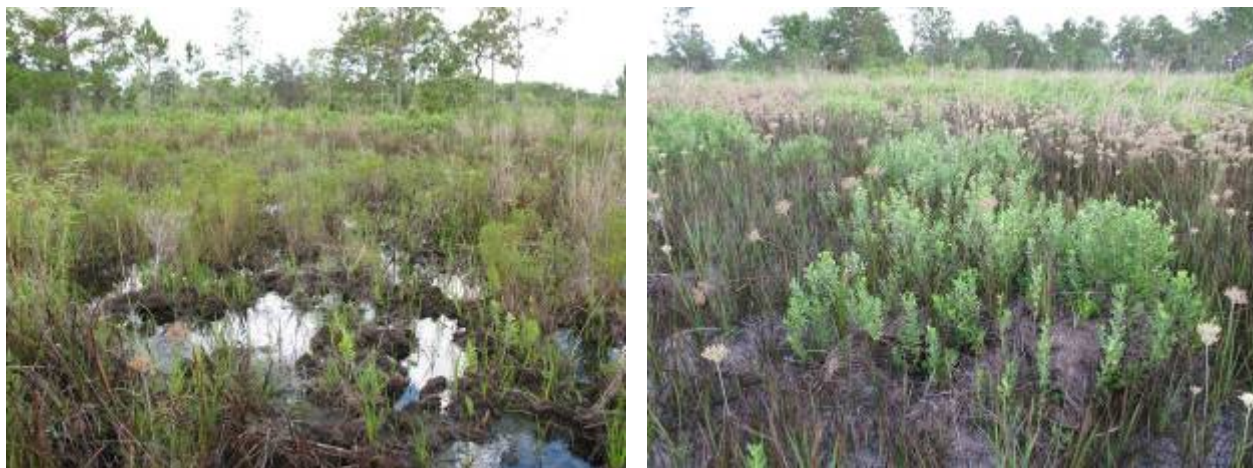
Wetland ID: 14A-04

Description: This wetland is a 0.4 ha ephemeral marsh. There is no tree canopy. Gallberry covers 25-50% of the wetland. Sedges/grasses and redroot grow throughout the wetland, and cover 50-75% of the basin. The wetland has severe feral hog damage. The hogs have altered the wetland topography, creating small hills and valleys in an otherwise relatively flat basin. Gallberry clumps have established on the tops of these hillocks. This marsh provides a good example of how feral hogs can alter plant communities in a wetland. The adjacent uplands are mesic flatwoods and sandhills. The uplands appear to have been fire suppressed but now are receiving prescribed fire.

Wetland Disturbance: Feral hog damage, Woody encroachment

Restoration Action Recommended: Because of the widespread damage to ephemeral wetlands on CWMA, we recommend aggressive action to reduce the overall numbers of feral hogs on the property. Mechanically re-sculpt this wetland basin, and simultaneously remove the gallberry, when the wetland is completely dry. The goal is to restore the original topography of the wetland and reduce the potential for upland plants to become established in the wetland basin.

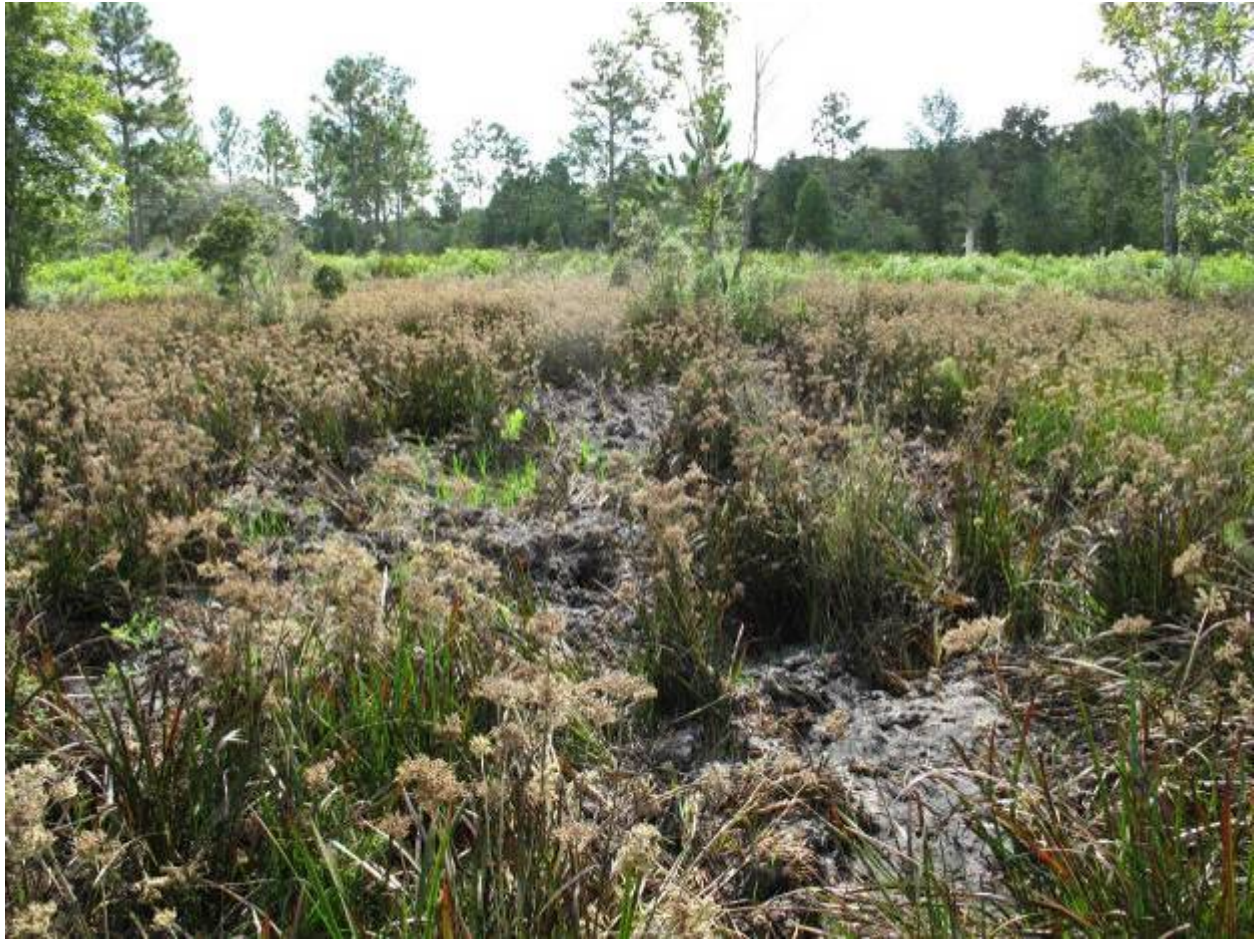
Description: This wetland is a 0.2 ha ephemeral marsh. Maple trees dominate the canopy, and cover 5-25% of the wetland basin. The midstory is dominated by wax myrtle and holly, and covers 5-25% of the wetland. Redroot grows throughout, covering >75% of the wetland. The wetland has severe hog damage. The adjacent uplands are sandhills. The uplands appear to have been fire suppressed but now are receiving prescribed fire.

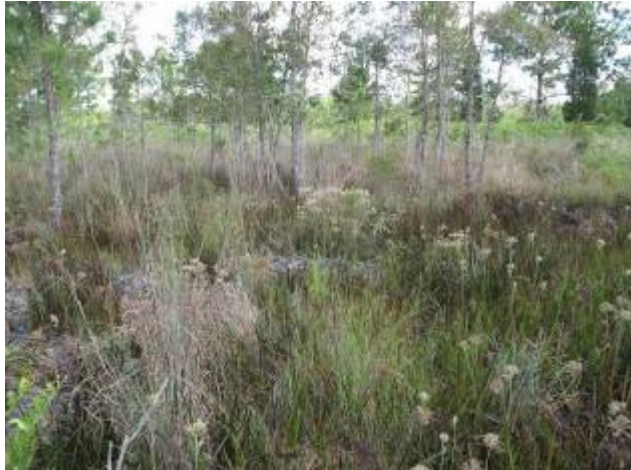
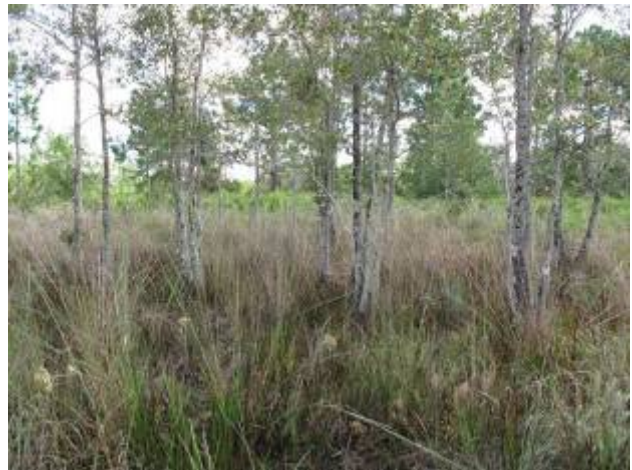
Wetland ID: 14A-06

Description: This wetland is a 0.1 ha ephemeral marsh. Gum trees are encroaching into the marsh, covering 5-25% of the wetland basin. There is no midstory layer. Redroot and sedges/grasses grow throughout the wetland, and cover >75% of the basin. The wetland has old and new hog damage. This wetland is a potential striped newt breeding pond. The adjacent uplands are sandhills. The uplands appear to have been fire suppressed but now are receiving prescribed fire.

Wetland Disturbance: Feral hog damage, Woody encroachment

Restoration Action Recommended: Because of the widespread damage to ephemeral wetlands on CWMA, we recommend aggressive action to reduce the overall numbers of feral hogs on the property. This wetland is in the early stages of succeeding from a marsh to a gum swamp. To maintain this wetland as a marsh, remove the gum trees from the wetland interior and encourage periodic fire to prevent further encroachment.

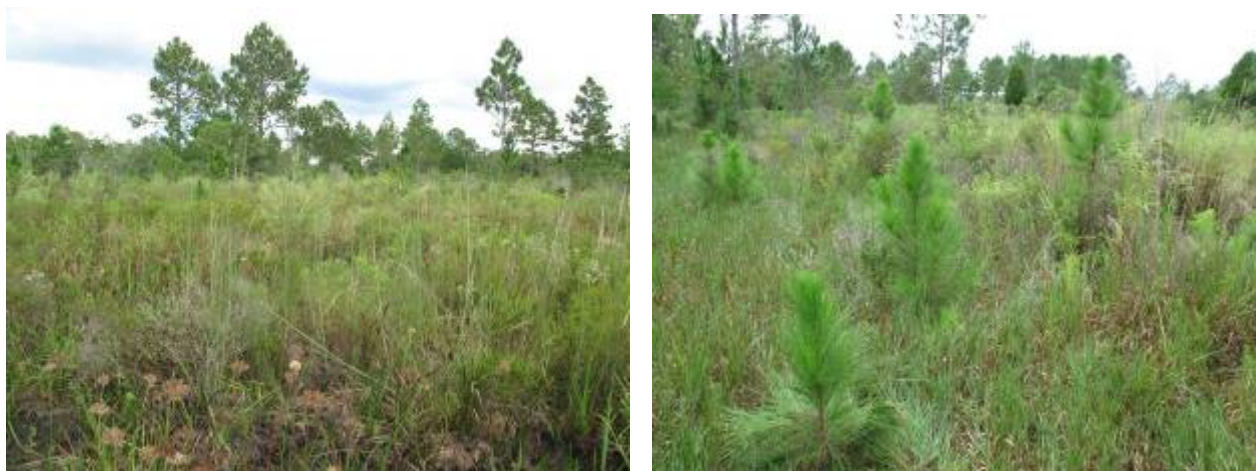
Wetland ID: 16A-01

Description: This wetland is a 0.3 ha ephemeral marsh. There is no tree canopy. Small pine trees are beginning to encroaching, and cover 5-25% of the wetland. Maidencane and redroot grow throughout the wetland, and cover >75% of the basin. The wetland has severe feral hog damage. A fireline bisects the west edge of the wetland. The adjacent uplands are sandhill. The uplands appear to have been fire suppressed but now are receiving prescribed fire.

Wetland Disturbance: Feral hog damage, Fireline, Woody encroachment

Restoration Action Recommended: Because of the widespread damage to ephemeral wetlands on CWMA, we recommend aggressive action to reduce the overall numbers of feral hogs on the property. Monitor this wetland to ensure pine trees are killed with the next fire or inundation. If they become established, the encroaching pine trees will need to be removed from the wetland. Alternatively, the small pine trees can be hand-chopped now.

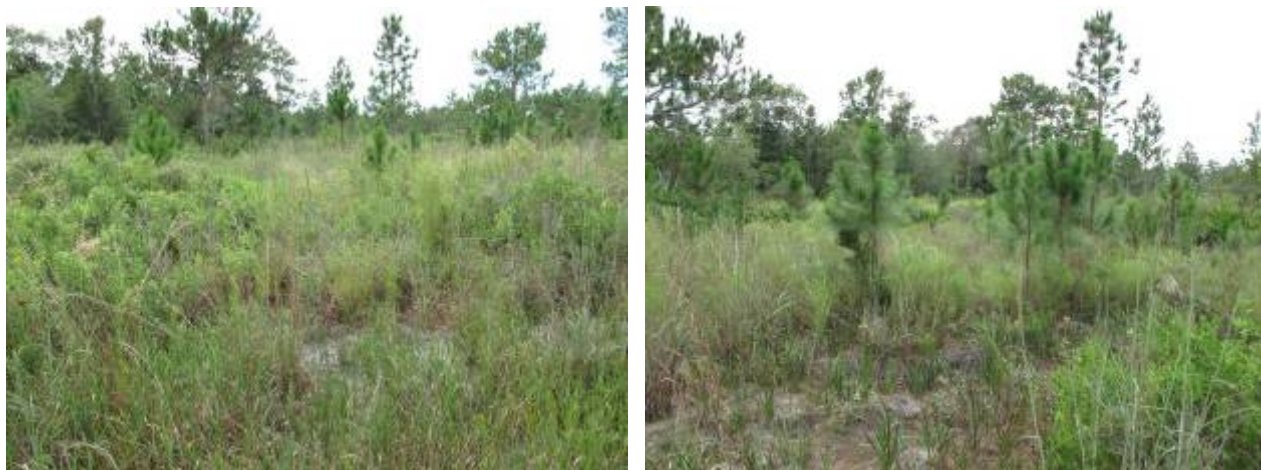
Wetland ID: 16A-02

Description: This wetland is a 0.2 ha highly ephemeral marsh. Pine trees dominate the canopy, and cover 5-25% of the wetland basin. The midstory also is dominated by small pine trees, and covers 5-25% of the wetland. Sedges/grasses and redroot grow throughout the wetland, and cover >75% of the basin. The wetland has new and old feral hog damage. The adjacent uplands are sandhill. The uplands appear to have been fire suppressed but now are receiving prescribed fire.

Wetland Disturbance: Feral hog damage, Woody encroachment

Restoration Action Recommended: Because of the widespread damage to ephemeral wetlands on CWMA, we recommend aggressive action to reduce the overall numbers of feral hogs on the property. Monitor this wetland to ensure the small pine trees are killed with the next fire or inundation. If they become established, the encroaching pine trees will need to be removed from the wetland. Alternatively, the small pine trees can be hand-chopped now. Monitor the larger pine trees in the wetland. If they begin to shade out the herbaceous vegetation, the pine trees should be thinned from the wetland interior.

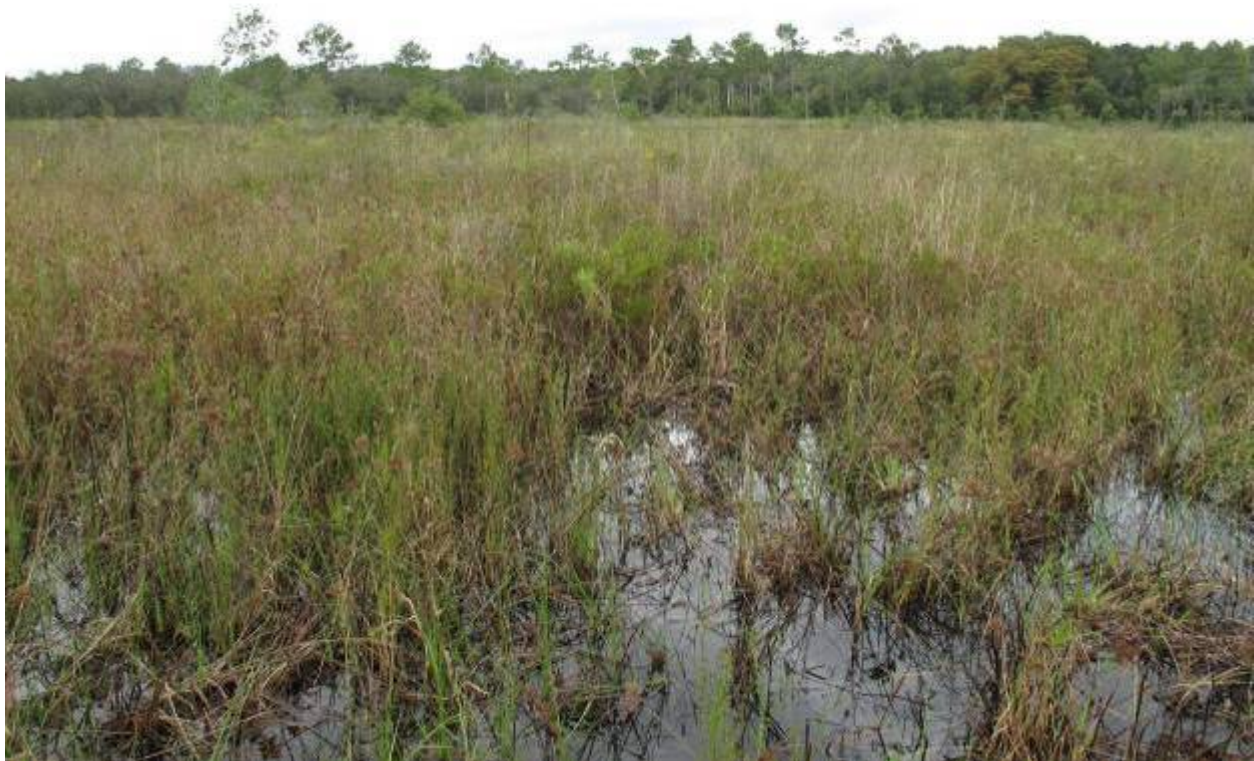
Wetland ID: 17A-01

Description: This wetland is a 2.0 ha ephemeral marsh. There is no canopy or midstory cover. Sedges/grasses, maidencane, and redroot grow throughout the wetland, and cover >75% of the basin. The wetland has widespread feral hog damage. This wetland has diverse herbaceous vegetation and is in fire maintenance condition. The wetland is a potential striped newt breeding pond. The adjacent uplands are sandhills and currently are managed with prescribed fire and mechanical vegetation removal.

Wetland Disturbance: Feral hog damage

Restoration Action Recommended: Because of the widespread damage to ephemeral wetlands on CWMA, we recommend aggressive action to reduce the overall numbers of feral hogs on the property.

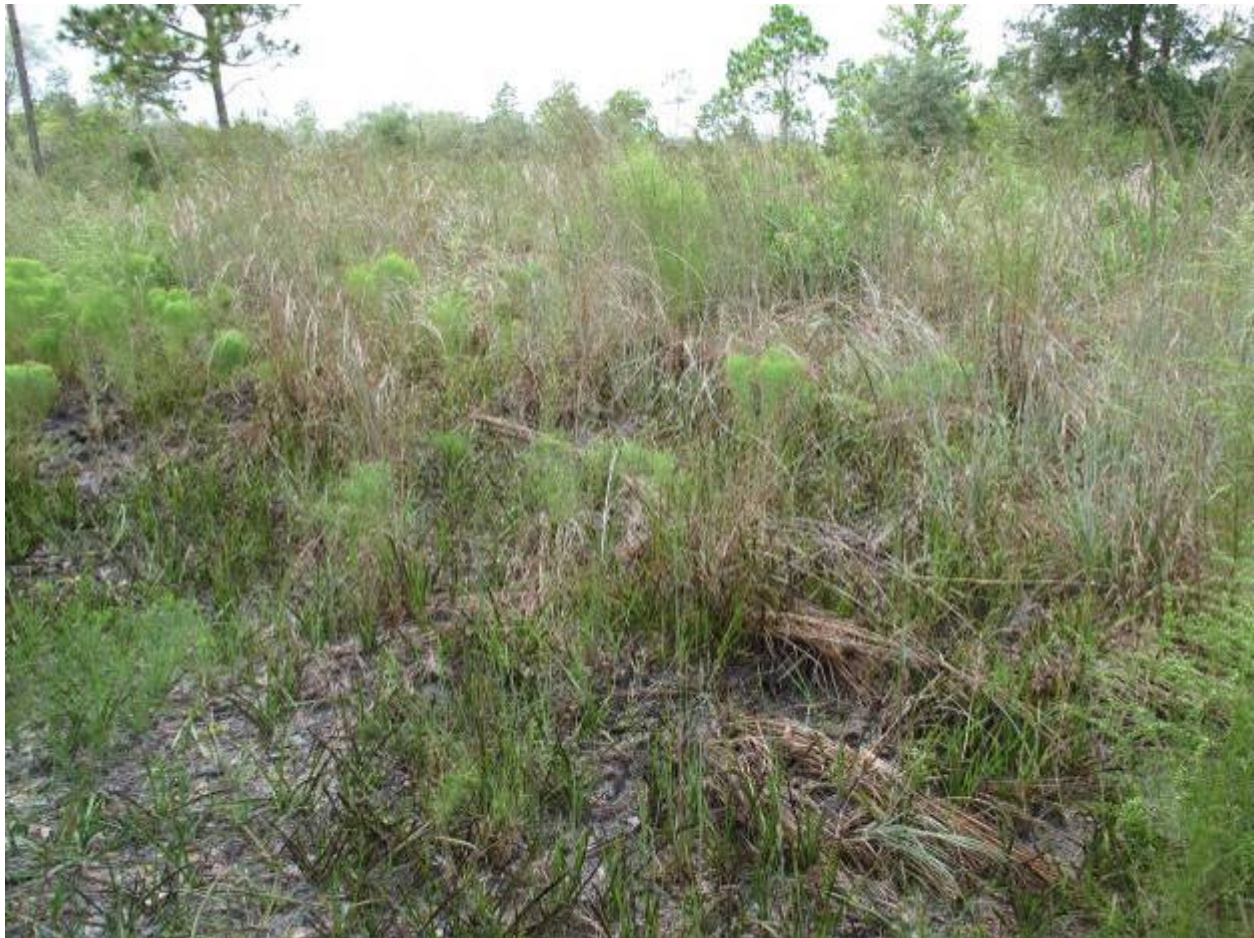
Wetland ID: 17A-02

Description: This wetland is a 0.1 ha highly ephemeral marsh. There is no canopy or midstory cover. Sedges/grasses and redroot grow throughout the wetland, and cover >75% of the basin. The wetland has both old and new feral hog damage. This wetland is in fire maintenance condition. The adjacent uplands are sandhills and currently are managed with prescribed fire and mechanical vegetation removal.

Wetland Disturbance: Feral hog damage

Restoration Action Recommended: Because of the widespread damage to ephemeral wetlands on CWMA, we recommend aggressive action to reduce the overall numbers of feral hogs on the property.

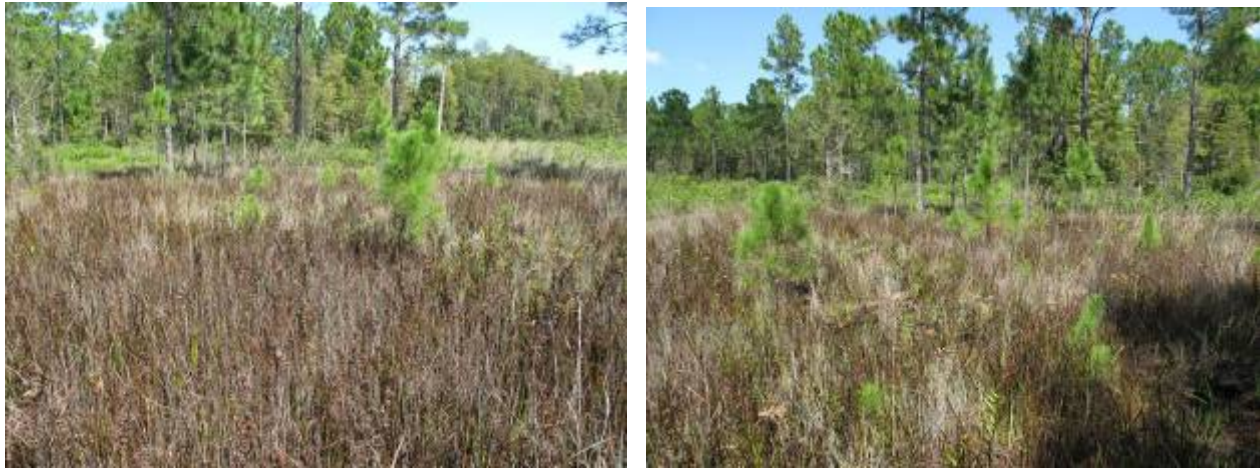
Wetland ID: 18A-01

Description: This wetland is a 0.1 ha ephemeral marsh. Multiple cohorts of slash pine trees are encroaching into the wetland basin. Pine trees dominate the canopy, and cover 5-25% of the wetland basin. Small pine trees are beginning to encroach, and covers 5-25% of the wetland. Redroot grows throughout the wetland, and covers >75% of the basin. The wetland has extensive old and new feral hog damage. This wetland is a potential striped newt breeding pond. The adjacent uplands are sandhills and currently are managed with prescribed fire and mechanical vegetation removal.

Wetland Disturbance: Feral hog damage, Woody encroachment

Restoration Action Recommended: Because of the widespread damage to ephemeral wetlands on CWMA, we recommend aggressive action to reduce the overall numbers of feral hogs on the property. Monitor this wetland to ensure small pine trees are killed with the next fire or inundation. If they become established, the encroaching pine trees will need to be removed from the wetland. Alternatively, the small pine trees can be hand-chopped now. Monitor the larger pine trees in the wetland. If they begin to shade out the herbaceous vegetation, the pine trees should be thinned from the wetland interior.

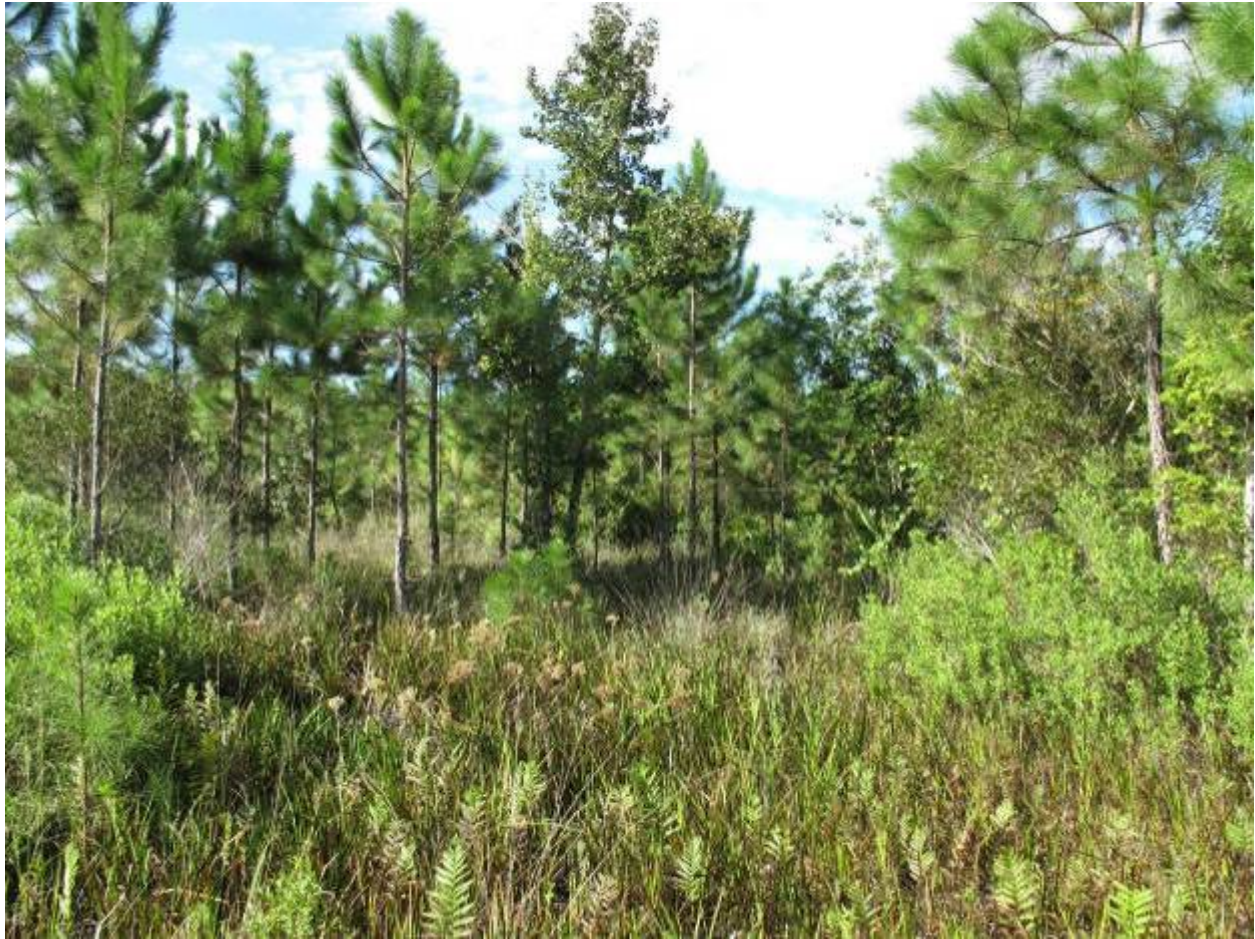
Description: This wetland is a 0.1 ha ephemeral marsh. Pine trees are encroaching into the wetland, and cover 25-50% of the basin. The midstory is dominated by gallberry, and covers 5-25% of the wetland. Redroot and fern grow throughout the wetland, and cover >75% of the basin. The wetland has new and old feral hog damage. The adjacent uplands are mesic flatwoods. The uplands appear to have been fire suppressed but now are receiving prescribed fire. Planted longleaf pine trees are growing nearby.

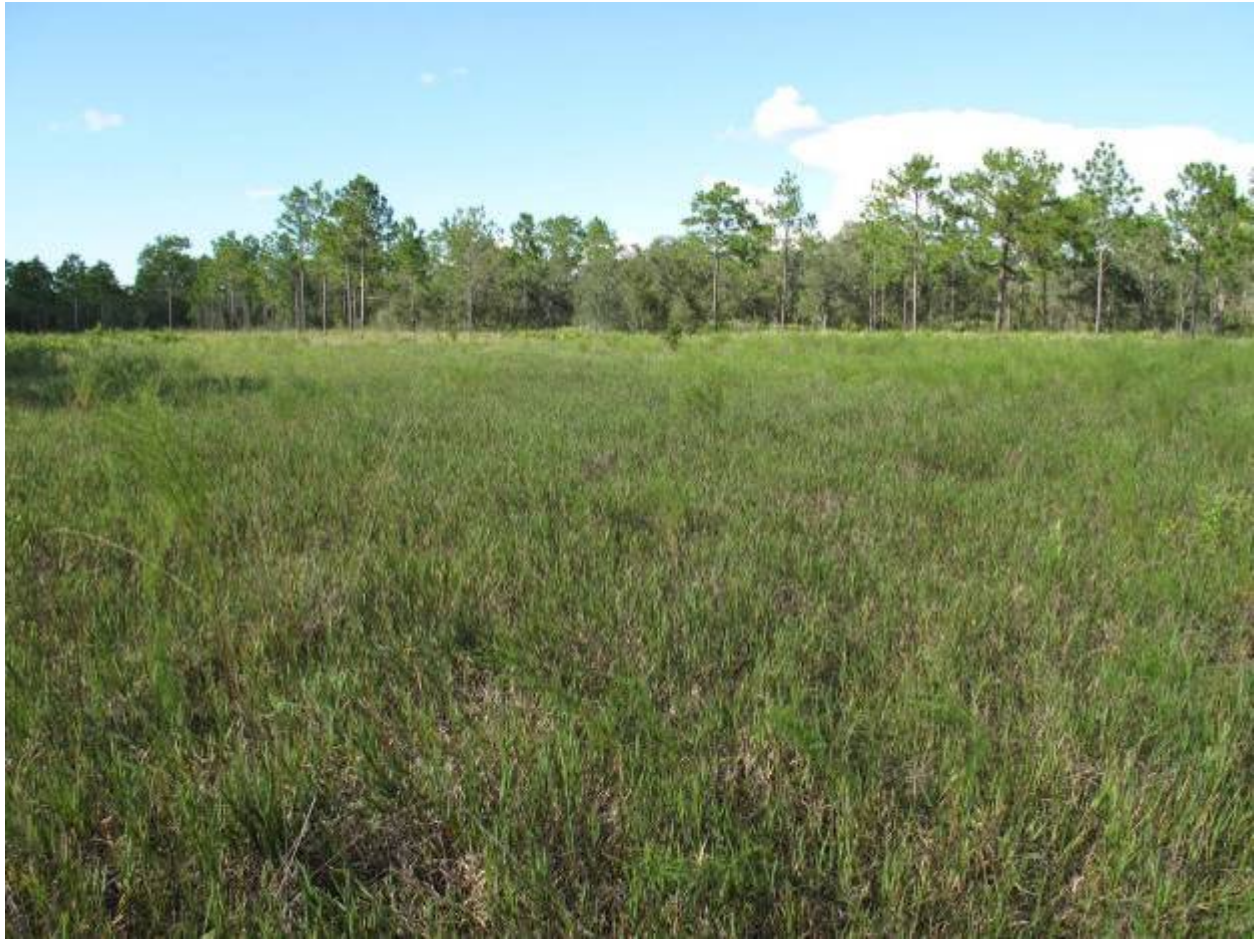
Description: This wetland is a 0.4 ha ephemeral marsh. There is no canopy or midstory cover. Maidencane grows throughout the wetland, and covers >75% of the basin. Old feral hog damage has grown over with vegetation but the hillocks in the wetland basin are still evident. This wetland will connect to wetland 02B-02 during periods of high water. This wetland is in fire maintenance condition and is a potential striped newt breeding pond. The adjacent uplands are sandhill. The sandhills appear to have been fire suppressed but now are managed with prescribed fire.

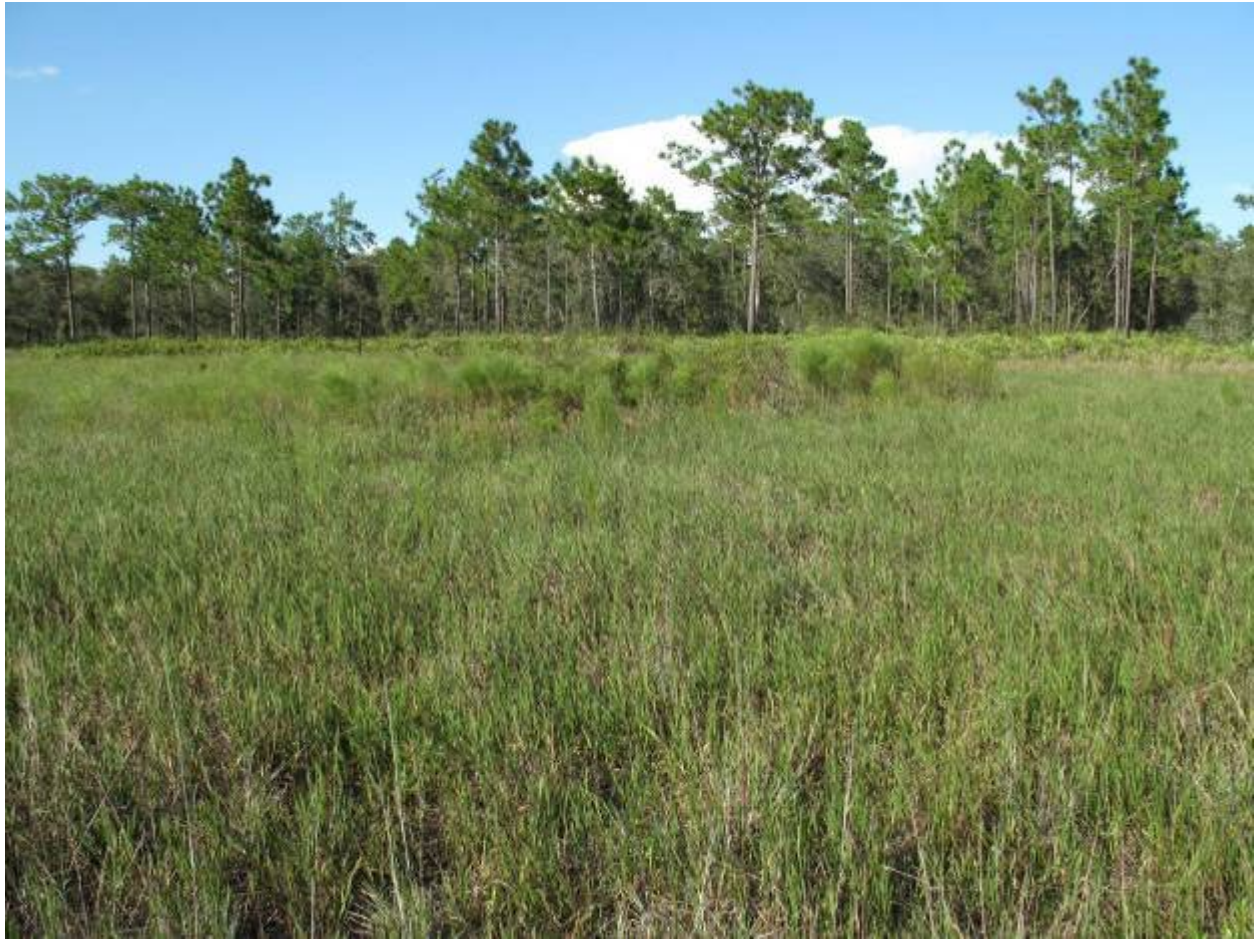
Description: This wetland is a 0.6 ha ephemeral marsh. There is no canopy or midstory cover. Maidencane grows throughout the wetland, and covers >75% of the basin. Old feral hog rootings have grown over with vegetation but the hillocks in the wetland basin are still evident. This wetland will connect to wetland 02B-01 during periods of high water. This wetland is in fire maintenance condition and is a potential striped newt breeding pond. The adjacent uplands are sandhill. The sandhills appear to have been fire suppressed but now are managed with prescribed fire.
