Inventory, Assessment, and Restoration Potential of Ephemeral Wetlands on FFWCC Wildlife Management Areas

Chassahowitzka WMA Final Report

Submitted by: Rebecca P.M. Means¹, Ryan C. Means¹, Steven A. Johnson²

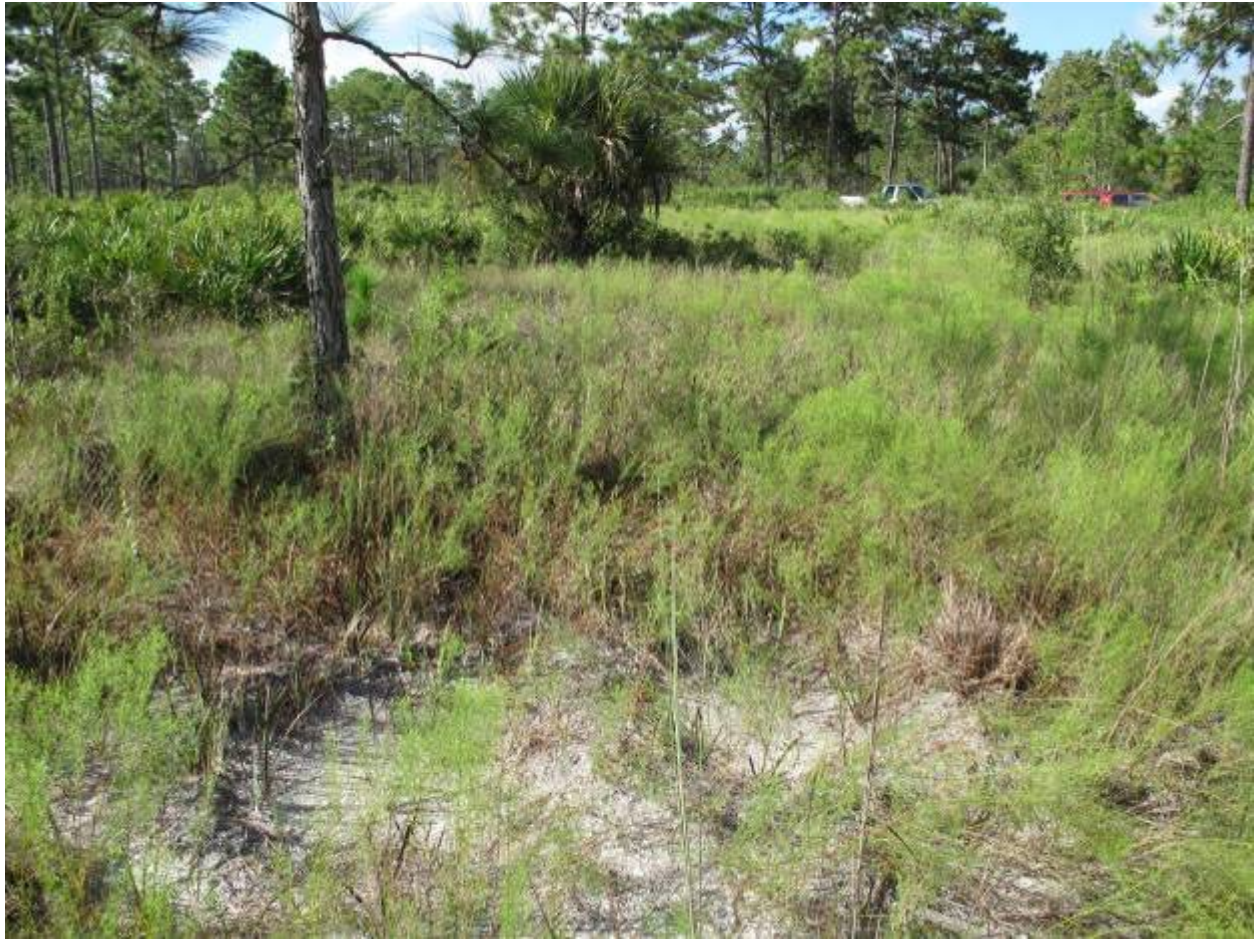
Description: This wetland is a 0.2 ha highly ephemeral marsh. There is no canopy or midstory cover. Sedges/grasses and redroot grow throughout the wetland, and cover >75% of the basin. Feral hog damage is extensive. The adjacent uplands are mesic flatwoods and xeric hammock. The uplands appear to have been fire suppressed but now are receiving prescribed fire.

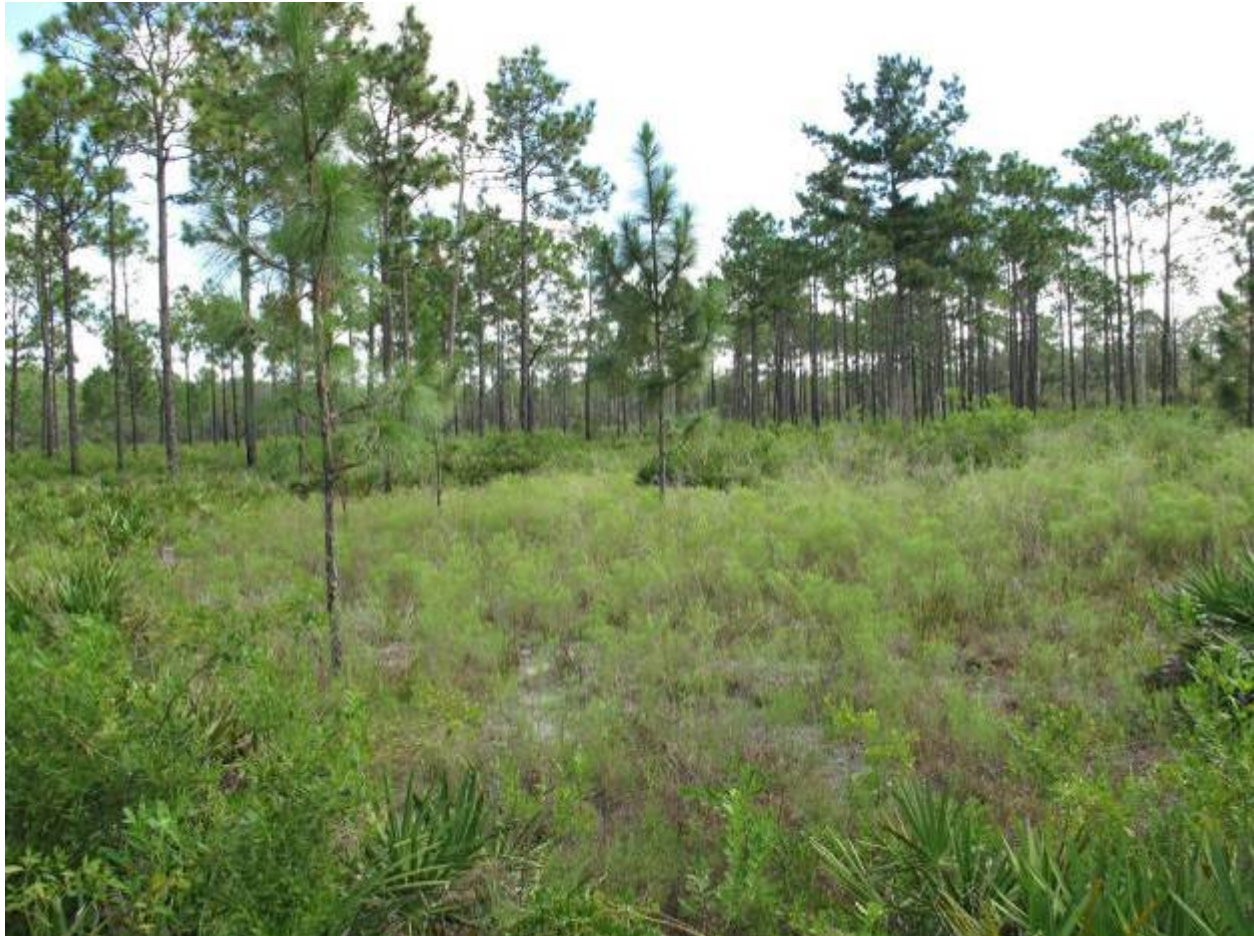
Wetland ID: 02B-04

Description: This wetland is a 0.1 ha highly ephemeral marsh. There is no canopy or midstory cover. Maidencane grows throughout the wetland, and covers >75% of the basin. The wetland has extensive old feral hog damage. This wetland is doughnut-shaped with a saw palmetto/galberry island in the center, indicative of either an extended dry period or higher elevation. The adjacent uplands are mesic flatwoods. The flatwoods appear to have been fire suppressed but now are receiving prescribed fire.

Wetland Disturbance: Feral hog damage, Woody encroachment

Restoration Action Recommended: Because of the widespread damage to ephemeral wetlands on CWMA, we recommend aggressive action to reduce the overall numbers of feral hogs on the property. Remove shrub island to prevent encroachment of the shrubs into the surrounding wetland. The shrub island could be burned repeatedly, removed by hand, or removed by mechanical means when the wetland is completely dry.

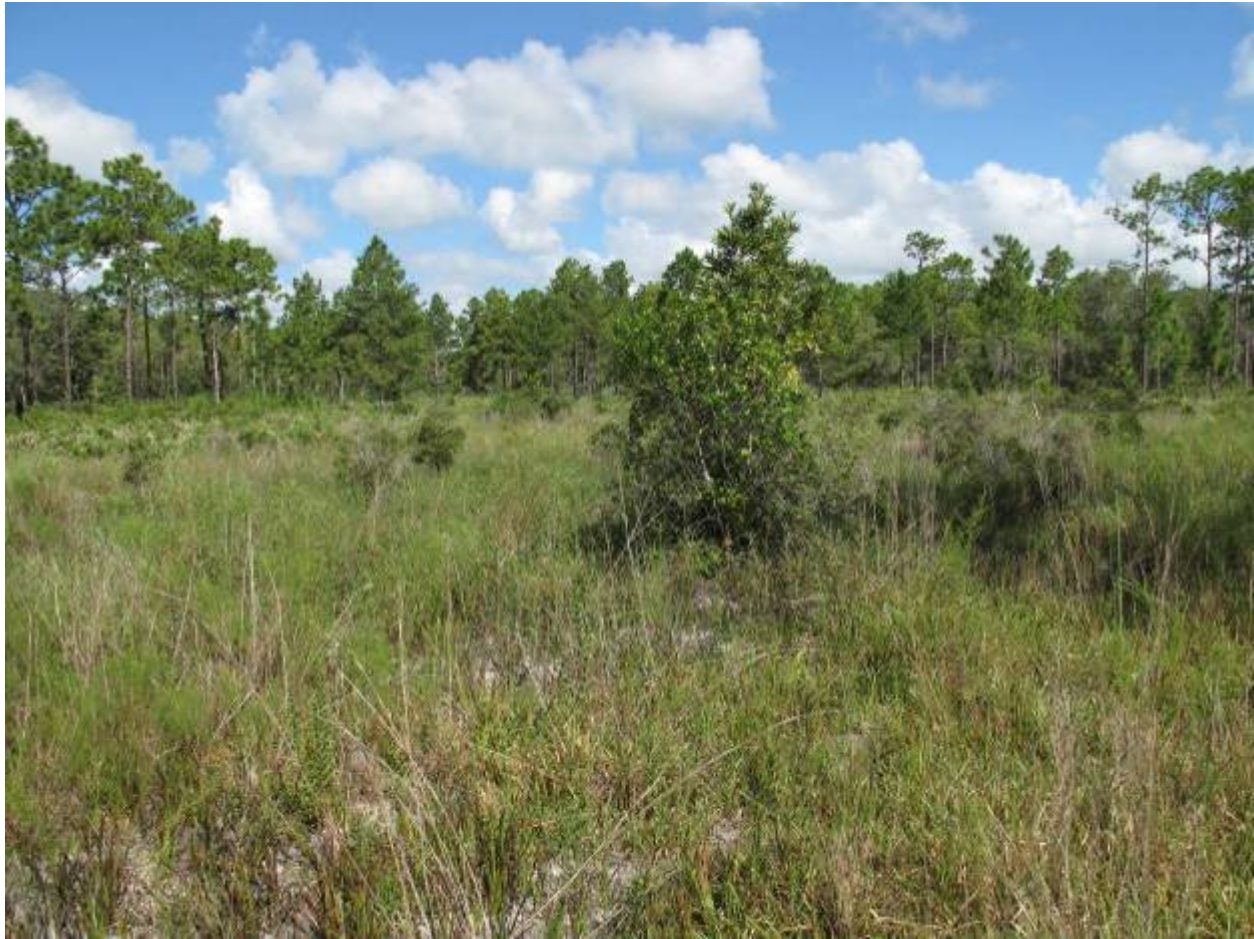
Description: This wetland is a 0.6 ha ephemeral marsh. There is no tree canopy. Wax myrtle is beginning to encroach into the wetland, and covers 5-25% of the basin. Maidencane, sedges/grasses, and redroot grow throughout the wetland, and cover >75% of the basin. There is evidence of past feral hog damage. The adjacent uplands are mesic flatwoods. The flatwoods appear to have been fire suppressed but now are receiving prescribed fire.

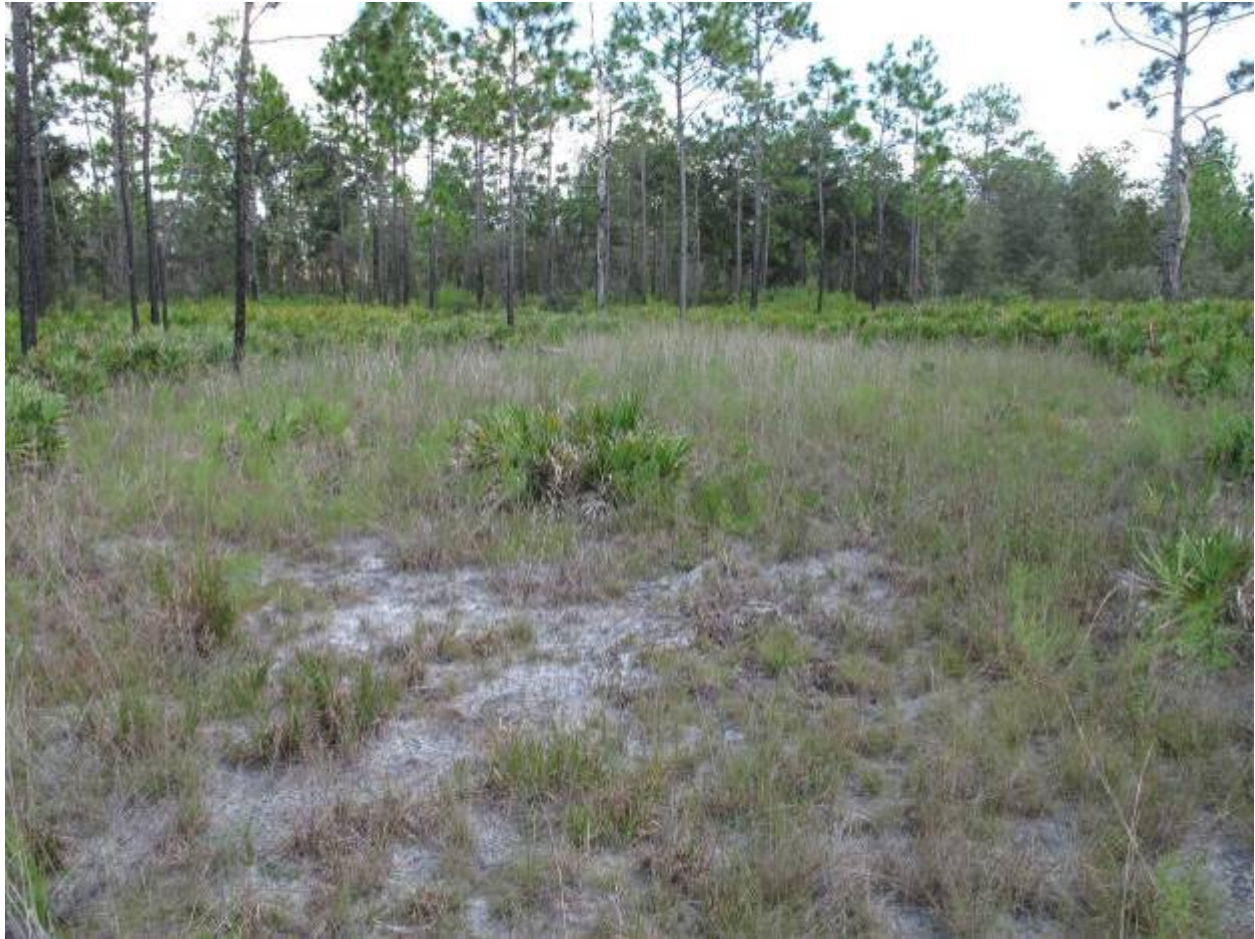
Description: This wetland is a 0.1 ha highly ephemeral marsh. There is no canopy or midstory cover. Sedges/grasses grow throughout the wetland, and cover >75% of the basin. This wetland is in fire maintenance condition and is a potential striped newt breeding pond. The adjacent uplands are sandhills. The uplands appear to have been fire suppressed but now are receiving prescribed fire.

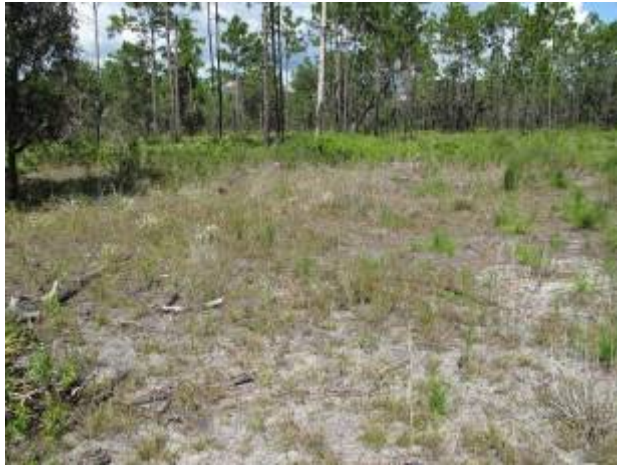
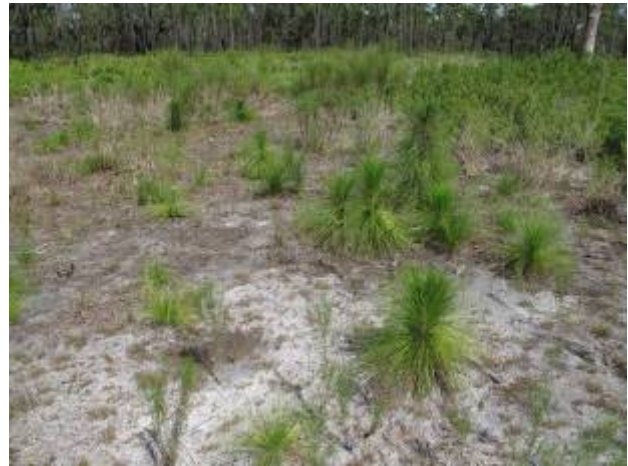
Wetland ID: 02B-07

Description: This wetland is a 0.2 ha highly ephemeral marsh. There is no tree canopy. Small longleaf pine trees are beginning to establish in the wetland basin, and cover 5-25% of the wetland. Sedges/grasses grow throughout the wetland, and cover >75% of the basin. The longleaf pines establishing is a sign of a prolonged dry period. The wetland is a potential striped newt breeding pond. The adjacent uplands are sandhills. The uplands appear to have been fire suppressed but now are receiving prescribed fire.

Wetland Disturbance: Woody encroachment

Restoration Action Recommended: Monitor this wetland to ensure pine trees are killed with the next fire or inundation. If they become established, the encroaching pine trees will need to be removed from the wetland. Alternatively, the small pine trees can be hand-chopped now.

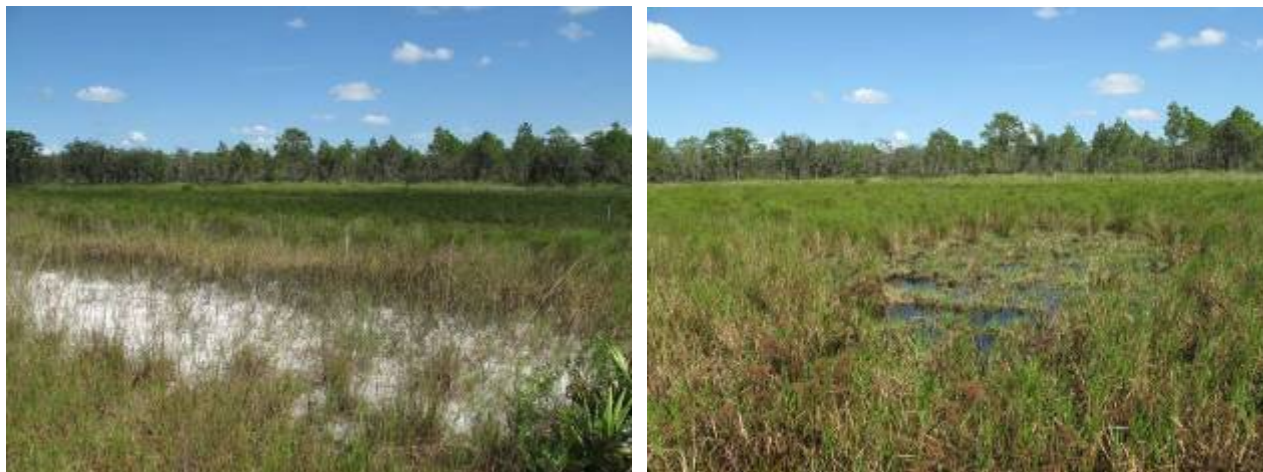
Wetland ID: 03B-01

Description: This wetland is a 1.7 ha ephemeral marsh. There is no tree canopy. *Hypericum* covers 5-25% of the wetland. Maidencane and sedges/grasses grow throughout the wetland, and cover >75% of the basin. Old feral hog damage has grown over with vegetation. There is a peizometer and a depth gauge in the wetland. This wetland is in fire maintenance condition and is a potential striped newt breeding pond. The adjacent uplands are sandhills. The uplands appear to have been fire suppressed but now are receiving prescribed fire.

Wetland Disturbance: Feral hog damage

Restoration Action Recommended: Because of the widespread damage to ephemeral wetlands on CWMA, we recommend aggressive action to reduce the overall numbers of feral hogs on the property.

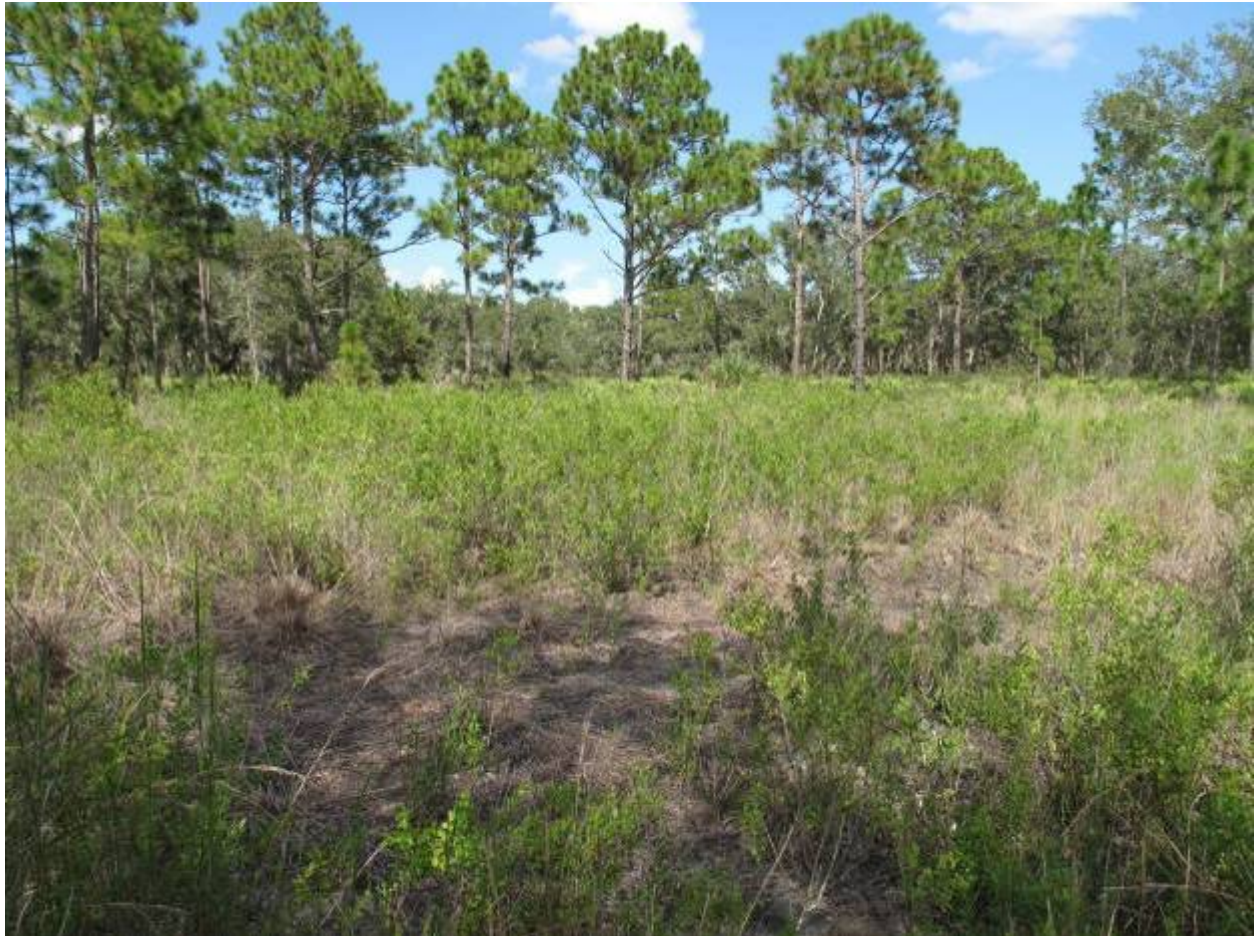
Wetland ID: 03B-02

Description: This wetland is a 0.2 ha highly ephemeral marsh. There is no tree canopy. A prolonged dry period and the lack of fire have allowed gallberry to establish in the marsh. The gallberry covers 50-75% of the wetland. Sedges/grasses grow throughout the wetland, and cover 50-75% of the basin. The adjacent uplands are sandhills. The uplands appear to have been fire suppressed but now are receiving prescribed fire.

Wetland Disturbance: Woody encroachment

Restoration Action Recommended: Encourage fire in the wetland to reduce the encroaching gallberry.

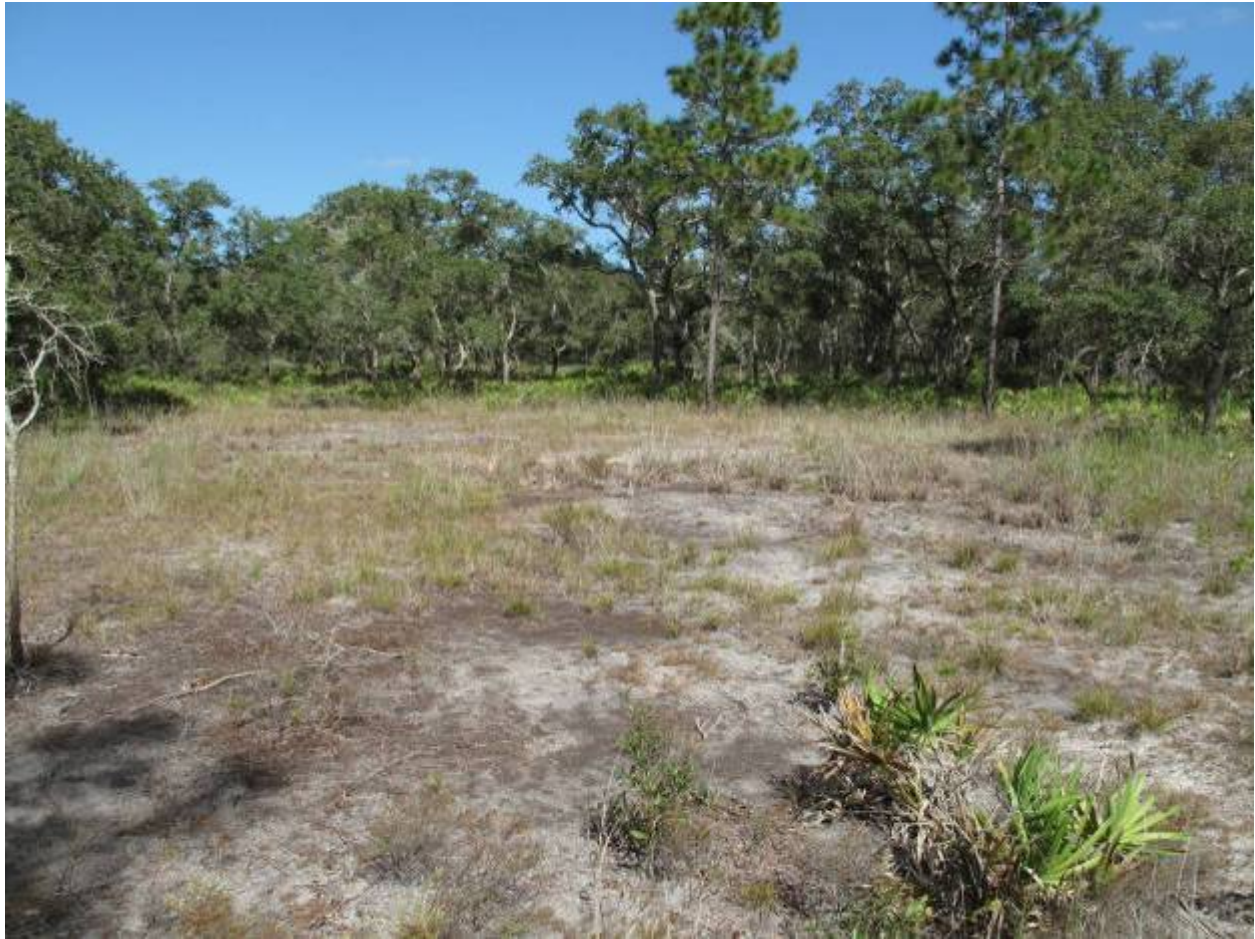
Description: This wetland is a 0.1 ha ephemeral marsh. There is no tree canopy or midstory cover. Sedges/grasses grow in scattered patches, and cover 25-50% of the wetland. This wetland is in fire maintenance condition and is a potential striped newt breeding pond. There is evidence of past fire in the wetland. The adjacent uplands are sandhills. The uplands appear to have been fire suppressed but now are receiving prescribed fire.

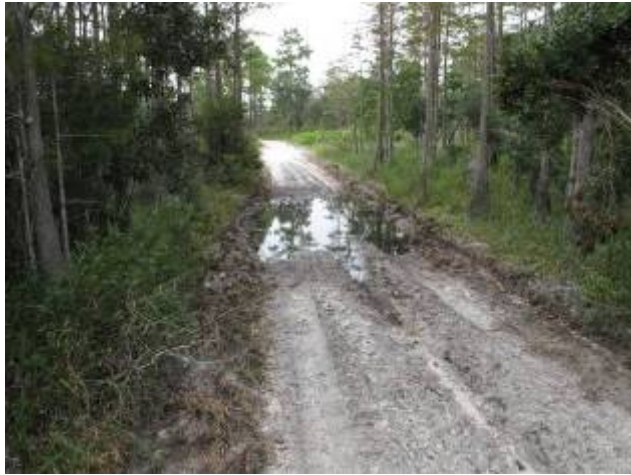
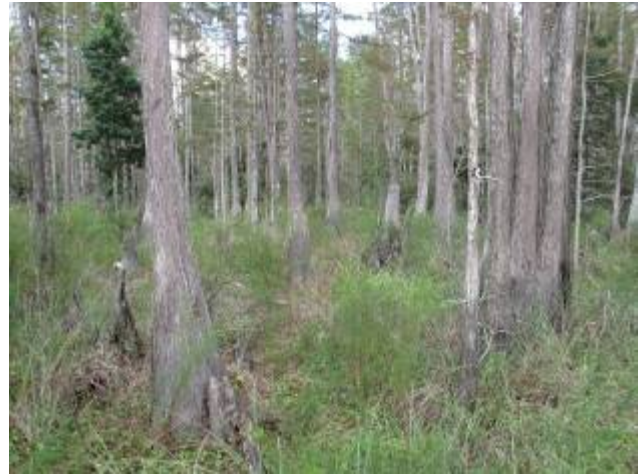
Wetland ID: 04B-01

Description: This wetland is an 8.1 ha ephemeral forested swamp. Cypress trees dominate the canopy, and cover >75% of the wetland basin. The midstory is dominated by wax myrtle, and covers 5-25% of the wetland. Sedges/grasses grow throughout the wetland, and cover >75% of the basin. The wetland has minor feral hog damage. A fireline/MU boundary bisects the wetland. The larger portion of the wetland lies to the west of the MU boundary in MU 11B. The interior of the wetland has burned in the past and is in good ecological condition. The adjacent uplands are sandhills. The uplands appear to have been fire suppressed but now are receiving prescribed fire.

Wetland Disturbance: Feral hog damage, Fireline

Restoration Action Recommended: Because of the widespread damage to ephemeral wetlands on CWMA, we recommend aggressive action to reduce the overall numbers of feral hogs on the property. The fireline/MU boundary should be re-routed away from the wetland. If the fireline cannot be re-routed, monitor the wetland to ensure fire is not excluded. Maintain the fireline when the wetland is completely dry to prevent ruts from developing.

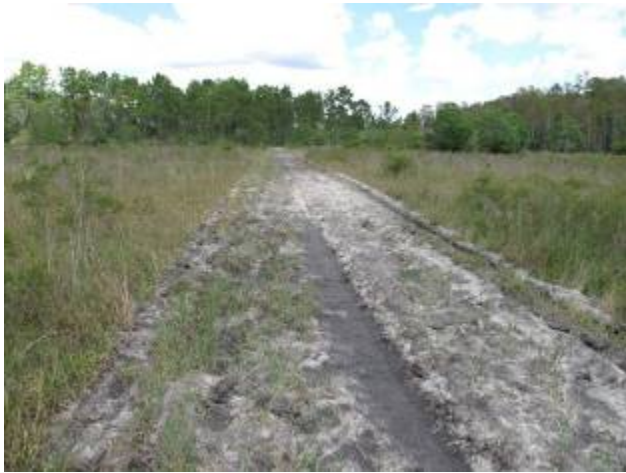
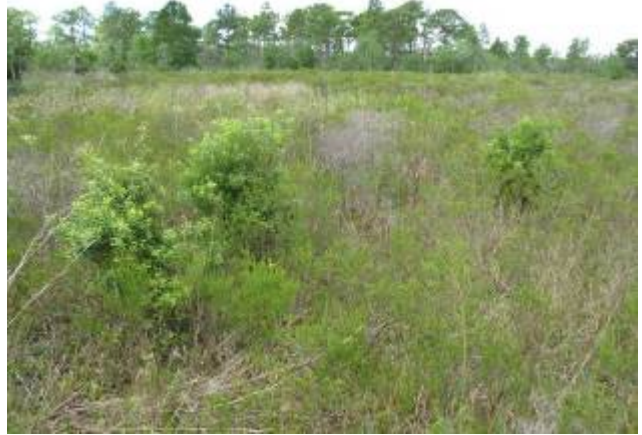
Wetland ID: 05B-01

Description: This wetland is a 3.8 ha ephemeral marsh. There is no tree canopy. Wax myrtle, holly, *Hypericum*, and small slash pine trees are beginning to encroach into the wetland, and cover 5-25% of the basin. Sedges/grasses and maidencane grow throughout the wetland, covering >75% of the basin. This wetland likely connects to the big swamp to the east during periods of high water. The wetland has both old and new feral hog damage. A fireline/MU boundary bisects the east side of the wetland. The adjacent uplands are fire-suppressed sandhills and currently are managed with mechanical treatments.

Wetland Disturbance: Feral hog damage, Fireline, Woody encroachment

Restoration Action Recommended: Because of the widespread damage to ephemeral wetlands on CWMA, we recommend aggressive action to reduce the overall numbers of feral hogs on the property. The fireline/MU boundary should be re-routed away from the wetland. If the fireline cannot be re-routed, monitor the wetland to ensure fire is not excluded. Maintain the fireline when the wetland is completely dry to prevent ruts from developing. Encourage fire to burn through the wetland to prevent further woody encroachment.

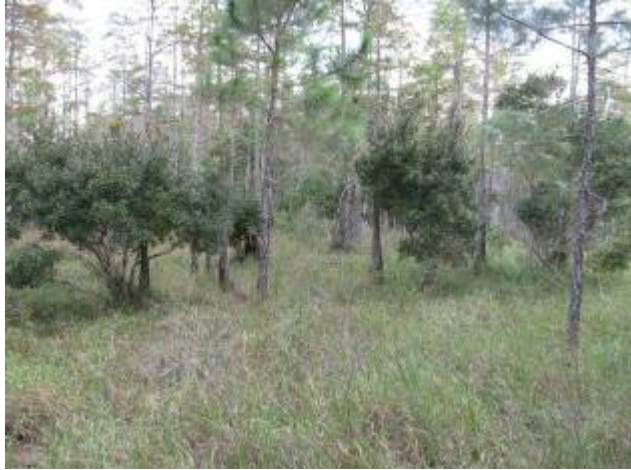
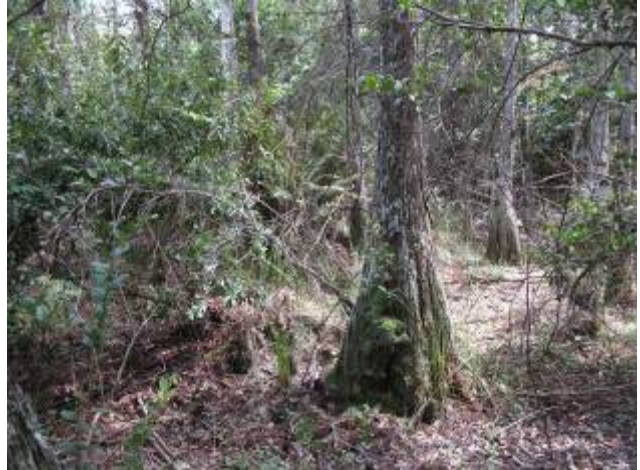
Wetland ID: 05B-02

Description: This wetland is a 6.8 ha ephemeral mixed swamp. Cypress trees dominate the canopy, and cover 50-75% of the wetland basin. The midstory is dominated by wax myrtle, fetterbush, and holly, and covers 50-75% of the wetland. Maidencane grows throughout the wetland, and covers 50-75% of the basin. The wetland has both old and new feral hog damage. Old stumps provide evidence of historic logging within the wetland. An unpaved road bisects the northern edge of the wetland. The adjacent uplands are fire-suppressed sandhills and currently are managed with mechanical treatments.

Wetland Disturbance: Feral hog damage, Road

Restoration Action Recommended: Because of the widespread damage to ephemeral wetlands on CWMA, we recommend aggressive action to reduce the overall numbers of feral hogs on the property.

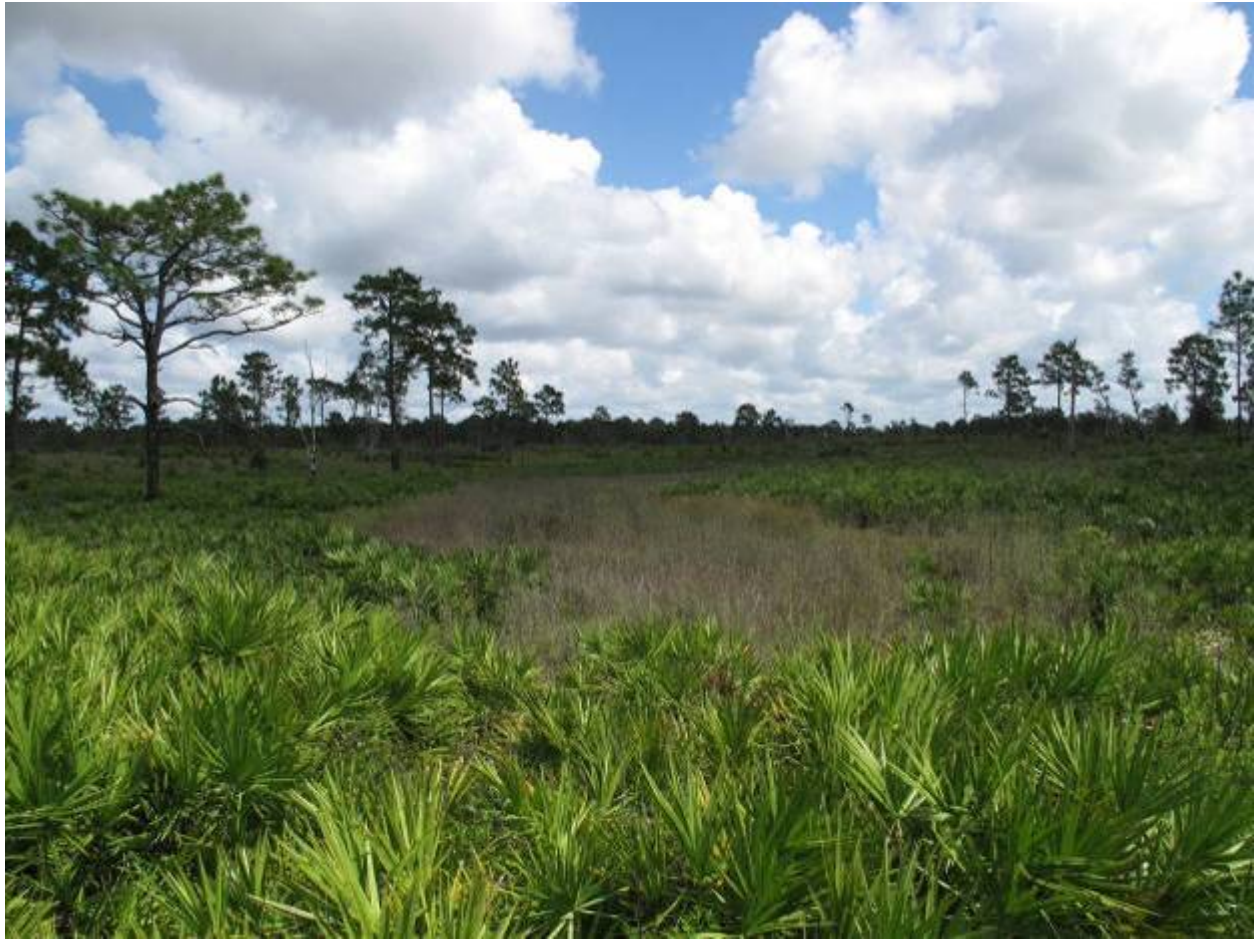
Description: This wetland is a 0.2 ha ephemeral marsh. There is no tree canopy or midstory cover. Sedges/grasses and redroot grow throughout the wetland, and cover >75% of the basin. The wetland has both old and new feral hog damage. This depressional wetland is fire maintenance condition and is a potential striped newt breeding pond. The adjacent uplands are fire maintained sandhills.

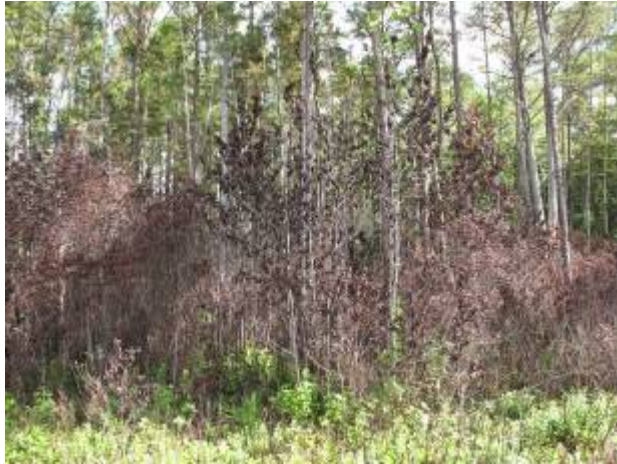
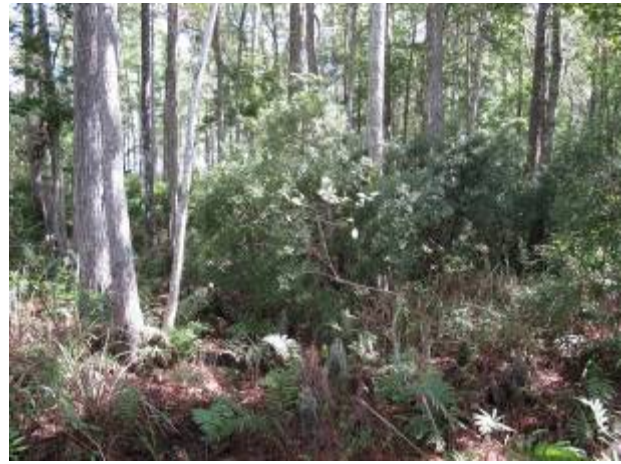
Wetland ID: 07B-01

Description: This wetland is a 1.9 ha ephemeral mixed swamp. Pine, cypress, gum, and maple trees dominate the canopy, and cover >75% of the wetland basin. The midstory is dominated by wax myrtle, and covers 50-75% of the wetland basin. Sawgrass and fern grow throughout the wetland, and cover 25-50% of the basin. Lack of fire, coupled with a long dry period, has encouraged the encroachment of shrubs into this swamp. A recent fire burned deep into the wetland around all sides, killing sweet gum, wax myrtle, and fetterbush. A layer of thick duff still remains. The adjacent uplands are sandhills and currently are managed with mechanical treatments.

Wetland Disturbance: Woody encroachment

Restoration Action Recommended: Encourage periodic fire in the wetland to reduce encroaching woody shrubs.

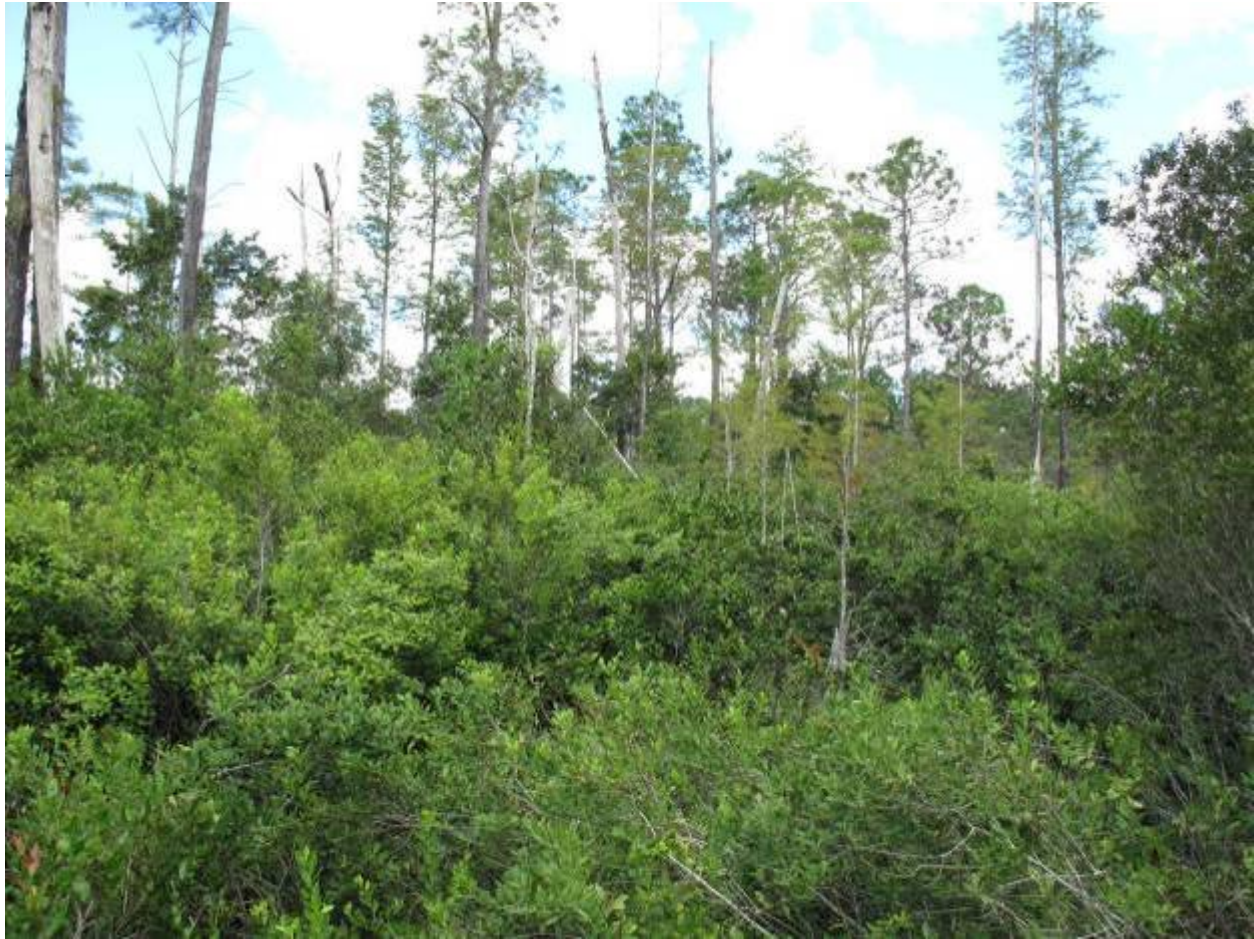
Description: This wetland is a 0.7 ha ephemeral baygall community. Cypress and bay trees dominate the canopy, and cover 5-25% of the wetland basin. The midstory is dominated by fetterbush and gallberry, and covers >75% of the wetland basin. There is no herbaceous vegetation. This wetland likely connects to the big swamp to the west. A fire recently burned into the wetland. The adjacent uplands are sandhills and currently are managed with mechanical treatments.

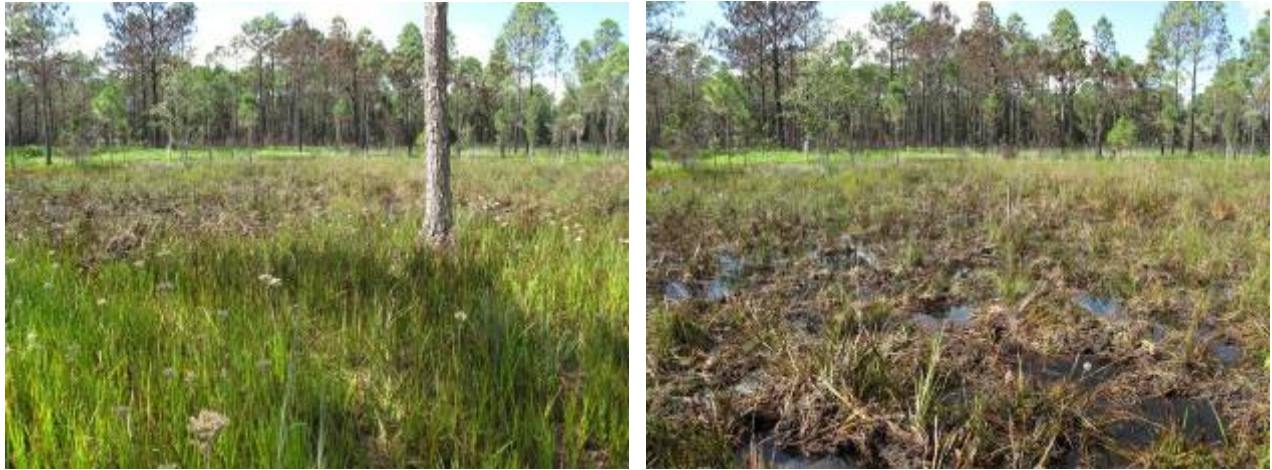
Wetland ID: 08B-01

Description: This wetland is a 0.3 ha ephemeral marsh. There is no tree canopy cover. The wetland is ringed with holly and small slash pine trees, which cover 5-25% of the wetland. Redroot grows throughout, covering >75% of the wetland. The wetland has severe feral hog damage. A recent fire did not burn into the wetland basin. This wetland is a potential striped newt breeding pond. The adjacent uplands are sandhills and currently are managed with mechanical treatments.

Wetland Disturbance: Feral hog damage

Restoration Action Recommended: Because of the widespread damage to ephemeral wetlands on CWMA, we recommend aggressive action to reduce the overall numbers of feral hogs on the property.

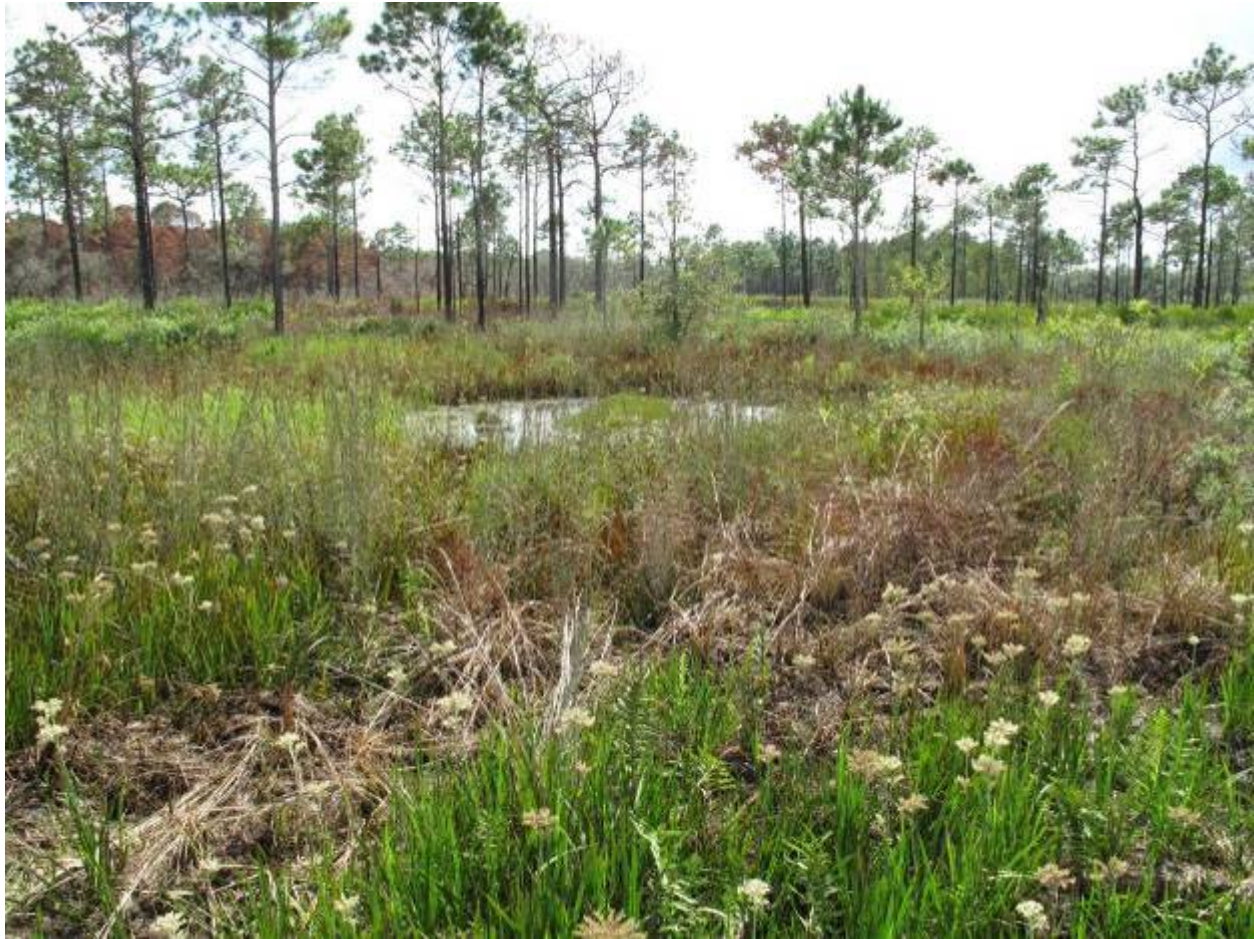
Wetland ID: 09B-01

Description: This wetland is a 0.1 ha ephemeral marsh. There is no tree canopy or midstory cover. A diverse array of redroot and sedges/grasses grows throughout the wetland, and covers >75% of the basin. The wetland has severe feral hog damage. This wetland has is a potential striped newt breeding pond. The adjacent uplands are sandhills and currently are managed with prescribed fire and mechanical vegetation removal.

Wetland Disturbance: Feral hog damage

Restoration Action Recommended: Because of the widespread damage to ephemeral wetlands on CWMA, we recommend aggressive action to reduce the overall numbers of feral hogs on the property.

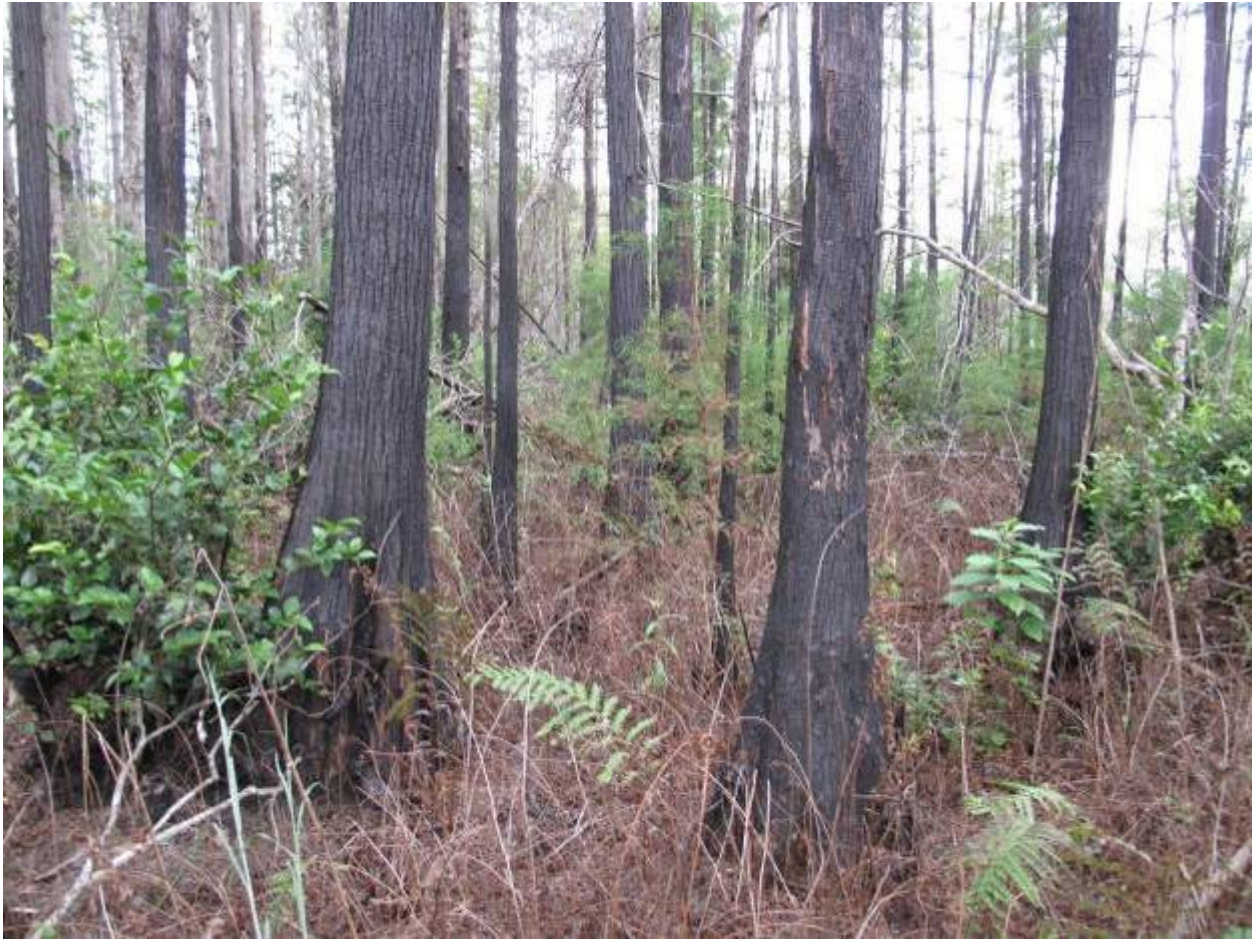
Wetland ID: 09B-02

Description: This wetland is a 2.0 ha ephemeral forested swamp. Cypress trees dominate the canopy, and cover >75% of the wetland basin. The midstory is dominated by fetterbush and dog fennel, and covers 25-50% of the wetland. Fern and sedges/grasses grow throughout the wetland, and cover 50-75% of the basin. The wetland has minor, old feral hog damage. A fire burned through the wetland and thinned much of the brushy vegetation. Some fetterbush is resprouting. This wetland provides a good example of the beneficial effects of fire in swamps. The adjacent uplands are sandhills and currently are managed with prescribed fire and mechanical vegetation removal.

Wetland Disturbance: Feral hog damage

Restoration Action Recommended: Because of the widespread damage to ephemeral wetlands on CWMA, we recommend aggressive action to reduce the overall numbers of feral hogs on the property.

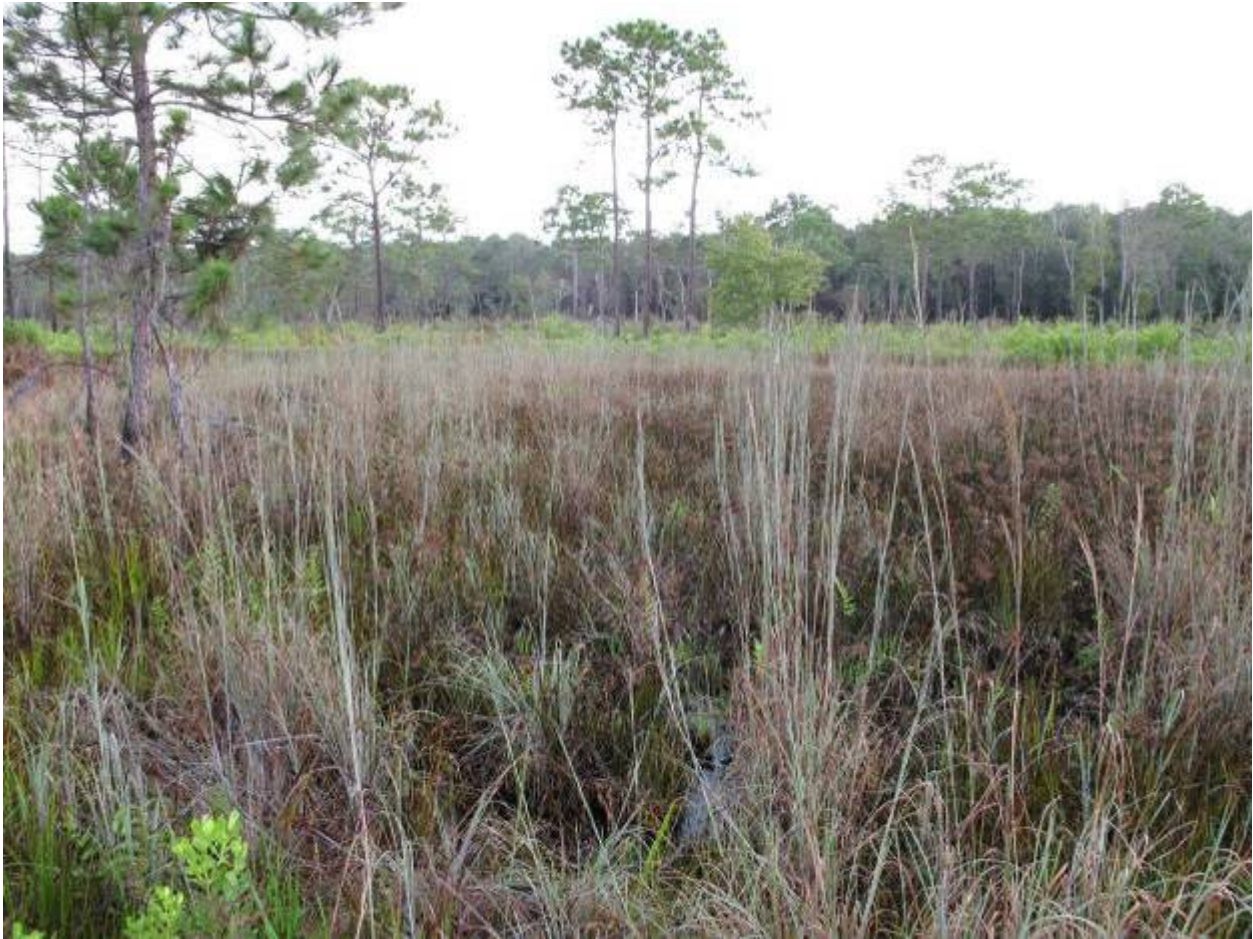
Wetland ID: 09B-03

Description: This wetland is a 0.2 ha ephemeral marsh. There is no tree canopy or midstory cover. Redroot and sedges/grasses grow throughout the wetland, and cover >75% of the basin. The wetland has both old and new feral hog damage. A fire recently burned through the wetland basin. This wetland is in fire-maintenance condition and is a potential striped newt breeding pond. The adjacent uplands are sandhills and currently are managed with prescribed fire and mechanical vegetation removal.

Wetland Disturbance: Feral hog damage

Restoration Action Recommended: Because of the widespread damage to ephemeral wetlands on CWMA, we recommend aggressive action to reduce the overall numbers of feral hogs on the property.

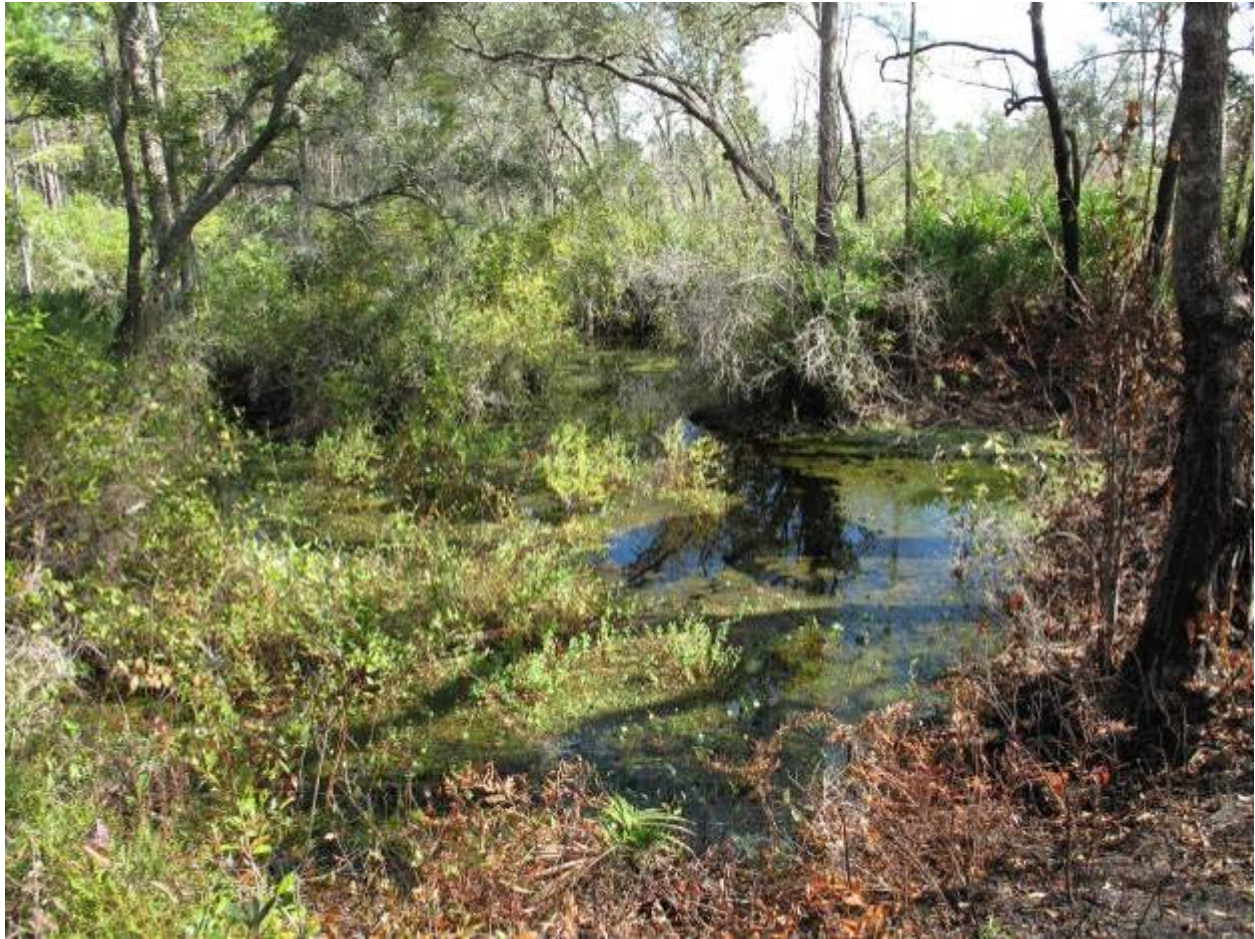
Description: This wetland is a 0.1 ha semi-permanent, steep-sided, sink depression pond. The tree canopy is dominated by oaks, and covers 25-50% of the wetland basin. Buttonbush grows in a ring around the wetland edge, and covers 5-25% of the wetland. Emergent vegetation grows throughout the wetland, and covers 50-75% of the basin. The wetland currently has fish. When the wetland dries and refills (thereby eliminating the fish), it will be a great potential striped newt breeding pond. The adjacent uplands are sandhills and currently are managed with prescribed fire and mechanical vegetation removal.

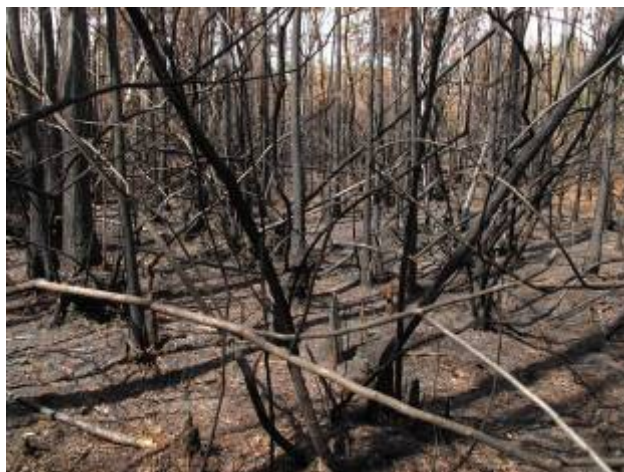
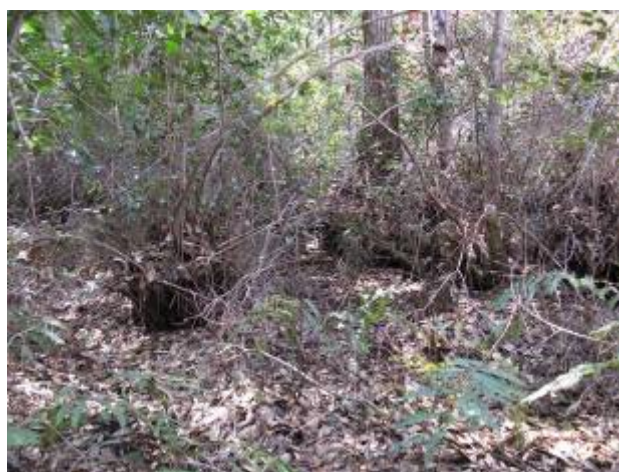
Wetland ID: 10B-01

Description: This wetland is a 1.5 ha ephemeral mixed swamp. Cypress trees dominate the canopy, and cover >75% of the wetland basin. The midstory is dominated by fetterbush and wax myrtle, and covers 50-75% of the wetland. There is no herbaceous vegetation. Old stumps provide evidence of historic logging in the wetland. A recent fire burned deeply into the wetland, reducing the woody vegetation and duff. The deep interior did not burn and is still thick with brush and duff. This wetland provides a good example of the positive effects of a summer fire in a previously fire suppressed wetland. The adjacent uplands are sandhills and currently are managed with prescribed fire and mechanical vegetation removal.

Wetland Disturbance: Woody encroachment

Restoration Action Recommended: Encourage fire in the wetland interior to reduce the dense brush.
