Inventory, Assessment, and Restoration Potential of Ephemeral Wetlands on FFWCC Wildlife Management Areas

Chassahowitzka WMA Final Report

Submitted by: Rebecca P.M. Means¹, Ryan C. Means¹, Steven A. Johnson²

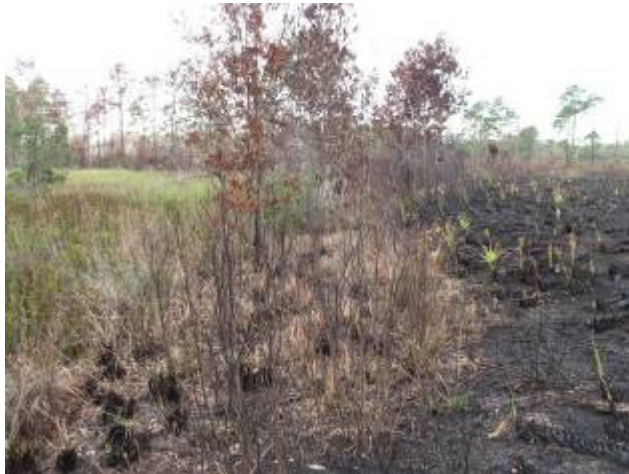
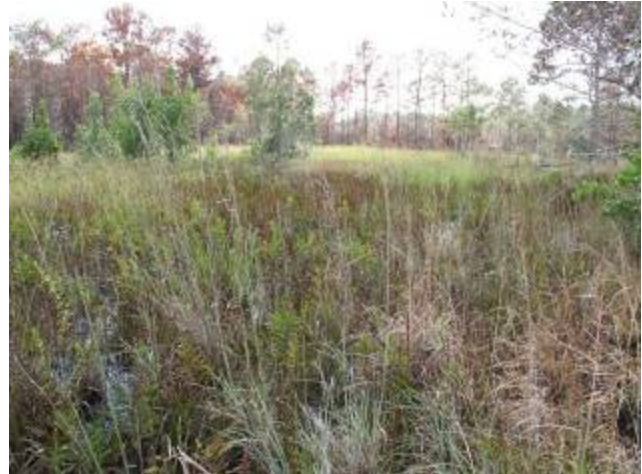
Wetland ID: 10B-02

Description: This wetland is a 0.5 ha ephemeral mixed swamp. Gum and holly trees mostly grow in a ring around the wetland edge, and cover 5-25% of the wetland basin. The midstory is dominated by loblolly bay and holly, and covers 5-25% of the wetland. Redroot and sedges/grasses grow throughout the wetland, and cover >75% of the basin. The wetland has old feral hog damage that is now recovering. A recent fire burned around the wetland edges. This wetland is in fire-maintenance condition and is a potential striped newt breeding pond. The adjacent uplands are sandhills and currently are managed with prescribed fire and mechanical vegetation removal.

Wetland Disturbance: Feral hog damage

Restoration Action Recommended: Because of the widespread damage to ephemeral wetlands on CWMA, we recommend aggressive action to reduce the overall numbers of feral hogs on the property.

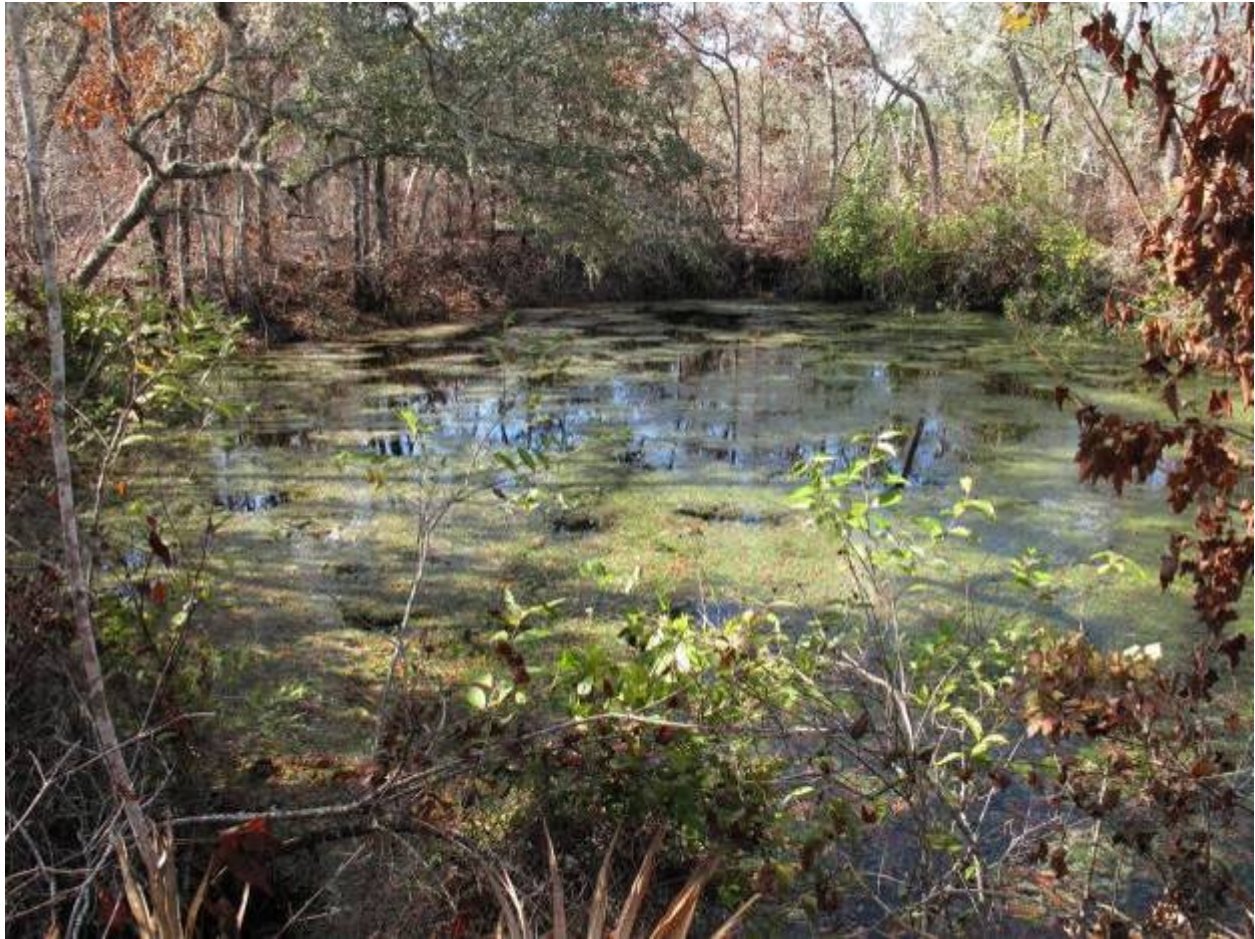
Description: This wetland is a <0.1 ha semi-permanent sinkhole pond. Oak trees grow in a ring around the wetland, and cover 25-50% of the wetland basin. Buttonbush also grows in a ring around the wetland, and covers 5-25% of the basin. Emergent vegetation grows throughout the wetland, and covers >75% of the wetland basin. A recent fire burned around the wetland edges. Fish were present on the day of our visit but the wetland. The adjacent uplands are sandhills and currently are managed with prescribed fire and mechanical vegetation removal.

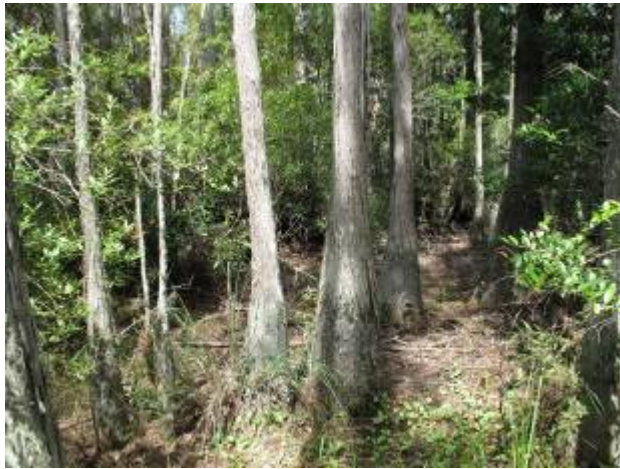
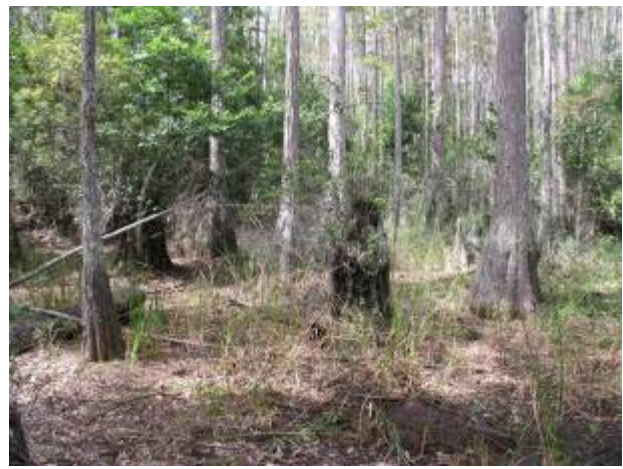
Wetland ID: 11B-01

Description: This wetland is a 3.1 ha ephemeral forested swamp. Cypress trees dominate the canopy, and cover >75% of the wetland basin. The midstory is dominated by fetterbush, holly, and wax myrtle, and covers 25-50% of the wetland. Maidencane and sawgrass grow in scattered patches, covering 25-50% of the basin. The wetland has minor feral hog damage. Old stumps provide evidence of historic logging in this wetland. This large, isolated cypress dome is a borderline semi-permanent wetland. The adjacent uplands are sandhills and currently are managed with mechanical treatments.

Wetland Disturbance: Feral hog damage

Restoration Action Recommended: Because of the widespread damage to ephemeral wetlands on CWMA, we recommend aggressive action to reduce the overall numbers of feral hogs on the property.

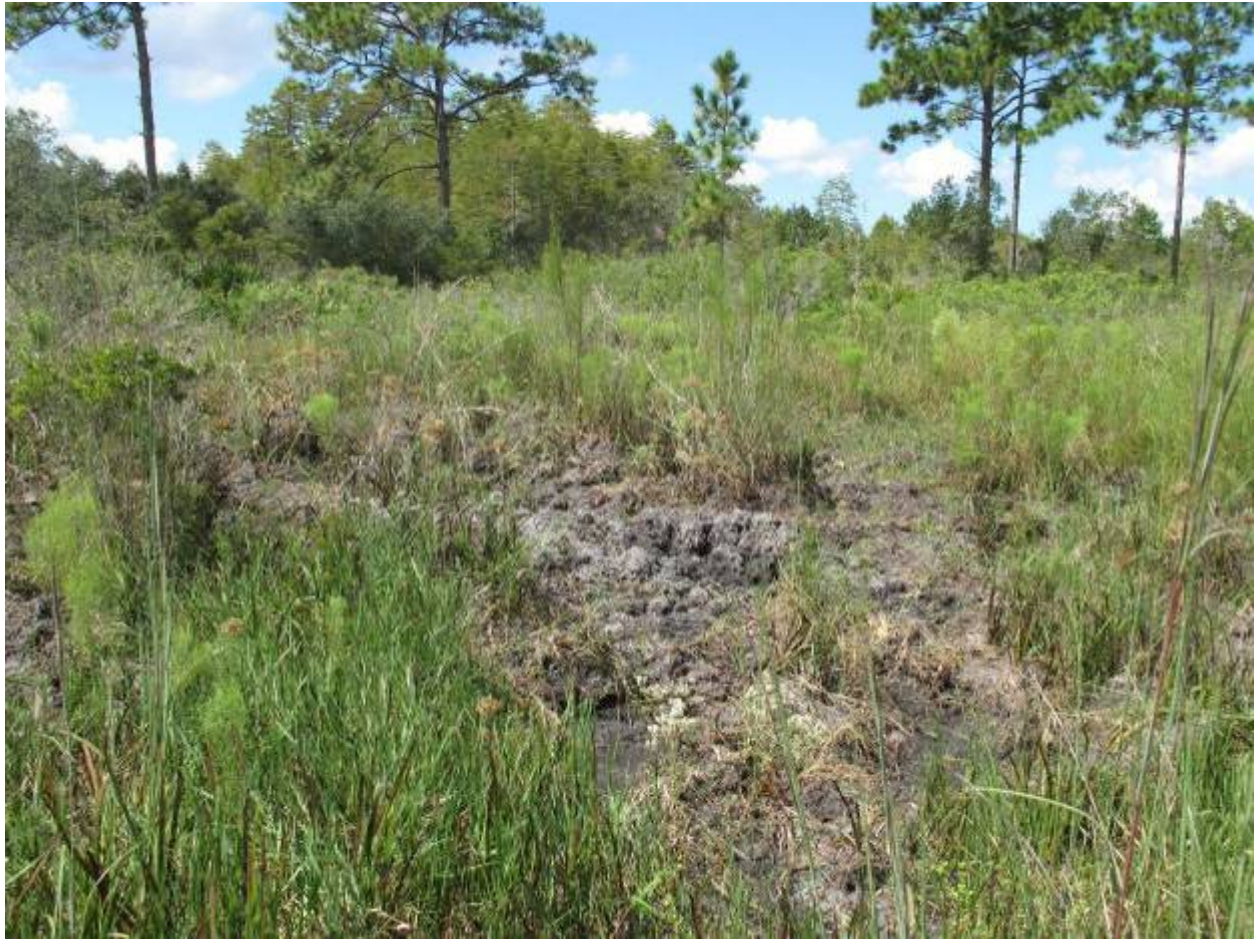
Description: This wetland is a 0.2 ha ephemeral marsh. There is no tree canopy. Dog fennel grows throughout the wetland, and covers 5-25% of the basin. Maidencane, sedges/grasses, and redroot grow throughout the wetland, and cover 50-75% of the basin. The wetland has severe feral hog damage. The adjacent uplands are sandhills and currently are managed with mechanical treatments.

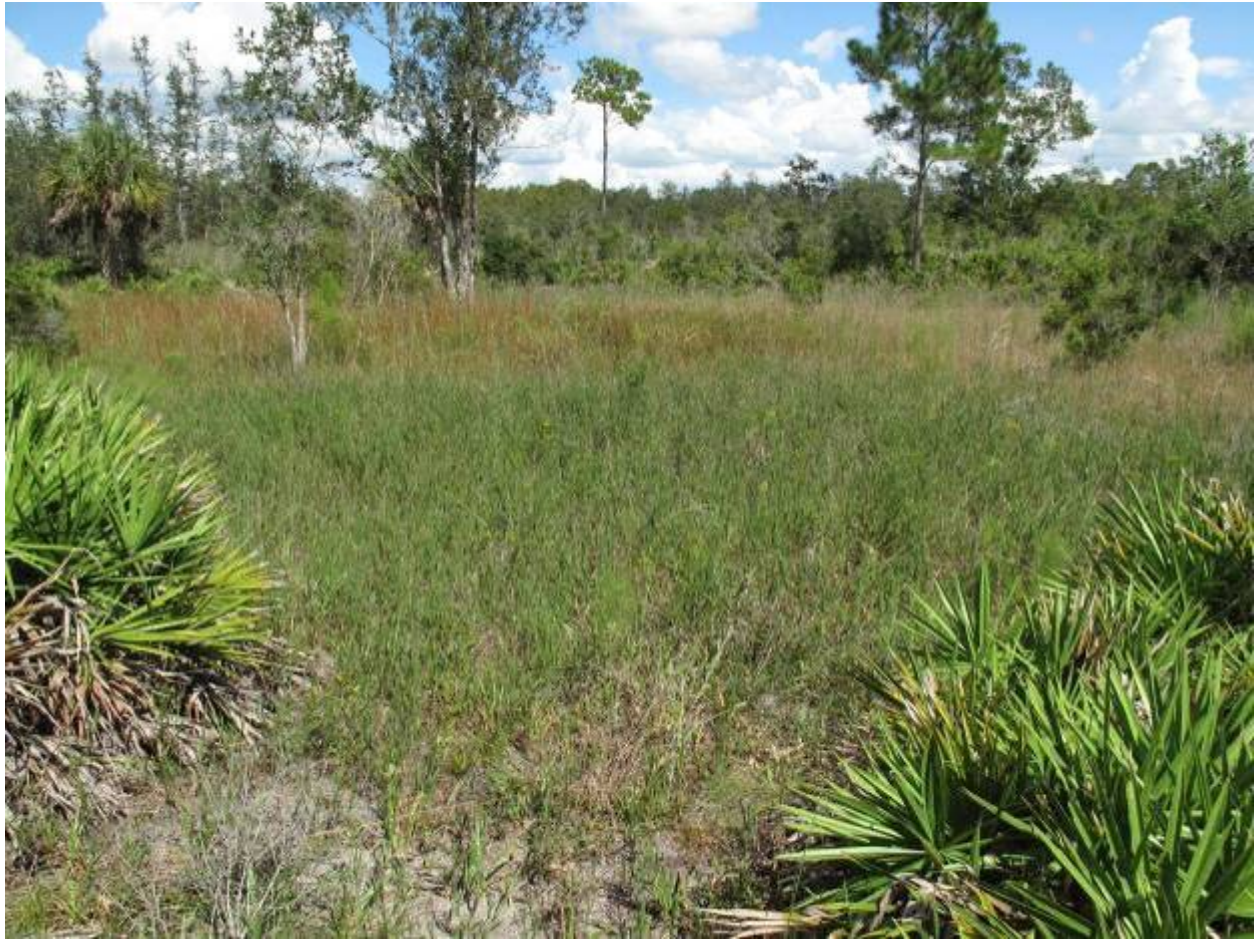
Description: This wetland is a 0.2 ha ephemeral marsh. There is no tree canopy or midstory cover. Sedges/grasses grow throughout the wetland, and cover >75% of the basin. The wetland has old feral hog damage that is recovering well. This marsh is in fire-maintenance condition and is a potential striped newt breeding pond. The adjacent uplands are sandhills and currently are managed with mechanical treatments.

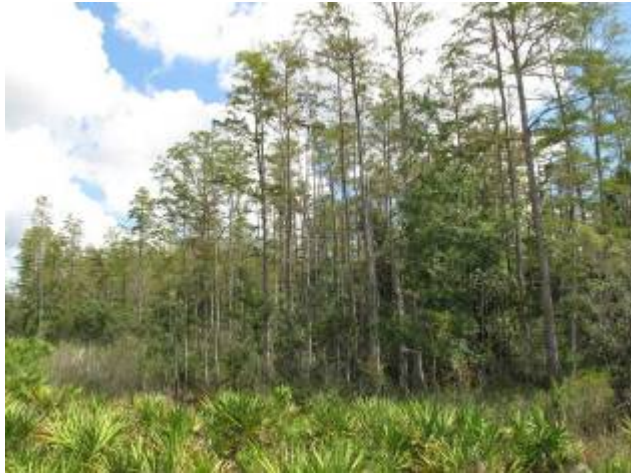
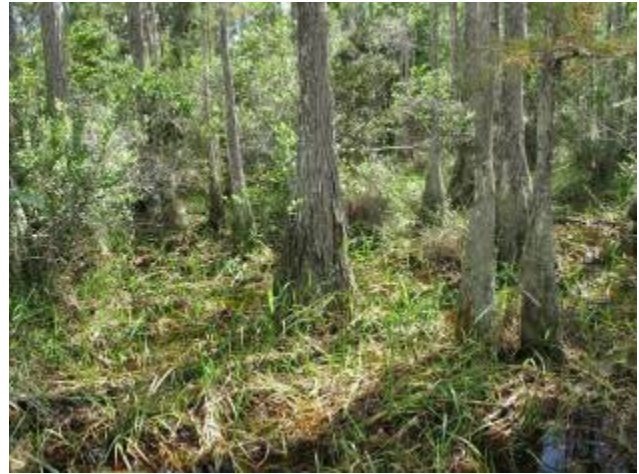
Wetland ID: 11B-04

Description: This wetland is a 9.6 ha ephemeral mixed swamp. Cypress trees dominate the canopy, and cover 50-75% of the wetland basin. The midstory is dominated by fetterbush and wax myrtle, and covers 50-75% of the wetland. Maidencane and redroot grow throughout the wetland, and cover 50-75% of the basin. This large cypress swamp has two big lobes connected by a skinny strand. The wetland has new feral hog damage. This wetland has a longer hydroperiod and appears not to have burned in a long time. The adjacent uplands are sandhills and currently are managed with mechanical treatments.

Wetland Disturbance: Feral hog damage, Woody encroachment

Restoration Action Recommended: Because of the widespread damage to ephemeral wetlands on CWMA, we recommend aggressive action to reduce the overall numbers of feral hogs on the property. Encourage fire when the wetland is completely dry to reduce the brush.

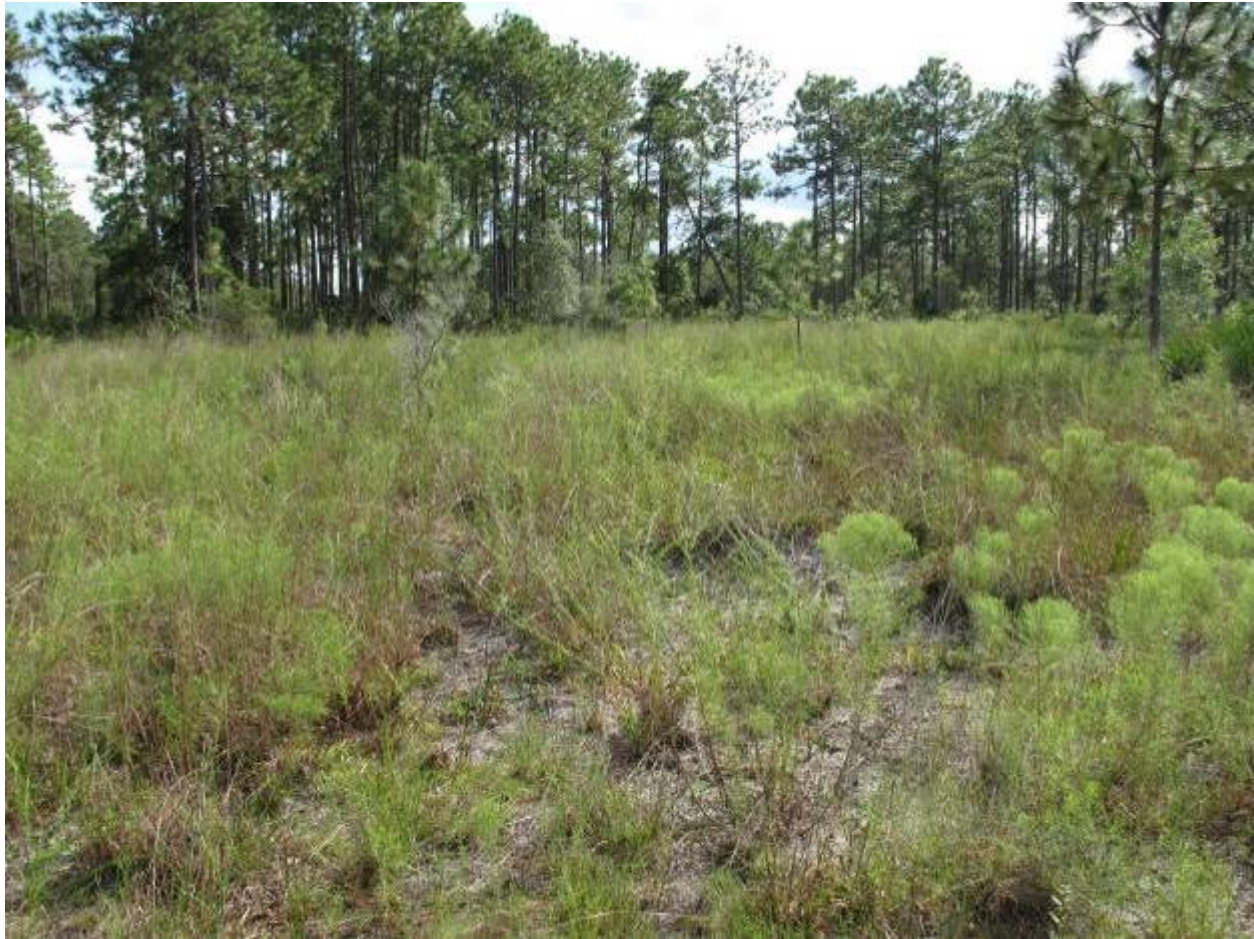
Wetland ID: 12B-01

Description: This wetland is a 0.2 ha ephemeral marsh. There is no tree canopy or midstory cover. Sedges/grasses grow throughout the wetland, and cover >75% of the basin. The wetland has old feral hog damage. This small, open marsh appears to have been dry for quite a while; a few pine trees have established in the wetland, mainly around edge. The wetland is a potential striped newt breeding pond. The adjacent uplands are sandhills and currently are managed with prescribed fire and mechanical vegetation removal.

Wetland Disturbance: Feral hog damage, Woody encroachment

Restoration Action Recommended: Because of the widespread damage to ephemeral wetlands on CWMA, we recommend aggressive action to reduce the overall numbers of feral hogs on the property. Monitor this wetland to ensure pine trees are killed with the next fire or inundation. If they become established, the encroaching pine trees will need to be removed from the wetland. Alternatively, the small pine trees can be hand-chopped now.

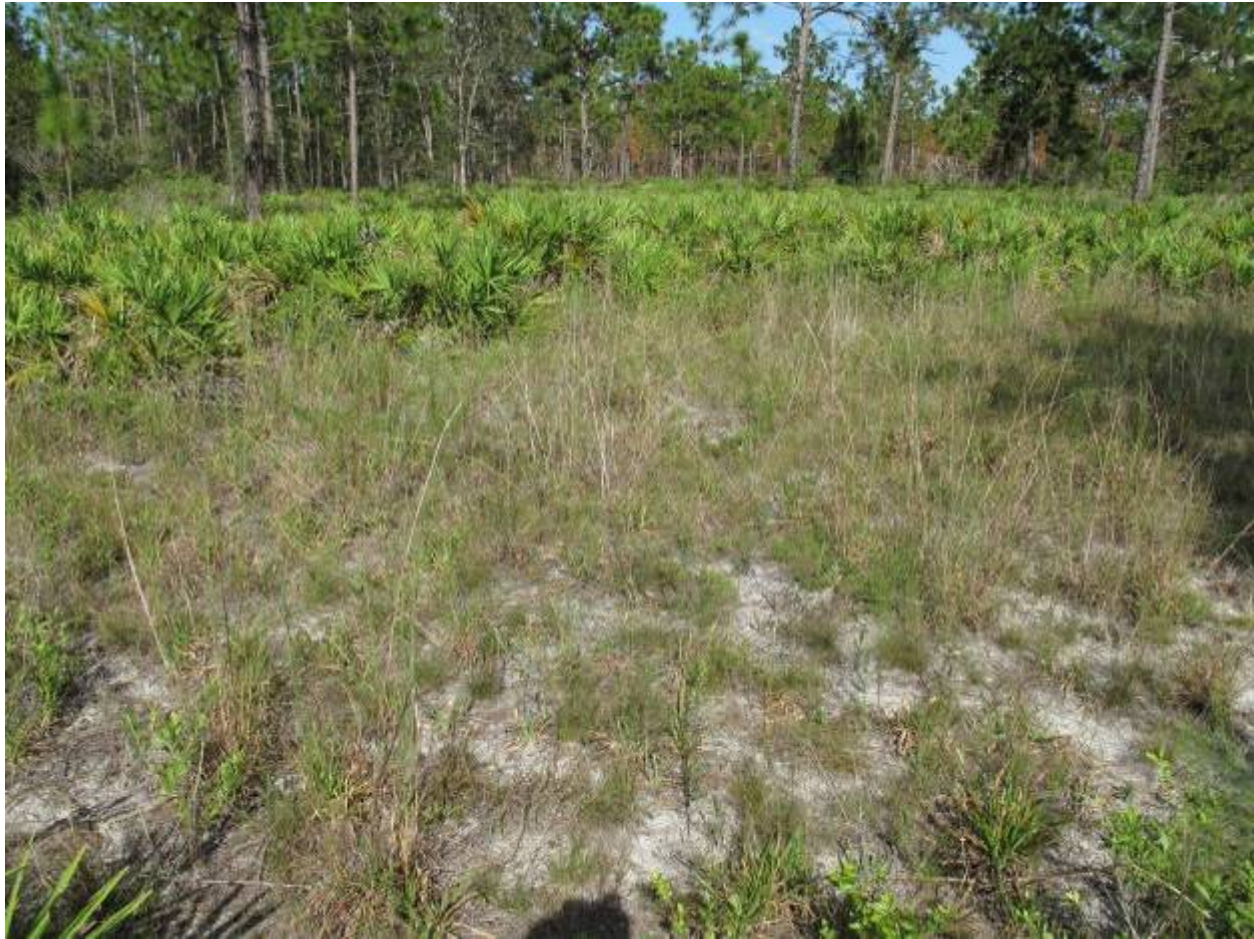
Wetland ID: 12B-02

Description: This wetland is a 0.2 ha highly ephemeral marsh. There is no tree canopy. Clumps of saw palmetto cover 5-25% of the wetland. Sedges/grasses grow throughout the wetland, and cover >75% of the basin. This marsh is in fire-maintenance condition and is a potential striped newt breeding pond. The adjacent uplands are sandhills and currently are managed with prescribed fire and mechanical vegetation removal.

Wetland Disturbance: None

Restoration Action Recommended: None

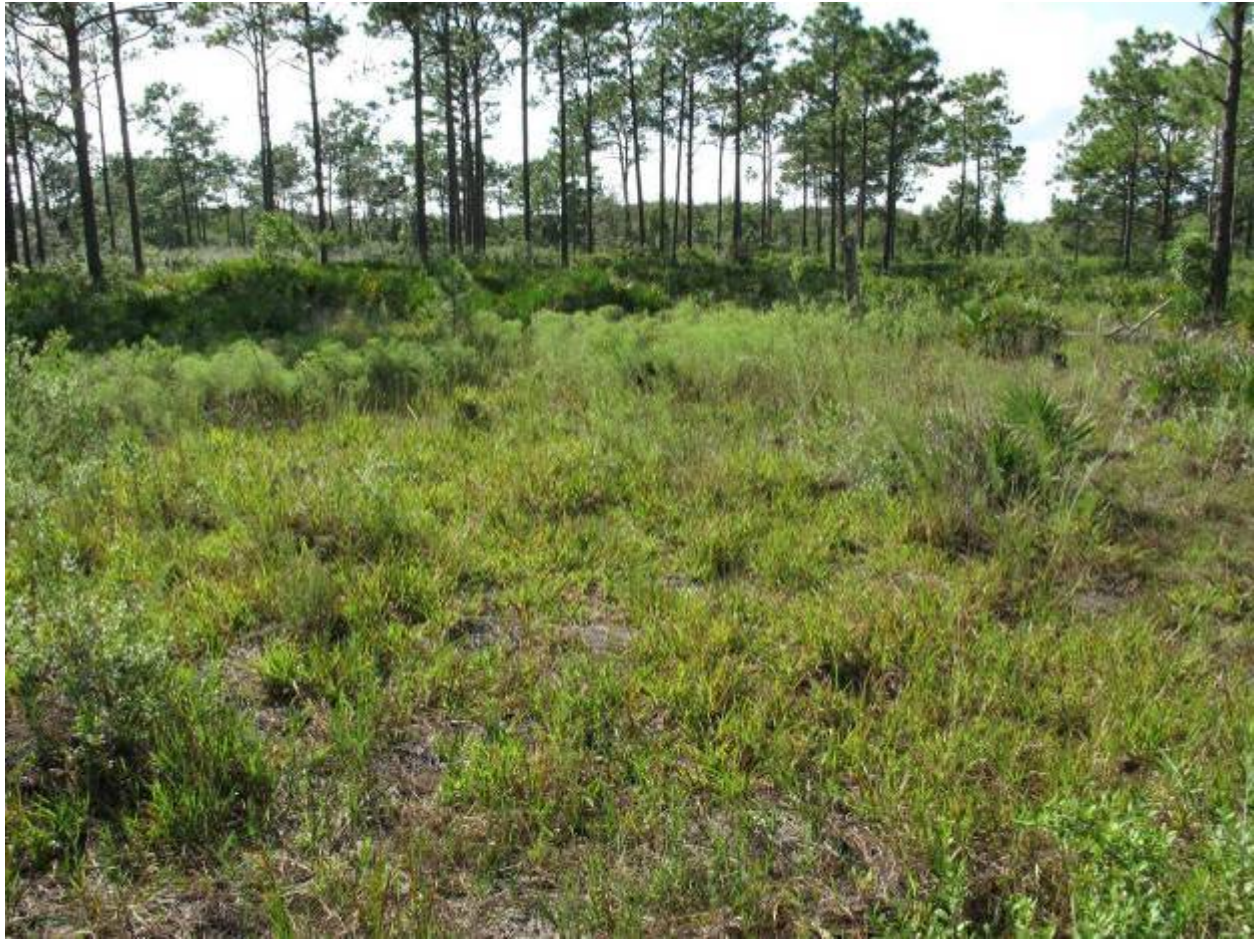
Wetland ID: 12B-03

Description: This wetland is a 0.1 ha highly ephemeral marsh. There is no tree canopy. Gallberry and saw palmetto cover 5-25% of the wetland basin. Sedges/grasses grow throughout the wetland, and cover >75% of the basin. A prolonged dry period in what was already a highly ephemeral marsh allowed the shrubs to establish. The adjacent uplands are mesic flatwoods and currently are managed with mechanical treatments.

Wetland Disturbance: None

Restoration Action Recommended: Encourage periodic fire in the wetland to prevent further gallberry encroachment. The wetland may need to be custom burned.

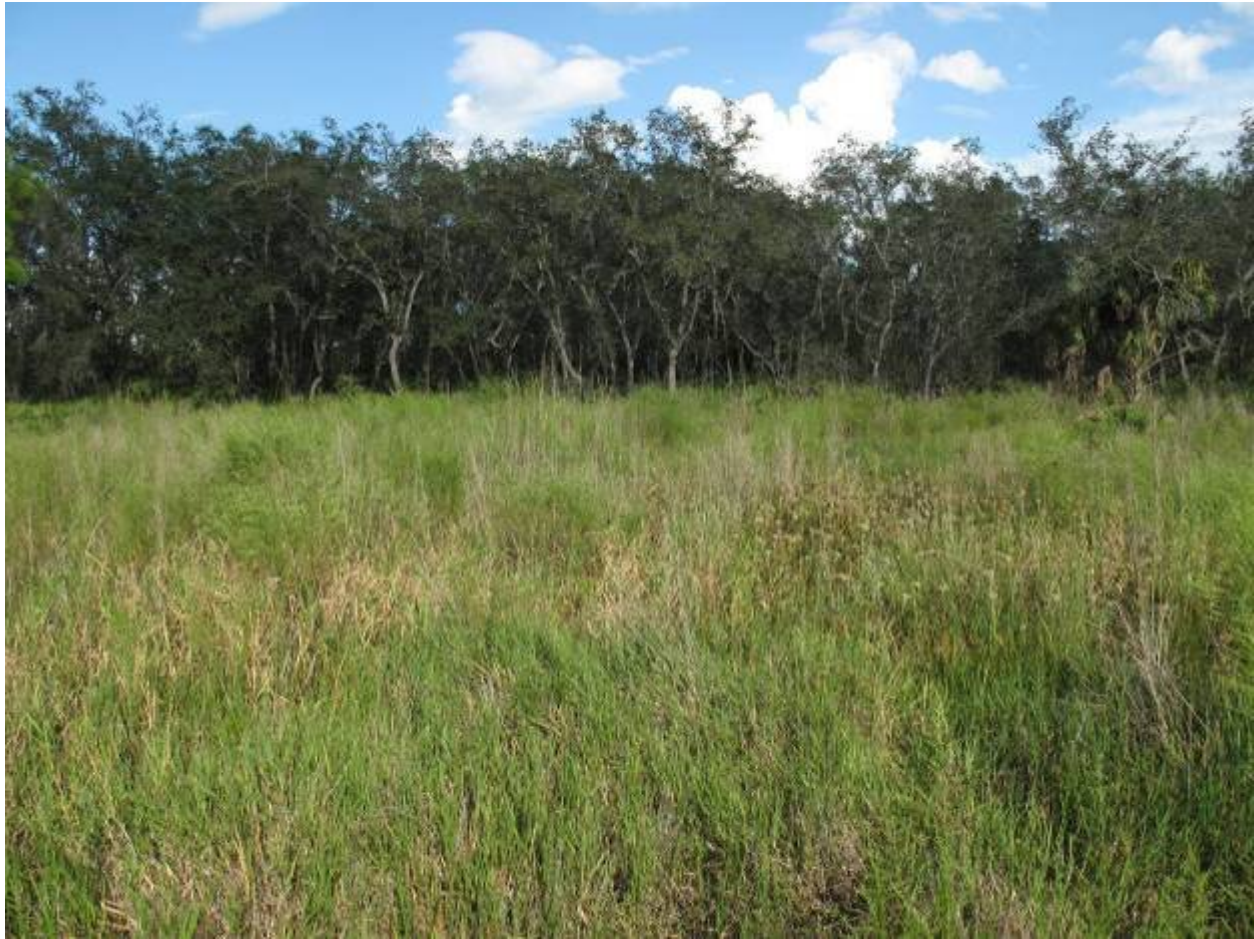
Wetland ID: 12B-04

Description: This wetland is a 0.2 ha ephemeral marsh. There is no tree canopy or midstory cover. Maidencane grows densely throughout the wetland, and covers >75% of the basin. The wetland has old feral hog damage that has grown over with vegetation. The adjacent uplands are scrubby flatwoods, sandhills, and xeric hammock. The uplands currently are managed with mechanical treatments.

Wetland Disturbance: Feral hog damage

Restoration Action Recommended: Because of the widespread damage to ephemeral wetlands on CWMA, we recommend aggressive action to reduce the overall numbers of feral hogs on the property. Encourage fire in the wetland to reduce the thick maidencane.

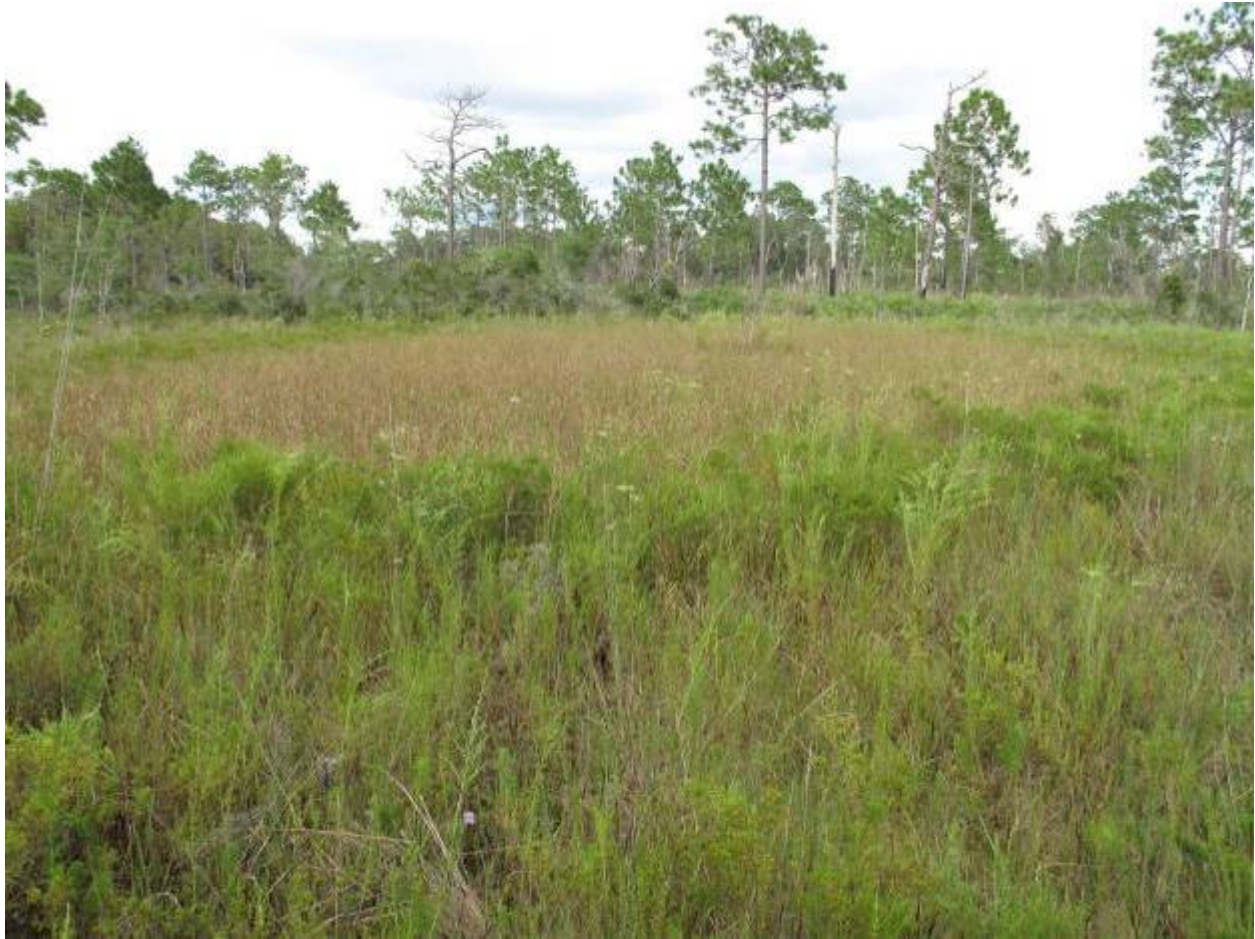
Description: This wetland is a 0.3 ha ephemeral marsh. There is no tree canopy or midstory cover. Sedges/grasses grow throughout the wetland, and cover >75% of the basin. The wetland has minor feral hog damage. This wetland will connect to the big swamp to the north during periods of high water. This marsh is in fire-maintenance condition and is a potential striped newt breeding pond. The adjacent uplands are sandhills and currently are managed with mechanical treatments.

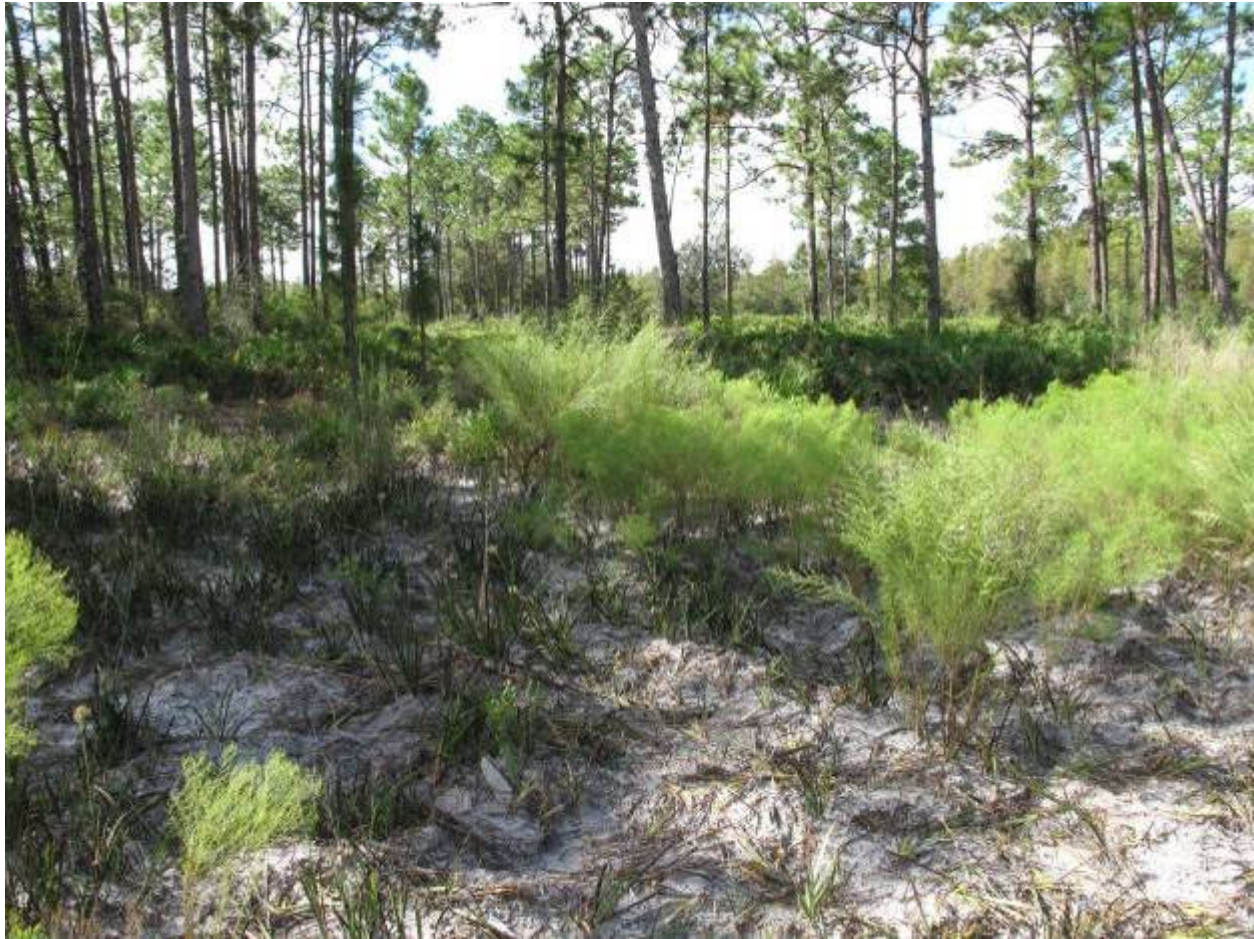
Wetland ID: 12B-06

Description: This wetland is a <0.1 ha highly ephemeral marsh. There is no tree canopy. Dog fennel covers 50-75% of the wetland basin. Redroot grows throughout the wetland, and cover 50-75% of the basin. The wetland has severe feral hog damage. The adjacent uplands are mesic flatwoods and sandhill and currently are managed with mechanical treatments.

Wetland Disturbance: Feral hog damage

Restoration Action Recommended: Because of the widespread damage to ephemeral wetlands on CWMA, we recommend aggressive action to reduce the overall numbers of feral hogs on the property.

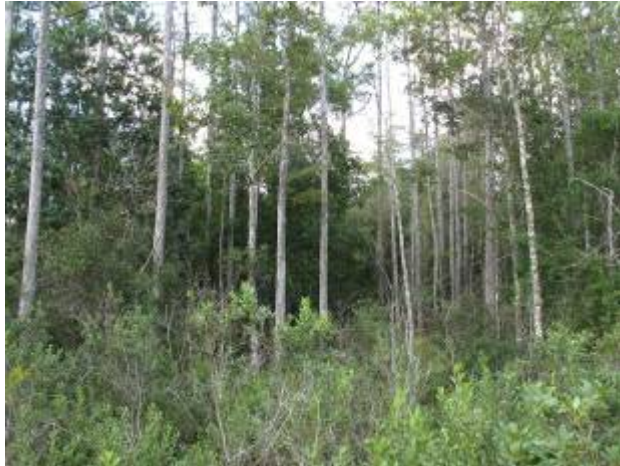
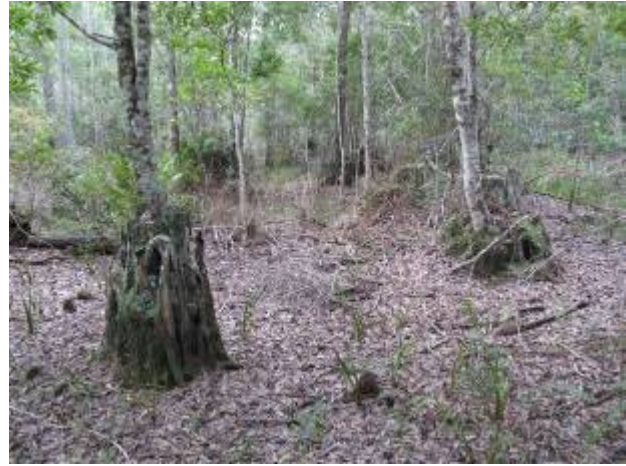
Wetland ID: 12B-07

Description: This wetland is a 0.9 ha ephemeral forested swamp. Cypress and holly trees dominate the canopy, and cover >75% of the wetland basin. The midstory is dominated by wax myrtle and holly, and covers 25-50% of the wetland basin. Fern grow throughout the wetland, and cover 5-25% of the basin. The wetland has minor, old feral hog damage and thick duff. Cypress stumps provide evidence of historical logging in the wetland. The wetland is surrounded by a dense ring of gallberry and saw palmetto. The adjacent uplands are sandhills and currently are managed with mechanical treatments.

Wetland Disturbance: Feral hog damage, Woody encroachment

Restoration Action Recommended: Because of the widespread damage to ephemeral wetlands on CWMA, we recommend aggressive action to reduce the overall numbers of feral hogs on the property. Encourage periodic fire in the wetland to reduce the brush and prevent further encroachment of woody vegetation.

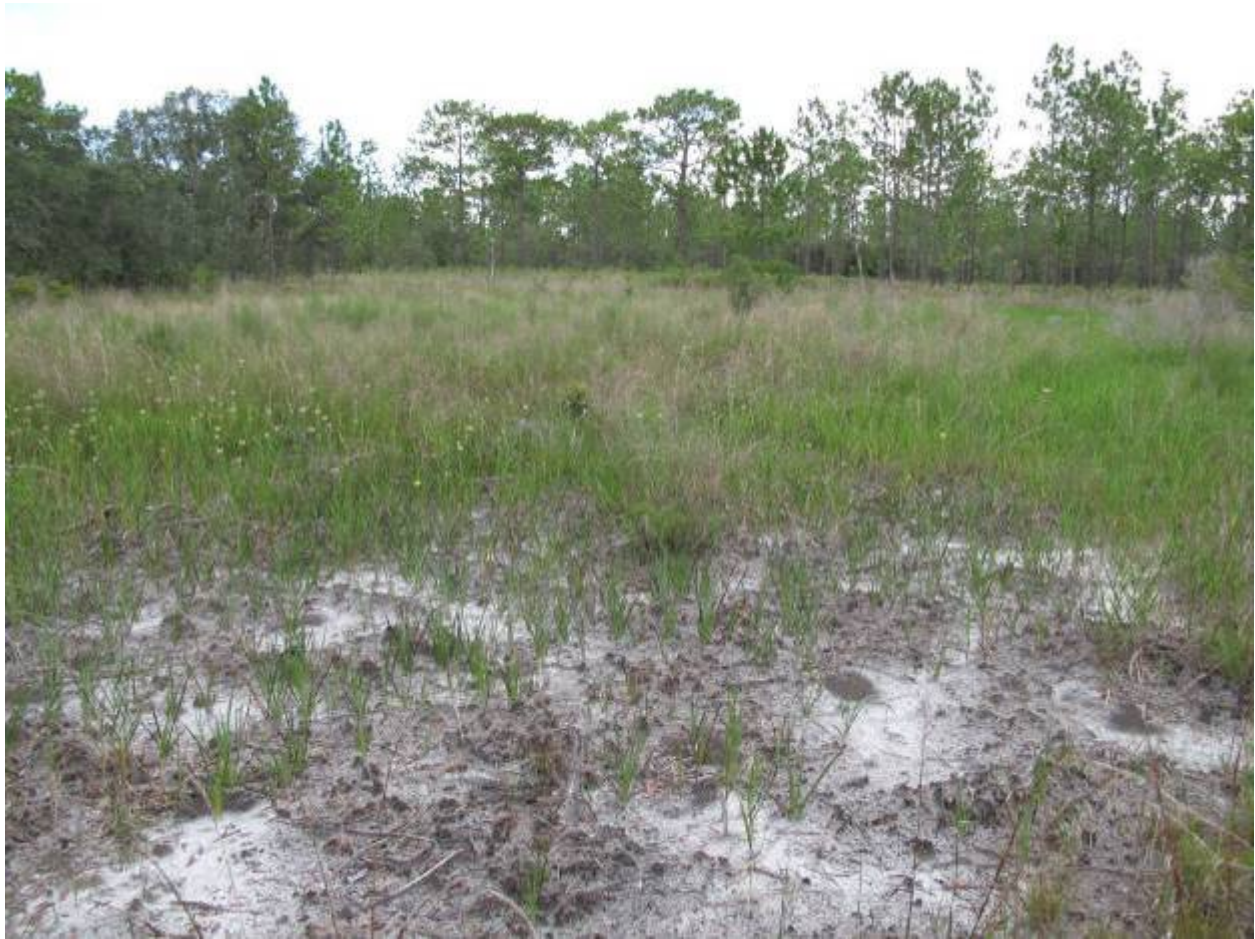
Description: This wetland is a 0.4 ha ephemeral marsh. There is no canopy or midstory cover. A diverse array of sedges/grasses grows throughout the wetland, and covers >75% of the basin. The wetland has a heavy ring of feral hog rooting around the perimeter. This marsh is in fire-maintenance condition and is a potential striped newt breeding pond. The adjacent uplands are sandhills. The sandhills appear to have been fire suppressed but now are managed with prescribed fire.

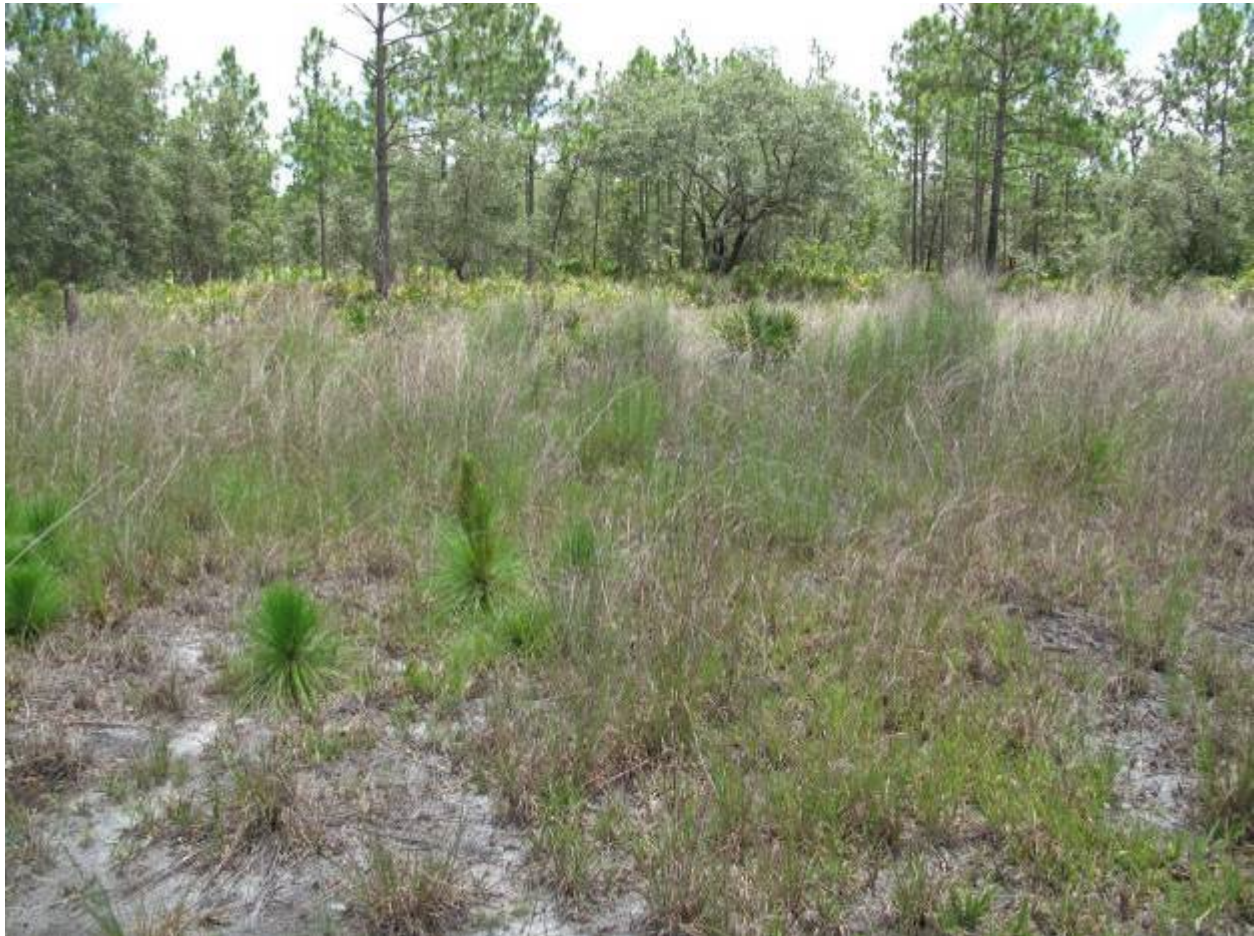
Wetland ID: 01C-02

Description: This wetland is a 0.1 ha ephemeral marsh. There is no canopy or midstory cover. Sedges/grasses grow throughout the wetland, and cover >75% of the basin. This marsh is in fire-maintenance condition and is a potential striped newt breeding pond. The adjacent uplands are sandhills. The sandhills appear to have been fire suppressed but now are managed with prescribed fire.

Wetland Concerns: None

Restoration Action Recommended: None

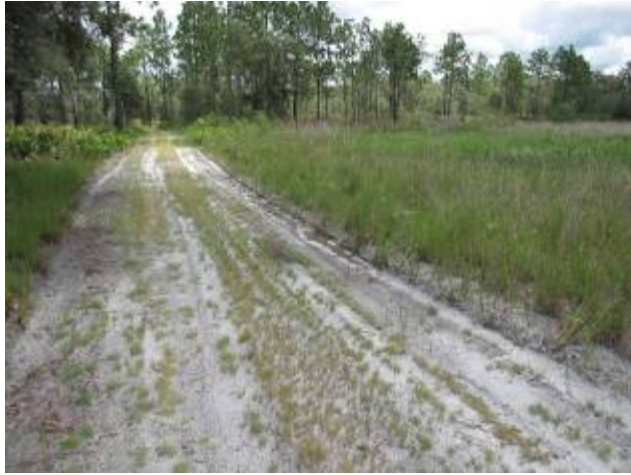
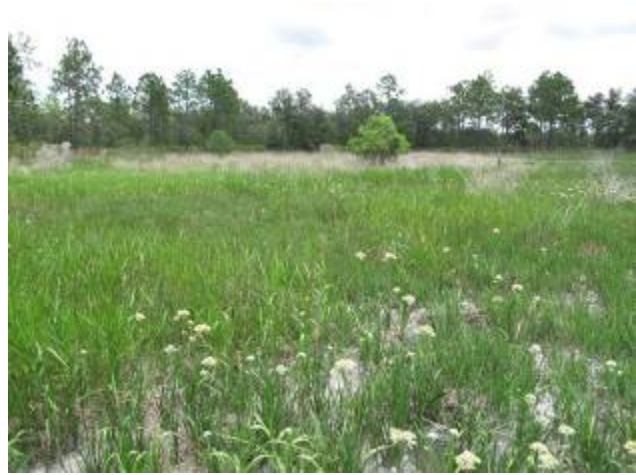
Wetland ID: 01C-03

Description: This wetland is a 0.5 ha ephemeral marsh. There is no canopy or midstory cover. Maidencane and redroot grow throughout the wetland, and cover >75% of the basin. The wetland has extensive feral hog damage that is recovering well. A fireline/MU boundary runs along the west side of the wetland. The wetland has a monitoring well. This marsh is in fire-maintenance condition and is a potential striped newt breeding pond. The adjacent uplands are sandhills. The sandhills appear to have been fire suppressed but now are managed with prescribed fire.

Wetland Concerns: Feral hog damage, Fireline

Restoration Action Recommended: Because of the widespread damage to ephemeral wetlands on CWMA, we recommend aggressive action to reduce the overall numbers of feral hogs on the property. The fireline/MU boundary should be re-routed away from the wetland. If the fireline cannot be re-routed, monitor the wetland to ensure fire is not excluded. Maintain the fireline when the wetland is completely dry to prevent ruts from developing.

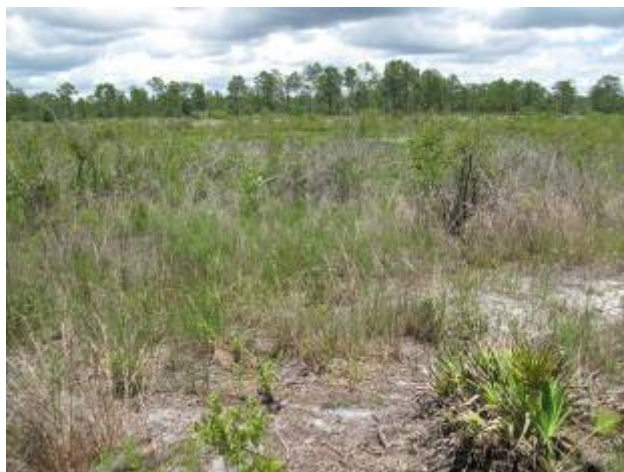
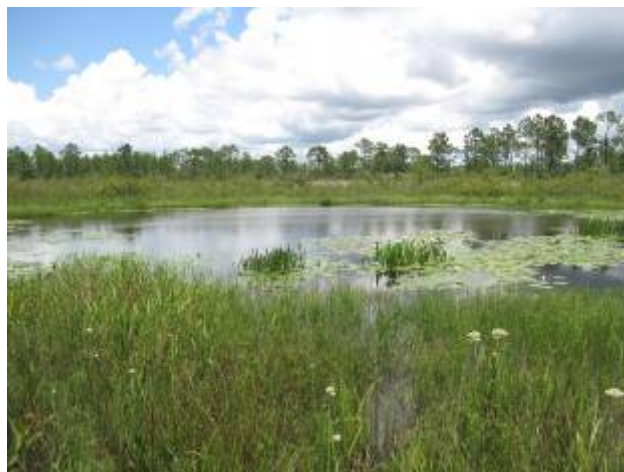
Wetland ID: 01C-04

Description: This wetland is a 4.5 ha semi-permanent marsh. There is no tree canopy. Buttonbush covers 25-50% of the wetland. Sedges/grasses grow throughout the wetland, and cover >75% of the basin. This large, treeless marsh has a deep, water-filled center hole. The wetland has light feral hog damage. A very shallow ditch bisects the wetland, and appears to manage storm water run-off for the nearby highway (US 19). This wetland has diverse herbaceous vegetation and would be a great striped newt breeding pond if it does not harbor carnivorous fish. The adjacent uplands are sandhills. The sandhills appear to have been fire suppressed but now are managed with prescribed fire.

Wetland Concerns: Ditching, Feral hog damage, Woody encroachment

Restoration Action Recommended: Fill the ditch to break the connection of this wetland to potential road run-off. Because of the widespread damage to ephemeral wetlands on CWMA, we recommend aggressive action to reduce the overall numbers of feral hogs on the property. Encourage periodic fire in the wetland to prevent further shrub encroachment.

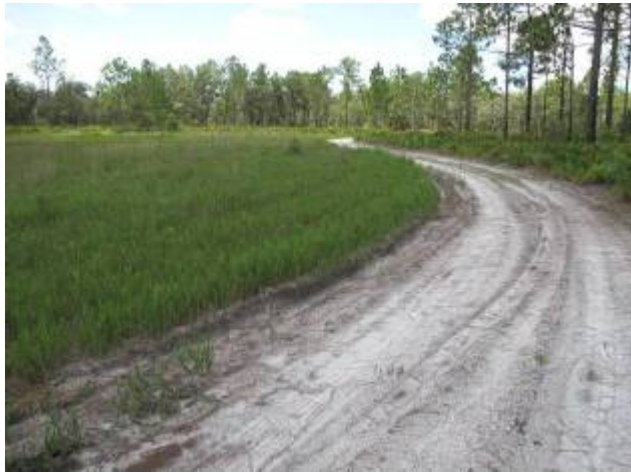
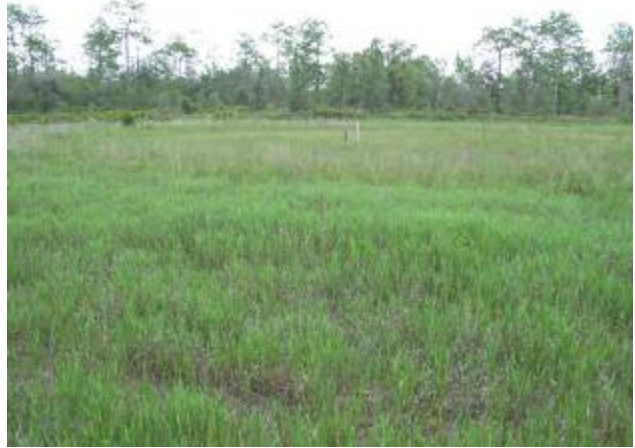
Wetland ID: 02C-01

Description: This wetland is a 0.6 ha ephemeral marsh. There is no canopy or midstory cover. A diverse array of sedges/grasses and maidencane grows throughout the wetland, and covers >75% of the basin. The wetland has old feral hog damage that is recovering nicely. A fireline/MU boundary runs along the west side of the wetland. This marsh is in fire-maintenance condition and is a potential striped newt breeding pond. The adjacent uplands are sandhills. The sandhills appear to have been fire suppressed but now are managed with prescribed fire.

Wetland Concerns: Feral hog damage, Fireline

Restoration Action Recommended: Because of the widespread damage to ephemeral wetlands on CWMA, we recommend aggressive action to reduce the overall numbers of feral hogs on the property. The fireline/MU boundary should be re-routed away from the wetland. If the fireline cannot be re-routed, monitor the wetland to ensure fire is not excluded. Maintain the fireline when the wetland is completely dry to prevent ruts from developing.

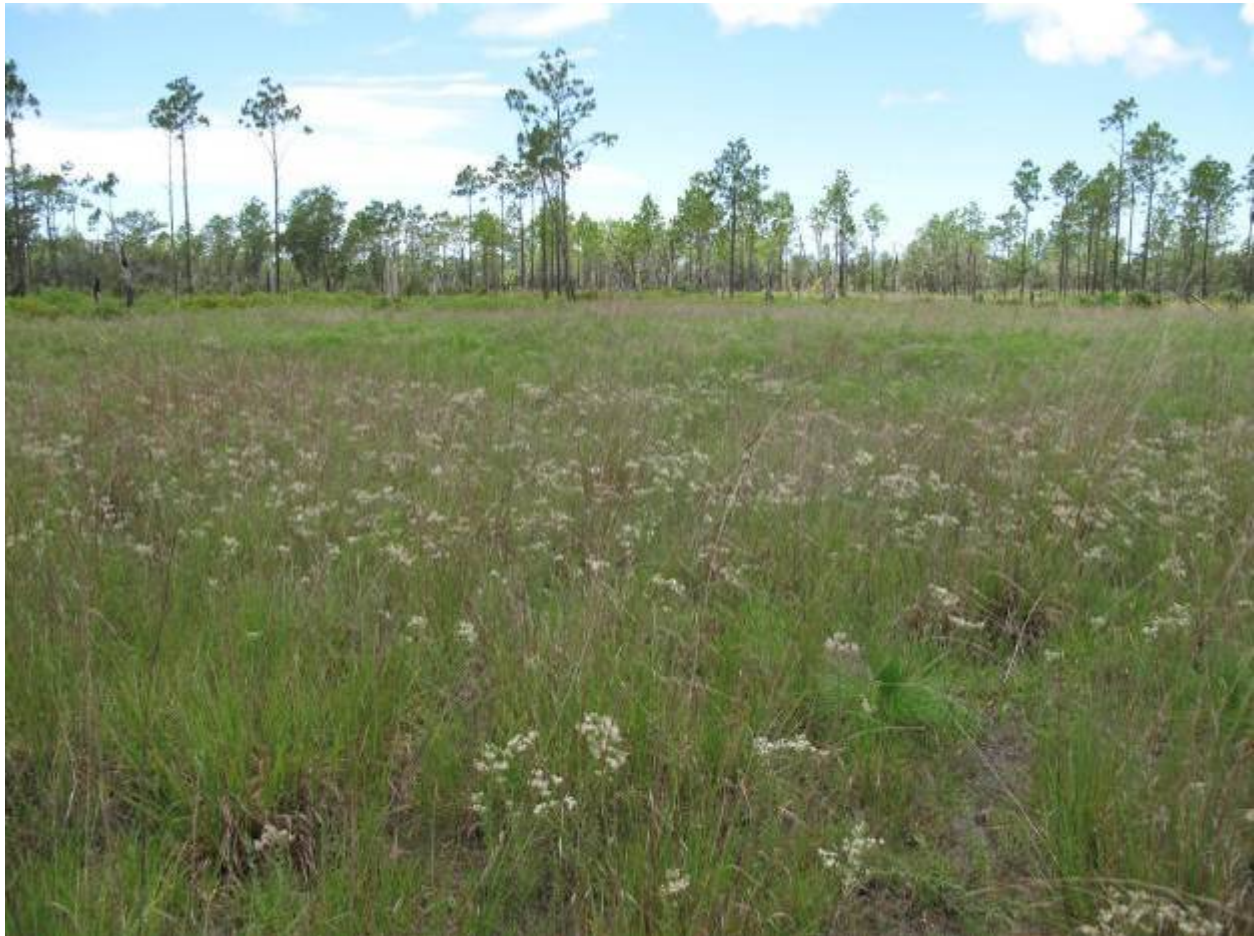
Wetland ID: 02C-02

Description: This wetland is a 0.6 ha ephemeral marsh. There is no canopy or midstory cover. A diverse array of sedges/grasses grows throughout the wetland, and covers >75% of the basin. A recent fire eliminated many large slash pine trees around the edge of the wetland. This marsh is in fire-maintenance condition and is a potential striped newt breeding pond. The adjacent uplands are sandhills. The sandhills appear to have been fire suppressed but now are managed with prescribed fire.

Wetland Concerns: None

Restoration Action Recommended: None
