Inventory, Assessment, and Restoration Potential of Ephemeral Wetlands on FFWCC Wildlife Management Areas

Chassahowitzka WMA Final Report

Submitted by: Rebecca P.M. Means¹, Ryan C. Means¹, Steven A. Johnson²

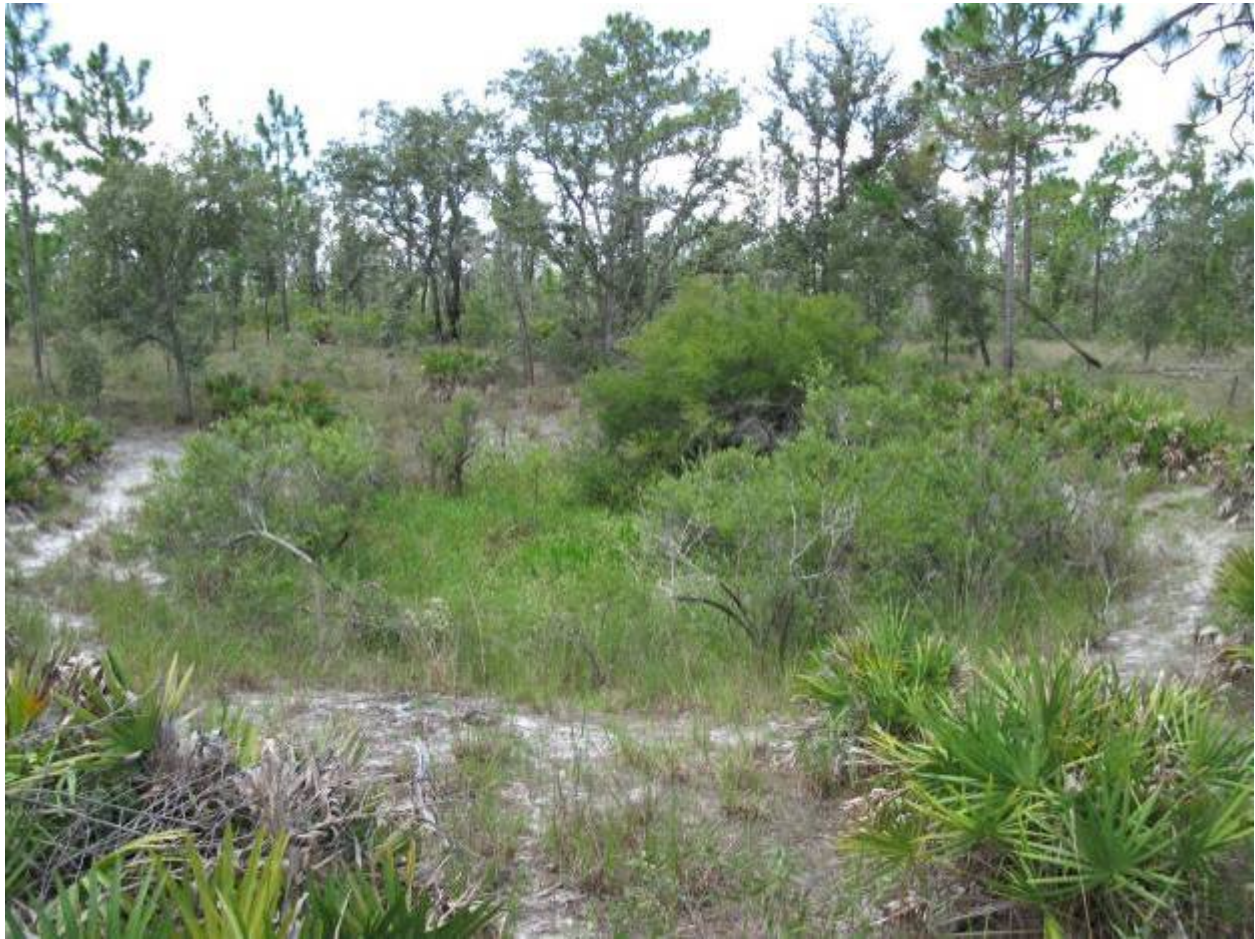
Description: This wetland is a <0.1 ha ephemeral marsh in a steep-sided sink depression. This small, yet potentially very productive wetland, is a classical depressional ephemeral marsh in sandhills created by local karst geology. There is no tree canopy. Buttonbush covers 25-50% of the wetland. The interior shrubbery occupies a natural fire shadow caused by steep sidewalls and long hydroperiod. Maidencane grows throughout the wetland, and covers >75% of the basin. This marsh is a potential striped newt breeding pond. The adjacent uplands are sandhills. The sandhills appear to have been fire suppressed but now are managed with prescribed fire.

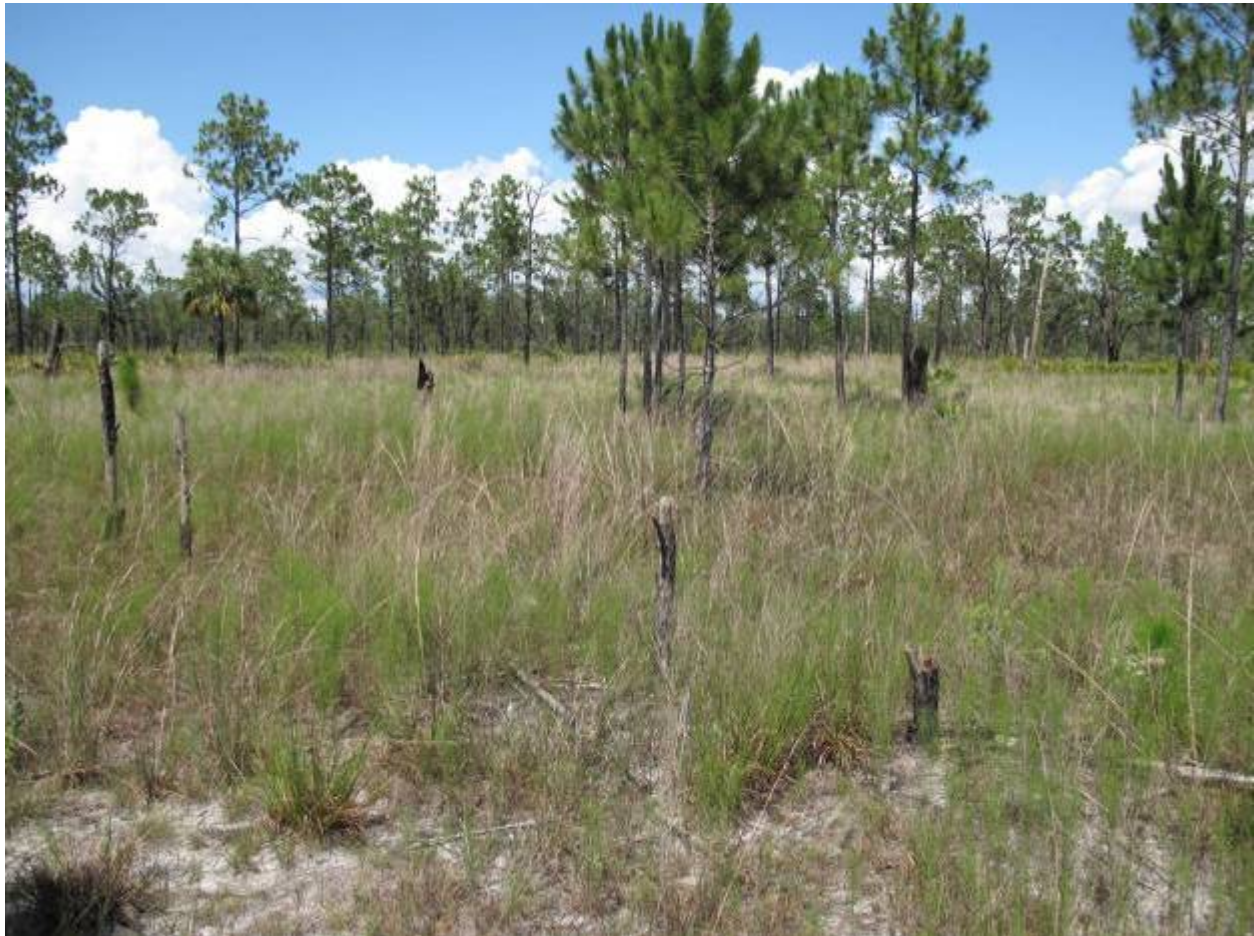
Wetland ID: 02C-04

Description: This wetland is a 0.2 ha highly ephemeral marsh. Pine trees dominate the canopy, and cover 5-25% of the wetland. There is no midstory cover. Sedges/grasses grow throughout the wetland, and cover >75% of the basin. Recent inundation and fire killed almost all the encroaching slash pine trees. This wetland provides a good example for observing the opposing forces of encroachment, and inundation and fire. The adjacent uplands are sandhills. The sandhills appear to have been fire suppressed but now are managed with prescribed fire.

Wetland Concerns: Woody Encroachment

Restoration Action Recommended: Monitor this wetland to ensure remaining pine trees are killed with the next fire or inundation. If they become established, the encroaching pine trees will need to be removed from the wetland. Alternatively, the small pine trees can be hand-chopped now.

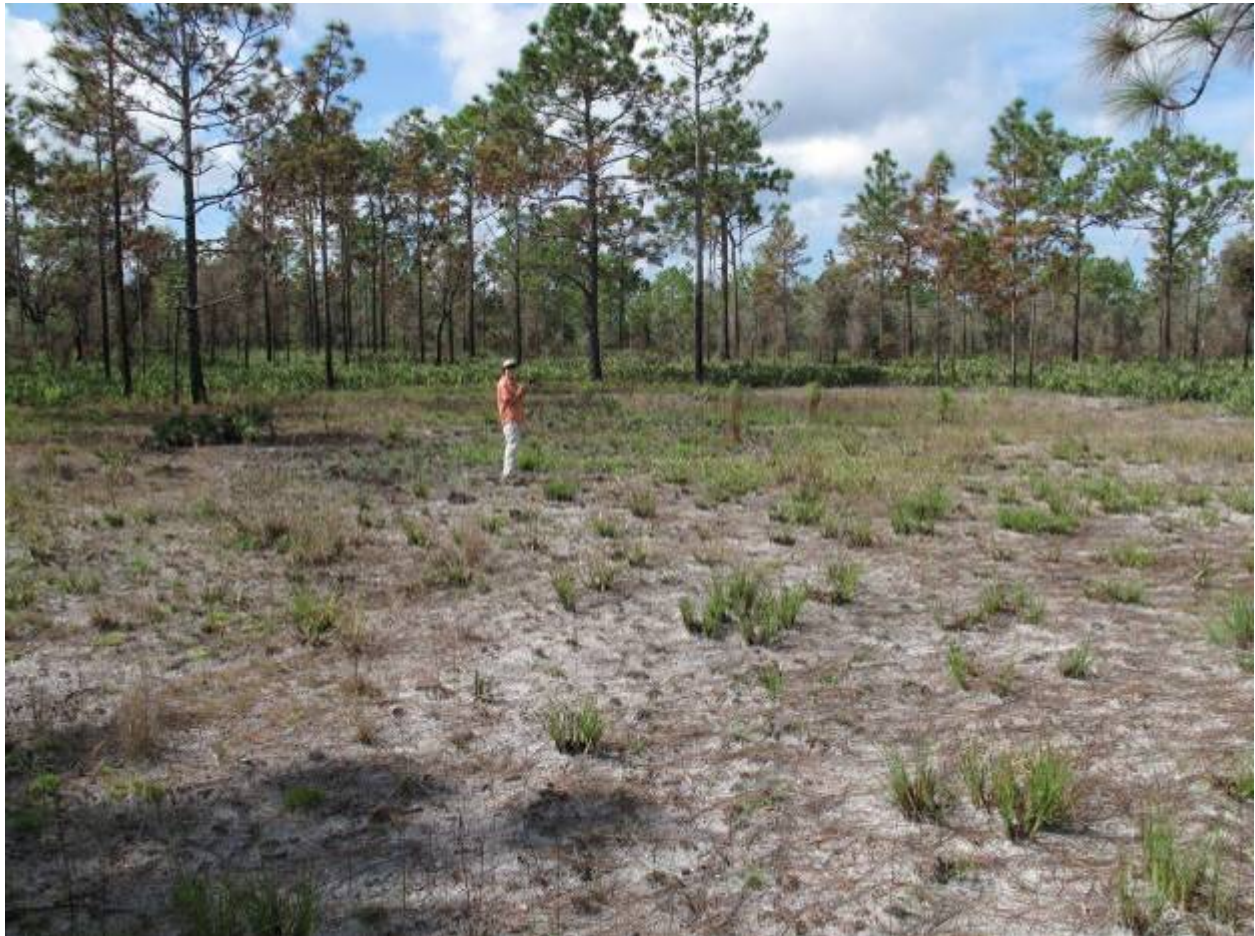
Wetland ID: 02C-05

Description: This wetland is a 0.1 ha highly ephemeral marsh. There is no tree canopy or midstory cover. Sedges/grasses grow in scattered patches, and cover 25-50% of the wetland basin. A recent fire burned through the wetland. This marsh is in fire-maintenance condition and is a potential striped newt breeding pond. The adjacent uplands are sandhills. The sandhills appear to have been fire suppressed but now are managed with prescribed fire.

Wetland Concerns: None

Restoration Action Recommended: None

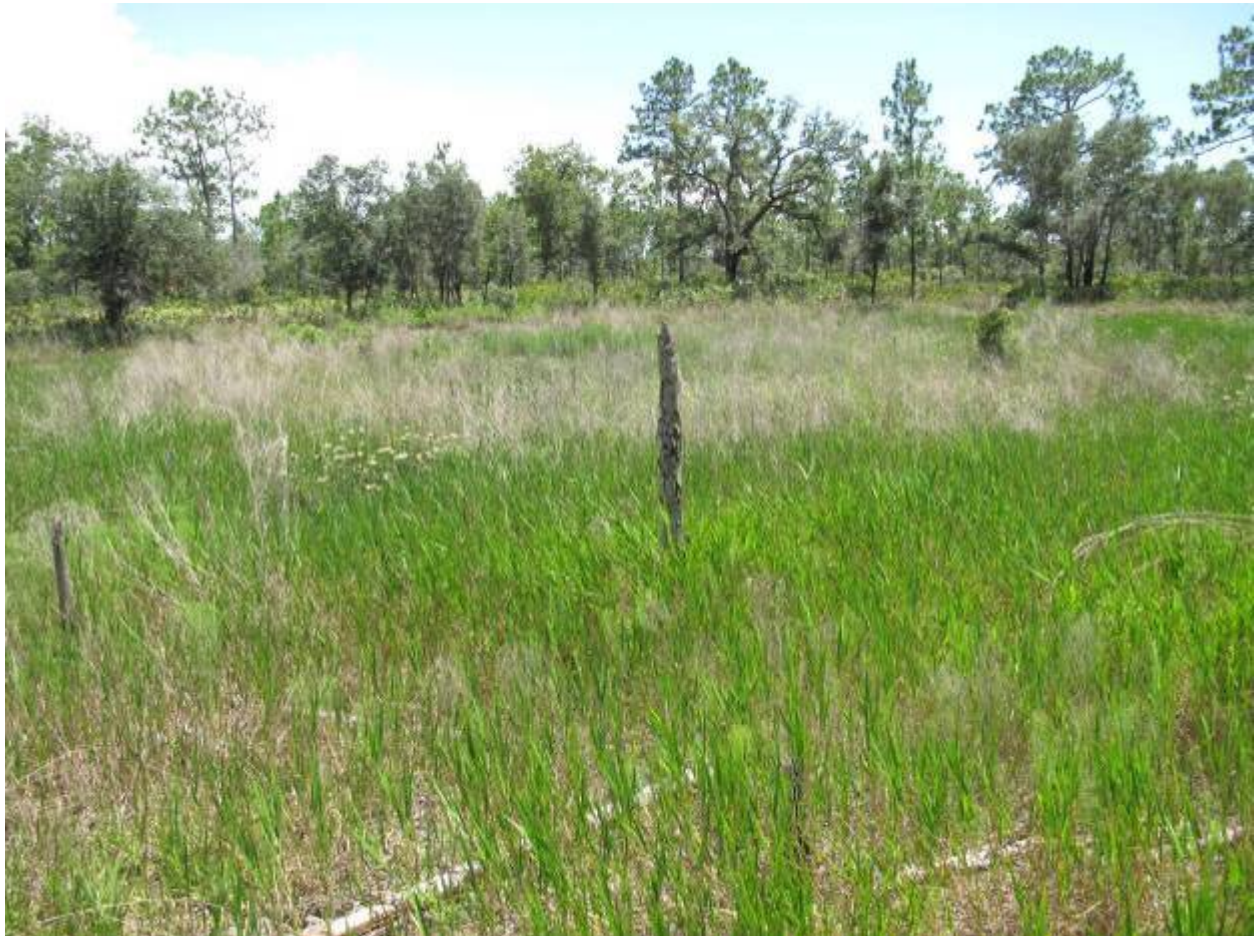
Wetland ID: 03C-01

Description: This wetland is a 0.2 ha ephemeral marsh. There is no tree canopy or midstory cover. A diverse array of sedges/grasses grows throughout the wetland, and covers >75% of the basin. The wetland has minor, old feral hog damage. This marsh is in fire-maintenance condition and is a potential striped newt breeding pond. The adjacent uplands are sandhills. The sandhills appear to have been fire suppressed but now are managed with prescribed fire.

Wetland Concerns: Feral hog damage

Restoration Action Recommended: Because of the widespread damage to ephemeral wetlands on CWMA, we recommend aggressive action to reduce the overall numbers of feral hogs on the property.

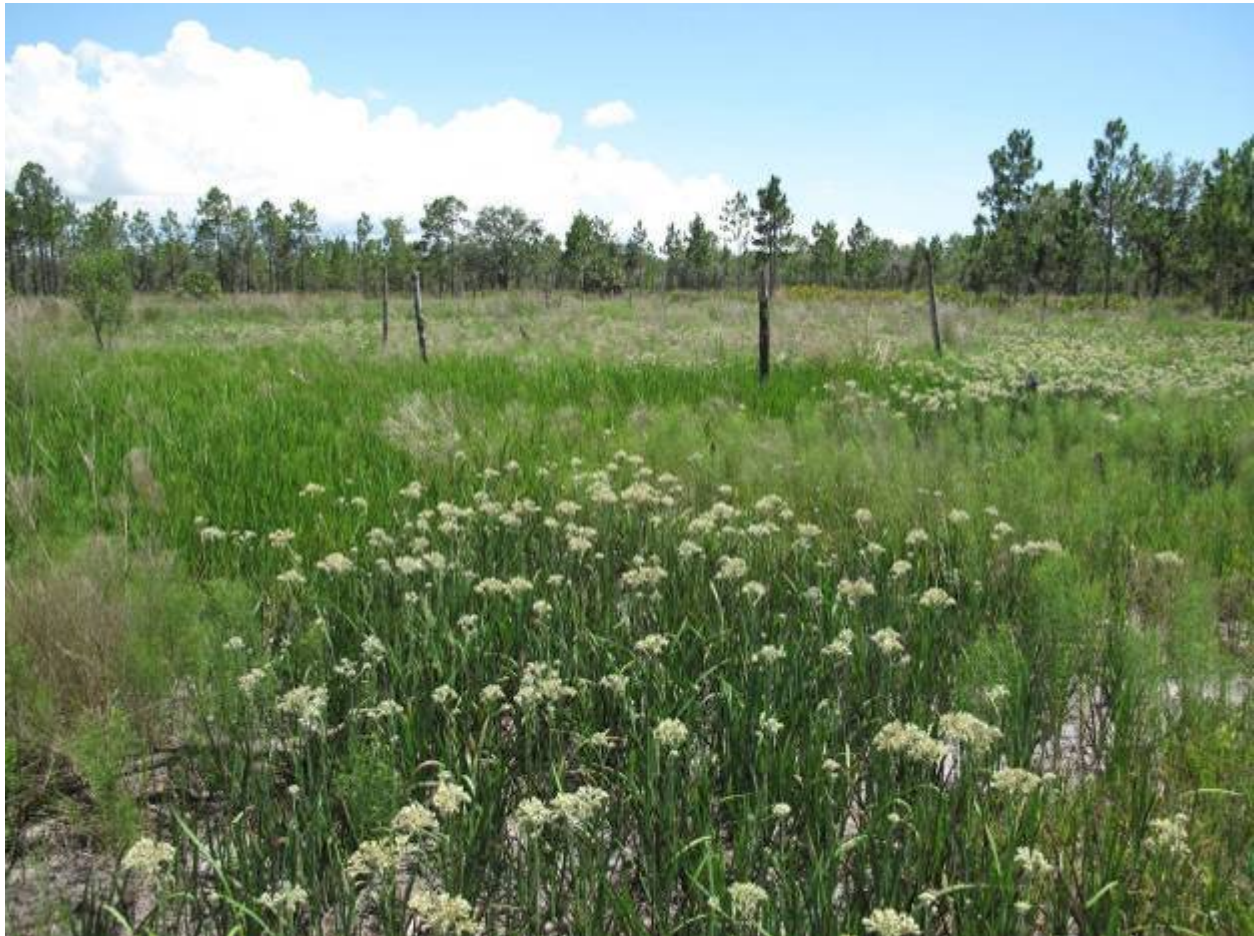
Wetland ID: 03C-02

Description: This wetland is a 1.0 ha ephemeral marsh. There is no tree canopy or midstory cover. Redroot and maidencane grow throughout the wetland, and cover >75% of the basin. The wetland has widespread feral hog damage that has grown over with redroot. There are some small, dead pine trees in the wetland basin that were killed by recent inundation. This marsh is a potential striped newt breeding pond. The adjacent uplands are sandhills. The sandhills appear to have been fire suppressed but now are managed with prescribed fire.

Wetland Concerns: Feral hog damage

Restoration Action Recommended: Because of the widespread damage to ephemeral wetlands on CWMA, we recommend aggressive action to reduce the overall numbers of feral hogs on the property.

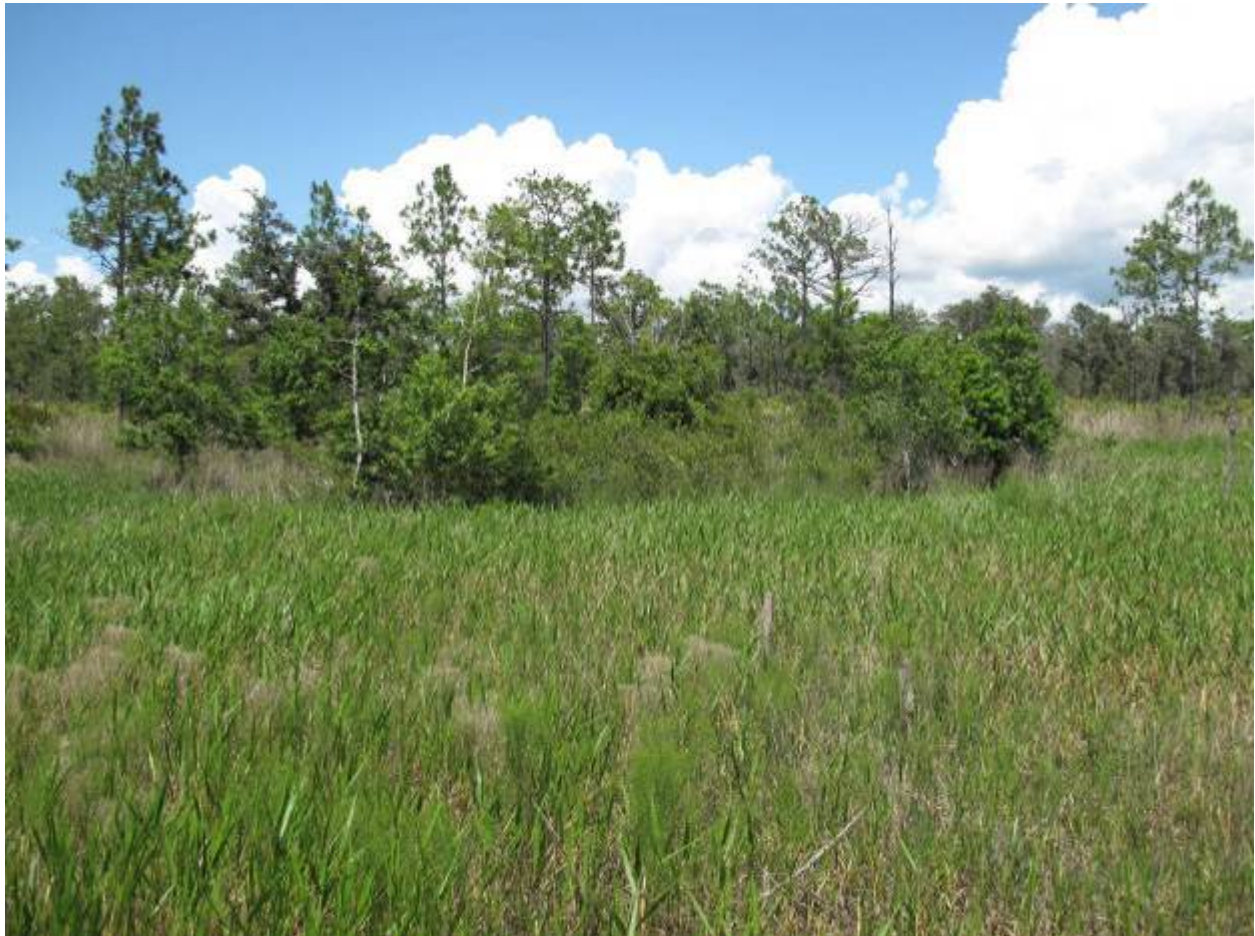
Wetland ID: 03C-03

Description: This wetland is a 0.2 ha ephemeral marsh. There is no tree canopy. Buttonbush grows in the deeper wetland center, and covers 5-25% of the wetland. Maidencane grows throughout the wetland, and covers >75% of the basin. The wetland has minor, old feral hog damage. There are some small, dead pine trees in the wetland basin that were killed by recent inundation. This wetland is a potential striped newt breeding pond. The adjacent uplands are sandhills. The sandhills appear to have been fire suppressed but now are managed with prescribed fire.

Wetland Concerns: Feral hog damage

Restoration Action Recommended: Because of the widespread damage to ephemeral wetlands on CWMA, we recommend aggressive action to reduce the overall numbers of feral hogs on the property.

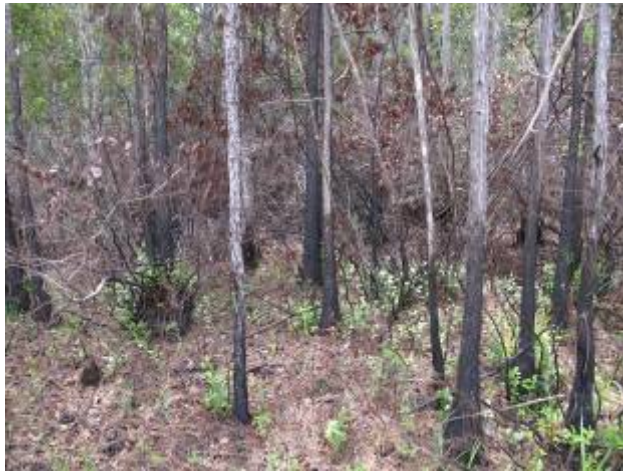
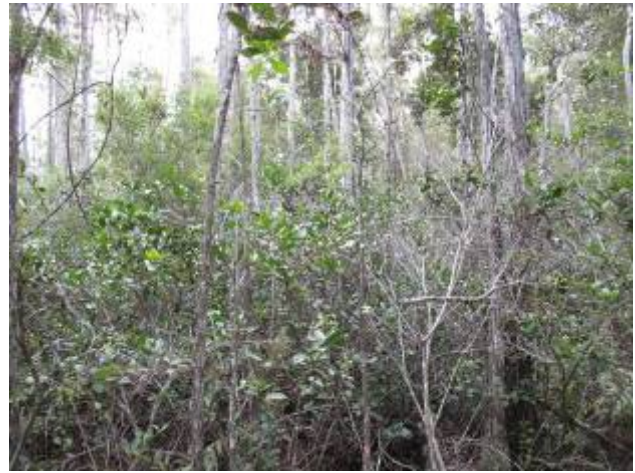
Wetland ID: 04C-01

Description: This wetland is a 1.9 ha ephemeral mixed swamp. Cypress trees dominate the canopy, and cover >75% of the wetland basin. The midstory is dominated by wax myrtle and fetterbush, and covers >75% of the wetland. Fern grows sparsely, and covers 5-25% of the wetland basin. This cypress dome has a very dense brush midstory. A recent fire burned deep into the wetland edges, eliminating the perimeter brush; interior brush remains dense. The adjacent uplands are sandhills and currently are managed with prescribed fire and mechanical vegetation removal.

Wetland Concerns: Woody encroachment

Restoration Action Recommended: Encourage periodic fire in the wetland basin to reduce the dense brush.

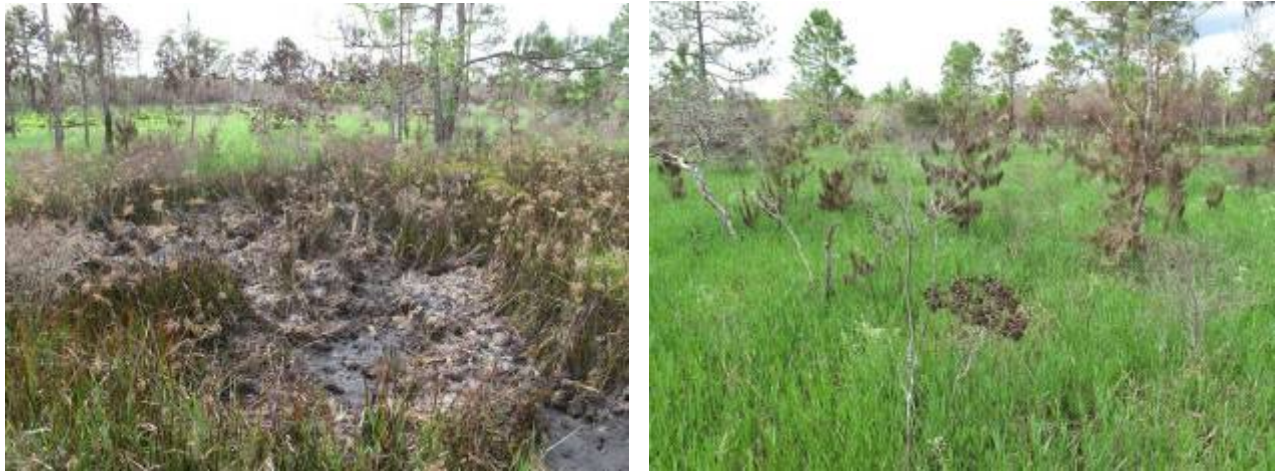
Wetland ID: 05C-01

Description: This wetland is a 1.1 ha ephemeral marsh. Pine trees dominate the canopy, and cover 5-25% of the wetland basin. The midstory also is dominated by small pine trees, and covers 5-25% of the wetland. Maidencane grows throughout, covering >75% of the wetland basin. Pine trees are encroaching as a result of an extended dry period and a lack of fire in the wetland. A recent fire burned through the wetland and killed many encroaching pine trees. The wetland has old and new feral hog damage. This wetland is a potential striped newt breeding pond. The adjacent uplands are sandhills and currently are managed with fire and mechanical vegetation removal.

Wetland Concerns: Feral hog damage, Woody encroachment

Restoration Action Recommended: Because of the widespread damage to ephemeral wetlands on CWMA, we recommend aggressive action to reduce the overall numbers of feral hogs on the property. Monitor this wetland to ensure pine trees are killed with the next fire or inundation. If they become established, the encroaching pine trees will need to be removed from the wetland. Alternatively, the small pine trees can be hand-chopped now.

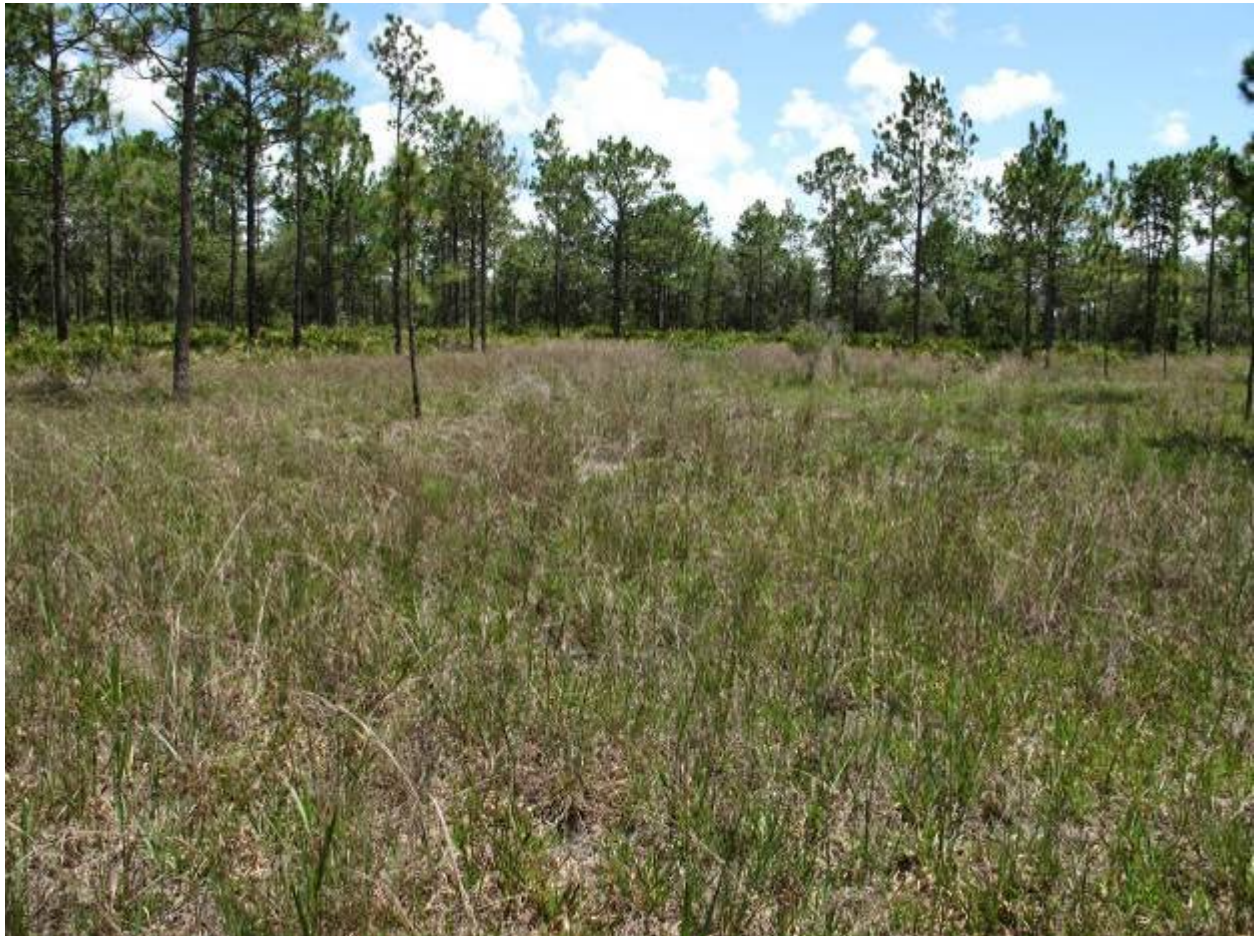
Wetland ID: 06C-01

Description: This wetland is a 0.3 ha ephemeral marsh. There is no canopy or midstory cover. Sedges/grasses grow throughout the wetland, and cover >75% of the basin. The wetland has old feral hog damage that is recovering well. This marsh is in fire-maintenance condition and is a potential striped newt breeding pond. The adjacent uplands are sandhills and currently are managed with mechanical treatments.

Wetland Concerns: Feral hog damage

Restoration Action Recommended: Because of the widespread damage to ephemeral wetlands on CWMA, we recommend aggressive action to reduce the overall numbers of feral hogs on the property.

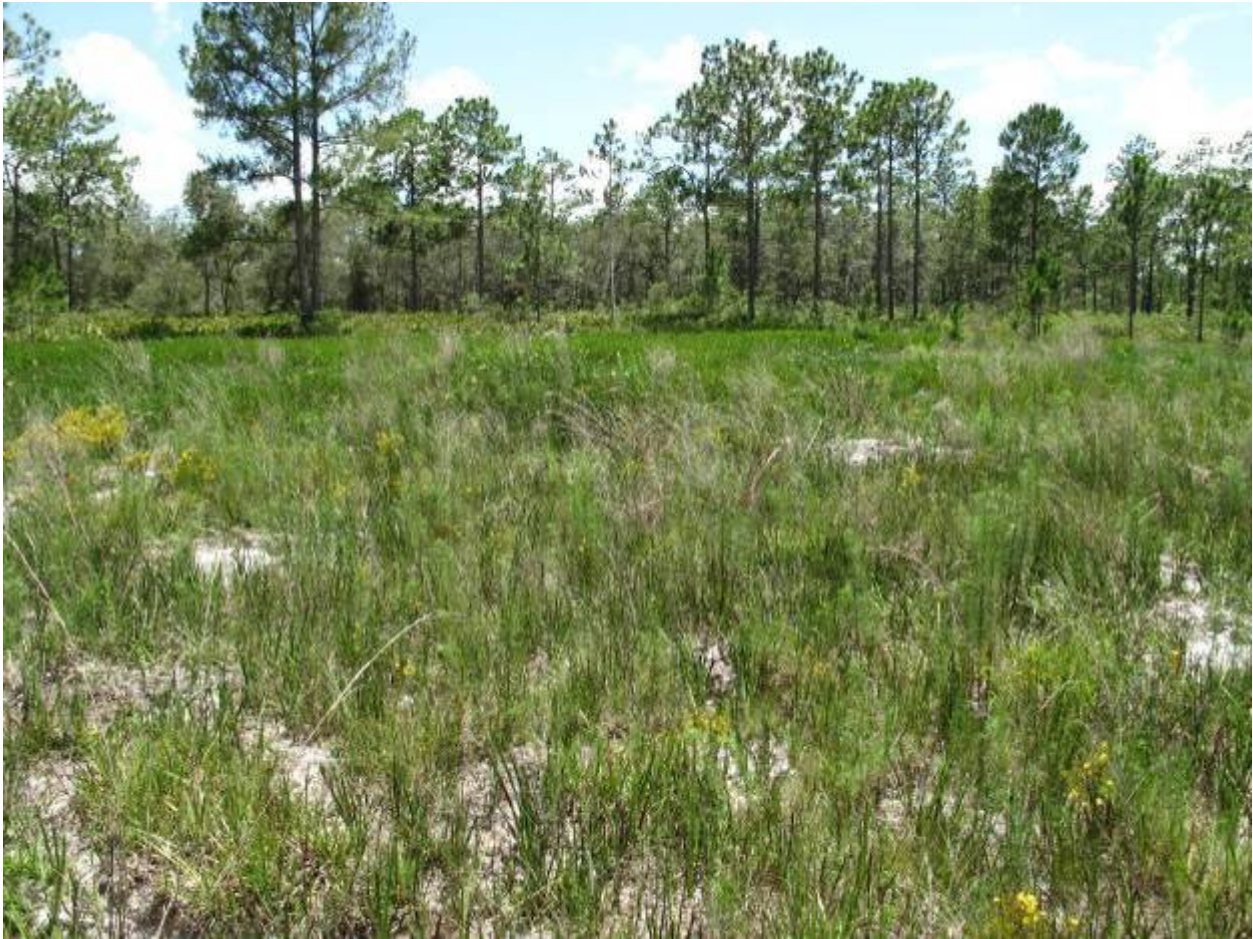
Wetland ID: 06C-02

Description: This wetland is a 0.6 ha ephemeral marsh. There is no canopy or midstory cover. Sedges/grasses and maidencane grow throughout the wetland, and cover >75% of the basin. The wetland has old and new feral hog rooting. The damage was once severe but is now recovering. This marsh is in fire-maintenance condition and is a potential striped newt breeding pond. The adjacent uplands are sandhills and currently are managed with mechanical treatments.

Wetland Concerns: Feral hog damage

Restoration Action Recommended: Because of the widespread damage to ephemeral wetlands on CWMA, we recommend aggressive action to reduce the overall numbers of feral hogs on the property.

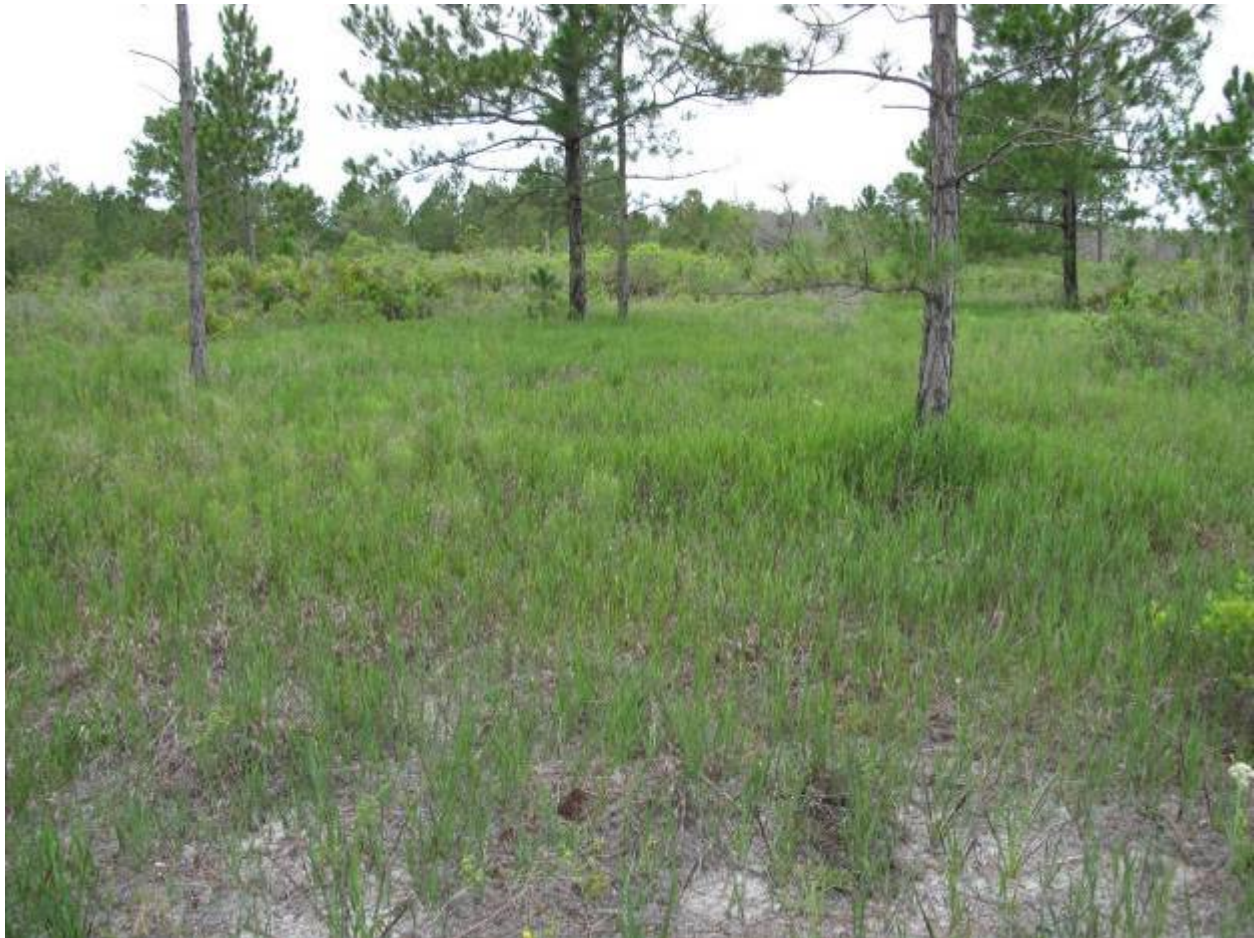
Wetland ID: 06C-03

Description: This wetland is a 0.1 ha ephemeral marsh. Pine trees grow around the wetland, and cover 5-25% of the wetland. There is no midstory layer. Maidencane grows throughout the wetland, and covers >75% of the basin. The wetland has old feral hog rooting that is recovering well. The adjacent uplands are mesic flatwoods with dense palmetto and gallberry. The uplands currently are managed with mechanical treatments.

Wetland Disturbance: Feral hog damage

Restoration Action Recommended: Because of the widespread damage to ephemeral wetlands on CWMA, we recommend aggressive action to reduce the overall numbers of feral hogs on the property.

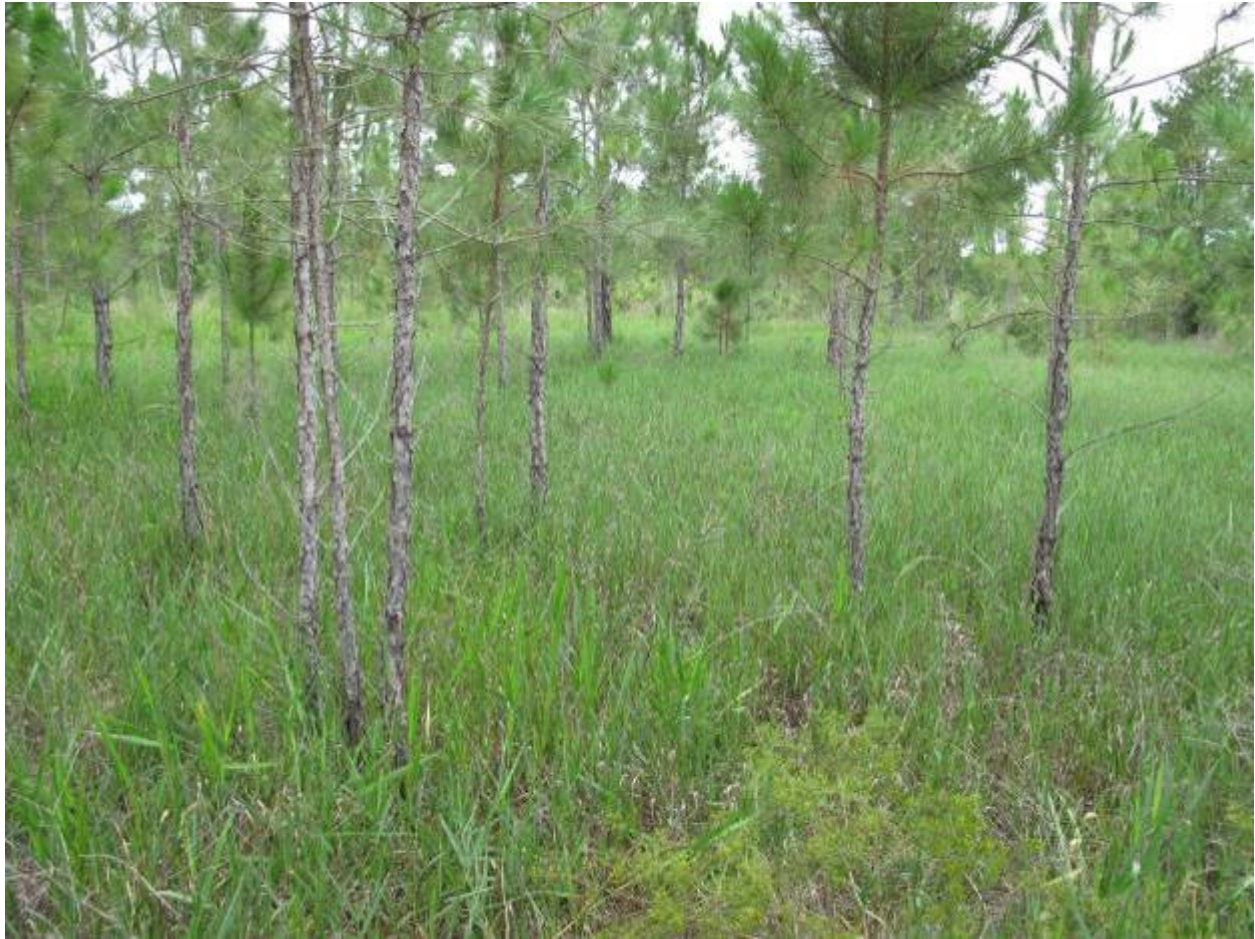
Description: This wetland is a 1.1 ha ephemeral marsh. Pine trees dominate the canopy, and cover 25-50% of the wetland. There is no midstory layer. Maidencane grows throughout the wetland, and covers >75% of the basin. The wetland has patchy feral hog rooting and is heavily encroached by pine trees. This large, shallow wetland will connect to the hydric swamp to the west during periods of high water. The adjacent uplands are mesic flatwoods that have not been burned in a long time. The uplands currently are managed with mechanical treatments.

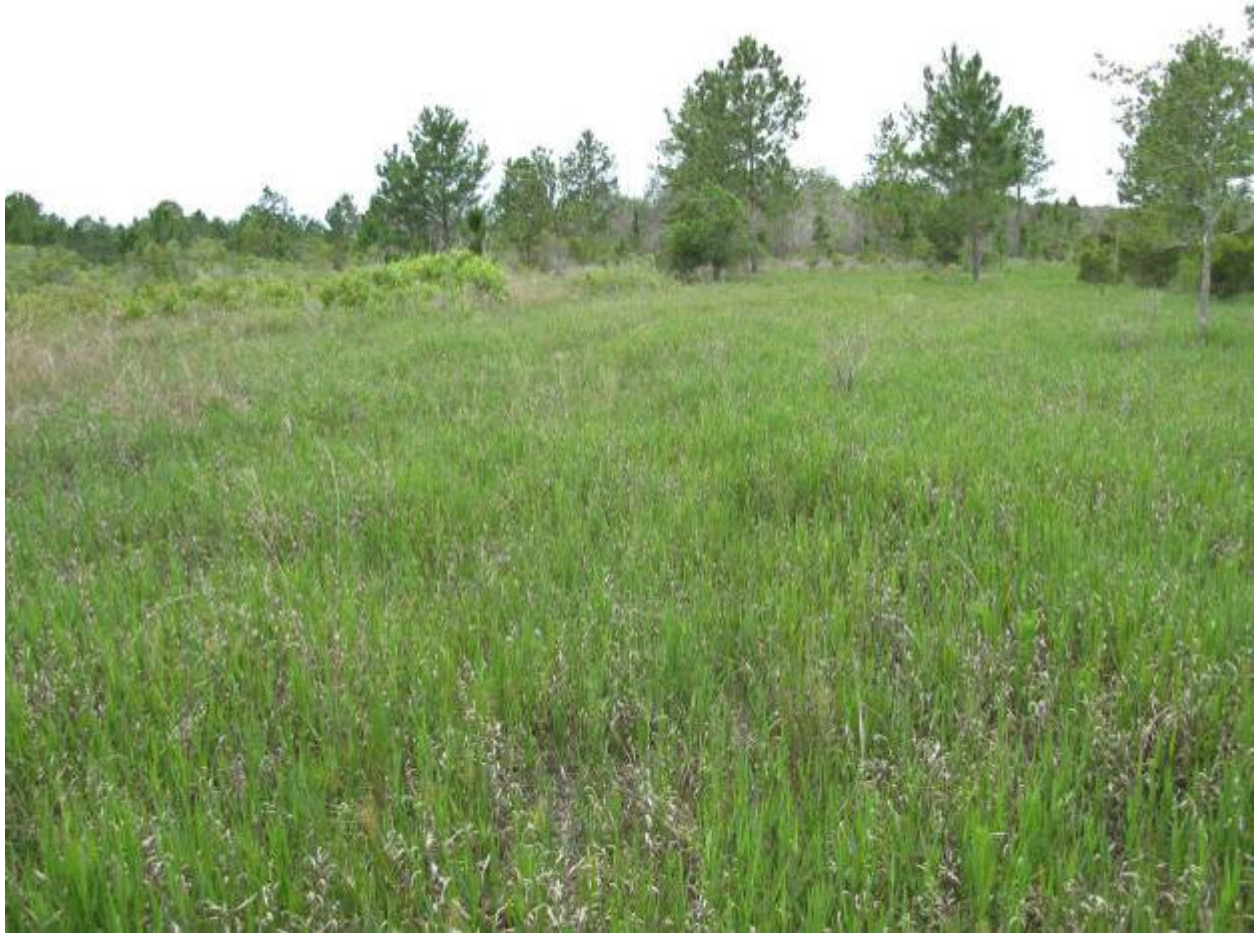
Wetland ID: 06C-05

Description: This wetland is a 1.0 ha ephemeral marsh. There is no tree canopy. A few small pine trees and wax myrtles are scattered around this large, shallow marsh but the encroachment is minimal. The midstory covers 5-25% of the wetland. Maidencane grows throughout the wetland, and covers >75% of the basin. The wetland has minor feral hog rooting. A very shallow ditch bisects the wetland on the south side. This ditch connects to wetlands 07C-02 and 07C-03. The adjacent uplands are mesic flatwoods and low sandhills and currently are managed with mechanical treatments.

Wetland Concerns: Ditching, Feral hog damage

Restoration Action Recommended: Allow the ditch to erode and to fill in with vegetation. Because of the widespread damage to ephemeral wetlands on CWMA, we recommend aggressive action to reduce the overall numbers of feral hogs on the property. Encourage periodic fire to prevent further woody encroachment.

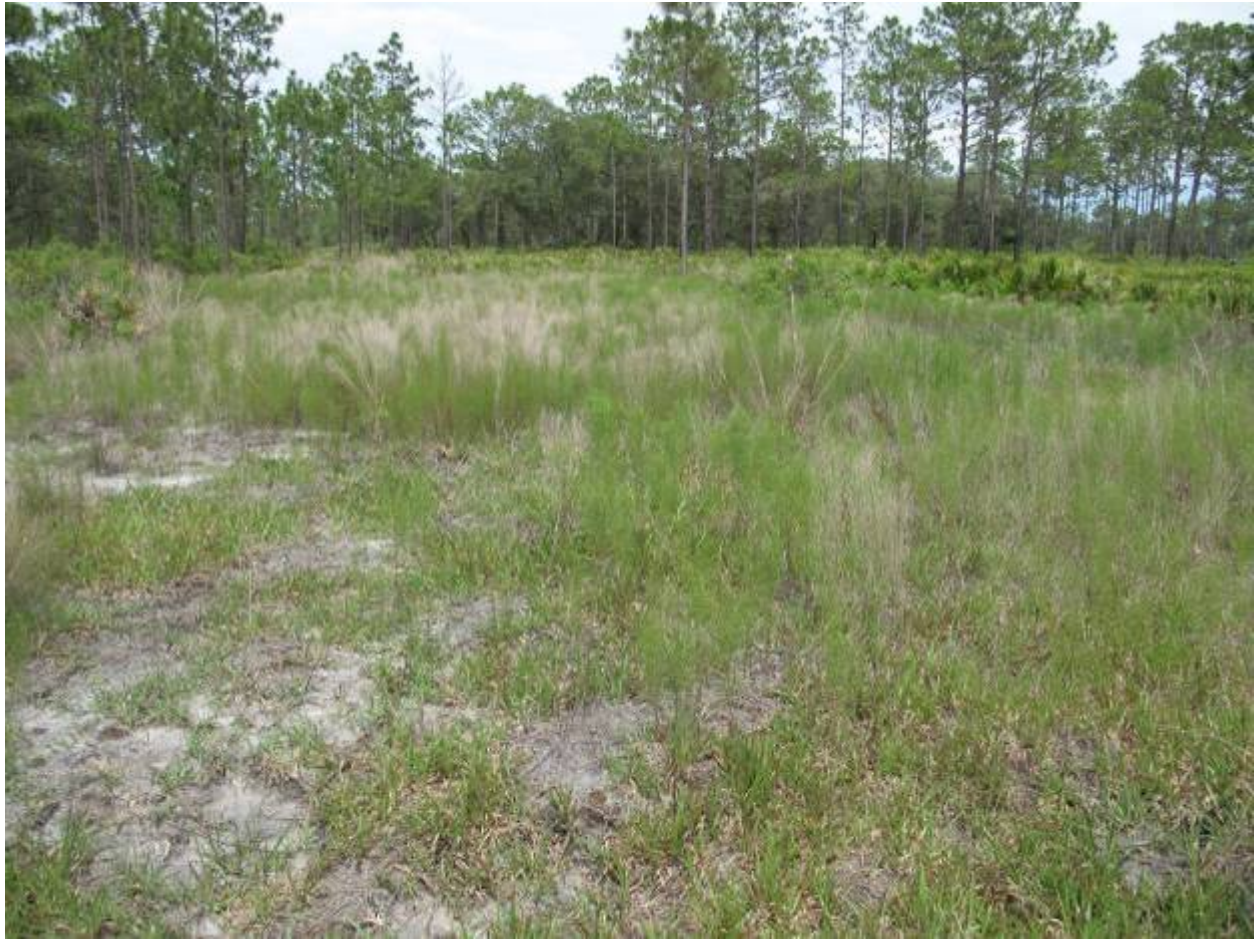
Description: This wetland is a 0.2 ha highly ephemeral marsh. There is no canopy or midstory cover. Sedges/grasses grow throughout the wetland, and cover >75% of the basin. This shallow wetland has old feral hog rootings that are recovering well. The adjacent uplands are mesic flatwoods and low sandhills with dense palmetto. The uplands currently are managed with mechanical treatments.

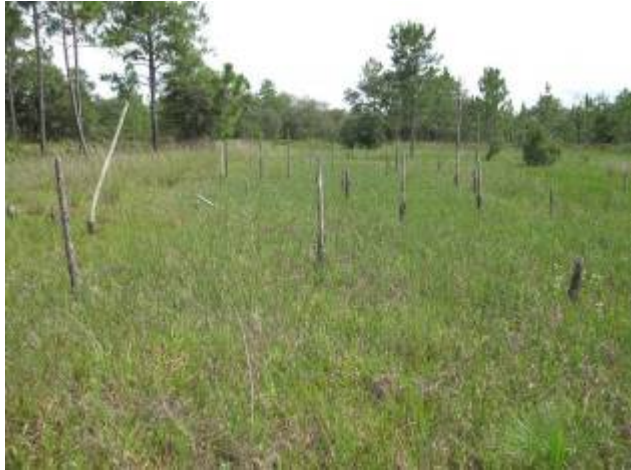
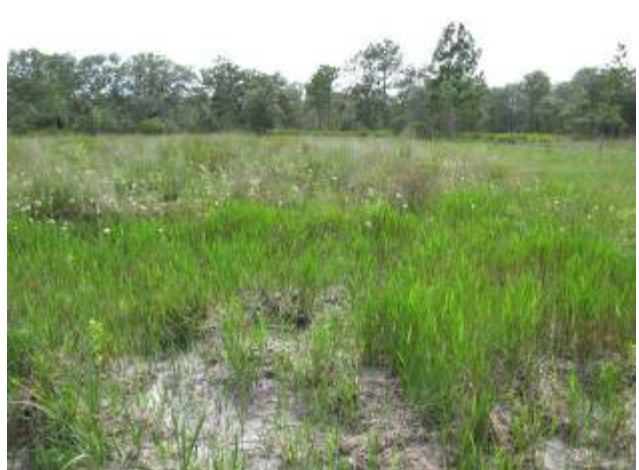
Wetland ID: 06C-07

Description: This wetland is a 0.9 ha ephemeral marsh. There is no canopy or midstory cover. Maidencane grows throughout the wetland, and covers >75% of the basin. The wetland has patchy feral hog rooting. Many encroaching pine trees were killed by recent inundation. This marsh is in fire-maintenance condition and is a potential striped newt breeding pond. The adjacent uplands are sandhills with dense palmetto and currently are managed with mechanical treatments.

Wetland Concerns: Feral hog damage

Restoration Action Recommended: Because of the widespread damage to ephemeral wetlands on CWMA, we recommend aggressive action to reduce the overall numbers of feral hogs on the property.

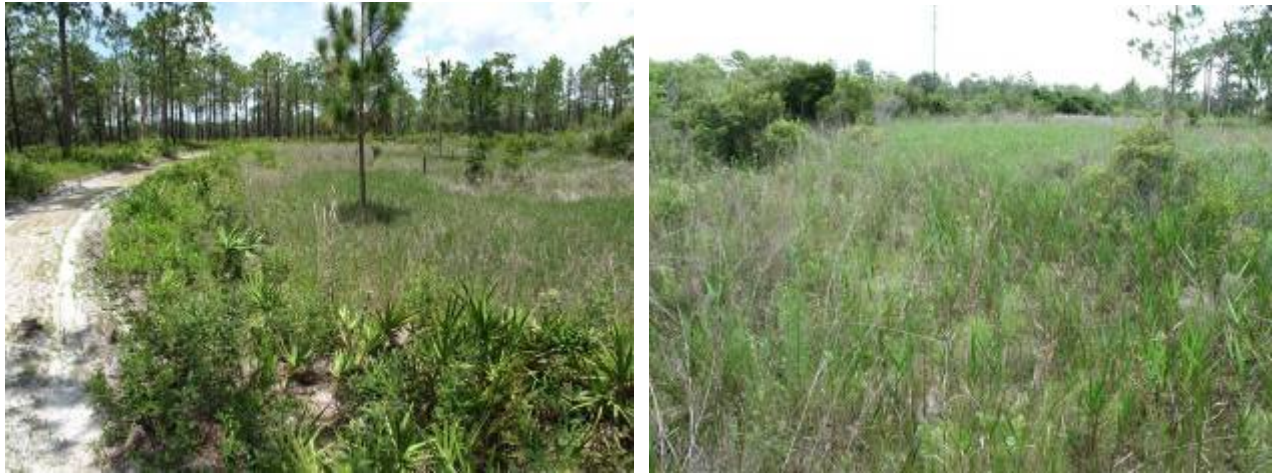
Wetland ID: 07C-01

Description: This wetland is a 1.3 ha ephemeral marsh. There is no tree canopy. Wax myrtle grows throughout the wetland, and willow and buttonbush grow in a patch in the wetland center. The woody vegetation covers 5-25% of the wetland. Maidencane grows throughout the wetland, and covers >75% of the basin. The wetland has very minor feral hog damage. A major highway (US 19) runs along the east side of the wetland and a fireline bisects the west side. This wetland is a potential striped newt breeding pond. The adjacent uplands are sandhill and currently are managed with mechanical treatments.

Wetland Concerns: Feral hog damage, Fireline, Road, Woody encroachment,

Restoration Action Recommended: Because of the widespread damage to ephemeral wetlands on CWMA, we recommend aggressive action to reduce the overall numbers of feral hogs on the property. The fireline/MU boundary should be re-routed away from the wetland. If the fireline cannot be re-routed, monitor the wetland to ensure fire is not excluded. Maintain the fireline when the wetland is completely dry to prevent ruts from developing. Monitor this wetland to ensure wax myrtle are reduced with the next fire or inundation. If they become established, the encroaching shrubs will need to be thinned or removed.

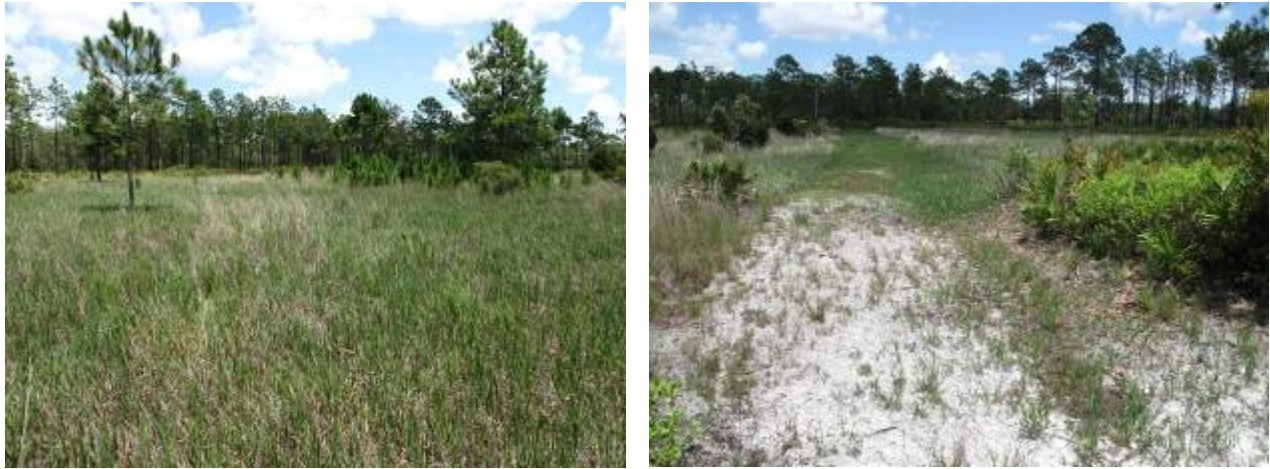
Wetland ID: 07C-02

Description: This wetland is a 0.9 ha ephemeral marsh. There is no tree canopy. Wax myrtle and small pine trees grow in a patch in the wetland center, and cover 5-25% of the wetland. Maidencane grows throughout the wetland, and covers >75% of the basin. This open marsh has old feral hog rooting that is recovering well. A shallow ditch was dug through the center of the wetland but does not seem to be adversely affecting the wetland hydrology. The ditch connects this wetland with 07C-02 and 06C-05. This marsh is in fire-maintenance condition and is a potential striped newt breeding pond. The adjacent uplands are sandhill and currently are managed with mechanical treatments.

Wetland Concerns: Feral hog damage, Ditching

Restoration Action Recommended: Because of the widespread damage to ephemeral wetlands on CWMA, we recommend aggressive action to reduce the overall numbers of feral hogs on the property. Allow the ditch to erode and to fill in with vegetation.

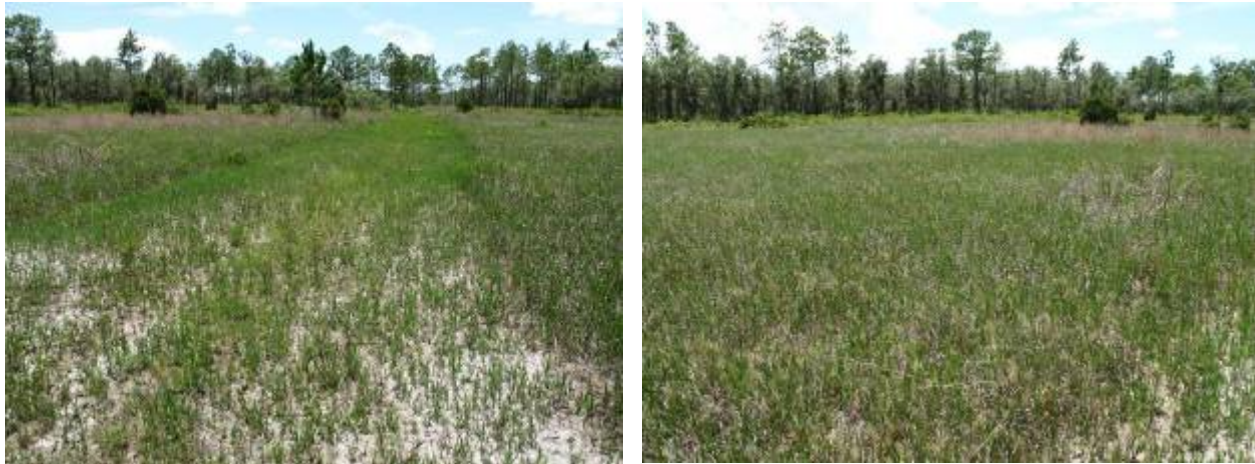
Wetland ID: 07C-03

Description: This wetland is a 1.1 ha ephemeral marsh. There is no canopy or midstory cover. Maidencane and sedges/grasses grow throughout the wetland, and cover >75% of the basin. A shallow ditch was dug through the center of the wetland but does not seem to be adversely affecting the wetland hydrology. The ditch connects this wetland with 07C-02 and 06C-05. This wetland is a potential striped newt breeding pond. The adjacent uplands are sandhills and currently are managed with mechanical treatments.

Wetland Concerns: Ditching

Restoration Action Recommended: Allow the ditch to erode and to fill in with vegetation

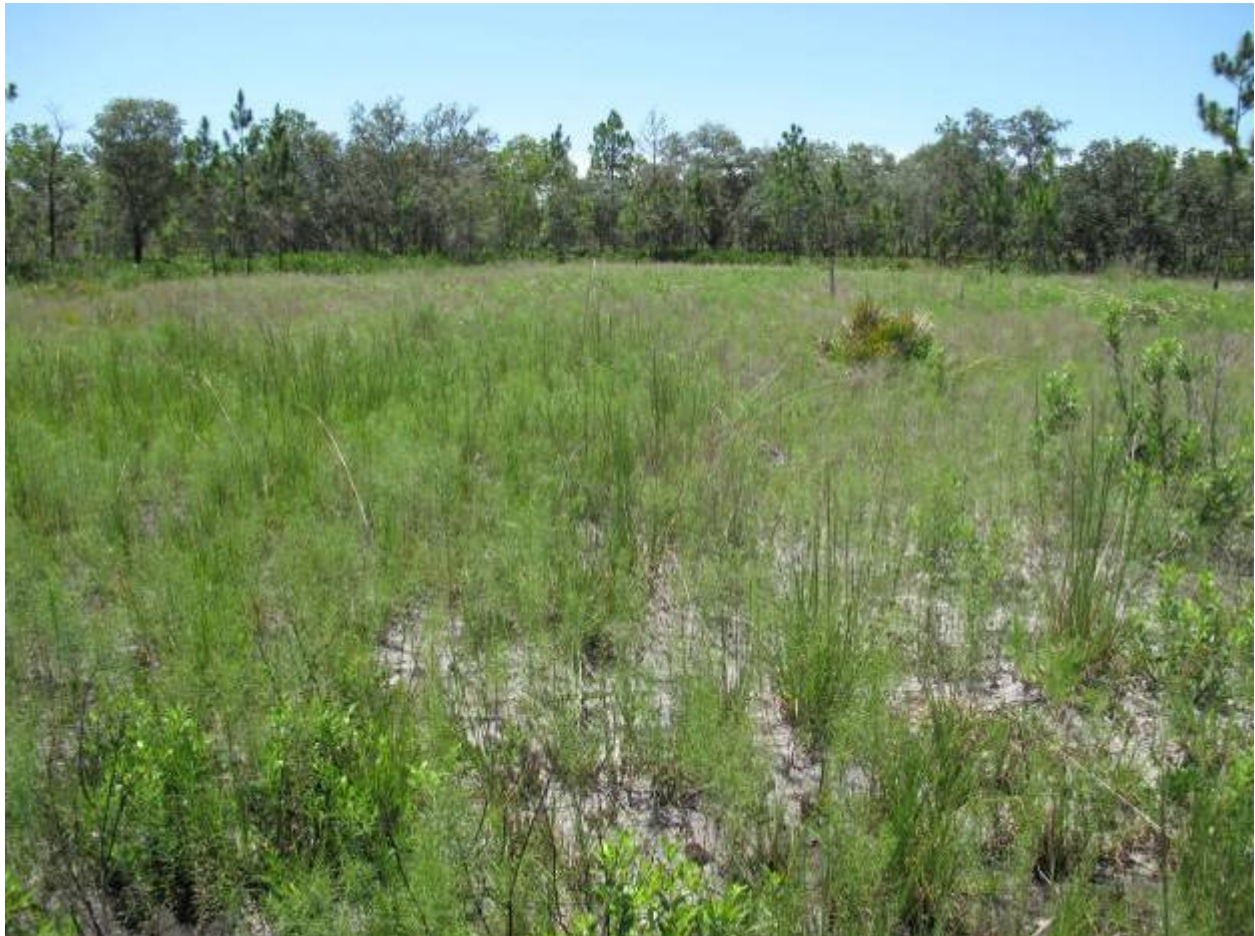
Wetland ID: 08C-01

Description: This wetland is a 0.5 ha ephemeral marsh. There is no tree canopy. Dog fennel covers >75% of the wetland. Feral hogs have rooted in a few small areas. A recent fire burned through the wetland, charring broomsedge clumps. This wetland is a potential striped newt breeding pond. The adjacent uplands are sandhills. The sandhills appear to have been fire suppressed but now are managed with prescribed fire.

Wetland Concerns: Feral hog damage

Restoration Action Recommended: Because of the widespread damage to ephemeral wetlands on CWMA, we recommend aggressive action to reduce the overall numbers of feral hogs on the property.
