Inventory, Assessment, and Restoration Potential of Ephemeral Wetlands on FFWCC Wildlife Management Areas

Chassahowitzka WMA Final Report

Submitted by: Rebecca P.M. Means¹, Ryan C. Means¹, Steven A. Johnson²

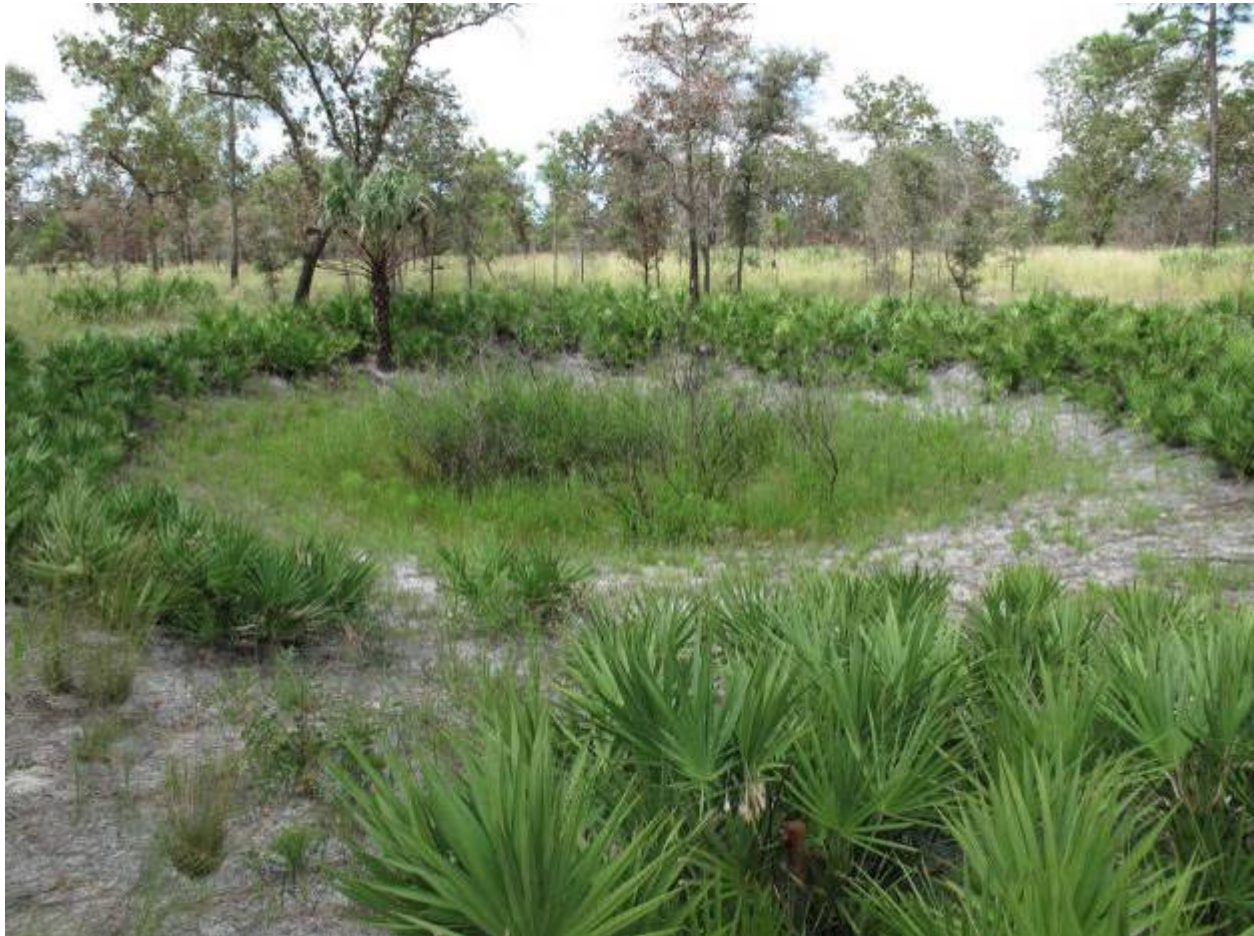
Wetland ID: 09C-01

Description: This wetland is a <0.1 ha ephemeral marsh in a circular sink depression. This is a classical small ephemeral wetland formed by karst processes. There is no tree canopy. Buttonbush grows in the deeper wetland center, and covers 5-25% of the wetland. Maidencane grows throughout the wetland, and covers 50-75% of the basin. A recent fire burned through the wetland. This wetland is in great ecological condition and is a potential striped newt breeding pond. The adjacent uplands are sandhills and currently are managed with prescribed fire. An upland ring of palmetto encircles the wetland. The uplands in this vicinity are in some of the best ecological condition on the CWMA.

Wetland Concerns: None

Restoration Action Recommended: None

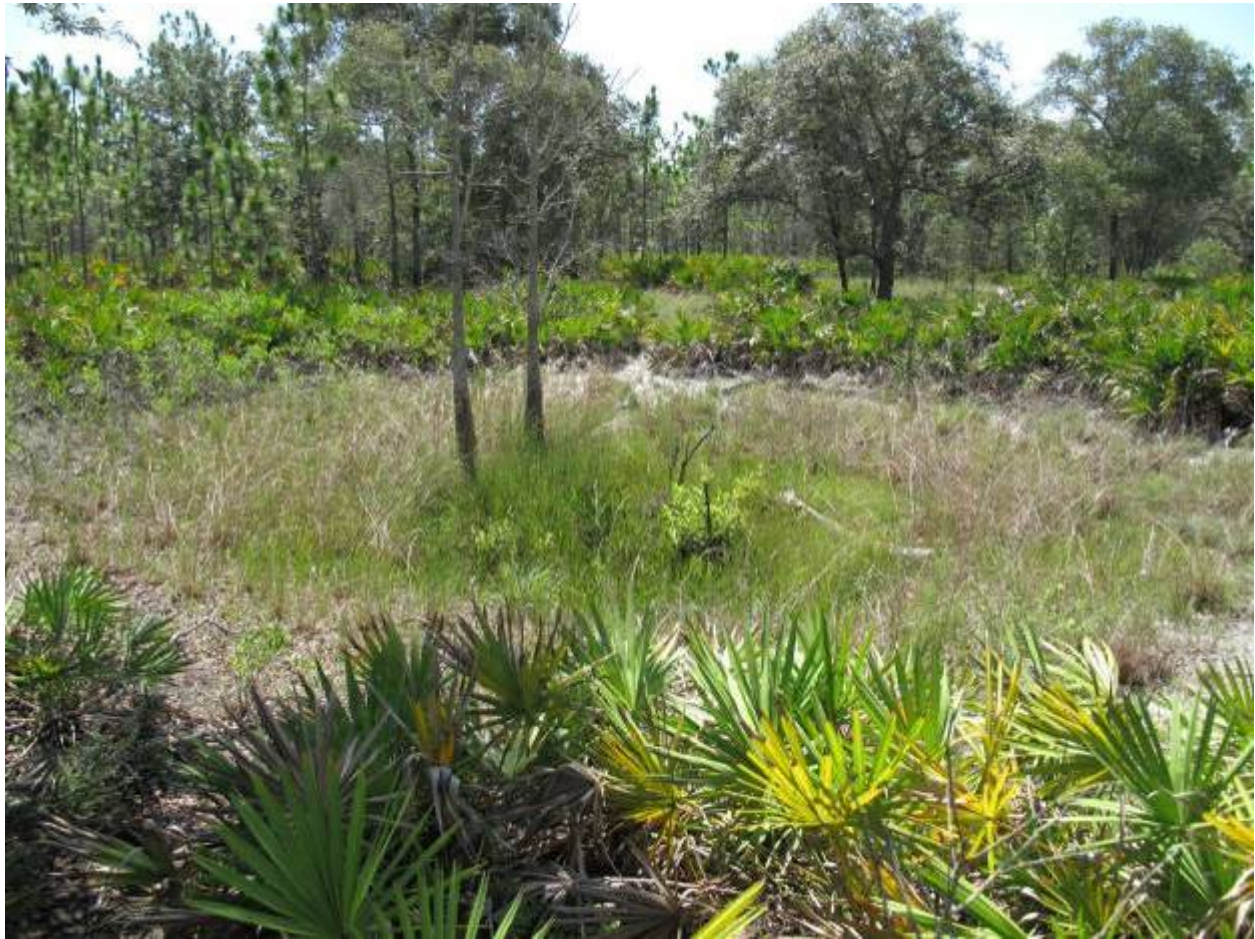
Description: This wetland is a <0.1 ha ephemeral marsh in a circular sink depression. This is a classical small ephemeral wetland formed by karst processes. There is no tree canopy or midstory cover. Sedges/grasses grow throughout the wetland, and cover >75% of the basin. This wetland is in good ecological condition and is a potential striped newt breeding pond. The adjacent uplands are sandhills with a dense ring of palmetto surrounding the wetland. The uplands appear to have been fire suppressed but now are managed with prescribed fire.

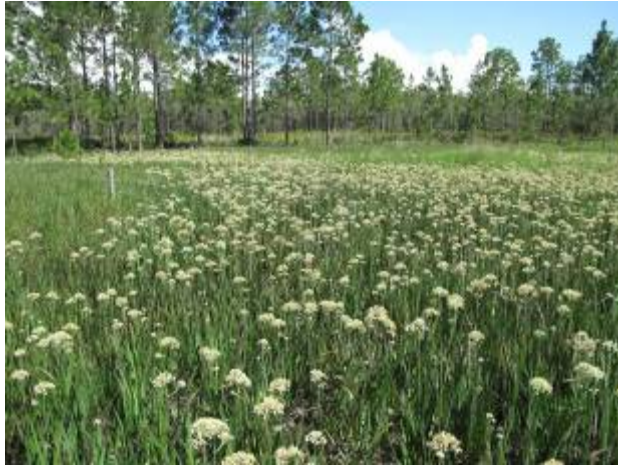
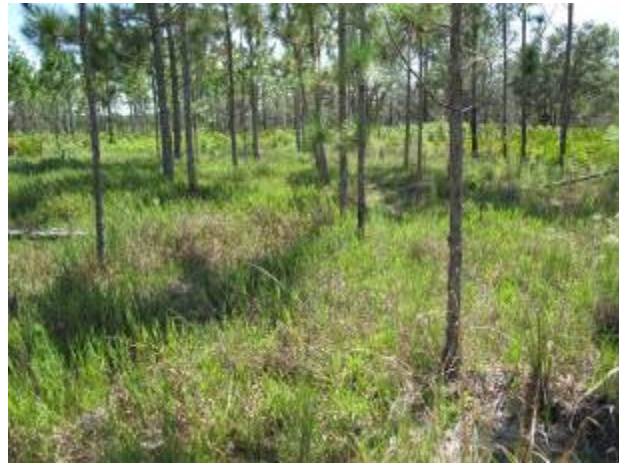
Wetland ID: 10C-02

Description: This wetland is a 0.4 ha ephemeral marsh. Pine trees grow around the wetland edge, and cover 5-25% of the basin. There is no midstory layer. Maidencane and redroot grow throughout the wetland, and cover >75% of the basin. The wetland has extensive, old feral hog damage that has grown over with redroot. Pine trees were planted through the wetland but the majority have died due to water inundation. The adjacent uplands are sandhills grading to mesic flatwoods. The uplands appear to have been fire suppressed but now are managed with prescribed fire.

Wetland Concerns: Feral hog damage, Planted pine trees

Restoration Action Recommended: Because of the widespread damage to ephemeral wetlands on CWMA, we recommend aggressive action to reduce the overall numbers of feral hogs on the property. Remove planted pine trees from the wetland interior.

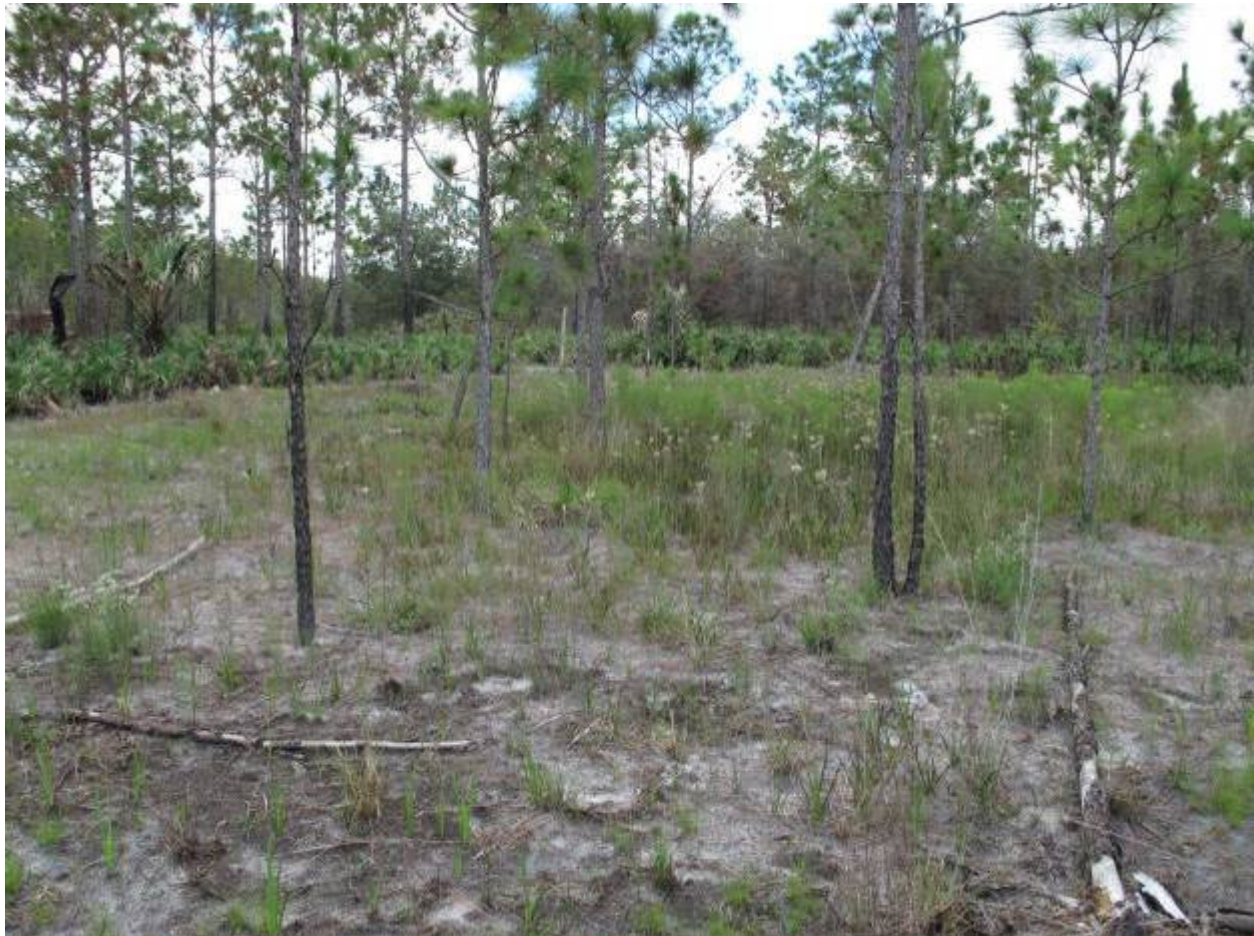
Wetland ID: 10C-03

Description: This wetland is a 0.1 ha ephemeral marsh. Pine trees dominate the canopy, and cover 5-25% of the wetland basin. There is no midstory layer. Sedges/grasses and redroot grow throughout the wetland, and cover 50-75% of the basin. The wetland has old feral hog damage that has grown over with redroot. The wetland was bedded and planted with pine trees. Bedding rows have eroded somewhat. This marsh is a potential striped newt breeding pond. The adjacent uplands are sandhills and currently are managed with prescribed fire.

Wetland Concerns: Bedding, Feral hog damage, Planted pine trees

Restoration Action Recommended: No action to remove the bedding is recommended; the bedding rows will erode over time. Because of the widespread damage to ephemeral wetlands on CWMA, we recommend aggressive action to reduce the overall numbers of feral hogs on the property. Remove the planted pine trees from the wetland interior.

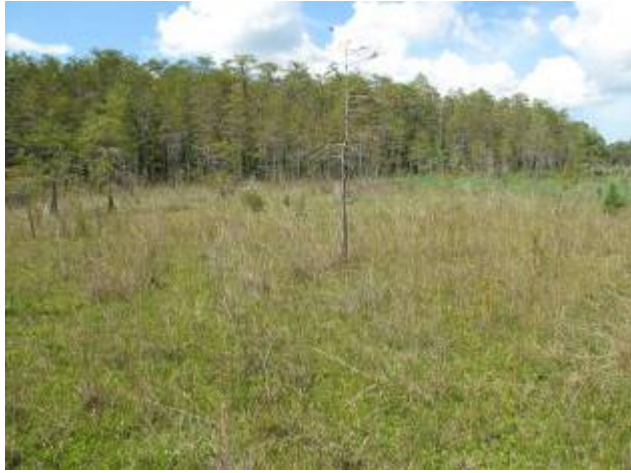
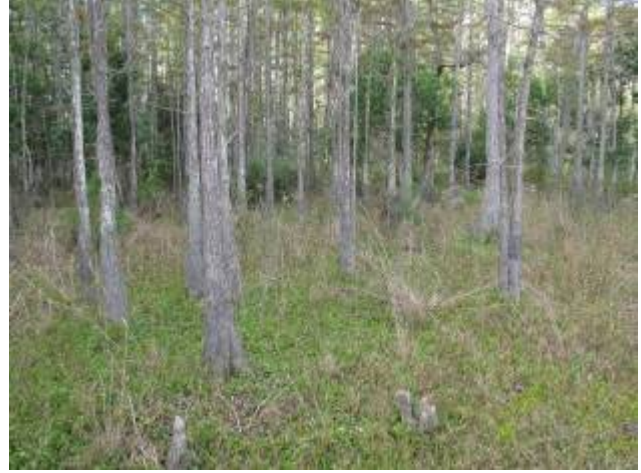
Wetland ID: 10C-04

Description: This wetland is a 2.9 ha ephemeral forested swamp. Cypress and holly trees dominate the canopy, and cover 50-75% of the wetland basin. The midstory is dominated by wax myrtle, and covers 5-25% of the wetland. Maidencane and sedges/grasses grow throughout the wetland, and cover >75% of the basin. The wetland has minor feral hog damage. This large wetland has a forested interior and a very wide littoral zone. The adjacent uplands are mix of scrubby flatwoods and sandhills and are managed with prescribed fire.

Wetland Concerns: Feral hog damage

Restoration Action Recommended: Because of the widespread damage to ephemeral wetlands on CWMA, we recommend aggressive action to reduce the overall numbers of feral hogs on the property.

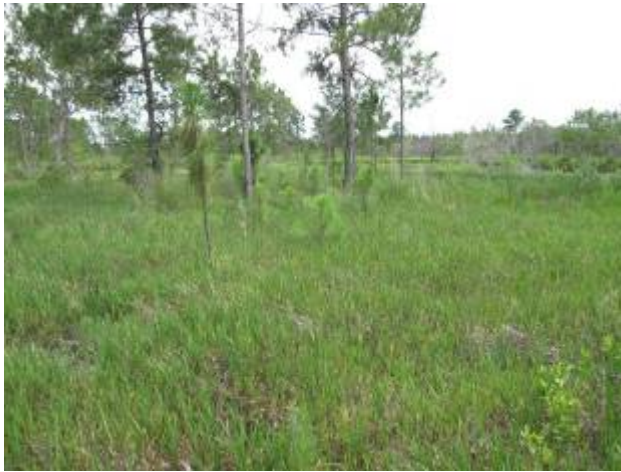
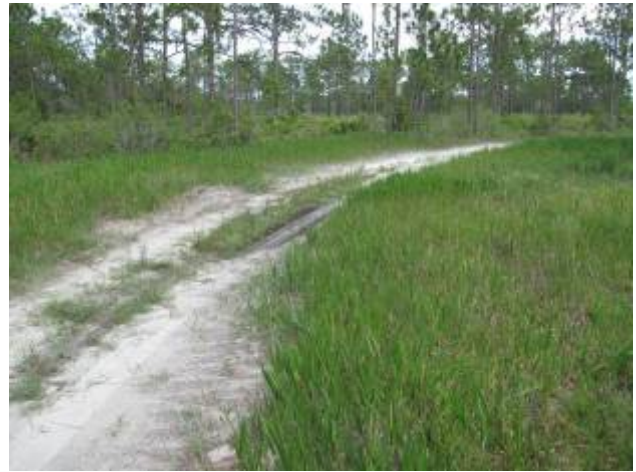
Wetland ID: 13C-01

Description: This wetland is a 0.2 ha ephemeral marsh. Pine trees dominate the canopy, and cover 5-25% of the wetland basin. There is no midstory layer. Maidencane grows throughout the wetland, and covers >75% of the basin. There is light and patchy feral hog damage in the wetland. Several young pine trees are established in the wetland basin. There is a fireline through the eastern edge of the wetland. The adjacent uplands are mesic flatwoods and low sandhills and currently are managed with prescribed fire and mechanical vegetation removal.

Wetland Concerns: Feral hog damage, Fireline, Woody encroachment

Restoration Action Recommended: Because of the widespread damage to ephemeral wetlands on CWMA, we recommend aggressive action to reduce the overall numbers of feral hogs on the property. The fireline/MU boundary should be re-routed away from the wetland. If the fireline cannot be re-routed, monitor the wetland to ensure fire is not excluded. Maintain the fireline when the wetland is completely dry to prevent ruts from developing. Hand chop the small pine trees from the wetland interior.

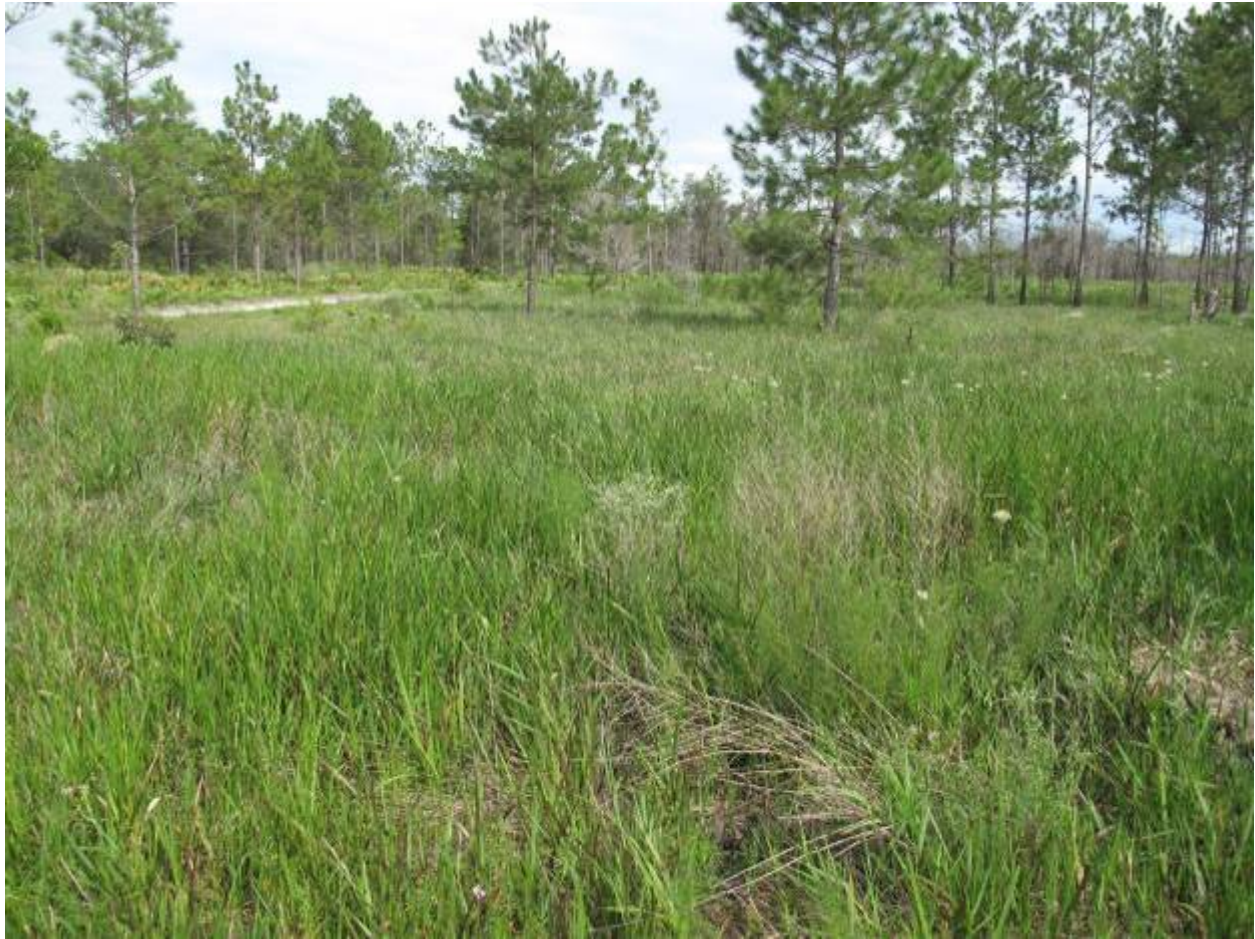
Description: This wetland is a 0.5 ha ephemeral marsh. Pine trees dominate the canopy, and cover 5-25% of the wetland basin. There is no midstory layer. Maidencane grows throughout the wetland, and covers >75% of the basin. There is old feral hog damage in the wetland. The adjacent uplands are mesic flatwoods and low sandhills and currently are managed with prescribed fire and mechanical vegetation removal.

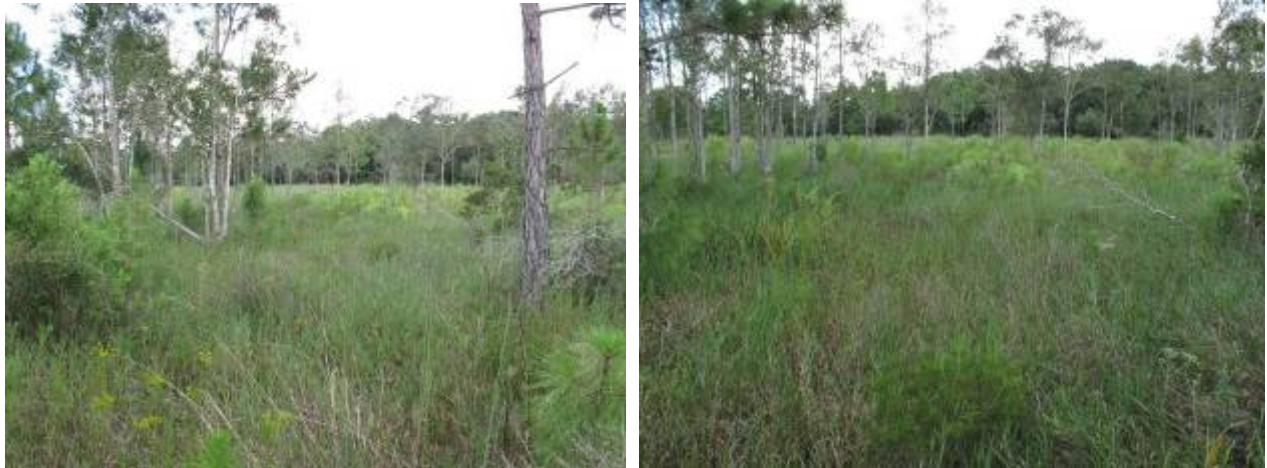
Wetland ID: 13C-03

Description: This wetland is a 0.4 ha ephemeral marsh. Gum and holly trees dominate the canopy, and cover 5-25% of the wetland basin. There is no midstory layer. Maidencane and sedges/grasses grow throughout the wetland, and cover >75% of the basin. There is old feral hog damage in the wetland. This marsh is near the edge of the large hydric hammock. A recent fire burned through the wetland. The adjacent uplands are scrubby flatwoods and currently are managed with prescribed fire and mechanical vegetation removal.

Wetland Concerns: Feral hog damage

Restoration Action Recommended: Because of the widespread damage to ephemeral wetlands on CWMA, we recommend aggressive action to reduce the overall numbers of feral hogs on the property.

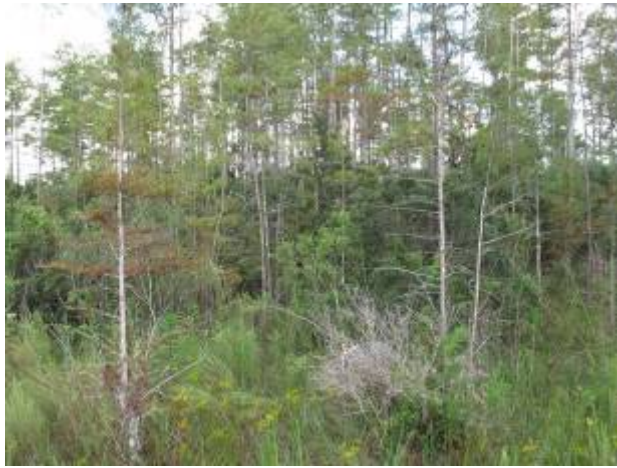
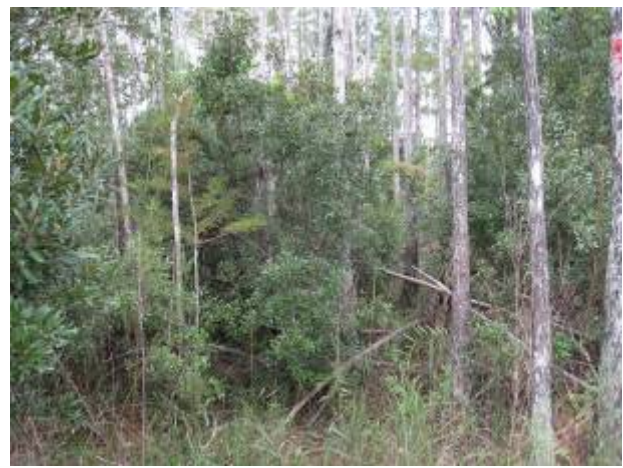
Wetland ID: 13C-04

Description: This wetland is a 0.6 ha ephemeral forested swamp. Cypress trees dominate the canopy, and cover >75% of the wetland basin. The midstory is dominated by wax myrtle, and covers 50-75% of the wetland. Sedges/grasses are distributed throughout, and cover 50-75% of the wetland basin. This small cypress dome has a brushy midstory. A recent fire burned to the wetland edge. The adjacent uplands are scrubby flatwoods and currently are managed with prescribed fire and mechanical vegetation removal.

Wetland Concerns: Woody encroachment

Restoration Action Recommended: Encourage fire in the wetland when the basin is dry to reduce the dense brush.

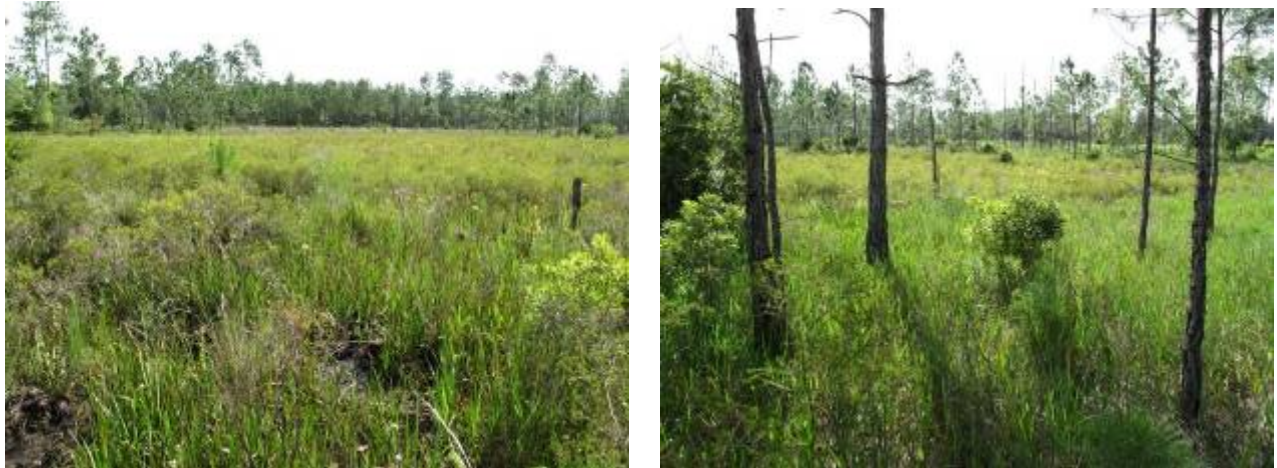
Wetland ID: 14C-01

Description: This wetland is a 1.9 ha ephemeral marsh. Pine trees dominate the canopy, and cover 5-25% of the wetland basin around the edge. The midstory is dominated by *Hypericum*, and covers 25-50% of the wetland. Maidencane and sedges/grasses grow throughout the wetland, and cover >75% of the basin. There is patchy feral hog damage in the wetland. Some pine trees are beginning to encroach from around the wetland edges. This large marsh has rich, diverse herbaceous vegetation and is a potential striped newt breeding pond. The adjacent uplands are fire suppressed mesic and scrubby flatwoods and currently are managed with mechanical treatments.

Wetland Concerns: Feral hog damage, Woody encroachment

Restoration Action Recommended: Because of the widespread damage to ephemeral wetlands on CWMA, we recommend aggressive action to reduce the overall numbers of feral hogs on the property. Encourage periodic fire to reduce the encroaching pine trees. Monitor the wetland to ensure pine trees are killed with the next fire or inundation. If they become established, the encroaching pine trees will need to be removed from the wetland. Alternatively, the small pine trees can be thinned back to the wetland edge.

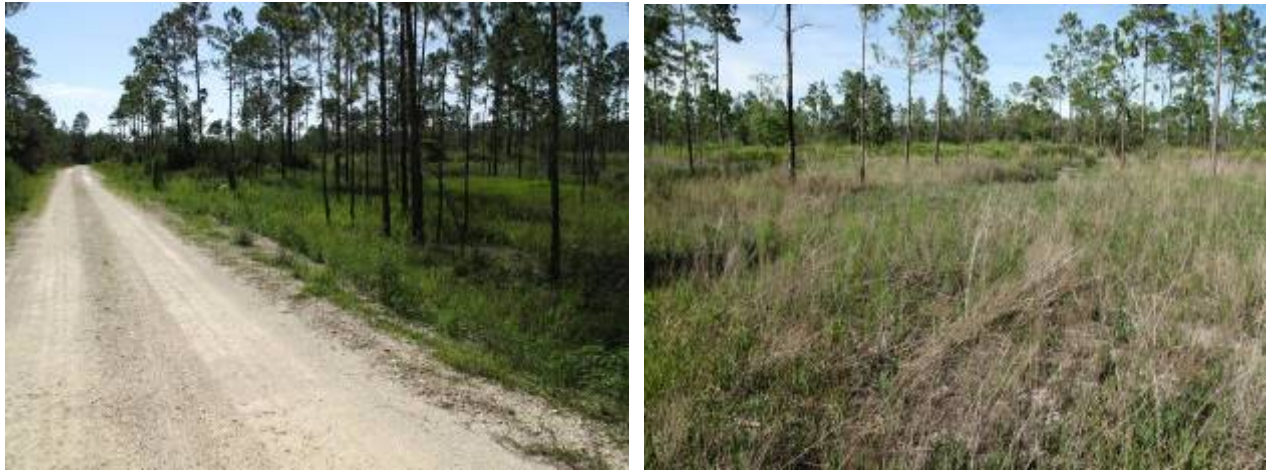
Wetland ID: 14C-02

Description: This wetland is a 0.3 ha ephemeral marsh. Pine trees are beginning to encroach from the wetland edge, and cover 5-25% of the basin. There is no midstory layer. Maidencane grows throughout the wetland, and covers >75% of the basin. There is minor feral hog damage in the wetland. This wetland was connected to wetland 05D-06 before it was bisected by an unpaved road (Rattlesnake Branch Rd). The adjacent uplands are fire suppressed mesic and scrubby flatwoods and currently are managed with mechanical treatments.

Wetland Concerns: Feral hog damage, Road, Woody encroachment

Restoration Action Recommended: Because of the widespread damage to ephemeral wetlands on CWMA, we recommend aggressive action to reduce the overall numbers of feral hogs on the property. In order to restore the hydrology of this wetland and the larger wetland system, the road would have to be removed. Recognizing that this road is now a permanent attribute to the property, we do not recommend any action relating to the road. Encourage periodic fire to reduce the encroaching pine trees. Monitor the wetland to ensure pine trees are killed with the next fire or inundation. If they become established, the encroaching pine trees will need to be removed from the wetland. Alternatively, the small pine trees can be thinned back to the wetland edge.

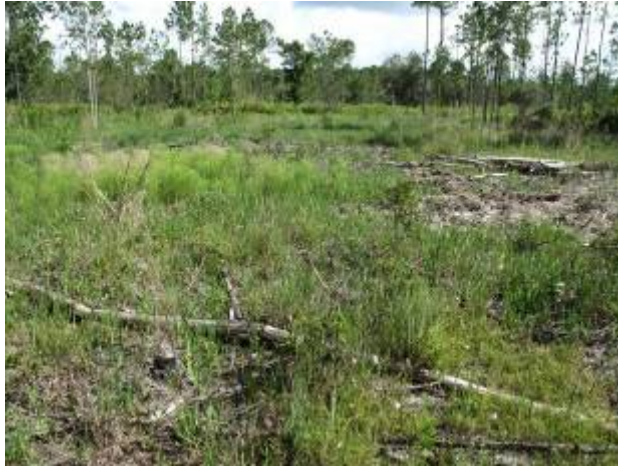
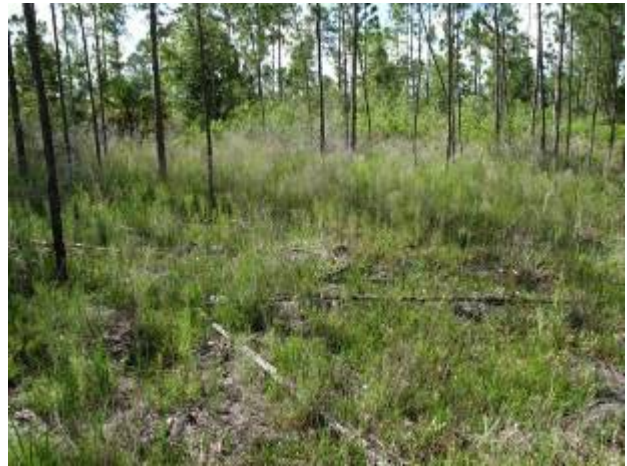
Wetland ID: 14C-03

Description: This wetland is a 0.3 ha ephemeral marsh. Pine trees recently were thinned from around the wetland edge. A few pine trees remain and cover 5-25% of the wetland basin. There is no midstory layer. Maidencane and sedges/grasses grow throughout the wetland, and cover >75% of the basin. There is severe feral hog damage in the wetland. There are rotting pine logs in the wetland depression. The adjacent uplands are fire suppressed mesic and scrubby flatwoods and currently are managed with mechanical treatments.

Wetland Concerns: Feral hog damage

Restoration Action Recommended: Because of the widespread damage to ephemeral wetlands on CWMA, we recommend aggressive action to reduce the overall numbers of feral hogs on the property.

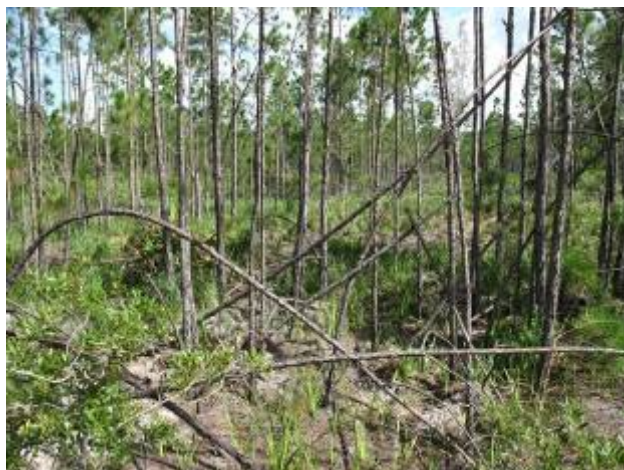
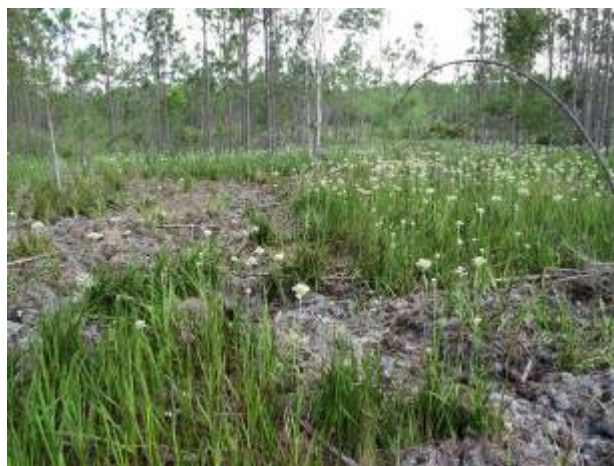
Wetland ID: 14C-04

Description: This wetland is a 0.3 ha ephemeral marsh. Pine trees dominate the canopy, and cover 25-50% of the wetland basin. There is no midstory layer. Redroot is distributed throughout the wetland, and cover 50-75% of the basin. There is severe feral hog damage in the wetland. Some thinning occurred in the wetland though there are still young pine trees remaining. The adjacent uplands are fire suppressed mesic and scrubby flatwoods and currently are managed with mechanical treatments.

Wetland Concerns: Feral hog damage, Woody encroachment

Restoration Action Recommended: Because of the widespread damage to ephemeral wetlands on CWMA, we recommend aggressive action to reduce the overall numbers of feral hogs on the property. Monitor this wetland to ensure pine trees are killed with the next fire or inundation. If they become established, the encroaching pine trees will need to be removed from the wetland. Alternatively, the small pine trees can be hand-chopped now.

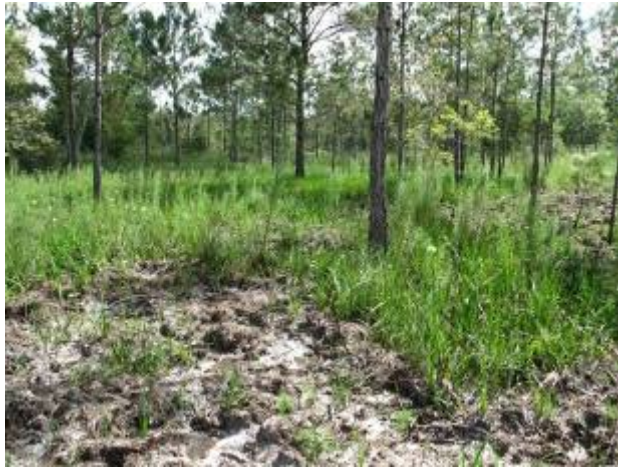
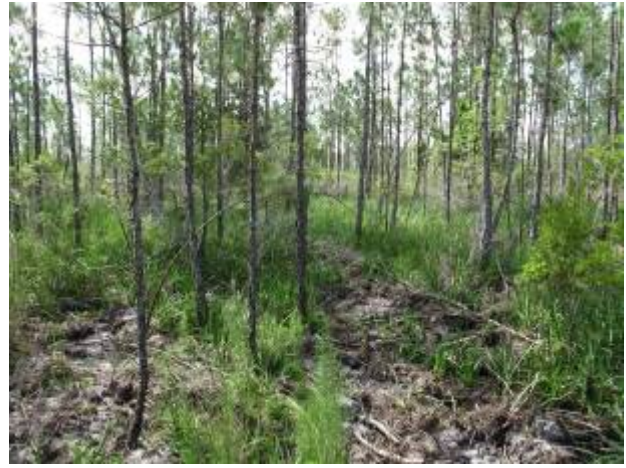
Wetland ID: 14C-05

Description: This wetland is a 0.4 ha ephemeral marsh. Pine trees dominate the canopy, and cover 25-50% of the wetland basin. There is no midstory layer. Maidencane grows throughout the wetland, and covers >75% of the basin. There is severe feral hog damage in the wetland. Some thinning occurred in the wetland though there are still young pine trees remaining. The adjacent uplands are fire suppressed mesic and scrubby flatwoods and currently are managed with mechanical treatments.

Wetland Concerns: Feral hog damage, Woody encroachment

Restoration Action Recommended: Because of the widespread damage to ephemeral wetlands on CWMA, we recommend aggressive action to reduce the overall numbers of feral hogs on the property. Monitor this wetland to ensure pine trees are killed with the next fire or inundation. If they become established, the encroaching pine trees will need to be removed from the wetland. Alternatively, the small pine trees can be hand-chopped now.

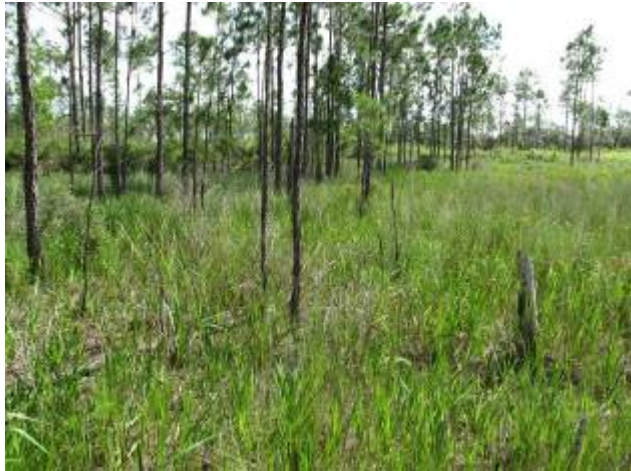
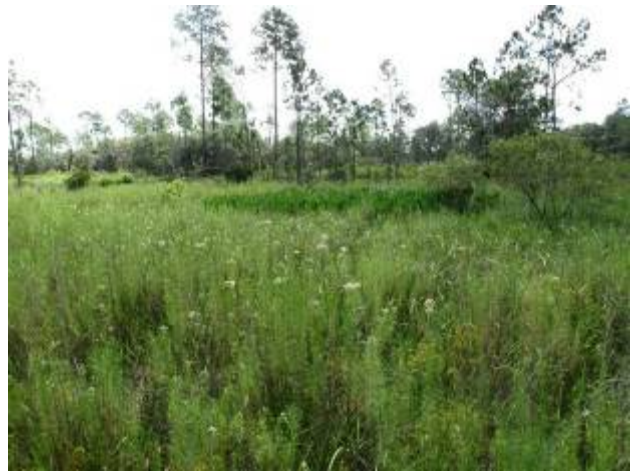
Wetland ID: 14C-06

Description: This wetland is a 0.3 ha ephemeral marsh. Young pine trees grow in a ring around the wetland, and cover 5-25% of the wetland basin. There is no midstory layer. Sedges/grasses grow throughout the wetland, and cover >75% of the basin. There is minor feral hog damage in the wetland. Pickerelweed grows in the deeper center of this marsh and there is a ring of young pine trees encroaching from the wetland edge. This large marsh has rich, diverse herbaceous vegetation and is a potential striped newt breeding pond. The adjacent uplands are fire suppressed mesic and scrubby flatwoods and currently are managed with mechanical treatments.

Wetland Concerns: Feral hog damage, Woody encroachment

Restoration Action Recommended: Because of the widespread damage to ephemeral wetlands on CWMA, we recommend aggressive action to reduce the overall numbers of feral hogs on the property. Encourage periodic fire in the wetland to eliminate encroaching pine trees. Monitor this wetland to ensure pine trees are killed with the next fire or inundation. If they become established, the encroaching pine trees will need to be removed from the wetland. Alternatively, the small pine trees can be hand-chopped now.

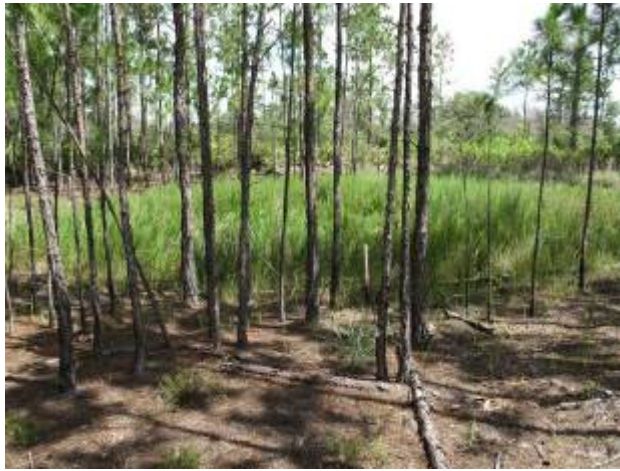
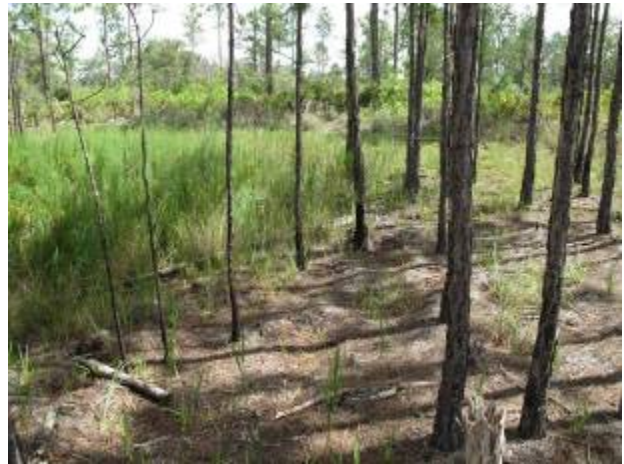
Wetland ID: 14C-07

Description: This wetland is a 0.1 ha ephemeral marsh. A ring of young pine trees surround this circular sink depression, shading out the herbaceous vegetation. The pine trees cover 25-50% of the wetland basin. Maidencane grows in the wetland center where there is no canopy cover and plenty of sunlight. The herbaceous vegetation covers 50-75% of the basin. There is minor feral hog damage in the wetland. This marsh is a potential striped newt breeding pond. This wetland provides a perfect example of how the shade and needle duff from encroaching pine trees can exclude herbaceous vegetation in a marsh. The adjacent uplands are fire suppressed mesic and scrubby flatwoods and currently are managed with mechanical treatments.

Wetland Concerns: Feral hog damage, Woody encroachment

Restoration Action Recommended: Because of the widespread damage to ephemeral wetlands on CWMA, we recommend aggressive action to reduce the overall numbers of feral hogs on the property. Remove all slash pine trees from the wetland interior. Encourage periodic fire to prevent further pine encroachment.

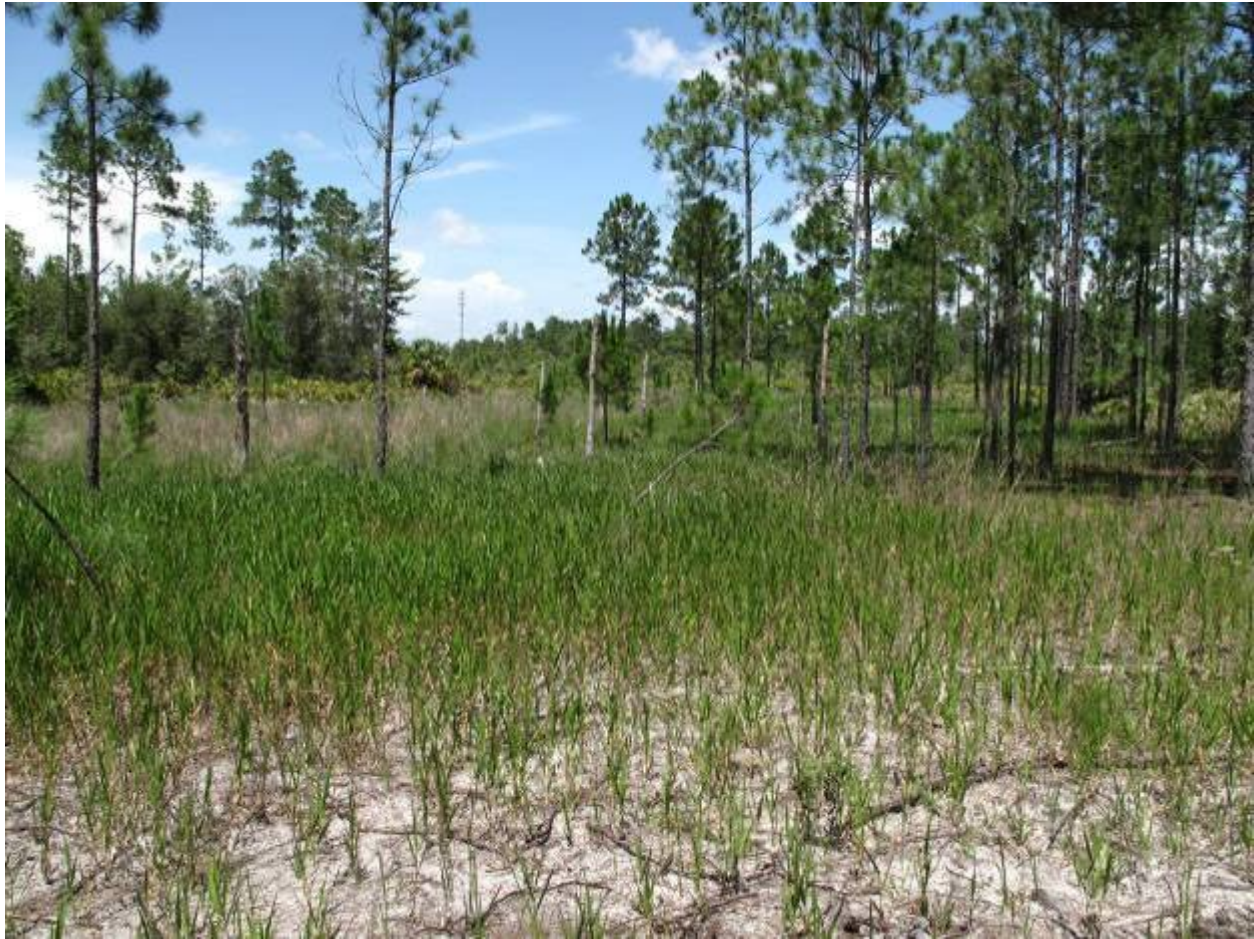
Wetland ID: 15C-01

Description: This wetland is a 0.3 ha ephemeral marsh. Pine trees dominate the canopy, and cover 5-25% of the wetland basin around the edge. There is no midstory layer. Maidencane grows throughout the wetland, and covers >75% of the basin. There is a little feral hog damage in the wetland. Some pine trees are encroaching from the wetland edge. This marsh is a potential striped newt breeding pond. The adjacent uplands are fire suppressed scrubby flatwoods and currently are managed with mechanical treatments.

Wetland Concerns: Feral hog damage, Woody encroachment

Restoration Action Recommended: Because of the widespread damage to ephemeral wetlands on CWMA, we recommend aggressive action to reduce the overall numbers of feral hogs on the property. Encourage periodic fire in the wetland to eliminate encroaching pine trees. Monitor this wetland to ensure pine trees are killed with the next fire or inundation. If they become established, the encroaching pine trees will need to be removed from the wetland. Alternatively, the small pine trees can be hand-chopped now.

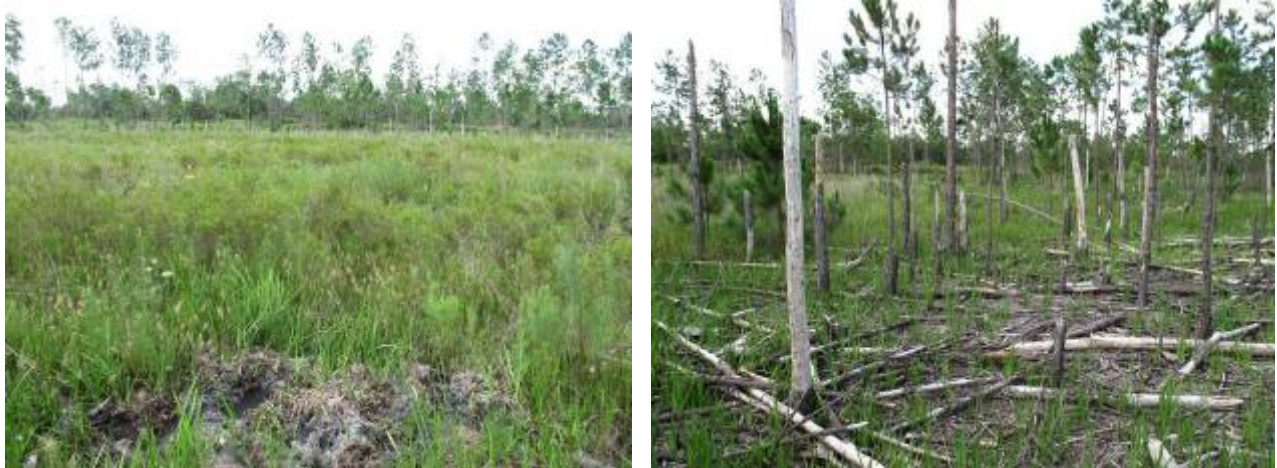
Wetland ID: 15C-02

Description: This wetland is a 1.1 ha ephemeral marsh. The wetland is ringed with encroaching pine trees. Some trees recently were killed, most likely by water inundation, but many remain. The pine trees cover 5-25% of the wetland. The midstory is dominated by *Hypericum*, and covers 5-25% of the wetland. Maidencane and sedges/grasses grow throughout the wetland, and cover >75% of the basin. There is moderate, patchy feral hog damage in the wetland. This is a good place to observe the opposing forces of upland plant encroachment and water inundation. The wetland will connect to 15C-03 during periods of high water. This marsh has rich, diverse vegetation and is a potential striped newt breeding pond. The adjacent uplands are fire suppressed mesic and scrubby flatwoods and currently are managed with mechanical treatments.

Wetland Concerns: Feral hog damage, Woody encroachment

Restoration Action Recommended: Because of the widespread damage to ephemeral wetlands on CWMA, we recommend aggressive action to reduce the overall numbers of feral hogs on the property. Encourage periodic fire in the wetland to eliminate remaining encroaching pine trees. Monitor this wetland to ensure pine trees are killed with the next fire or inundation. If they become established, the encroaching pine trees will need to be removed from the wetland. Alternatively, the small pine trees can be hand-chopped now.

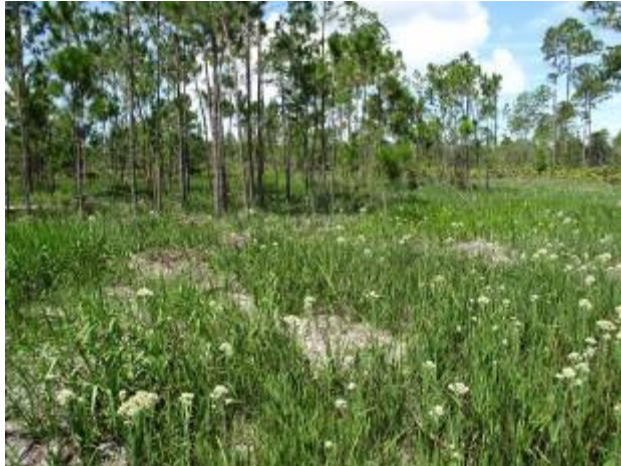
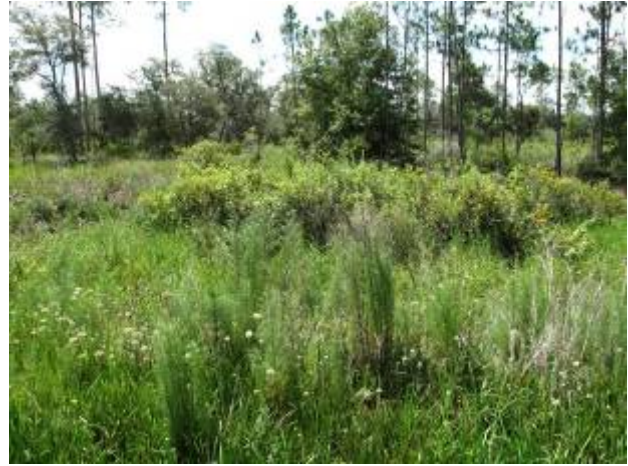
Wetland ID: 15C-03

Description: This wetland is a 0.3 ha ephemeral marsh. Pine trees dominate the canopy, and cover 5-25% of the wetland basin. There is no midstory layer. Maidencane and redroot grow throughout the wetland, and cover >75% of the basin. This oblong wetland has a deeper sink hole at the east end. There is extensive feral hog damage in the wetland. Encroaching pine trees are patchy and some thinning of larger pine trees has occurred. The wetland will connect to 15C-02 during periods of high water. This marsh is a potential striped newt breeding wetland, especially in the sink depression. The adjacent uplands are fire suppressed mesic and scrubby flatwoods and currently are managed with mechanical treatments.

Wetland Concerns: Feral hog damage, Woody encroachment

Restoration Action Recommended: Because of the widespread damage to ephemeral wetlands on CWMA, we recommend aggressive action to reduce the overall numbers of feral hogs on the property. Remove pine trees from the wetland interior.

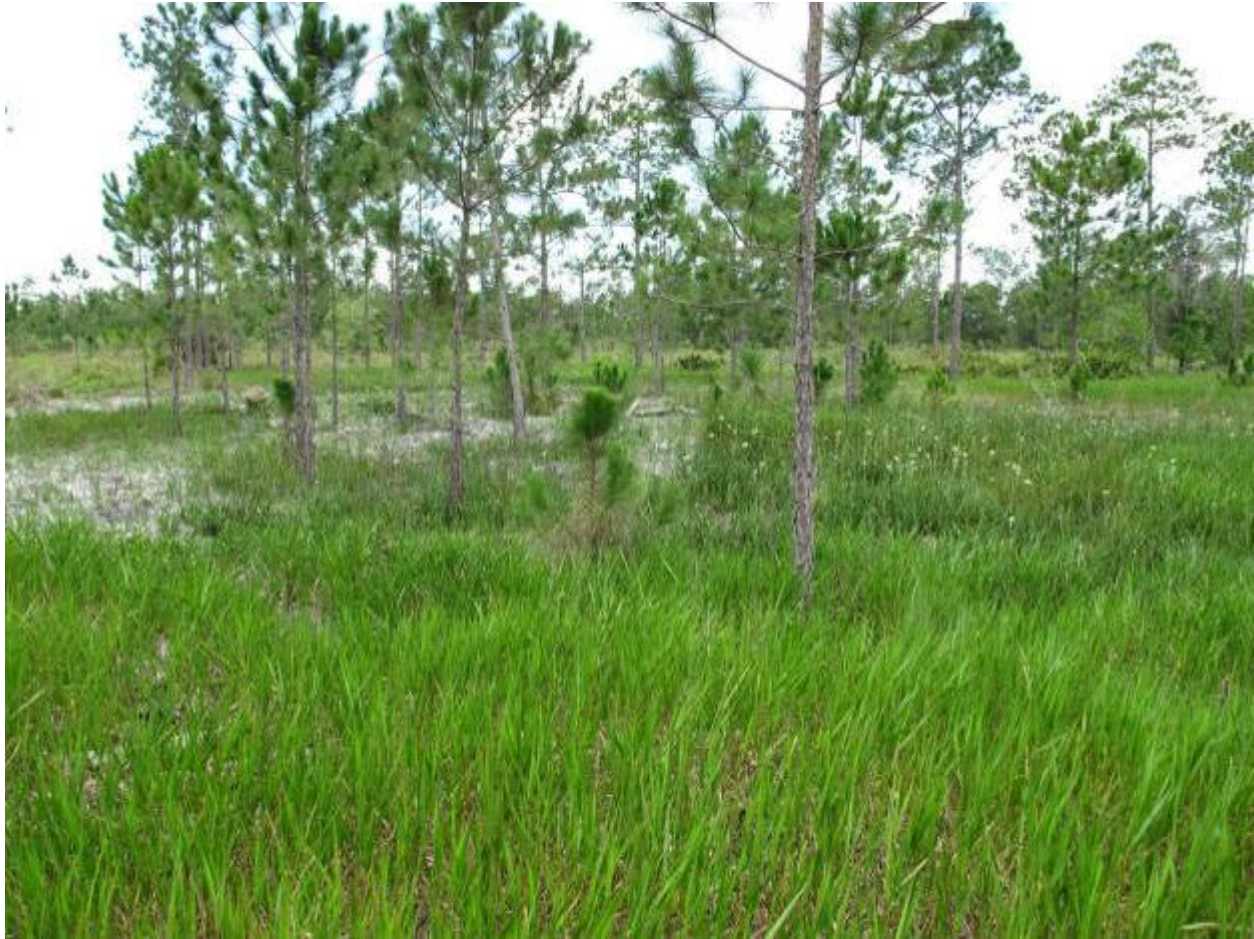
Wetland ID: 15C-04

Description: This wetland is a 1.2 ha ephemeral marsh. The wetland is ringed with encroaching pine trees. Some trees recently were killed, most likely by inundation, but many remain. The pine trees cover 5-25% of the wetland basin. There is no midstory layer. Maidencane grows throughout the wetland, and covers >75% of the basin. There is extensive feral hog damage in the wetland. This marsh is a potential striped newt breeding pond. The adjacent uplands are fire suppressed sandhills and currently are managed with mechanical treatments.

Wetland Concerns: Feral hog damage, Woody encroachment

Restoration Action Recommended: Because of the widespread damage to ephemeral wetlands on CWMA, we recommend aggressive action to reduce the overall numbers of feral hogs on the property. Remove pine trees in the wetland out to the upland/wetland ecotone

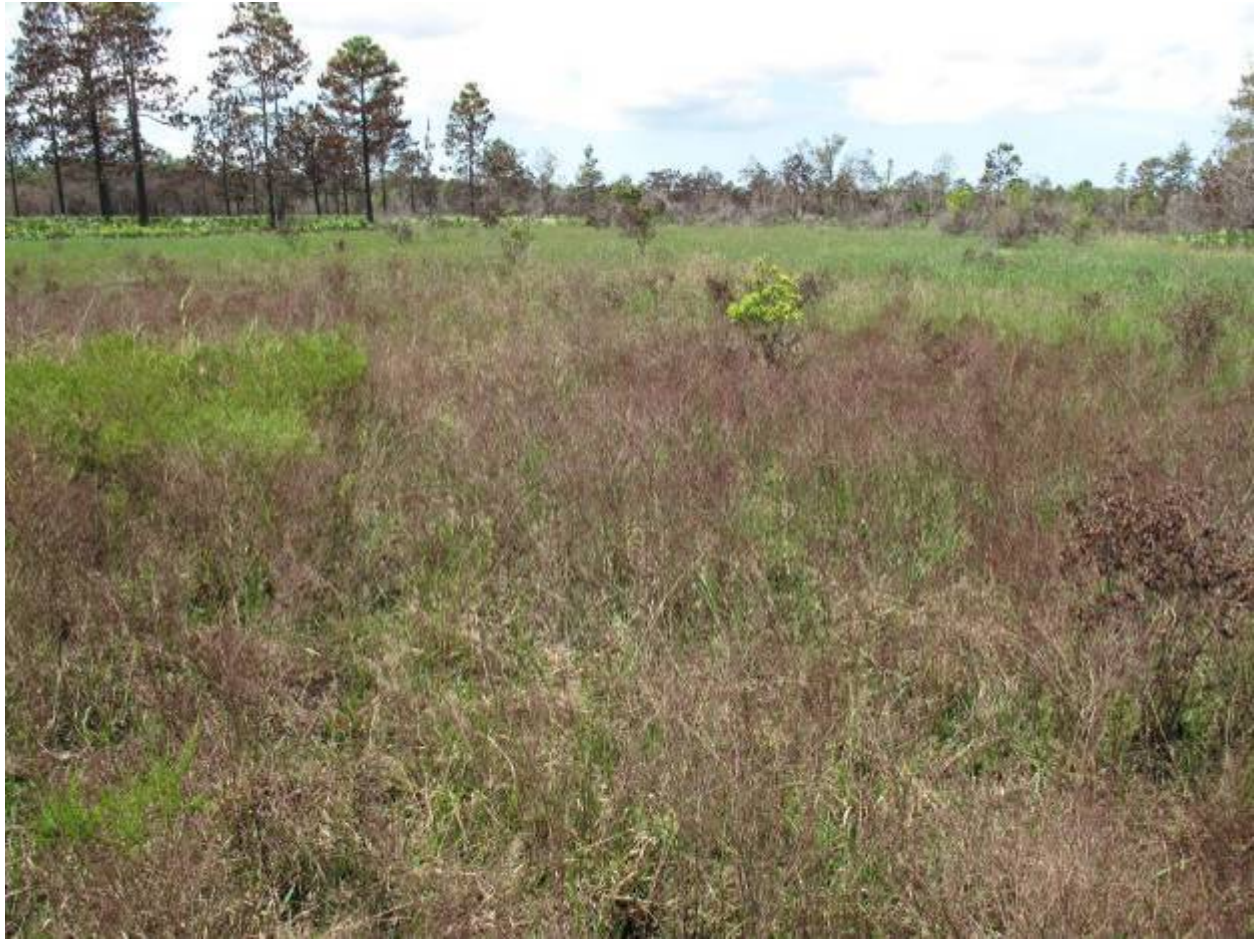
Wetland ID: 16C-01

Description: This wetland is a 1.3 ha ephemeral marsh. There is no tree canopy or midstory cover. A recent fire burned into the wetland, eliminating the encroaching wax myrtle. A small patch of buttonbush remains in the wetland center. Sedges/grasses grow throughout the wetland, and cover >75% of the basin. The wetland has minor old and new feral hog damage. This marsh is in fire-maintenance condition and is a potential striped newt breeding pond. The adjacent uplands are sandhills and currently are managed with mechanical vegetation removal and prescribed fire.

Wetland Concerns: Feral hog damage

Restoration Action Recommended: Because of the widespread damage to ephemeral wetlands on CWMA, we recommend aggressive action to reduce the overall numbers of feral hogs on the property.
