Inventory, Assessment, and Restoration Potential of Ephemeral Wetlands on FFWCC Wildlife Management Areas

Chassahowitzka WMA Final Report

Submitted by: Rebecca P.M. Means¹, Ryan C. Means¹, Steven A. Johnson²

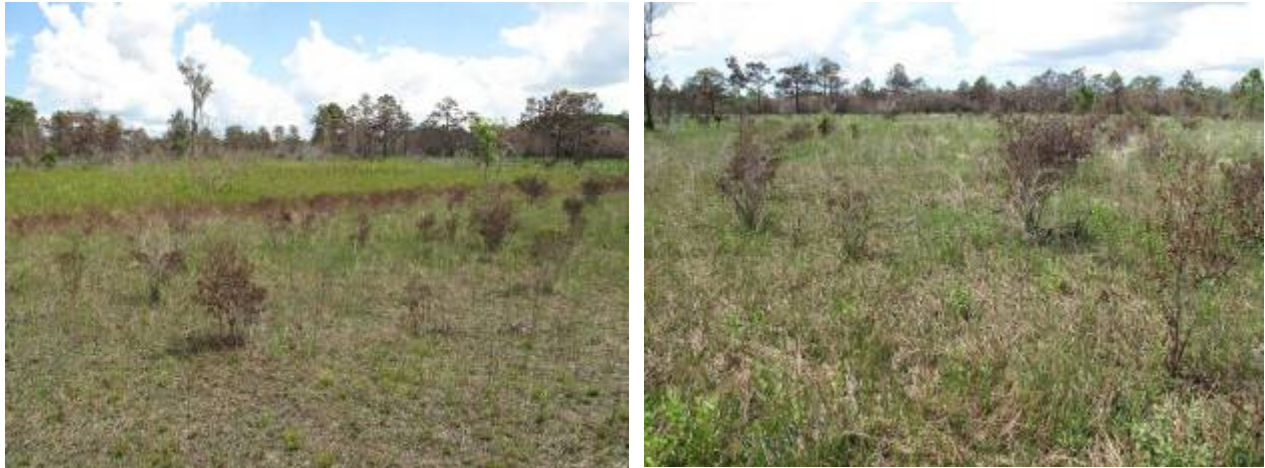
Wetland ID: 16C-02

Description: This wetland is a 1.5 ha ephemeral marsh. There is no tree canopy. This large marsh is in excellent ecological condition. A recent fire burned deep into the wetland, eliminating encroaching wax myrtles and pine trees. The deepest center of the wetland did not burn. Wax myrtle covers 5-25% of the wetland basin. Maidencane and sedges/grasses grow throughout the wetland, and cover >75% of the basin. This wetland provides a good example of the direct effect of fire in a wetland. This marsh is in fire-maintenance condition and is a potential striped newt breeding pond. The adjacent uplands are sandhills and currently are managed with mechanical vegetation removal and prescribed fire.

Wetland Concerns: None

Restoration Action Recommended: None

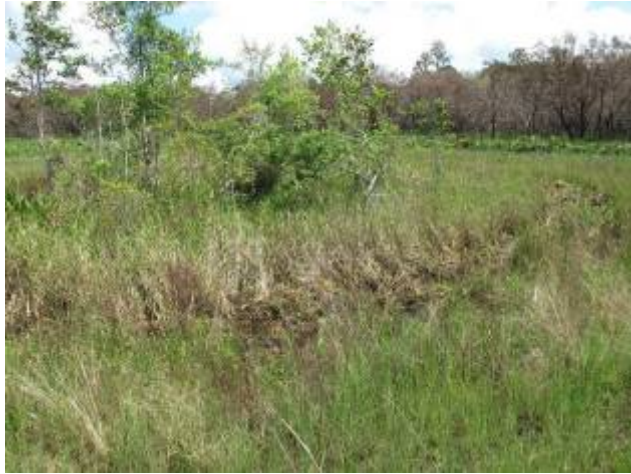
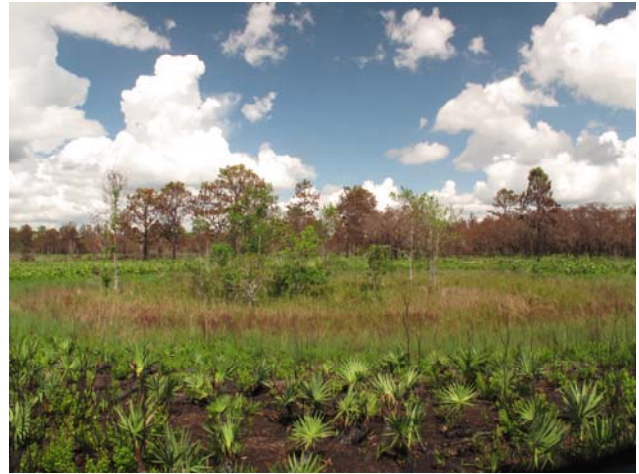
Wetland ID: 16C-03

Description: This wetland is a 0.1 ha ephemeral marsh in a circular depression. Holly trees grow in the deeper wetland center, and cover 5-25% of the wetland basin. There is no midstory layer. Sedges/grasses grow throughout the wetland, and cover >75% of the basin. The wetland has a ring of feral hog rooting. A recent fire burned into the wetland, but the wetter center of the wetland did not burn. This marsh is in fire-maintenance condition and is a potential striped newt breeding pond. The adjacent uplands are sandhills and currently are managed with mechanical vegetation removal and prescribed fire.

Wetland Concerns: Feral hog damage

Restoration Action Recommended: Because of the widespread damage to ephemeral wetlands on CWMA, we recommend aggressive action to reduce the overall numbers of feral hogs on the property.

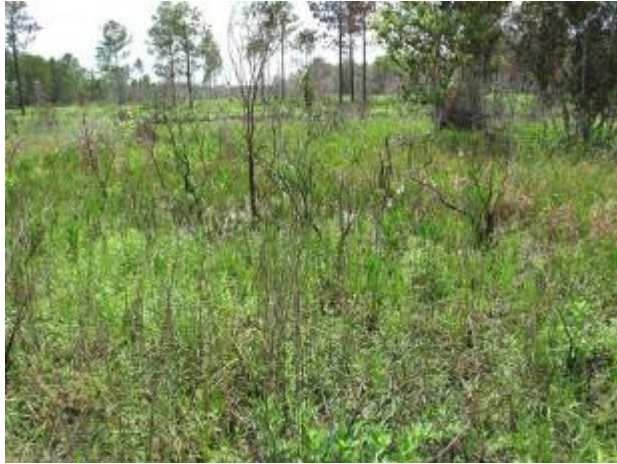
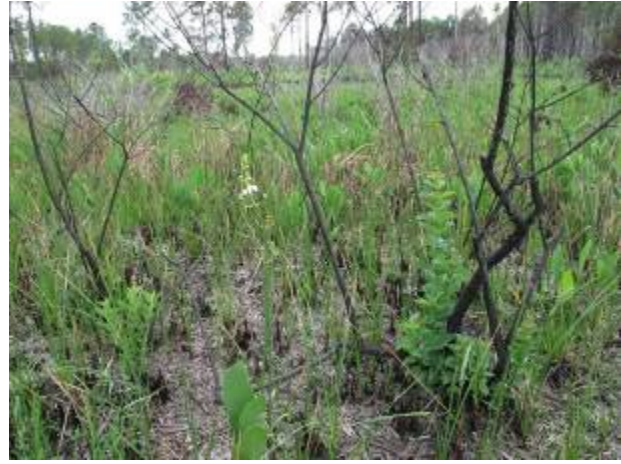
Wetland ID: 16C-04

Description: This wetland is a 0.4 ha ephemeral marsh. There is no tree canopy. Wax myrtle and buttonbush cover 5-25% of the wetland. Sedges/grasses grow throughout the wetland, and cover >75% of the basin. The wetland has extensive feral hog damage that has grown over with vegetation. A recent fire burned into the wetland. This marsh is in fire-maintenance condition and is a potential striped newt breeding pond. The adjacent uplands are sandhills and currently are managed with mechanical vegetation removal and prescribed fire.

Wetland Concerns: Feral hog damage

Restoration Action Recommended: Because of the widespread damage to ephemeral wetlands on CWMA, we recommend aggressive action to reduce the overall numbers of feral hogs on the property.

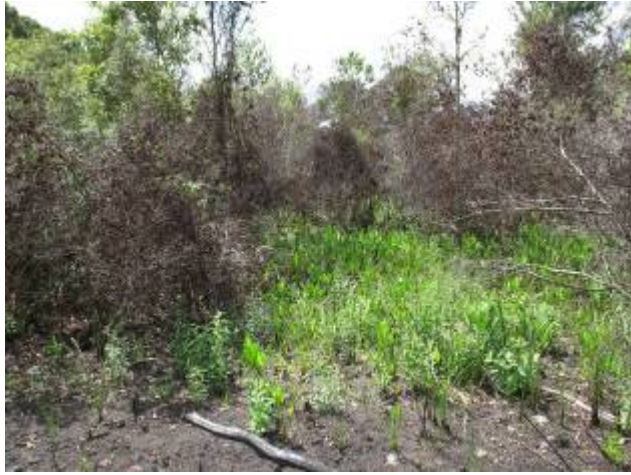
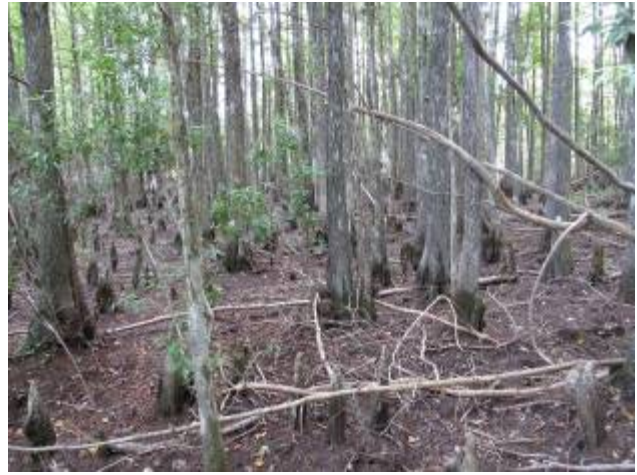
Wetland ID: 16C-05

Description: This wetland is a 2.9 ha ephemeral forested swamp. Cypress trees are dense and cover >75% of the wetland basin. The midstory is dominated by wax myrtle, and covers 5-25% of the wetland. Sedges/grasses grow sparsely and cover 5-25% of the wetland basin. A recent fire burned to the wetland edges. The adjacent uplands are sandhills and currently are managed with mechanical vegetation removal and prescribed fire.

Wetland Concerns: None

Restoration Action Recommended: None

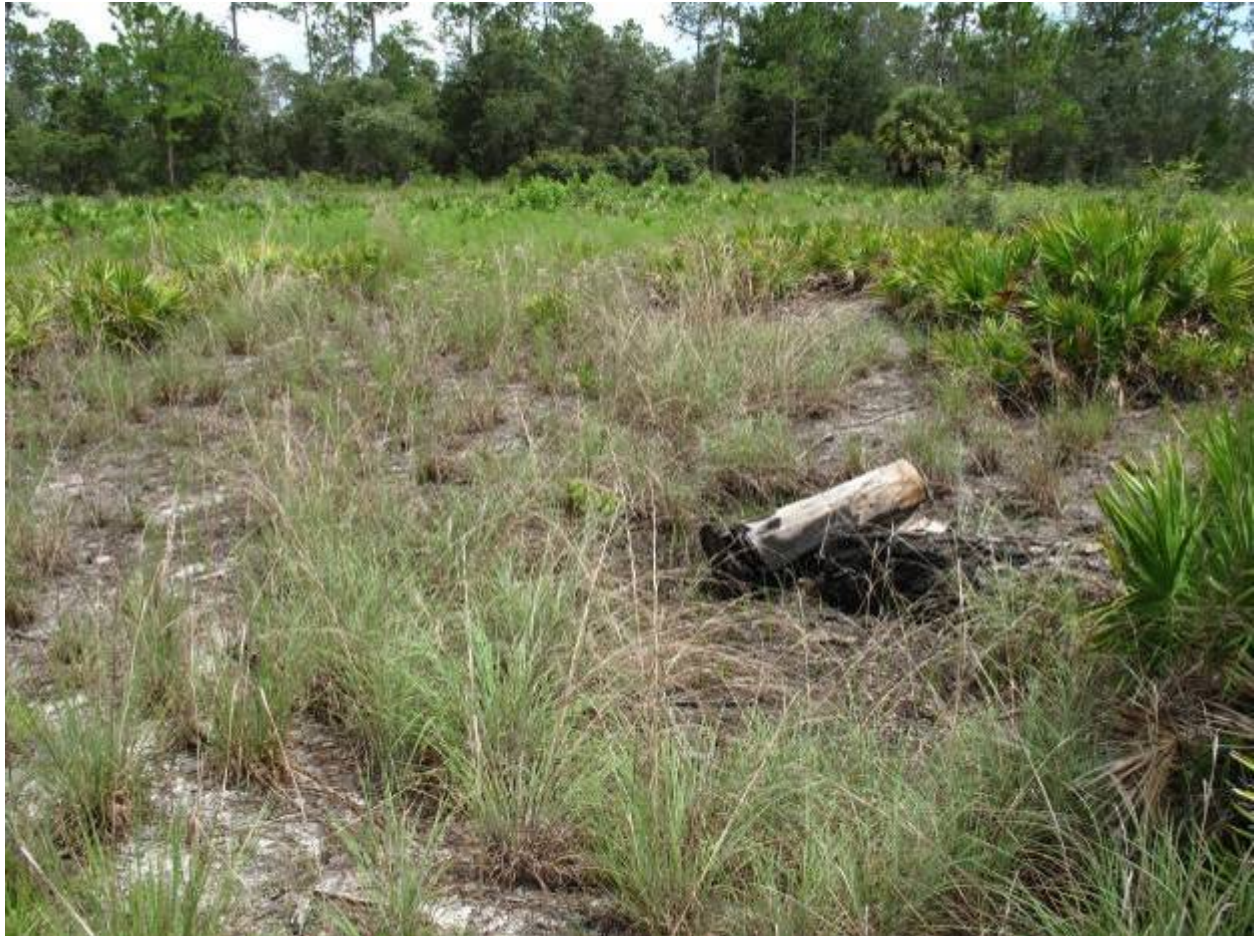
Wetland ID: 01D-01

Description: This wetland is a <0.1 ha ephemeral marsh in a sink depression. There is no canopy or midstory cover. Sedges/grasses grow throughout the wetland, and cover 50-75% of the basin. There are 2, 6' long pine log sections left in the wetland from when the area was logged. This marsh is in fire-maintenance condition and is a potential striped newt breeding pond. The adjacent uplands are scrubby flatwoods and currently are managed with prescribed fire and mechanical vegetation removal.

Wetland Concerns: None

Restoration Action Recommended: None

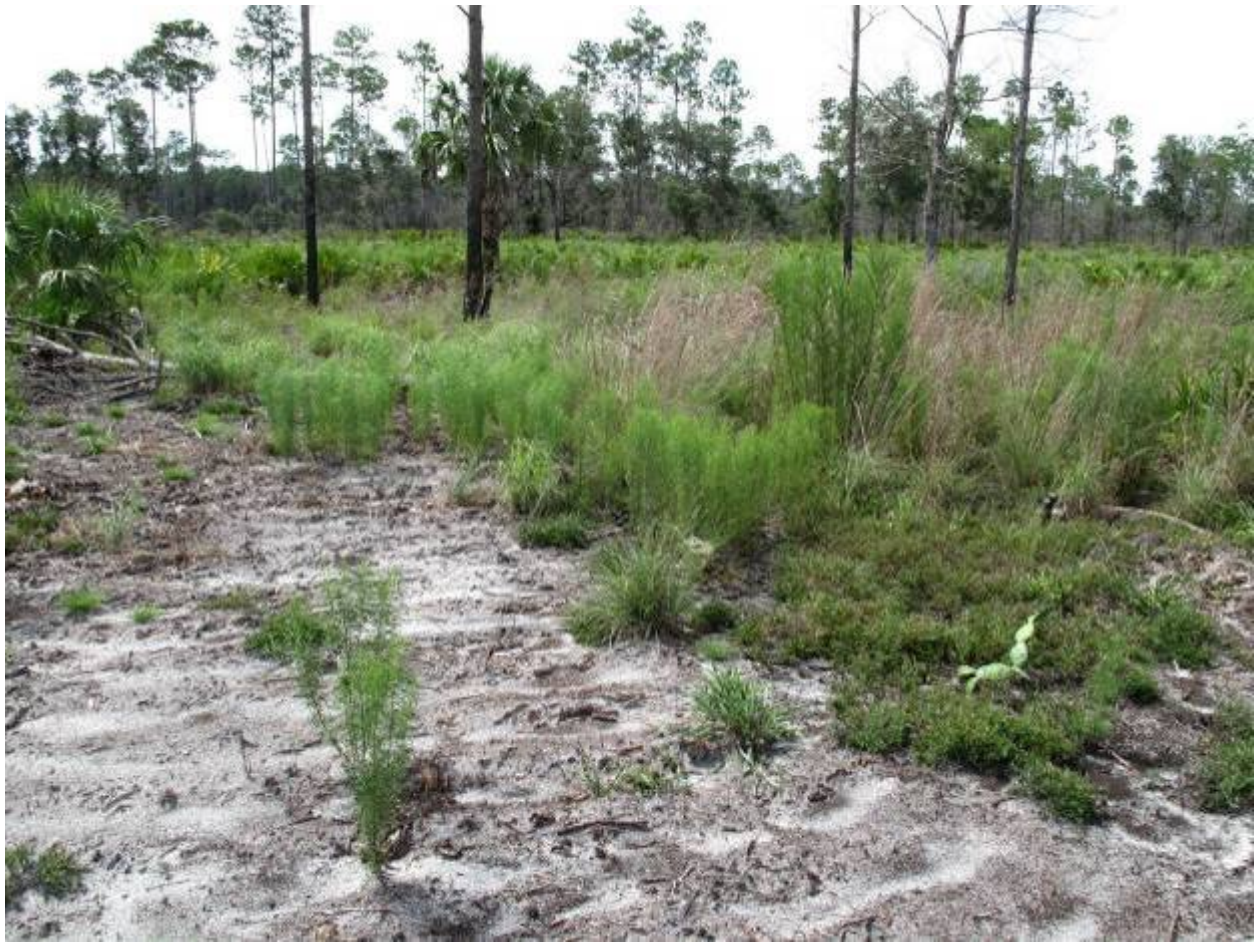
Description: This wetland is a 0.1 ha ephemeral marsh. There is no canopy or midstory cover. Sedges/grasses grow in scattered patches, and cover 50-75% of the wetland basin. There are some roll-chopper tracks through the center of the wetland that eliminated some vegetation, but the vehicles did not create deep ruts. This wetland is a potential striped newt breeding pond. The adjacent uplands are scrubby flatwoods and currently are managed with prescribed fire and mechanical vegetation removal.

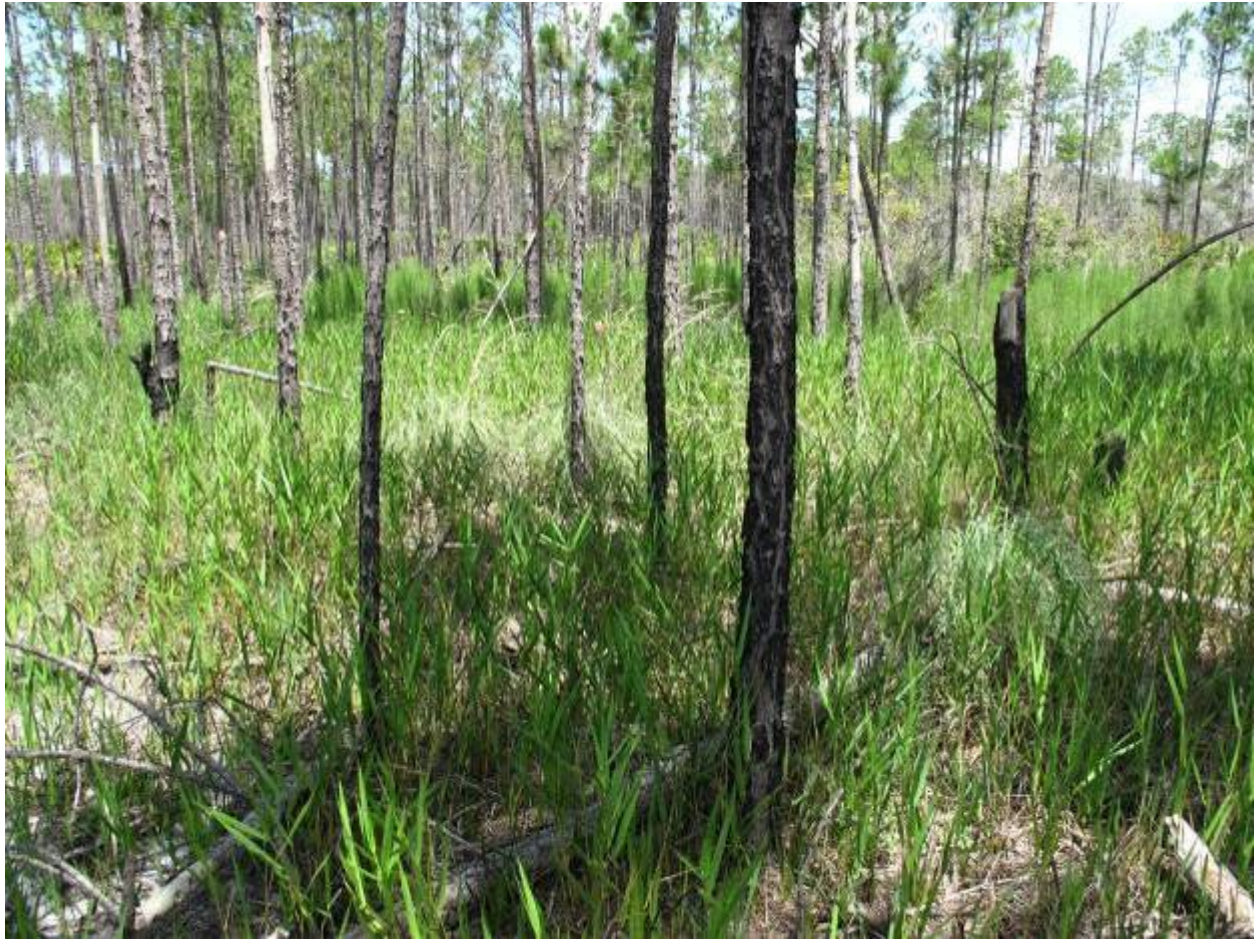
Description: This wetland is a 0.5 ha ephemeral marsh. Pine trees have encroached in the wetland, and cover 25-50% of the basin. There is no midstory layer. Maidencane and redroot grow throughout the wetland, and cover >75% of the basin. The trees have charred bases, indicating the wetland basin has received fire in the recent past. However, the pine trees now are too large to be killed by a typical prescribed fire. The wetland has extensive feral hog damage. The adjacent uplands are scrubby flatwoods and currently are managed with prescribed fire and mechanical vegetation removal.

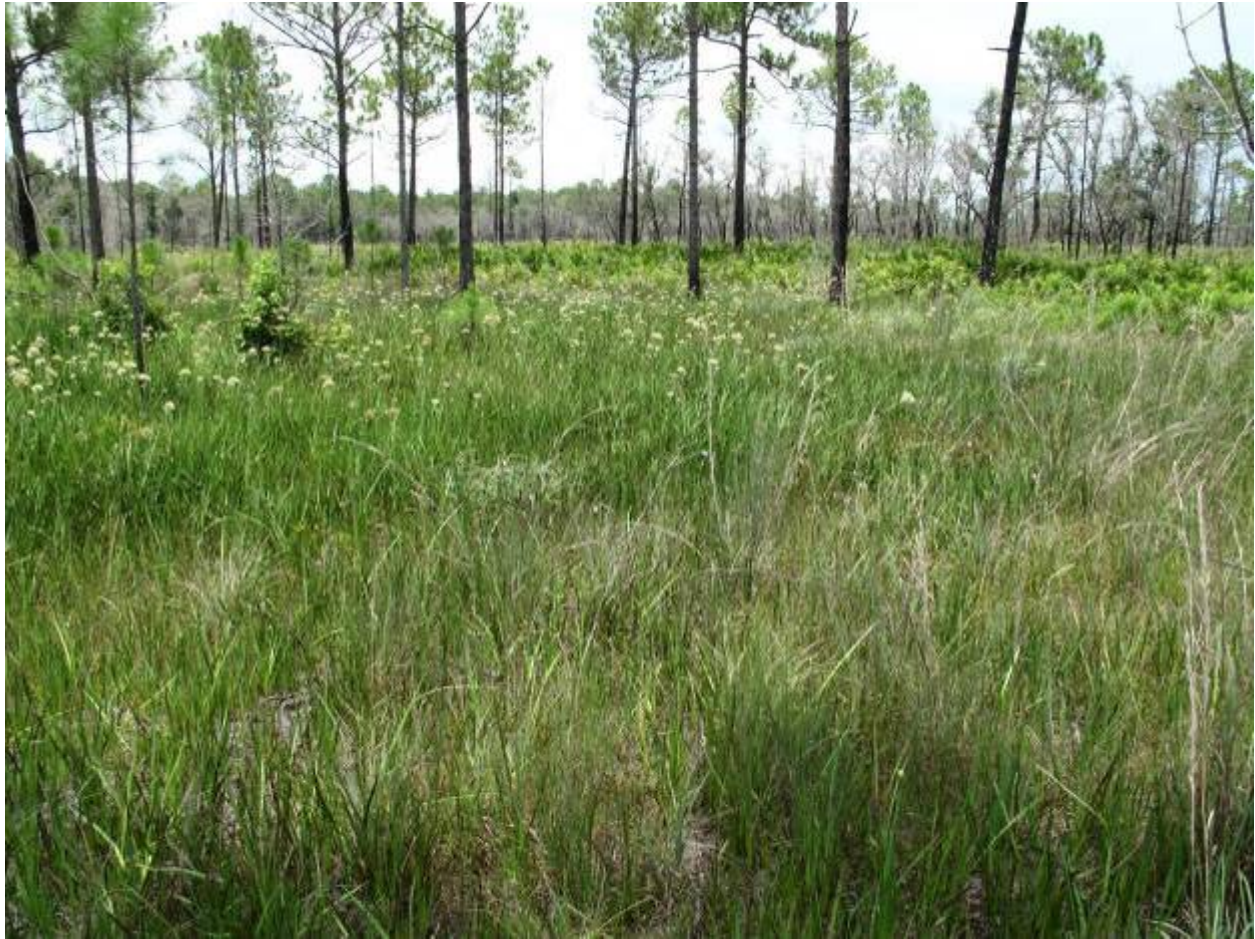
Description: This wetland is a 0.1 ha ephemeral marsh. Pine trees grow around the wetland edge, and cover 5-25% of the basin. There is no midstory layer. Sedges/grasses and redroot grow throughout the wetland, and cover >75% of the basin. The wetland is recovering well from past feral hog damage but also has some new, minor damage. This marsh is in fire-maintenance condition and is a potential striped newt breeding pond. The adjacent uplands are scrubby flatwoods and currently are managed with prescribed fire and mechanical vegetation removal.

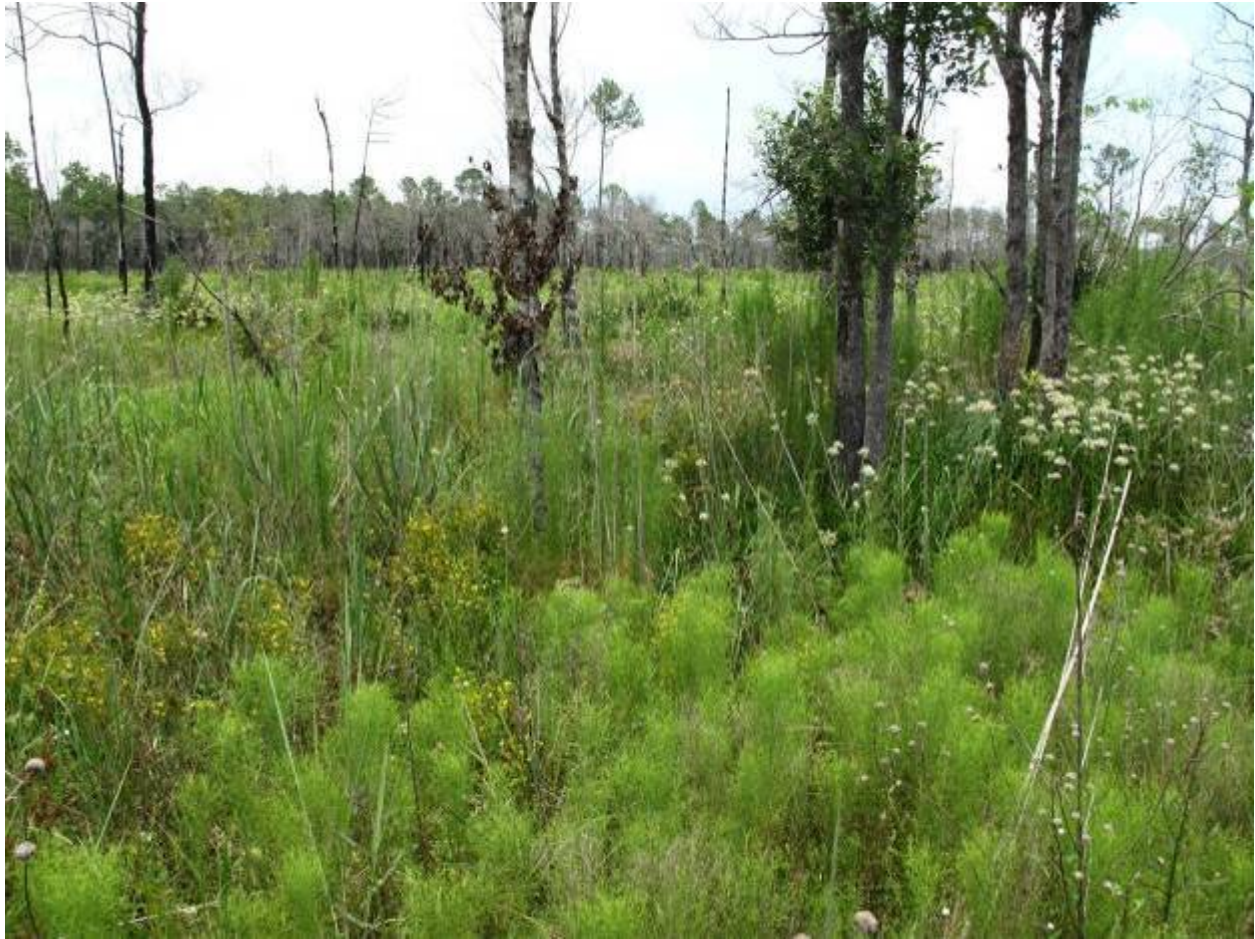
Description: This wetland is a <0.1 ha ephemeral marsh. Gum trees dominate the canopy, and cover 5-25% of the wetland basin. There is no midstory layer. Sedges/grasses and redroot grow throughout the wetland, and cover >75% of the basin. This pristine little flatwoods pond is situated on the edge of the big hydric hammock. The adjacent uplands are mesic flatwoods and currently are managed with prescribed fire and mechanical vegetation removal.

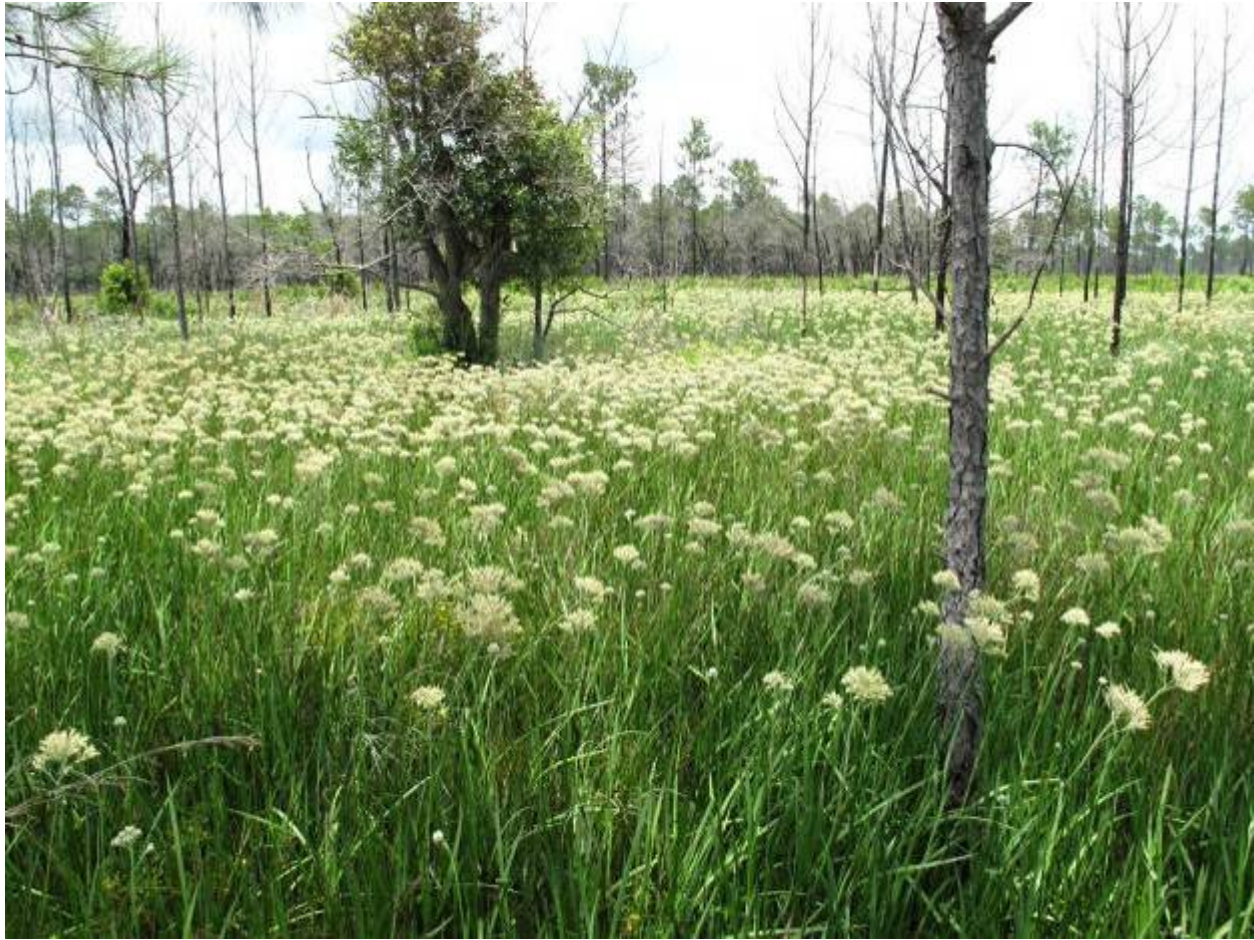
Description: This wetland is a 0.1 ha ephemeral marsh. Some young pine trees are encroaching from the edge of the wetland; many were killed during a recent fire. Pine trees cover 5-25% of the wetland basin. There is no midstory layer. Sedges/grasses and redroot grow throughout the wetland, and cover >75% of the basin. The wetland has old and new feral hog damage. The adjacent uplands are scrubby flatwoods and currently are managed with prescribed fire and mechanical vegetation removal.

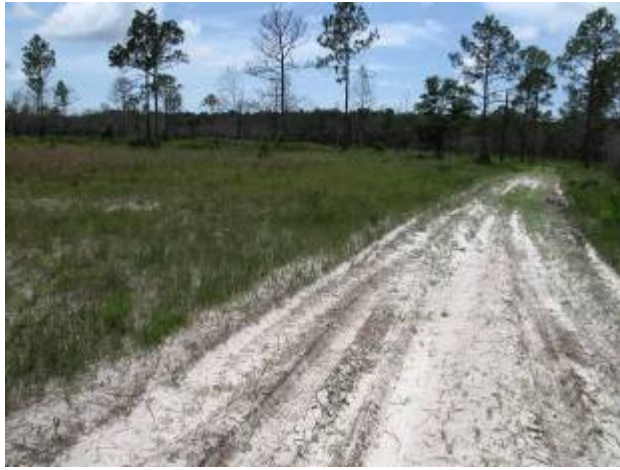
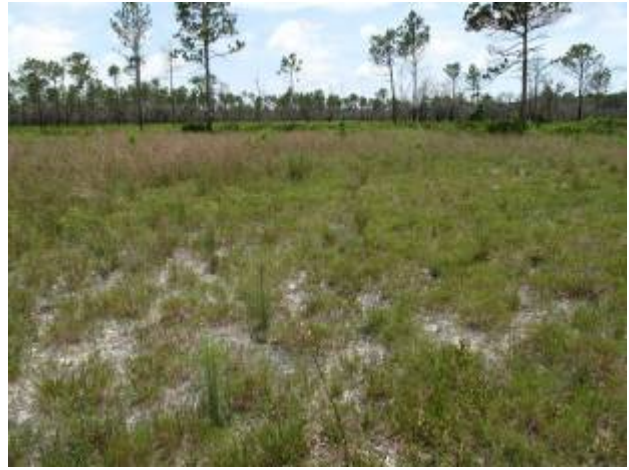
Wetland ID: 02D-04

Description: This wetland is a 0.3 ha ephemeral human-made or enhanced marsh. It is a square-shaped grassy plot, human-made, and functions as an ephemeral marsh. There is no canopy or midstory cover. Sedges/grasses grow throughout the wetland, and cover >75% of the basin. Firelines bisect the north and east sides. This marsh is in fire-maintenance condition and is a potential striped newt breeding pond. The adjacent uplands are scrubby flatwoods and currently are managed with prescribed fire and mechanical vegetation removal.

Wetland Disturbance: Fireline

Restoration Action Recommended: Although this is a man-made marsh, and could be considered a disturbance itself, this grassy plot is functioning as an ephemeral wetland and could be managed as such. We have found striped newts breeding in other human-made wetlands, such as borrow pits. We recommend moving the firelines outward at least 15m from the wetland edge. If the firelines cannot be re-routed, monitor the wetland to ensure fire is not excluded. Maintain the fireline when the wetland is completely dry to prevent ruts from developing.

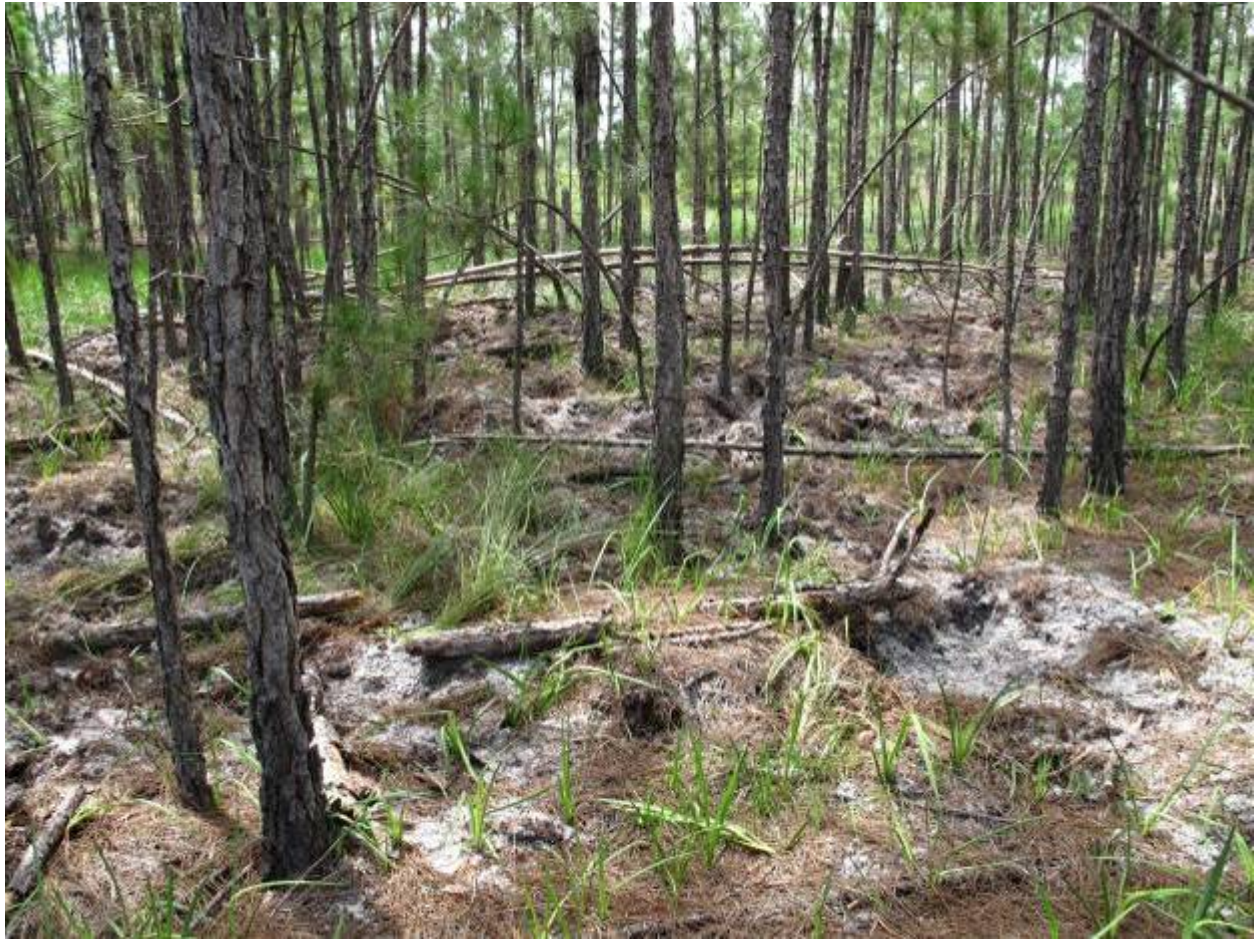
Wetland ID: 03D-01

Description: This wetland is a 13.7 ha ephemeral marsh. Hundreds of small slash pine trees have established in the wetland, presumably due to lack of fire. The pine trees cover 25-50% of the basin. There is no midstory layer. Maidencane grows throughout the wetland, and covers >75% of the basin. The wetland has widespread feral hog damage. The adjacent uplands are fire suppressed mesic flatwoods and currently are managed with mechanical treatments.

Wetland Concerns: Feral hog damage, Woody encroachment

Restoration Action Recommended: Because of the widespread damage to ephemeral wetlands on CWMA, we recommend aggressive action to reduce the overall numbers of feral hogs on the property. Remove dense pine trees from the wetland interior and thin the pine trees around the wetland edge.

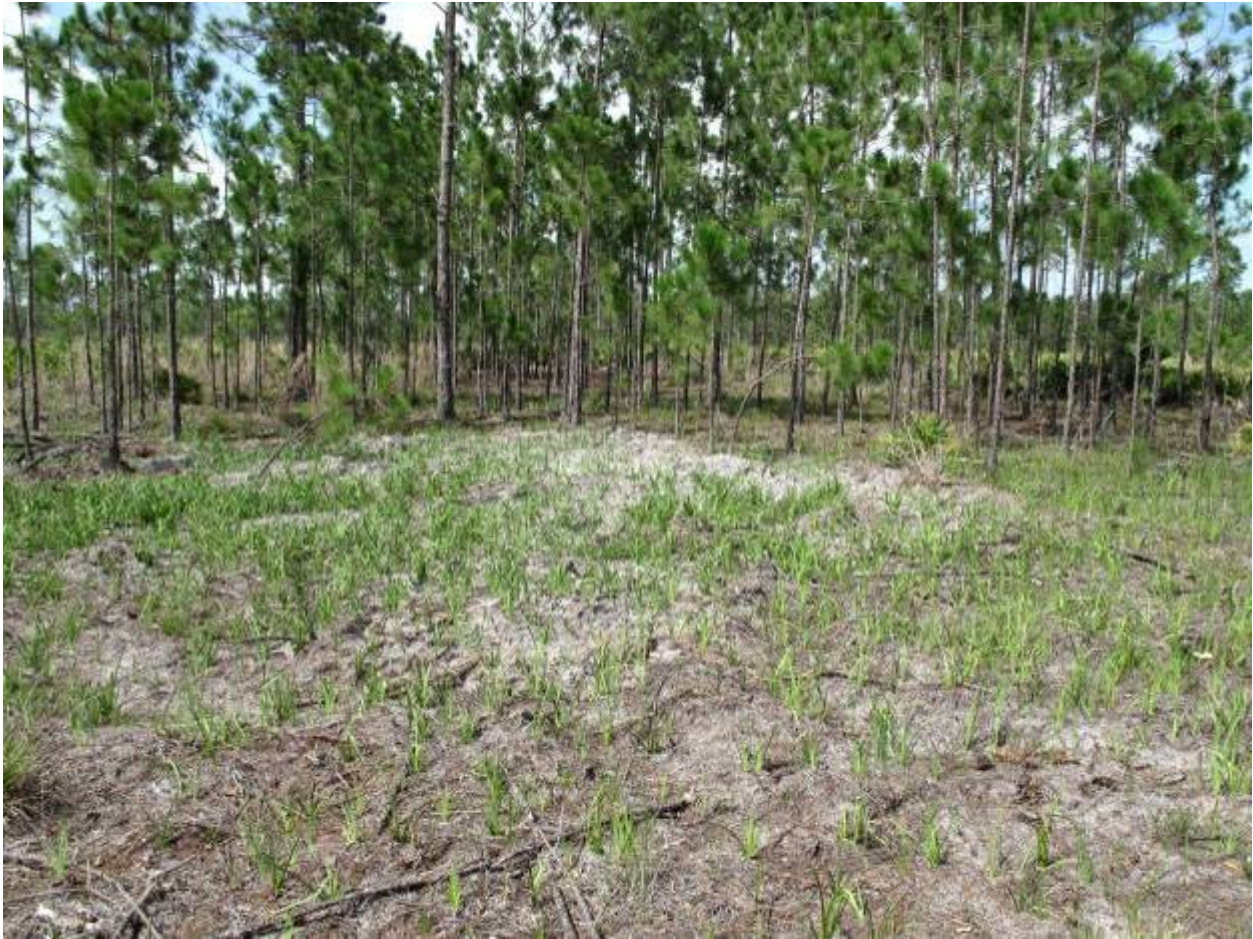
Wetland ID: 03D-02

Description: This wetland is a 0.1 ha ephemeral marsh. Young pine trees are encroaching into the wetland basin; some larger pine trees were removed during a recent thinning operation. The pine trees cover 25-50% of the wetland basin. There is no midstory layer. Redroot grows in scattered patches, covering 25-50% of the wetland basin. The wetland has severe feral hog damage. The adjacent uplands are fire suppressed mesic flatwoods and currently are managed with mechanical treatments.

Wetland Concerns: Feral hog damage, Woody encroachment

Restoration Action Recommended: Because of the widespread damage to ephemeral wetlands on CWMA, we recommend aggressive action to reduce the overall numbers of feral hogs on the property. Remove dense pine stand from the wetland.

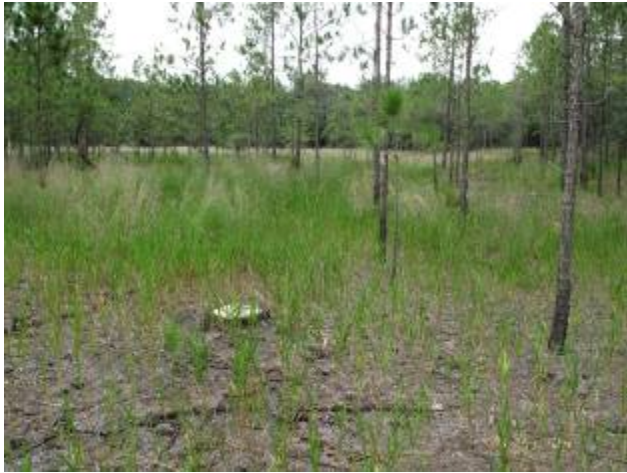
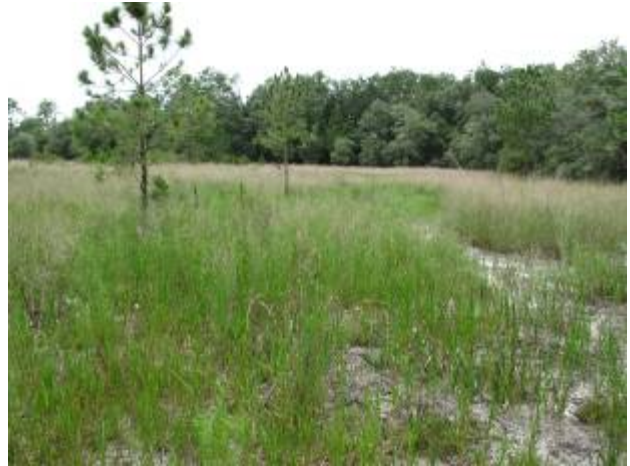
Wetland ID: 04D-01

Description: This wetland is a 1.8 ha ephemeral marsh. Pine trees dominate the canopy, and cover 5-25% of the wetland basin. There is no midstory layer. Sedges/grasses and dog fennel grow throughout the wetland, and cover >75% of the basin. The wetland has some feral hog damage. There are multiple 1m tall linear earthen berms constructed into the wetland basin from the south side and one on the east side. This wetland is a potential striped newt breeding pond. The adjacent uplands are fire suppressed sandhills with a dense oak and palmetto ring. The uplands currently are managed with mechanical treatments.

Wetland Concerns: Berm, Feral hog damage, Woody encroachment

Restoration Action Recommended: Remove the berms and the pine trees from the wetland interior. Because of the widespread damage to ephemeral wetlands on CWMA, we recommend aggressive action to reduce the overall numbers of feral hogs on the property.

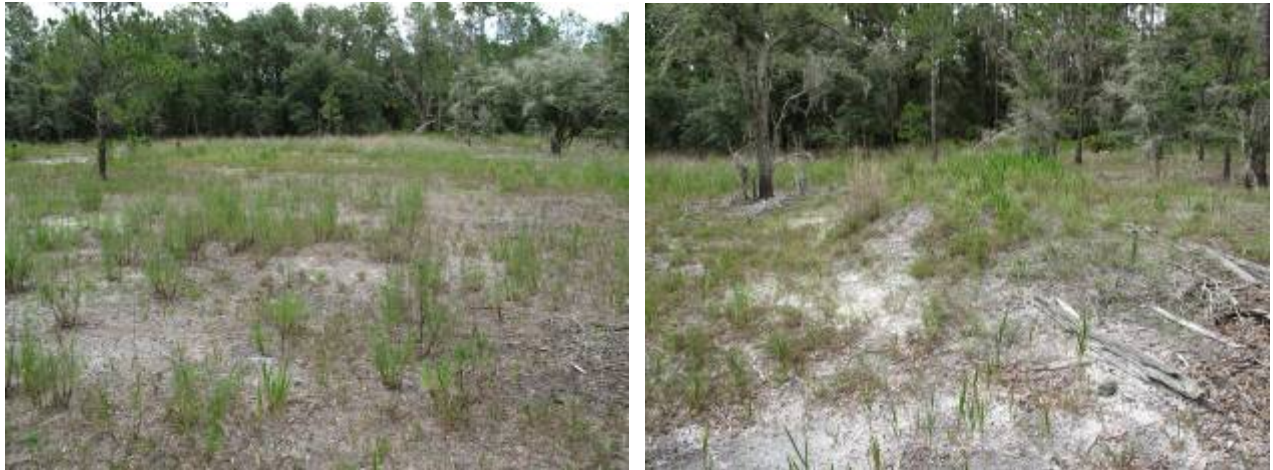
Wetland ID: 04D-02

Description: This wetland is a 0.6 ha ephemeral marsh. There is no canopy or midstory cover. Sedges/grasses grow throughout the wetland, and cover 50-75% of the basin. The wetland has minor feral hog damage. This circular marsh has old dirt mounds and rows in and around the wetland perimeter. They do not seem to be adversely affecting the wetland ecology. This wetland is a potential striped newt breeding pond. The adjacent uplands are fire suppressed sandhills with a dense oak and palmetto ring. The uplands currently are managed with mechanical treatments.

Wetland Concerns: Feral hog damage, Dirt piles and rows

Restoration Action Recommended: Because of the widespread damage to ephemeral wetlands on CWMA, we recommend aggressive action to reduce the overall numbers of feral hogs on the property. The dirt piles are not large enough to merit attention and should erode over time.

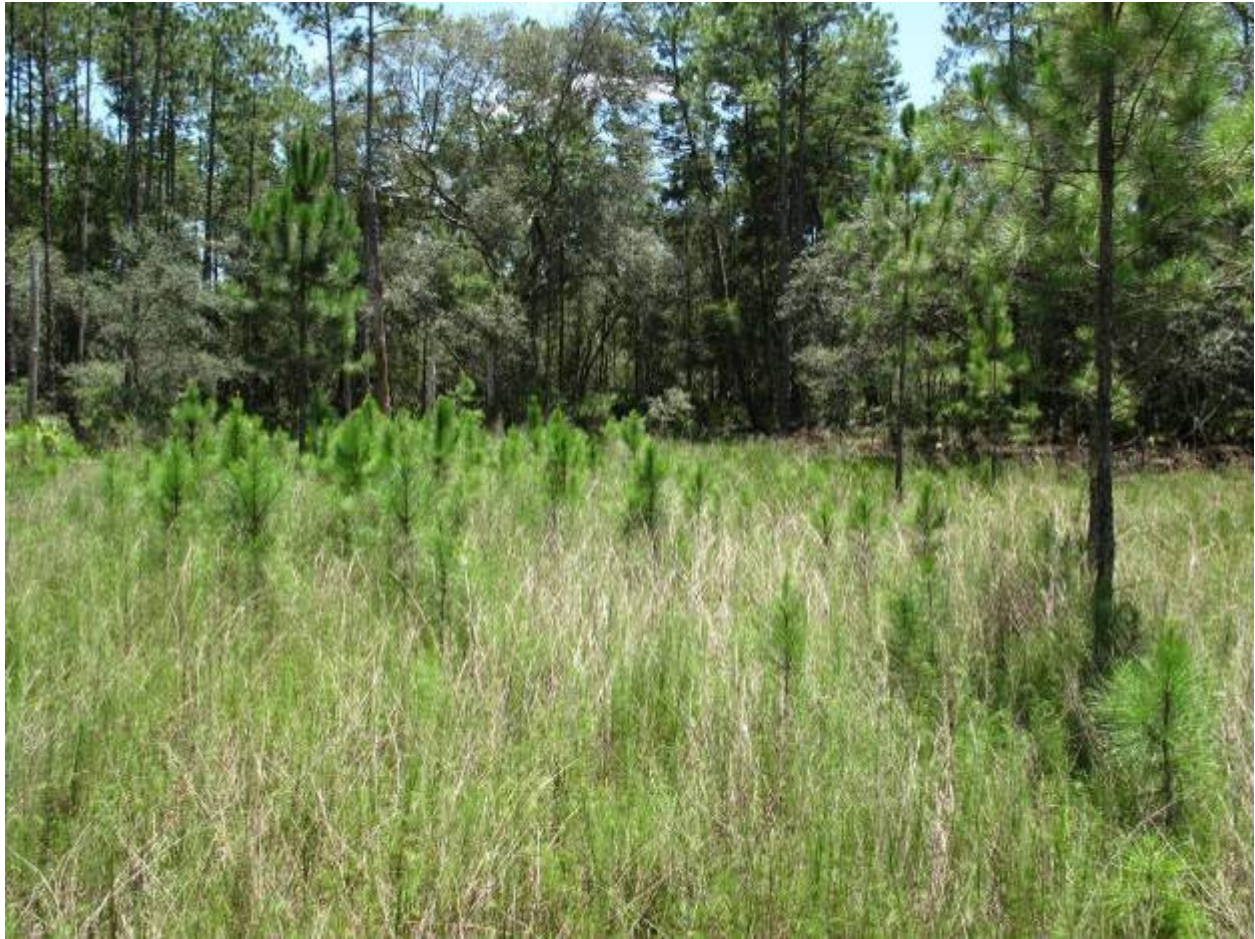
Description: This wetland is a 0.1 ha ephemeral marsh. There is no tree canopy. Many small pine trees are encroaching into the wetland, and cover 5-25% of the basin. Sedges/grasses grow throughout the wetland, and cover >75% of the basin. This circular sink depression is a potential striped newt breeding pond. The adjacent uplands are fire suppressed upland pine forest and currently are managed with mechanical treatments.

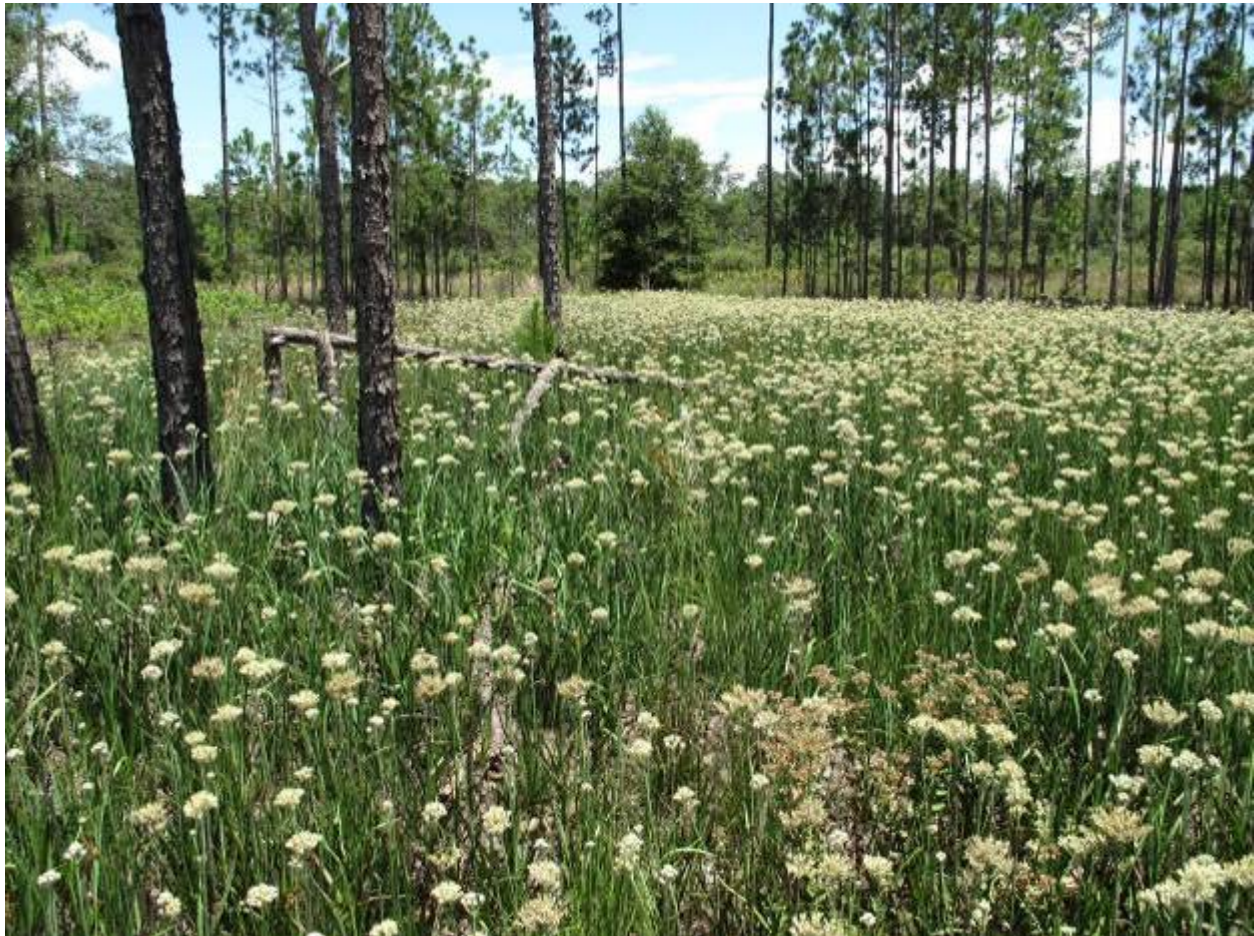
Wetland ID: 05D-02

Description: This wetland is a 0.2 ha ephemeral marsh. Pine trees dominate the canopy, and cover 5-25% of the wetland basin. There is no midstory layer. Redroot grows throughout, covering >75% of the wetland basin. This wetland has extensive feral hog rooting; much of the disturbed soil is grown over with redroot. Some small pine trees are beginning to encroach from the wetland perimeter. This wetland is a potential striped newt breeding pond. The adjacent uplands are fire suppressed scrubby flatwoods and currently are managed with mechanical treatments.

Wetland Concerns: Feral hog damage, Woody encroachment

Restoration Action Recommended: Because of the widespread damage to ephemeral wetlands on CWMA, we recommend aggressive action to reduce the overall numbers of feral hogs on the property. Monitor this wetland to ensure pine trees are killed with the next fire or inundation. If they become established, the encroaching pine trees will need to be removed from the wetland. Alternatively, the small pine trees can be hand-chopped now.

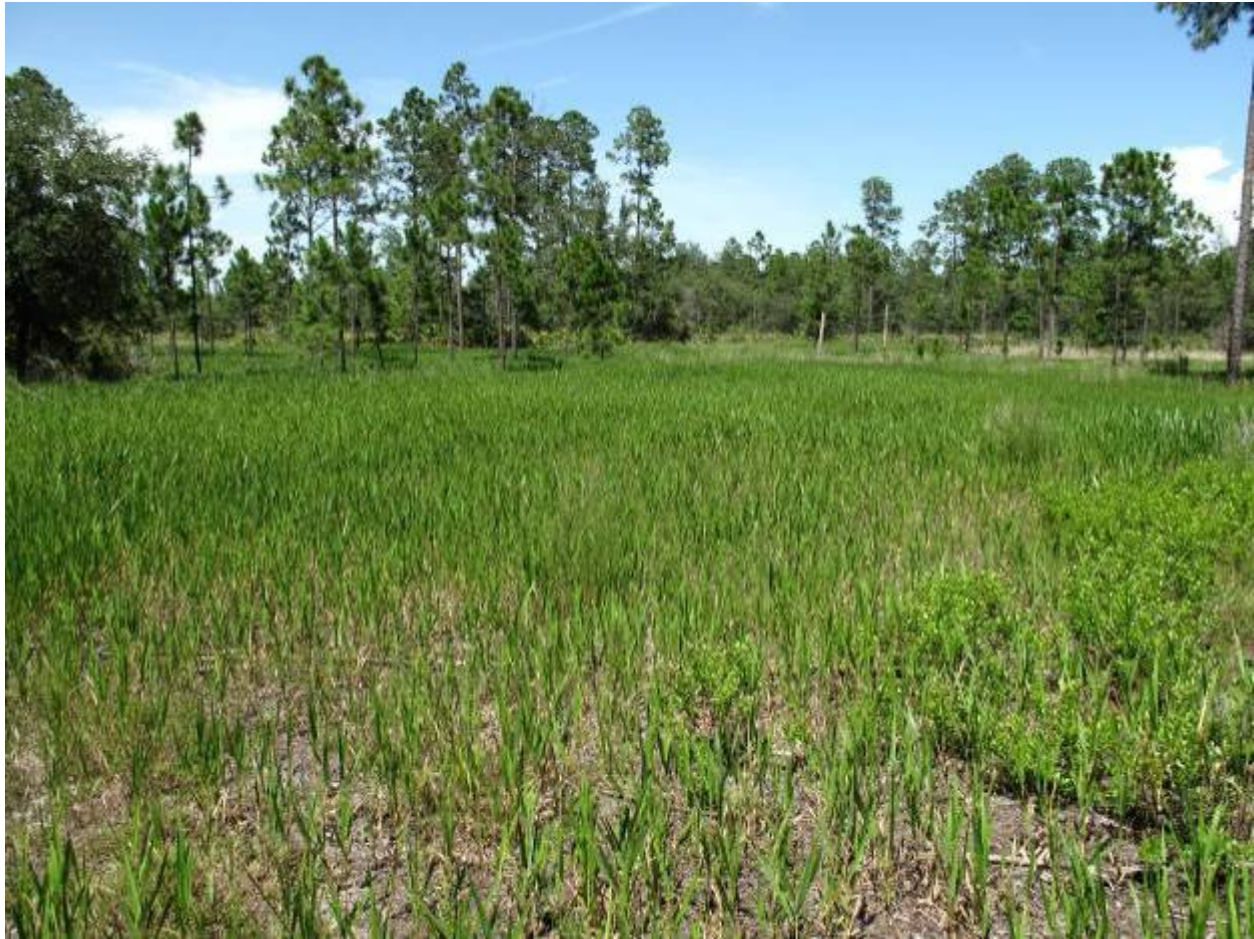
Wetland ID: 05D-03

Description: This wetland is a 0.8 ha ephemeral marsh. Pine trees dominate the canopy, and cover 5-25% of the wetland basin. There is no midstory layer. Maidencane grows throughout, covering >75% of the wetland basin. Some small pine trees are encroaching into the wetland basin. The wetland has minor hog damage. This marsh is a potential striped newt breeding pond. The adjacent uplands are fire suppressed upland pine forest and currently are managed with mechanical treatments.

Wetland Concerns: Feral hog damage, Woody encroachment

Restoration Action Recommended: Because of the widespread damage to ephemeral wetlands on CWMA, we recommend aggressive action to reduce the overall numbers of feral hogs on the property. Monitor this wetland to ensure pine trees are killed with the next fire or inundation. If they become established, the encroaching pine trees will need to be removed from the wetland. Alternatively, the small pine trees can be hand-chopped now. Thin a few pine trees from the denser stands along wetland edge.

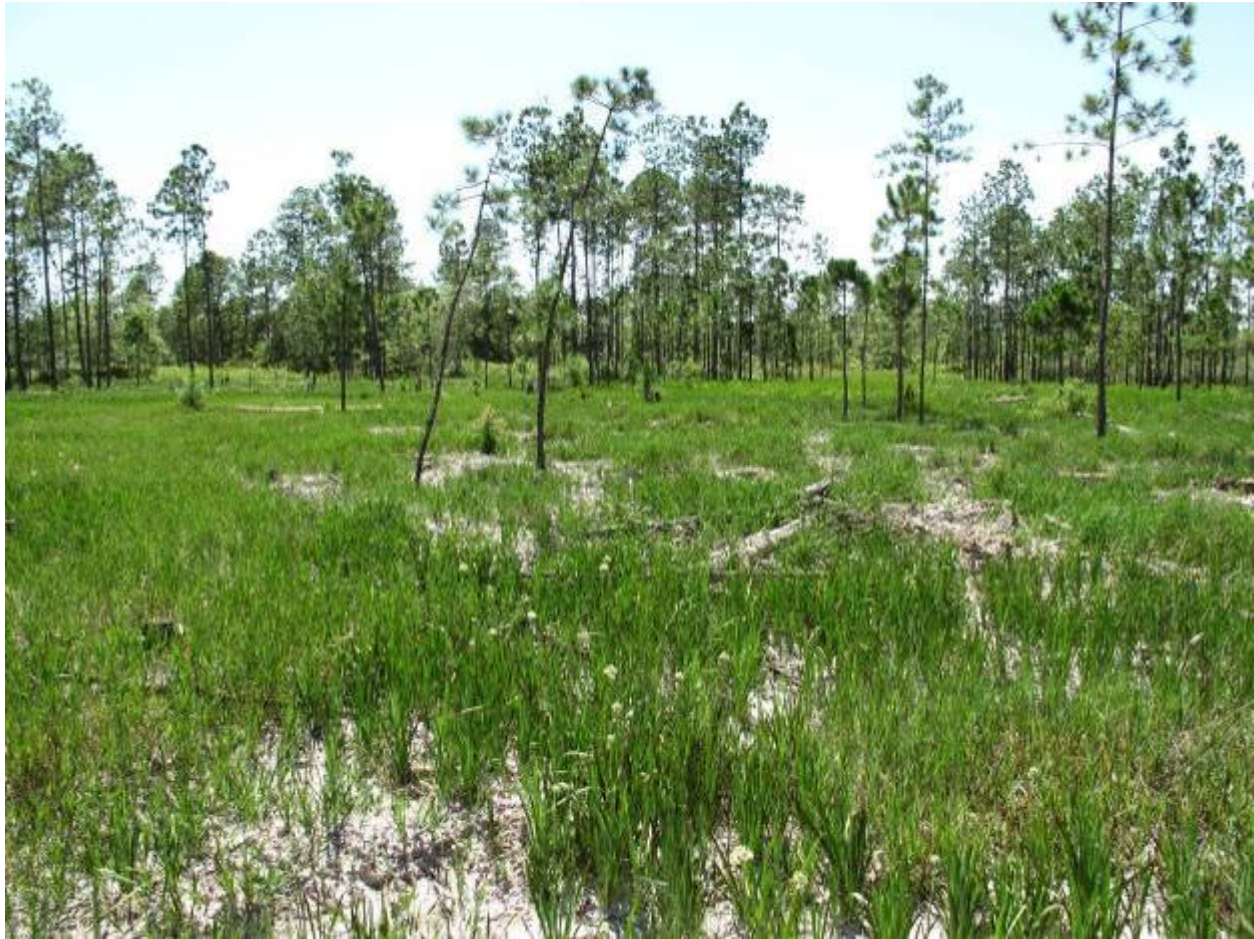
Wetland ID: 05D-04

Description: This wetland is a 0.6 ha ephemeral marsh. Large pine trees were thinned within the wetland and pine logs are scattered across the marsh. Some smaller pine trees remain and are encroaching into the wetland basin. The trees cover 5-25% of the wetland basin. There is no midstory layer. Maidencane grows throughout the wetland, and covers >75% of the basin. The wetland has extensive hog damage but appears to be healthy overall. This wetland will connect to wetland 05D-5 during periods of high water. This wetland is a potential striped newt breeding pond. The adjacent uplands are fire suppressed upland pine forest and currently are managed with mechanical treatments.

Wetland Concerns: Feral hog damage, Woody encroachment

Restoration Action Recommended: Because of the widespread damage to ephemeral wetlands on CWMA, we recommend aggressive action to reduce the overall numbers of feral hogs on the property. Hand chop the remaining pine trees from the wetland interior.
