Inventory, Assessment, and Restoration Potential of Ephemeral Wetlands on FFWCC Wildlife Management Areas

Chassahowitzka WMA Final Report

Submitted by: Rebecca P.M. Means¹, Ryan C. Means¹, Steven A. Johnson²

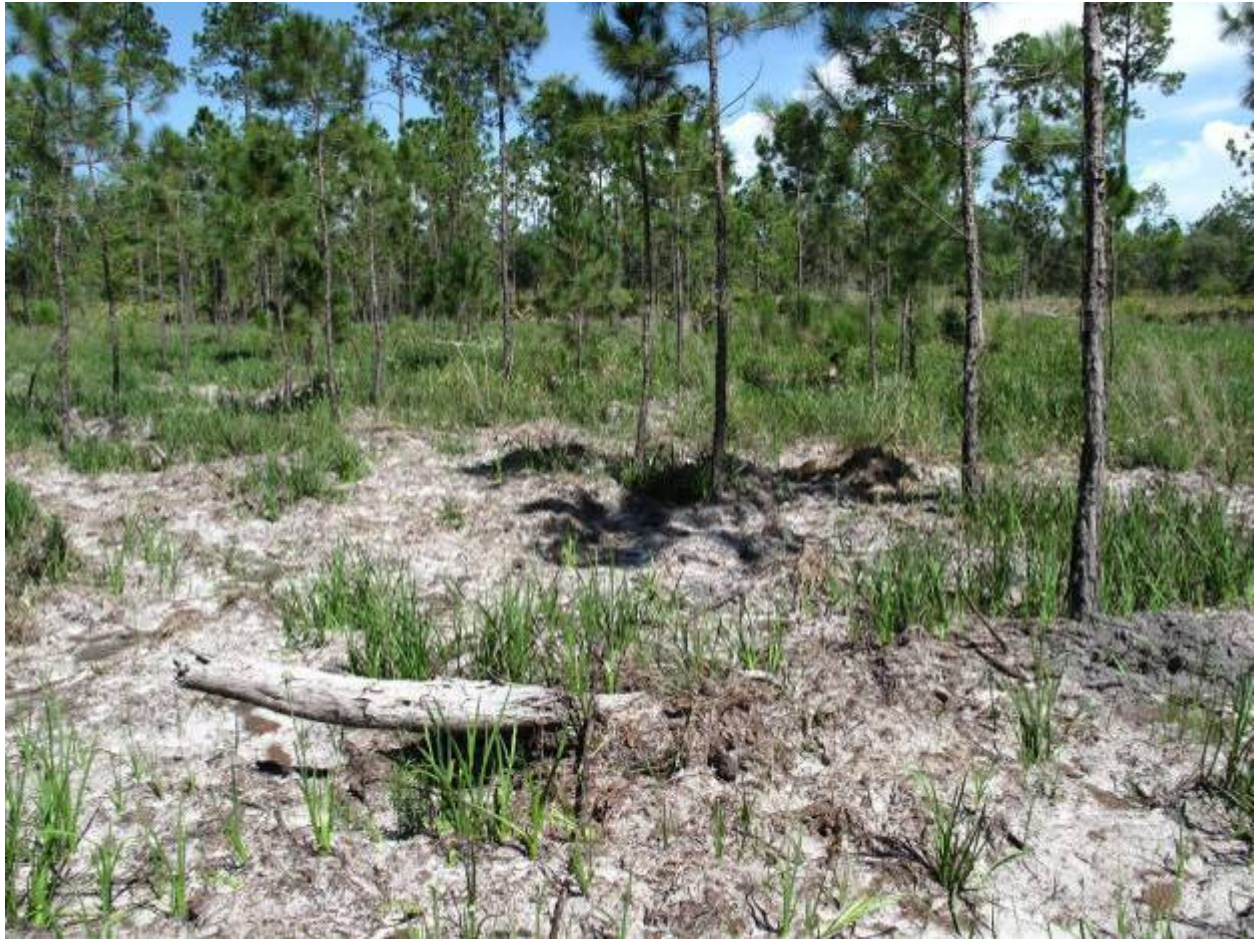
Wetland ID: 05D-05

Description: This wetland is a 0.3 ha ephemeral marsh. Some small pine trees are encroaching into the wetland, and cover 5-25% of the basin. There is no midstory layer. Maidencane grows throughout the wetland, and cover 50-75% of the basin. The wetland has severe hog damage. This wetland will connect to wetland 05D-04 during periods of high water. This wetland is a potential striped newt breeding pond. The adjacent uplands are fire suppressed mesic and scrubby flatwoods and currently are managed with mechanical treatments.

Wetland Concerns: Feral hog damage, Woody encroachment

Restoration Action Recommended: Because of the widespread damage to ephemeral wetlands on CWMA, we recommend aggressive action to reduce the overall numbers of feral hogs on the property. Hand remove pine trees from the wetland interior.

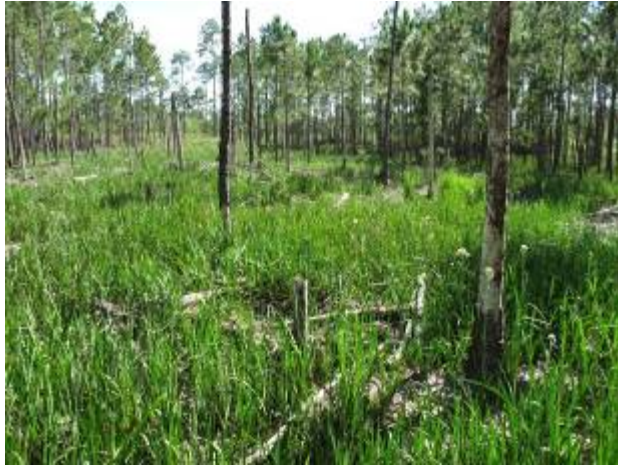
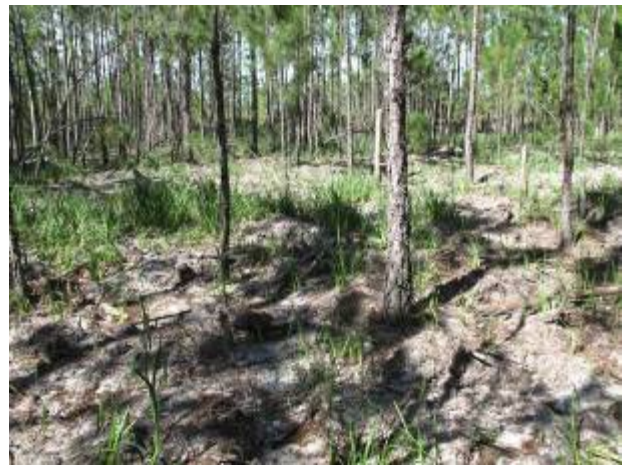
Wetland ID: 05D-06

Description: This wetland is a 0.7 ha ephemeral marsh. Young slash pine trees are extensively encroaching into the wetland, and cover 50-75% of the wetland basin. There is no midstory layer. Maidencane and redroot grow throughout the wetland, and cover 50-75% of the basin. The wetland has severe hog damage. An unpaved road (Rattlesnake Ranch Rd.) bisects this wetland on the north side, creating 2 wetlands, this one and 14C-02. This wetland is a potential striped newt breeding pond. The adjacent uplands are fire suppressed mesic and scrubby flatwoods and currently are managed with mechanical treatments.

Wetland Concerns: Feral hog damage, Road, Woody encroachment

Restoration Action Recommended: Because of the widespread damage to ephemeral wetlands on CWMA, we recommend aggressive action to reduce the overall numbers of feral hogs on the property. In order to restore the hydrology of this wetland and the larger wetland system, the road would have to be removed. Recognizing that this road is now a permanent attribute to the property, we do not recommend any action relating to the road. Hand remove pine trees from wetland basin

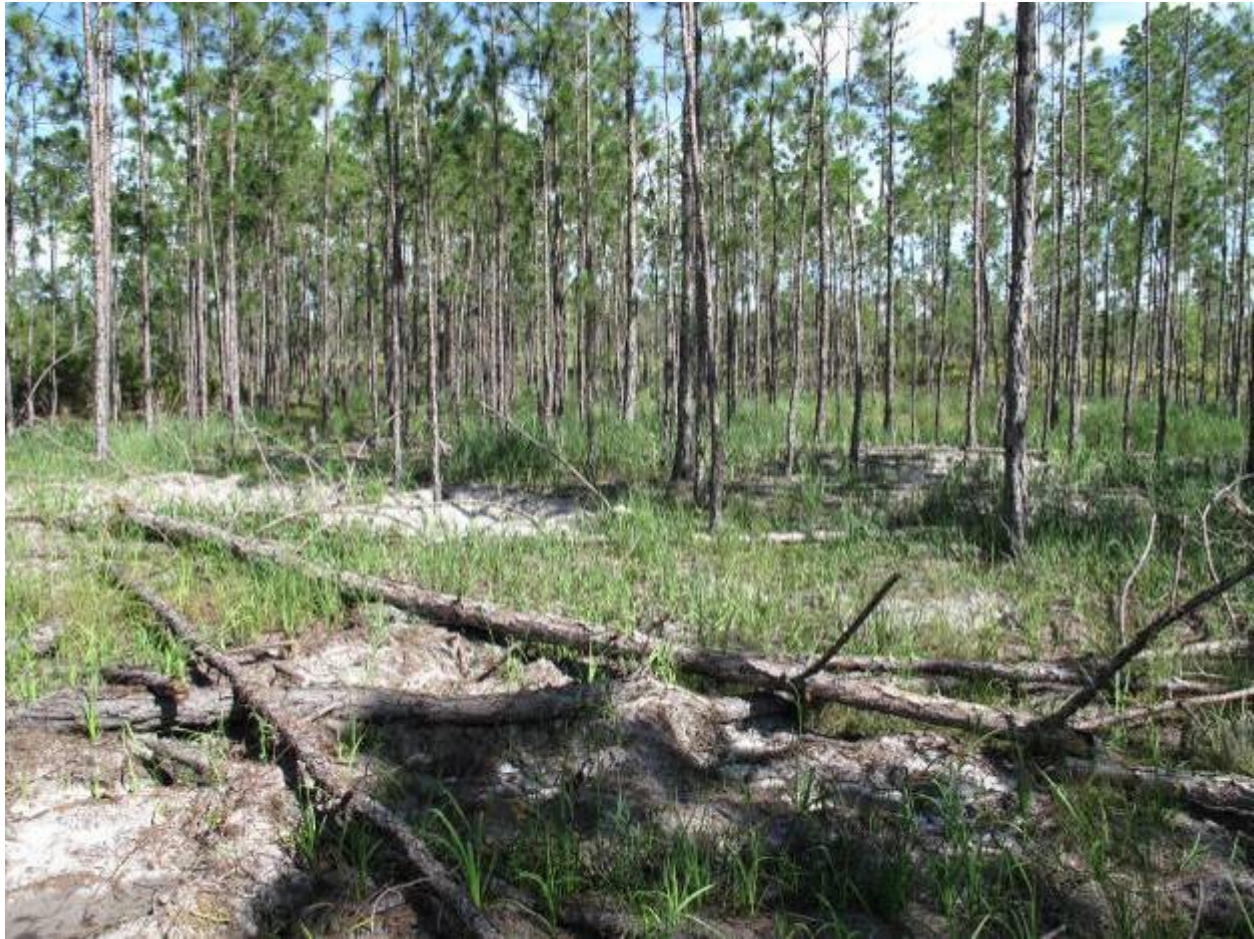
Wetland ID: 05D-07

Description: This wetland is a 0.3 ha ephemeral marsh. Slash pine trees are encroaching into the wetland, and cover 50-75% of the wetland basin. There is no midstory layer. Maidencane grows throughout the wetland, and covers 50-75% of the basin. The wetland has extensive hog damage. The adjacent uplands are fire suppressed mesic and scrubby flatwoods and currently are managed with mechanical treatments.

Wetland Concerns: Feral hog damage, Woody encroachment

Restoration Action Recommended: Because of the widespread damage to ephemeral wetlands on CWMA, we recommend aggressive action to reduce the overall numbers of feral hogs on the property. Hand remove pine trees from the wetland interior.

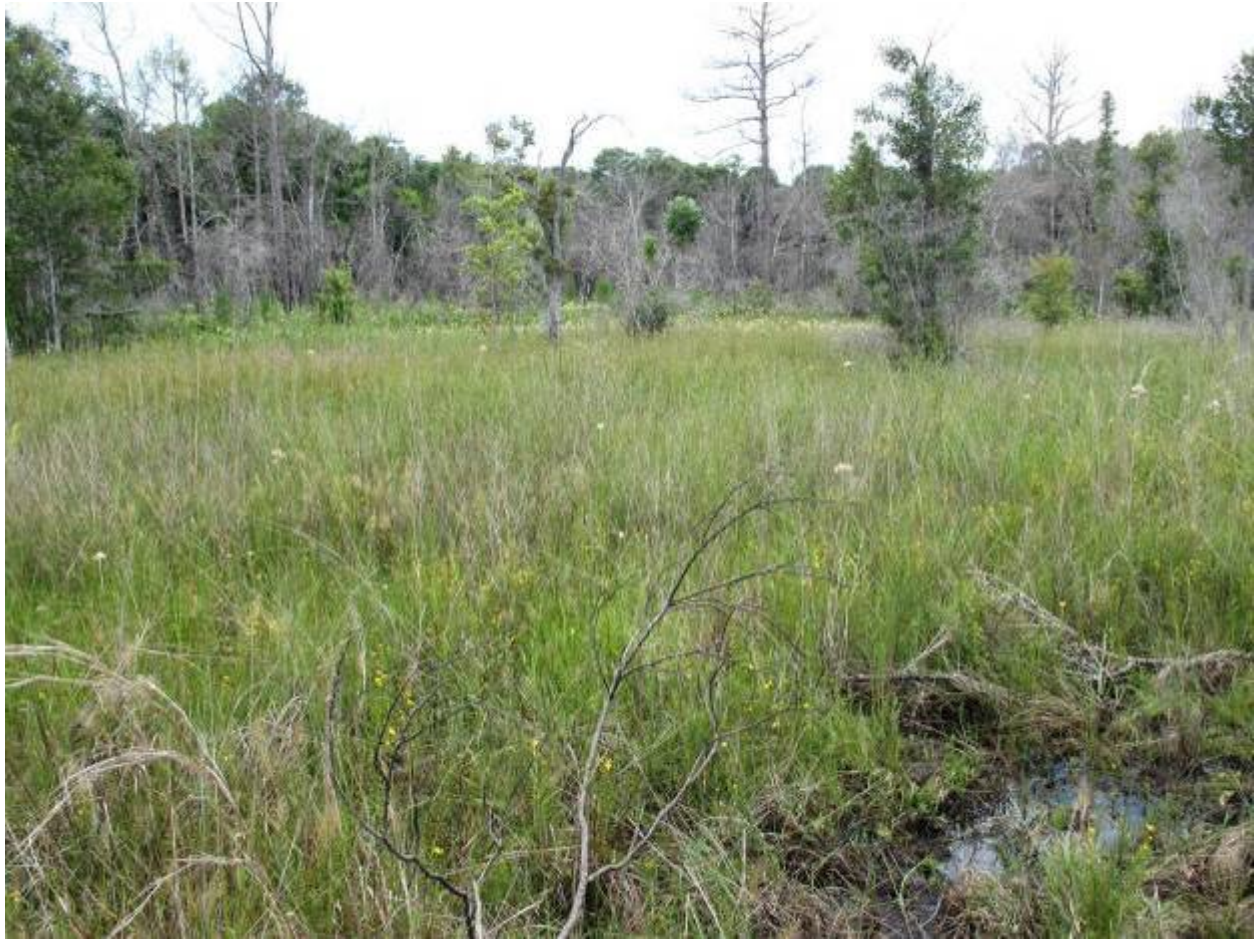
Description: This wetland is a 0.3 ha ephemeral marsh. There is no canopy or midstory layer. Sedges/grasses grow throughout the wetland, and cover >75% of the basin. The wetland has minor hog damage. A recent fire burned through the wetland killing many shrubs; diverse herbaceous vegetation is growing back. This wetland provides a great example of the positive effects of prescribed fire, particularly growing season fire, to marsh restoration and management. The wetland is situated on the eastern edge of the big hydric hammock and is a potential striped newt breeding pond. The adjacent uplands are mesic flatwoods and hydric hammock.

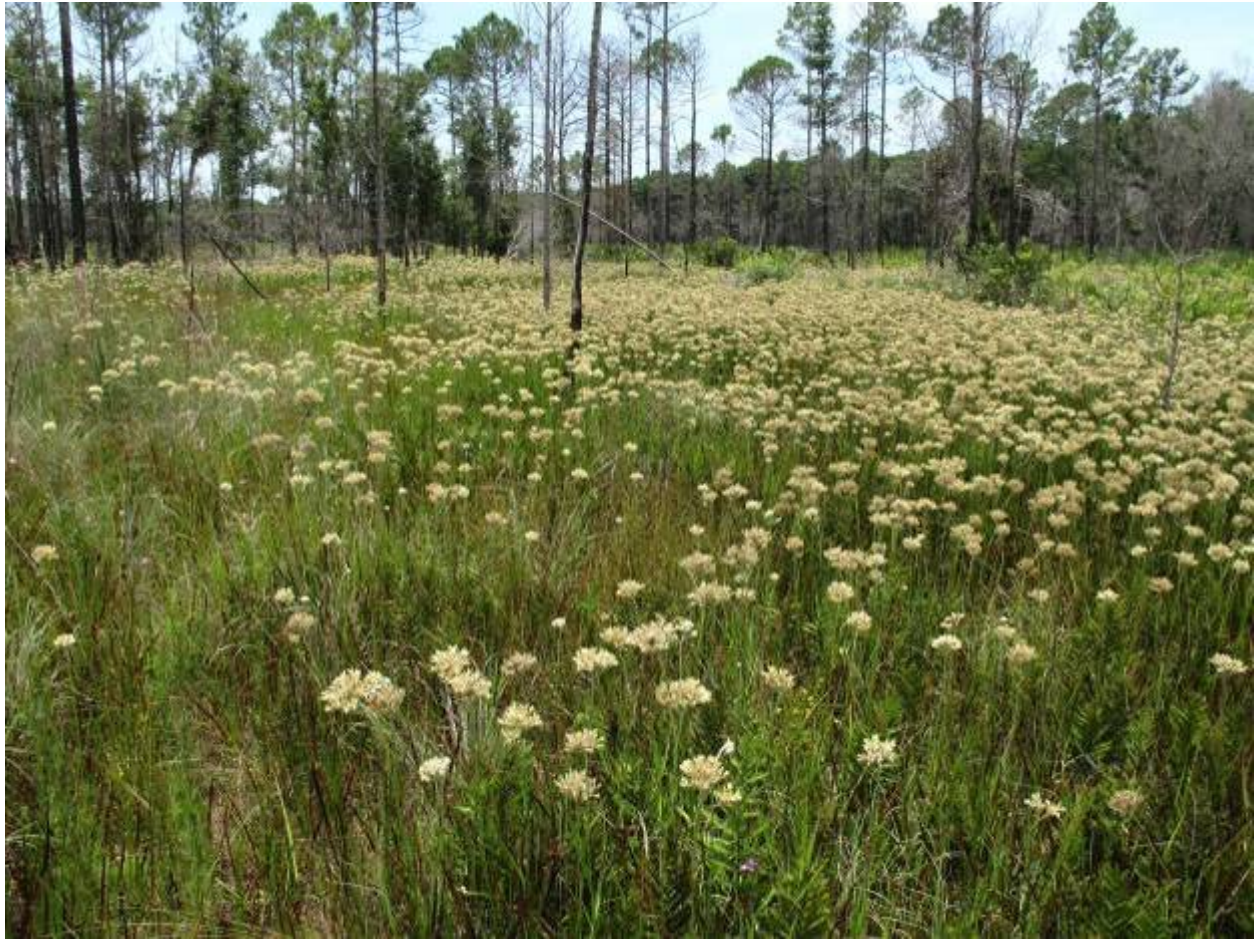
Description: This wetland is a <0.1 ha ephemeral marsh. There is no canopy or midstory cover. Sedges/grasses and redroot grow throughout the wetland, and cover >75% of the basin. The wetland has minor, old hog damage. A recent fire burned through the wetland basin. This wetland provides a great example of the positive effects of prescribed fire, particularly growing season fire, to marsh restoration and management. The adjacent uplands are mesic flatwoods and hydric hammock.

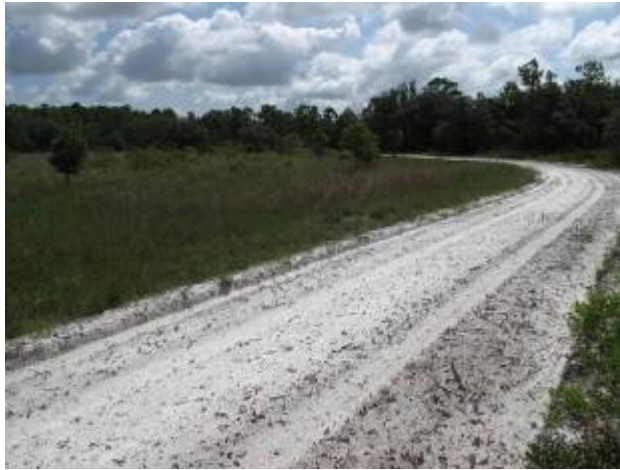
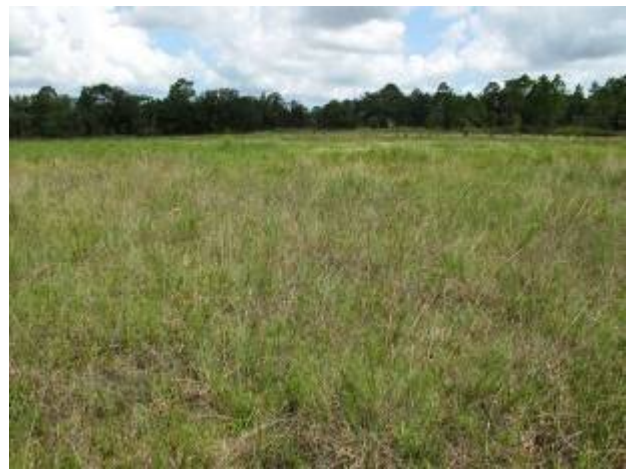
Wetland ID: 07D-01

Description: This wetland is a 2.9 ha ephemeral marsh. There is no canopy or midstory layer. Sedges/grasses and maidencane grow throughout the wetland, and cover >75% of the basin. The wetland has patches of old feral hog rooting, although most of the damage has grown over with vegetation. The entire wetland is ringed with a wide, sandy fireline. This wetland is an excellent potential striped newt breeding pond. The adjacent uplands are historically fire suppressed sandhills, although a wildfire burned through this MU in 2006.

Wetland Disturbance: Feral hog damage, Fireline

Restoration Action Recommended: Because of the widespread damage to ephemeral wetlands on CWMA, we recommend aggressive action to reduce the overall numbers of feral hogs on the property. The fireline/MU boundary should be re-routed away from the wetland. If the fireline cannot be re-routed, monitor the wetland to ensure fire is not excluded. Maintain the fireline when the wetland is completely dry to prevent ruts from developing.

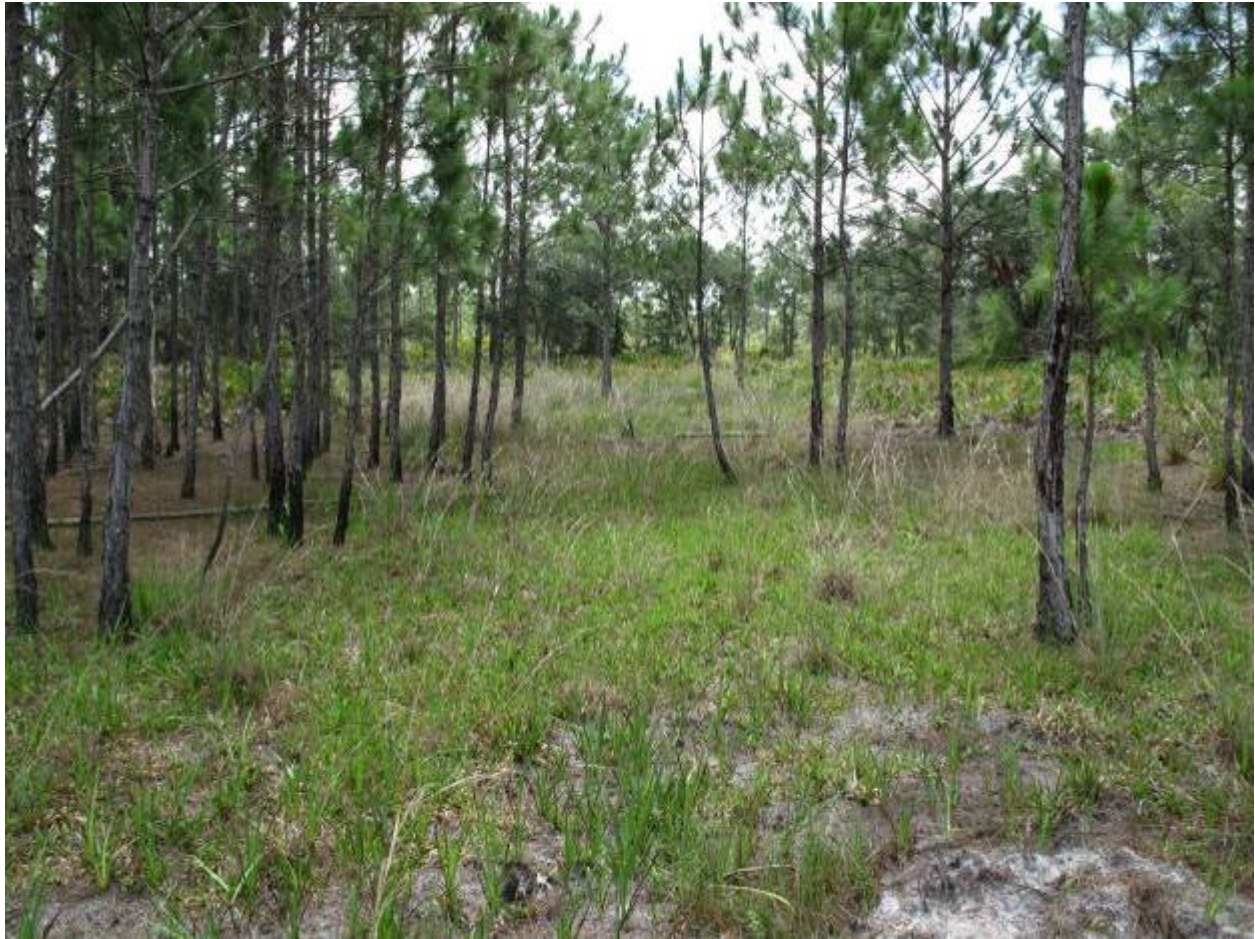
Description: This wetland is a 0.2 ha ephemeral marsh. Pine trees dominate the canopy, and cover 5-25% of the wetland basin. There is no midstory layer. Sedges/grasses grow throughout the wetland, and cover 50-75% of the basin. Charred pine bases in the depression show evidence of fire in the wetland. The wetland has new feral hog damage. A fireline bisects the western end of the wetland. This wetland is a potential striped newt breeding pond. The adjacent uplands are historically fire suppressed sandhills, although a wildfire burned through this MU in 2006.

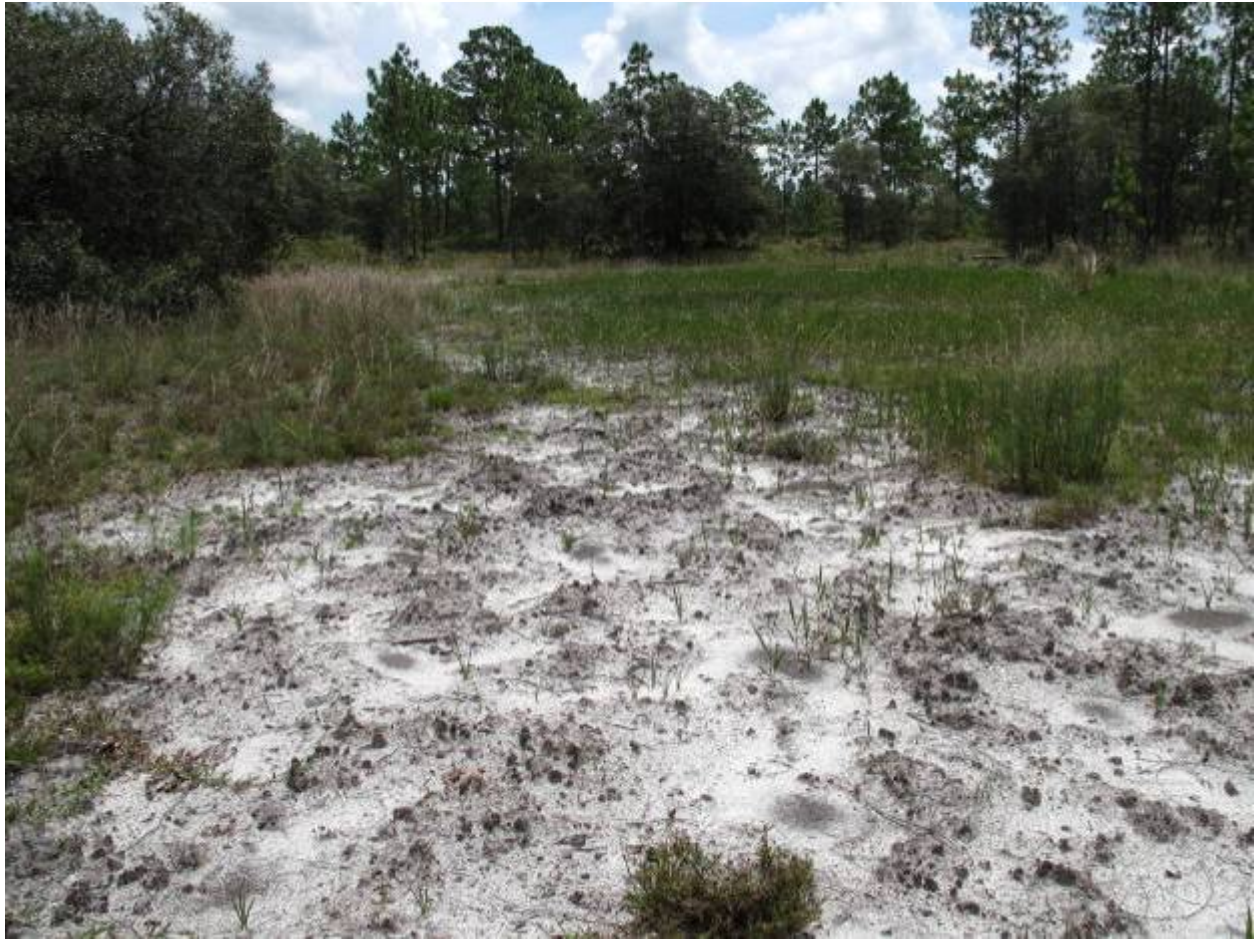
Wetland ID: 07D-03

Description: This wetland is a 0.6 ha ephemeral marsh. There is no canopy or midstory layer. Sedges/grasses and maidencane grow throughout the wetland, and cover >75% of the basin. Extensive feral hog damage rings the wetland. This marsh is in fire-maintenance condition and is a potential striped newt breeding pond. The adjacent uplands are historically fire suppressed sandhills, although a wildfire burned through this MU in 2006.

Wetland Disturbance: Feral hog damage

Restoration Action Recommended: Because of the widespread damage to ephemeral wetlands on CWMA, we recommend aggressive action to reduce the overall numbers of feral hogs on the property.

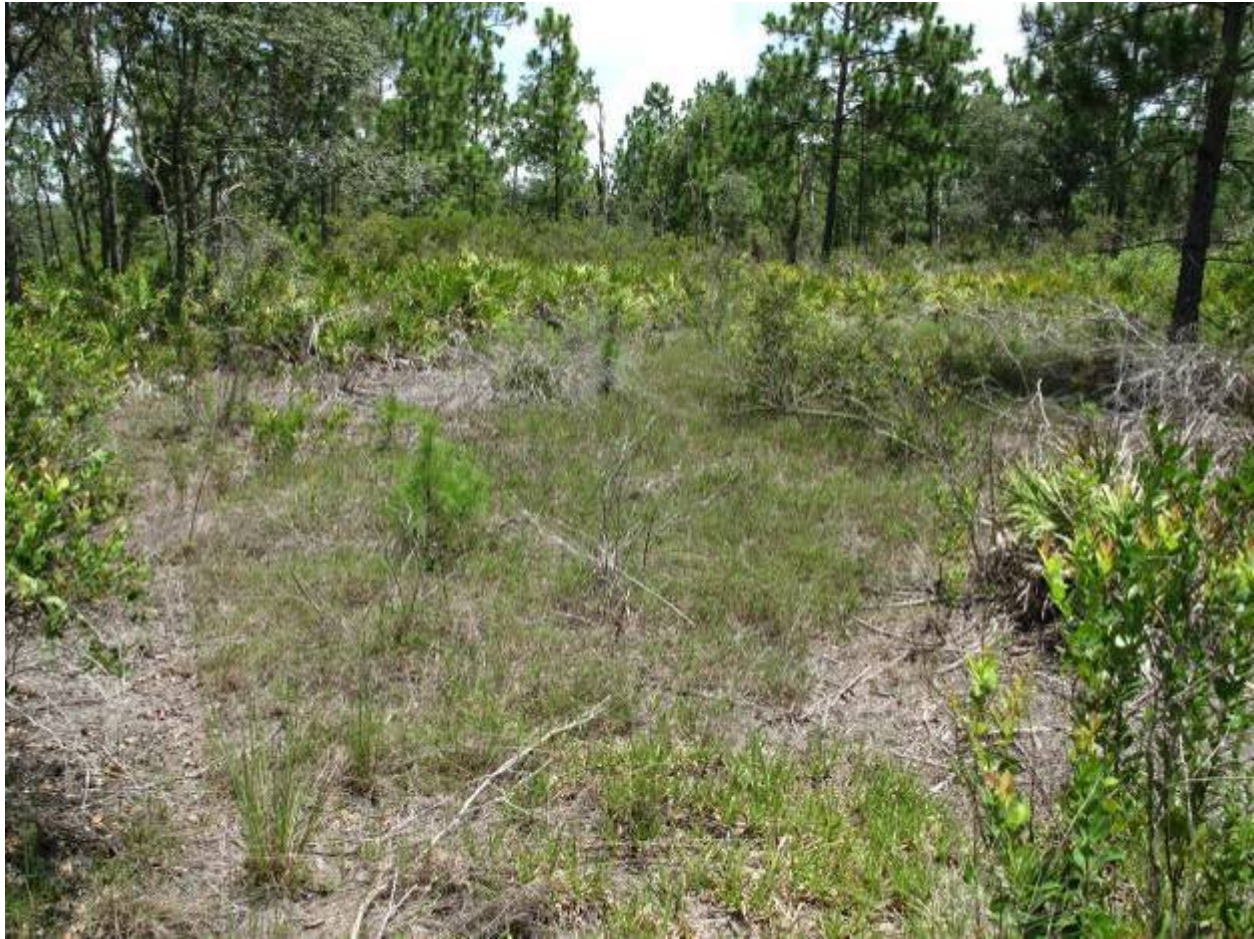
Wetland ID: 07D-04

Description: This wetland is a 0.1 ha highly ephemeral marsh. There is no canopy or midstory layer. Sedges/grasses grow throughout the wetland, and cover 50-75% of the basin. The wetland is ringed with extremely dense palmetto in the adjacent uplands. The adjacent uplands are historically fire suppressed sandhills with dense palmetto, although a wildfire burned through this MU in 2006.

Wetland Disturbance: None

Restoration Action Recommended: None

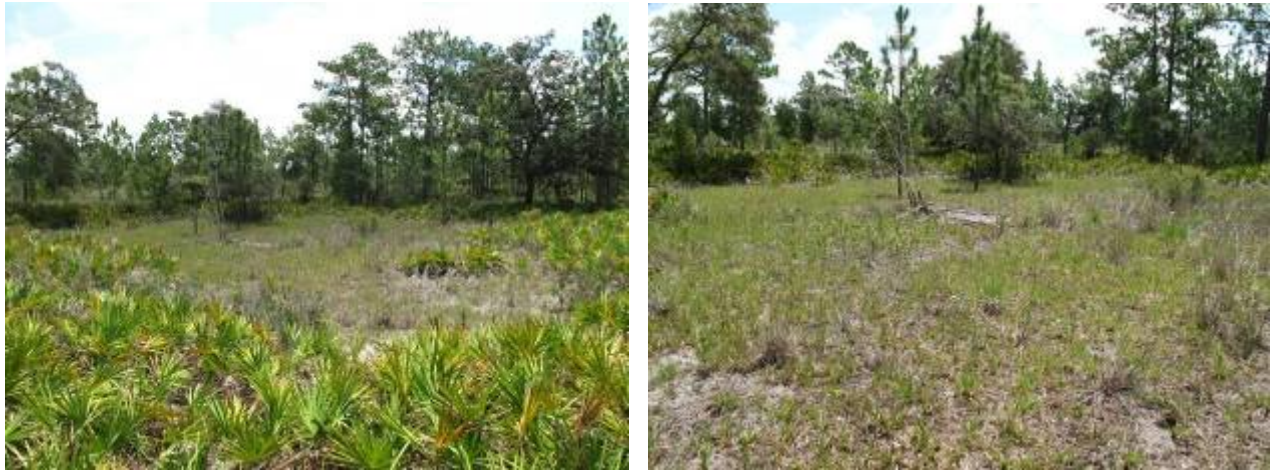
Wetland ID: 07D-05

Description: This wetland is a 0.1 ha ephemeral marsh. There is no canopy or midstory layer. Sedges/grasses grow throughout the wetland, and cover >75% of the basin. This marsh is in fire-maintenance condition and is a potential striped newt breeding pond. The wetland is ringed with extremely dense palmetto. The adjacent uplands are historically fire suppressed sandhills, although a wildfire burned through this MU in 2006.

Wetland Disturbance: None

Restoration Action Recommended: None

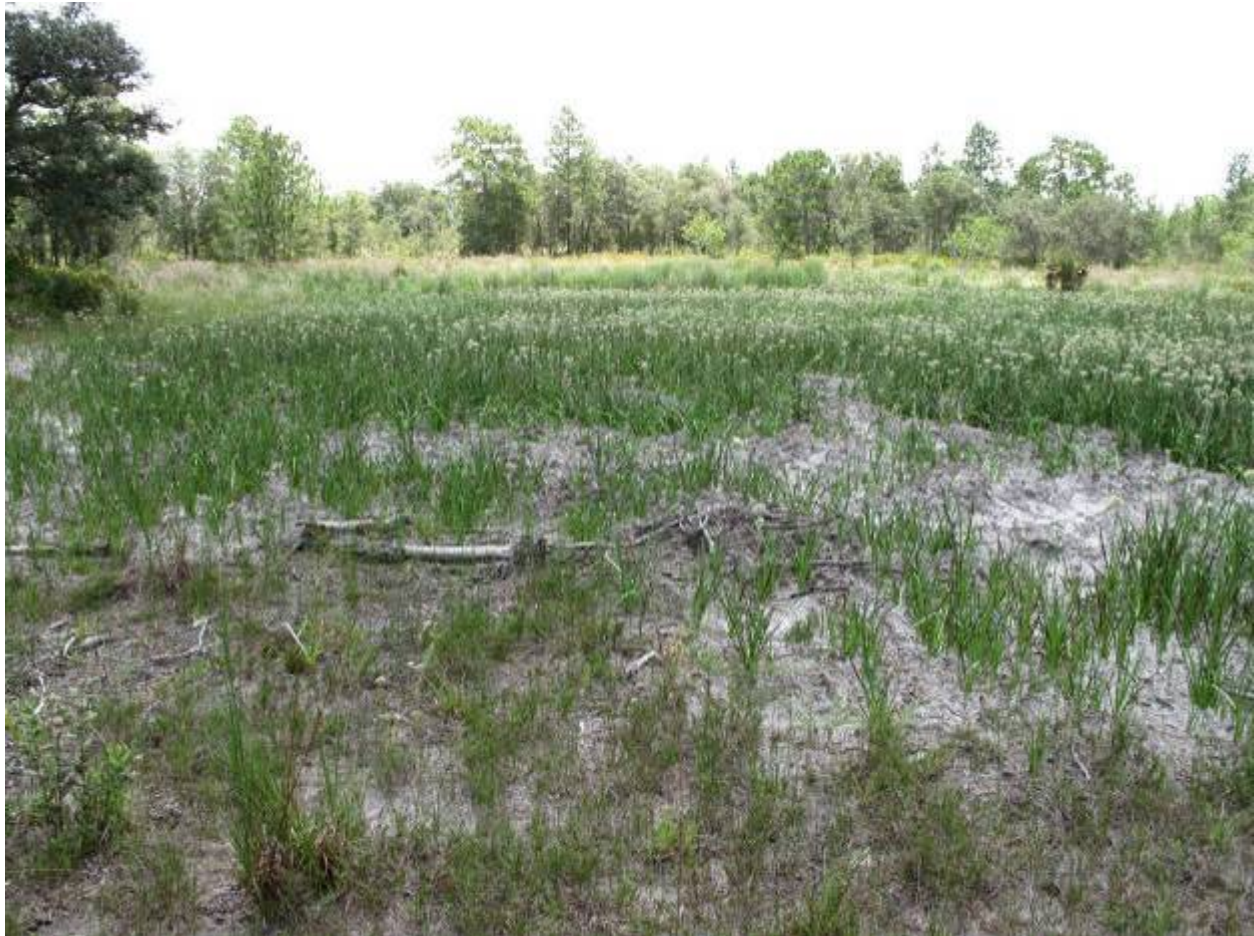
Wetland ID: 07D-06

Description: This wetland is a 0.6 ha ephemeral marsh. There is no canopy or midstory layer. Sedges/grasses and redroot grow throughout the wetland, and cover >75% of the basin. The wetland has severe feral hog damage. This marsh is in fire-maintenance condition and is a potential striped newt breeding pond. Dense saw palmetto surround the wetland. The adjacent uplands are historically fire suppressed sandhills, although a wildfire burned through this MU in 2006.

Wetland Disturbance: Feral hog damage

Restoration Action Recommended: Because of the widespread damage to ephemeral wetlands on CWMA, we recommend aggressive action to reduce the overall numbers of feral hogs on the property.

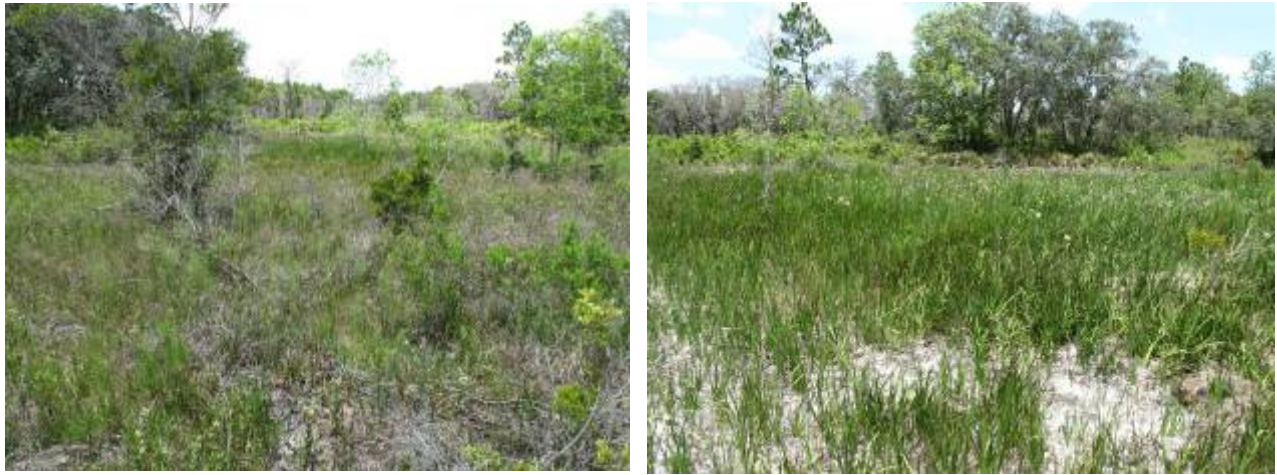
Wetland ID: 07D-07

Description: This wetland is a 0.2 ha ephemeral marsh. There is no tree canopy. Holly covers 5-25% of the wetland. Sedges/grasses and redroot grow throughout the wetland, and cover >75% of the basin. The wetland has old and new feral hog damage. This marsh is in fire-maintenance condition and is a potential striped newt breeding pond. Dense saw palmetto surround the wetland. The adjacent uplands are historically fire suppressed sandhills, although a wildfire burned through this MU in 2006.

Wetland Disturbance: Feral hog damage

Restoration Action Recommended: Because of the widespread damage to ephemeral wetlands on CWMA, we recommend aggressive action to reduce the overall numbers of feral hogs on the property.

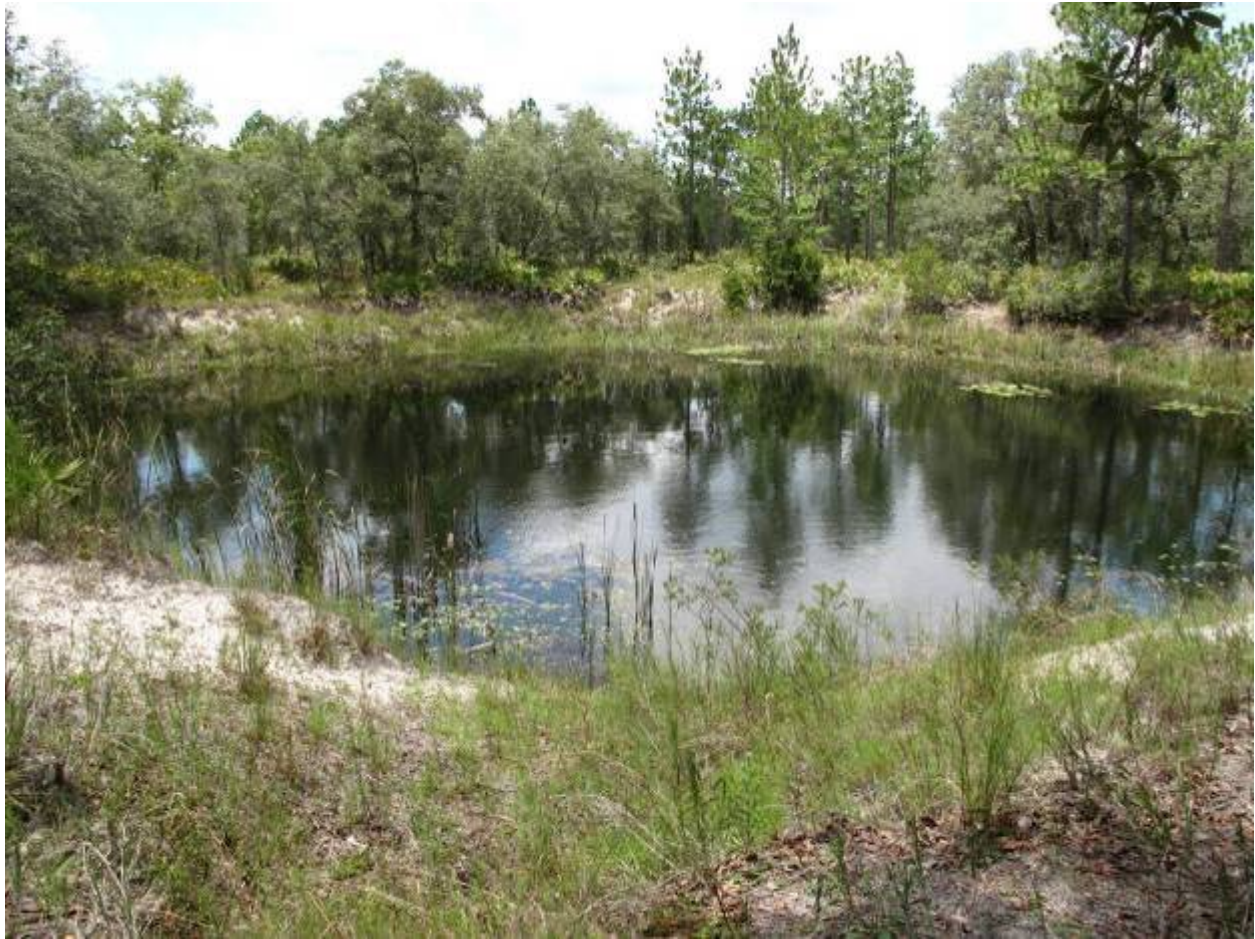
Description: This wetland is a 0.2 ha semi-permanent to permanent sinkhole pond. There is no canopy or midstory layer. Sedges/grasses and emergent vegetation grow in a ring around the wetland edge, and cover 5-25% of the wetland basin. This pond has steep edges with 3m tall sandy walls, and a deep center. Various fish species are present, including bass and other Centrarchids. The wetland serves as a stable water hole, with game trails leading to and from the wetland. This pond is the first in a series of sinks that likely collapsed along a linear subterranean cave system. The adjacent uplands are historically fire suppressed sandhills, although a wildfire burned through this MU in 2006.

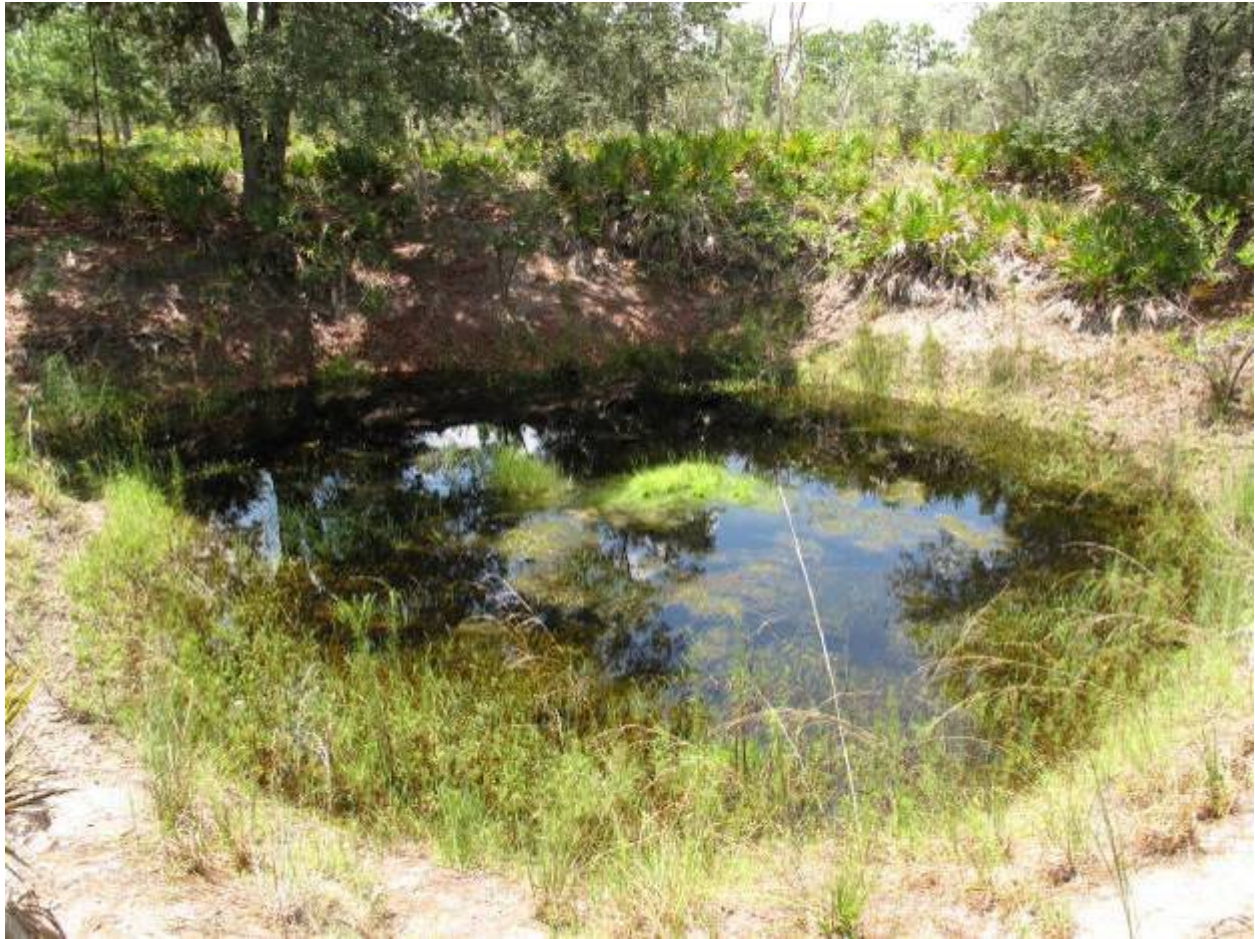
Description: This wetland is a <0.1 ha ephemeral sinkhole pond. Live oak trees grow around the wetland edge, and cover 5-25% of the wetland. There is no midstory layer. Sedges/grasses grow throughout the wetland, and cover 50-75% of the basin. The pond has steep, 3m tall sandy walls. The wetland serves as a stable water hole, with game trails leading to and from the wetland. This pond is the second in a series of sinks that likely collapsed along a linear subterranean cave system. This is a potential striped newt breeding pond. The adjacent uplands are historically fire suppressed sandhills, although a wildfire burned through this MU in 2006.

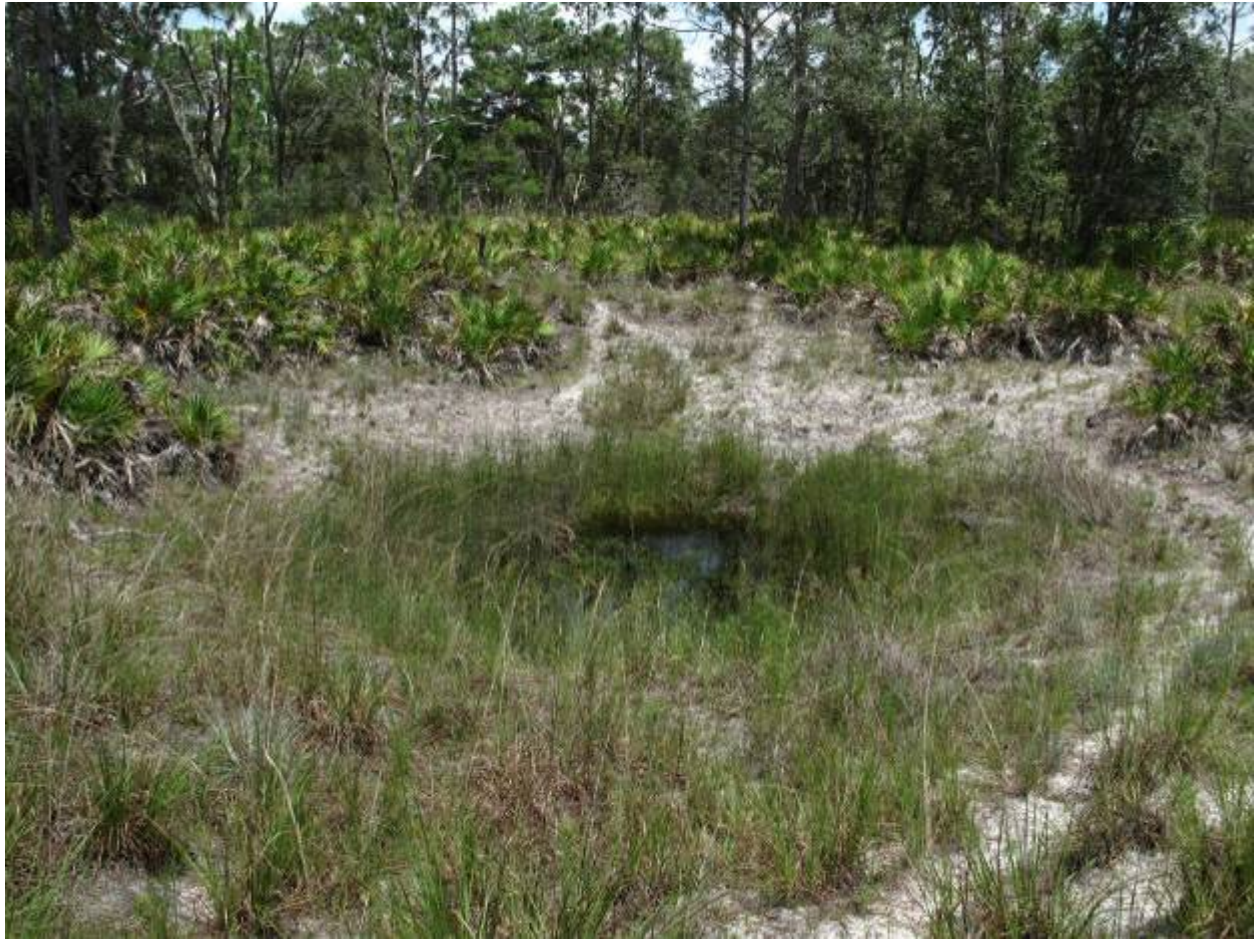
Description: This wetland is a <0.1 ha ephemeral sinkhole pond. There is no canopy or midstory layer. Sedges/grasses grow throughout the wetland, and cover >75% of the basin. This pond has steep 2m tall sandy walls and is a potential striped newt breeding pond. The wetland serves as a stable water hole, with game trails leading to and from the wetland. This pond is the 3rd in a series of sinks that likely collapsed along a linear subterranean cave system. The adjacent uplands are historically fire suppressed sandhills, although a wildfire burned through this MU in 2006.

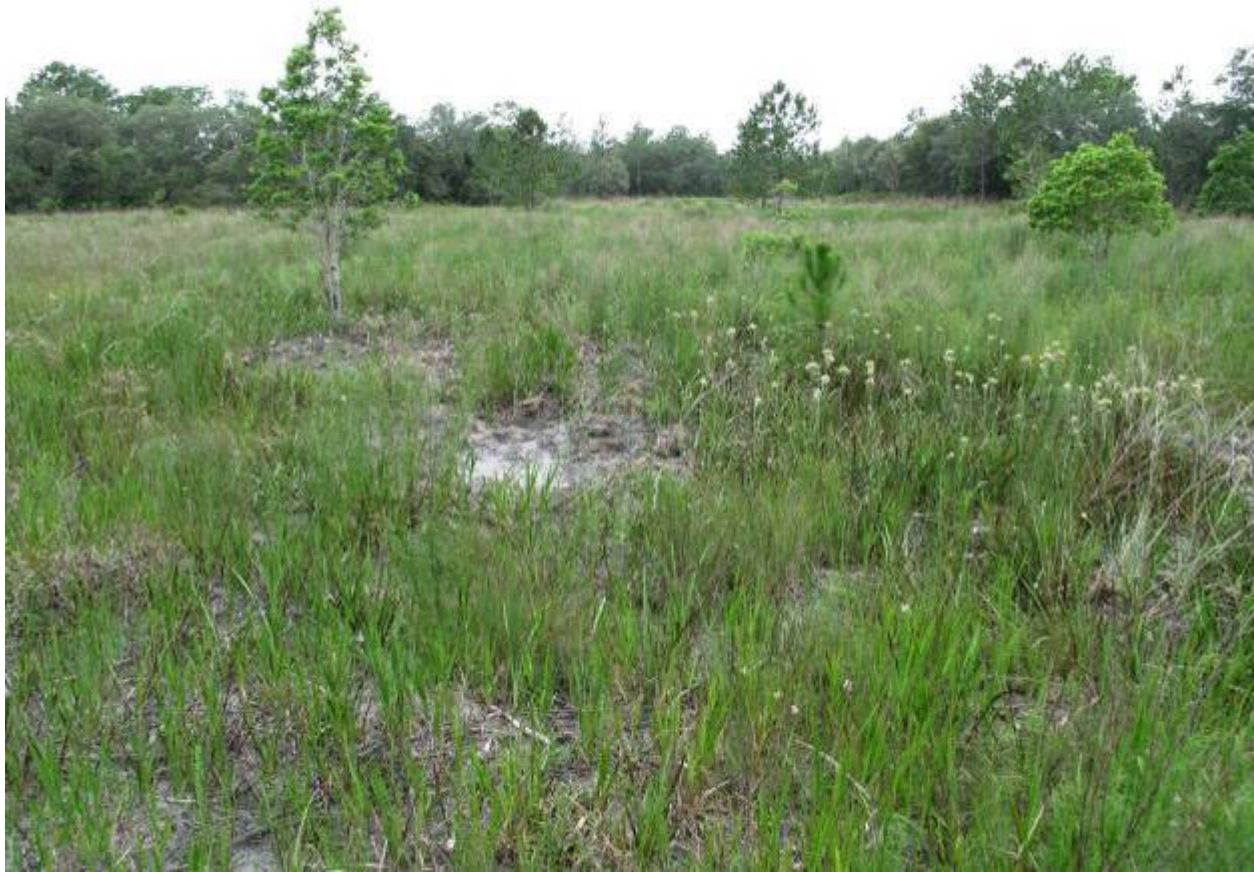
Wetland ID: 07D-11

Description: This wetland is a 1.9 ha ephemeral marsh. There is no canopy or midstory cover. Sedges/grasses grow throughout the wetland, and cover >75% of the basin. The wetland has widespread feral hog damage. This marsh is in fire-maintenance condition and is a potential striped newt breeding pond. The adjacent uplands are historically fire suppressed sandhills, although a wildfire burned through this MU in 2006.

Wetland Disturbance: Feral hog damage

Restoration Action Recommended: Because of the widespread damage to ephemeral wetlands on CWMA, we recommend aggressive action to reduce the overall numbers of feral hogs on the property.

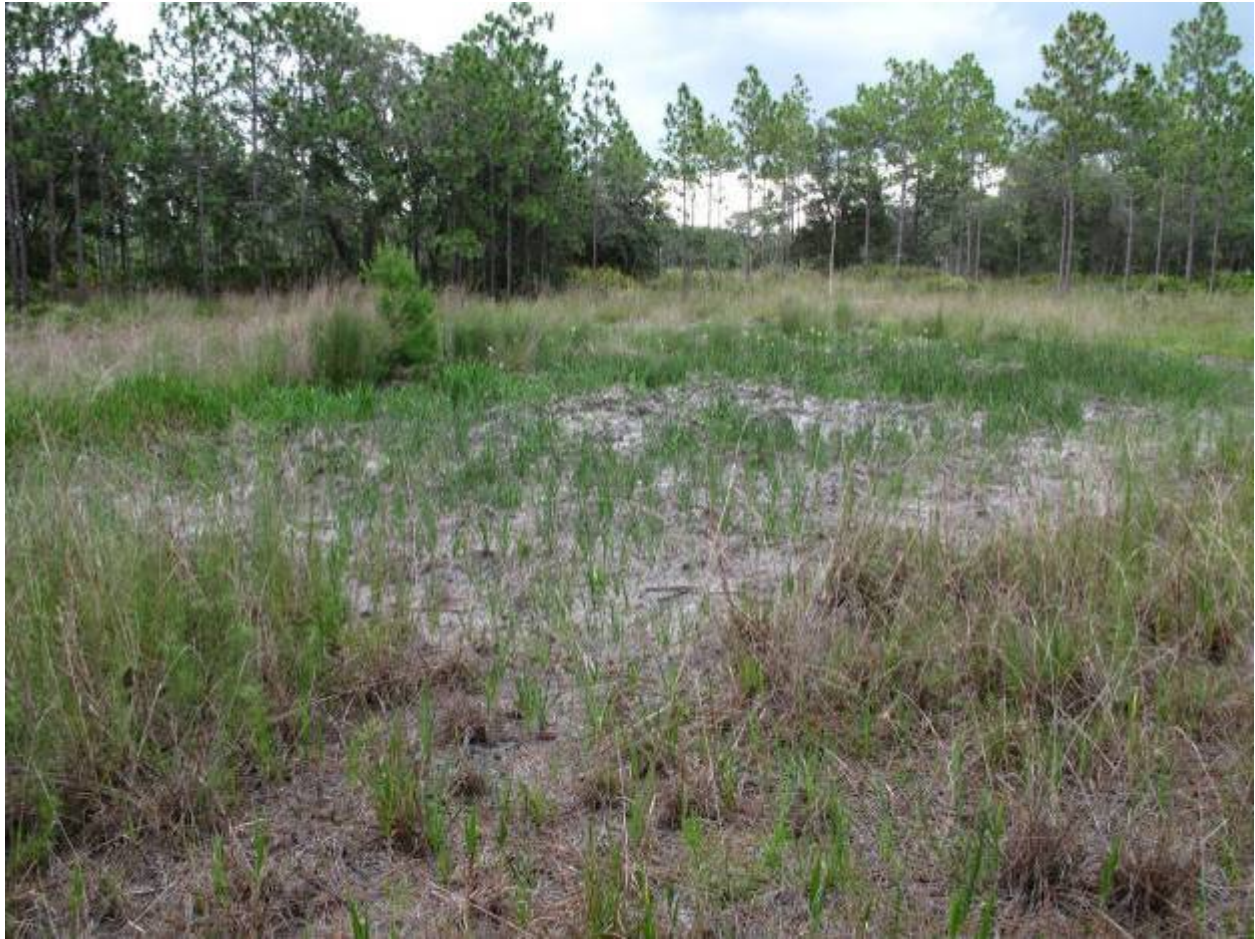
Description: This wetland is a 0.2 ha ephemeral marsh. There is no canopy or midstory cover. Sedges/grasses and redroot grow throughout the wetland, and cover >75% of the basin. The wetland has extensive feral hog damage. This marsh is in fire-maintenance condition and is a potential striped newt breeding pond. A dense ring of palmetto and oak surrounds the wetland. The adjacent uplands are historically fire suppressed sandhills, although a wildfire burned through this MU in 2006.

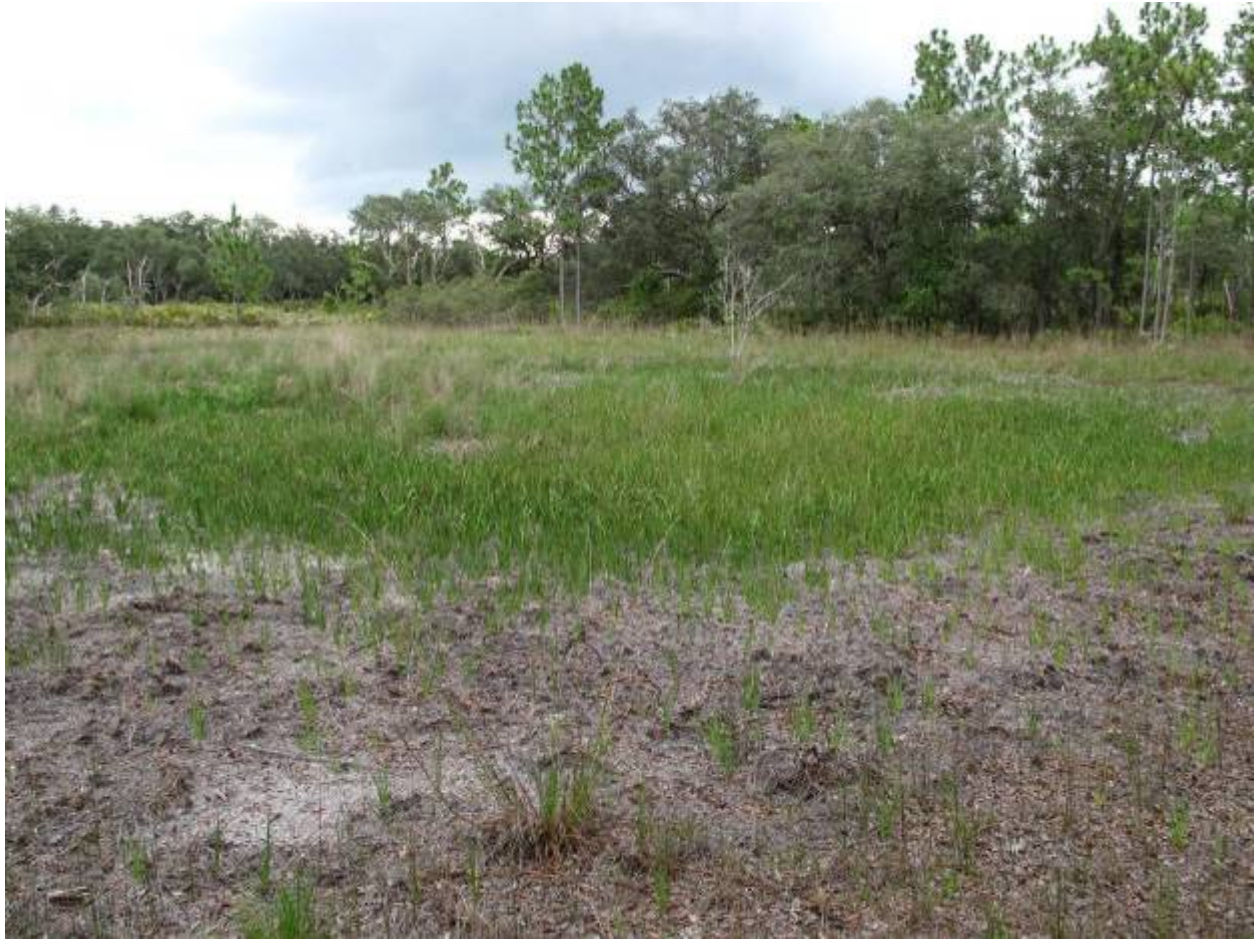
Description: This wetland is a 0.3 ha ephemeral marsh. There is no canopy or midstory cover. Sedges/grasses and redroot grow throughout the wetland, and cover >75% of the basin. The wetland has extensive feral hog damage. This marsh is in fire-maintenance condition and is a potential striped newt breeding pond. A dense ring of palmetto and oak surrounds the wetland. The adjacent uplands are historically fire suppressed sandhills, although a wildfire burned through this MU in 2006.
