Inventory, Assessment, and Restoration Potential of Ephemeral Wetlands on FFWCC Wildlife Management Areas

Chassahowitzka WMA Final Report

Submitted by: Rebecca P.M. Means¹, Ryan C. Means¹, Steven A. Johnson²

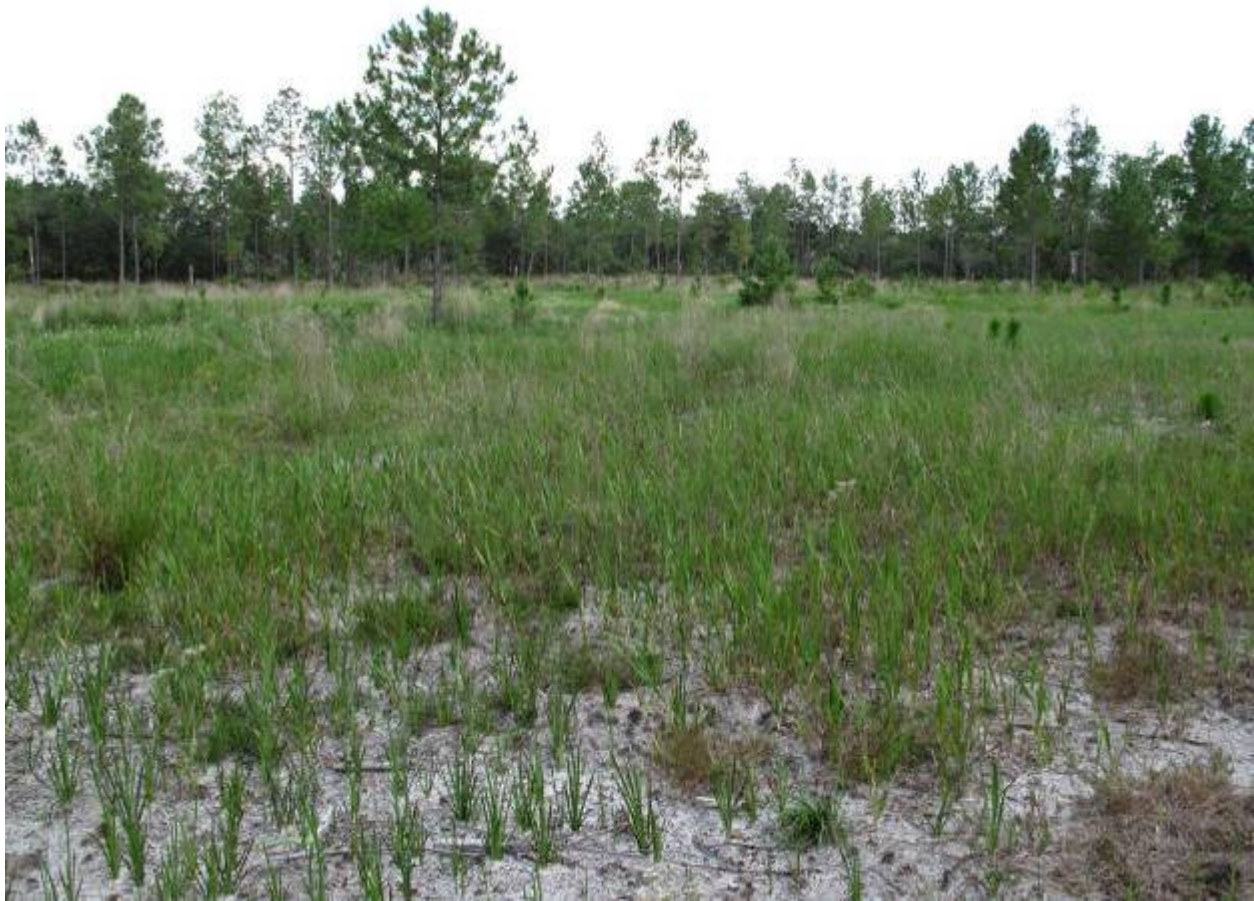
Wetland ID: 08D-01

Description: This wetland is a 1.6 ha ephemeral marsh. There is no canopy or midstory cover. Sedges/grasses and redroot grow throughout the wetland, and cover >75% of the basin. The wetland has extensive feral hog damage. This marsh is in fire-maintenance condition and is a potential striped newt breeding pond. The adjacent uplands are historically fire suppressed sandhills and a dense ring of palmetto and oak surround the wetland. The uplands currently are managed with herbicide.

Wetland Disturbance: Feral hog damage

Restoration Action Recommended: Because of the widespread damage to ephemeral wetlands on CWMA, we recommend aggressive action to reduce the overall numbers of feral hogs on the property.

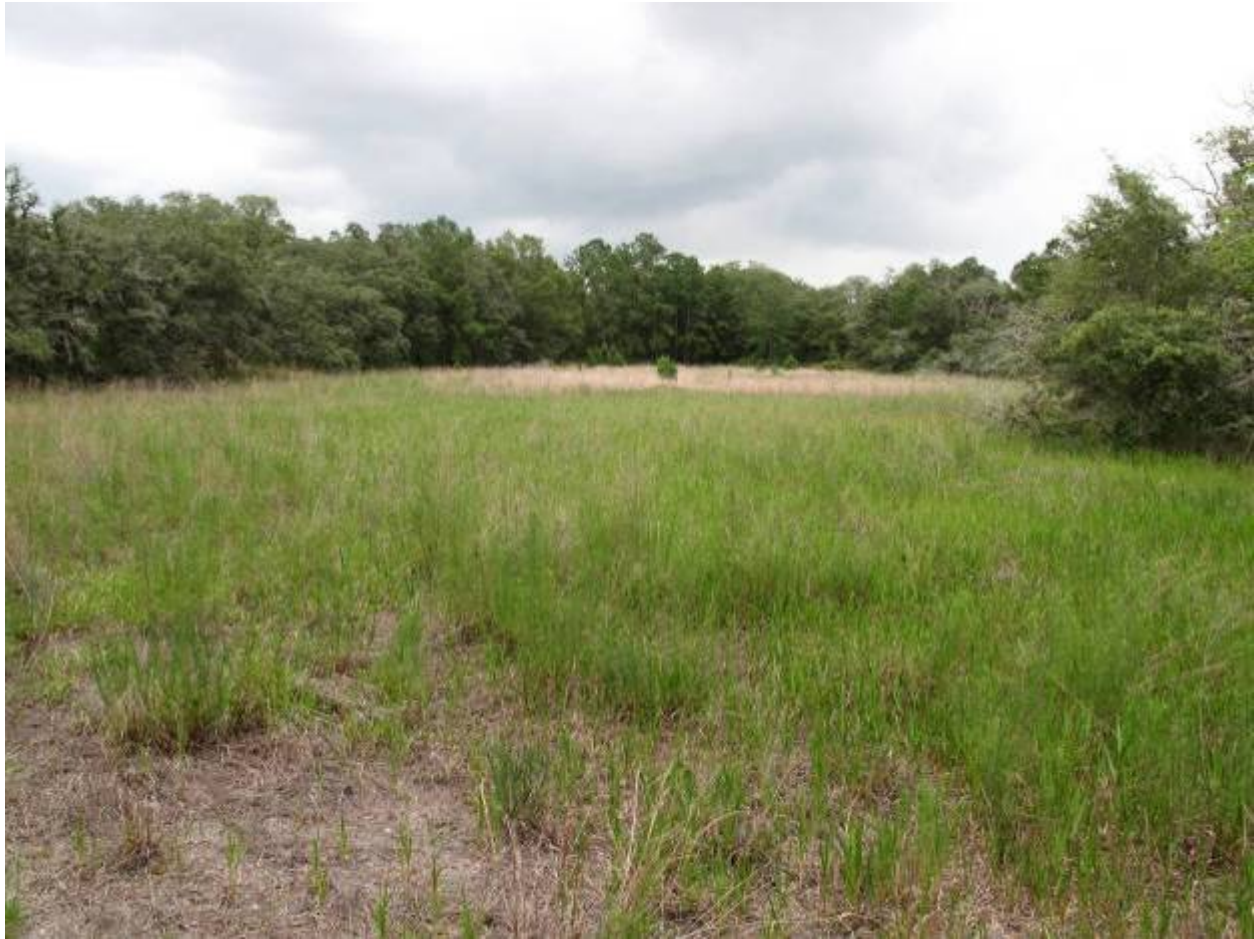
Wetland ID: 08D-02

Description: This wetland is a 0.7 ha ephemeral marsh. There is no canopy or midstory cover. Sedges/grasses grow throughout the wetland, and cover >75% of the basin. The wetland has minor feral hog damage. This marsh is in fire-maintenance condition and is a potential striped newt breeding pond. The adjacent uplands are historically fire suppressed sandhills and a dense ring of palmetto and oak surround the wetland. The uplands currently are managed with herbicide.

Wetland Disturbance: Feral hog damage

Restoration Action Recommended: Because of the widespread damage to ephemeral wetlands on CWMA, we recommend aggressive action to reduce the overall numbers of feral hogs on the property.

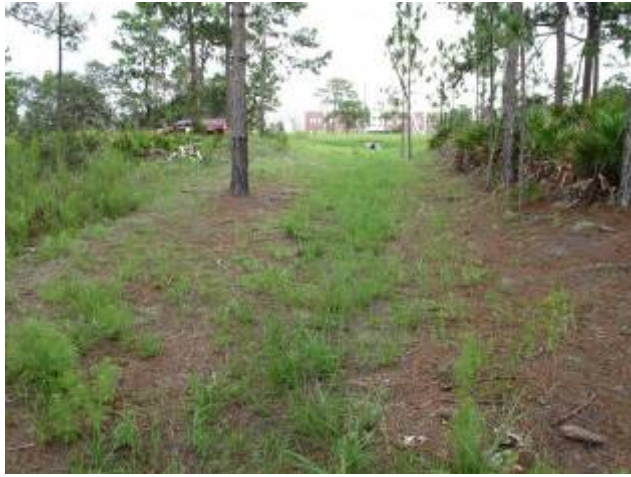
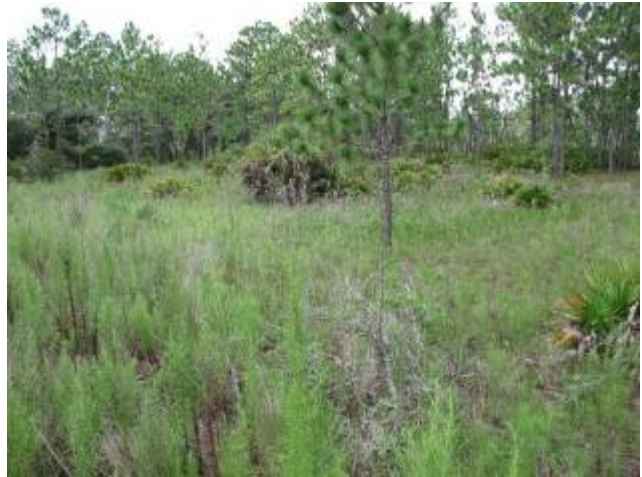
Wetland ID: 08D-03

Description: This wetland is a 0.1 ha ephemeral marsh. There is no canopy or midstory cover. Sedges/grasses grow throughout the wetland, and cover >75% of the basin. A canal that drains US 19 runoff during heavy rains enters the wetland on the east side. A fireline runs along the south end of the wetland. This wetland may have originated as a borrow pit for ditch construction, but now functions as a small, ephemeral marsh. The adjacent uplands are historically fire suppressed sandhills and currently are managed with herbicide.

Wetland Disturbance: Ditching, Fireline

Restoration Action Recommended: Fill in the ditch and allow vegetation to regenerate. The fireline/MU boundary should be re-routed away from the wetland. If the fireline cannot be re-routed, monitor the wetland to ensure fire is not excluded. Maintain the fireline when the wetland is completely dry to prevent ruts from developing.

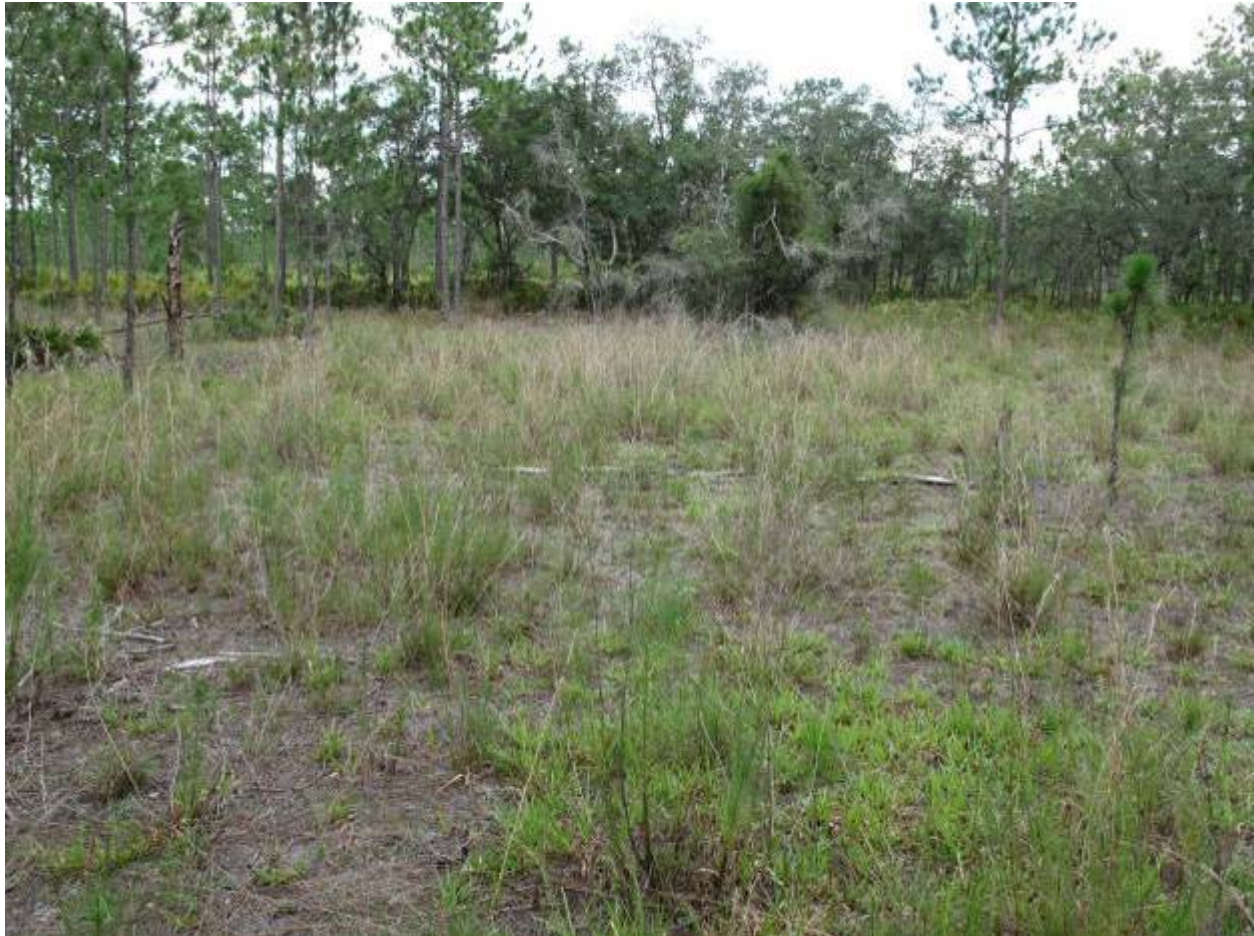
Wetland ID: 08D-04

Description: This wetland is a 0.2 ha highly ephemeral marsh. Pine trees dominate the canopy, and cover 5-25% of the wetland basin. There is no midstory layer. Sedges/grasses grow throughout the wetland, and cover 50-75% of the basin. This marsh is in fire-maintenance condition. The adjacent uplands are historically fire suppressed sandhills and currently are managed with herbicide.

Wetland Disturbance: None

Restoration Action Recommended: None

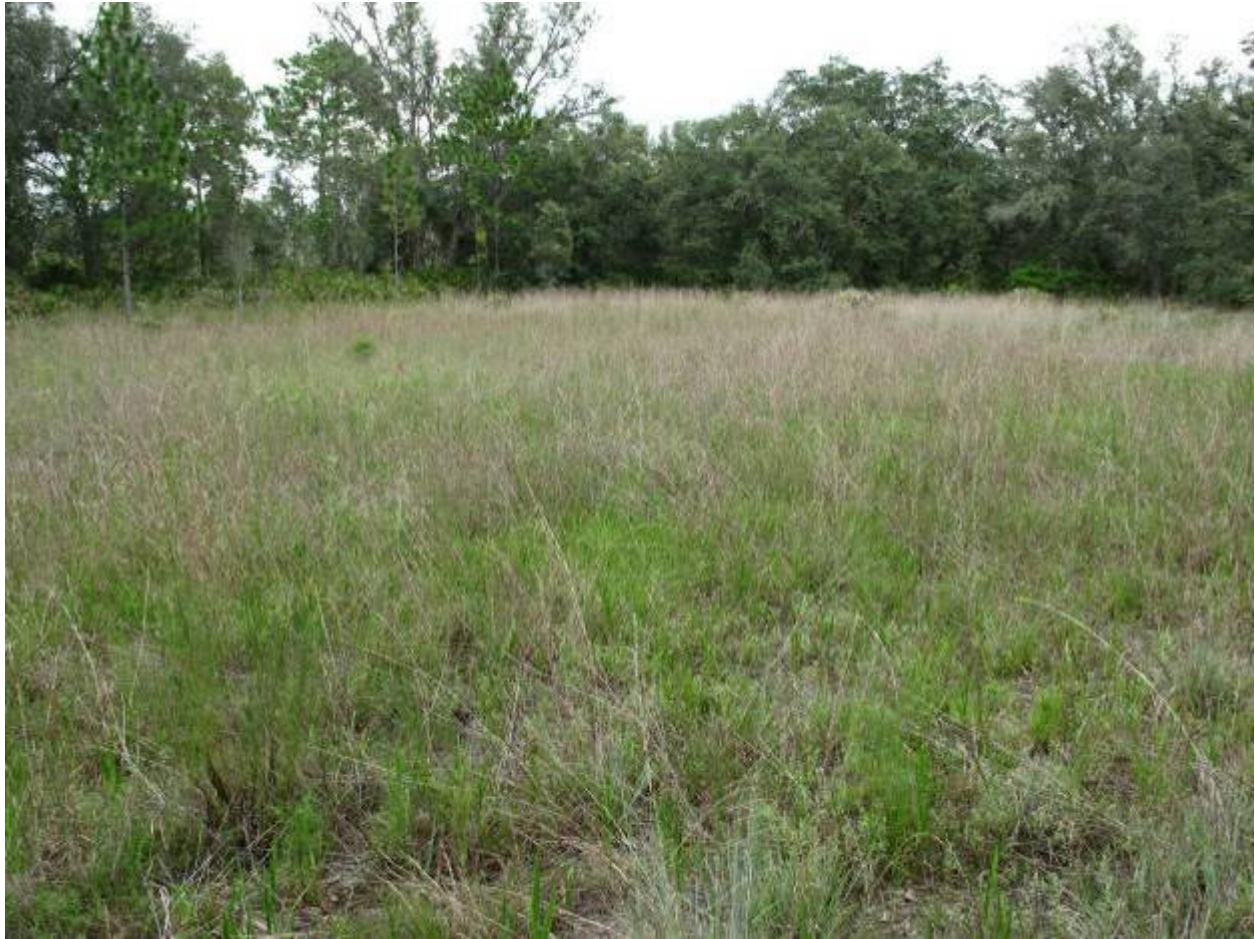
Wetland ID: 08D-05

Description: This wetland is a 0.3 ha ephemeral marsh. There is no canopy or midstory cover. A diverse array of sedges/grasses grows throughout the wetland, and covers >75% of the basin. This marsh is in fire-maintenance condition and is a potential striped newt breeding pond. The adjacent uplands are historically fire suppressed sandhills. A dense ring of palmetto and oak surround the wetland. The uplands currently are managed with herbicide.

Wetland Disturbance: None

Restoration Action Recommended: None

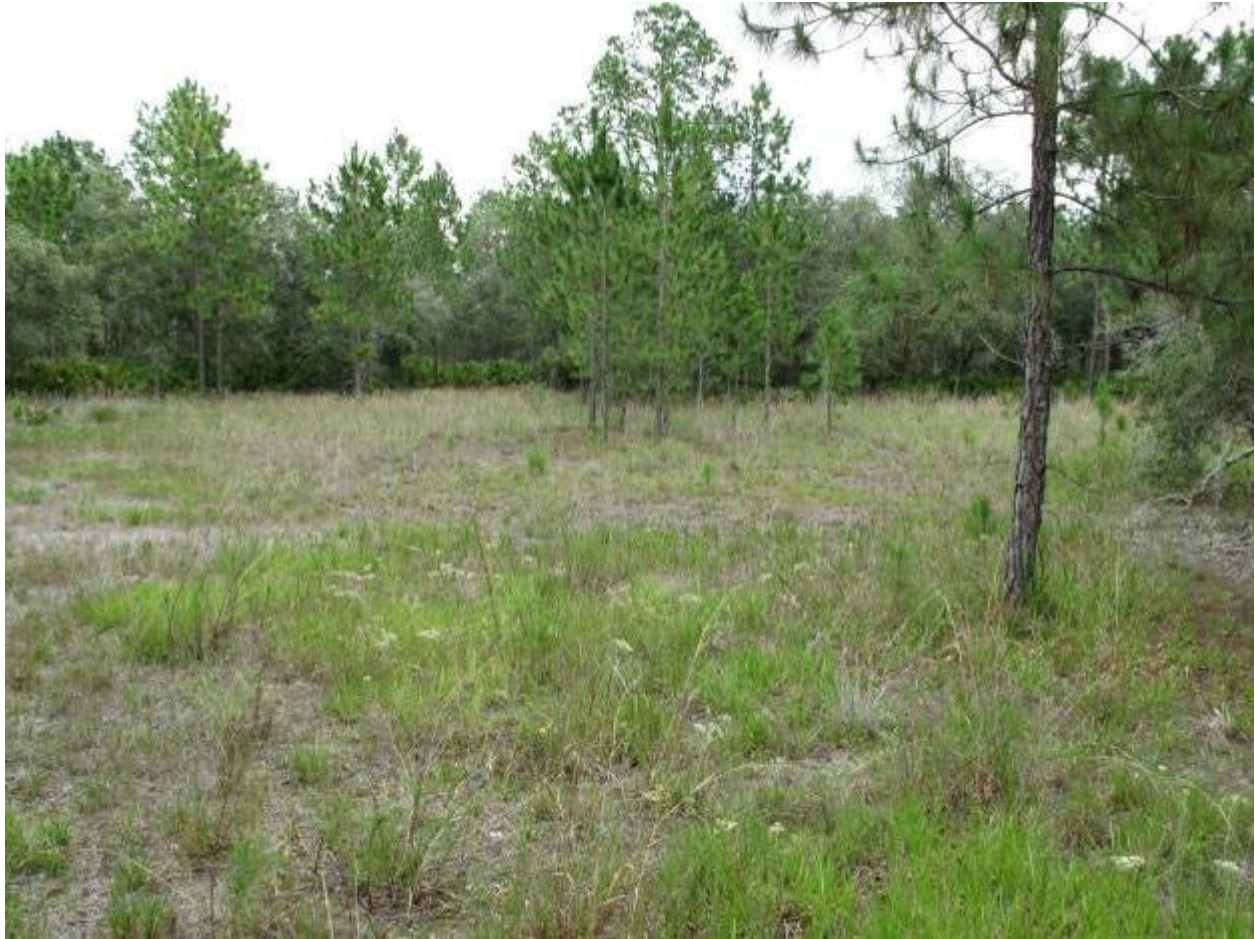
Wetland ID: 08D-06

Description: This wetland is a 0.2 ha ephemeral marsh. There is no canopy or midstory cover. Sedges/grasses grow throughout the wetland, and cover 50-75% of the basin. This marsh is in fire-maintenance condition and is a potential striped newt breeding pond. The adjacent uplands are historically fire suppressed sandhills. A dense ring of palmetto and oak surround the wetland. The uplands currently are managed with herbicide.

Wetland Disturbance: None

Restoration Action Recommended: None

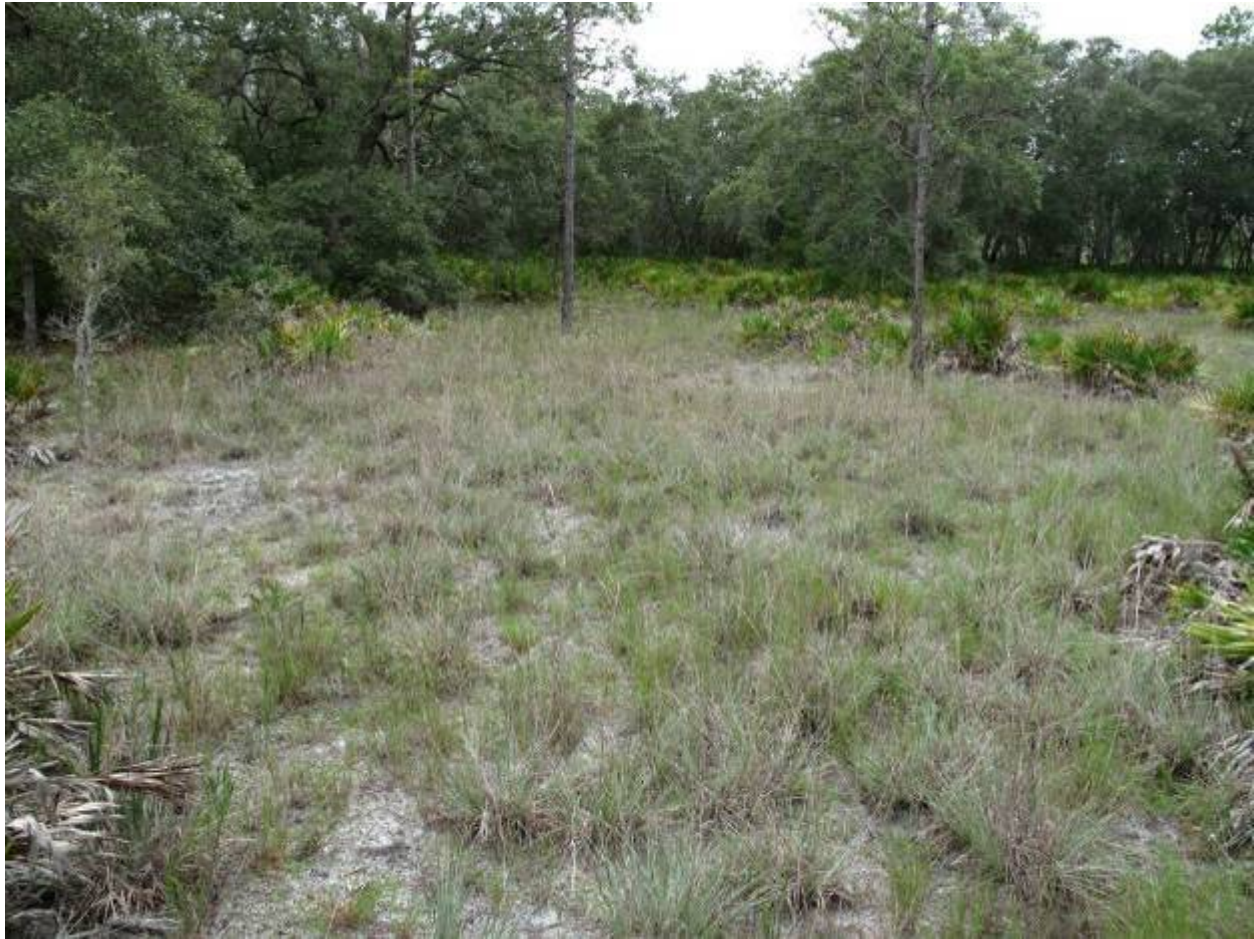
Wetland ID: 08D-07

Description: This wetland is a 0.1 ha highly ephemeral marsh. There is no tree canopy. Patches of saw palmetto grow within the wetland, and cover 5-25% of the wetland. Sedges/grasses grow throughout the wetland, and cover 50-75% of the basin. This marsh is in fire-maintenance condition. The adjacent uplands are historically fire suppressed sandhills. A dense ring of palmetto and oak surround the wetland. The uplands currently are managed with herbicide.

Wetland Disturbance: None

Restoration Action Recommended: None

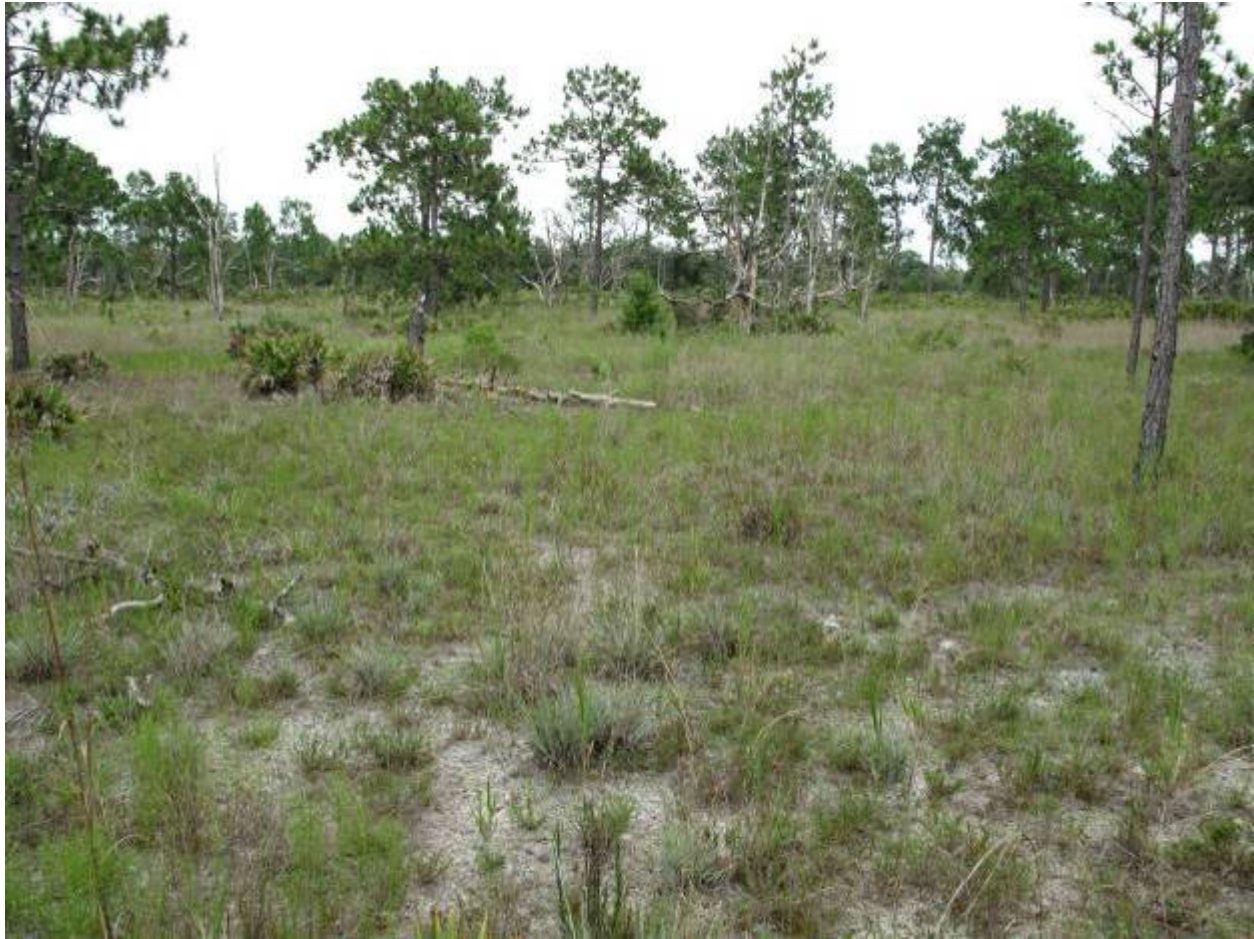
Wetland ID: 08D-08

Description: This wetland is a 0.2 ha highly ephemeral marsh. There is no canopy or midstory cover. Sedges/grasses grow throughout the wetland, and cover >75% of the basin. A couple of longleaf pine trees grow within the wetland. This marsh is in fire-maintenance condition. The adjacent uplands are historically fire suppressed sandhills. A dense ring of palmetto and oak surround the wetland. The uplands currently are managed with herbicide.

Wetland Disturbance: None

Restoration Action Recommended: None

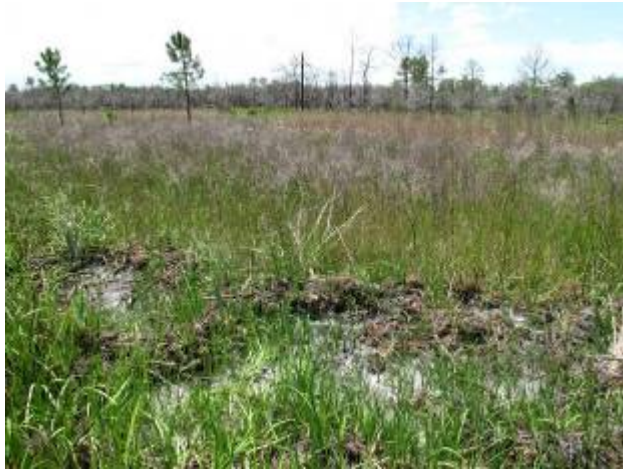
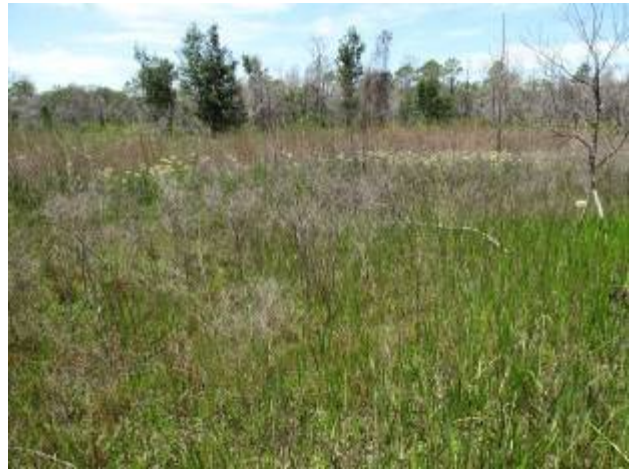
Wetland ID: 09D-01

Description: This wetland is a 1.2 ha ephemeral marsh. There is no canopy or midstory cover. Sedges/grasses grow throughout the wetland, and cover >75% of the basin. The wetland has minor feral hog damage. A fireline runs along the north side of the wetland, bisecting a small connector arm that would link this wetland with wetland 09D-02. This marsh is in fire-maintenance condition and is a potential striped newt breeding pond. The adjacent uplands are scrubby flatwoods and currently are managed with prescribed fire and mechanical vegetation removal.

Wetland Concerns: Feral hog damage, Fireline

Restoration Action Recommended: Because of the widespread damage to ephemeral wetlands on CWMA, we recommend aggressive action to reduce the overall numbers of feral hogs on the property. The fireline/MU boundary should be re-routed away from the wetland, south of the 09D-01, 02, 03 pond complex. If the fireline cannot be re-routed, monitor the wetland to ensure fire is not excluded. Maintain the fireline when the wetland is completely dry to prevent ruts from developing.

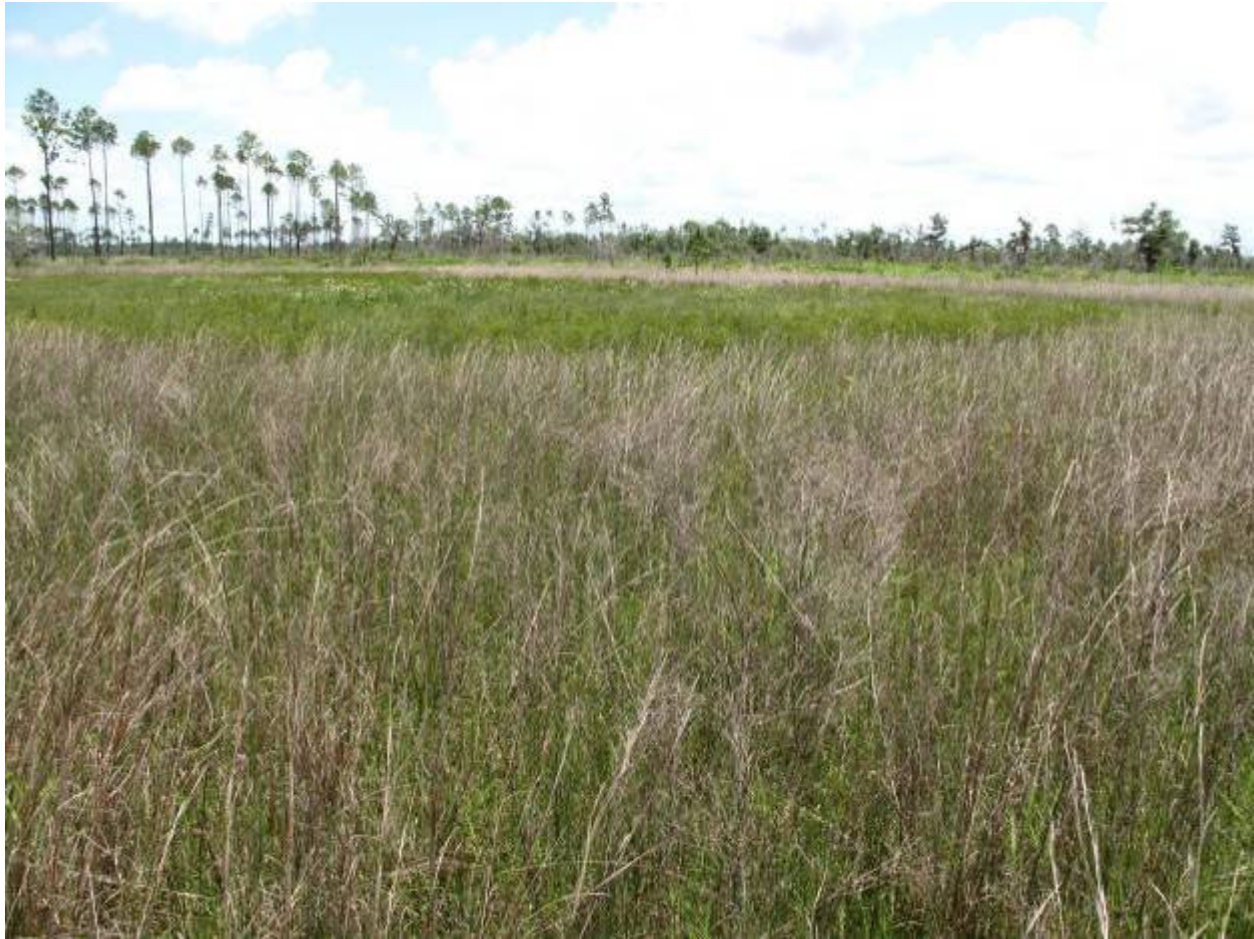
Wetland ID: 09D-02

Description: This wetland is a 2.4 ha ephemeral marsh. There is no tree canopy. *Hypericum* covers 5-25% of the wetland. A diverse array of sedges/grasses grows throughout the wetland, and covers >75% of the basin. The wetland has minor and patchy feral hog damage. A fireline near the south side of the wetland bisects a small connector arm that would link this wetland with wetland 09D-01. This marsh is in fire-maintenance condition and is a potential striped newt breeding pond. The adjacent uplands are scrubby flatwoods and currently are managed with prescribed fire and mechanical vegetation removal.

Wetland Concerns: Feral hog damage, Fireline

Restoration Action Recommended: Because of the widespread damage to ephemeral wetlands on CWMA, we recommend aggressive action to reduce the overall numbers of feral hogs on the property. The fireline/MU boundary should be re-routed away from the wetland, south of the 09D-01, 02, 03 pond complex. If the fireline cannot be re-routed, monitor the wetland to ensure fire is not excluded. Maintain the fireline when the wetland is completely dry to prevent ruts from developing.

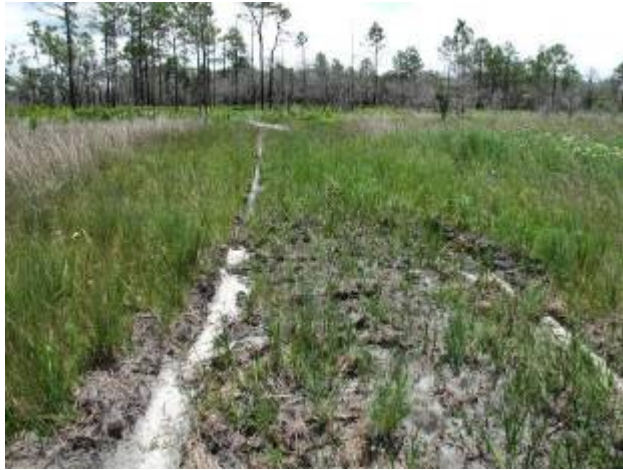
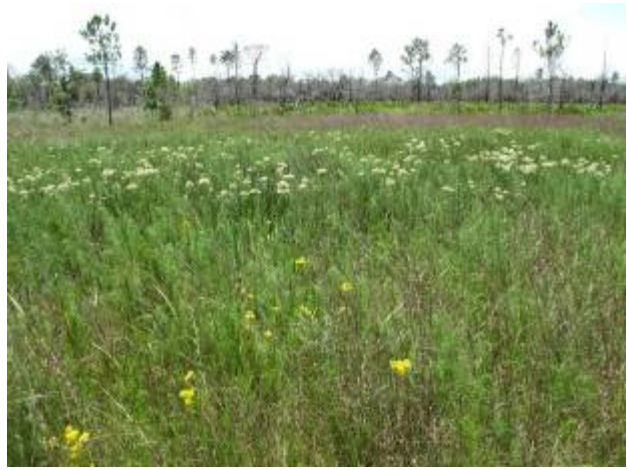
Wetland ID: 09D-03

Description: This wetland is a 0.8 ha ephemeral marsh. There is no canopy or midstory cover. Sedges/grasses grow throughout the wetland, and cover >75% of the basin. The wetland has minor feral hog damage. A fireline bisects the wetland. This marsh is in fire-maintenance condition and is a potential striped newt breeding pond. The adjacent uplands are scrubby flatwoods and currently are managed with prescribed fire and mechanical vegetation removal.

Wetland Concerns: Feral hog damage, Fireline

Restoration Action Recommended: Because of the widespread damage to ephemeral wetlands on CWMA, we recommend aggressive action to reduce the overall numbers of feral hogs on the property. The fireline/MU boundary should be re-routed away from the wetland, south of the 09D-01, 02, 03 pond complex. If the fireline cannot be re-routed, monitor the wetland to ensure fire is not excluded. Maintain the fireline when the wetland is completely dry to prevent ruts from developing.

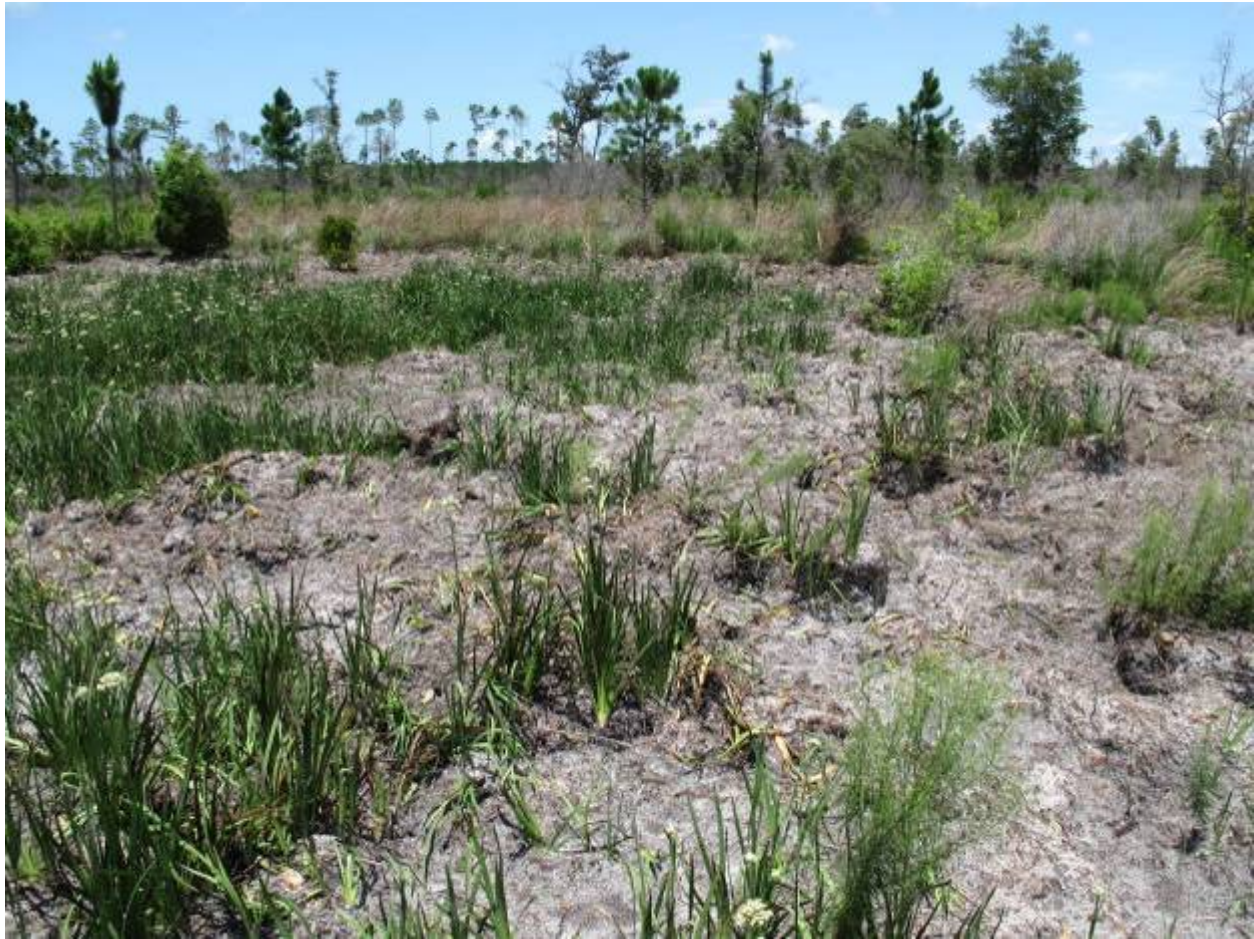
Wetland ID: 09D-04

Description: This wetland is a 0.2 ha ephemeral marsh. There is no canopy or midstory cover. Sedges/grasses and redroot grow throughout the wetland, and cover >75% of the basin. The wetland has extensive hog damage. The adjacent uplands are scrubby flatwoods and currently are managed with prescribed fire and mechanical vegetation removal

Wetland Concerns: Feral hog damage

Restoration Action Recommended: Because of the widespread damage to ephemeral wetlands on CWMA, we recommend aggressive action to reduce the overall numbers of feral hogs on the property.

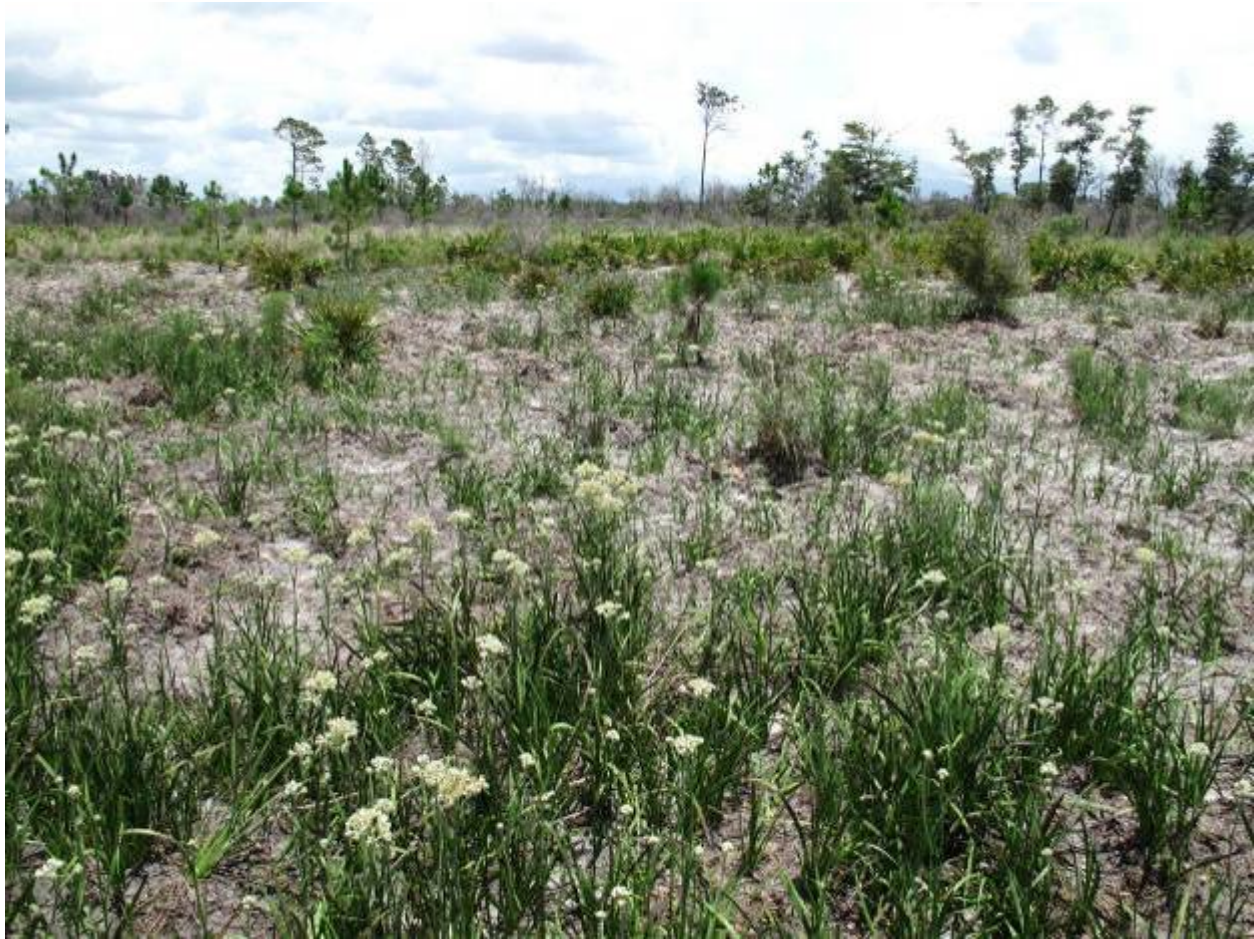
Wetland ID: 09D-05

Description: This wetland is a 0.3 ha ephemeral marsh. There is no canopy or midstory cover. Redroot is distributed throughout the wetland, and cover 50-75% of the basin. The wetland has extensive and severe hog damage. The adjacent uplands are scrubby flatwoods and currently are managed with prescribed fire and mechanical vegetation removal.

Wetland Disturbance: Feral hog damage

Restoration Action Recommended: Because of the widespread damage to ephemeral wetlands on CWMA, we recommend aggressive action to reduce the overall numbers of feral hogs on the property.

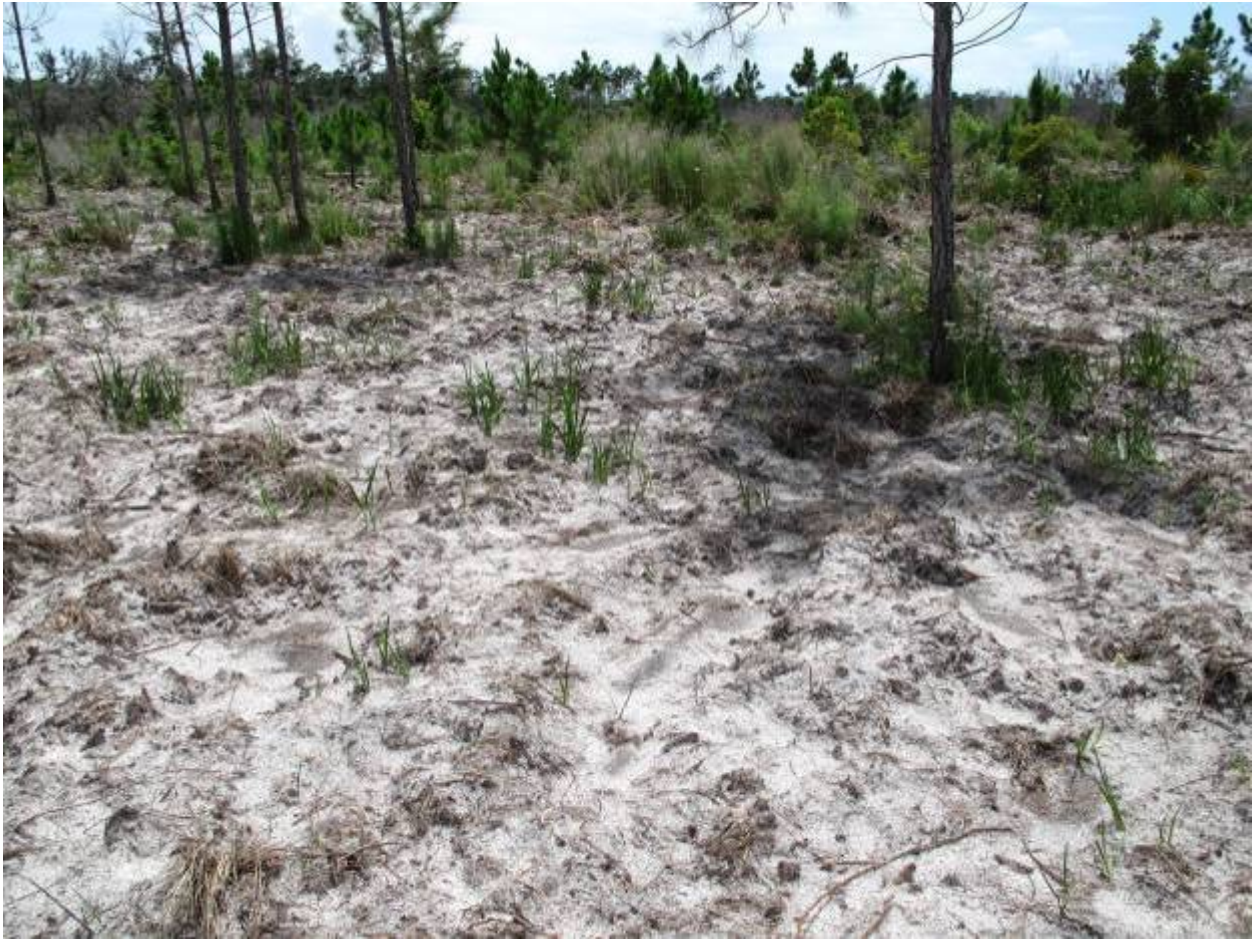
Wetland ID: 09D-06

Description: This wetland is a 0.2 ha ephemeral marsh. Pine trees dominate the canopy, and cover 5-25% of the wetland. There is no midstory cover. Redroot grows in scattered patches, covering 5-25% of the wetland basin. The wetland has severe hog damage. A fireline runs along the east side of the pond, barely touching the wetland edge. The adjacent uplands are scrubby flatwoods and currently are managed with prescribed fire and mechanical vegetation removal.

Wetland Concerns: Feral hog damage, Fireline

Restoration Action Recommended: Because of the widespread damage to ephemeral wetlands on CWMA, we recommend aggressive action to reduce the overall numbers of feral hogs on the property. The fireline/MU boundary should be re-routed away from the wetland. If the fireline cannot be re-routed, monitor the wetland to ensure fire is not excluded. Maintain the fireline when the wetland is completely dry to prevent ruts from developing.

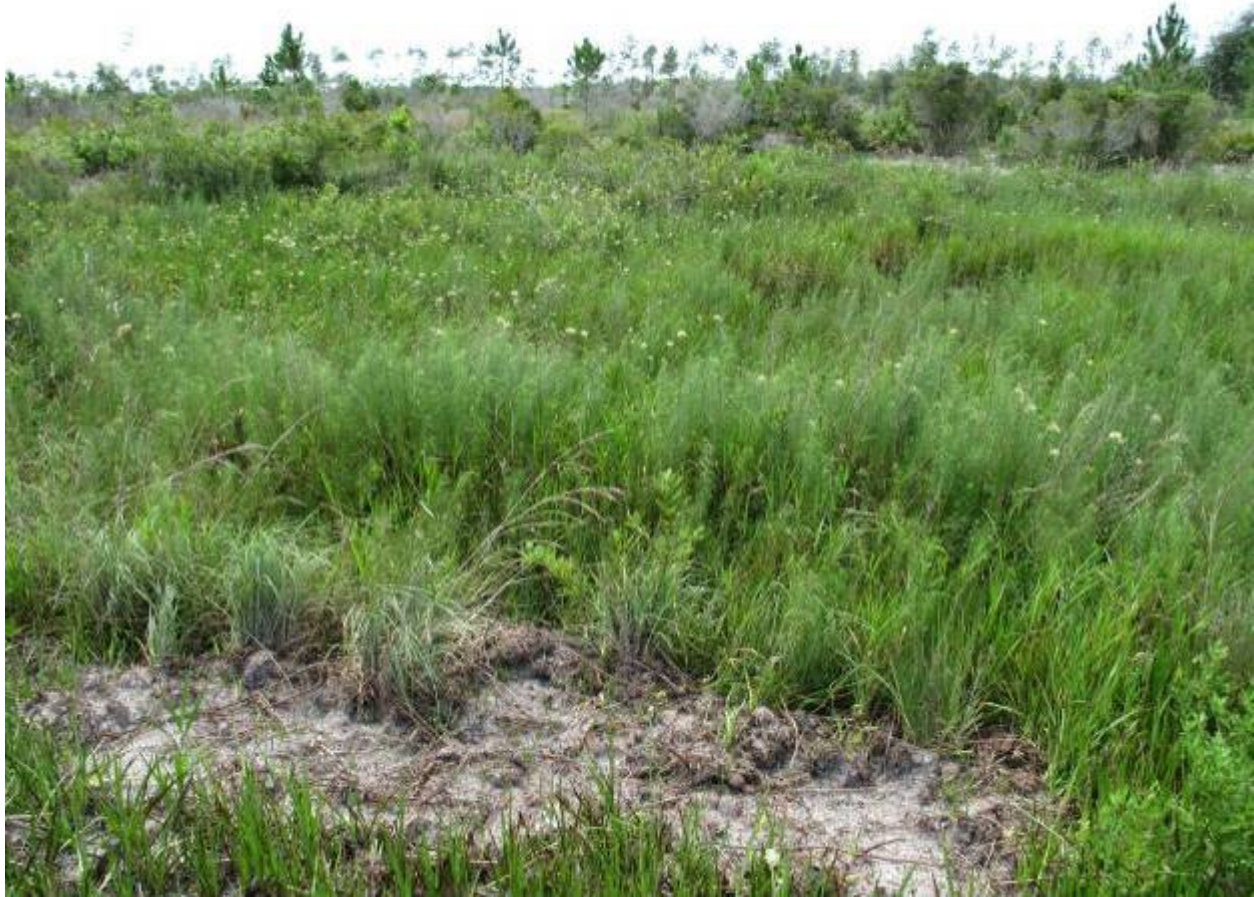
Wetland ID: 09D-07

Description: This wetland is a 0.1 ha ephemeral marsh. There is no tree canopy. Buttonbush grows throughout 5-25% of the wetland. Sedges/grasses and maidencane grow throughout the wetland, and cover >75% of the basin. The wetland has minor hog damage in a ring around the pond edge. This marsh is in fire-maintenance condition and is a potential striped newt breeding pond. The adjacent uplands are scrubby flatwoods and currently are managed with prescribed fire and mechanical vegetation removal.

Wetland Concerns: Feral hog damage

Restoration Action Recommended: Because of the widespread damage to ephemeral wetlands on CWMA, we recommend aggressive action to reduce the overall numbers of feral hogs on the property.

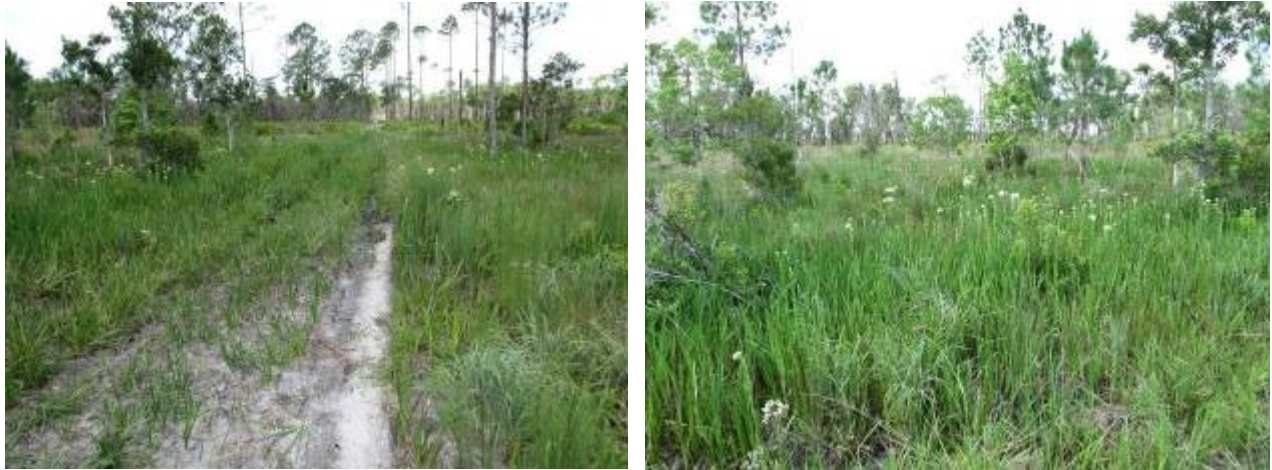
Wetland ID: 10D-01

Description: This wetland is a 0.9 ha ephemeral marsh. Holly and pine trees dominate the canopy, and cover 5-25% of the wetland. There is no midstory layer. Sedges/grasses and redroot grow throughout the wetland, and cover >75% of the basin. The wetland has new and old feral hog damage. A fireline bisects the wetland. This marsh is in fire-maintenance condition and is a potential striped newt breeding pond. The adjacent uplands are scrubby flatwoods managed with growing season prescribed fires.

Wetland Concerns: Feral hog damage, Fireline

Restoration Action Recommended: Because of the widespread damage to ephemeral wetlands on CWMA, we recommend aggressive action to reduce the overall numbers of feral hogs on the property. The fireline/MU boundary should be re-routed away from the wetland. If the fireline cannot be re-routed, monitor the wetland to ensure fire is not excluded. Maintain the fireline when the wetland is completely dry to prevent ruts from developing.

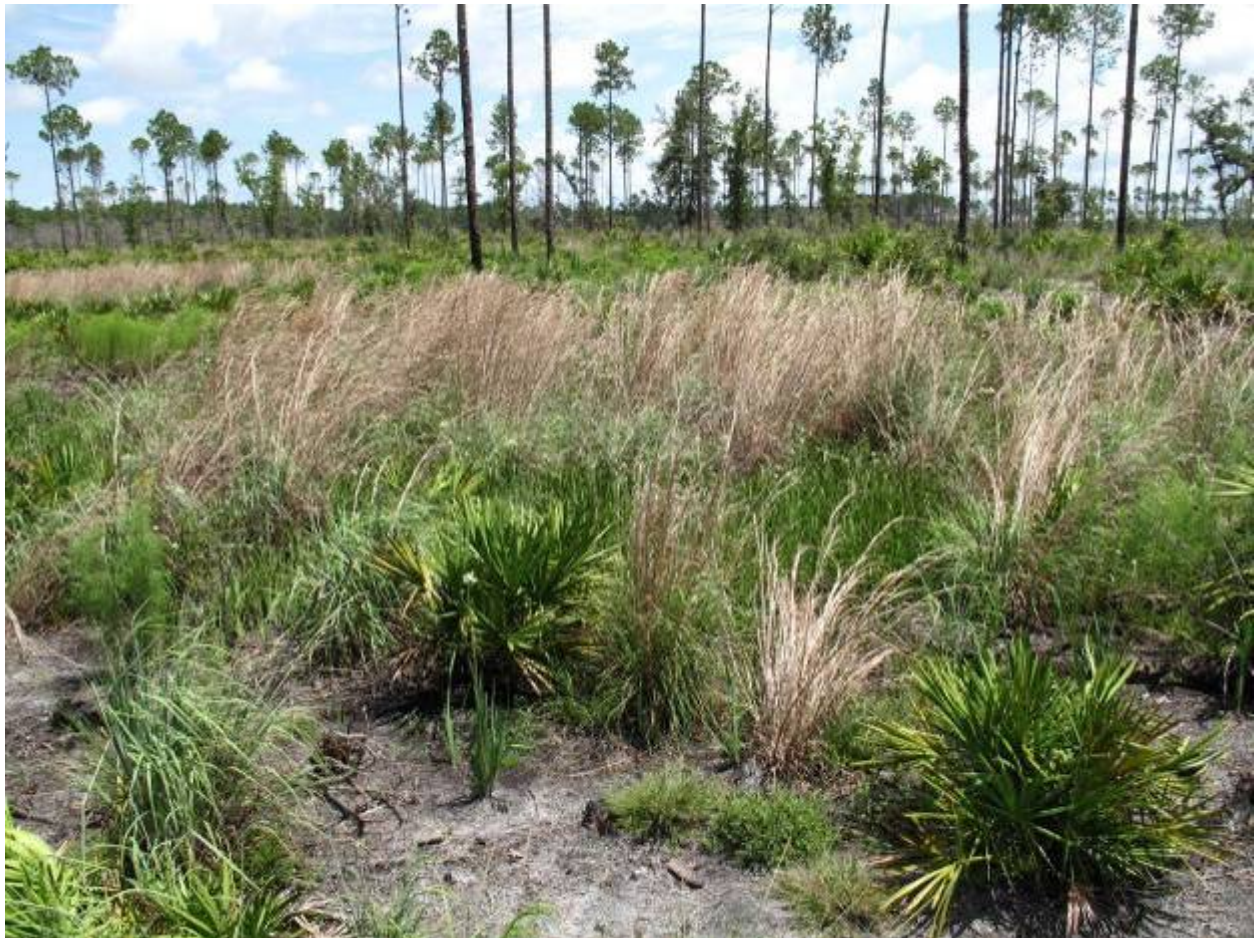
Wetland ID: 10D-02

Description: This wetland is a 0.1 ha ephemeral marsh. There is no canopy or midstory cover. Sedges/grasses and redroot grow throughout the wetland, and cover >75% of the basin. This marsh is in fire-maintenance condition and is a potential striped newt breeding pond. The adjacent uplands are scrubby flatwoods managed with growing season prescribed fires.

Wetland Concerns: None

Restoration Action Recommended: None

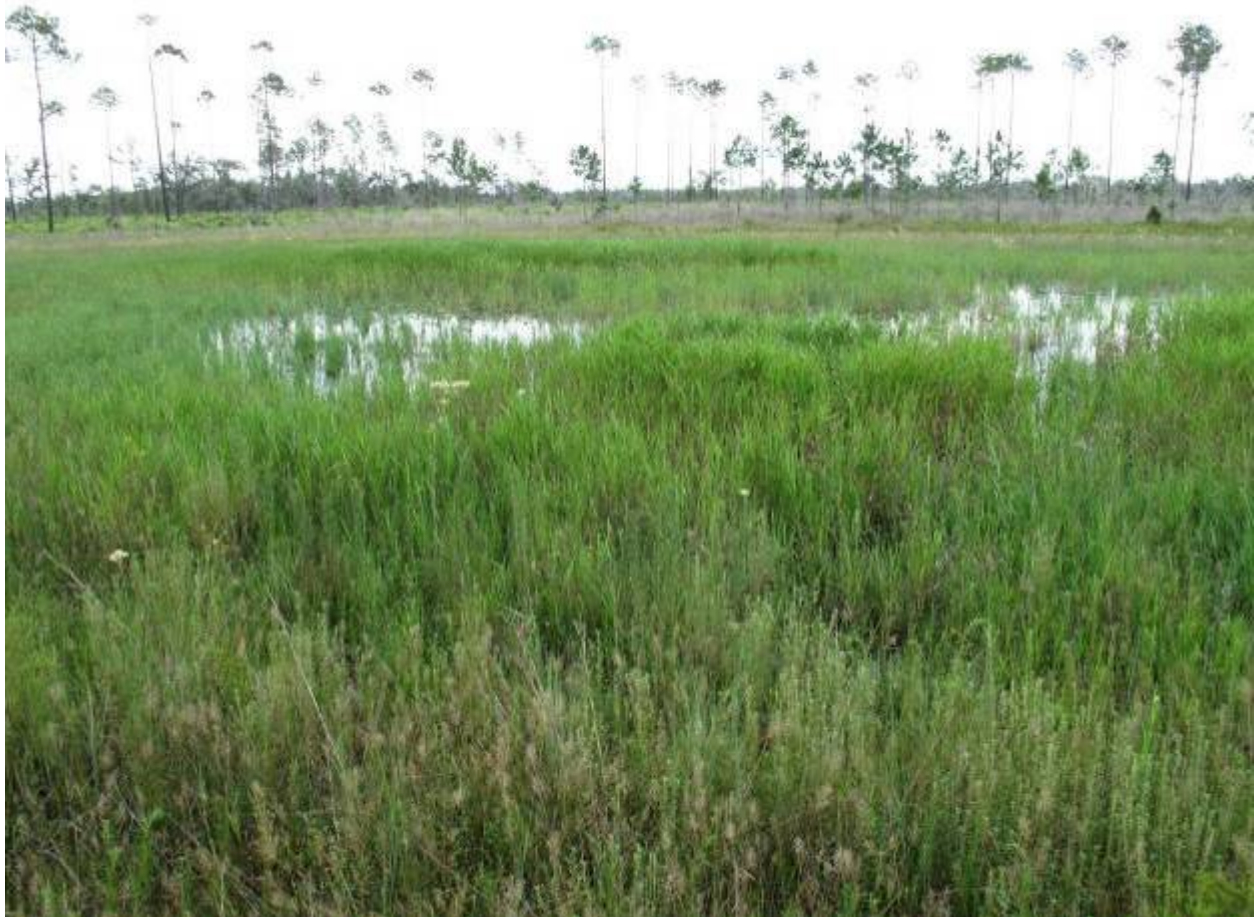
Wetland ID: 10D-03

Description: This wetland is a 1.4 ha ephemeral marsh. There is no canopy or midstory cover. A diverse array of sedges/grasses grows throughout the wetland, and covers >75% of the basin. This marsh is in fire-maintenance condition and is a potential striped newt breeding pond. The adjacent uplands are scrubby flatwoods managed with growing season prescribed fires.

Wetland Concerns: None

Restoration Action Recommended: None
