Inventory, Assessment, and Restoration Potential of Ephemeral Wetlands on FFWCC Wildlife Management Areas

Chassahowitzka WMA Final Report

Submitted by: Rebecca P.M. Means¹, Ryan C. Means¹, Steven A. Johnson²

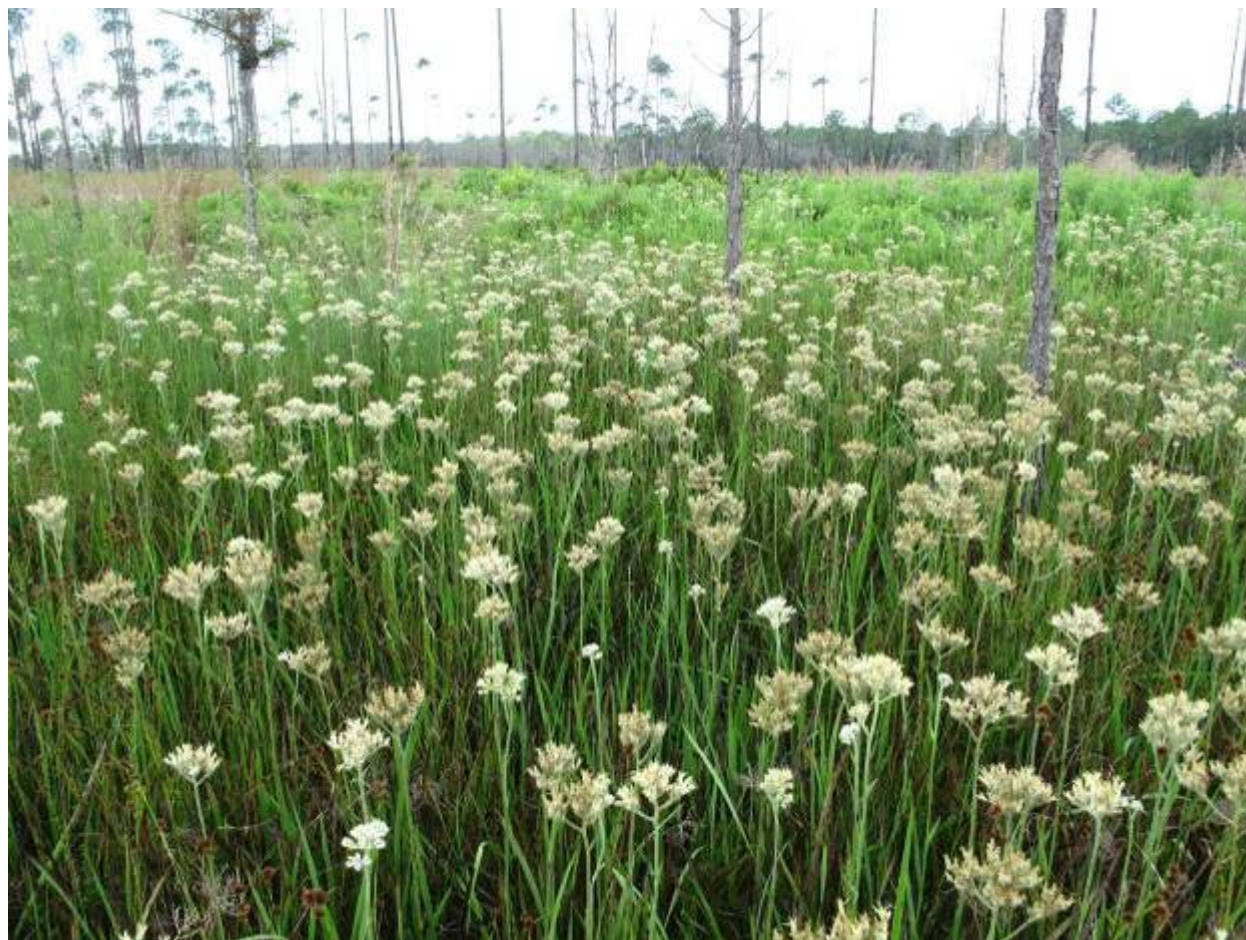
Wetland ID: 10D-04

Description: This wetland is a 0.3 ha ephemeral marsh. There is no canopy or midstory cover. Sedges/grasses and redroot grow throughout the wetland, and cover >75% of the basin. Feral hog rootings are patchy in the wetland. A fireline runs bisects the north side of the wetland. This oblong marsh is a potential striped newt breeding pond. The adjacent uplands are scrubby flatwoods managed with growing season prescribed fires.

Wetland Concerns: Feral hog damage, Fireline

Restoration Action Recommended: Because of the widespread damage to ephemeral wetlands on CWMA, we recommend aggressive action to reduce the overall numbers of feral hogs on the property. The fireline in the interior of the MU is not a MU boundary. We recommend it be abandoned and allowed to recover over time. If the fireline cannot be re-routed, monitor the wetland to ensure fire is not excluded. Maintain the fireline when the wetland is completely dry to prevent ruts from developing.

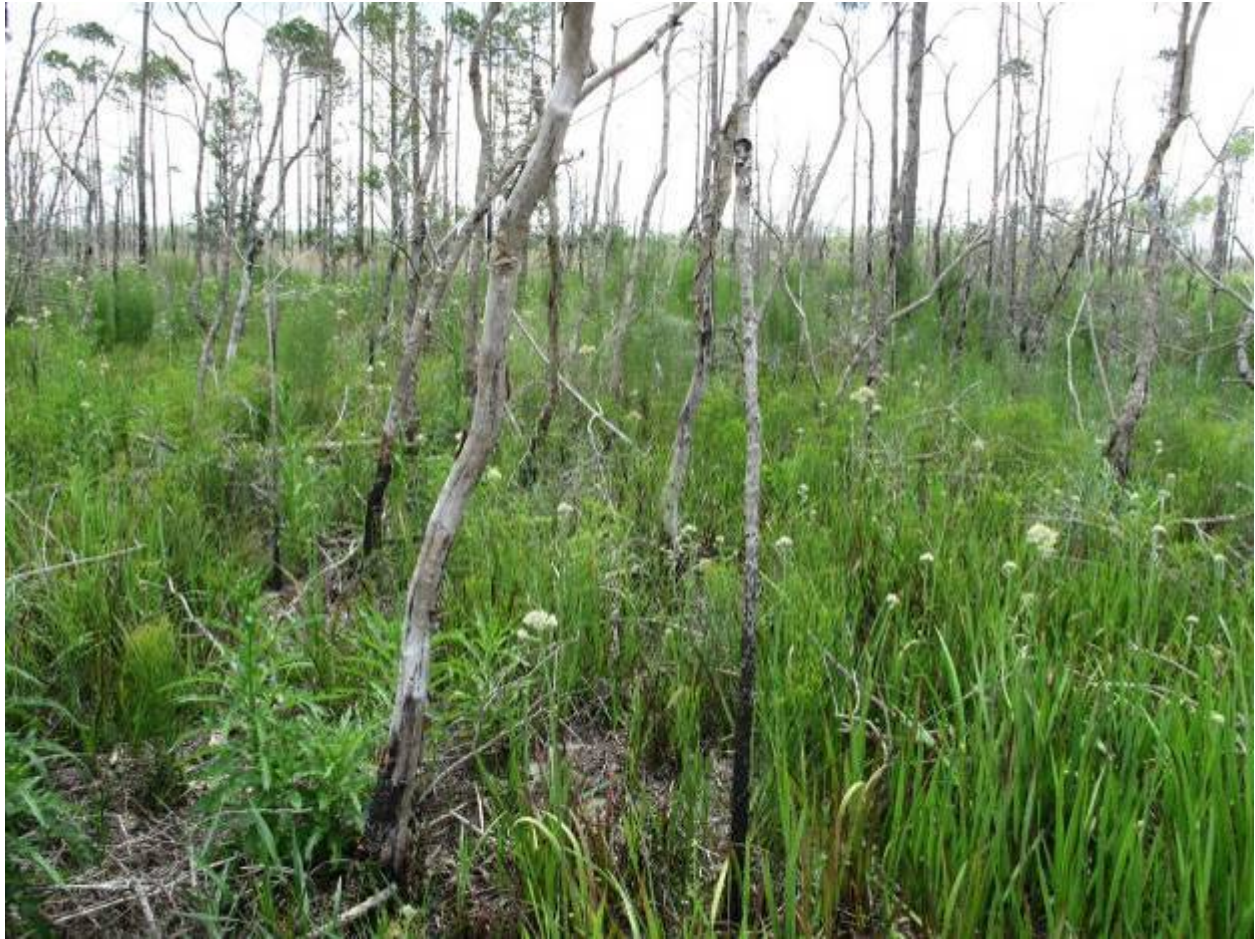
Wetland ID: 10D-05

Description: This wetland is a 0.5 ha ephemeral marsh. Pine trees dominate the canopy, and cover 5-25% of the wetland basin. There is no midstory layer. Sedges/grasses and redroot grow throughout the wetland, and cover >75% of the basin. The wetland has minor, patchy feral hog damage. A recent fire killed the holly and bay that used to form a midstory layer, now the marsh is open with dead shrub snags. This marsh provides a good example of the benefits of prescribed fires to marsh management and restoration. The adjacent uplands are mesic flatwoods managed with growing season prescribed fires.

Wetland Concerns: Feral hog damage

Restoration Action Recommended: Because of the widespread damage to ephemeral wetlands on CWMA, we recommend aggressive action to reduce the overall numbers of feral hogs on the property.

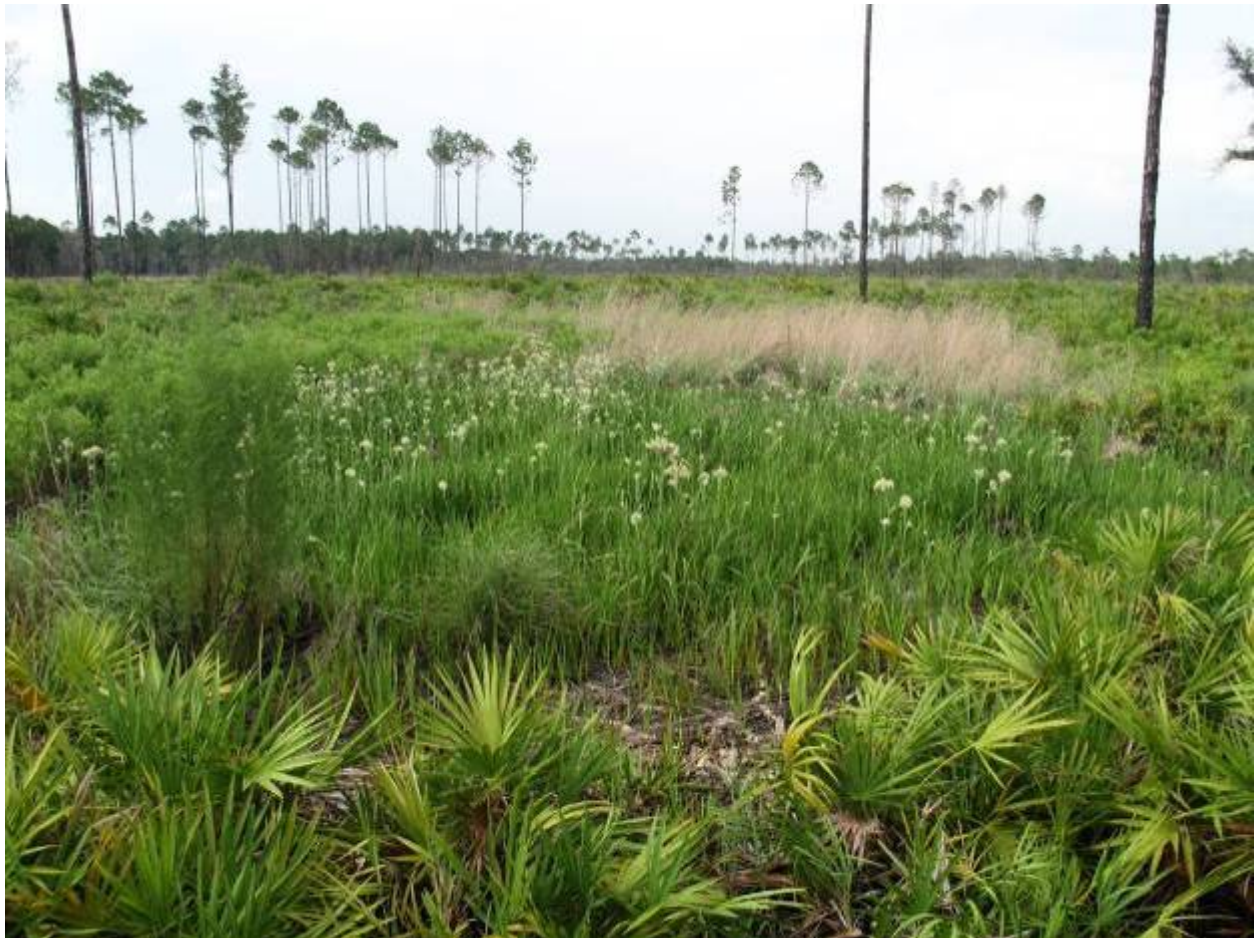
Wetland ID: 10D-06

Description: This wetland is a 0.1 ha ephemeral marsh. There is no canopy or midstory cover. Sedges/grasses and redroot grow throughout the wetland, and cover >75% of the basin. Minor damage from feral hogs has grown over with vegetation. This marsh is in fire-maintenance condition. The adjacent uplands are scrubby flatwoods managed with growing season prescribed fires.

Wetland Concerns: Feral hog damage

Restoration Action Recommended: Because of the widespread damage to ephemeral wetlands on CWMA, we recommend aggressive action to reduce the overall numbers of feral hogs on the property.

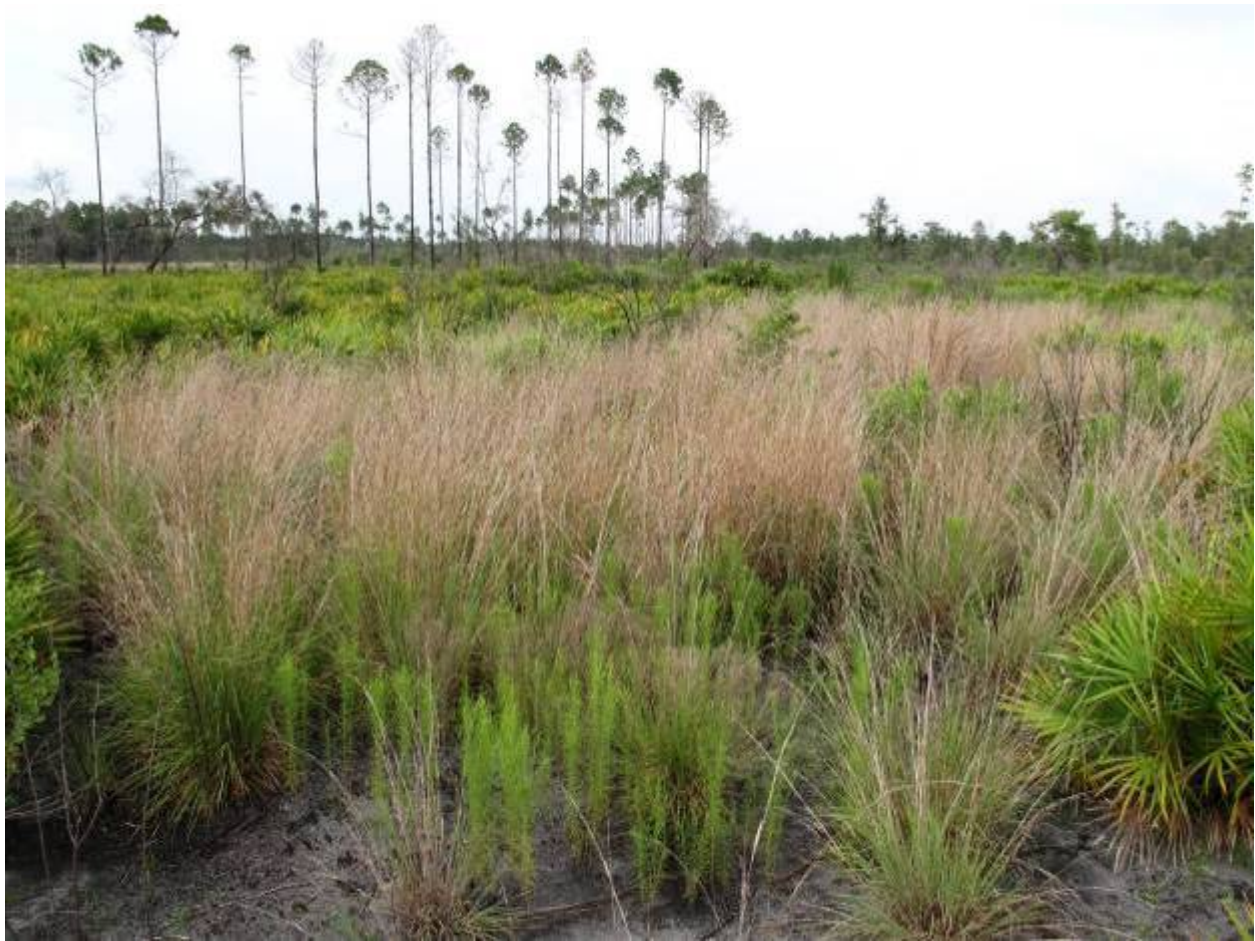
Wetland ID: 10D-07

Description: This wetland is a 0.1 ha ephemeral marsh. There is no canopy or midstory cover. Sedges/grasses grow throughout the wetland, and cover >75% of the basin. This marsh is in fire-maintenance condition. The adjacent uplands are scrubby flatwoods managed with growing season prescribed fires.

Wetland Concerns: None

Restoration Action Recommended: None

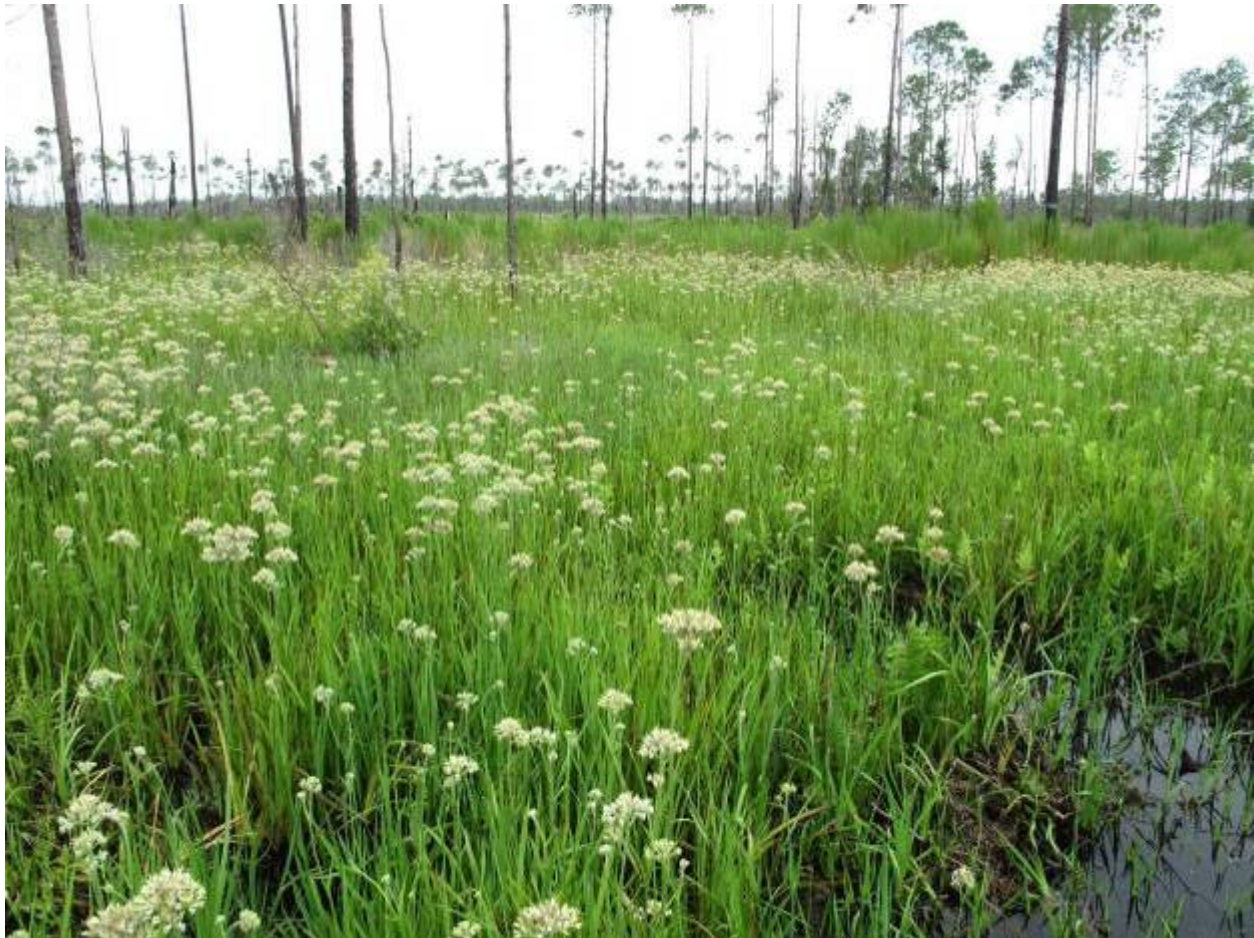
Wetland ID: 10D-08

Description: This wetland is a 0.7 ha ephemeral marsh. There is no canopy or midstory cover. Sedges/grasses and redroot grow throughout the wetland, and cover >75% of the basin. The wetland has minor feral hog damage. A recent fire burned through the wetland. This low-lying marsh likely connects with the adjacent hydric hammock during periods of high water. The adjacent uplands are mesic flatwoods and hydric hammock managed with growing season prescribed fires.

Wetland Concerns: Feral hog damage

Restoration Action Recommended: Because of the widespread damage to ephemeral wetlands on CWMA, we recommend aggressive action to reduce the overall numbers of feral hogs on the property.

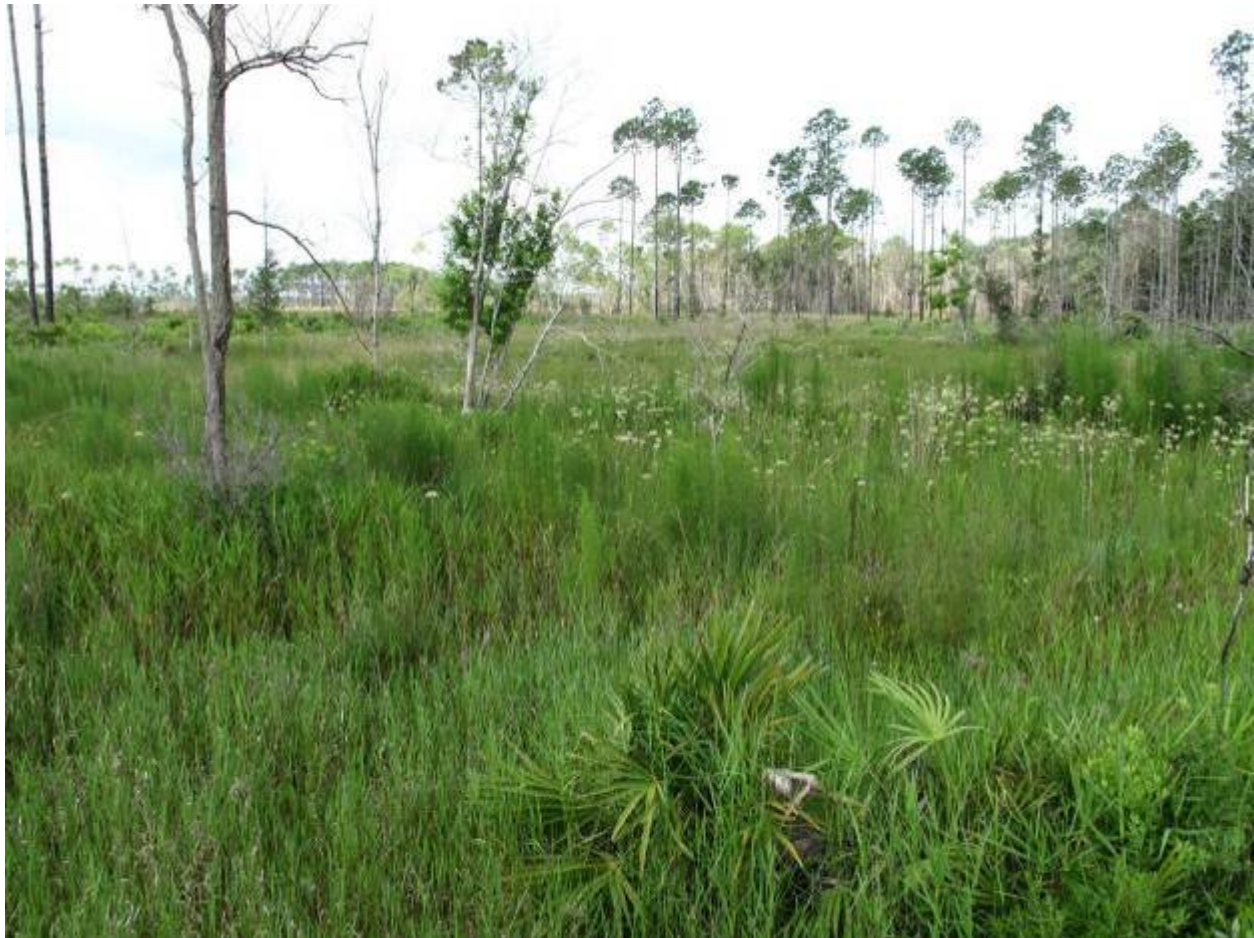
Wetland ID: 10D-09

Description: This wetland is a 0.3 ha ephemeral marsh. There is no canopy or midstory cover. A diverse array of sedges/grasses grows throughout the wetland, and covers >75% of the basin. This marsh is in fire-maintenance condition. The adjacent uplands are scrubby flatwoods managed with growing season prescribed fires.

Wetland Concerns: None

Restoration Action Recommended: None

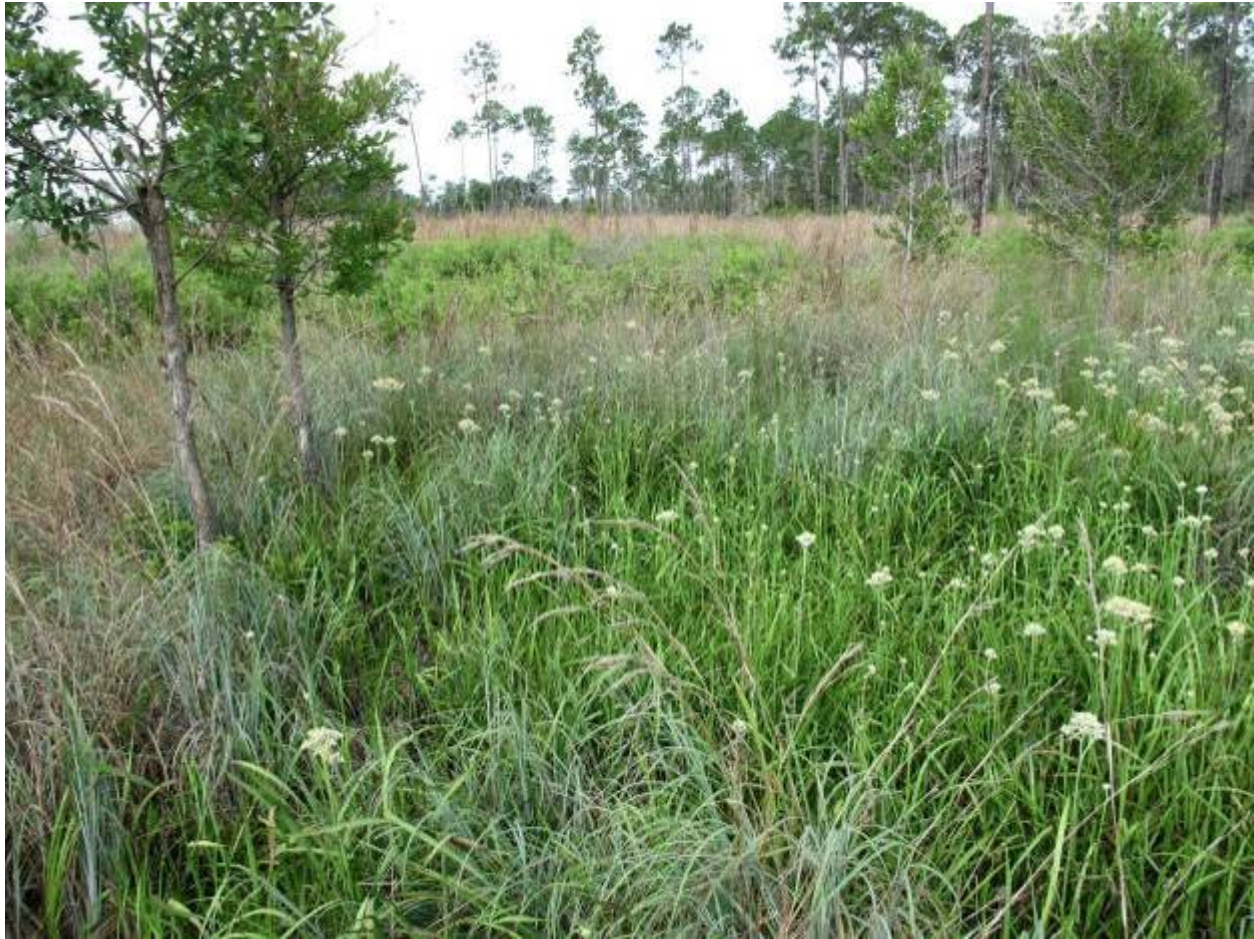
Wetland ID: 10D-10

Description: This wetland is a <0.1 ha ephemeral marsh. Gum trees dominate the canopy, and cover 5-25% of the wetland basin. There is no midstory layer. Sedges/grasses and redroot grow throughout the wetland, and cover >75% of the basin. The wetland has old and new feral hog damage. A recent fire burned through the wetland. The adjacent uplands are scrubby flatwoods managed with growing season prescribed fires.

Wetland Concerns: Feral hog damage

Restoration Action Recommended: Because of the widespread damage to ephemeral wetlands on CWMA, we recommend aggressive action to reduce the overall numbers of feral hogs on the property.

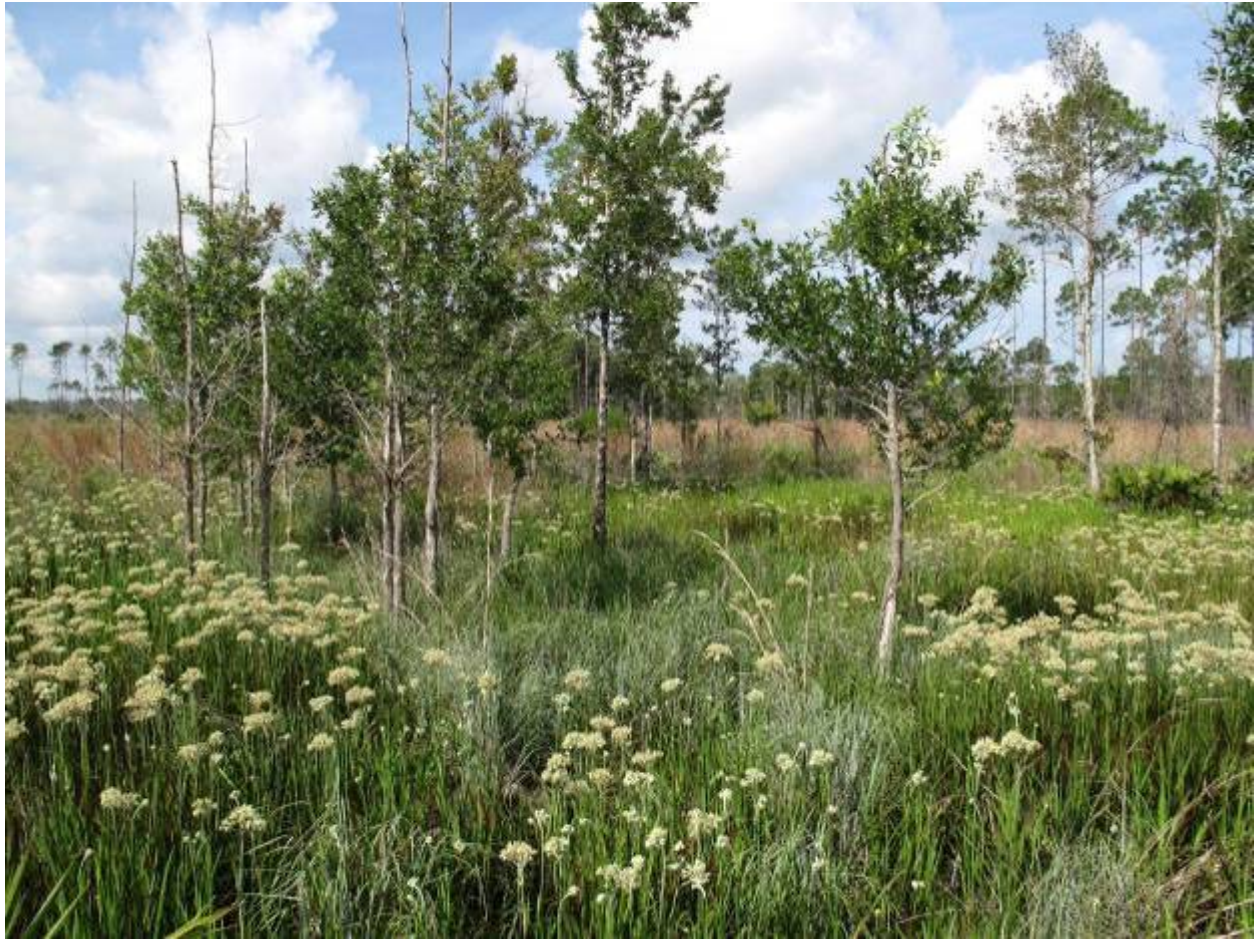
Wetland ID: 10D-11

Description: This wetland is a 0.1 ha ephemeral marsh. Gum trees dominate the canopy, and cover 5-25% of the wetland basin. There is no midstory layer. Sedges/grasses and redroot grow throughout the wetland, and cover >75% of the basin. The wetland has minor feral hog damage. A recent fire burned through the wetland. This circular depression marsh is in fire-maintenance condition and is a potential striped newt breeding pond. The adjacent uplands are mesic flatwoods and hydric hammock managed with growing season prescribed fires.

Wetland Concerns: Feral hog damage

Restoration Action Recommended: Because of the widespread damage to ephemeral wetlands on CWMA, we recommend aggressive action to reduce the overall numbers of feral hogs on the property.

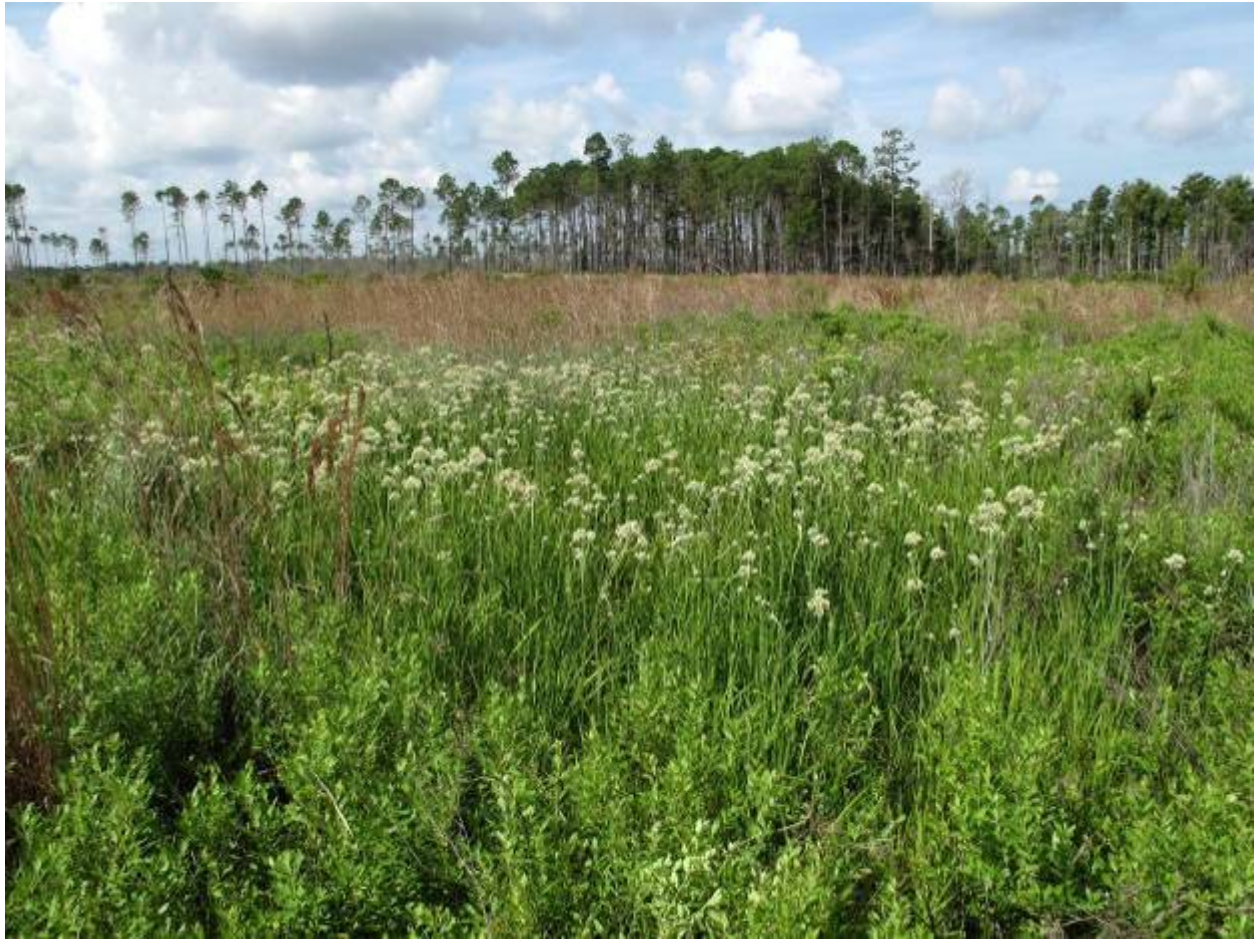
Wetland ID: 10D-12

Description: This wetland is a 0.1 ha ephemeral marsh. There is no canopy or midstory cover. Redroot grows throughout the wetland, and covers >75% of the basin. The wetland has old feral hog damage that is grown over with vegetation. This marsh is in fire-maintenance condition. The adjacent uplands are mesic flatwoods and hydric hammock managed with growing season prescribed fires.

Wetland Concerns: Feral hog damage

Restoration Action Recommended: Because of the widespread damage to ephemeral wetlands on CWMA, we recommend aggressive action to reduce the overall numbers of feral hogs on the property.

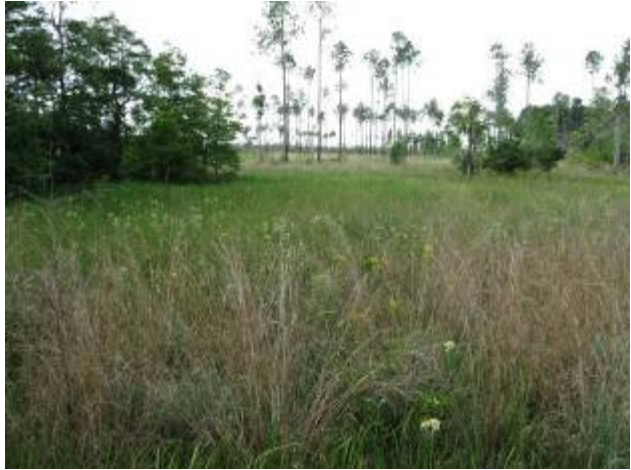
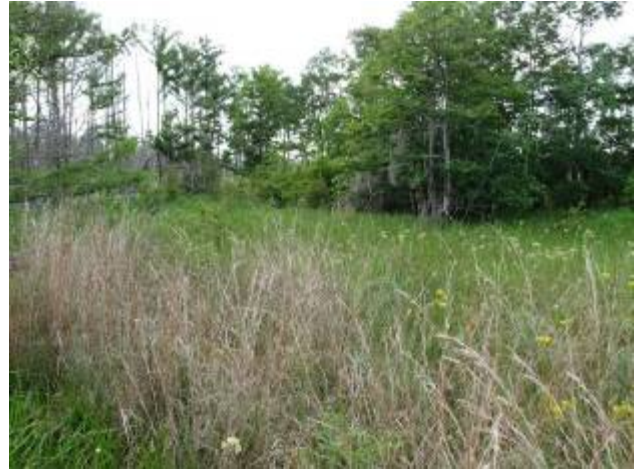
Wetland ID: 10D-13

Description: This wetland is a 0.7 ha ephemeral marsh. Cypress trees dominate the canopy, and cover 5-25% of the wetland basin. There is no midstory layer. A diverse array of sedges/grasses grows throughout the wetland, and covers >75% of the basin. The wetland has minor feral hog damage. A recent fire burned through the wetland. This marsh is in fire-maintenance condition and is a potential striped newt breeding pond. The adjacent uplands are mesic and scrubby flatwoods managed with growing season prescribed fires.

Wetland Concerns: Feral hog damage

Restoration Action Recommended: Because of the widespread damage to ephemeral wetlands on CWMA, we recommend aggressive action to reduce the overall numbers of feral hogs on the property.

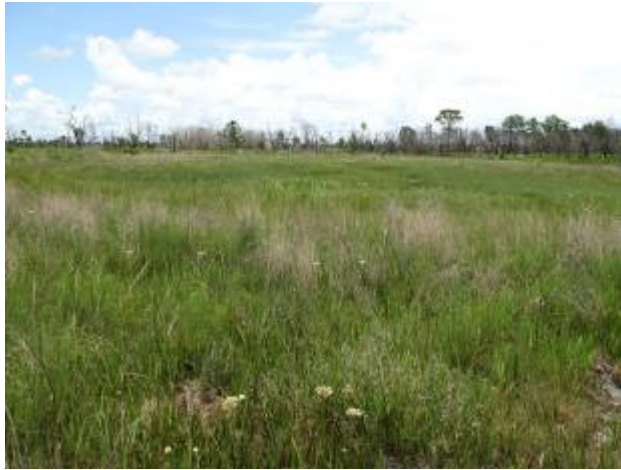
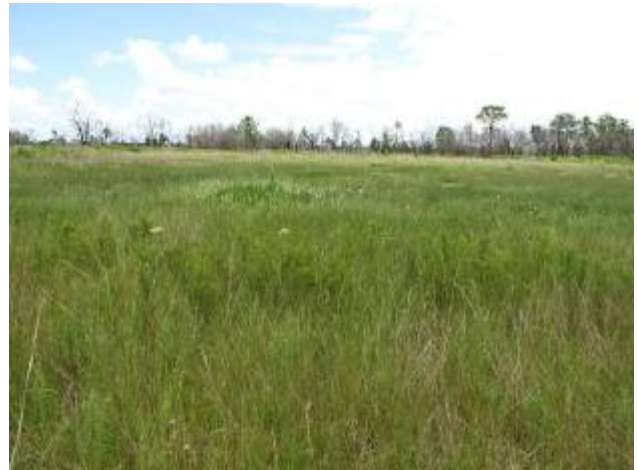
Wetland ID: 13D-01

Description: This wetland is a 1.1 ha ephemeral marsh. There is no midstory or canopy cover. A diverse array of sedges/grasses grows throughout the wetland, and covers >75% of the basin. The wetland has minor feral hog damage. This marsh is in fire-maintenance condition and is a potential striped newt breeding pond. The adjacent uplands are xeric hammock and currently are managed with prescribed fire.

Wetland Concerns: Feral hog damage

Restoration Action Recommended: Because of the widespread damage to ephemeral wetlands on CWMA, we recommend aggressive action to reduce the overall numbers of feral hogs on the property.

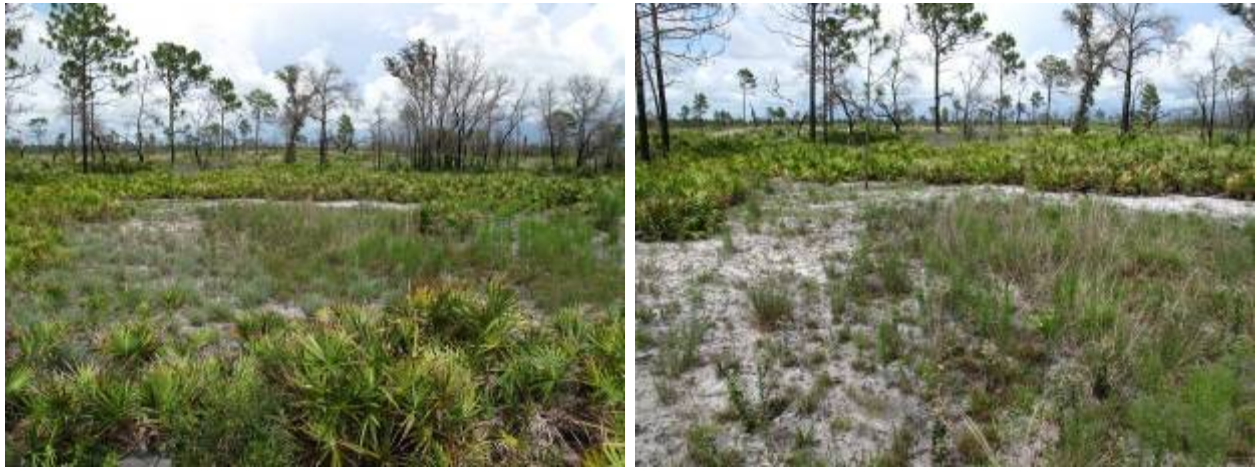
Wetland ID: 13D-02

Description: This wetland is a 0.1 ha ephemeral marsh. There is no midstory or canopy cover. Sedges/grasses are distributed throughout the wetland, and cover 50-75% of the basin. This marsh is in fire-maintenance condition. The adjacent uplands are scrubby flatwoods with a thick ring of low palmetto encircling the wetland. The uplands currently are managed with prescribed fire.

Wetland Concerns: None

Restoration Action Recommended: None

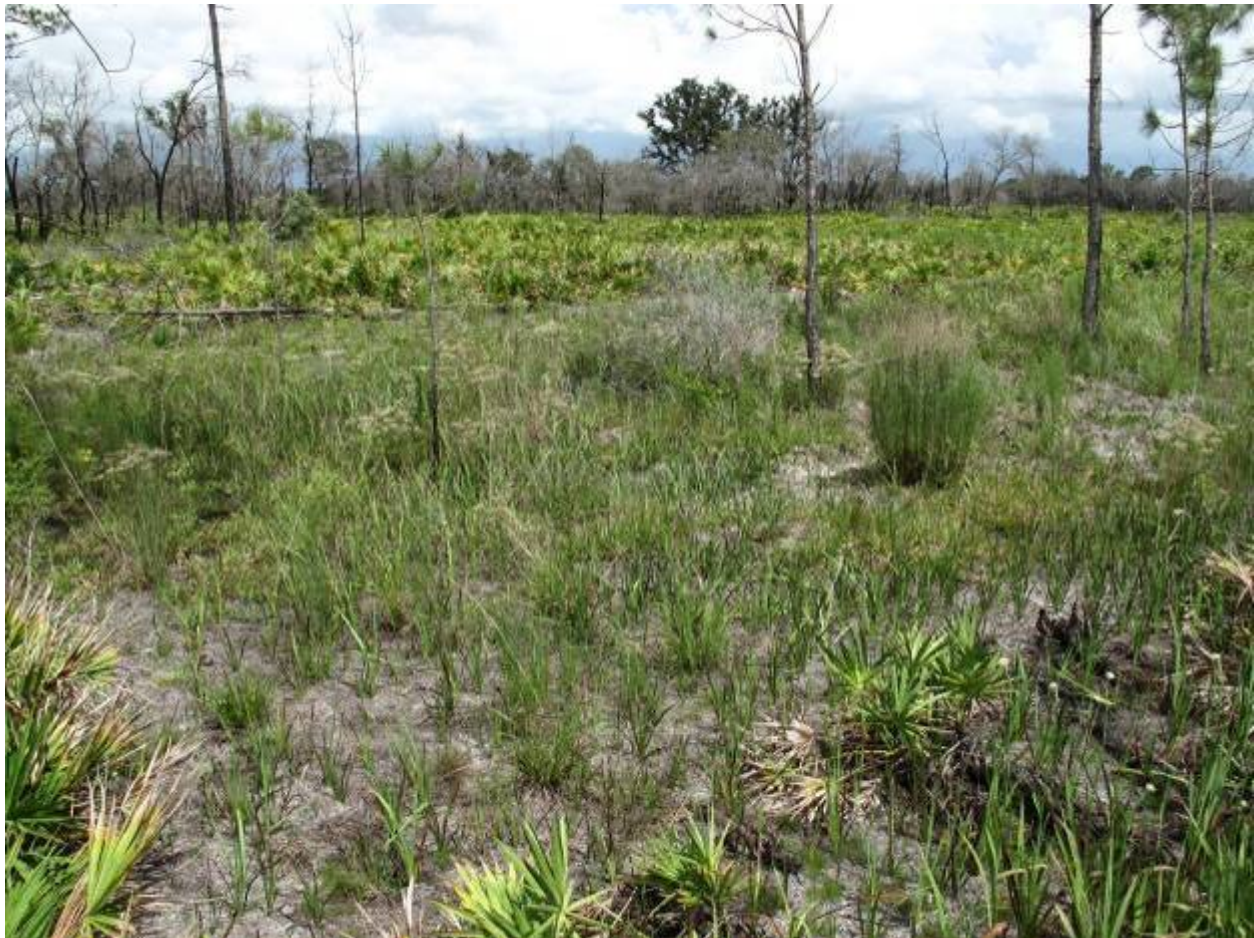
Wetland ID: 13D-03

Description: This wetland is a <0.1 ha ephemeral marsh. Pine trees dominate the canopy, and cover 5-25% of the wetland. There is no midstory. Sedge/grasses and redroot grow throughout the wetland, and cover >75% of the basin. The wetland has minor feral hog damage. A fireline runs through the uplands on the west side of the wetland. This marsh is in fire-maintenance condition. The adjacent uplands are scrubby flatwoods and currently are managed with prescribed fire.

Wetland Concerns: Feral hog damage

Restoration Action Recommended: Because of the widespread damage to ephemeral wetlands on CWMA, we recommend aggressive action to reduce the overall numbers of feral hogs on the property.

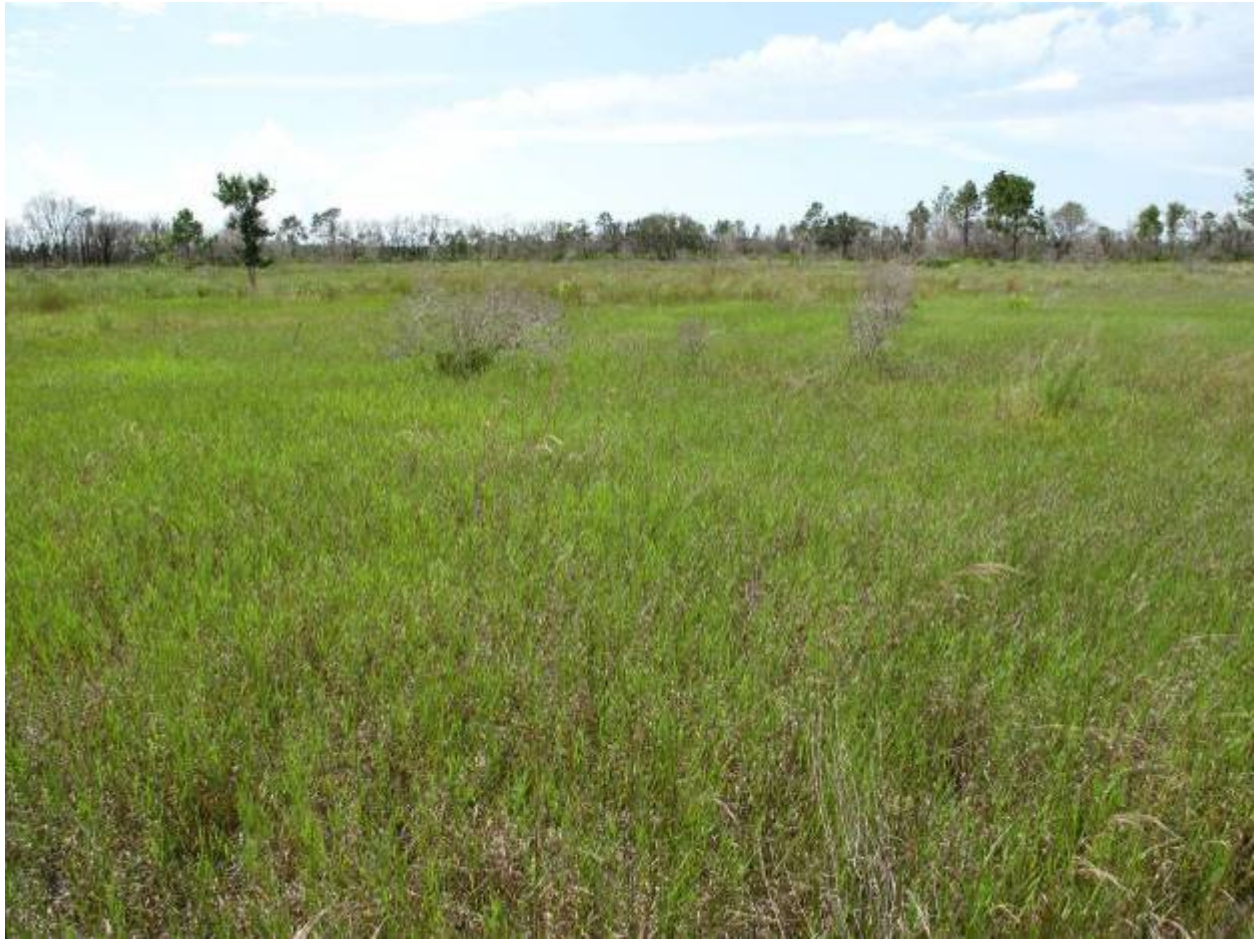
Wetland ID: 13D-04

Description: This wetland is a 6.8 ha ephemeral marsh. There is no midstory or canopy cover. Maidencane grows throughout the wetland, and covers >75% of the basin. This large basin marsh has a few deep pot holes and is a potential striped newt breeding pond. This wetland is in fire-maintenance condition. The adjacent uplands are scrubby flatwoods and currently are managed with prescribed fire.

Wetland Concerns: None

Restoration Action Recommended: None

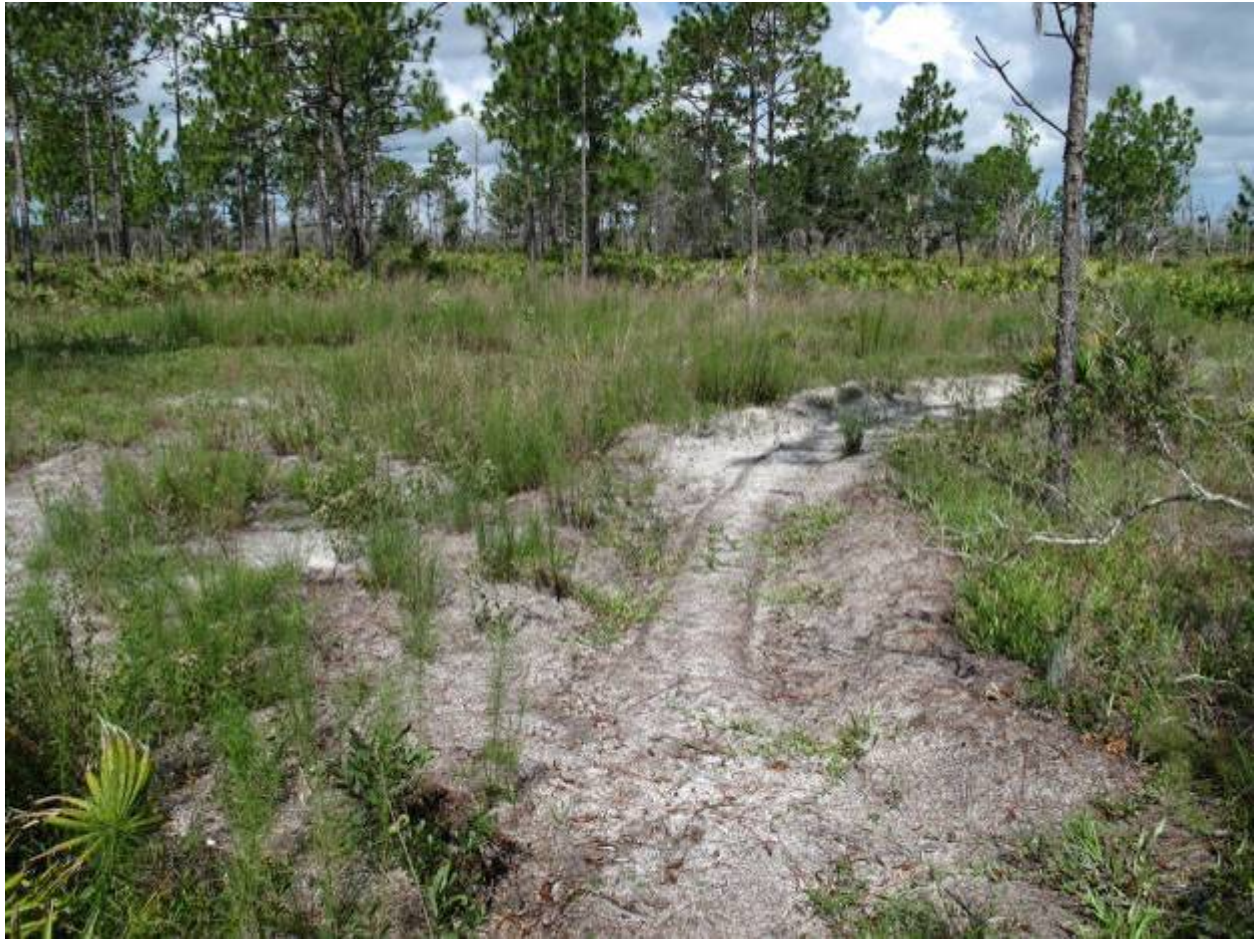
Wetland ID: 13D-05

Description: This wetland is a 0.1 ha ephemeral marsh. There is no midstory or canopy cover. Sedges/grasses grow throughout the wetland, and cover >75% of the basin. A fireline bisects the center of the depression marsh. This marsh is in fire-maintenance condition and is a potential striped newt breeding pond. The adjacent uplands are sandhills and currently are managed with prescribed fire.

Wetland Concerns: Fireline

Restoration Action Recommended: The fireline/MU boundary should be re-routed away from the wetland. If the fireline cannot be re-routed, monitor the wetland to ensure fire is not excluded. Maintain the fireline when the wetland is completely dry to prevent ruts from developing.

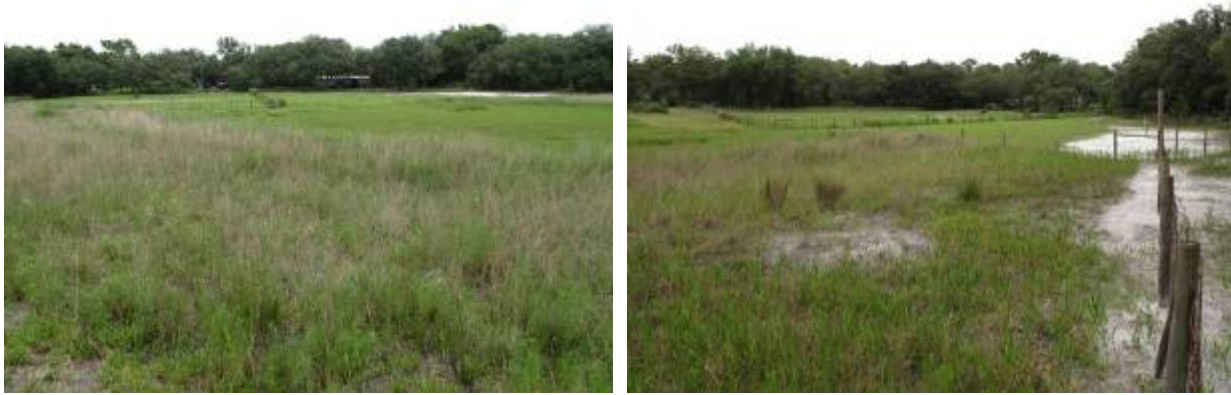
Wetland ID: 01E-01

Description: This wetland is a 1.7 ha ephemeral marsh. There is no canopy or midstory cover. Maidencane and sedges/grasses grow throughout the wetland, and cover >75% of the basin. This wetland is bisected by a property line. The east side is private property and has been dug out. The wetland is located on an urban/wildland interface. A housing development is located to the east; the remaining uplands are xeric hammock.

Wetland Concerns: Dug out, Upland condition

Restoration Action Recommended: None, the WMA portion of this wetland is in good ecological condition.

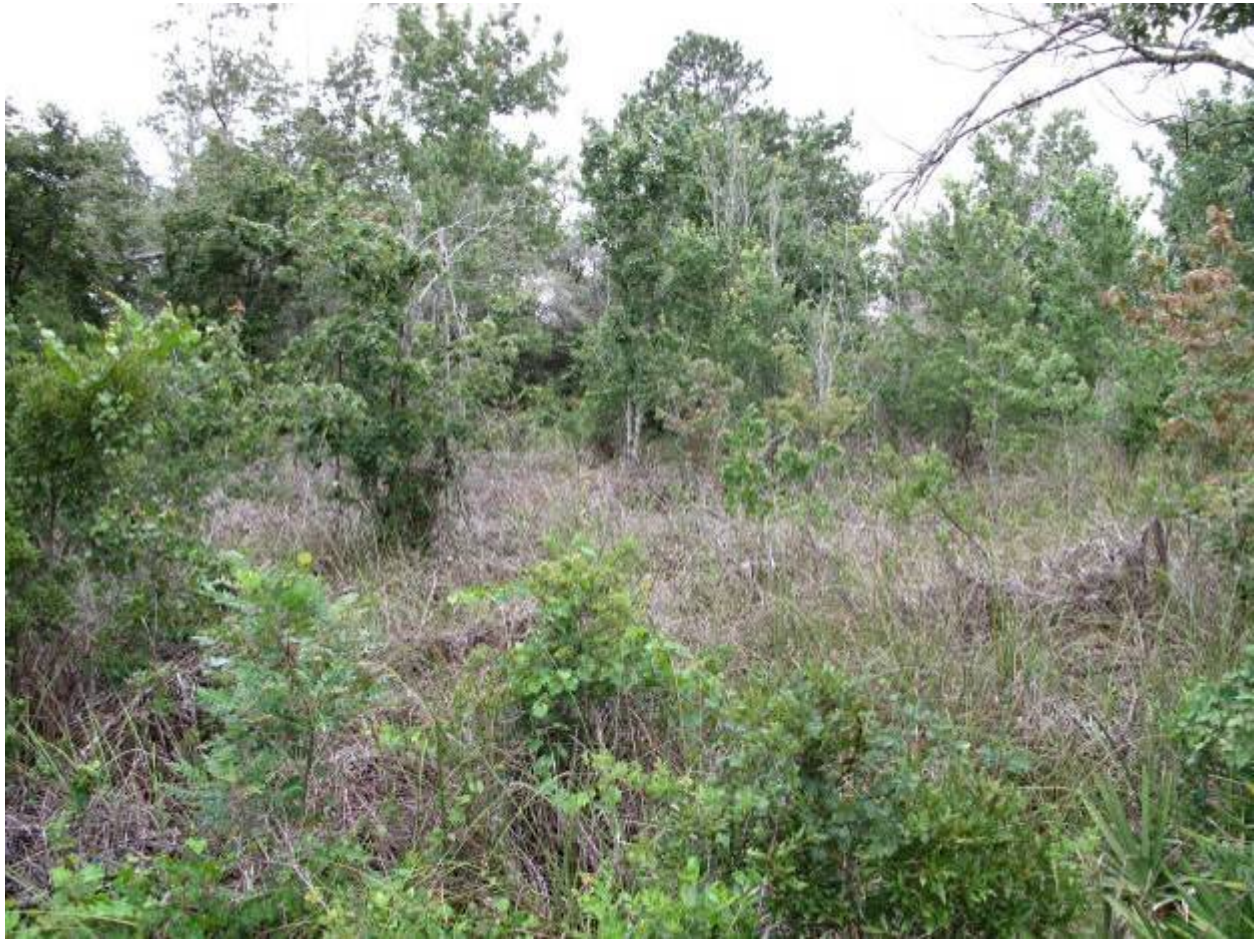
Wetland ID: 02E-01

Description: This wetland is a 0.4 ha ephemeral shrub swamp. Maple trees dominate the canopy, and cover 25-50% of the wetland. The midstory is dominated by wax myrtle and young maple and loblolly bay trees, and covers 50-75% of the wetland. Sawgrass grows throughout the wetland, and cover 50-75% of the basin. This wetland appears to be a fire-excluded marsh succeeded to a shrub swamp. The adjacent uplands are xeric hammock.

Wetland Concerns: Woody encroachment

Restoration Action Recommended: Encourage periodic fire in the wetland to reduce encroachment of woody vegetation.

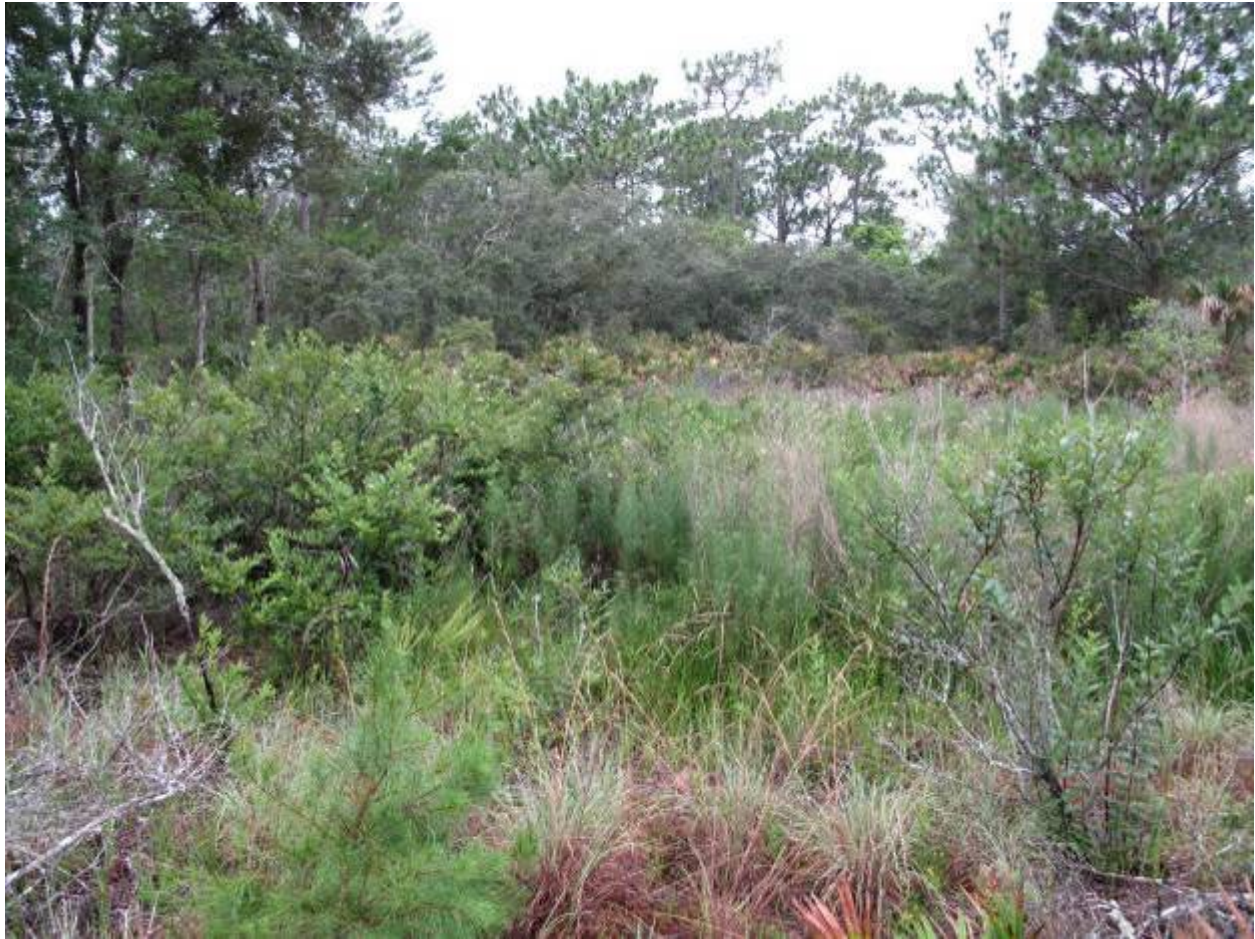
Wetland ID: 02E-02

Description: This wetland is a 0.1 ha ephemeral marsh. There is no tree canopy. Buttonbush grows in a deeper sinkhole within the wetland, and covers 5-25% of the wetland. Sedges/grasses grow throughout the wetland, and cover >75% of the basin. The wetland has minor feral hog rooting around the edges that has now filled in with vegetation. The adjacent uplands are sandhill.

Wetland Concerns: Feral hog damage

Restoration Action Recommended: Because of the widespread damage to ephemeral wetlands on CWMA, we recommend aggressive action to reduce the overall numbers of feral hogs on the property.

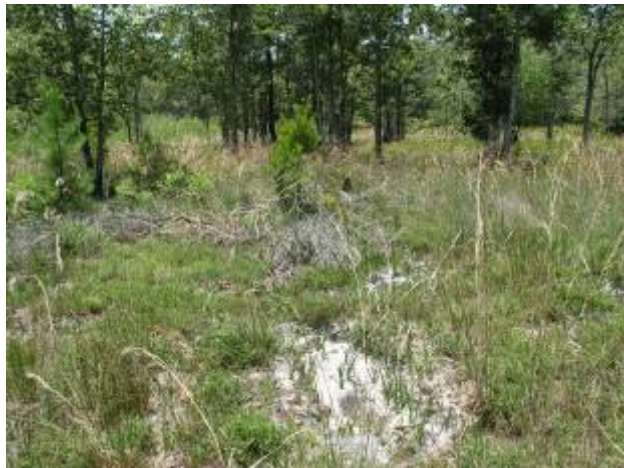
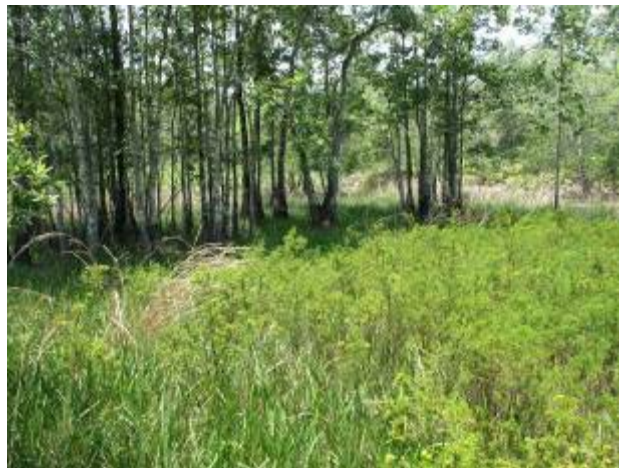
Wetland ID: 04E-01

Description: This wetland is a 0.2 ha ephemeral marsh. Gum trees grow in the deepest part of the wetland interior, and cover 25-50% of the basin. *Hypericum* covers 5-25% of the wetland. Redroot and sedges/grasses grow throughout the wetland, and cover >75% of the basin. Both old and new feral hog damage is evident in the wetland. The new hog damage is minor. The adjacent uplands are fire-suppressed mesic flatwoods. Palmetto grows in a thick ring around the wetland. The uplands currently are managed with herbicide.

Wetland Concerns: Feral hog damage

Restoration Action Recommended: Because of the widespread damage to ephemeral wetlands on CWMA, we recommend aggressive action to reduce the overall numbers of feral hogs on the property.
