Inventory, Assessment, and Restoration Potential of Ephemeral Wetlands on FFWCC Wildlife Management Areas

Chassahowitzka WMA Final Report

Submitted by: Rebecca P.M. Means¹, Ryan C. Means¹, Steven A. Johnson²

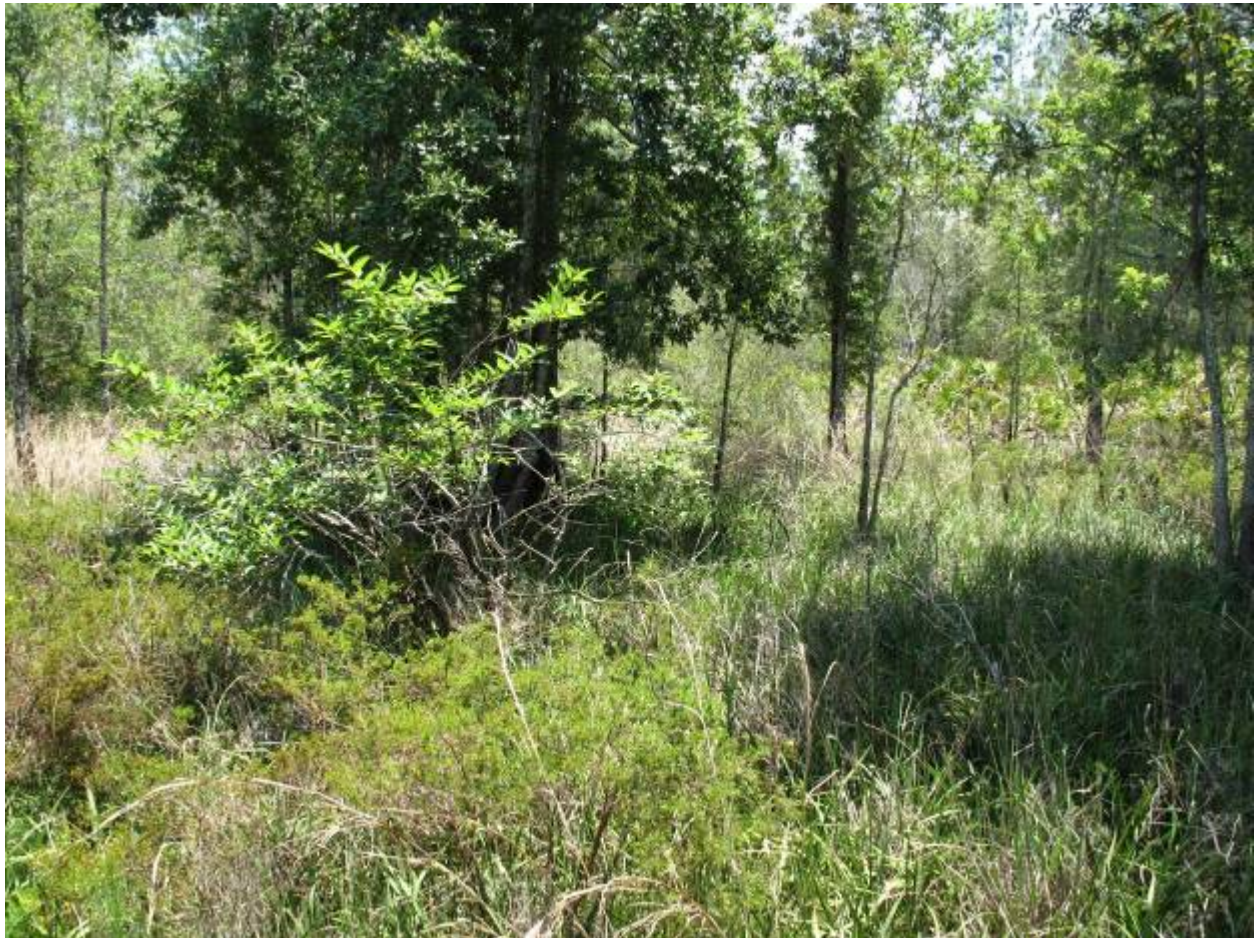
Wetland ID: 04E-02

Description: This wetland is a 0.2 ha ephemeral marsh. Gum trees dominate the canopy, and cover 5-25% of the wetland. The midstory is dominated by *Hypericum* and buttonbush, and covers 5-25% of the wetland. Redroot and sedges/grasses grow throughout the wetland, and cover >75% of the basin. This wetland is beginning to show signs of fire suppression with patches of thick woody shrubs. The adjacent uplands are fire-suppressed sandhills. Palmetto grows in a thick ring around the wetland. The uplands currently are managed with herbicide.

Wetland Concerns: Woody encroachment

Restoration Action Recommended: Encourage periodic fire in the wetland to reduce the patches of dense brush.

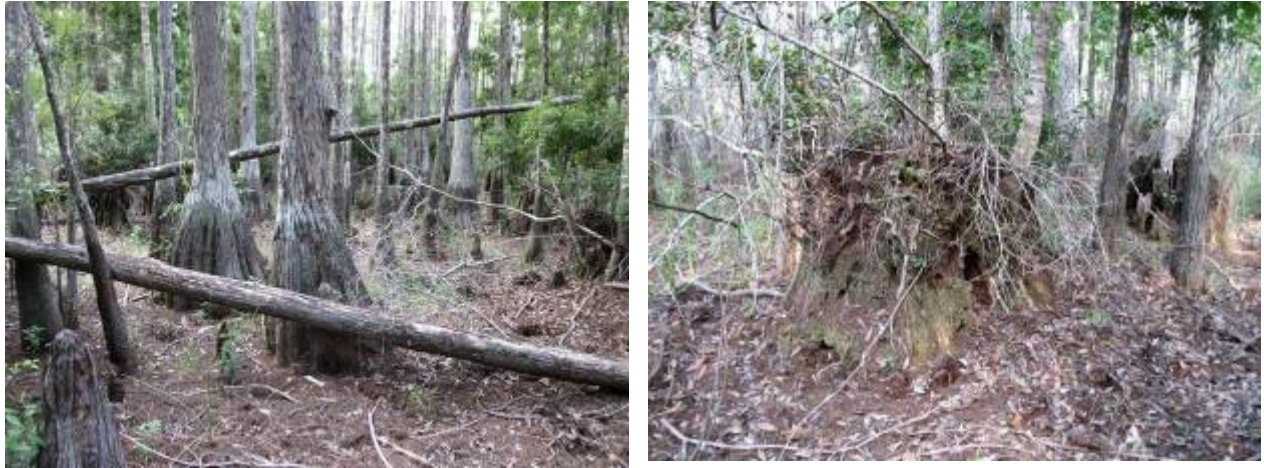
Wetland ID: 04E-03

Description: This wetland is a 1.5 ha ephemeral forested swamp. Cypress trees dominate the canopy, and cover >75% of the wetland. The midstory is dominated by wax myrtle and buttonbush, and covers 25-50% of the wetland. Sawgrass and other herbaceous vegetation grow in scattered patches, and cover 5-25% of the wetland basin. This wetland was logged years ago and shrubs now grow on stump hummocks in the wetland. Thick needle duff covers the wetland floor. The adjacent uplands are fire-suppressed mesic flatwoods and xeric hammock and currently are managed with herbicide.

Wetland Concerns: None

Restoration Action Recommended: None

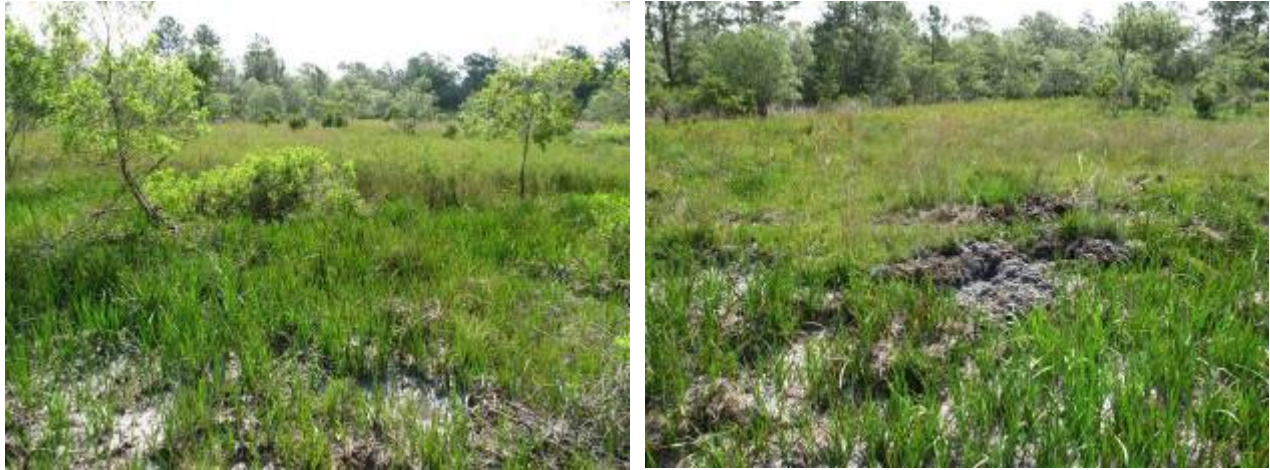
Wetland ID: 04E-04

Description: This wetland is a 0.6 ha ephemeral marsh. There is no tree canopy. *Hypericum* covers 5-25% of the wetland. Sedges/grasses and redroot grow throughout the wetland, and cover >75% of the basin. Old and new feral hog damage is evident in the wetland. The new damage is moderate to bad in spots and is recovering in other spots. This marsh is in fire-maintenance condition and is a potential striped newt breeding pond. The adjacent uplands are fire-suppressed sandhill and xeric hammock with a dense palmetto ring surrounding the wetland. The uplands currently are managed with herbicide.

Wetland Concerns: Feral hog damage

Restoration Action Recommended: Because of the widespread damage to ephemeral wetlands on CWMA, we recommend aggressive action to reduce the overall numbers of feral hogs on the property.

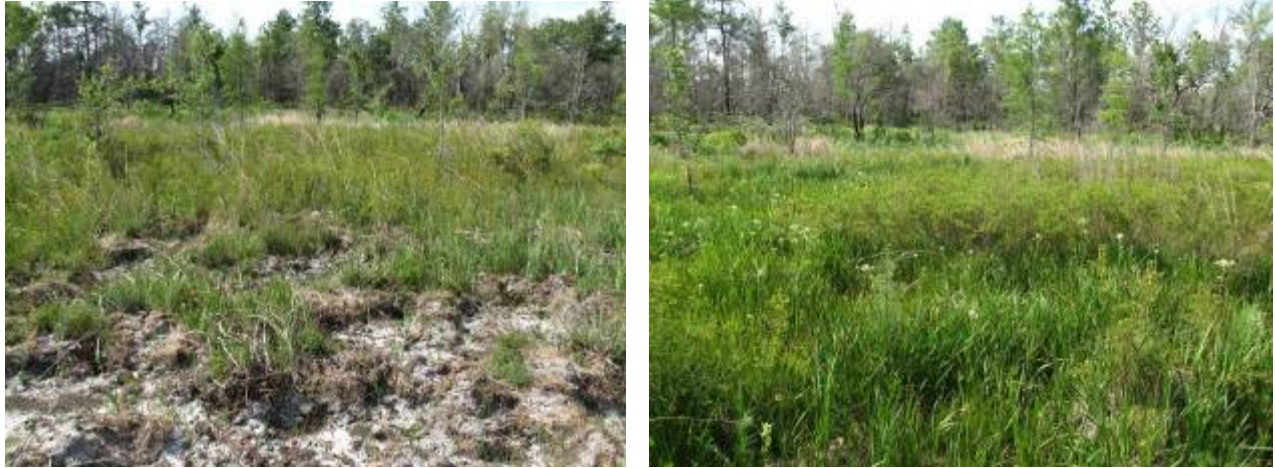
Wetland ID: 04E-05

Description: This wetland is a 0.3 ha ephemeral marsh. There is no tree canopy. *Hypericum* covers 25-50% of the wetland. Sedges/grasses and redroot grow throughout the wetland, and cover >75% of the basin. Feral hogs have created deep rootings in places. This marsh is in fire-maintenance condition and is a potential striped newt breeding pond. The adjacent uplands are sandhills and were managed with herbicide. A growing season wildfire burned in 2008 killing most of the oaks.

Wetland Concerns: Feral hog damage

Restoration Action Recommended: Because of the widespread damage to ephemeral wetlands on CWMA, we recommend aggressive action to reduce the overall numbers of feral hogs on the property.

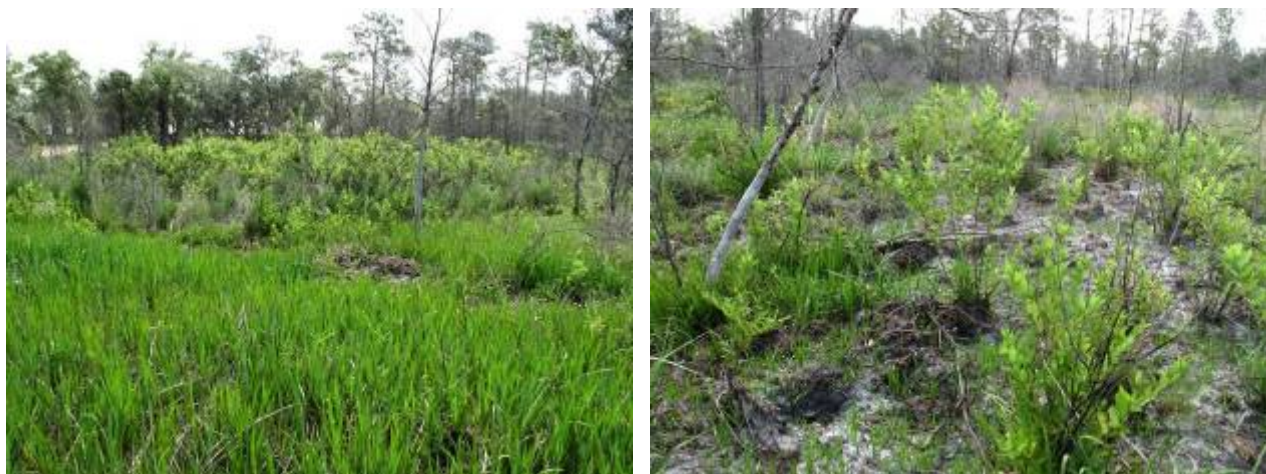
Wetland ID: 04E-06

Description: This wetland is a 0.2 ha ephemeral marsh. There is no tree canopy. Buttonbush covers 25-50% of the wetland. Most of the buttonbush is established in a deeper section of the wetland in a natural fire shadow. However, many buttonbushes have established throughout the basin as a result of a prolonged dry period and fire absence in the wetland. Sedges/grasses and redroot grow throughout the wetland, and cover >75% of the basin. There is extensive feral hog damage in the south half of the wetland and around the wetland edge. The adjacent uplands are sandhills and were managed with herbicide. A growing season wildfire burned in 2008 killing most of the oaks. Selective logging occurred around the wetland.

Wetland Concerns: Feral hog damage, Woody encroachment

Restoration Action Recommended: Because of the widespread damage to ephemeral wetlands on CWMA, we recommend aggressive action to reduce the overall numbers of feral hogs on the property. Encourage fire to prevent further encroachment of buttonbush.

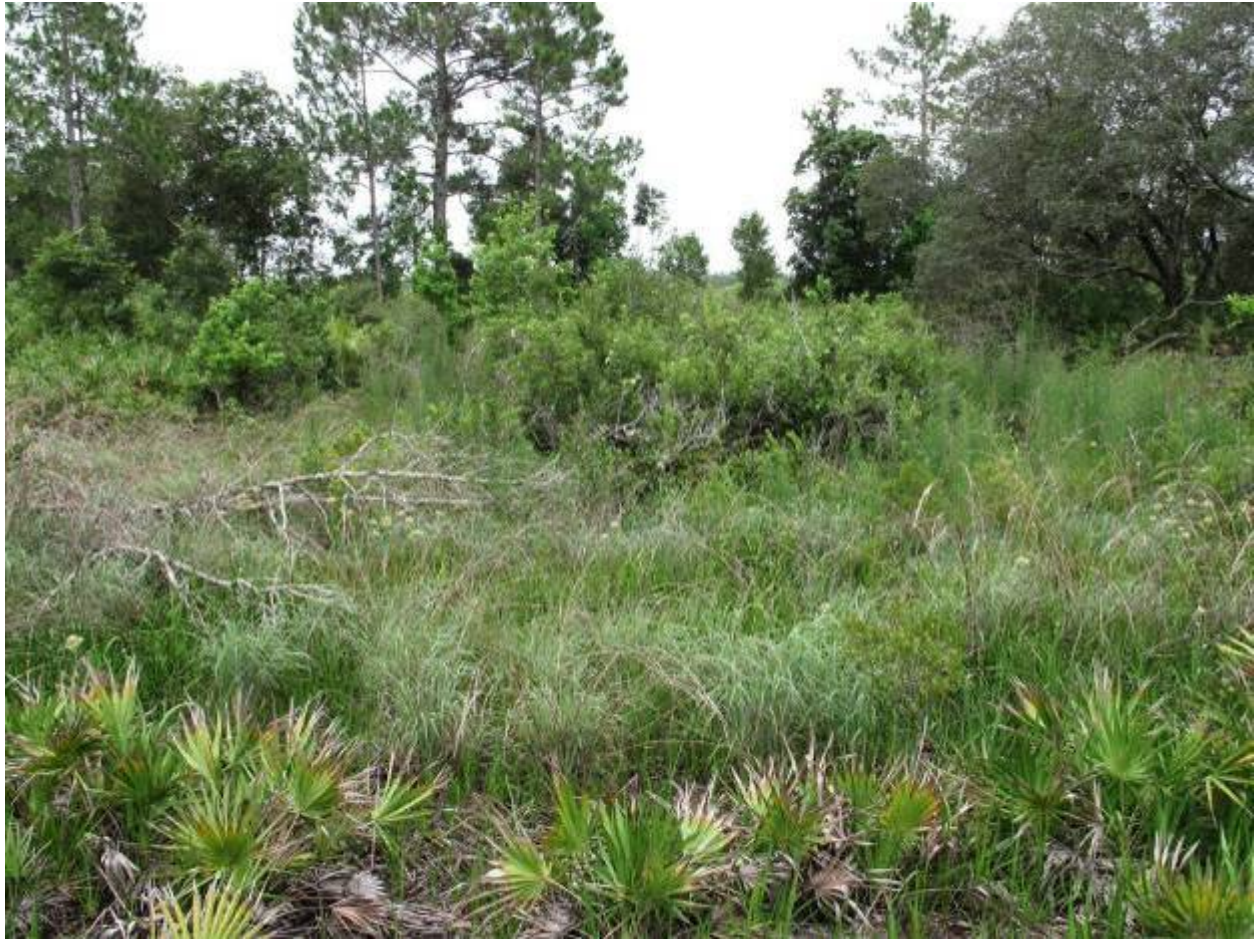
Wetland ID: 04E-07

Description: This wetland is a <0.1 ha ephemeral marsh. There is no tree canopy. Buttonbush grows in the deepest portion of the wetland, and covers 5-25% of the wetland. Sedges/grasses grow throughout the wetland, and cover >75% of the basin. The wetland has old feral hog damage that has grown over with vegetation. The edges of this circular, depressional marsh were mowed to reduce the palmetto ring. The adjacent uplands are xeric hammock and were managed with herbicide. A growing season wildfire burned in 2008.

Wetland Concerns: Feral hog damage

Restoration Action Recommended: Because of the widespread damage to ephemeral wetlands on CWMA, we recommend aggressive action to reduce the overall numbers of feral hogs on the property.

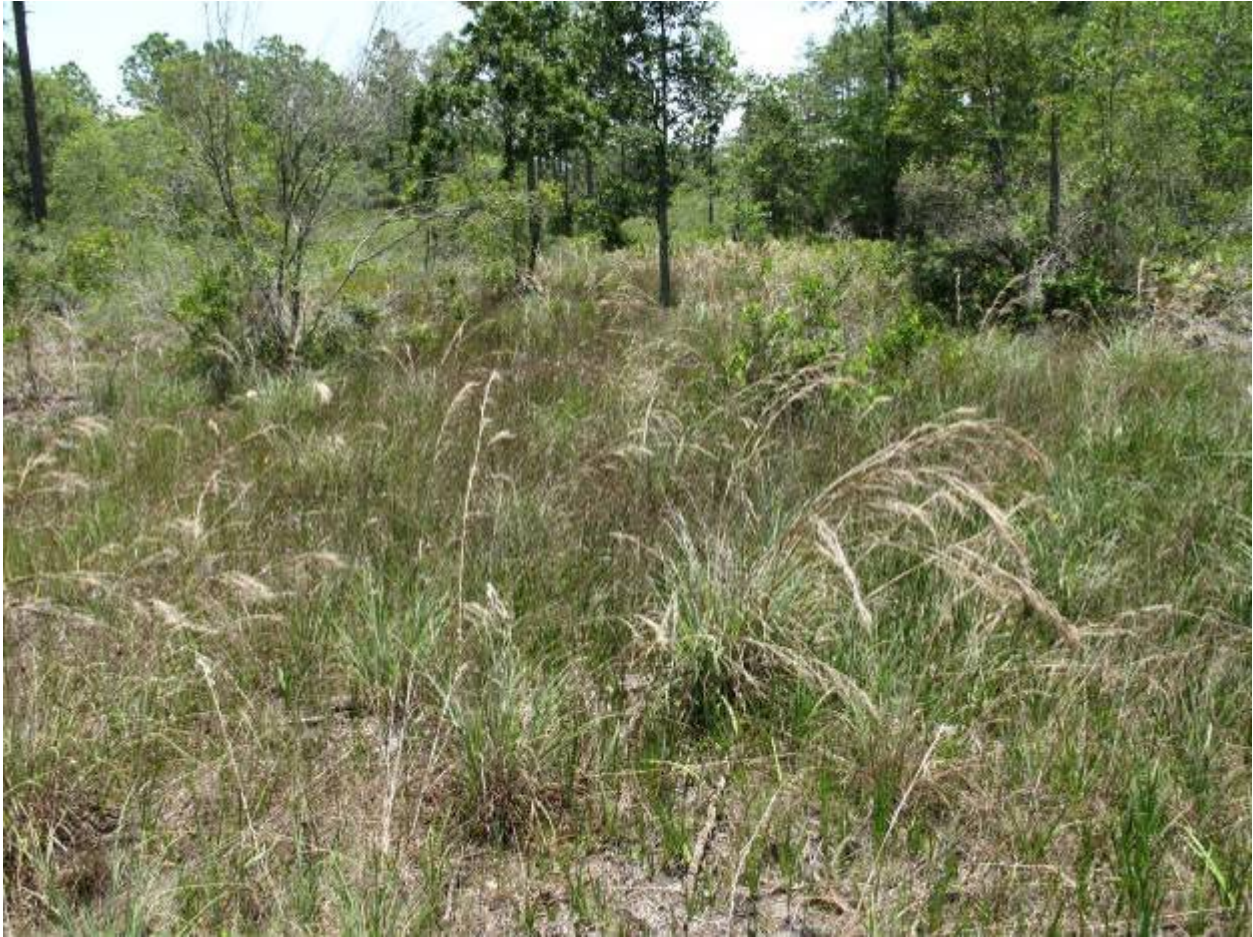
Wetland ID: 05E-01

Description: This wetland is a 0.1 ha ephemeral marsh. There is no canopy or midstory cover. Sedges/grasses grow throughout the wetland, and cover >75% of the basin. Herbaceous vegetation is growing over old feral hog damage. The wetland basin has diverse herbaceous vegetation and is in good ecological condition. There is thick brush in the upland margin. The adjacent uplands are fire-suppressed mesic flatwoods and currently are managed with herbicide and mechanical vegetation removal.

Wetland Concerns: Feral hog damage

Restoration Action Recommended: Because of the widespread damage to ephemeral wetlands on CWMA, we recommend aggressive action to reduce the overall numbers of feral hogs on the property. This MU is just north of a suburban landscape and therefore the wetland may develop issues associated with fire suppression and exotic species. The wetland could be monitored to ensure exotic species, and the encroachment of woody vegetation, do not become an issue.

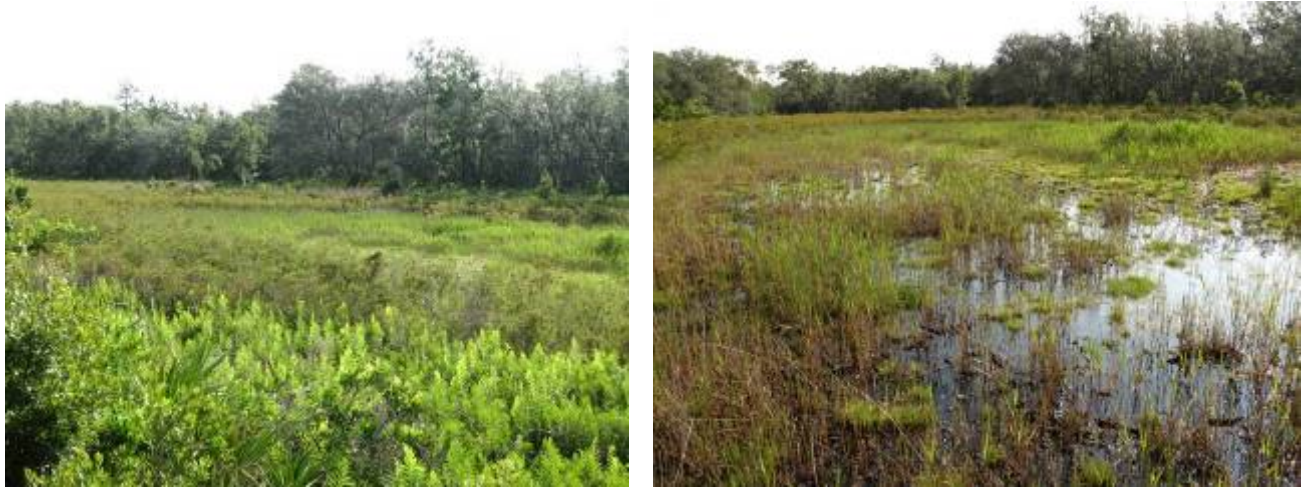
Wetland ID: 05E-02

Description: This wetland is a 0.8 ha ephemeral marsh. There is no tree canopy. *Hypericum* covers 5-25% of the wetland. Sedges/grasses and maidencane grow throughout the wetland, and cover >75% of the basin. Old feral hog damage is recovering; new hog damage is minor. This marsh is in fire-maintenance condition and is a potential striped newt breeding pond. The adjacent uplands are fire-suppressed xeric hammock and currently are managed with herbicide and mechanical vegetation removal.

Wetland Concerns: Feral hog damage

Restoration Action Recommended: Because of the widespread damage to ephemeral wetlands on CWMA, we recommend aggressive action to reduce the overall numbers of feral hogs on the property. This MU is just north of a suburban landscape and therefore the wetland may develop issues associated with fire suppression and exotic species. The wetland could be monitored to ensure exotic species, and encroachment of woody vegetation, do not become an issue.

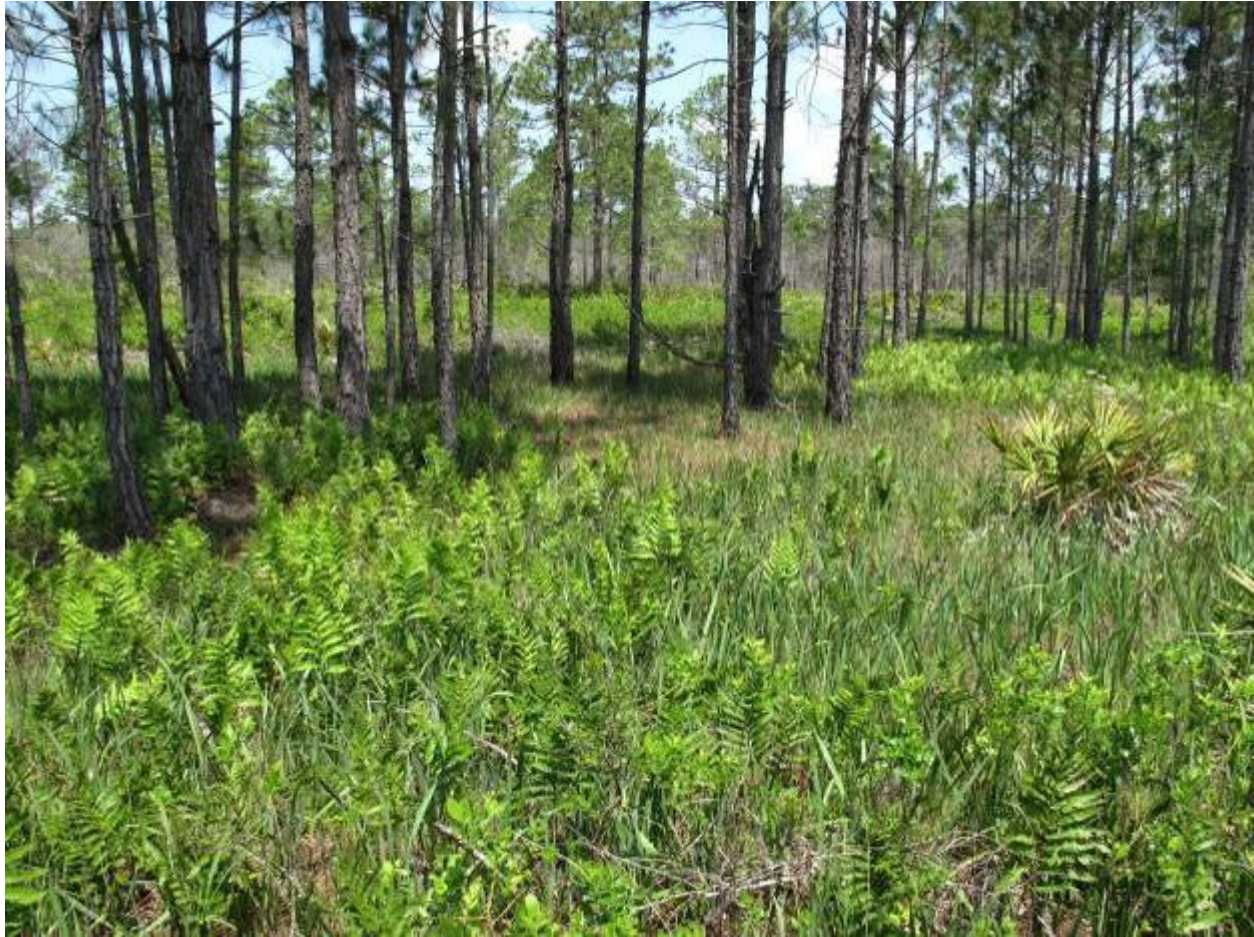
Wetland ID: 06E-01

Description: This wetland is a 0.2 ha highly ephemeral marsh. A stand of slash pine trees grows in the wetland, and covers 50-75% of the wetland. There is no midstory cover. Fern and redroot are distributed throughout the wetland, and cover 50-75% of the basin. Feral hogs severely rooted the wetland basin but the vegetation has recovered. The adjacent uplands are mesic flatwoods and currently are managed with mechanical treatments.

Wetland Concerns: Feral hog damage, Woody encroachment

Restoration Action Recommended: Because of the widespread damage to ephemeral wetlands on CWMA, we recommend aggressive action to reduce the overall numbers of feral hogs on the property. Remove pine trees from the wetland interior. This MU is just north of a suburban landscape and therefore the wetland may develop issues associated with fire suppression and exotic species. The wetland could be monitored to ensure exotic species, and the encroachment of woody vegetation, do not become an issue.

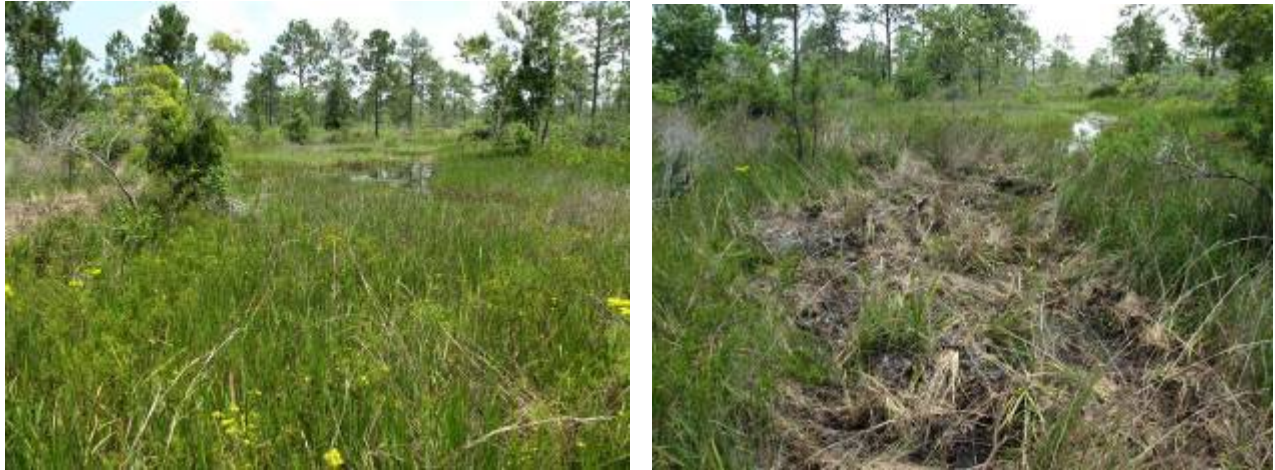
Wetland ID: 06E-02

Description: This wetland is a 0.3 ha ephemeral marsh. There is no canopy or midstory cover. Sedges/grasses and maidencane grow throughout the wetland, and cover >75% of the basin. Feral hog damage is minor. The adjacent uplands are fire-suppressed mesic flatwoods and currently are managed with mechanical treatments.

Wetland Concerns: Feral hog damage

Restoration Action Recommended: Because of the widespread damage to ephemeral wetlands on CWMA, we recommend aggressive action to reduce the overall numbers of feral hogs on the property. This MU is just north of a suburban landscape and therefore may the wetland may develop issues associated with fire suppression and exotic species. The wetland could be monitored to ensure exotic species, and the encroachment of woody vegetation, do not become an issue.

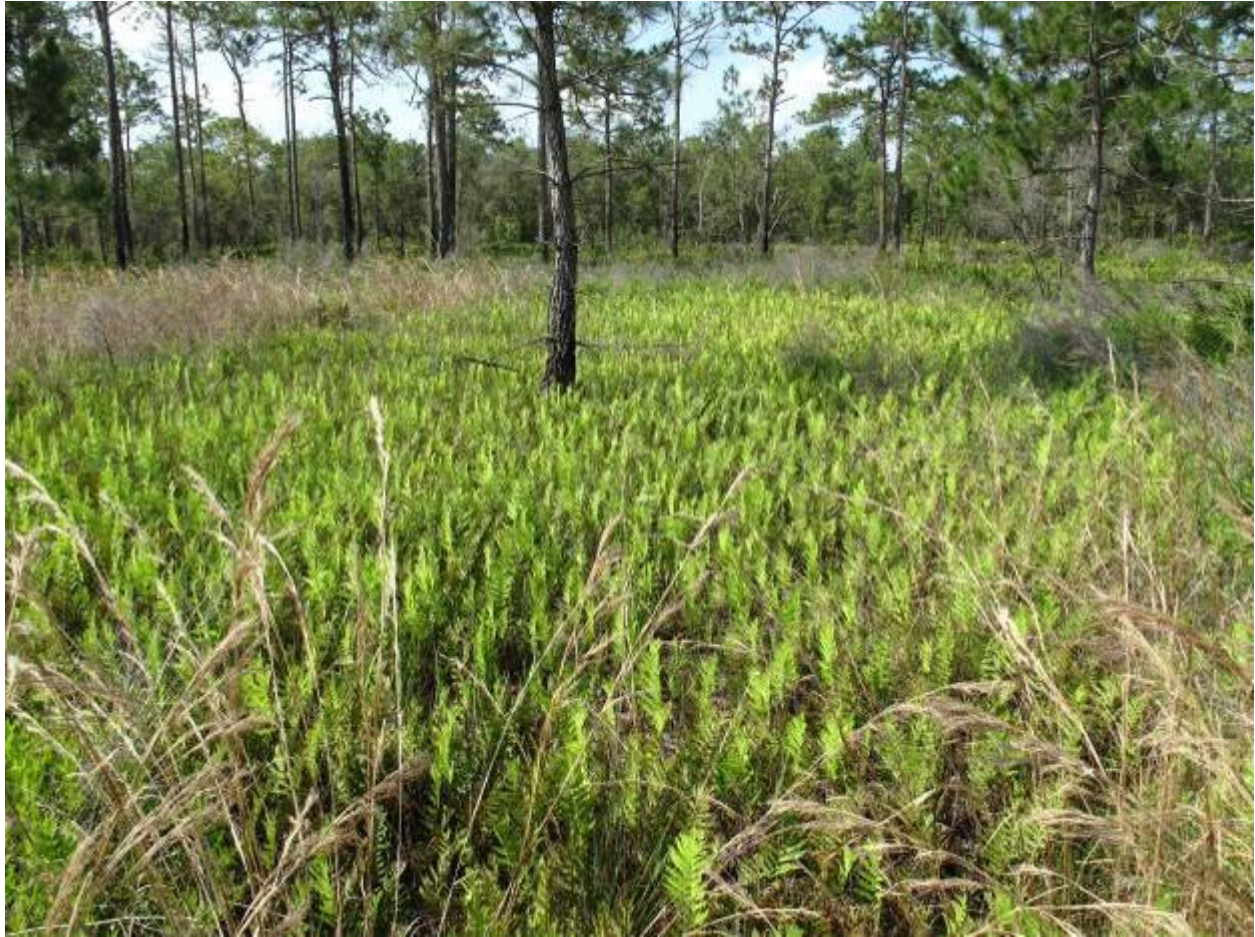
Wetland ID: 07E-01

Description: This wetland is a 0.2 ha ephemeral marsh. There is no canopy or midstory cover. Sedges/grasses, fern, and redroot grow throughout the wetland, and cover >75% of the basin. Old and new feral hog damage is evident in the wetland. The new hog damage is minor. The adjacent uplands are sandhills. A wildfire burned through this MU in 2008. The uplands directly surrounding this wetland are thick with palmetto and don't appear to have burned.

Wetland Concerns: Feral hog damage

Restoration Action Recommended: Because of the widespread damage to ephemeral wetlands on CWMA, we recommend aggressive action to reduce the overall numbers of feral hogs on the property.

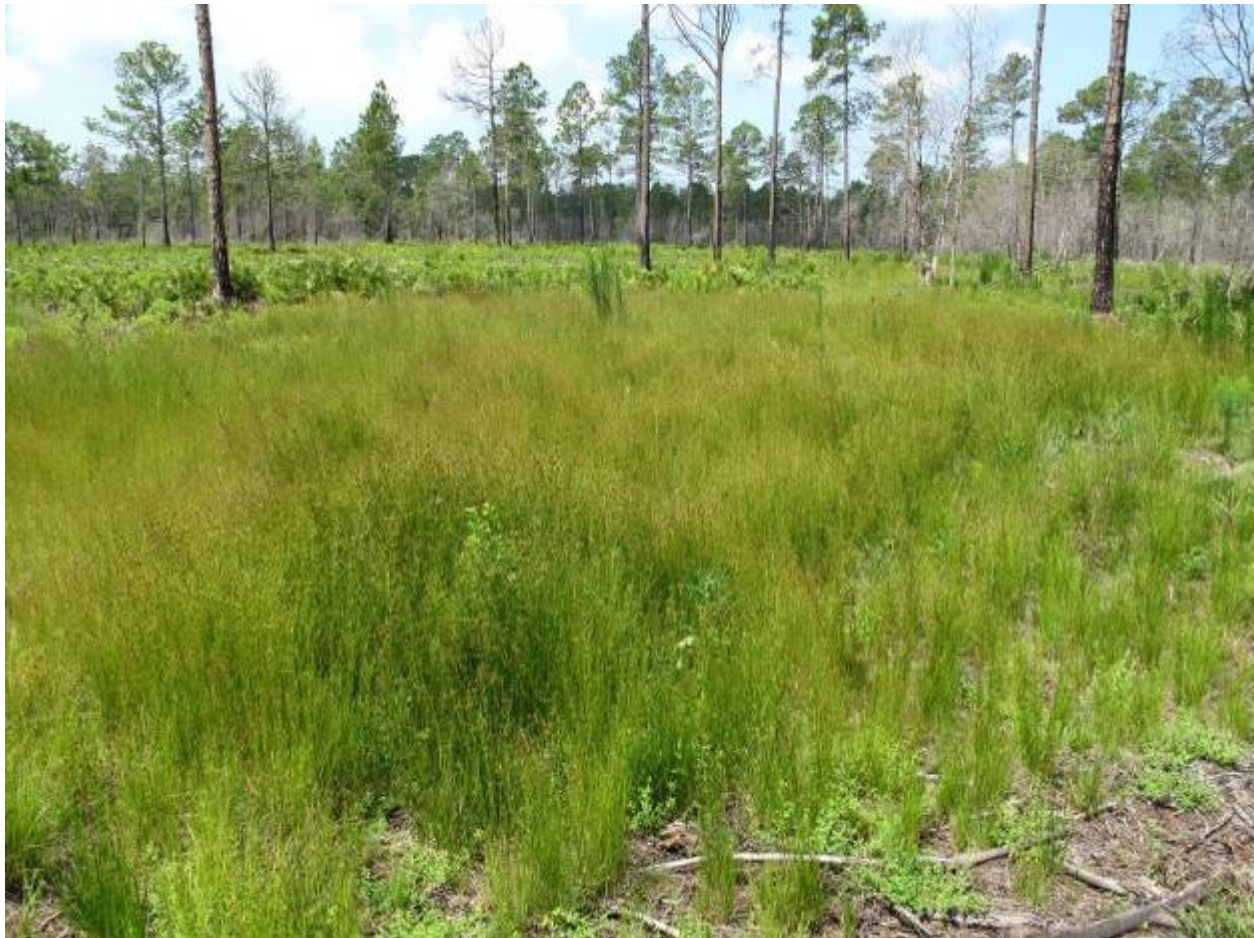
Wetland ID: 07E-02

Description: This wetland is a <0.1 ha ephemeral marsh. There is no canopy or midstory cover. Grasses grow throughout the wetland, and cover >75% of the basin. This wide, open grassy marsh burned recently. The adjacent uplands are mesic flatwoods that burned during a 2008 wildfire. The uplands also are managed with mechanical treatments.

Wetland Concerns: None

Restoration Action Recommended: None

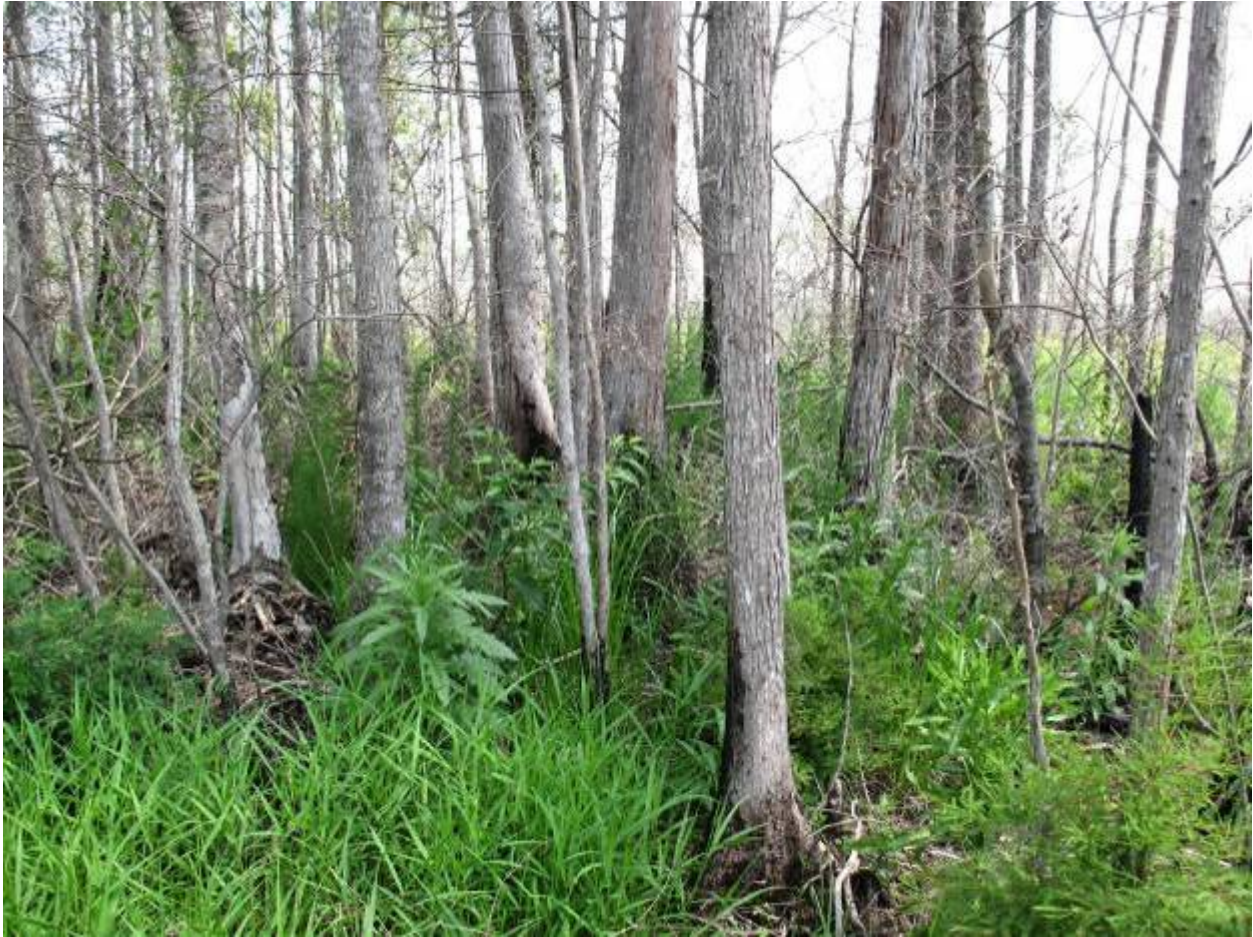
Wetland ID: 07E-03

Description: This wetland is a 0.1 ha ephemeral forested swamp. Cypress trees dominate the canopy, and cover >75% of the wetland. There is no midstory cover. Sawgrass grows in scattered patches, covering 5-25% of the wetland basin. A recent fire burned entirely through the wetland basin, killing the dense shrubs and opening up the midstory. The wetland floor was probably damp during the fire as the peat did not appear to burn. The adjacent uplands are mesic flatwoods that burned during a 2008 wildfire. The uplands also are managed with mechanical treatments.

Wetland Concerns: None

Restoration Action Recommended: None

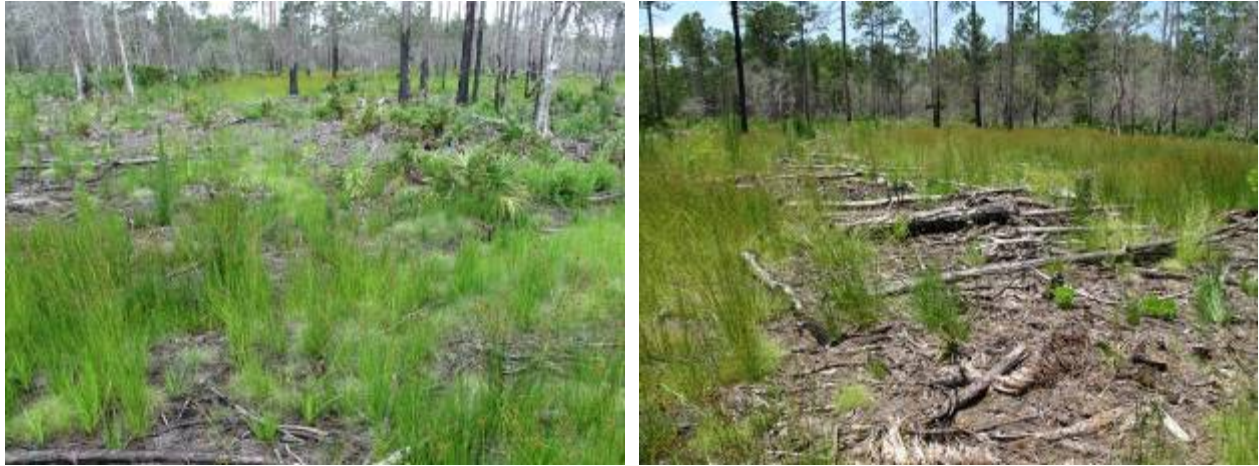
Wetland ID: 07E-04

Description: This wetland is a 0.4 ha highly ephemeral marsh. Large slash pine trees were logged from the wetland. Medium-sized pine trees remain and cover 5-25% of the wetland. There is no midstory cover. Sedges/grasses are distributed throughout the wetland, and cover 50-75% of the basin. A recent fire burned entirely through the wetland basin. There are no vehicular ruts from the recent logging activity but slash was left in the wetland. A MU boundary/fireline bisects the eastern edge of the wetland. The adjacent uplands are mesic flatwoods that burned during a 2008 wildfire. The uplands also are managed with mechanical treatments.

Wetland Concerns: Fireline, Slash, Woody encroachment

Restoration Action Recommended: Remove remaining pine trees from the wetland interior. The slash will likely burn during the next fire. The fireline/MU boundary should be re-routed away from the wetland. If the fireline cannot be re-routed, monitor the wetland to ensure fire is not excluded. Maintain the fireline when the wetland is completely dry to prevent ruts from developing.

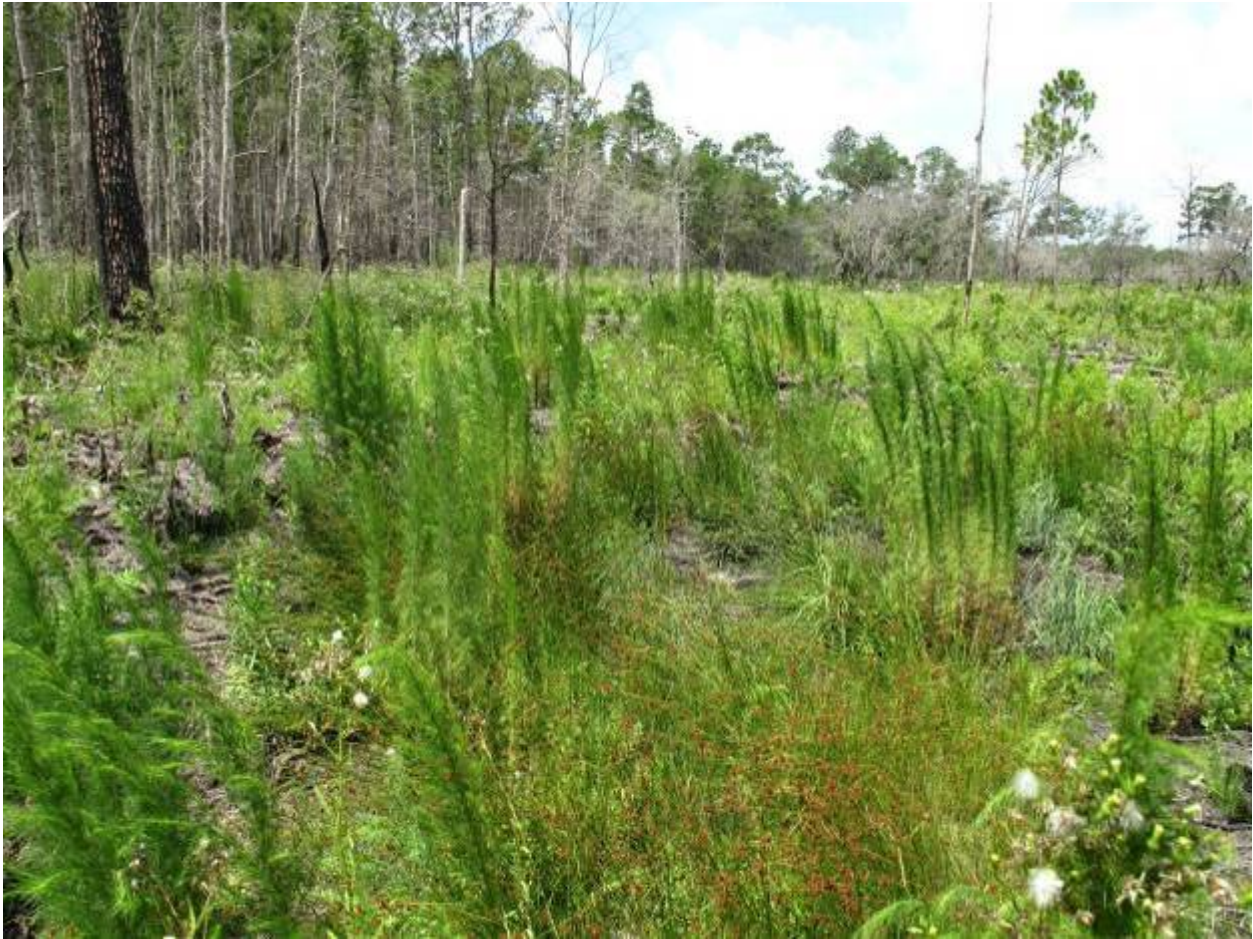
Wetland ID: 07E-05

Description: This wetland is a <0.1 ha ephemeral marsh. There is no canopy or midstory cover. Sedges/grasses grow throughout the wetland, and cover 50-75% of the basin. A recent fire burned entirely through the wetland basin. The wetland has minor feral hog damage. This small marsh is close to the west side of a large swamp/marsh. The adjacent uplands are scrubby flatwoods that burned during a 2008 wildfire. The uplands also are managed with mechanical treatments.

Wetland Concerns: Feral hog damage

Restoration Action Recommended: Because of the widespread damage to ephemeral wetlands on CWMA, we recommend aggressive action to reduce the overall numbers of feral hogs on the property.

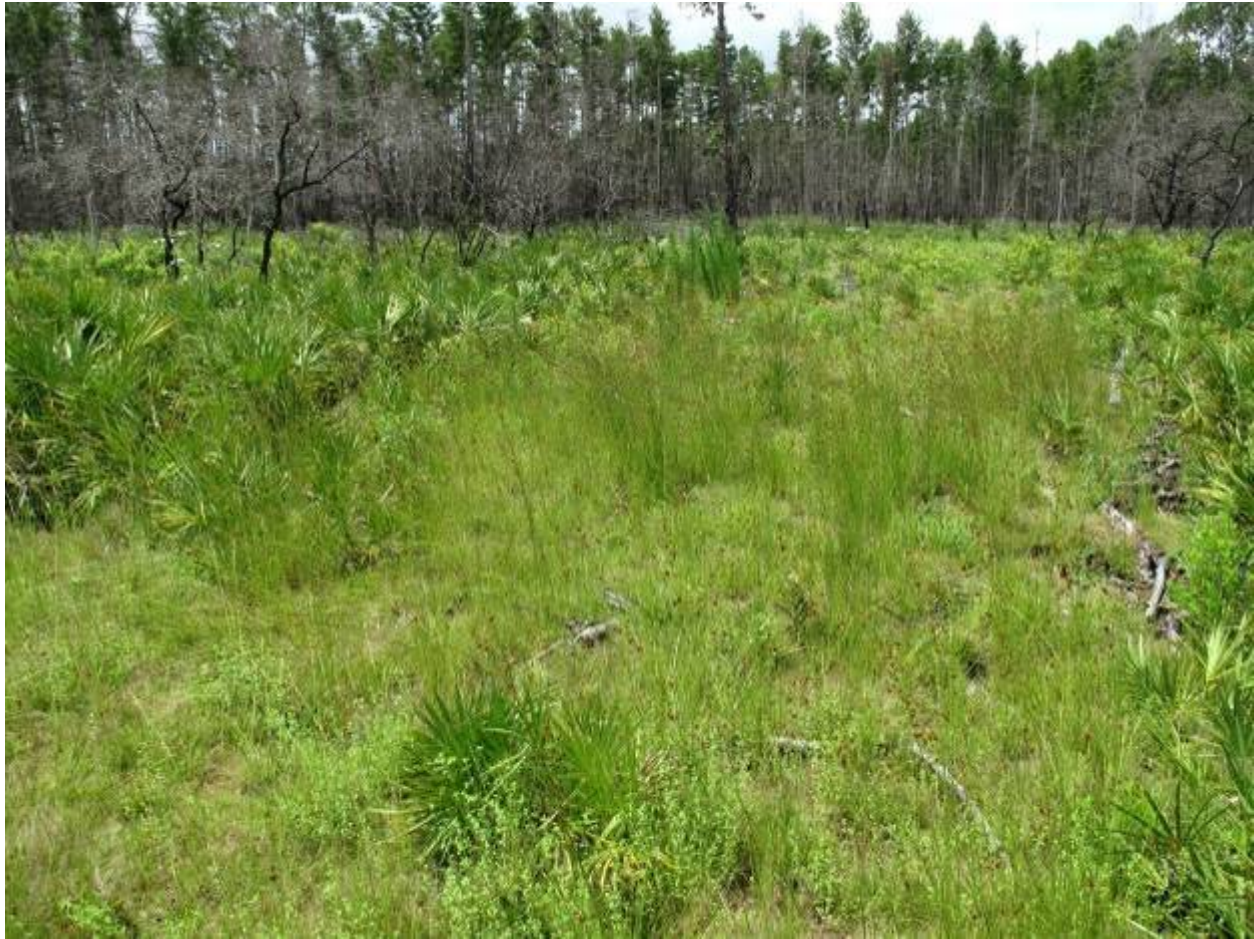
Wetland ID: 07E-06

Description: This wetland is a 0.2 ha highly ephemeral marsh. There is no canopy or midstory cover. Sedges/grasses grow throughout the wetland, and cover >75% of the basin. A recent fire burned entirely through the wetland basin. This small marsh is surrounded by thinned palmetto and is adjacent to a large swamp. The adjacent uplands are scrubby flatwoods that burned during a 2008 wildfire. The uplands also are managed with mechanical treatments.

Wetland Concerns: None

Restoration Action Recommended: None

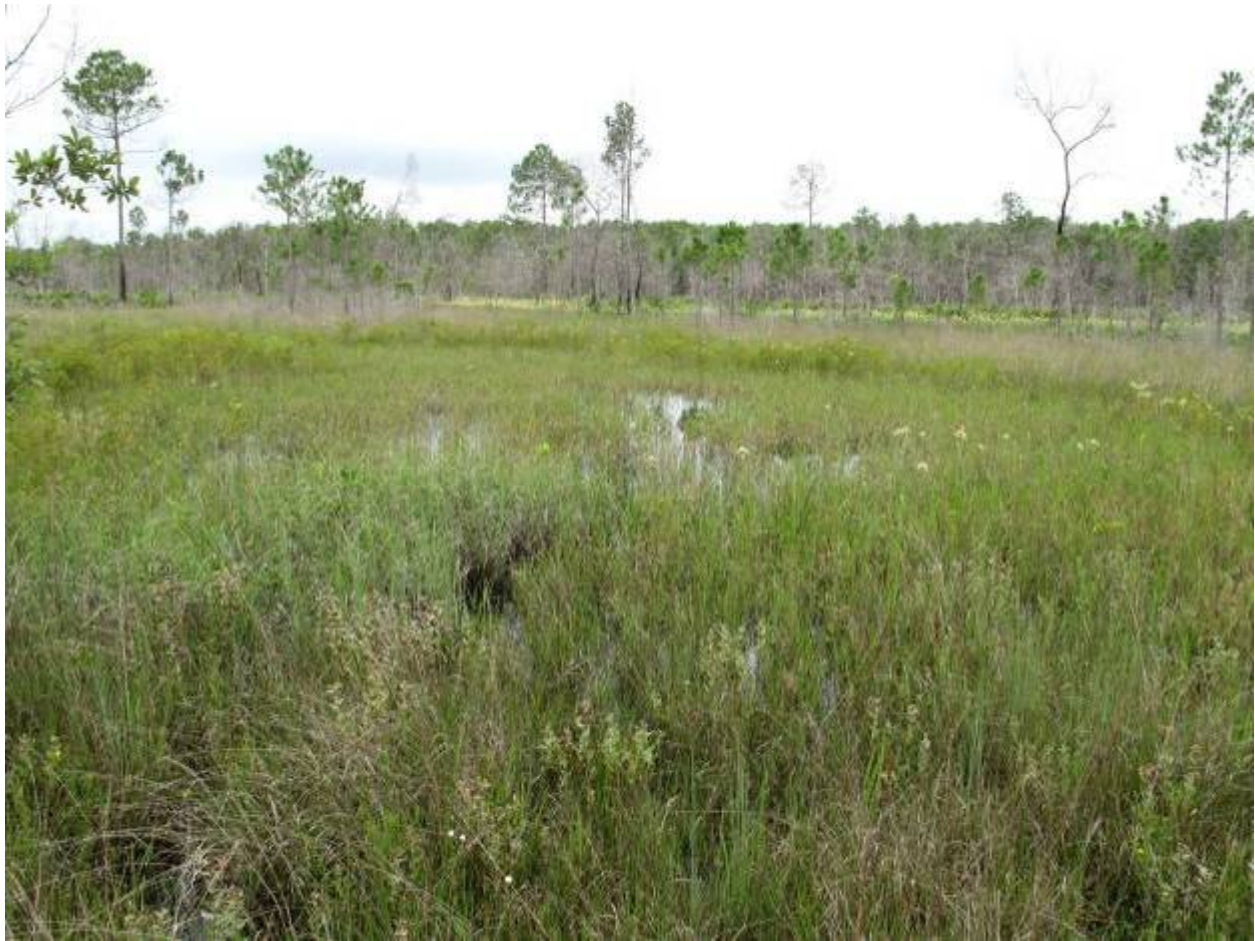
Wetland ID: 07E-07

Description: This wetland is a 0.5 ha ephemeral marsh. There is no tree canopy. *Hypericum* covers 5-25% of the wetland. Sedges/grasses grow throughout the wetland, and cover >75% of the basin. There is a dirt WMA access road along the north side of the wetland. The adjacent uplands are scrubby and mesic flatwoods that burned during a 2008 wildfire. The uplands also are managed with mechanical treatments.

Wetland Concerns: None

Restoration Action Recommended: None

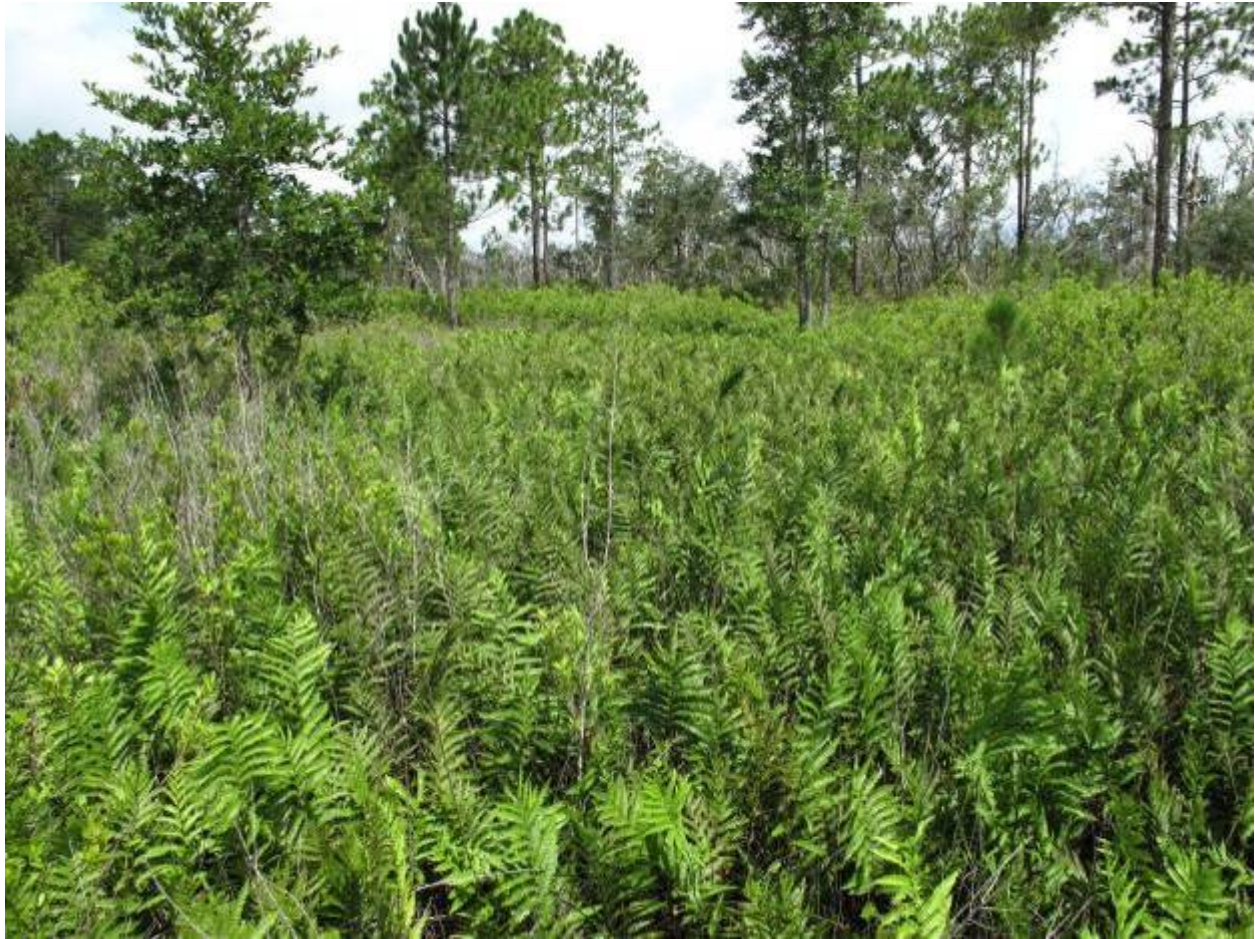
Wetland ID: 09E-01

Description: This wetland is a 0.3 ha ephemeral marsh. There is no canopy or midstory cover. Sedges/grasses and fern grow throughout the wetland, and cover >75% of the basin. The wetland burned fairly recently. The adjacent uplands are sandhill and are managed with mechanical treatments.

Wetland Disturbance: None

Restoration Action Recommended: None

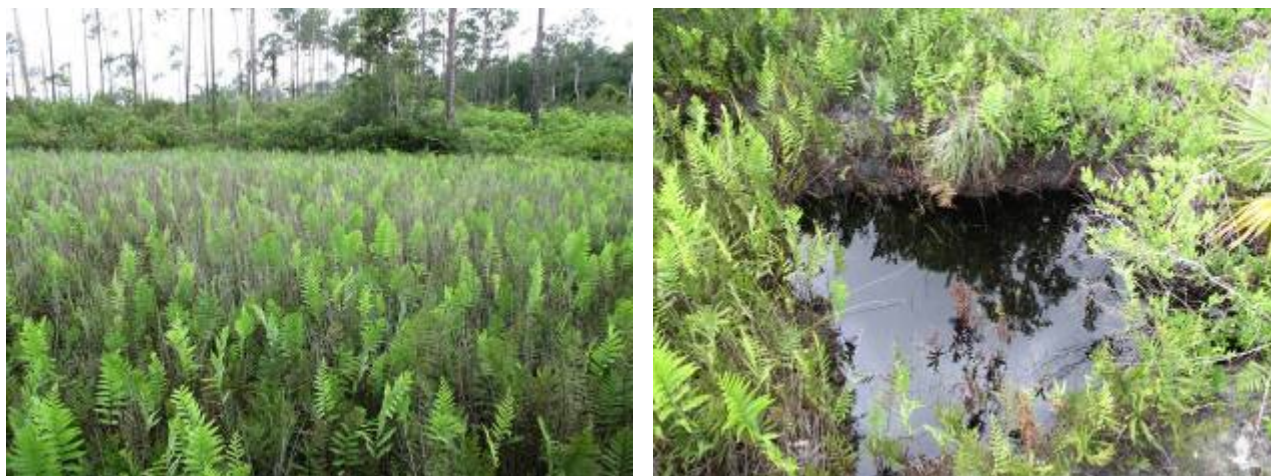
Wetland ID: 09E-02

Description: This wetland is a 0.1 ha ephemeral marsh. There is no canopy or midstory cover. Fern grow throughout the wetland, and cover >75% of the basin. The wetland has very old, almost unnoticeable feral hog damage across the wetland. There is a mechanically dug hole on the east side of the wetland. The marsh has a very defined ecotonal boundary. The adjacent uplands are mesic flatwoods managed with mechanical vegetation removal.

Wetland Disturbance: Dug-out, Feral hog damage

Restoration Action Recommended: Fill the dug-out. Because of the widespread damage to ephemeral wetlands on CWMA, we recommend aggressive action to reduce the overall numbers of feral hogs on the property.
