Inventory, Assessment, and Restoration Potential of Ephemeral Wetlands on FFWCC Wildlife Management Areas

Chassahowitzka WMA Final Report

Submitted by: Rebecca P.M. Means¹, Ryan C. Means¹, Steven A. Johnson²

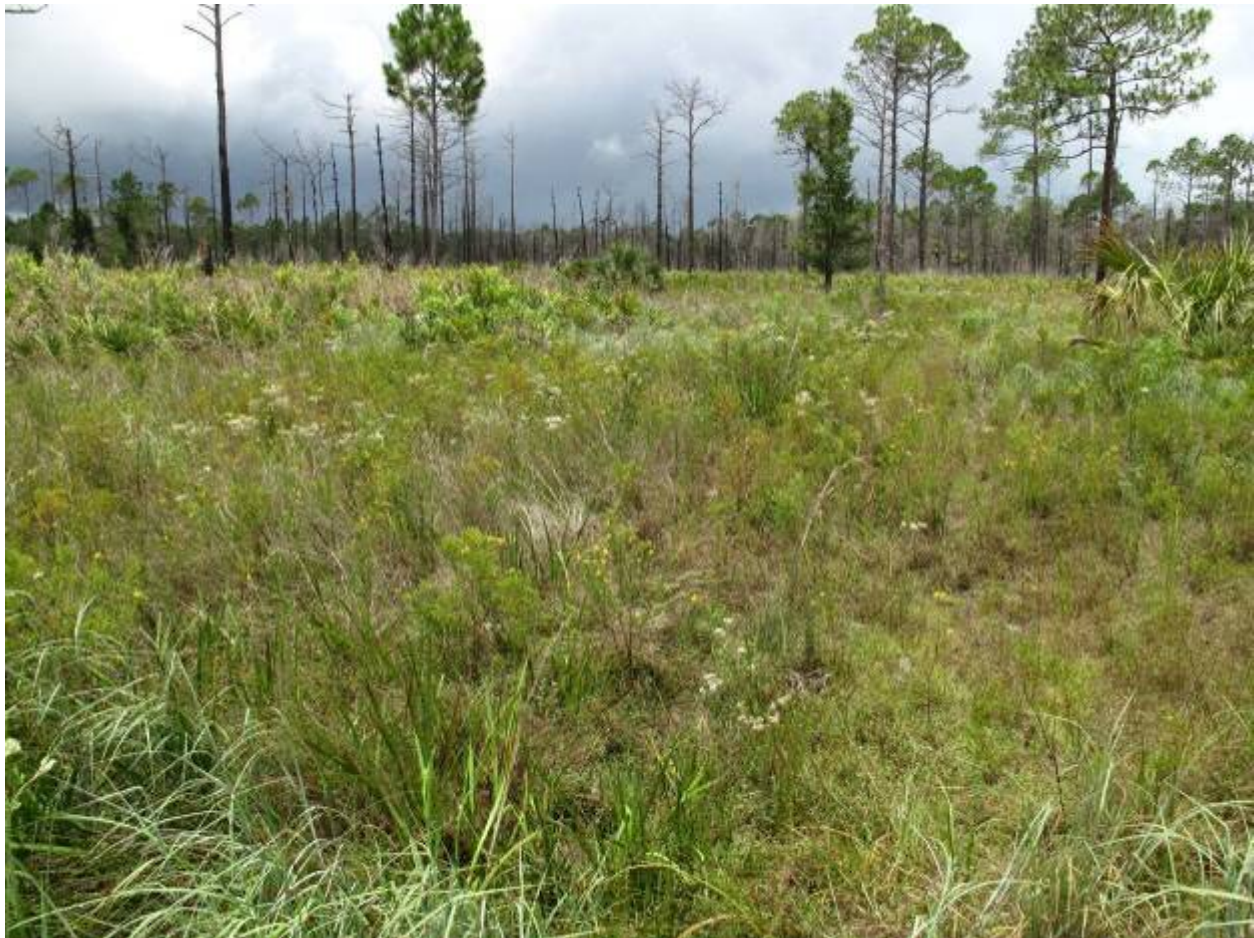
Wetland ID: 09E-03

Description: This wetland is a 0.1 ha ephemeral marsh. There is no tree canopy. *Hypericum* covers 5-25% of the wetland. Sedges/grasses grow throughout the wetland, and cover >75% of the basin. There is a small four-wheeler track around the wetland but the damage is minimal and most likely done while the wetland was dry. The adjacent uplands are scrubby flatwoods and are managed with mechanical treatments.

Wetland Disturbance: None

Restoration Action Recommended: None

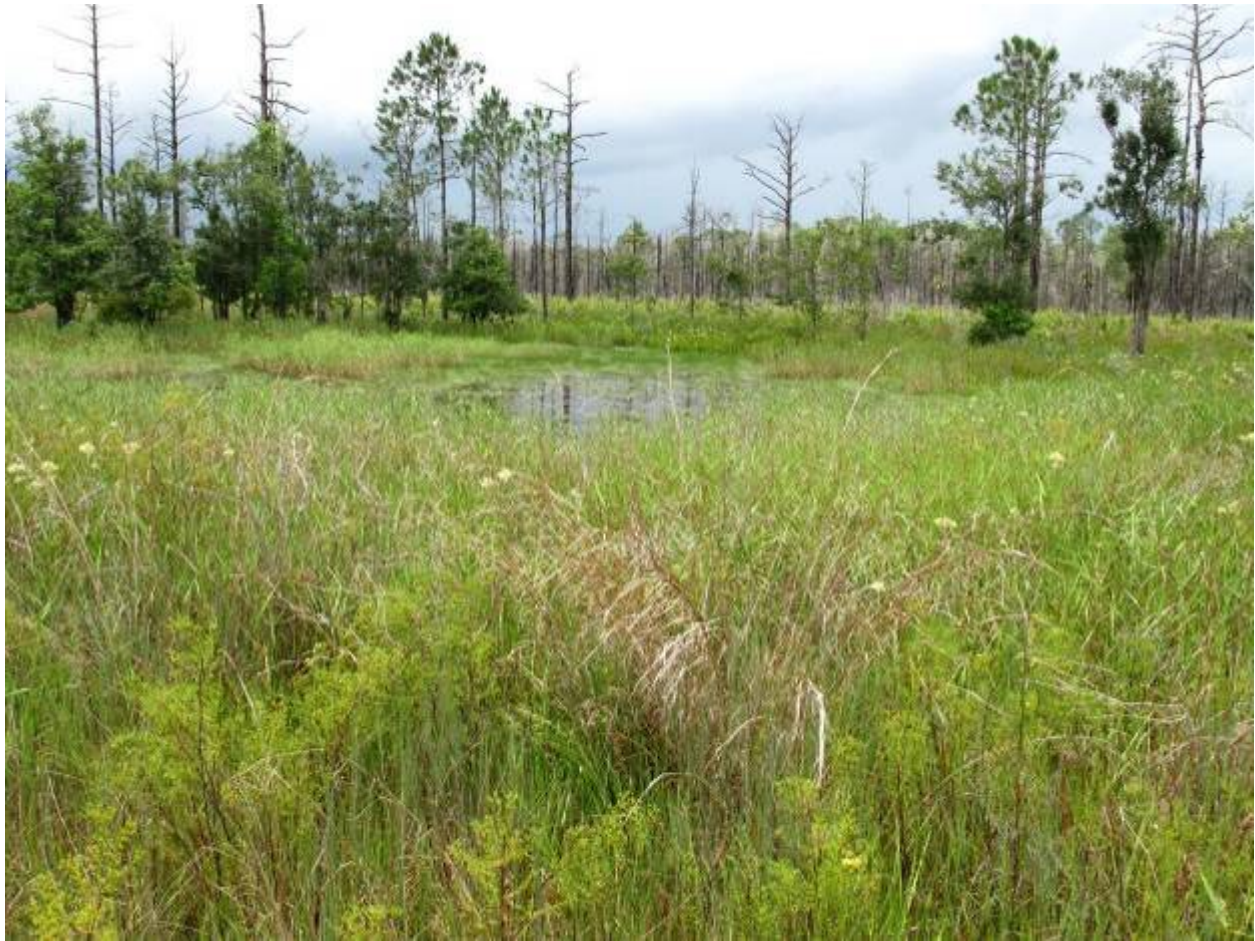
Wetland ID: 09E-04

Description: This wetland is a 0.5 ha ephemeral marsh. There is no tree canopy. *Hypericum* covers 5-25% of the wetland. Sedges/grasses grow throughout the wetland, and cover >75% of the basin. The wetland burned fairly recently. This circular wetland has diverse herbaceous vegetation and is in great ecological condition. The adjacent uplands are mesic flatwoods and are managed with mechanical treatments.

Wetland Disturbance: None

Restoration Action Recommended: None

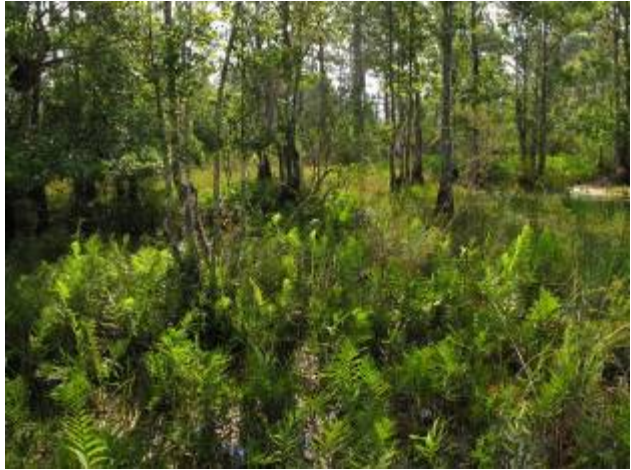
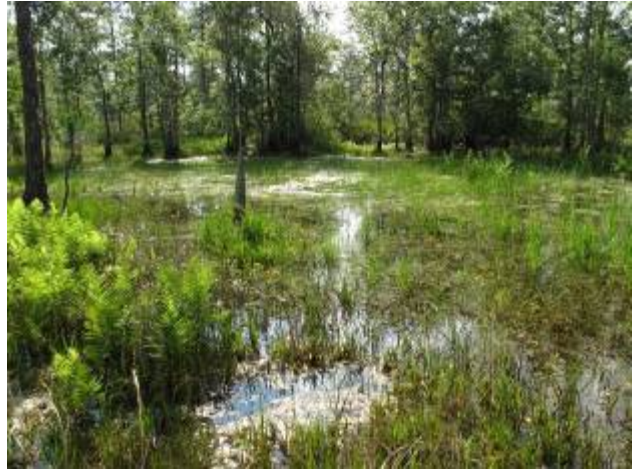
Wetland ID: 10E-01

Description: This wetland is a 0.1 ha ephemeral marsh. Gum trees dominate the canopy, and cover 5-25% of the wetland. There is no midstory layer. Sedges/grasses and fern grow throughout the wetland, and cover >75% of the basin. Feral hog damage is old and recovering well. This wetland is a potential striped newt breeding pond. The adjacent uplands are fire-suppressed sandhills with a thick palmetto ring around wetland. The uplands were managed with an herbicide treatment.

Wetland Disturbance: Feral hog damage

Restoration Action Recommended: Because of the widespread damage to ephemeral wetlands on CWMA, we recommend aggressive action to reduce the overall numbers of feral hogs on the property.

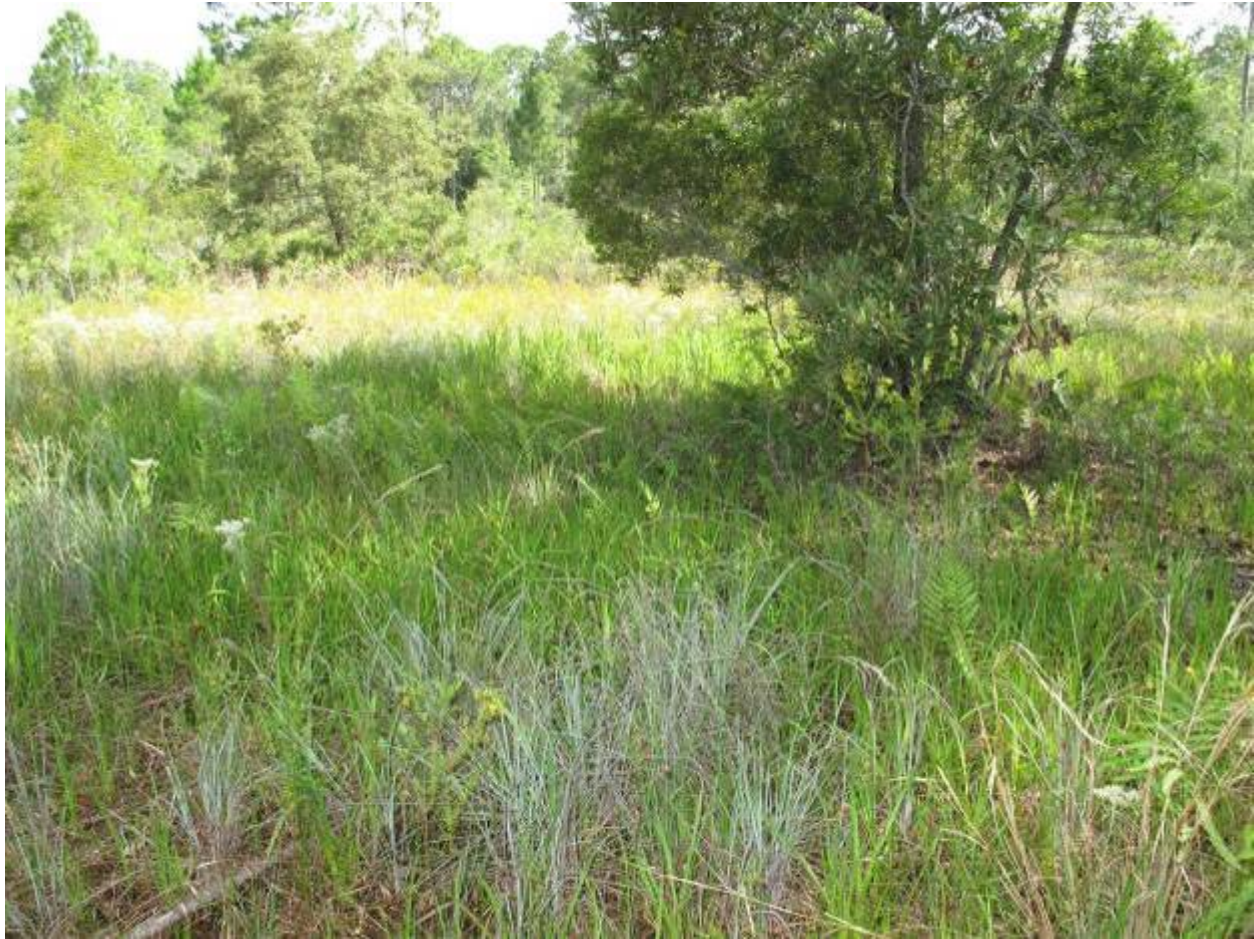
Wetland ID: 10E-02

Description: This wetland is a 0.1 ha ephemeral marsh. There is no canopy or midstory cover. Sedges/grasses and redroot grow throughout the wetland, and cover >75% of the basin. Feral hog damage is old and recovering well. The adjacent uplands are fire-suppressed sandhills to the south and hydric hammock to the north. A thick palmetto ring surrounds the wetland. The uplands were managed with an herbicide treatment.

Wetland Concerns: Feral hog damage

Restoration Action Recommended: Because of the widespread damage to ephemeral wetlands on CWMA, we recommend aggressive action to reduce the overall numbers of feral hogs on the property.

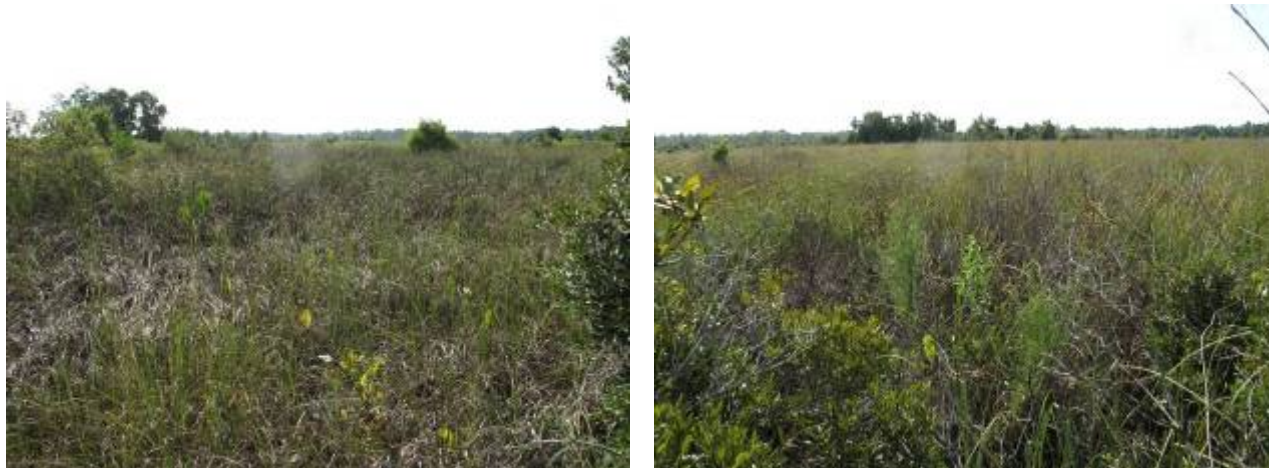
Wetland ID: 11E-01

Description: This wetland is a 79.0 ha semi-permanent marsh. Cypress trees grow in 3 deeper holes in the bottom lobe of the wetland. The cypress tree canopy covers 5-25% of the wetland. Cypress and maple grow in a deeper hole in the northeast corner as well. The midstory is dominated by wax myrtle, willow, and small maples, and covers 5-25% of the wetland. Sawgrass grows densely throughout, covering >75% of the wetland basin. The effects of fire suppression are evident. A brush and cypress ring is forming around the wetland edge and the marsh is choked with sawgrass. The adjacent uplands are fire-suppressed sandhills and are managed with mechanical treatments. A palmetto ring was recently chopped around the wetland perimeter.

Wetland Concerns: Herbaceous density, Woody encroachment

Restoration Action Recommended: Prescribe burn promptly when wetland has normal water levels to reduce initial fuel load. Burn again approximately a year later when water levels are lower (late spring/early summer if dry year) to remove upper duff and peat levels and more thoroughly reduce sawgrass density. Alternatively, if not worried about initial fire intensity, provide first burn when water is low so that encroaching woody shrub zones and dense sawgrass are reduced.

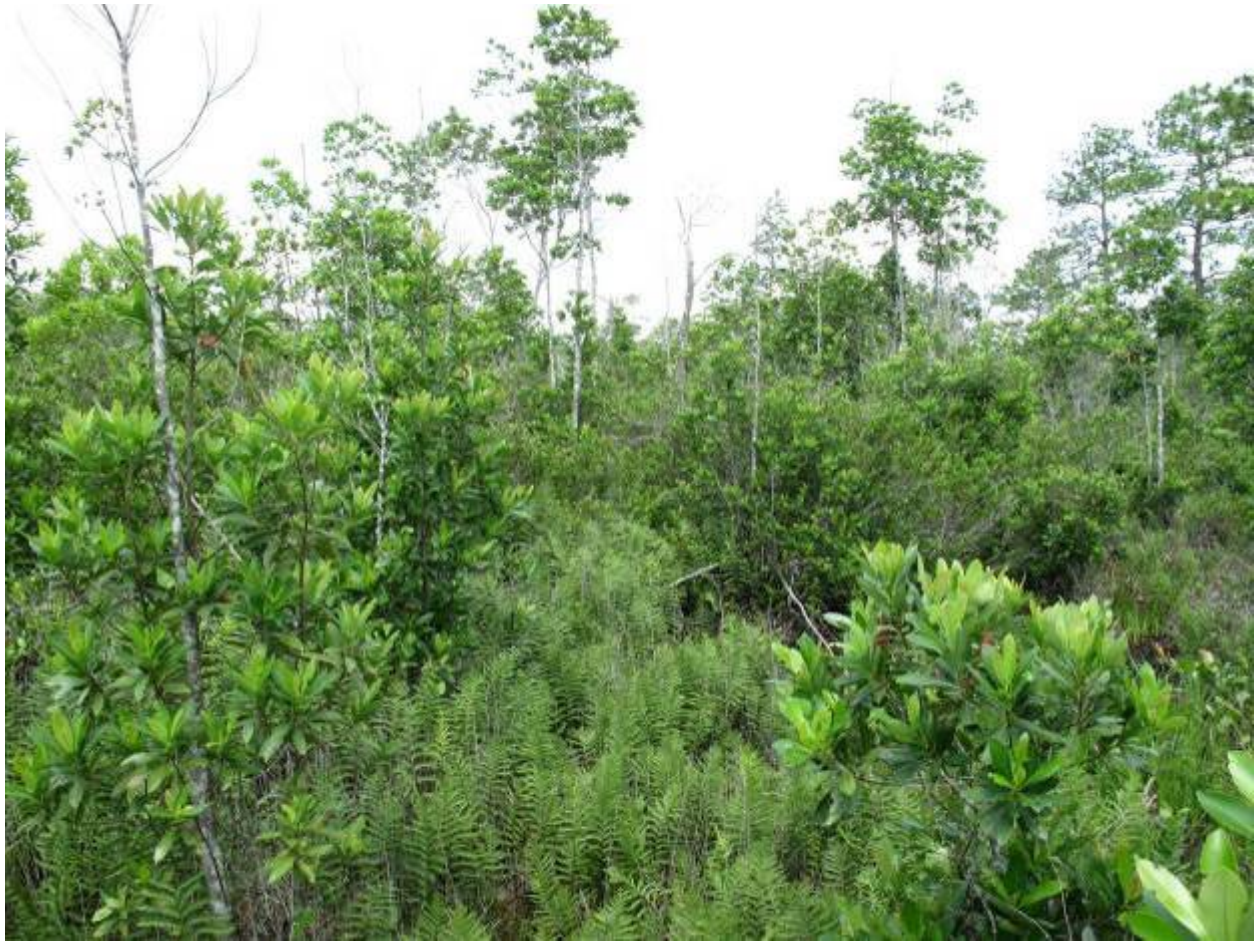
Wetland ID: 01F-01

Description: This wetland is a 1.8 ha semi-permanent shrub swamp, baygall community. There is no tree canopy. Fetterbush and loblolly bay saplings cover >75% of the wetland. Fern grow throughout the wetland, and cover >75% of the basin. The wetland has patchy feral hog damage. There is a thick layer of peat and duff in the wetland basin. The adjacent uplands are sandhills and currently are managed with prescribed fire and herbicide treatment.

Wetland Concerns: Feral hog damage, Woody encroachment

Restoration Action Recommended: Because of the widespread damage to ephemeral wetlands on CWMA, we recommend aggressive action to reduce the overall numbers of feral hogs on the property. Encourage periodic fire in the wetland basin to reduce the dense shrubs and duff layer.

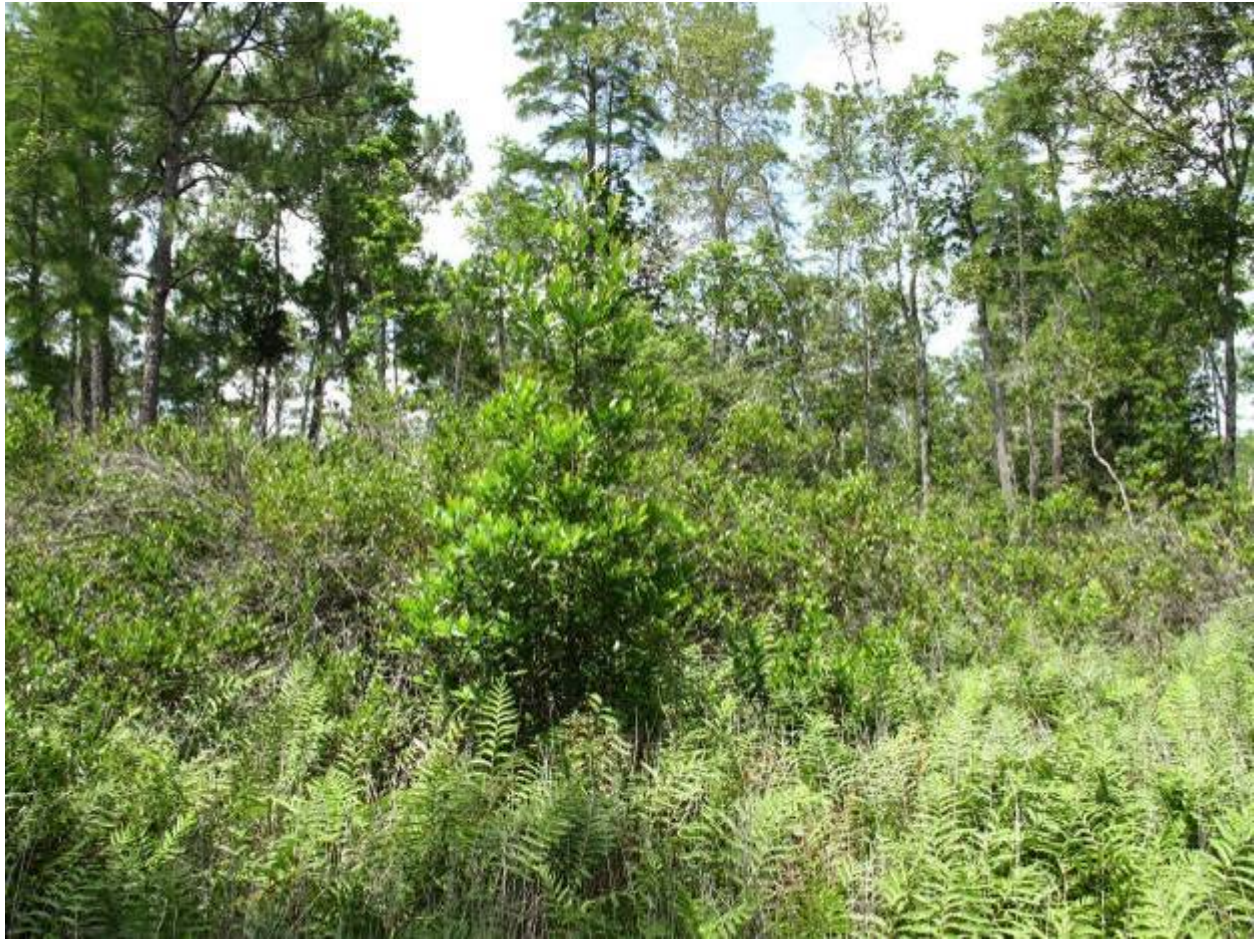
Wetland ID: 01F-02

Description: This wetland is a 0.4 ha ephemeral shrub swamp. Cypress trees dominate the canopy, and cover 5-25% of the wetland. The midstory is dominated by fetterbush, loblolly bay, and wax myrtle, and covers 50-75% of the wetland. Fern are distributed throughout the wetland, and cover 50-75% of the basin. There is a thick layer duff in the wetland basin. This small swamp is very close to a much larger swamp to the west. The adjacent uplands are sandhills and currently are managed with prescribed fire and herbicide treatment.

Wetland Concerns: None

Restoration Action Recommended: Encourage periodic fire in the wetland to prevent the woody vegetation from becoming too dense.

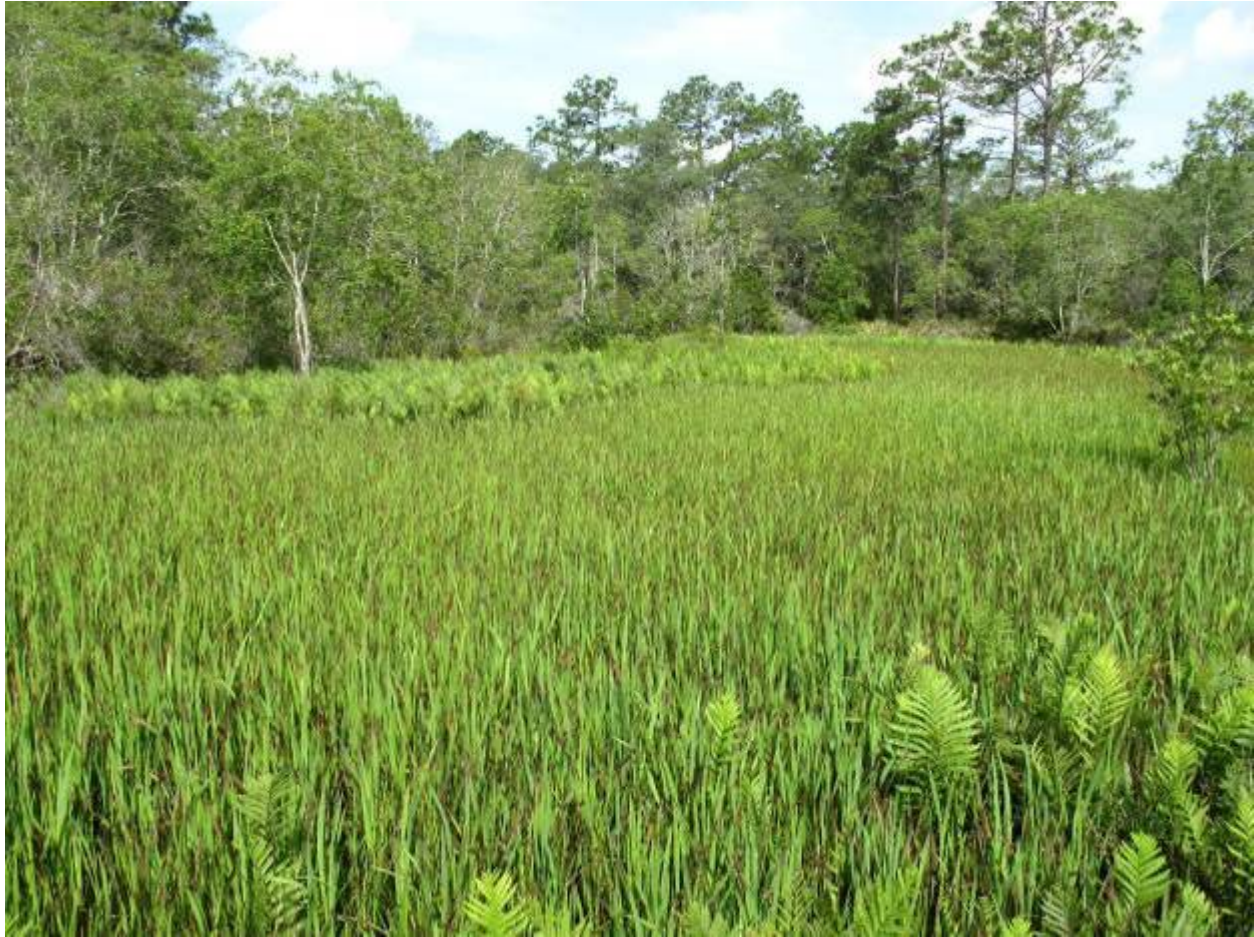
Wetland ID: 03F-01

Description: This wetland is a 0.1 ha ephemeral marsh. There is no tree canopy. Loblolly bay saplings cover 5-25% of the wetland. Redroot and fern grow throughout the wetland, and cover >75% of the basin. Uneven ground in the wetland and the presence of disturbance-colonizing vegetation suggest this wetland was disturbed by feral hogs in the past, but old rooting is now eroding. Woody vegetation is beginning to encroach in the wetland basin along the edge. The adjacent uplands are fire-suppressed sandhills.

Wetland Concerns: Feral hog damage, Woody encroachment

Restoration Action Recommended: Because of the widespread damage to ephemeral wetlands on CWMA, we recommend aggressive action to reduce the overall numbers of feral hogs on the property. Encourage periodic fire in the wetland to prevent further shrub encroachment.

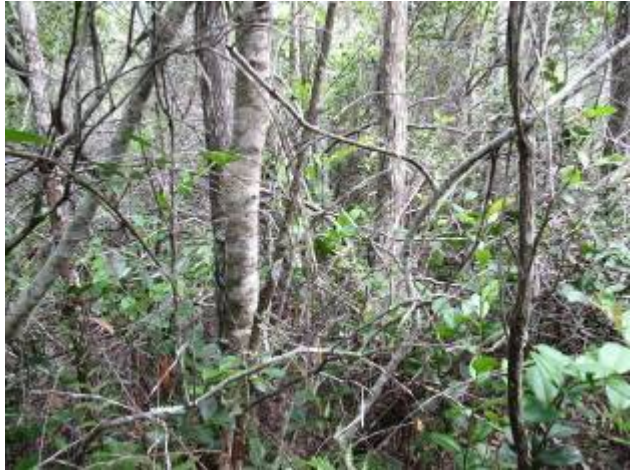
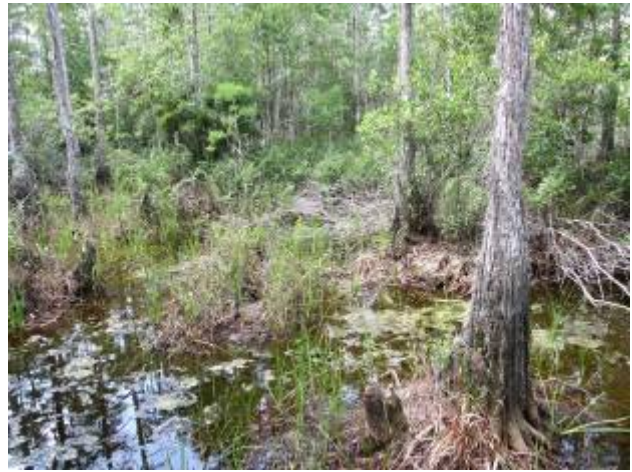
Wetland ID: 03F-02

Description: This wetland is a 1.2 ha ephemeral mixed swamp. Cypress trees dominate the canopy, and cover 50-75% of the wetland. The midstory is dominated by fetterbush and wax myrtle, and covers >75% of the wetland. Sedges/grasses grow throughout the wetland, and cover 5-25% of the basin. This large, circular swamp is surrounded by a thick ring of brush and has a thick duff and peat layer in the basin. There is minor feral hog damage in the wetland. The adjacent uplands are fire-suppressed sandhills.

Wetland Concerns: Feral hog damage, Woody encroachment

Restoration Action Recommended: Because of the widespread damage to ephemeral wetlands on CWMA, we recommend aggressive action to reduce the overall numbers of feral hogs on the property. Encourage periodic fire in the wetland to reduce the dense shrubs.

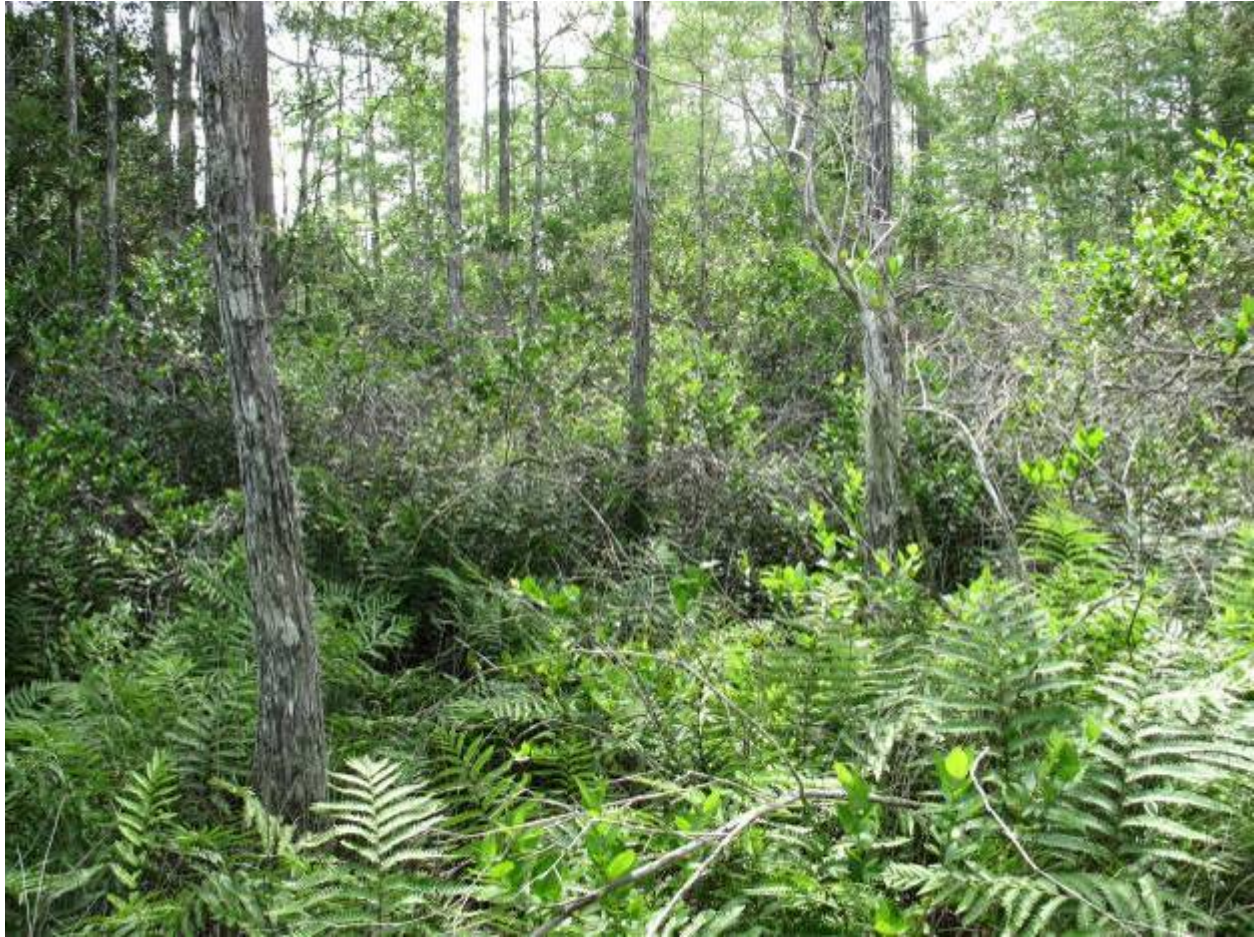
Wetland ID: 03F-03

Description: This wetland is a 0.4 ha ephemeral mixed swamp. Cypress trees dominate the canopy, and cover 50-75% of the wetland. The midstory is dominated by fetterbush and wax myrtle, and covers 50-75% of the wetland. Fern grow throughout the wetland, and cover 50-75% of the basin. This circular swamp has a thick duff layer, very tall ferns, and patches of thick brush in the basin. The wetland is surrounded by a thick ring of brush. The adjacent uplands are fire-suppressed sandhills.

Wetland Concerns: Woody encroachment

Restoration Action Recommended: Encourage periodic fire in the wetland to reduce the thick patches of brush and prevent further shrub encroachment.

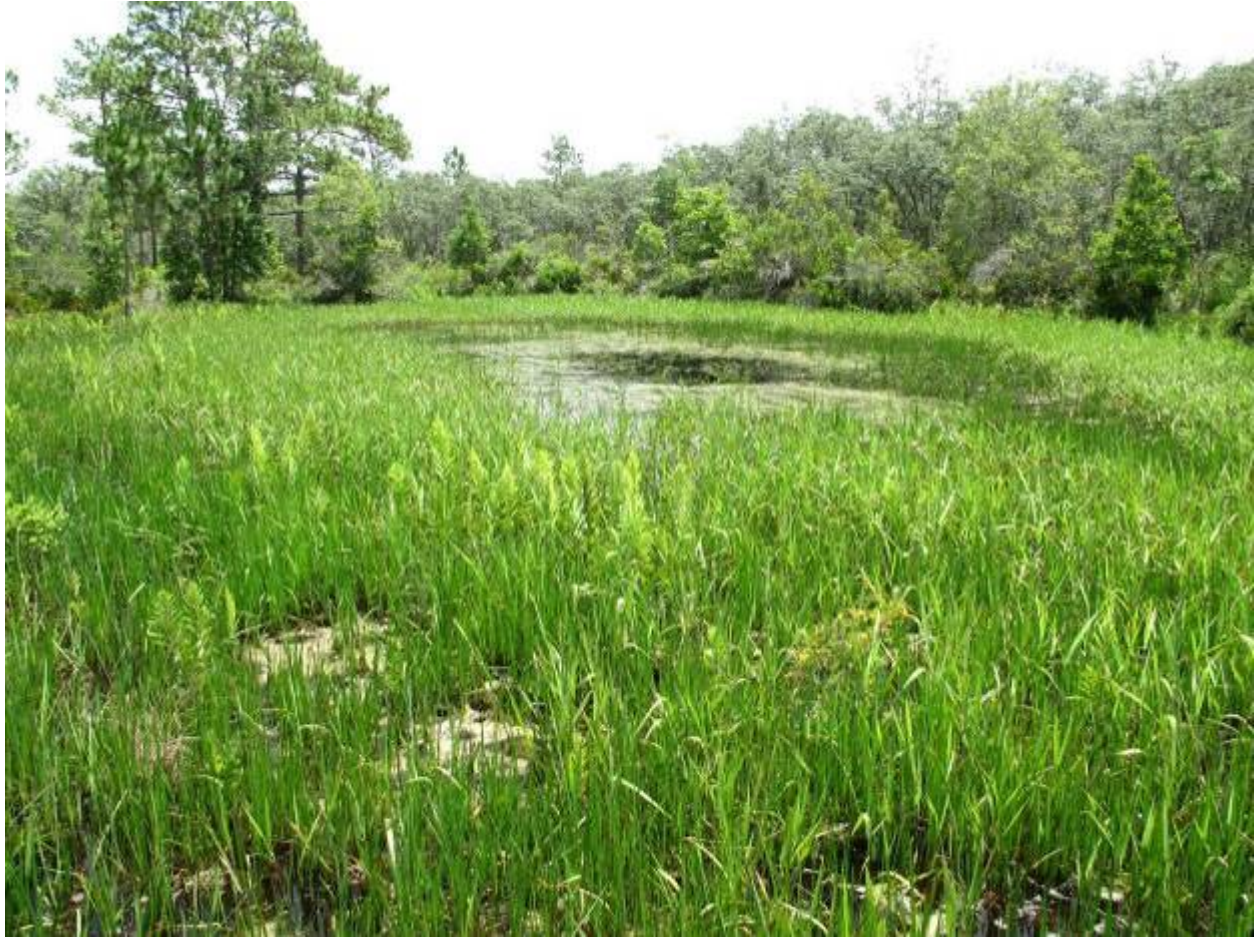
Wetland ID: 03F-04

Description: This wetland is a 0.1 ha ephemeral marsh. There is no canopy or midstory cover. Maidencane and redroot grow throughout the wetland, and cover >75% of the basin. The wetland has minor, old feral hog damage. The adjacent uplands are fire-suppressed sandhills.

Wetland Concerns: Feral hog damage

Restoration Action Recommended: Because of the widespread damage to ephemeral wetlands on CWMA, we recommend aggressive action to reduce the overall numbers of feral hogs on the property.

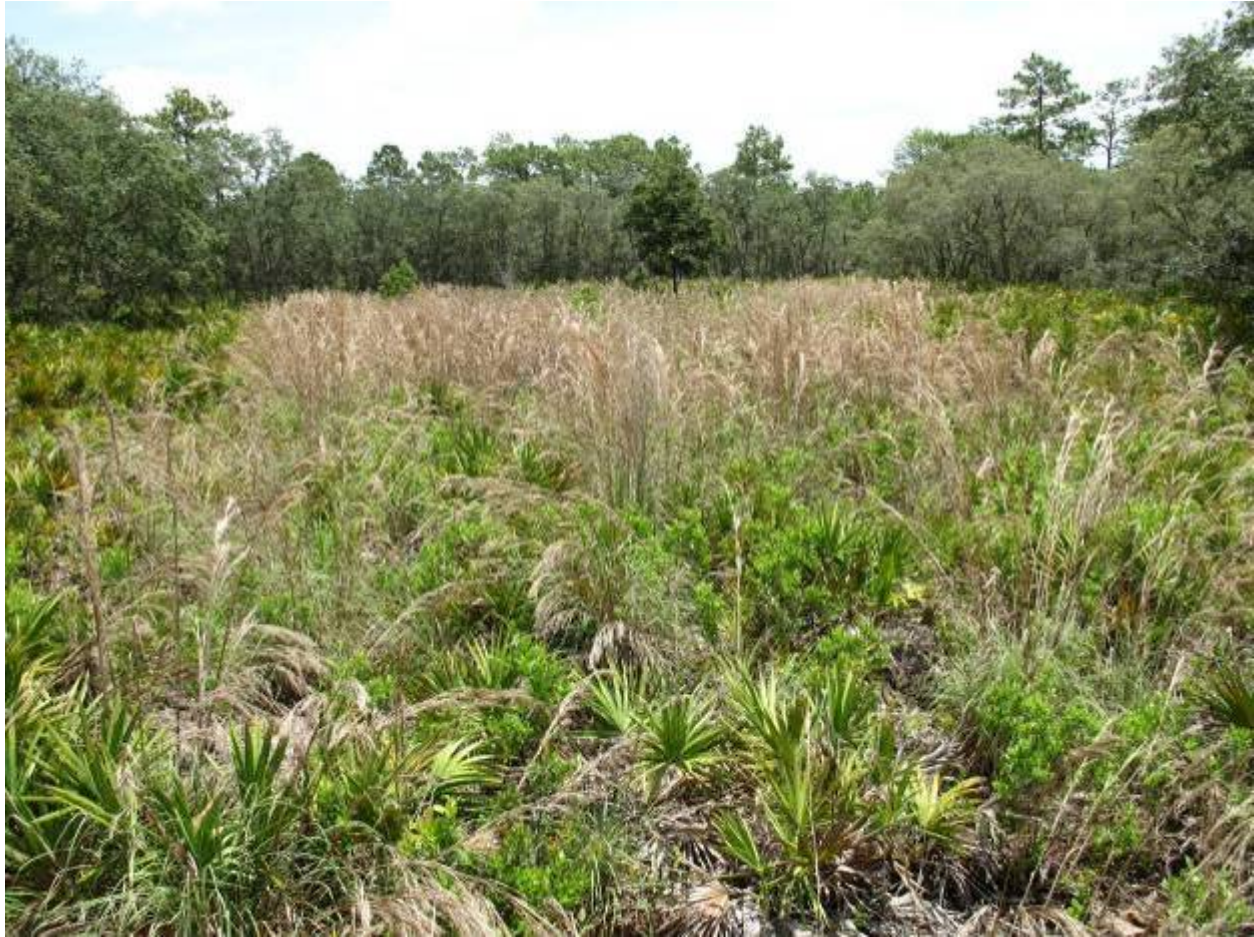
Wetland ID: 03F-05

Description: This wetland is a 0.1 ha highly ephemeral marsh. There is no canopy or midstory cover. Sedges/grasses and fern grow throughout the wetland, and cover >75% of the basin. The herbaceous vegetation is diverse and very dense. Gallberry is beginning to encroach into the wetland basin. The adjacent uplands are fire-suppressed sandhills.

Wetland Concerns: None

Restoration Action Recommended: Encourage periodic fire in the wetland to reduce dense herbaceous vegetation and prevent the encroachment of gallberry.

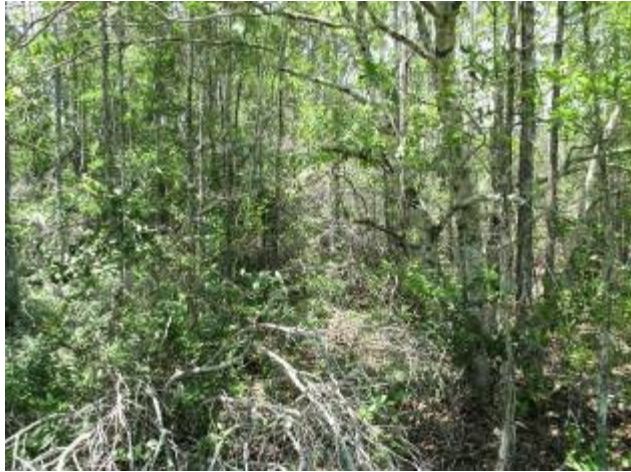
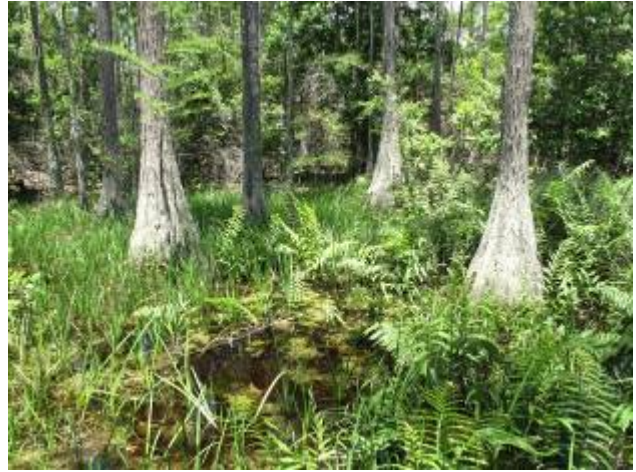
Wetland ID: 03F-06

Description: This wetland is a 0.2 ha ephemeral mixed swamp. Cypress and holly trees dominate the canopy, and cover 50-75% of the wetland. The midstory is dominated by fetterbush and wax myrtle, and covers 50-75% of the wetland. Fern, redroot, and sphagnum grow throughout the wetland, and cover 50-75% of the basin. This wetland has a thick brush ring and an open interior. There is a thick duff layer in and around the wetland. The adjacent uplands are fire-suppressed sandhills.

Wetland Concerns: Woody encroachment

Restoration Action Recommended: Encourage periodic fire to reduce the dense brush ring and prevent further shrub encroachment.

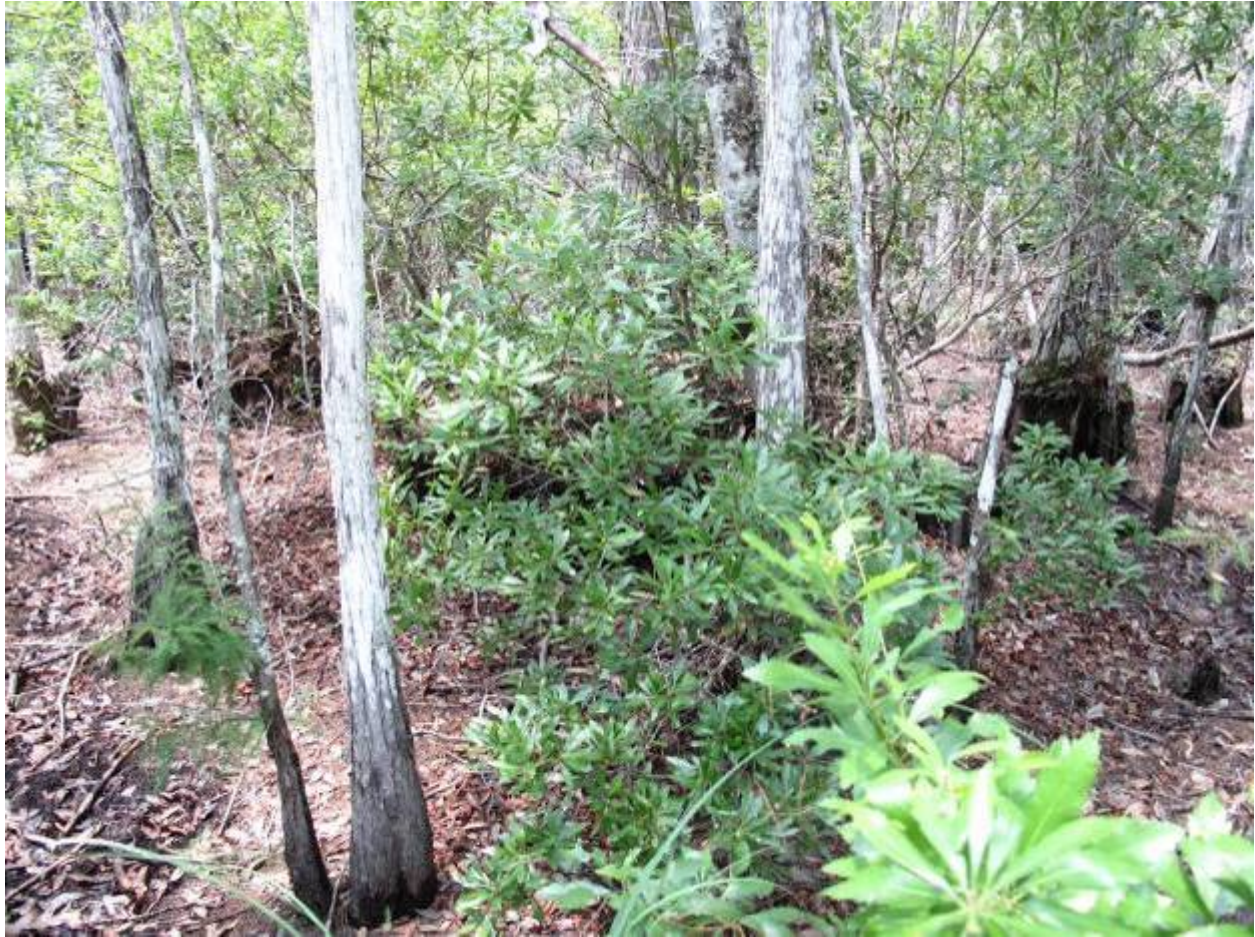
Wetland ID: 03F-07

Description: This wetland is a 1.3 ha ephemeral mixed swamp. Cypress trees dominate the canopy, and cover >75% of the wetland. The midstory is dominated by wax myrtle, and covers 50-75% of the wetland. Sedges/grasses grow in scattered patches, covering 5-25% of the wetland basin. This wetland has a dense brush ring and a thick duff layer. The adjacent uplands are fire-suppressed sandhills.

Wetland Concerns: Woody encroachment

Restoration Action Recommended: Encourage periodic fire to reduce the dense brush ring and prevent further shrub encroachment.

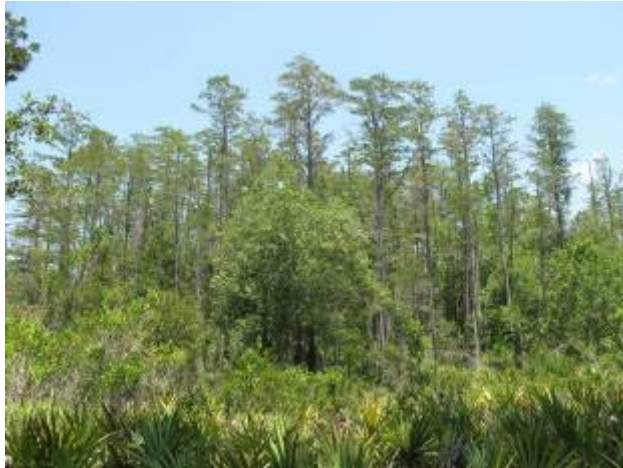
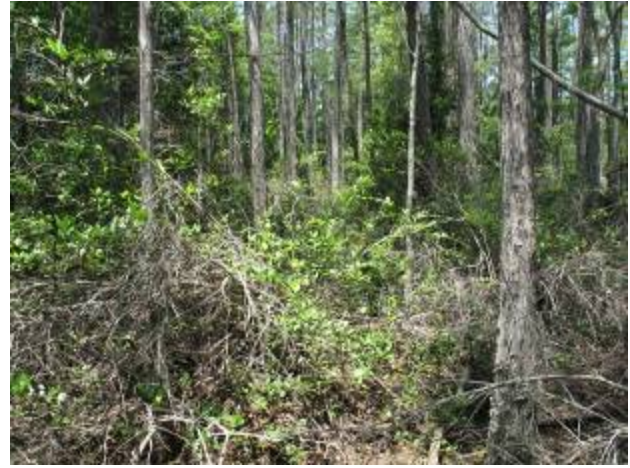
Wetland ID: 03F-08

Description: This wetland is a 0.6 ha ephemeral mixed swamp. The presence of old cypress stumps provides evidence of historical logging. The cypress have regenerated and cover >75% of the wetland. The midstory is dominated by fetterbush and holly, and covers >75% of the wetland. There is no herbaceous vegetation. Hummocks have developed around old stumps and are now supporting the shrubs. There is a thick layer of duff in the wetland. The adjacent uplands are fire-suppressed sandhills that are thick with brush and oaks.

Wetland Concerns: Woody encroachment

Restoration Action Recommended: Encourage periodic fire in the wetland to reduce the thick brush and duff layer.

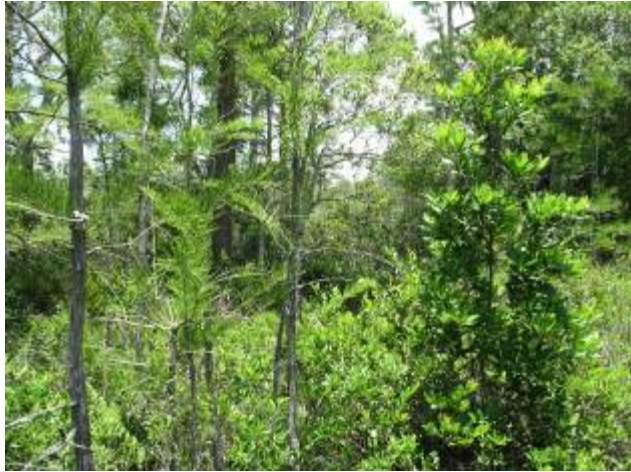
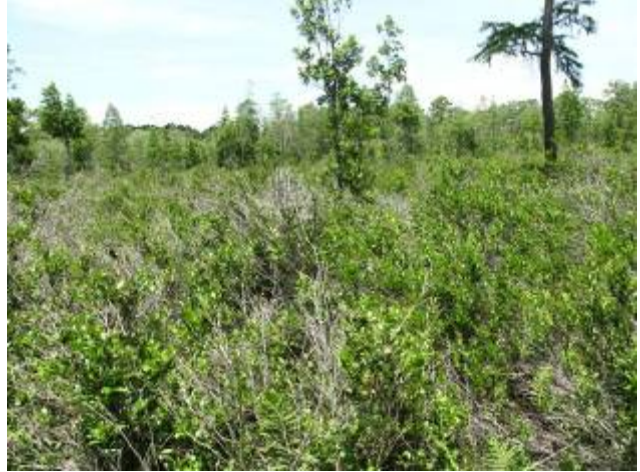
Wetland ID: 04F-01

Description: This wetland is a 1.3 ha semi-permanent shrub swamp. Cypress and loblolly bay trees dominate the canopy, and cover 5-25% of the wetland. The midstory is dominated by fetterbush, and covers >75% of the wetland. Fern grow in scattered patches, covering 5-25% of the wetland basin. This baygall swamp has very thick duff and peat and is likely an old cypress dome. The adjacent uplands are sandhills. The sandhills appear to have been fire suppressed but now are managed with prescribed fire.

Wetland Concerns: Woody encroachment

Restoration Action Recommended: Encourage periodic fire in the wetland to reduce the thick brush and duff layer.

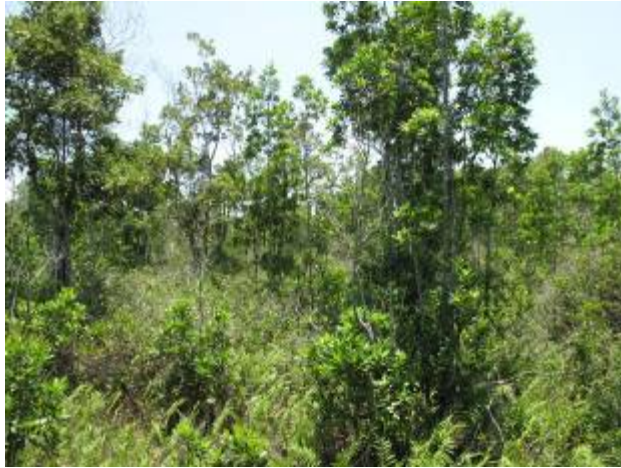
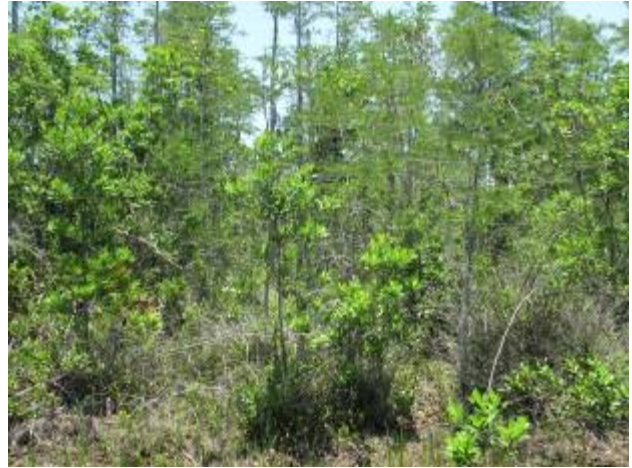
Wetland ID: 04F-02

Description: This wetland is a 1.0 ha ephemeral shrub swamp. Cypress and loblolly bay trees dominate the canopy, and cover 25-50% of the wetland. The midstory is dominated by buttonbush and loblolly bay, and covers >75% of the wetland. Sedges/grasses and redroot grow in scattered patches, covering 5-25% of the wetland basin. The north end of this baygall wetland has a cypress-dominated lobe and the rest is an impenetrable fetterbush/bay thicket. Feral hog damage is spotty and is both old and new. The adjacent uplands are sandhills. The sandhills appear to have been fire suppressed but now are managed with prescribed fire.

Wetland Concerns: Feral hog damage, Woody encroachment

Restoration Action Recommended: Because of the widespread damage to ephemeral wetlands on CWMA, we recommend aggressive action to reduce the overall numbers of feral hogs on the property. Encourage periodic fire in the wetland to reduce the thick brush.

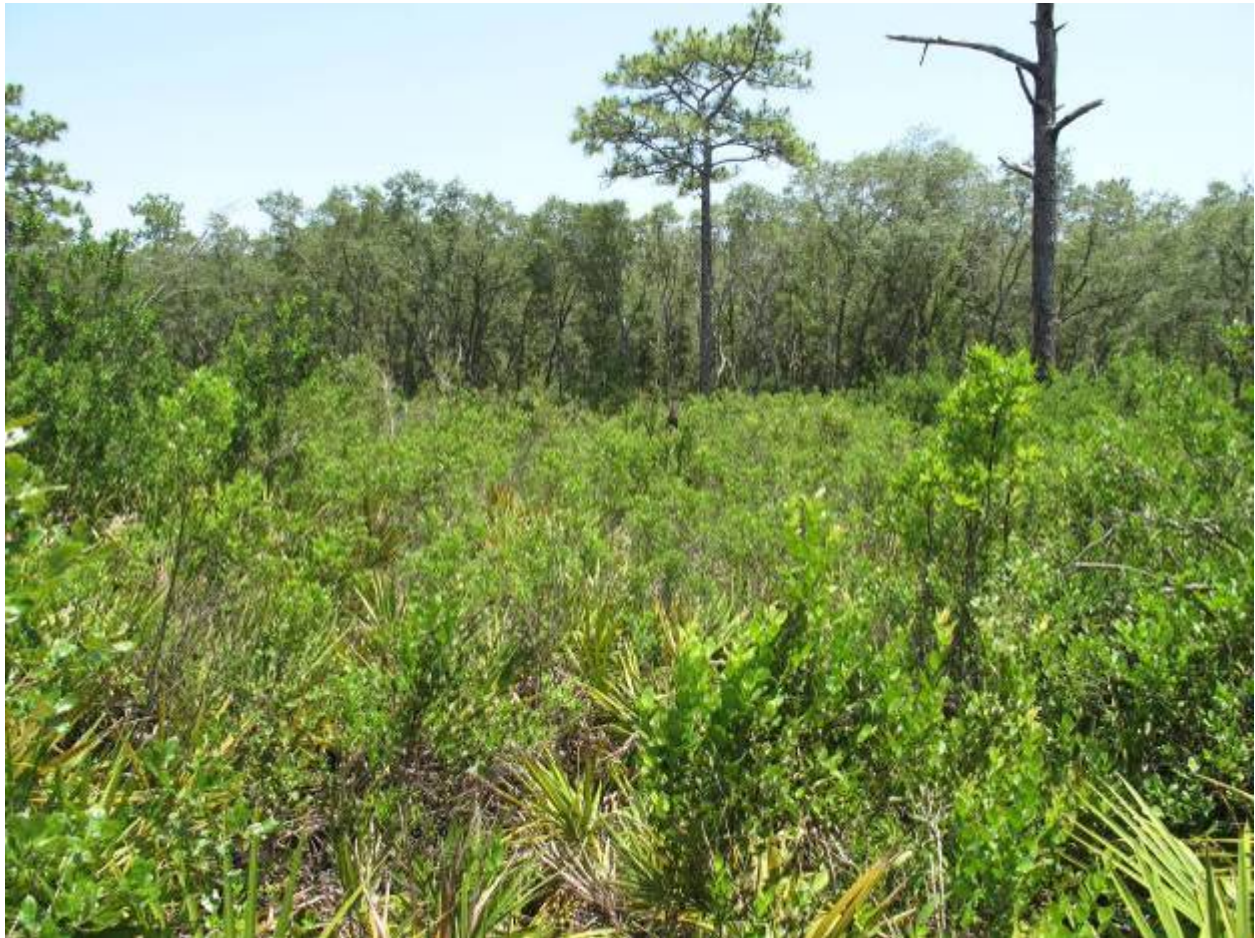
Wetland ID: 04F-03

Description: This wetland is a 0.2 ha ephemeral shrub swamp. There is no tree canopy. Fetterbush and gallberry cover >75% of the wetland. There is no herbaceous vegetation. This baygall swamp has burned in the past but is extremely thick with shrubs. The adjacent uplands are sandhills. The sandhills appear to have been fire suppressed but now are managed with prescribed fire.

Wetland Concerns: Woody encroachment

Restoration Action Recommended: Encourage periodic fire in the wetland to reduce the thick brush.

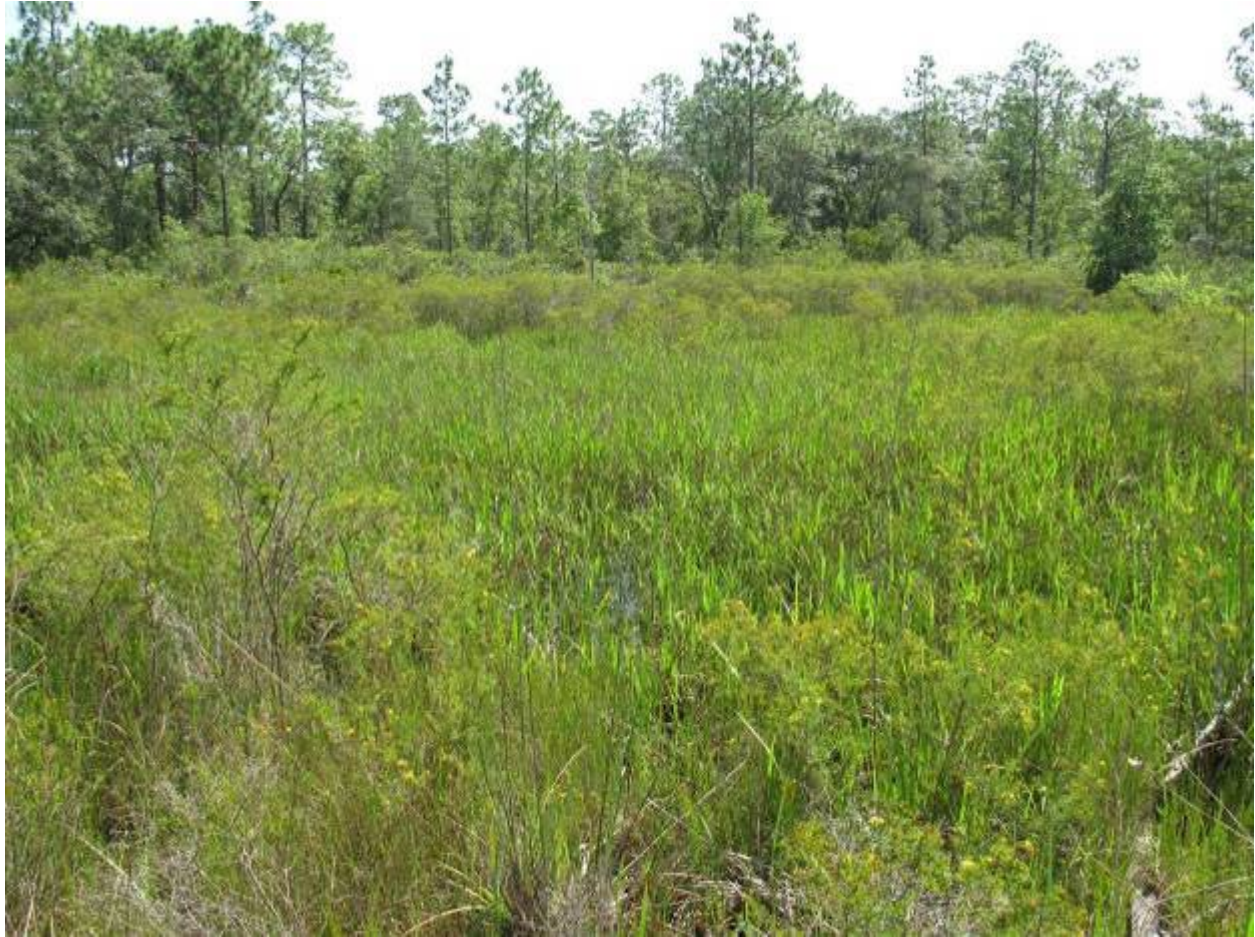
Wetland ID: 05F-01

Description: This wetland is a 0.3 ha ephemeral marsh. There is no tree canopy. Holly and *Hypericum* cover 5-25% of the wetland. Sedges/grasses and redroot grow throughout the wetland, and cover >75% of the basin. Feral hog damage is old and has recolonized with redroot. There is a 5 m diameter sinkhole on the west side of the depression in the ecotone. Palmetto grows in a dense ring around the wetland. The adjacent uplands are fire-suppressed sandhills and currently are managed with mechanical treatments.

Wetland Concerns: Feral hog damage

Restoration Action Recommended: Because of the widespread damage to ephemeral wetlands on CWMA, we recommend aggressive action to reduce the overall numbers of feral hogs on the property.

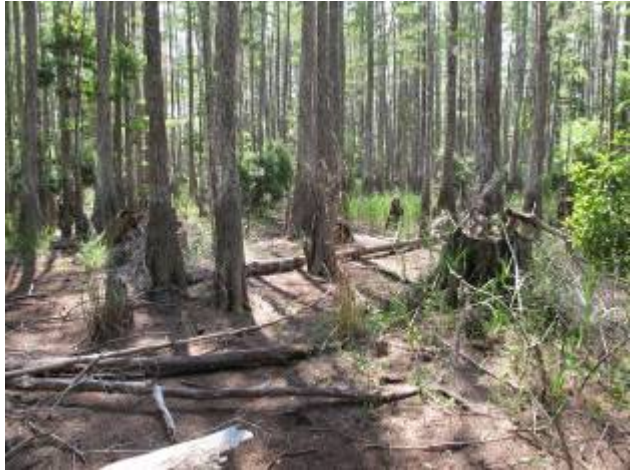
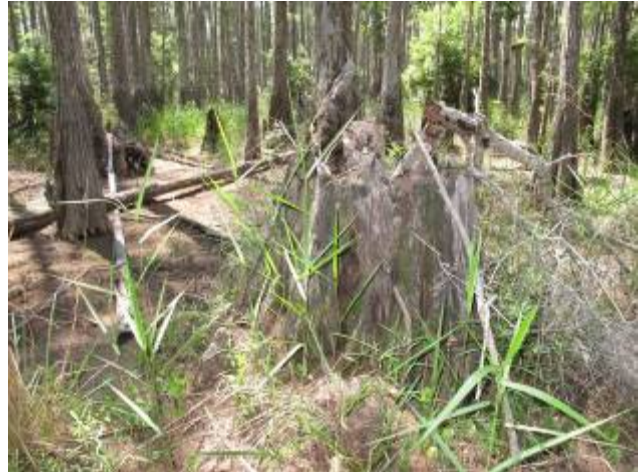
Wetland ID: 05F-02

Description: This wetland is a 3.7 ha ephemeral forested swamp. Cypress trees dominate the canopy, and cover >75% of the wetland. The midstory is dominated by buttonbush and wax myrtle, and covers 25-50% of the wetland. Sedges/grasses and maidencane grow in scattered patches, and cover 25-50% of the wetland basin. This swamp is located on a private land boundary, two-thirds of the wetland is owned by CWMA and the other third is private. The edge of the wetland was mechanically treated but there are no vehicular tracks. There is evidence of fire on some cypress bases in the wetland interior. The adjacent uplands are fire-suppressed sandhills and currently are managed with mechanical treatments.

Wetland Concerns: None

Restoration Action Recommended: None
