Inventory, Assessment, and Restoration Potential of Ephemeral Wetlands on FFWCC Wildlife Management Areas

Chassahowitzka WMA Final Report

Submitted by: Rebecca P.M. Means¹, Ryan C. Means¹, Steven A. Johnson²

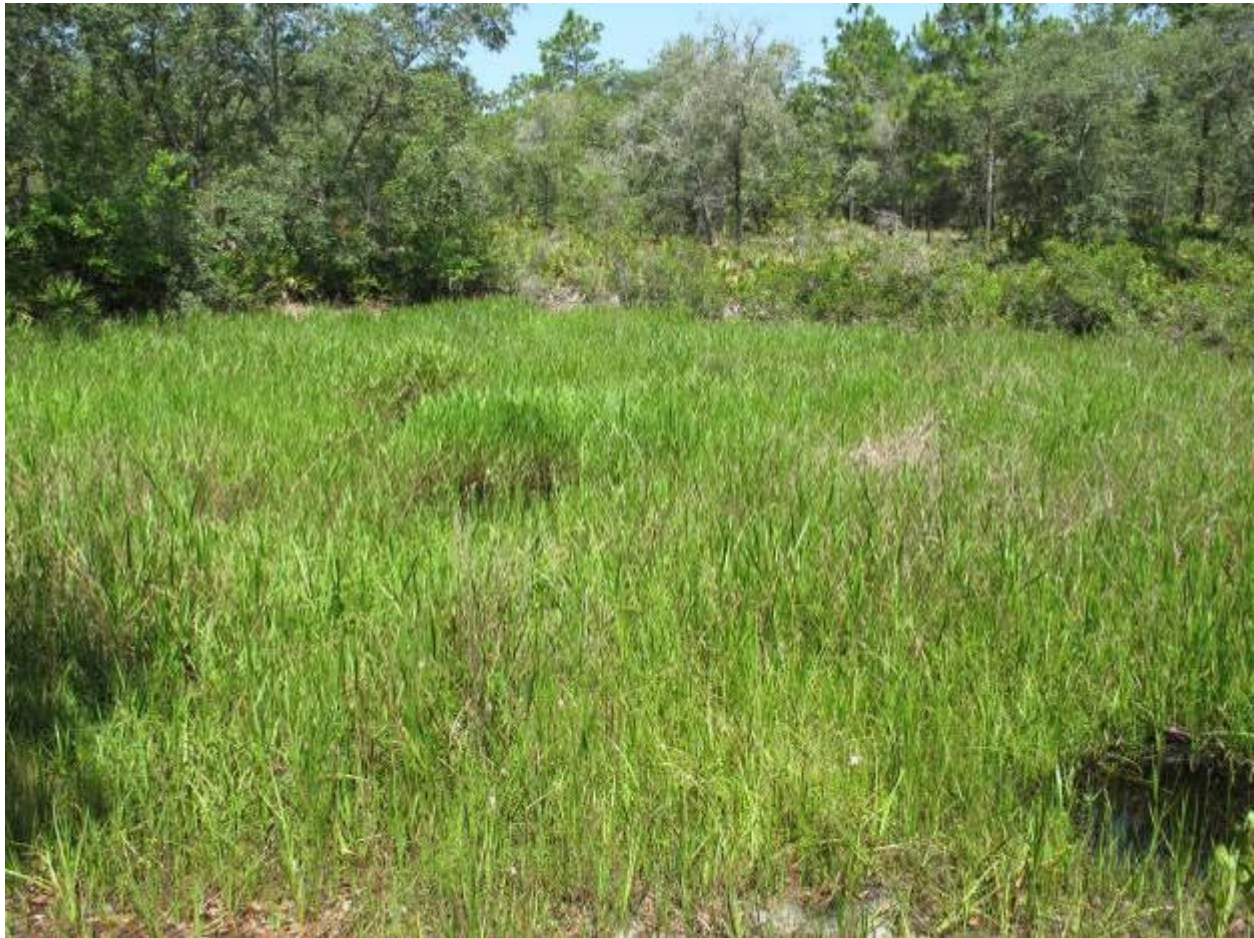
Wetland ID: 05F-03

Description: This wetland is a 0.1 ha ephemeral marsh. There is no canopy or midstory cover. Sedges/grasses and maidencane grow throughout the wetland, and cover >75% of the basin. Feral hog damage is minimal. Saw palmetto grows in a thick ring around the wetland. The adjacent uplands are fire-suppressed sandhills and currently are managed with mechanical treatments.

Wetland Concerns: Feral hog damage

Restoration Action Recommended: Because of the widespread damage to ephemeral wetlands on CWMA, we recommend aggressive action to reduce the overall numbers of feral hogs on the property.

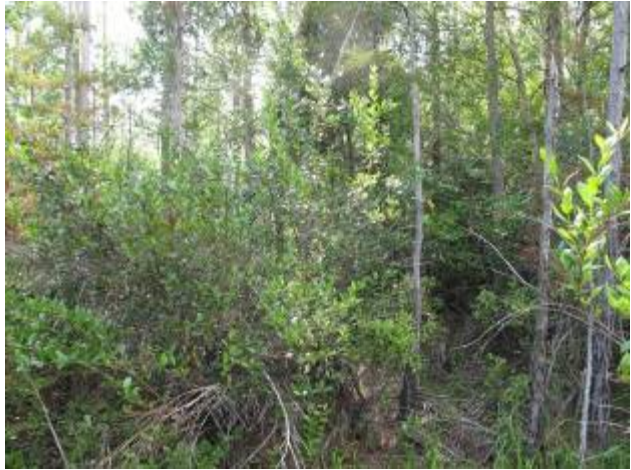
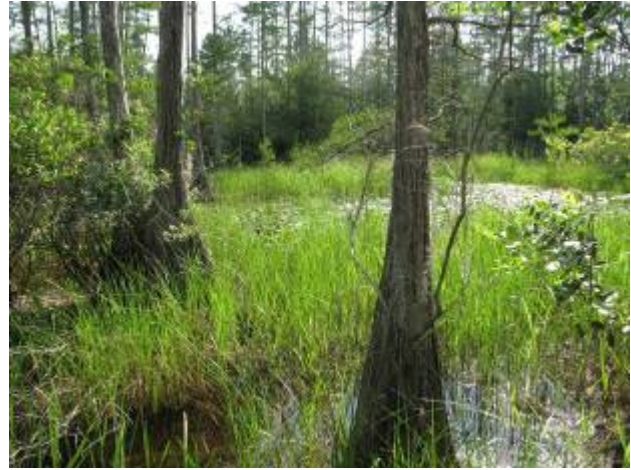
Wetland ID: 07F-01

Description: This wetland is a 0.6 ha semi-permanent mixed swamp. Cypress and holly trees dominate the canopy, and cover 50-75% of the wetland. The midstory is dominated by wax myrtle, fetterbush, and holly, and covers 50-75% of the wetland. Sedges/grasses and maidencane grow in scattered patches, and cover 25-50% of the wetland basin. The wetland is surrounded by a thick ring of brush and saw palmetto. The adjacent uplands are sandhills and currently are managed with mechanical treatments.

Wetland Concerns: Woody encroachment

Restoration Action Recommended: Encourage periodic fire in the wetland to prevent further shrub encroachment.

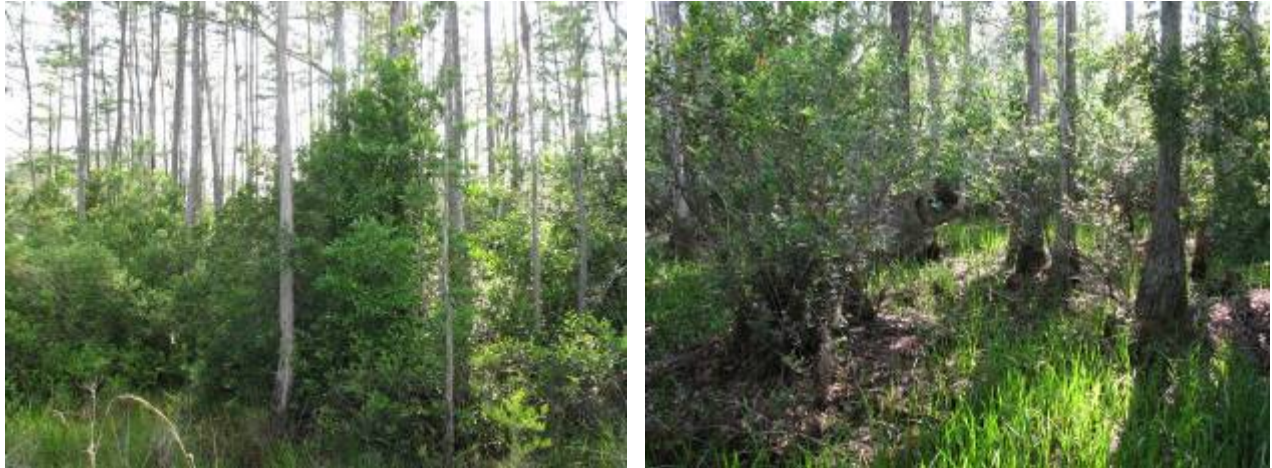
Wetland ID: 07F-02

Description: This wetland is a 0.3 ha ephemeral mixed swamp. Cypress trees dominate the canopy, and cover >75% of the wetland. The midstory is dominated by fetterbush, wax myrtle, and holly, and covers 50-75% of the wetland. Redroot and fern grow in scattered patches, and cover 25-50% of the wetland basin. There is evidence of previous fire around the wetland edge and a thick layer of duff in the wetland. Feral hog damage is old and recovering. The adjacent uplands are sandhills and currently are managed with mechanical treatments.

Wetland Concerns: Feral hog damage, Woody encroachment

Restoration Action Recommended: Because of the widespread damage to ephemeral wetlands on CWMA, we recommend aggressive action to reduce the overall numbers of feral hogs on the property. Encourage periodic fire in the wetland to prevent further shrub encroachment.

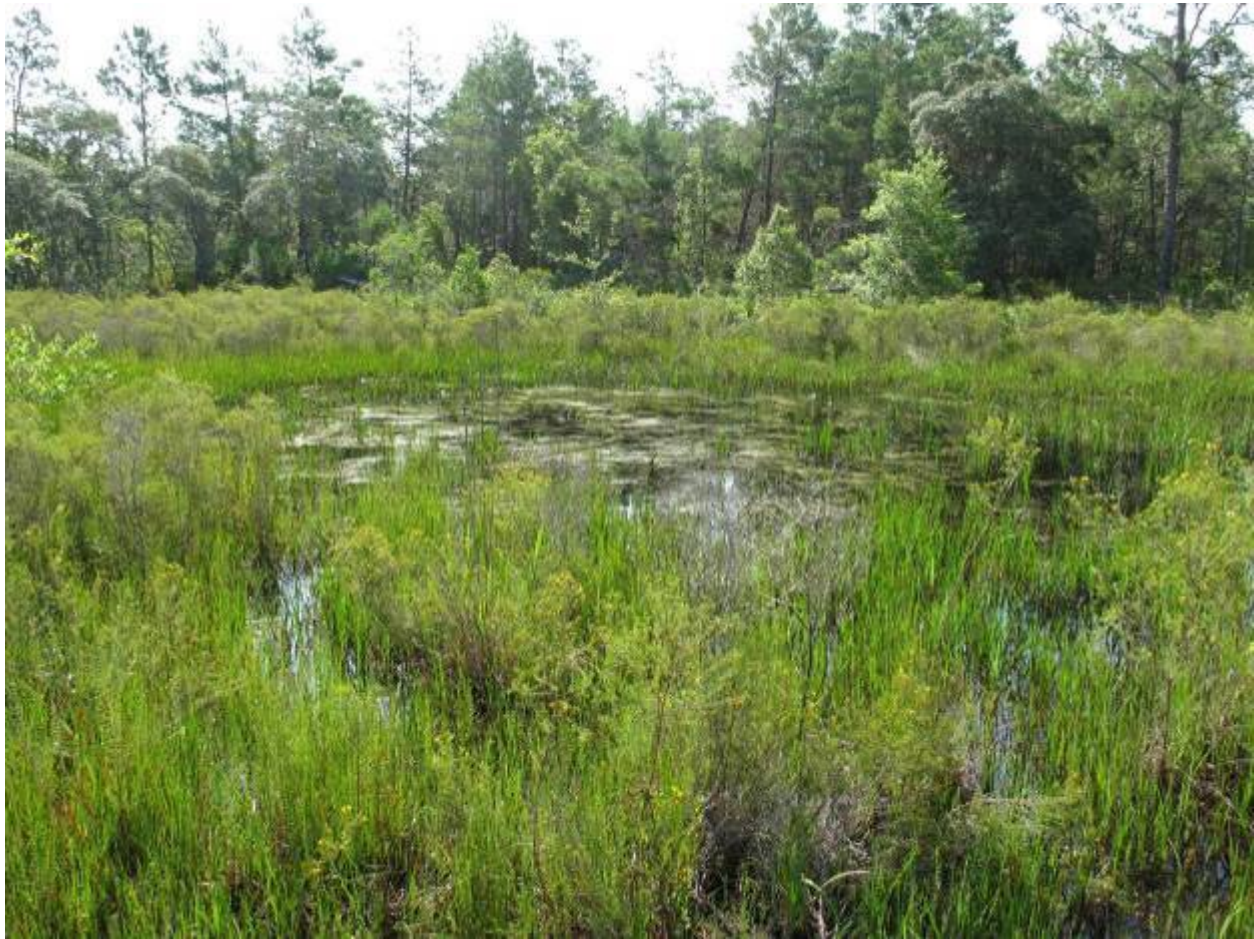
Wetland ID: 07F-03

Description: This wetland is a 0.3 ha ephemeral marsh. There is no tree canopy. *Hypericum* covers 25-50% of the wetland. Sedges/grasses and redroot grow throughout the wetland, and cover >75% of the basin. Past feral hog damage has re-vegetated with redroot and new feral hog damage is minor. The wetland is surrounded by a thick ring of *Hypericum*. This marsh is in fire-maintenance condition and is a potential striped newt breeding pond. The adjacent uplands are sandhills and currently are managed with mechanical treatments.

Wetland Concerns: Feral hog damage

Restoration Action Recommended: Because of the widespread damage to ephemeral wetlands on CWMA, we recommend aggressive action to reduce the overall numbers of feral hogs on the property.

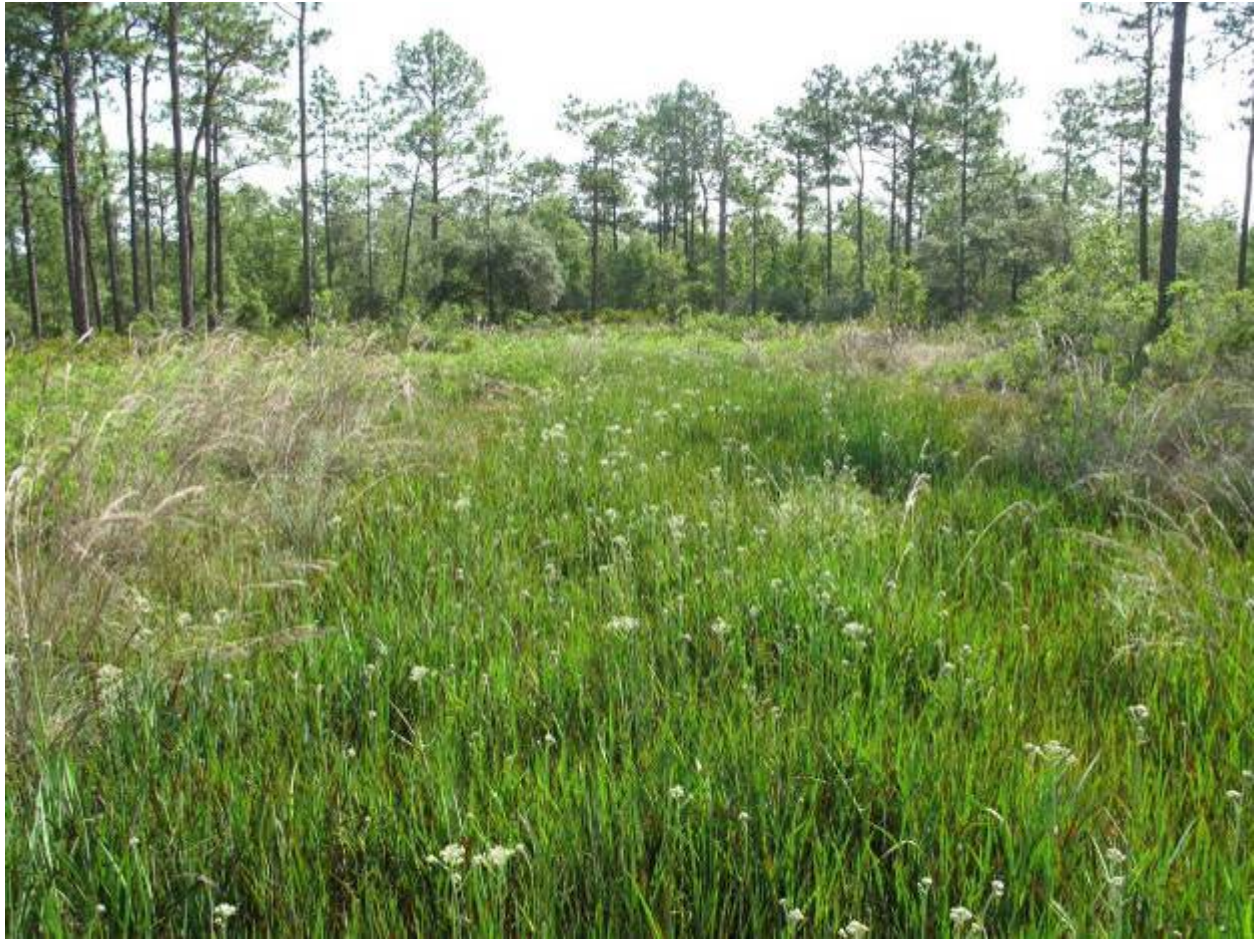
Wetland ID: 07F-04

Description: This wetland is a 0.1 ha ephemeral marsh. There is no canopy or midstory cover. Sedges/grasses and redroot grow throughout the wetland, and cover >75% of the basin. This wetland has extensive, old feral hog damage that has grown over with redroot. This wetland is in fire maintenance condition. The adjacent uplands are sandhills and currently are managed with mechanical treatments.

Wetland Concerns: Feral hog damage

Restoration Action Recommended: Because of the widespread damage to ephemeral wetlands on CWMA, we recommend aggressive action to reduce the overall numbers of feral hogs on the property.

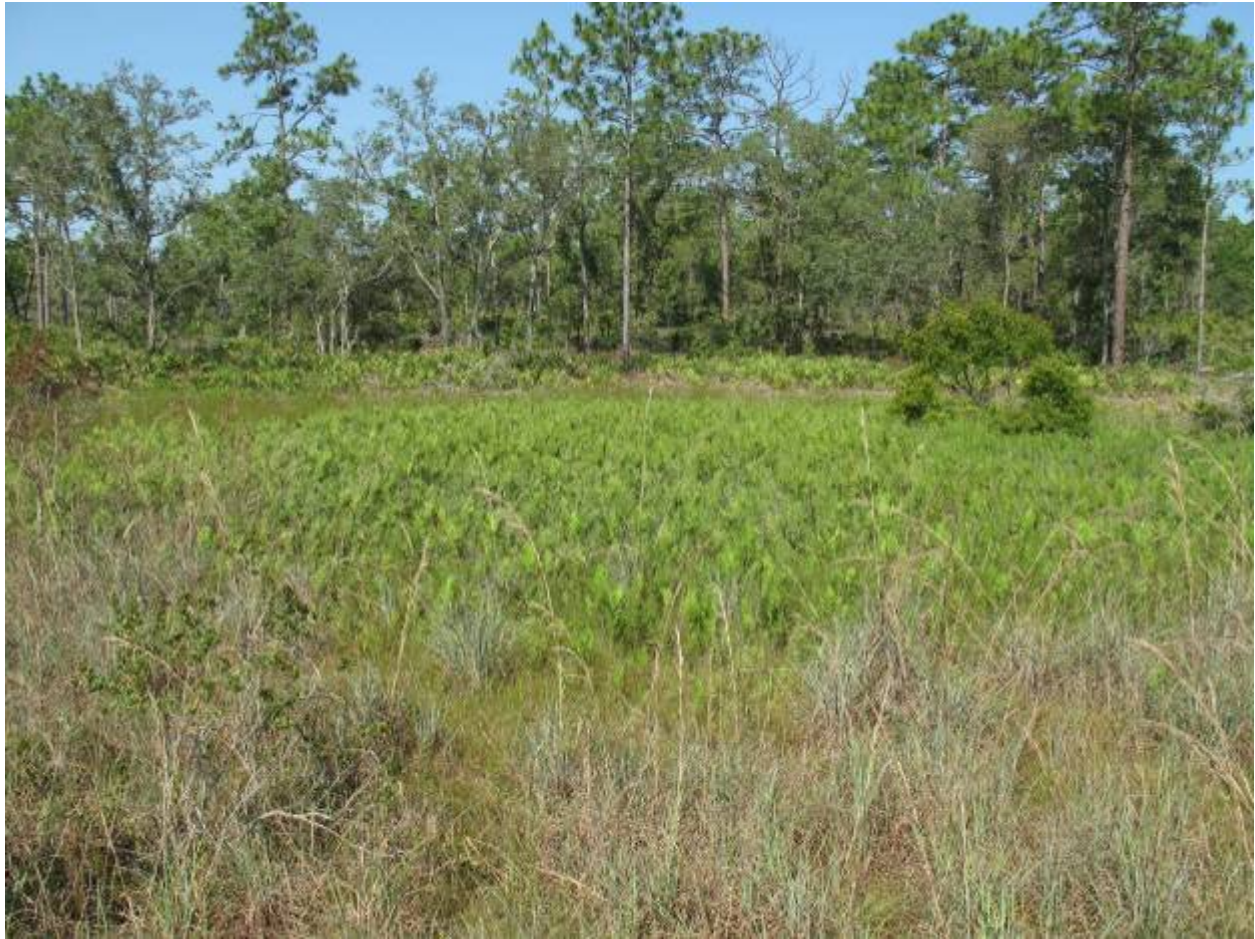
Wetland ID: 07F-05

Description: This wetland is a 0.1 ha ephemeral marsh. There is no canopy or midstory cover. Sedges/grasses and fern grow throughout the wetland, and cover >75% of the basin. This marsh is in fire-maintenance condition and is a potential striped newt breeding pond. The adjacent uplands are sandhills and currently are managed with mechanical treatments.

Wetland Concerns: None

Restoration Action Recommended: None

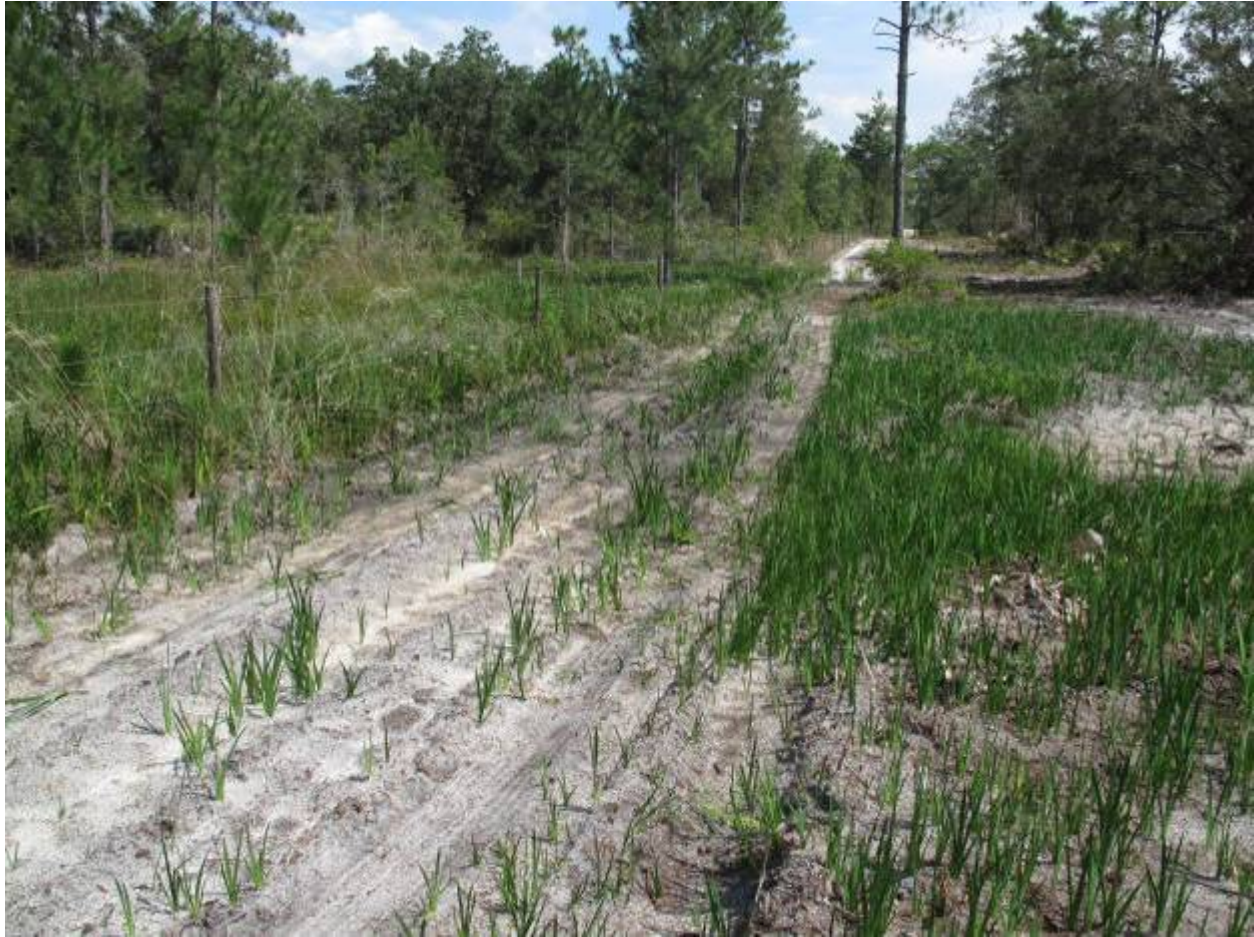
Wetland ID: 08F-01

Description: This wetland is a 0.1 ha ephemeral marsh. There is no canopy or midstory cover. Redroot grows throughout the wetland, and covers >75% of the basin. A property boundary/fireline and fence bisect the center of the wetland. The wetland has some feral hog damage. The adjacent uplands are fire suppressed sandhills and currently are managed with mechanical treatments.

Wetland Concerns: Feral hog damage, Property boundary/fireline

Restoration Action Recommended: Because of the widespread damage to ephemeral wetlands on CWMA, we recommend aggressive action to reduce the overall numbers of feral hogs on the property. The fireline/boundary should be re-routed away from the wetland if feasible. If the fireline cannot be re-routed, monitor the wetland to ensure fire is not excluded. Maintain the fireline when the wetland is completely dry to prevent ruts from developing.

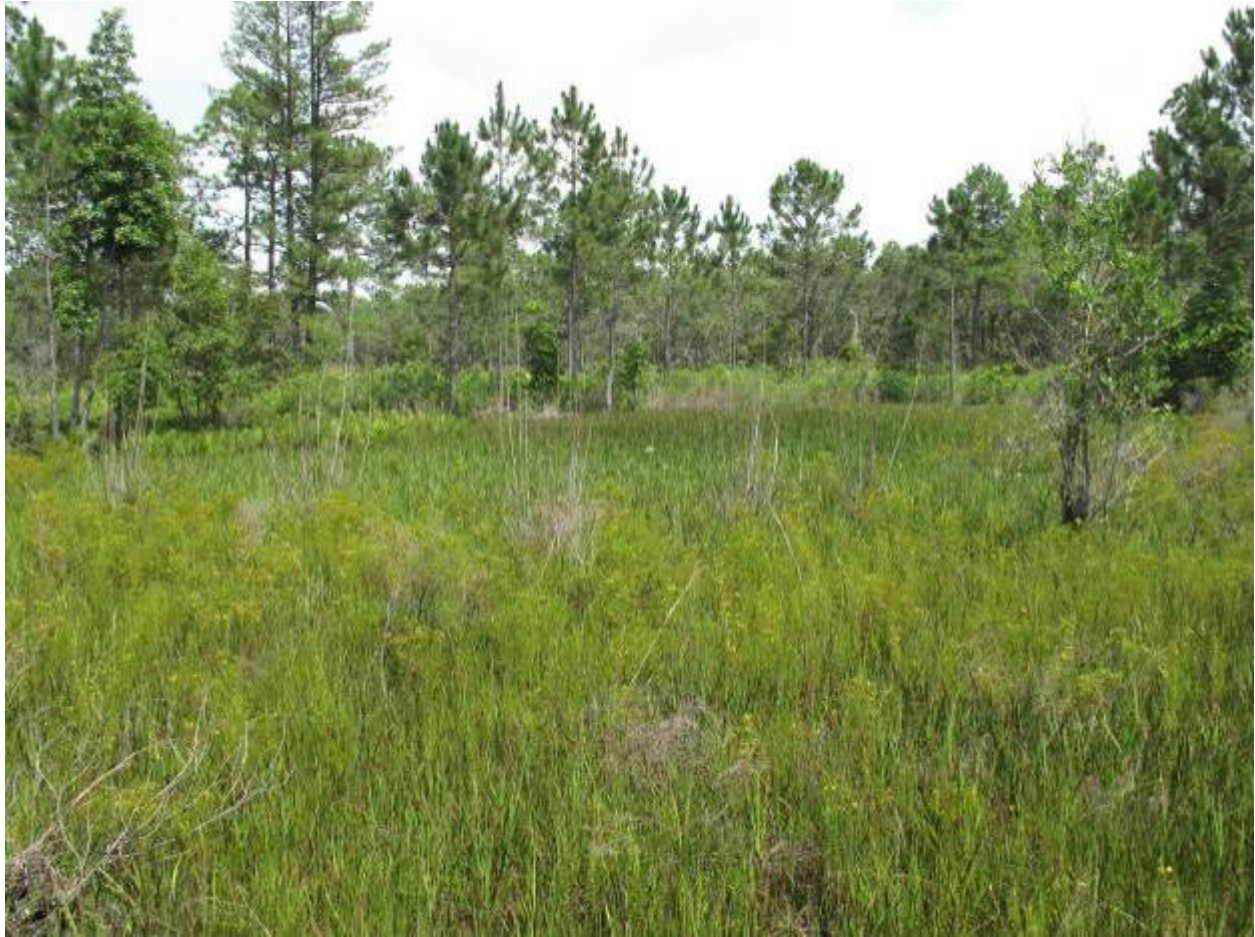
Wetland ID: 02G-01

Description: This wetland is a 0.1 ha ephemeral marsh. There is no tree canopy. *Hypericum* covers 5-25% of the wetland. Sedges/grasses and redroot grow throughout the wetland, and cover >75% of the basin. Feral hog damage is old and grown over with redroot. The rooting pock marks have eroded. The adjacent uplands are a mix of flatwoods, xeric hammock, and scrubby flatwoods and currently are managed with mechanical treatments. The mechanically treated area directly adjacent to the wetland looks very good.

Wetland Concerns: Feral hog damage

Restoration Action Recommended: Because of the widespread damage to ephemeral wetlands on CWMA, we recommend aggressive action to reduce the overall numbers of feral hogs on the property.

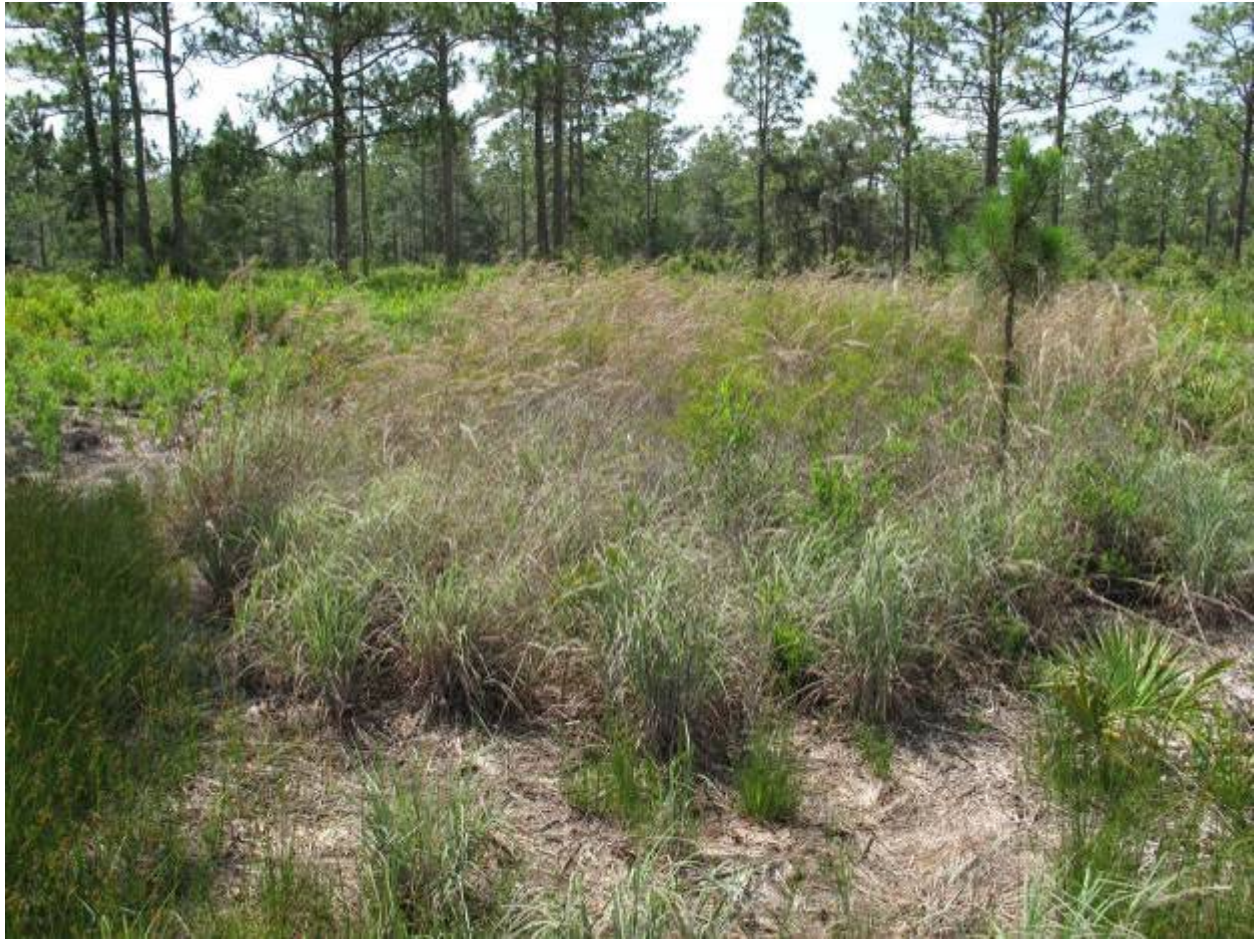
Wetland ID: 02G-02

Description: This wetland is a <0.1 ha highly ephemeral marsh. There is no tree canopy. *Hypericum* covers 5-25% of the wetland. Sedges/grasses grow throughout the wetland, and cover >75% of the basin. The adjacent uplands are a mix of sandhill, xeric hammock, and mesic flatwoods and currently are managed with mechanical treatments. The mechanically treated area directly adjacent to the wetland looks very good.

Wetland Concerns: None

Restoration Action Recommended: None

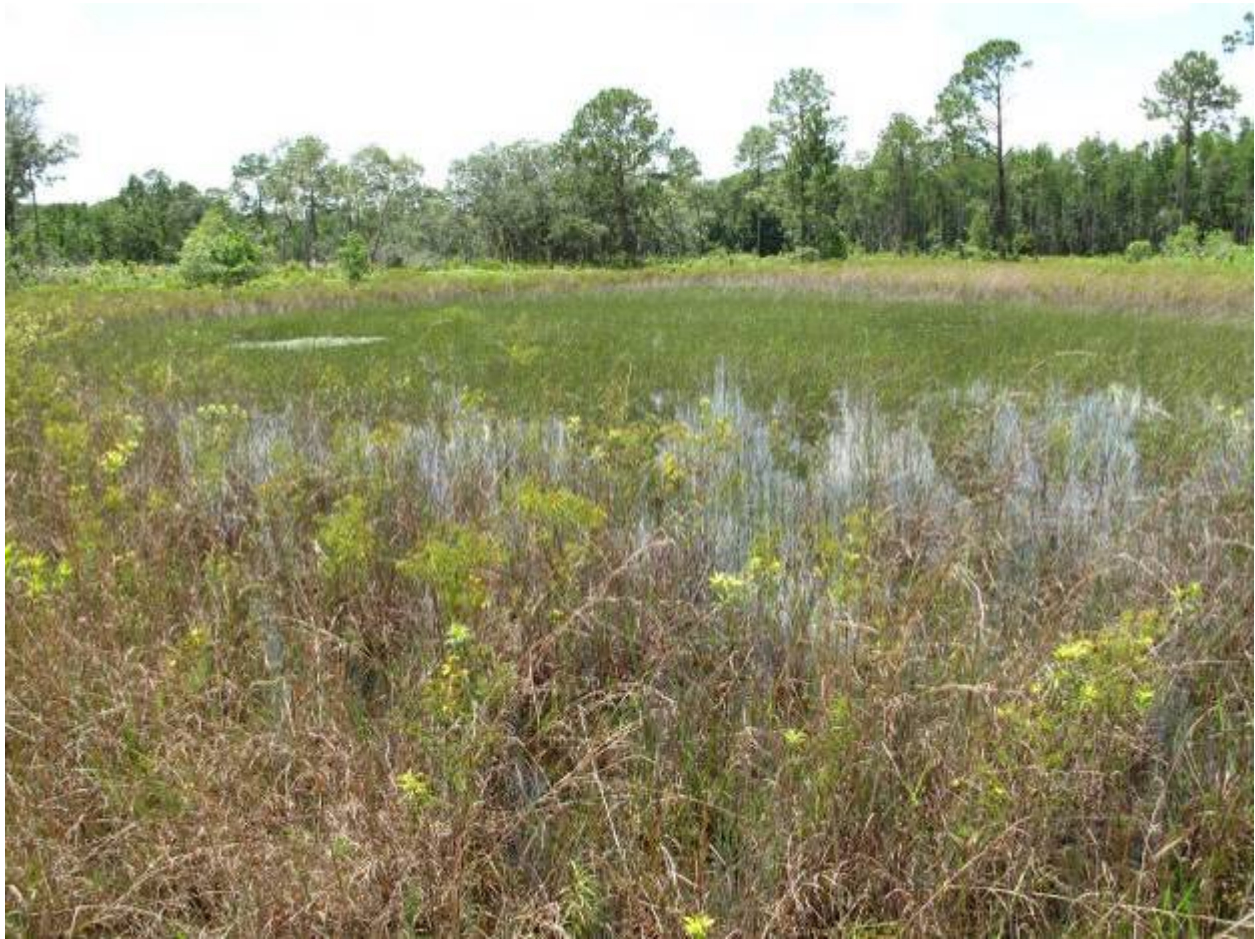
Wetland ID: 03G-01

Description: This wetland is a 0.6 ha ephemeral marsh. There is no tree canopy. *Hypericum* grows in a ring around the wetland, and covers 5-25% of the basin. Sedges/grasses and maidencane grow throughout the wetland, and cover >75% of the basin. Feral hog damage is old and minor. The rare corkwood plant (*Leitneria* sp.) is present in the *Hypericum* ring. This wetland is a potential striped newt breeding pond and has diverse herbaceous vegetation and a nice littoral zone. The adjacent uplands are fire suppressed sandhills and currently are managed with mechanical treatments.

Wetland Concerns: Feral hog damage

Restoration Action Recommended: Because of the widespread damage to ephemeral wetlands on CWMA, we recommend aggressive action to reduce the overall numbers of feral hogs on the property.

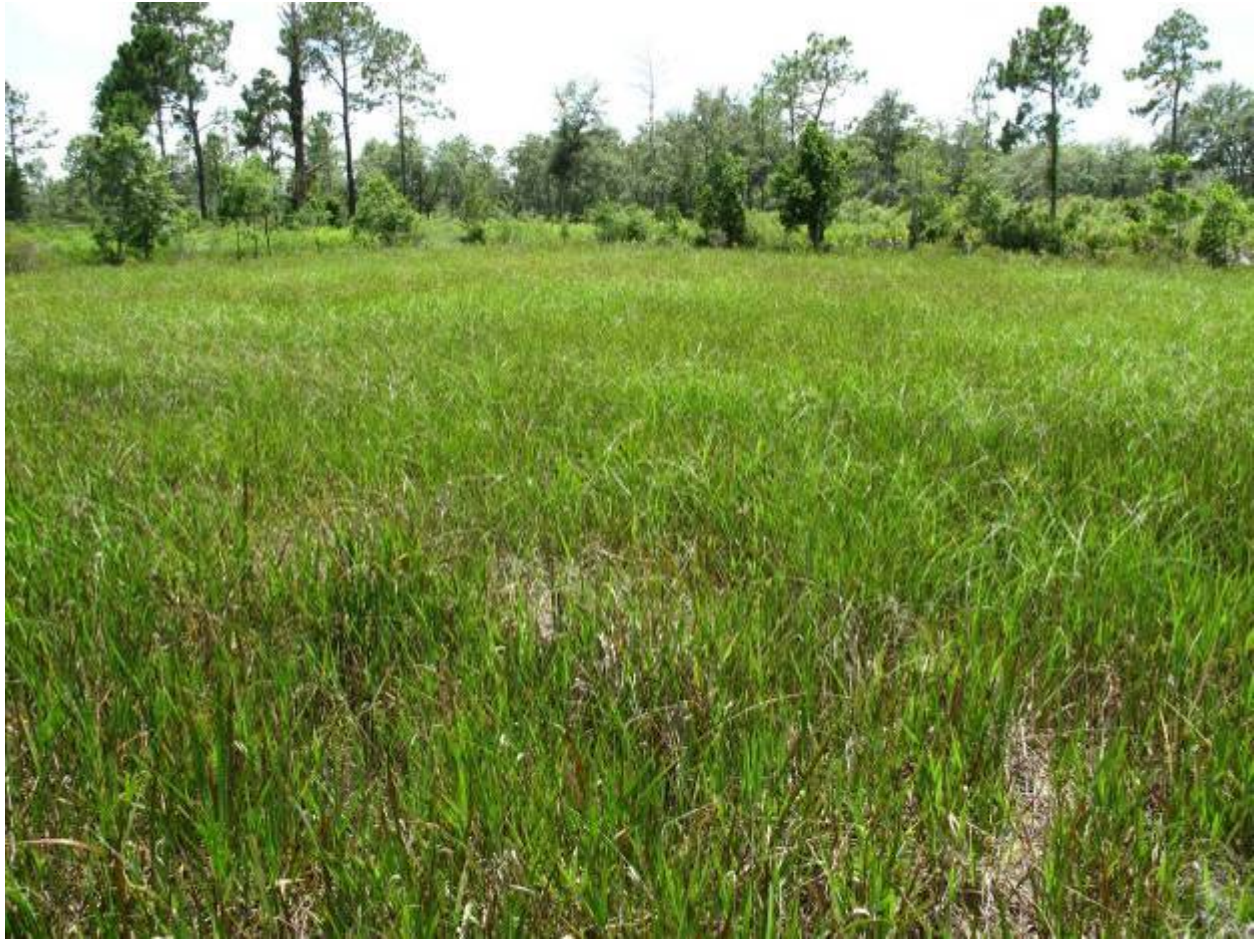
Wetland ID: 03G-02

Description: This wetland is a 0.2 ha ephemeral marsh. There is no canopy or midstory cover. Sedges/grasses grow throughout the wetland, and cover >75% of the basin. Feral hog damage is old and minor and is grown over with vegetation. This wetland is a potential striped newt breeding pond and has diverse herbaceous vegetation. The adjacent uplands are fire suppressed sandhills and currently are managed with mechanical treatments.

Wetland Concerns: Feral hog damage

Restoration Action Recommended: Because of the widespread damage to ephemeral wetlands on CWMA, we recommend aggressive action to reduce the overall numbers of feral hogs on the property.

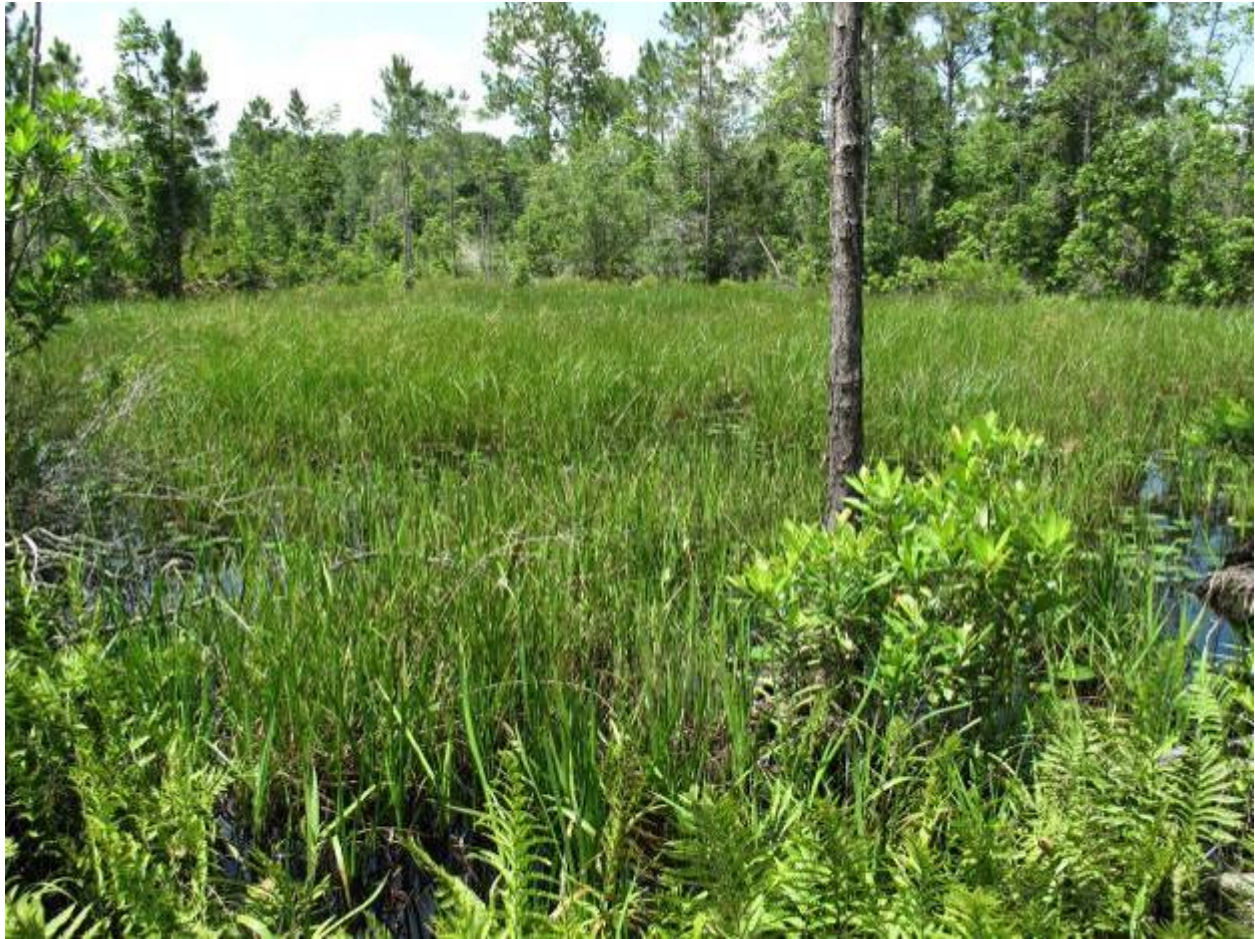
Wetland ID: 03G-03

Description: This wetland is a 0.2 ha semi-permanent marsh. There is no tree canopy. Fetterbush, holly, and bay grow in a dense ring around the wetland, and cover 5-25% of the basin. Sedges/grasses grow throughout the wetland, and cover >75% of the basin. The adjacent uplands are fire suppressed sandhills and scrubby flatwoods and currently are managed with mechanical treatments.

Wetland Concerns: Woody encroachment

Restoration Action Recommended: Encourage periodic fire in the wetland to prevent further shrub encroachment.

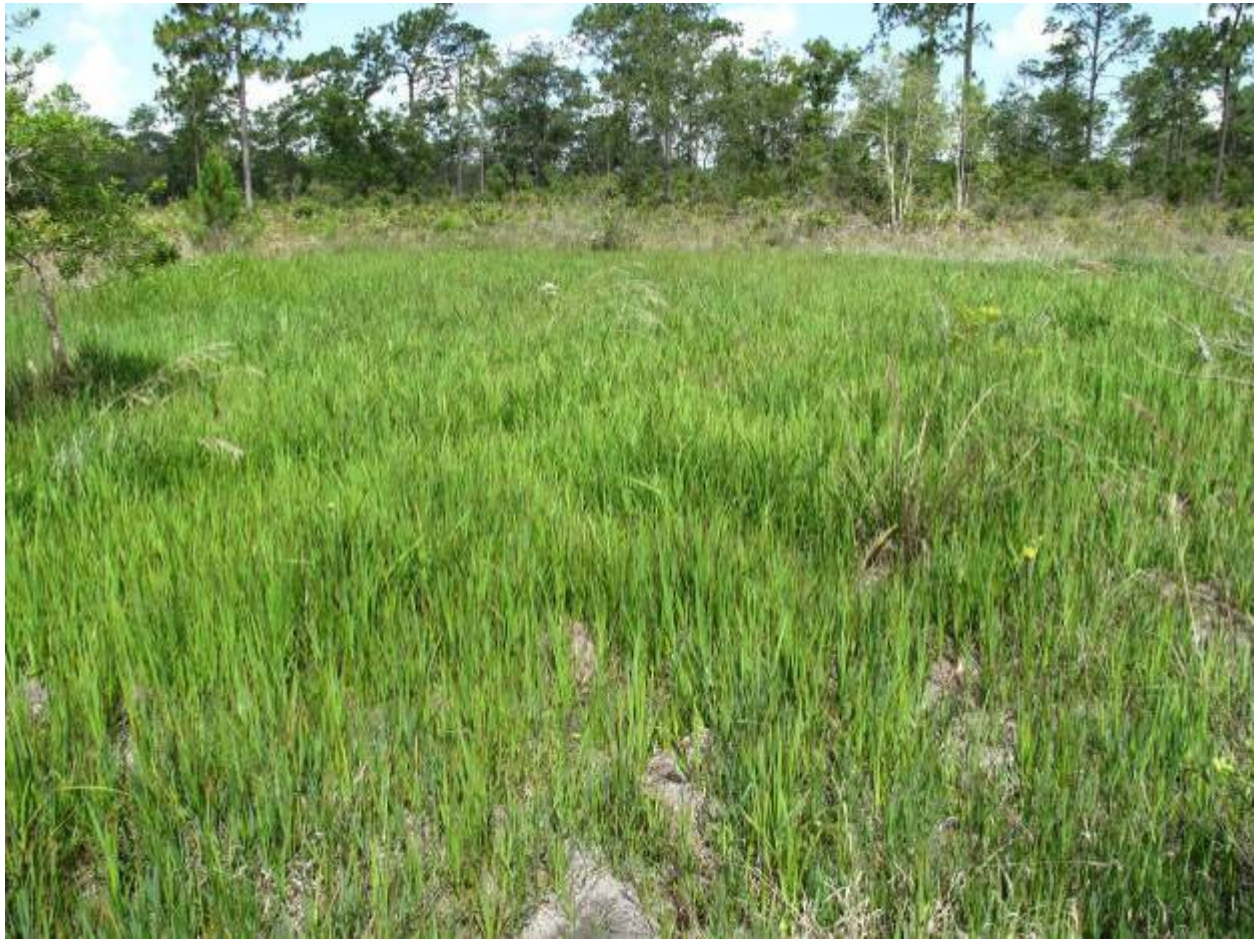
Wetland ID: 04G-01

Description: This wetland is a 0.1 ha ephemeral marsh. There is no canopy or midstory cover. Redroot grows throughout the wetland, and covers >75% of the basin. Feral hog damage is extensive. The adjacent uplands are fire suppressed sandhills and currently are managed with mechanical treatments.

Wetland Concerns: Feral hog damage

Restoration Action Recommended: Because of the widespread damage to ephemeral wetlands on CWMA, we recommend aggressive action to reduce the overall numbers of feral hogs on the property.

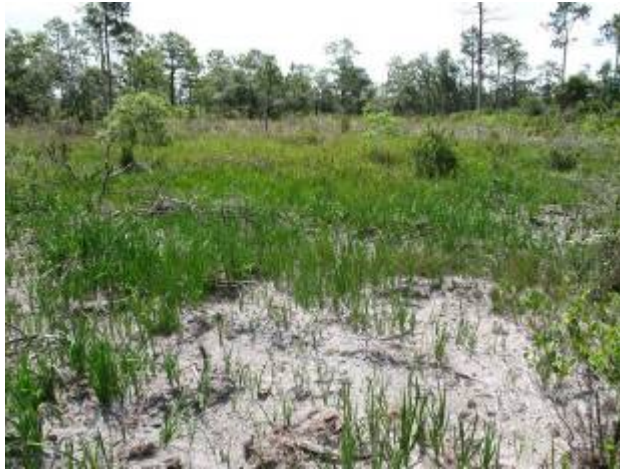
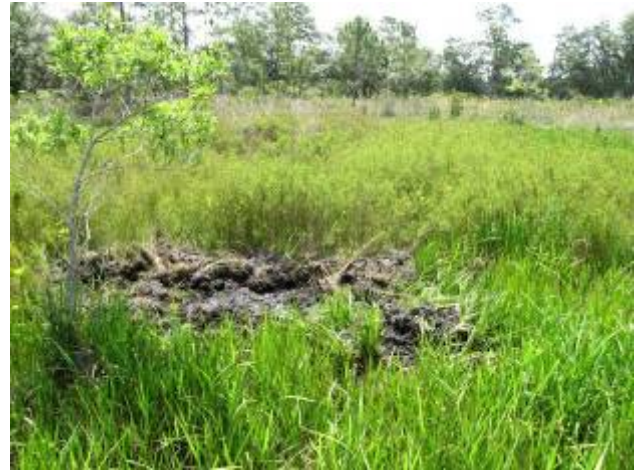
Wetland ID: 04G-02

Description: This wetland is a 0.2 ha ephemeral marsh. There is no tree canopy. *Hypericum* covers 50-75% of the wetland. Maidencane, sedges/grasses, and redroot grow throughout the wetland, and cover >75% of the basin. The wetland has extensive old and new feral hog damage. The adjacent uplands are fire suppressed sandhills and currently are managed with mechanical treatments.

Wetland Concerns: Feral hog damage

Restoration Action Recommended: Because of the widespread damage to ephemeral wetlands on CWMA, we recommend aggressive action to reduce the overall numbers of feral hogs on the property.

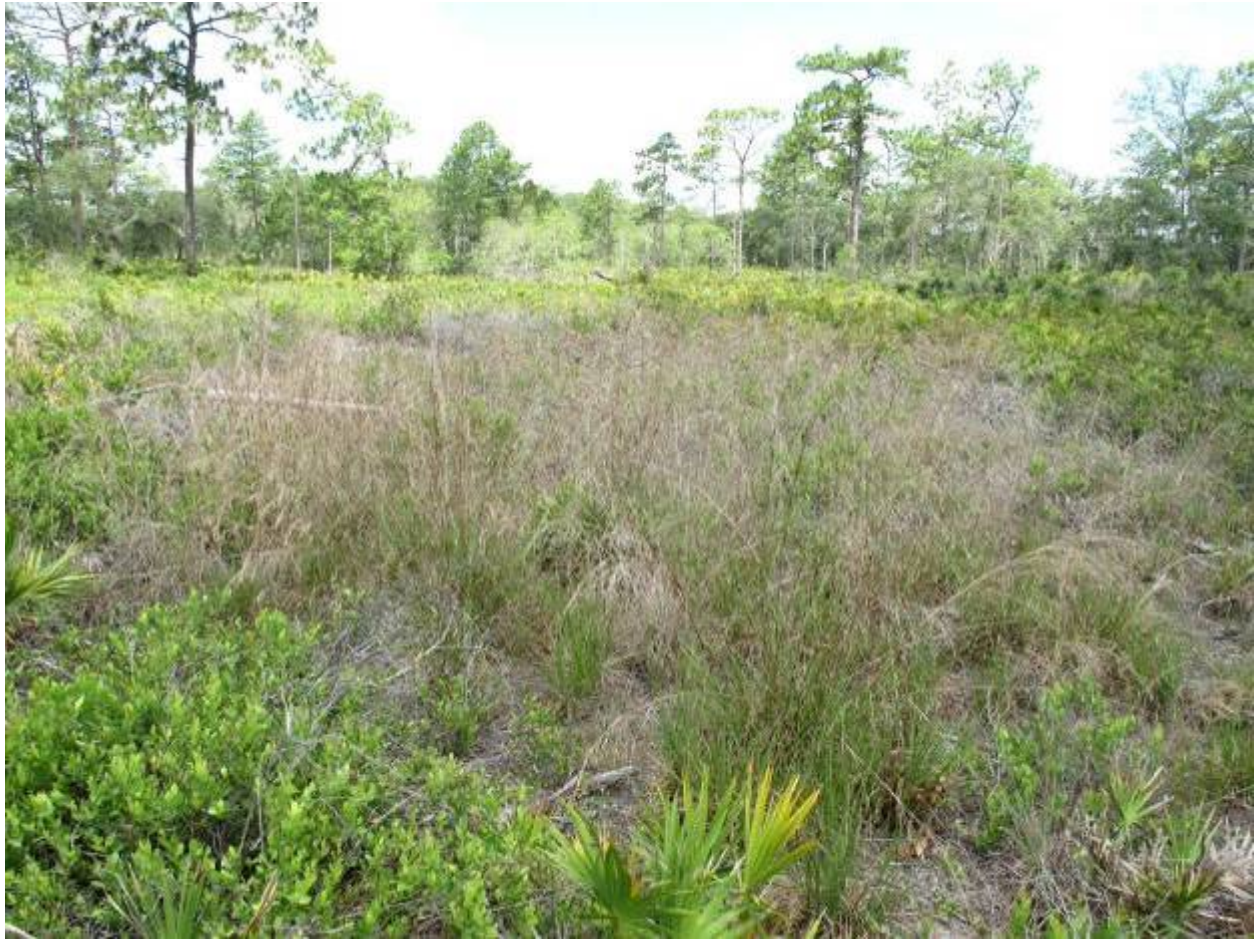
Wetland ID: 04G-03

Description: This wetland is a <0.1 ha highly ephemeral marsh. There is no tree canopy. Fetterbush covers 5-25% of the wetland. Sedges/grasses grow throughout the wetland, and cover >75% of the basin. There is minor feral hog damage in the wetland. The adjacent uplands are fire suppressed sandhills and currently are managed with mechanical treatments.

Wetland Concerns: Feral hog damage

Restoration Action Recommended: Because of the widespread damage to ephemeral wetlands on CWMA, we recommend aggressive action to reduce the overall numbers of feral hogs on the property.

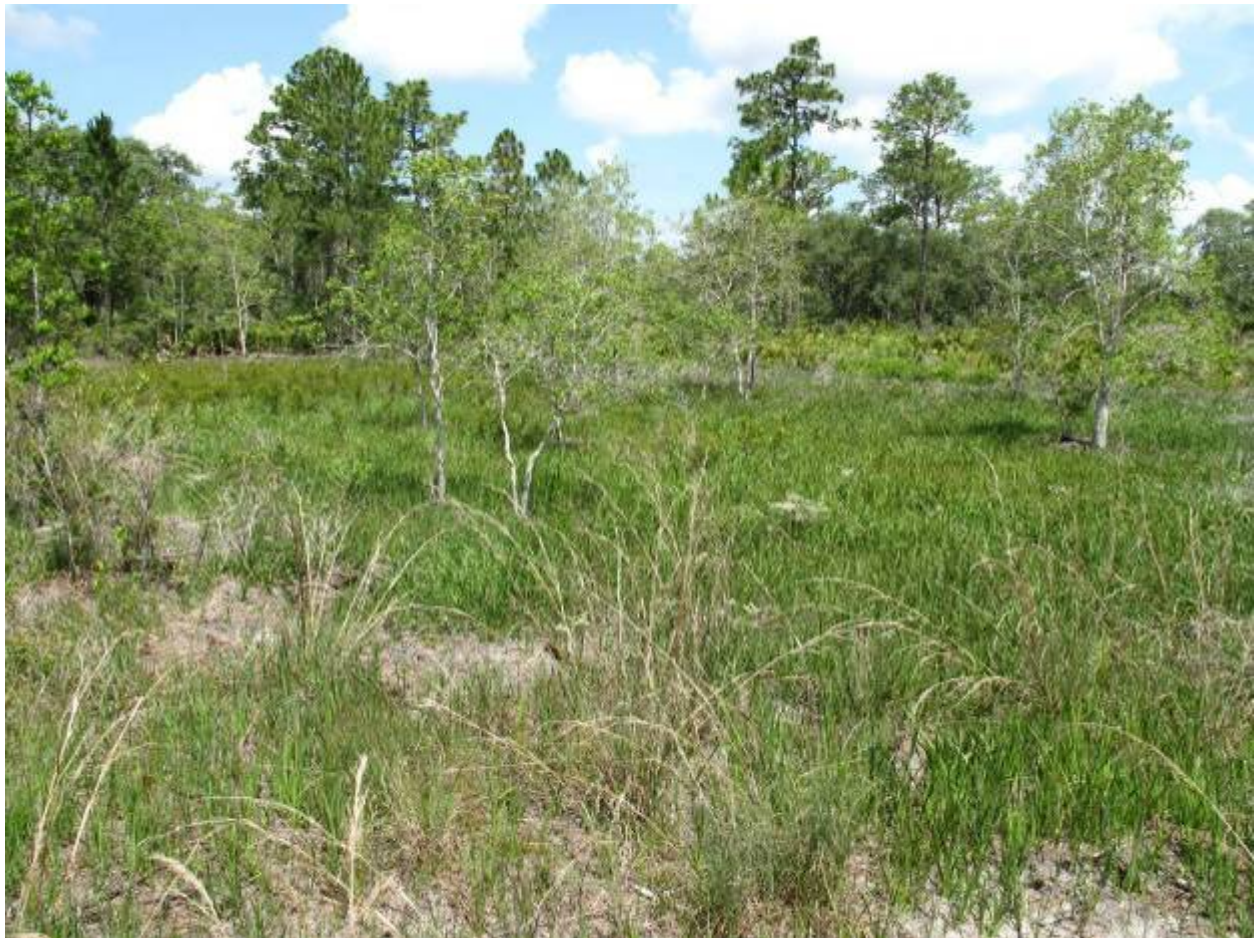
Wetland ID: 04G-04

Description: This wetland is a 0.1 ha ephemeral marsh. Several holly trees grow throughout the wetland and cover 5-25% of the basin. Sedges/grasses and redroot grow throughout the wetland, and cover >75% of the basin. The wetland has extensive old and new feral hog damage that is mostly grown over with redroot. The adjacent uplands are fire suppressed sandhills and currently are managed with mechanical treatments.

Wetland Concerns: Feral hog damage

Restoration Action Recommended: Because of the widespread damage to ephemeral wetlands on CWMA, we recommend aggressive action to reduce the overall numbers of feral hogs on the property.

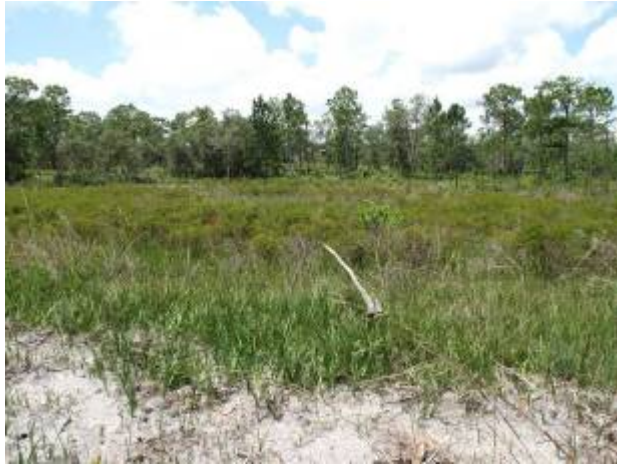
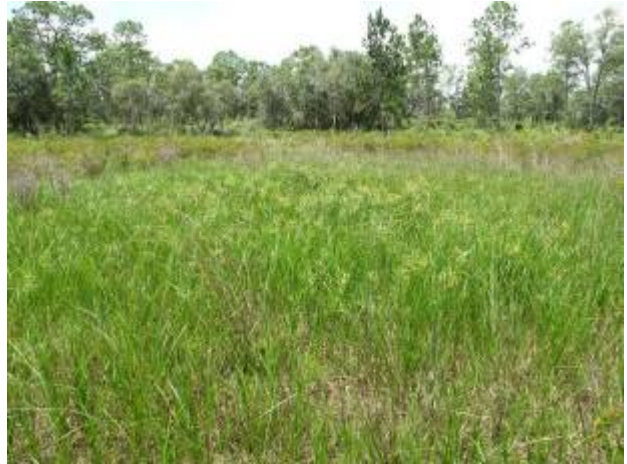
Wetland ID: 04G-05

Description: This wetland is a 0.4 ha ephemeral marsh. There is no tree canopy. *Hypericum* covers 5-25% of the wetland. A diverse array of sedges/grasses grows throughout the wetland, and covers >75% of the basin. The wetland has minor feral hog damage around some of the edge. This marsh is in fire-maintenance condition and is a potential striped newt breeding pond. The adjacent uplands are fire suppressed sandhills and currently are managed with mechanical treatments.

Wetland Concerns: Feral hog damage

Restoration Action Recommended: Because of the widespread damage to ephemeral wetlands on CWMA, we recommend aggressive action to reduce the overall numbers of feral hogs on the property.

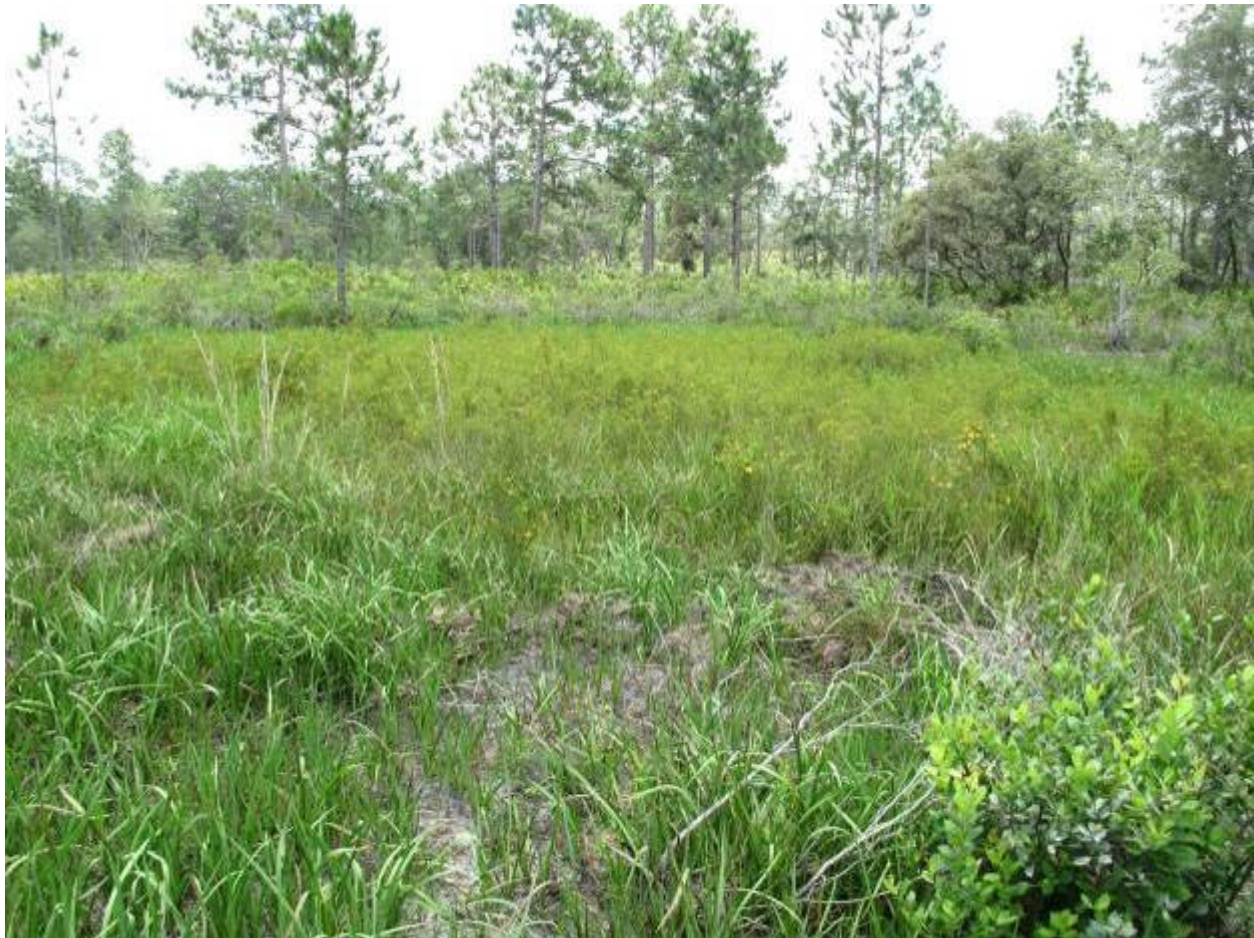
Wetland ID: 04G-06

Description: This wetland is a 0.1 ha ephemeral marsh. There is no tree canopy. *Hypericum* covers 50-75% of the wetland. Maidencane and redroot grow throughout the wetland, and cover >75% of the basin. The wetland has moderate feral hog damage. The adjacent uplands are fire suppressed sandhills and currently are managed with mechanical treatments.

Wetland Concerns: Feral hog damage

Restoration Action Recommended: Because of the widespread damage to ephemeral wetlands on CWMA, we recommend aggressive action to reduce the overall numbers of feral hogs on the property.

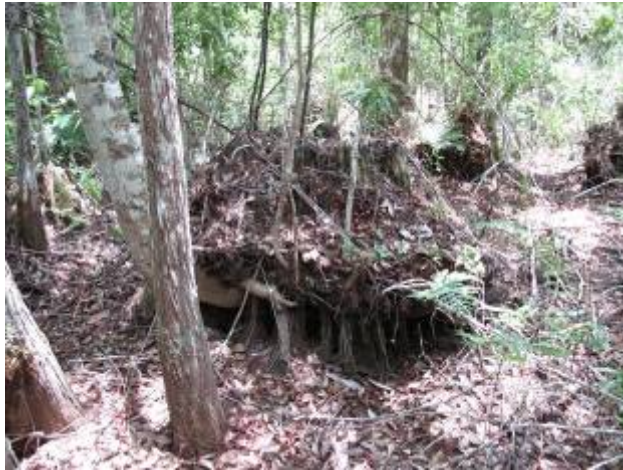
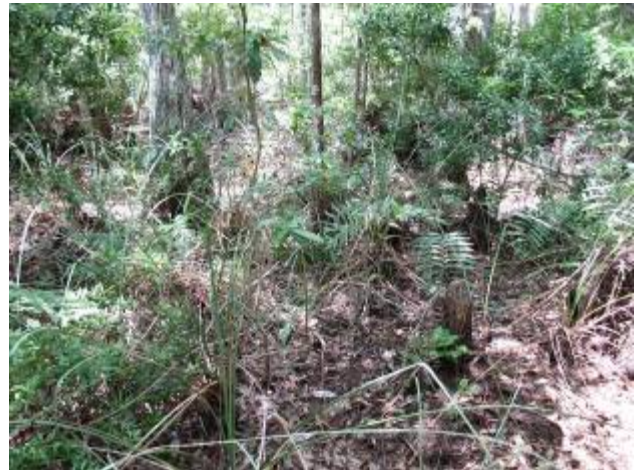
Wetland ID: 04G-07

Description: This wetland is a 2.1 ha ephemeral mixed swamp. Cypress and holly trees dominate the canopy, and cover >75% of the wetland. The midstory is dominated by wax myrtle, and covers 50-75% of the wetland. Sawgrass grows in scattered patches, and covers 5-25% of the wetland basin. The wetland has very thick duff and moderately thick brush. The adjacent uplands are fire suppressed sandhills and currently are managed with mechanical treatments.

Wetland Concerns: Woody encroachment

Restoration Action Recommended: Encourage periodic fire in the wetland to reduce the thick brush and duff layer.
