Inventory, Assessment, and Restoration Potential of Ephemeral Wetlands on FFWCC Wildlife Management Areas

Chassahowitzka WMA Final Report

Submitted by: Rebecca P.M. Means¹, Ryan C. Means¹, Steven A. Johnson²

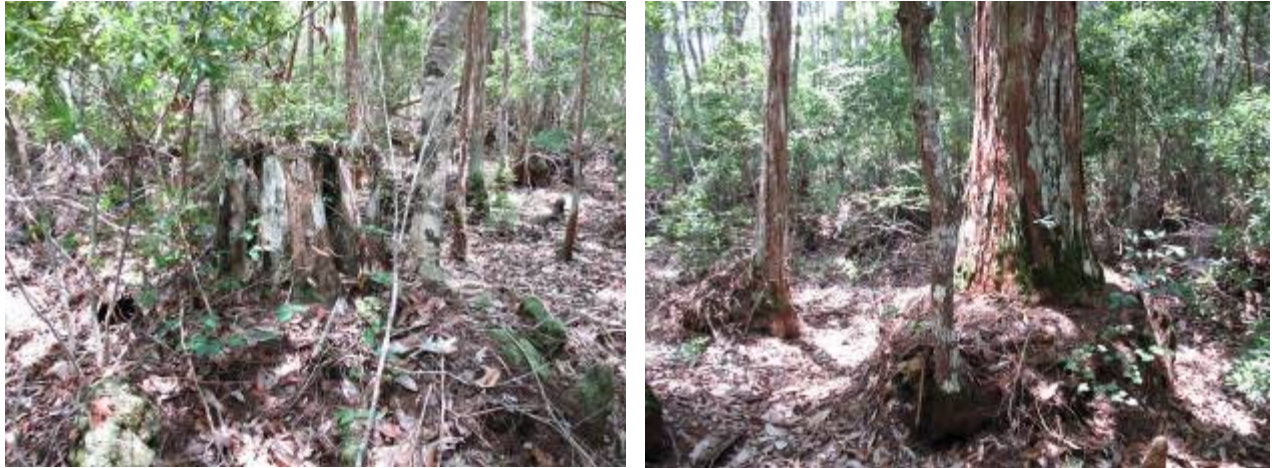
Wetland ID: 04G-08

Description: This wetland is a 0.8 ha ephemeral mixed swamp. Cypress and holly trees dominate the canopy, and cover >75% of the wetland. The midstory is dominated by wax myrtle, and covers 50-75% of the wetland. There is no herbaceous cover. The wetland has very thick duff and moderately thick brush. The adjacent uplands are fire suppressed sandhills and currently are managed with mechanical treatments.

Wetland Concerns: Woody encroachment

Restoration Action Recommended: Encourage periodic fire in the wetland to reduce the thick brush and duff layer.

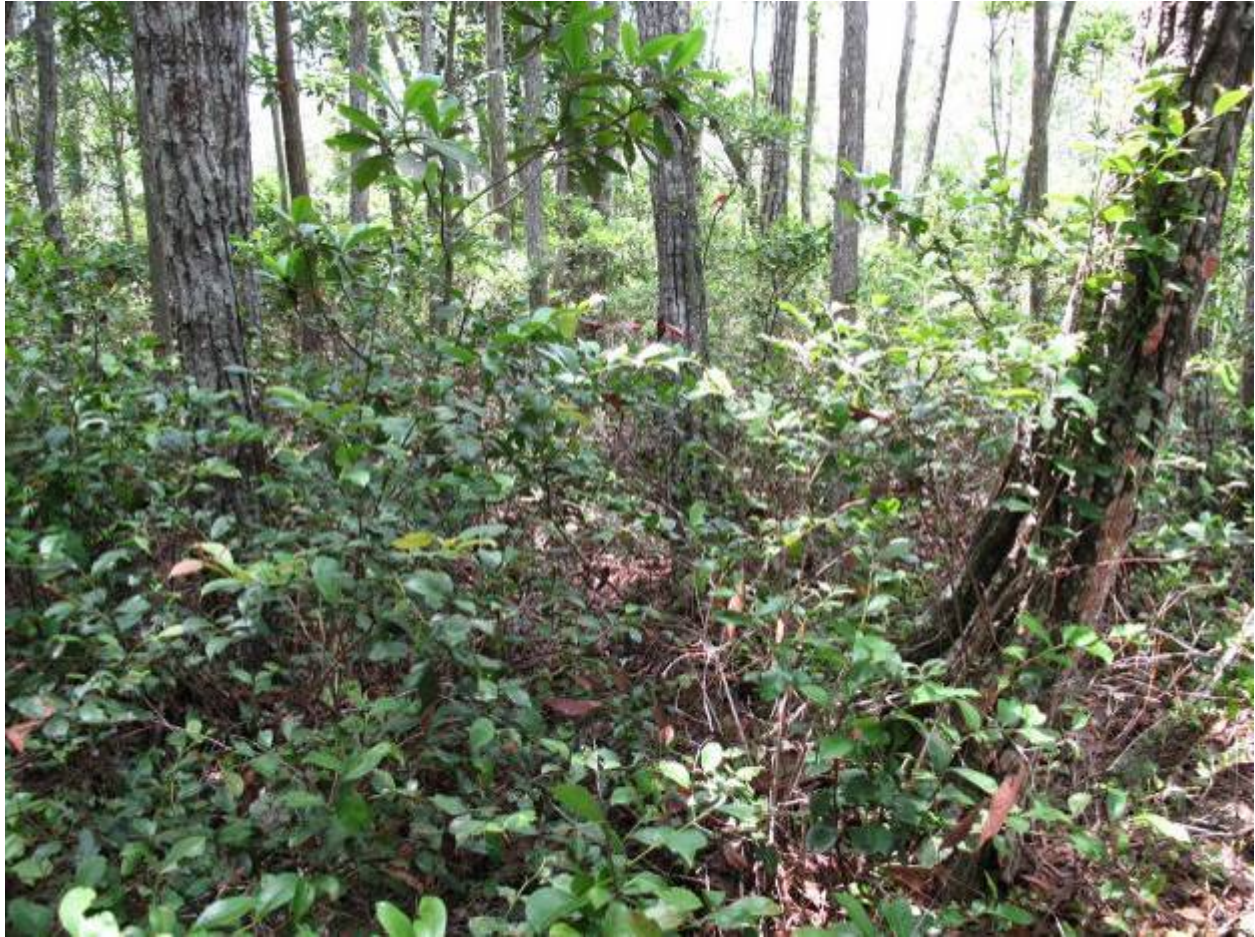
Wetland ID: 04G-09

Description: This wetland is a 0.7 ha ephemeral mixed swamp. Cypress and loblolly bay trees dominate the canopy, and cover >75% of the wetland. The midstory is dominated by wax myrtle, fetterbush, and young loblolly bay trees, and covers >75% of the wetland. There is no herbaceous vegetation. The wetland has very thick duff and dense shrubs, especially around the wetland edge. The adjacent uplands are fire suppressed sandhills and currently are managed with mechanical treatments.

Wetland Concerns: Woody encroachment

Restoration Action Recommended: Encourage periodic fire in the wetland to reduce the thick brush and duff layer.

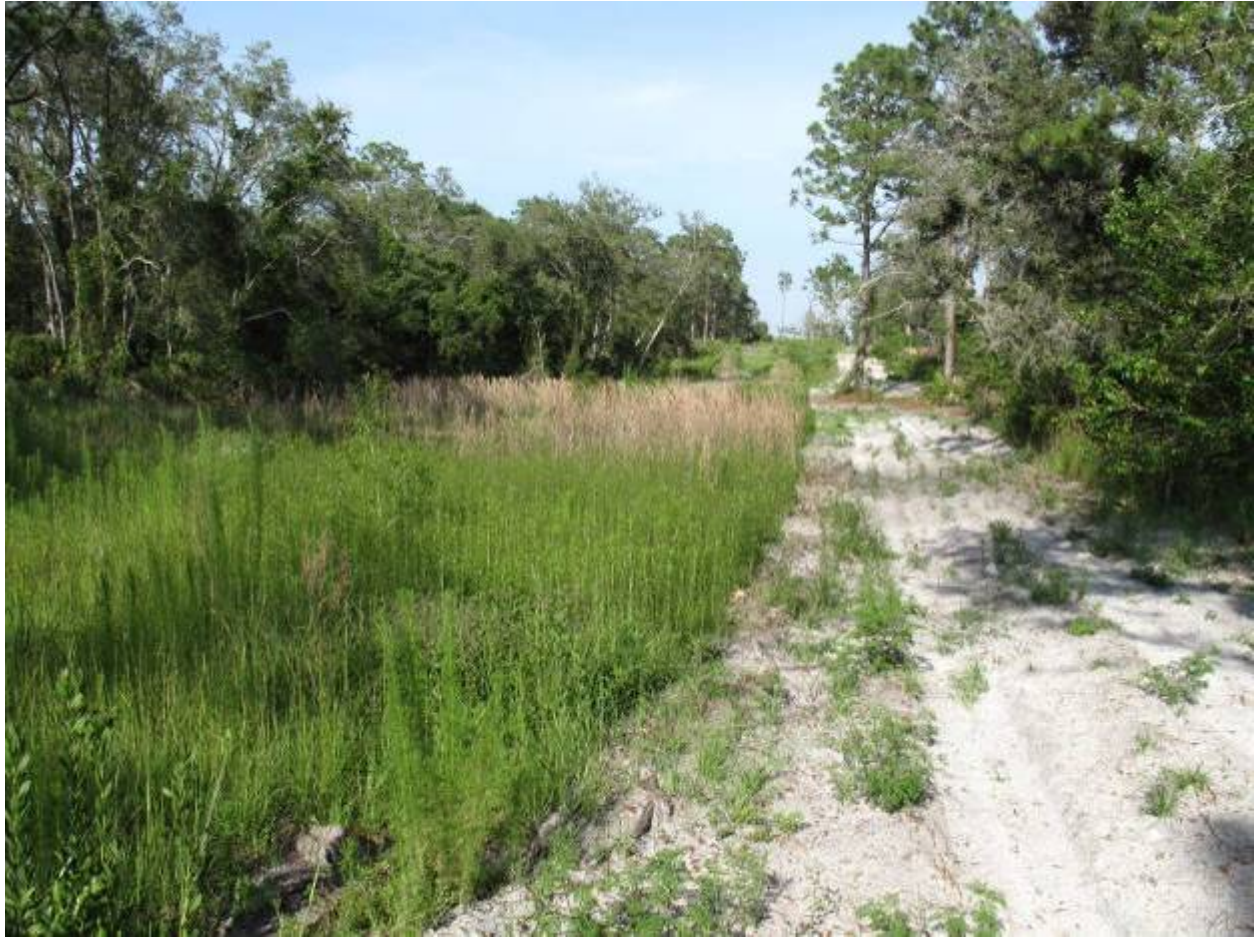
Wetland ID: 09G-01

Description: This wetland is a 0.1 ha ephemeral marsh. There is no canopy or midstory cover. Sedges/grasses and redroot grow throughout the wetland, and cover >75% of the basin. A property boundary/fireline bisects through the south side of the wetland. The wetland is located on an urban/wildland interface. A housing development is located to the south and the uplands adjacent north are a fire suppressed oak/pine forest. The uplands currently are managed with mechanical treatments.

Wetland Concerns: Property boundary/fireline, Upland condition

Restoration Action Recommended: The fireline/MU boundary should be re-routed away from the wetland if feasible. If the fireline cannot be re-routed, monitor the wetland to ensure fire is not excluded. Maintain the fireline when the wetland is completely dry to prevent ruts from developing. Due to the proximity of houses, this wetland is at risk of becoming fire suppressed. The wetland could be monitored to ensure exotic species, and the encroachment of woody vegetation, do not become an issue.

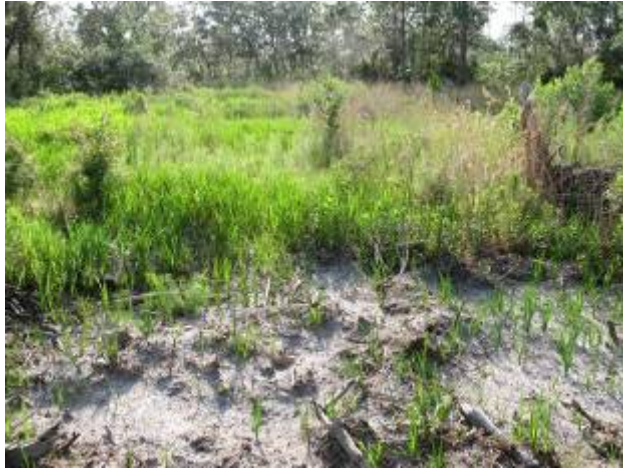
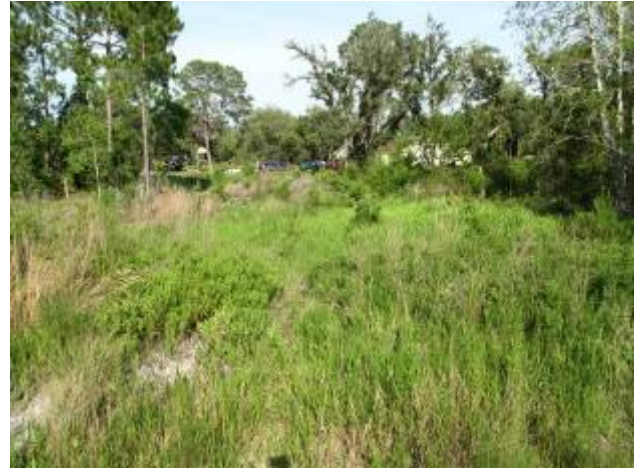
Wetland ID: 09G-02

Description: This wetland is a 0.2 ha ephemeral marsh. There is no tree canopy. *Baccharis* covers 5-25% of the wetland. Sedges/grasses and maidencane grow throughout the wetland, and cover >75% of the basin. There is old and new feral hog damage in the wetland. The wetland is located on an urban/wildland interface. A housing development is located to the east; the remaining uplands are fire suppressed sandhills/oak. The uplands currently are managed with mechanical treatments.

Wetland Concerns: Feral hog damage, Woody encroachment, Upland condition

Restoration Action Recommended: Because of the widespread damage to ephemeral wetlands on CWMA, we recommend aggressive action to reduce the overall numbers of feral hogs on the property. Encourage periodic fire in the wetland to prevent further shrub encroachment. Due to the proximity of houses, this wetland is at risk of becoming fire suppressed. The wetland could be monitored to ensure exotic species, and the encroachment of woody vegetation, do not become an issue.

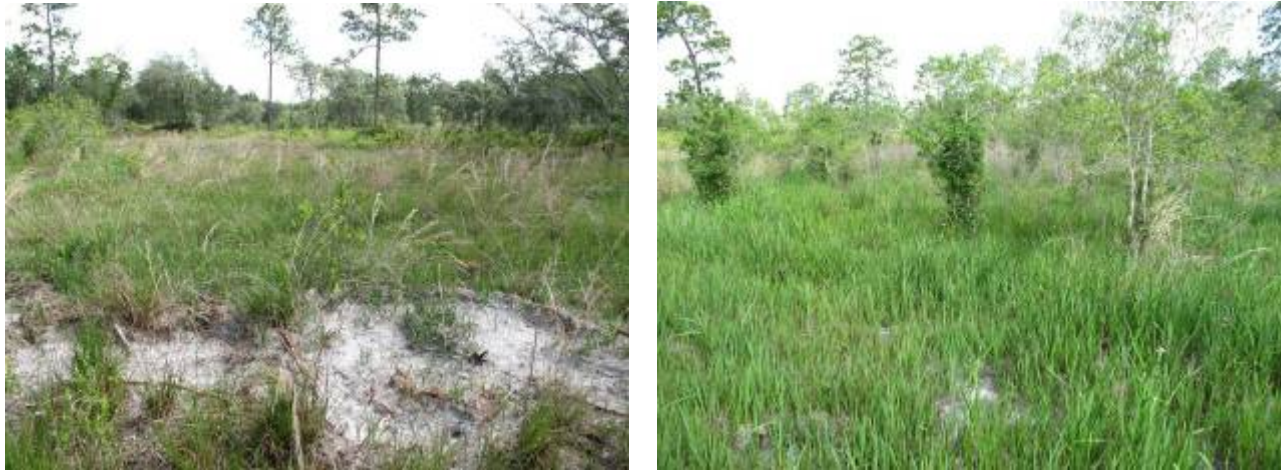
Wetland ID: 09G-03

Description: This wetland is a 0.2 ha ephemeral marsh. There is no tree canopy. Holly covers 5-25% of the wetland. Maidencane and redroot grow throughout the wetland, and cover >75% of the basin. The wetland has extensive feral hog damage. The wetland is located near an urban/wildland interface. A housing development is located approximately 300m to the east; the immediate adjacent uplands are fire suppressed sandhills. The uplands currently are managed with mechanical treatments.

Wetland Concerns: Feral hog damage, Upland condition

Restoration Action Recommended: Because of the widespread damage to ephemeral wetlands on CWMA, we recommend aggressive action to reduce the overall numbers of feral hogs on the property. Due to the proximity of houses, this wetland is at risk of becoming fire suppressed. The wetland could be monitored to ensure exotic species, and the encroachment of woody vegetation, do not become an issue.

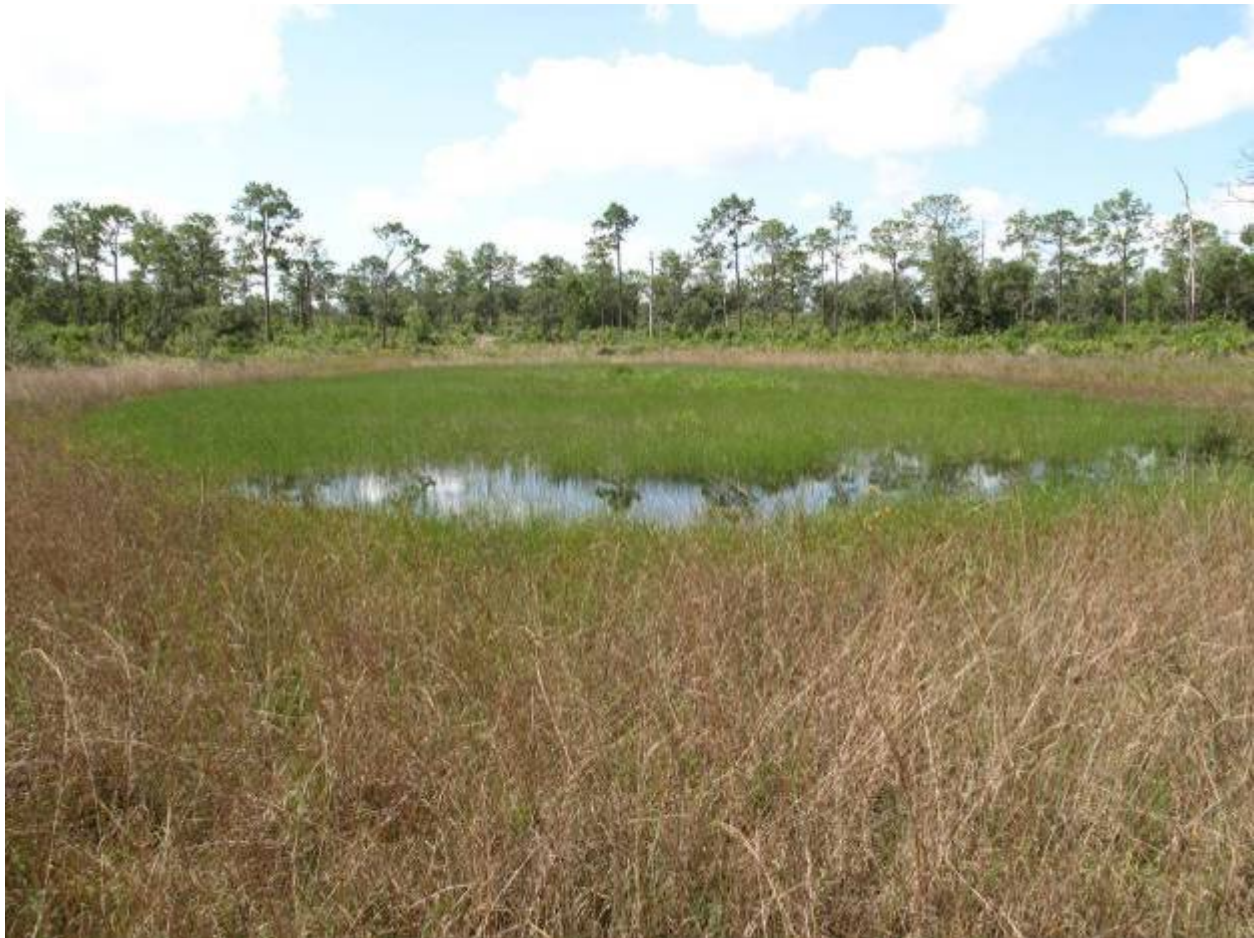
Wetland ID: 09G-04

Description: This wetland is a 0.9 ha ephemeral marsh. There is no canopy or midstory cover. Sedges/grasses grow throughout the wetland, and cover >75% of the basin. The wetland has minor feral hog damage. This wetland is a potential striped newt breeding pond with diverse herbaceous vegetation and a shallow herbaceous littoral zone. This wetland will connect to a larger depressional marsh on private land to the north during high water. An old car is located on the south side of the wetland. A housing development is located approximately 500m to the east; the immediate adjacent uplands are fire suppressed sandhills. The uplands currently are managed with mechanical treatments.

Wetland Concerns: Feral hog damage, Vehicle

Restoration Action Recommended: Because of the widespread damage to ephemeral wetlands on CWMA, we recommend aggressive action to reduce the overall numbers of feral hogs on the property. Remove vehicle as it may be a point source of chemical contamination that could leach into wetland.

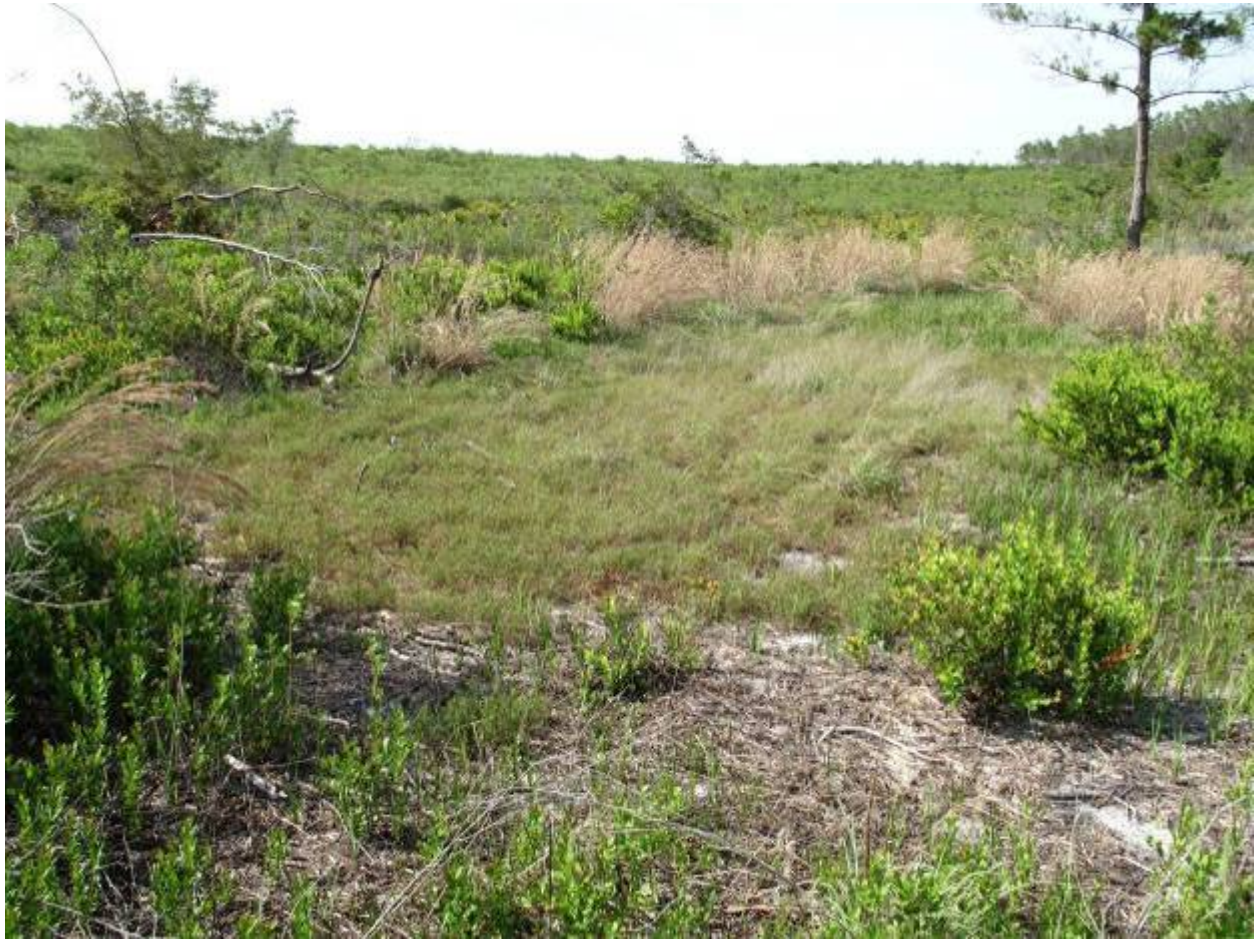
Wetland ID: 01H-01

Description: This wetland is a 0.1 ha highly ephemeral marsh. There is no canopy or midstory cover. Sedges/grasses and redroot grow throughout the wetland, and cover >75% of the basin. The adjacent uplands are scrub that was converted to sand pine plantation. The sand pine was clearcut 10 years ago and now the scrub is regenerating.

Wetland Concerns: None

Restoration Action Recommended: None

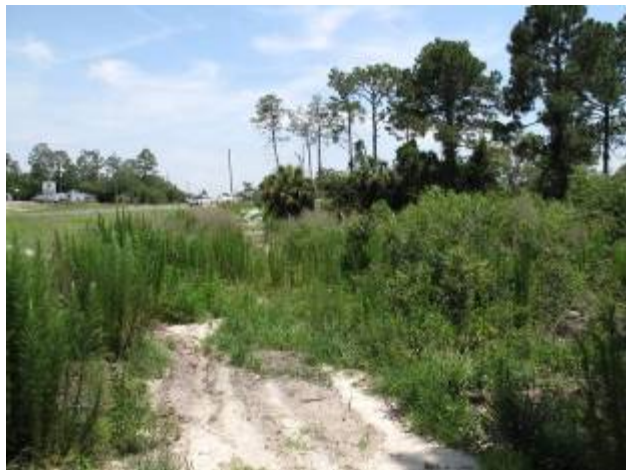
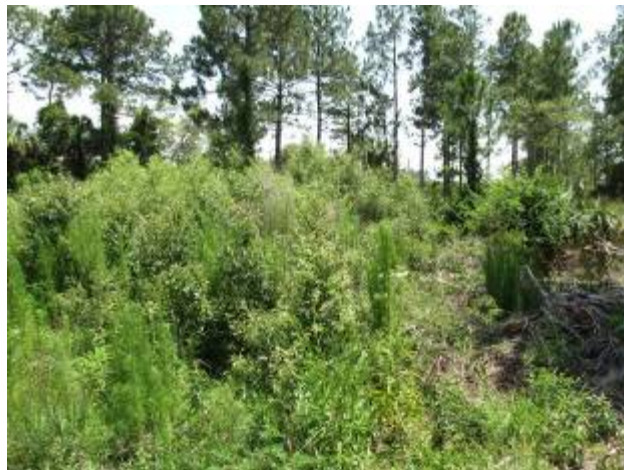
Wetland ID: 01W-01

Description: This wetland is a 0.1 ha ephemeral shrub swamp. Pine trees grow in a ring around the wetland, and cover 5-25% of the basin. The midstory is dominated by willow and an unidentified shrub, and covers 50- 75% of the wetland. Sedges/grasses grow in scattered patches, and cover 25-50% of the wetland basin. This wetland was a marsh is succeeding to a shrub swamp. A thick brush ring surrounds the wetland ecotone. A fireline and a major highway (US 19) run along the northeast side of the wetland. The wetland receives road and sand runoff. The adjacent uplands are scrub that was converted to sand pine plantation. The sand pine was clearcut 10 years ago and now the scrub is regenerating.

Wetland Concerns: Fireline, Road, Woody encroachment

Restoration Action Recommended: The fireline/MU boundary should be re-routed away from the wetland if feasible. If the fireline cannot be re-routed, monitor the wetland to ensure fire is not excluded. Maintain the fireline when the wetland is completely dry to prevent ruts from developing. Provide prescribed fire whenever possible to eliminate the shrub encroachment. Alternatively, the shrubs could be mechanically removed when the wetland is completely dry.

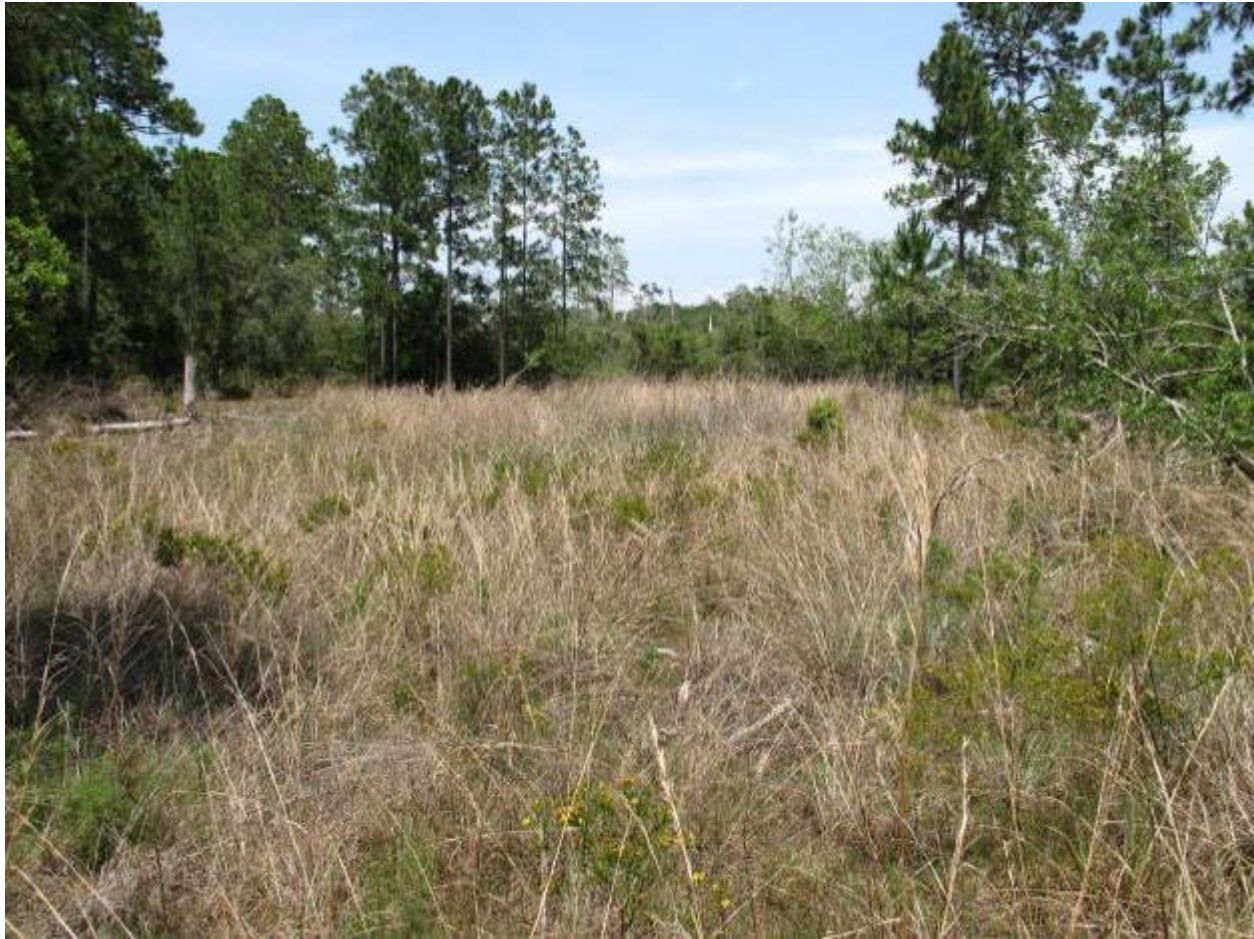
Wetland ID: 01W-02

Description: This wetland is a 0.2 ha ephemeral marsh. There is no canopy or midstory cover. Sedges/grasses grow throughout the wetland, and cover >75% of the basin. This wetland appears to be in excellent ecological condition. The adjacent uplands are scrub that was converted to sand pine plantation. The sand pine was clearcut 10 years ago and now the scrub is regenerating.

Wetland Concerns: None

Restoration Action Recommended: None

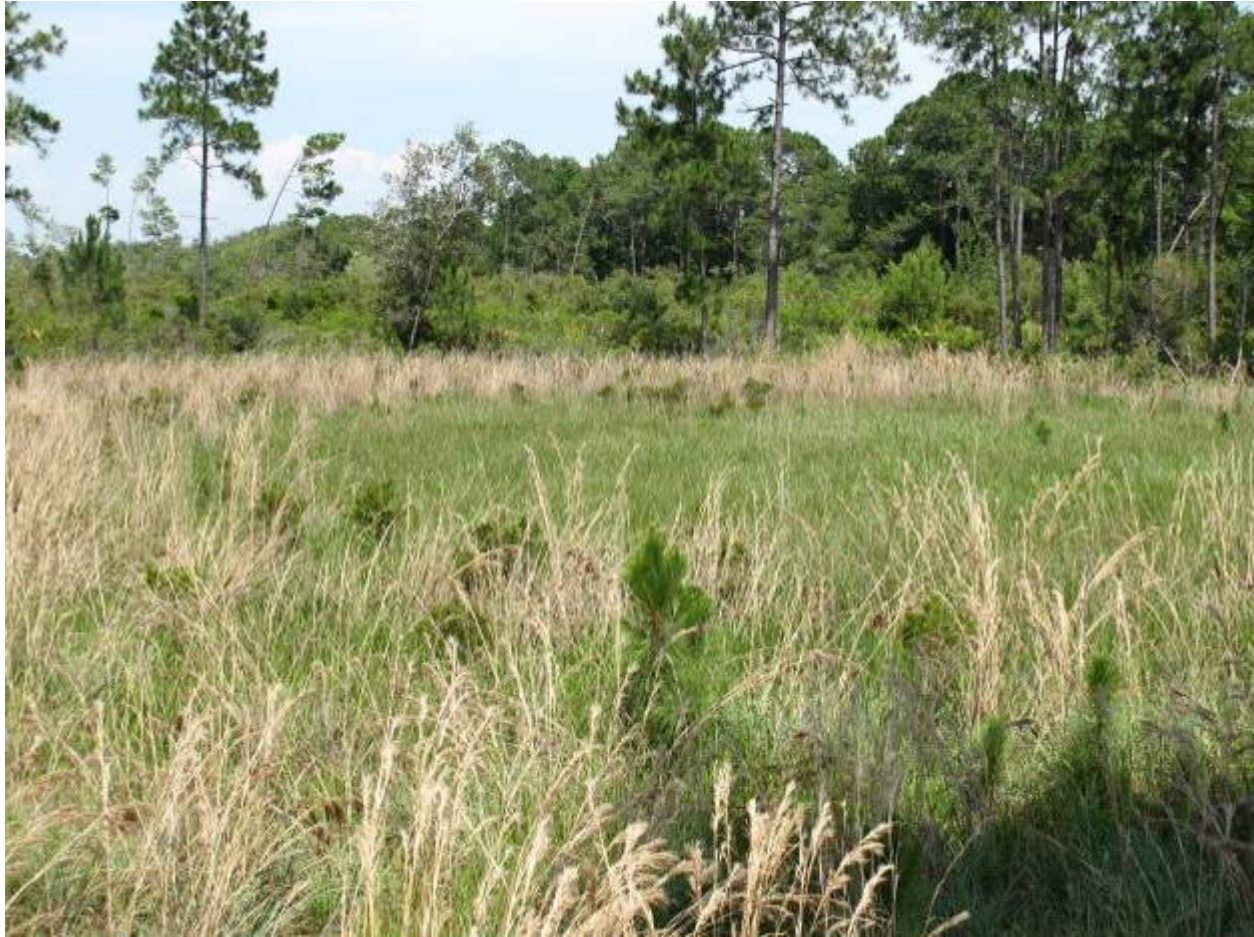
Wetland ID: 01W-03

Description: This wetland is a 0.3 ha ephemeral marsh. Small pine trees and shrubs are beginning to encroach into the wetland but cover <5% of the basin. Sedges/grasses and maidencane grow throughout the wetland, and cover >75% of the basin. This circular wetland has diverse herbaceous vegetation and is in good ecological condition. The center of the wetland has a thick layer of peat. The adjacent uplands are scrub that was converted to sand pine plantation. The sand pine was clearcut 10 years ago and now the scrub is regenerating.

Wetland Concerns: Woody encroachment

Restoration Action Recommended: The longer fire interval of scrub habitat facilitates woody plant colonization during drought periods more than marshes within sandhill or flatwoods. If WMA personnel want to retain this wetland as a marsh in the long term, then removal of small shrubs and pine trees in the basin will be necessary. Promptly provide fire before small shrubs and trees become well-established. If fire cannot be provided within a year or two, then hand-remove pine trees and shrubs in wetland basin.

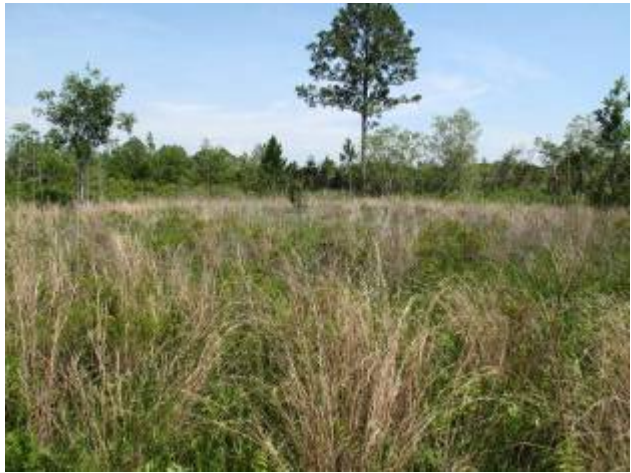
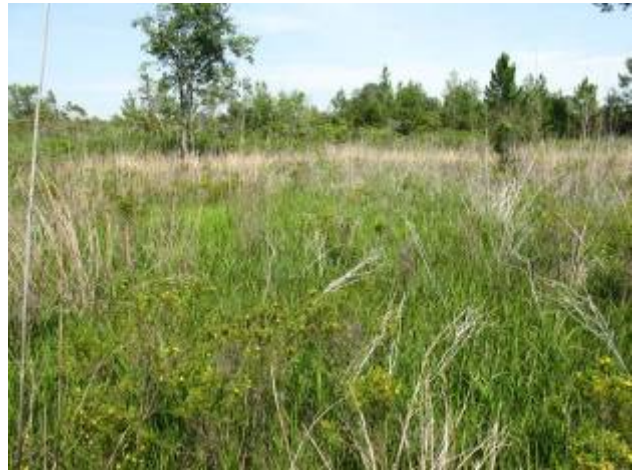
Wetland ID: U1-01

Description: This wetland is a 0.3 ha ephemeral marsh. There is no canopy or midstory cover. Sedges/grasses and redroot grow throughout the wetland, and cover >75% of the basin. The wetland appears to have been disturbed by hogs in the past but the vegetation has completely regenerated. The peat layer is thick in the wetland basin. The adjacent uplands are scrub that was converted to sand pine plantation. The sand pine was clearcut 10 years ago and now the scrub is regenerating.

Wetland Concerns: None

Restoration Action Recommended: None

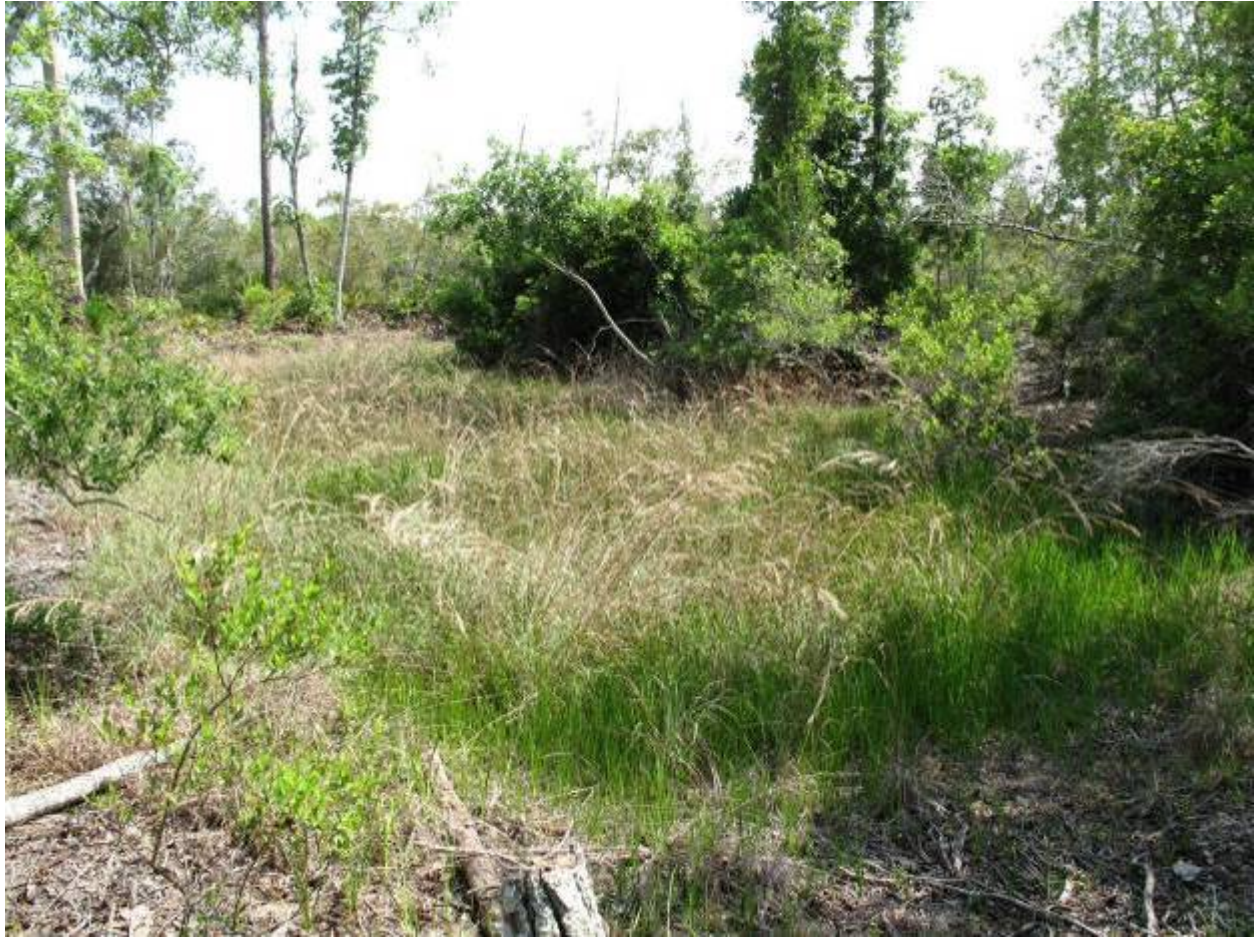
Wetland ID: U1-02

Description: This wetland is a 0.1 ha ephemeral marsh. There is no tree canopy. Holly covers 5-25% of the wetland. Sedges/grasses and redroot grow throughout the wetland, and cover >75% of the basin. The wetland appears to have been disturbed by hogs in the past but the vegetation (mostly redroot) has completely regenerated. The adjacent uplands are scrub that was converted to sand pine plantation. The sand pine was clearcut 10 years ago and now the scrub is regenerating.

Wetland Concerns: None

Restoration Action Recommended: None

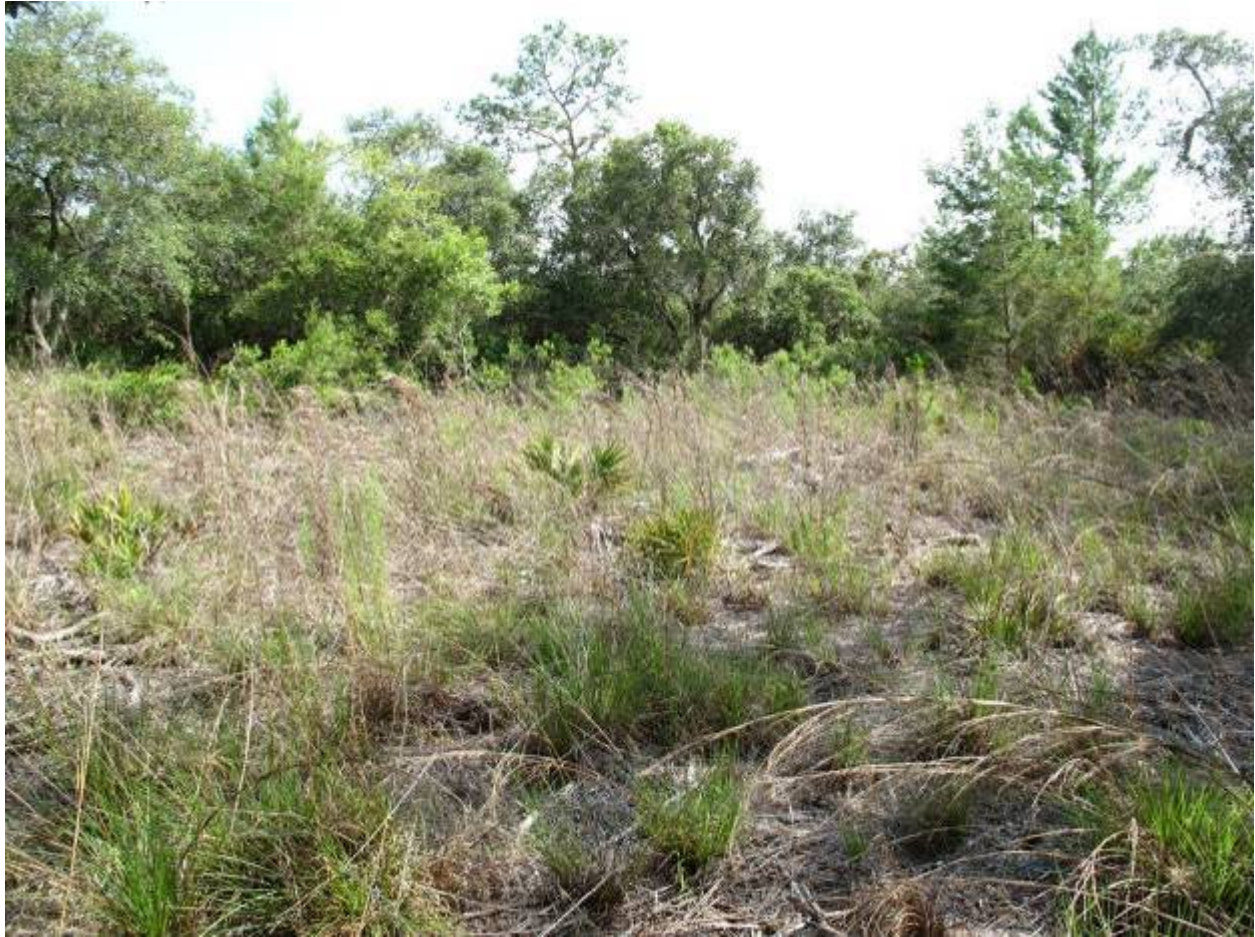
Wetland ID: U1-03

Description: This wetland is a 0.1 ha highly ephemeral marsh. There is no canopy or midstory cover. Sedges/grasses grow throughout the wetland, and cover 50-75% of the basin. This depressional wetland has been dry for a long time. The adjacent uplands are scrub that was converted to sand pine plantation. The sand pine was clearcut 10 years ago and now the scrub is regenerating.

Wetland Concerns: None

Restoration Action Recommended: None

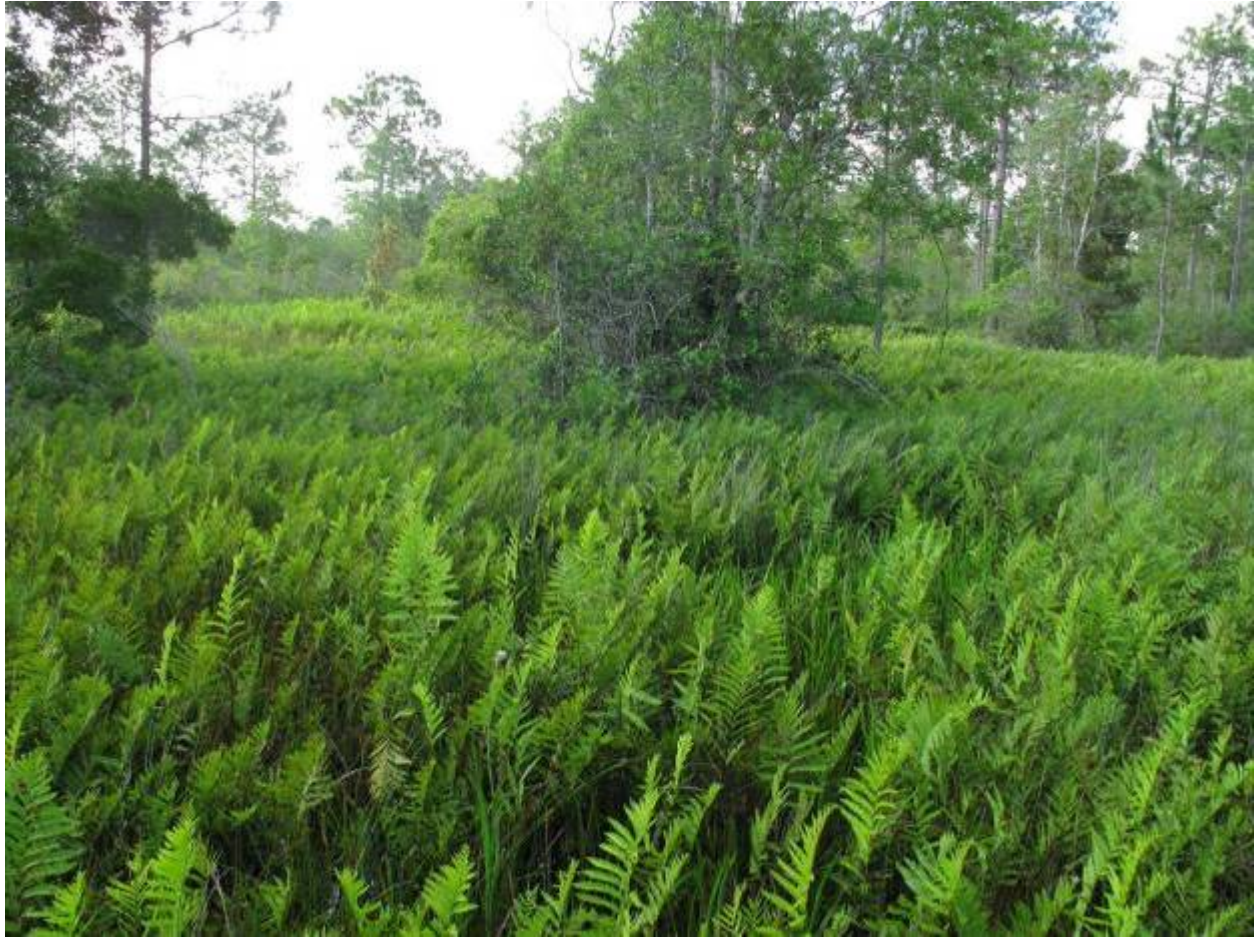
Wetland ID: U1-04

Description: This wetland is a 0.3 ha ephemeral marsh. There is no tree canopy. Holly covers 5-25% of the wetland. Sedges/grasses, fern, and redroot grow throughout the wetland, and cover 50-75% of the basin. The wetland has old and new feral hog damage. The old hog damage has grown over with redroot and fern. A very thick shrub and palmetto ring encircles the wetland in the wetland/upland ecotone. The adjacent uplands are sandhills and flatwoods

Wetland Concerns: Feral hog damage

Restoration Action Recommended: Because of the widespread damage to ephemeral wetlands on CWMA, we recommend aggressive action to reduce the overall numbers of feral hogs on the property.

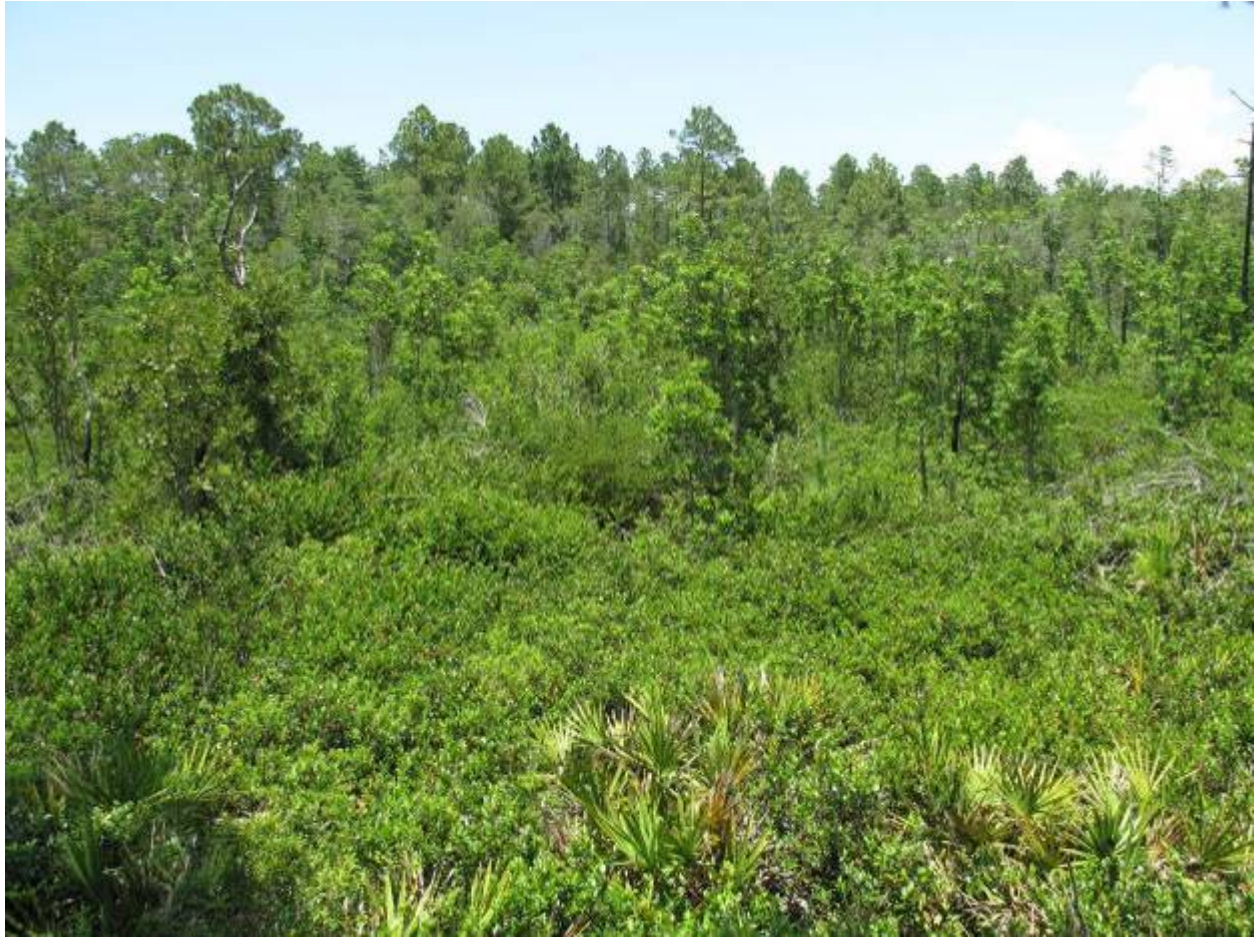
Wetland ID: U2-01

Description: This wetland is a 0.3 ha ephemeral shrub swamp/baygall community. Loblolly bay trees dominate the canopy, and cover 5-25% of the wetland. The midstory is dominated by fetterbush and young loblolly bay trees, and covers >75% of the wetland. There is no herbaceous vegetation. This baygall community has extremely dense shrubs. Charred stems provide evidence of a recent fire. The adjacent uplands are fire suppressed sandhills.

Wetland Concerns: Woody encroachment

Restoration Action Recommended: Encourage periodic fire in the wetland to reduce the dense brush.

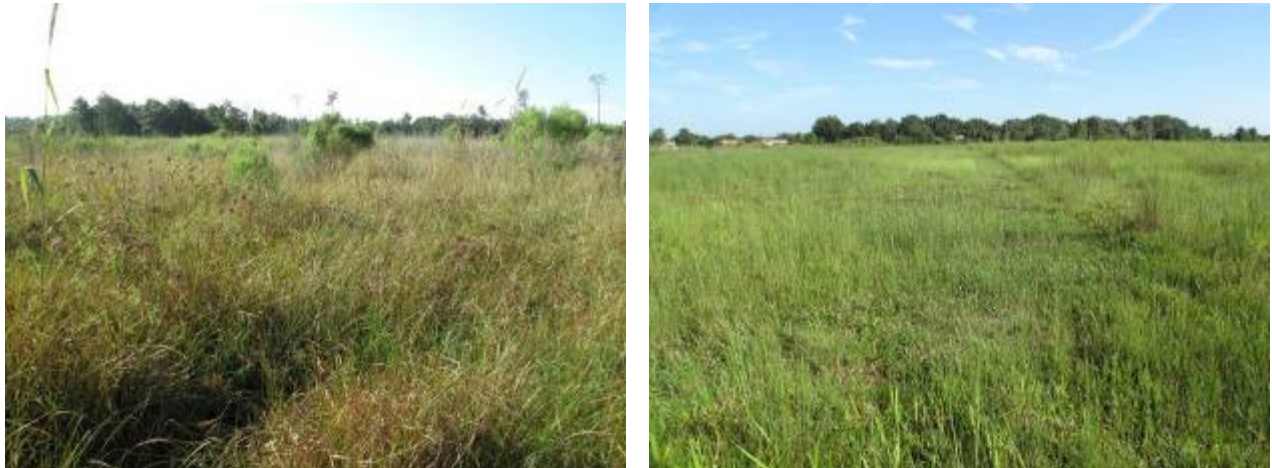
Wetland ID: U3-01

Description: This wetland is a 30.7 ha ephemeral marsh. There is no tree canopy. Wax myrtle, willow, and baccharis cover 25-50% of the wetland. Maidencane and sedge/grass are the dominant herbaceous vegetation, and cover >75% of the wetland. The center of this very large marsh is deeper than the surrounding area and has taller vegetation and shrubs. The area surrounding the shrubby center has a thick peat layer and a variety of herbaceous vegetation. A major highway (US 19) runs along the east side of the wetland and a suburban development lies to the north. The adjacent uplands to the south are scrub.

Wetland Concerns: Road, Upland condition

Restoration Action Recommended: The major management concern with this wetland is related to the wildland/suburban interface, major highway, and predominant wind direction, which present a difficult combination for prescribed fire. We recommend waiting for a good burn window sometime in the next 5-10 years. If after that period no fire was possible, the managers could consider mechanically thinning some shrubs when the wetland is dry. Currently, the wetland is in good condition.

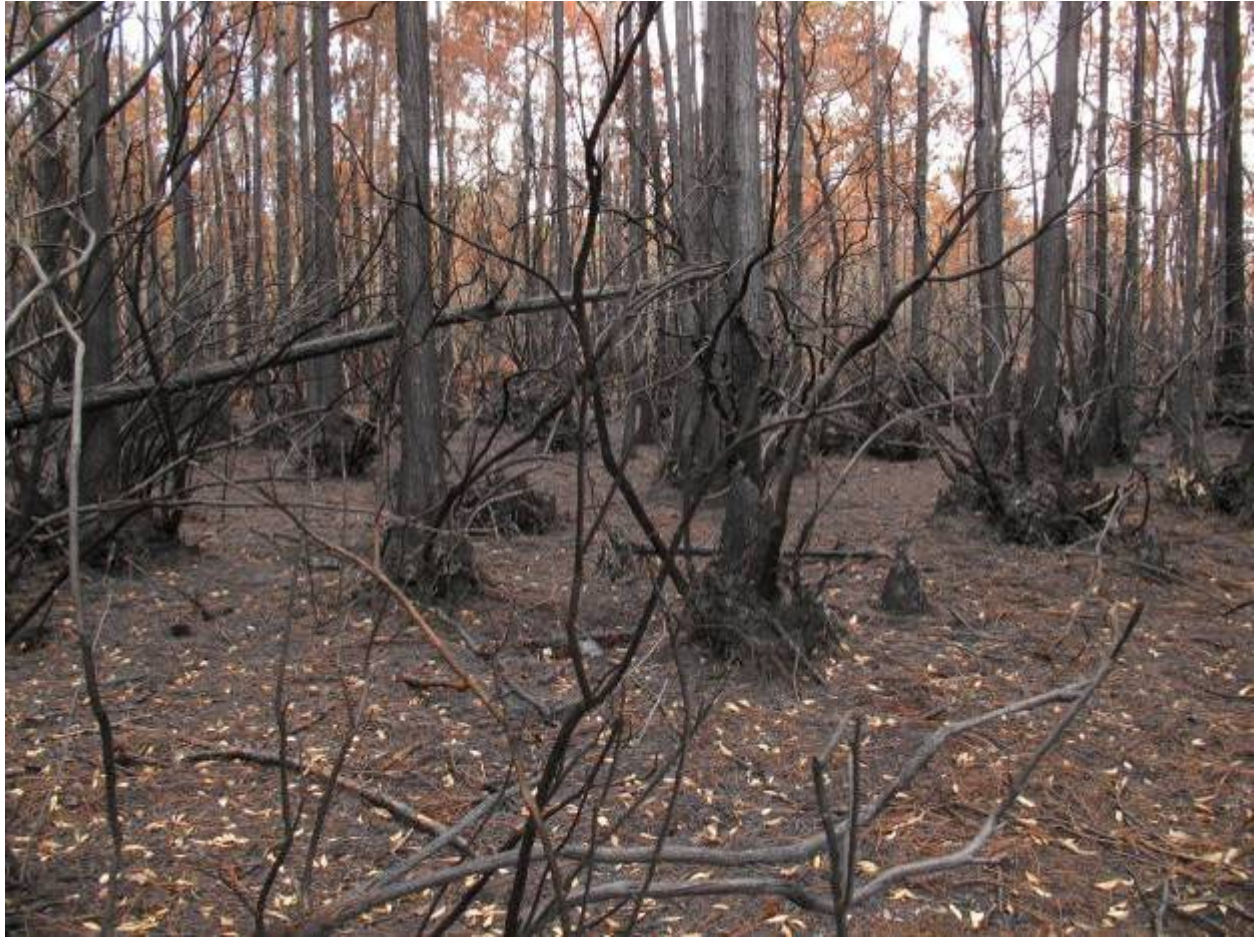
Wetland ID: U4-01

Description: This wetland is a 0.2 ha ephemeral mixed swamp. Cypress trees dominate the canopy, and cover >75% of the wetland. The midstory was dominated by fetterbush and wax myrtle, and covered >75% of the wetland. There is no herbaceous vegetation. This wetland was a mixed swamp with thick brush. Within the past month or two, a fire burned completely through the wetland, charring every single shrub in the wetland, as well as reducing the thick duff. This wetland provides an excellent example of how powerful a summer fire can be as a brush management tool. The wetland 80m to the south (04C-01) may provide a good example of a “before fire” wetland. The adjacent uplands are sandhills.

Wetland Concerns: None

Restoration Action Recommended: None

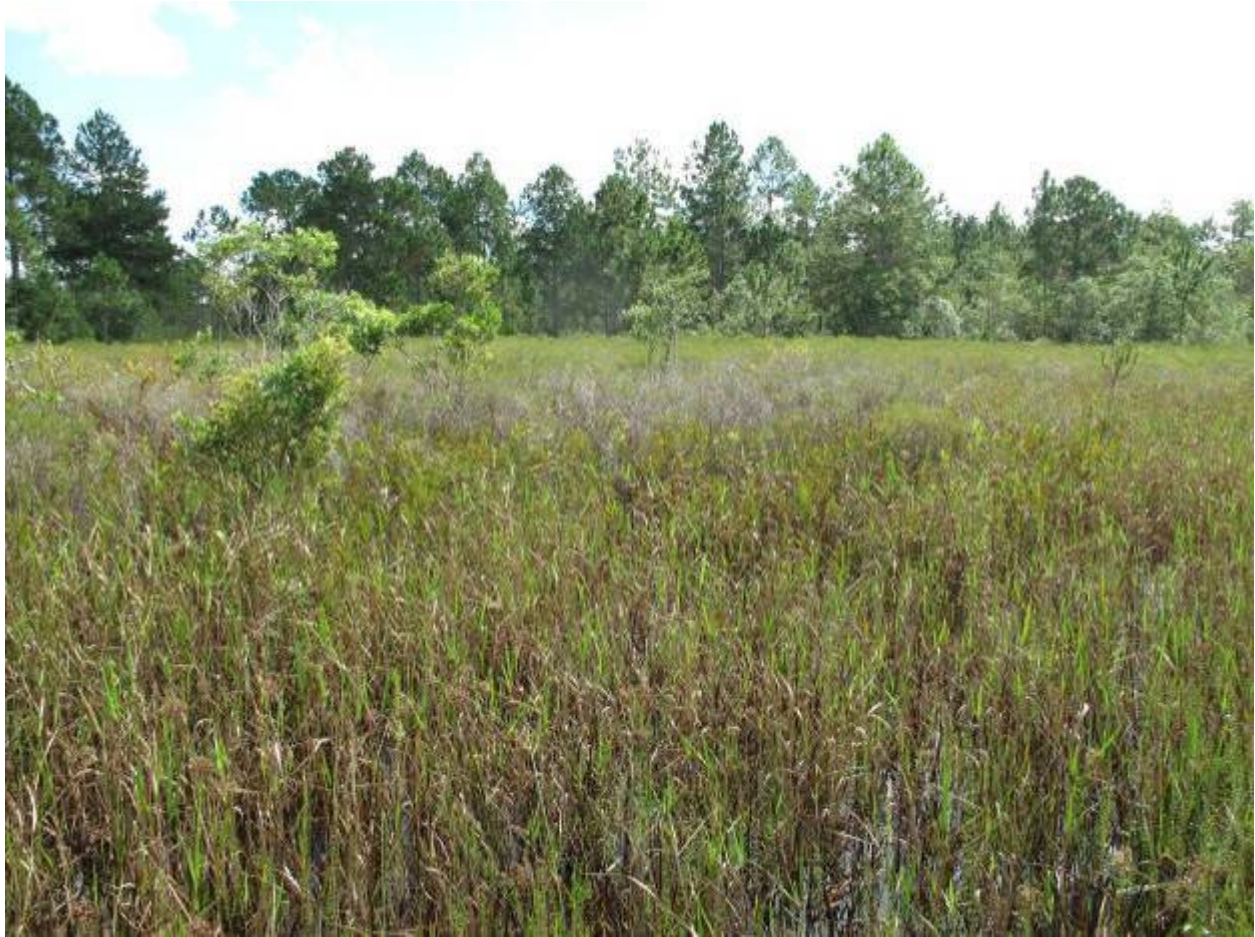
Wetland ID: U5-01

Description: This wetland is a 1.0 ha ephemeral marsh. There is no tree canopy. *Hypericum* covers 50-75% of the wetland. Maidencane and sedges/grasses grow throughout the wetland, and cover >75% of the basin. A dense ring of brush grows around the wetland. The wetland has old feral hog damage that is recovering well. This marsh is a potential striped newt breeding pond. The adjacent uplands are sandhills. The uplands appear to have been fire suppressed but now are managed with prescribed fire.

Wetland Concerns: Feral hog damage

Restoration Action Recommended: Because of the widespread damage to ephemeral wetlands on CWMA, we recommend aggressive action to reduce the overall numbers of feral hogs on the property.

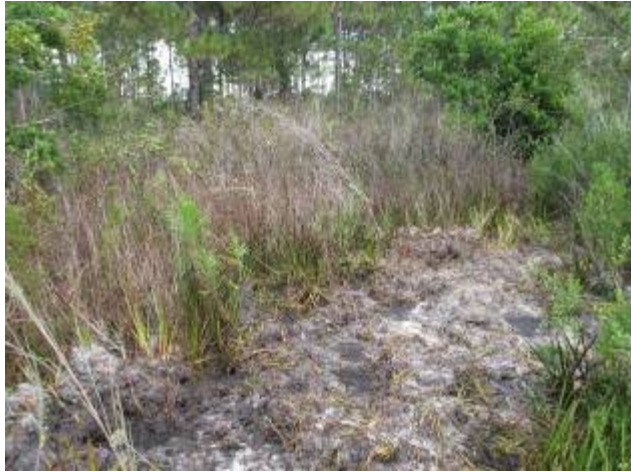
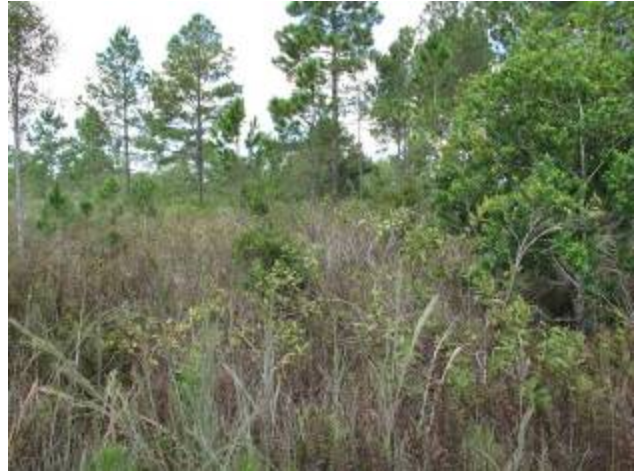
Wetland ID: U5-02

Description: This wetland is a 0.1 ha ephemeral marsh. There is no tree canopy. Buttonbush grows in the deeper wetland center and a few small pine trees are encroaching into the basin. The woody vegetation covers 25-50% of the wetland. Fern and redroot grow throughout the wetland, and cover >75% of the basin. The wetland has old and new feral hog damage. This depression marsh is a potential striped newt breeding pond. The adjacent uplands are sandhills. The uplands appear to have been fire suppressed but now are managed with prescribed fire.

Wetland Concerns: Feral hog damage, Woody encroachment

Restoration Action Recommended: Because of the widespread damage to ephemeral wetlands on CWMA, we recommend aggressive action to reduce the overall numbers of feral hogs on the property. Encourage periodic fire in the wetland to reduce the encroaching pine trees and prevent the buttonbush from encroaching into the wetland basin. Monitor this wetland to ensure pine trees are killed with the next fire or inundation. If they become established, the encroaching pine trees will need to be removed from the wetland. Alternatively, the small pine trees can be hand-chopped now.
