Inventory, Assessment, and Restoration Potential of Ephemeral Wetlands on FFWCC Wildlife Management Areas

Chassahowitzka WMA Final Report

Submitted by: Rebecca P.M. Means¹, Ryan C. Means¹, Steven A. Johnson²

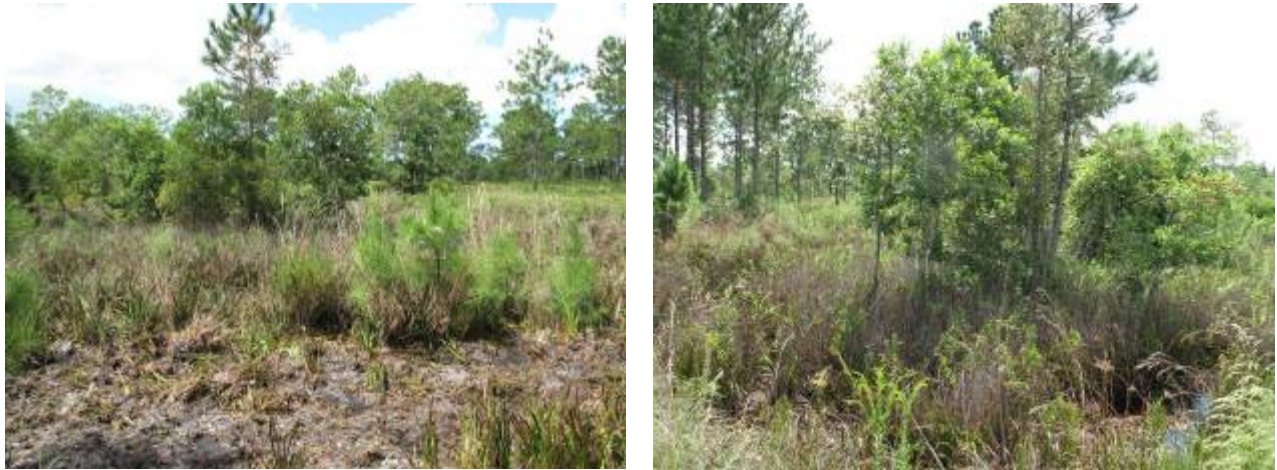
Wetland ID: U5-03

Description: This wetland is a 0.1 ha ephemeral marsh. There is no tree canopy. Wax myrtle and holly grow in the deeper wetland center and a few small pine trees and shrubs are encroaching inward from the edges. The woody vegetation covers 25-50% of the wetland. Fern, sedges/grasses, and redroot grow throughout the wetland, and cover >75% of the basin. The wetland has extensive feral hog damage. This depression marsh is a potential striped newt breeding pond. The adjacent uplands are sandhills. The uplands appear to have been fire suppressed but now are managed with prescribed fire.

Wetland Concerns: Feral hog damage, Woody encroachment

Restoration Action Recommended: Because of the widespread damage to ephemeral wetlands on CWMA, we recommend aggressive action to reduce the overall numbers of feral hogs on the property. Encourage periodic fire in the wetland to reduce the encroaching pine trees and shrubs. Monitor this wetland to ensure the encroaching vegetation is killed with the next fire or inundation. If they become established, the shrubs and pine trees will need to be removed from the wetland. Alternatively, they can be hand-chopped now.
