# **Inventory, Assessment, and Restoration Potential of Ephemeral Wetlands on FFWCC Wildlife Management Areas**

## **Guana River WMA Final Report**

Submitted by: Rebecca P.M. Means<sup>1</sup>, Ryan C. Means<sup>1</sup>, Steven A. Johnson<sup>2</sup>

April - May 2009

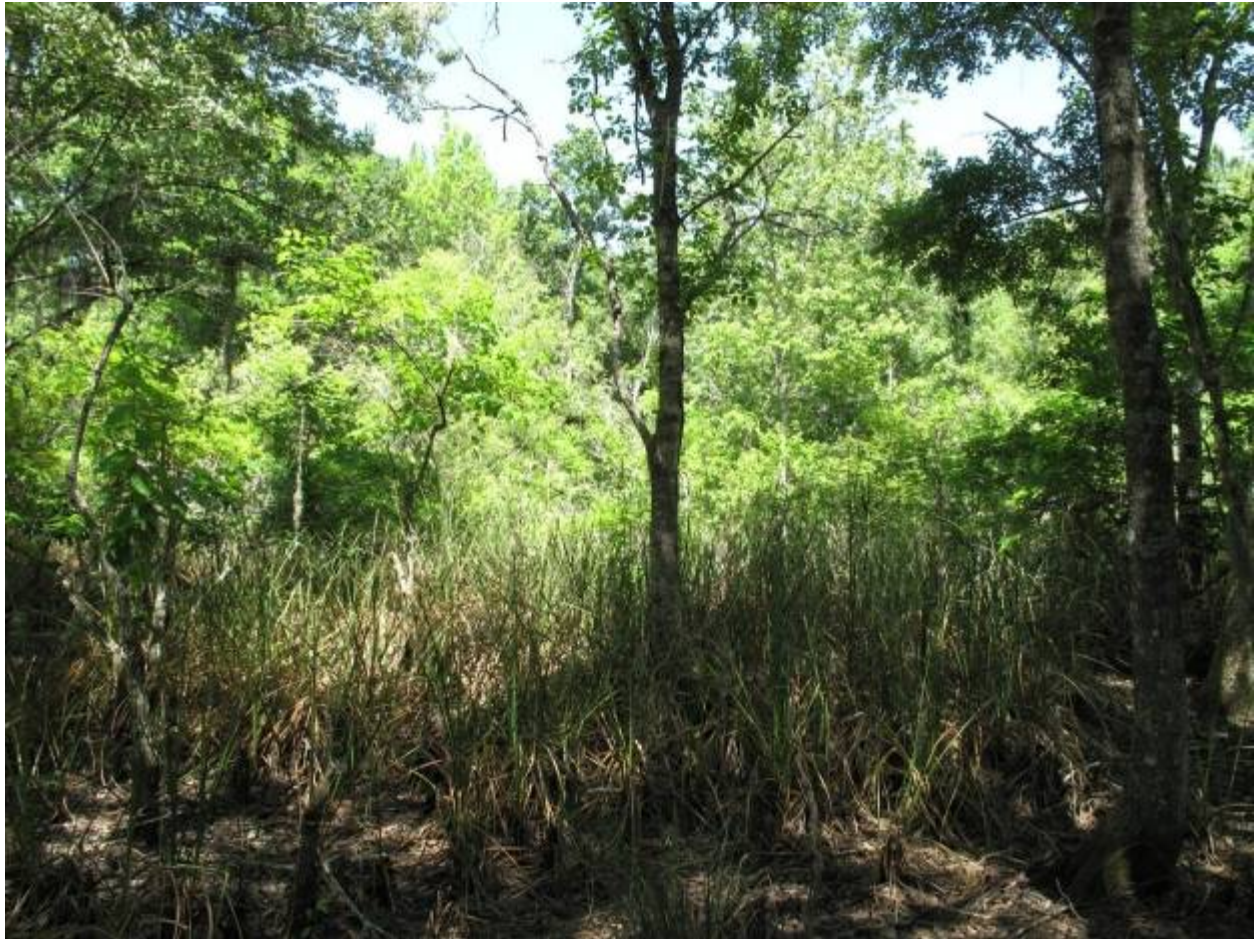
**Wetland ID: 01-01**

**Description:** This wetland is a 0.3 ha semi-permanent forested swamp. Gum trees dominate the canopy, and cover 50-75% of the wetland. The midstory is dominated by a mixture of wax myrtle, willow, and buttonbush, and covers 50- 75% of the wetland. Sawgrass grows throughout the wetland, and covers 50-75% of the basin. The vegetation in this swamp is diverse. The adjacent uplands are mesic hammock.

**Wetland Disturbance:** None

**Restoration Action Recommended:** None

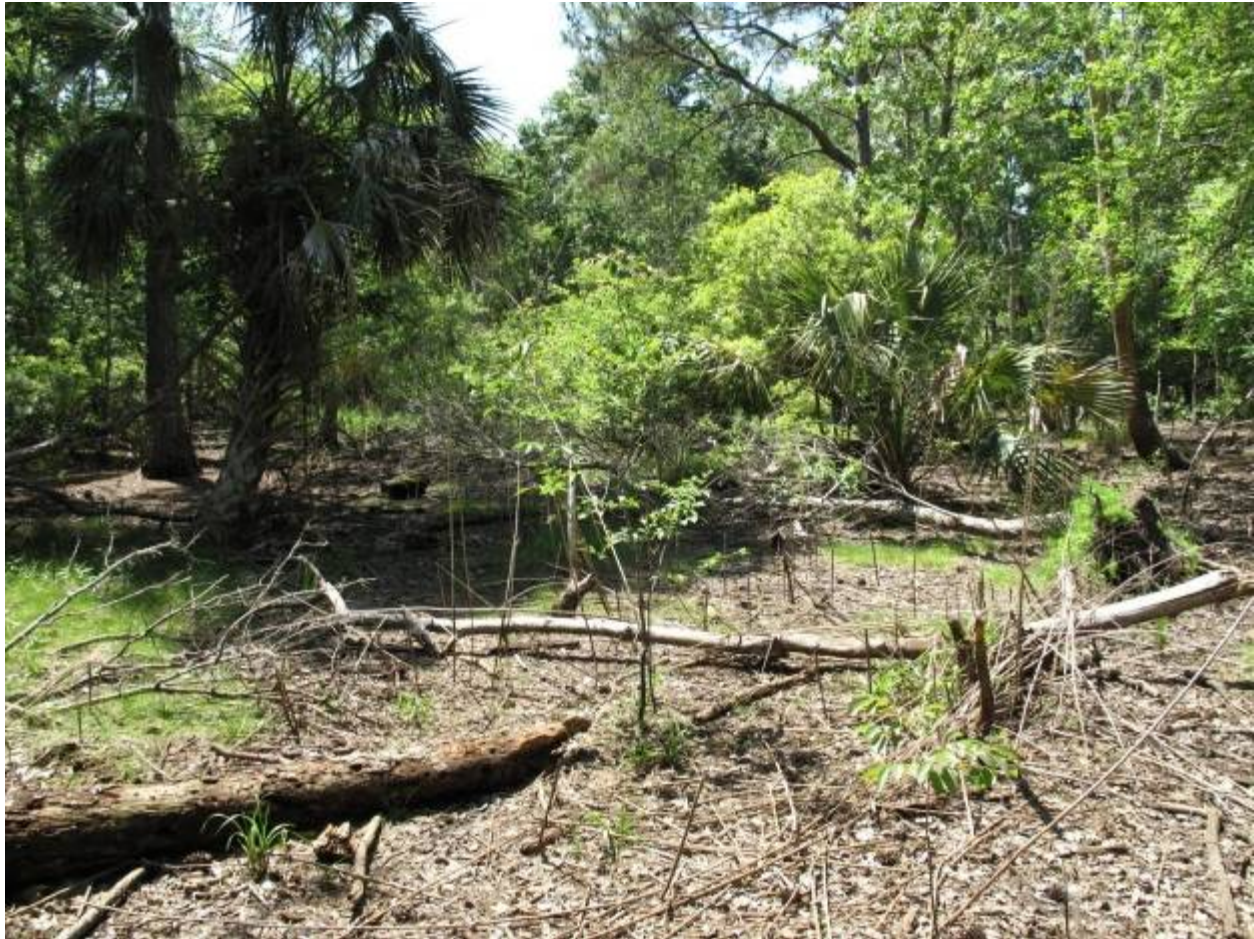
**Wetland ID: 01-02**

**Description:** This wetland is a 1.0 ha ephemeral forested swamp. Gum and maple trees dominate the canopy, and cover 50-75% of the wetland. The midstory is dominated by wax myrtle and buttonbush, and covers 25-50% of the wetland. Sedges/grasses grow in scattered patches, and cover 5-25% of the wetland basin. This wetland was likely a marsh at one time but has succeeded to an open forested swamp. The adjacent uplands are mesic hammock.

**Wetland Disturbance:** None

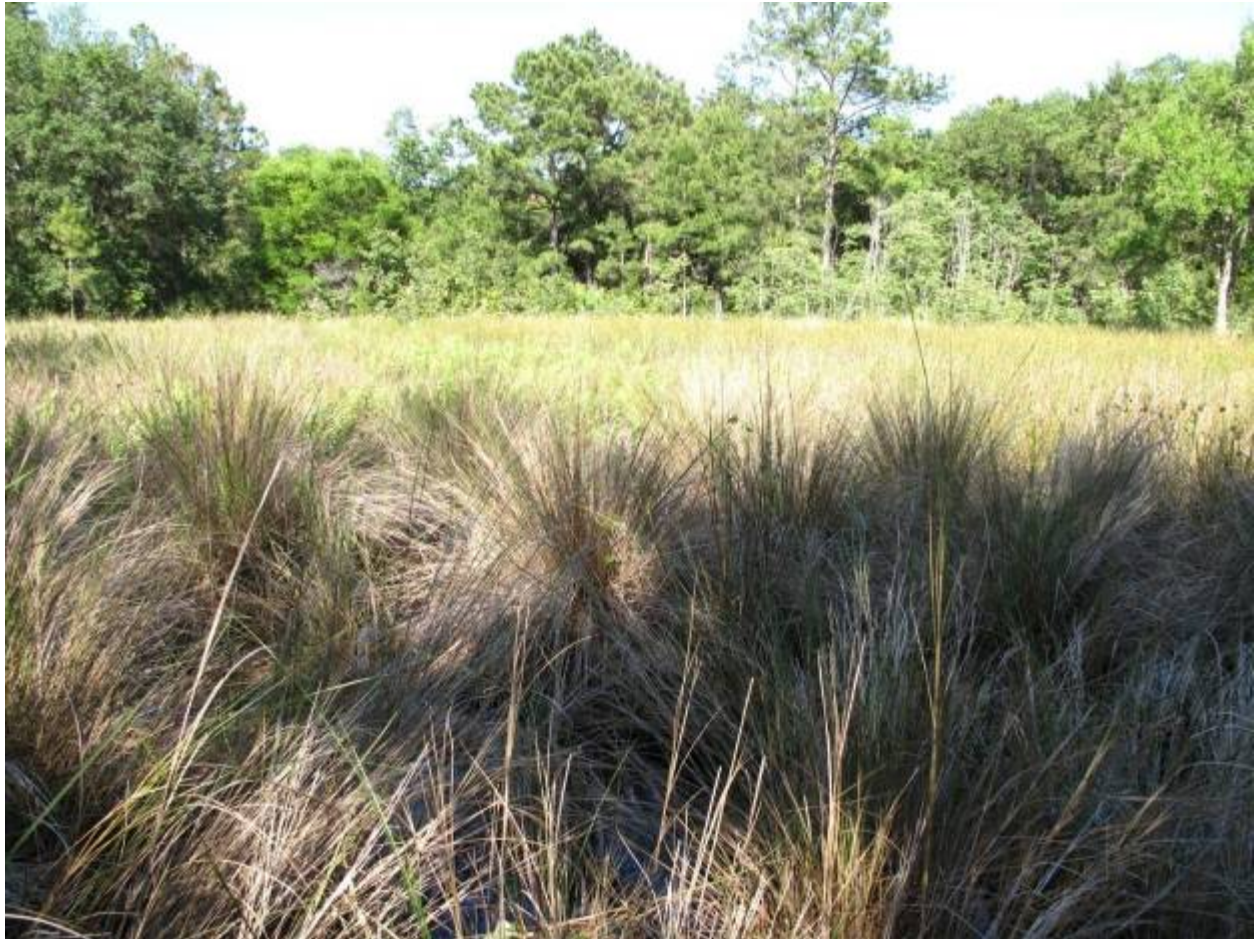
**Wetland ID: 01-03**

**Description:** This wetland is a 0.3 ha ephemeral marsh. There is no tree canopy or midstory cover. A diverse array of sedges/grasses grow throughout the wetland, and cover >75% of the wetland basin. This marsh is in fire-maintenance condition. The adjacent uplands are mesic and scrubby flatwoods.

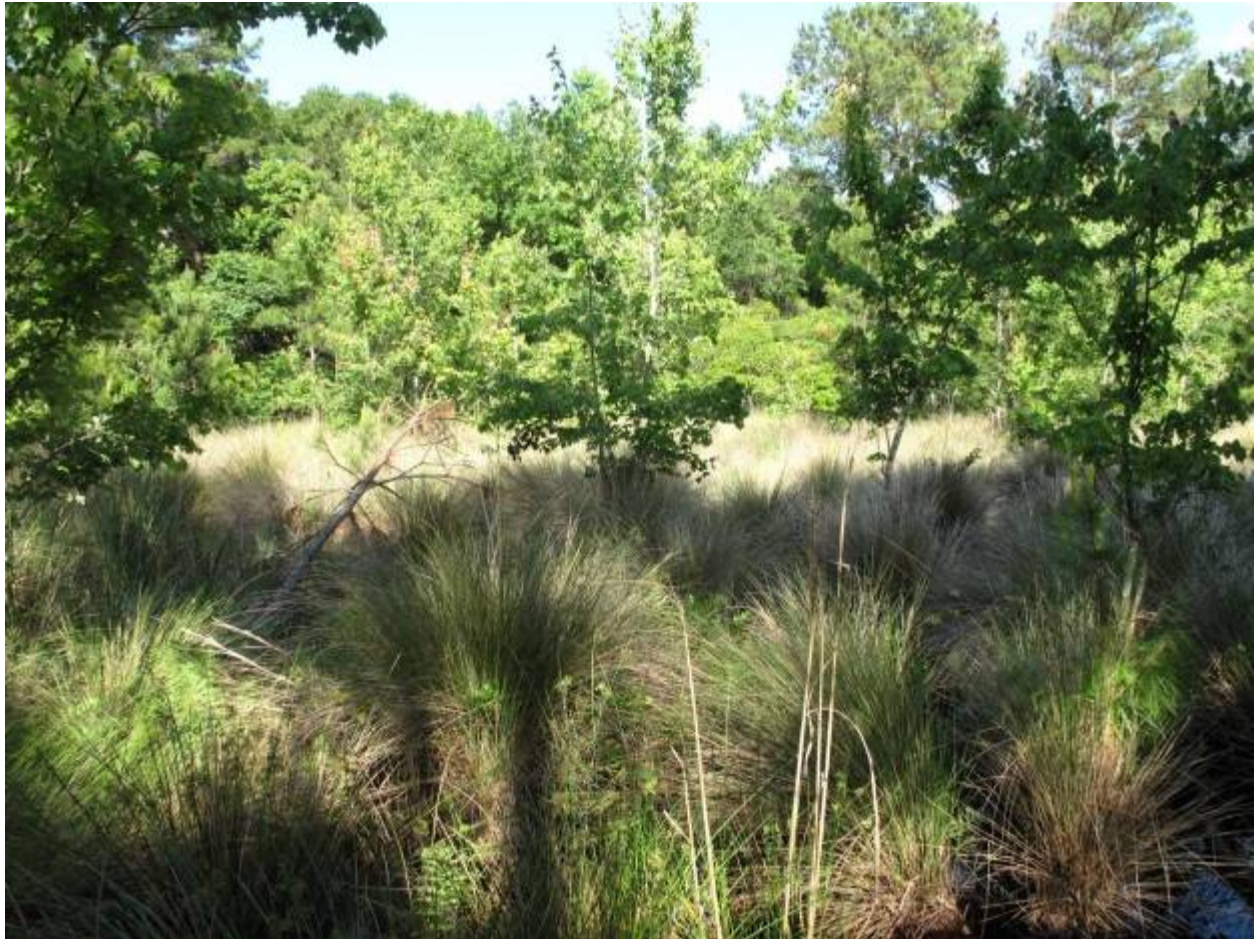
**Wetland ID: 01-04**

**Description:** This wetland is a 0.2 ha ephemeral marsh. Small maple trees dominate the canopy, and cover 25-50% of the wetland. There is no midstory cover. Sedges/grasses grow throughout the wetland, and cover >75% of the basin. This wetland is starting to show signs of the encroachment of woody vegetation. The adjacent uplands are mesic flatwoods and hammock.

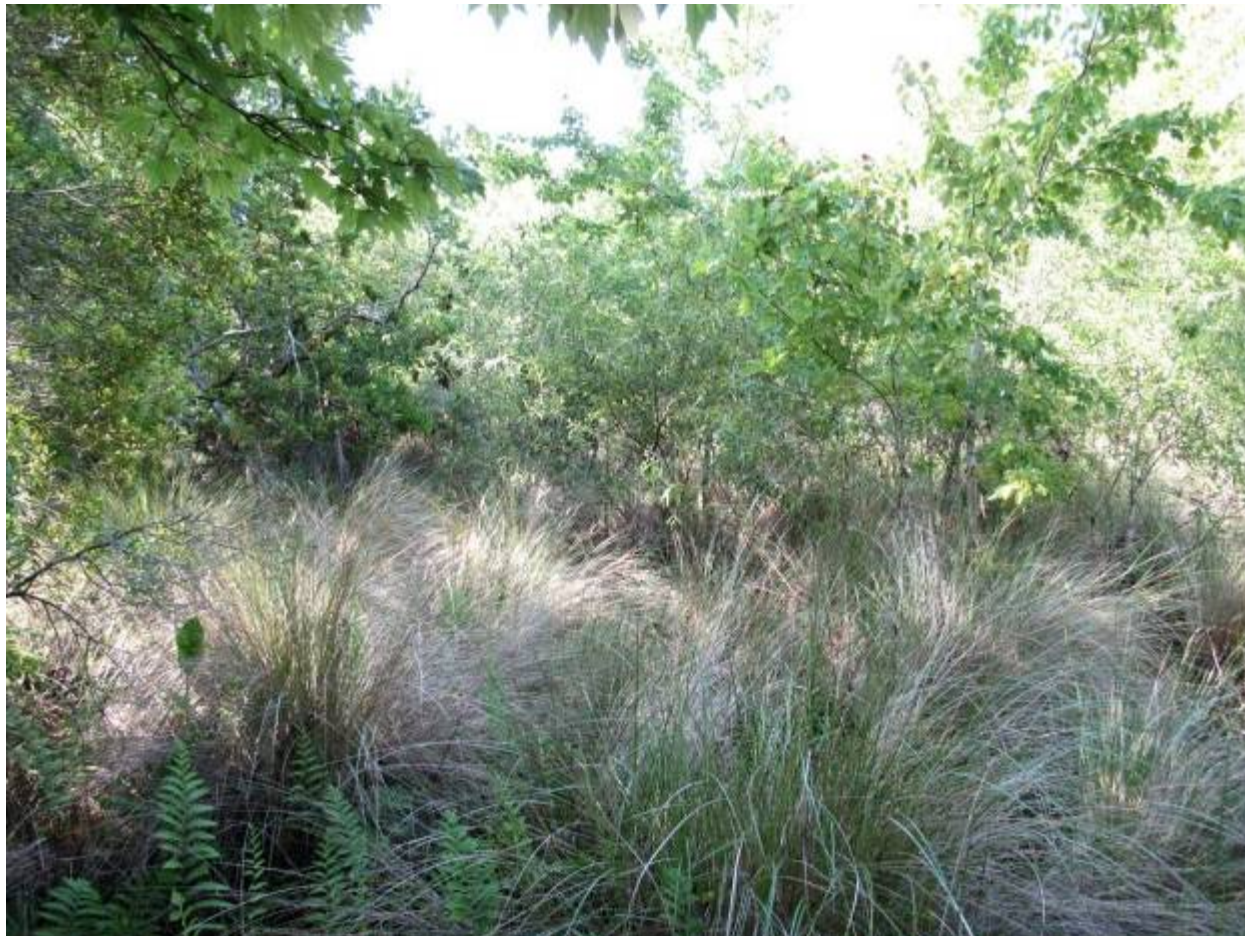
**Wetland ID: 01-05**

**Description:** This wetland is a 0.3 ha ephemeral marsh. Maple trees dominate the canopy, and cover 50-75% of the wetland. The midstory is dominated by small maple trees, and covers 25-50% of the wetland. Sedges/grasses grow throughout, and cover >75% of the wetland basin. Maple trees likely established in the wetland as a result of fire suppression and/or a long dry period. The adjacent uplands are mesic flatwoods and hammock.

**Wetland Disturbance:** Woody encroachment

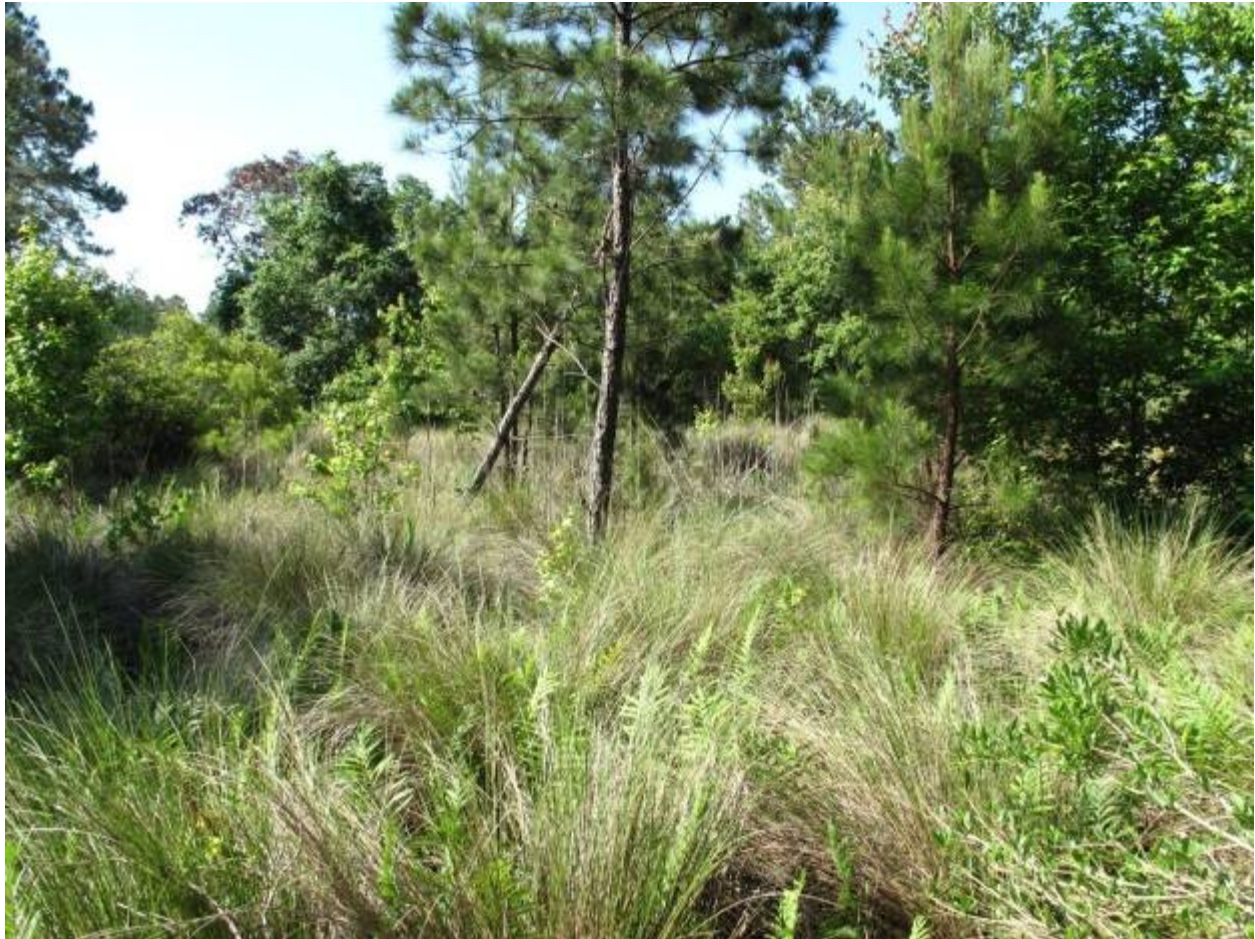
**Wetland ID: 01-06**

**Description:** This wetland is a 0.2 ha ephemeral marsh. Small pine, sweet gum, and maple trees are beginning to encroach and cover 5-25% of the wetland. Sedges/grasses grow throughout the wetland, and cover >75% of the basin. The adjacent uplands are mesic flatwoods and hammock.

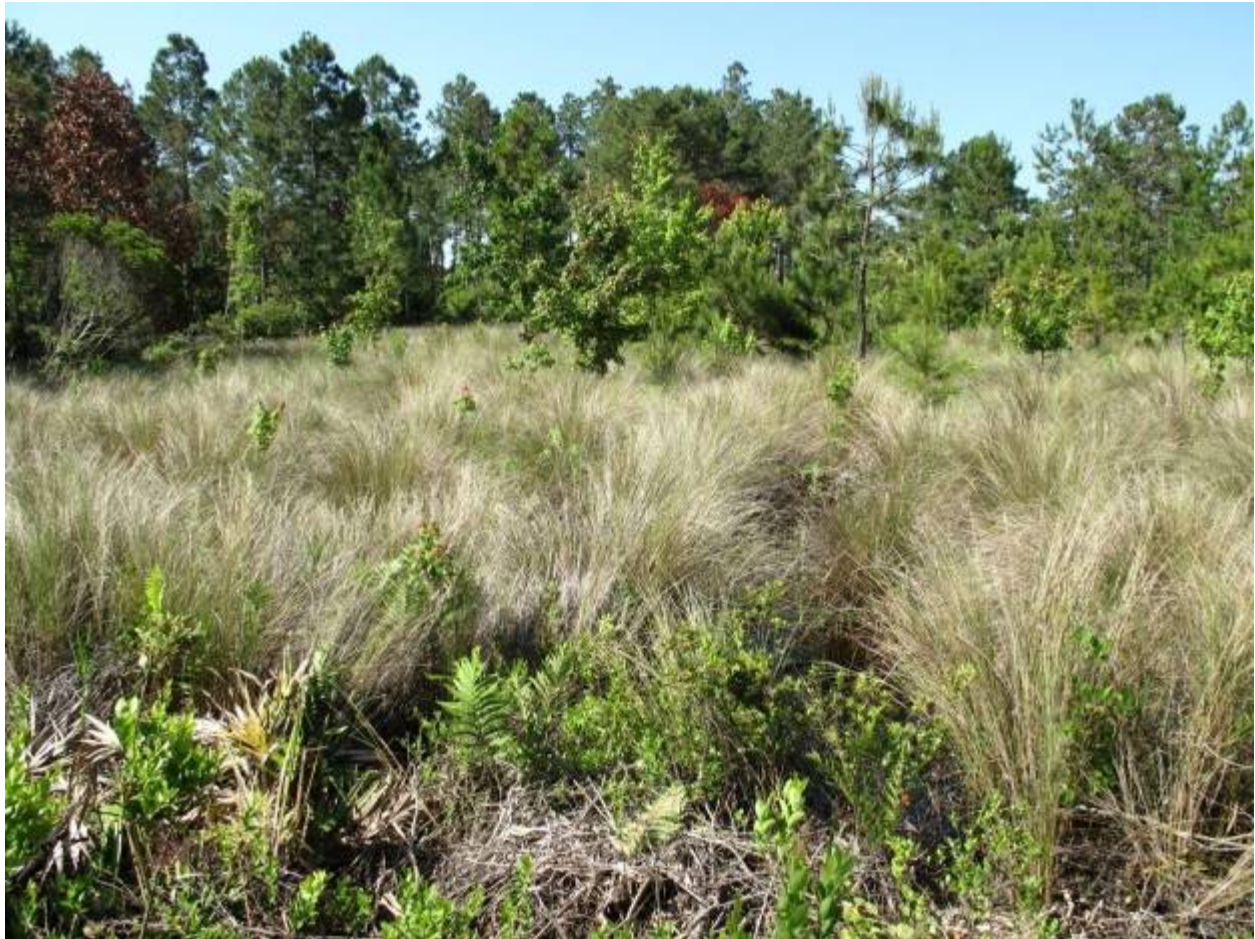
**Description:** This wetland is a 0.3 ha ephemeral marsh. Small pine trees are beginning to encroach and cover 5-25% of the wetland. Sedges/grasses grow throughout the wetland, and cover >75% of the basin. The adjacent uplands are mesic flatwoods.

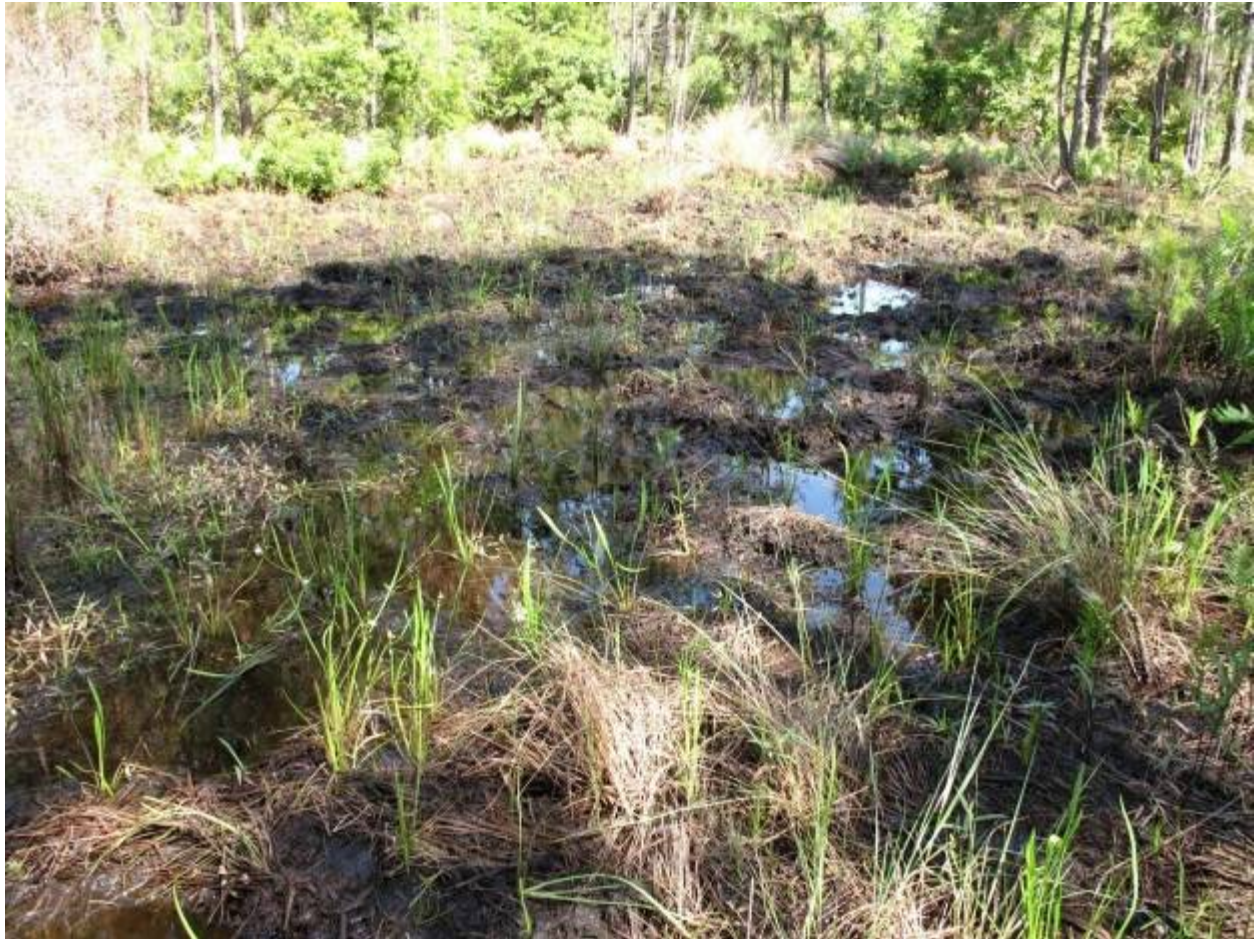
**Description:** This wetland is a 0.1 ha ephemeral marsh. There is no tree canopy or midstory cover. Sedges/grasses and redroot grow in scattered patches, and cover 5-25% of the wetland basin. This elongated wetland has been extensively damaged by feral hogs. The adjacent uplands are mesic flatwoods.

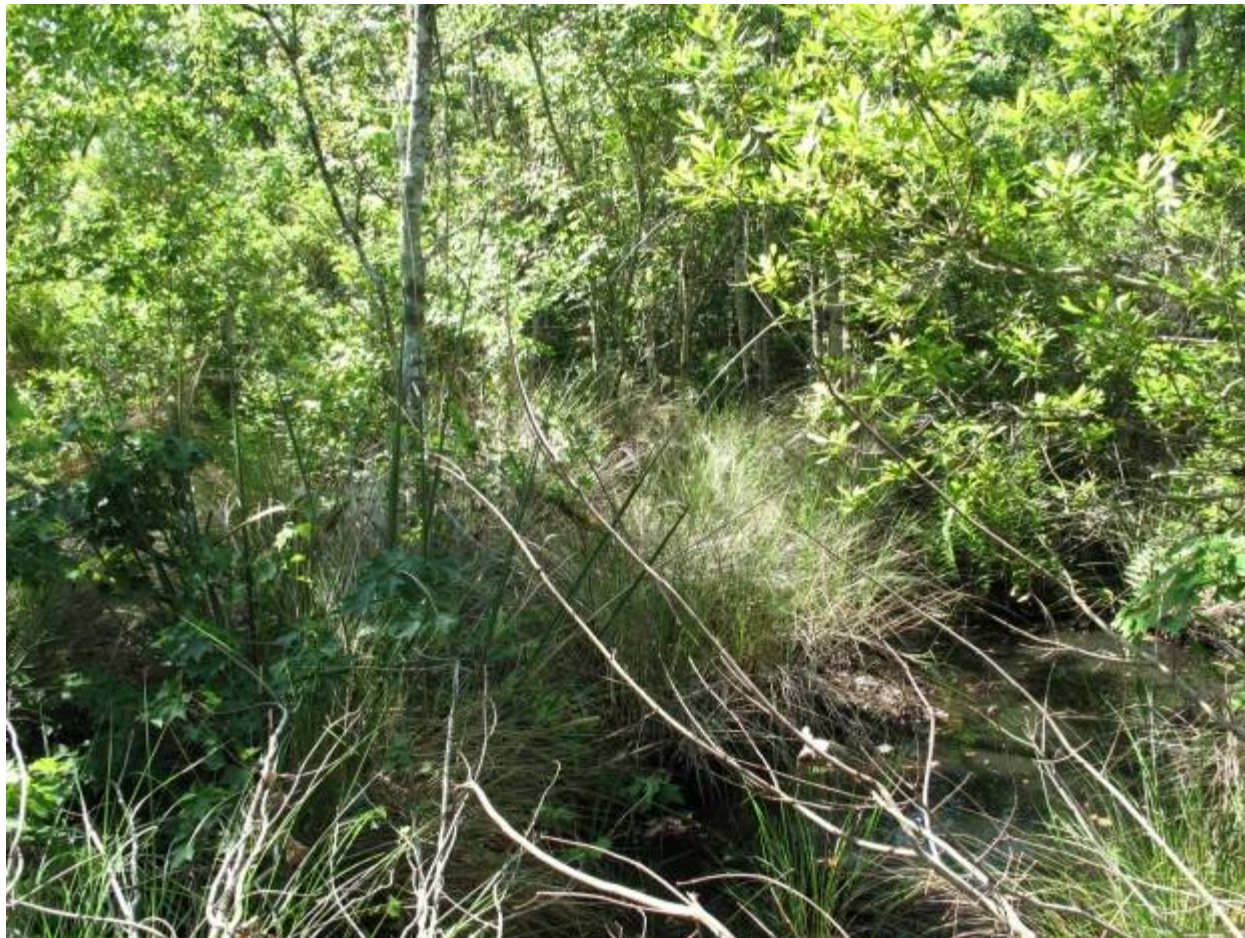
**Wetland ID: 01-09**

**Description:** This wetland is a 0.5 ha semi-permanent shrub swamp. Maple trees dominate the canopy, and cover 25-50% of the wetland. The midstory is dominated by small maple trees and wax myrtle, and covers 50-75% of the wetland. Sedges/grasses grow throughout the wetland, and cover >75% of the basin. This wetland appears to have been a marsh that is now succeeding to a maple-hardwood swamp. The adjacent uplands are a mixture of mesic and scrubby flatwoods and hammock.

**Wetland Disturbance:** Woody encroachment

**Restoration Action Recommended:** Encourage periodic fire in the wetland to reduce the woody encroachment.

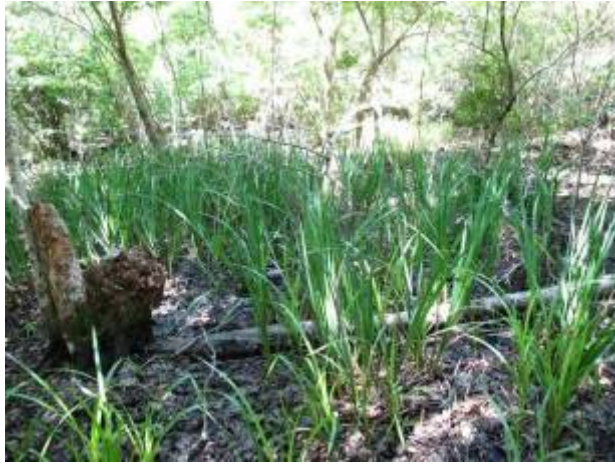
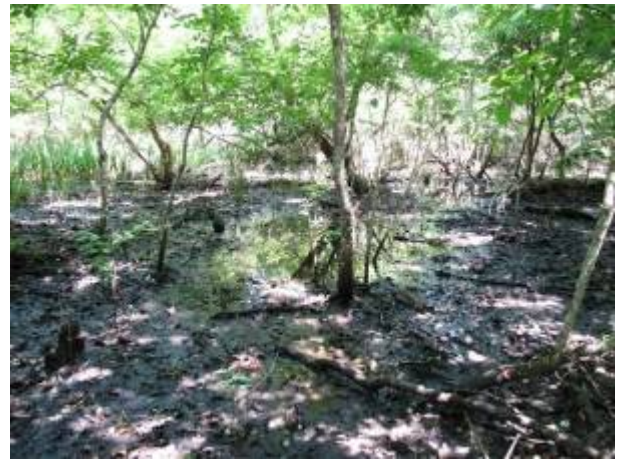
**Wetland ID: 01-10**

**Description:** This wetland is a 0.9 ha semi-permanent forested swamp. Maple and gum trees dominate the canopy, and cover >75% of the wetland. The midstory is dominated by wax myrtle and buttonbush, and covers 50-75% of the wetland. Sedges/grasses and emergent vegetation are sparse, and cover 5-25% of the wetland basin. The wetland appears to be a healthy, isolated swamp. The adjacent uplands are mesic flatwoods and hammock.

**Wetland Disturbance:** None

**Restoration Action Recommended:** None

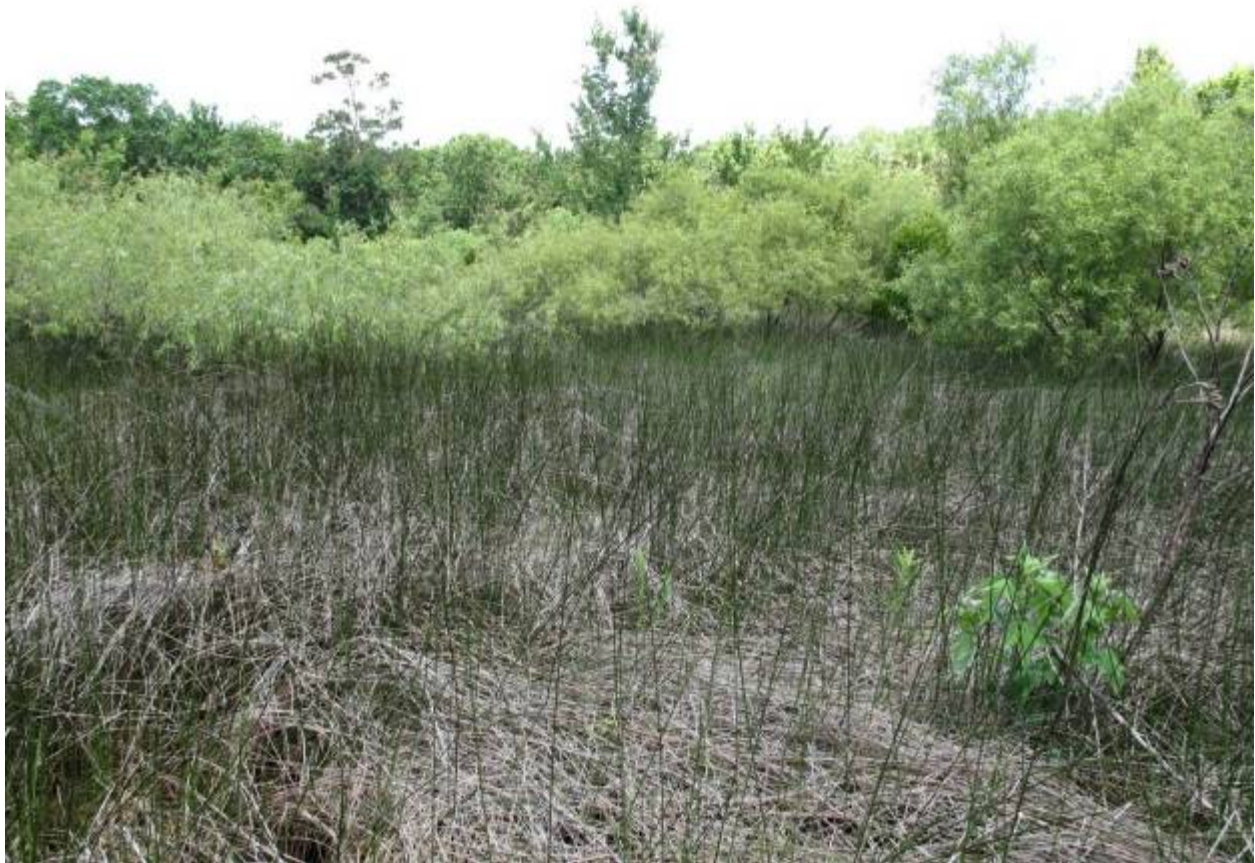
**Wetland ID: 01-11**

**Description:** This wetland is a 0.8 ha ephemeral marsh. Willow grows in a deeper hole in the wetland center, and covers 25-50% of the wetland. Rush grows throughout the wetland, and covers >75% of the basin. This needle rush marsh appears to be a freshwater isolated wetland, but it may receive some brackish influence. The adjacent uplands are hardwood hammock.

**Wetland Disturbance:** None

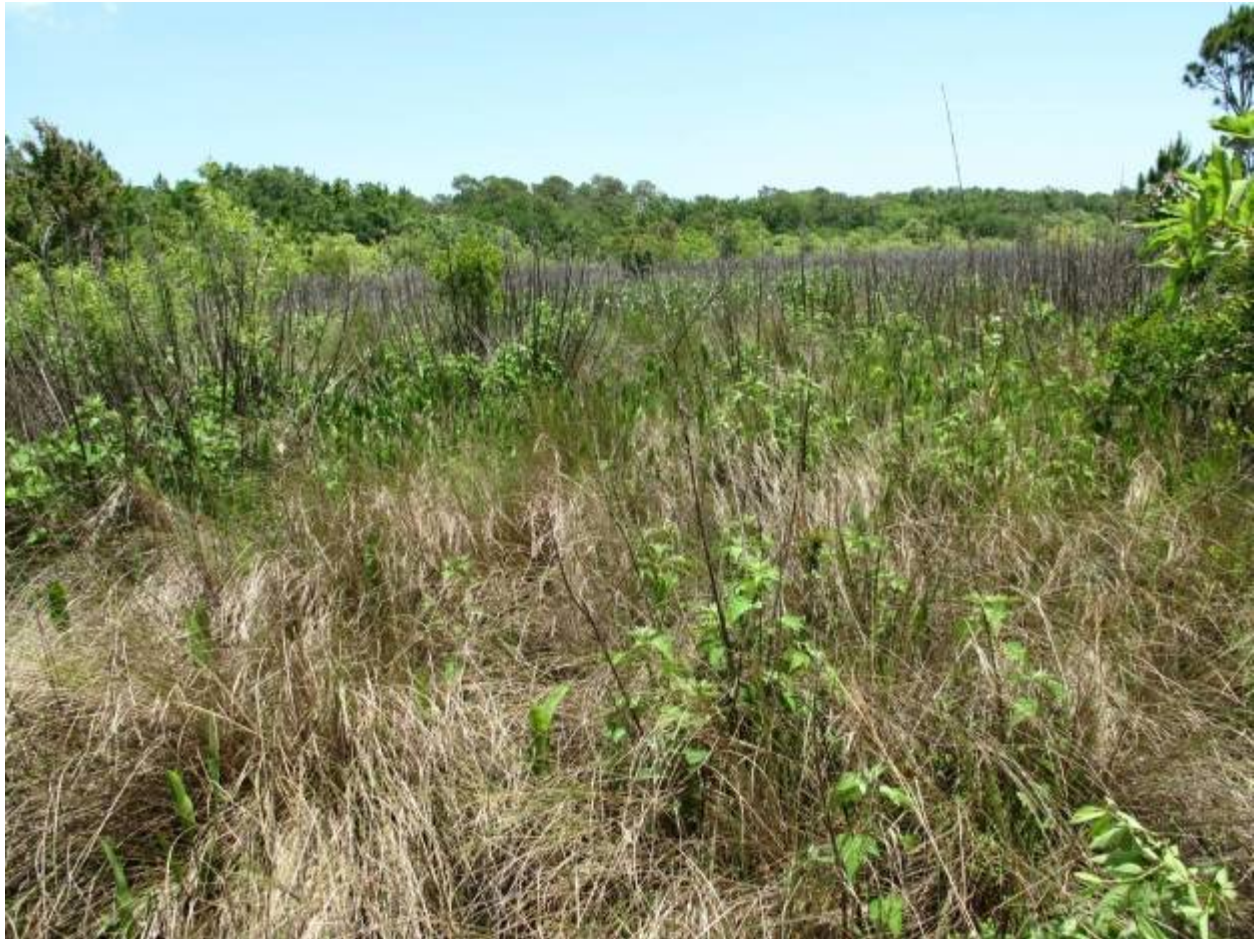
**Description:** This wetland is a 6.4 ha semi-permanent marsh. A mixture of wax myrtle, willow, buttonbush, and maple trees cover 5-25% of the wetland. Sedges/grasses and emergent vegetation grow throughout the wetland, and cover >75% of the basin. While this very large prairie marsh is in good condition, woody vegetation is beginning to encroach. The adjacent uplands are hammock.

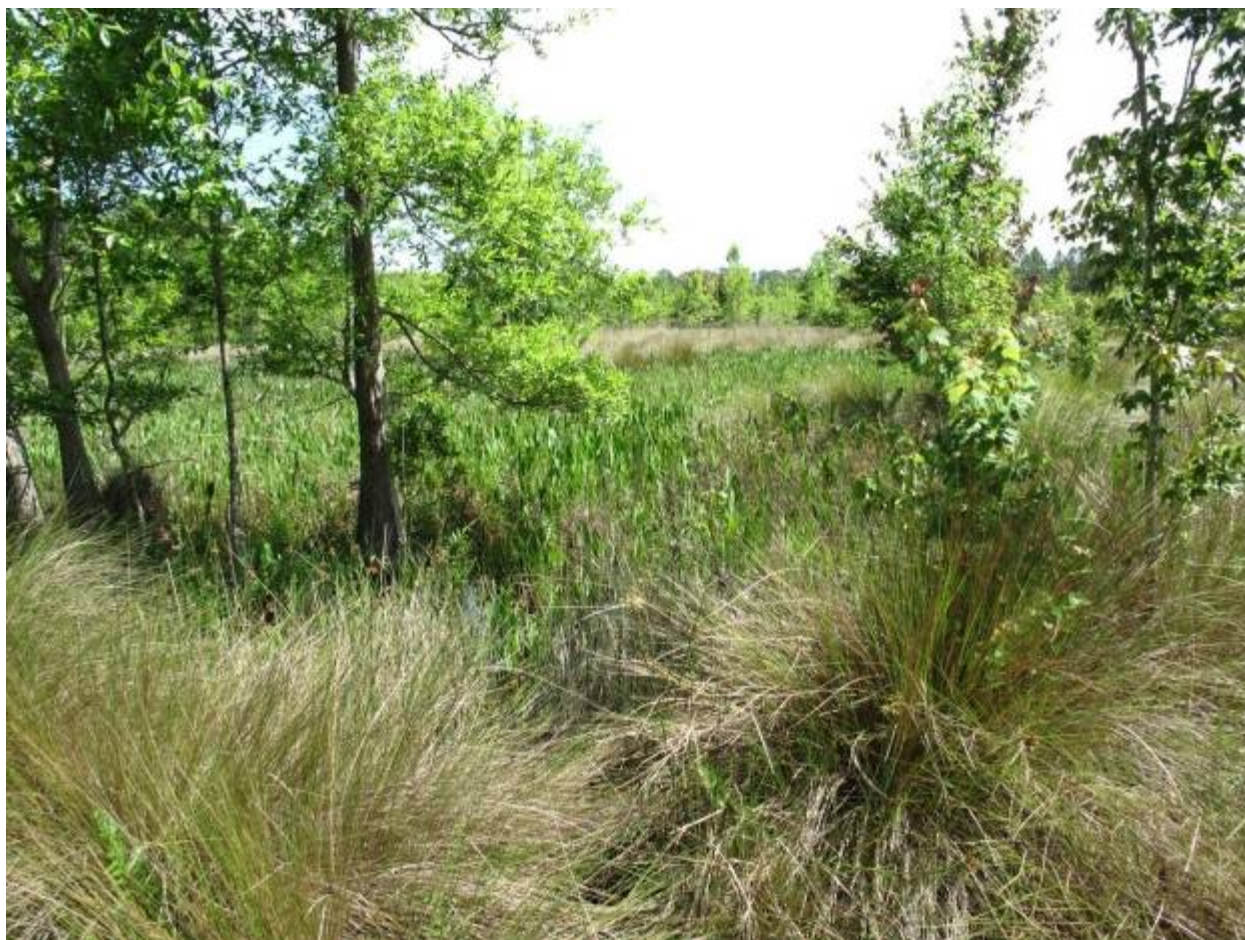
**Wetland ID: 01-13**

**Description:** This wetland is a 3.6 ha semi-permanent marsh. Small maple and gum trees are beginning to encroach, and cover 5-25% of the wetland. Sedges/grasses and rush grow throughout the wetland, and cover >75% of the basin. The adjacent uplands are hammock.

**Wetland Disturbance:** Woody encroachment

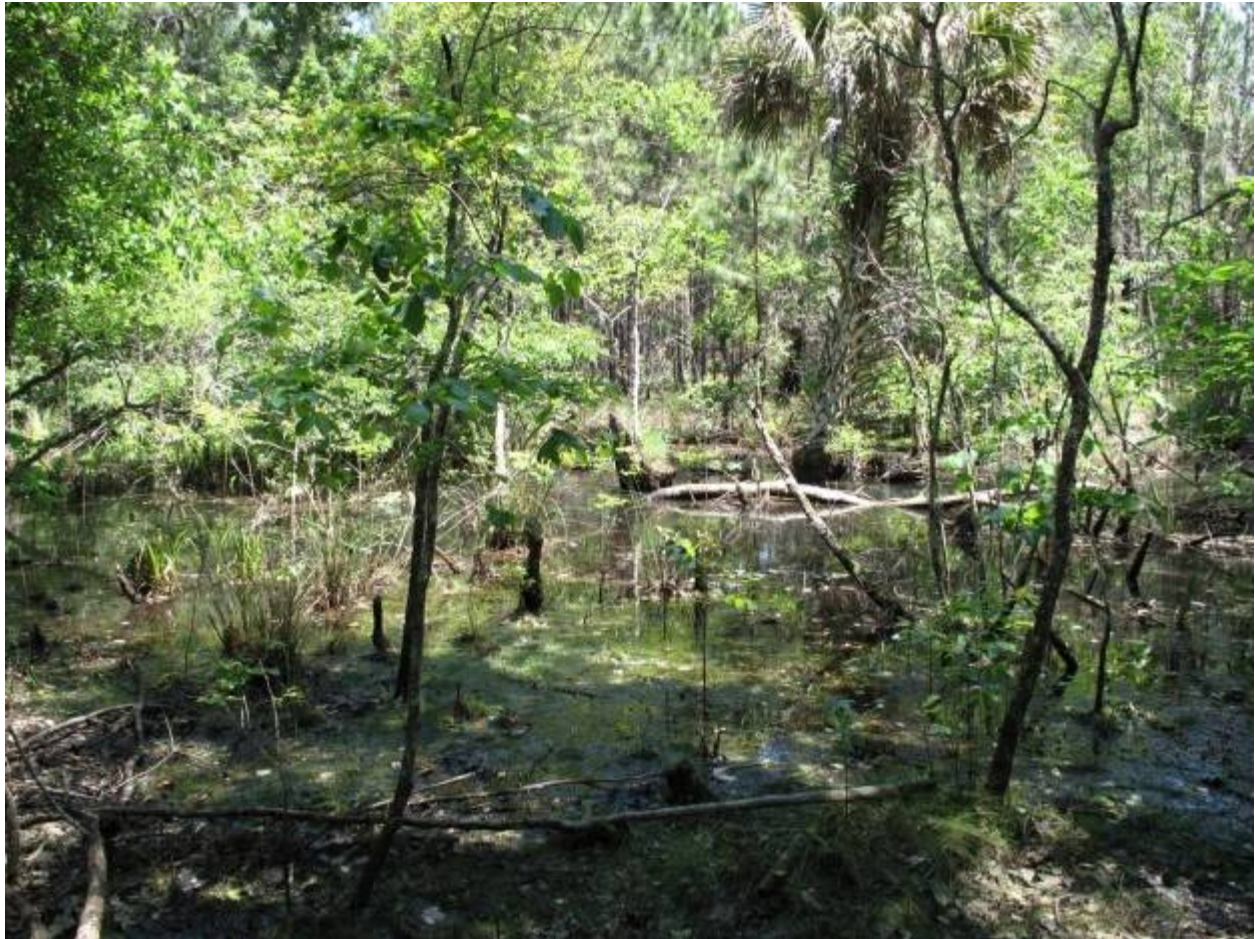
**Description:** This wetland is a 1.2 ha ephemeral mixed swamp. Maple trees dominate the canopy, and cover 25-50% of the wetland. The midstory is dominated by willow and small maple trees, and covers 25-50% of the wetland. Sedges/grasses grow in scattered patches, and cover 25-50% of the wetland basin. Old berms and dug out areas are present in and around the wetland, but do not appear to be affecting the wetland health. The adjacent uplands are mesic flatwoods that were converted to a pine plantation. The uplands have been thinned and burned in order to restore them to a more open flatwoods community.

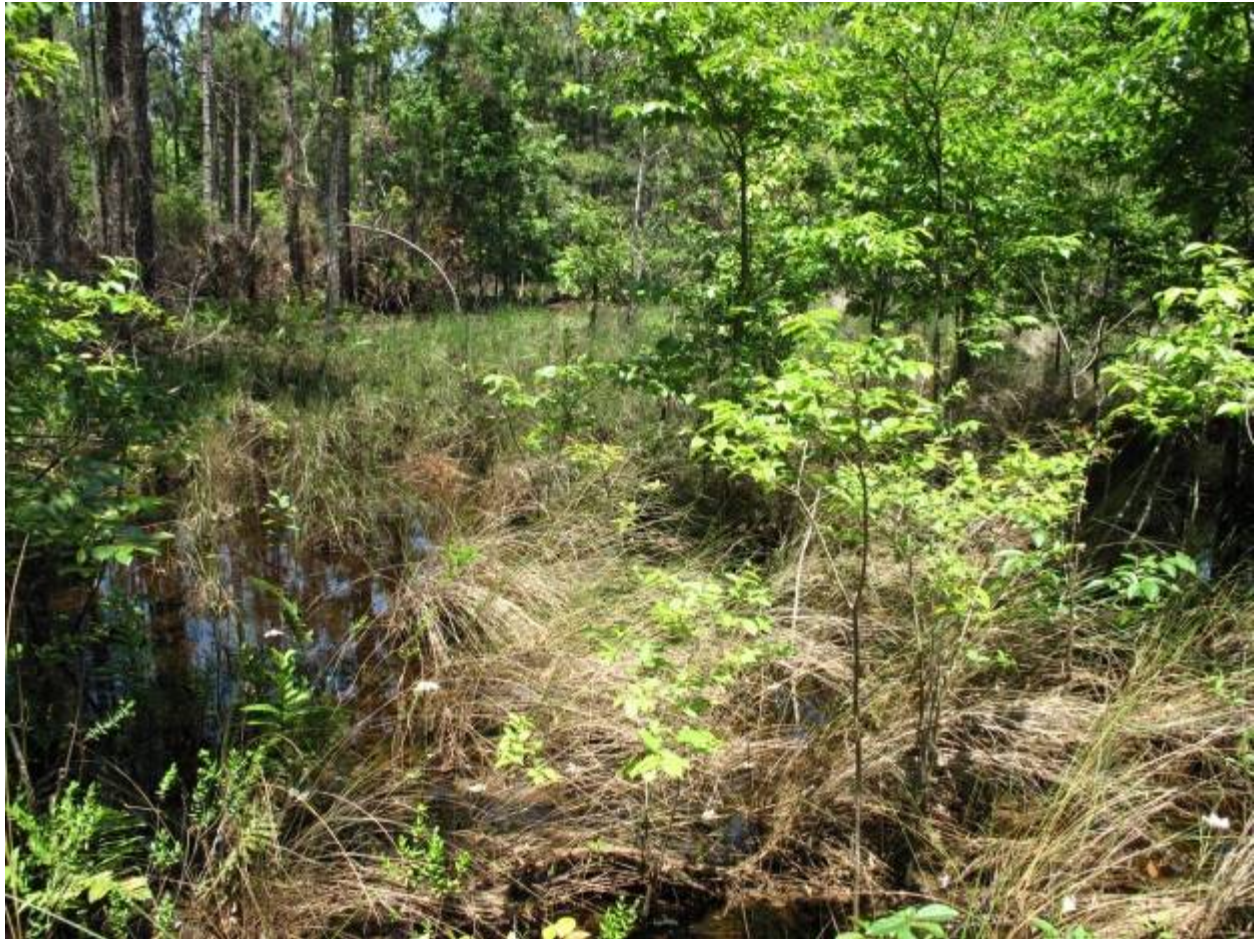
**Description:** This wetland is a 0.2 ha ephemeral marsh. Small maple trees are beginning to encroach, and cover 5-25% of the wetland. Sedges/grasses grow throughout the wetland, and cover >75% of the basin. The adjacent uplands are mesic flatwoods that were converted to a pine plantation. The uplands have been thinned and burned in order to restore them to a more open flatwoods community.

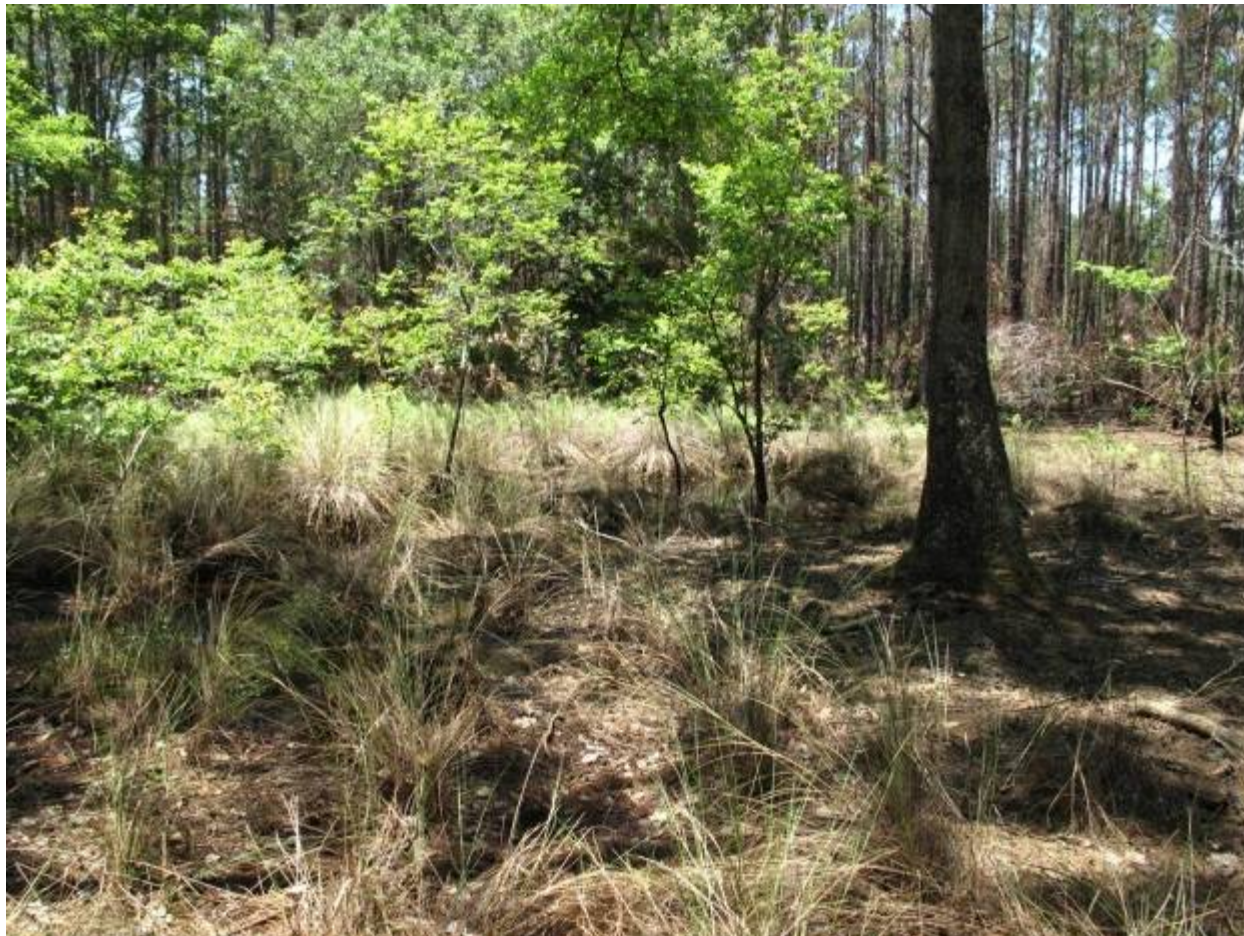
**Wetland ID: 02-03**

**Description:** This wetland is a 0.1 ha ephemeral marsh. Gum trees dominate the canopy, and cover 25-50% of the wetland. The midstory is dominated by small gum trees, and covers 25-50% of the wetland. Sedges/grasses grow in scattered patches, and cover 50-75% of the wetland basin. This marsh will likely succeed to a gum pond if fire remains absent from the wetland. The adjacent uplands are mesic flatwoods that were converted to a pine plantation. The uplands have been thinned and burned in order to restore them to a more open flatwoods community.

**Wetland Disturbance:** Woody encroachment

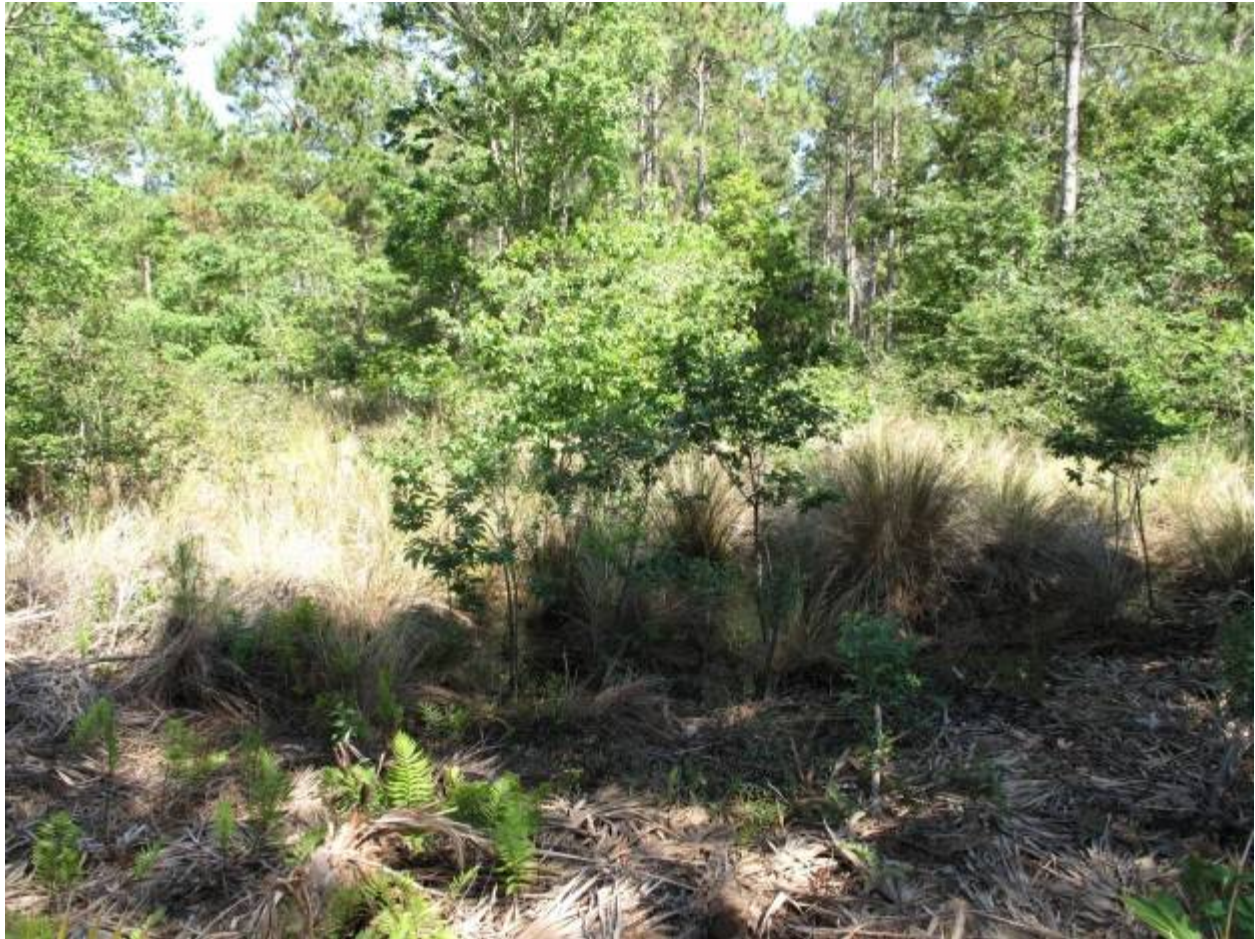
**Description:** This wetland is a 0.1 ha ephemeral marsh. An unidentified shrub is the dominant woody vegetation, and covers 25-50% of the wetland. Grass clumps grow throughout the wetland, and cover >75% of the basin. The adjacent uplands are mesic flatwoods that were converted to a pine plantation. The uplands have been thinned and chopped in order to restore them to a more open flatwoods community.

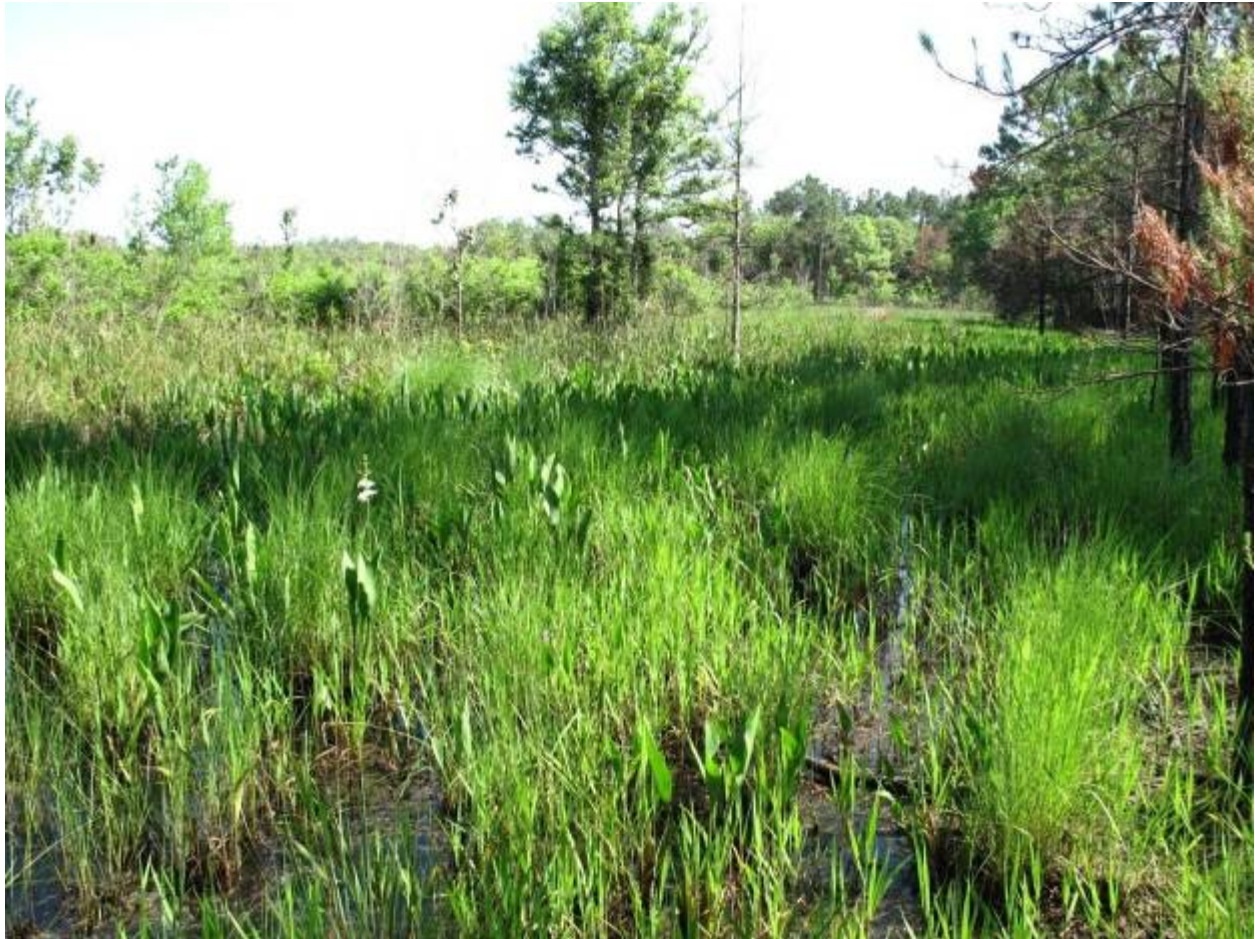
**Description:** This wetland is a 1.0 ha semi-permanent marsh. Buttonbush is the dominant woody vegetation, and covers 5-25% of the wetland. Sedges/grasses and emergent vegetation grow throughout the wetland, and cover >75% of the basin. This large marsh has a high diversity of herbaceous vegetation. The wetland just burned during the recent prescribed fire treatment and appears to be in great ecological condition. The adjacent uplands are a mix of scrubby flatwoods and an old pine plantation.
