# **Inventory, Assessment, and Restoration Potential of Ephemeral Wetlands on FFWCC Wildlife Management Areas**

## **Guana River WMA Final Report**

Submitted by: Rebecca P.M. Means<sup>1</sup>, Ryan C. Means<sup>1</sup>, Steven A. Johnson<sup>2</sup>

April - May 2009

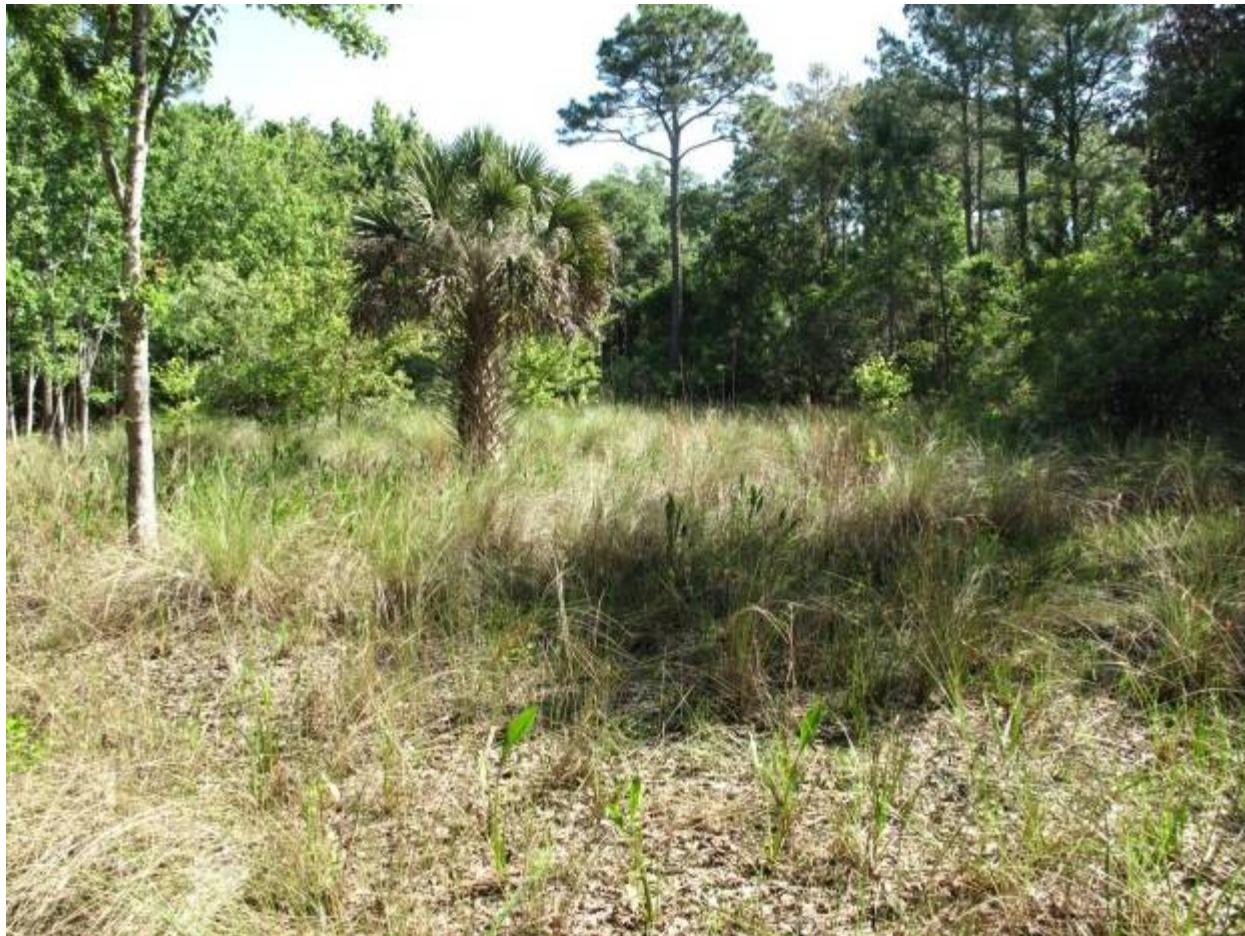
**Wetland ID: 03-03**

**Description:** This wetland is a 0.2 ha ephemeral marsh. There is no tree canopy or midstory cover in the wetland, although a few small trees are beginning to encroach. Sedges/grasses grow throughout the wetland, and cover >75% of the basin. The adjacent uplands are mesic flatwoods and hammock. The uplands recently were mowed in preparation for a prescribed burn.

**Wetland Disturbance:** None

**Restoration Action Recommended:** Monitor this wetland to ensure the small trees are killed with the next fire or inundation. If they become established, the trees may need to be removed from the wetland.

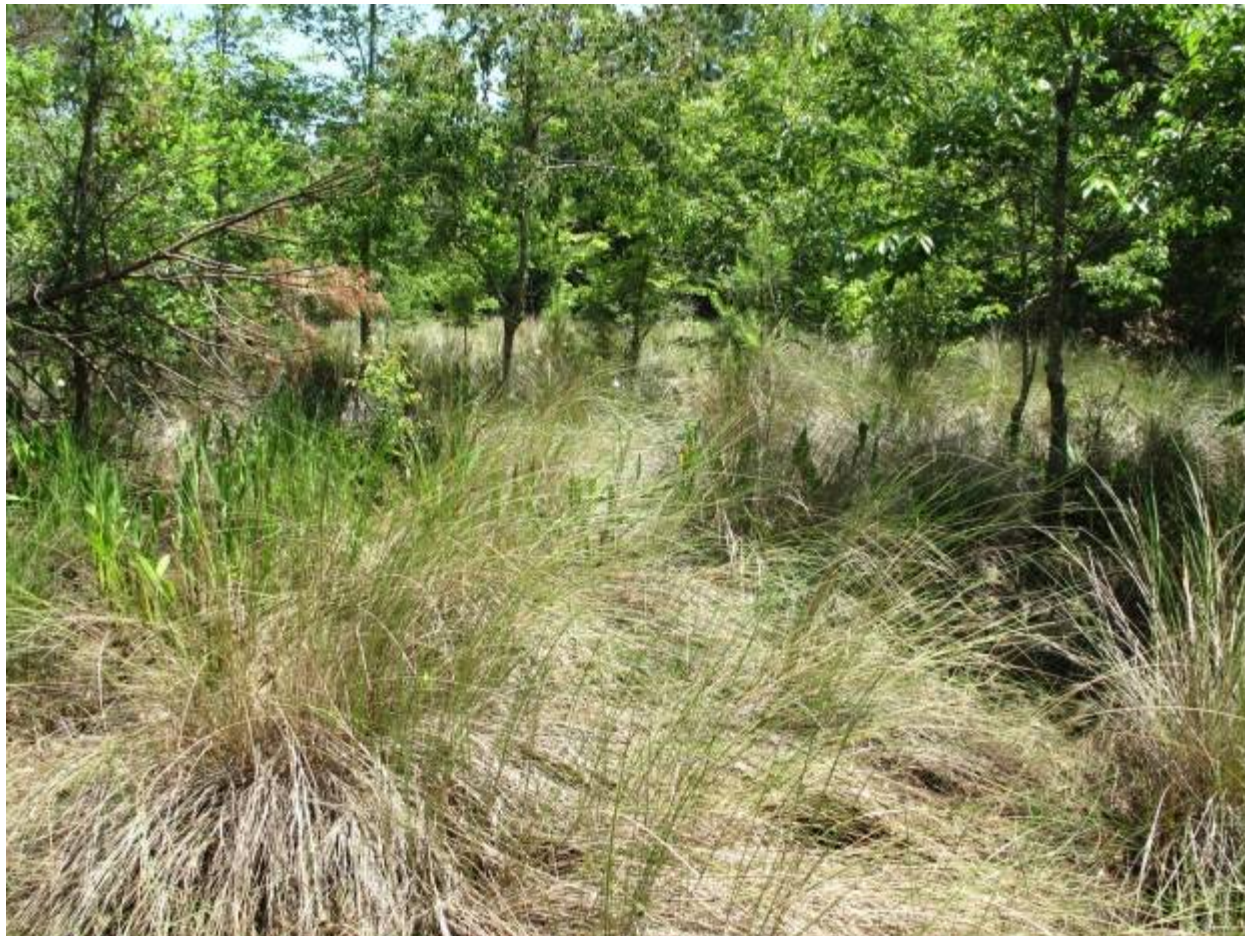
**Wetland ID: 03-04**

**Description:** This wetland is a 0.2 ha ephemeral marsh. Small gum trees cover 5-25% of the wetland. There is no midstory cover. Sedges/grasses grow throughout the wetland, and cover >75% of the basin. A recent fire burned into the wetland edges. The adjacent uplands are mesic and scrubby flatwoods.

**Wetland Disturbance:** None

**Restoration Action Recommended:** This wetland is in the very early stages of succeeding to a gum swamp. To maintain this wetland as a marsh, monitor to ensure gum trees do not become established. The trees could be removed from the wetland if they are not killed by the next fire.

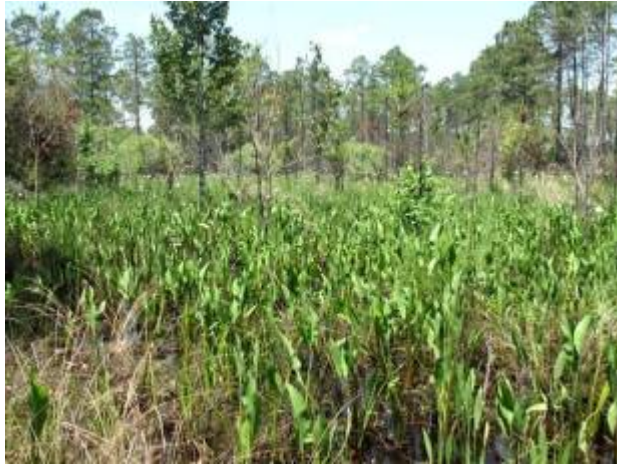
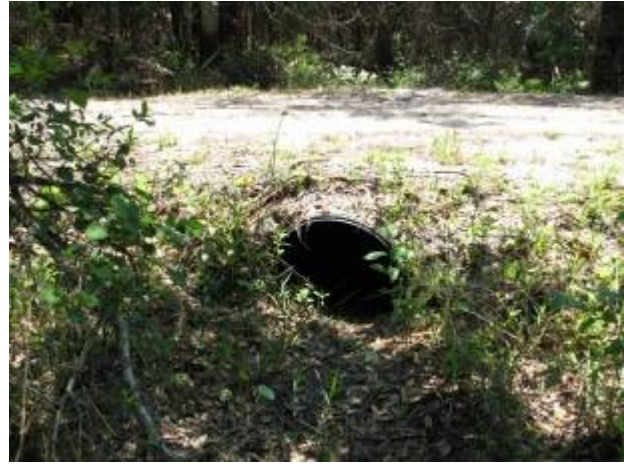
**Wetland ID: 03-05**

**Description:** This wetland is a 0.4 ha semi-permanent marsh. There is no tree canopy or midstory cover. Sedges/grasses and emergent vegetation grow throughout the wetland, and cover >75% of the basin. A culvert drains the wetland under the adjacent road to the east side. The adjacent uplands are scrubby flatwoods.

**Wetland Disturbance:** Culvert

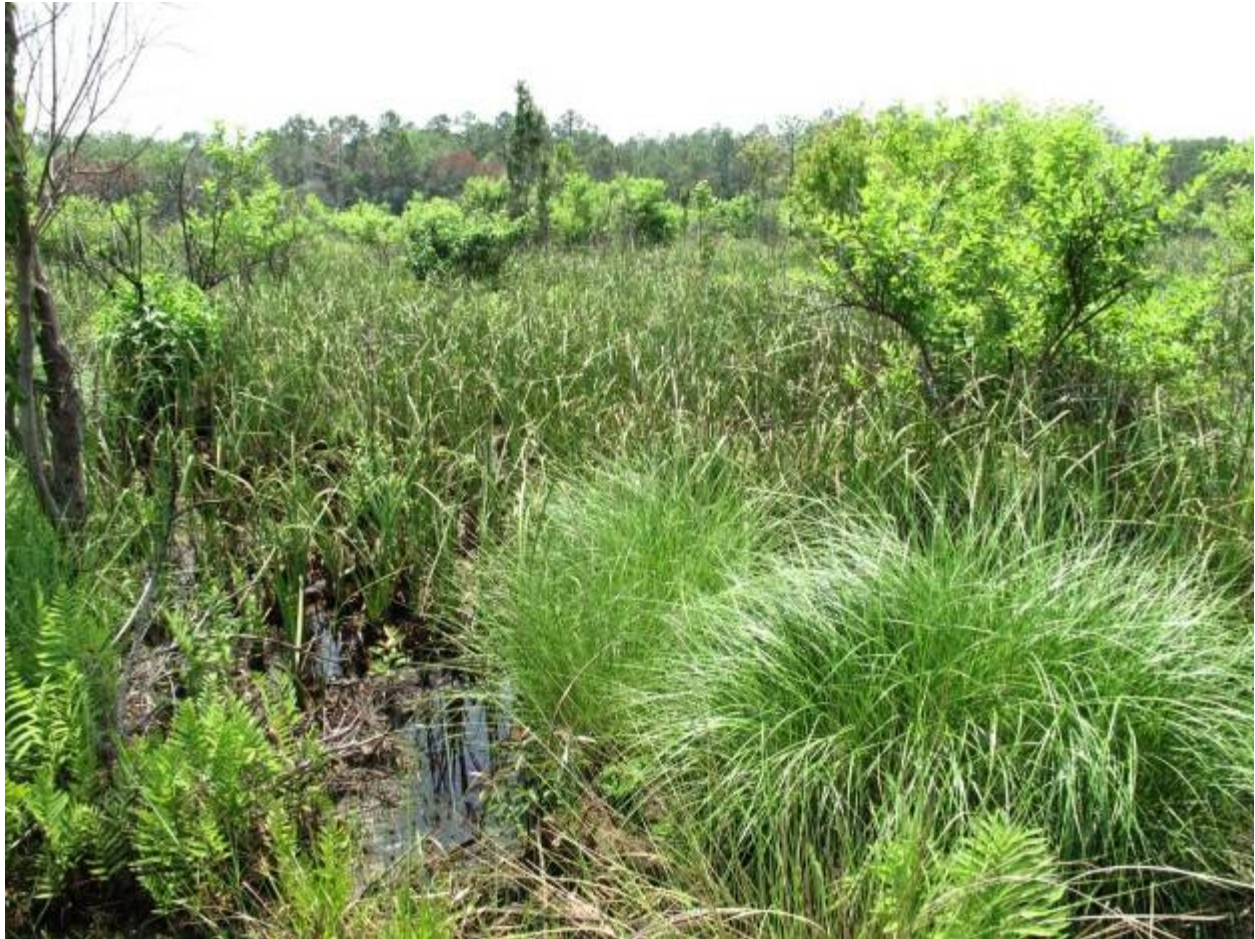
**Description:** This wetland is a 6.2 ha semi-permanent marsh. Buttonbush and small maple trees are the dominant woody vegetation, and cover 5-25% of the wetland. Sedge/grass, sawgrass, and emergent vegetation grow throughout the wetland, and cover >75% of the basin. This very large prairie marsh has diverse herbaceous vegetation. A recent fire burned into the wetland basin. The adjacent uplands are scrubby flatwoods.

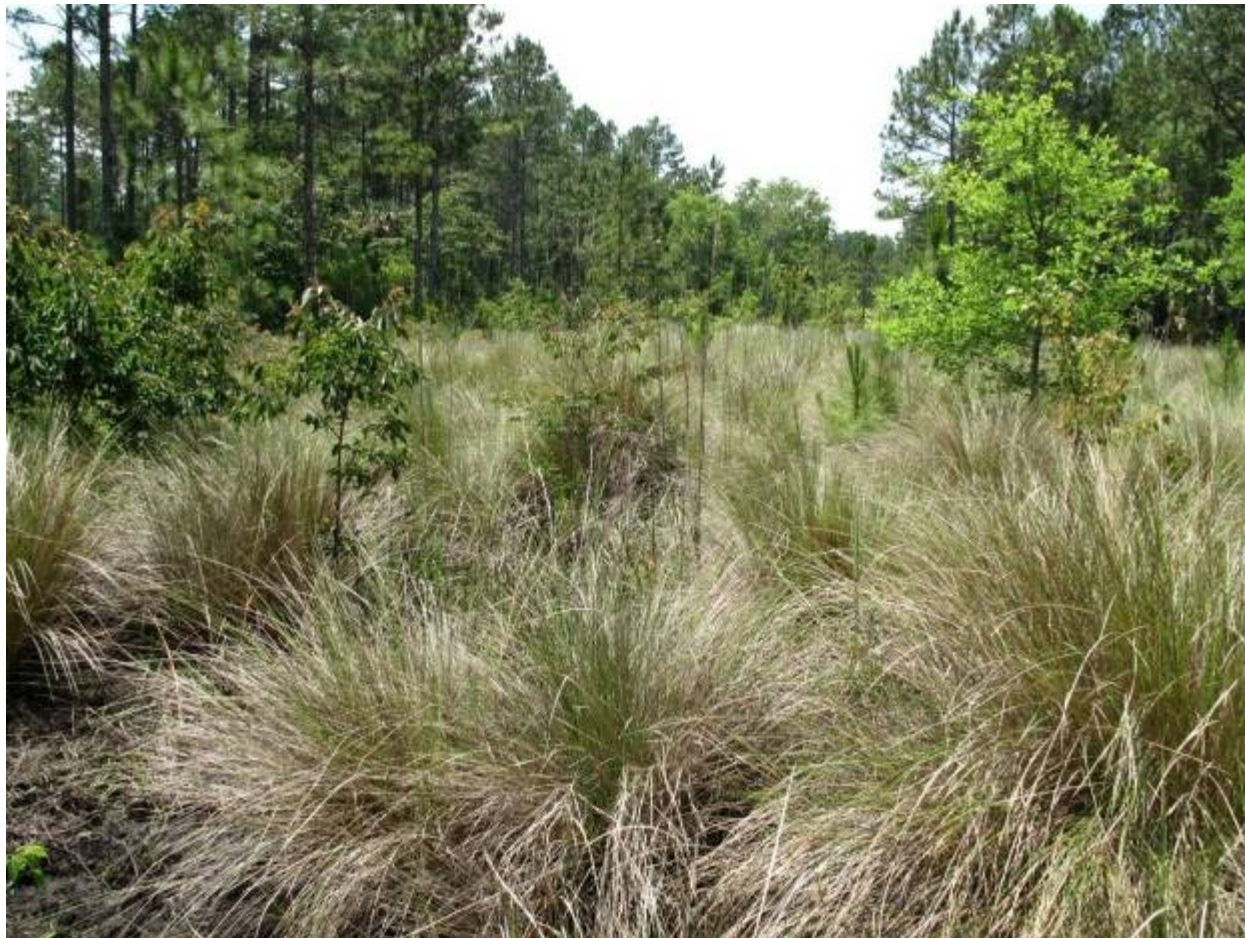
**Wetland ID: 04-01**

**Description:** This wetland is a 0.7 ha ephemeral marsh. Persimmon is beginning to encroach, and covers 5-25% of the wetland. Sedges/grasses grow throughout the wetland, and cover >75% of the basin. There is some feral hog damage in the wetland. The adjacent uplands are mesic and scrubby flatwoods.

**Wetland Disturbance:** Feral hog damage, Woody encroachment

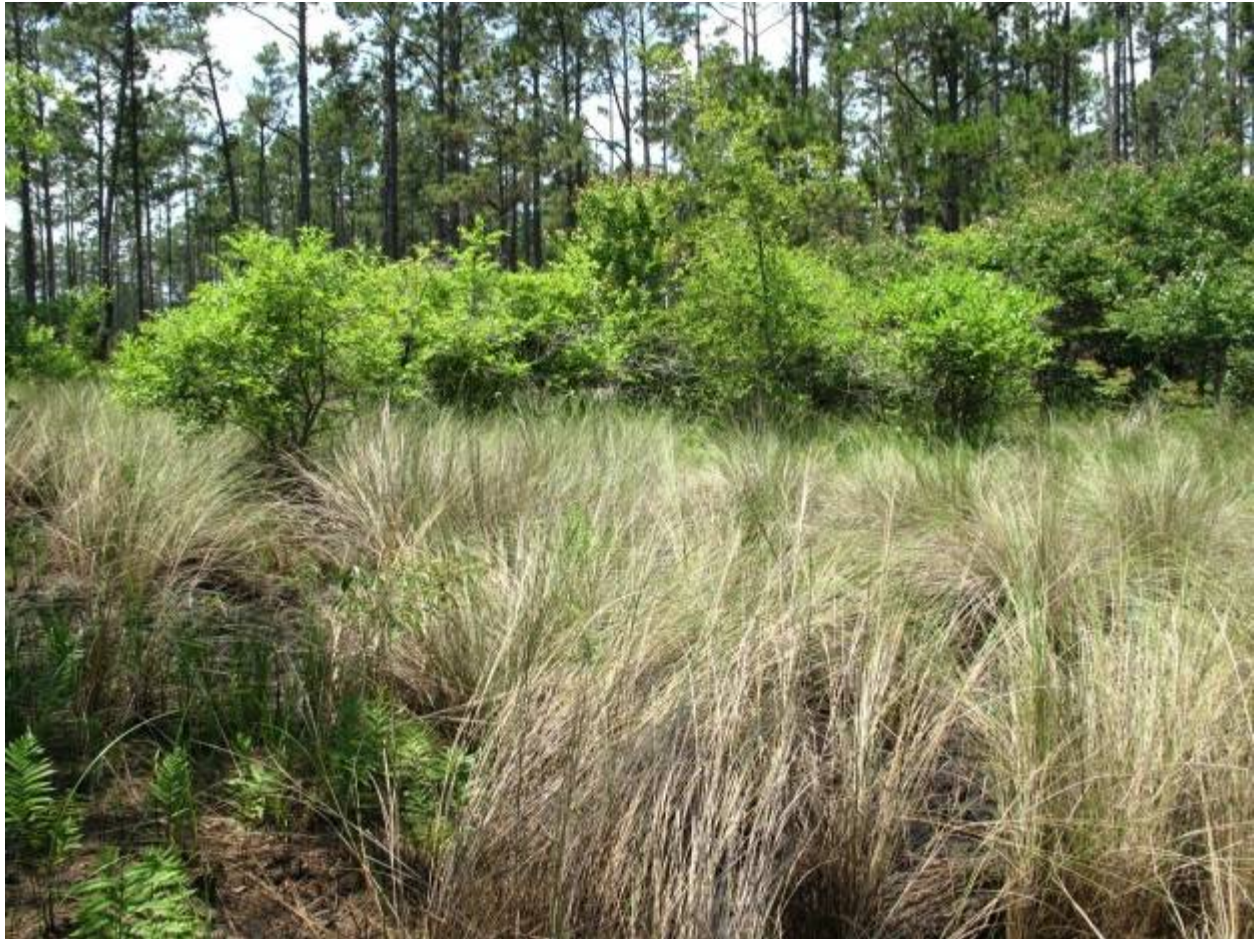
**Description:** This wetland is a 0.3 ha ephemeral marsh. Buttonbush is the dominant woody vegetation, and covers 5-25% of the wetland. There is moderate feral hog damage in the wetland. Sedges/grasses and fern grow throughout the wetland, and cover >75% of the basin. There is a moderate amount of hog rooting in the wetland. This marsh is in fire-maintenance condition. The adjacent uplands are scrubby flatwoods.

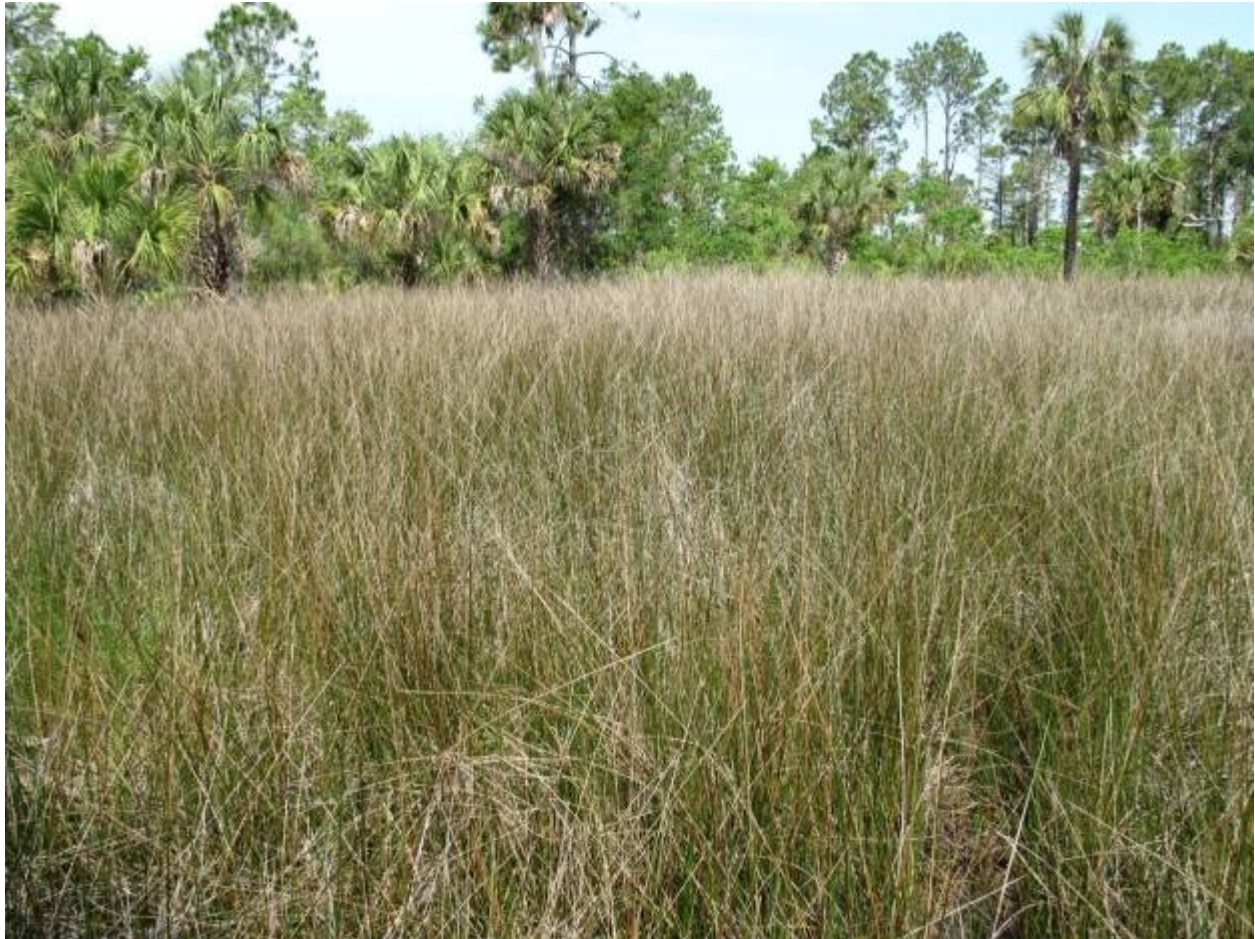
**Description:** This wetland is a 0.2 ha ephemeral marsh. There is no tree canopy or midstory cover. Rushes grow throughout the wetland, and cover >75% of the basin. This healthy, isolated marsh may have some brackish influence. This wetland is in fire-maintenance condition. The adjacent uplands are mesic flatwoods and hammock.

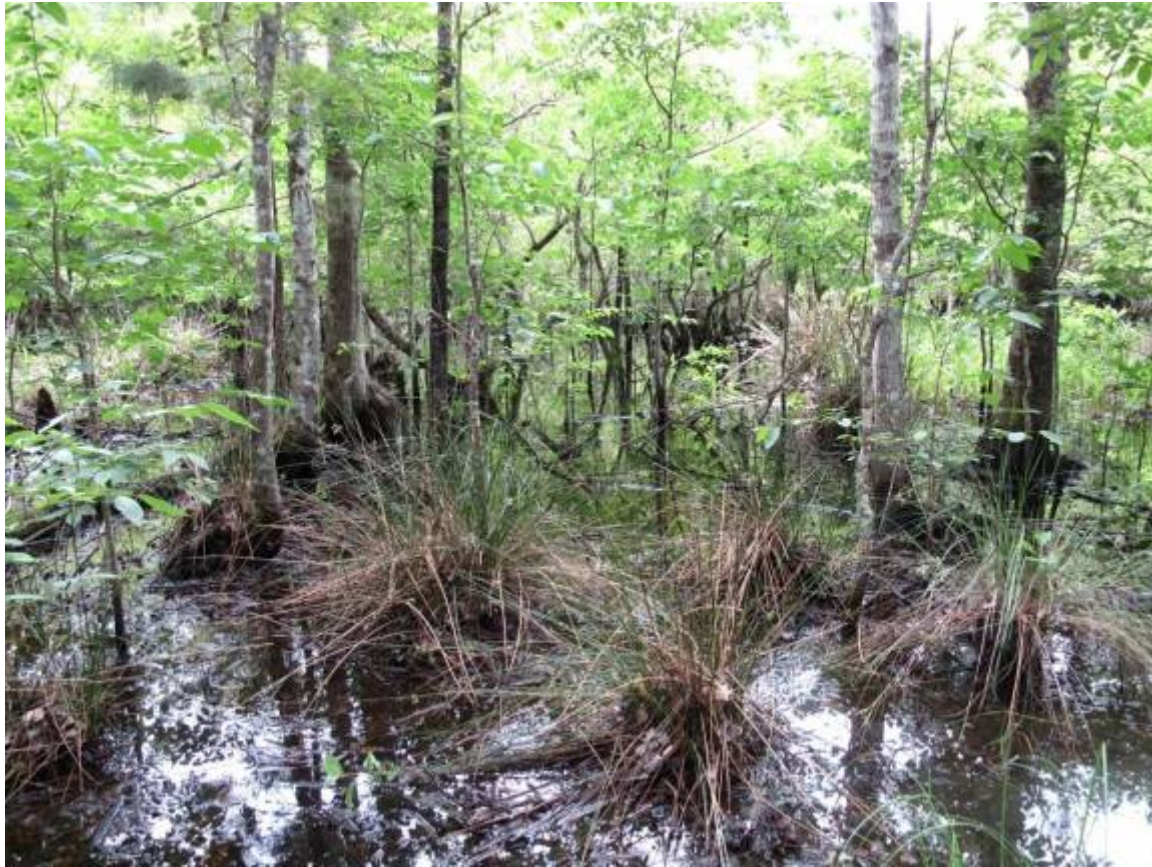
**Wetland ID: 05-02**

**Description:** This wetland is a 0.6 ha semi-permanent shrub swamp. Maple and willow dominate the canopy, and cover 5-25% of the wetland. The midstory is dominated by willow, buttonbush, and small maples, and covers >75% of the wetland. Rushes, sedge/grass, and emergent vegetation grow in scattered patches, and covers 25-50% of the wetland basin. This wetland may once have been a marsh but has succeeded to a shrub swamp. During times of high rainfall, this wetland will connect to Wetland 05-03. The adjacent uplands are mesic flatwoods and hammock. Fire in the uplands is less frequent here than in most other management units.

**Wetland Disturbance:** Woody encroachment

**Restoration Action Recommended:** None. We believe that this wetland was once a marsh; however, it has succeeded to a healthy looking shrub swamp. Because there are so many healthy marshes on the GRWMA landscape, it would be an inefficient use of resources to restore this wetland. Fire will no longer carry easily through this wetland basin so mechanical removal of woody shrubs/trees would be necessary in order to restore this wetland back to a marsh. We recommend nothing here beyond simply keeping the wetland and surrounding landscape fire-maintained.

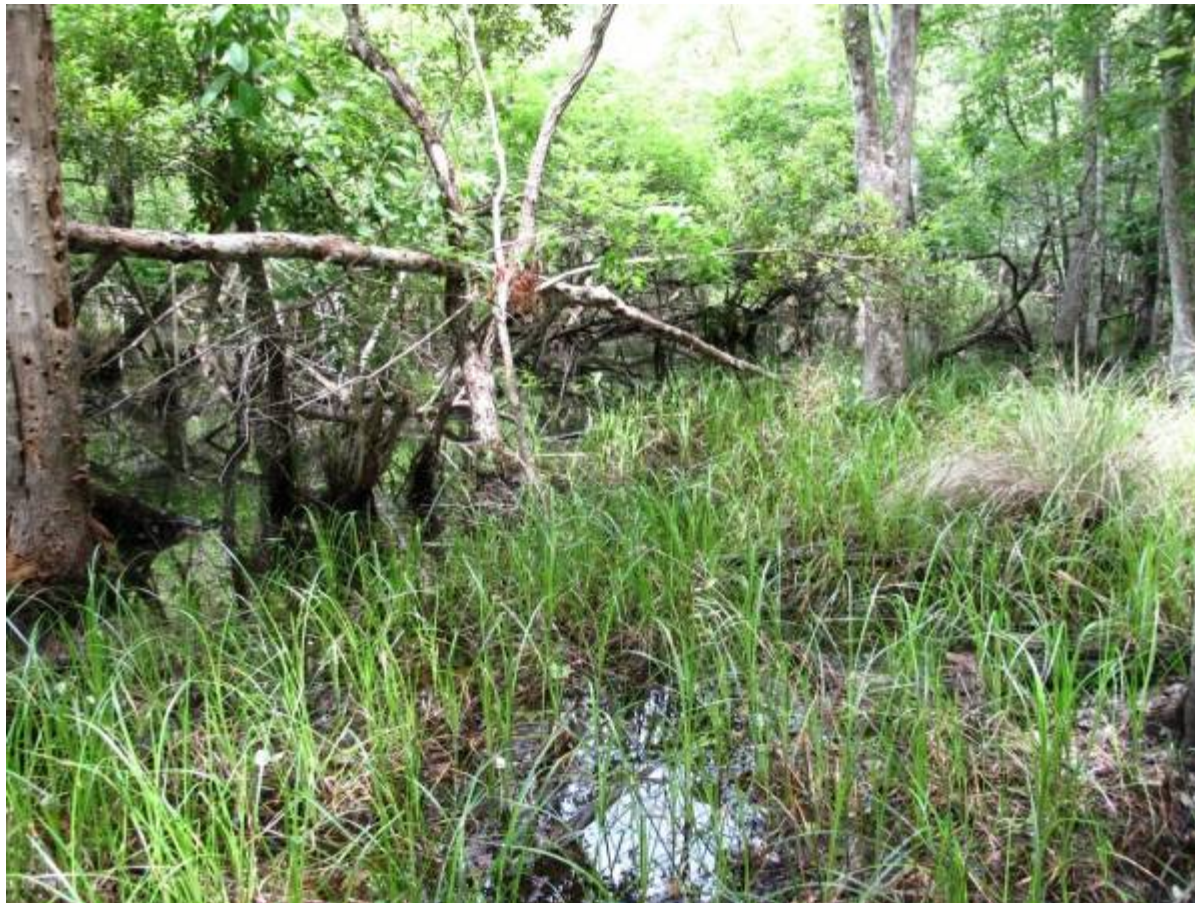
**Wetland ID: 05-03**

**Description:** This wetland is a 0.9 ha semi-permanent shrub swamp. Maple trees dominate the canopy, and cover 25-50% of the wetland. The midstory is dominated by willow, buttonbush, wax myrtle and small maples, and covers >75% of the wetland. Sedges/grasses grow in scattered patches, and cover 5-25% of the wetland basin. This wetland may once have been a marsh but has succeeded to a shrub swamp. During times of high rainfall, this wetland will connect to wetland 05-02. The adjacent uplands are scrubby flatwoods and hammock.

**Wetland Disturbance:** Woody encroachment

**Restoration Action Recommended:** None. We believe that this wetland was once a marsh; however, it has succeeded to a healthy looking shrub swamp. Because there are so many healthy marshes on the GRWMA landscape, it would be an inefficient use of resources to restore this wetland. Fire will no longer carry easily through this wetland basin so mechanical removal of woody shrubs/trees would be necessary in order to restore this wetland back to a marsh. We recommend nothing here beyond simply keeping the wetland and surrounding landscape fire-maintained.

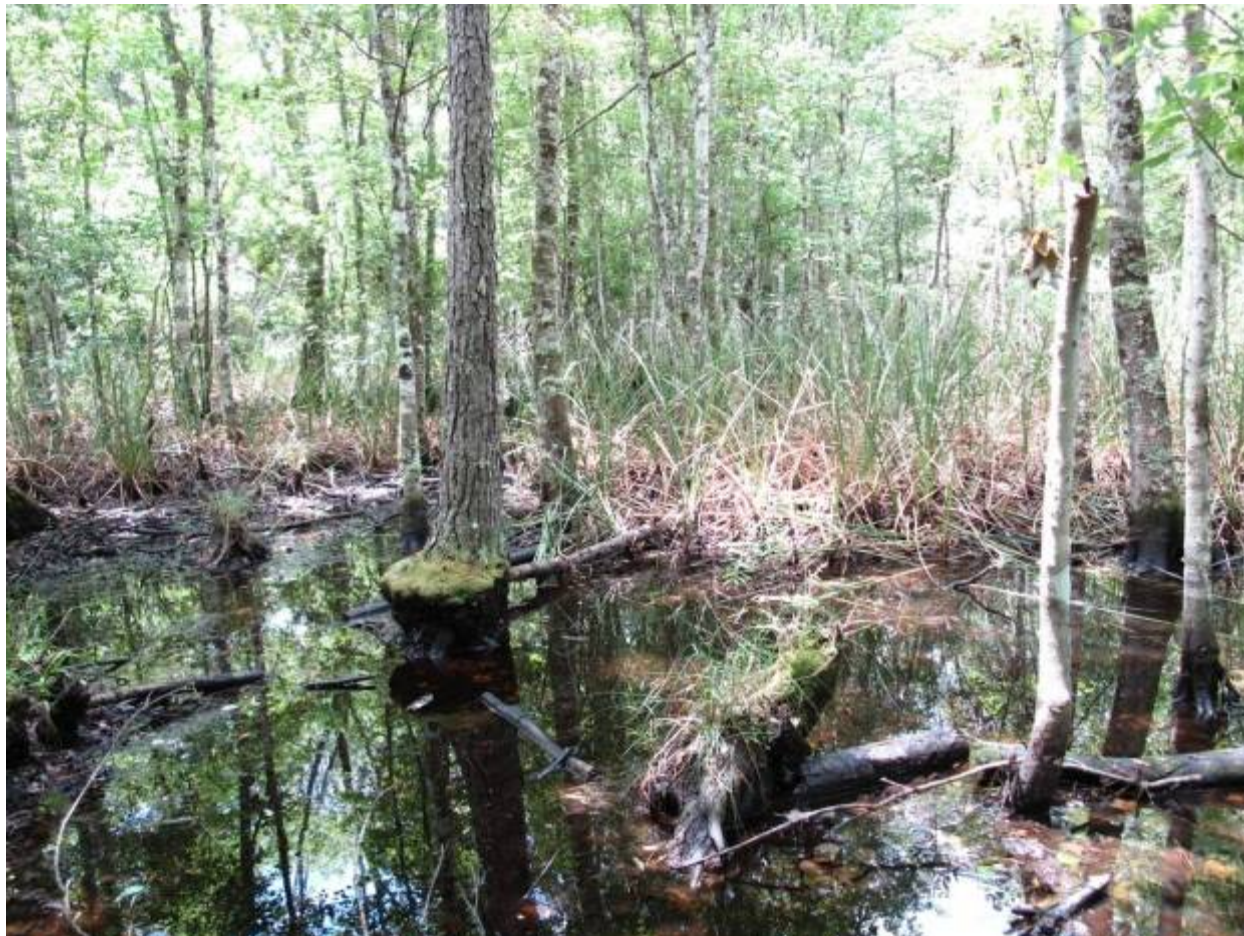
**Wetland ID: 05-04**

**Description:** This wetland is a 1.2 ha semi-permanent forested swamp. Maple trees dominate the canopy, and cover >75% of the wetland. The midstory is dominated by buttonbush and small maples, and covers 5-25% of the wetland. Sedges/grasses and sawgrass grow in scattered patches, and cover 5-25% of the wetland basin. This wetland may once have been a marsh but has succeeded to a forested swamp. The adjacent uplands are hammock.

**Wetland Disturbance:** Woody encroachment

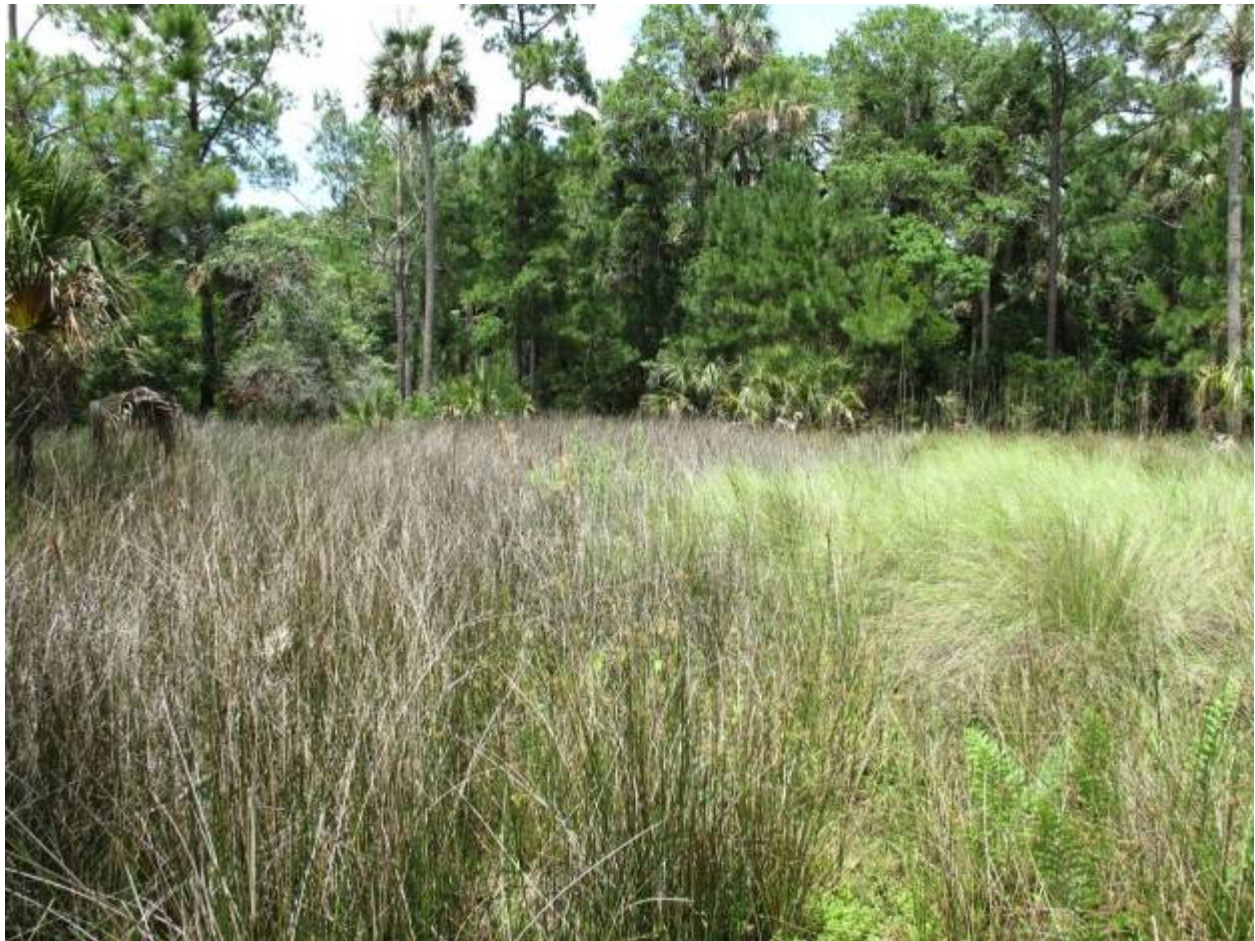
**Description:** This wetland is a 0.1 ha ephemeral marsh. There is no tree canopy or midstory cover. Rushes and sedges/grasses grow throughout the wetland, and cover >75% of the basin. This marsh is located at the head of a tidal strand that becomes brackish to the south. This wetland is in fire-maintenance condition. The adjacent uplands are hammock.

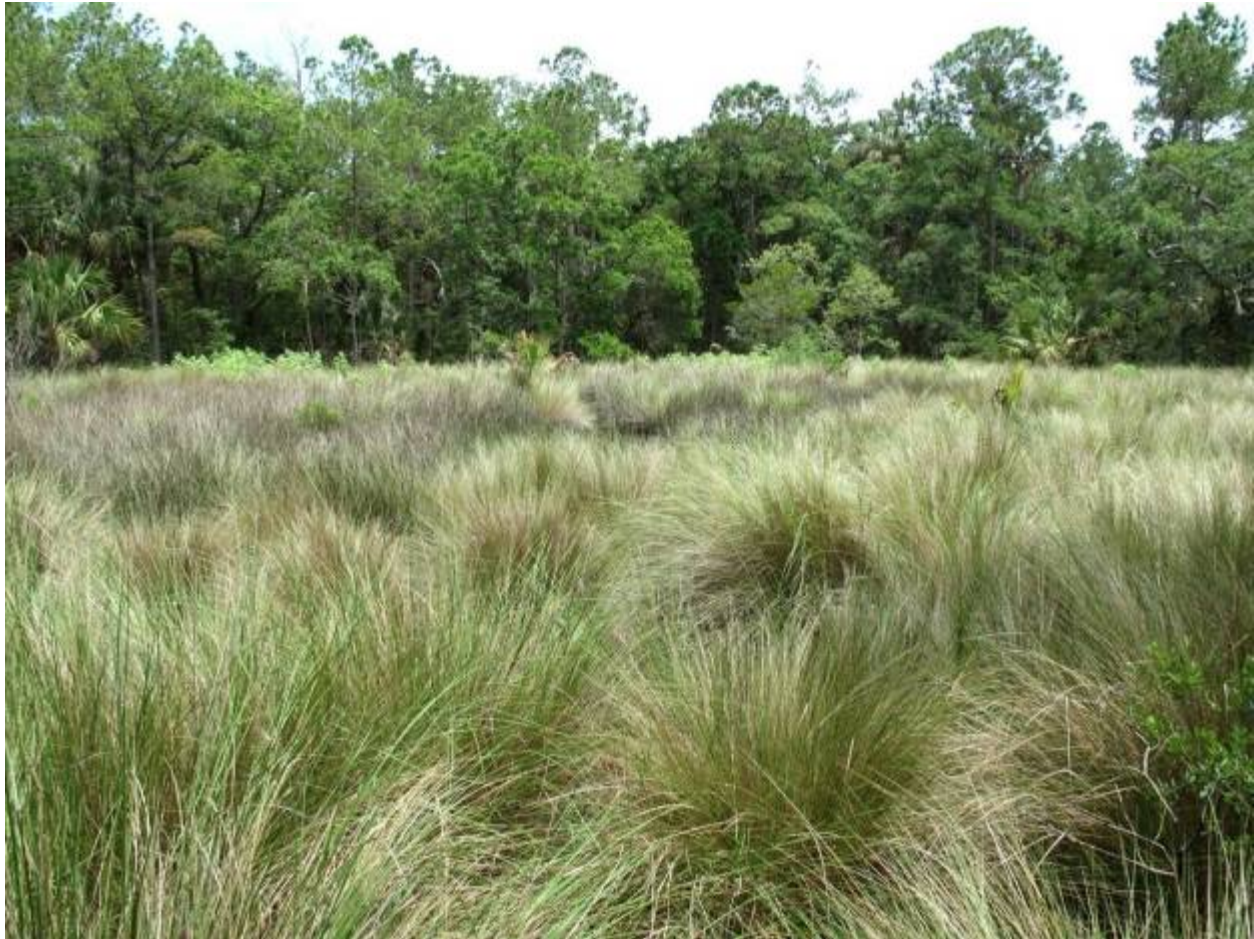
**Wetland ID: 05-06**

**Description:** This wetland is a 0.2 ha ephemeral marsh. There is no tree canopy or midstory cover. Rushes and sedges/grasses grow throughout the wetland, and cover >75% of the basin. This marsh is in fire-maintenance condition. The adjacent uplands are hammock.

**Wetland Disturbance:** None

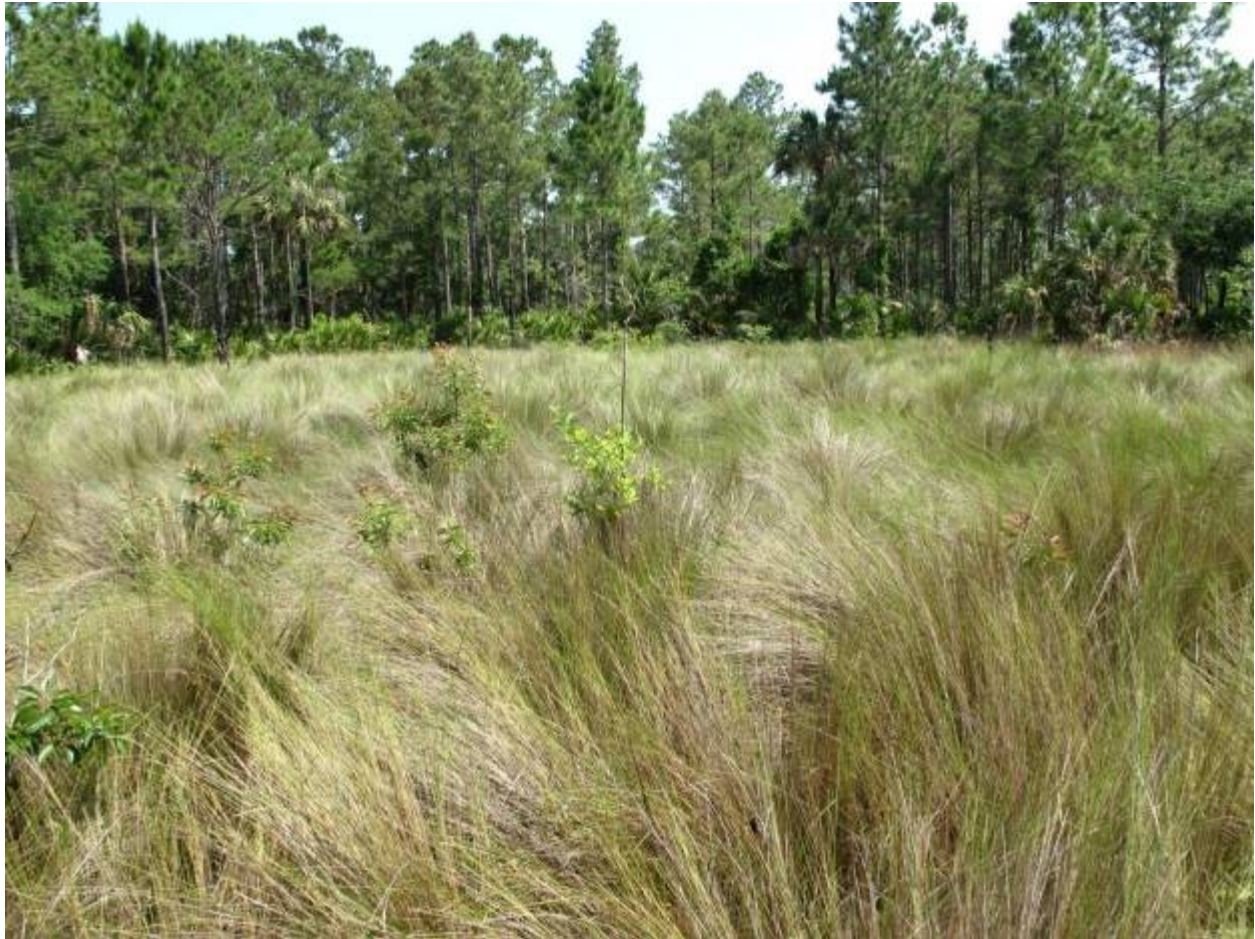
**Description:** This wetland is a 0.2 ha ephemeral marsh. There is no tree canopy or midstory cover. Sedges/grasses grow throughout the wetland, and cover >75% of the basin. This marsh is in fire-maintenance condition. The adjacent uplands are scrubby flatwoods.

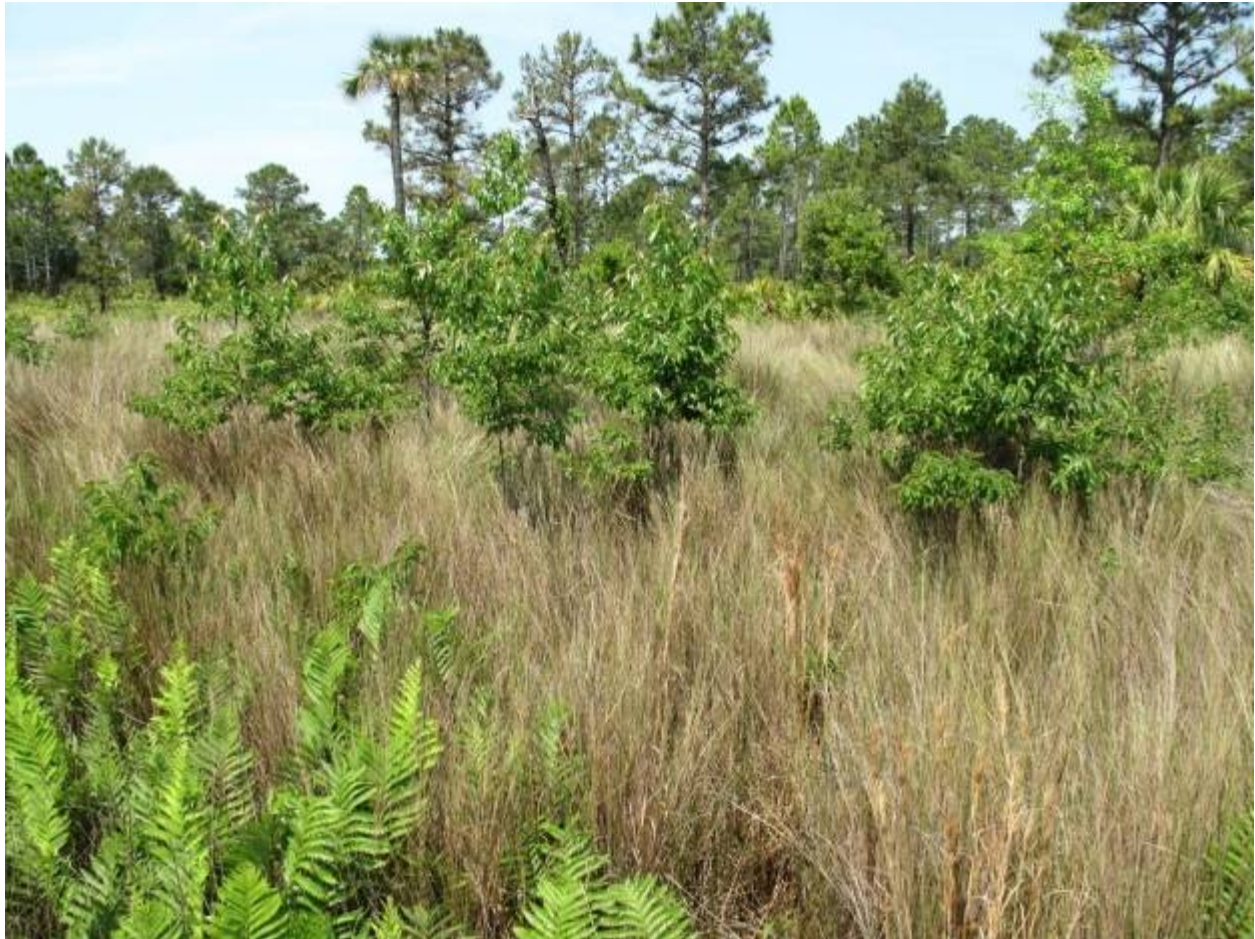
**Description:** This wetland is a 0.2 ha ephemeral marsh. Persimmon is the dominant woody vegetation, and covers 5-25% of the wetland. Sedges/grasses grow throughout the wetland, and cover >75% of the basin. The adjacent uplands are scrubby flatwoods.

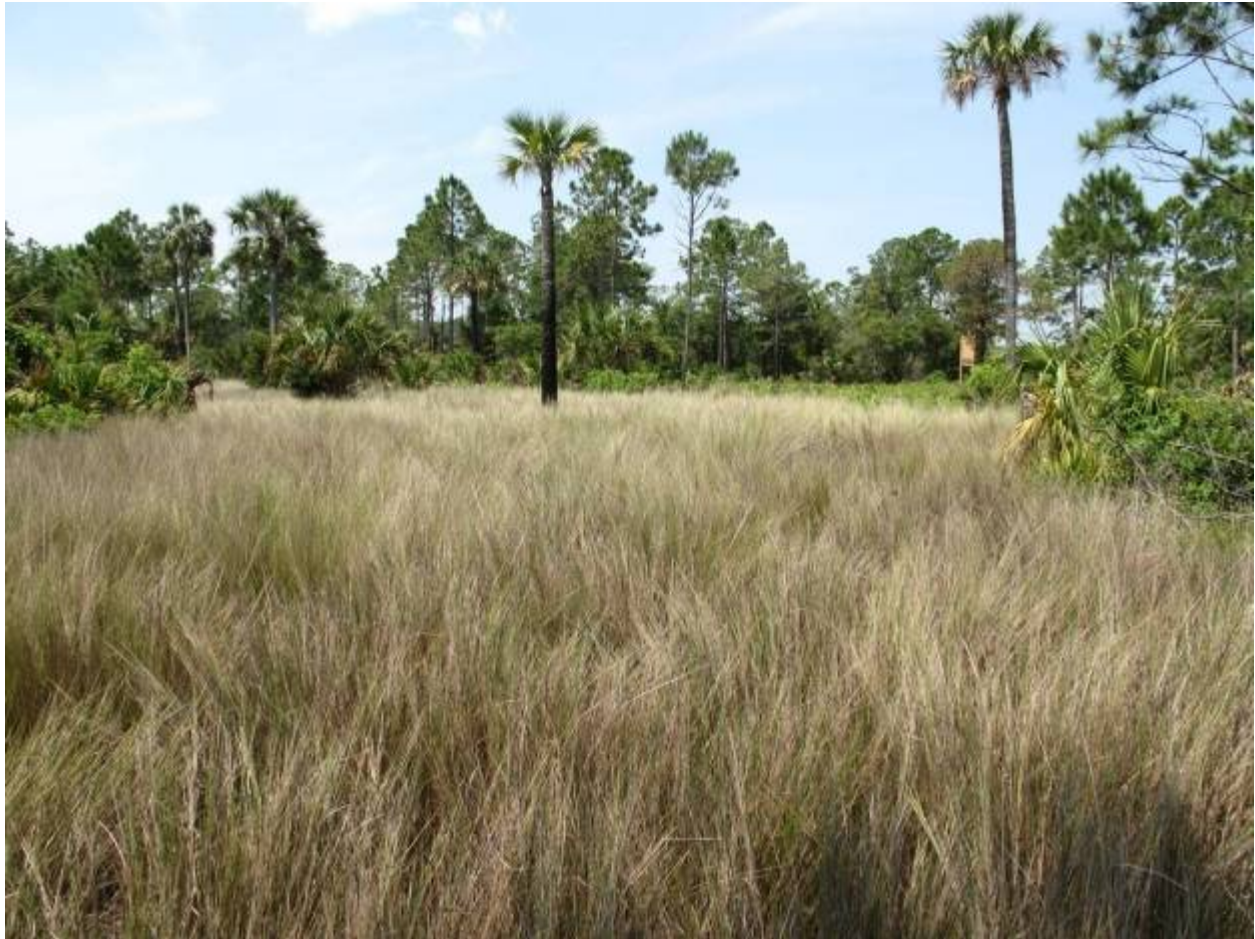
**Description:** This wetland is a 0.2 ha ephemeral marsh. There is no tree canopy or midstory cover. Grasses grow throughout the wetland, and cover >75% of the basin. This marsh is in fire-maintenance condition. The adjacent uplands are scrubby flatwoods.

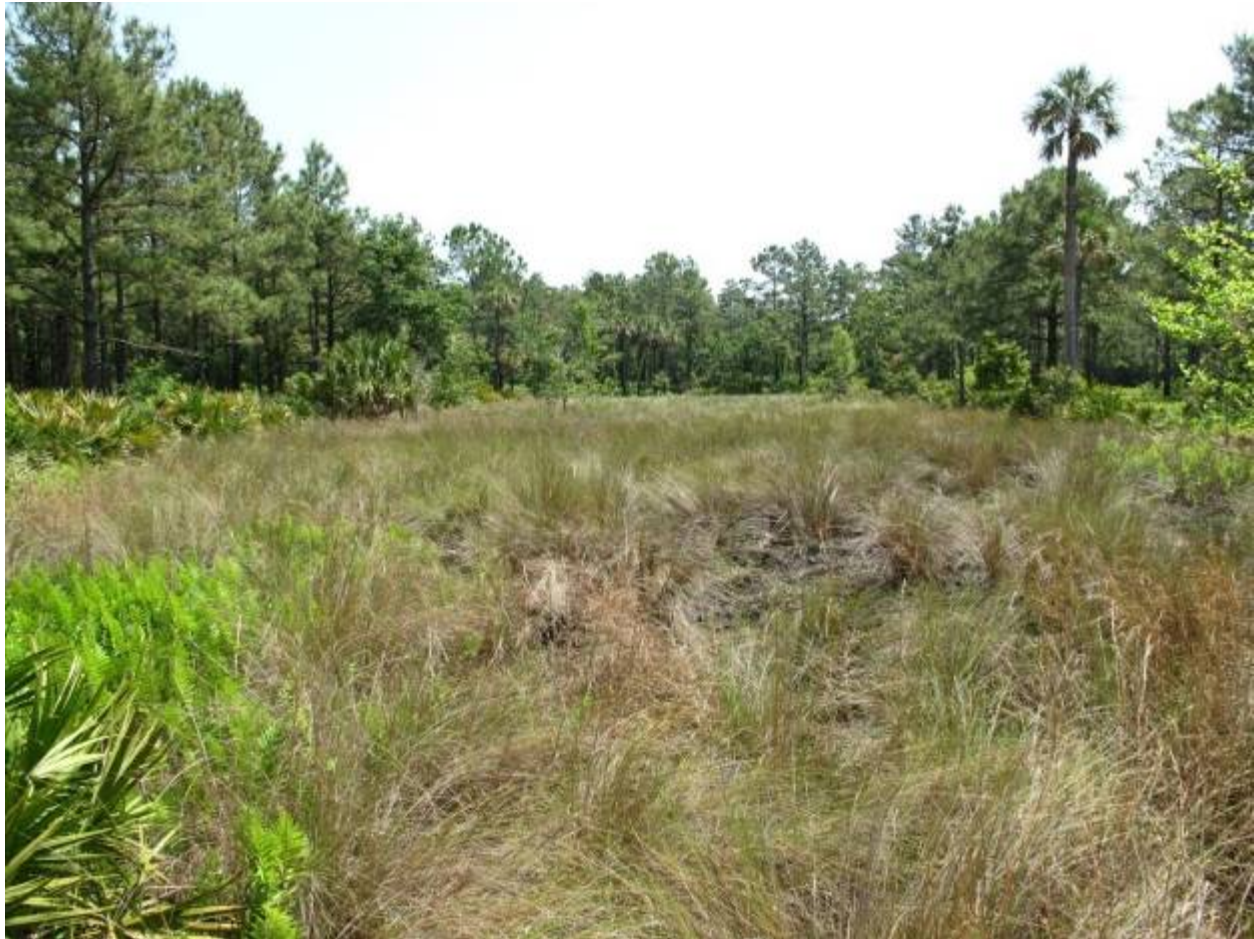
**Wetland ID: 06-04**

**Description:** This wetland is a 0.4 ha ephemeral marsh. There is no tree canopy or midstory cover. Grasses grow throughout the wetland, and cover >75% of the basin. This marsh is in fire-maintenance condition. The adjacent uplands are mesic and scrubby flatwoods.

**Wetland Disturbance:** None

**Restoration Action Recommended:** None

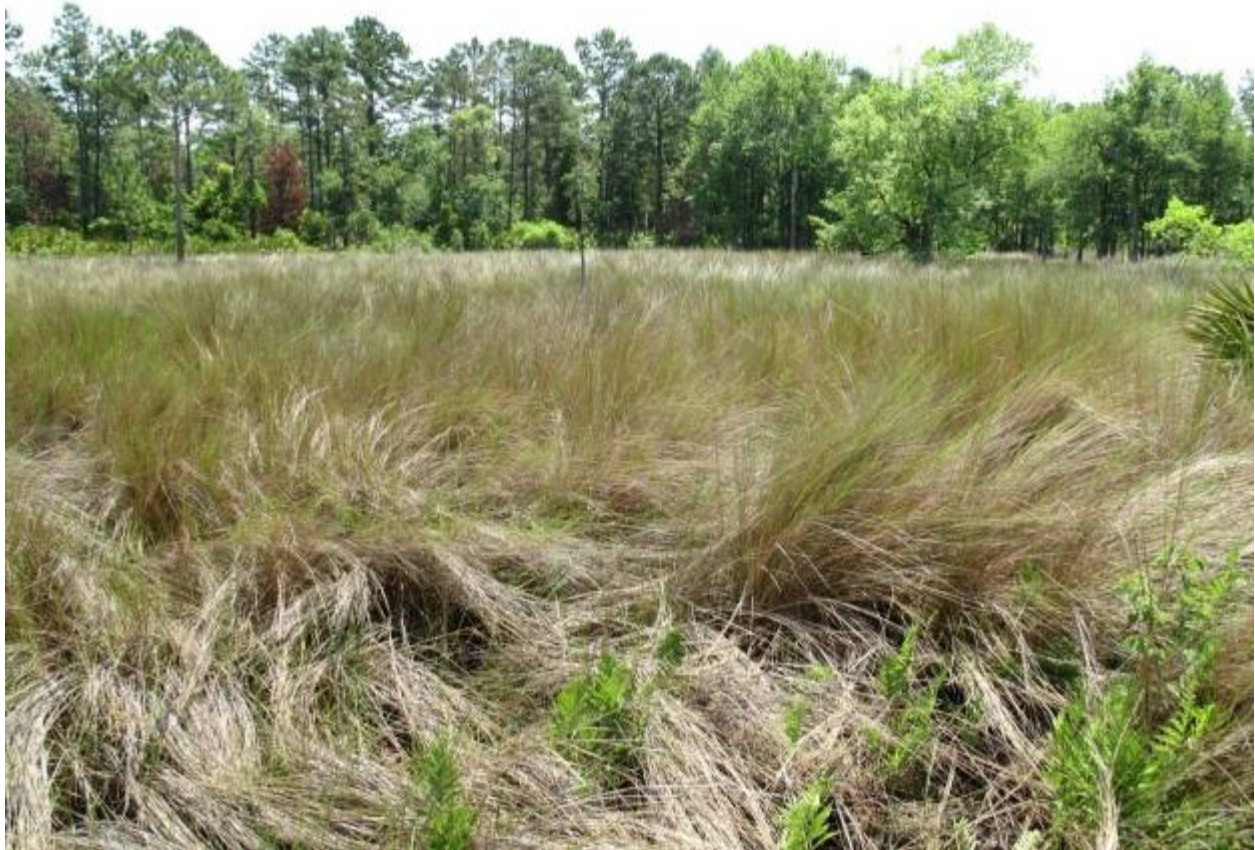
**Wetland ID: 06-05**

**Description:** This wetland is a 0.9 ha ephemeral marsh. Gum trees dominate the canopy, and cover 5-25% of the wetland. There is no midstory cover. Sedges/grasses grow throughout the wetland, and cover >75% of the basin. Hog damage is light around the wetland edge. This marsh is in fire-maintenance condition. The adjacent uplands are mesic and scrubby flatwoods.

**Wetland Disturbance:** Hog damage

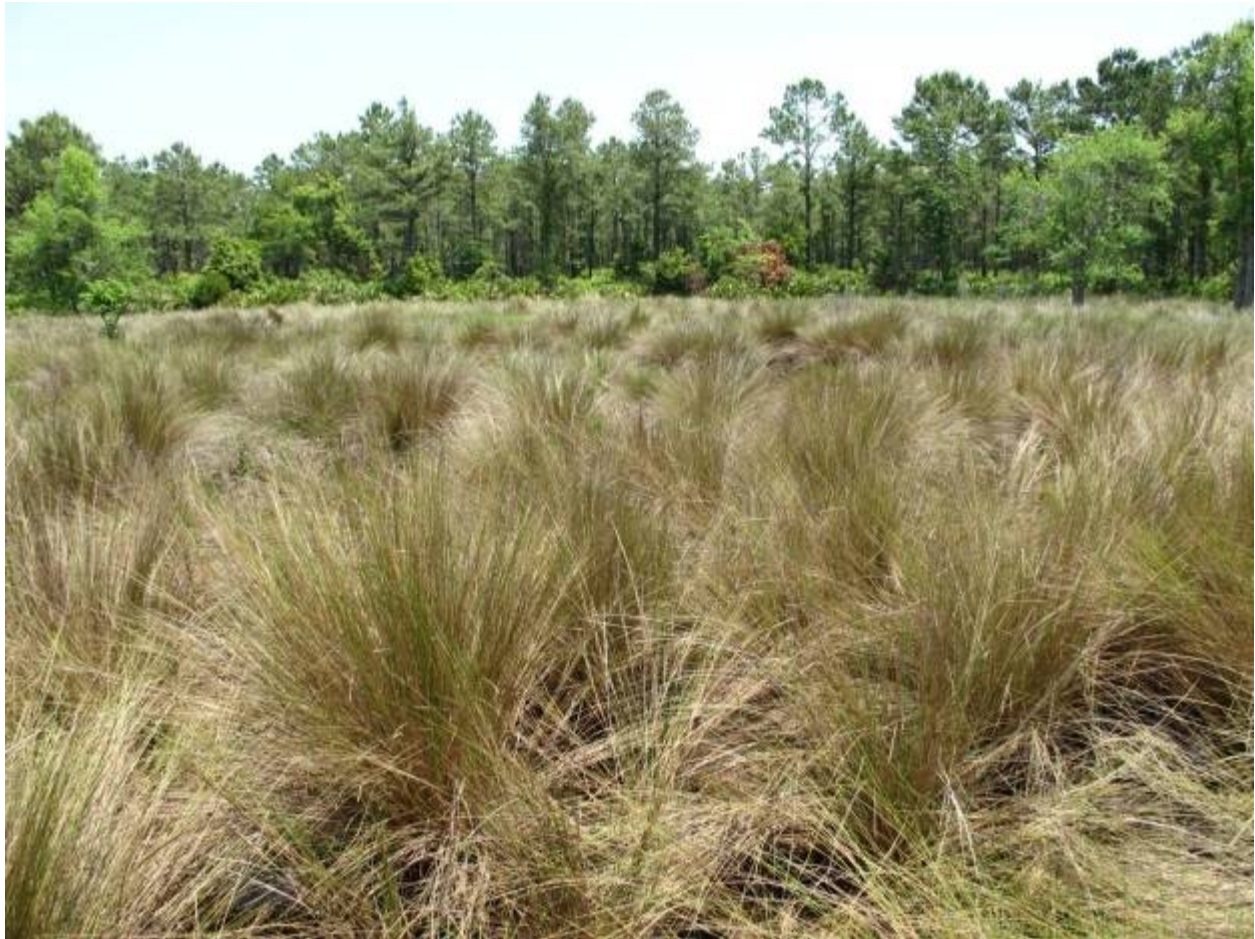
**Description:** This wetland is a 0.6 ha ephemeral marsh. There is no tree canopy or midstory cover. Grasses grow throughout the wetland, and cover >75% of the basin. Hog rooting is fairly widespread between the grass clumps. This marsh is in fire-maintenance condition. The adjacent uplands are scrubby and mesic flatwoods.
