# **Inventory, Assessment, and Restoration Potential of Ephemeral Wetlands on FFWCC Wildlife Management Areas**

## **Guana River WMA Final Report**

Submitted by: Rebecca P.M. Means<sup>1</sup>, Ryan C. Means<sup>1</sup>, Steven A. Johnson<sup>2</sup>

April - May 2009

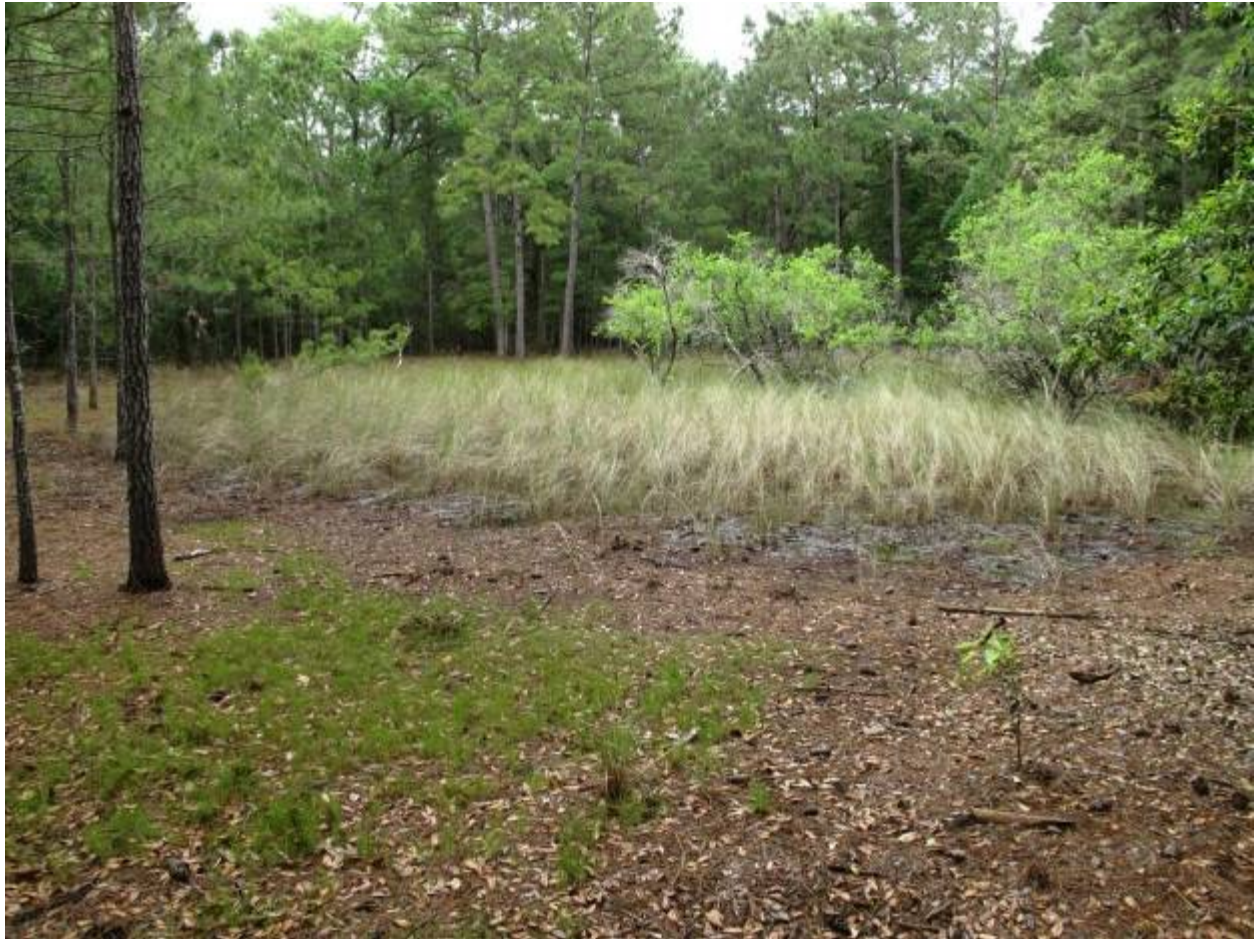
**Description:** This wetland is a 0.1 ha ephemeral marsh. Pine trees grow in a ring around the wetland, and cover 5-25% of the basin. The midstory is dominated by buttonbush, and covers 5-25% of the wetland. Sedges/grasses grow in scattered patches, and cover 50-75% of the wetland basin. The adjacent uplands are mesic hammock. The mesic hammock in this area looks to have once been a pine forest that has succeeded to more hammock conditions in the absence of fire. The wetland appears to be quite healthy despite upland fire-suppression.

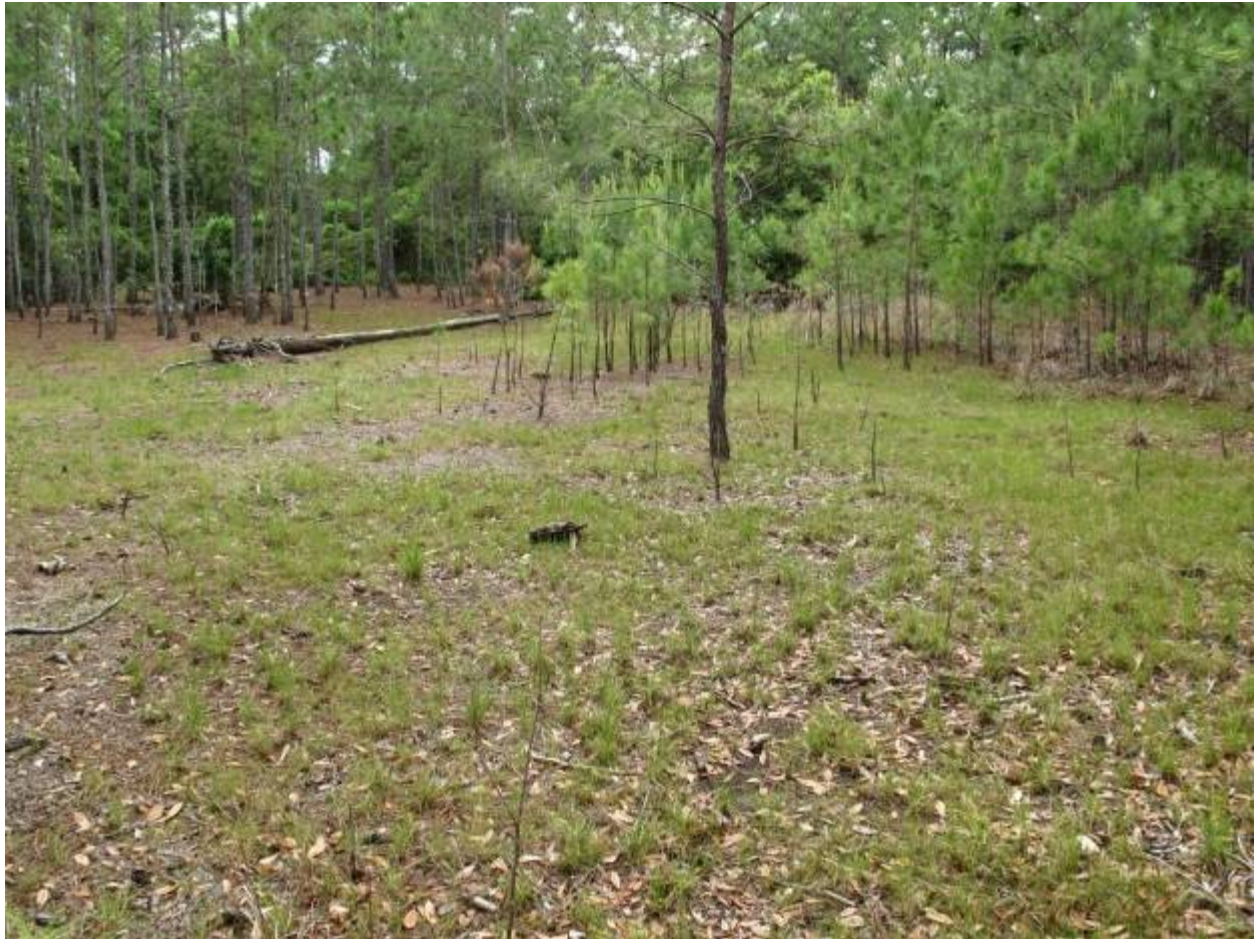
**Description:** This wetland is a 0.1 ha highly ephemeral marsh. Pine trees dominate the canopy, and cover 5-25% of the wetland. The midstory is dominated by young pine trees, and covers 5-25% of the wetland. Sedges/grasses grow in scattered patches, and covers 25-50% of the wetland basin. We observed old pine stumps in the wetland. The adjacent uplands are mesic hammock. The mesic hammock in this area looks to have once been a pine forest that has succeeded to more hammock conditions in the absence of fire.

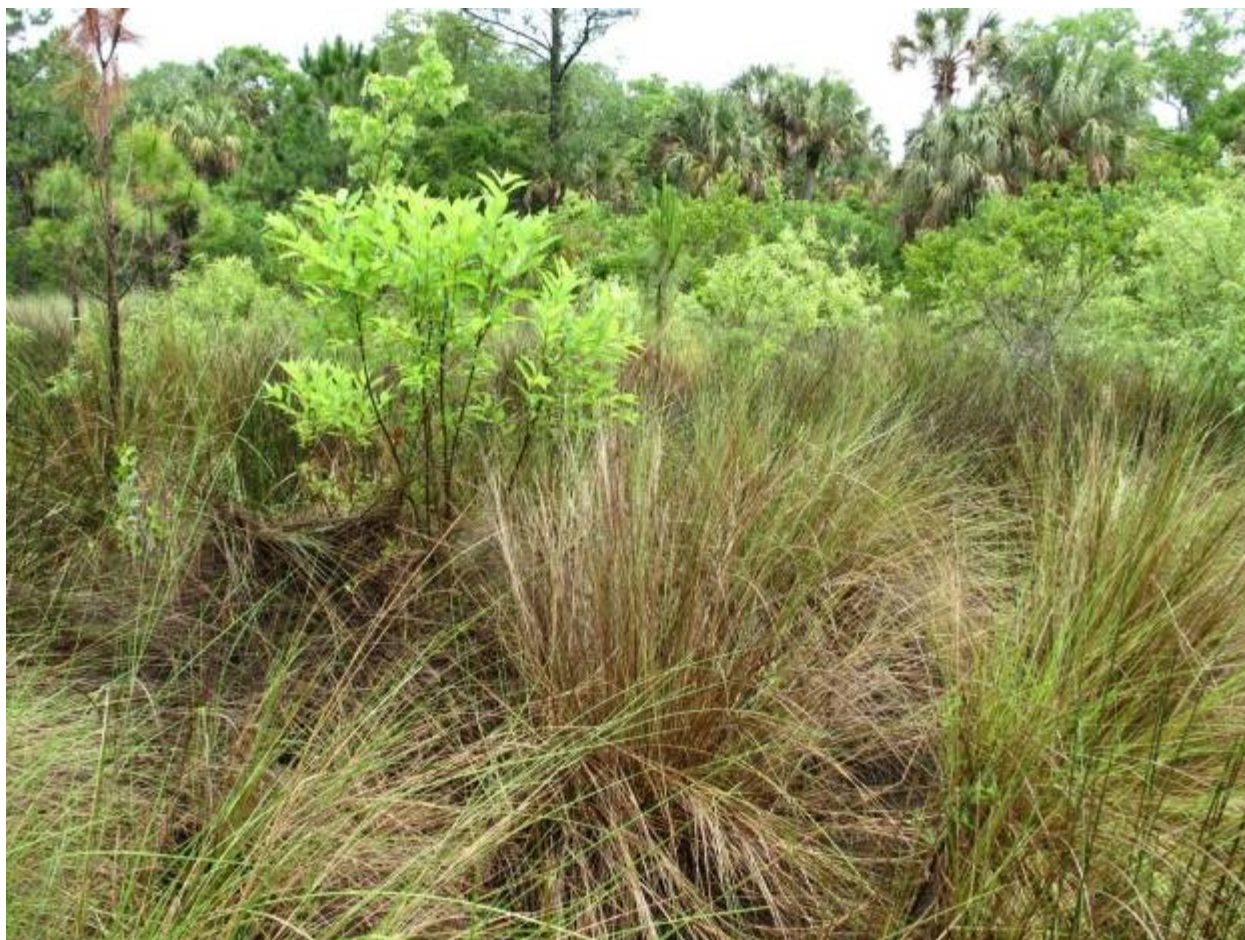
**Wetland ID: 09-01**

**Description:** This wetland is a 0.4 ha ephemeral marsh. Buttonbush, willow, and wax myrtle are the dominant woody vegetation, and cover 5-25% of the wetland. Sedges/grasses and rush grow throughout the wetland, and cover >75% of the basin. This wetland may occasionally have some brackish influence. The adjacent uplands are mesic hammock. The uplands around this wetland do not appear to burn as frequently as in other MUs on the property.

**Wetland Disturbance:** Woody encroachment

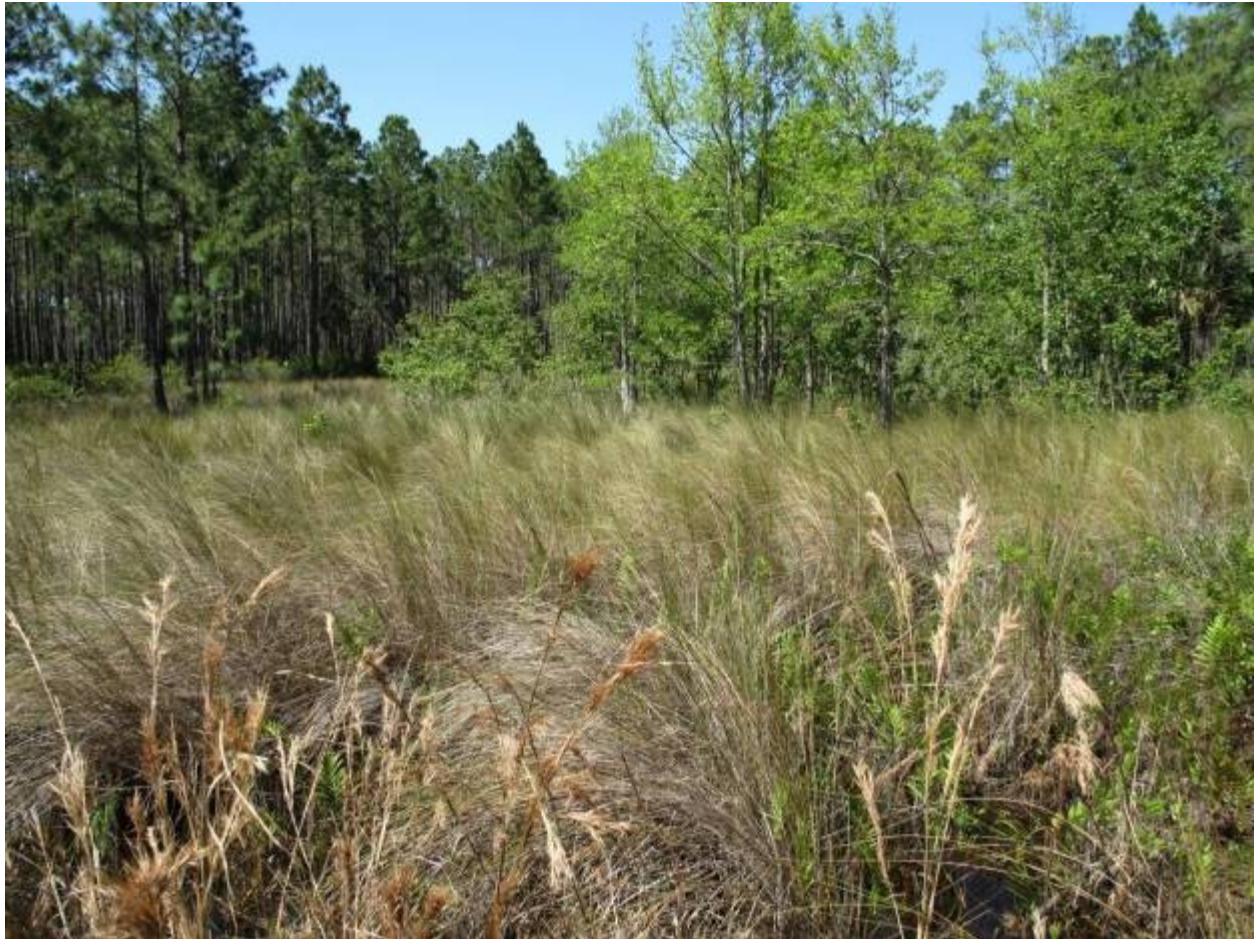
**Description:** This wetland is a 0.4 ha ephemeral marsh. Gum trees dominate the canopy, and cover 5-25% of the wetland. There is no midstory cover. Sedges/grasses grow throughout the wetland, and cover >75% of the basin. This marsh is in fire-maintenance condition. The adjacent uplands are mesic flatwoods.

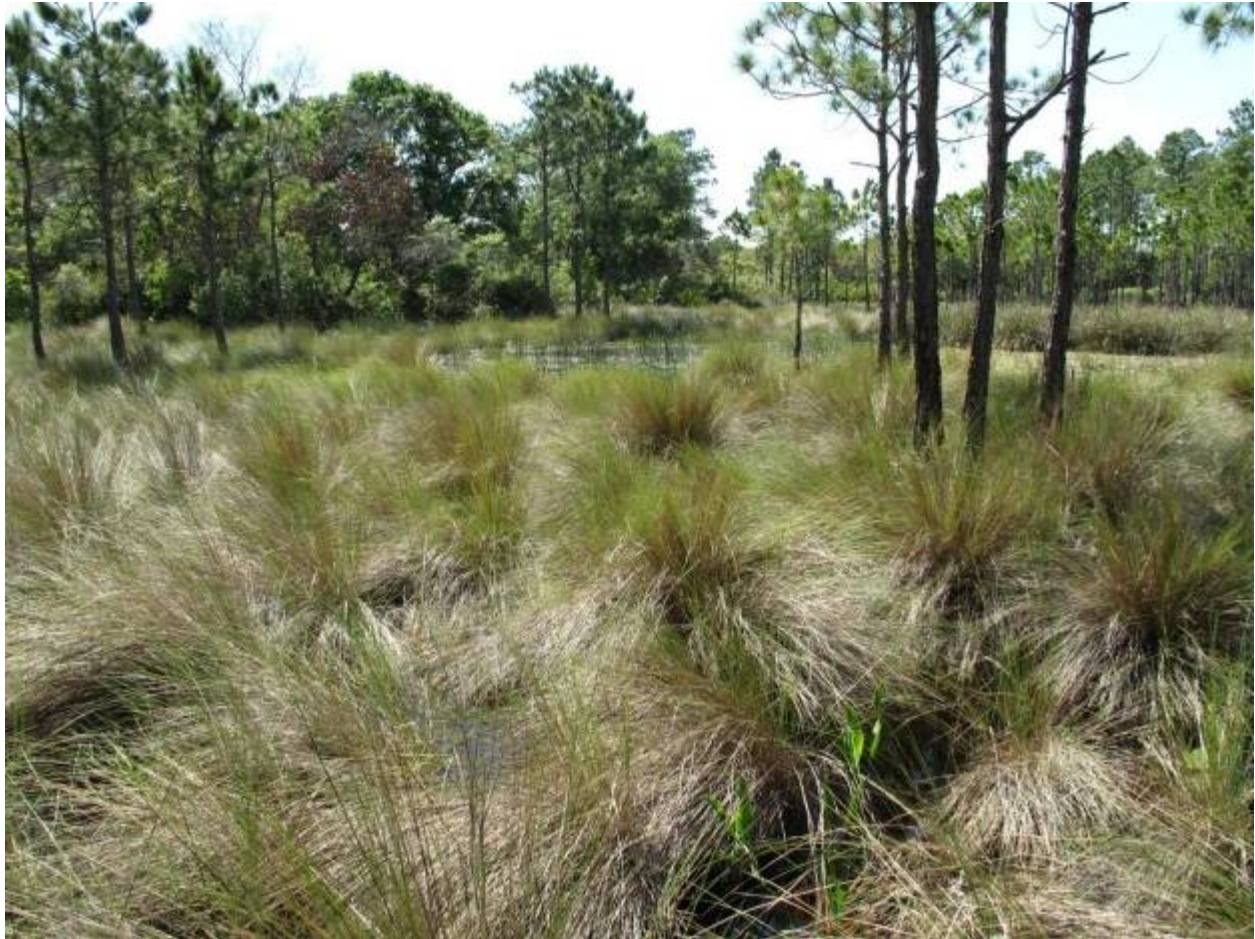
**Description:** This wetland is a 1.4 ha semi-permanent marsh. Pine trees dominate the canopy, and cover 5-25% of the wetland. There is no midstory cover. Sedge/grass, rushes, and emergent vegetation grow throughout the wetland, and cover >75% of the basin. This marsh is in fire-maintenance condition. The adjacent uplands are mesic flatwoods.

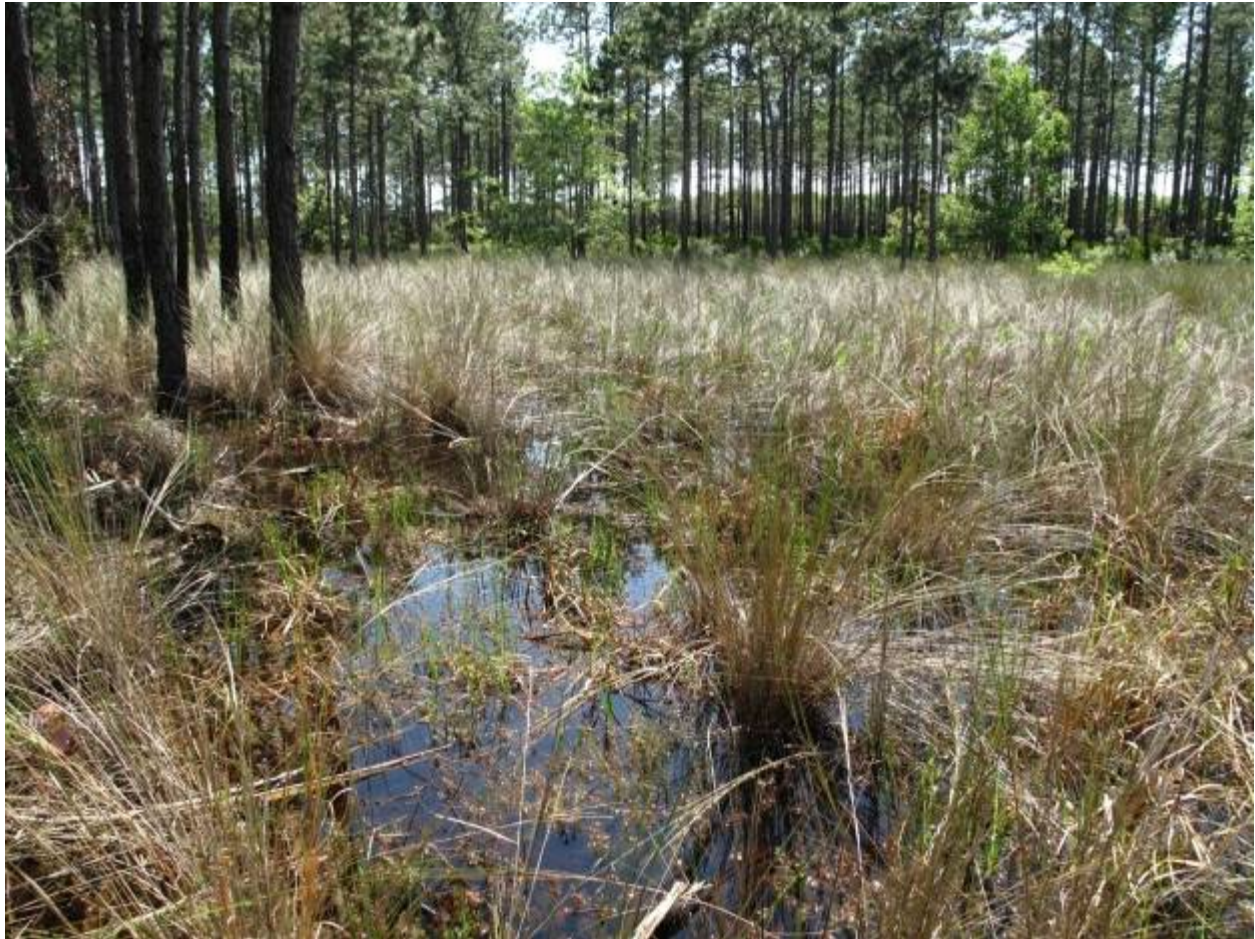
**Description:** This wetland is a 0.2 ha ephemeral marsh. Pine trees grow in a ring around the wetland, and cover 5-25% of the wetland. There is no midstory cover. Sedges/grasses grow throughout the wetland, and cover >75% of the basin. This marsh is in fire-maintenance condition. The adjacent uplands are mesic flatwoods.

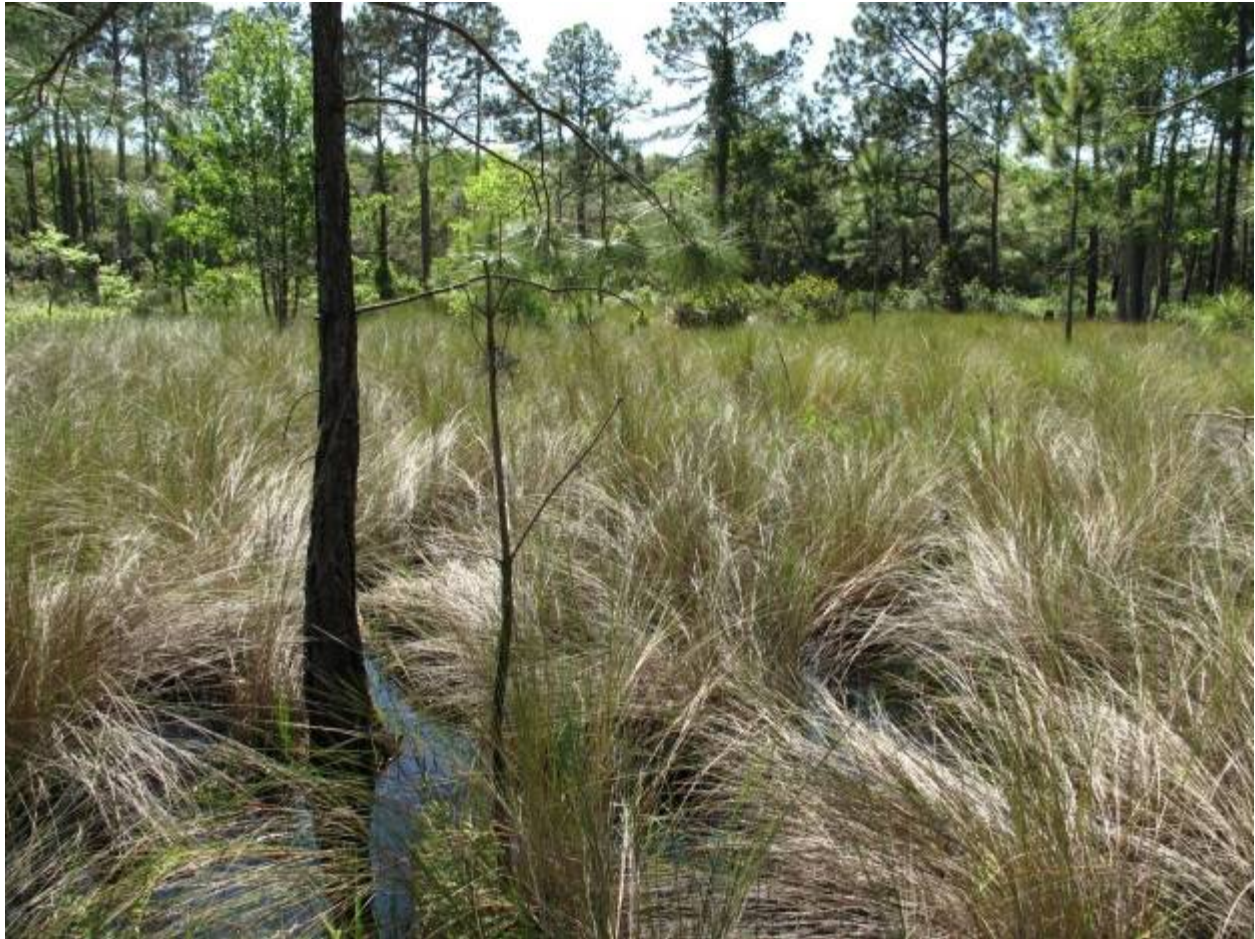
**Description:** This wetland is a 0.3 ha ephemeral marsh. Pine trees dominate the canopy, and cover 5-25% of the wetland. There is no midstory cover. Sedges/grasses grow throughout the wetland, and cover >75% of the basin. This marsh is in fire-maintenance condition. The adjacent uplands are mesic flatwoods.

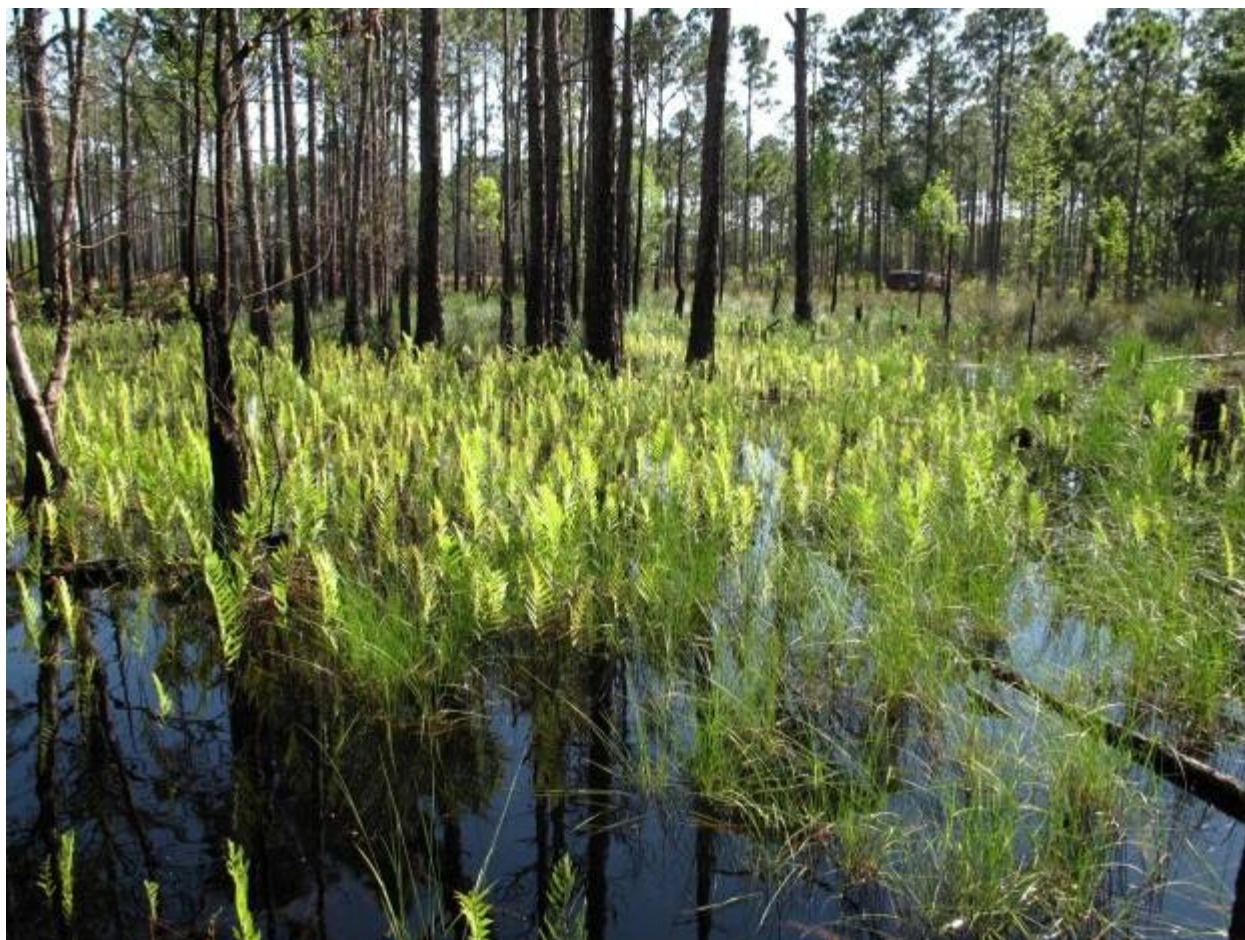
**Wetland ID: 11-05**

**Description:** This wetland is a 1.6 ha ephemeral marsh. Pine trees dominate the canopy, and cover 25-50% of the wetland. There is no midstory cover. Sedges/grasses and fern grow throughout the wetland, and cover >75% of the basin. A culvert under the adjacent road connects this wetland to a larger swamp to the east. It appears this culvert maintains connectivity that was severed when the road was built. There is an old fireline/ditch on the south side of the wetland and evidence of past mechanical activity around this wetland. The wetland may have been enhanced decades ago by prior landowners. The adjacent uplands are mesic flatwoods.

**Wetland Disturbance:** Woody encroachment

**Restoration Action Recommended:** Monitor the pine trees in the wetland. If they begin to shade out the herbaceous vegetation, the pine trees should be thinned. Allow the old fireline/ditch to continue to erode.

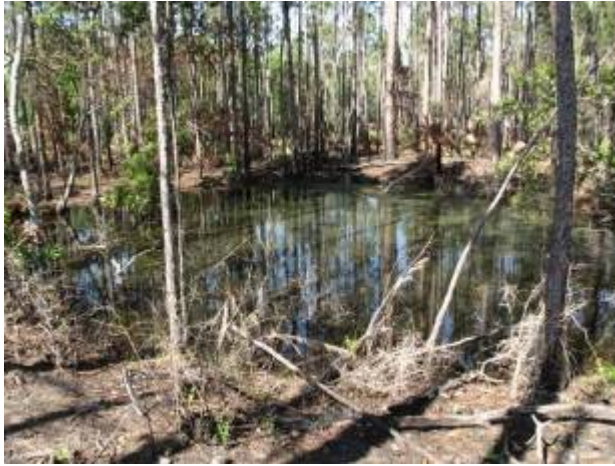
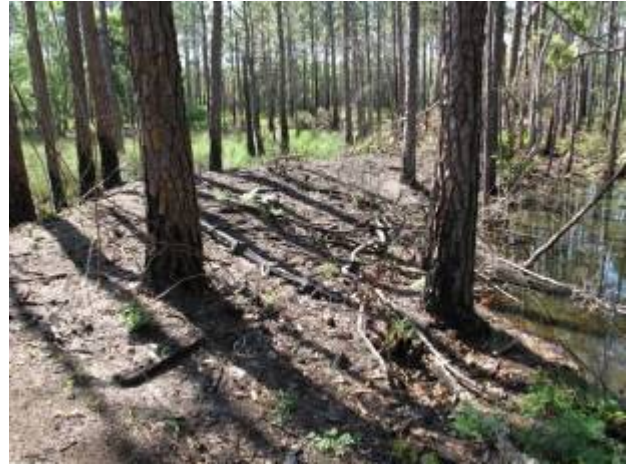
**Wetland ID: 11-06**

**Description:** This wetland is a 0.3 ha semi-permanent man-made wetland. Pine trees grow in a ring around the wetland, and cover 5-25% of the basin. There is no midstory cover and no herbaceous vegetation. This man-made circular pond is ringed with a 4 foot high berm. The pond likely dates back to cattle ranching days, created as a water source. It currently functions as an ephemeral, isolated wetland, with a fairly long hydroperiod. The adjacent uplands are mesic flatwoods.

**Wetland Disturbance:** Berm

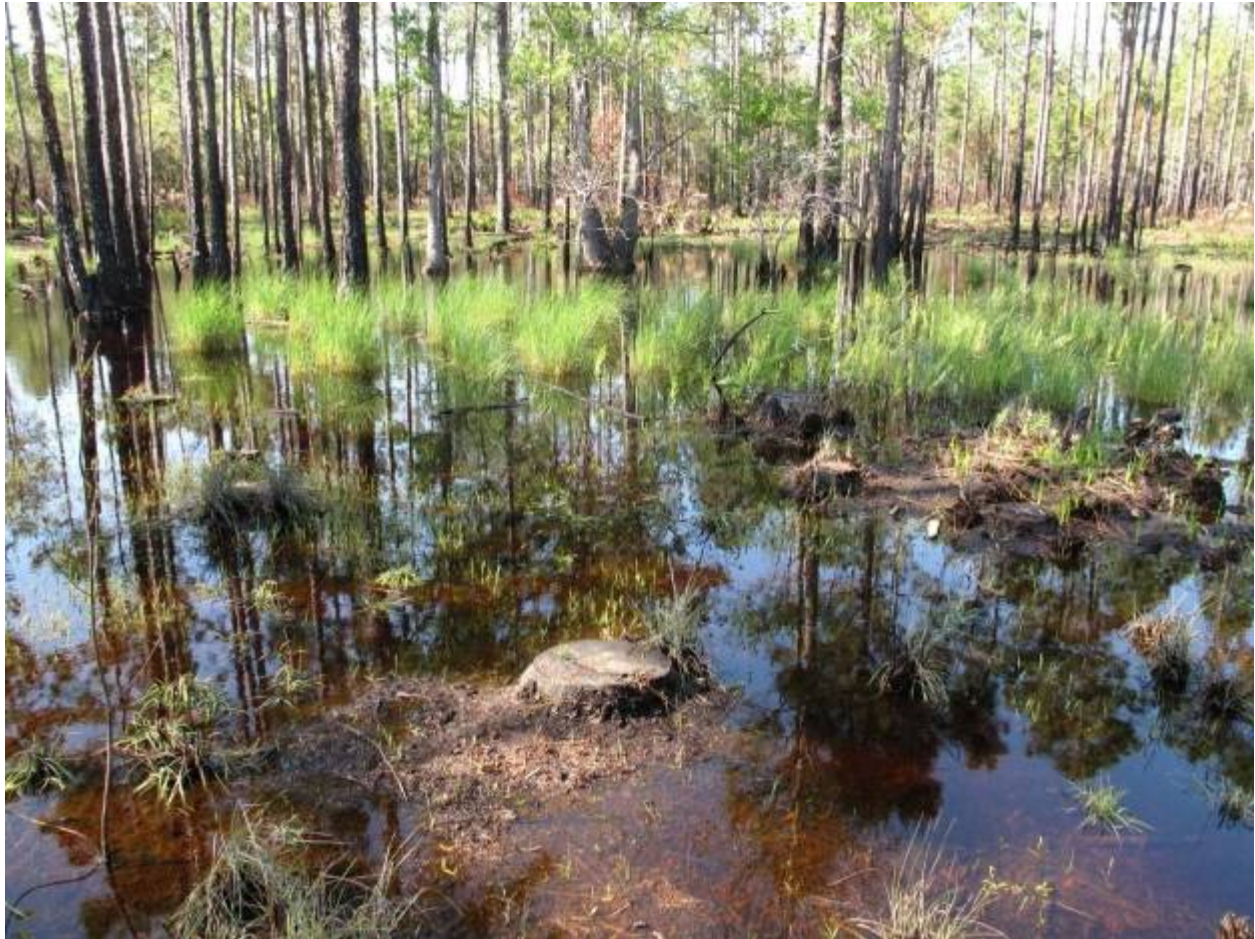
**Description:** This wetland is a 0.3 ha ephemeral marsh. Pine trees dominate the canopy, and cover 5-25% of the wetland. There is no midstory cover. Sedges/grasses and fern grow throughout the wetland, and cover 50-75% of the basin. This wetland likely was human-enhanced but it currently functions as an ephemeral wetland. There are many signs of past mechanical activity and pine thinning. It appears these disturbances were associated with restoration activities. The adjacent uplands are mesic flatwoods.

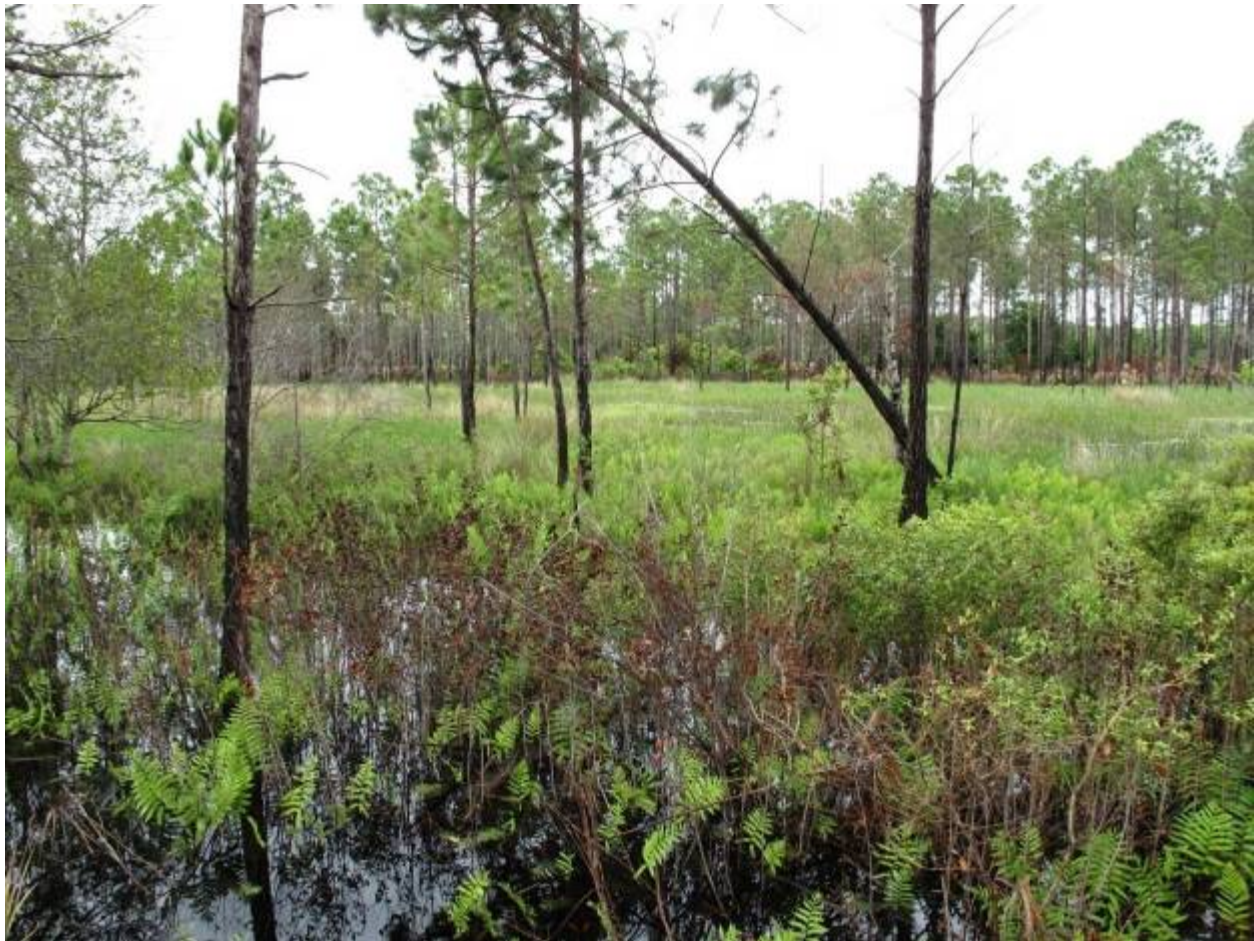
**Description:** This wetland is a 1.5 ha semi-permanent marsh. Pine trees dominate the canopy, and cover 5-25% of the wetland. There is no midstory cover. Sedge/grass, fern, and emergent vegetation grow throughout the wetland, and cover >75% of the basin. A recent fire burned through the wetland basin. The adjacent uplands are mesic and scrubby flatwoods that were converted to a pine plantation. The uplands have been thinned and burned to restore them to a more open flatwoods community.

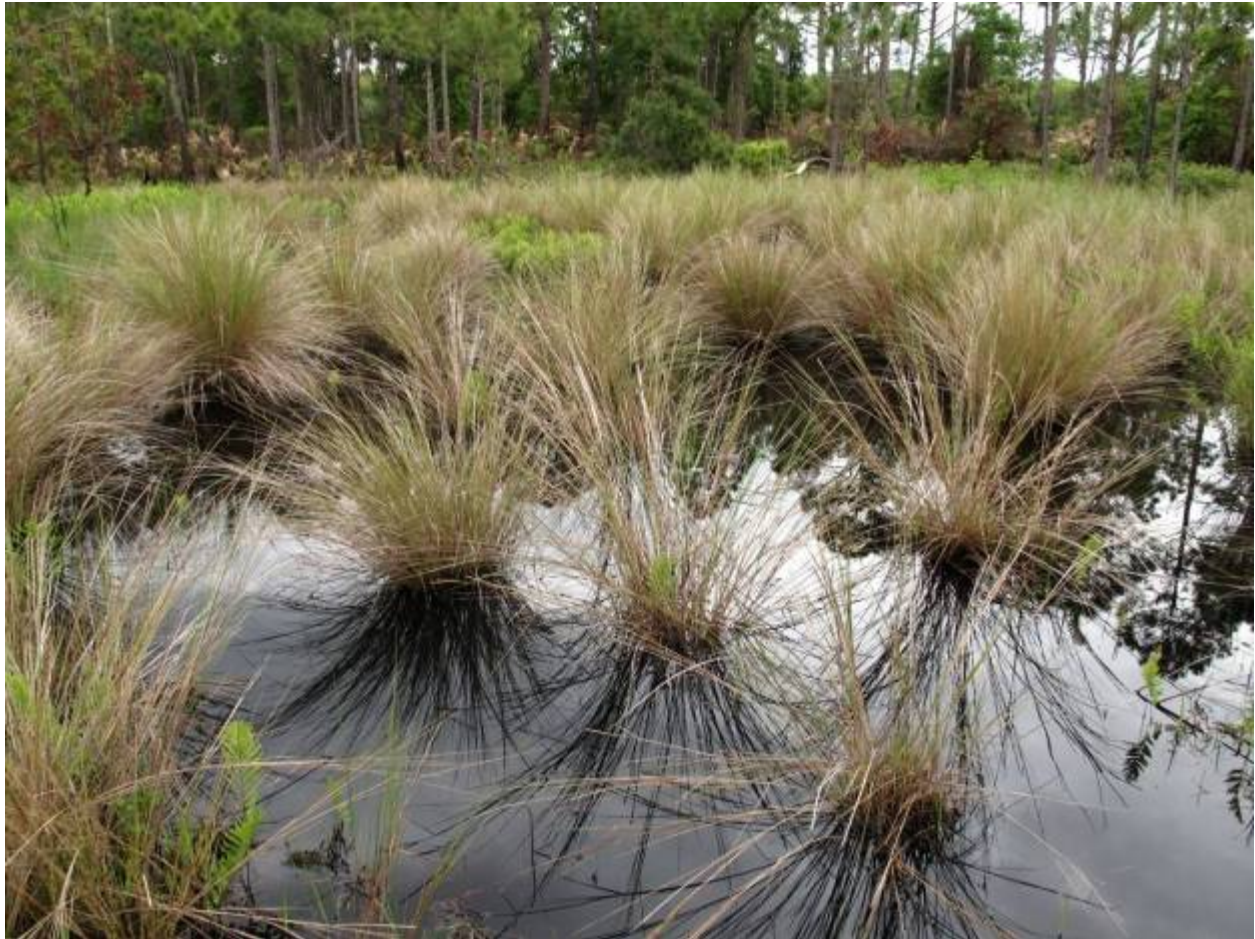
**Description:** This wetland is a 0.1 ha ephemeral marsh. There is no tree canopy or midstory cover. Sedges/grasses grow throughout the wetland, and cover 50-75% of the basin. There is a dirt berm on the east side of the wetland. A recent fire burned through the wetland basin. The adjacent uplands are mesic and scrubby flatwoods that were converted to a pine plantation. The uplands have been thinned and burned to restore them to a more open flatwoods community.

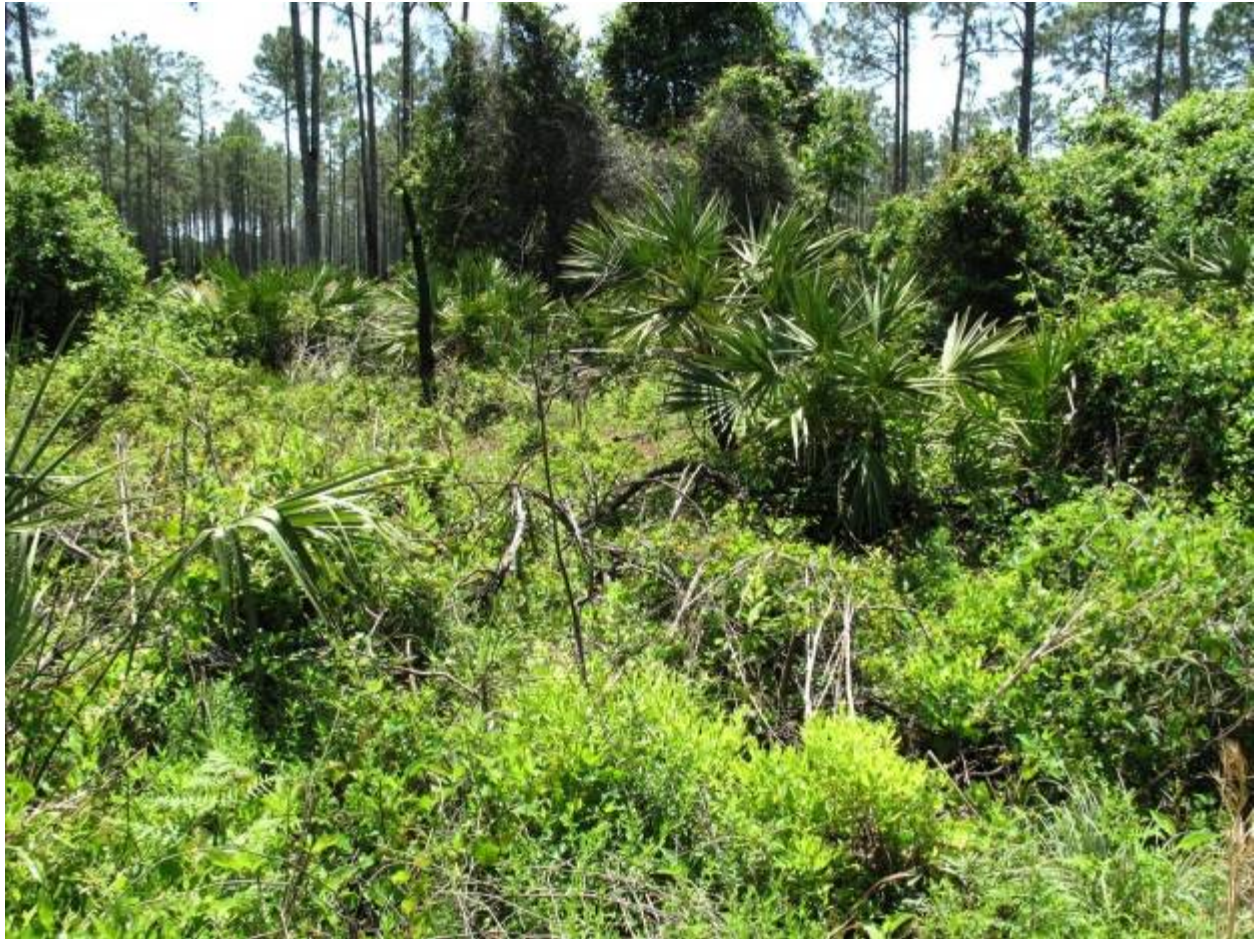
**Description:** This wetland is a 0.5 ha ephemeral marsh. There is no canopy cover. Muscadine grape dominates the midstory, and covers 25-50% of the wetland. Sedges/grasses and emergent vegetation grow in scattered patches, and cover 25-50% of the wetland basin. A recent fire burned through the wetland basin. This wetland may have formed from a mechanically formed dug-out. The adjacent uplands are mesic flatwoods.

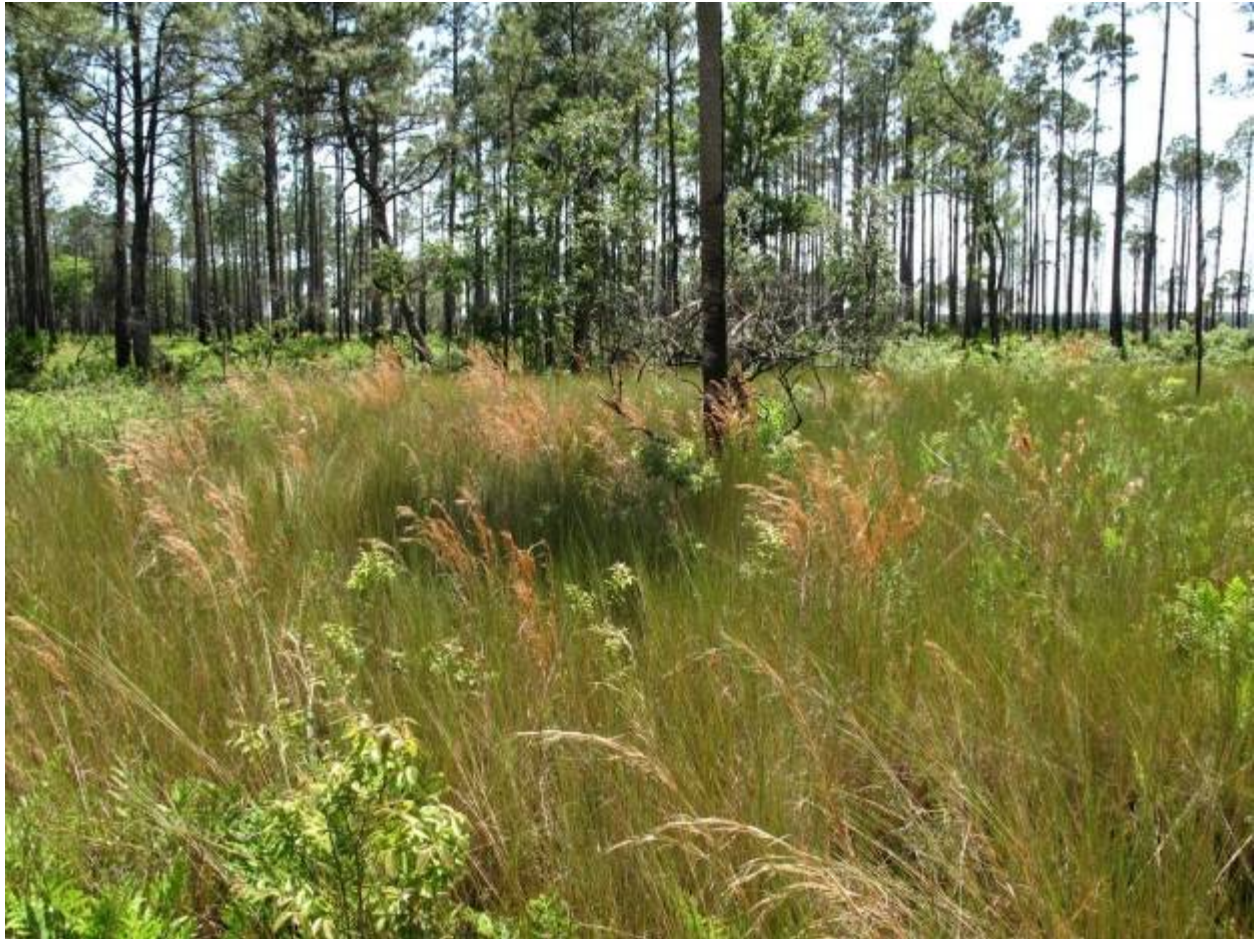
**Description:** This wetland is a 0.1 ha ephemeral marsh. There is no tree canopy or midstory cover. Sedges/grasses grow throughout the wetland, and cover >75% of the basin. This marsh is in fire-maintenance condition. The adjacent uplands are mesic flatwoods.

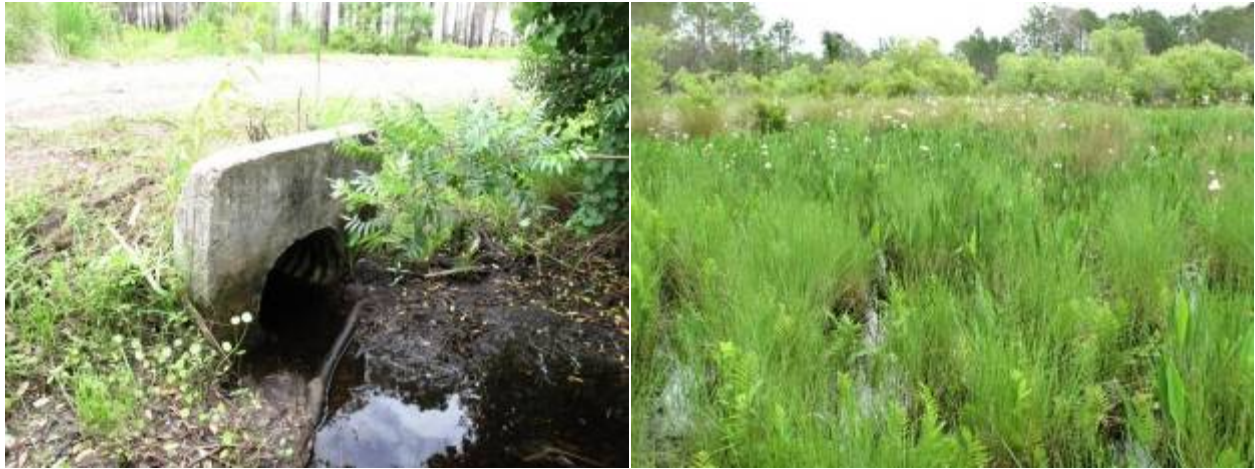
**Wetland ID: 14-05**

**Description:** This wetland is a 6.5 ha semi-permanent marsh. Willow is the dominant woody vegetation, and covers 5-25% of the wetland. Sedges/grasses and emergent vegetation grow throughout the wetland, and cover >75% of the basin. This elongated wetland contains multiple ephemeral depressions that all connect during high water. There is a culvert leading under the road on the south side of the wetland. The adjacent uplands are mesic flatwoods.

**Wetland Disturbance:** None

**Restoration Action Recommended:** We discussed with GRWMA personnel their plans to replace the culvert draining the wetland with flash boarding. The flash boarding could then be lowered to drain the wetland as needed for burning or other management purposes. We agree with these plans but caution that the wetland could become more permanent if the flash boarding remains in place for a long time.

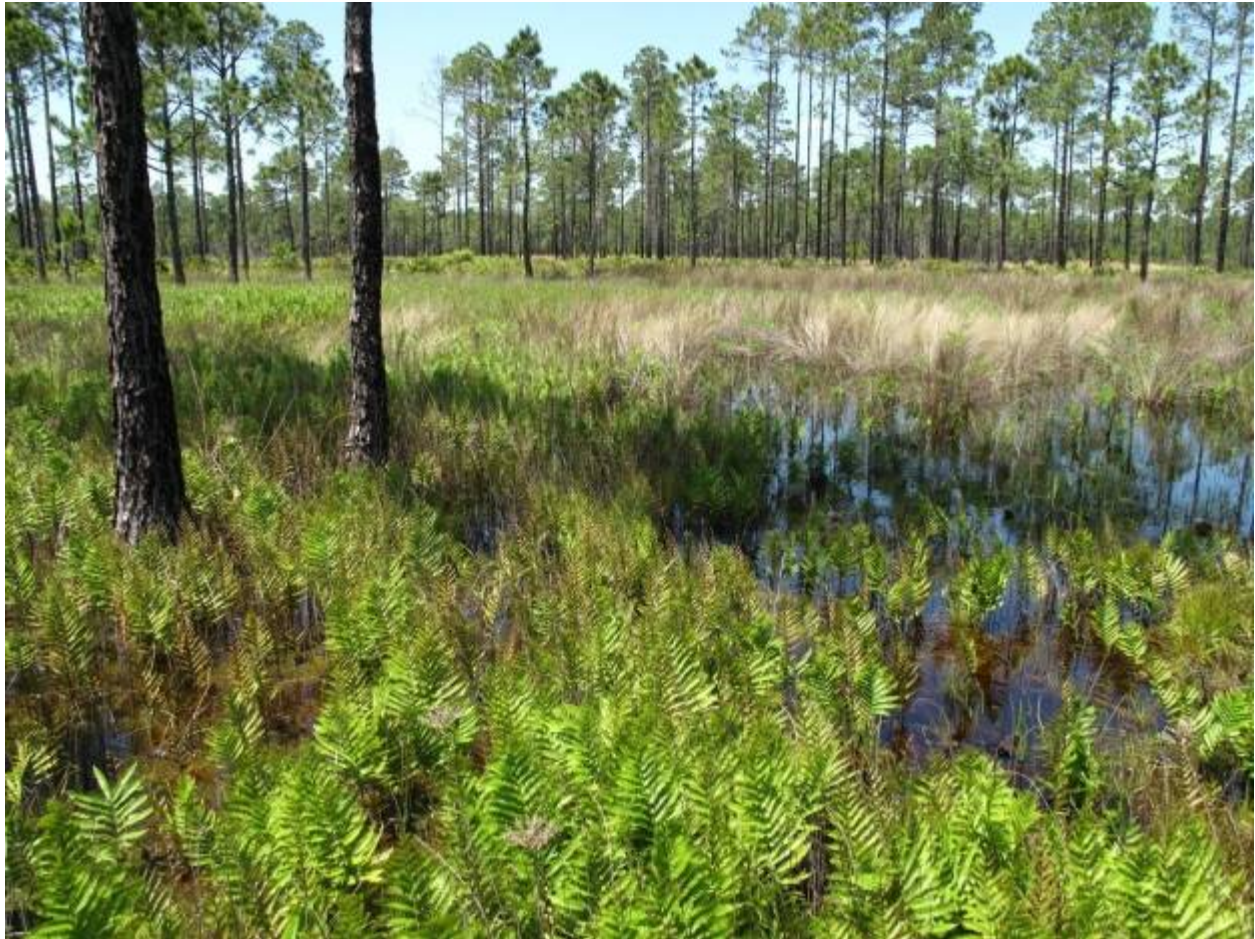
**Description:** This wetland is a 0.5 ha ephemeral marsh. Pine trees dominate the canopy, and cover 5-25% of the wetland. There is no midstory cover. Sedges/grasses and fern grow throughout the wetland, and cover >75% of the basin. This marsh is in fire-maintenance condition. The adjacent uplands are scrubby flatwoods.

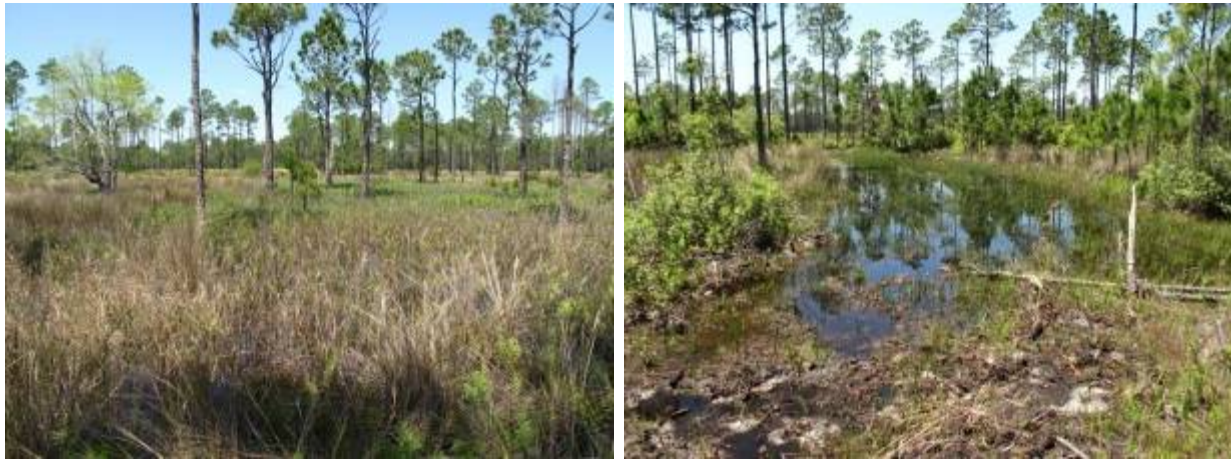
**Wetland ID: 18-02**

**Description:** This wetland is a 3.1 ha ephemeral marsh. Pine trees dominate the canopy, and cover 5-25% of the wetland. Young pine trees around the wetland edge form the midstory, and cover 5-25% of the wetland. Sedges/grasses and fern grow throughout the wetland, and cover >75% of the basin. A fireline bisects the top lobe of the wetland. The adjacent uplands are scrubby flatwoods.

**Wetland Disturbance:** Fireline

**Restoration Action Recommended:** Re-routed the fireline around the top of the marsh. The old fireline should restore over time.

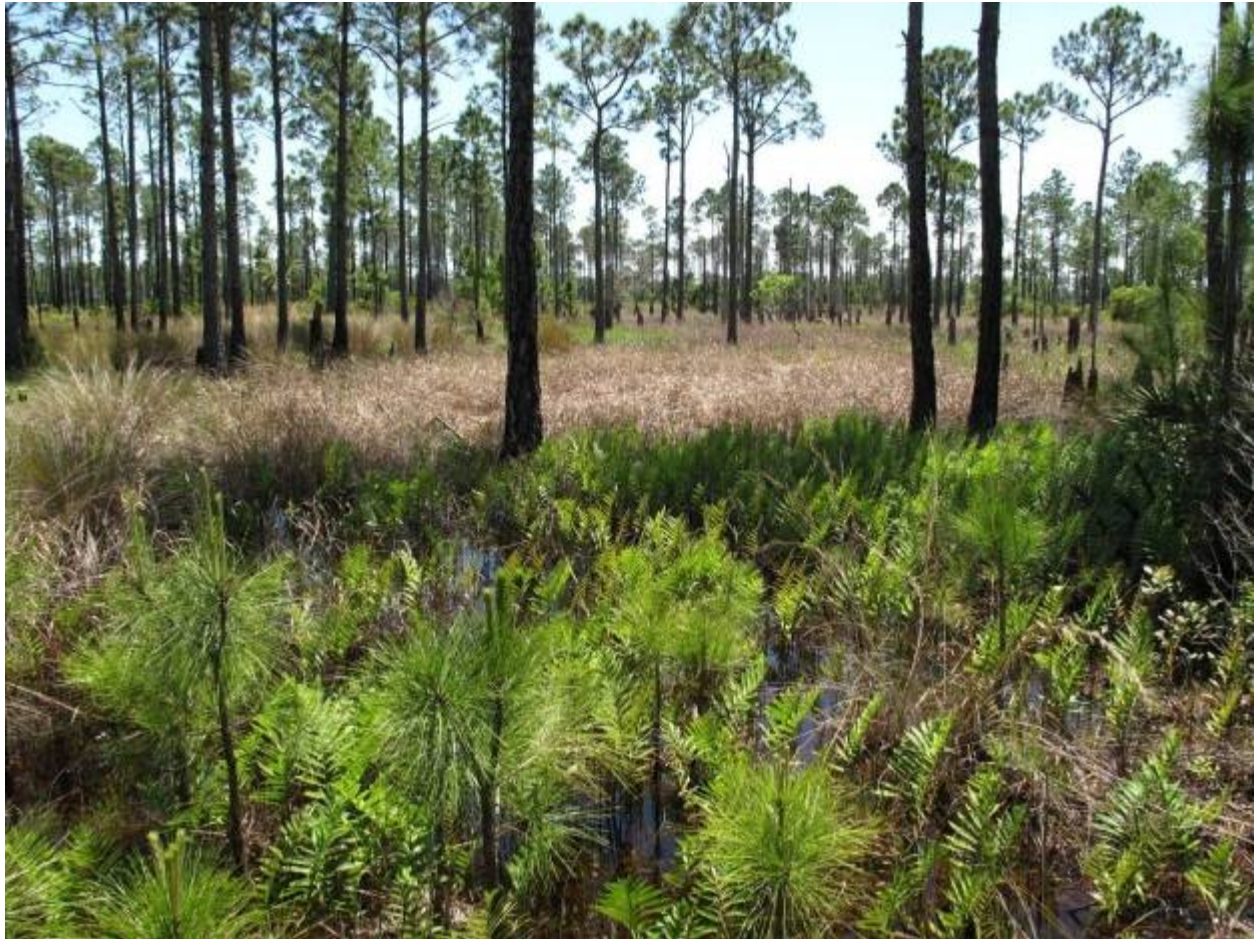
**Description:** This wetland is a 1.3 ha ephemeral marsh. Pine trees dominate the canopy, and cover 5-25% of the wetland. There is no midstory cover. Sedges/grasses and maidencane grow throughout the wetland, and cover >75% of the basin. A fireline bisects the northern tip of the marsh. The adjacent uplands are mesic flatwoods.

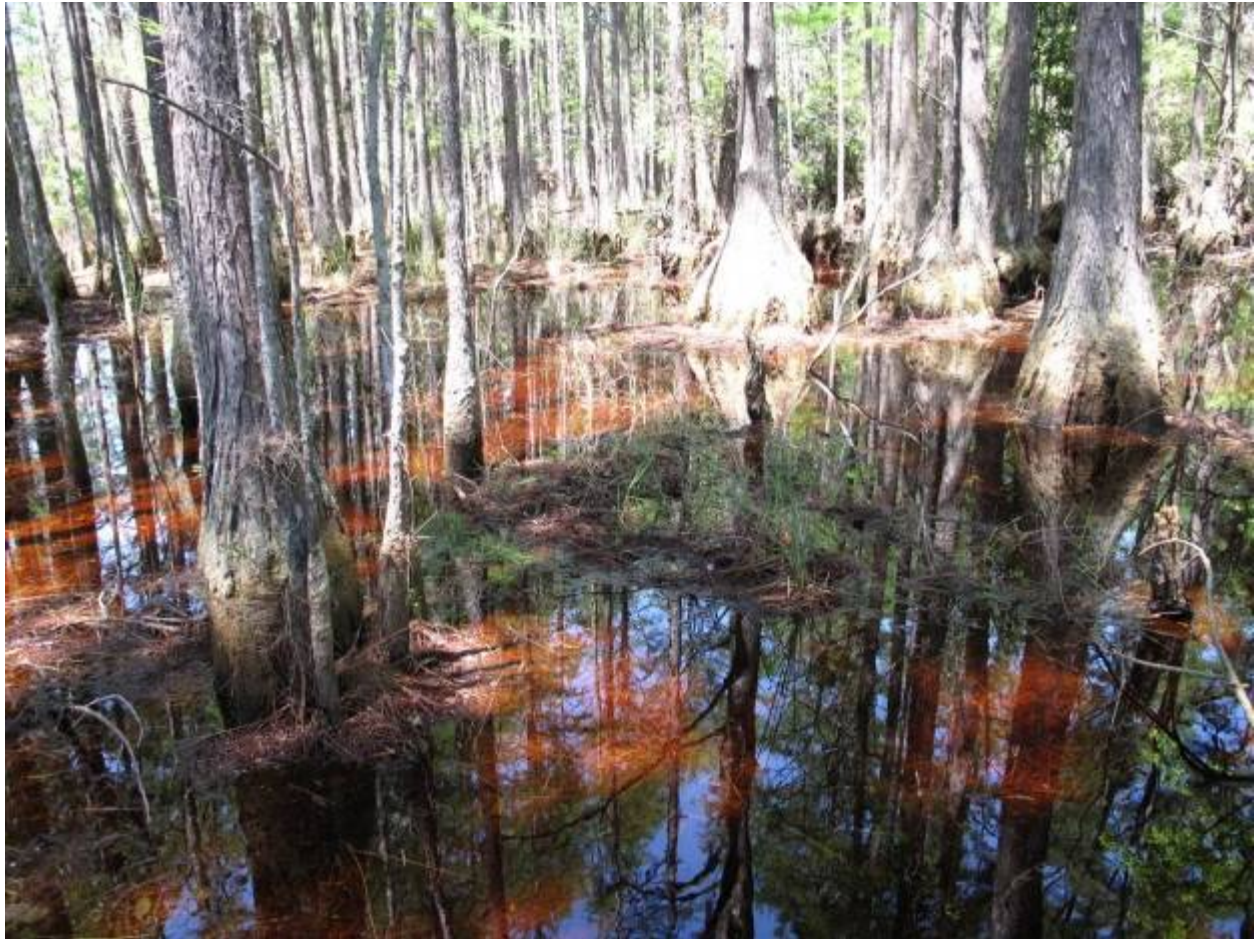
**Wetland ID: 18-04**

**Description:** This wetland is a 0.4 ha semi-permanent forested swamp. Cypress trees dominate the canopy, and cover >75% of the wetland. The midstory is dominated by wax myrtle, and covers 5-25% of the wetland. There is no herbaceous vegetation. This swamp connects to a much larger swamp to the north and east. The adjacent uplands are mesic flatwoods and hammock.

**Wetland Disturbance:** None

**Restoration Action Recommended:** None
