# **Inventory, Assessment, and Restoration Potential of Ephemeral Wetlands on FFWCC Wildlife Management Areas**

## **Guana River WMA Final Report**

Submitted by: Rebecca P.M. Means<sup>1</sup>, Ryan C. Means<sup>1</sup>, Steven A. Johnson<sup>2</sup>

April - May 2009

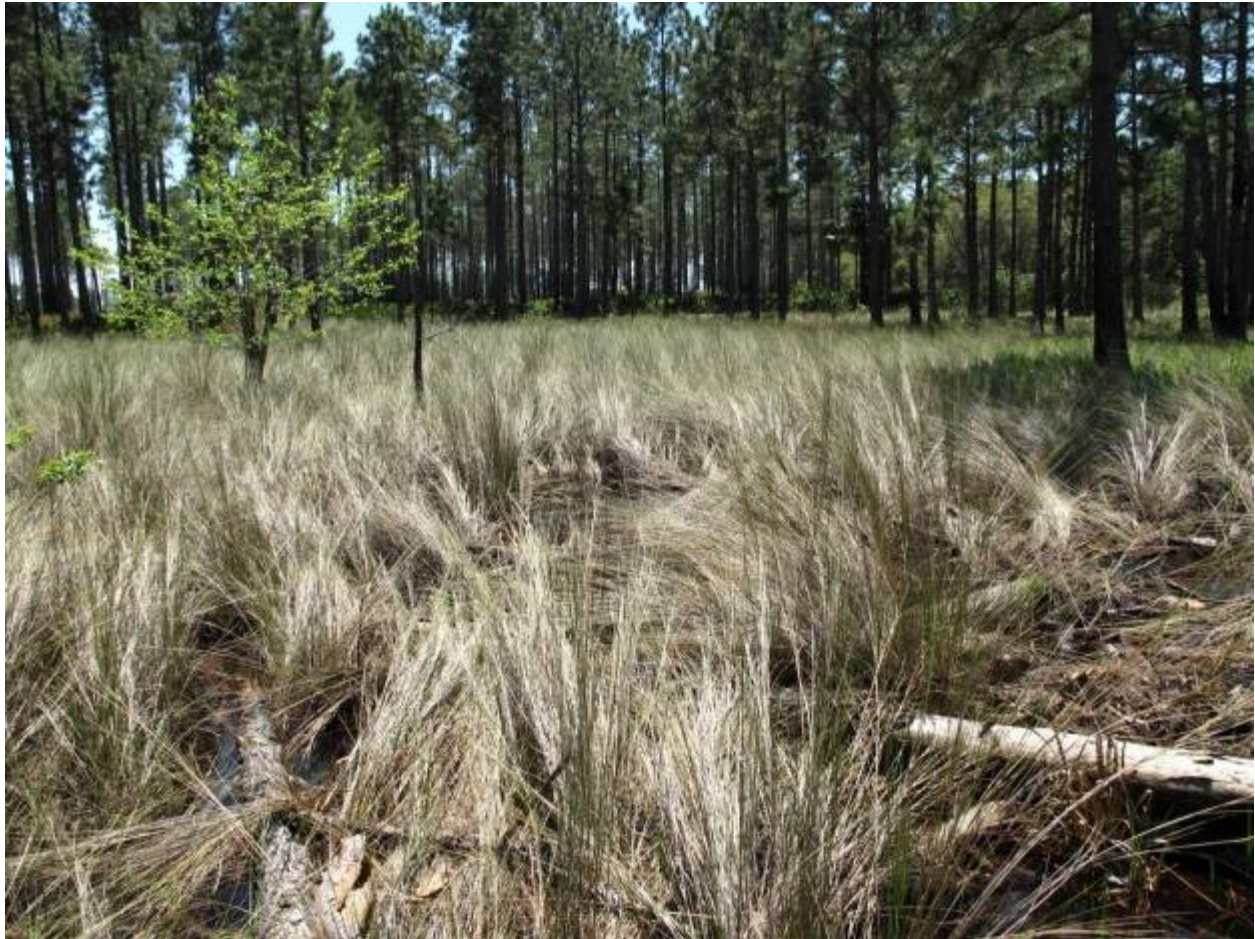
**Description:** This wetland is a 0.3 ha ephemeral marsh. Pine trees grow in a ring around the wetland, and cover 5-25% of the basin. There is no midstory cover. Sedges/grasses and fern grow throughout the wetland, and cover >75% of the basin. This marsh is in fire-maintenance condition. The adjacent uplands are mesic flatwoods and hammock.

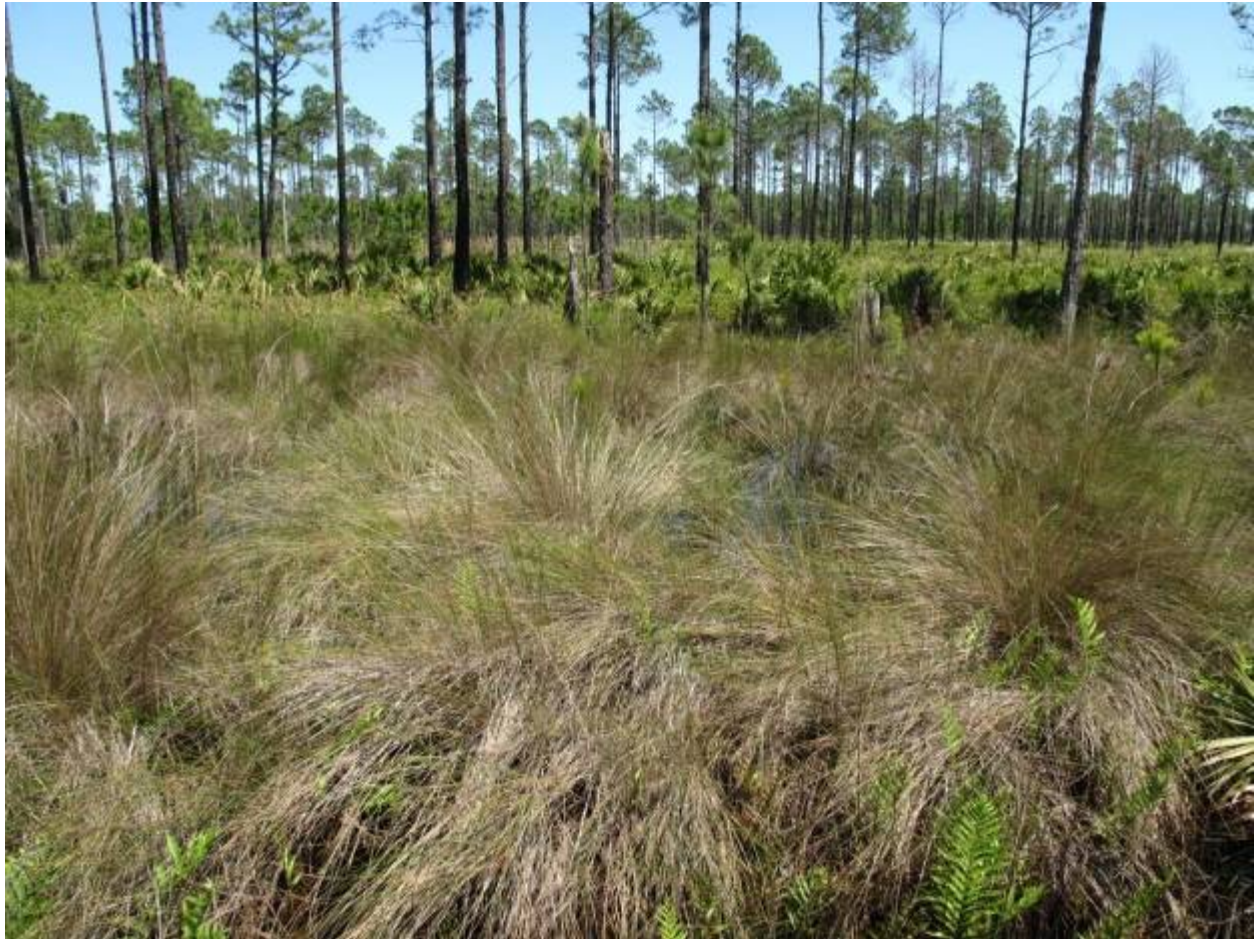
**Description:** This wetland is a 0.4 ha ephemeral marsh. There is no tree canopy or midstory cover. Sedges/grasses grow throughout the wetland, and cover >75% of the basin. This marsh is in fire-maintenance condition. The adjacent uplands are mesic flatwoods.

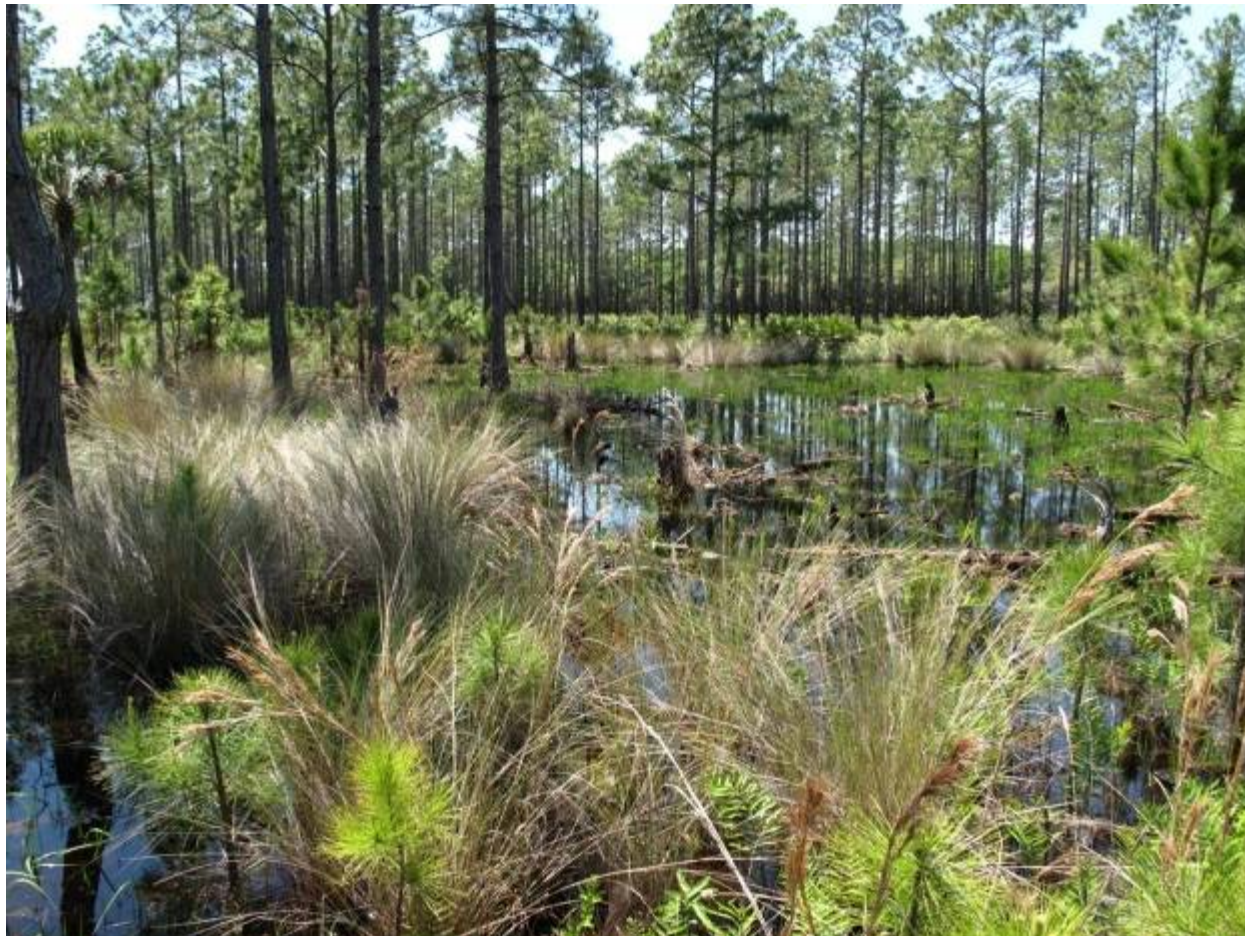
**Wetland ID: 18-07**

**Description:** This wetland is a 0.3 ha ephemeral marsh. Pine trees dominate the canopy, and cover 5-25% of the wetland. Young pine trees are beginning to encroach, and cover 5-25% of the wetland. Sedges/grasses grow throughout, and cover 50-75% of the wetland basin. This pineland marsh has nice, open water areas with herbaceous vegetation. The adjacent uplands are mesic flatwoods.

**Wetland Disturbance:** Woody encroachment

**Restoration Action Recommended:** Monitor this wetland to ensure encroaching pine trees are killed with the next fire or inundation. If they become established, the trees will need to be removed from the wetland.

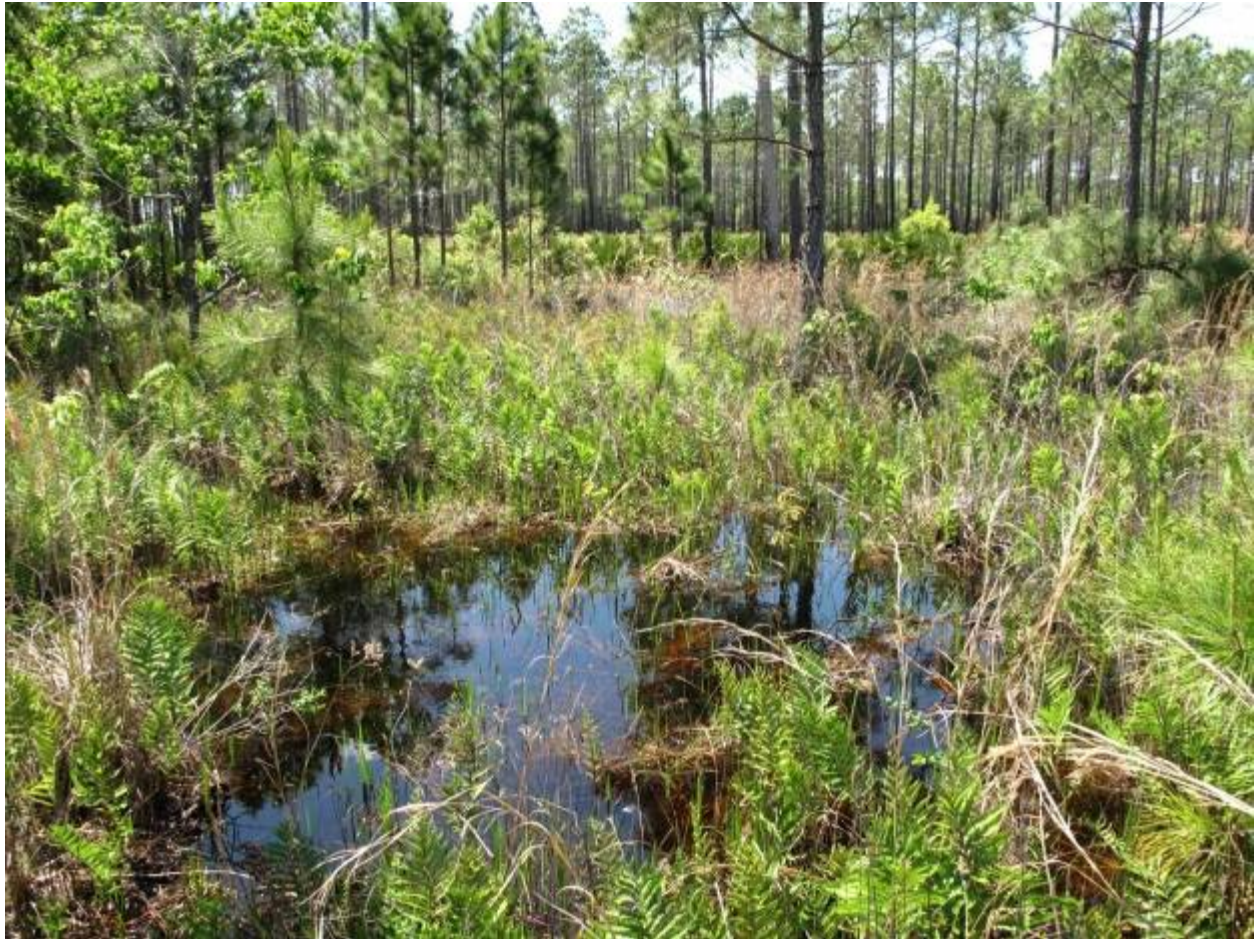
**Description:** This wetland is a 0.1 ha ephemeral marsh. Pine trees dominate the canopy, and cover 5-25% of the wetland. Young pine trees and an unidentified shrub are beginning to encroach, and cover 5-25% of the wetland. Sedges/grasses and fern grow throughout the wetland, and cover >75% of the basin. The adjacent uplands are mesic flatwoods.

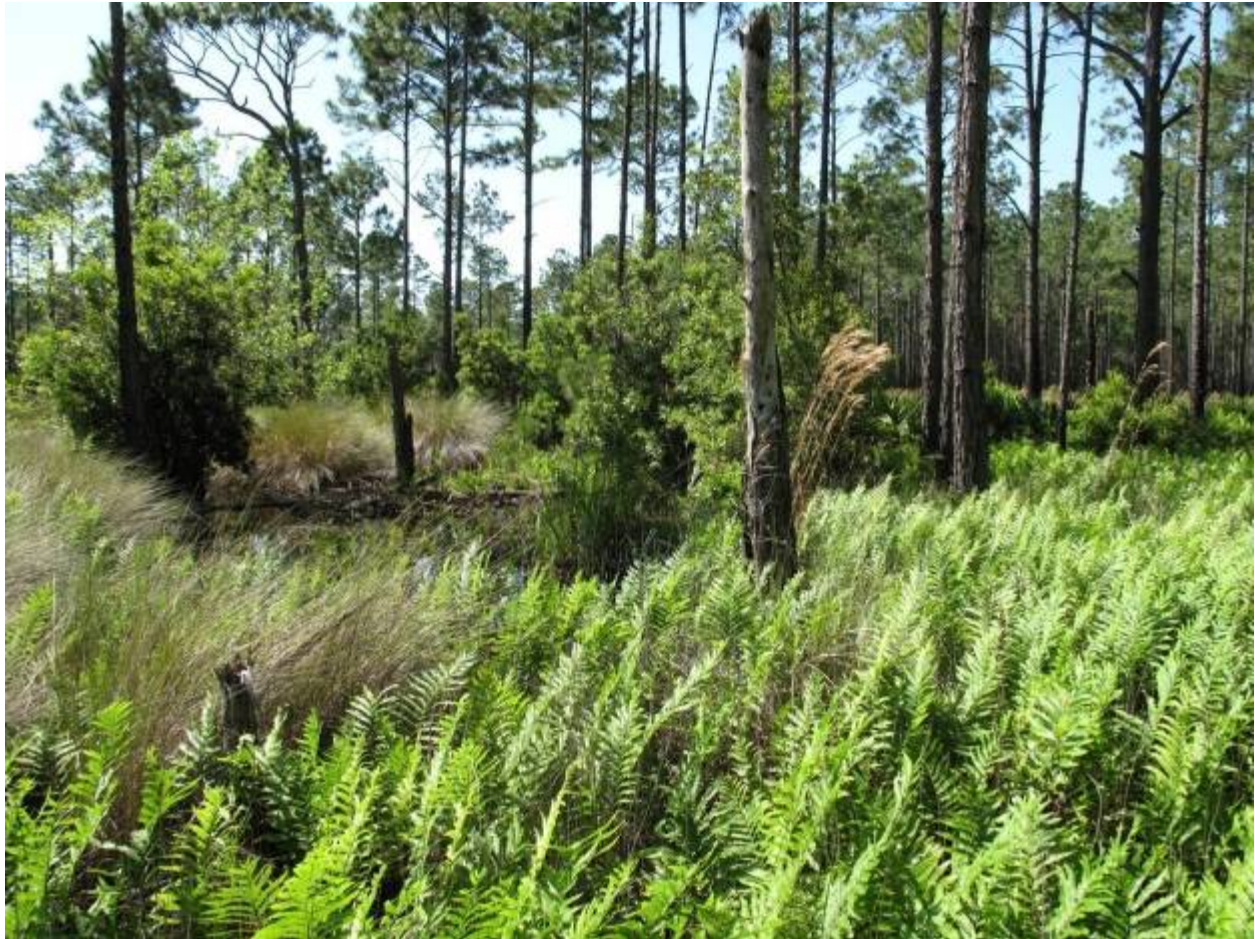
**Description:** This wetland is a 0.4 ha ephemeral marsh. Pine trees dominate the canopy, and cover 5-25% of the wetland. There is no midstory cover. Sedges/grasses and fern grow throughout the wetland, and cover >75% of the basin. This marsh is in fire-maintenance condition. The adjacent uplands are mesic flatwoods.

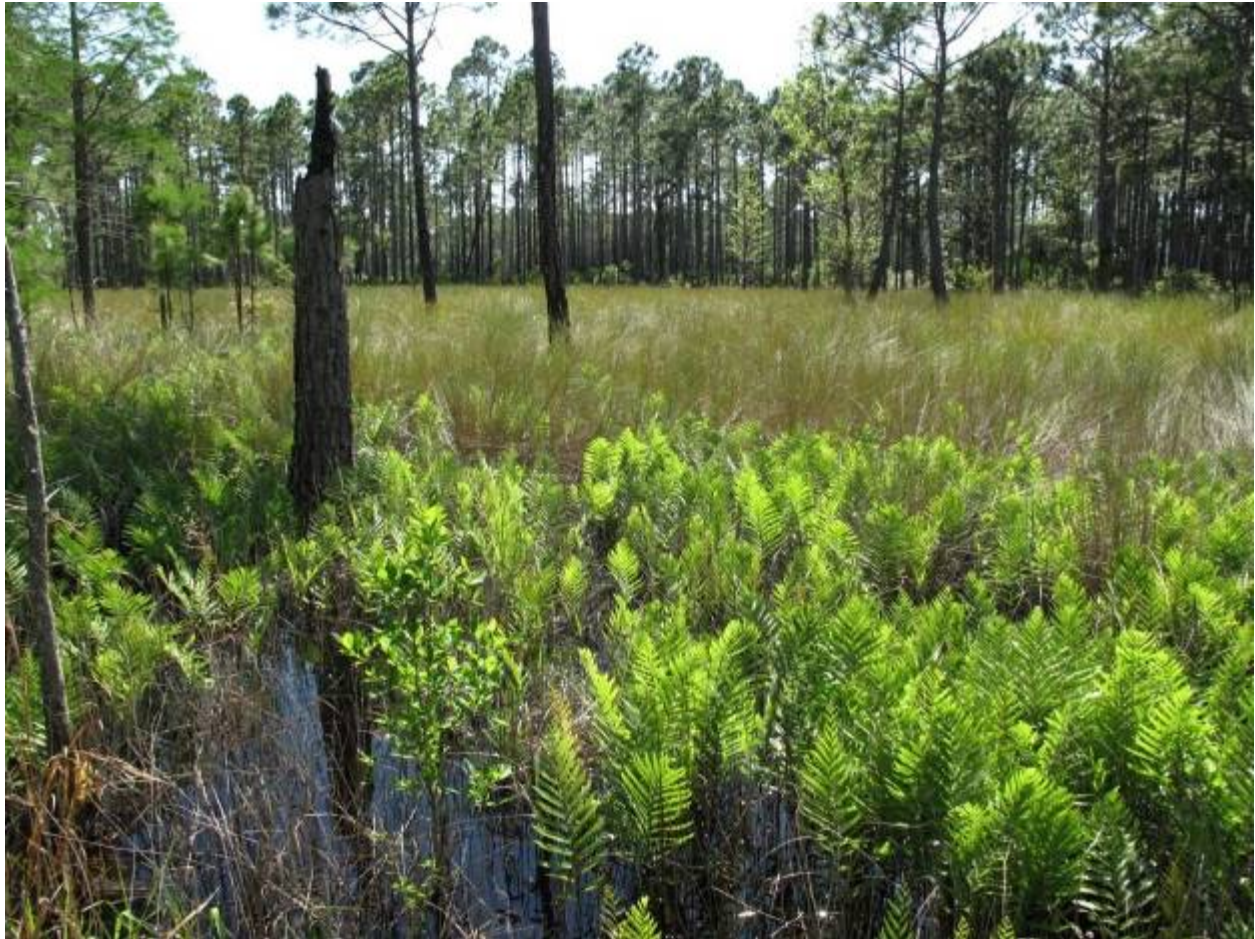
**Description:** This wetland is a 0.8 ha ephemeral marsh. Pine trees dominate the canopy, and cover 5-25% of the wetland. There is no midstory cover. Sedges/grasses and fern grow throughout the wetland, and cover >75% of the basin. This marsh is in fire-maintenance condition. The adjacent uplands are mesic and scrubby flatwoods.

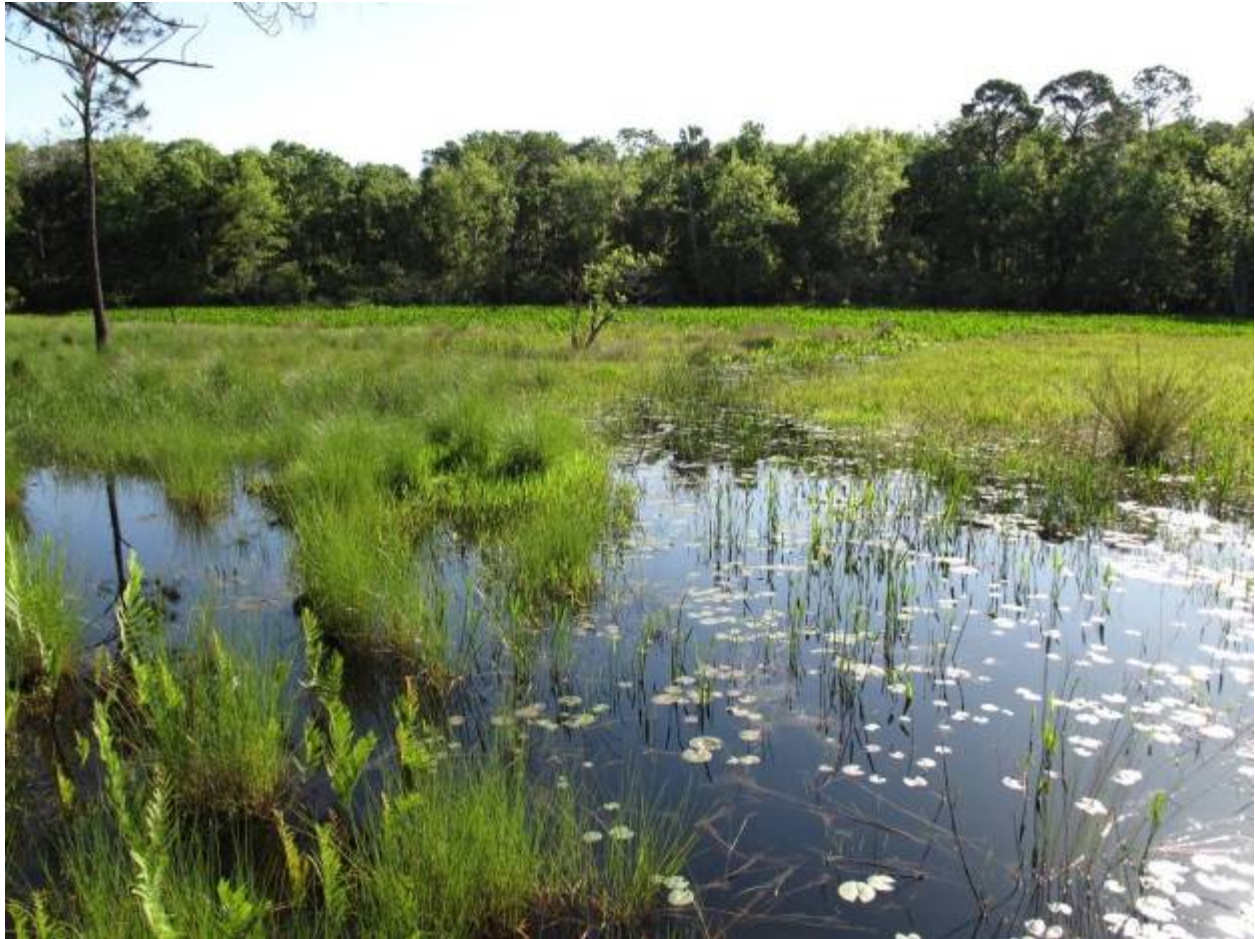
**Description:** This wetland is a 1.5 ha semi-permanent marsh. There is no tree canopy or midstory cover. Sedges/grasses and emergent vegetation grow throughout the wetland, and cover >75% of the basin. This wetland appears to be human-enhanced, or was a borrow pit, but is now a functioning ephemeral wetland with diverse herbaceous vegetation. The adjacent uplands are scrubby flatwoods and lowland.

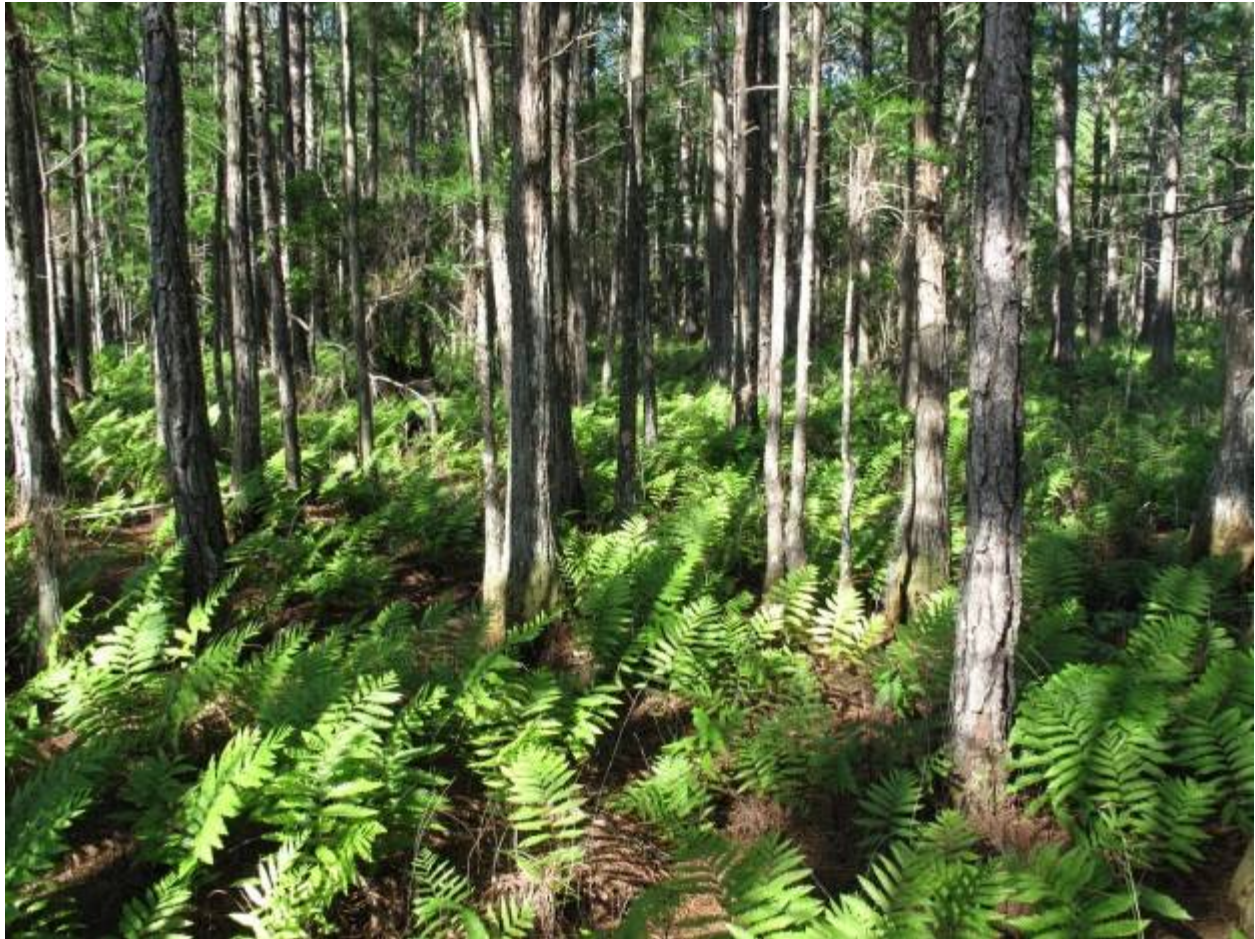
**Description:** This wetland is a 1.5 ha ephemeral forested swamp. Cypress and pine trees dominate the canopy, and cover >75% of the wetland. The midstory is dominated by wax myrtle, and covers 5-25% of the wetland. Fern grow throughout the wetland, and cover >75% of the basin. The pine needle duff is thick on the wetland floor. The adjacent uplands are mesic flatwoods.

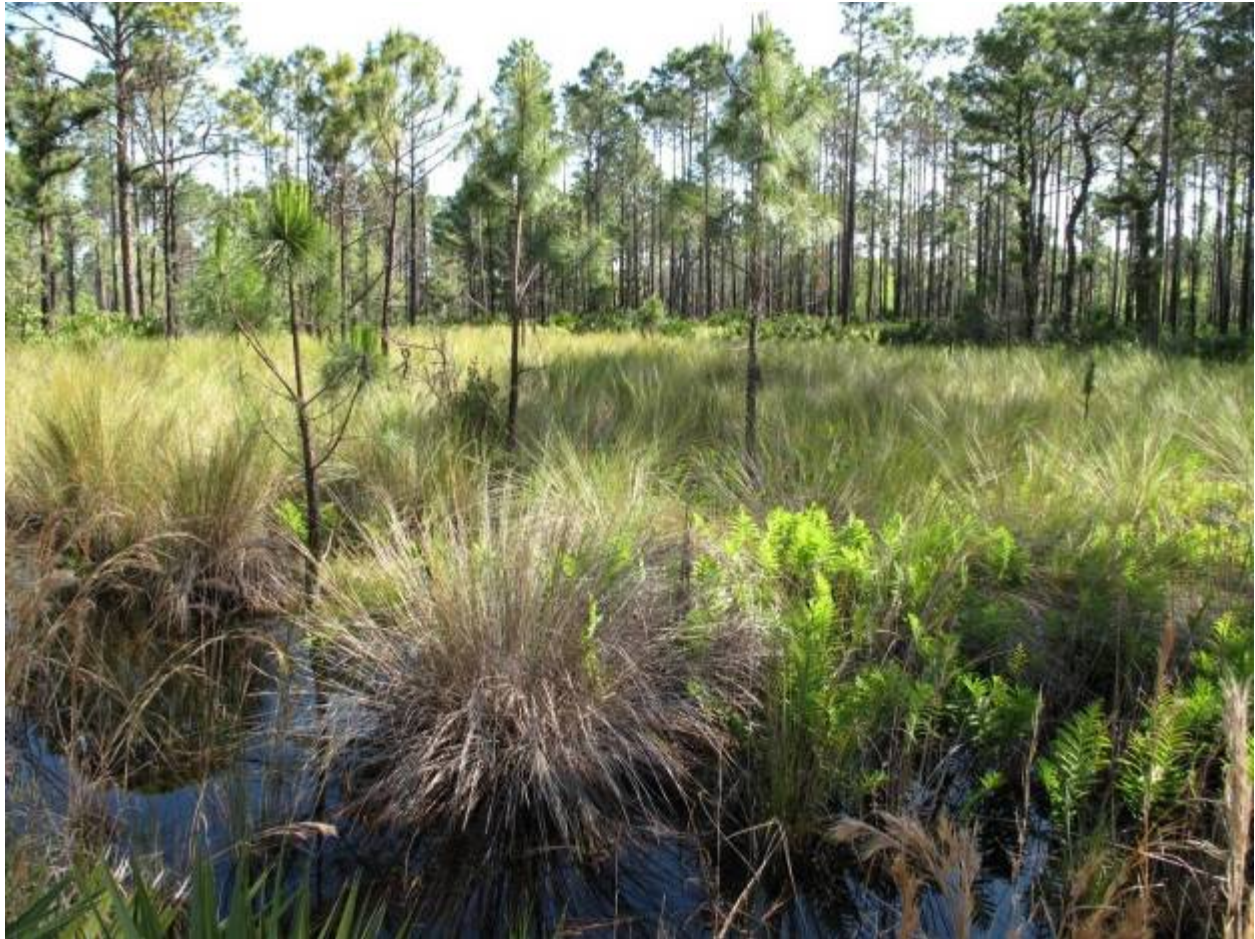
**Description:** This wetland is a 0.2 ha ephemeral marsh. Pine trees dominate the canopy, and cover 5-25% of the wetland. There is no midstory cover. Sedges/grasses grow throughout the wetland, and cover >75% of the basin. This marsh is in fire-maintenance condition. The adjacent uplands are mesic flatwoods.

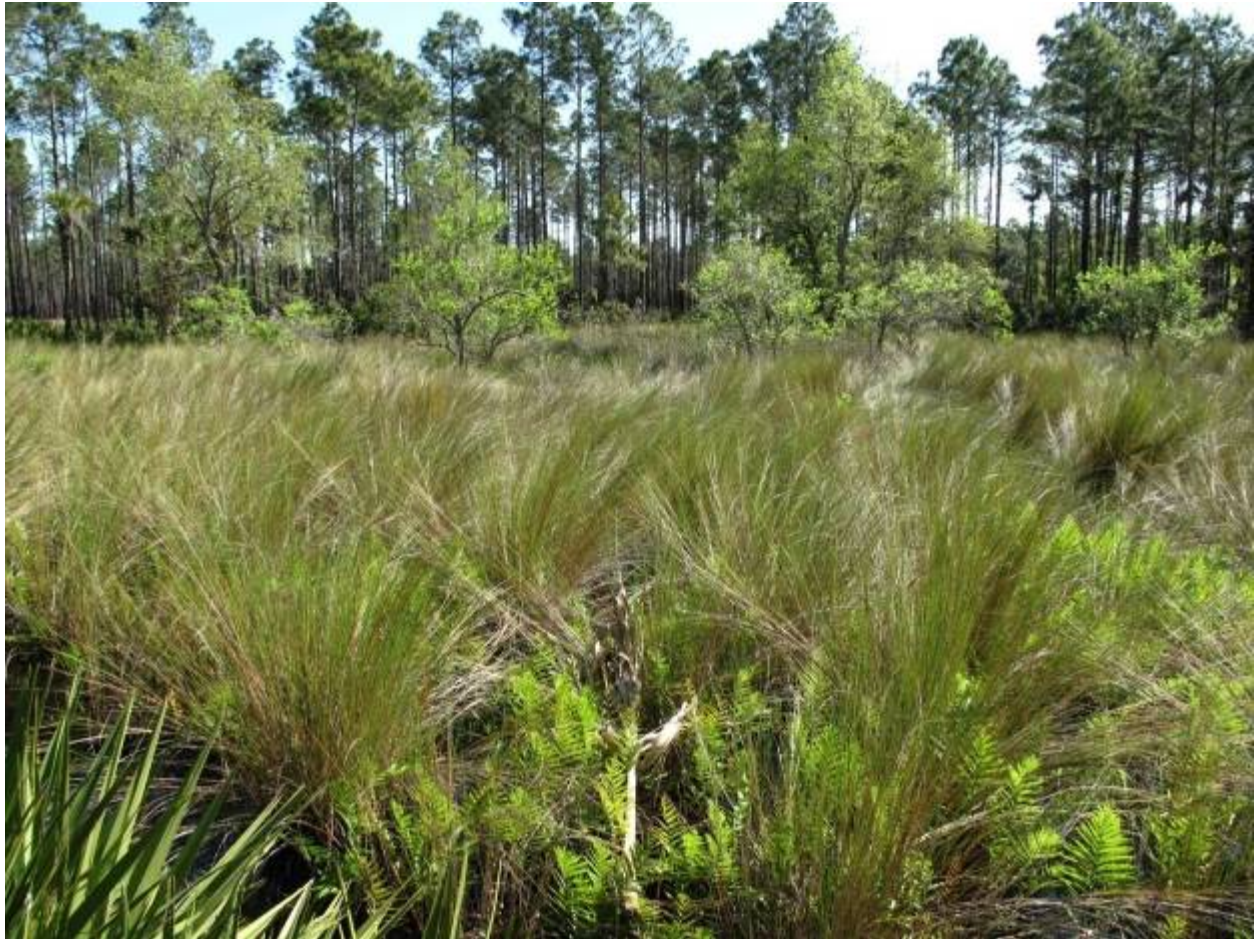
**Description:** This wetland is a 0.2 ha ephemeral marsh. Buttonbush is the dominant woody vegetation, and covers 5-25% of the wetland. Sedges/grasses grow throughout the wetland, and cover >75% of the basin. This marsh is in fire-maintenance condition. The adjacent uplands are mesic flatwoods that were converted to a pine plantation. The uplands have been thinned and burned to restore them to a more open flatwoods community.

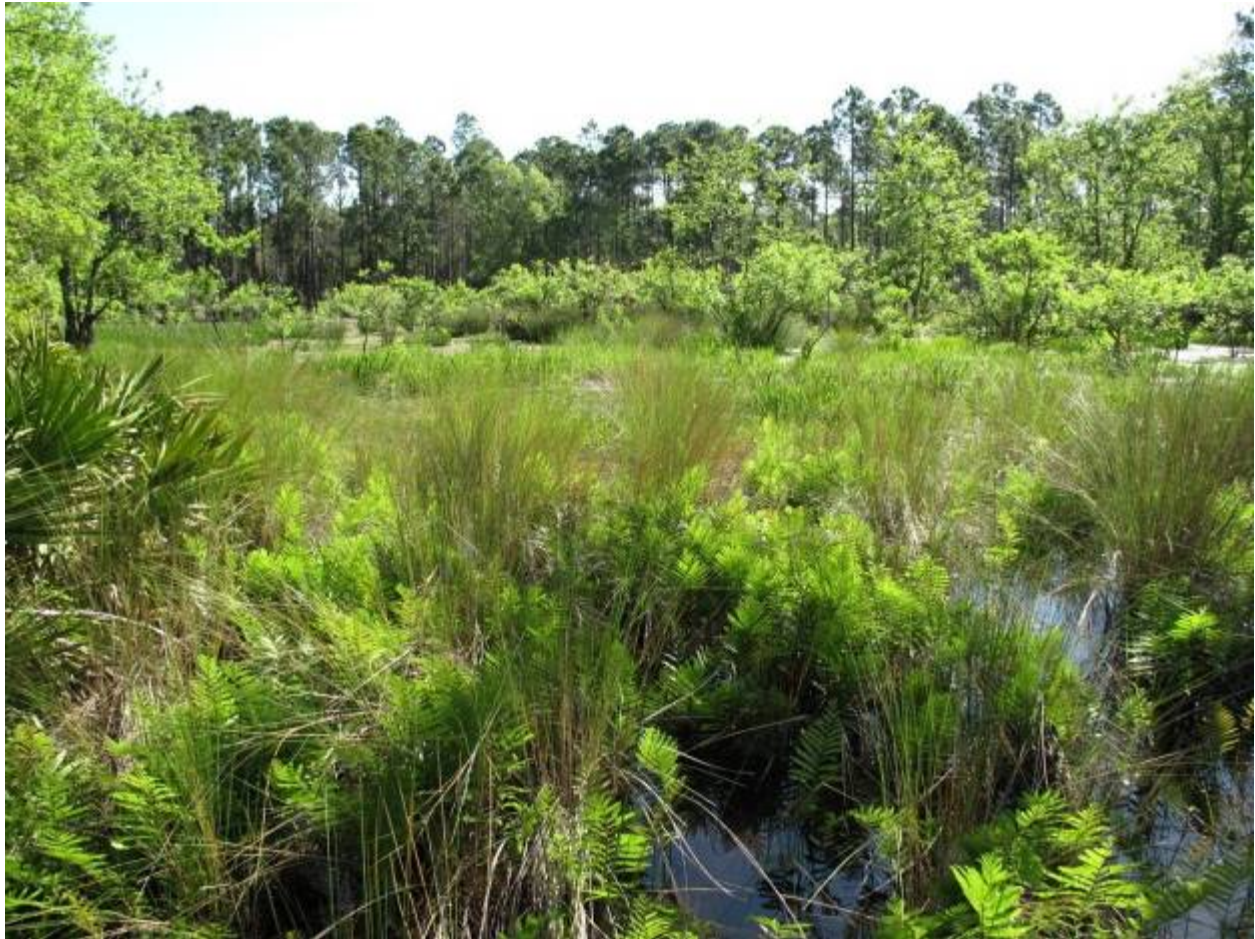
**Description:** This wetland is a 0.9 ha semi-permanent marsh. Gum trees dominate the canopy, and cover 5-25% of the wetland. The midstory is dominated by buttonbush, and covers 5-25% of the wetland. Sedge/grass, maidencane, and emergent vegetation grow throughout the wetland, and cover >75% of the basin. This marsh is in fire-maintenance condition. The adjacent uplands are mesic flatwoods that were converted to a pine plantation. The uplands have been thinned and burned to restore them to a more open flatwoods community.

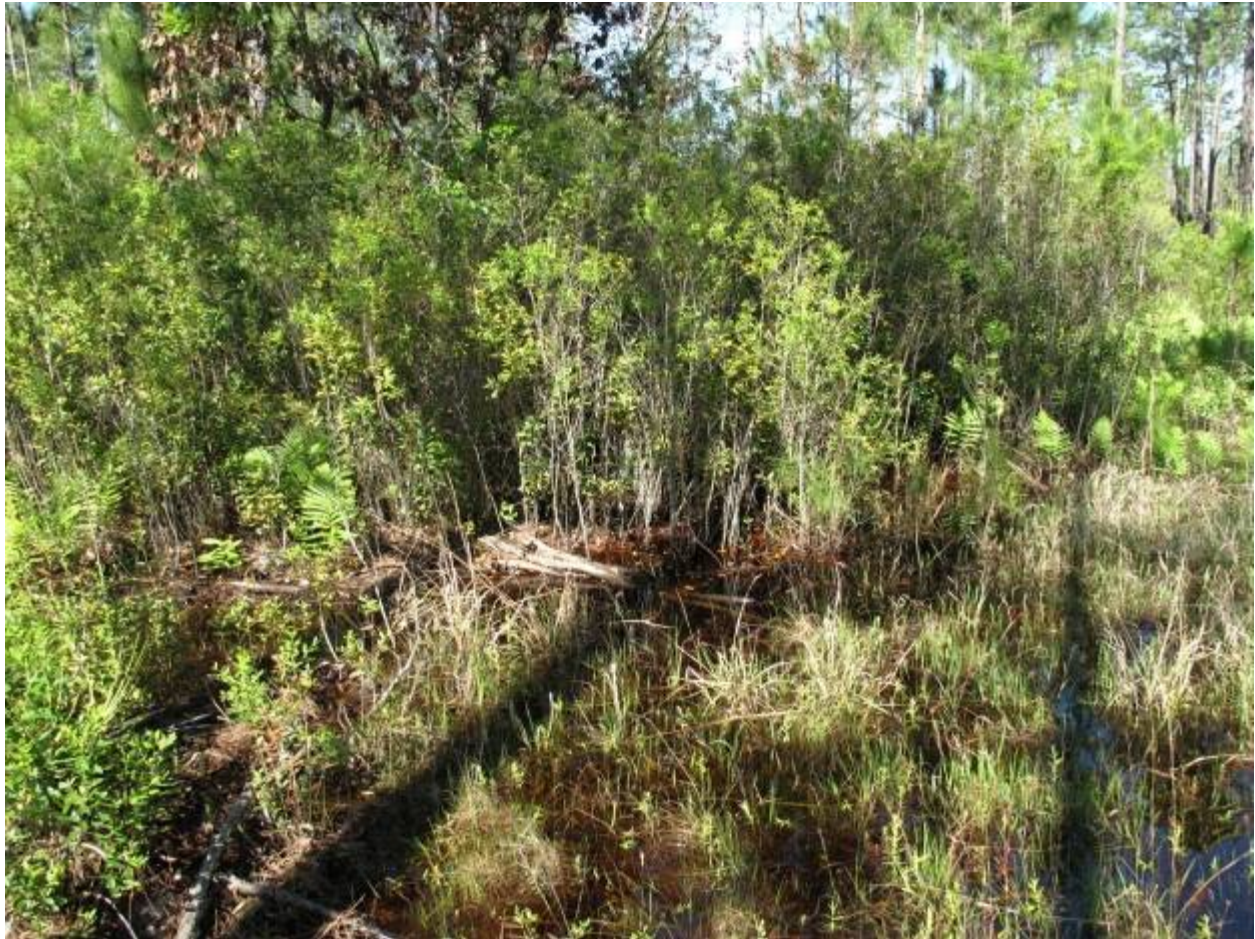
**Description:** This wetland is a 0.1 ha ephemeral shrub swamp. Pine trees dominate the canopy, and cover 5-25% of the wetland. Gallberry is encroaching into the wetland, and covers 50-75% of the basin. Sedges/grasses and fern grow throughout the wetland, and cover 50-75% of the basin. It appears this wetland was human-enhanced on the north side; an old dig hole or scrape is still evident. The adjacent uplands are mesic flatwoods that were converted to a pine plantation. The uplands have been thinned and burned to restore them to a more open flatwoods community.

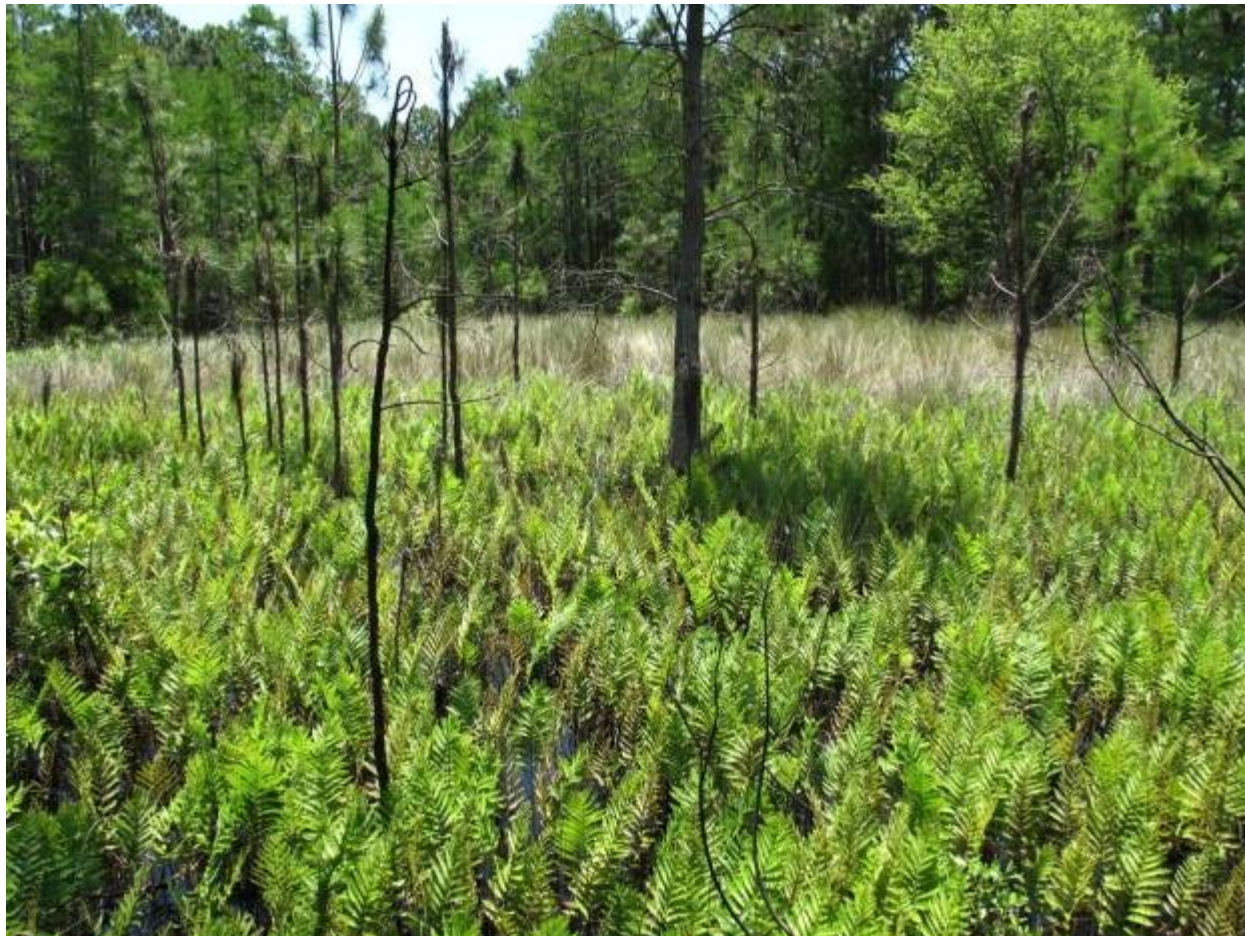
**Wetland ID: 18-17**

**Description:** This wetland is a 0.6 ha ephemeral marsh. Cypress and pine trees dominate the canopy, and cover 25-50% of the wetland. The midstory is dominated by wax myrtle and small pine trees, and covers 25-50% of the wetland. Sedges/grasses and fern grow throughout, and cover 50-75% of the wetland. The north side of the wetland is marsh and the southern half is forested swamp. Pine trees are beginning to encroach in the marsh basin. The adjacent uplands are mesic flatwoods.

**Wetland Disturbance:** Woody encroachment

**Restoration Action Recommended:** Encourage periodic fire in the wetland to prevent further encroachment of woody vegetation. Alternatively, the pine trees can be hand-chopped from the wetland interior.

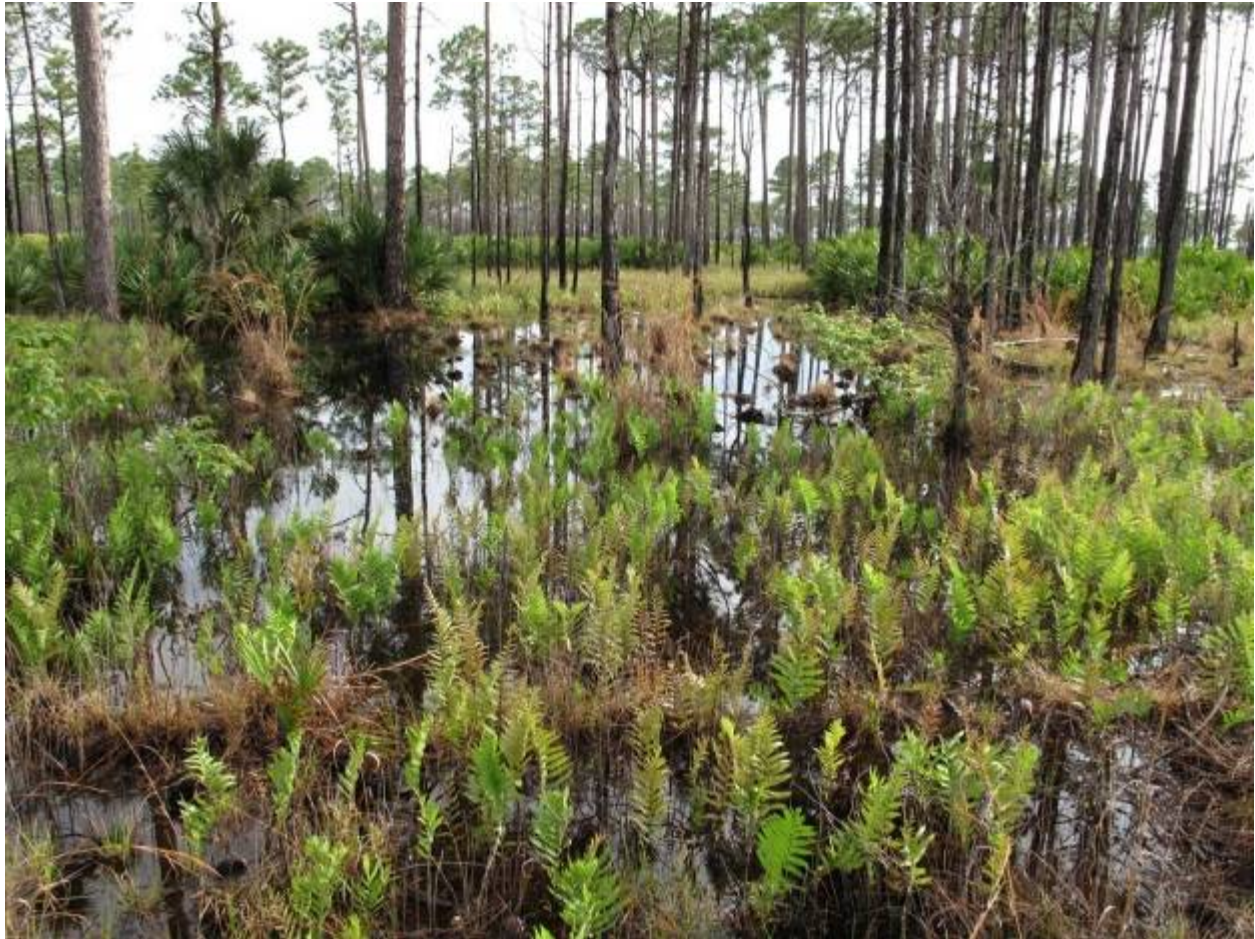
**Description:** This wetland is a 0.2 ha ephemeral marsh. Pine trees dominate the canopy, and cover 5-25% of the wetland. There is no midstory cover. Sedges/grasses and fern grow throughout the wetland, and cover 50-75% of the basin. This marsh may be a human created depression but now it is functioning as an ephemeral wetland. This marsh is in fire-maintenance condition. The adjacent uplands are scrubby flatwoods.

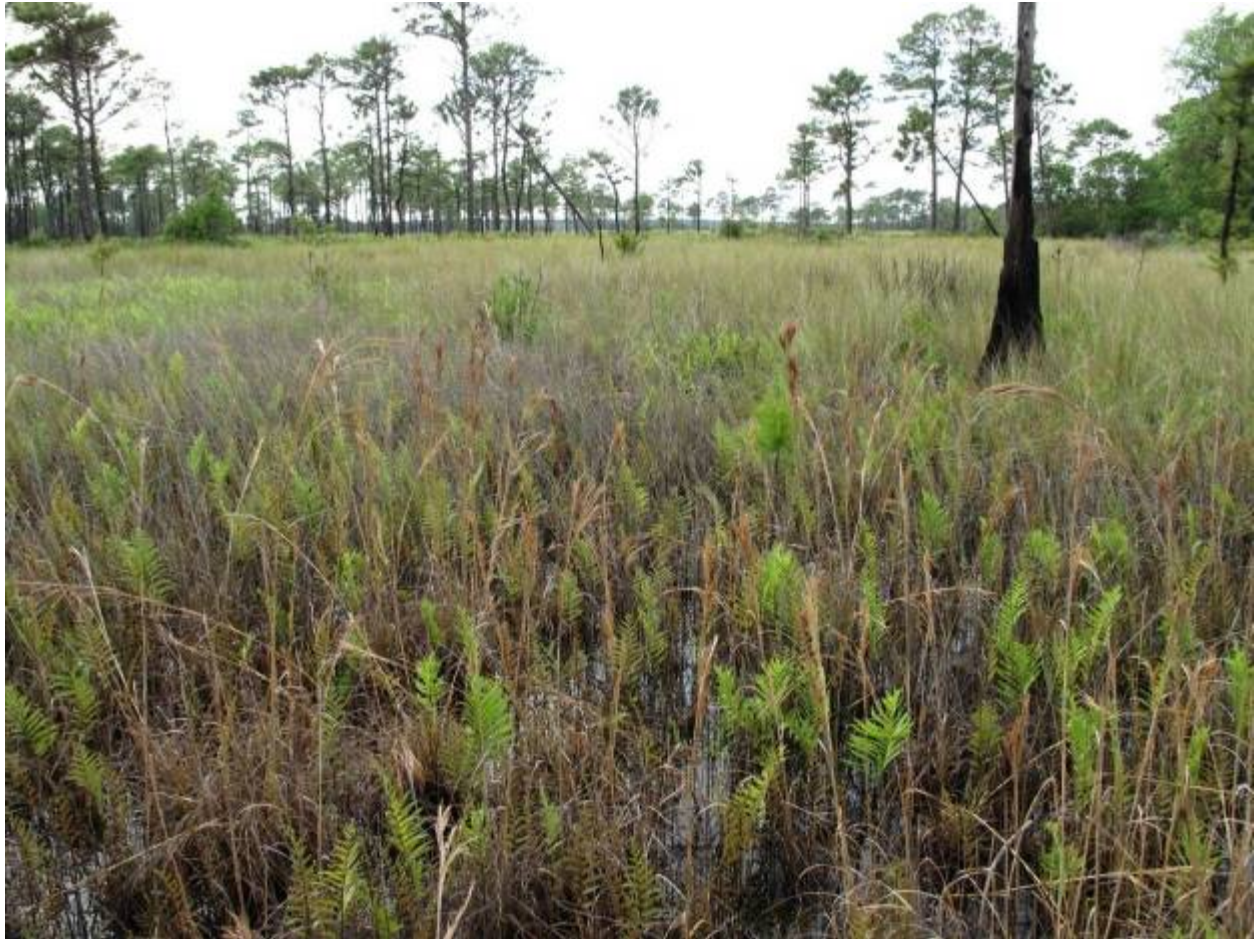
**Description:** This wetland is a 0.5 ha ephemeral marsh. There is no tree canopy or midstory cover. Sedges/grasses grow throughout the wetland, and cover >75% of the basin. This marsh is in fire-maintenance condition. The adjacent uplands are scrubby flatwoods.

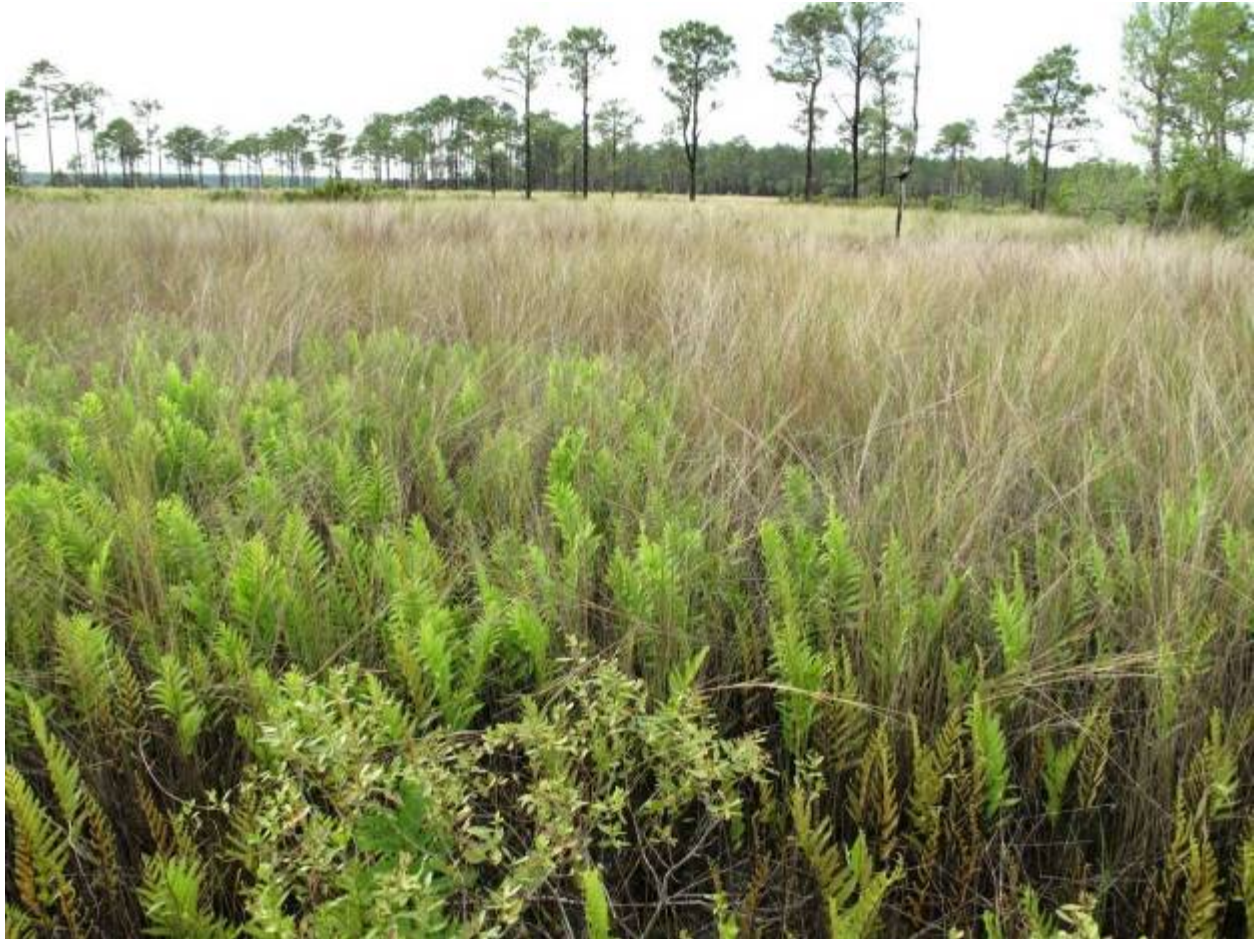
**Wetland ID: 23-03**

**Description:** This wetland is a 0.7 ha ephemeral marsh. There is no tree canopy or midstory cover. Sedges/grasses grow throughout the wetland, and cover >75% of the basin. This marsh is in fire-maintenance condition. The adjacent uplands are scrubby flatwoods.

**Wetland Disturbance:** None

**Restoration Action Recommended:** None

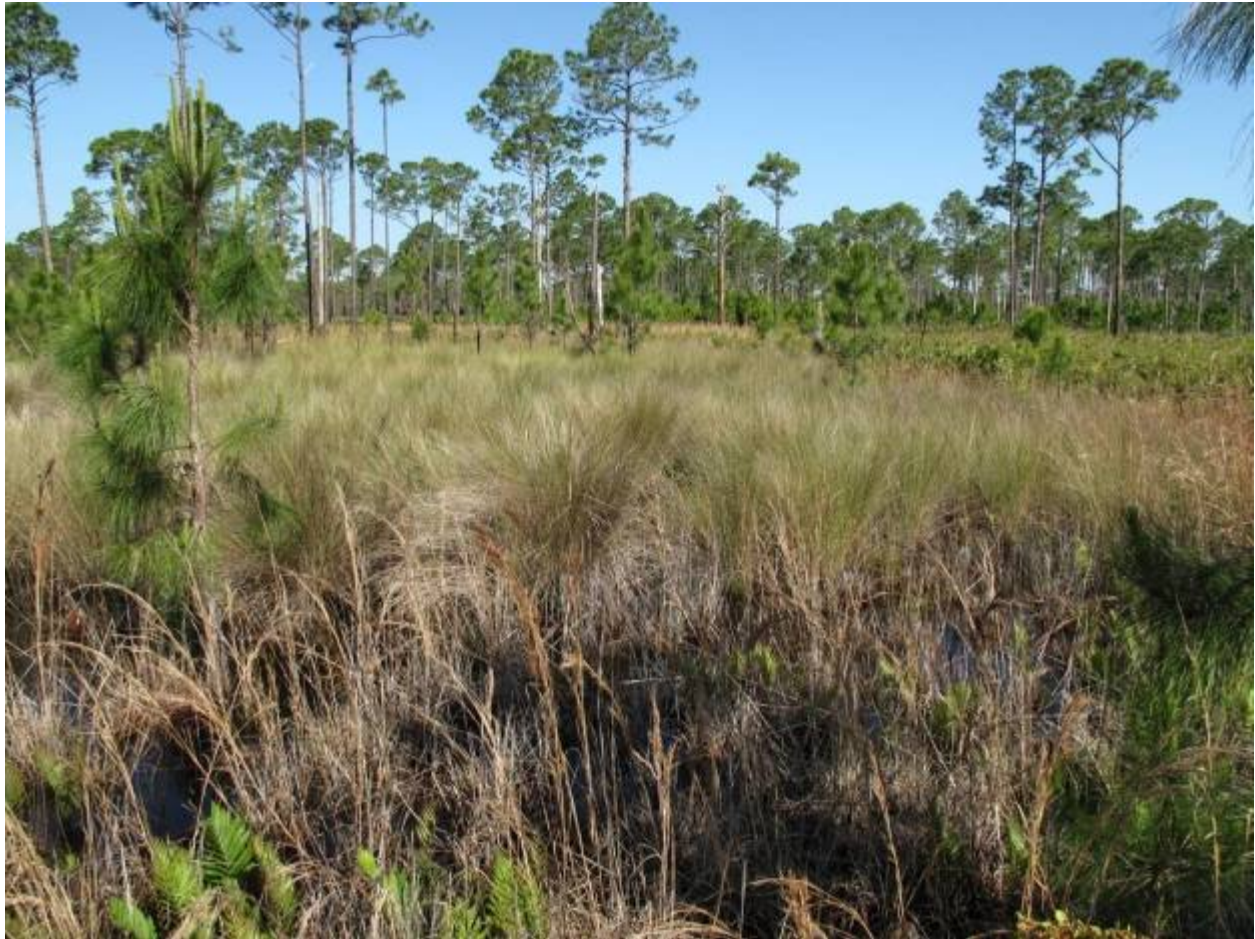
**Description:** This wetland is a 0.4 ha ephemeral marsh. Small pine trees are beginning to encroach into the wetland, and cover 5-25% of the wetland. Sedges/grasses grow throughout the wetland, and cover >75% of the basin. The adjacent uplands are scrubby flatwoods.
