# **Inventory, Assessment, and Restoration Potential of Ephemeral Wetlands on FFWCC Wildlife Management Areas**

## **Guana River WMA Final Report**

Submitted by: Rebecca P.M. Means<sup>1</sup>, Ryan C. Means<sup>1</sup>, Steven A. Johnson<sup>2</sup>

April - May 2009

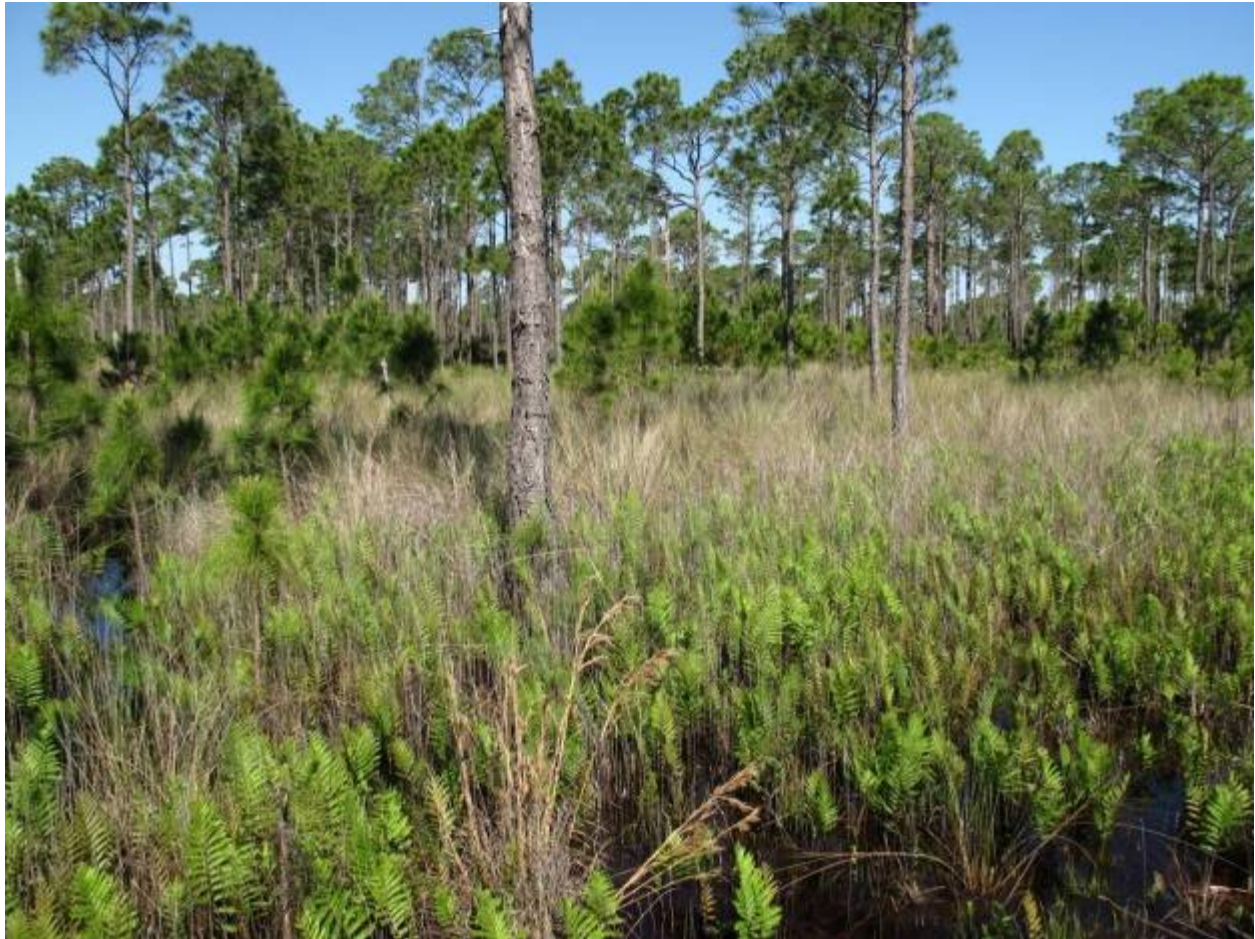
**Description:** This wetland is a 1.2 ha ephemeral marsh. Pine trees dominate the canopy, and cover 5-25% of the wetland. Small pine trees are beginning to encroach into the wetland, and cover 5-25% of the basin. Sedges/grasses and fern grow throughout the wetland, and cover >75% of the basin. The adjacent uplands are scrubby flatwoods.

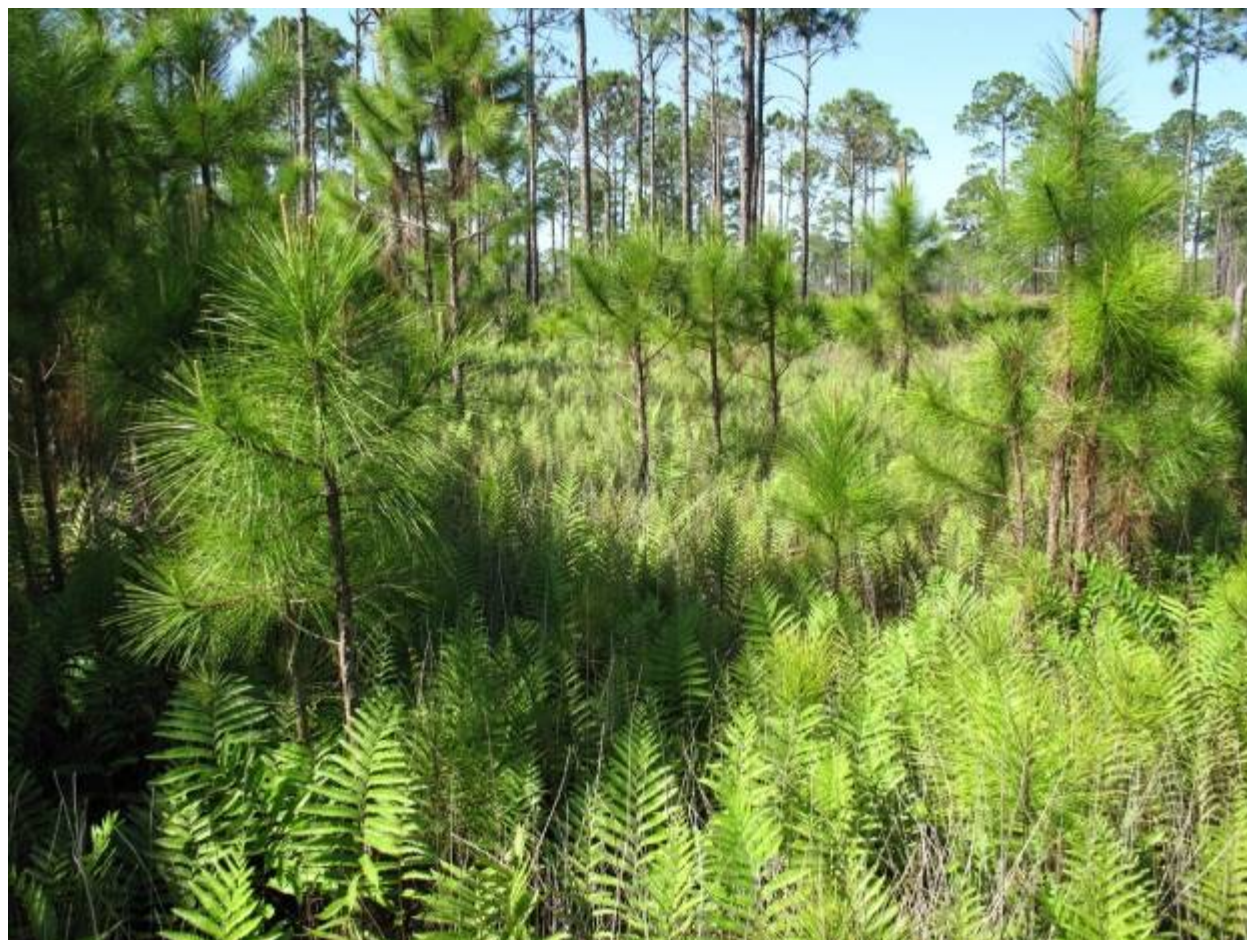
**Wetland ID: 23-06**

**Description:** This wetland is a 0.7 ha ephemeral marsh. Pine trees dominate the canopy, and cover 5-25% of the wetland. Small pine trees are beginning to encroach into the wetland, and cover 5-25% of the basin. Sedges/grasses and fern grow throughout the wetland, and cover >75% of the basin. The adjacent uplands are scrubby flatwoods.

**Wetland Disturbance:** Woody encroachment

**Restoration Action Recommended:** If the next fire or inundation does not kill the encroaching pine trees, they may need to be hand-chopped from the wetland interior.

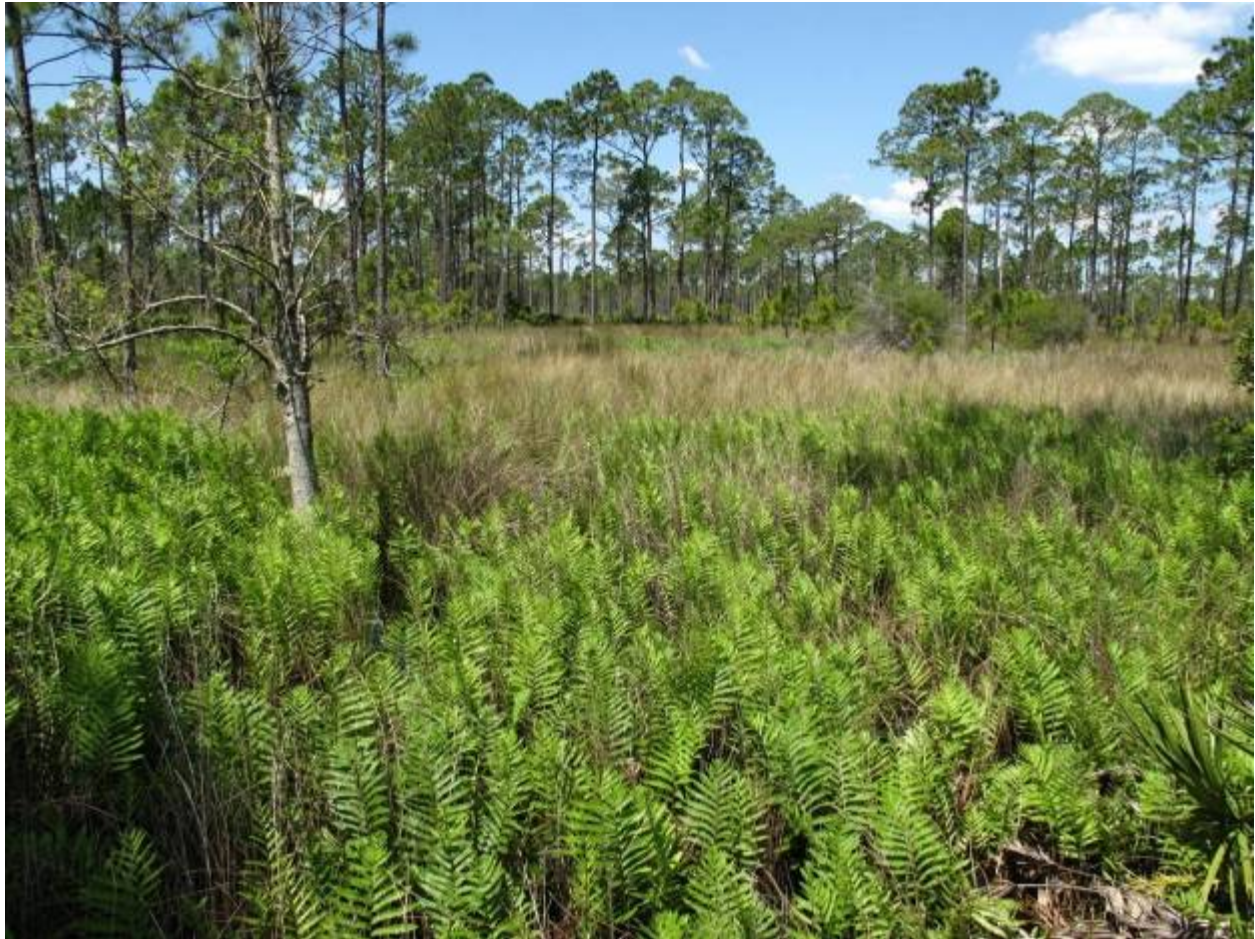
**Description:** This wetland is a 0.4 ha ephemeral marsh. There is no tree canopy or midstory cover. Sedges/grasses and fern grow throughout the wetland, and cover >75% of the basin. This marsh is in fire-maintenance condition. The adjacent uplands are scrubby flatwoods.

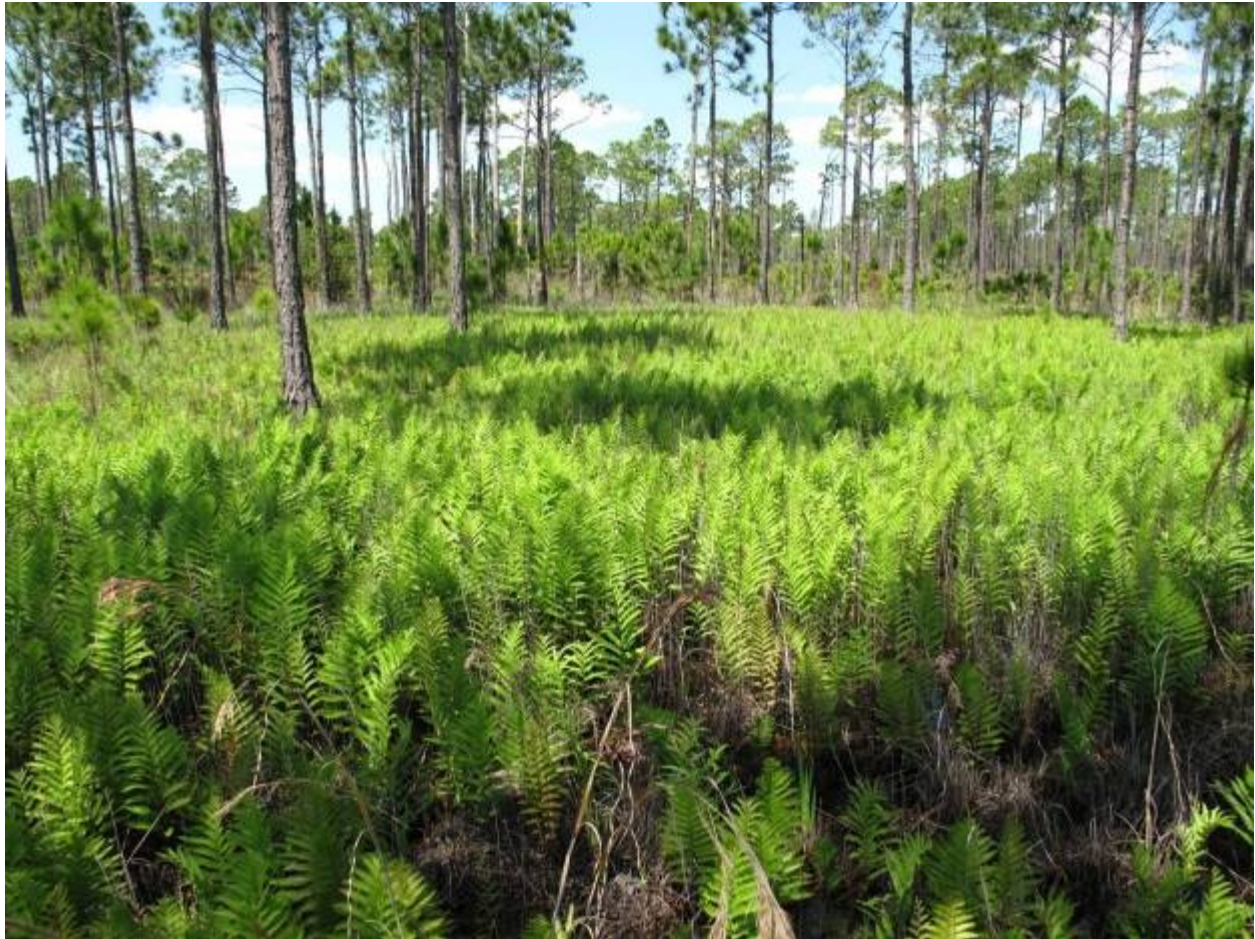
**Wetland ID: 23-08**

**Description:** This wetland is a 0.3 ha ephemeral marsh. Pine trees dominate the canopy, and cover 5-25% of the wetland. There is no midstory cover. Fern grow throughout the wetland, and cover >75% of the basin. This marsh is in fire-maintenance condition. The adjacent uplands are scrubby flatwoods.

**Wetland Disturbance:** None

**Restoration Action Recommended:** None

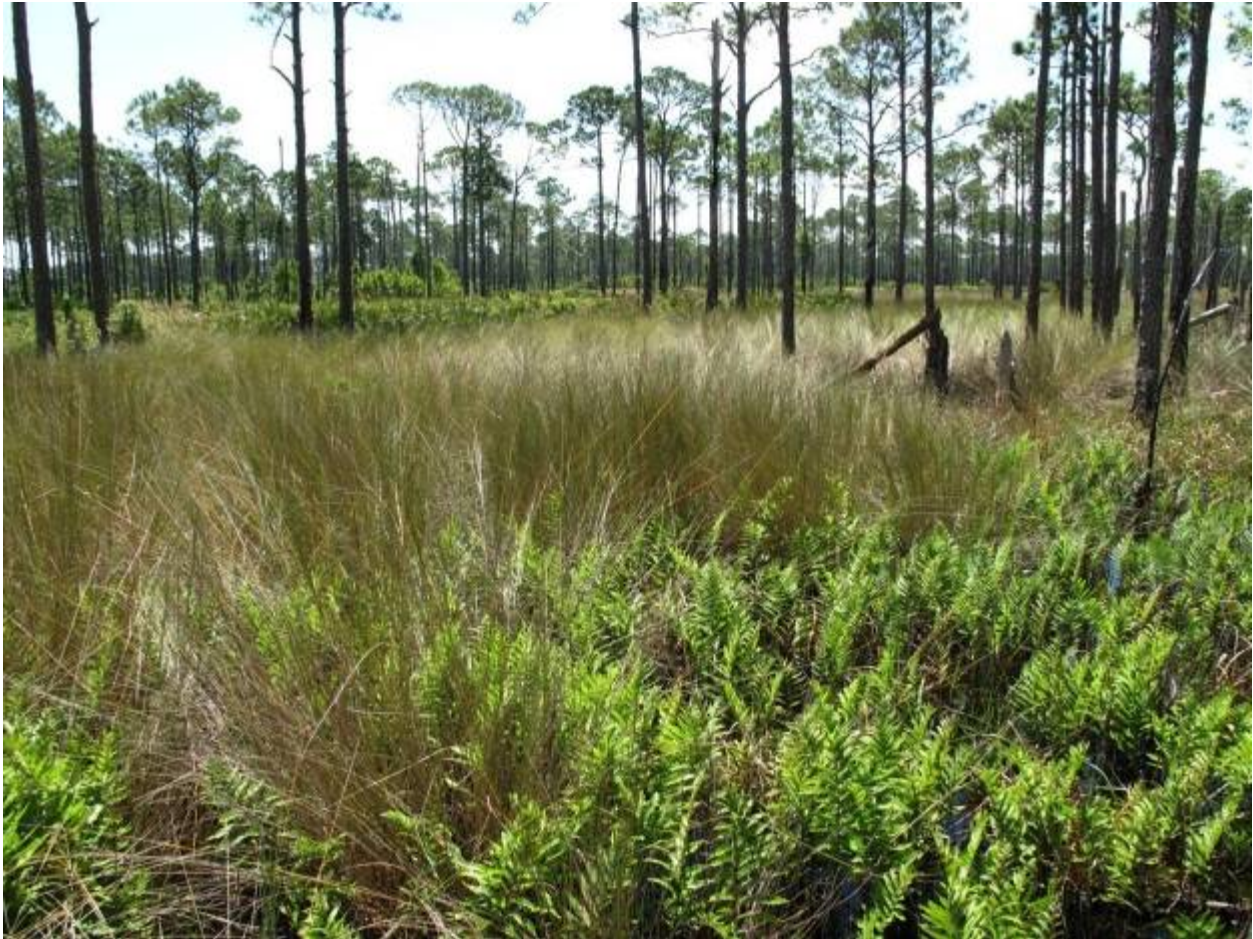
**Wetland ID: 23-09**

**Description:** This wetland is a 2.8 ha semi-permanent marsh. Pine trees dominate the canopy, and cover 5-25% of the wetland. There is no midstory cover. Sedges/grasses and fern grow throughout the wetland, and cover >75% of the basin. This marsh is in fire-maintenance condition. The adjacent uplands are scrubby flatwoods.

**Wetland Disturbance:** None

**Restoration Action Recommended:** None

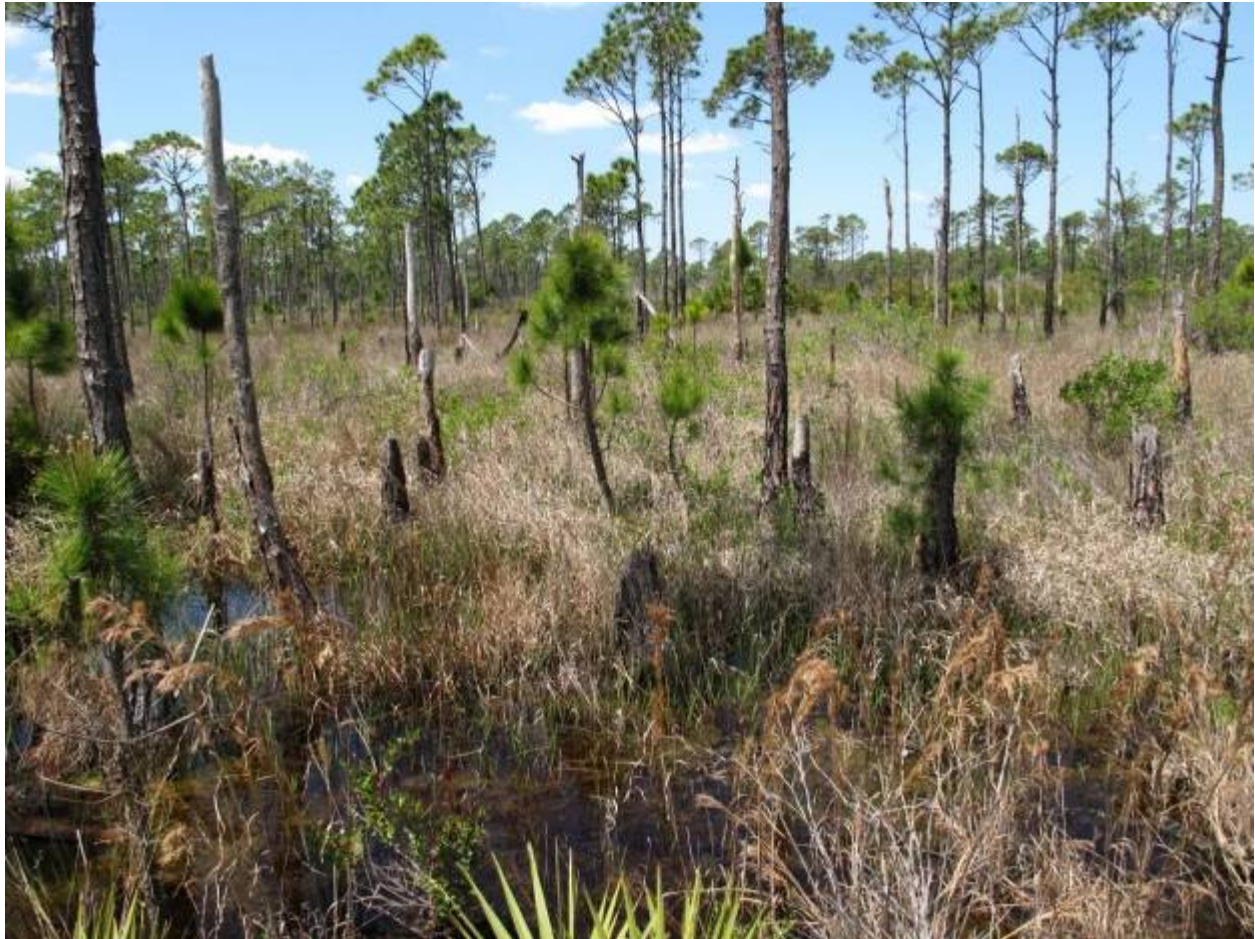
**Wetland ID: 23-10**

**Description:** This wetland is a 3.2 ha ephemeral marsh. Pine trees dominate the canopy, and cover 5-25% of the wetland. The midstory is dominated by buttonbush and fetterbush, and covers 5-25% of the wetland. Sedges/grasses and fern grow throughout the wetland, and cover >75% of the basin. A previous fire killed the large pines growing in the wetland. The adjacent uplands are scrubby flatwoods.

**Wetland Disturbance:** None

**Restoration Action Recommended:** None

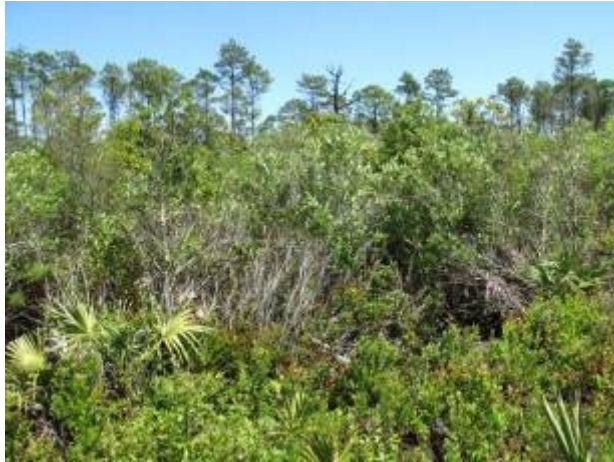
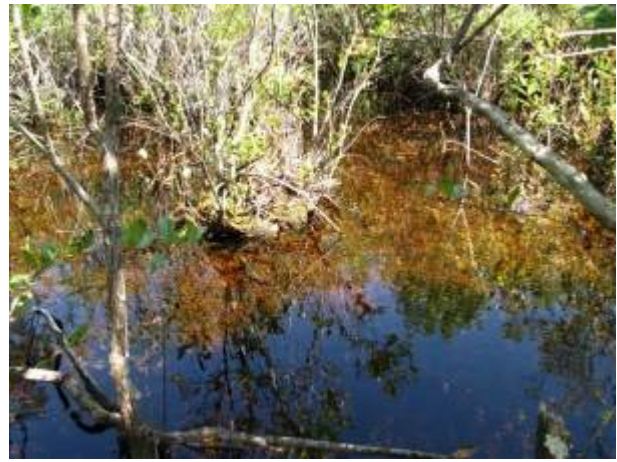
**Wetland ID: 23-11**

**Description:** This wetland is a 0.7 ha semi-permanent shrub swamp. Buttonbush and fetterbush are the dominant woody vegetation and cover >75% of the wetland. Emergent vegetation is sparsely distributed, and covers 5-25% of the wetland. This wetland has a long hydroperiod and therefore does not burn frequently. The adjacent uplands are scrubby flatwoods.

**Wetland Disturbance:** None

**Restoration Action Recommended:** None

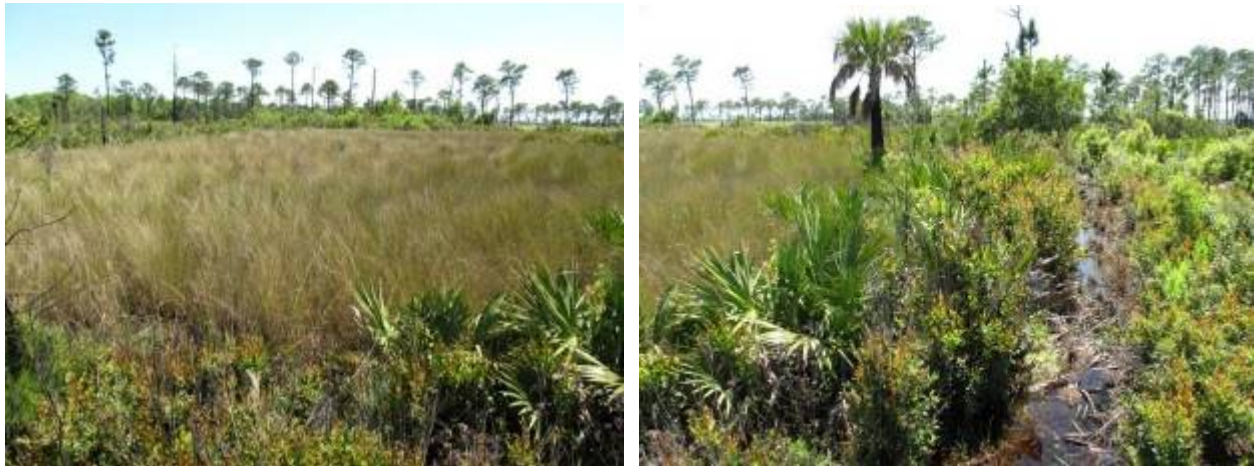
**Wetland ID: 23-12**

**Description:** This wetland is a 0.3 ha ephemeral marsh. There is no tree canopy or midstory cover. Sedges/grasses grow throughout the wetland, and cover >75% of the basin. There is a fireline around the north side of the wetland. The fireline does not appear to be affecting the fire return interval at this wetland. The adjacent uplands are scrubby flatwoods.

**Wetland Disturbance:** Fireline

**Restoration Action Recommended:** If the fireline is a necessary attribute to the property, re-route it away from the wetland.

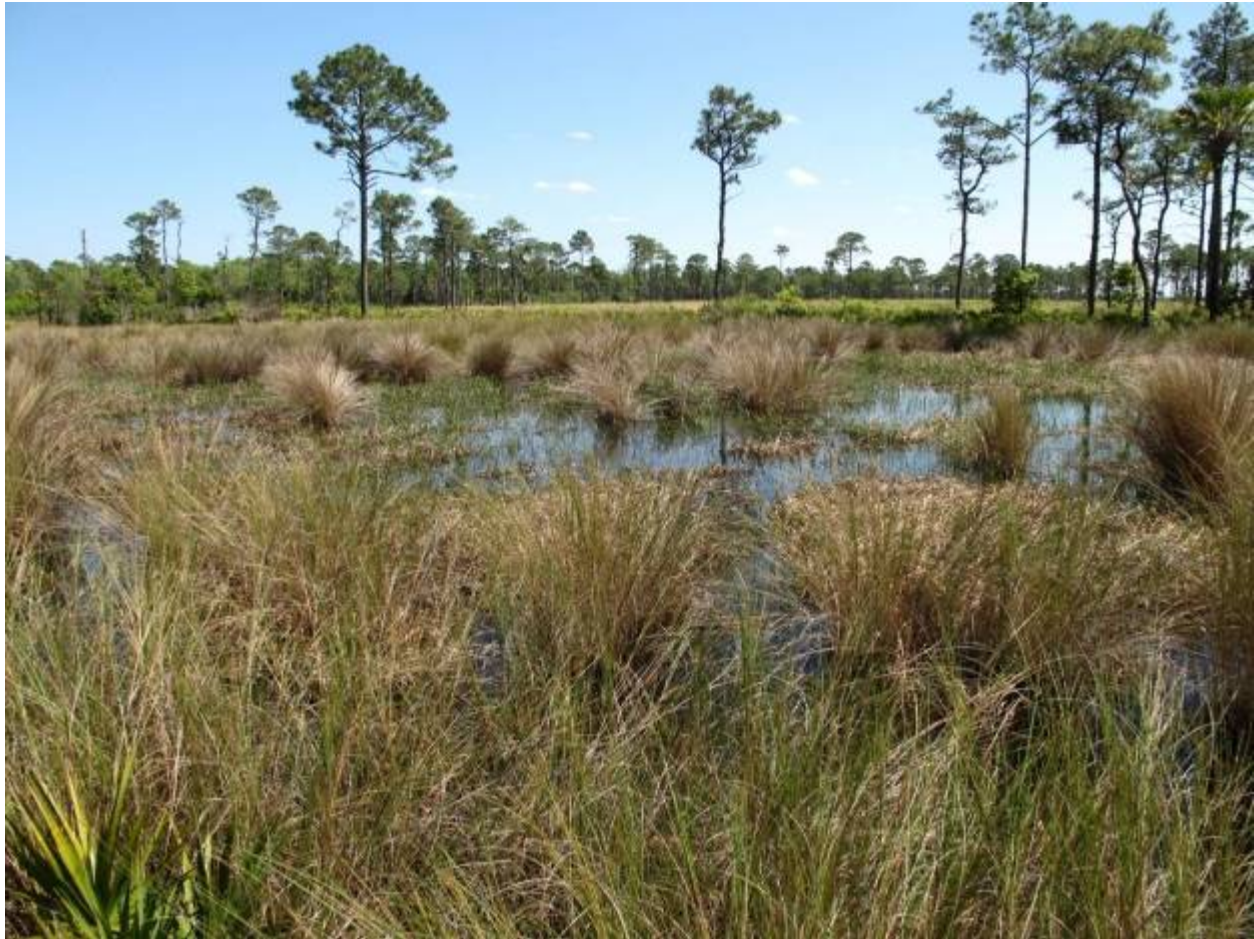
**Wetland ID: 23-13**

**Description:** This wetland is a 0.3 ha ephemeral marsh. There is no tree canopy or midstory cover. Sedges/grasses and maidencane grow throughout the wetland, and cover >75% of the basin. This marsh will connect to Wetland 23-12 during periods of high water. This wetland is in fire-maintenance condition. The adjacent uplands are scrubby flatwoods.

**Wetland Disturbance:** None

**Restoration Action Recommended:** None

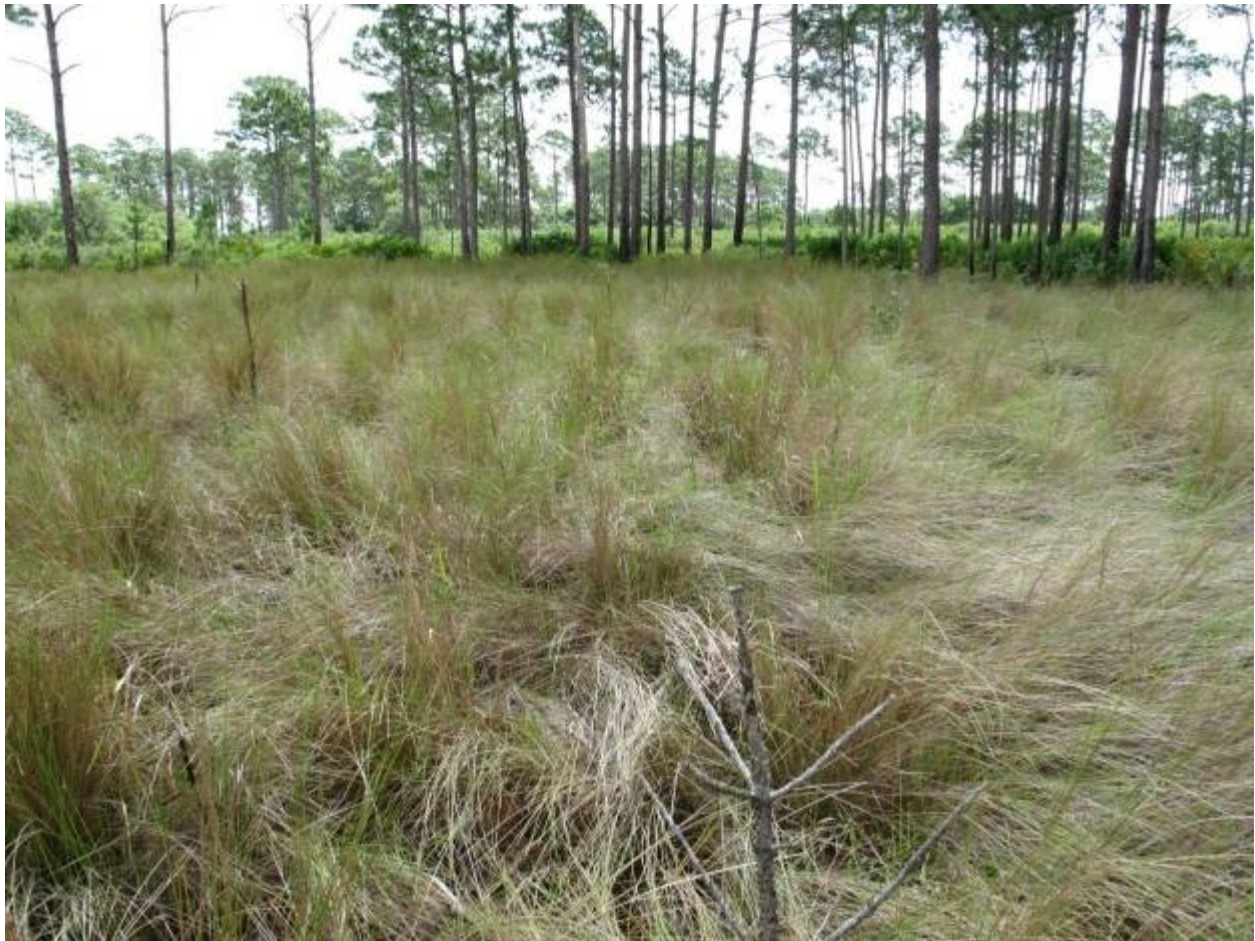
**Wetland ID: 23-14**

**Description:** This wetland is a 0.3 ha ephemeral marsh. There is no tree canopy or midstory cover. Sedges/grasses grow throughout the wetland, and cover >75% of the basin. This wetland is in fire-maintenance condition. The adjacent uplands are scrubby flatwoods.

**Wetland Disturbance:** None

**Restoration Action Recommended:** None

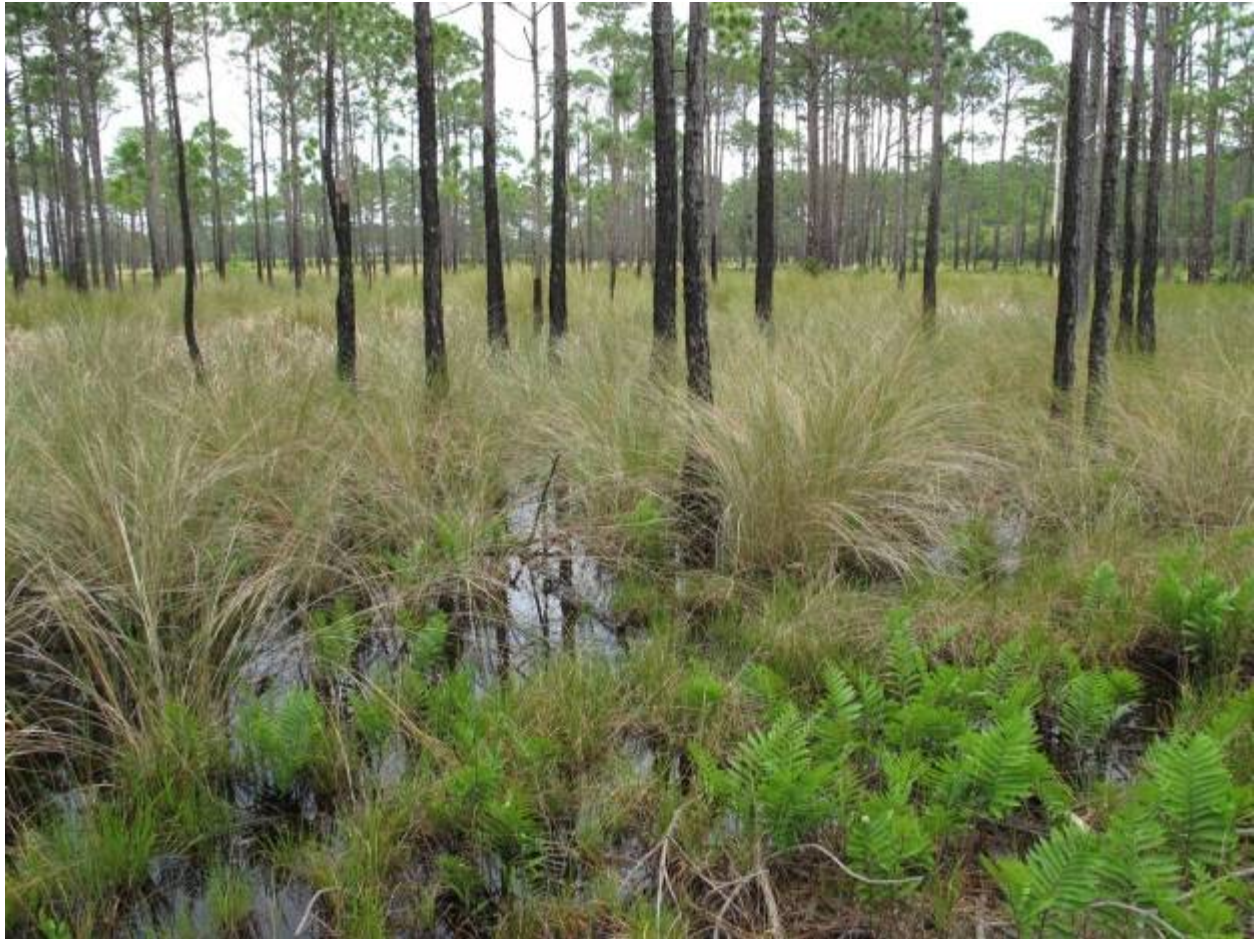
**Wetland ID: 27-01**

**Description:** This wetland is a 1.3 ha ephemeral marsh. Pine trees dominate the canopy, and cover 25-50% of the wetland. There is no midstory cover. Sedges/grasses grow throughout the wetland, and cover >75% of the basin. This marsh is in fire-maintenance condition. The adjacent uplands are scrubby and mesic flatwoods.

**Wetland Disturbance:** Woody encroachment

**Restoration Action Recommended:** Monitor the pine trees in the wetland. If they begin to shade out the herbaceous vegetation, the pine trees should be thinned from the wetland interior.

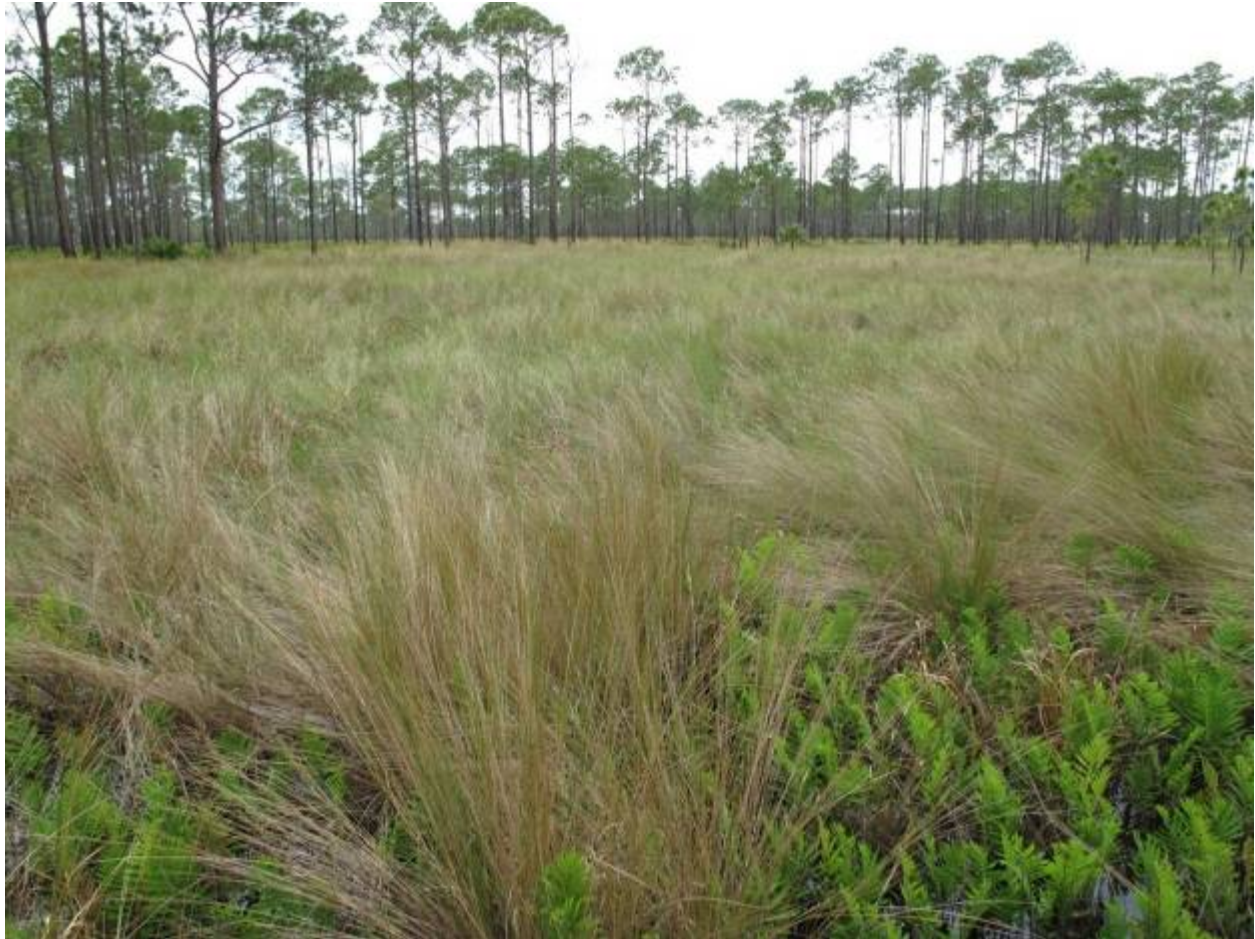
**Wetland ID: 27-02**

**Description:** This wetland is a 0.9 ha ephemeral marsh. There is no tree canopy or midstory cover. Sedges/grasses grow throughout the wetland, and cover >75% of the basin. This marsh is in fire-maintenance condition. The adjacent uplands are scrubby and mesic flatwoods.

**Wetland Disturbance:** None

**Restoration Action Recommended:** None

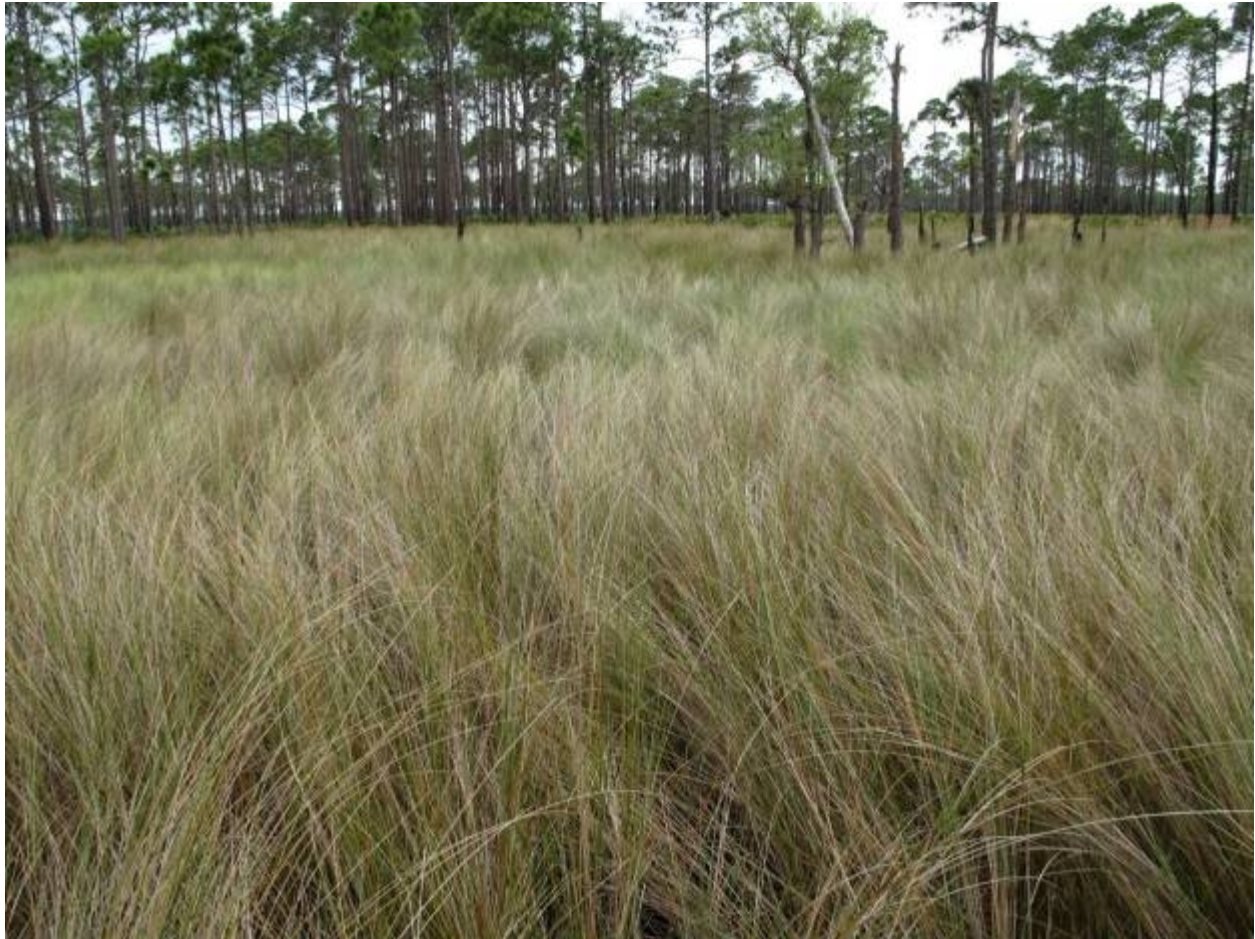
**Wetland ID: 27-03**

**Description:** This wetland is a 0.5 ha ephemeral marsh. There is no tree canopy or midstory cover. Sedges/grasses grow throughout the wetland, and cover >75% of the basin. This marsh is in fire-maintenance condition. The adjacent uplands are scrubby and mesic flatwoods.

**Wetland Disturbance:** None

**Restoration Action Recommended:** None

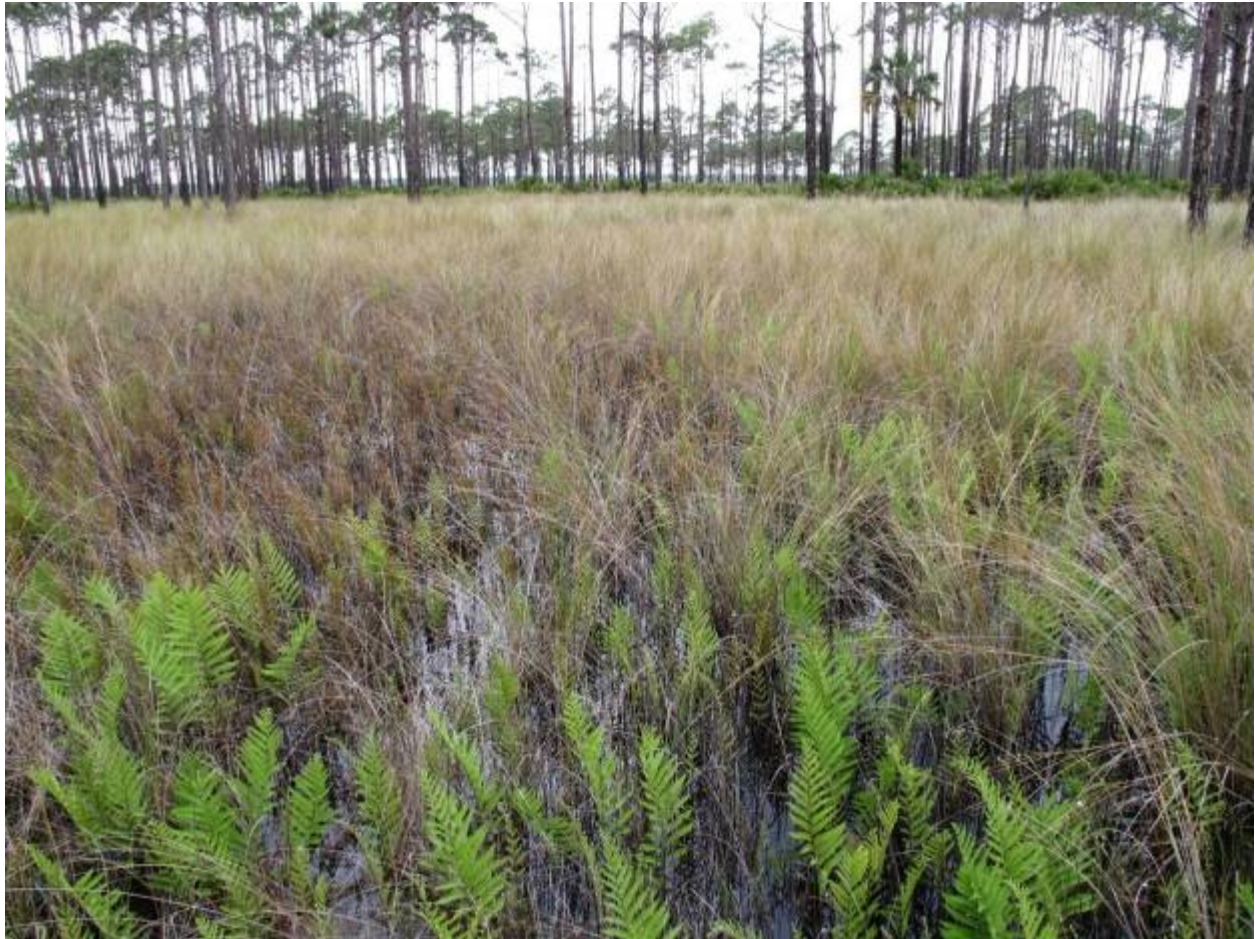
**Wetland ID: 27-04**

**Description:** This wetland is a 0.5 ha ephemeral marsh. There is no tree canopy or midstory cover. Sedges/grasses grow throughout the wetland, and cover >75% of the basin. This marsh is in fire-maintenance condition. The adjacent uplands are scrubby and mesic flatwoods.

**Wetland Disturbance:** None

**Restoration Action Recommended:** None

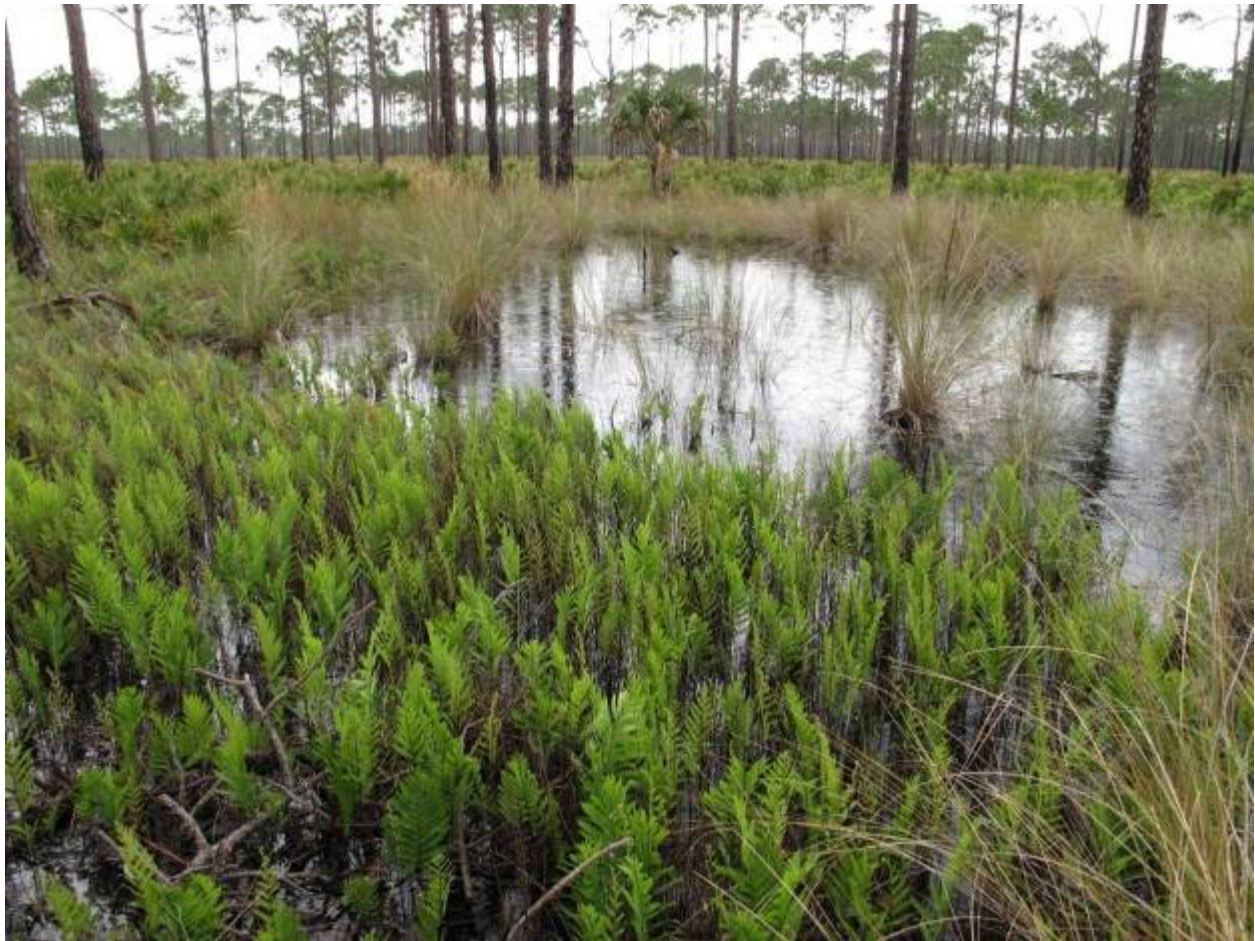
**Wetland ID: 27-05**

**Description:** This wetland is a 0.1 ha ephemeral marsh. There is no tree canopy or midstory cover. Sedges/grasses and fern grow throughout the wetland, and cover 50-75% of the basin. This marsh is in fire-maintenance condition. The adjacent uplands are scrubby and mesic flatwoods.

**Wetland Disturbance:** None

**Restoration Action Recommended:** None

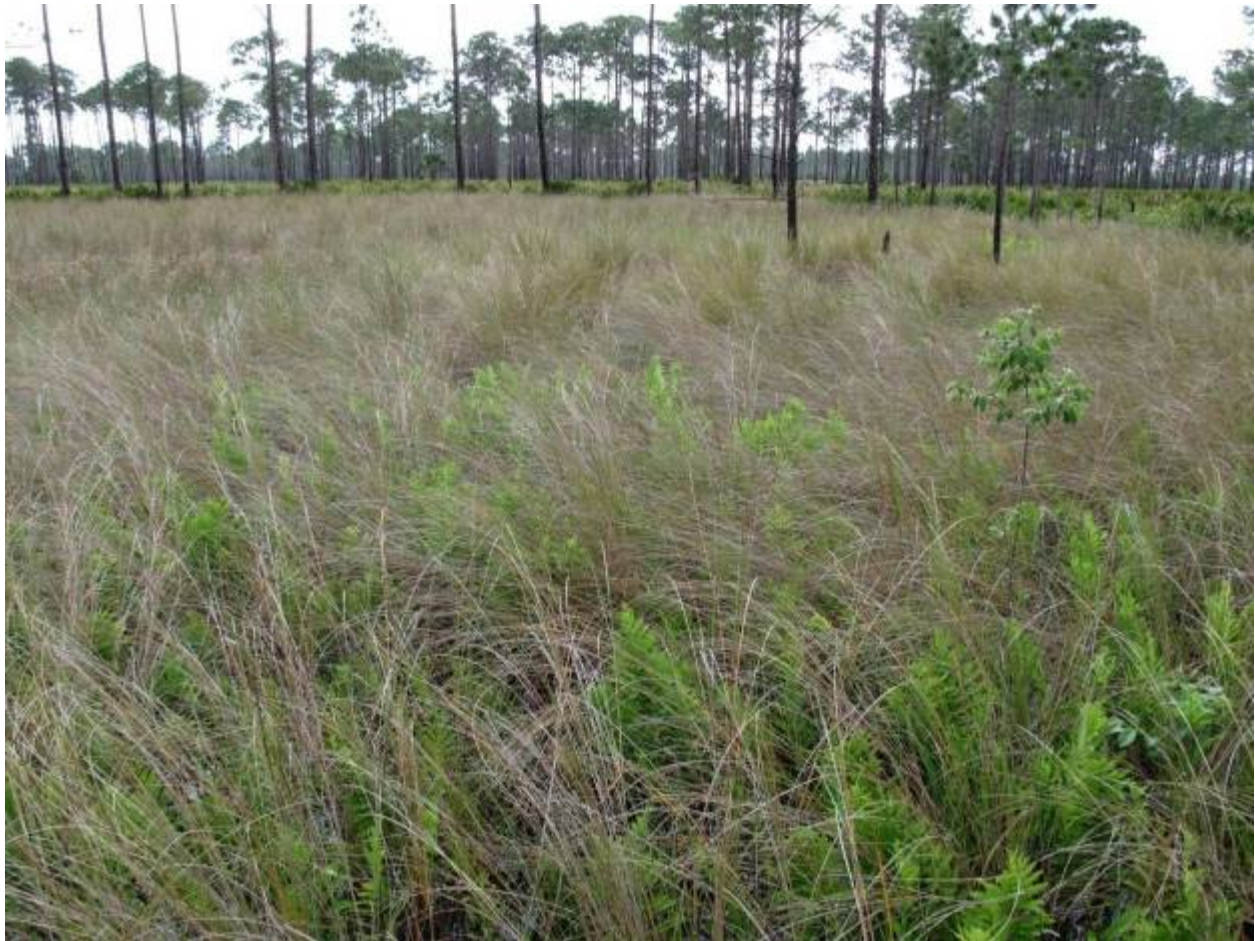
**Wetland ID: 27-06**

**Description:** This wetland is a 0.3 ha ephemeral marsh. There is no tree canopy or midstory cover. Sedges/grasses grow throughout the wetland, and cover >75% of the basin. This marsh is in fire-maintenance condition. The adjacent uplands are scrubby and mesic flatwoods.

**Wetland Disturbance:** None

**Restoration Action Recommended:** None

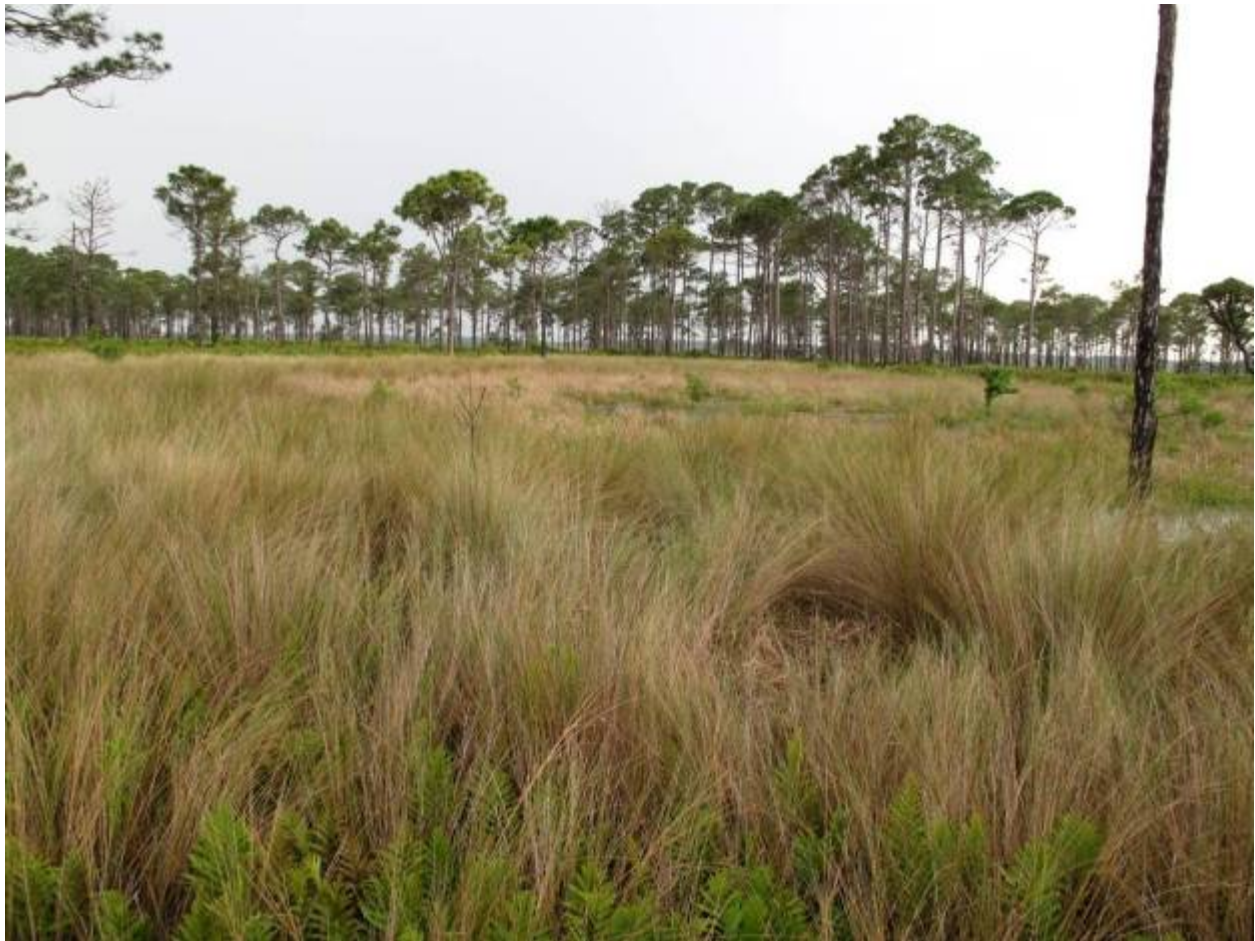
**Wetland ID: 27-07**

**Description:** This wetland is a 0.7 ha ephemeral marsh. There is no tree canopy or midstory cover. Sedges/grasses grow throughout the wetland, and cover >75% of the basin. This marsh is in fire-maintenance condition. The adjacent uplands are scrubby flatwoods.

**Wetland Disturbance:** None

**Restoration Action Recommended:** None

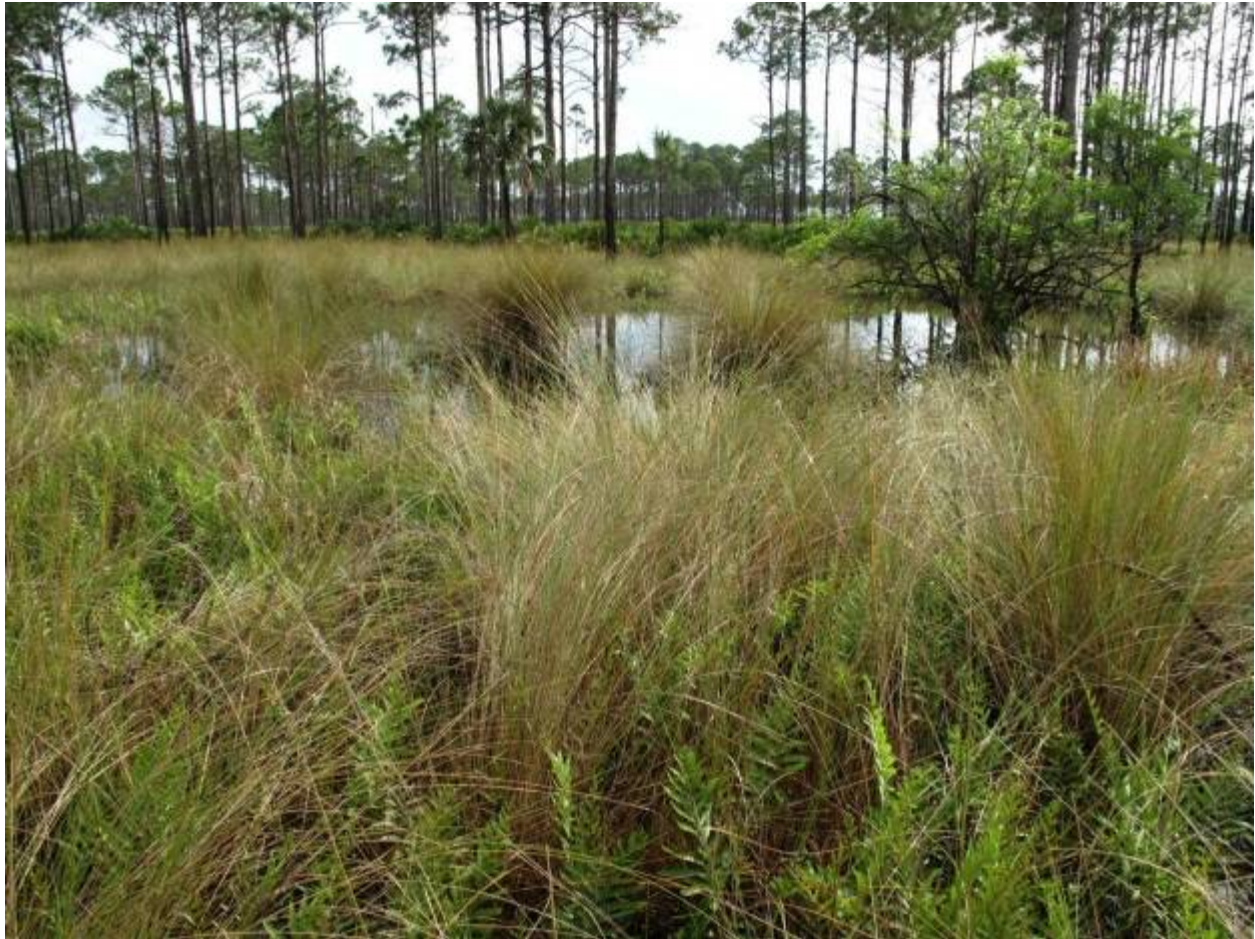
**Wetland ID: 27-08**

**Description:** This wetland is a 0.3 ha ephemeral marsh. There is no tree canopy or midstory cover. Sedges/grasses grow throughout the wetland, and cover >75% of the basin. This marsh is in fire-maintenance condition. The adjacent uplands are scrubby flatwoods.

**Wetland Disturbance:** None

**Restoration Action Recommended:** None
