# **Inventory, Assessment, and Restoration Potential of Ephemeral Wetlands on FFWCC Wildlife Management Areas**

## **Guana River WMA Final Report**

Submitted by: Rebecca P.M. Means<sup>1</sup>, Ryan C. Means<sup>1</sup>, Steven A. Johnson<sup>2</sup>

April - May 2009

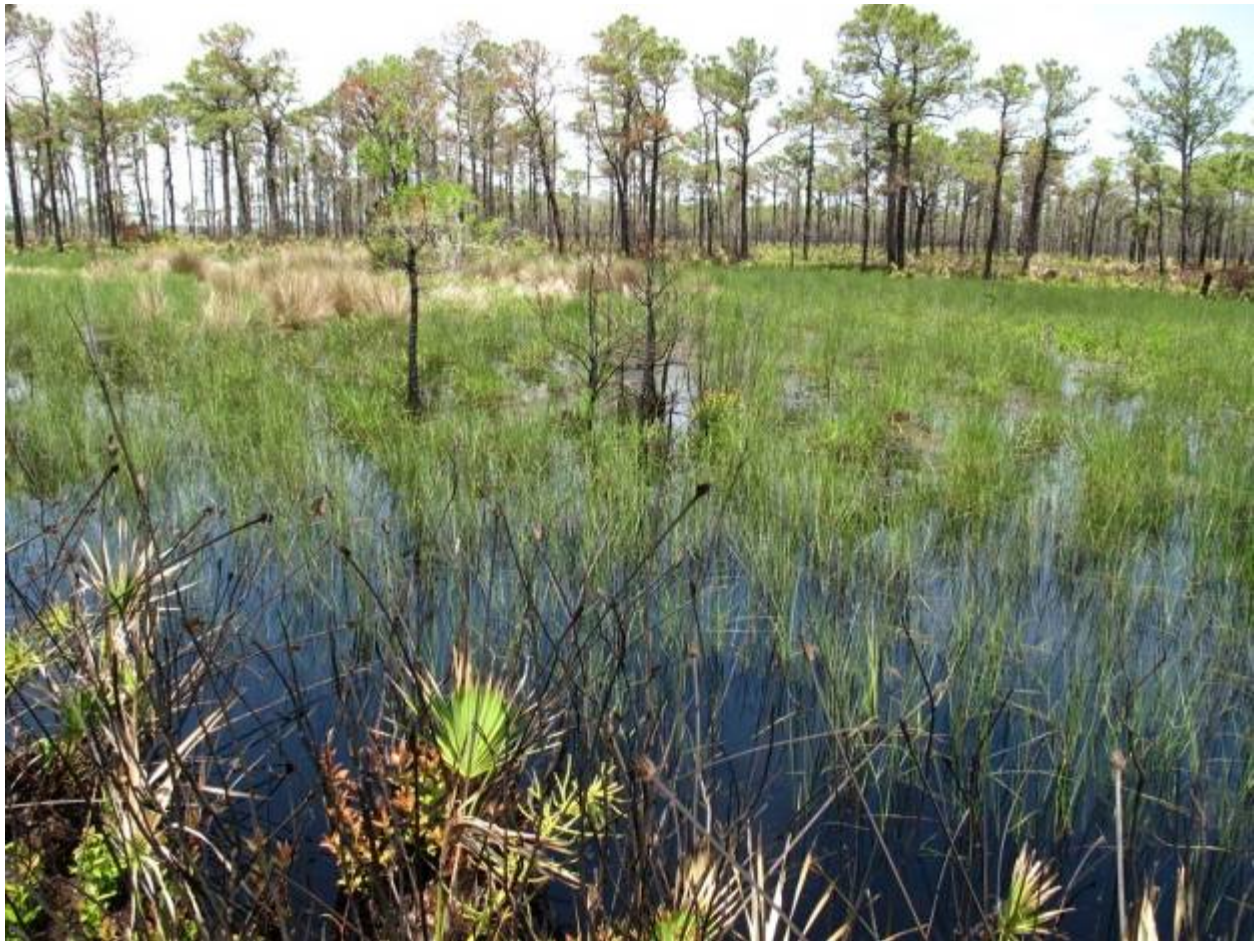
**Wetland ID: 31-01**

**Description:** This wetland is a 0.4 ha ephemeral marsh. There is no tree canopy or midstory cover. Sedges/grasses and sawgrass grow throughout the wetland, and cover >75% of the basin. A recent fire burned through the wetland basin and new herbaceous shoots are sprouting. The adjacent uplands are scrubby flatwoods.

**Wetland Disturbance:** None

**Restoration Action Recommended:** None

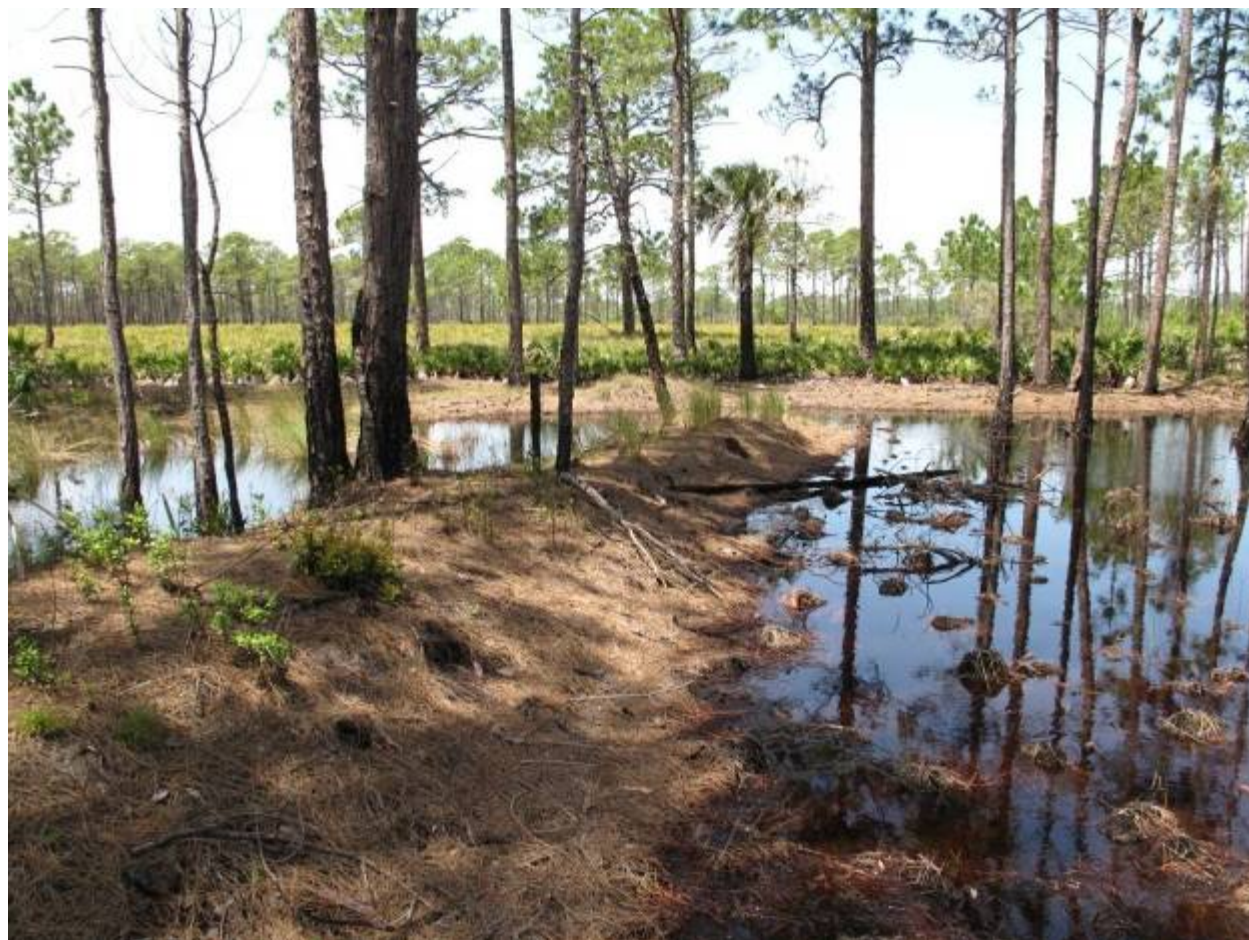
**Wetland ID: 31-02**

**Description:** This wetland is a 0.1 ha ephemeral borrow pit. Pine trees dominate the canopy, and cover 25-50% of the wetland. There is no midstory cover. Sedges/grasses are sparsely distributed, and cover 5-25% of the wetland basin. This man-made pond is functioning as an ephemeral wetland. The adjacent uplands are scrubby flatwoods.

**Wetland Disturbance:** None

**Restoration Action Recommended:** If GRWMA personnel wish to improve this borrow pit, the pine trees could be removed from the wetland interior. The removal of trees will reduce the shading effect and encourage the grow of more herbaceous vegetation.

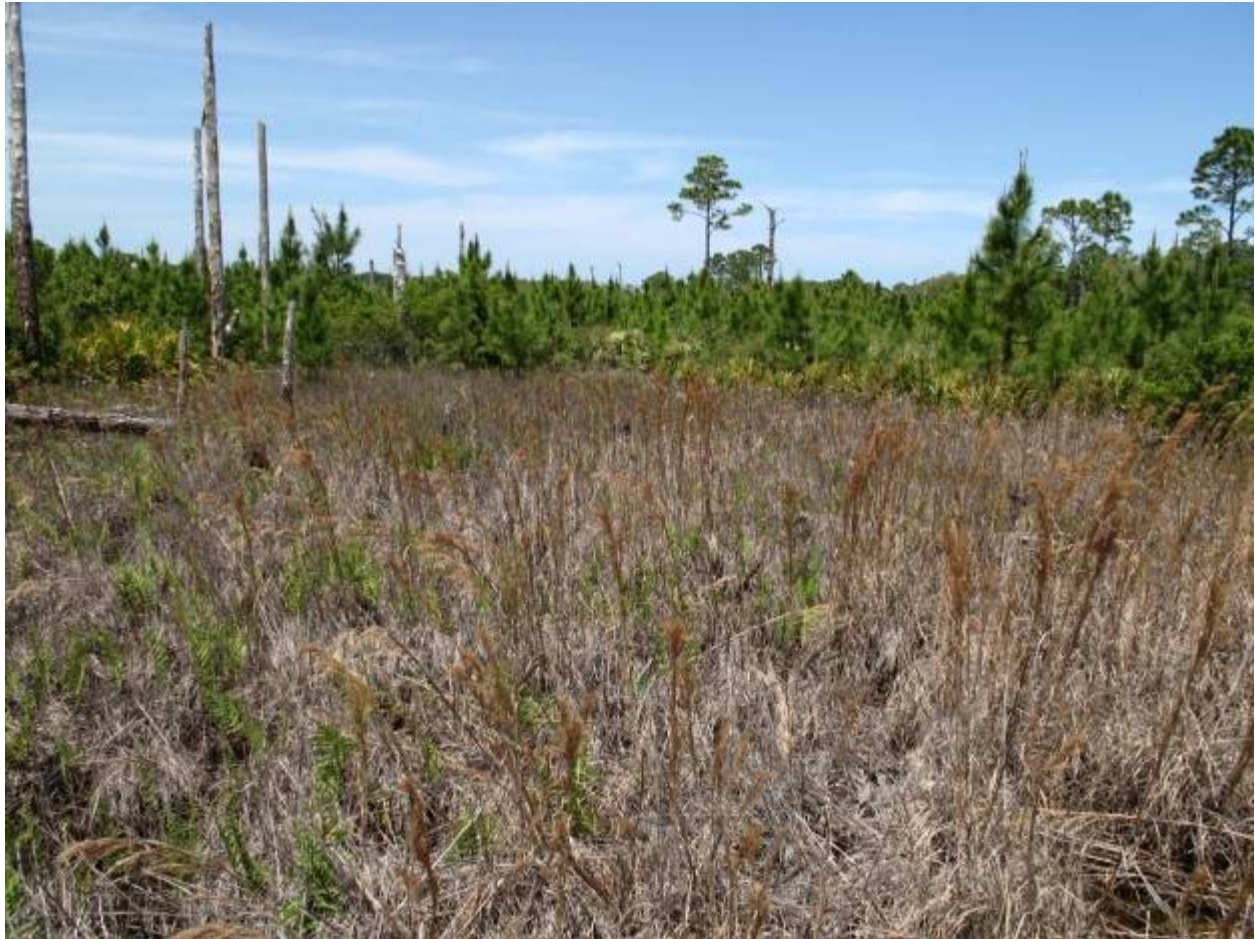
**Wetland ID: 31-03**

**Description:** This wetland is a 0.1 ha ephemeral marsh. There is no tree canopy or midstory cover. Sedges/grasses grow throughout the wetland, and cover >75% of the basin. This marsh is in fire-maintenance condition. The adjacent uplands are densely stocked mesic and scrubby flatwoods.

**Wetland Disturbance:** None

**Restoration Action Recommended:** None

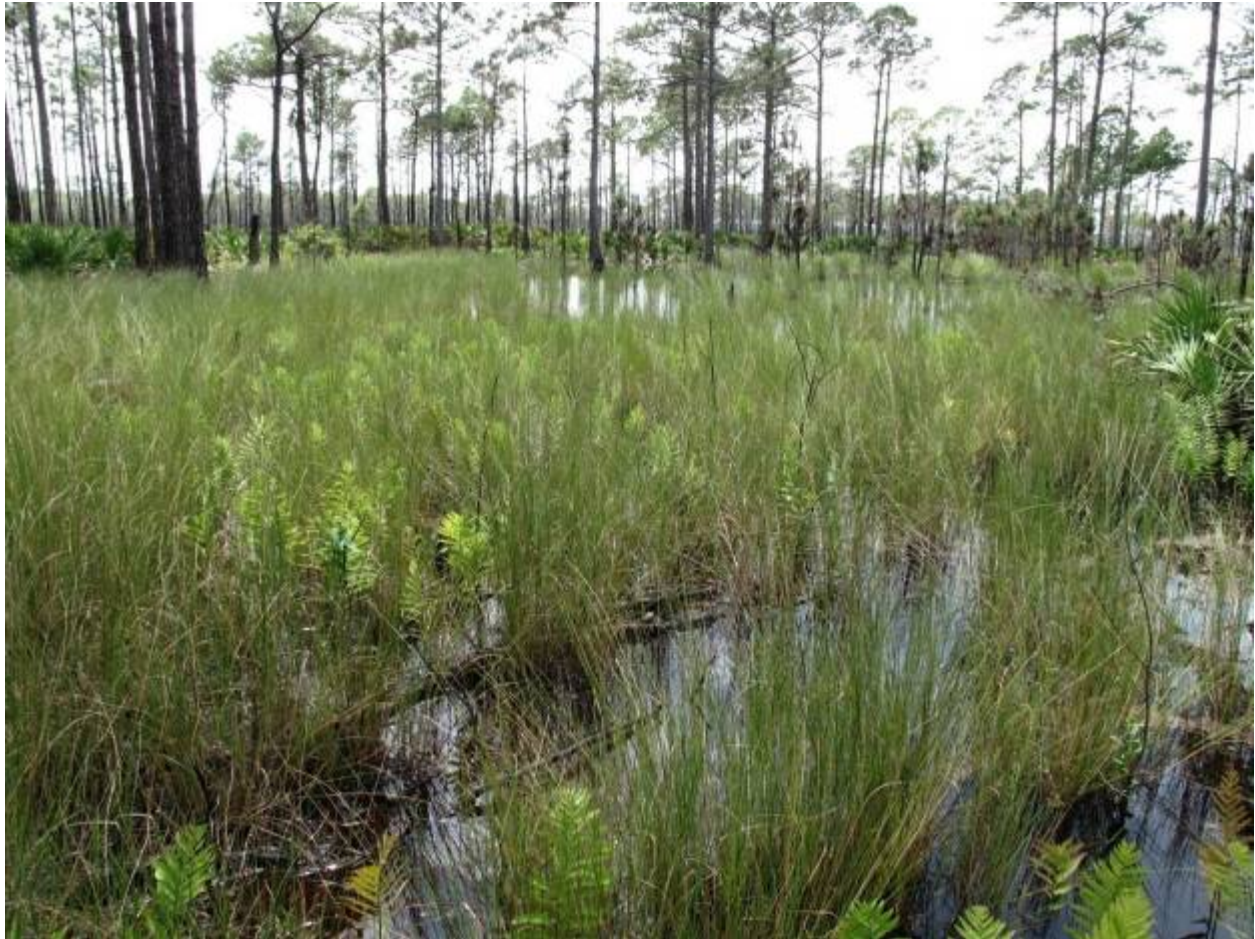
**Wetland ID: 31-04**

**Description:** This wetland is a 0.3 ha ephemeral marsh. There is no tree canopy or midstory cover. Sawgrass grows throughout the wetland, and covers >75% of the basin. There is a fireline along the northern edge of the wetland. The wetland basin of this marsh burned recently and has new herbaceous shoots sprouting. The adjacent uplands are scrubby flatwoods.

**Wetland Disturbance:** Fireline

**Restoration Action Recommended:** Re-routed the fireline away from the wetland.

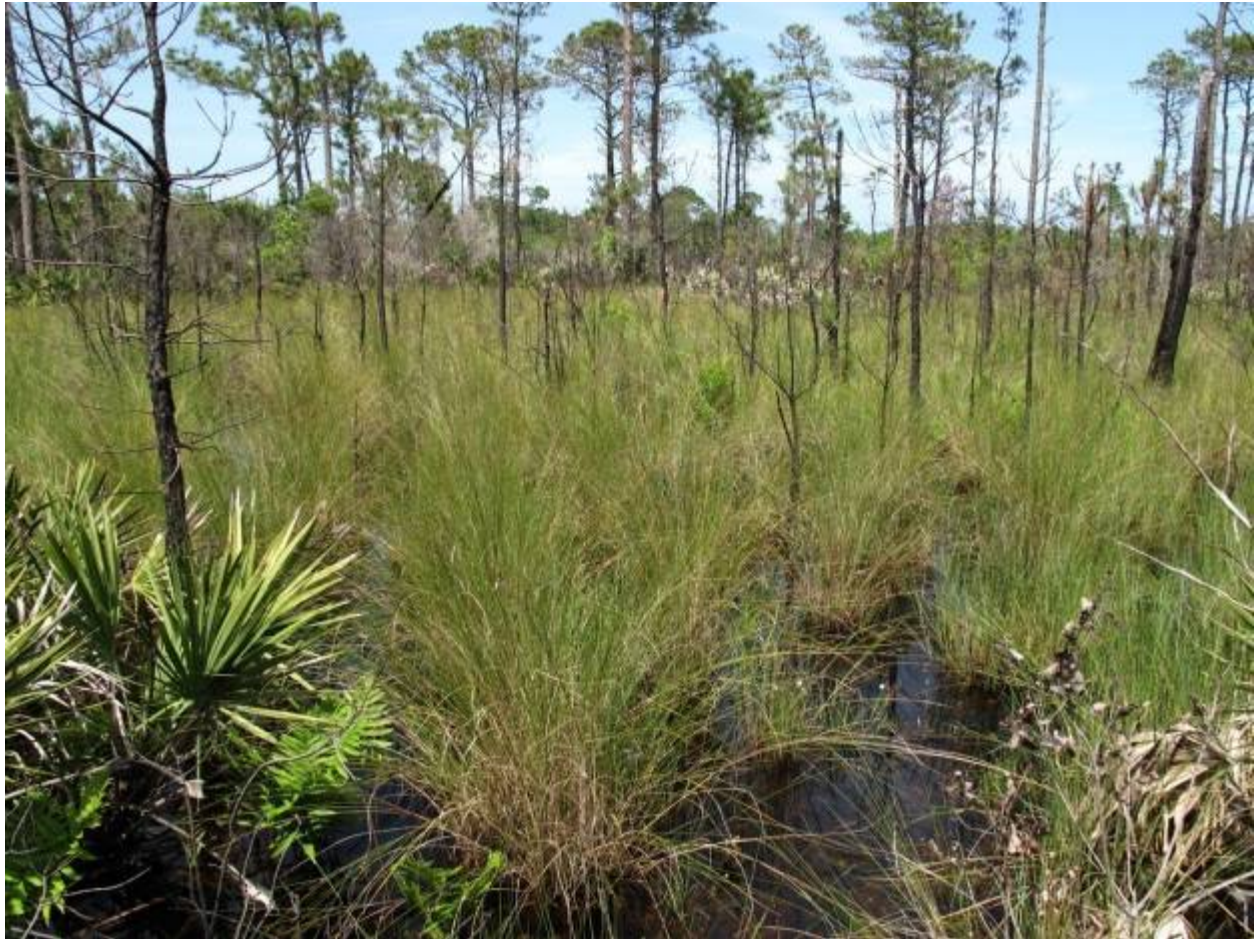
**Wetland ID: 31-05**

**Description:** This wetland is a 0.2 ha ephemeral marsh. There is no tree canopy or midstory cover. Sawgrass grows throughout the wetland, and covers >75% of the basin. A recent fire burned through the wetland basin and killed the encroaching slash pine saplings. The adjacent uplands are mesic and scrubby flatwoods.

**Wetland Disturbance:** None

**Restoration Action Recommended:** None

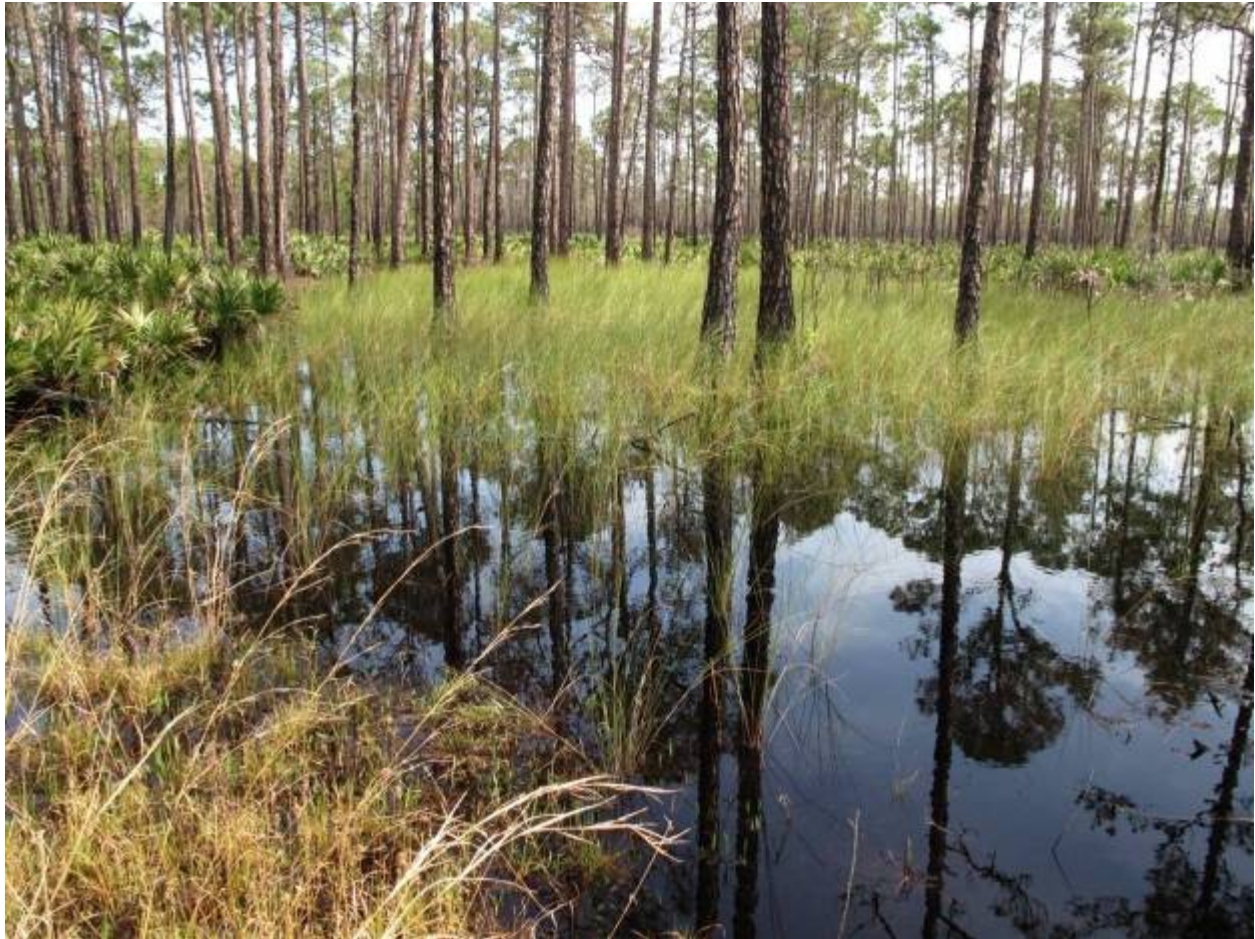
**Wetland ID: 31-06**

**Description:** This wetland is a 0.2 ha ephemeral marsh. Pine trees dominate the canopy, and cover 5-25% of the wetland. There is no midstory cover. Sawgrass grows throughout the wetland, and covers >75% of the basin. This marsh is in fire-maintenance condition. The adjacent uplands are mesic flatwoods.

**Wetland Disturbance:** None

**Restoration Action Recommended:** None

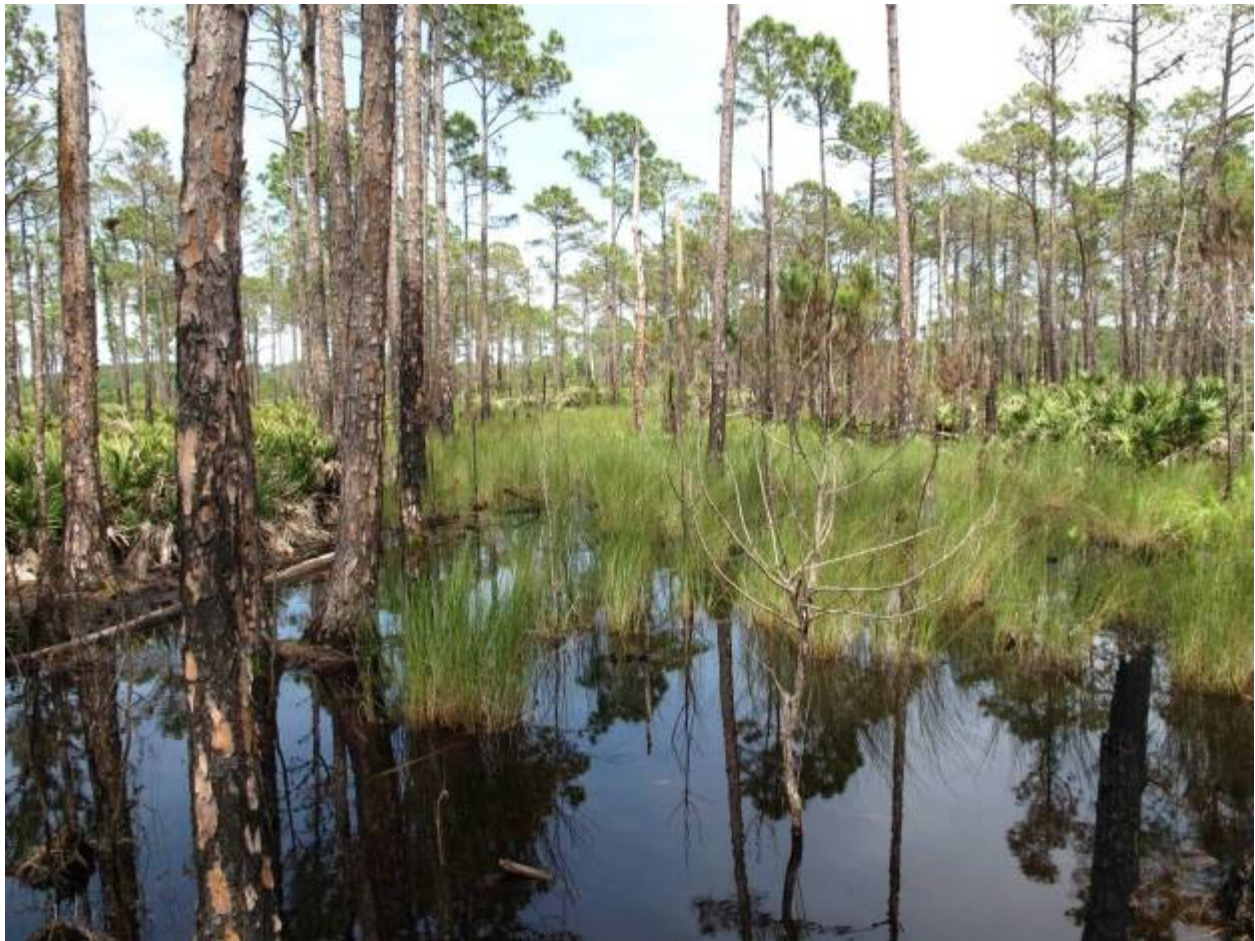
**Wetland ID: 31-07**

**Description:** This wetland is a 0.2 ha ephemeral marsh. Pine trees dominate the canopy, and cover 5-25% of the wetland. There is no midstory cover. Sawgrass grows throughout the wetland, and covers 50-75% of the basin. An old fireline is still evident along the west side of the wetland. This marsh is in fire-maintenance condition. The adjacent uplands are mesic flatwoods.

**Wetland Disturbance:** Fireline

**Restoration Action Recommended:** None. Allow the old fireline to fill in with vegetation over time.

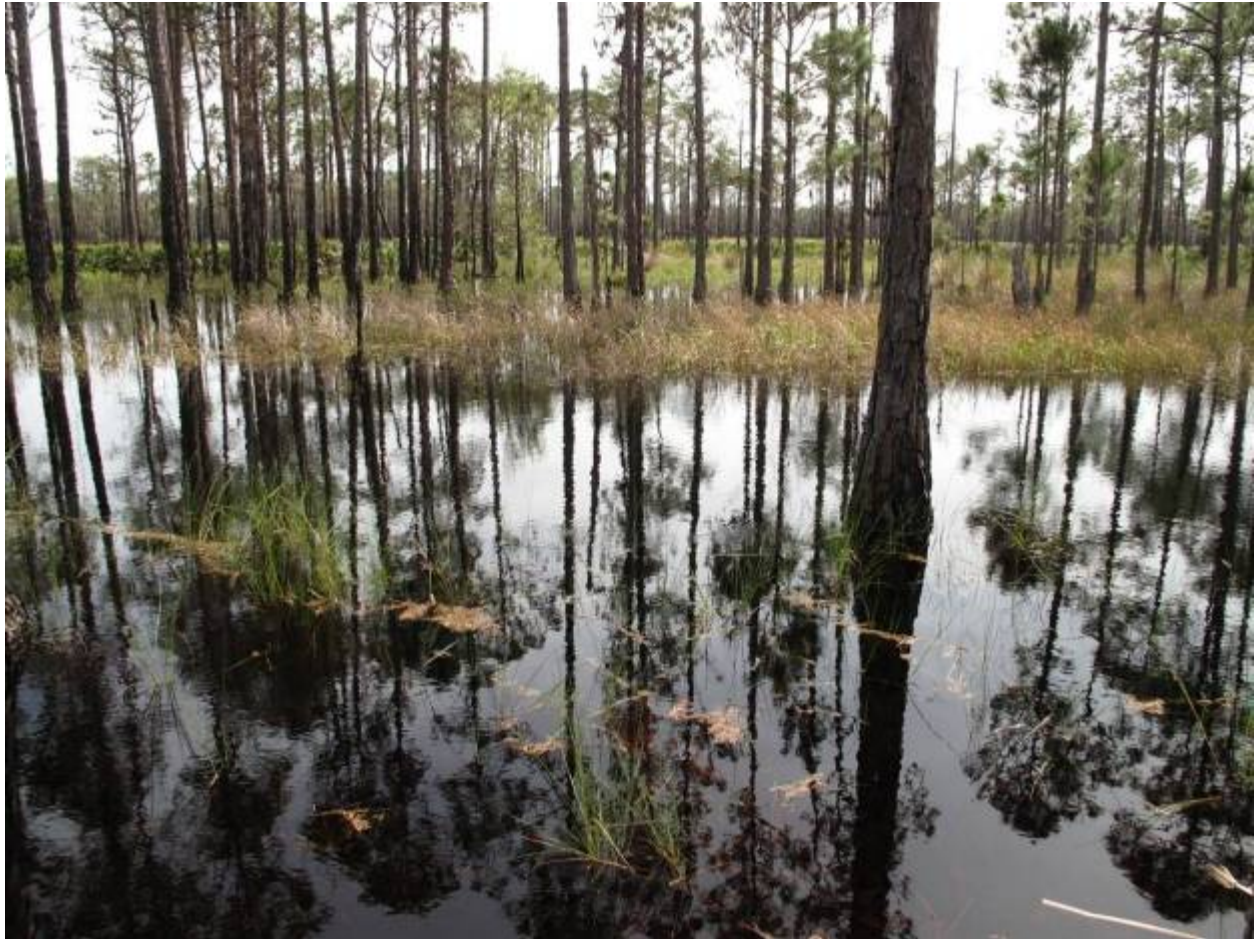
**Wetland ID: 31-08**

**Description:** This wetland is a 0.5 ha ephemeral marsh. Pine trees dominate the canopy, and cover 5-25% of the wetland. There is no midstory cover. Sawgrass and maidencane grow in scattered patches, and cover 50-75% of the wetland basin. This marsh is in fire-maintenance condition. The adjacent uplands are mesic and scrubby flatwoods.

**Wetland Disturbance:** None

**Restoration Action Recommended:** None

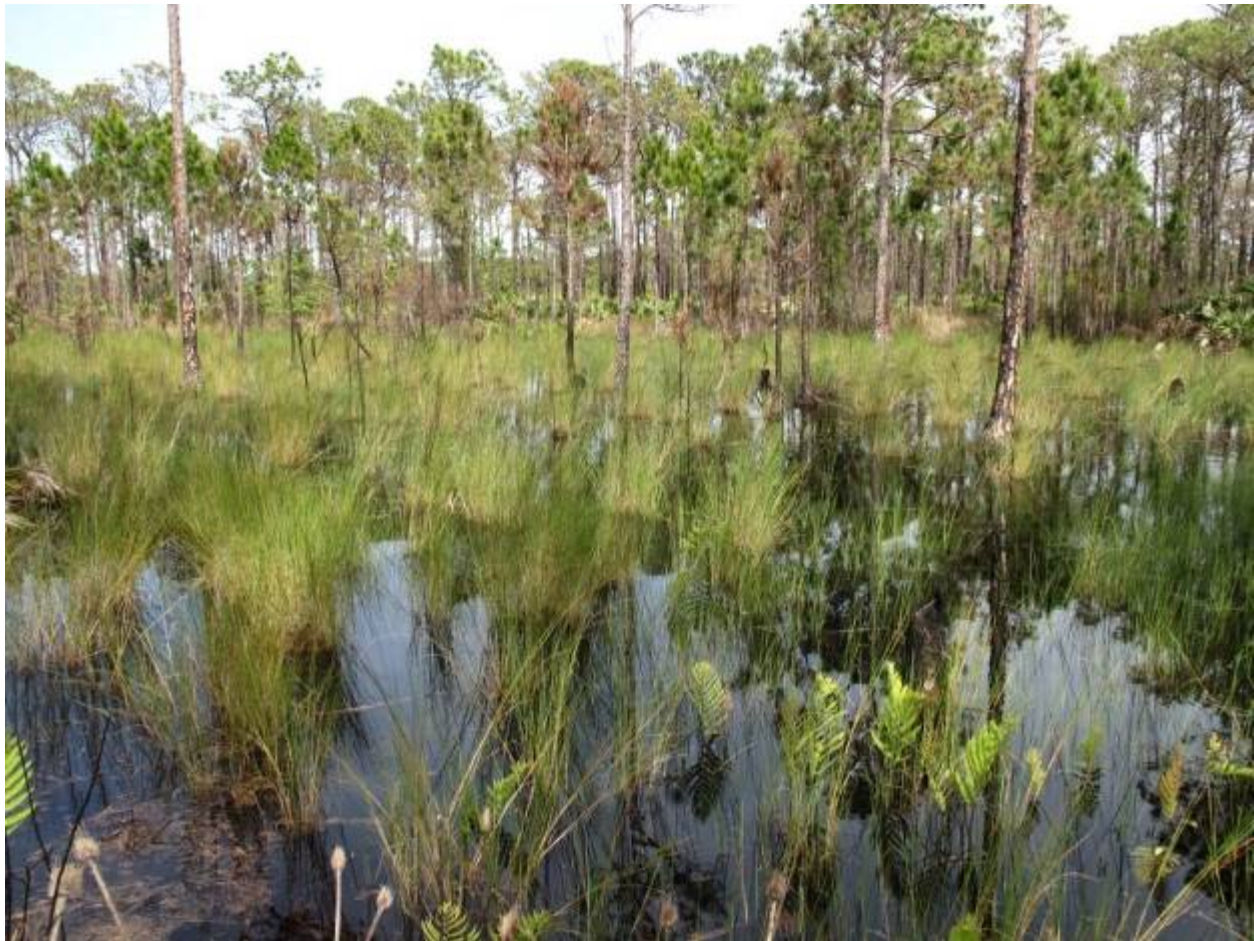
**Wetland ID: 31-09**

**Description:** This wetland is a 0.3 ha ephemeral marsh. Pine trees dominate the canopy, and cover 5-25% of the wetland. There is no midstory cover. Sawgrass grows throughout the wetland, and covers 50-75% of the basin. This marsh is in fire-maintenance condition. The adjacent uplands are mesic and scrubby flatwoods.

**Wetland Disturbance:** None

**Restoration Action Recommended:** None

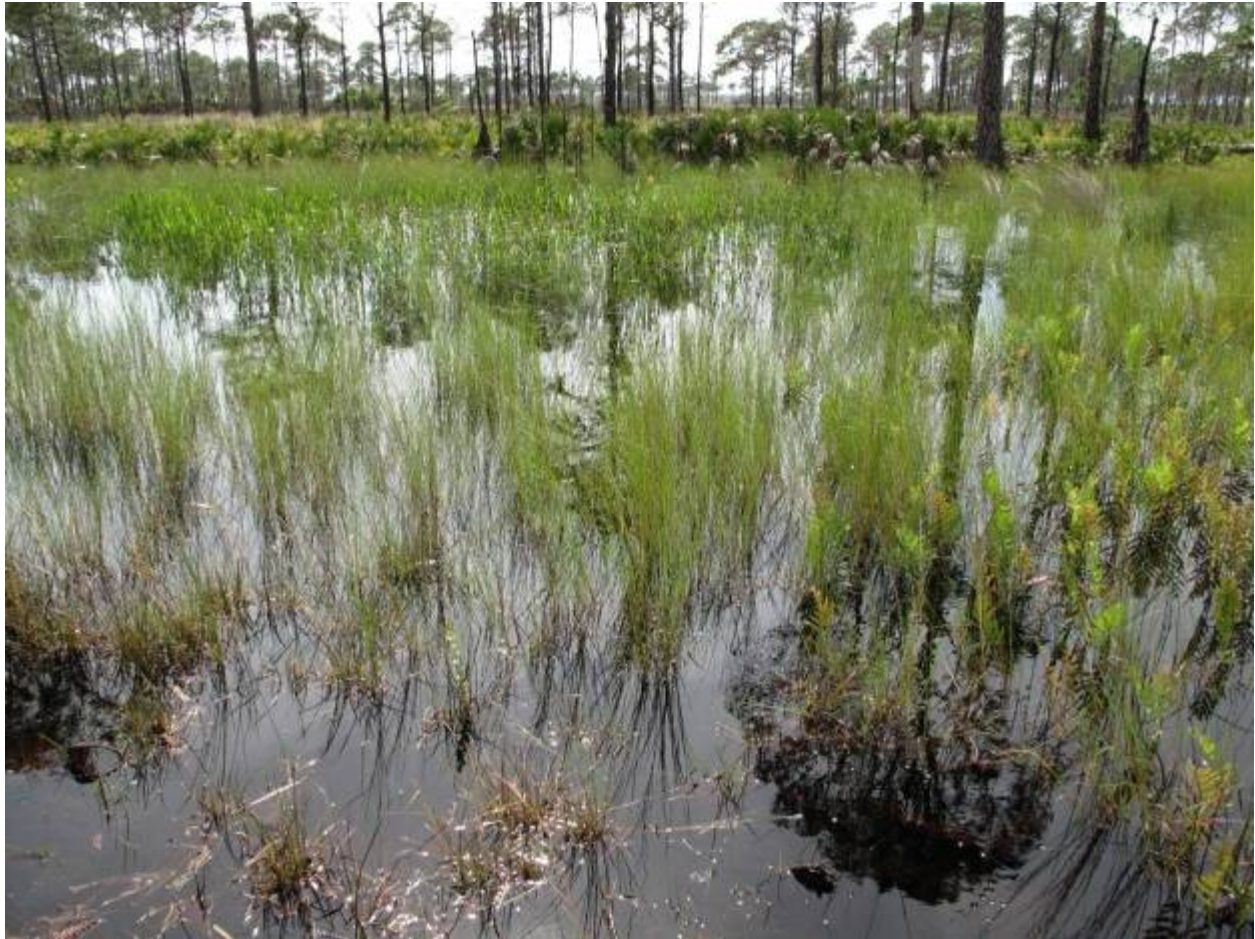
**Wetland ID: 31-10**

**Description:** This wetland is a 0.1 ha ephemeral marsh. There is no tree canopy or midstory cover. Sedges/grasses, fern, and pickerelweed grow throughout the wetland, and cover >75% of the basin. This marsh is in fire-maintenance condition. The adjacent uplands are mesic flatwoods.

**Wetland Disturbance:** None

**Restoration Action Recommended:** None

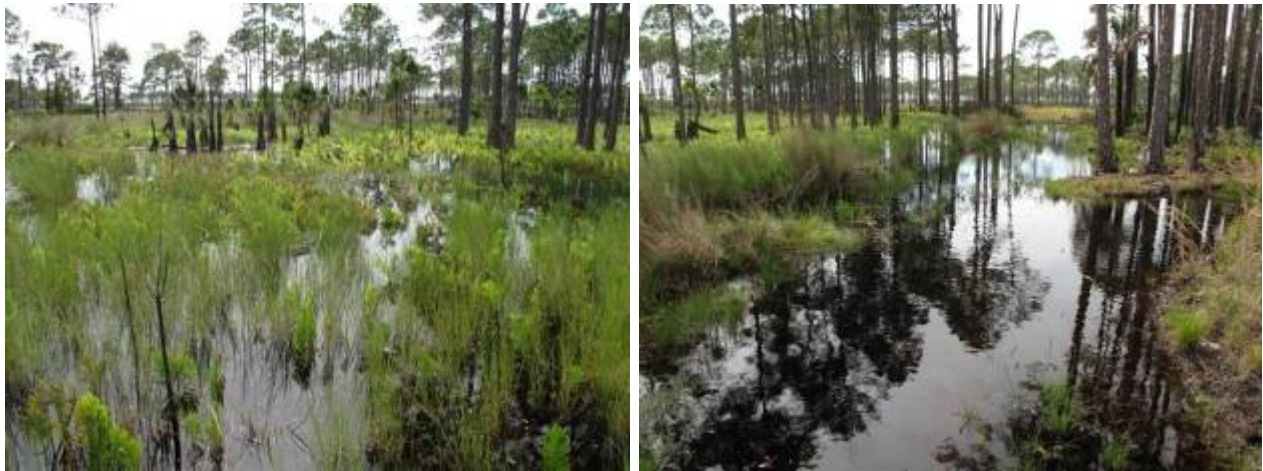
**Wetland ID: 31-11**

**Description:** This wetland is a 0.7 ha ephemeral marsh. Pine trees dominate the canopy, and cover 5-25% of the wetland. There is no midstory cover. Sedges/grasses and fern grow throughout the wetland, and cover >75% of the basin. A fireline bisects the north end of the wetland. This marsh is in fire-maintenance condition. The adjacent uplands are scrubby flatwoods.

**Wetland Disturbance:** Fireline

**Restoration Action Recommended:** Re-route the fireline away from the wetland.

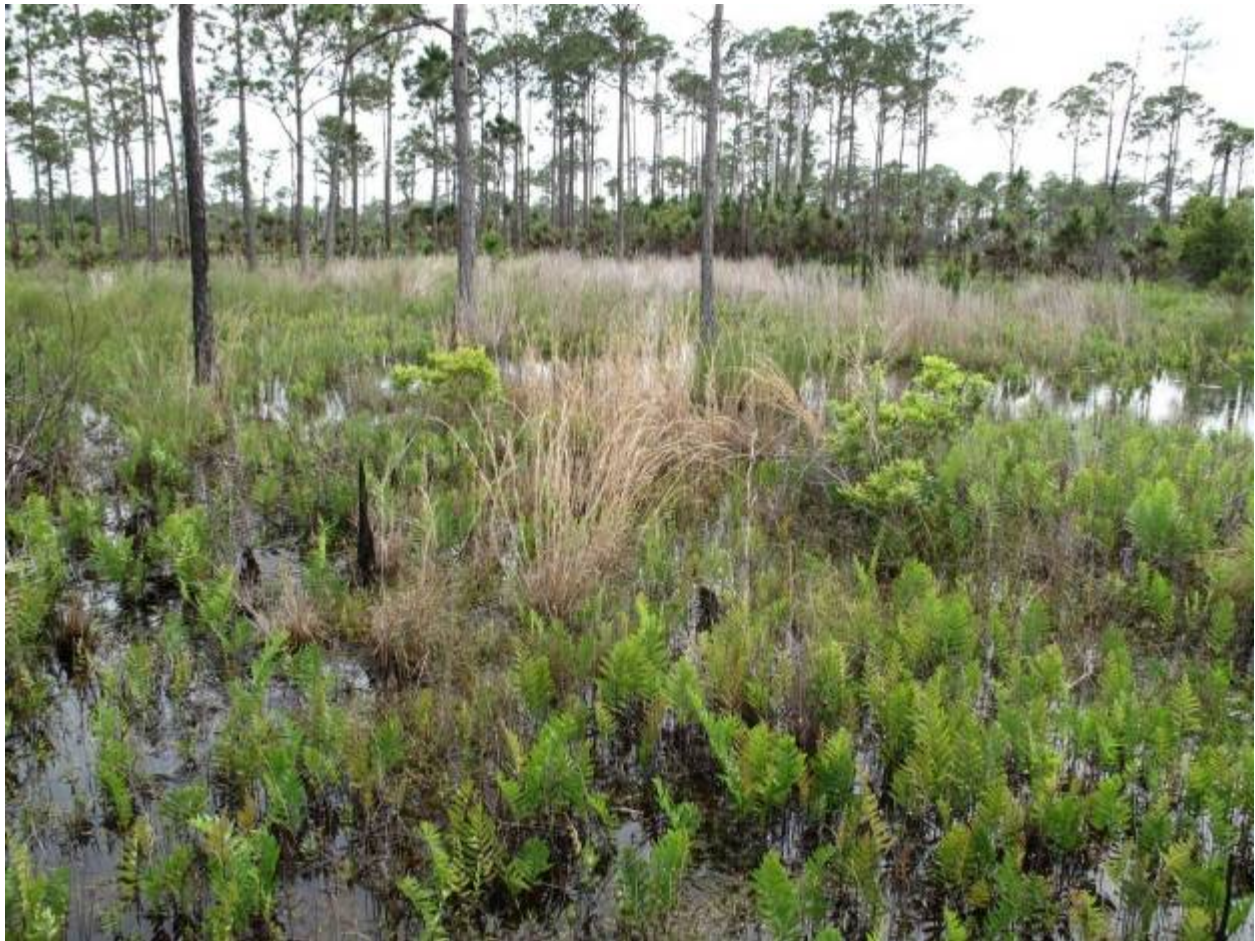
**Wetland ID: 31-12**

**Description:** This wetland is a 0.4 ha ephemeral marsh. There is no tree canopy or midstory cover. Some small pines are beginning to encroach on the south side of the wetland but cover <5% of the wetland basin. Sedges/grasses and fern grow throughout the wetland, and cover >75% of the basin. The adjacent uplands are mesic and scrubby flatwoods

**Wetland Disturbance:** None

**Restoration Action Recommended:** Continue ensuring that fire burns in the wetland basin to prevent young pine trees from establishing.

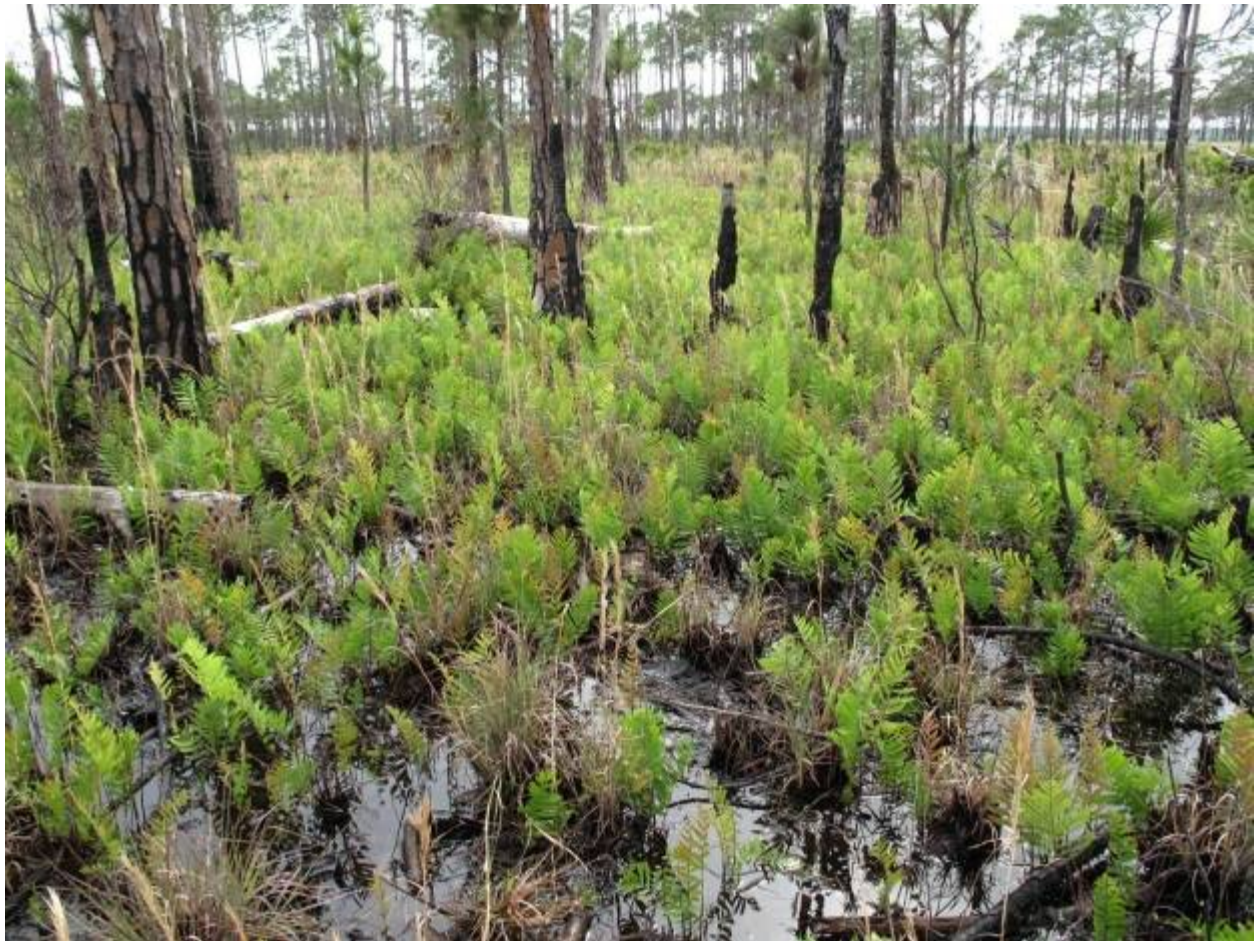
**Wetland ID: 31-13**

**Description:** This wetland is a 0.2 ha ephemeral marsh. There is no tree canopy or midstory cover. Sedges/grasses and fern grow throughout the wetland, and cover >75% of the basin. A recent fire burned through the wetland and killed some established pine trees. The adjacent uplands are scrubby flatwoods.

**Wetland Disturbance:** None

**Restoration Action Recommended:** None

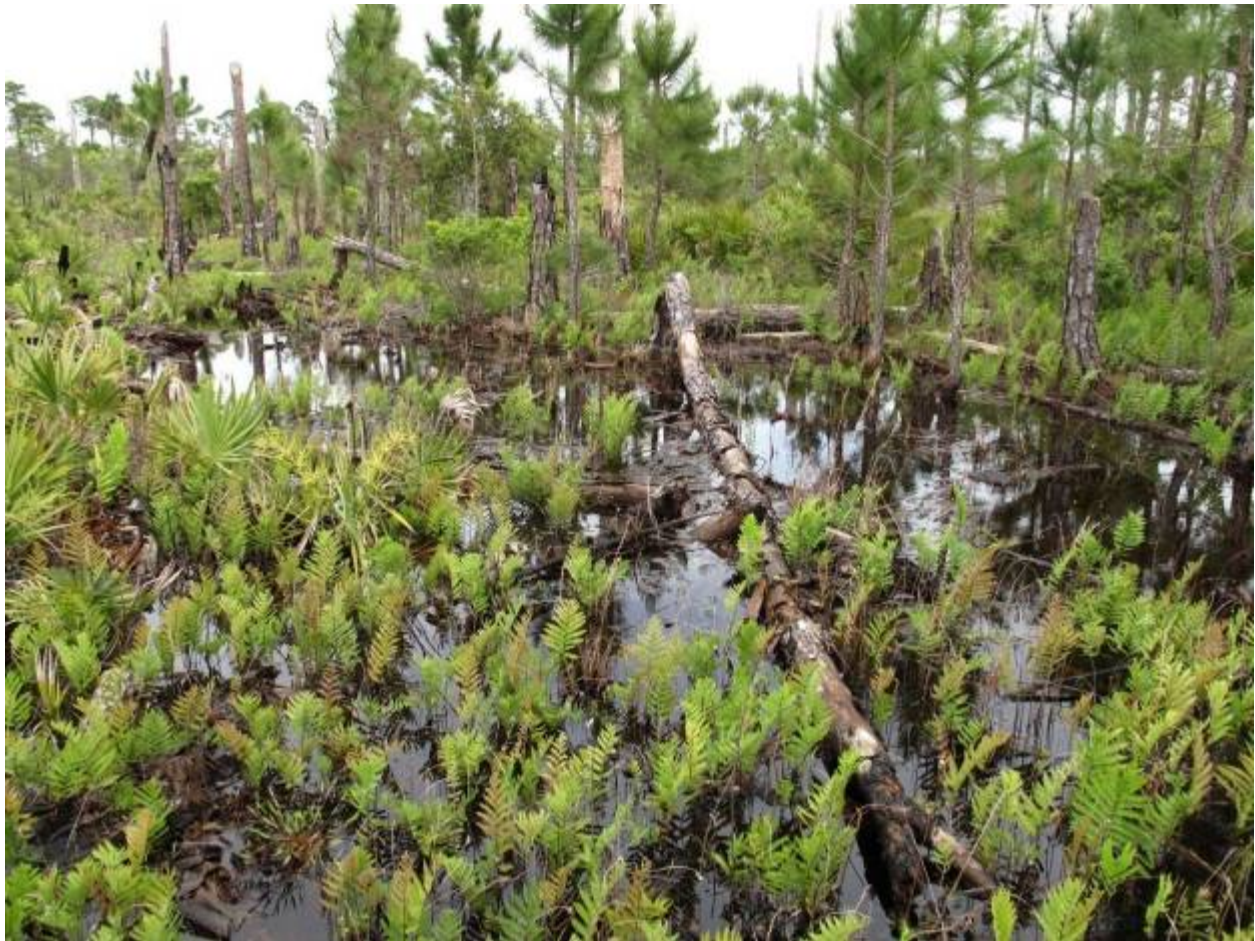
**Wetland ID: 31-14**

**Description:** This wetland is a 0.2 ha ephemeral marsh. There is no tree canopy or midstory cover. Sedges/grasses and fern grow throughout the wetland, and cover >75% of the basin. The area appears to have been fire-suppressed but recent burns are restoring the wetland and eliminating encroaching pines. The adjacent uplands are mesic and scrubby flatwoods.

**Wetland Disturbance:** None

**Restoration Action Recommended:** None

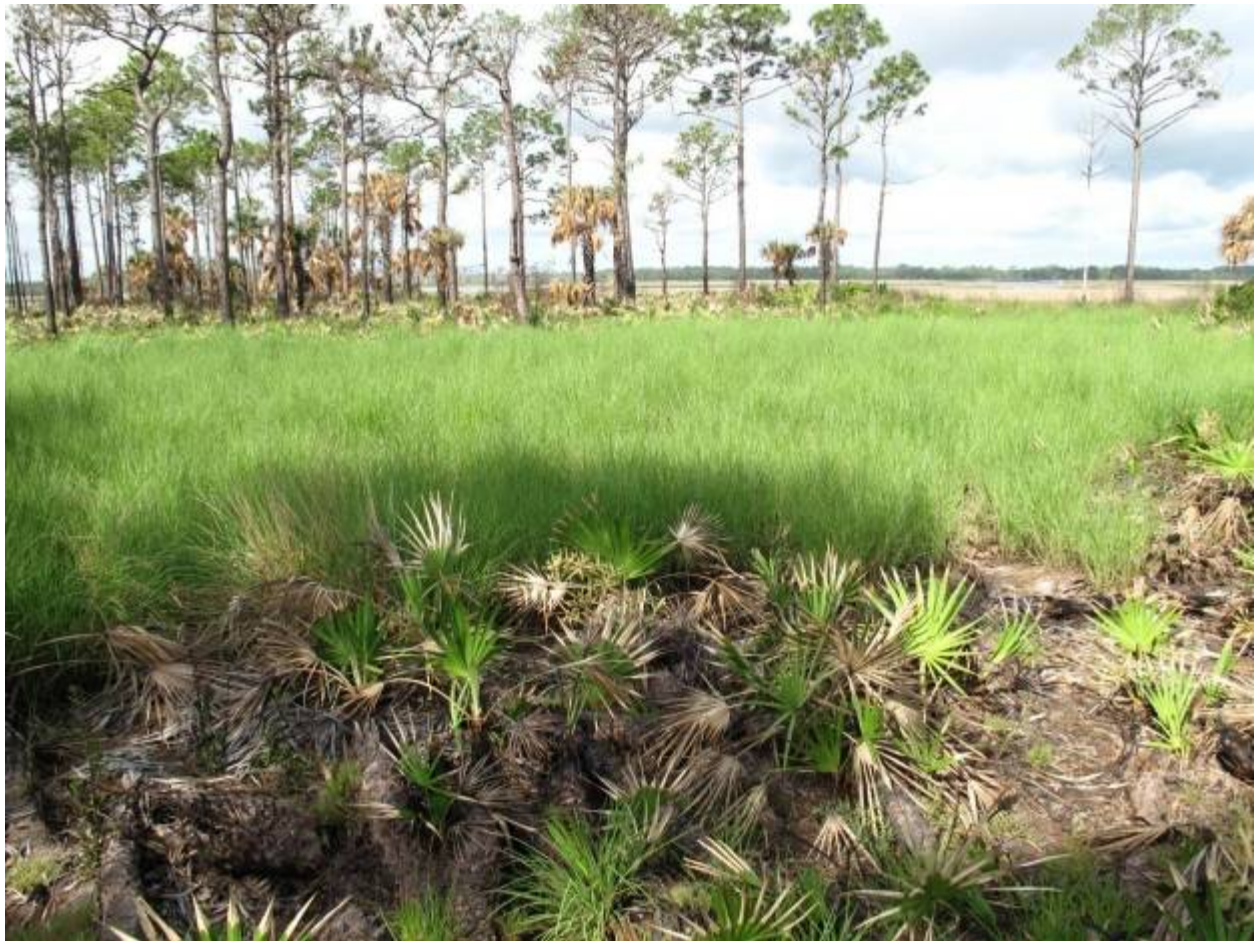
**Wetland ID: 31-15**

**Description:** This wetland is a 0.1 ha ephemeral marsh. There is no tree canopy or midstory cover. Sawgrass grows throughout the wetland, and covers >75% of the basin. This wetland is directly adjacent to the brackish Tolomato River (Intracoastal Waterway). This marsh is in fire-maintenance condition. The adjacent uplands are scrubby flatwoods.

**Wetland Disturbance:** None

**Restoration Action Recommended:** None

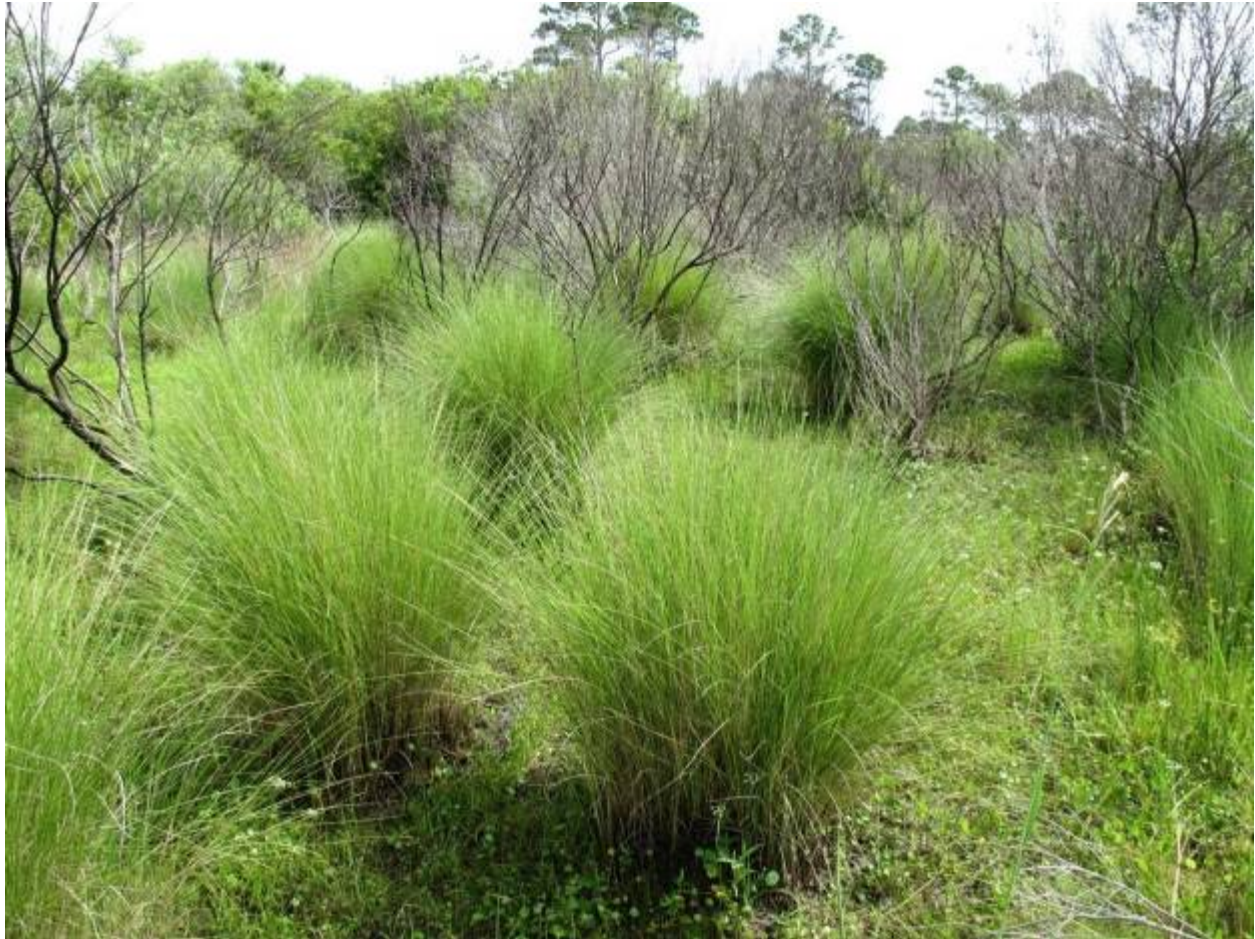
**Wetland ID: 31-16**

**Description:** This wetland is a 0.4 ha ephemeral marsh. Wax myrtle is the dominant woody vegetation and covers 5-25% of the wetland. Sedges/grasses grow throughout the wetland, and cover >75% of the basin. A recent fire burned entirely through the wetland, killing some large, encroaching wax myrtles. The adjacent uplands are scrubby flatwoods.

**Wetland Disturbance:** None

**Restoration Action Recommended:** None

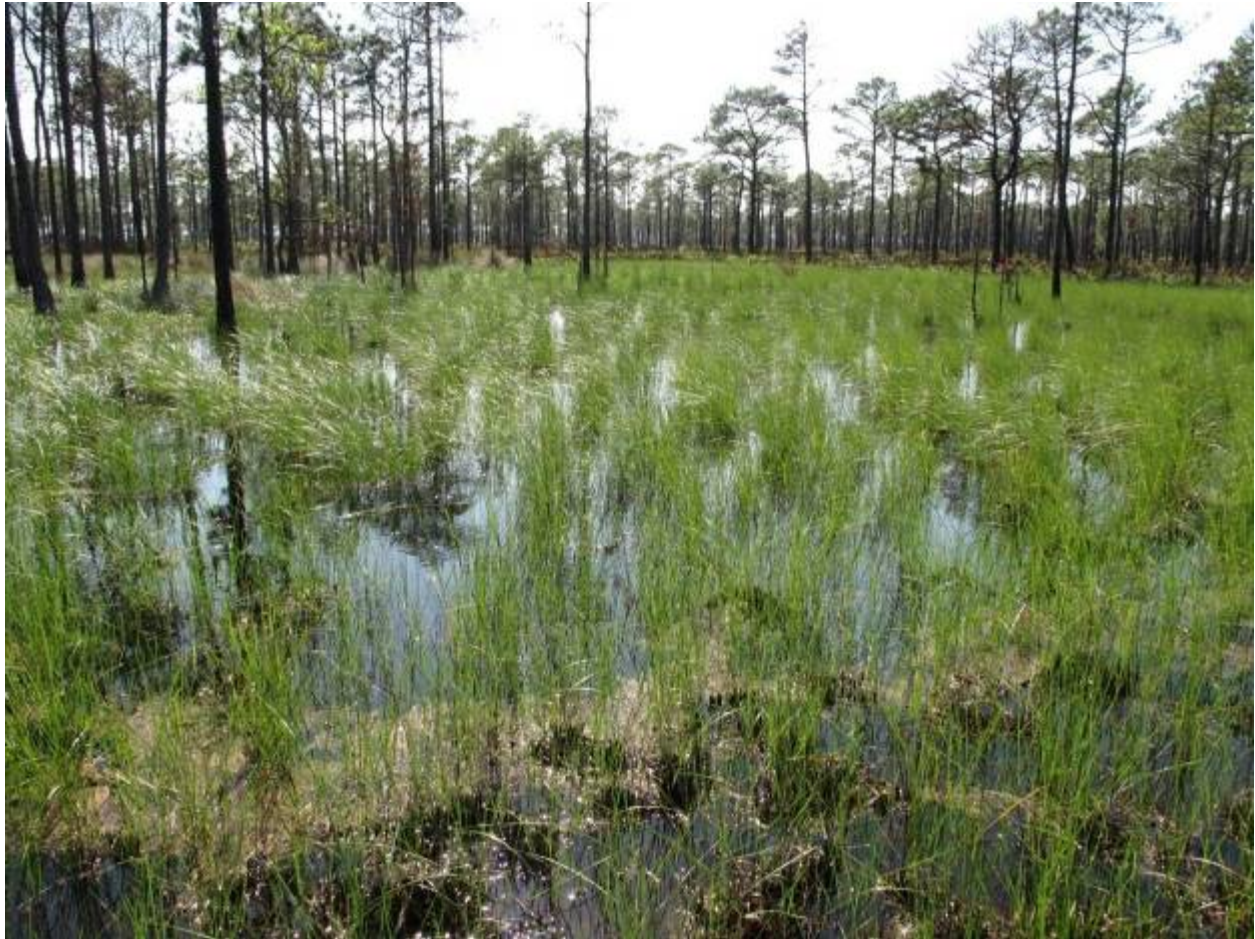
**Wetland ID: 33-01**

**Description:** This wetland is a 0.4 ha ephemeral marsh. Pine trees dominate the canopy, and cover 5-25% of the wetland. There is no midstory cover. Sawgrass grows throughout the wetland, and covers >75% of the basin. This wetland is half in MU 33 and half in MU 35. This marsh is in fire-maintenance condition. The adjacent uplands are mesic flatwoods.

**Wetland Disturbance:** None

**Restoration Action Recommended:** None

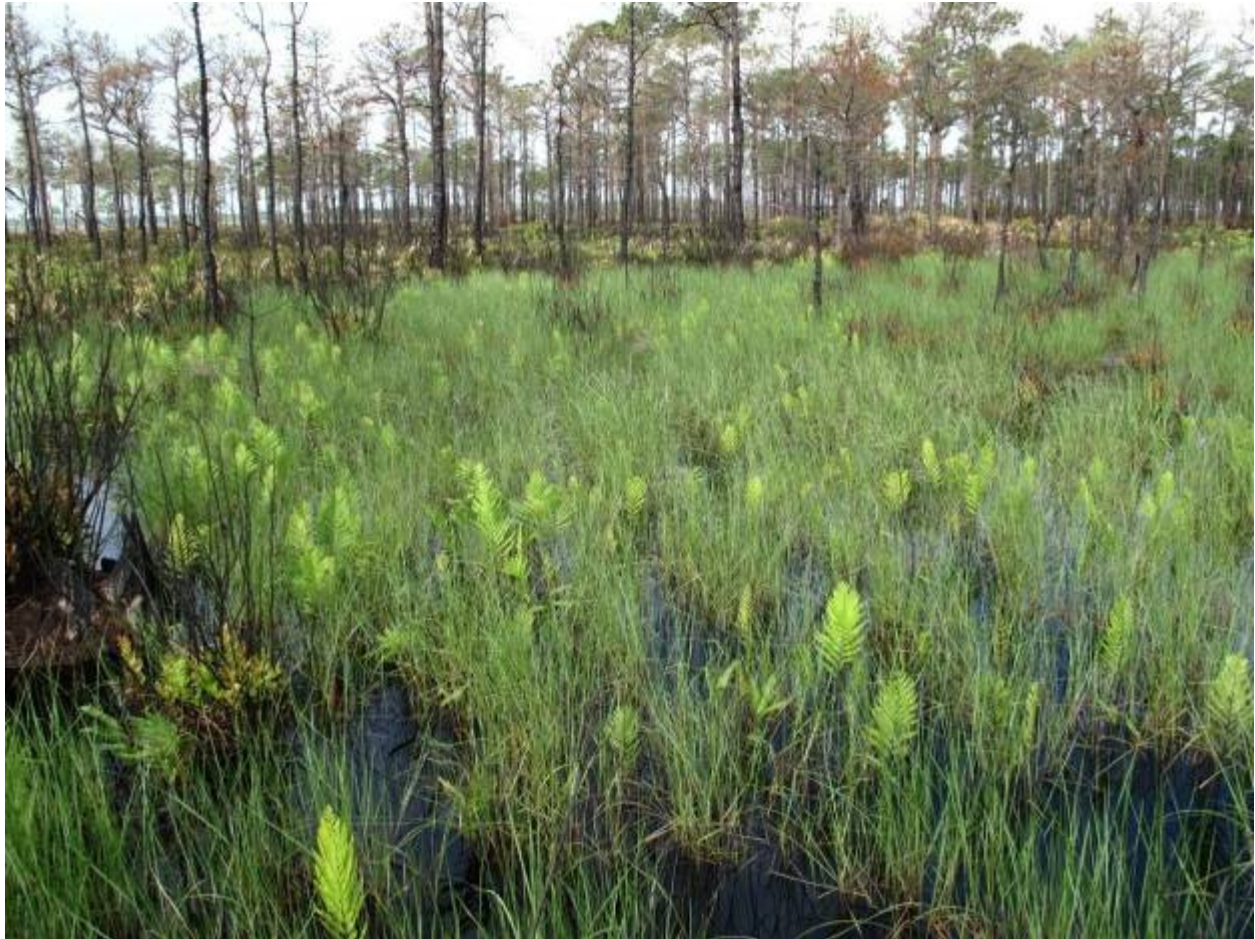
**Wetland ID: 33-02**

**Description:** This wetland is a 0.3 ha ephemeral marsh. There is no tree canopy or midstory cover. Sawgrass grows throughout the wetland, and covers >75% of the basin. A recent fire burned entirely through the wetland, killing some small, encroaching shrubs and pine trees. The adjacent uplands are mesic flatwoods.

**Wetland Disturbance:** None

**Restoration Action Recommended:** None
