# **Inventory, Assessment, and Restoration Potential of Ephemeral Wetlands on FFWCC Wildlife Management Areas**

## **Guana River WMA Final Report**

Submitted by: Rebecca P.M. Means<sup>1</sup>, Ryan C. Means<sup>1</sup>, Steven A. Johnson<sup>2</sup>

April - May 2009

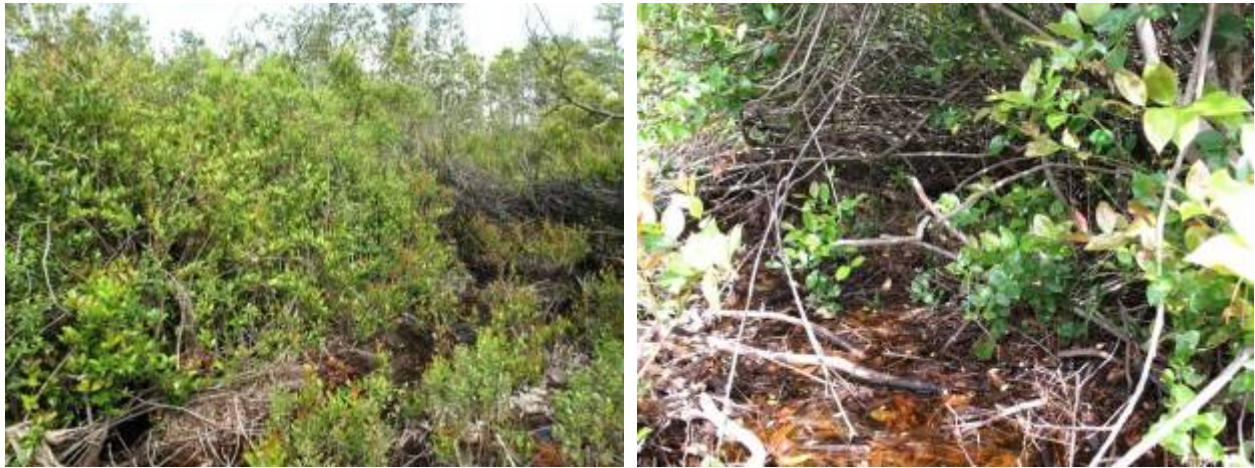
**Wetland ID: 33-03**

**Description:** A <0.1 ha ephemeral shrub swamp. Loblolly bay trees dominate the canopy, and cover 25-50% of the wetland. The midstory is dominated by fetterbush, and covers >75% of the wetland. There is no herbaceous vegetation. Fire does not appear to have burned in this wetland for a long time. The adjacent uplands are mesic flatwoods.

**Wetland Disturbance:** Woody encroachment

**Restoration Action Recommended:** Custom burn this to reduce the dense brush.

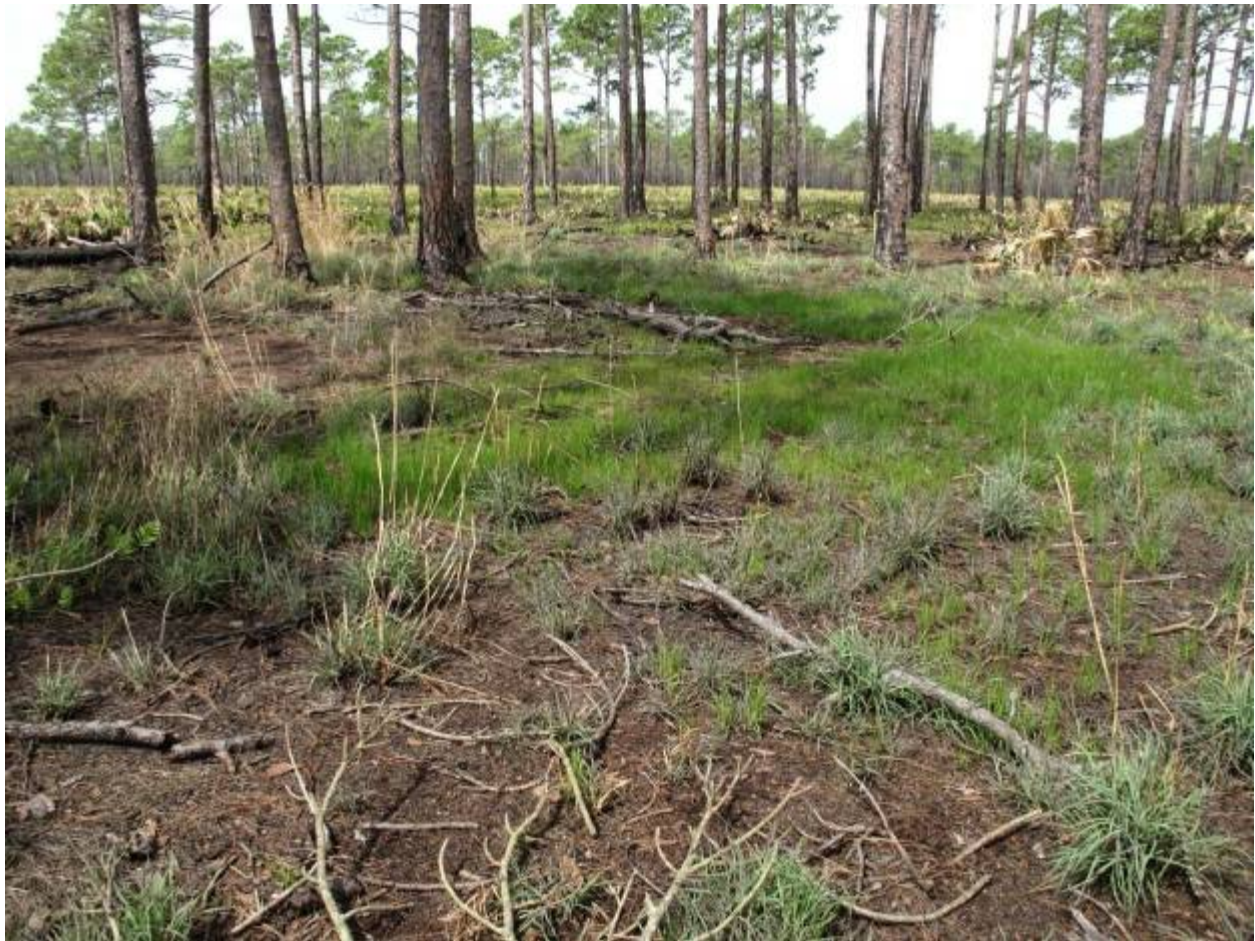
**Wetland ID: 33-04**

**Description:** This wetland is a 0.1 ha highly ephemeral marsh. Pine trees dominate the canopy, and cover 5-25% of the wetland. There is no midstory cover. Sedges/grasses grow throughout the wetland, and cover 50-75% of the basin. This marsh is in fire-maintenance condition. The adjacent uplands are scrubby flatwoods.

**Wetland Disturbance:** None

**Restoration Action Recommended:** None

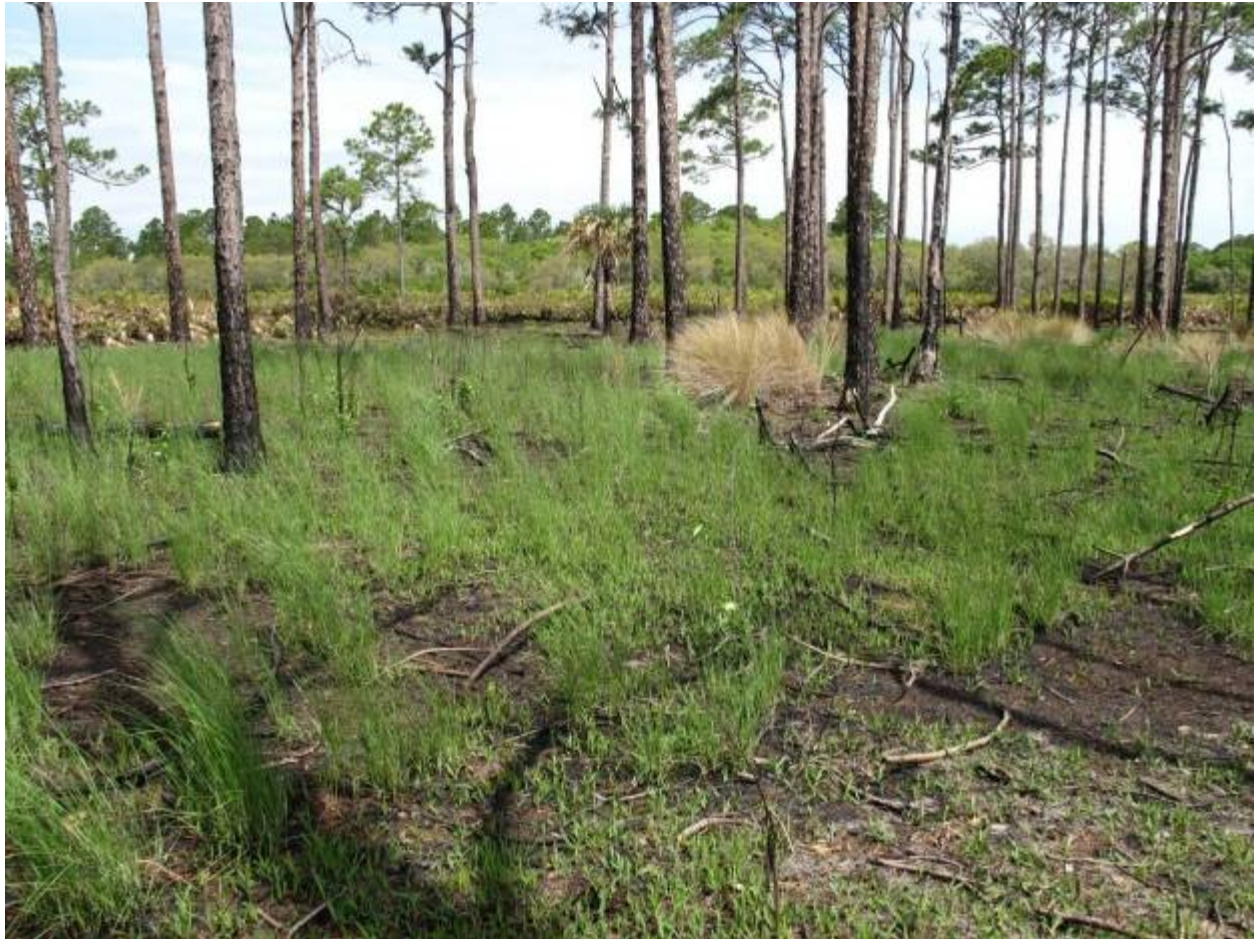
**Wetland ID: 33-05**

**Description:** This wetland is a 0.2 ha ephemeral marsh. Pine trees dominate the canopy, and cover 5-25% of the wetland. There is no midstory cover. Sawgrass and maidencane grow throughout the wetland, and cover >75% of the basin. This marsh is in fire-maintenance condition. The adjacent uplands are scrubby flatwoods.

**Wetland Disturbance:** None

**Restoration Action Recommended:** None

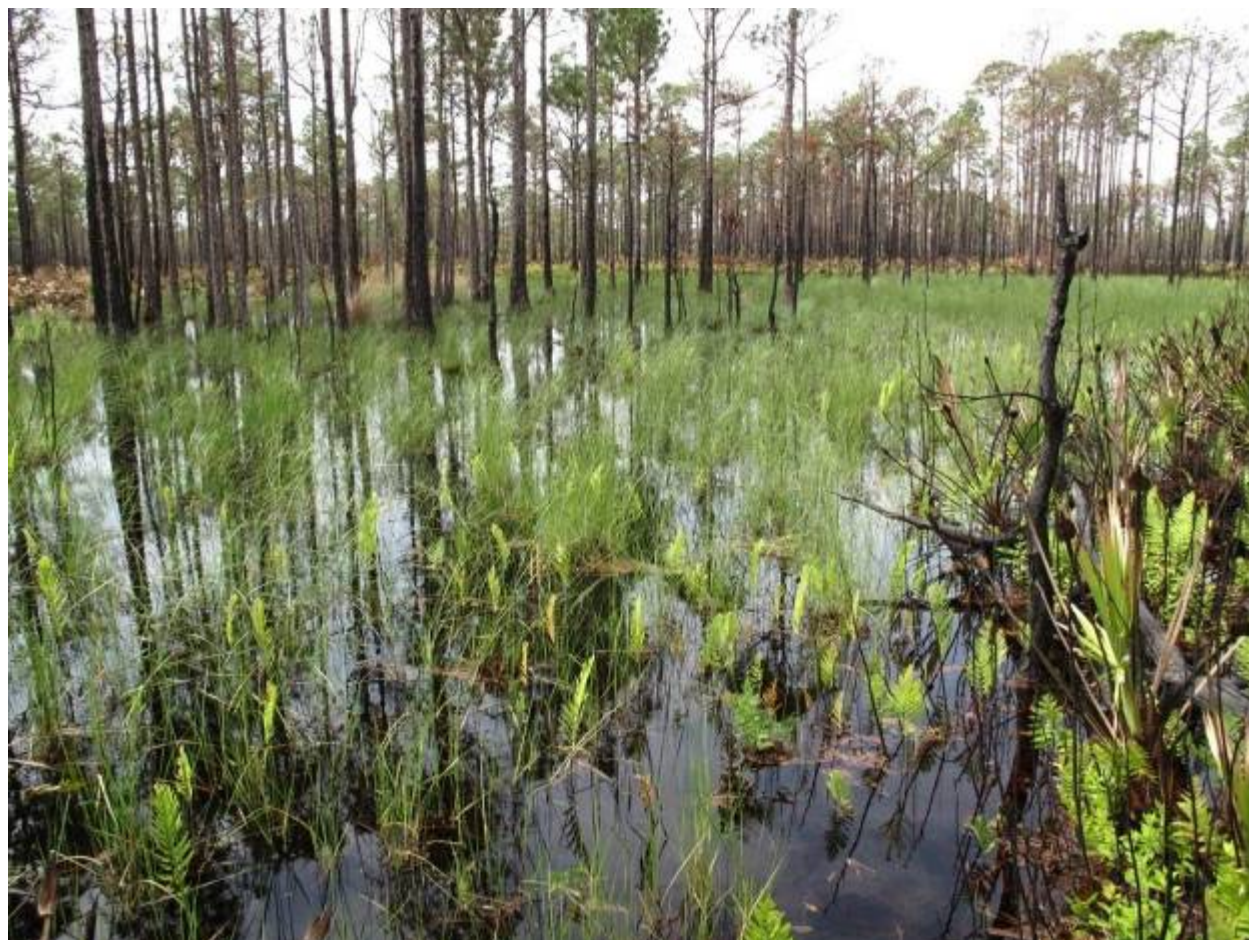
**Wetland ID: 33-06**

**Description:** This wetland is a 0.4 ha ephemeral marsh. Pine trees dominate the canopy, and cover 5-25% of the wetland. There is no midstory cover. Sawgrass grows throughout the wetland, and covers >75% of the basin. There is a fireline along the north side of the wetland. A fire recently burned through the wetland basin. The adjacent uplands are scrubby flatwoods.

**Wetland Disturbance:** Fireline

**Restoration Action Recommended:** The fireline obviously is not impacting the fire periodicity of this wetland. However, we recommend firelines be routed away from wetlands.

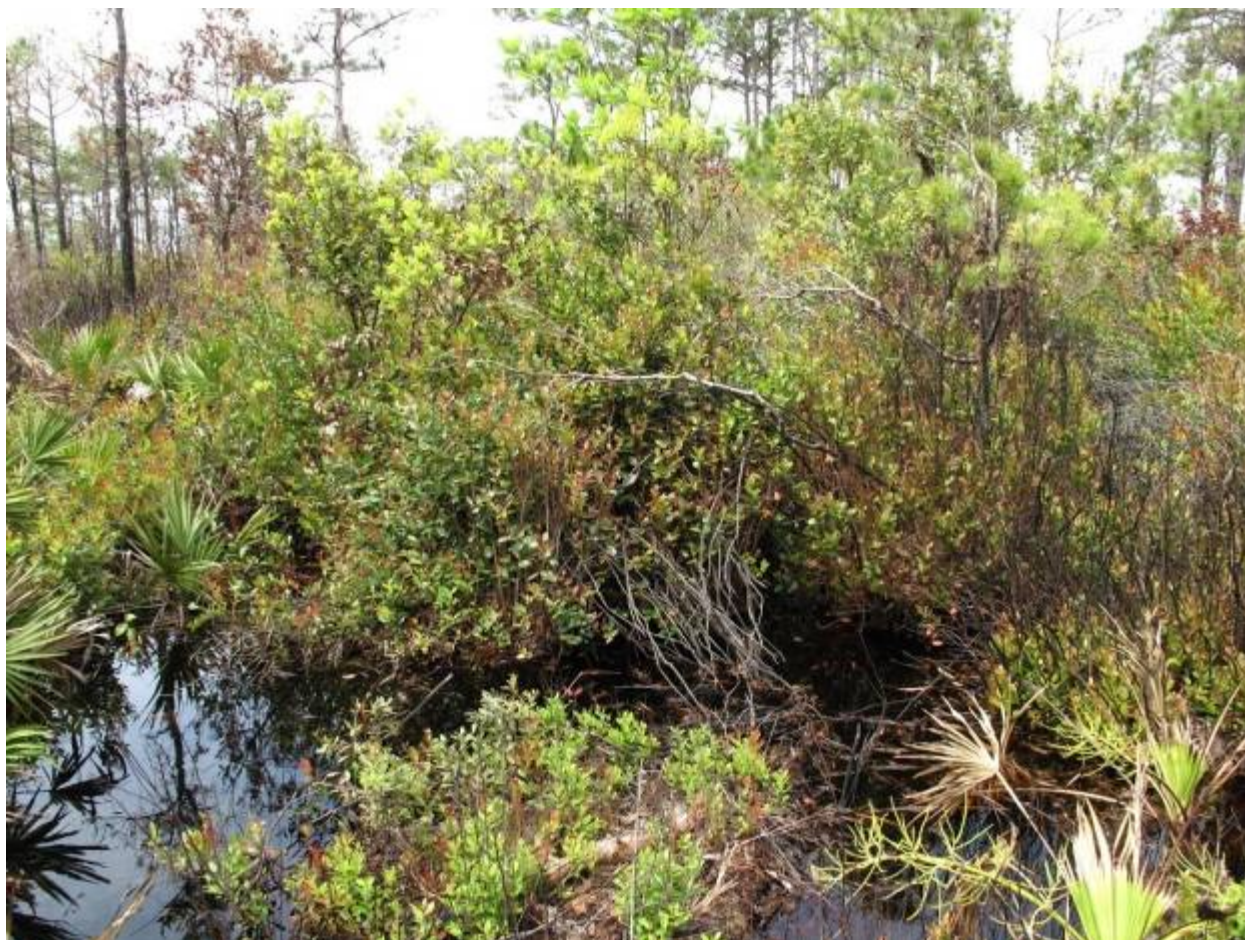
**Wetland ID: 33-07**

**Description:** This wetland is a 0.1 ha ephemeral shrub swamp. Pine trees dominate the canopy, and cover 5-25% of the wetland. The midstory is dominated by fetterbush, and covers >75% of the wetland. There is no herbaceous vegetation. Fire does not appear to have burned in this wetland for a long time. The adjacent uplands are mesic flatwoods. The uplands show no signs of fire suppression.

**Wetland Disturbance:** Woody encroachment

**Restoration Action Recommended:** Custom burn this wetland to reduce the dense brush.

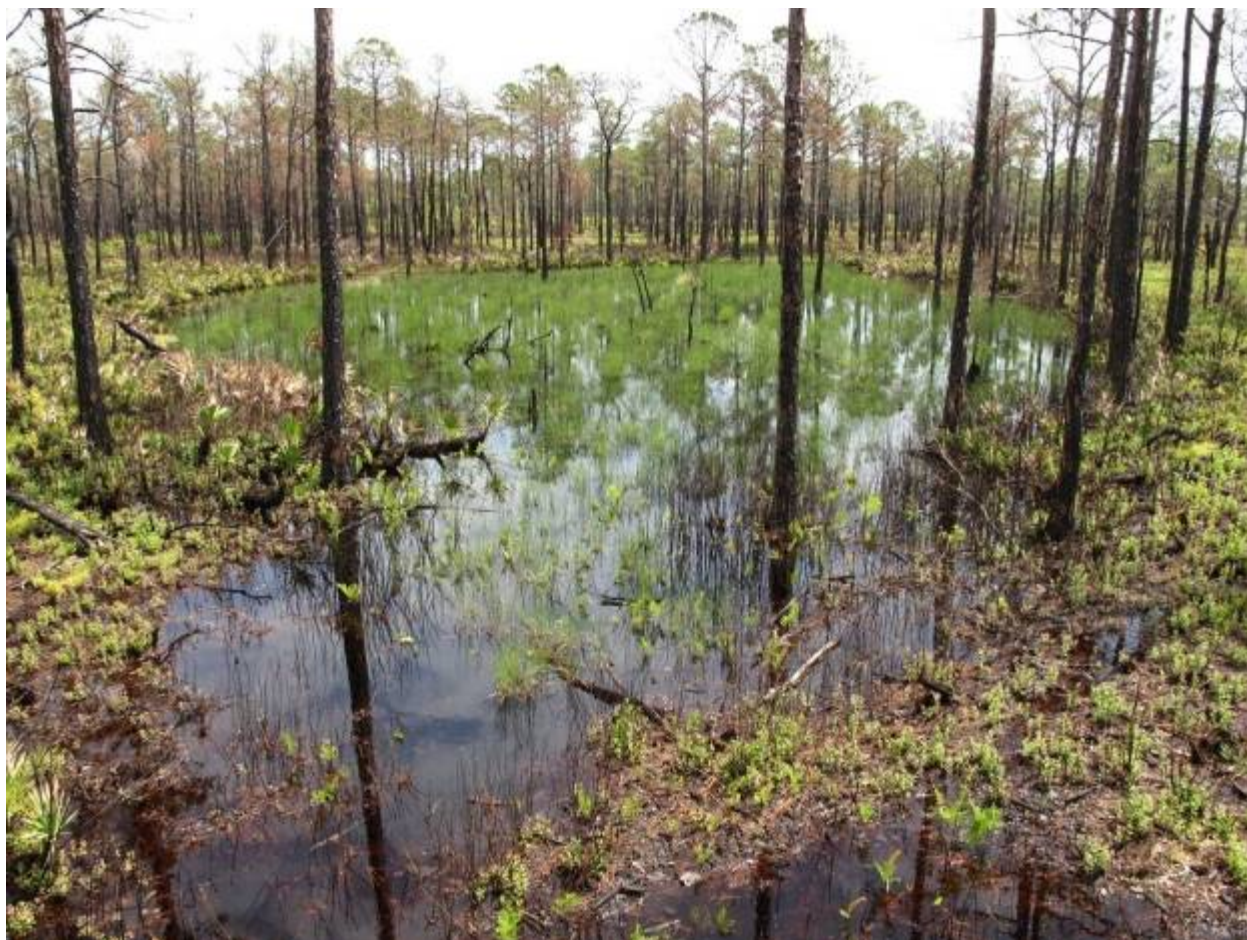
**Wetland ID: 33-08**

**Description:** This wetland is a 0.2 ha ephemeral marsh. There is no tree canopy or midstory cover. Sawgrass grows throughout the wetland, and covers >75% of the basin. A fire recently burned through the wetland basin. The adjacent uplands are scrubby flatwoods.

**Wetland Disturbance:** None

**Restoration Action Recommended:** None

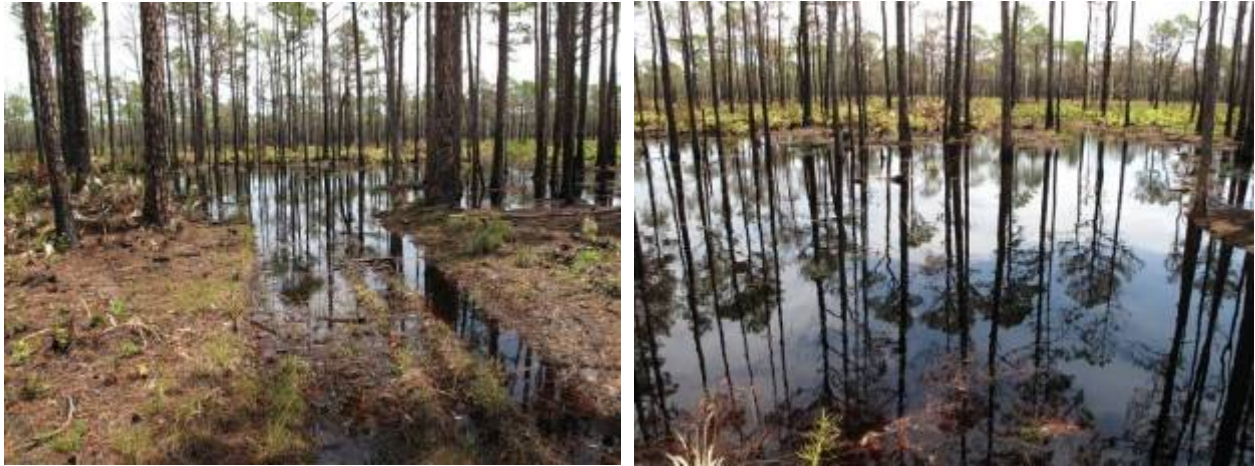
**Wetland ID: 33-09**

**Description:** This wetland is a 0.1 ha ephemeral marsh. Pine trees dominate the canopy, and cover 25-50% of the wetland. There is no midstory cover. Sedges/grasses are sparsely distributed, and cover 5-25% of the wetland. A fireline bisects the wetland. A fire recently burned through the wetland. The adjacent uplands are scrubby flatwoods.

**Wetland Disturbance:** Fireline, Woody encroachment

**Restoration Action Recommended:** The fireline obviously is not impacting the fire periodicity of this wetland. However, we recommend firelines be routed away from wetlands. The pine trees in the wetland interior could be removed to reduce shading and allow for the growth of more herbaceous vegetation.

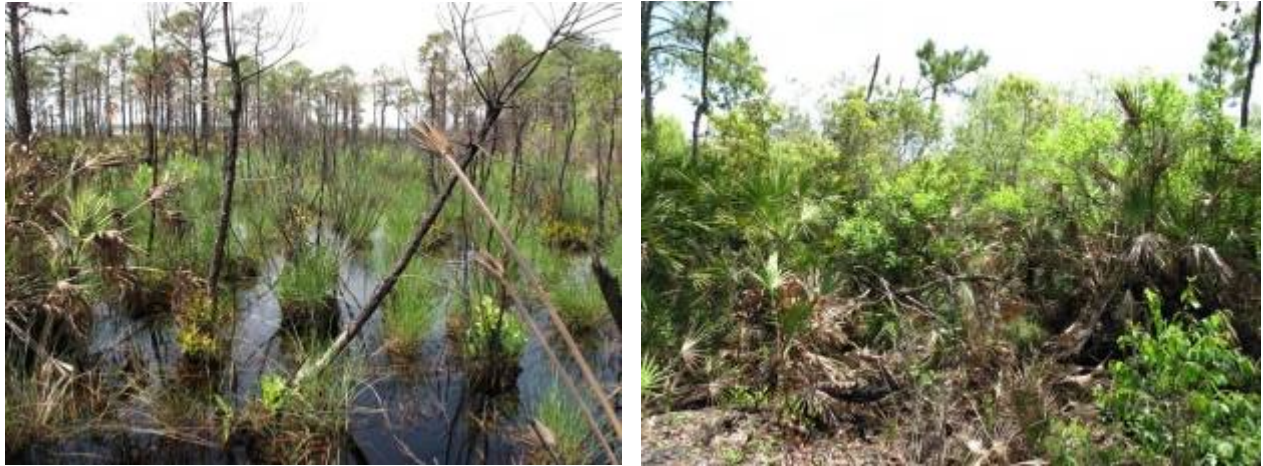
**Wetland ID: 33-10**

**Description:** This wetland is a 0.5 ha semi-permanent shrub swamp. Gum and pine trees dominate the canopy, and cover 5-25% of the wetland. The midstory is dominated by buttonbush and fetterbush, and covers 50-75% of the wetland. Sawgrass grows in scattered patches, and covers 5-25% of the wetland basin. This wetland has areas of thick brush and areas of open marsh. A recent fire burned through half of the wetland basin. The adjacent uplands are mesic flatwoods.

**Wetland Disturbance:** None

**Restoration Action Recommended:** None

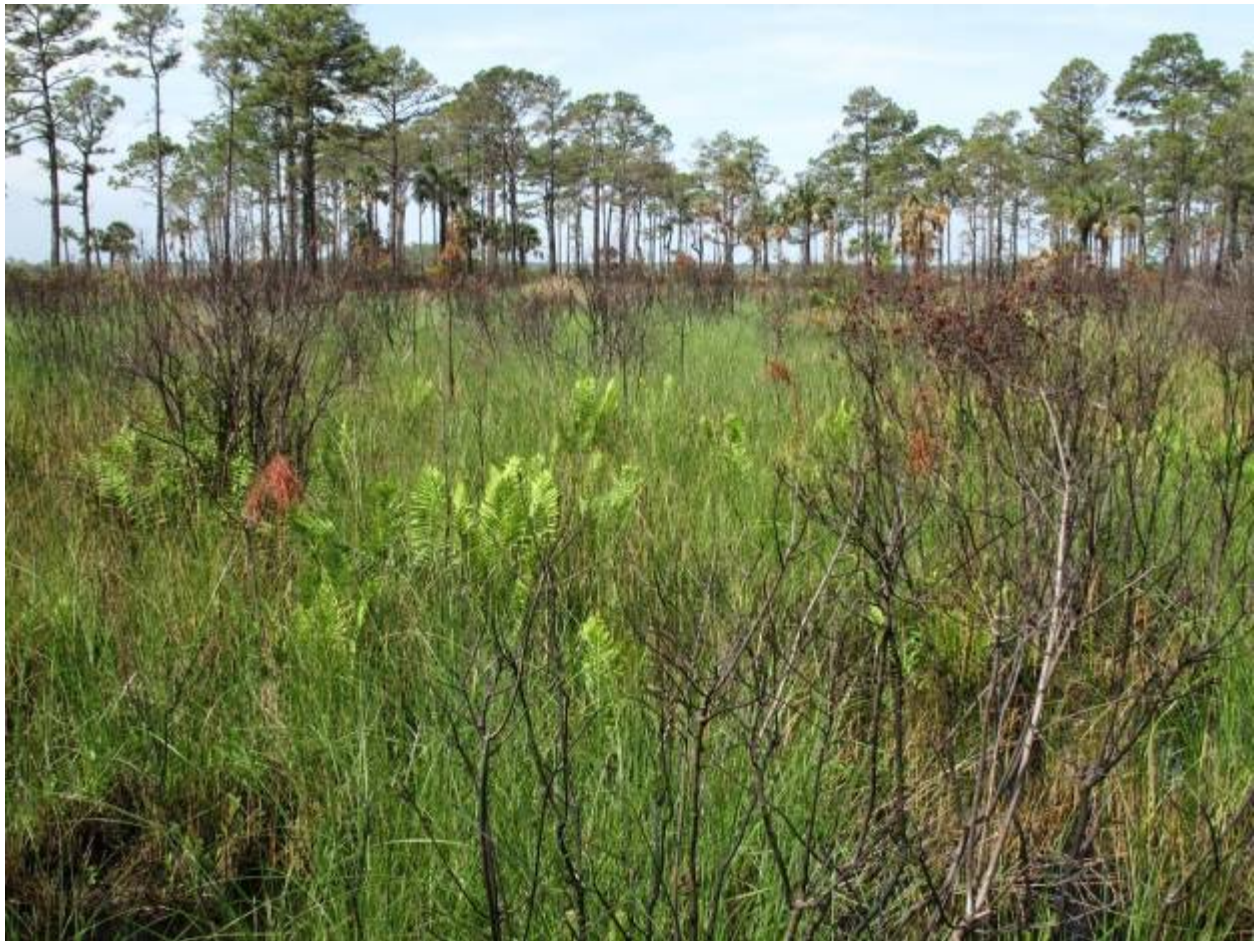
**Wetland ID: 35-01**

**Description:** This wetland is a 0.6 ha ephemeral marsh. Wax myrtle is the dominant woody vegetation and covers 5-25% of the wetland. Rush, sedges/grasses, and sawgrass grow throughout the wetland, and cover >75% of the basin. A recent fire burned through the wetland, and killed the encroaching wax myrtle. The adjacent uplands are mesic flatwoods.

**Wetland Disturbance:** None

**Restoration Action Recommended:** None

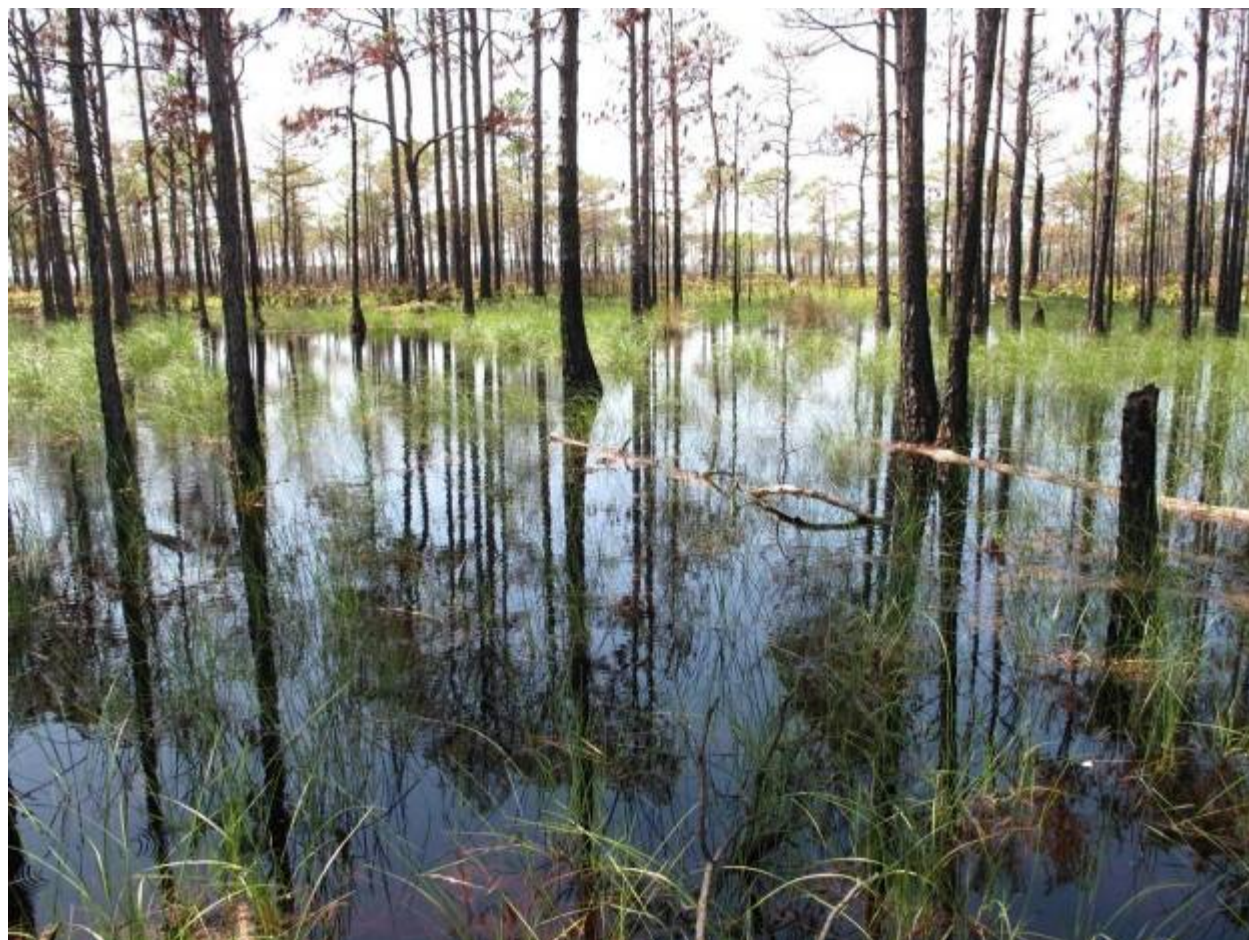
**Wetland ID: 35-02**

**Description:** This wetland is a 1.0 ha ephemeral marsh. Pine trees dominate the canopy, and cover 25-50% of the wetland. There is no midstory cover. Sawgrass grows throughout the wetland, and covers >75% of the basin. This wetland connects with Wetland 35-03 during periods of high water. A fire recently burned through the wetland and new sawgrass shoots are sprouting. The adjacent uplands are mesic flatwoods.

**Wetland Disturbance:** Woody encroachment

**Restoration Action Recommended:** Monitor the pine trees in the wetland. If they begin to shade out the herbaceous vegetation, the pine trees should be thinned from the wetland interior.

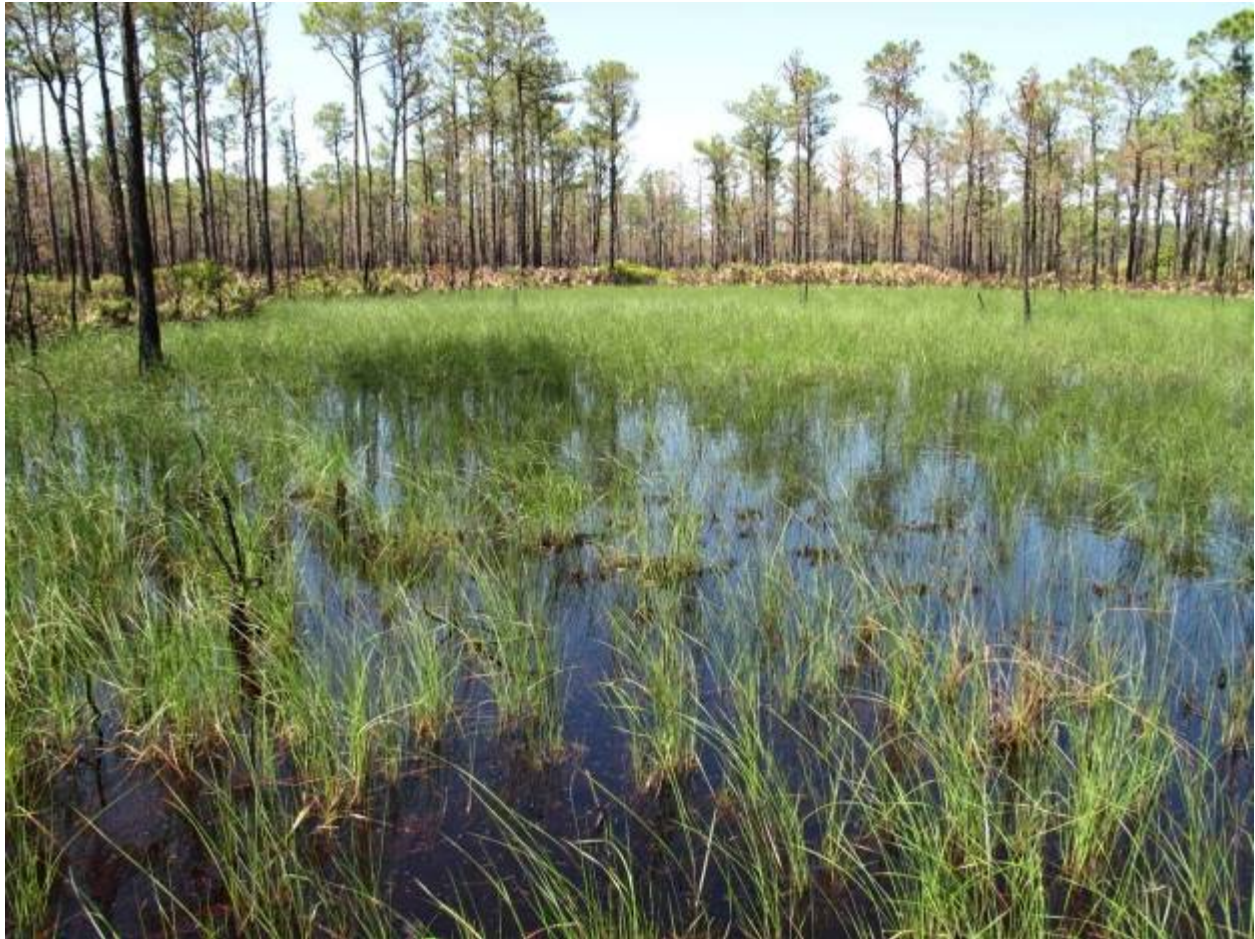
**Wetland ID: 35-03**

**Description:** This wetland is a 0.2 ha ephemeral marsh. There is no tree canopy or midstory cover. Sawgrass grows throughout the wetland, and covers >75% of the basin. This wetland connects with Wetland 35-02 during high water periods. A fire recently burned through the wetland and new sawgrass shoots are sprouting. The adjacent uplands are mesic flatwoods.

**Wetland Disturbance:** None

**Restoration Action Recommended:** None

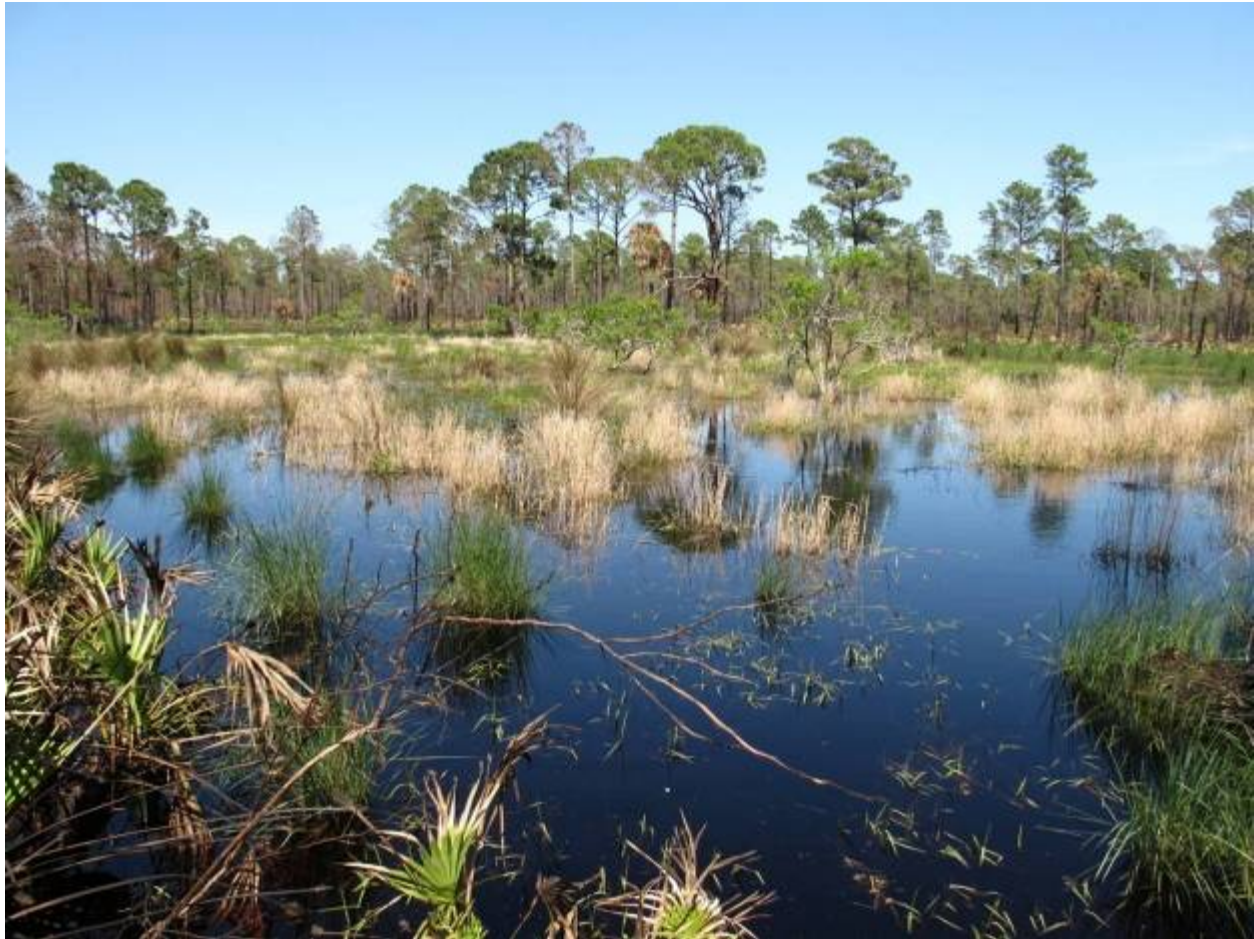
**Wetland ID: 35-04**

**Description:** This wetland is a 1.8 ha semi-permanent marsh. Buttonbush is the dominant woody vegetation, and covers 5-25% of the wetland. Sedges/grasses and sawgrass grow in scattered patches, and cover 50-75% of the basin. This long, strand wetland has lily pads in the center. A fire recently burned through the wetland. The adjacent uplands are scrubby flatwoods.

**Wetland Disturbance:** None

**Restoration Action Recommended:** None

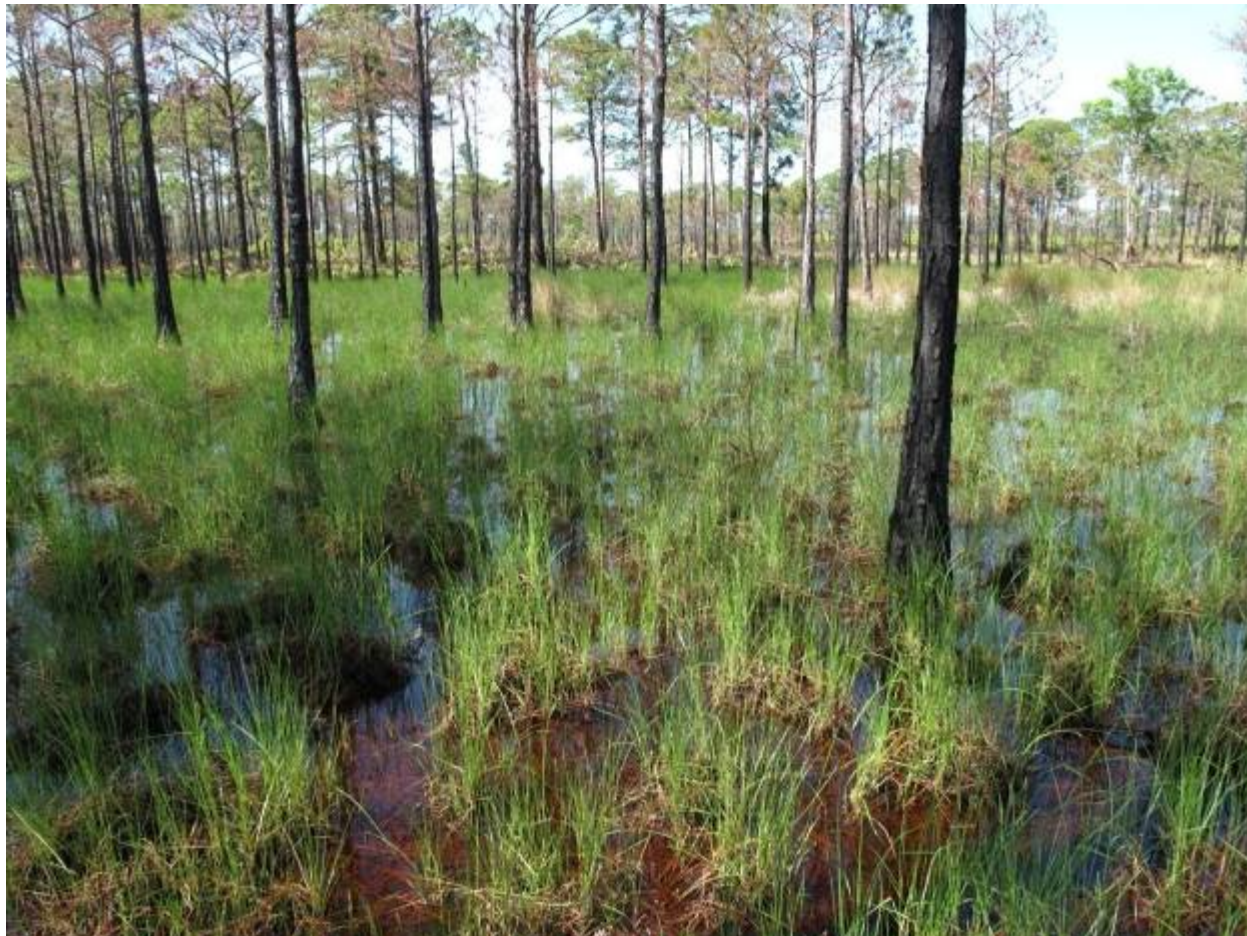
**Wetland ID: 35-05**

**Description:** This wetland is a 0.4 ha ephemeral marsh. Pine trees dominate the canopy, and cover 25-50% of the wetland. There is no midstory cover. Sawgrass grows throughout the wetland, and covers >75% of the basin. This wetland connects with Wetland 35-06 during periods of high water. A fire recently burned through the wetland and new sawgrass shoots are sprouting. The adjacent uplands are mesic flatwoods.

**Wetland Disturbance:** Woody encroachment

**Restoration Action Recommended:** Monitor the pine trees in the wetland. If they begin to shade out the herbaceous vegetation, the pine trees should be thinned from the wetland interior.

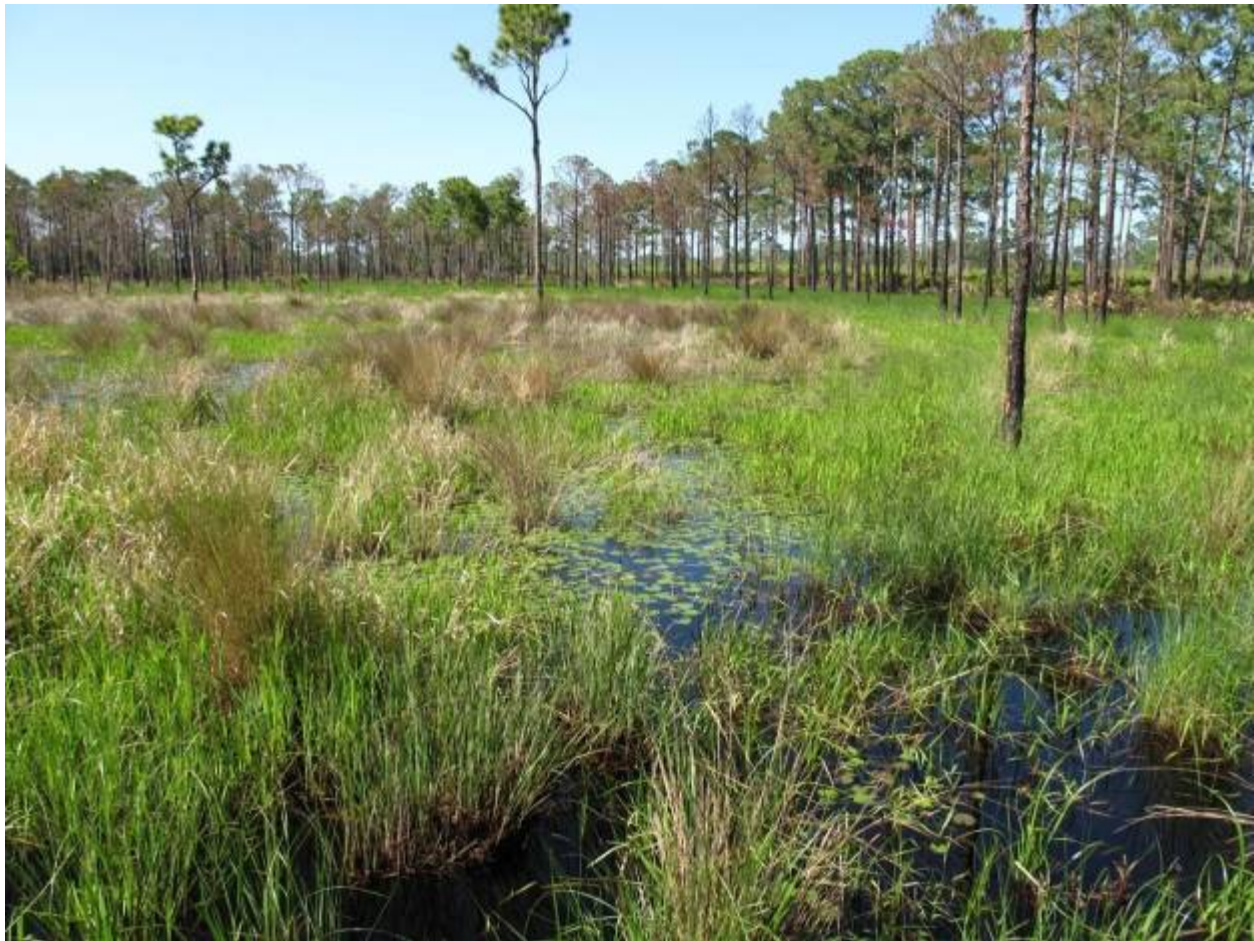
**Wetland ID: 35-06**

**Description:** This wetland is a 1.4 ha semi-permanent marsh. There is no tree canopy or midstory cover. Sawgrass, maidencane, and sedges/grasses grow throughout the wetland, and cover >75% of the basin. This wetland connects with Wetland 35-05 during periods of high water. A fire recently burned through the wetland and new herbaceous shoots are sprouting. The adjacent uplands are mesic flatwoods.

**Wetland Disturbance:** None

**Restoration Action Recommended:** None

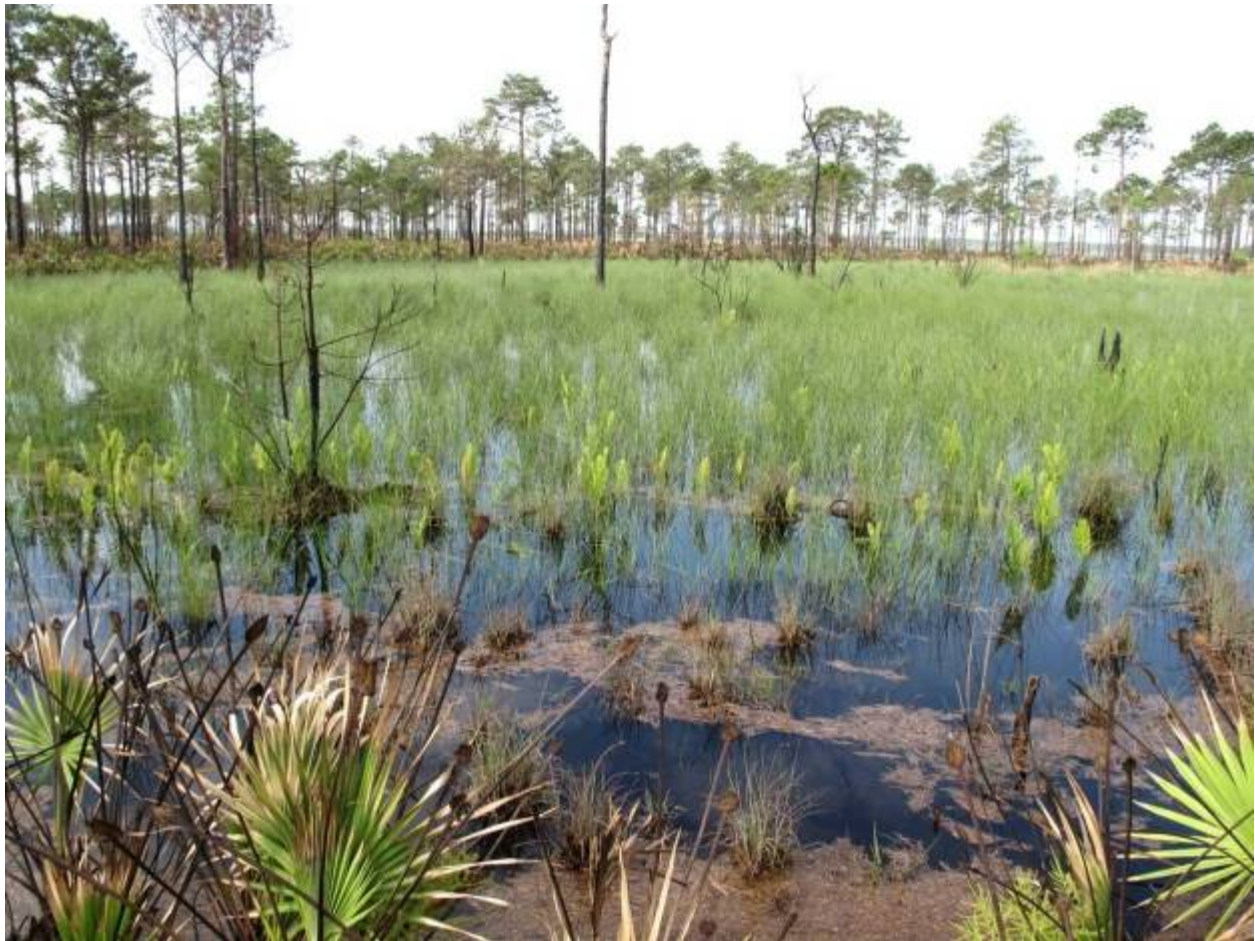
**Wetland ID: 35-07**

**Description:** This wetland is a 0.5 ha ephemeral marsh. There is no tree canopy or midstory cover. Sawgrass grows throughout the wetland, and covers >75% of the basin. A fire recently burned through the wetland and new sawgrass shoots are sprouting. The adjacent uplands are mesic flatwoods.

**Wetland Disturbance:** None

**Restoration Action Recommended:** None

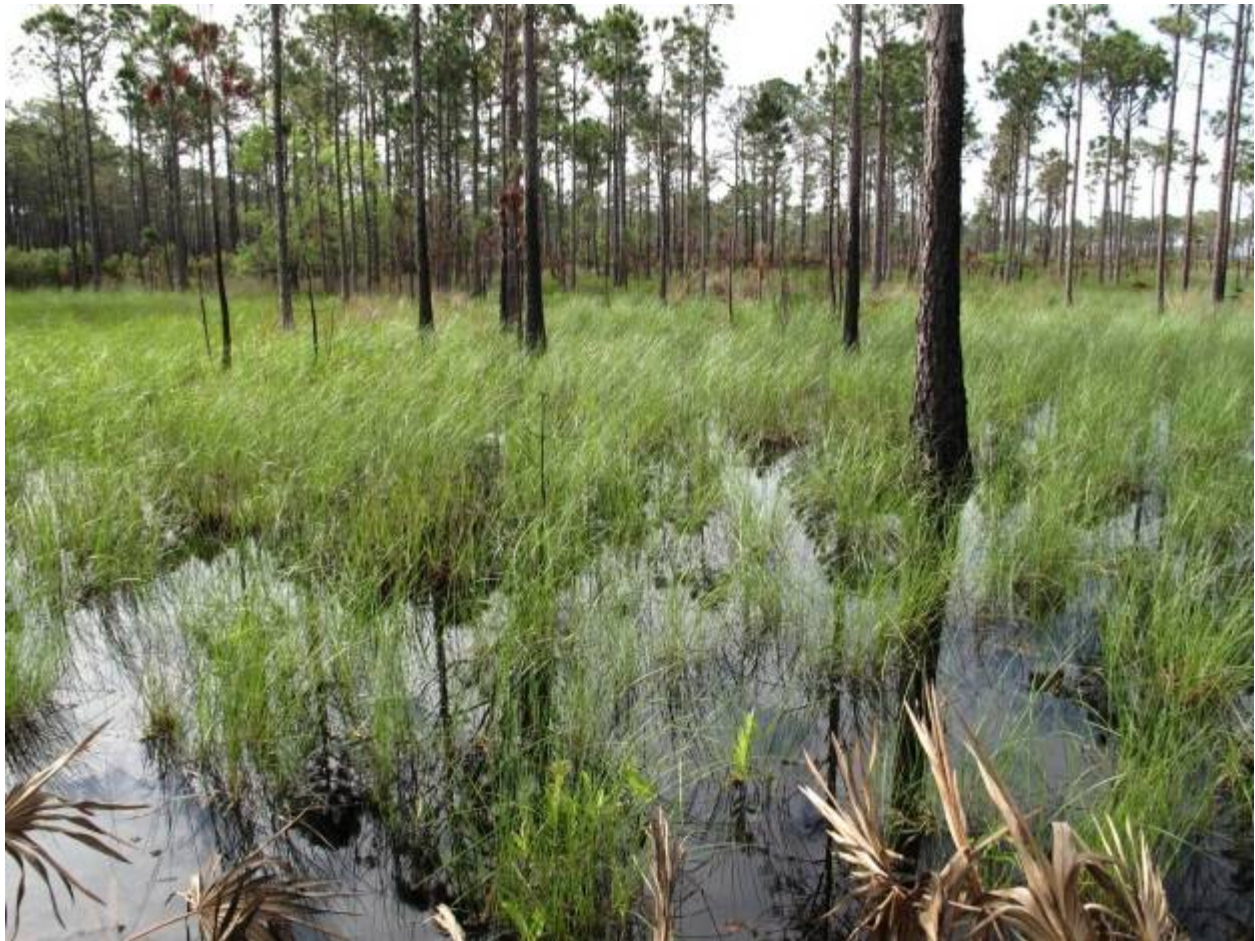
**Wetland ID: 35-08**

**Description:** This wetland is a 0.7 ha ephemeral marsh. Pine trees dominate the canopy, and cover 5-25% of the wetland. There is no midstory cover. Sawgrass and maidencane grow throughout the wetland, and cover >75% of the basin. A fire recently burned through the wetland and new herbaceous shoots are sprouting. The adjacent uplands are mesic flatwoods.

**Wetland Disturbance:** None

**Restoration Action Recommended:** None

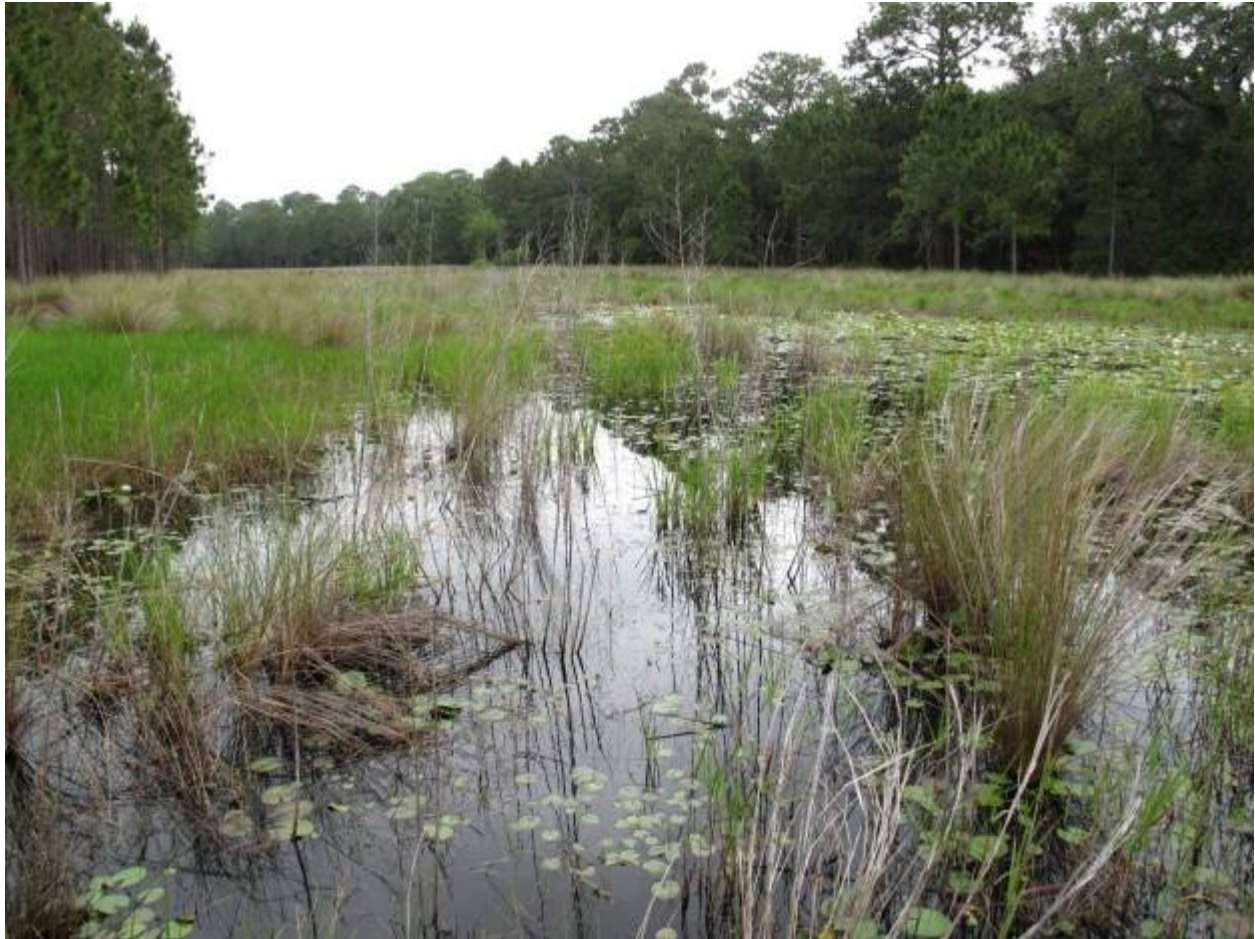
**Wetland ID: 37-01**

**Description:** This wetland is a 0.5 ha semi-permanent marsh. There is no tree canopy or midstory cover. Sedges/grasses, maidencane, and emergent vegetation grow throughout the wetland, and cover >75% of the basin. This deeper wetland is the southern-most depression in a long, elongated strand. During periods of high water, all 3 of the wetlands identified in this MU will connect. The adjacent uplands are scrubby flatwoods and hammock.

**Wetland Disturbance:** None

**Restoration Action Recommended:** J. Ellenberger informed us that it was difficult to get a fire into the wetland because it is surrounded by scrub, which is burned every 6 years. Currently, the wetland appears to be very healthy. In the future, the wetland may need to be custom burned if the upland burn cycle is too long and woody vegetation encroaches.

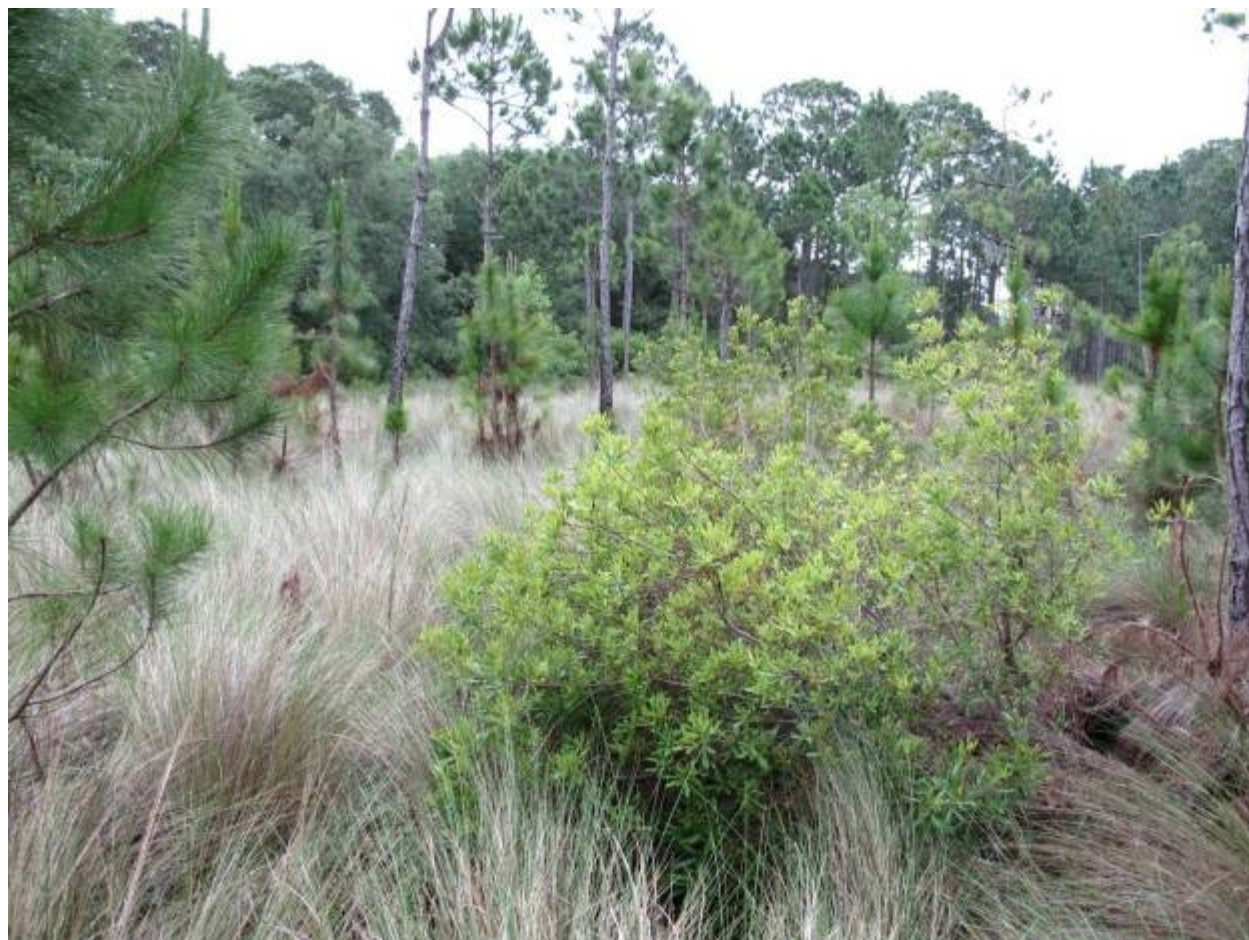
**Wetland ID: 37-02**

**Description:** This wetland is a 0.5 ha ephemeral marsh. Pine trees dominate the canopy, and cover 5-25% of the wetland. Small pines trees are beginning to encroach, and cover 5-25% of the wetland. Sedges/grasses grow throughout the wetland, and cover >75% of the basin. This wetland is the northern most depression in a long, elongated strand. During periods of high water, all 3 of the wetlands identified in this MU will connect. The adjacent uplands are scrubby flatwoods and hammock.

**Wetland Disturbance:** Woody encroachment

**Restoration Action Recommended:** J. Ellenberger informed us that it was difficult to get a fire into the wetland because it is surrounded by scrub, which is burned every 6 years. This depression has burned in the past, but is encircled by a dense brush ring and pine trees are beginning to encroach. In the future, the wetland may need to be custom burned if the upland burn cycle is too long and woody vegetation encroaches.
