# **Inventory, Assessment, and Restoration Potential of Ephemeral Wetlands on FFWCC Wildlife Management Areas**

## **Guana River WMA Final Report**

Submitted by: Rebecca P.M. Means<sup>1</sup>, Ryan C. Means<sup>1</sup>, Steven A. Johnson<sup>2</sup>

April - May 2009

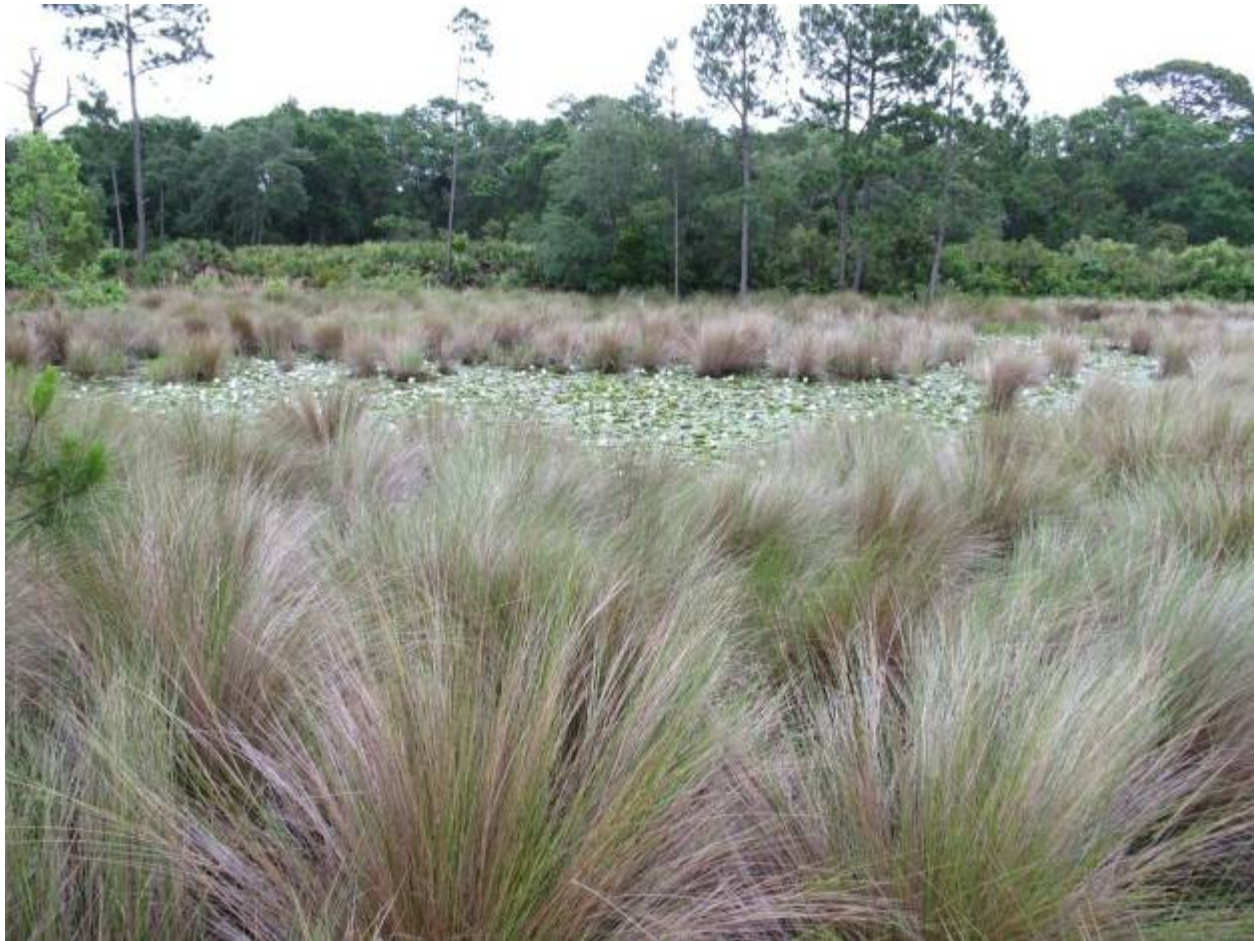
**Wetland ID: 37-03**

**Description:** This wetland is a 1.3 ha semi-permanent marsh. There is no tree canopy or midstory cover. Sedges/grasses and emergent vegetation grow throughout the wetland, and cover >75% of the basin. During periods of high water, all 3 of the wetlands identified in this MU will connect. The adjacent uplands are scrubby flatwoods and hammock.

**Wetland Disturbance:** None

**Restoration Action Recommended:** J. Ellenberger informed us that it was difficult to get a fire into the wetland because it is surrounded by scrub, which is burned every 6 years. Currently, the wetland appears to be very healthy. In the future, the wetland may need to be custom burned if the upland burn cycle is too long and woody vegetation encroaches.

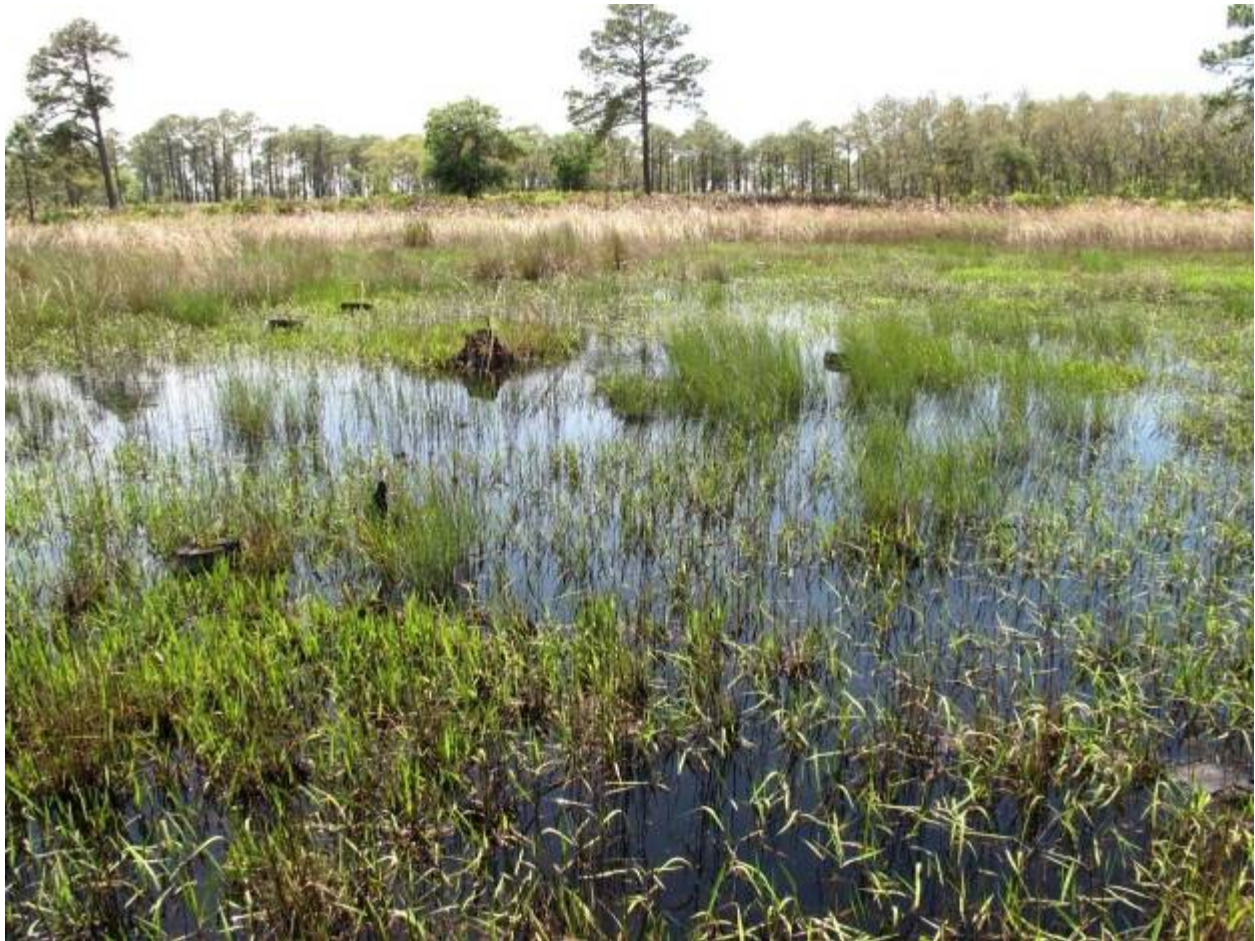
**Wetland ID: 40-01**

**Description:** This wetland is a 0.7 ha ephemeral marsh. The area is managed for turkeys and is burned annually. There is no tree canopy or midstory cover. Sedges/grasses grow throughout the wetland, and cover >75% of the basin. There are numerous pine stumps across the wetland. There is a ditch on the south end of the wetland that has a water control box. A recent fire burned through the wetland basin. The adjacent uplands are scrubby flatwoods. The area is managed for turkeys and is burned annually.

**Wetland Disturbance:** None

**Restoration Action Recommended:** We acknowledge the water in this wetland is controlled for wildlife management purposes.

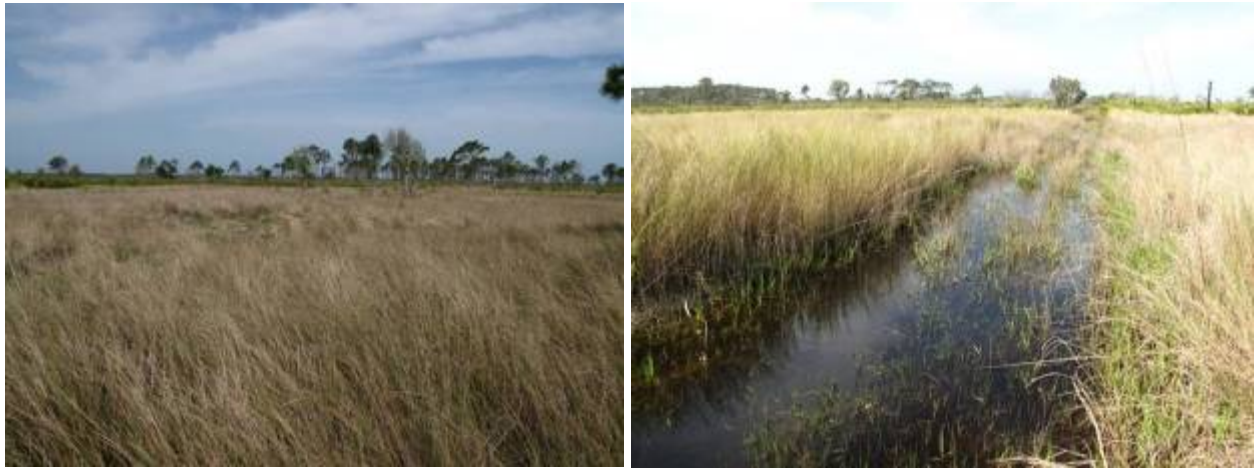
**Wetland ID: 50-01**

**Description:** This wetland is a 0.6 ha ephemeral marsh. There is no tree canopy or midstory cover. Sedges/grasses grow throughout the wetland, and cover >75% of the basin. A fireline bisects the middle of the wetland. The adjacent uplands are scrubby flatwoods.

**Wetland Disturbance:** Fireline

**Restoration Action Recommended:** Re-route the fireline away from the wetland.

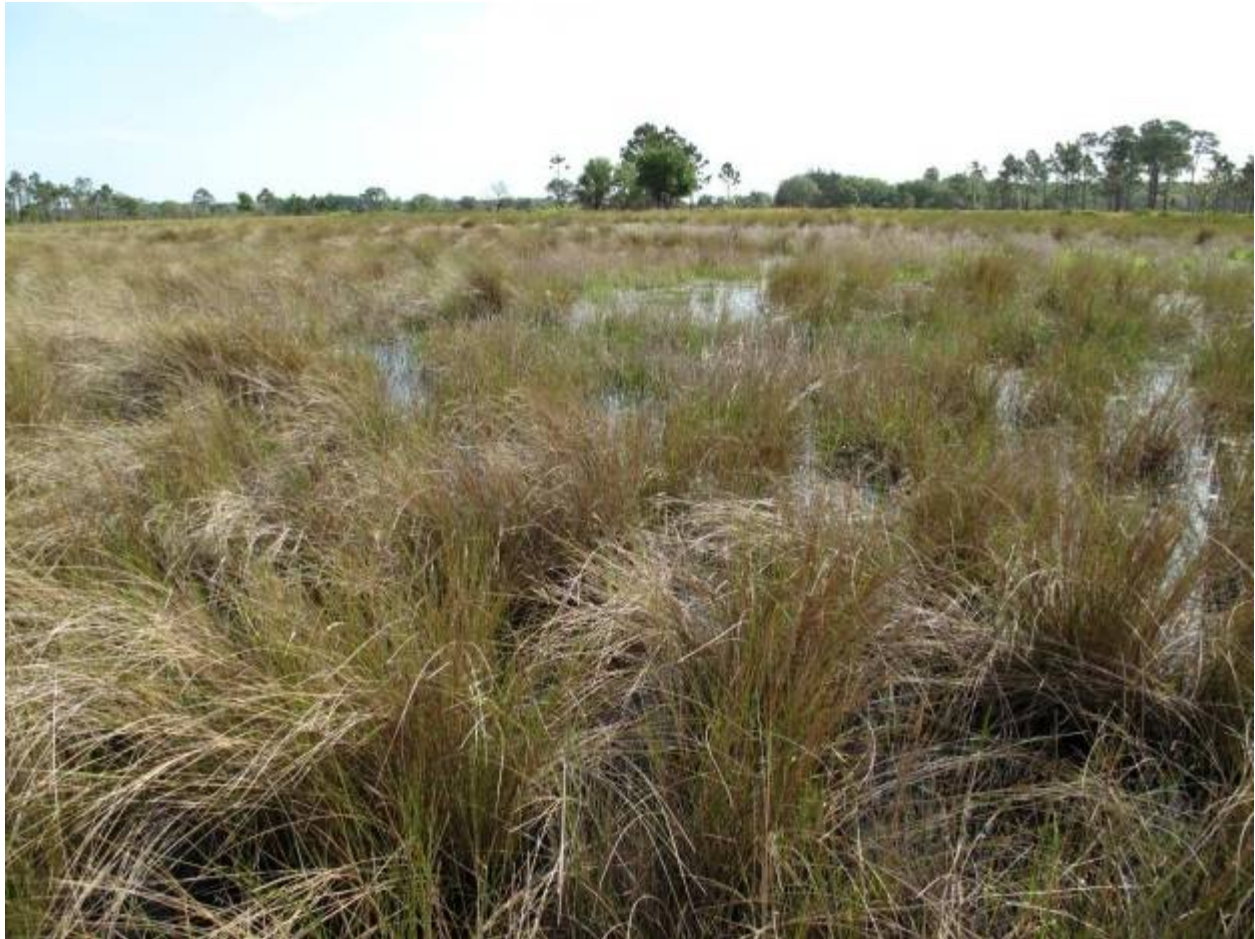
**Wetland ID: 52-01**

**Description:** This wetland is a 2.5 ha ephemeral marsh. There is no tree canopy or midstory cover. Sedges/grasses grow throughout the wetland, and cover >75% of the basin. This marsh is in fire-maintenance condition. The adjacent uplands are scrubby flatwoods.

**Wetland Disturbance:** None

**Restoration Action Recommended:** None

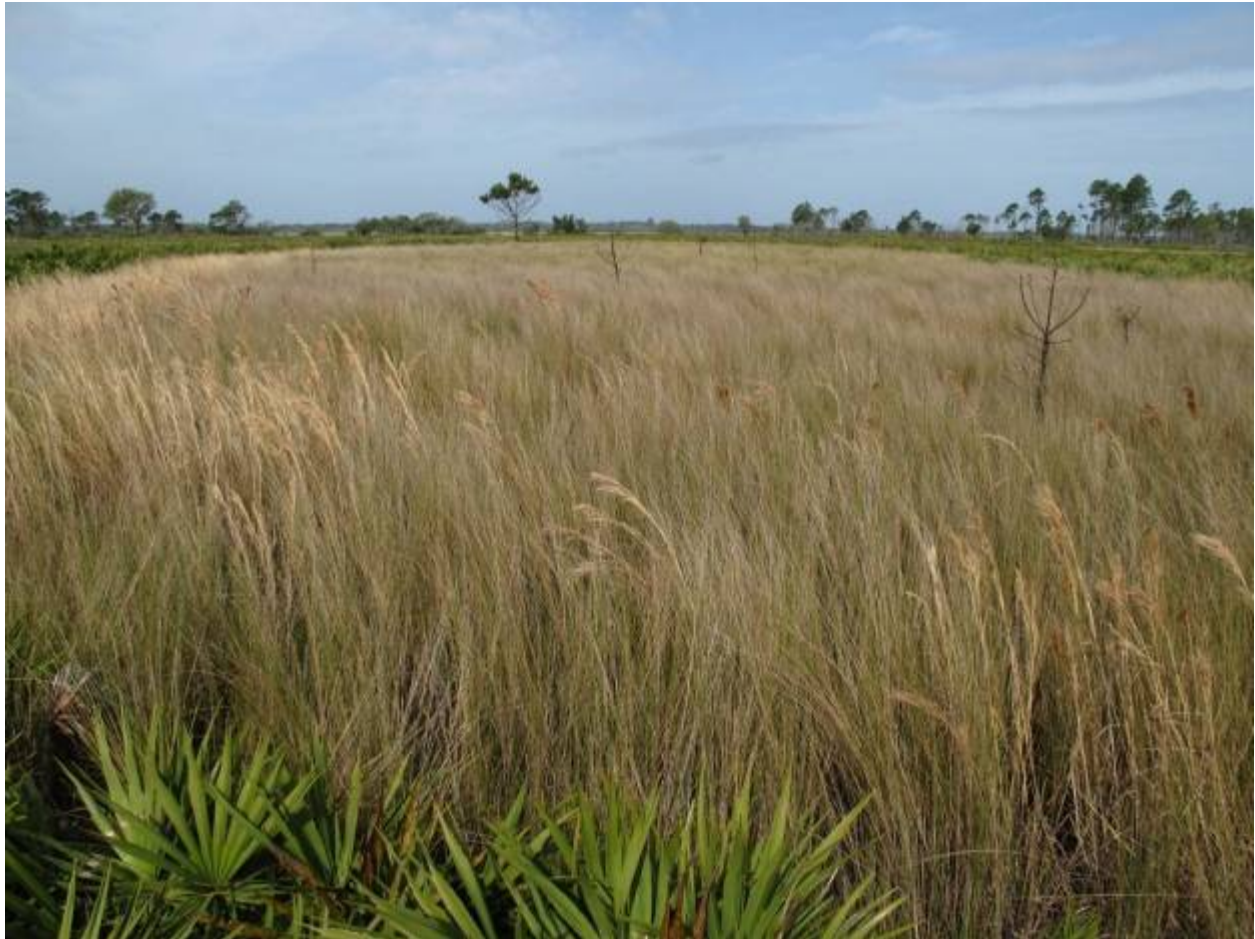
**Wetland ID: 52-02**

**Description:** This wetland is a 0.3 ha ephemeral marsh. There is no tree canopy or midstory cover. Sedges/grasses grow throughout the wetland, and cover >75% of the basin. A recent fire burned through the wetland basin, and killed some encroaching slash pine trees. The adjacent uplands are scrubby flatwoods.

**Wetland Disturbance:** None

**Restoration Action Recommended:** None

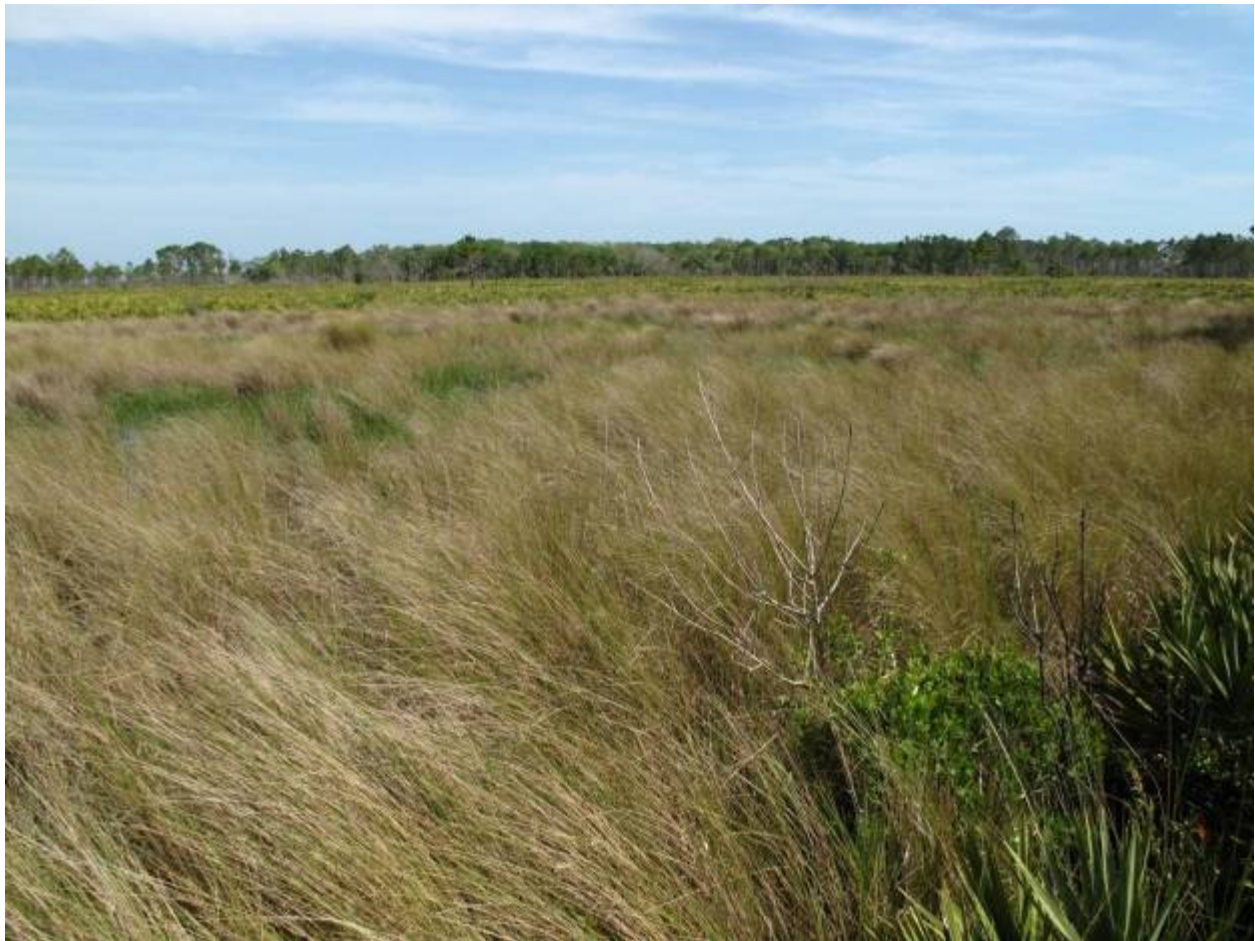
**Wetland ID: 52-03**

**Description:** This wetland is a 1.5 ha ephemeral marsh. There is no tree canopy or midstory cover. Sedges/grasses grow throughout the wetland, and cover >75% of the basin. This marsh is in fire-maintenance condition. The adjacent uplands are scrubby flatwoods.

**Wetland Disturbance:** None

**Restoration Action Recommended:** None

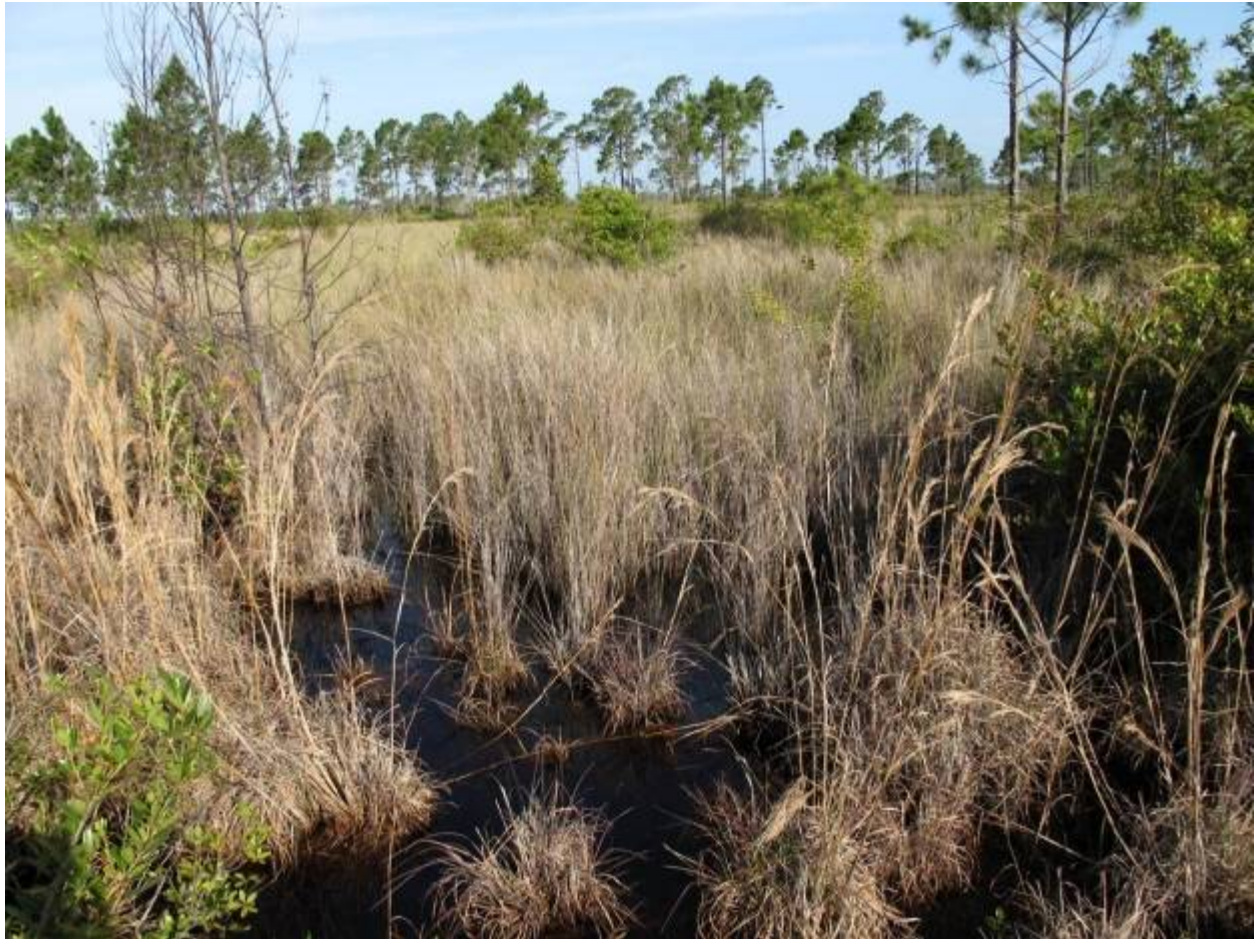
**Wetland ID: 55-01**

**Description:** This wetland is a 2.7 ha ephemeral marsh. Wax myrtle, fetterbush, and small redbay are the dominant woody vegetation, and covers 5-25% of the wetland. Sedges/grasses grow throughout the wetland, and cover >75% of the basin. The adjacent uplands are scrubby flatwoods.

**Wetland Disturbance:** None

**Restoration Action Recommended:** Monitor this wetland to ensure the shrubs do not become established and further encroach.

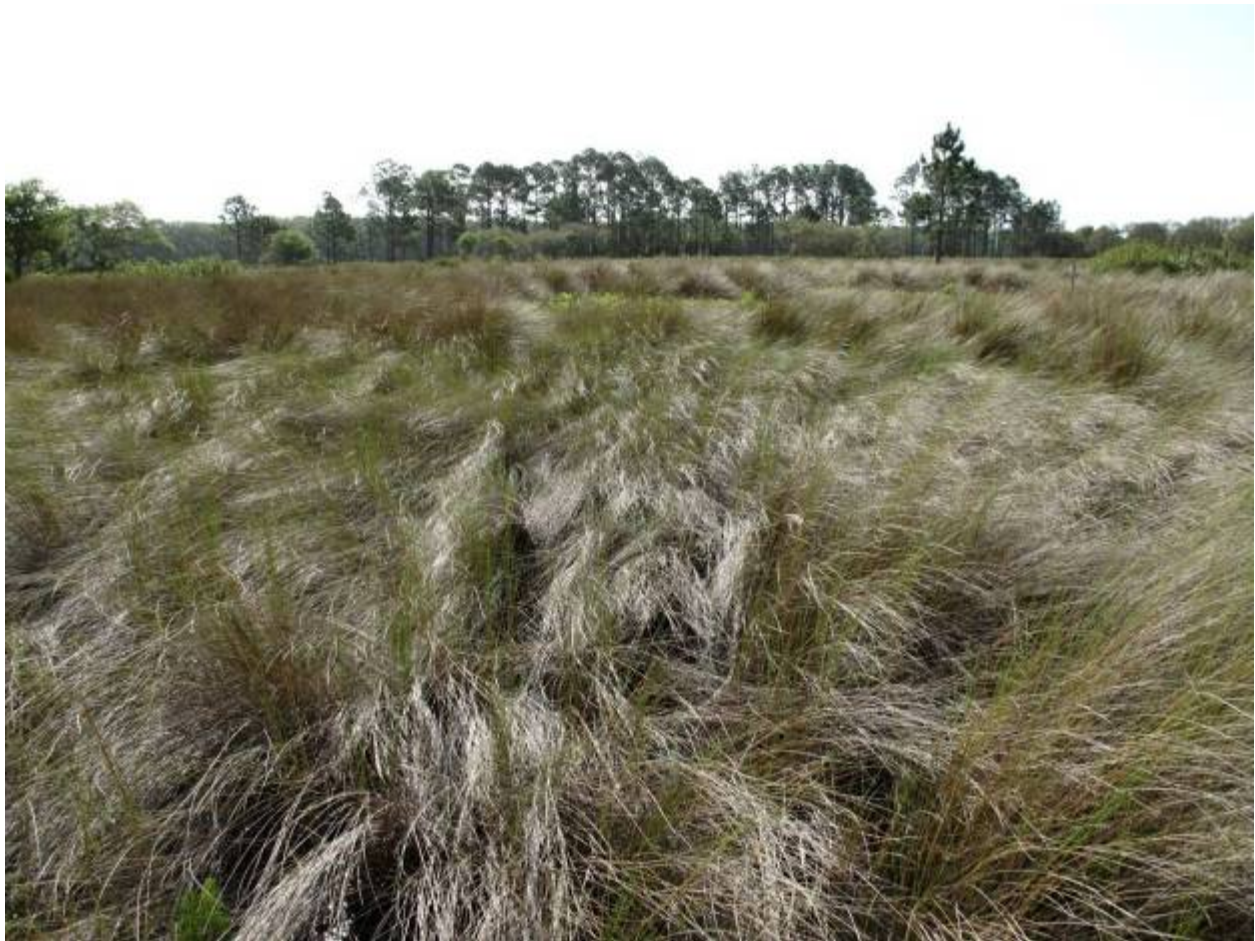
**Wetland ID: 55-02**

**Description:** This wetland is a 0.5 ha ephemeral marsh. There is no tree canopy or midstory cover. Sedges/grasses grow throughout the wetland, and cover >75% of the basin. This marsh is in fire-maintenance condition. The adjacent uplands are scrubby flatwoods.

**Wetland Disturbance:** None

**Restoration Action Recommended:** None
