Inventory, Assessment, and Restoration Potential of Ephemeral Wetlands on FFWCC Wildlife Management Areas

Half Moon WMA Final Report

Submitted by: Rebecca P.M. Means¹, Ryan C. Means¹, Steven A. Johnson²

¹Coastal Plains Institute

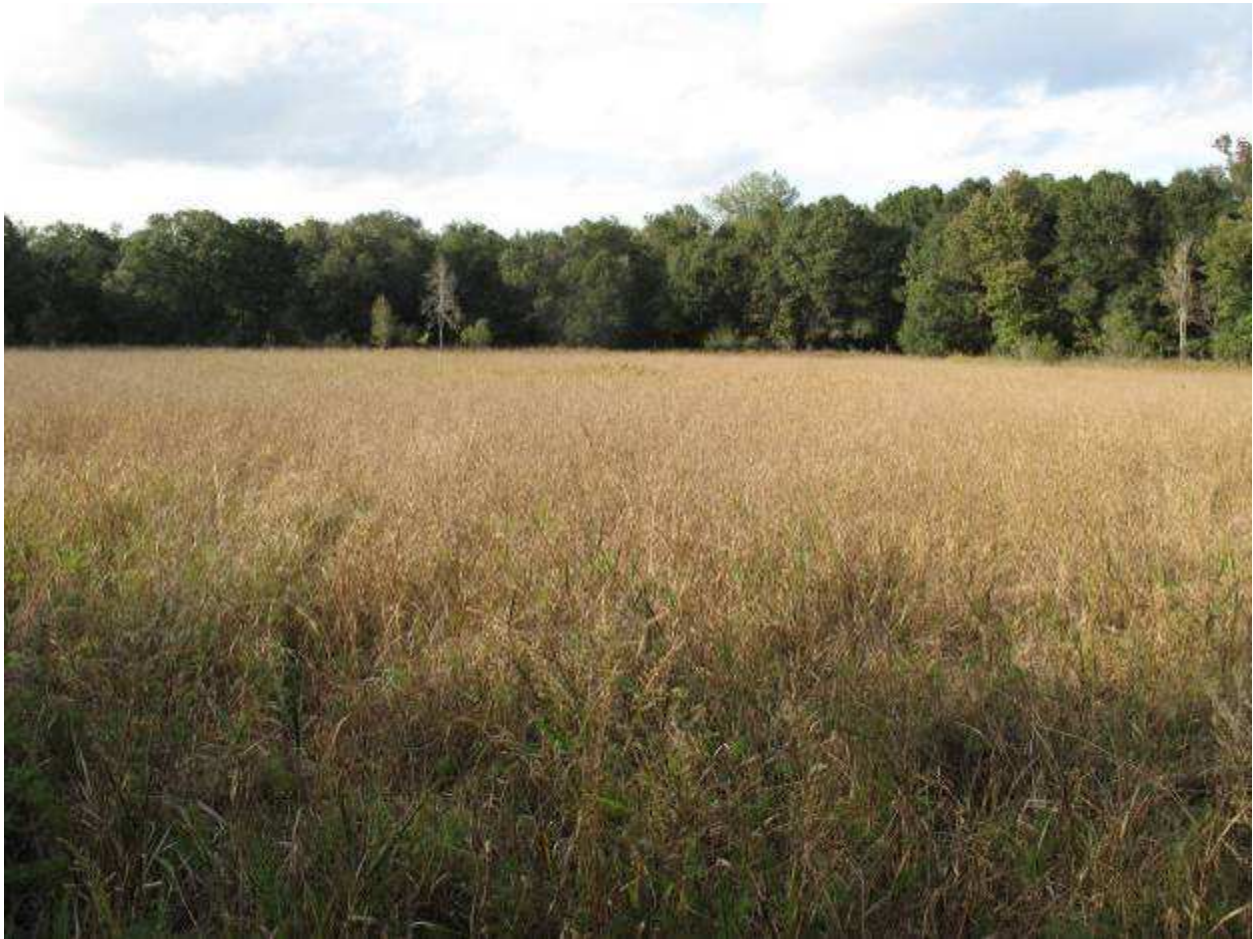
Wetland ID: 00-01

Description: This wetland is a 1.3 ha ephemeral marsh. There is no tree canopy or midstory cover. Sedges/grasses and maidencane grow throughout the wetland, and cover >75% of the basin. This wetland is a good example of an ecologically healthy marsh and is a potential striped newt breeding pond. The adjacent uplands are scrubby flatwoods and hardwood hammock. Cattle are allowed to graze in this unit but do not appear to have impacted this wetland significantly.

Wetland Concerns: Cattle

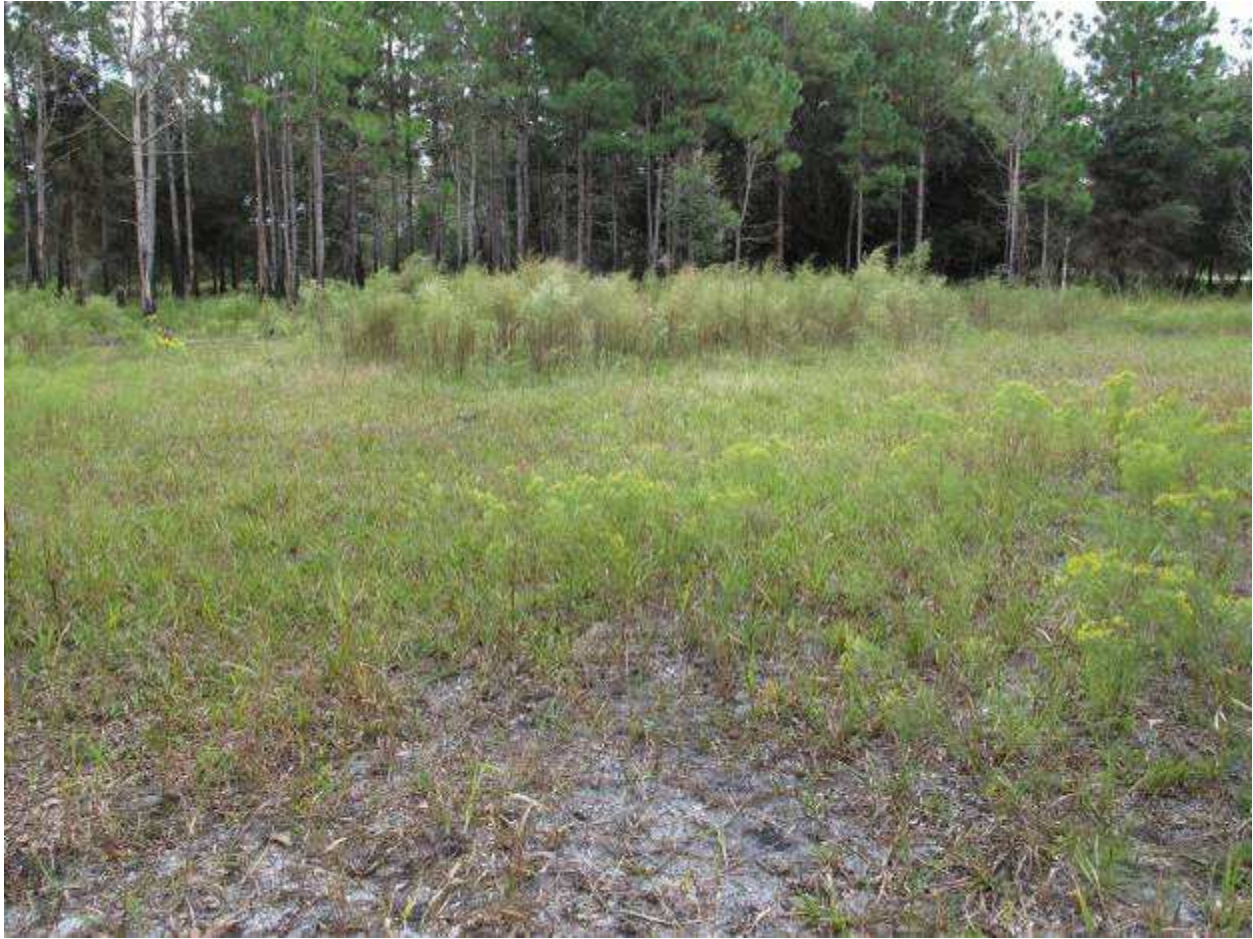
Wetland ID: 02-01

Description: This wetland is a 0.1 ha highly ephemeral marsh. There is no tree canopy or midstory cover. Sedges/grasses grow throughout the wetland, and cover >75% of the basin. This wetland does not have classic wetland plants but is a depression and will fill with water infrequently. Large pine trees form a ring around the wetland. The adjacent uplands are grazed pasture with oaks and pine, and are currently managed with prescribed fire and herbicide.

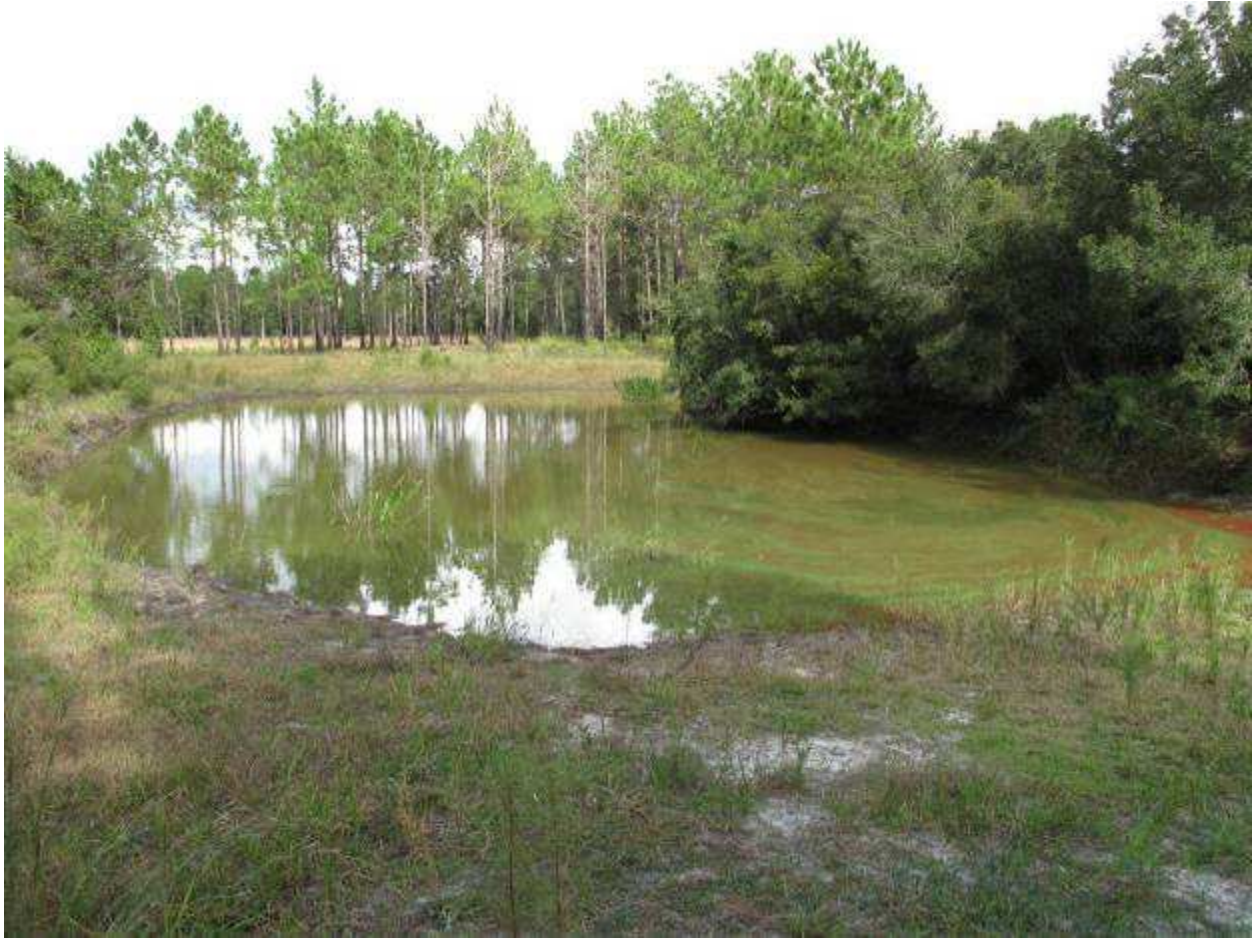
Wetland ID: 02-02

Description: This wetland is a 0.1 ha semi-permanent, dug-out cattle pond. There is no tree canopy or midstory cover. Sedges/grasses grow in a ring around the wetland edge, and cover 5-25% of the basin. A berm surrounds the pond. Cattle are impacting the wetland, as evidenced by the excess nutrient load. The adjacent uplands are pasture and sandhill, and are currently managed with prescribed fire and herbicide.

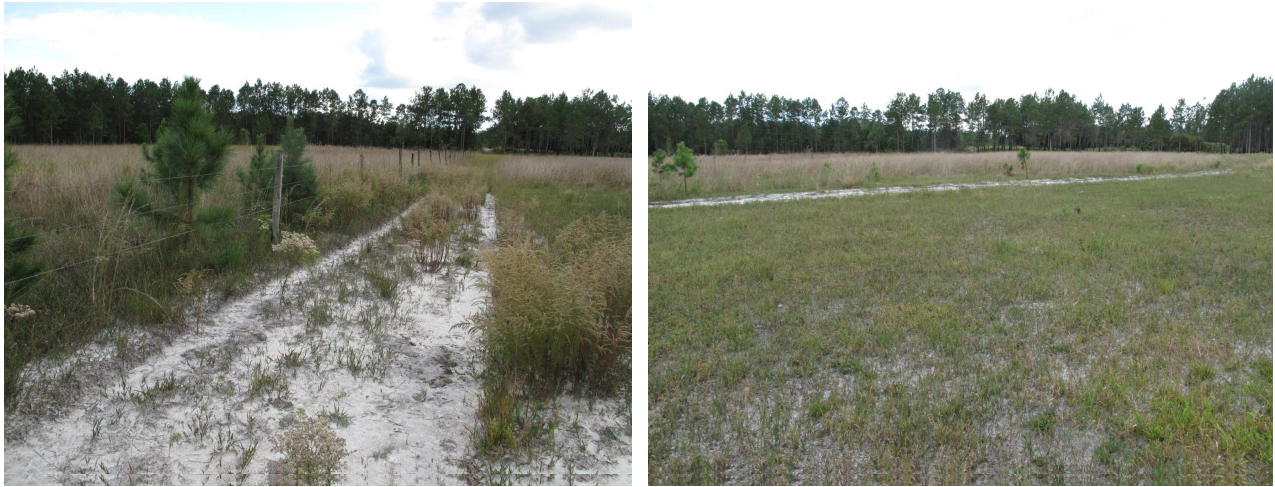
Wetland ID: 02-03

Description: This wetland is an 8.1 ha ephemeral marsh. A few small and large pine trees are growing in the wetland, but cover <5% of the basin. Sedges/grasses and maidencane grow throughout the wetland, and cover >75% of the basin. A property boundary with a fence and fireline bisect the wetland. There are cattle trails in the wetland. The adjacent uplands are pasture and sandhill, and are currently managed with prescribed fire and herbicide.

Wetland Concerns: Cattle, Fireline/private property boundary, Upland condition

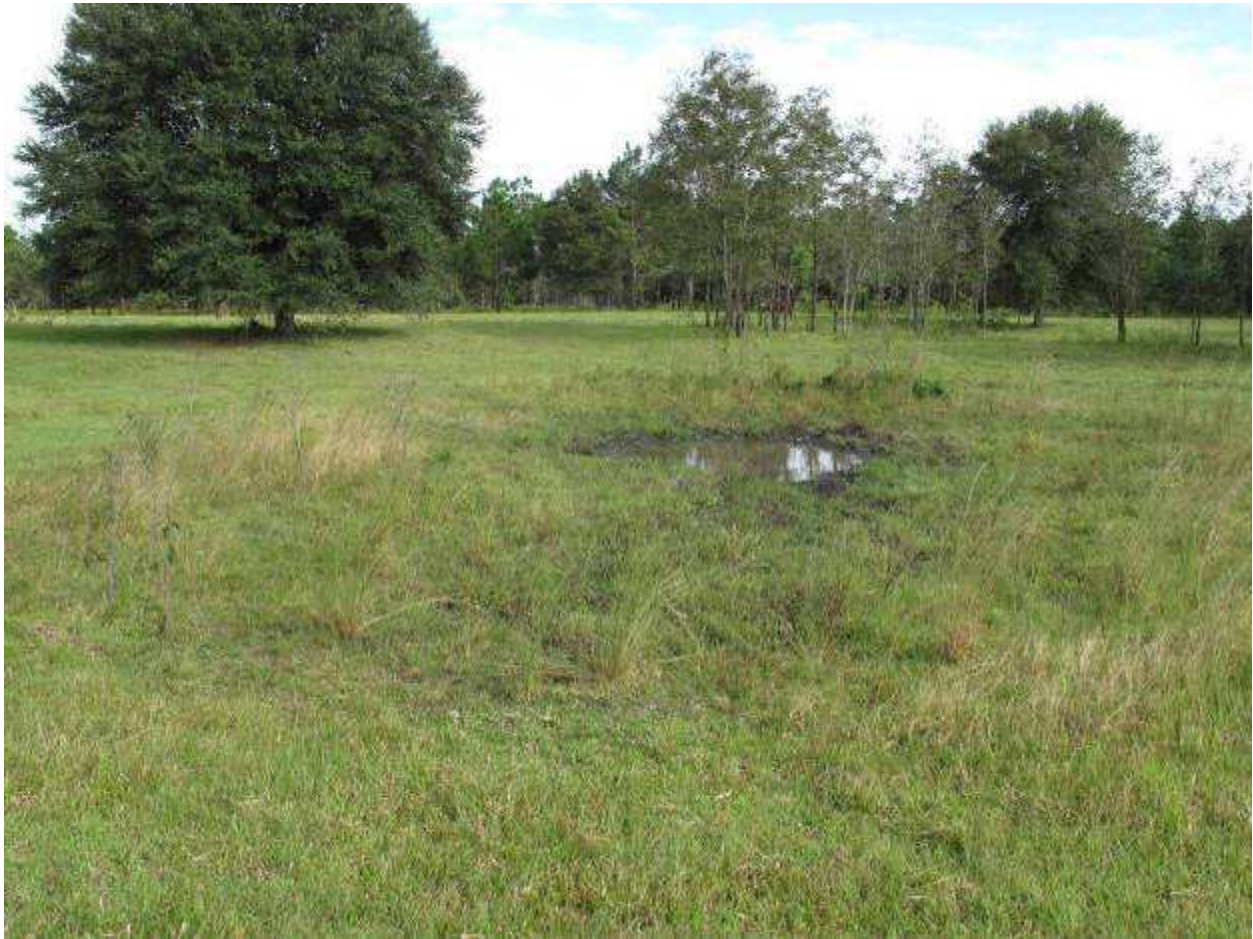
Wetland ID: 02-04

Description: This wetland is <0.1 ha ephemeral marsh. There is no tree canopy or midstory cover. Sedges/grasses and maidencane grow throughout, this herbaceous vegetation covers 50-75% of the wetland basin. This depressional marsh is over-utilized by cattle, as evidenced by the trampling of soil and vegetation and the nutrient pollution. The adjacent uplands are pasture and sandhill, and are currently managed with prescribed fire and herbicide.

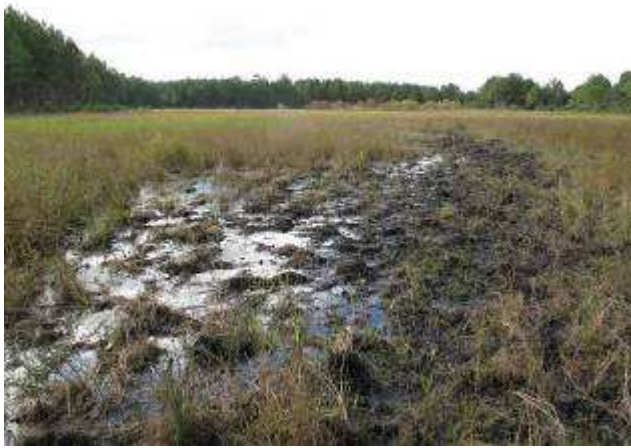
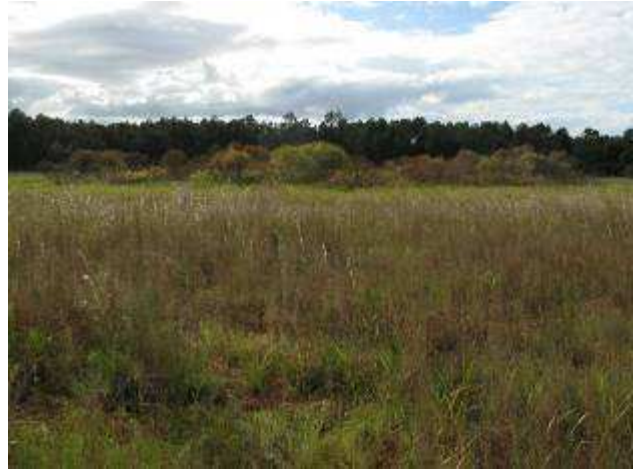
Wetland ID: 04-01

Description: This wetland is 6.1 ha semi-permanent marsh. Pine trees grow in a dense ring around the wetland, and cover 5-25% of the basin. Willow grow in the deeper wetland center, and cover 5-25% of the wetland. Sedges/grasses and maidencane grow throughout the wetland, and cover >75% of the basin. There is cattle and feral hog damage in the wetland. The adjacent uplands are pasture and sandhill with a dense palmetto ring. The uplands are currently managed with prescribed fire.

Wetland Concerns: Cattle, Feral hog damage, Upland condition, Woody encroachment

Restoration Action Recommended: Thin the dense ring of pine trees that grow around the wetland edge. In order to restore the full ecological potential of the wetland, the cattle would need to be removed and the uplands restored.

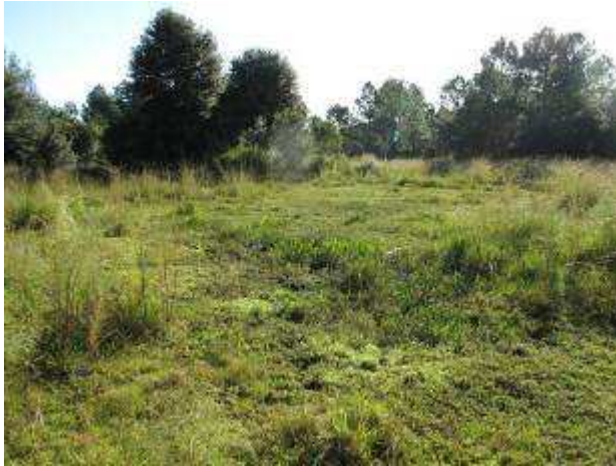
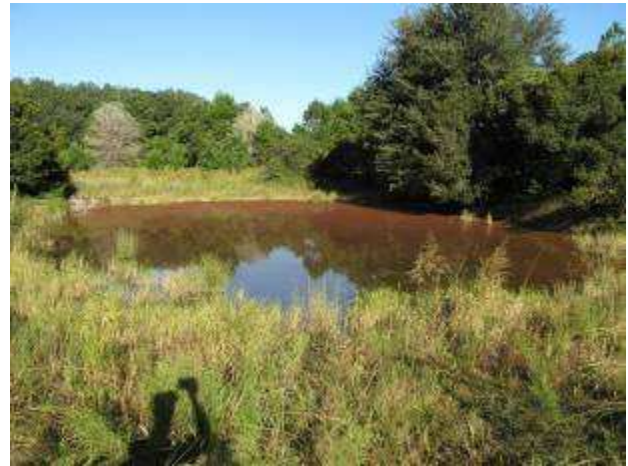
Wetland ID: 04-02

Description: This wetland is a 0.5 ha ephemeral marsh with a semi-permanent dug-out. There is no tree canopy or midstory cover. Sedges/grasses and maidencane grow throughout the wetland, and cover >75% of the basin. The north side of the wetland has been dug-out, likely to provide water for cattle. This deeper section of the wetland has high levels of nutrients and is surrounded by a tall berm. The adjacent uplands are pasture and old field, and are currently managed with prescribed fire.

Wetland Concerns: Berm, Cattle, Dug-out, Upland condition

Restoration Action Recommended: Remove the berm and fill in the dug-out. In order to restore the full ecological potential of the wetland, the cattle would need to be removed and the uplands restored.

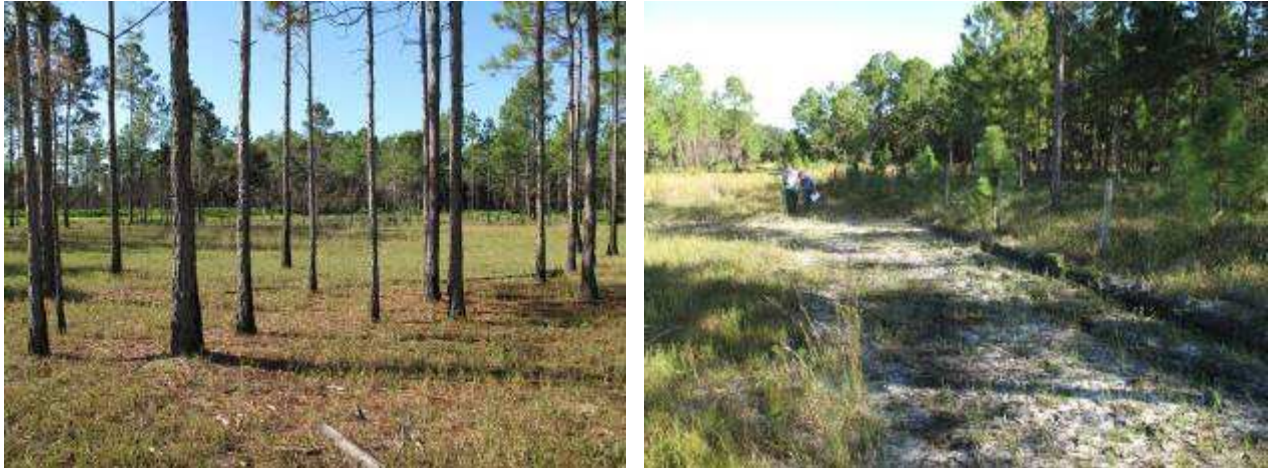
Wetland ID: 04-03

Description: This wetland is a 0.6 ha ephemeral marsh. Pine trees form a ring around the wetland, and cover 5-25% of the basin. There is no midstory layer. Sedges/grasses and maidencane grow throughout the wetland, and cover >75% of the basin. A fireline/private property boundary bisects the western side of the wetland. Some small pine trees were killed by a recent fire in the wetland basin; a few small pine trees remain. Cattle have grazed the herbaceous vegetation in the wetland. The adjacent uplands are pasture and old field, and are currently managed with prescribed fire.

Wetland Concerns: Cattle, Fireline/private property boundary, Upland condition, Woody encroachment

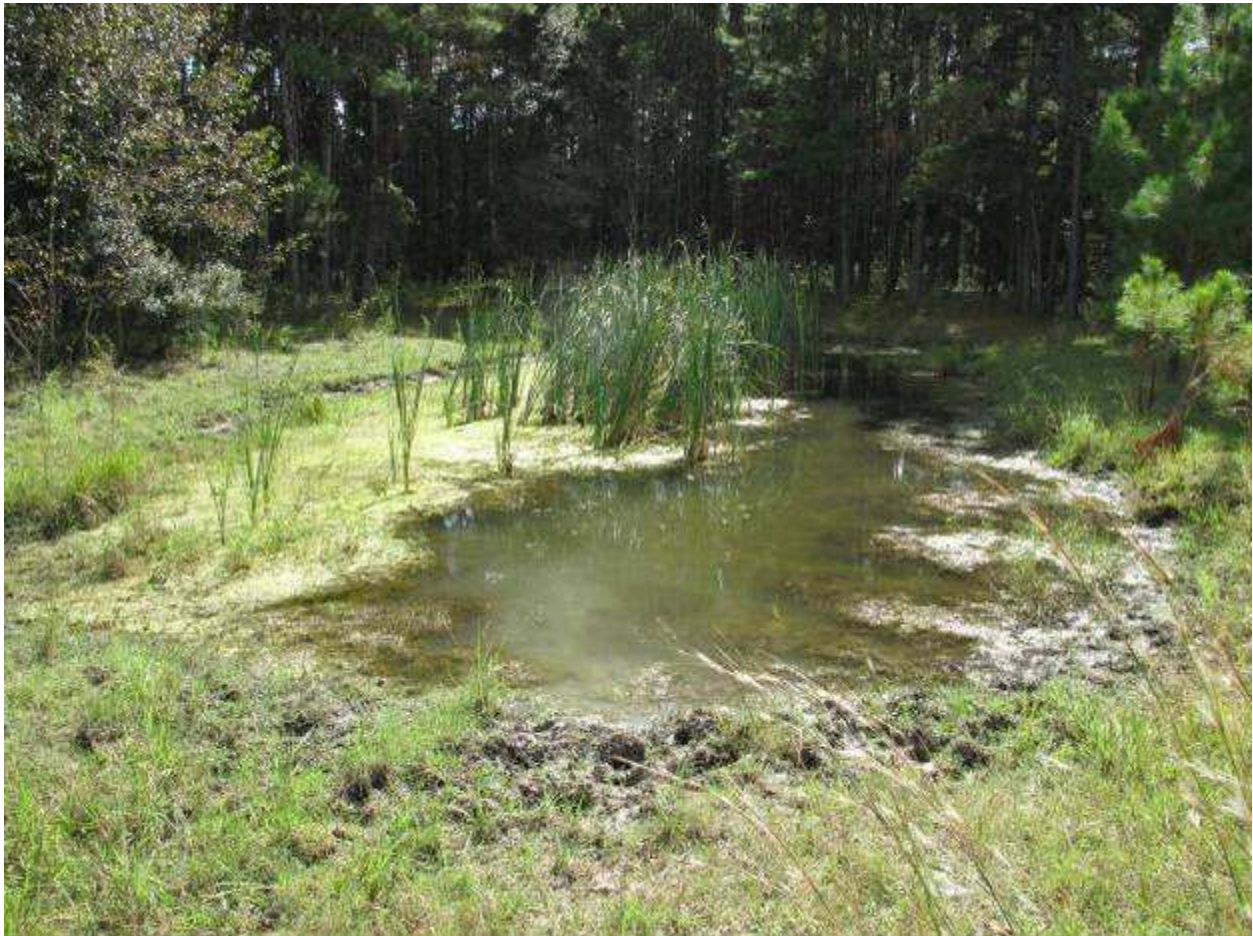
Wetland ID: 05-01

Description: This wetland is a <0.1 ha semi-permanent, dug-out cattle pond. There is no tree canopy or midstory cover. Emergent vegetation grows in a ring around the edge of the wetland and cattails grow in the wetland center. The herbaceous vegetation covers 25-50% of the wetland basin. The pond is over-utilized by cattle, as evidenced by the trampling of soil and vegetation and the nutrient pollution. The adjacent uplands are pasture and old field and grazed pineland.

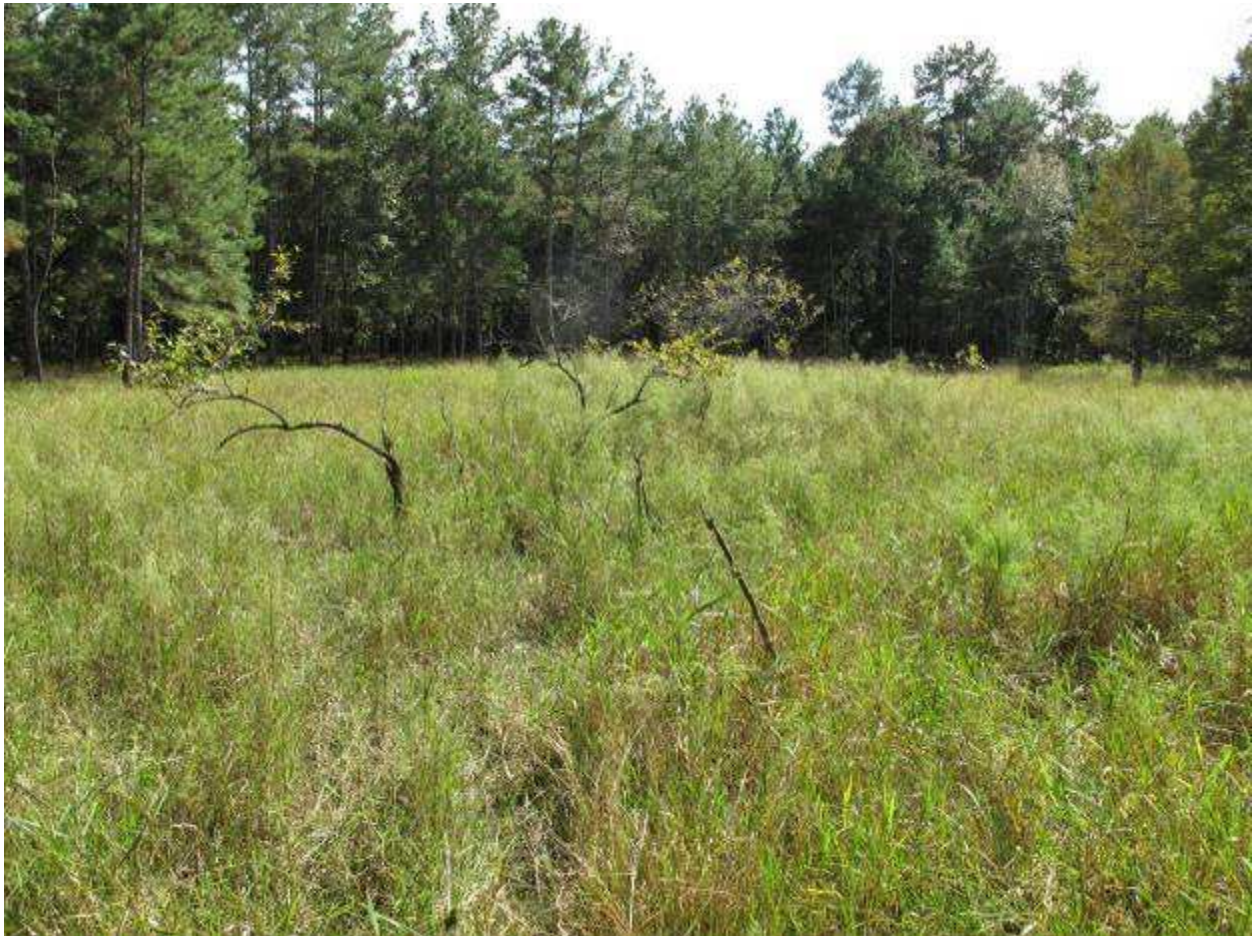
Description: This wetland is a 0.5 ha ephemeral marsh. Pine trees grow in a ring around the wetland and large oaks lean over the wetland edge. The tree canopy covers 5-25% of the wetland basin. A few small pine and gum trees grow throughout the basin but cover <5% of the wetland. Maidencane grows throughout the wetland, and covers >75% of the basin. The cattle impact is minor. A fenceline bisects the southwest corner of the wetland. The adjacent uplands are pasture and old field and grazed pineland.

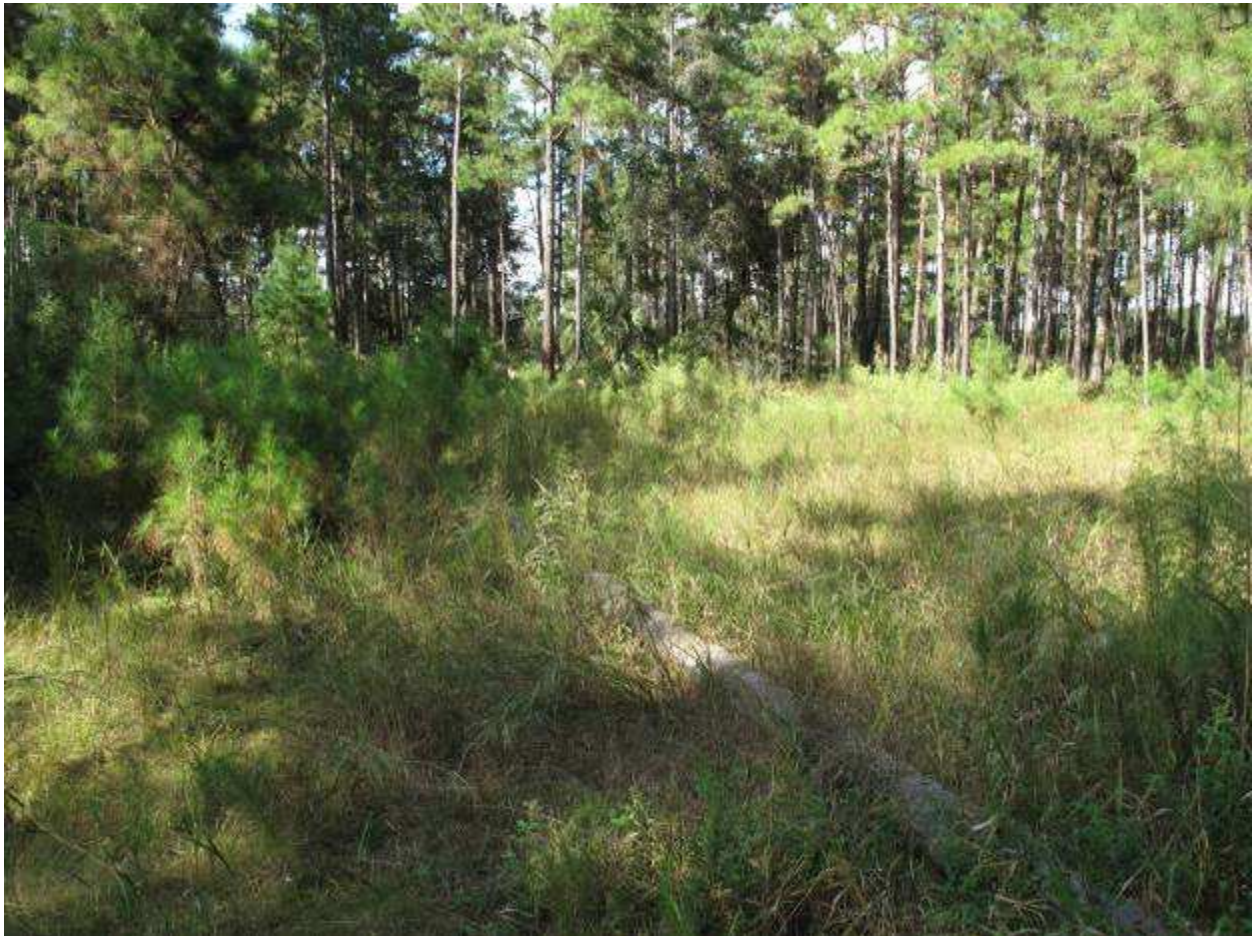
Description: This wetland is a 0.1 ha ephemeral marsh. Large and small pine trees surround the marsh, and cover 5-25% of the wetland basin. Maidencane and sedges/grasses grow throughout the wetland, and cover >75% of the basin. There is some evidence of grazing in and around the wetland. The adjacent uplands are pasture and old field and grazed pineland.

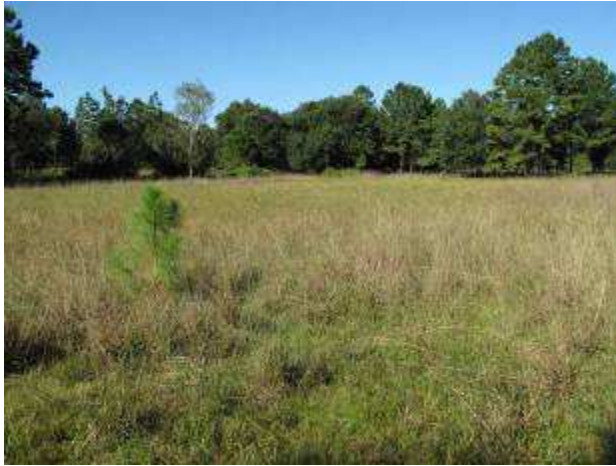
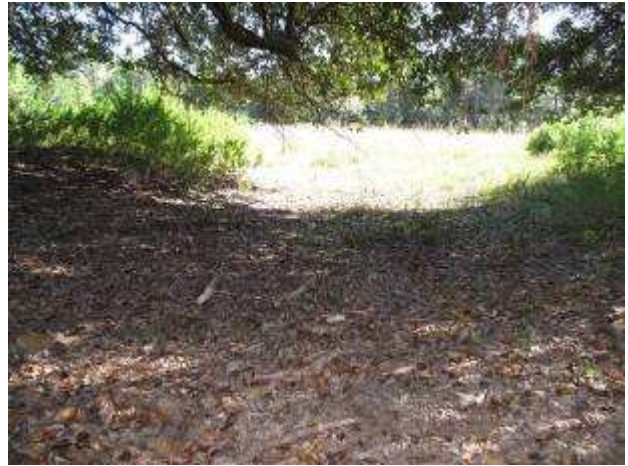
Wetland ID: 06-01

Description: This wetland is a 0.7 ha ephemeral marsh. Pine trees grow in a stand at the south end of the wetland, and cover 5-25% of the wetland basin. Small pine trees are encroaching from the edge of the wetland but cover <5% of the wetland. Maidencane and sedges/grasses grow throughout the wetland, and cover >75% of the basin. There is a ditch connected to the northwest corner of the wetland. The adjacent uplands are pasture and old field.

Wetland Concerns: Cattle, Ditching, Upland condition, Woody encroachment

Restoration Action Recommended: Fill the ditch to break connectivity with the wetland. Alternatively, the ditch could be plugged and vegetation allowed to regenerate. Remove or thin pine stand. Encourage fire in the wetland basin. Monitor the wetland to ensure encroaching pine trees are killed with the next fire or inundation. If they become established, the pine trees will need to be removed from the wetland. Alternatively, the small pine trees can be hand-chopped now. While cattle have not yet impacted the wetland, if they are present in the MU, they are a potential future threat. In order to restore the full ecological potential of the wetland, the cattle would need to be removed and the uplands restored.

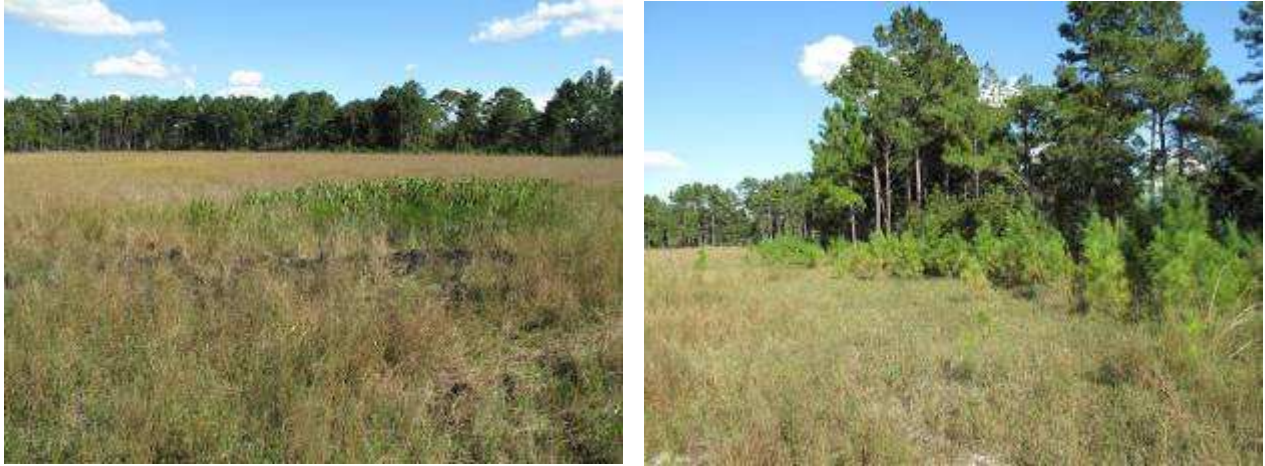
Wetland ID: 06-02

Description: This wetland is a 3.4 ha semi-permanent marsh. Pine trees grow around the wetland edge, and cover 5-25% of the wetland basin. Small pine trees are encroaching from the edge of the wetland but cover <5% of the wetland. Maidencane, sedges/grasses, and emergent vegetation grow throughout the wetland, and cover >75% of the basin. There is a ditch connected to the south side of the wetland. Cattle grazing and feral hog damage is light. The adjacent uplands are pasture and old field.

Wetland Concerns: Cattle, Ditching, Feral hog damage, Upland condition, Woody encroachment

Restoration Action Recommended: Fill the ditch to break connectivity with the wetland. Alternatively, the ditch could be plugged and vegetation allowed to regenerate. Encourage fire in the wetland basin. Monitor the wetland to ensure encroaching pine trees are killed with the next fire or inundation. If they become established, the pine trees will need to be removed from the wetland. Alternatively, the small pine trees can be hand-chopped now. In order to restore the full ecological potential of the wetland, the cattle would need to be removed and the uplands restored.

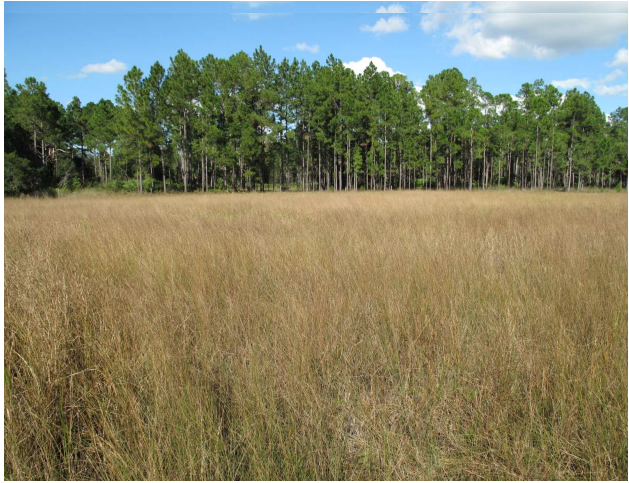
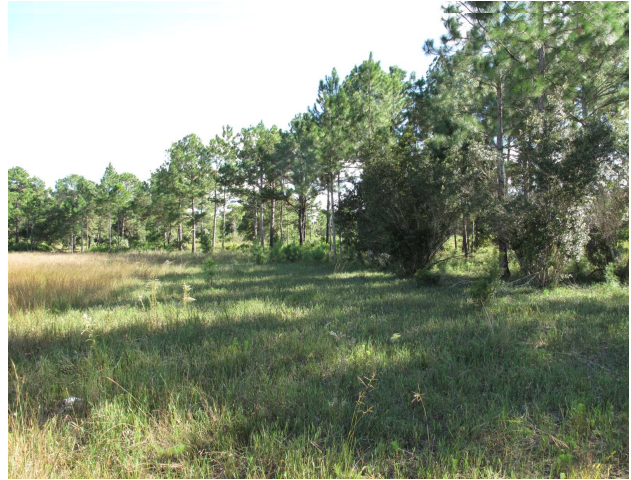
Wetland ID: 06-03

Description: This wetland is a 1.4 ha ephemeral marsh. Large and small pine trees, and a few wax myrtles, are encroaching from the edge of the wetland, especially along the west side. The tree canopy covers 5-25% of the wetland basin. There is no significant midstory cover. Maidencane and sedges/grasses grow throughout the wetland, and cover >75% of the basin. The adjacent uplands are pasture and old field.

Wetland Concerns: Cattle, Upland condition, Woody encroachment

Restoration Action Recommended: Monitor the wetland to ensure encroaching woody vegetation is killed with the next fire or inundation. If they become established, the pine trees and wax myrtle will need to be removed from the wetland. Alternatively, the encroaching vegetation can be hand-chopped now. While cattle have not yet impacted the wetland, if they are present in the MU, they are a potential future threat. In order to restore the full ecological potential of the wetland, the cattle would need to be removed and the uplands restored.

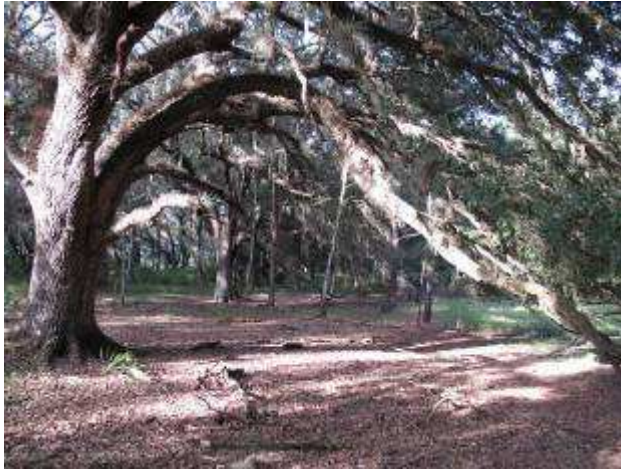
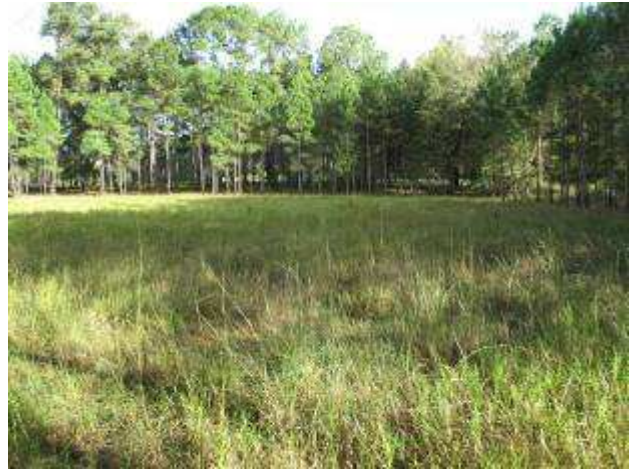
Wetland ID: 07-01

Description: This wetland is a 0.4 ha ephemeral marsh. Pine trees grow in a ring around the wetland and large oak trees lean into the edge of the wetland. The tree canopy covers 5-25% of the wetland basin. There is no midstory cover. Maidencane grows throughout and covers >75% of the wetland basin. There is evidence of cattle in the wetland basin. The adjacent uplands are oak hammock and pasture.

Wetland Concerns: Cattle, Upland condition, Woody encroachment

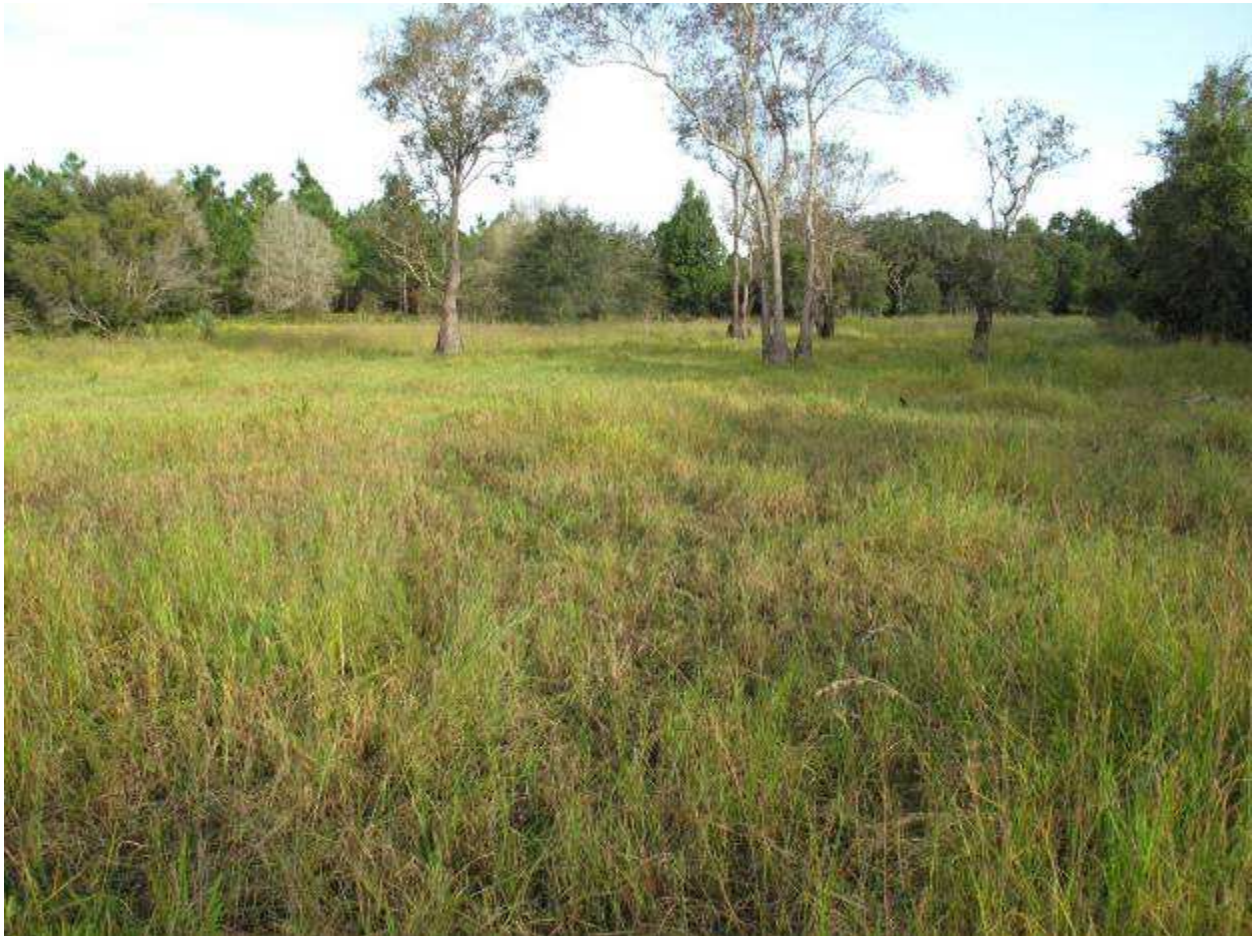
Description: This wetland is a 0.4 ha ephemeral marsh. There is no tree canopy or midstory cover. Maidencane and sedges/grasses grow throughout the wetland, and cover >75% of the basin. Cattle are grazing in the wetland, although the impact is light. The adjacent uplands are old field and pasture.

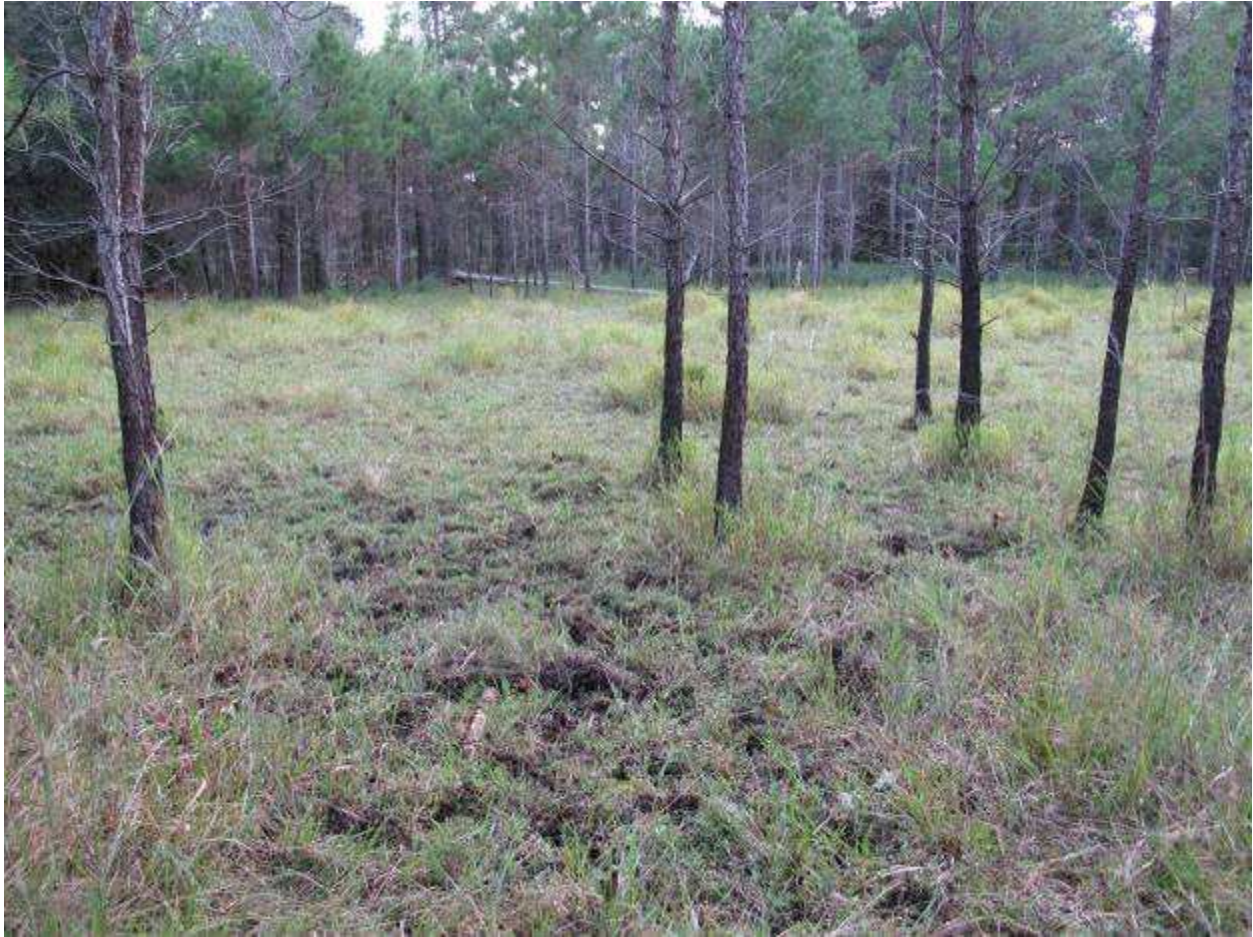
Description: This wetland is a 0.2 ha ephemeral marsh. There is an extensive pine ring around the wetland and large pine trees growing in the center of the wetland. The tree canopy covers 5-25% of the wetland. There is no midstory layer. Maidencane and emergent vegetation grow throughout the wetland, and cover >75% of the basin. A recent fire burned all the way through the wetland. Cattle are grazing in the wetland interior. The adjacent uplands are old field and pasture.

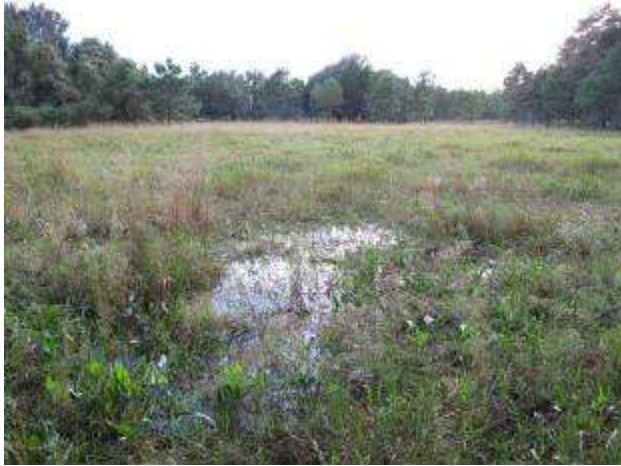
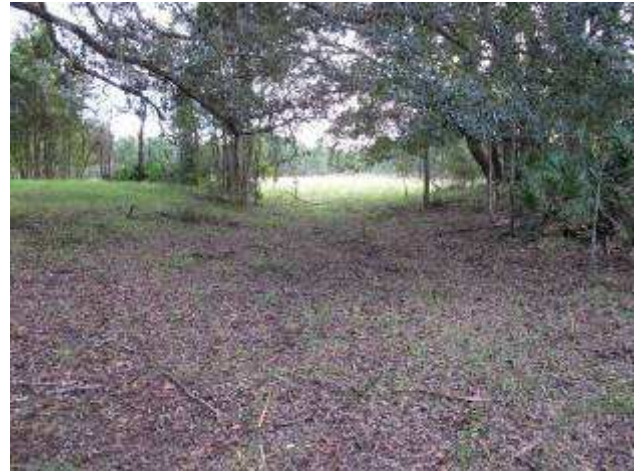
Wetland ID: 07-04

Description: This wetland is a 0.8 ha ephemeral marsh. There is no tree canopy or midstory layer. Maidencane and emergent vegetation grow throughout the wetland, and cover >75% of the basin. There is a ditch connected to the northeast side of the wetland. This large marsh has diverse herbaceous vegetation, although plants have grazed tips. A pine ring in the upland surrounds the wetland but is not yet encroaching into the basin. The adjacent uplands are old field and pasture.

Wetland Concerns: Cattle, Ditch, Upland condition

Restoration Action Recommended: Fill the ditch to break connectivity with the wetland. Alternatively, the ditch could be plugged and vegetation allowed to regenerate. In order to restore the full ecological potential of the wetland, the cattle would need to be removed and the uplands restored. The pine ring in the uplands could be removed during upland restoration efforts. The pine trees are not yet encroaching into the wetland basin but may potentially do so in the future.

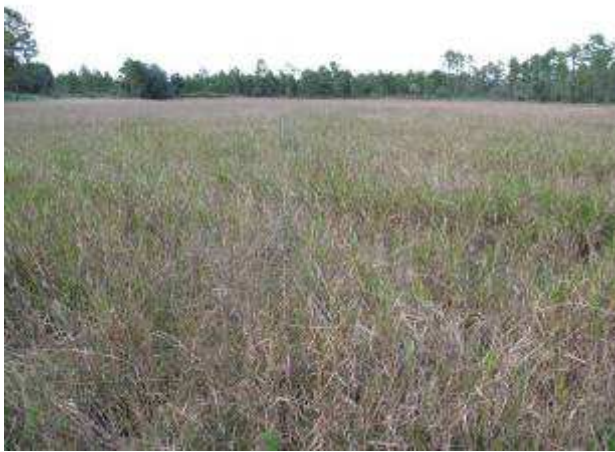
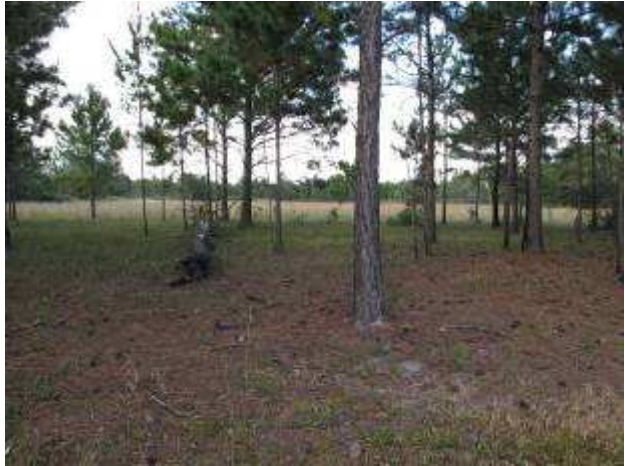
Wetland ID: 08-01

Description: This wetland is a 3.5 ha ephemeral marsh. Pine trees grow on a land ridge that bisects the wetland. A few pine trees also are encroaching from around the wetland edges. The tree canopy covers 5-25% of the wetland basin. There is no midstory layer. Maidencane and sedges/grasses grow throughout the wetland, and cover >75% of the basin. Feral hog and cattle impacts are minor. The marsh is large and open and in relatively good ecological condition. The wetland is surrounded by a dense palmetto ring and grazed uplands.

Wetland Concerns: Cattle, Feral hog damage, Upland condition, Woody encroachment

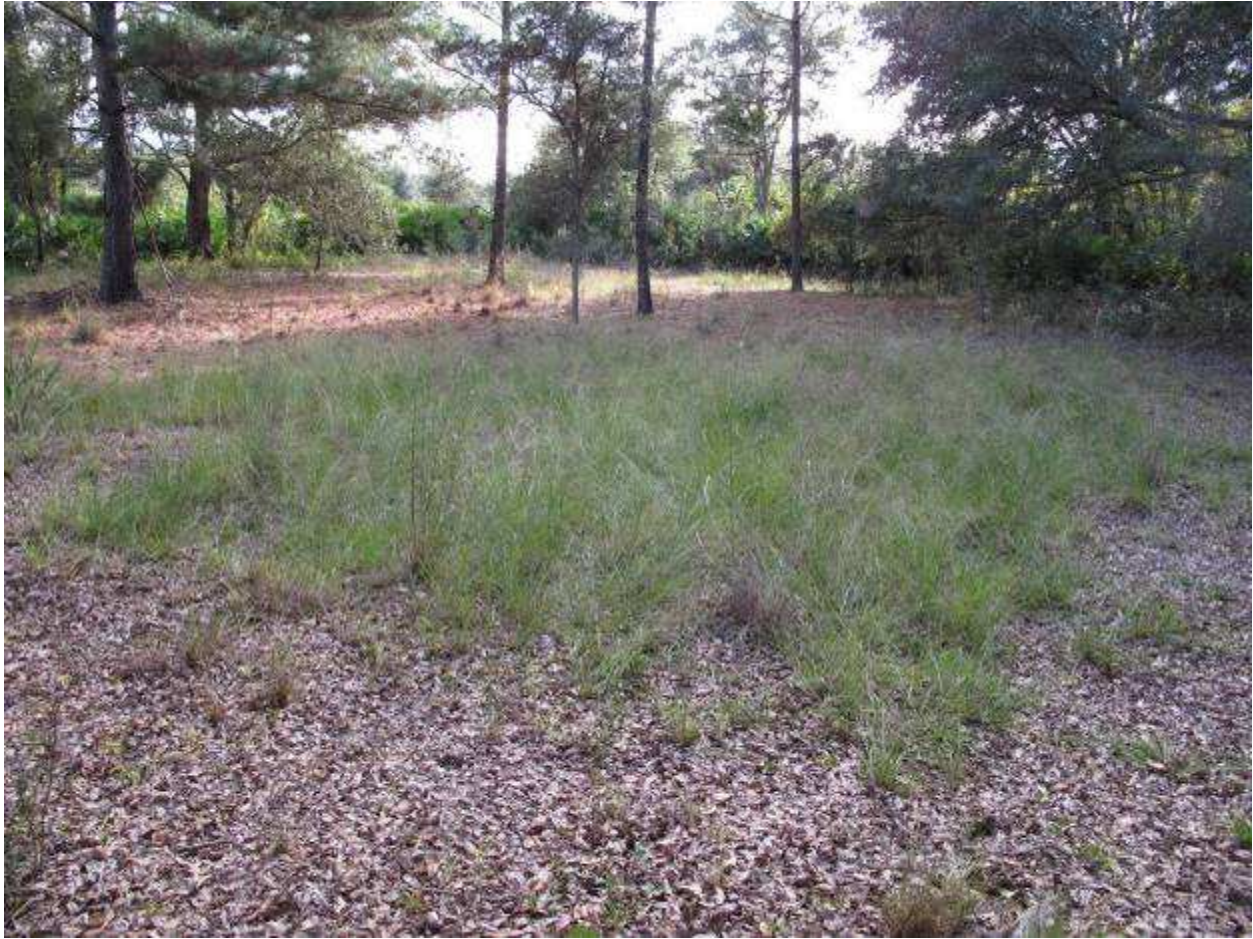
Description: This wetland is a 0.1 ha highly ephemeral marsh. Large pine trees grow in the wetland basin and live oak trees hang partially over the wetland. The tree canopy covers 25-50% of the wetland. There is no midstory layer. Sedges/grasses grow in the wetland center, and cover 25-50% of the basin. The wetland is surrounded by an extremely dense palmetto ring and grazed uplands.

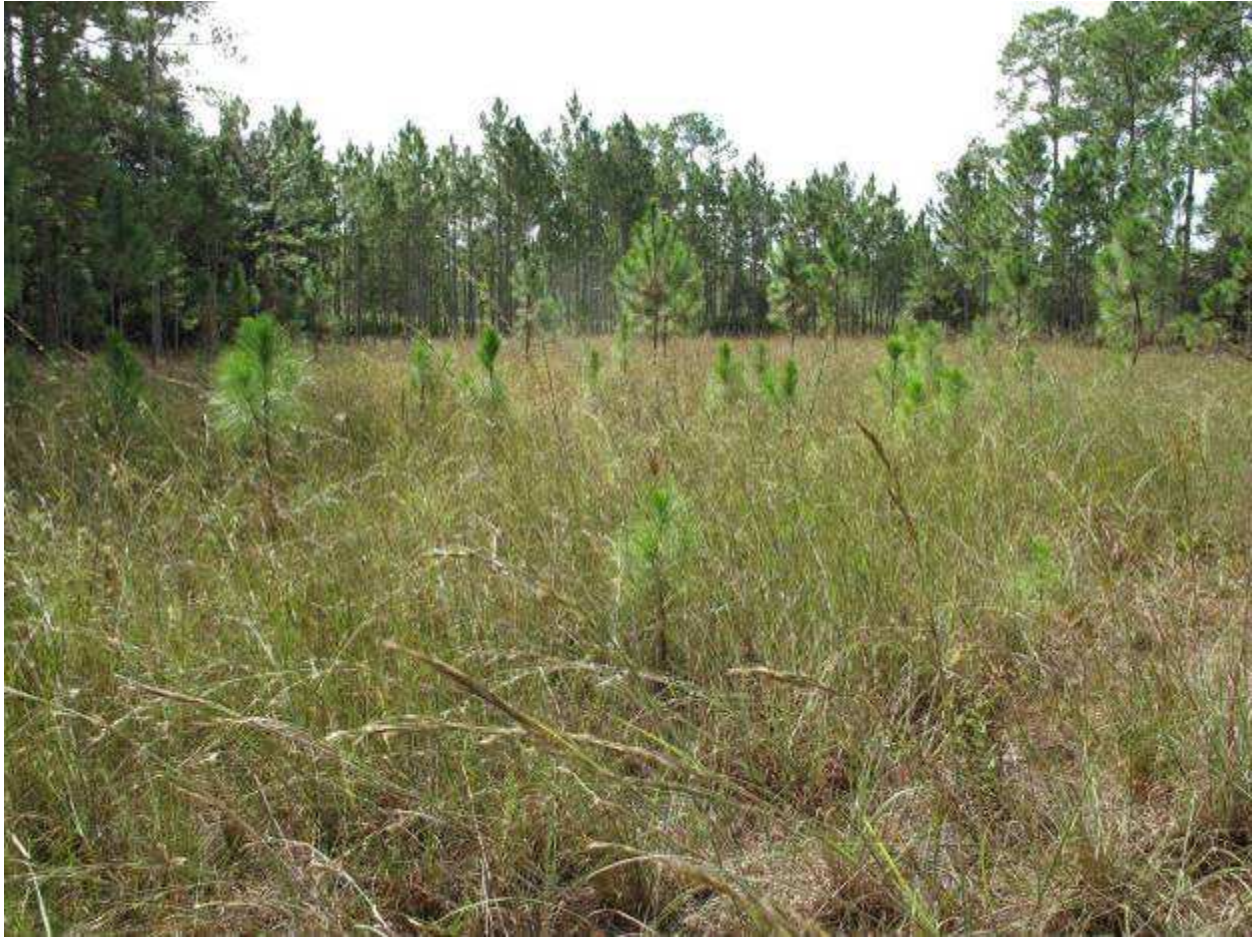
Description: This wetland is a 0.3 ha ephemeral marsh. This depression marsh is extensively encroached by pine trees. Small pine trees are scattered throughout the wetland interior, and the needle fall and shading from the pine ring hinder herbaceous vegetation growth. Large pine trees grow in a ring around the wetland and cover 25-50% of the wetland basin. There is no midstory layer. Sedges/grasses and maidencane grow throughout the wetland, and cover >75% of the basin. The wetland is surrounded by a dense brush ring and scrubby flatwoods. The uplands appear to have been fire suppressed but now are managed with prescribed fire and mechanical vegetation removal.
