Inventory, Assessment, and Restoration Potential of Ephemeral Wetlands on FFWCC Wildlife Management Areas

Half Moon WMA Final Report

Submitted by: Rebecca P.M. Means¹, Ryan C. Means¹, Steven A. Johnson²

¹Coastal Plains Institute

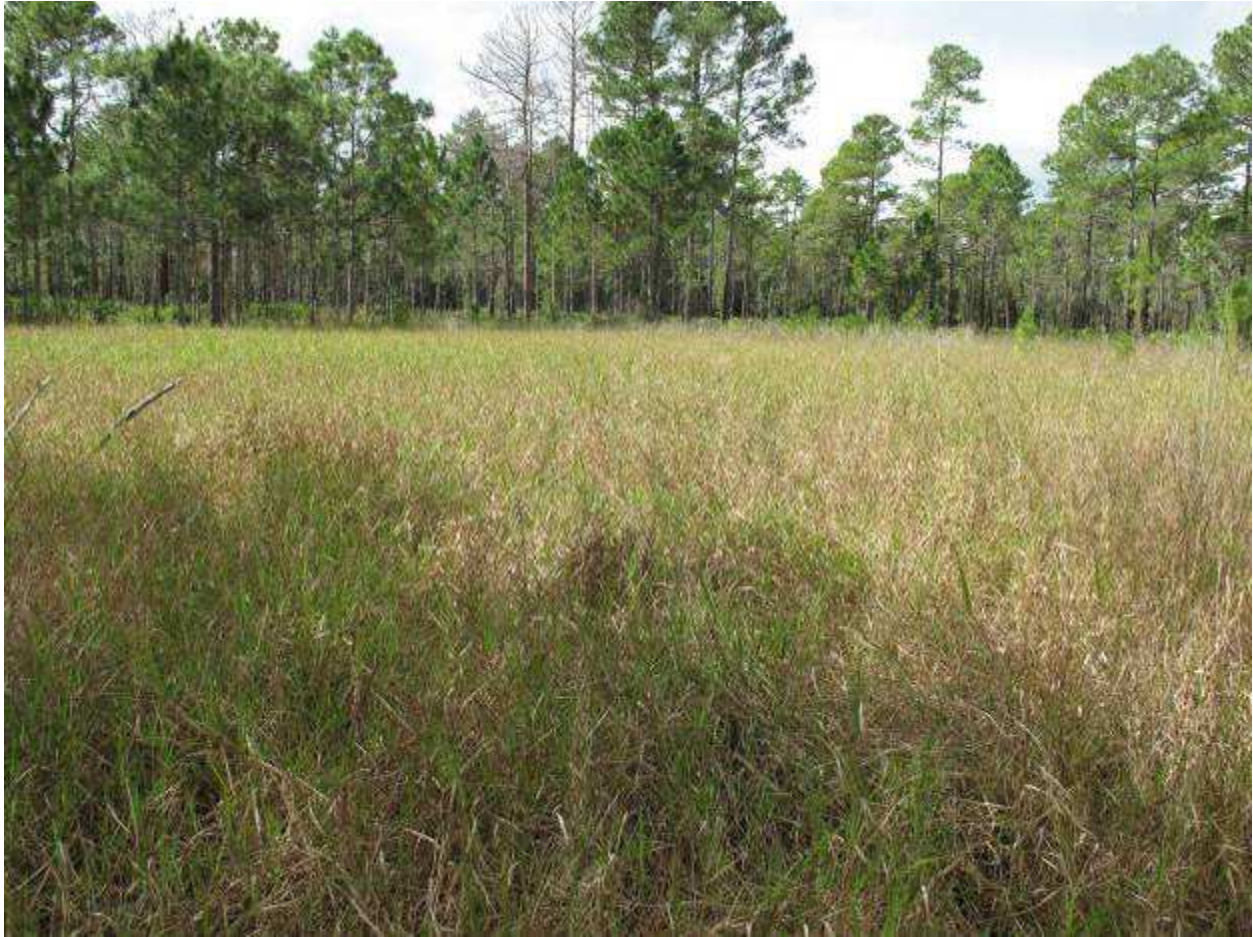
Description: This wetland is a 0.6 ha ephemeral marsh. Large pine trees grow in a loose ring around the wetland and cover 5-25% of the wetland basin. There is no midstory layer. Sedges/grasses and maidencane grow throughout the wetland, and cover >75% of the basin. Feral hog damage is patchy. The adjacent uplands are scrubby flatwoods. The flatwoods appear to have been fire suppressed but now are managed with prescribed fire and mechanical vegetation removal.

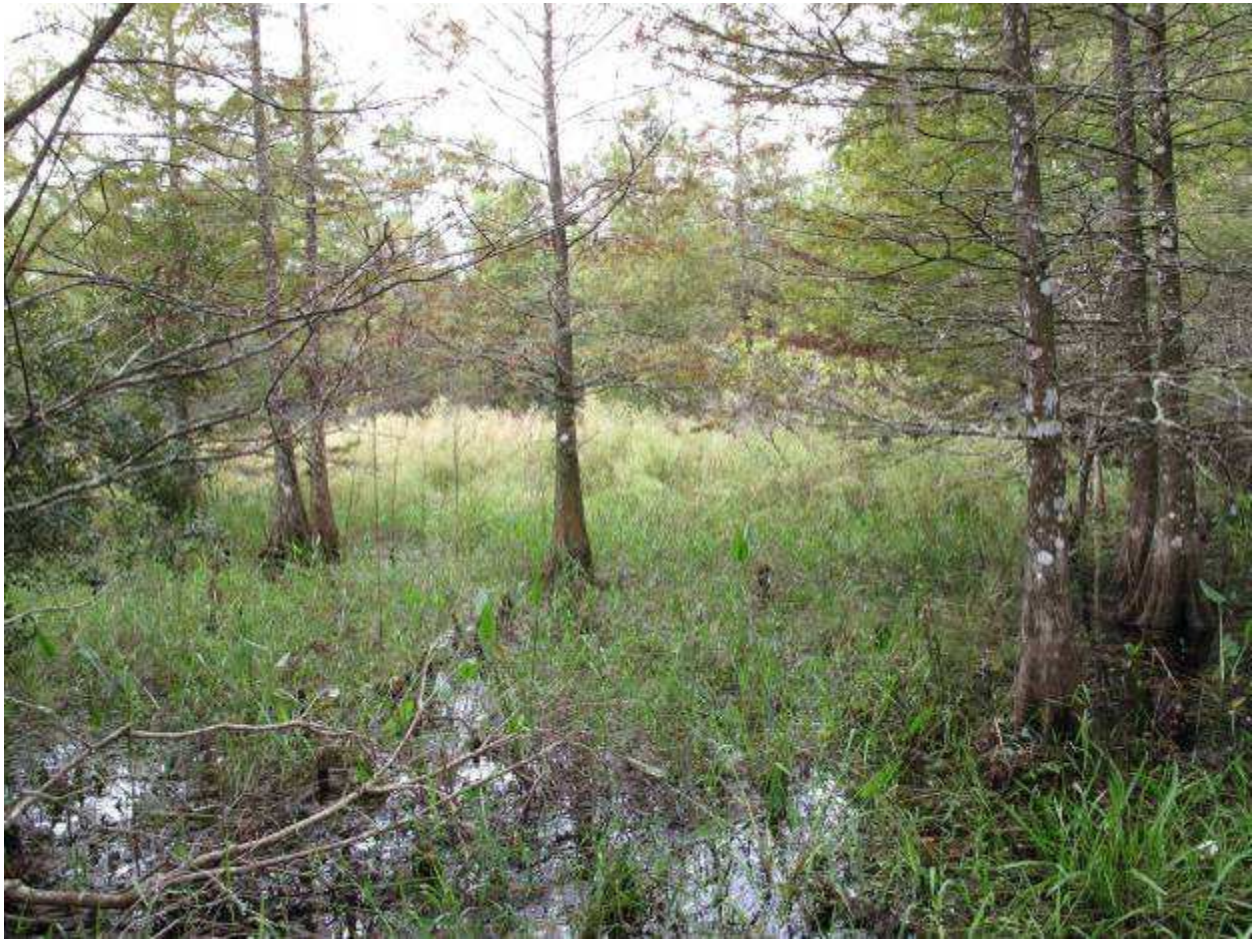
Description: This wetland is a 0.4 ha semi-permanent mixed swamp. Cypress trees dominate the canopy, and cover 50-75% of the wetland basin. The midstory is dominated by wax myrtle, and covers 50-75% of the wetland. Maidencane and emergent vegetation grow in scattered patches, and cover 25-50% of the wetland basin. This wetland appears to be a former marsh is succeeding into a swamp. The wetland has a marsh area on the south side. The adjacent uplands are scrubby flatwoods. The flatwoods appear to have been fire suppressed but now are managed with prescribed fire and mechanical vegetation removal.

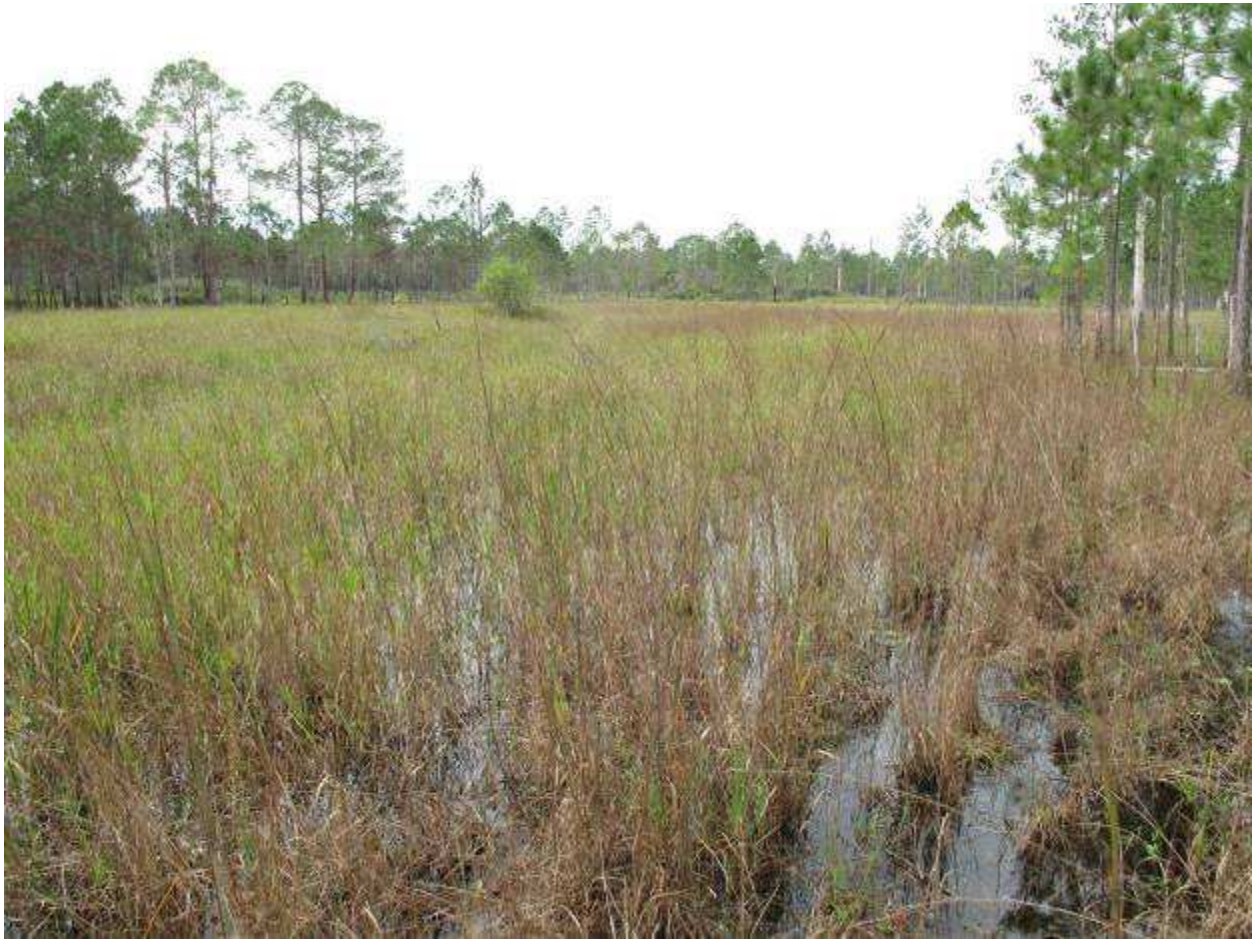
Description: This wetland is a 3.5 ha ephemeral marsh. Pine trees grow in a ring around the wetland and cover 5-25% of the basin. There is no midstory layer. Sedges/grasses and maidencane grow throughout the wetland, and cover >75% of the basin. There is evidence of fire in this large, L-shaped wetland. This marsh will connect with 10-02 during periods of high water. The wetlands are separated by a pine-encroached ridge. The adjacent uplands are mesic flatwoods managed with prescribed fire and mechanical vegetation removal.

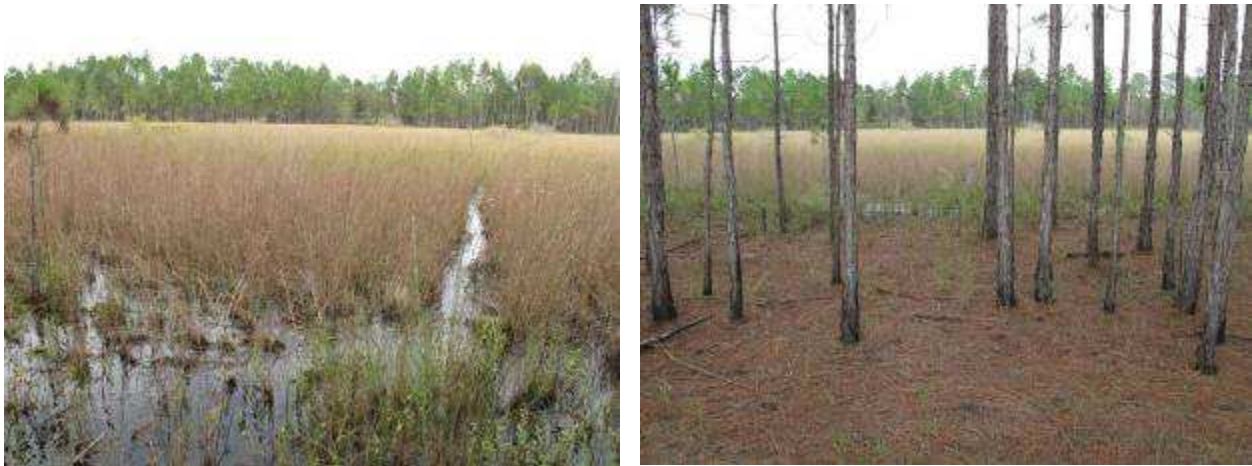
Wetland ID: 10-02

Description: This wetland is a 2.2 ha ephemeral marsh. Pine trees grow in a ring around the wetland and cover 5-25% of the basin. There is no midstory layer. Sedges/grasses and maidencane grow throughout the wetland, and cover >75% of the basin. This marsh will connect with 10-01 to the southwest and 10-03 to the southeast during periods of high water. The wetlands are separated by a pine-encroached ridge. A recent fire killed many pine trees but many still remain. The adjacent uplands are mesic flatwoods managed with prescribed fire and mechanical vegetation removal.

Wetland Concerns: Woody encroachment

Restoration Action Recommended: Thin pine trees around the wetland and growing on the ridge.

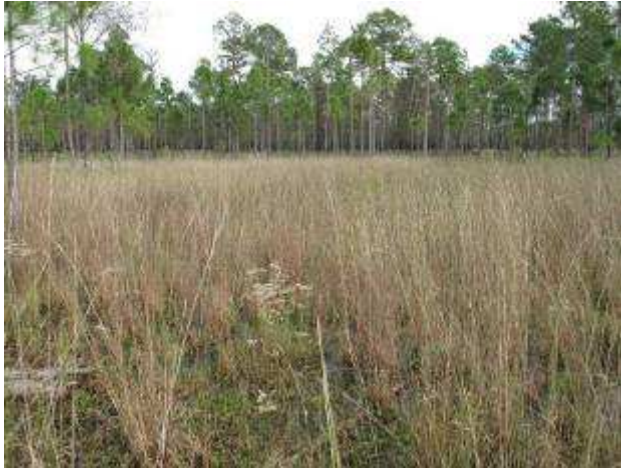
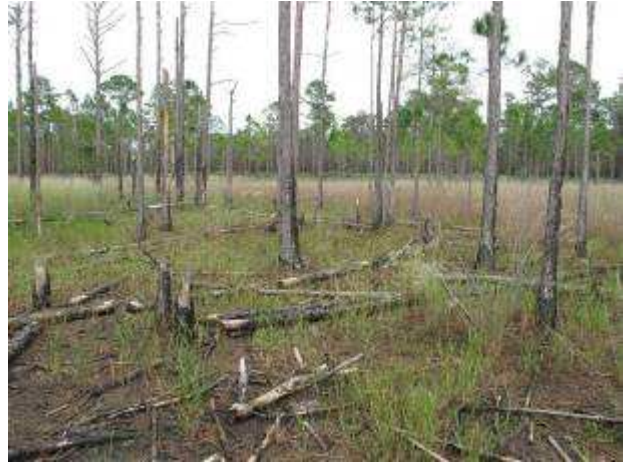
Wetland ID: 10-03

Description: This wetland is a 0.4 ha ephemeral marsh. Pine trees grow in a loose ring around the wetland and cover 5-25% of the basin. There is no midstory layer. Sedges/grasses and maidencane grow throughout the wetland, and cover >75% of the basin. A recent fire killed half of the encroaching pine trees. The southwest corner of this wetland will connect with 10-02 during periods of high water. The adjacent uplands are mesic flatwoods managed with prescribed fire and mechanical vegetation removal.

Wetland Concerns: Woody encroachment

Restoration Action Recommended: Thin remaining pine trees to the palmetto line.

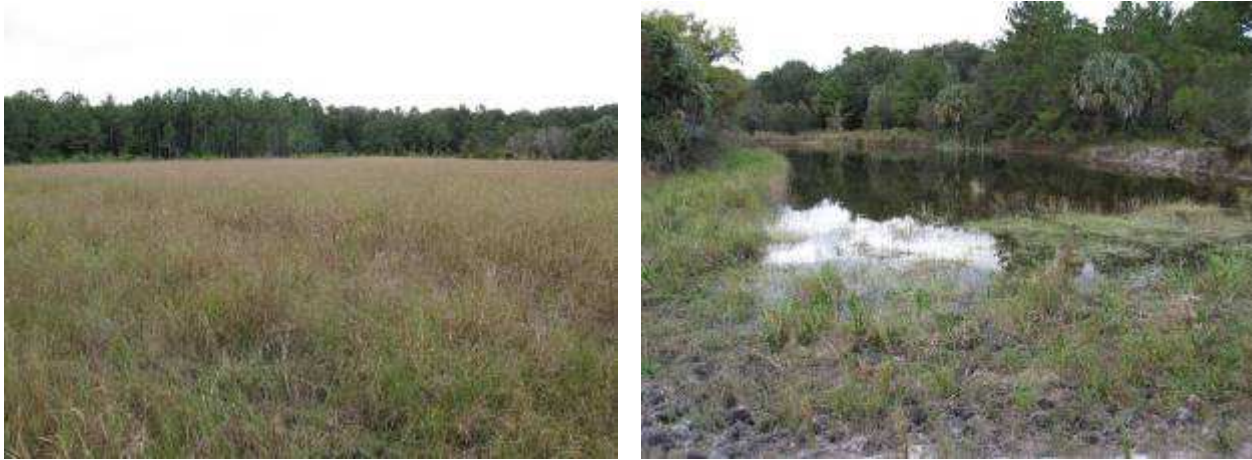
Wetland ID: 11-01

Description: This wetland is a 2.3 ha semi-permanent marsh. There is no significant tree canopy. Wax myrtle and small pine trees are encroaching from the wetland edge, and cover 5-25% of the wetland. Sedges/grasses, emergent vegetation, and maidencane grow throughout the wetland, and cover >75% of the basin. This large marsh has a dug-out on the north side with an associated berm. The wetland is surrounded by a dense pine/oak/palmetto ring and grazed uplands.

Wetland Concerns: Berm, Cattle, Dug-out, Upland condition, Woody encroachment

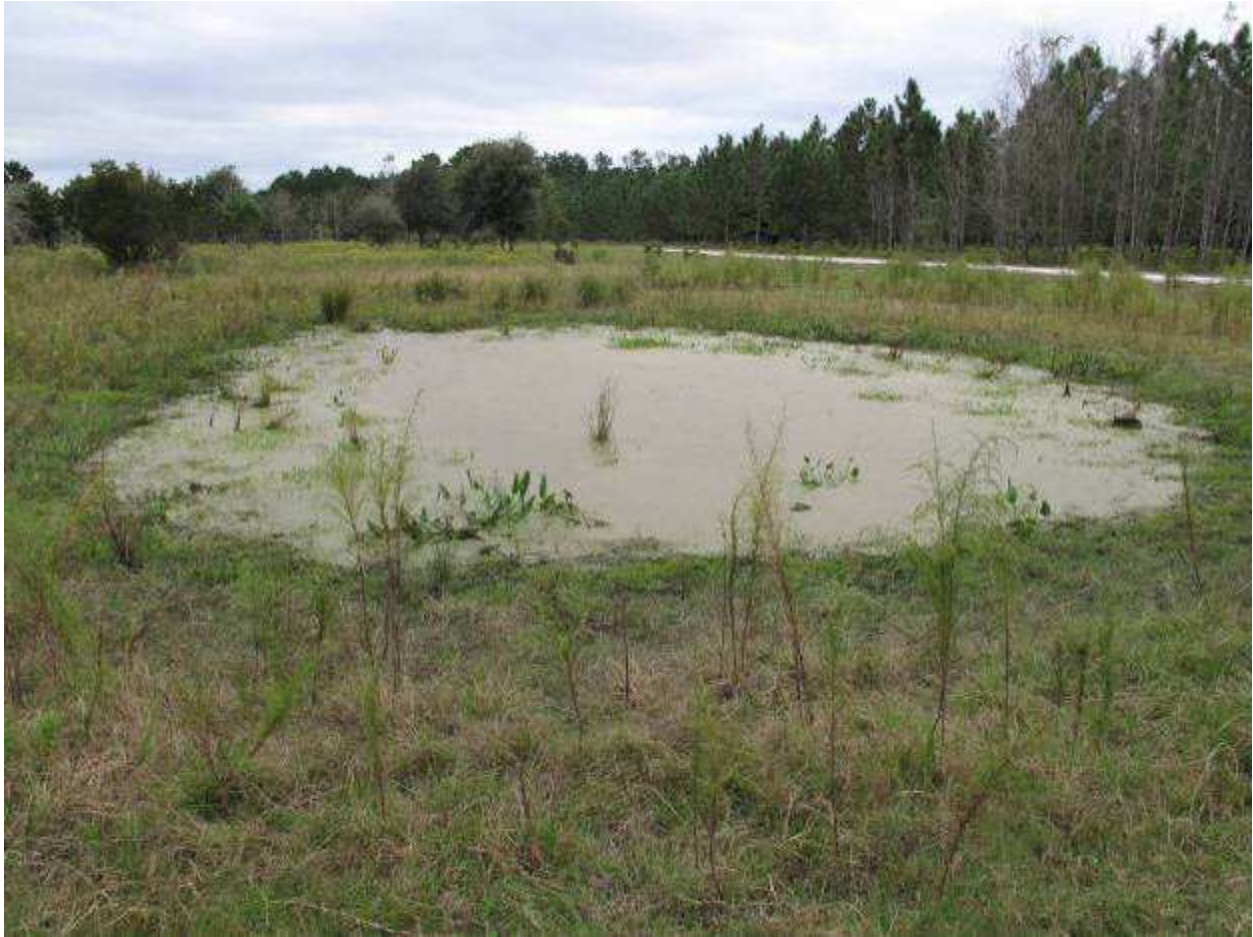
Description: This wetland is a <0.1 ha semi-permanent marsh. There is no tree canopy or midstory layer. Sedges/grasses grow in a ring around the wetland, and cover 25-50% of the wetland basin. This pasture pond is over-utilized by cattle, as evidenced by the trampling of soil and vegetation and the nutrient pollution. A layer of duckweed coats the water surface. The adjacent uplands are grazed pasture and old field.

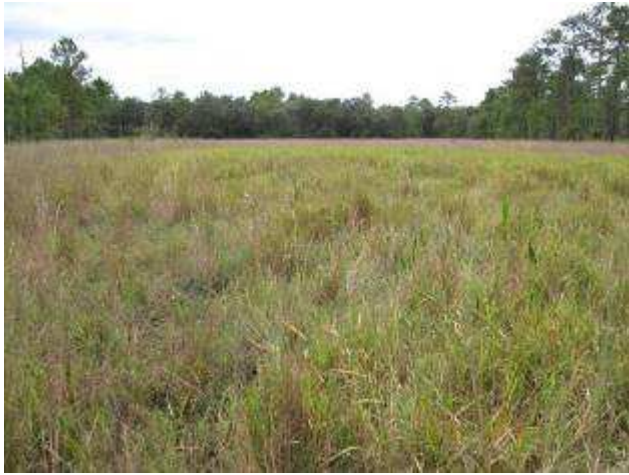
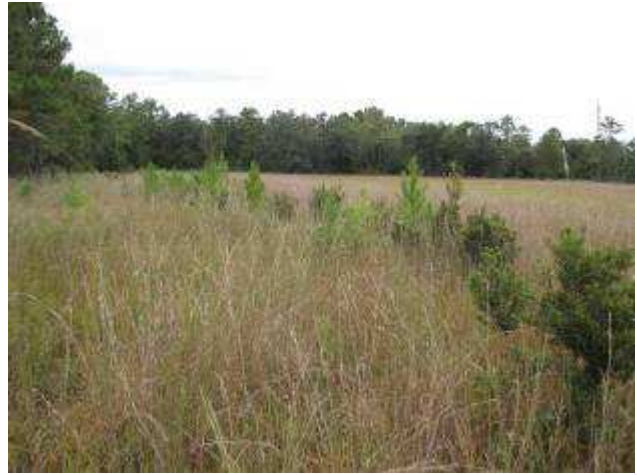
Wetland ID: 11-03

Description: This wetland is a 2.0 ha ephemeral marsh. Large and small pine trees ring the wetland, and some small pine trees and wax myrtle are beginning to encroach into the wetland. There is no significant tree canopy or midstory layer. Sedges/grasses and maidencane grow throughout the wetland, and cover >75% of the basin. There is a shallow ditch on the south side of the wetland associated with a culvert and a nearby road. The adjacent uplands are mesic flatwoods except on to the south where cattle graze on pasture.

Wetland Concerns: Ditch, Cattle, Upland condition

Restoration Action Recommended: Fill the ditch to break connectivity with the wetland. Alternatively, the ditch could be plugged and vegetation allowed to regenerate. Encourage fire in the wetland basin. Monitor the wetland to ensure encroaching woody vegetation is killed with the next fire or inundation. In order to restore the full ecological potential of the wetland, the cattle would need to be removed and the uplands to the south restored.

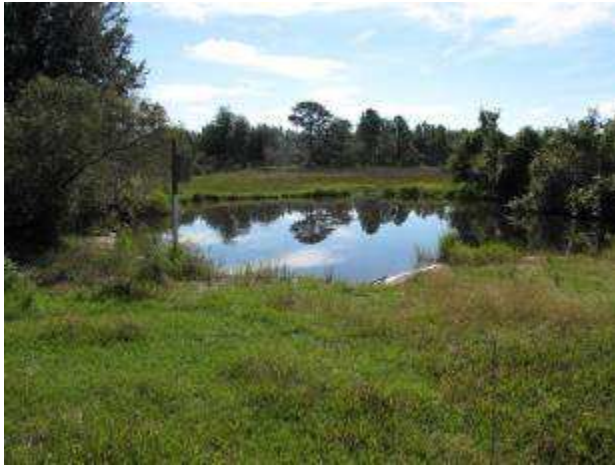
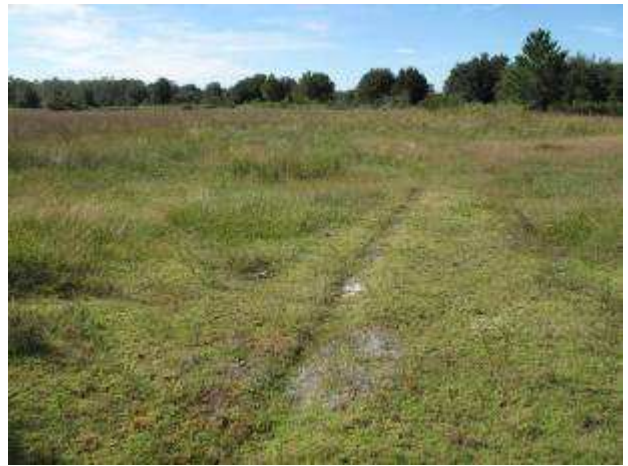
Wetland ID: 13-01

Description: This wetland is a 2.8 ha ephemeral marsh. There is no tree canopy or midstory layer. Sedges/grasses and maidencane grow throughout the wetland, and cover >75% of the basin. This wetland has diverse herbaceous vegetation but suffers from the effects of cattle. There is a dug-out pond on the north side of the marsh and several cattle trails leading around and in the basin. The adjacent uplands are grazed uplands with some planted longleaf pine rows.

Wetland Concerns: Cattle, Dug-out, Upland condition

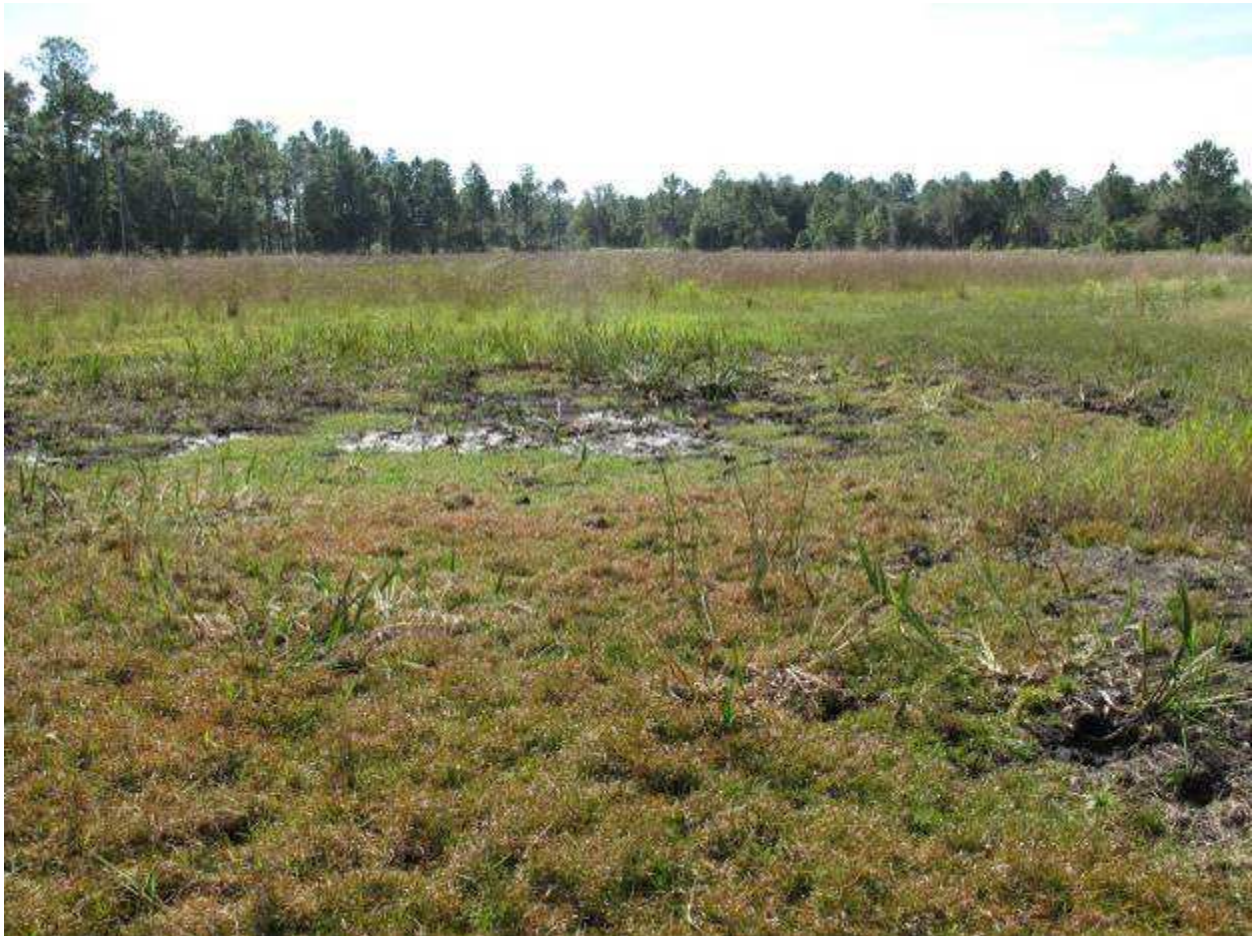
Description: This wetland is a 1.7 ha ephemeral marsh. There is no tree canopy or midstory layer. Sedges/grasses and maidencane grow throughout the wetland, and cover >75% of the basin. There is evidence of cattle in the form of trampling, excrement, and grazing. The wetland is surrounded by a pine/oak ring and grazed uplands. The adjacent pasture has been planted in longleaf pine rows.

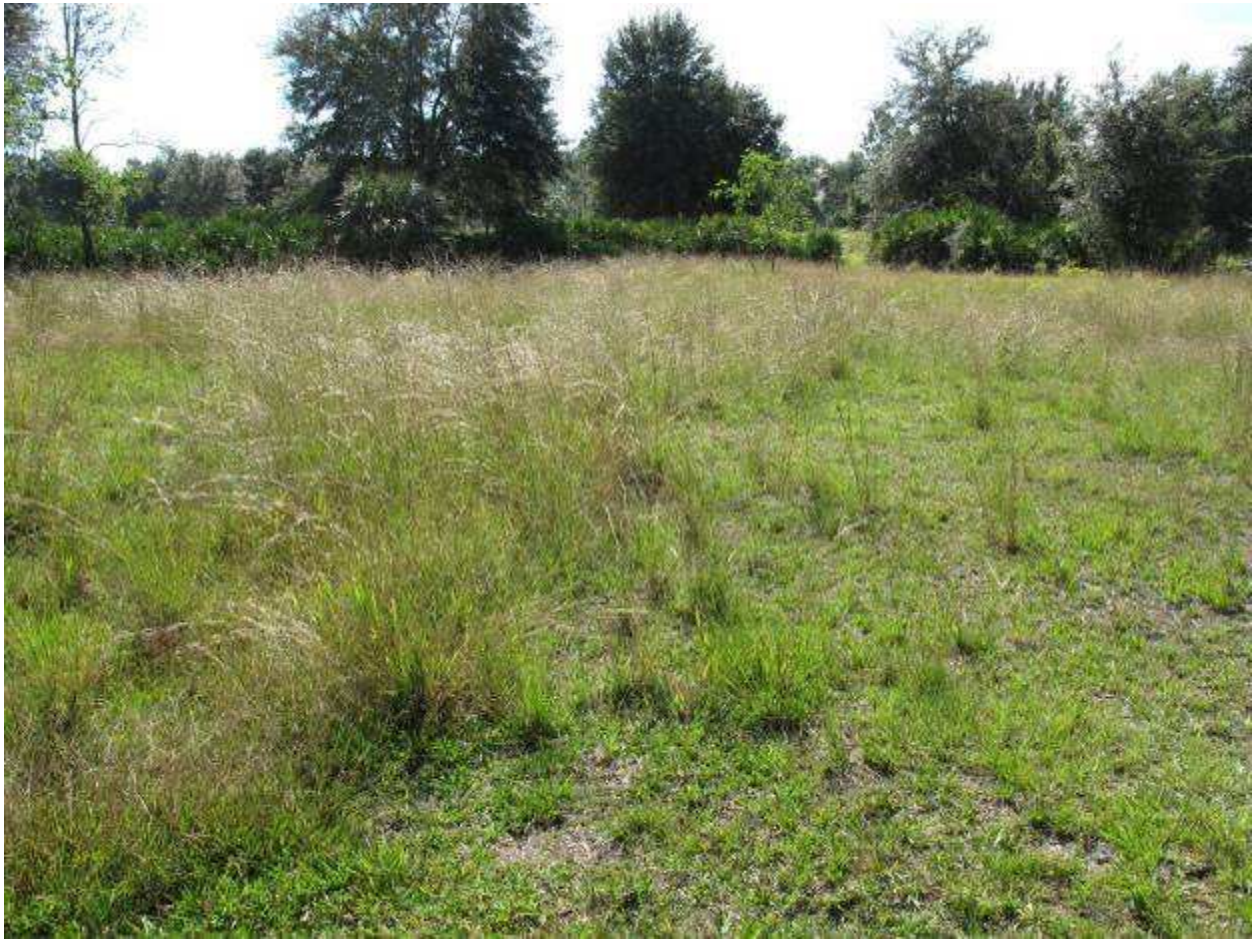
Description: This wetland is a 0.3 ha ephemeral marsh. There is no tree canopy or midstory layer. Sedges/grasses grow throughout the wetland, and cover >75% of the basin. Cattle have grazed within the wetland depression. The wetland is surrounded by a thick palmetto ring and grazed uplands. The adjacent pasture has been planted in longleaf pine rows.

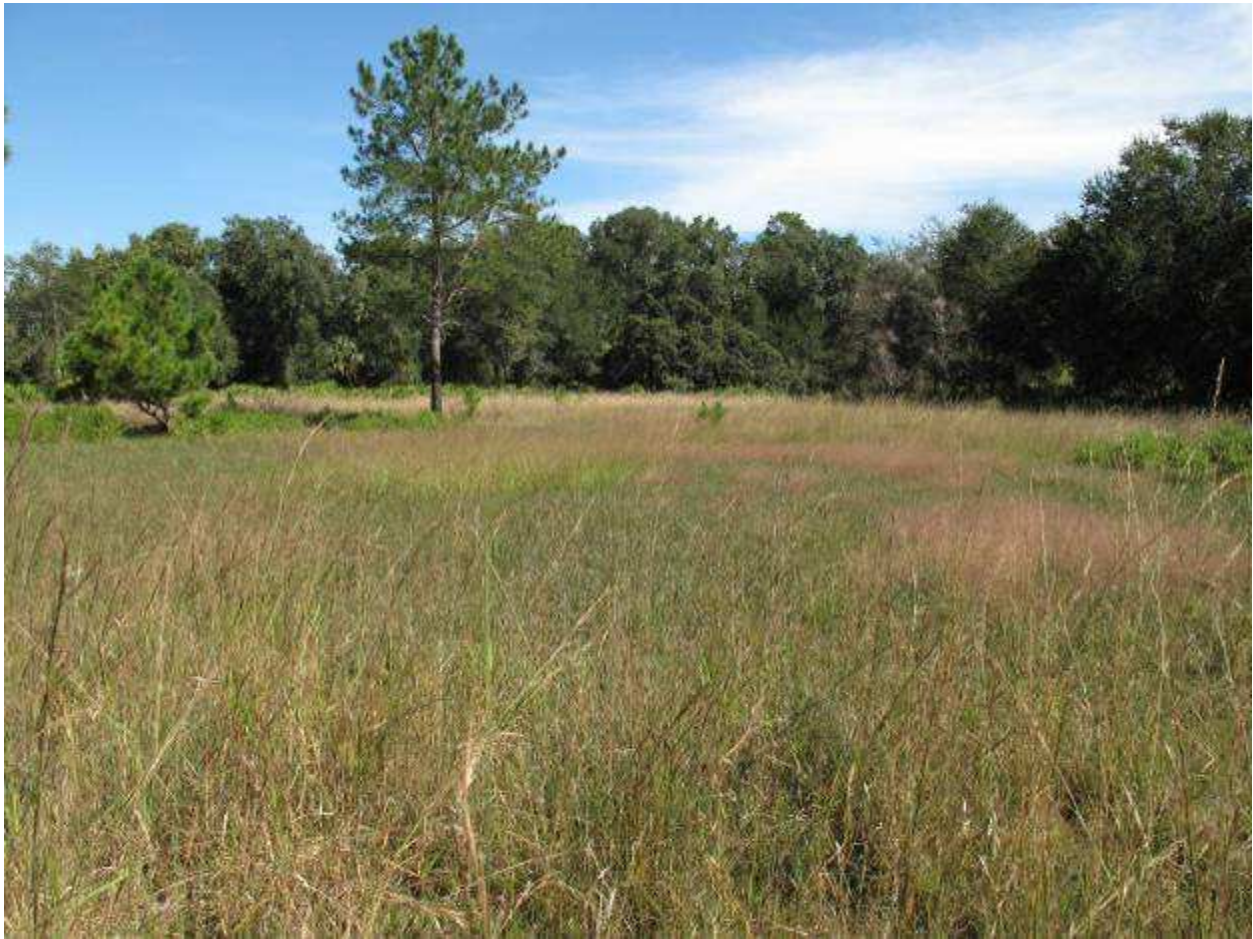
Description: This wetland is a 0.7 ha ephemeral marsh. Pine trees are encroaching into the wetland basin, mainly on the south end. There are a few patches of gallberry in the basin as well. The tree canopy covers 5-25% of the wetland basin. There is no significant midstory cover. Sedges/grasses and maidencane grow throughout the wetland, and cover >75% of the basin. Cattle have grazed in the wetland basin. The wetland is surrounded by a palmetto ring and grazed uplands.

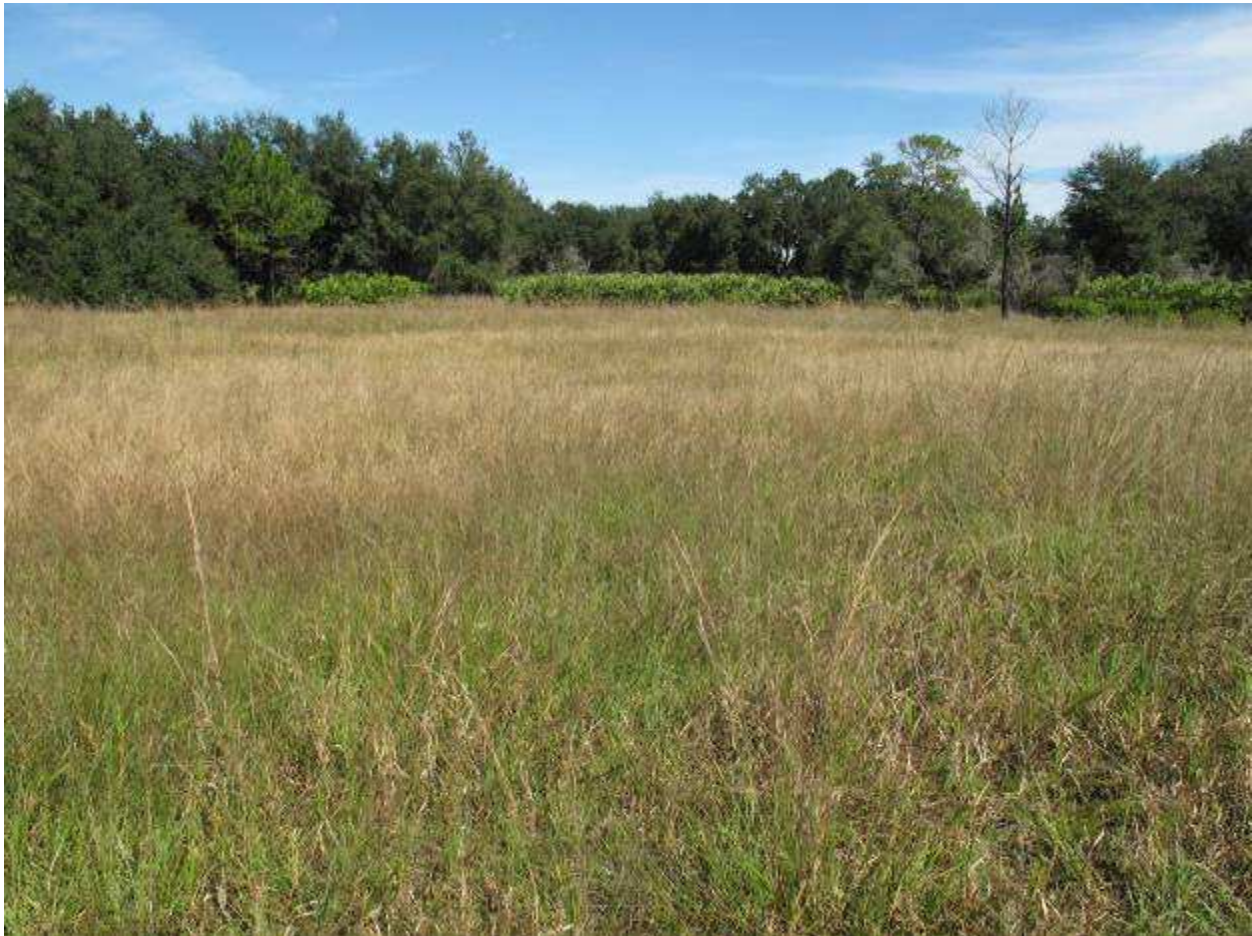
Wetland ID: 15-02

Description: This wetland is a 0.4 ha ephemeral marsh. There is no tree canopy or midstory cover. Sedges/grasses and maidencane grow throughout the wetland, and cover >75% of the basin. There is evidence of cattle grazing in the wetland. The wetland is surrounded by a palmetto ring and grazed uplands.

Wetland Concerns: Cattle, Upland condition

Restoration Action Recommended: In order to restore the full ecological potential of the wetland, the cattle would need to be removed and the uplands restored.

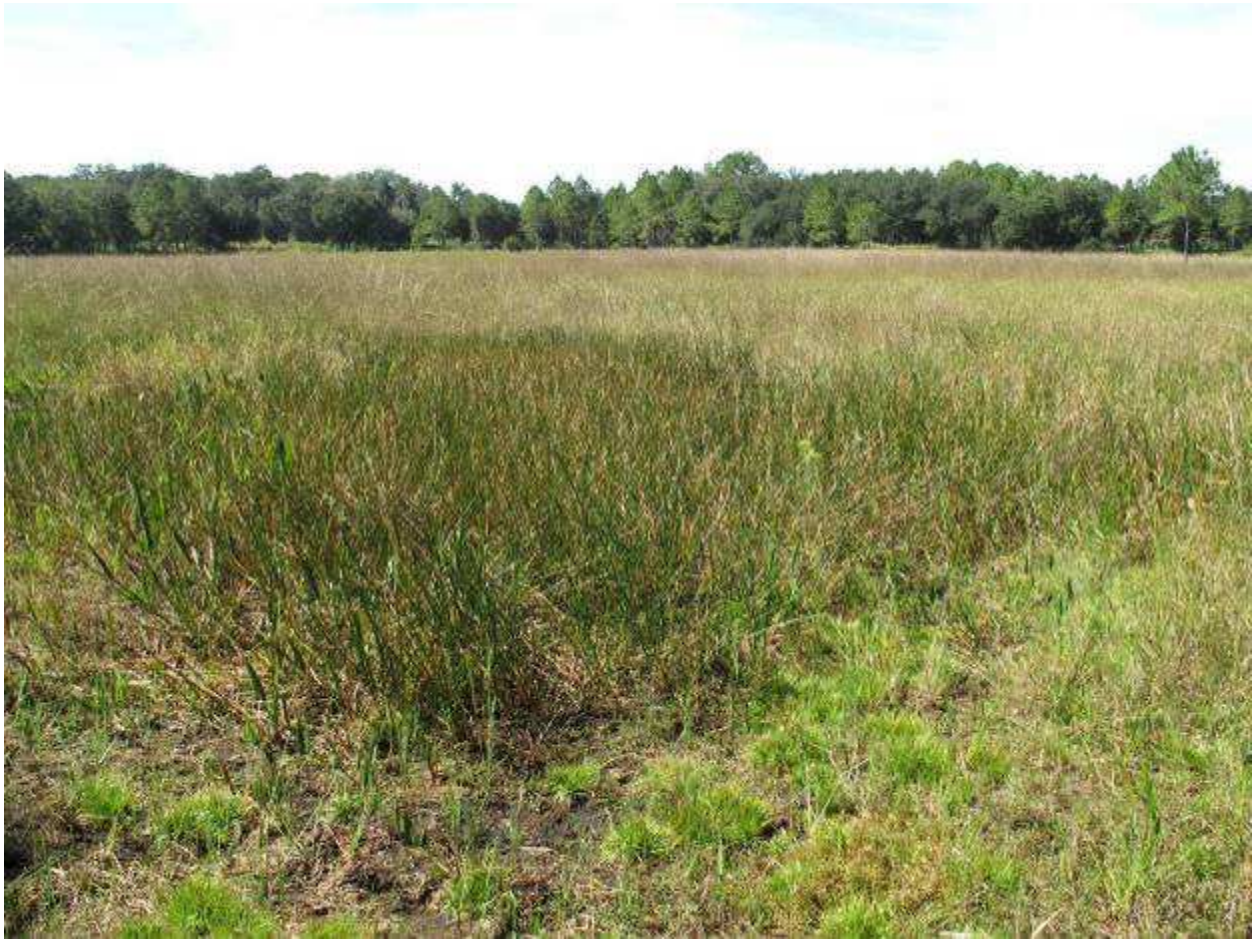
Description: This wetland is a 5.9 ha ephemeral marsh. Pine trees are encroaching into the wetland and cover 5-25% of the wetland basin. There is no midstory cover. Sedges/grasses and maidencane grow throughout the wetland, and cover >75% of the basin. The wetland is on the border with Water Management District land and a fireline and fence bisects the west side of the wetland. Pine tree and wax myrtle are establishing on the hillock along the fence. The wetland is surrounded by a palmetto ring and grazed uplands.

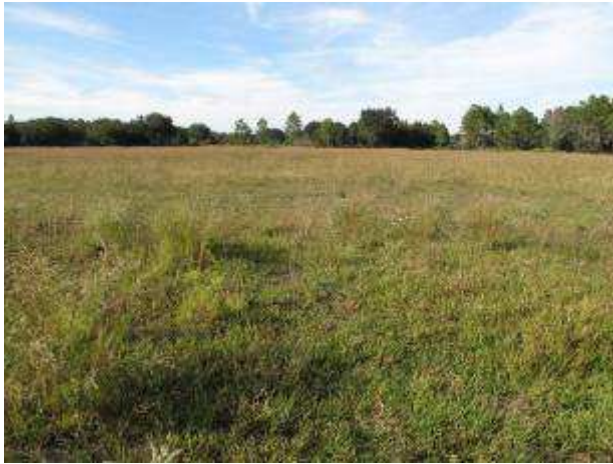
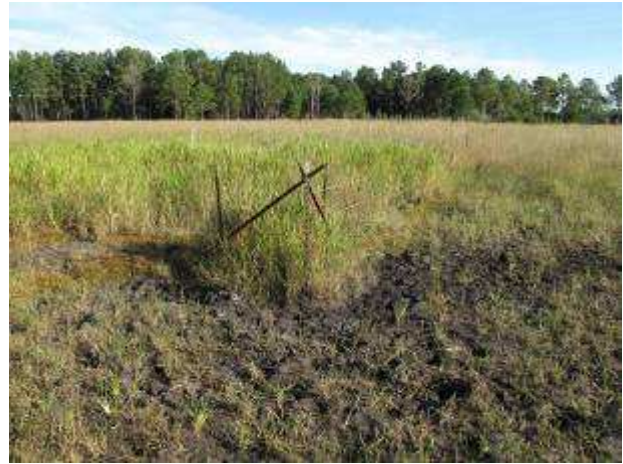
Wetland ID: 16-01

Description: This wetland is a 4.9 ha ephemeral marsh. Pine trees are beginning to encroach along the wetland edge, and cover 5-25% of the wetland basin. There is no midstory cover. Sedges/grasses and maidencane grow throughout the wetland, and cover >75% of the basin. This large, open marsh has a deeper depression in the center. There is a fenced-off area in the center of the wetland, possibly a research plot. Maidencane grows thick within the fenced area and sparser outside the fenced plot. The wetland is surrounded by a palmetto ring and grazed uplands.

Wetland Concerns: Cattle, Upland condition

Restoration Action Recommended: Encourage fire in the wetland to prevent further pine tree encroachment. In order to restore the full ecological potential of the wetland, the cattle would need to be removed and the uplands restored.

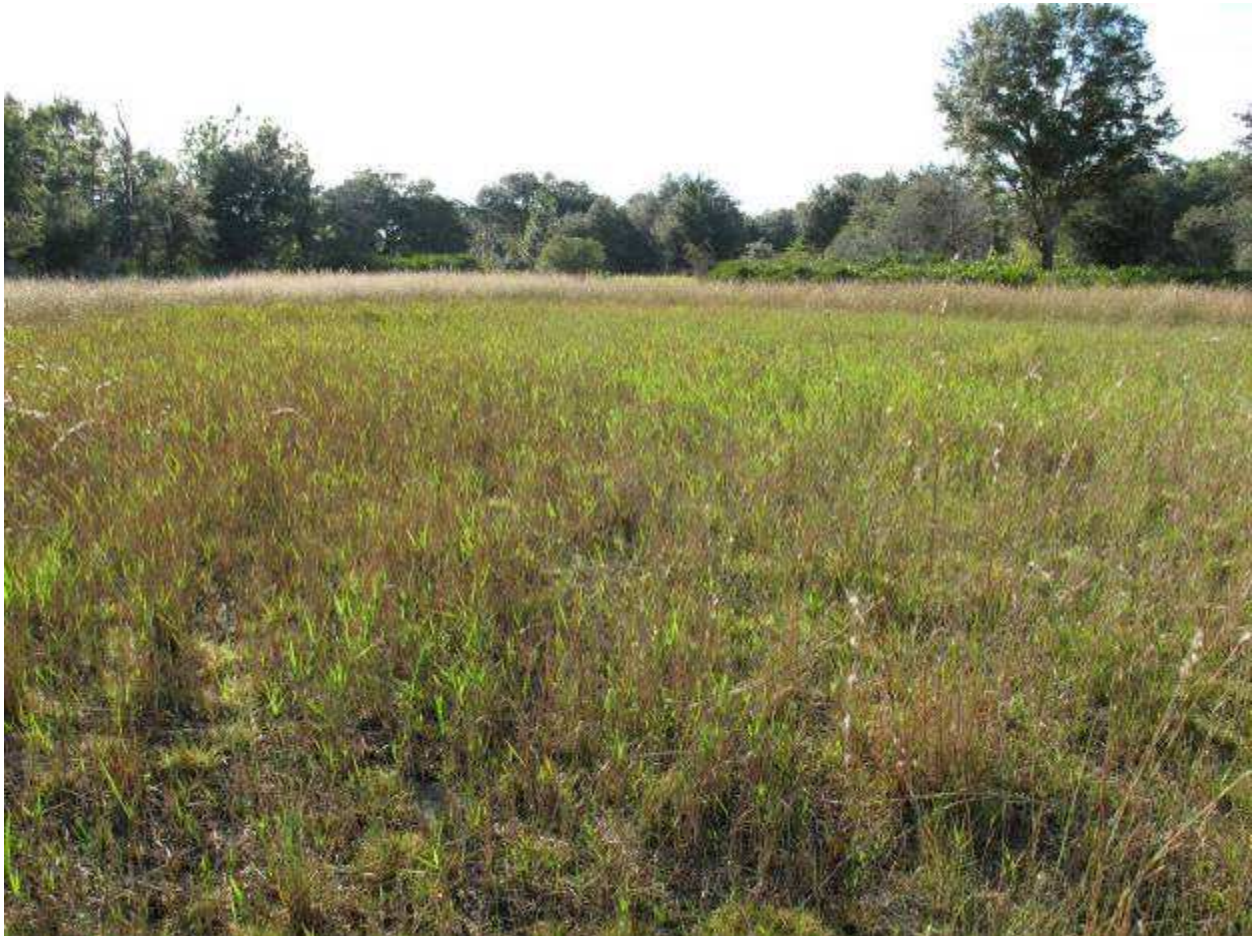
Wetland ID: 16-02

Description: This wetland is a 1.5 ha ephemeral marsh. A few pine trees (<5% coverage) are encroaching from the edge. There is no midstory cover. Sedges/grasses and maidencane grow throughout the wetland, and cover >75% of the basin. The grass in the wetland has been grazed. The adjacent uplands are grazed uplands.

Wetland Concerns: Cattle, Upland condition

Restoration Action Recommended: Encourage fire in the wetland to prevent further pine tree encroachment. In order to restore the full ecological potential of the wetland, the cattle would need to be removed and the uplands restored.

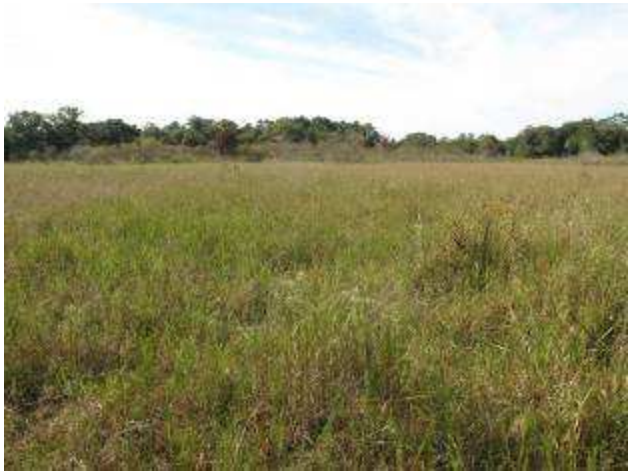
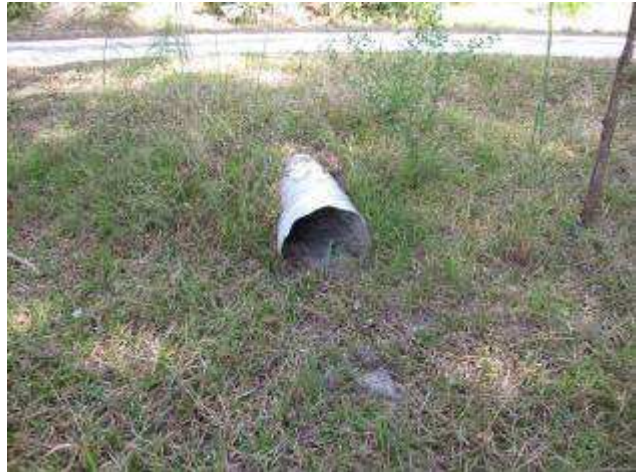
Wetland ID: 17-01

Description: This wetland is a 5.4 ha semi-permanent marsh. There is no tree canopy cover. Wax myrtle and willow cover 25-50% of the wetland basin. Sedges/grasses, maidencane, and emergent vegetation grow throughout the wetland, and cover >75% of the basin. This large marsh has several deeper areas in which the willow and emergent vegetation grow. Wax myrtle is encroaching around the edge of the entire wetland. The cattle impact is light but the feral hog damage is moderate in the wetland. There is a ditch on the north side of the wetland that connects this wetland with 17-02 and a ditch on the southwest side of the wetland that connects to a larger swamp system. The adjacent uplands are grazed uplands.

Wetland Concerns: Cattle, Feral hog damage, Ditching, Upland condition, Woody encroachment

Restoration Action Recommended: Fill the ditch to break connectivity with the wetland. Alternatively, the ditch could be plugged and vegetation allowed to regenerate. Encourage fire in the wetland basin. Monitor the wetland to ensure encroaching wax myrtle is killed with the next fire or inundation. If it becomes established, the woody vegetation will need to be removed from the wetland. Alternatively, wax myrtle can be hand-chopped now. In order to restore the full ecological potential of the wetland, the cattle would need to be removed and the uplands restored.

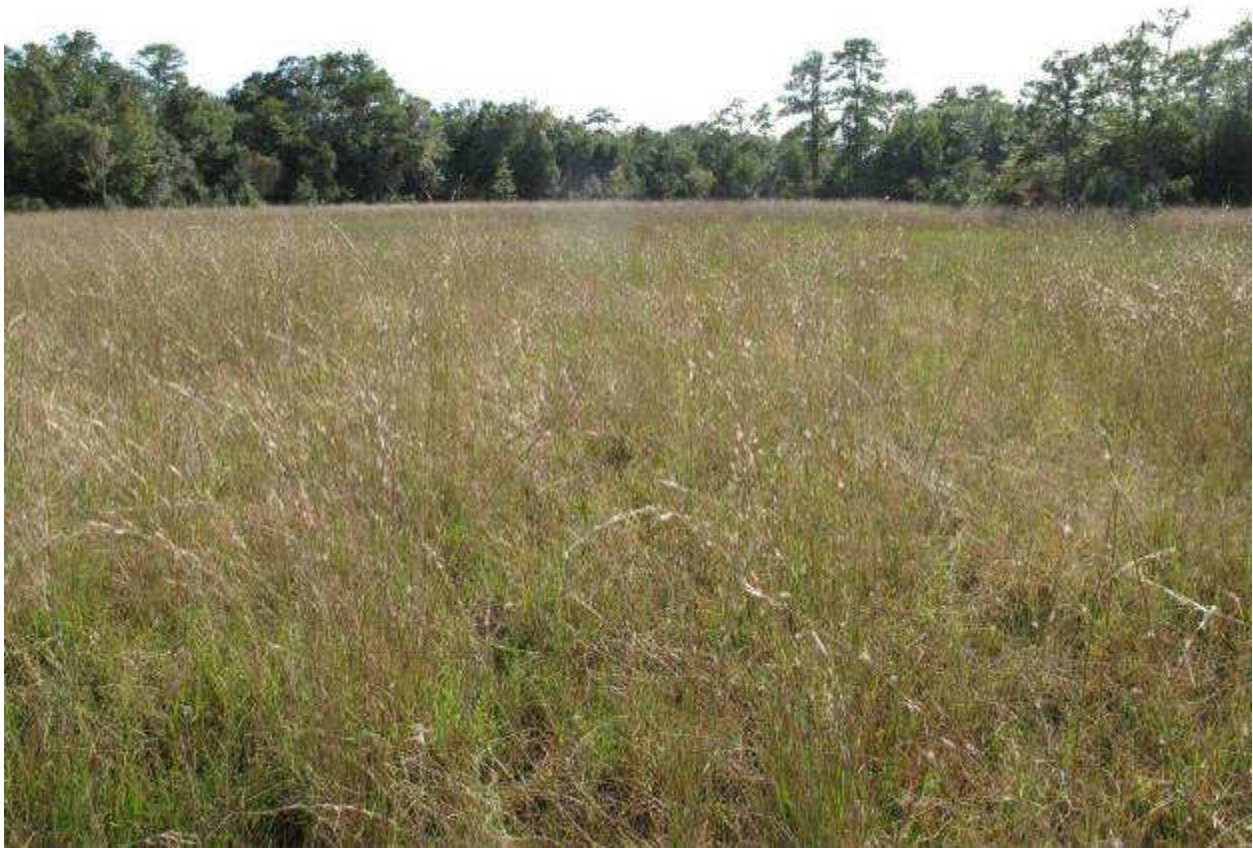
Wetland ID: 17-02

Description: This wetland is a 1.5 ha ephemeral marsh. There is no tree canopy cover. A thin ring of wax myrtle is beginning to encroach from around the wetland edge and covers 5-25% of the wetland basin. Sedges/grasses and maidencane grow throughout the wetland, and cover >75% of the basin. The cattle impact is light. There is a ditch on the south side of the wetland that connects to Wetland 17-01 and possibly one associated with a culvert under a road on the east side of the wetland. The adjacent uplands are grazed uplands.

Wetland Concerns: Cattle, Ditching, Upland condition, Woody encroachment

Restoration Action Recommended: Fill the ditch to break connectivity with the wetland. Alternatively, the ditch could be plugged and vegetation allowed to regenerate. Encourage fire in the wetland basin. Monitor the wetland to ensure encroaching woody vegetation is killed with the next fire or inundation. If it becomes established, the woody vegetation will need to be removed from the wetland. Alternatively, the wax myrtle can be hand-chopped now. In order to restore the full ecological potential of the wetland, the cattle would need to be removed and the uplands restored.

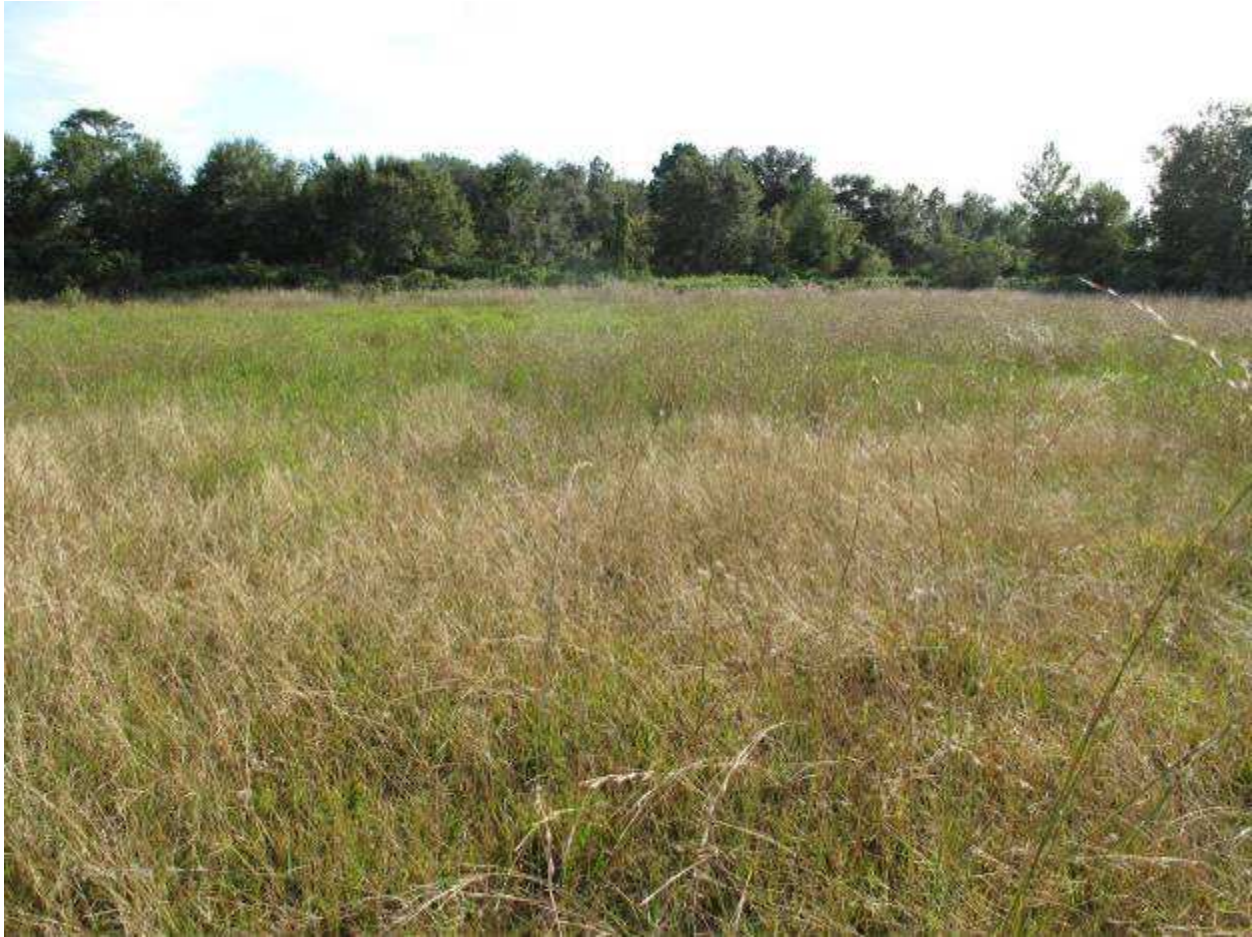
Description: This wetland is a 0.7 ha ephemeral marsh. There is no tree canopy cover. A dense ring of wax myrtle is beginning to encroach from around the wetland edge and cover 5-25% of the wetland basin. Sedges/grasses and maidencane grow throughout the wetland, and cover >75% of the basin. Cattle are grazing in the wetland basin. The adjacent uplands are grazed uplands.

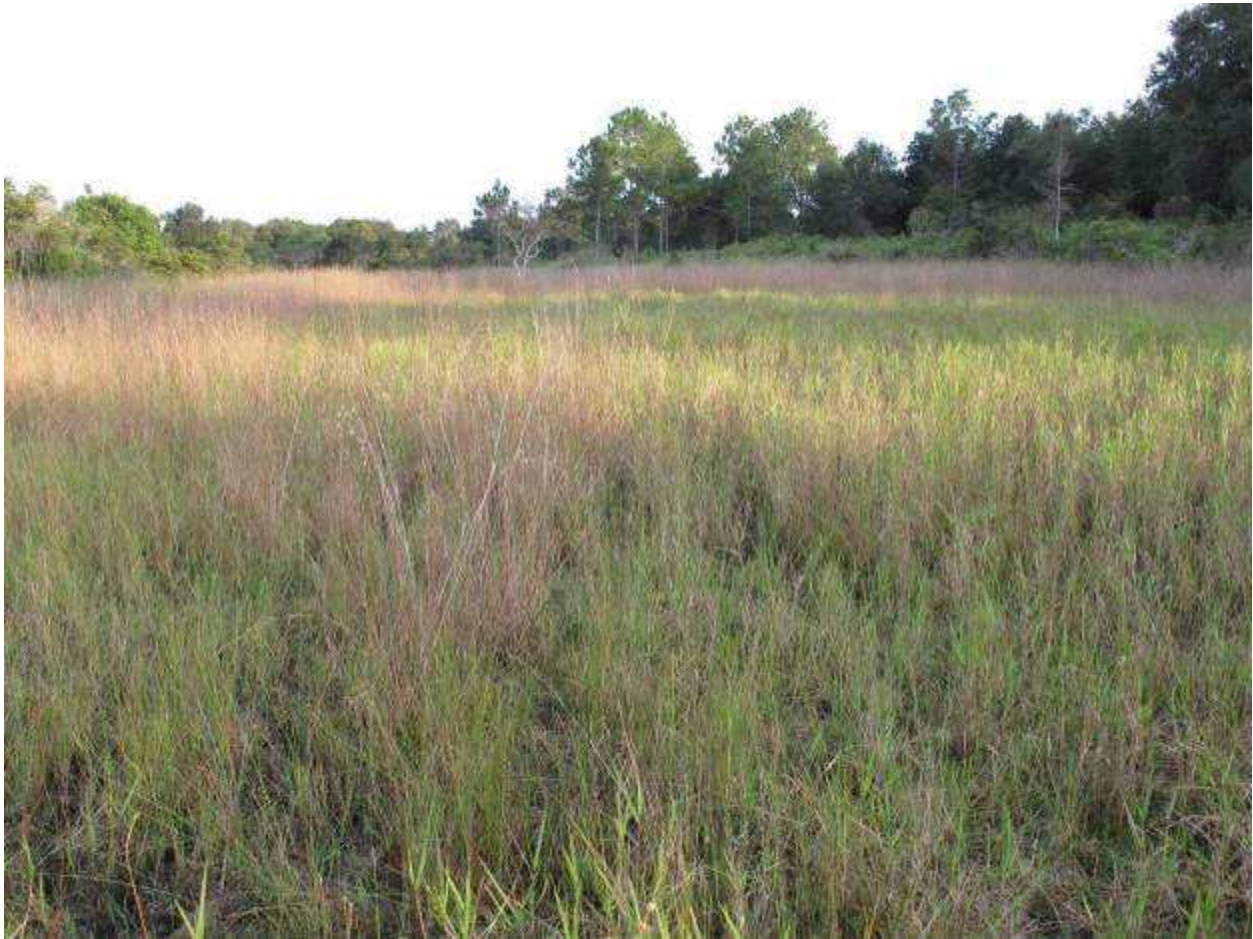
Description: This wetland is a 1.7 ha ephemeral marsh. There is no tree canopy or midstory cover. Maidencane grows throughout the wetland, and covers >75% of the basin. This 3-lobed wetland has elevated land bridges between the deeper spots. Shrubs are beginning to encroach from the land bridges though there are no shrubs in the wetland interior. A ditch on the south side of the wetland connects to Wetland 19-02. The adjacent uplands are grazed uplands.
