Inventory, Assessment, and Restoration Potential of Ephemeral Wetlands on FFWCC Wildlife Management Areas

Half Moon WMA Final Report

Submitted by: Rebecca P.M. Means¹, Ryan C. Means¹, Steven A. Johnson²

¹Coastal Plains Institute

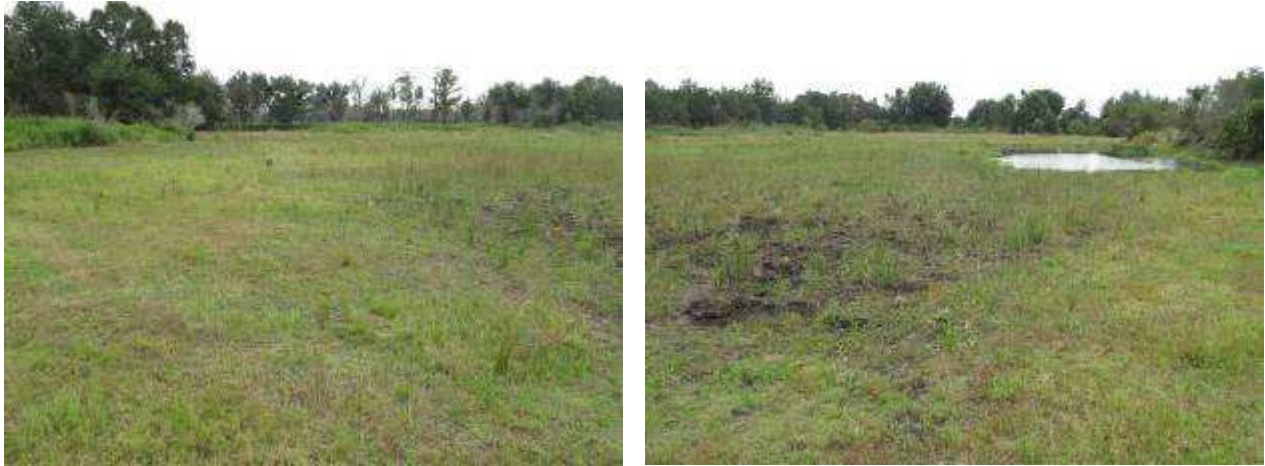
Wetland ID: 19-02

Description: This wetland is a 1.4 ha altered marsh. The wetland was an ephemeral marsh but a dug-out section has created a semi-permanent section, thereby allowing fish to persist. There is no tree canopy or midstory cover. Maidencane and sedges/grasses grow throughout the wetland, and cover >75% of the basin. There is a ditch on the north side of the wetland that connects this wetland with 19-02 and a ditch on the southeast side of the wetland that connects to a larger wetland that was not inventoried. The ditch on the southeast side has been plugged. This marsh also has been impacted by cattle and is nutrient-polluted. The adjacent uplands are grazed uplands.

Wetland Concerns: Cattle, Ditching, Dug-out, Upland condition

Restoration Action Recommended: Fill the ditch and the dug-out. In order to restore the full ecological potential of the wetland, the cattle would need to be removed and the uplands restored.

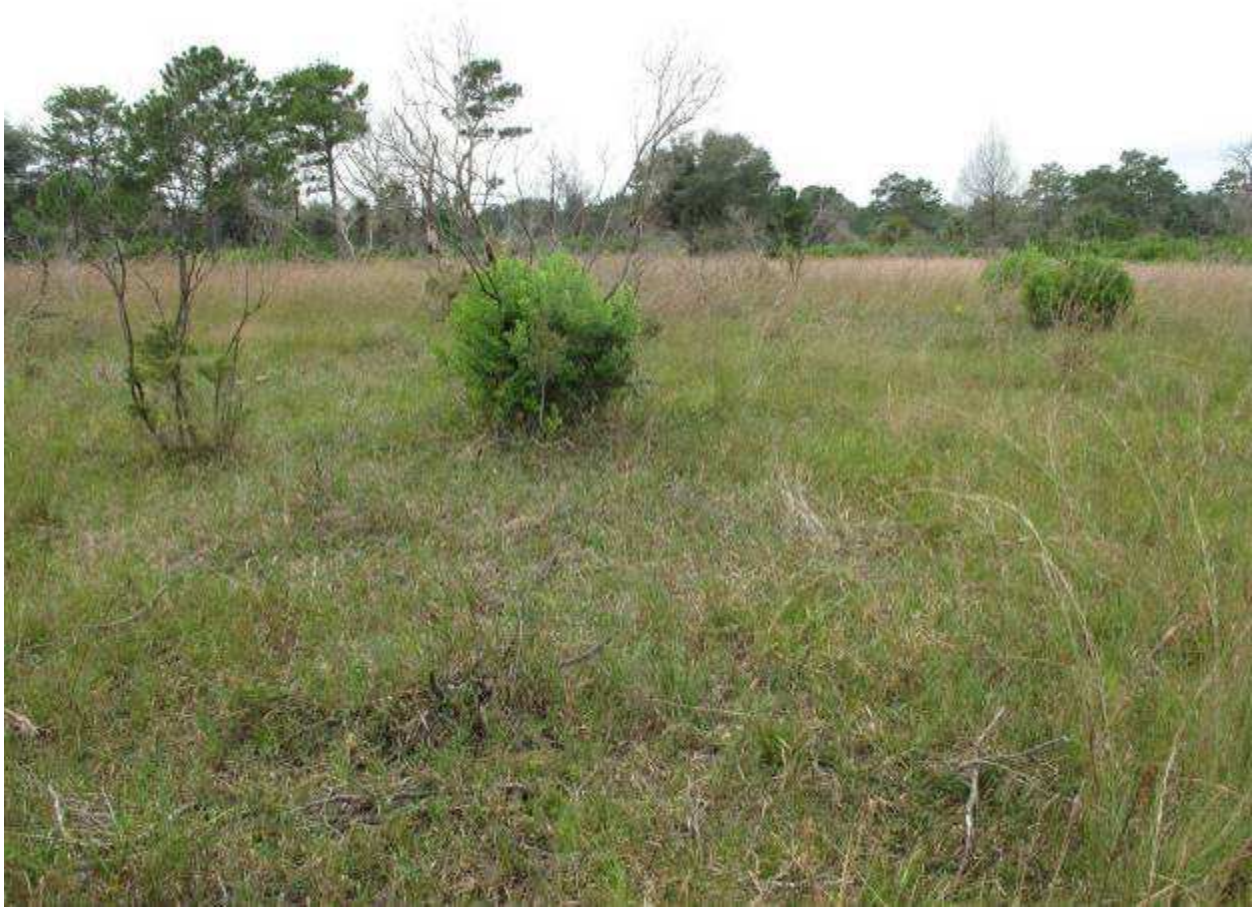
Wetland ID: 19-03

Description: This wetland is a 0.7 ha ephemeral marsh. There is no tree canopy cover. Wax myrtle shrubs grow throughout the wetland, and cover 5-25% of the wetland basin. A hot fire burned in the wetland and killed many of the shrubs and they are now re-sprouting. Maidencane and sedges/grasses grow throughout the wetland, and cover >75% of the basin. A connects the north side of the wetland with the bottom of Wetland 24-01. There is also a ditch on the south side of the wetland that connects with Wetland 58-10. This marsh also has been impacted by cattle. This wetland provides a great example of woody encroachment and how the encroachment can be managed by fire. The wetland is surrounded by a dense palmetto ring and grazed uplands.

Wetland Concerns: Cattle, Ditching, Upland condition, Woody encroachment

Restoration Action Recommended: Fill the ditch to break connectivity with the wetland. Alternatively, the ditch could be plugged and vegetation allowed to regenerate. Encourage periodic fire to prevent the encroachment of wax myrtle. In order to restore the full ecological potential of the wetland, the cattle would need to be removed and the uplands restored.

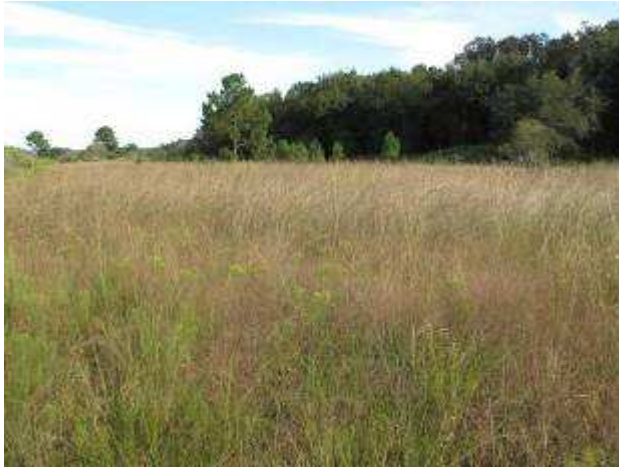
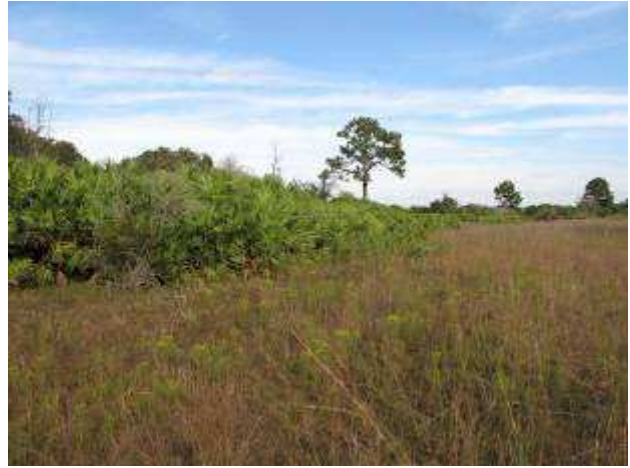
Wetland ID: 20-01

Description: This wetland is a 0.8 ha ephemeral marsh. There is no tree canopy cover. Small pine trees are beginning to encroach into the wetland center, and 5-25% of the wetland basin. Sedges/grasses grow throughout the wetland, and cover >75% of the basin. There is evidence of cattle in the wetland. The wetland is surrounded by a dense palmetto ring and grazed uplands.

Wetland Concerns: Cattle, Upland condition, Woody encroachment

Restoration Action Recommended: Encourage fire in the wetland basin. Monitor the wetland to ensure encroaching pine trees are killed with the next fire or inundation. If they become established, the pine trees will need to be removed from the wetland. Alternatively, the small pine trees can be hand-chopped now. In order to restore the full ecological potential of the wetland, the cattle would need to be removed and the uplands restored.

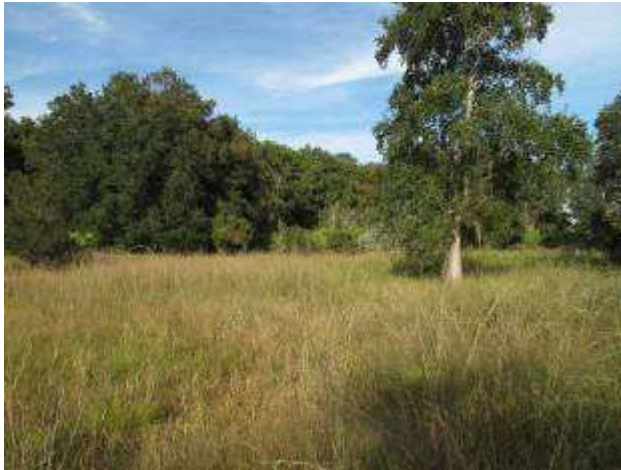
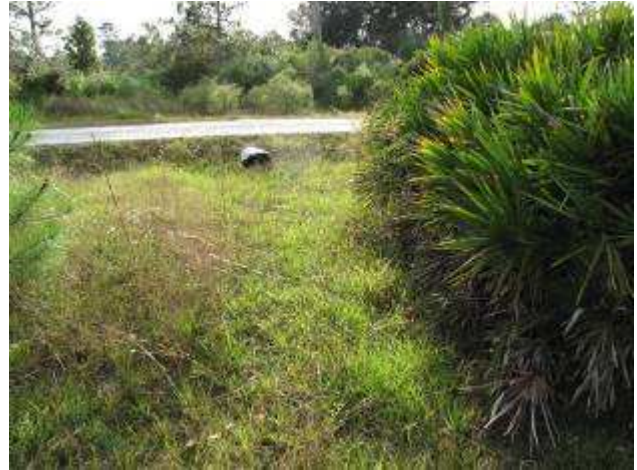
Wetland ID: 20-02

Description: This wetland is a 0.2 ha ephemeral marsh. There is no tree canopy cover. Wax myrtle is encroaching from the wetland edge and covers 5-25% of the wetland basin. Maidencane and sedges/grasses grow throughout the wetland, and cover >75% of the basin. There is evidence of cattle grazing in the wetland basin. A shallow ditch connects the west side of the wetland to a culvert under the road. The adjacent uplands are grazed uplands.

Wetland Concerns: Cattle, Ditching, Upland condition, Woody encroachment

Restoration Action Recommended: Fill the ditch to break connectivity with the wetland. Alternatively, the ditch could be plugged and vegetation allowed to regenerate. Encourage periodic fire to prevent further shrub encroachment. In order to restore the full ecological potential of the wetland, the cattle would need to be removed and the uplands restored.

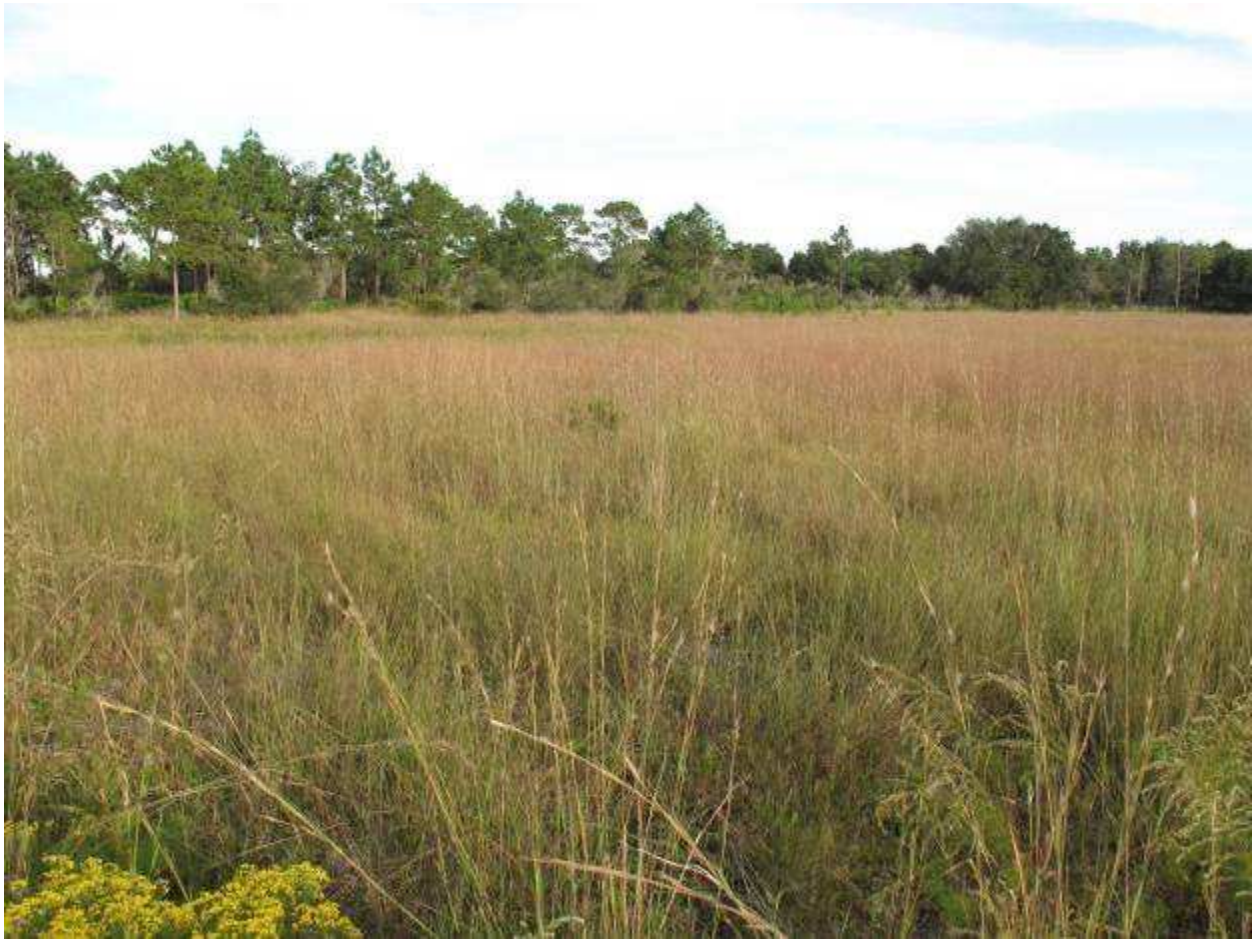
Description: This wetland is a 3.9 ha semi-permanent marsh. There is no tree canopy cover. A few wax myrtles and young pine trees (<5% cover) grow around the wetland edge. The woody vegetation is mostly on the wetland/upland ecotonal boundary. Cattle grazing is evident along this boundary. Maidencane and sedges/grasses grow throughout the wetland, and cover >75% of the basin. The adjacent uplands are grazed uplands.

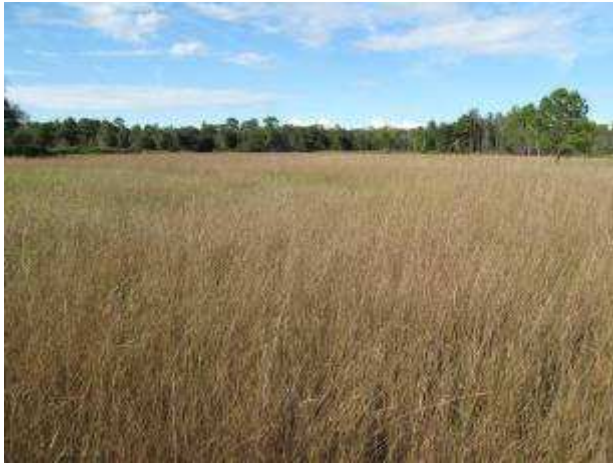
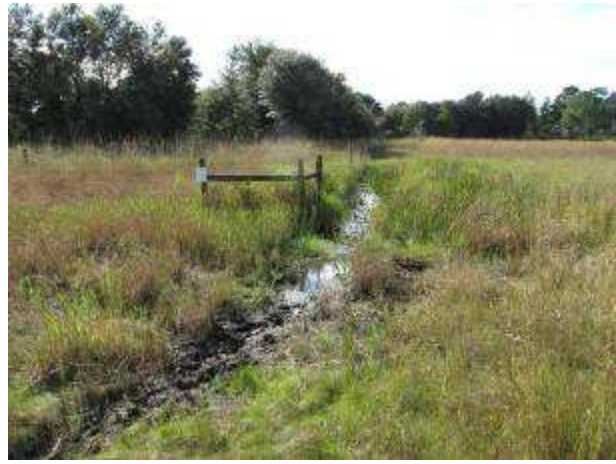
Wetland ID: 24-01

Description: This wetland is a 6.0 ha ephemeral marsh. A large pine tree grows in the center of the wetland basin but provides <5% cover. There is no midstory cover. Maidencane and sedges/grasses grow throughout the wetland, and cover >75% of the basin. Cattle have extensively grazed in the wetland basin. Two ditches in the southeast corner of the wetland connect to 19-01 to the east and Wetland19-03 to the south. A fireline/MU boundary bisects the south end of the wetland. The wetland is surrounded by a dense oak/palmetto ring and grazed uplands.

Wetland Concerns: Cattle, Ditching, Fireline/MU boundary, Upland condition

Restoration Action Recommended: Fill the ditches to break connectivity with the wetlands. Alternatively, the ditches could be plugged and vegetation allowed to regenerate. The Fireline/MU boundary should be re-routed away from the wetland if feasible. If the fireline cannot be re-routed, monitor the wetland to ensure fire is not excluded. Maintain the fireline when the wetland is completely dry to prevent ruts from developing.. In order to restore the full ecological potential of the wetland, the cattle would need to be removed and the uplands restored.

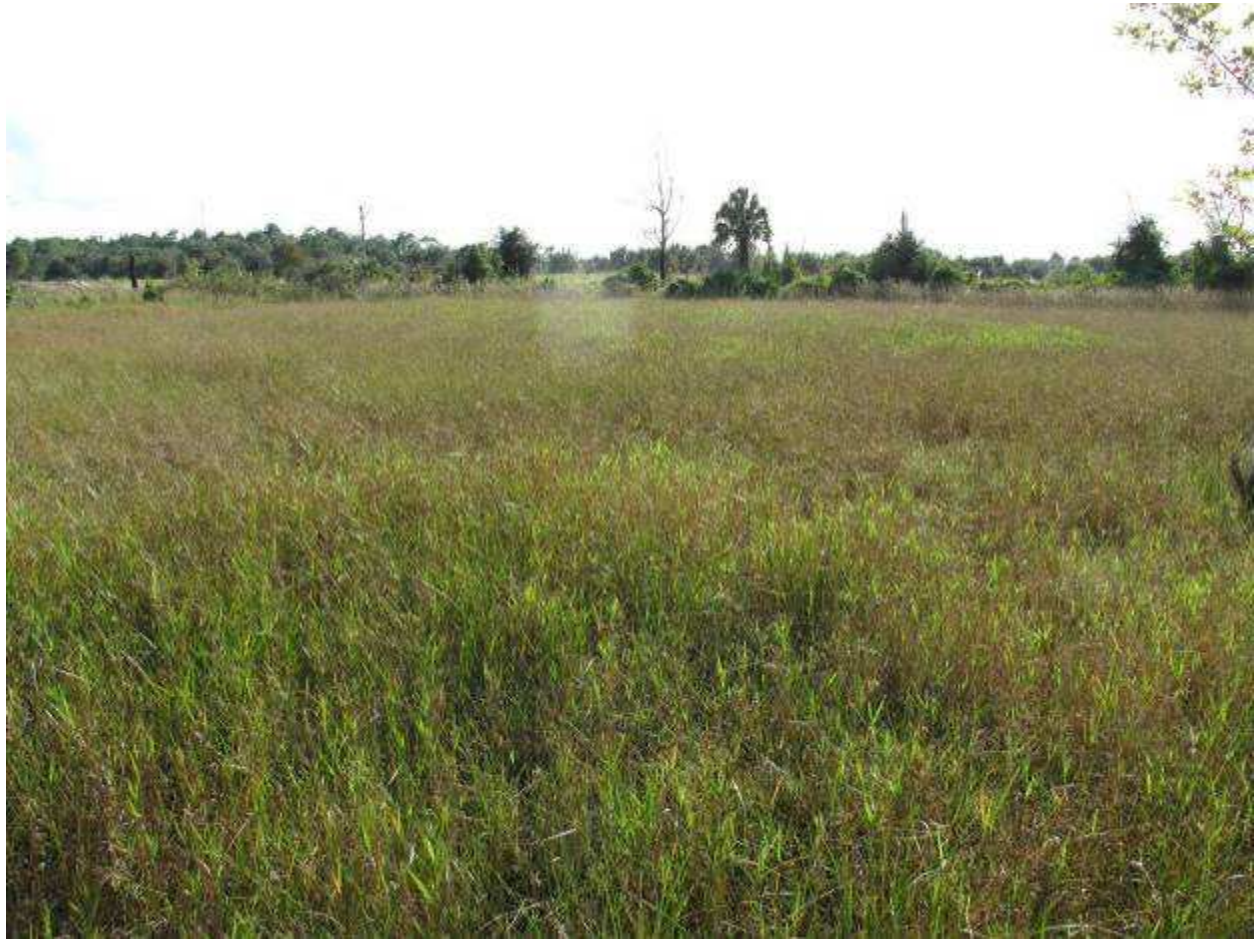
Description: This wetland is a 0.4 ha ephemeral marsh. There is no tree canopy or midstory cover. Maidencane and sedges/grasses grow throughout the wetland, and cover >75% of the basin. The wetland is surrounded by a dense brush ring and grazed uplands.

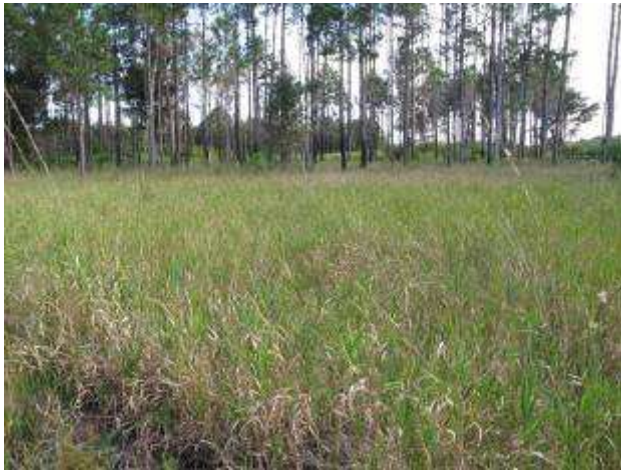
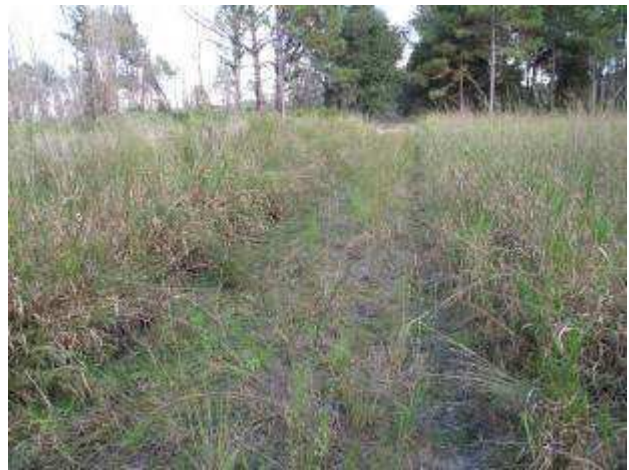
Wetland ID: 24-03

Description: This wetland is a 0.3 ha ephemeral marsh. Pine trees are encroaching, especially on the south side, and cover 5-25% of the wetland basin. There is no midstory cover. Maidencane and sedges/grasses grow throughout the wetland, and cover >75% of the basin. The south side of the wetland is impacted by cattle. A fireline/MU boundary bisects the center of the wetland. A recent fire burned into the wetland basin. The adjacent uplands are grazed uplands to the south and a pine/oak/palmetto community on the north side.

Wetland Concerns: Cattle, Fireline/MU boundary, Upland condition, Woody encroachment

Restoration Action Recommended: Move the fireline into the uplands and away from the wetland. Thin perimeter pine trees up to the palmetto/gallberry line. In order to restore the full ecological potential of the wetland, the cattle would need to be removed and the uplands restored.

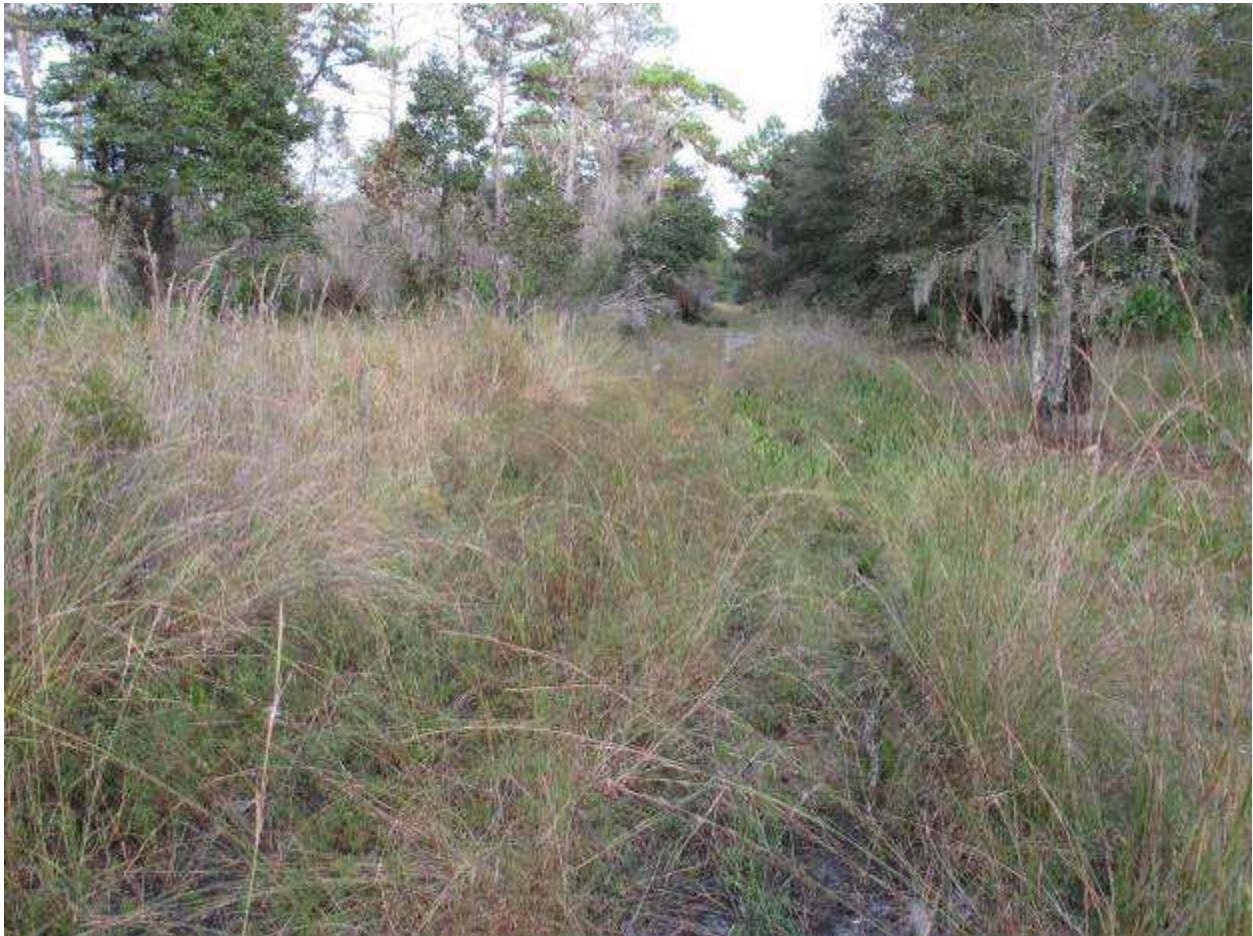
Description: This wetland is a 0.2 ha ephemeral marsh. Several gum trees grow in the wetland center, and cover 5-25% of the basin. There is no midstory cover. Sedges/grasses grow throughout the wetland, and cover >75% of the basin. The south side of the wetland is impacted by cattle. A fireline/MU boundary bisects the center of the wetland. The adjacent uplands are a pine/oak/palmetto community and grazed uplands.

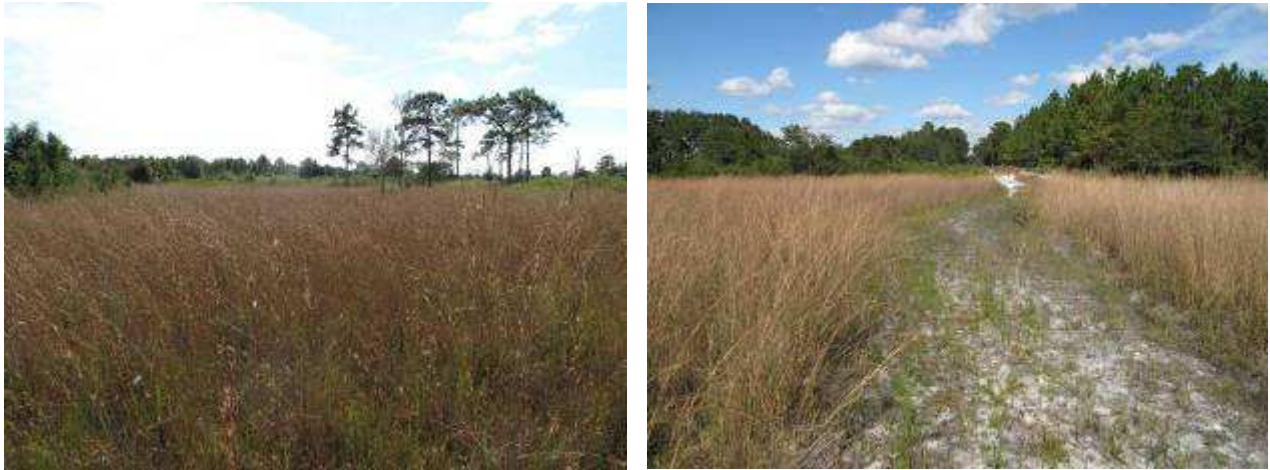
Wetland ID: 27-01

Description: This wetland is a 1.2 ha ephemeral marsh. There is no tree canopy or midstory cover. Sedges/grasses grow throughout the wetland, and cover >75% of the basin. A fireline/private property boundary bisects the northeast corner of the wetland. Heavy amounts of cattle tracks are in the fireline through the wetland. This wetland is a potential striped newt breeding pond. The adjacent uplands are scrubby flatwoods on the west side and planted pine trees to the east.

Wetland Concerns: Cattle, Fireline/private property boundary

Restoration Action Recommended: The boundary should be re-routed away from the wetland if feasible. If the boundary cannot be re-routed, monitor the wetland to ensure fire is not excluded. Maintain the fireline when the wetland is completely dry to prevent ruts from developing. The uplands in this MU are in good ecological condition, although we have observed some minor cattle-related effects in both wetlands and uplands in some areas. We recommend removing cattle from this unit to prevent destruction of the intact flatwoods community and the embedded wetlands.

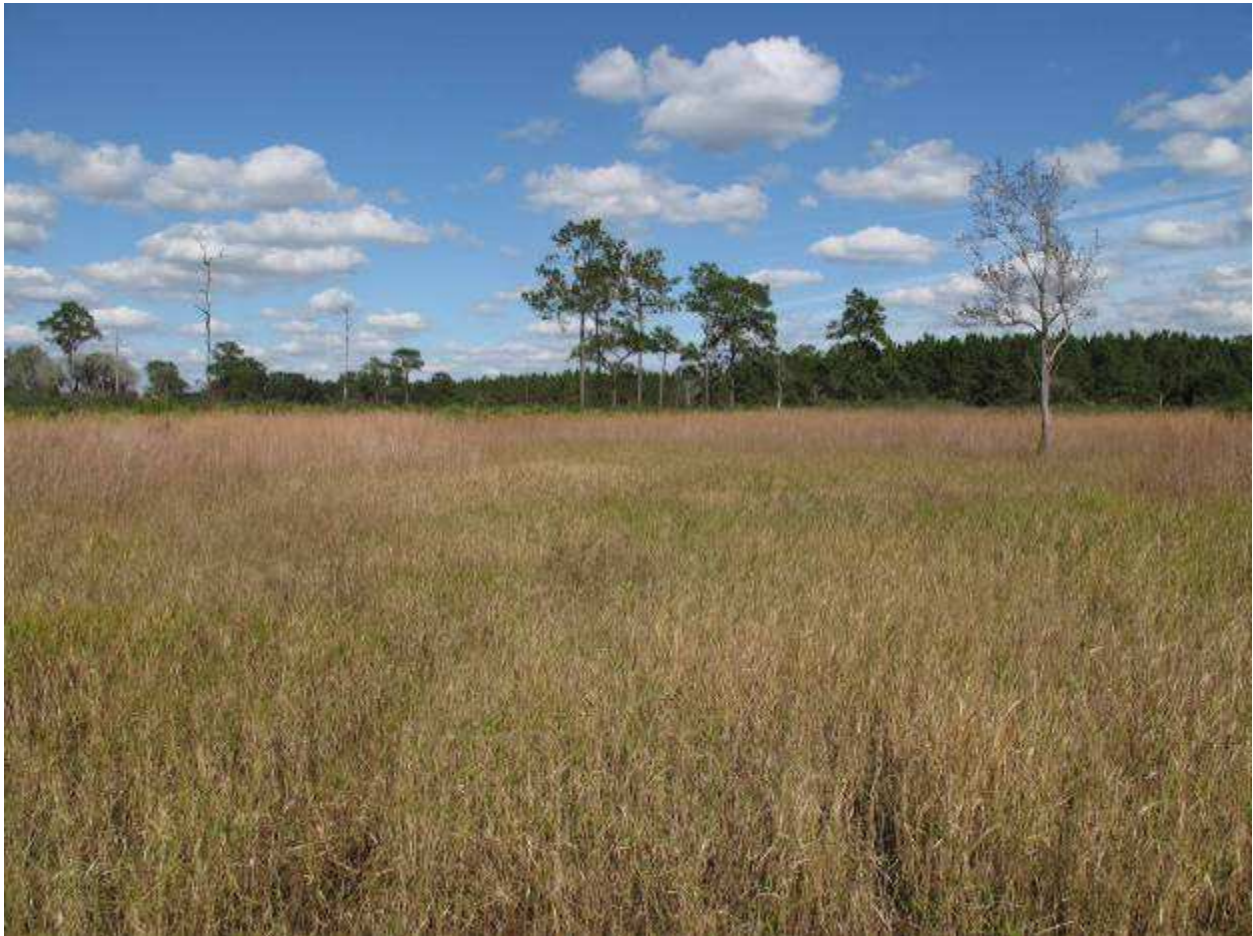
Description: This wetland is a 0.4 ha ephemeral marsh. There is no tree canopy or midstory cover. Maidencane grows in the center of the wetland and broomsedge grows around the wetland edges. The herbaceous vegetation covers >75% of the wetland basin. Even though cattle are allowed to graze in this area, there is no evidence of grazing or other impacts in the wetland basin. This wetland is a good example of a marsh without woody encroachment and is a potential striped newt breeding pond. The adjacent uplands are open scrubby flatwoods.

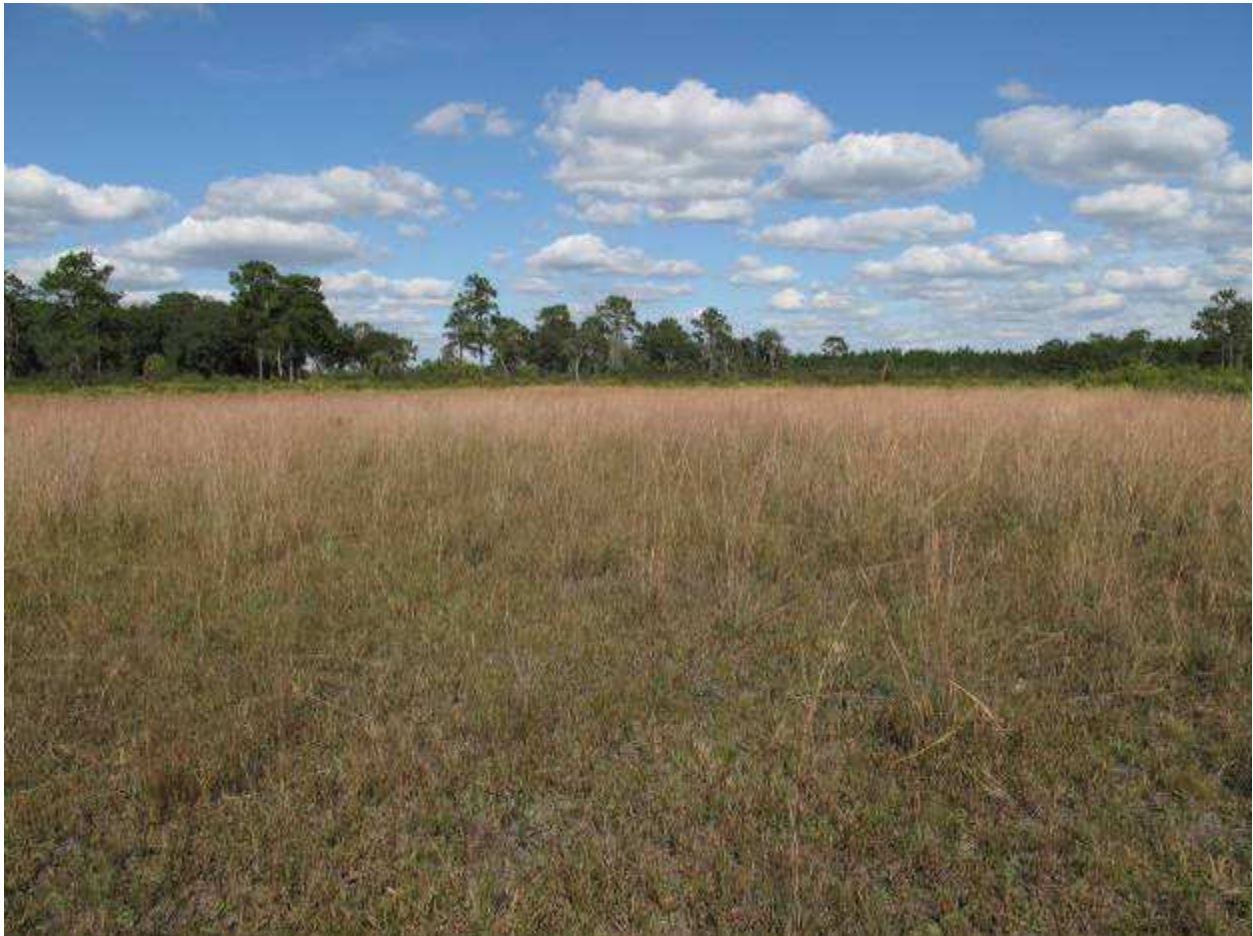
Description: This wetland is a 2.4 ha ephemeral marsh. There is no tree canopy or midstory cover. Maidencane and sedges/grasses grow throughout the wetland, and cover >75% of the basin. The wetland is impacted by cattle; there are cow patties and evidence of cattle grazing in the wetland basin. This wetland is a good example of a marsh without woody encroachment and is a potential striped newt breeding pond. The adjacent uplands are open scrubby flatwoods.

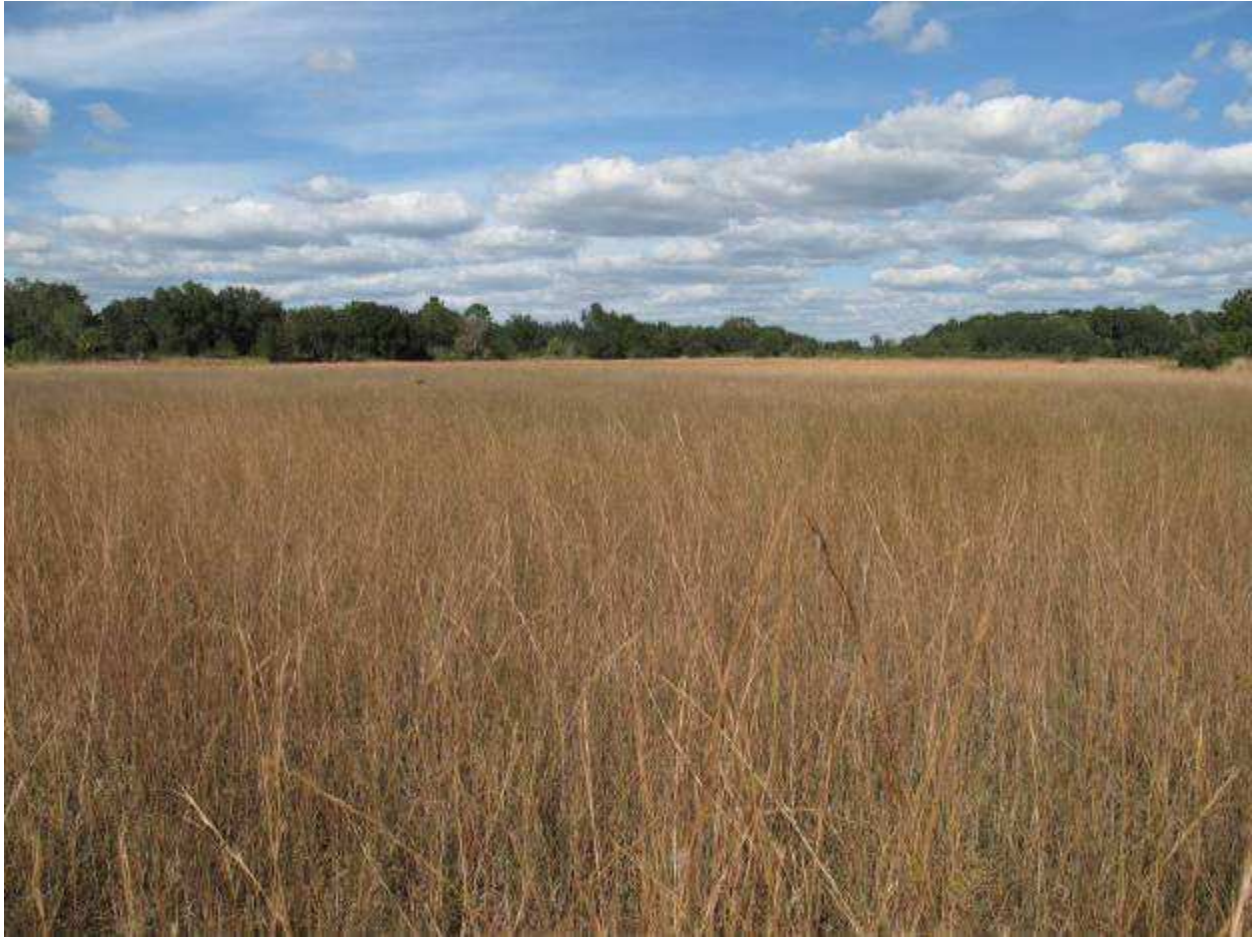
Description: This wetland is a 6.4 ha ephemeral marsh. There is no tree canopy or midstory cover. Maidencane and sedges/grasses grow throughout the wetland, and cover >75% of the basin. Cattle impact is minimal with a few trails leading to the wetland edge. This wetland is a good example of a marsh with wax myrtle and slash pine in an ecological balance and is a potential striped newt breeding pond. The adjacent uplands are scrubby flatwoods and oak/palmetto brush.

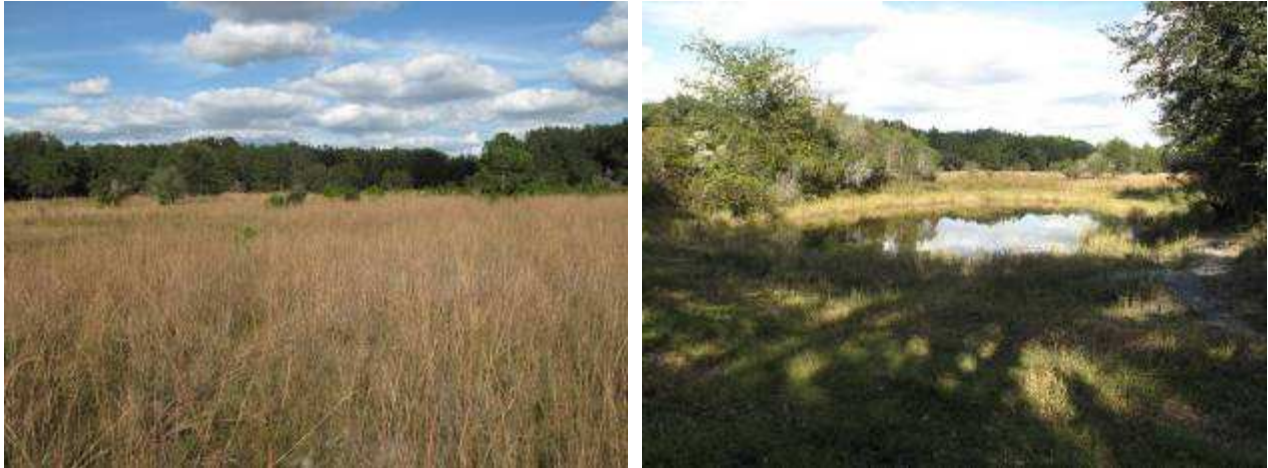
Wetland ID: 29-02

Description: This wetland is a 5.3 ha altered marsh. The wetland was an ephemeral marsh but a dug-out section on the west side created a semi-permanent section. There is no tree canopy cover. Small pine trees and wax myrtle grow in the wetland interior, and cover 5-25% of the wetland basin. Maidencane and sedges/grasses grow throughout the wetland, and cover >75% of the basin. There is a ditch on the west side of the wetland and evidence of cattle impacts throughout. The wetland is surrounded by a thick oak/palmetto ring, scrubby flatwoods, and oak hammock.

Wetland Concerns: Cattle, Ditching, Dug-out, Woody encroachment

Restoration Action Recommended: In order to restore the full ecological potential of the wetland, the cattle would need to be removed. Fill the ditch and the dug-out. Encourage periodic fire in the wetland to prevent further woody encroachment.

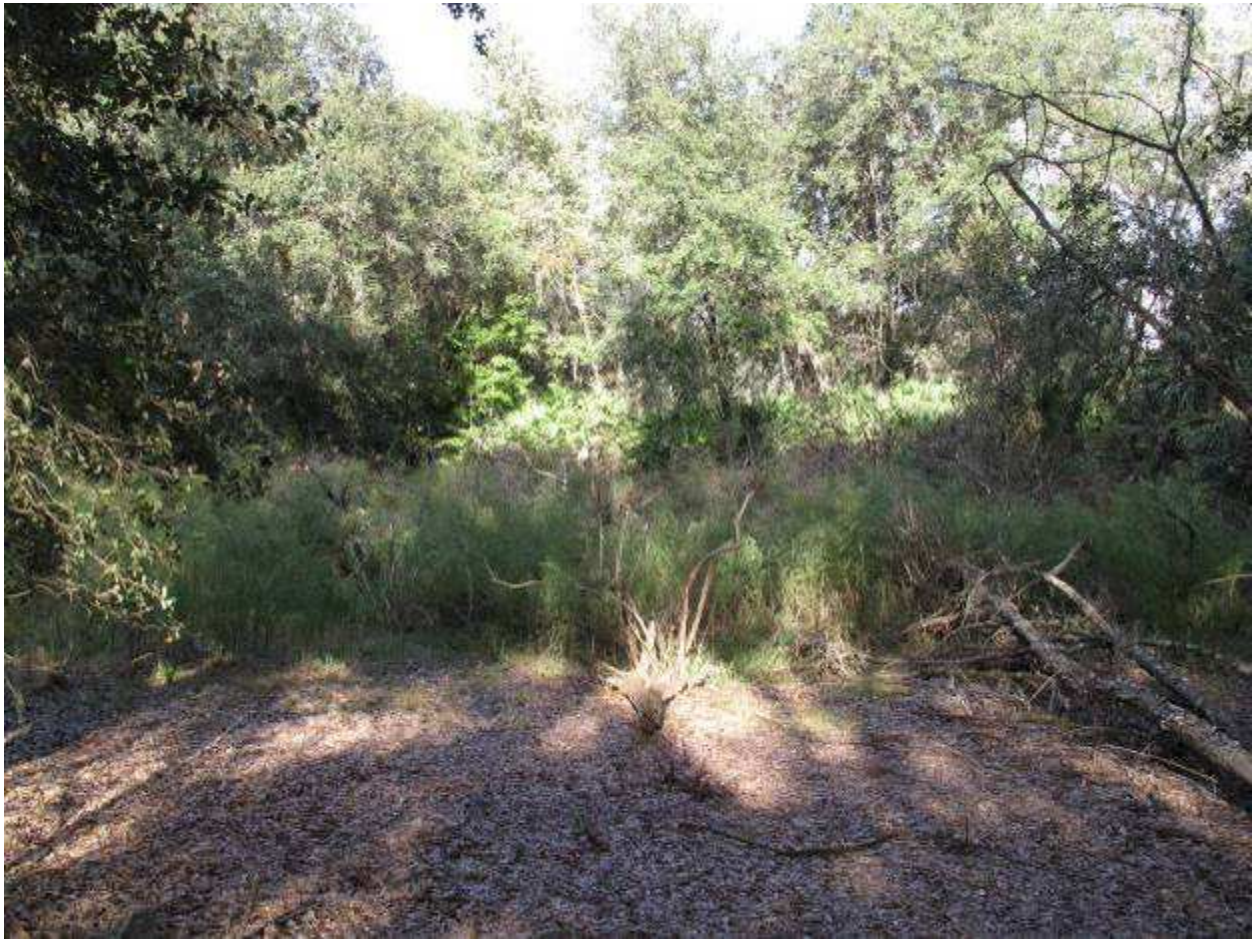
Description: This wetland is a <0.1 ha ephemeral marsh. Oak trees are leaning over the wetland edge, and cover 5-25% of the wetland basin. Buttonbush and dog fennel dominate the midstory, and cover 5-25% of the wetland basin. Maidencane grows throughout the wetland, and covers 25-50% of the basin. The wetland is surrounded by a dense oak/palmetto ring and grazed uplands.

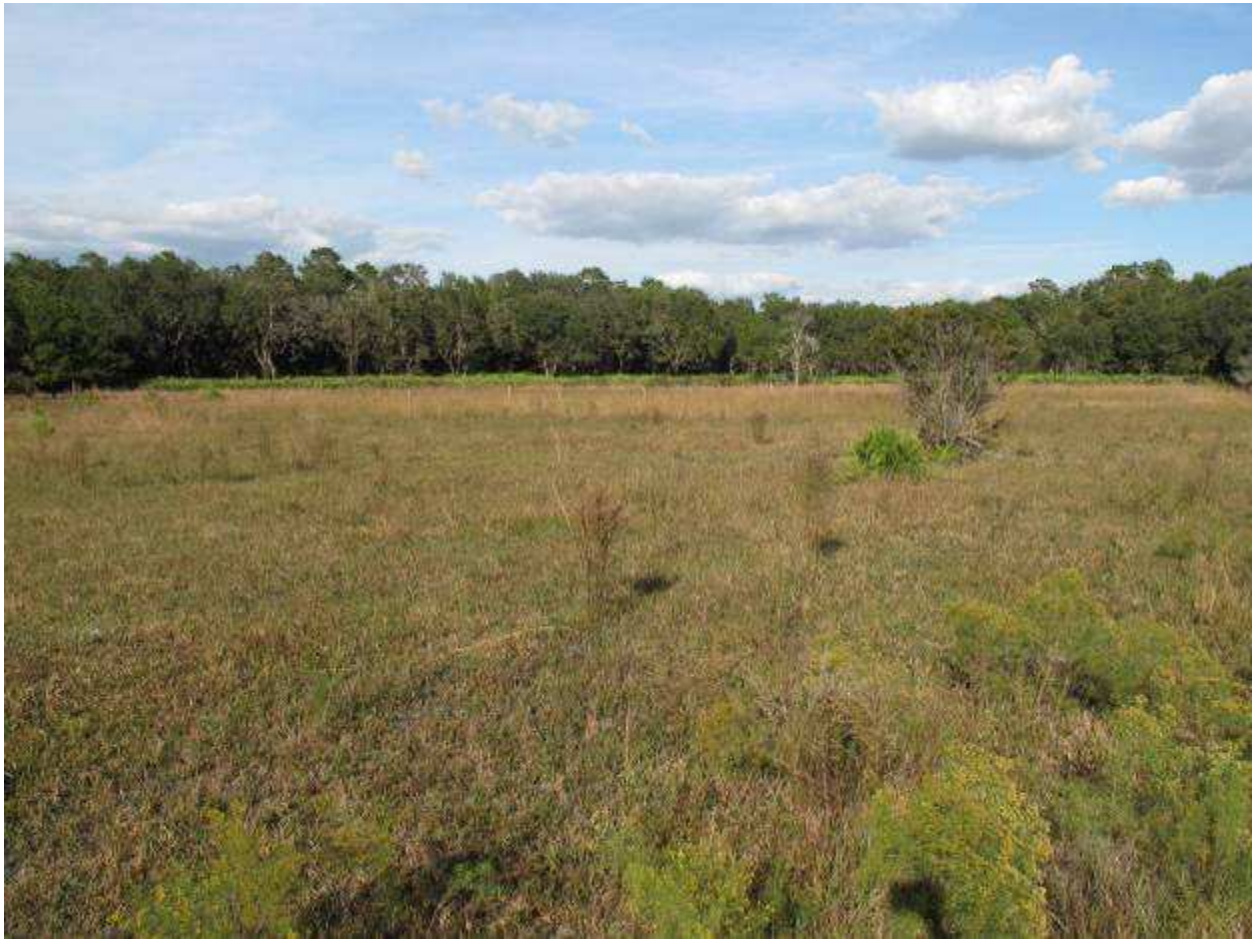
Description: This wetland is a 3.8 ha ephemeral marsh. There is no tree canopy or midstory cover. Maidencane and sedge/grasses grow throughout the wetland, and cover >75% of the basin. This oblong, large depression marsh has very diverse herbaceous vegetation but is impacted by extensive cattle grazing. The wetland is surrounded by a dense oak/palmetto ring and grazed uplands.

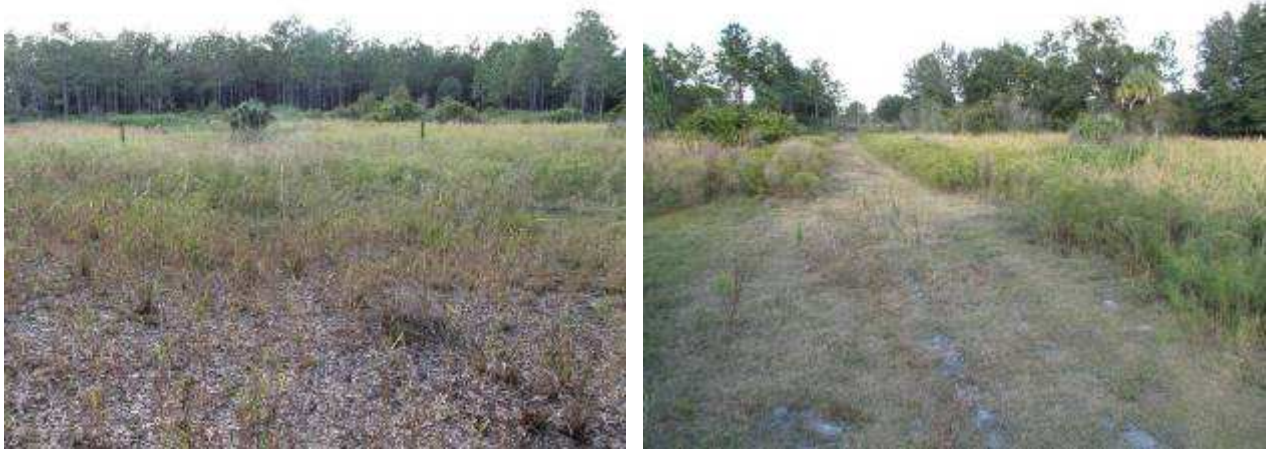
Wetland ID: 32-03

Description: This wetland is a 0.2 ha ephemeral marsh. There is no tree canopy or midstory cover. Maidencane and sedges/grasses grow throughout the wetland, and cover >75% of the basin. A fireline/MU boundary bisects the west side of the wetland. A ditch connects on the south side of the wetland connects to the larger Wetland 32-04. The adjacent uplands are grazed uplands and a longleaf pine stand.

Wetland Concerns: Cattle, Ditching, Fireline/MU boundary, Upland condition

Restoration Action Recommended: Move the fireline/MU boundary out of the wetland. Fill the ditch to break connectivity with the wetland. Alternatively, the ditch could be plugged and vegetation allowed to regenerate. In order to restore the full ecological potential of the wetland, the cattle would need to be removed and the uplands restored.

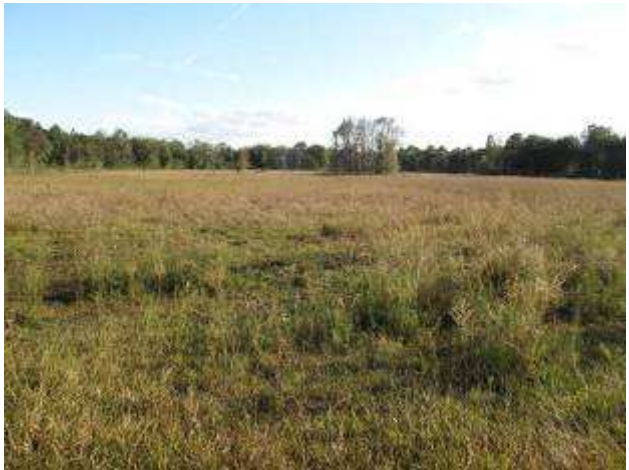
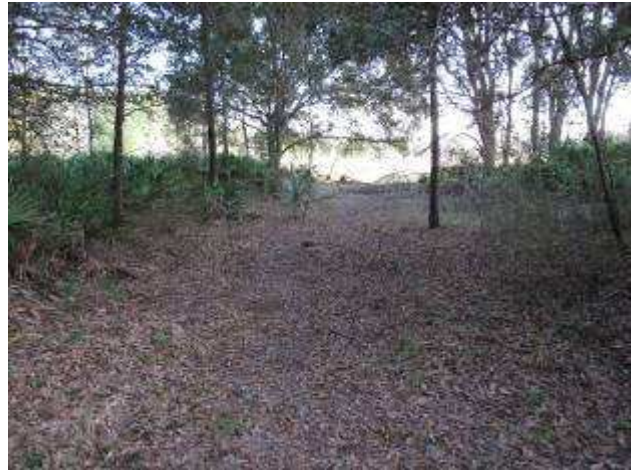
Wetland ID: 32-04

Description: This wetland is a 4.6 ha ephemeral marsh. There is no tree canopy or midstory cover. Maidencane and sedges/grasses grow throughout the wetland, and cover >75% of the basin. Impacts from feral hogs and cattle grazing are patchy in the wetland. There are ditches on the north and south sides of the wetland. A ditch on the north side of the wetland connects to Wetland 32-03 and a ditch on the south side of the wetland connects to a large wetland system that was not inventoried. The ditch on the south side of the wetland has been plugged. The wetland is surrounded by an oak/palmetto ring and grazed uplands.

Wetland Concerns: Cattle, Ditching, Feral hog damage, Upland condition

Restoration Action Recommended: Fill the ditch to the north to break connectivity with Wetland 32-03. Alternatively, the ditch could be plugged and vegetation allowed to regenerate. In order to restore the full ecological potential of the wetland, the cattle would need to be removed and the uplands restored.

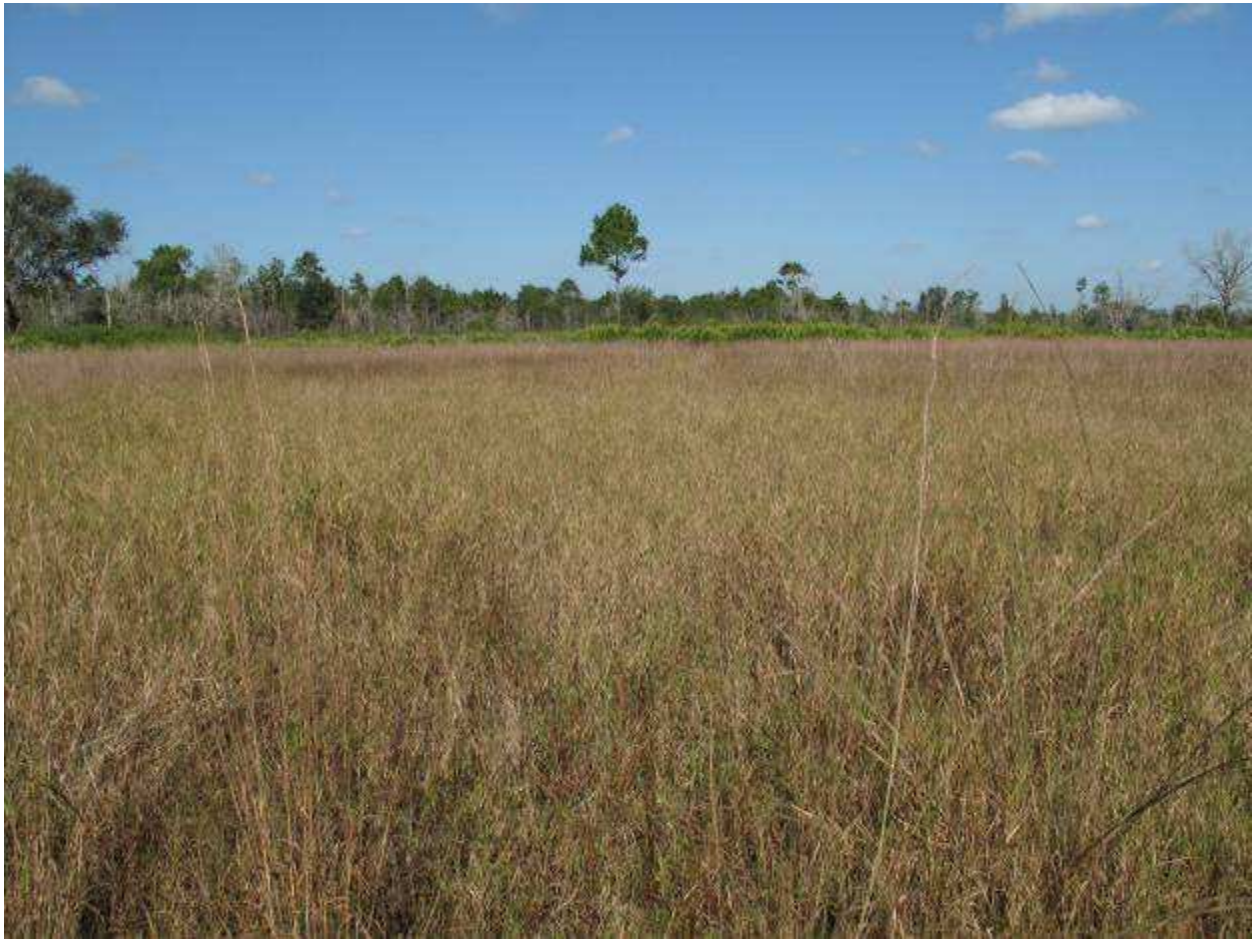
Description: This wetland is a 1.8 ha ephemeral marsh. There is no tree canopy or midstory cover. Maidencane and sedges/grasses grow throughout the wetland, and cover >75% of the basin. This marsh appears to be in good ecological condition despite the presence of cattle. The adjacent uplands are a recently burned pine/oak/palmetto community.

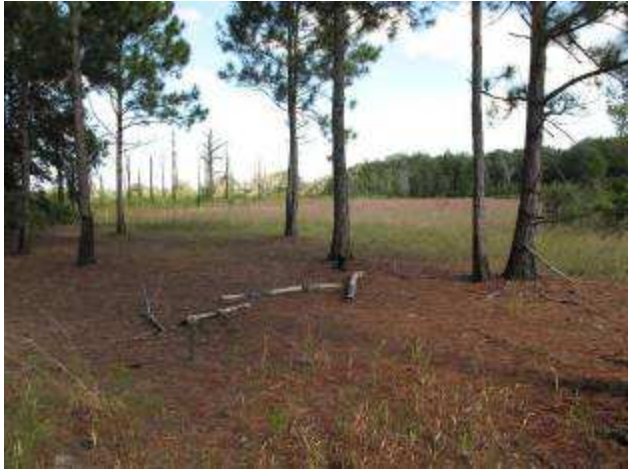
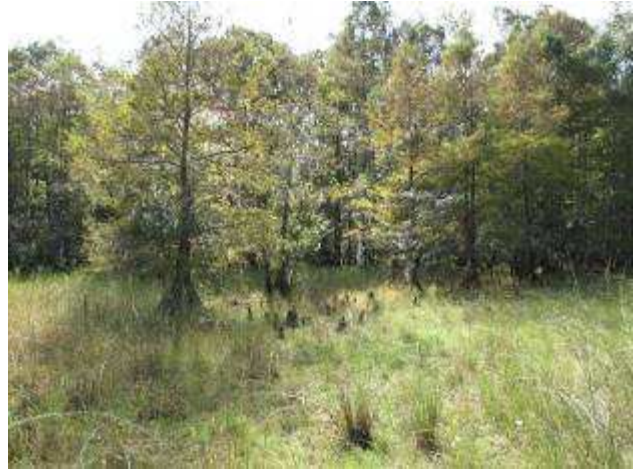
Wetland ID: 34-02

Description: This wetland is a 1.0 ha ephemeral marsh with a small forested swamp on the south side. Cypress and pine trees dominate the canopy, and cover 5-25% of the wetland. There is no midstory layer. Maidencane and sedges/grasses grow throughout the wetland, and cover >75% of the basin. There is a grouping of large pine trees in the southwest corner of the wetland. A fireline/MU boundary bisects the south end of the wetland and a fenced plot is located in the western section of the wetland. Cattle impacts are light. The adjacent uplands are a recently burned pine/oak/palmetto community.

Wetland Concerns: Cattle, Fireline/MU boundary

Restoration Action Recommended: Move the Fireline/MU boundary away from the wetland. While cattle have not yet impacted the wetland, if they are present in the MU, they are a potential future threat.

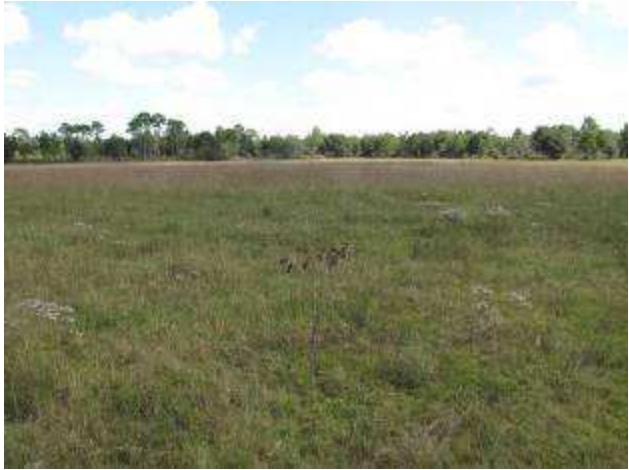
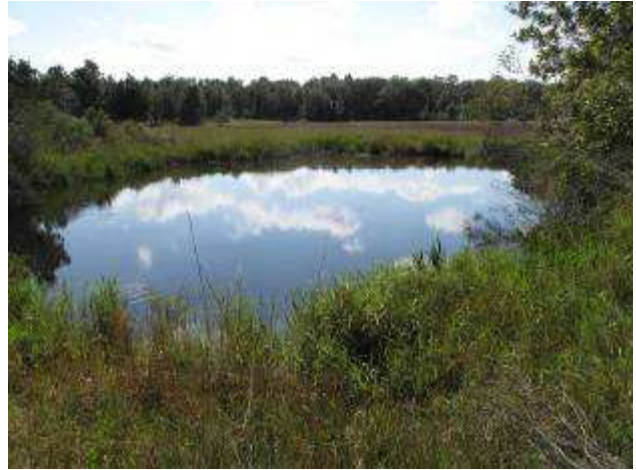
Wetland ID: 34-03

Description: This wetland is an 8.3 ha altered marsh. The wetland was an ephemeral marsh but a dug-out section has caused a section to remain semi-permanent, thereby allowing fish to persist. There is no tree canopy or midstory cover. Maidencane and sedges/grasses grow throughout the wetland, and cover >75% of the basin. This marsh would be a potential striped newt breeding pond if the marsh was restored and the dug-out filled. There is evidence of past cattle presence in the wetland. The adjacent uplands are a mix of scrubby flatwoods and upland pine forest.

Wetland Concerns: Cattle, Dug-out

Restoration Action Recommended: Fill the dug-out. In order to restore the full ecological potential of the wetland, the cattle would need to be removed.
