Inventory, Assessment, and Restoration Potential of Ephemeral Wetlands on FFWCC Wildlife Management Areas

Half Moon WMA Final Report

Submitted by: Rebecca P.M. Means¹, Ryan C. Means¹, Steven A. Johnson²

¹Coastal Plains Institute

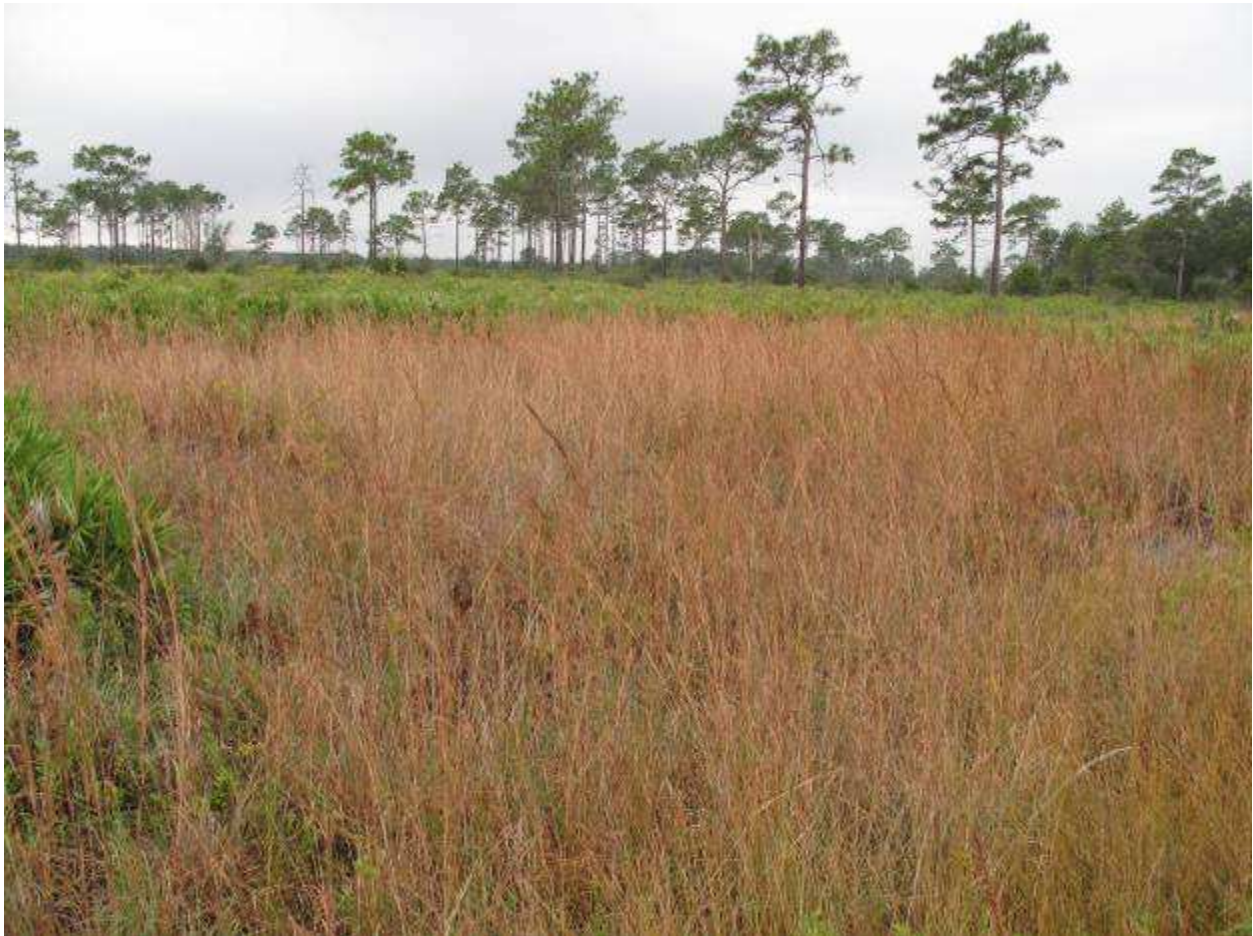
Description: This wetland is a <0.1 ha highly ephemeral marsh. There is no tree canopy or midstory cover. Sedges/grasses grow throughout the wetland, and cover >75% of the basin. This small, circular marsh is prime striped newt breeding habitat. There is some minor feral hog damage in the wetland. The adjacent uplands are fire-maintained scrubby flatwoods.

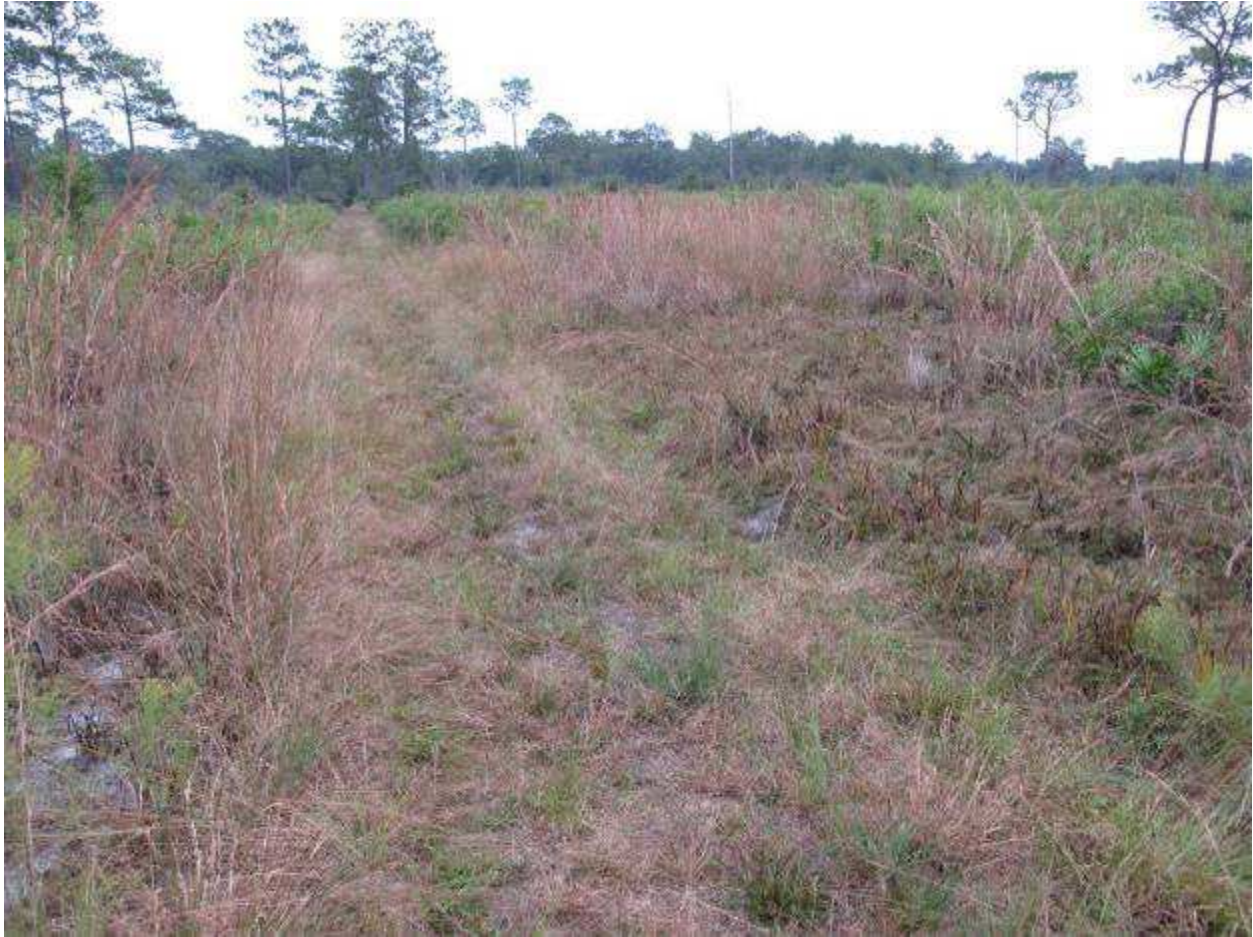
Description: This wetland is a <0.1 ha highly ephemeral marsh. There is no tree canopy or midstory cover. Sedges/grasses grow throughout the wetland, and cover >75% of the basin. A fireline/MU boundary bisects the wetland. The wetland has past and present feral hog damage and is a potential striped newt breeding pond. The adjacent uplands are fire-maintained scrubby flatwoods.

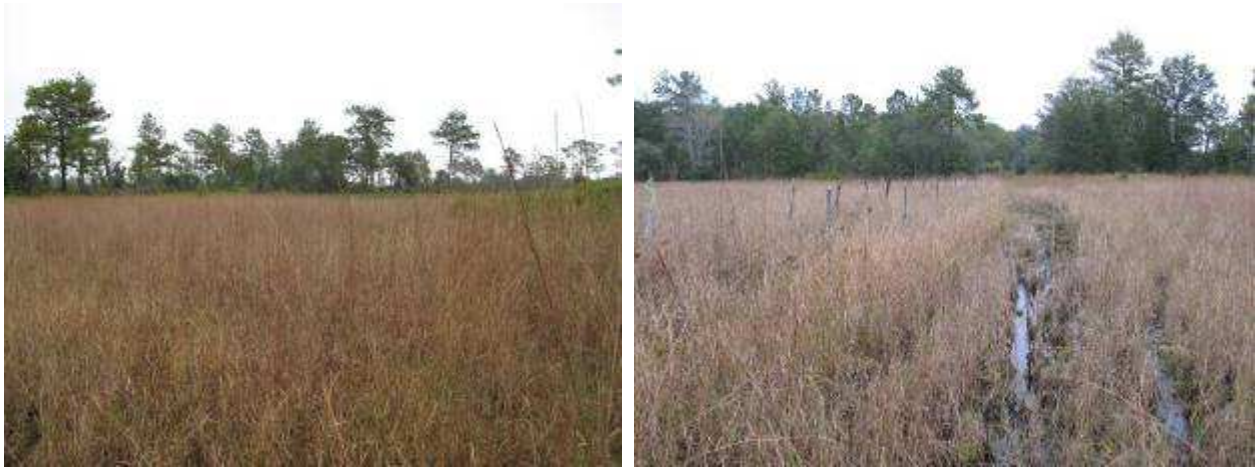
Wetland ID: 40-03

Description: This wetland is a 0.9 ha ephemeral marsh. There is no tree canopy or midstory cover. Sedges/grasses and maidencane grow throughout the wetland, and cover >75% of the basin. A fireline/private property boundary bisects the wetland. This wetland is a potential striped newt breeding pond. The adjacent uplands are fire-maintained scrubby flatwoods.

Wetland Concerns: Fireline/private property boundary

Restoration Action Recommended: The boundary should be re-routed away from the wetland if feasible. If the boundary cannot be re-routed, monitor the wetland to ensure fire is not excluded. Maintain the fireline when the wetland is completely dry to prevent ruts from developing.

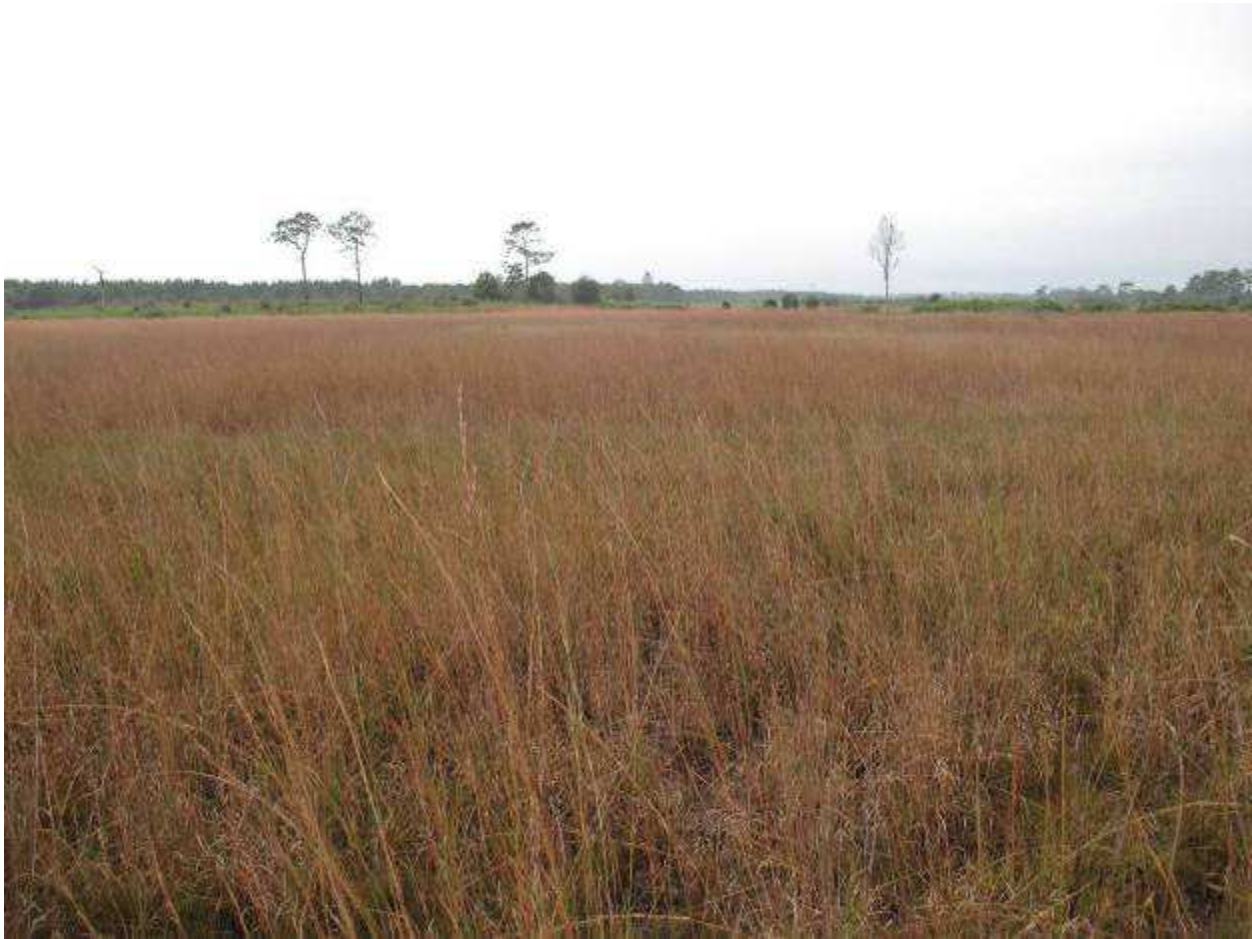
Description: This wetland is a 3.2 ha ephemeral marsh. There is no tree canopy or midstory cover. Sedges/grasses and maidencane grow throughout the wetland, and cover >75% of the basin. A fireline/private property boundary bisects the western edge of the wetland. This wetland is a potential striped newt breeding pond. The adjacent uplands are fire-maintained scrubby flatwoods.

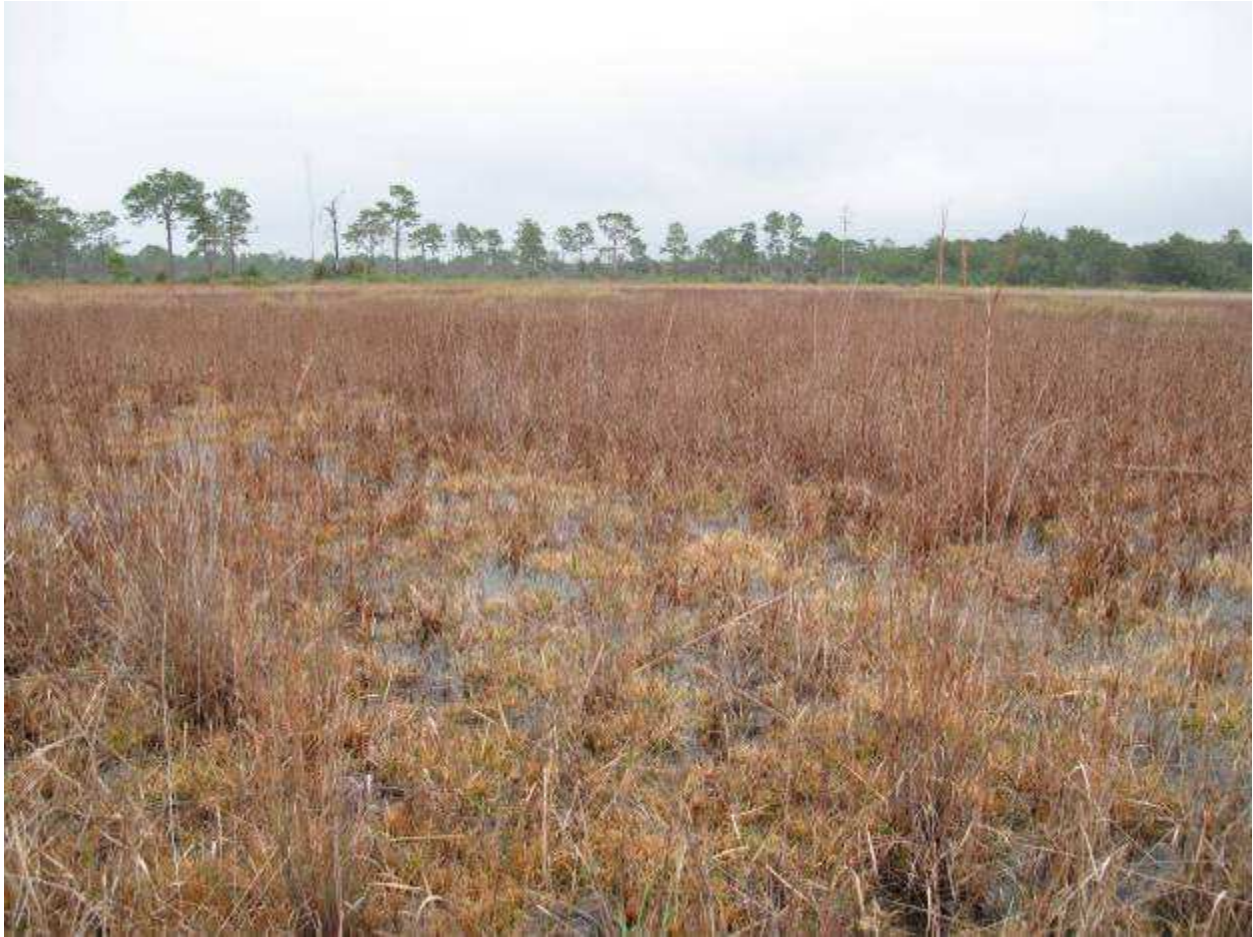
Description: This wetland is a 5.3 ha ephemeral marsh. There is no tree canopy or midstory cover. Sedges/grasses and maidencane grow throughout the wetland, and cover >75% of the basin. A fireline/private property boundary bisects the eastern edge of the wetland. The wetland is in great ecological condition and is a potential striped newt breeding pond. The adjacent uplands are fire-maintained scrubby flatwoods.

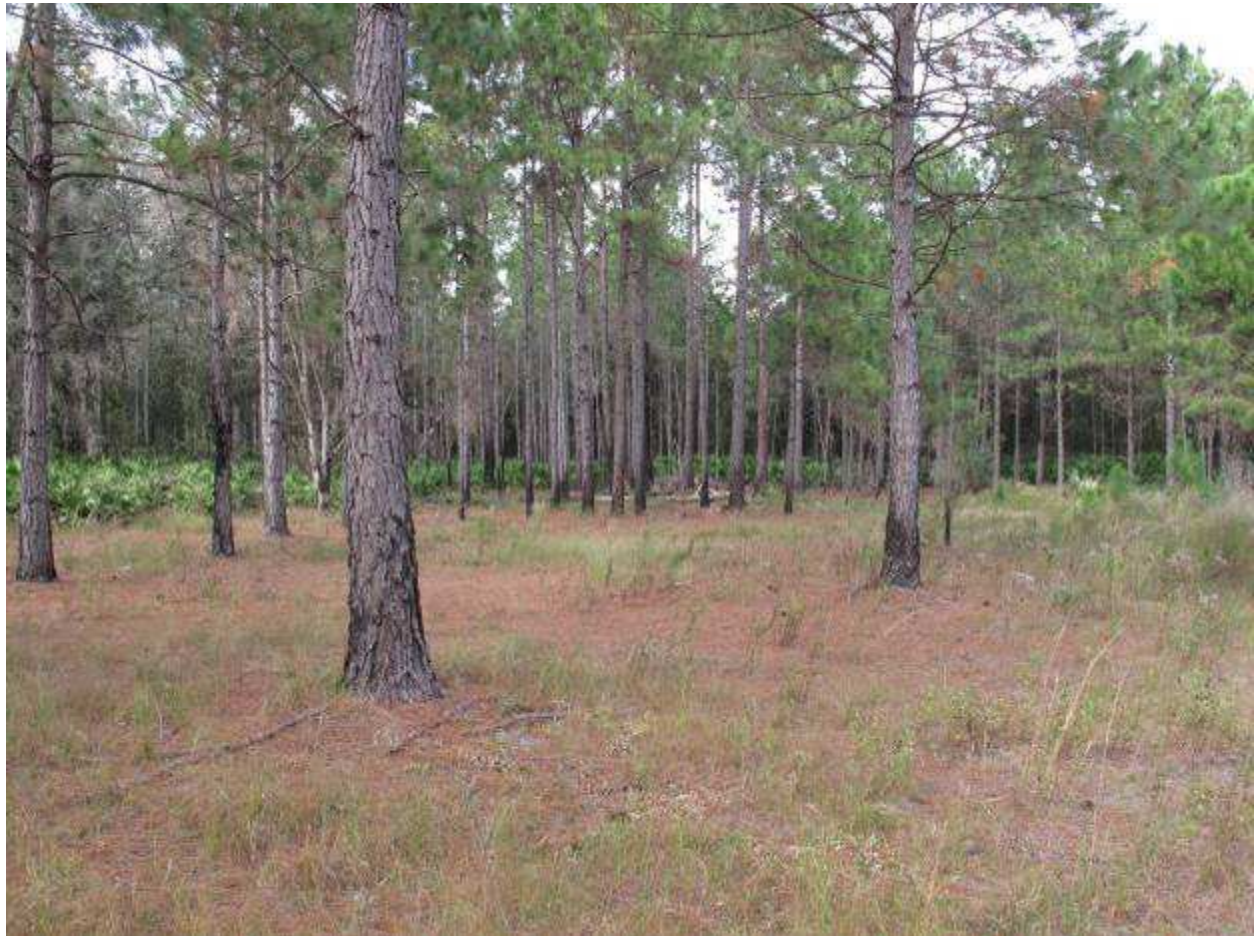
Description: This wetland is a 0.2 ha highly ephemeral marsh. Woody vegetation has heavily encroached into the wetland. Pine trees dominate the canopy, and cover 25-50% of the wetland basin. Small pine and sweet gum trees, and wax myrtle dominate the midstory, and cover 5-25% of the wetland. Sedges/grasses grow in scattered patches, and cover 50-75% of the wetland basin. Grazing is allowed in this MU, although there does not appear to be any cattle impact in the wetland. The adjacent uplands are scrubby flatwoods and pine/oak/palmetto thickets.

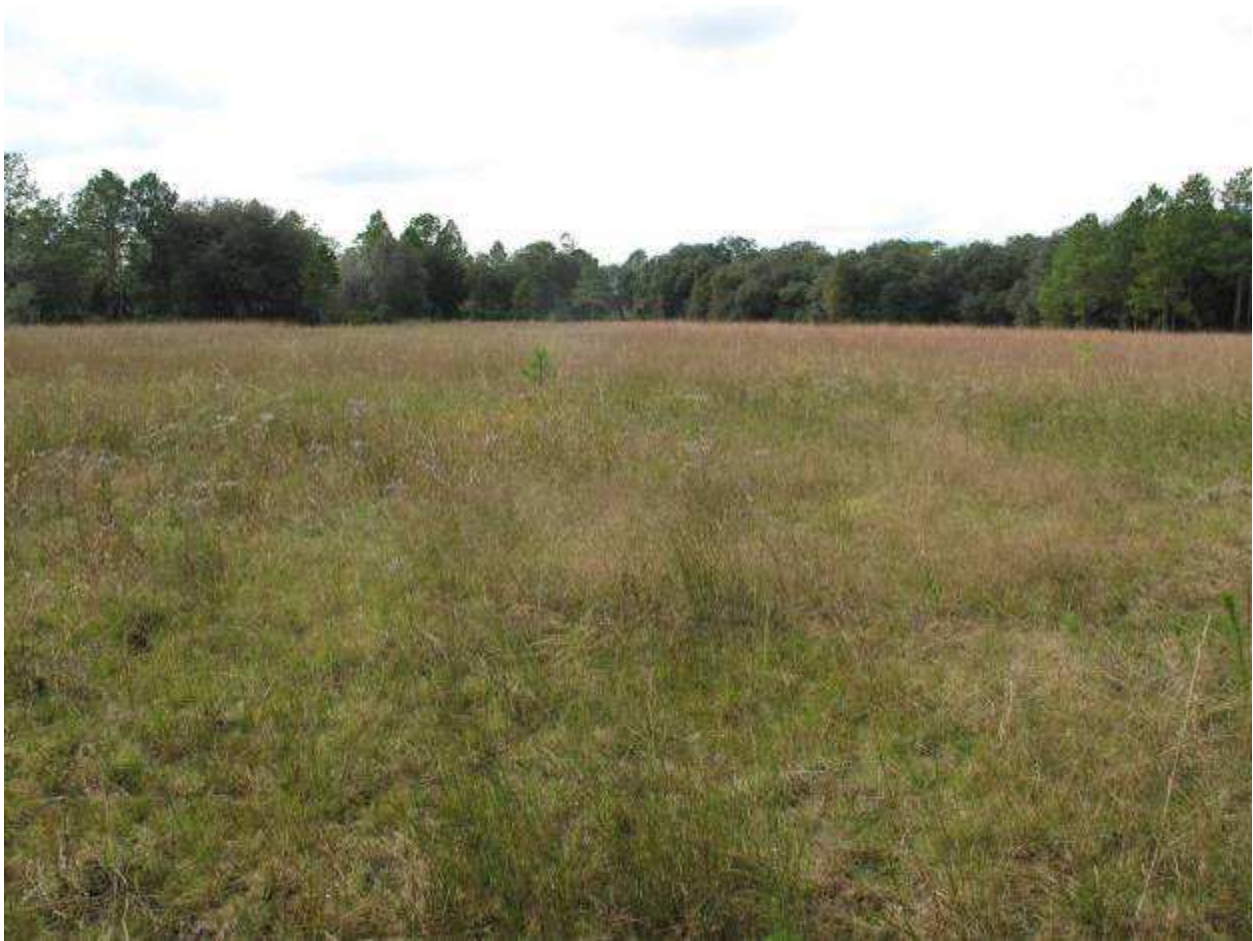
Description: This wetland is a 2.2 ha ephemeral marsh. Medium to large-sized pine grow in a ring around the wetland, and cover 5-25% of the basin. There is thick needle duff under the pine trees. There is no midstory layer and the wetland interior is open. Sedges/grasses grow throughout the wetland, and cover >75% of the basin. Cattle grazing impacts are patchy. This wetland will connect with 41-03 during periods of high water. This marsh is a potential striped newt breeding pond. The adjacent uplands are scrubby flatwoods and pine/oak/palmetto thickets.

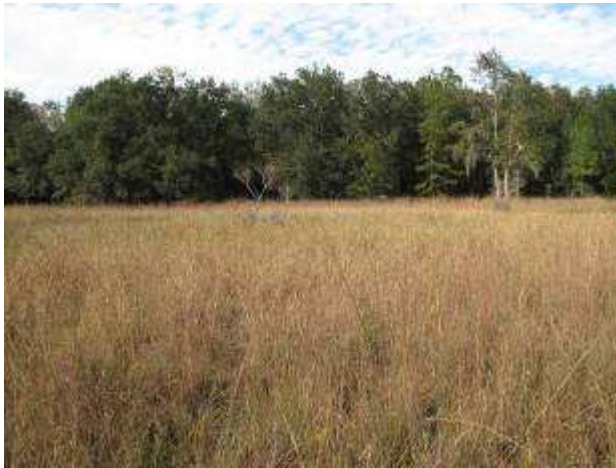
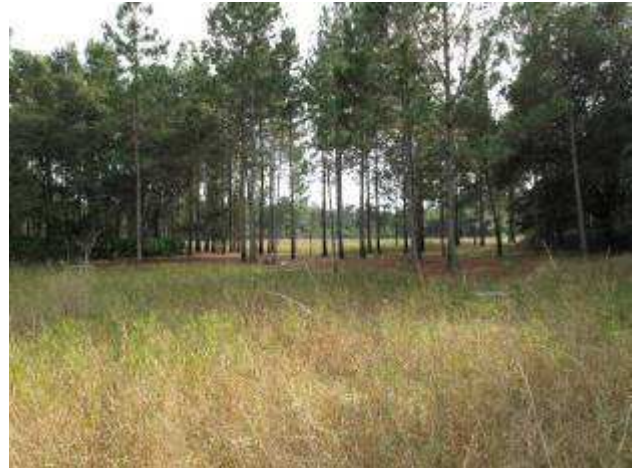
Wetland ID: 41-03

Description: This wetland is a 1.0 ha ephemeral marsh. Several large pine trees grow around the wetland edge, and cover 5-25% of the wetland basin. There is no midstory layer. Sedges/grasses and maidencane grow throughout the wetland, and cover >75% of the basin. Cattle trails are present through the wetland. This wetland will connect with 41-02 during periods of high water. The wetland is a potential striped newt breeding pond. The adjacent uplands are scrubby flatwoods and pine/oak/palmetto thickets.

Wetland Concerns: Cattle, Woody encroachment

Restoration Action Recommended: Thin pine trees in connector region between the two ponds. In order to restore the full ecological function of this wetland, the cattle should be removed.

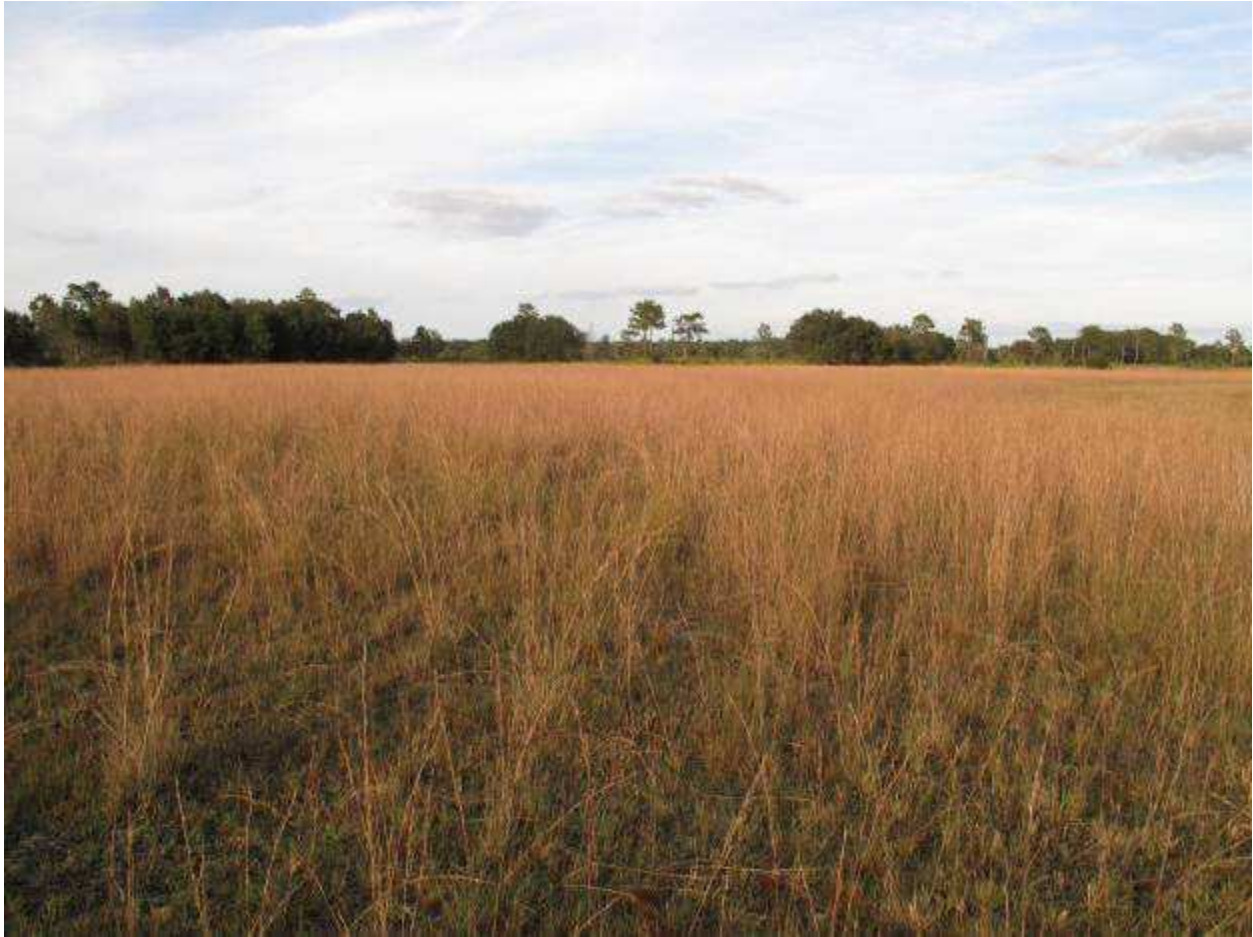
Description: This wetland is an 11.7 ha ephemeral marsh. There is no tree canopy or midstory layer. Maidencane grows in the deeper holes and broomsedge grows around the wetland edges. The herbaceous vegetation covers >75% of the wetland basin. Cattle impact is minimal and patchy in the wetland basin. This wetland appears to be in great ecological condition, is an excellent example of a wetland with no woody encroachment, and is a potential striped newt breeding pond. The adjacent uplands are scrubby flatwoods with patchy oak thickets.

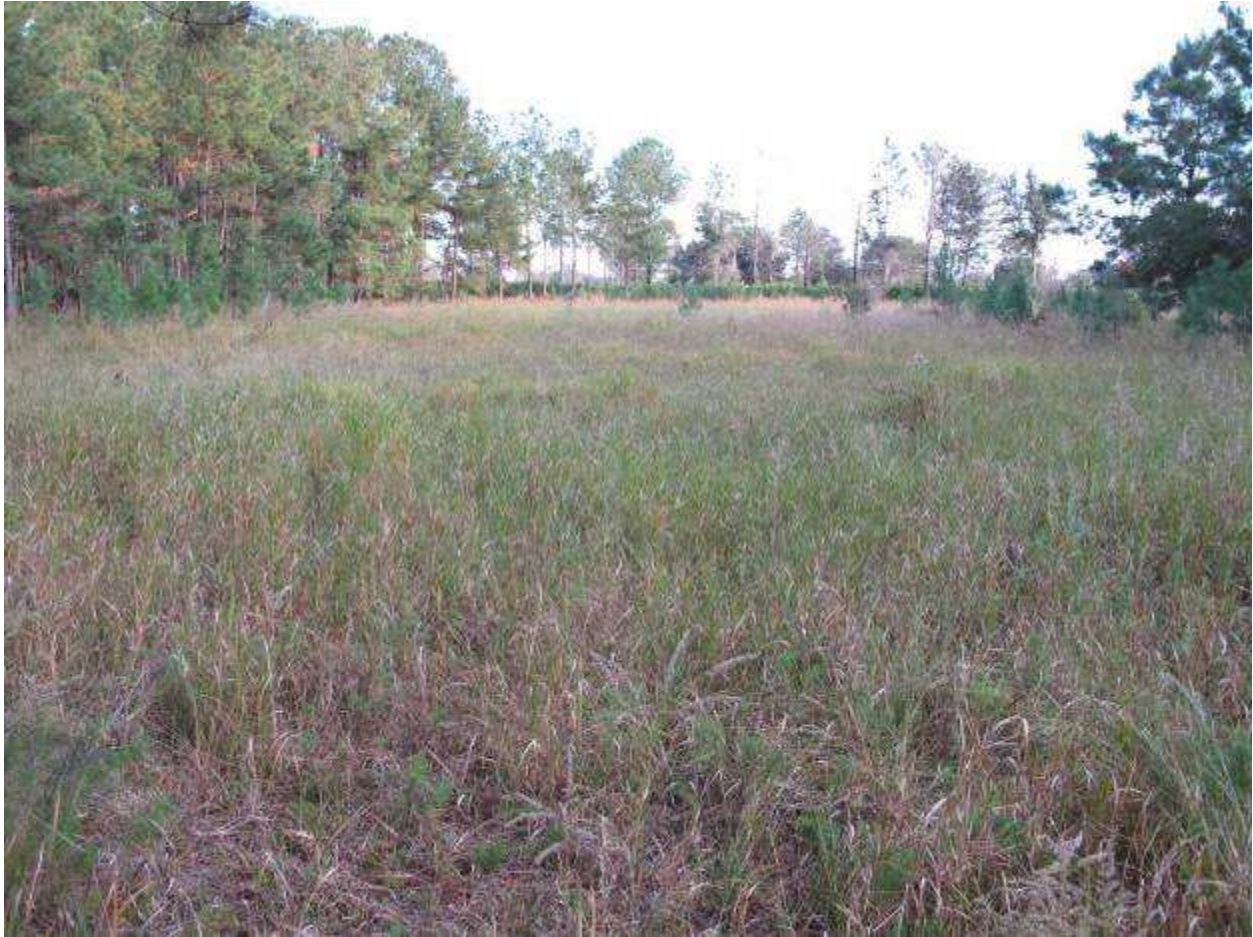
Description: This wetland is a 0.5 ha ephemeral marsh. Large pine trees form a ring around the wetland edge, and cover 5-25% of the wetland basin. Small pine trees are encroaching from the wetland edge and grow in patches in the wetland interior. The small pine trees cover 5-25% of the wetland. Maidencane grows throughout the wetland, and covers >75% of the basin. Cattle impacts include grazing and trails. The wetland is a potential striped newt breeding pond. The adjacent uplands are scrubby flatwoods with patchy oak thickets.

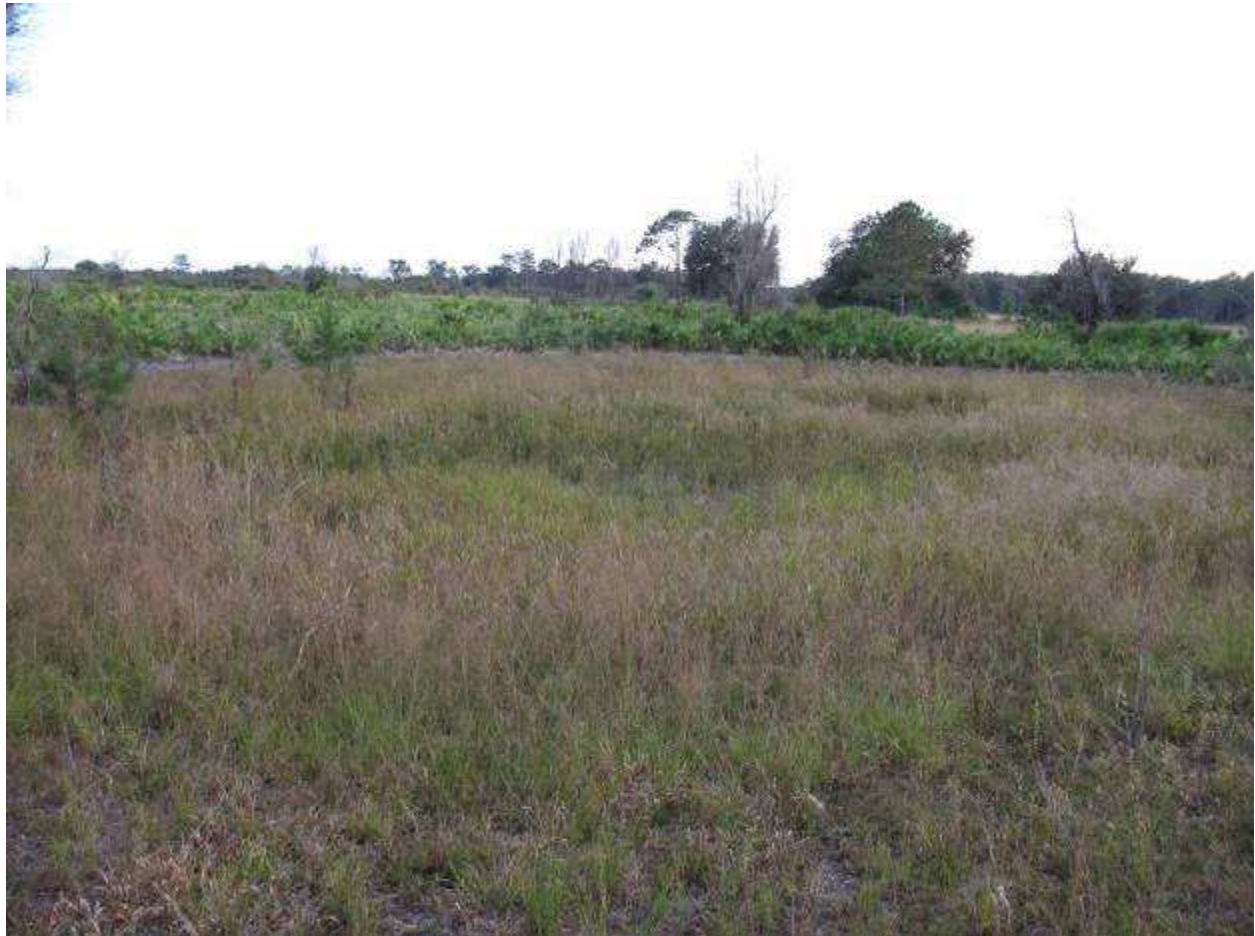
Description: This wetland is a <0.1 ha ephemeral marsh. There is no tree canopy or midstory cover. Maidencane and sedges/grasses grow throughout the wetland, and cover >75% of the basin. This wetland provides an excellent example of a pristine sink depressional marsh and is a potential striped newt breeding pond. The adjacent uplands are scrubby flatwoods.

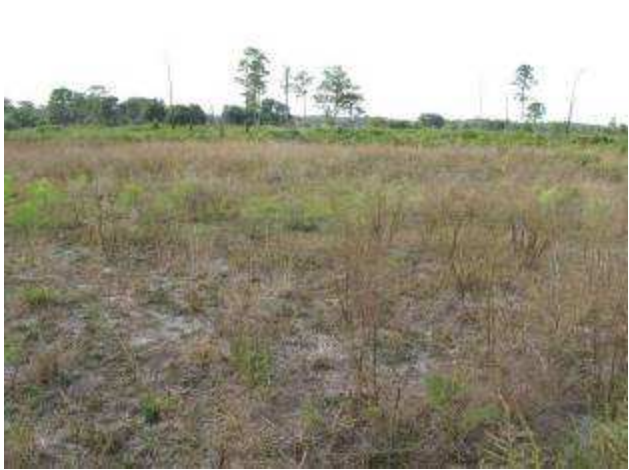
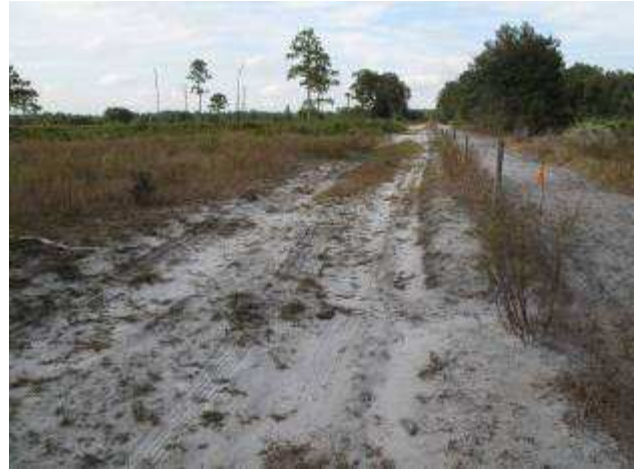
Wetland ID: 43-04

Description: This wetland is a 1.0 ha ephemeral marsh. There is no tree canopy or midstory cover. One large live oak grows on the west side, up on a hill along the wetland edge. Sedges/grasses grow throughout the wetland, and cover >75% of the basin. This wetland is bisected by a fireline/private property boundary. Grazing is allowed though no impact is evident in the wetland basin. The wetland appears to be in excellent ecological health and is a potential striped newt breeding pond. The adjacent uplands are scrubby flatwoods.

Wetland Concerns: Cattle, Fireline/private property boundary

Restoration Action Recommended: The uplands in this MU are in good ecological condition, although we have observed some minor cattle-related effects in both wetlands and uplands in some areas. We recommend removing cattle from this unit to prevent destruction of the intact flatwoods community and the embedded wetlands. Contact landowner to see if the boundary can be moved to encompass the entire wetland. If the boundary cannot be moved, monitor the wetland to ensure fire is not excluded. Maintain the fireline when the wetland is completely dry to prevent ruts from developing.

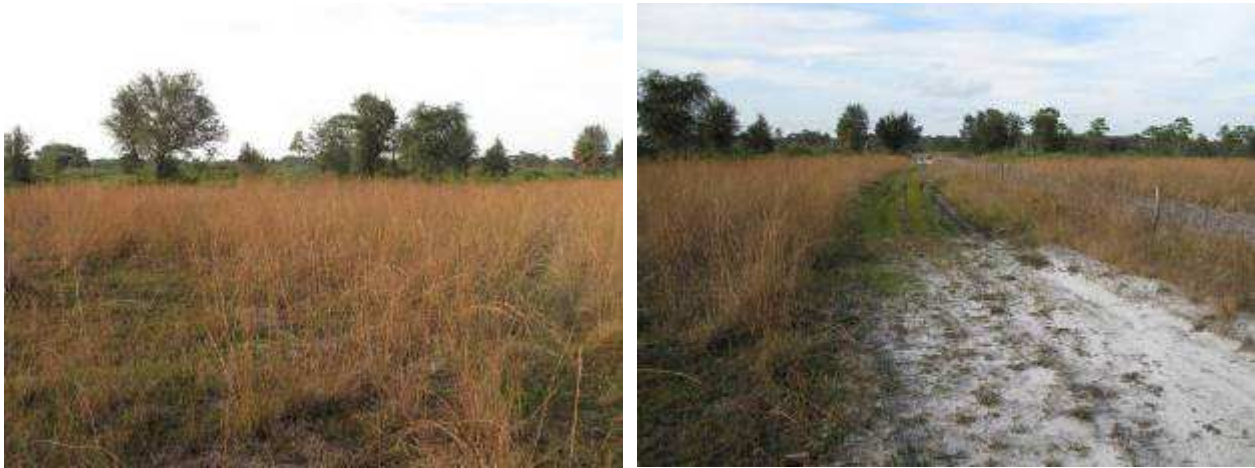
Wetland ID: 43-05

Description: This wetland is a 0.7 ha ephemeral marsh. There is no tree canopy or midstory cover. Sedges/grasses grow throughout the wetland, and cover >75% of the basin. This wetland is bisected by a fireline/private property boundary. Grazing is allowed though no impact is evident in the wetland basin. The wetland appears to be in excellent ecological health and is a potential striped newt breeding pond. The adjacent uplands are scrubby flatwoods.

Wetland Concerns: Cattle, Fireline/private property boundary

Restoration Action Recommended: The uplands in this MU are in good ecological condition, although we have observed some minor cattle-related effects in both wetlands and uplands in some areas. We recommend removing cattle from this unit to prevent destruction of the intact flatwoods community and the embedded wetlands. Contact landowner to see if boundary can be moved to encompass the entire wetland. If the boundary cannot be moved, monitor the wetland to ensure fire is not excluded. Maintain the fireline when the wetland is completely dry to prevent ruts from developing.

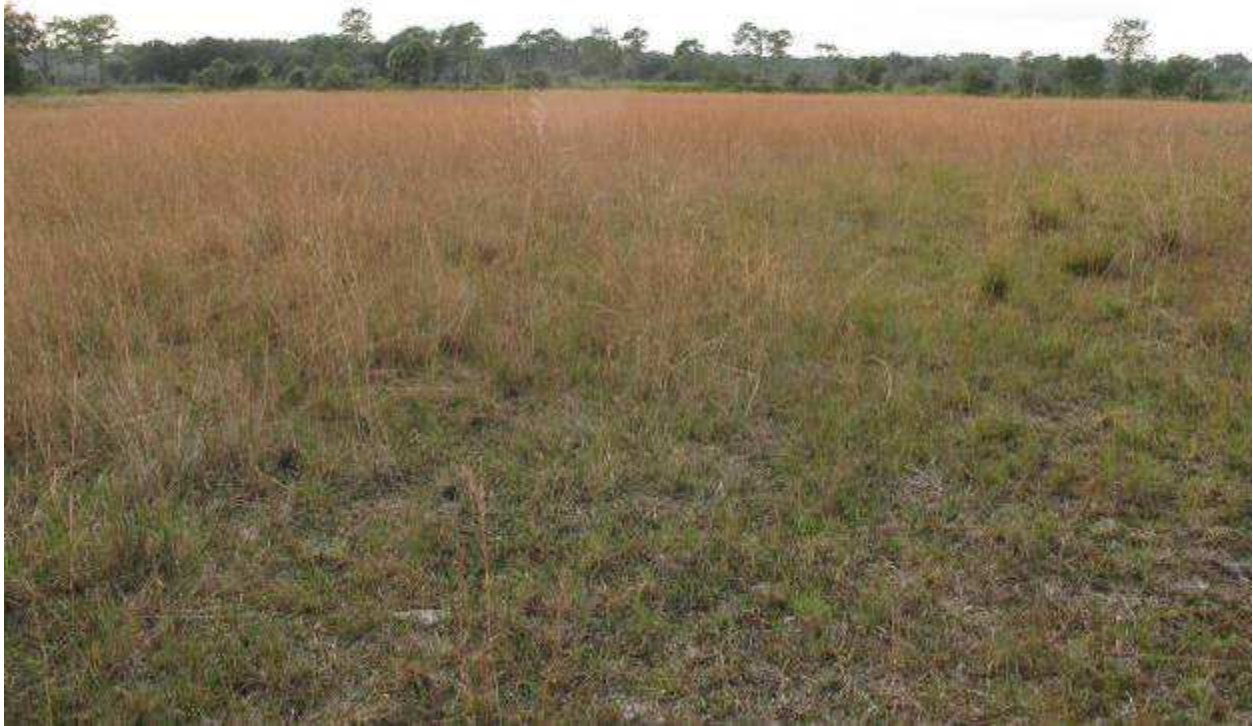
Wetland ID: 43-06

Description: This wetland is a 3.2 ha ephemeral marsh. There is no tree canopy or midstory cover. The marsh has very diverse herbaceous vegetation that covers >75% of the wetland basin. There is a minor patch of cattle grazing on the wetland edge. The wetland appears to be in excellent ecological health, is a great example of a wetland with no woody encroachment, and is a potential striped newt breeding pond. The adjacent uplands are scrubby flatwoods.

Wetland Concerns: Cattle

Restoration Action Recommended: The uplands in this MU are in good ecological condition, although we have observed some minor cattle-related effects in both wetlands and uplands in some areas. We recommend removing cattle from this unit to prevent destruction of the intact flatwoods community and the embedded wetlands.

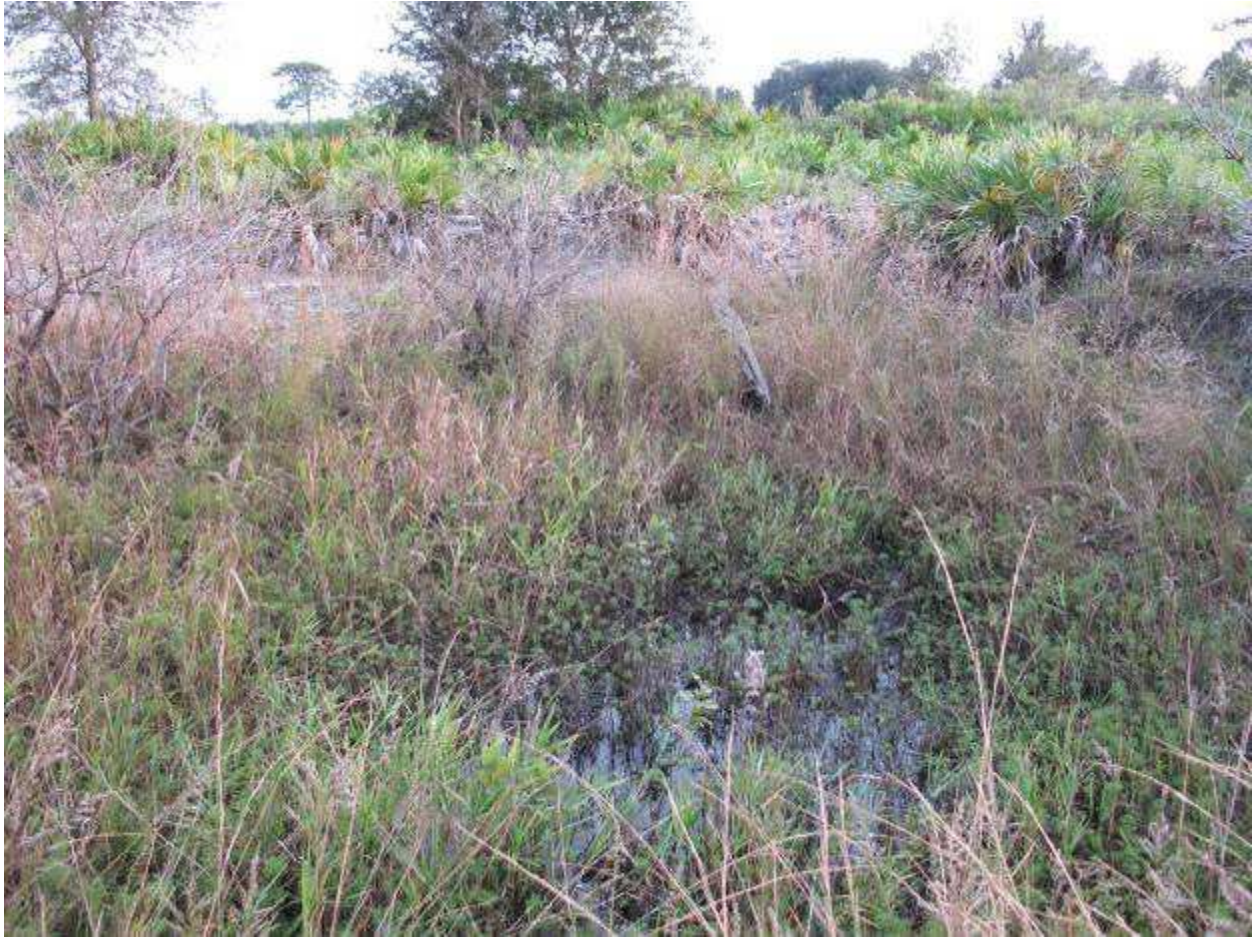
Description: This wetland is a <0.1 ha ephemeral marsh. There is no tree canopy. A ring of buttonbush surrounds the wetland, and covers 5-25% of the wetland basin. Sedges/grasses grow throughout the wetland, and cover >75% of the basin. This wetland is a great example of a very small sinkhole marsh. The buttonbushes exist in a natural fire shadow due to the steep slope and the wetland hydroperiod. The wetland appears to be in excellent ecological health and is a potential striped newt breeding pond. The adjacent uplands are scrubby flatwoods.

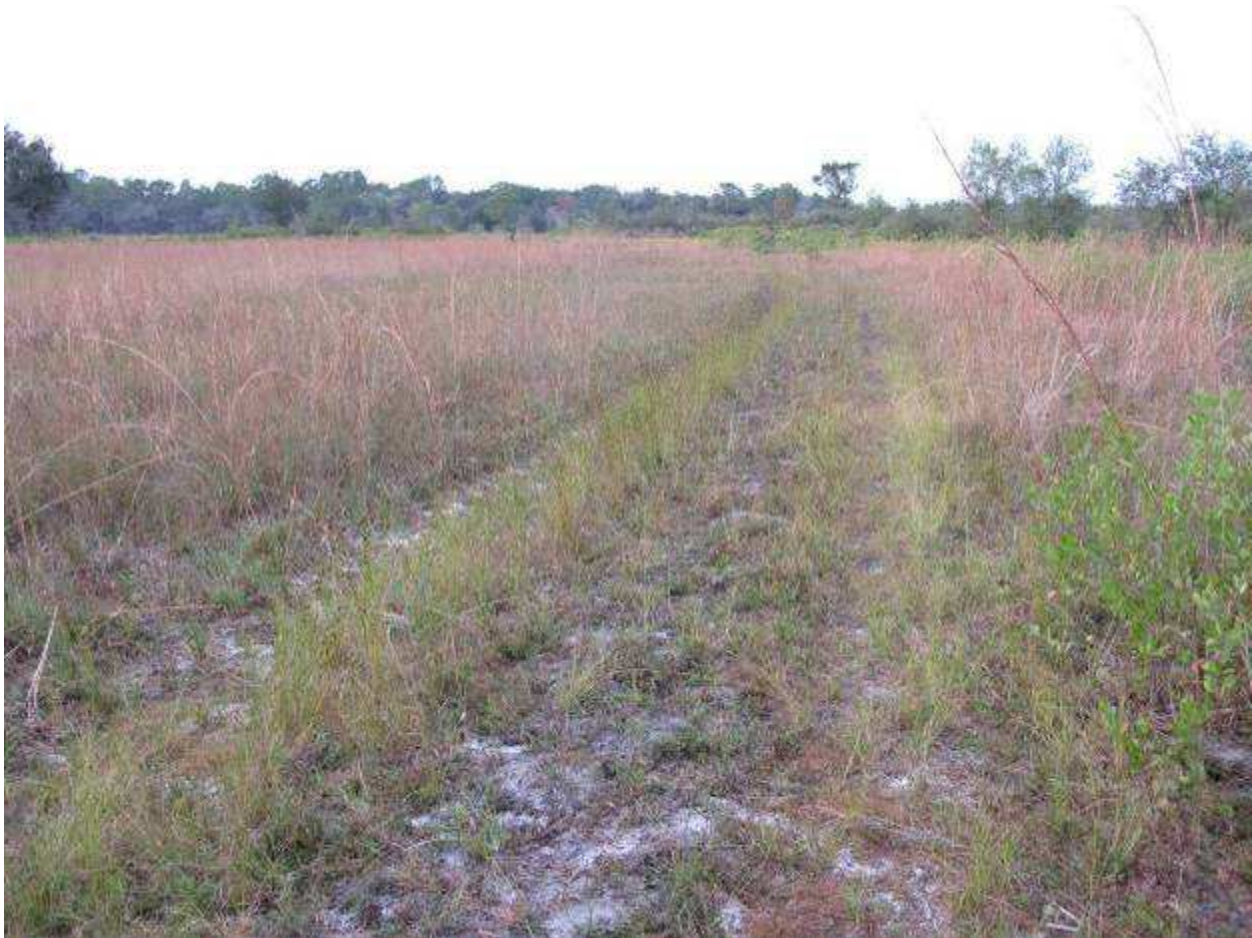
Description: This wetland is a 0.8 ha ephemeral marsh. There is no tree canopy or midstory cover. Sedges/grasses and maidencane grow throughout the wetland, and cover >75% of the basin. There is an automobile track through the east side of the wetland. A roller chopper passed along the wetland edge and left chop-gouges in the wetland soil. The wetland is a potential striped newt breeding pond. The adjacent uplands are scrubby flatwoods.

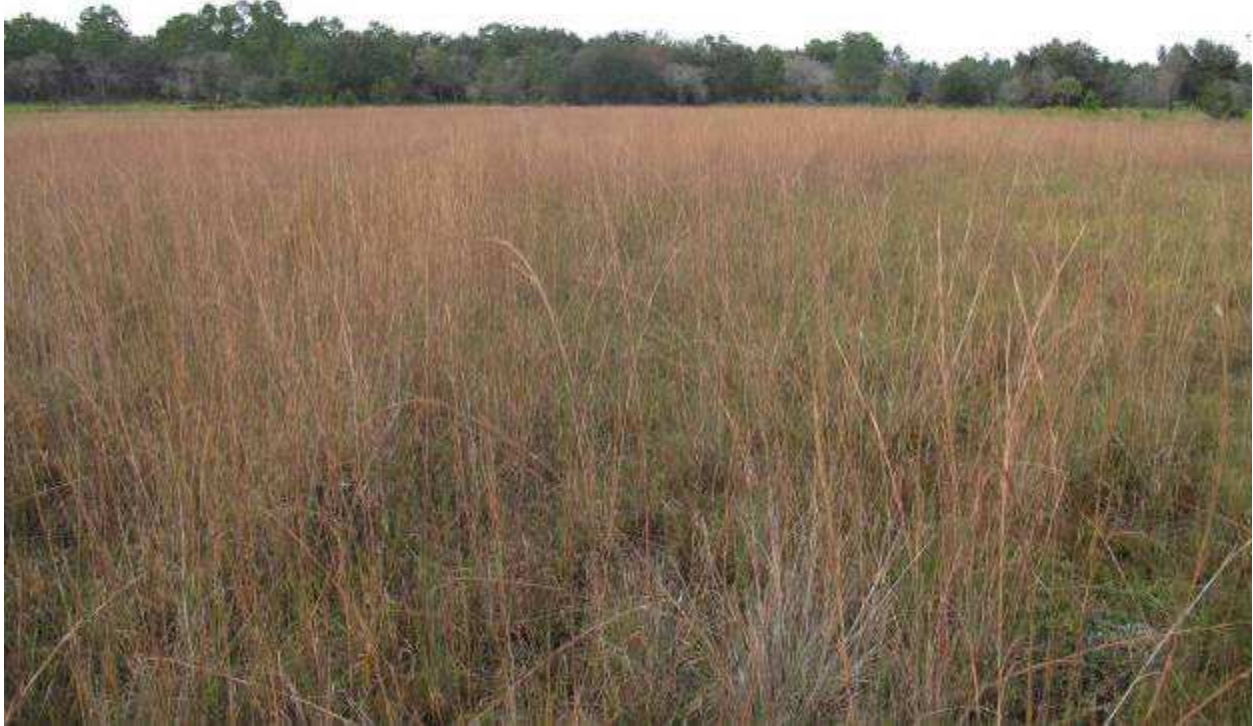
Wetland ID: 43-09

Description: This wetland is a 6.9 ha ephemeral marsh. There is no tree canopy or midstory cover. A few small pine trees are scattered sparsely around the wetland. Sedges/grasses and maidencane grow throughout the wetland, and cover >75% of the basin. An auto track is beginning to form along the eastern edge of the wetland. Cattle have grazed on a patch of the eastern wetland basin. The wetland provides a good example of how slash pine naturally occurs sparsely around a wetland edge. The wetland appears to be in good ecological condition and is a potential striped newt breeding pond. The adjacent uplands are scrubby flatwoods.

Wetland Concerns: Cattle, Vehicular damage

Restoration Action Recommended: The uplands in this MU are in good ecological condition, although we have observed some minor cattle-related effects in both wetlands and uplands in some areas. We recommend removing cattle from this unit to prevent destruction of the intact flatwoods community and the embedded wetlands. Discourage vehicular access to the wetland.

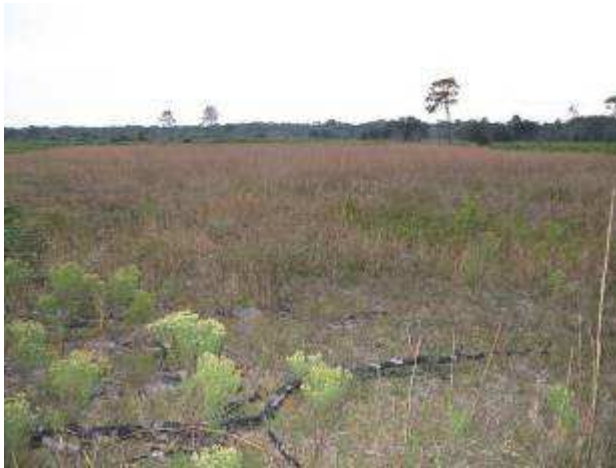
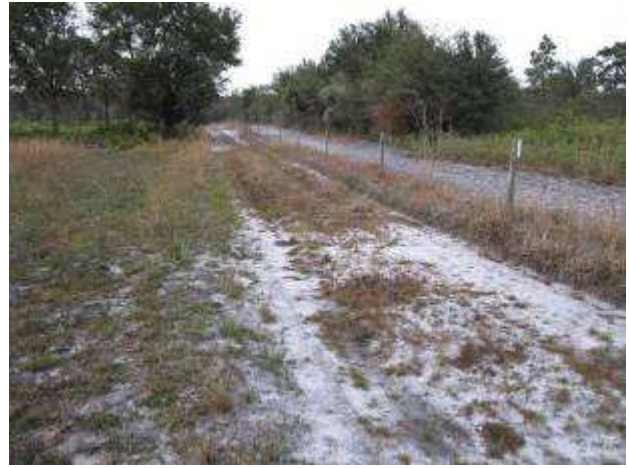
Wetland ID: 43-10

Description: This wetland is a 0.8 ha ephemeral marsh. There is no tree canopy or midstory cover. Sedges/grasses grow throughout the wetland, and cover >75% of the basin. A fireline/private property boundary runs along a small portion of the wetland's eastern edge but is not much of an impact. The wetland provides a great example of an open marsh with no woody encroachment and is a potential striped newt breeding pond. The adjacent uplands are scrubby flatwoods.

Wetland Concerns: Cattle, Fireline/private property boundary

Restoration Action Recommended: The uplands in this MU are in good ecological condition, although we have observed some minor cattle-related effects in both wetlands and uplands in some areas. We recommend removing cattle from this unit to prevent destruction of the intact flatwoods community and the embedded wetlands. Monitor the wetland to ensure fire is not excluded. Maintain the fireline when the wetland is completely dry to prevent ruts from developing.

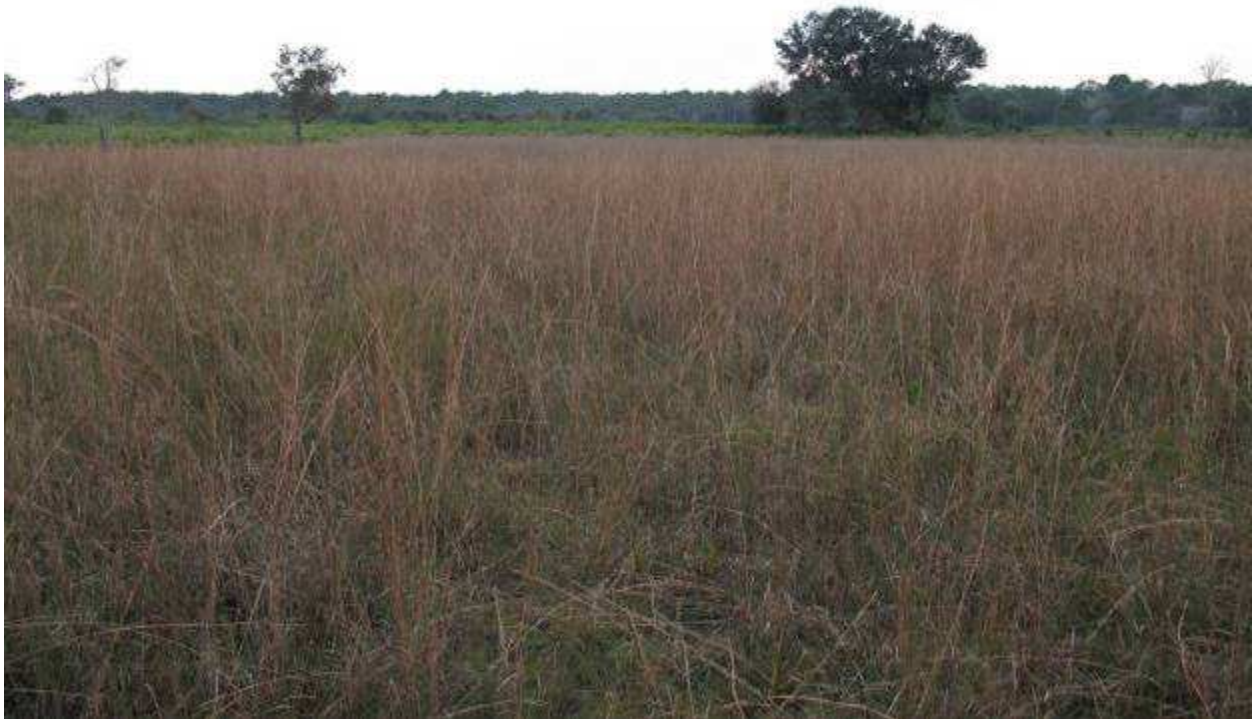
Wetland ID: 43-11

Description: This wetland is a 1.9 ha ephemeral marsh. There is no tree canopy or midstory cover. Sedges/grasses grow throughout the wetland, and cover >75% of the basin. The wetland appears to be in excellent ecological health and is a potential striped newt breeding pond. The adjacent uplands are scrubby flatwoods.

Wetland Concerns: Cattle

Restoration Action Recommended: The uplands in this MU are in good ecological condition, although we have observed some minor cattle-related effects in both wetlands and uplands in some areas. We recommend removing cattle from this unit to prevent destruction of the intact flatwoods community and the embedded wetlands.
