Inventory, Assessment, and Restoration Potential of Ephemeral Wetlands on FFWCC Wildlife Management Areas

Half Moon WMA Final Report

Submitted by: Rebecca P.M. Means¹, Ryan C. Means¹, Steven A. Johnson²

¹Coastal Plains Institute

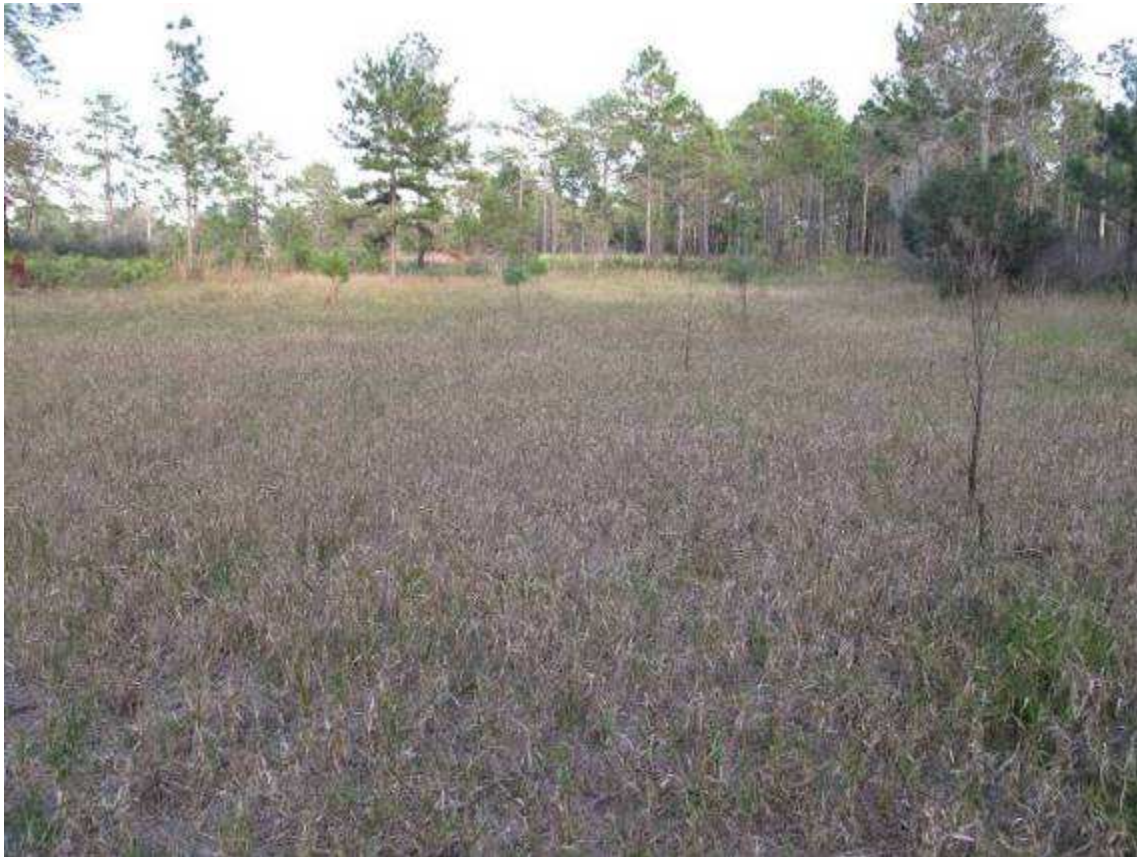
Wetland ID: 46-01

Description: This wetland is a 0.3 ha ephemeral marsh. There is no tree canopy cover. A few small pine trees are growing in the wetland interior, and cover 5-25% of the wetland basin. A fire killed many of the small pine trees but a few remain. Sedges/grasses and maidencane grow throughout the wetland, and cover >75% of the basin. Cattle are grazing the wetland grasses. The wetland provides a good example of fire managing encroaching pine trees. The wetland appears to be in excellent ecological health and is a potential striped newt breeding pond. The adjacent uplands are scrubby flatwoods and oak/palmetto thicket.

Wetland Concerns: Cattle, Woody encroachment

Restoration Action Recommended: The uplands in this MU are in good ecological condition, although we have observed some minor cattle-related effects in both wetlands and uplands in some areas. We recommend removing cattle from this unit to prevent destruction of the intact flatwoods community and the embedded wetlands. Encourage periodic fire in the wetland basin. Monitor the wetland to ensure encroaching pine trees are killed with the next fire or inundation. If they become established, the pine trees will need to be removed from the wetland. Alternatively, the small pine trees can be hand-chopped now.

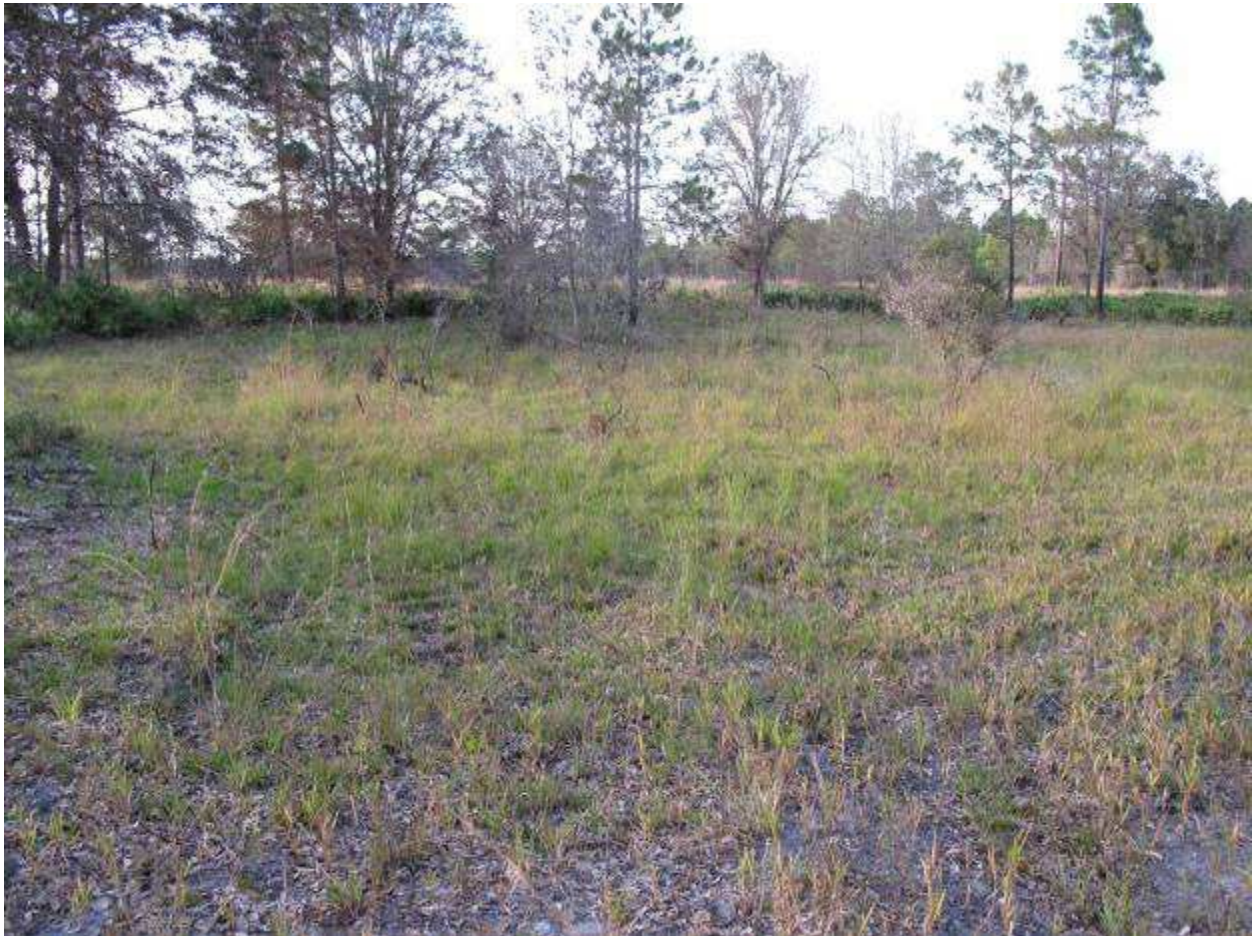
Wetland ID: 46-02

Description: This wetland is a 0.1 ha ephemeral marsh. There is no tree canopy cover. A recent fire burned through the entire wetland basin, killing some buttonbushes. The remaining buttonbushes cover 5-25% of the wetland basin. Sedges/grasses grow throughout the wetland, and cover >75% of the basin. Cattle are grazing the wetland grasses. The wetland appears to be in good ecological health and is a potential striped newt breeding pond. The adjacent uplands are scrubby flatwoods.

Wetland Concerns: Cattle

Restoration Action Recommended: The uplands in this MU are in good ecological condition, although we have observed some minor cattle-related effects in both wetlands and uplands in some areas. We recommend removing cattle from this unit to prevent destruction of the intact flatwoods community and the embedded wetlands.

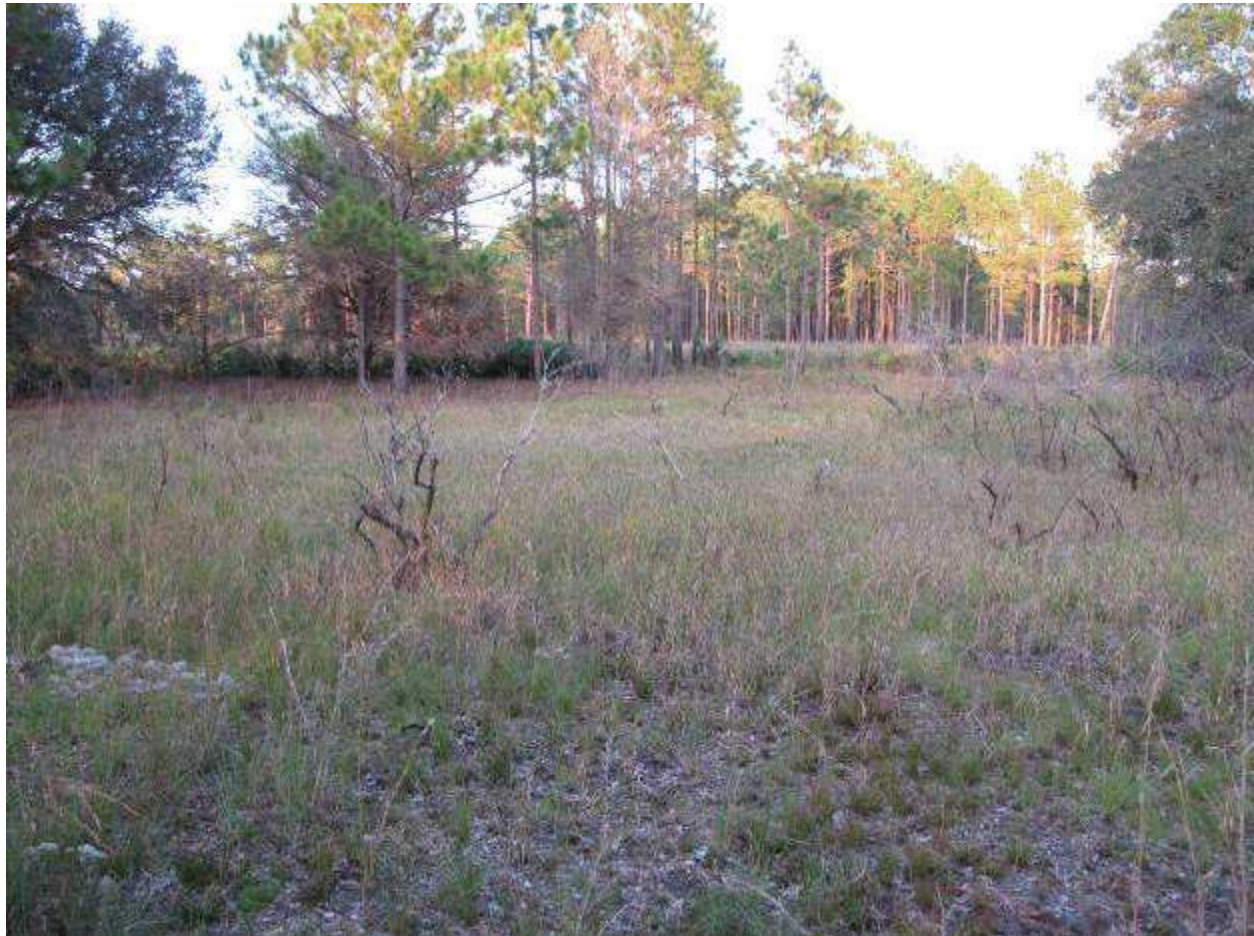
Description: This wetland is a 0.1 ha ephemeral marsh. Pine trees grow along the wetland edge, and cover 5-25% of the wetland basin. A recent fire burned through the wetland, killing some buttonbushes. The remaining buttonbushes cover 5-25% of the wetland basin.

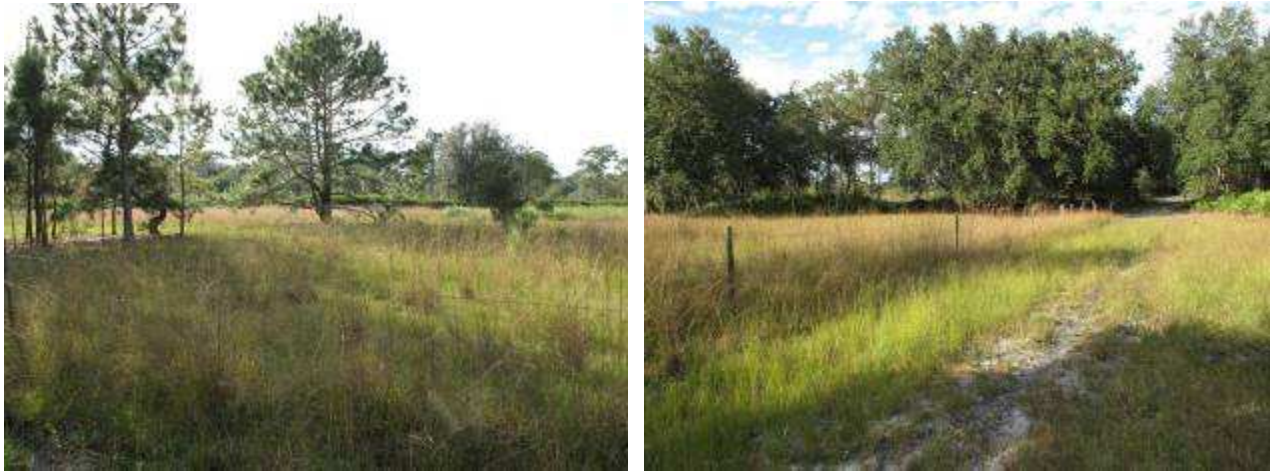
Wetland ID: 47-01

Description: This wetland is a 0.8 ha ephemeral marsh. Pine trees grow in a patch on the south side of the wetland, and cover 5-25% of the basin. There is no midstory cover. Sedges/grasses grow throughout the wetland, and cover >75% of the basin. Cattle are grazing in the wetland. A fence and fireline bisects the eastern side of the wetland. The wetland is surrounded by a dense brush ring and grazed uplands.

Wetland Concerns: Cattle, Fireline, Upland condition, Woody encroachment

Restoration Action Recommended: Use the adjacent MU boundary to serve as a fireline and allow the current fireline to recover, and remove patch of pine trees on south side of wetland. In order to restore the full ecological potential of the wetland, the cattle would need to be removed and the uplands restored.

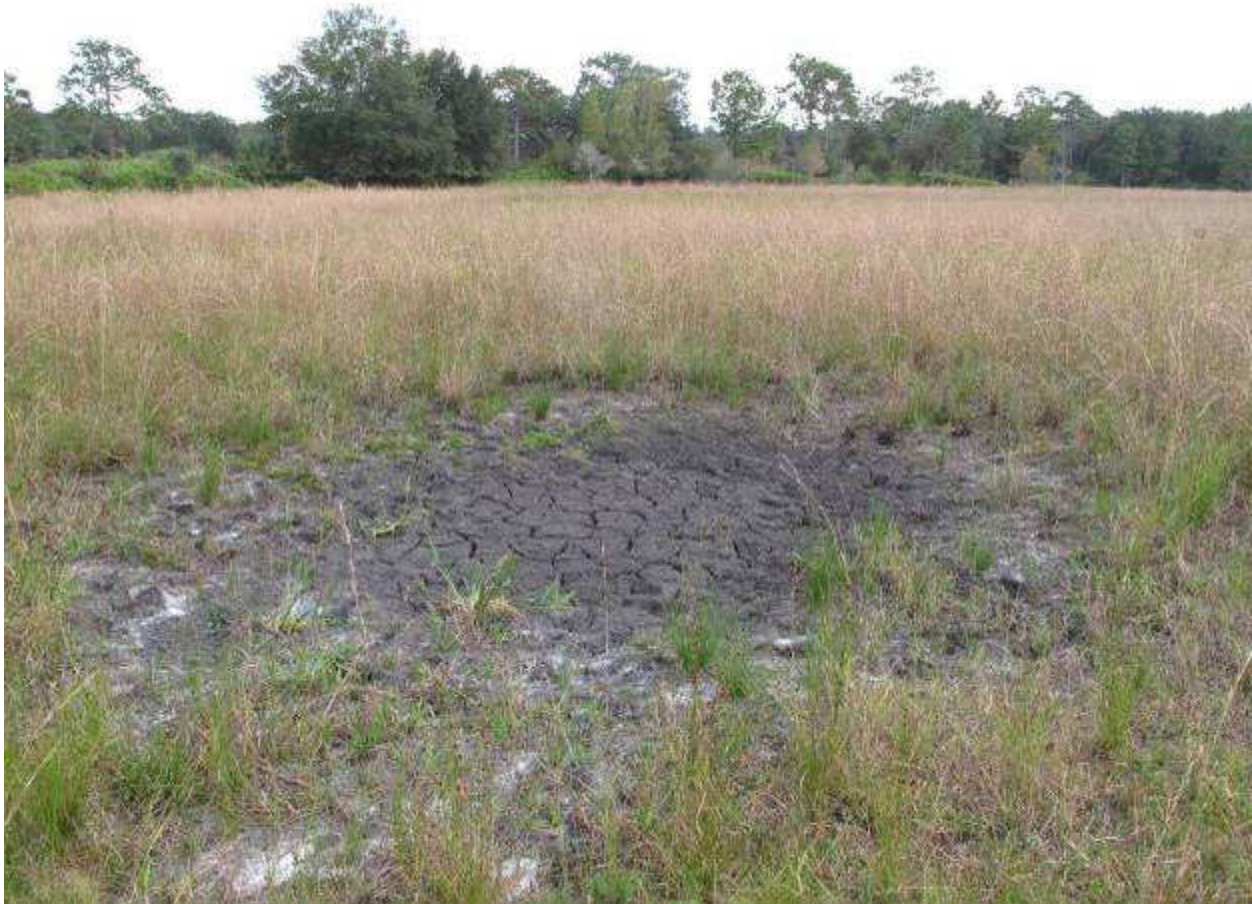
Wetland ID: 47-02

Description: This wetland is a 2.7 ha ephemeral marsh. There is no tree canopy or midstory cover. Sedges/grasses and maidencane grow throughout the wetland, and cover >75% of the basin. Cattle are grazing in the wetland. There is an outcropping of chert boulders on the north end of the wetland. This wetland will connect with 47-03 during periods of high water. The wetland is surrounded by a dense brush ring and grazed uplands.

Wetland Concerns: Cattle, Upland condition

Restoration Action Recommended: In order to restore the full ecological potential of the wetland, the cattle would need to be removed and the uplands restored.

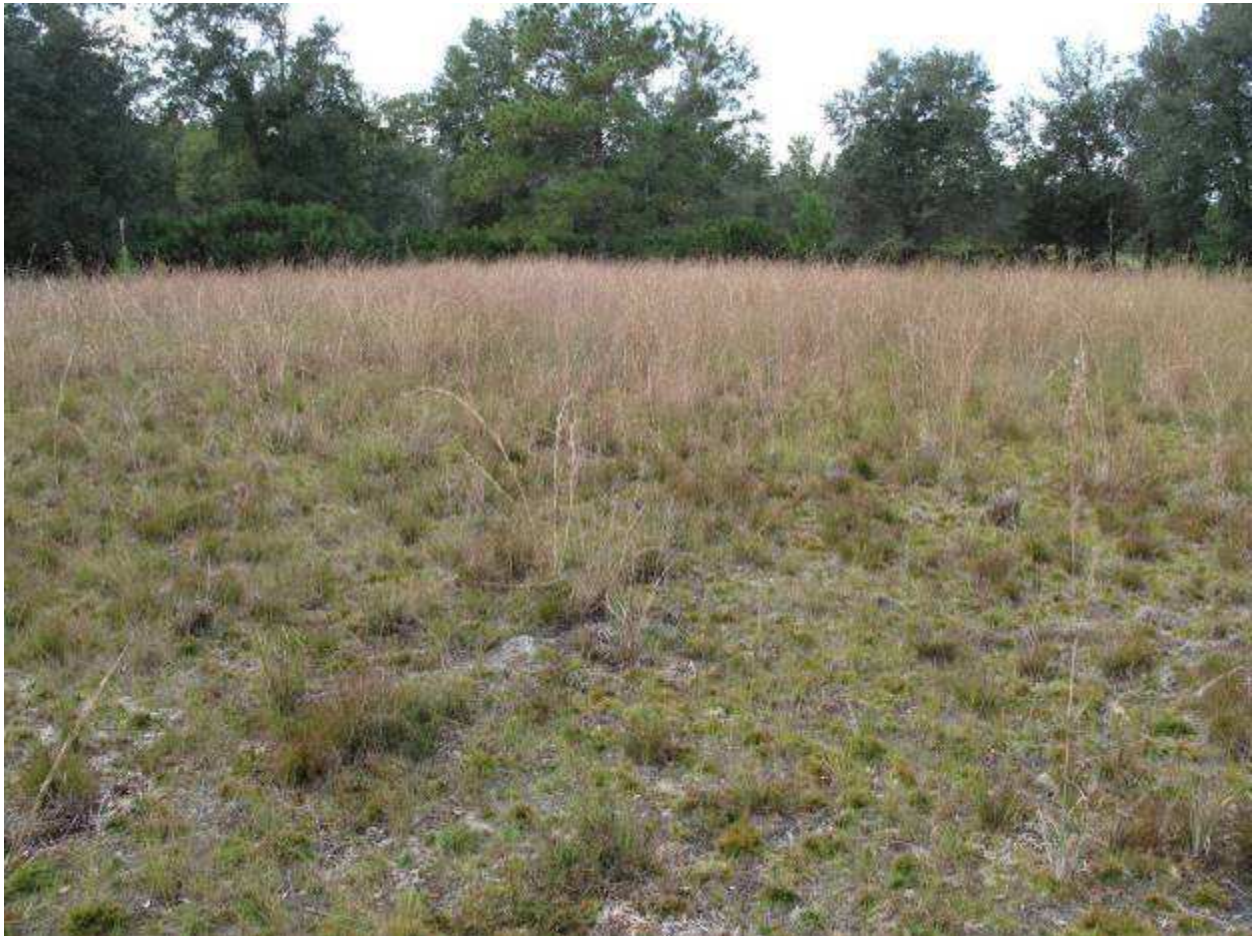
Wetland ID: 47-03

Description: This wetland is a 0.4 ha ephemeral marsh. There is no tree canopy or midstory cover. Sedges/grasses grow throughout the wetland, and cover >75% of the basin. Cattle are grazing in the wetland. This wetland will connect with 47-03 during periods of high water. The wetland is surrounded by a dense brush ring and grazed uplands.

Wetland Concerns: Cattle, Upland condition

Restoration Action Recommended: In order to restore the full ecological potential of the wetland, the cattle would need to be removed or eliminated and the uplands restored.

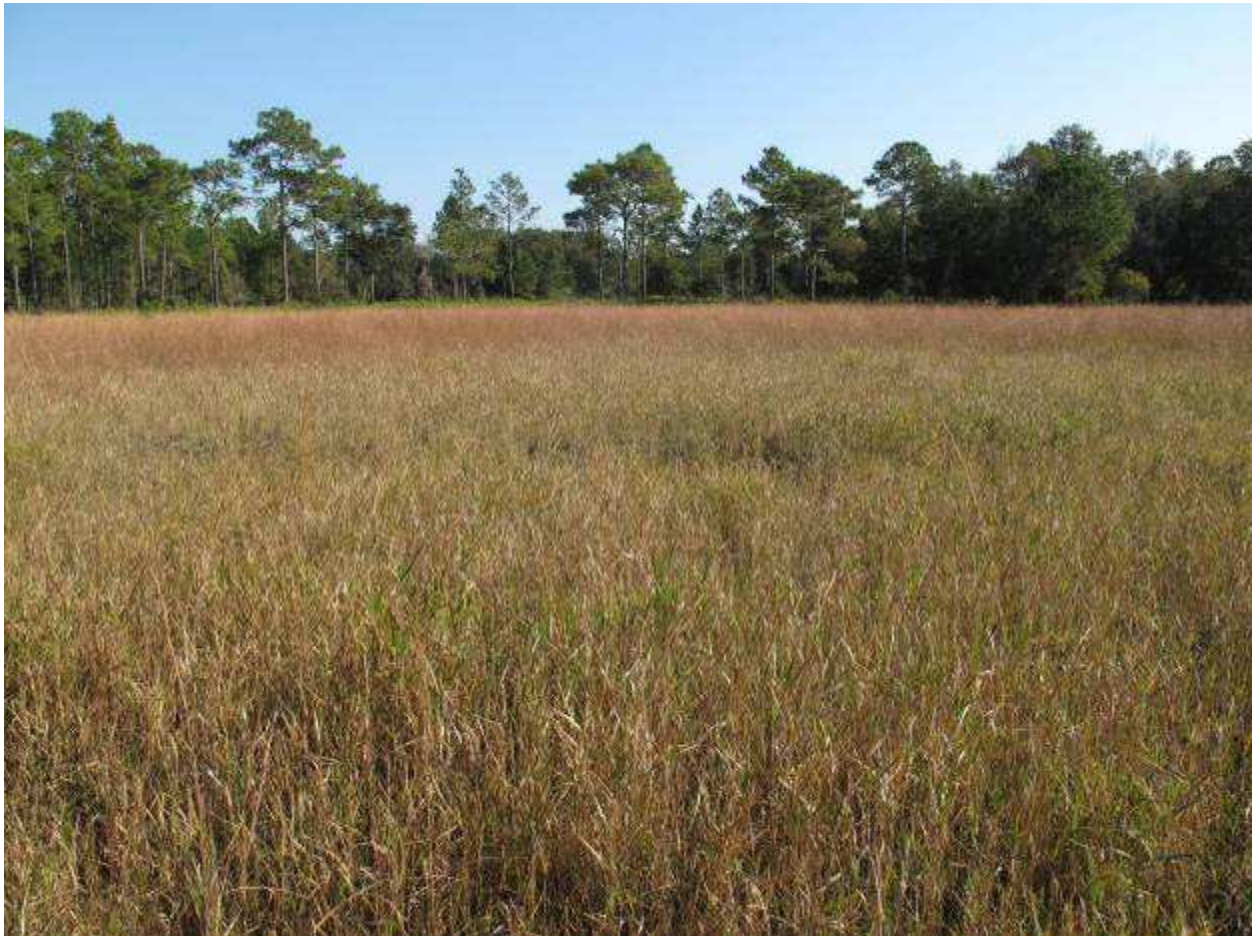
Wetland ID: 48-01

Description: This wetland is a 1.3 ha ephemeral marsh. There is no tree canopy or midstory cover. Maidencane grows in the wetland center and broomsedge grows around the outer edge. The herbaceous vegetation covers >75% of the wetland basin. Grazing is allowed in this MU but there are no observable impacts. This wetland is an example of a pristine, large, open marsh and is a potential striped newt breeding pond. The wetland is surrounded by scrubby flatwoods.

Wetland Concerns: Cattle

Restoration Action Recommended: The uplands in this MU are in good ecological condition, although we have observed some minor cattle-related effects in both wetlands and uplands in some areas. We recommend removing cattle from this unit to prevent destruction of the intact flatwoods community and the embedded wetlands.

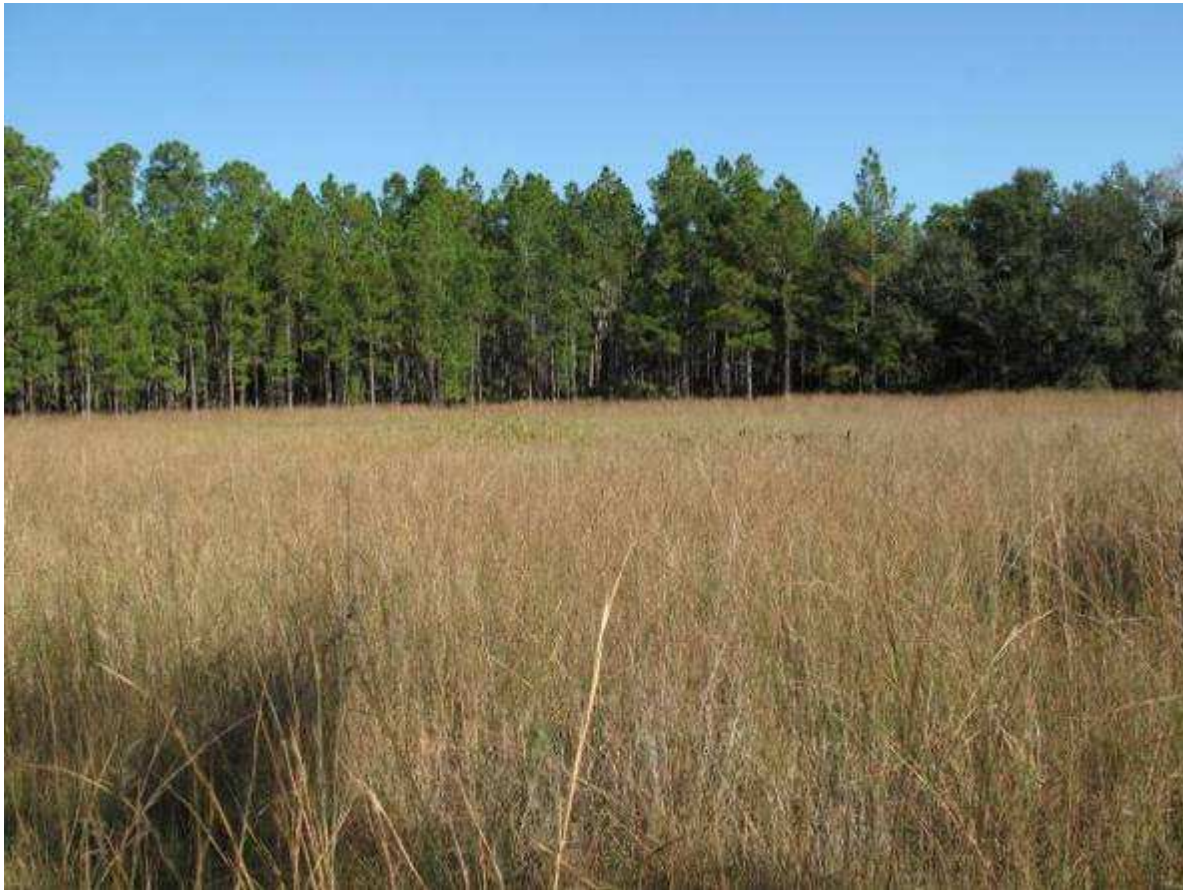
Wetland ID: 48-02

Description: This wetland is a 0.8 ha ephemeral marsh. Pine trees, with thick needle duff below, are encroaching on the north and west edges of the wetland. The tree canopy covers 5-25% of the basin. There is no midstory layer. Pickerelweed grows in the wetland's deep center; sedges/grasses and maidencane surround the center. The herbaceous vegetation covers >75% of the wetland basin. There is a pine-covered land bridge between this wetland and 48-03, which likely floods during periods of high water. This wetland will also connect with 48-04 on the east side during periods of high water. The eastern edge of the wetland has a few young encroaching pine trees. This circular depressional marsh is a potential striped newt breeding pond. The wetland is surrounded by scrubby flatwoods and oak hammock.

Wetland Concerns: Cattle, Woody encroachment

Restoration Action Recommended: The uplands in this MU are in good ecological condition, although we have observed some minor cattle-related effects in both wetlands and uplands in some areas. We recommend removing cattle from this unit to prevent destruction of the intact flatwoods community and the embedded wetlands. The pine trees on the east side of the wetland likely will be killed during the next fire or inundation. Thin the larger pine trees on the north and west side of the wetland and along the land bridge connecting to 48-03.

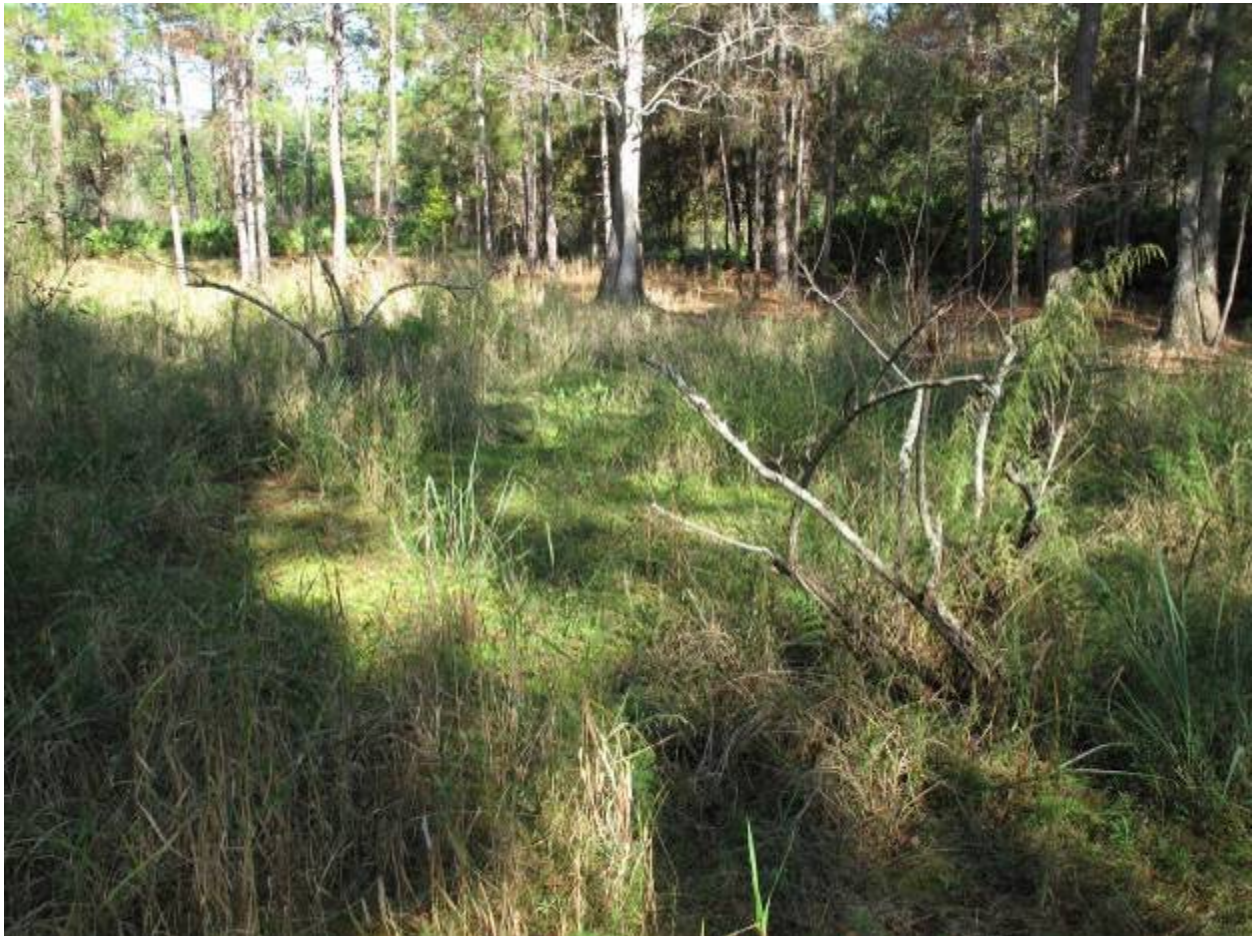
Wetland ID: 48-03

Description: This wetland is a 0.1 ha semi-permanent marsh. Gum trees grow in the deeper wetland center and pine trees grow in a ring around the wetland edge. The tree canopy covers 25-50% of the wetland. The midstory is dominated by buttonbush, and covers 5-25% of the wetland. Maidencane, sedges/grasses, and emergent vegetation grow throughout the wetland, and cover >75% of the basin. The wetland is surrounded by scrubby flatwoods and oak hammock.

Wetland Concerns: Cattle, Woody encroachment

Restoration Action Recommended: The uplands in this MU are in good ecological condition, although we have observed some minor cattle-related effects in both wetlands and uplands in some areas. We recommend removing cattle from this unit to prevent destruction of the intact flatwoods community and the embedded wetlands. Thin the pine trees around the wetland edge.

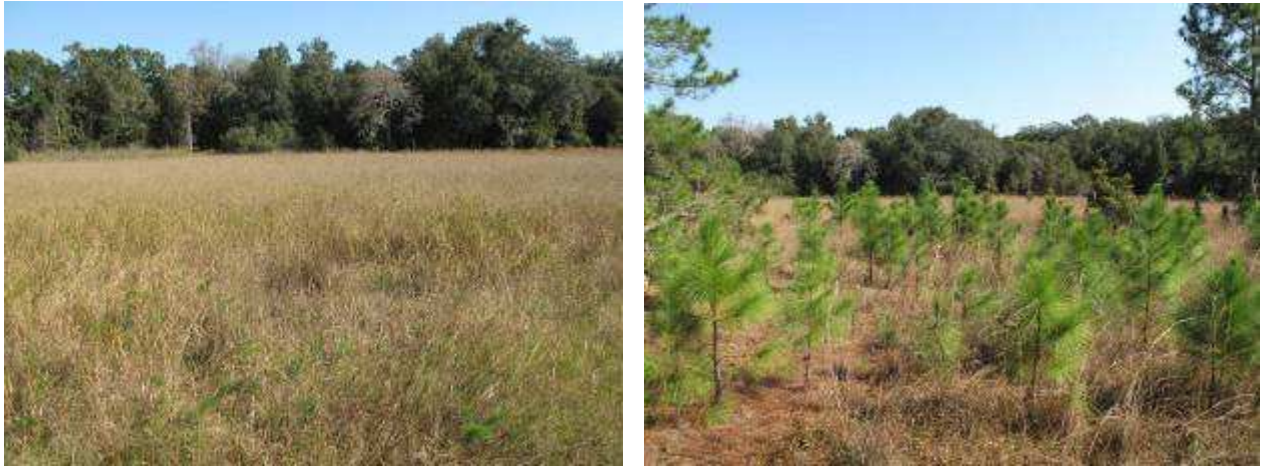
Wetland ID: 48-04

Description: This wetland is a 0.9 ha ephemeral marsh. Pine trees dominate the canopy, and cover 5-25% of the wetland basin. Small pine trees are encroaching from the wetland edge and cover 5-25% of the wetland. Maidencane and sedges/grasses grow throughout the wetland, and cover >75% of the basin. The wetland will connect with 48-03 during periods of high water. The connector zone on the southwest side is being populated by small pine trees and a few larger pine trees. The southwest side of the wetland provides a good example of how young pine trees will invade from the wetland edge during a drought and with the absence of fire. The rest of the marsh provides a good example of wax myrtle kept in check. The wetland is surrounded by hardwood hammock.

Wetland Concerns: Cattle, Woody encroachment

Restoration Action Recommended: The uplands in this MU are in good ecological condition, although we have observed some minor cattle-related effects in both wetlands and uplands in some areas. We recommend removing cattle from this unit to prevent destruction of the intact flatwoods community and the embedded wetlands. The connector between this wetland and 48-03 could be burned promptly to thin encroaching pine trees; alternatively the pine trees could be chopped.

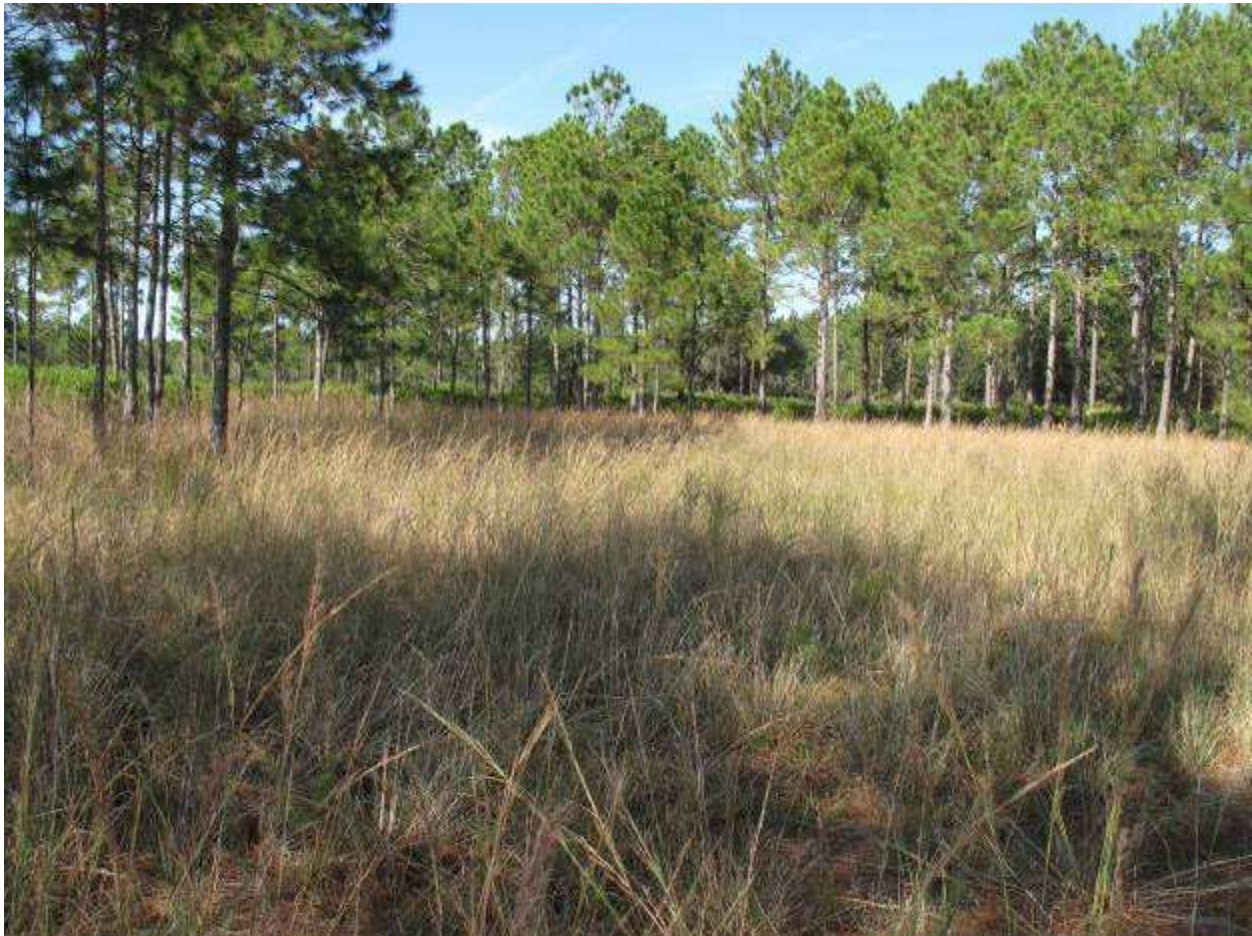
Wetland ID: 49-01

Description: This wetland is a 0.2 ha ephemeral marsh. Pine trees grow in a ring around the wetland edge, and cover 25-50% of the wetland. There is no midstory layer. Sedges/grasses grow throughout the wetland, and cover >75% of the basin. This circular depression marsh is a potential striped newt breeding pond. The wetland is surrounded by scrubby flatwoods.

Wetland Concerns: Cattle, Woody encroachment

Restoration Action Recommended: The uplands in this MU are in good ecological condition, although we have observed some minor cattle-related effects in both wetlands and uplands in some areas. We recommend removing cattle from this unit to prevent destruction of the intact flatwoods community and the embedded wetlands. Thin the pine trees around the wetland edge.

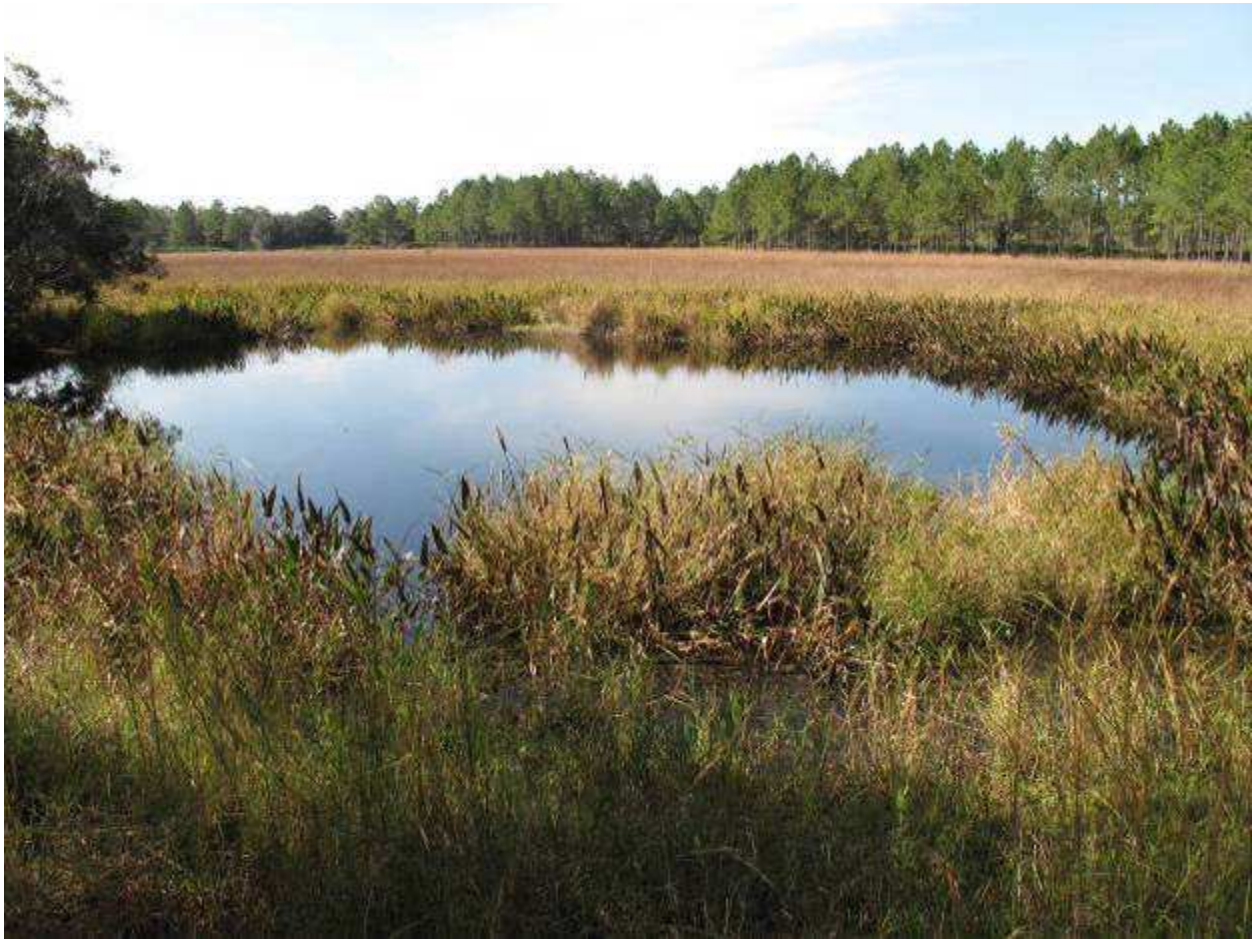
Description: This wetland is a 6.3 ha altered marsh. The wetland was an ephemeral marsh but a dug-out section on the east side created a semi-permanent section, thereby allowing fish to persist. Pine trees grow around the wetland edge and cover 5-25% of the wetland. There is no midstory layer. Sedges/grasses and maidencane grow throughout the wetland, and cover >75% of the basin. If the dug-out were filled and the fish eliminated, the wetland would be a potential striped newt breeding pond. The wetland is surrounded by scrubby flatwoods and grazed uplands.

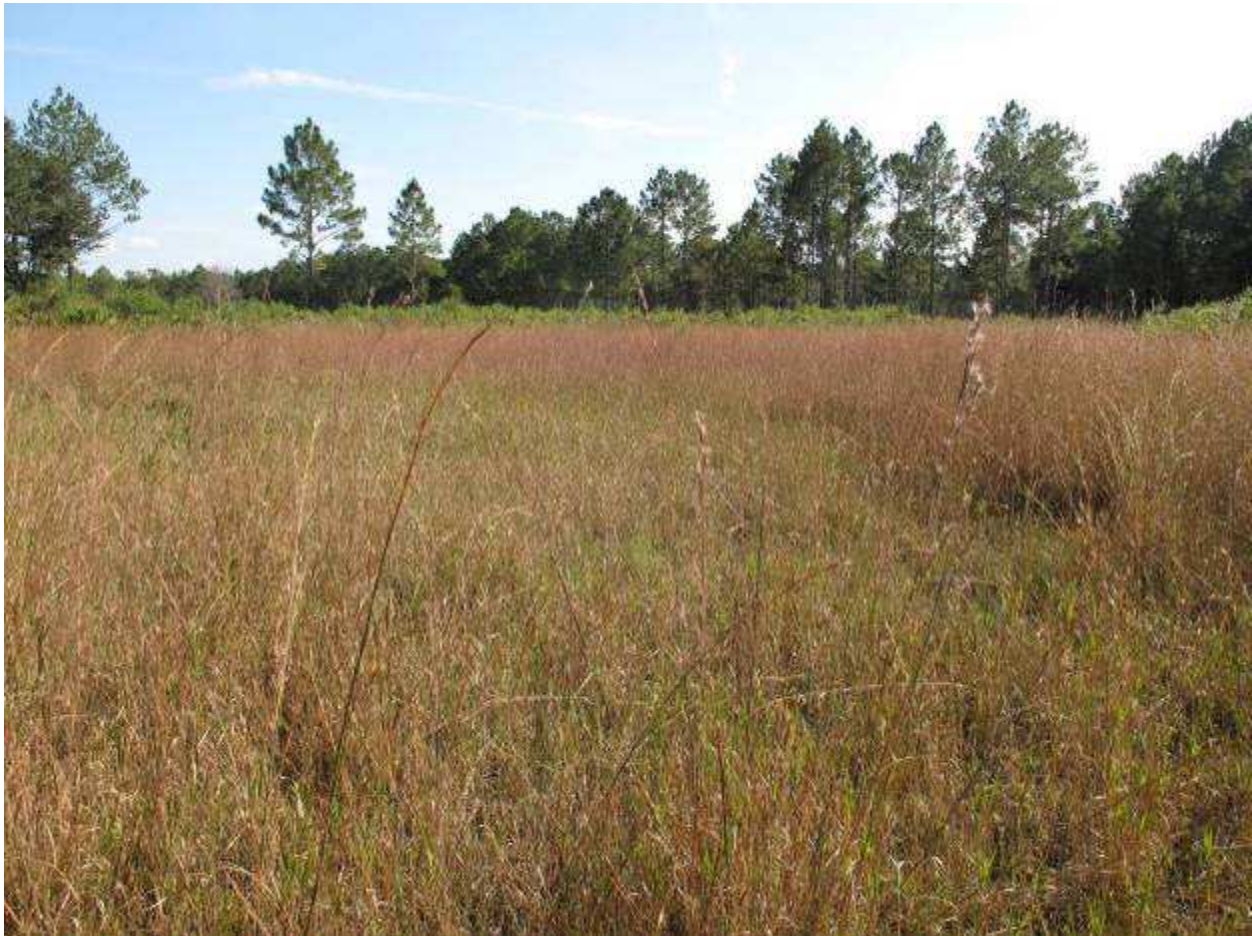
Wetland ID: 49-03

Description: This wetland is a 0.2 ha ephemeral marsh. There is no tree canopy or midstory layer. Sedges/grasses and maidencane grow throughout the wetland, and cover >75% of the basin. This circular depression marsh is a potential striped newt breeding pond. The wetland is surrounded by a dense palmetto/fetterbush/gallberry ring, a mixed pine/oak/palmetto community, and grazed uplands.

Wetland Concerns: Cattle, Upland condition

Restoration Action Recommended: Most of uplands in this management unit are in good ecological condition. We recommend removing cattle from this unit to prevent destruction of the intact scrubby flatwoods community. In order to restore the full ecological potential of this wetland, the uplands need to be restored.

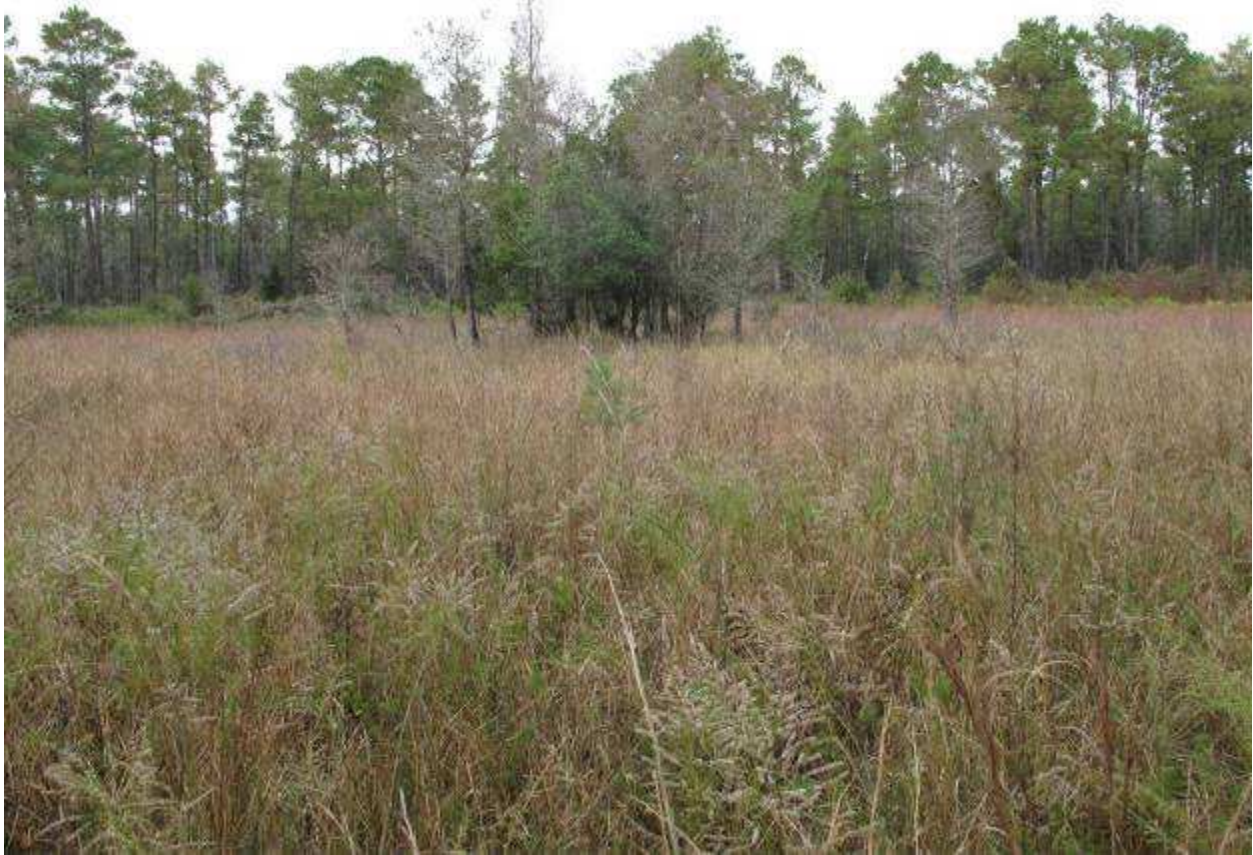
Wetland ID: 50-01

Description: This wetland is a 0.4 ha ephemeral marsh. A small island of gum trees grows in the deeper center of the wetland, and covers 5-25% of the wetland basin. There is no midstory layer. Sedges/grasses and maidencane grow throughout the wetland, and cover >75% of the basin. This wetland provides a good example of a healthy marsh and is a potential striped newt breeding pond. The adjacent uplands are scrubby and mesic flatwoods.

Wetland Concerns: None

Restoration Action Recommended: None

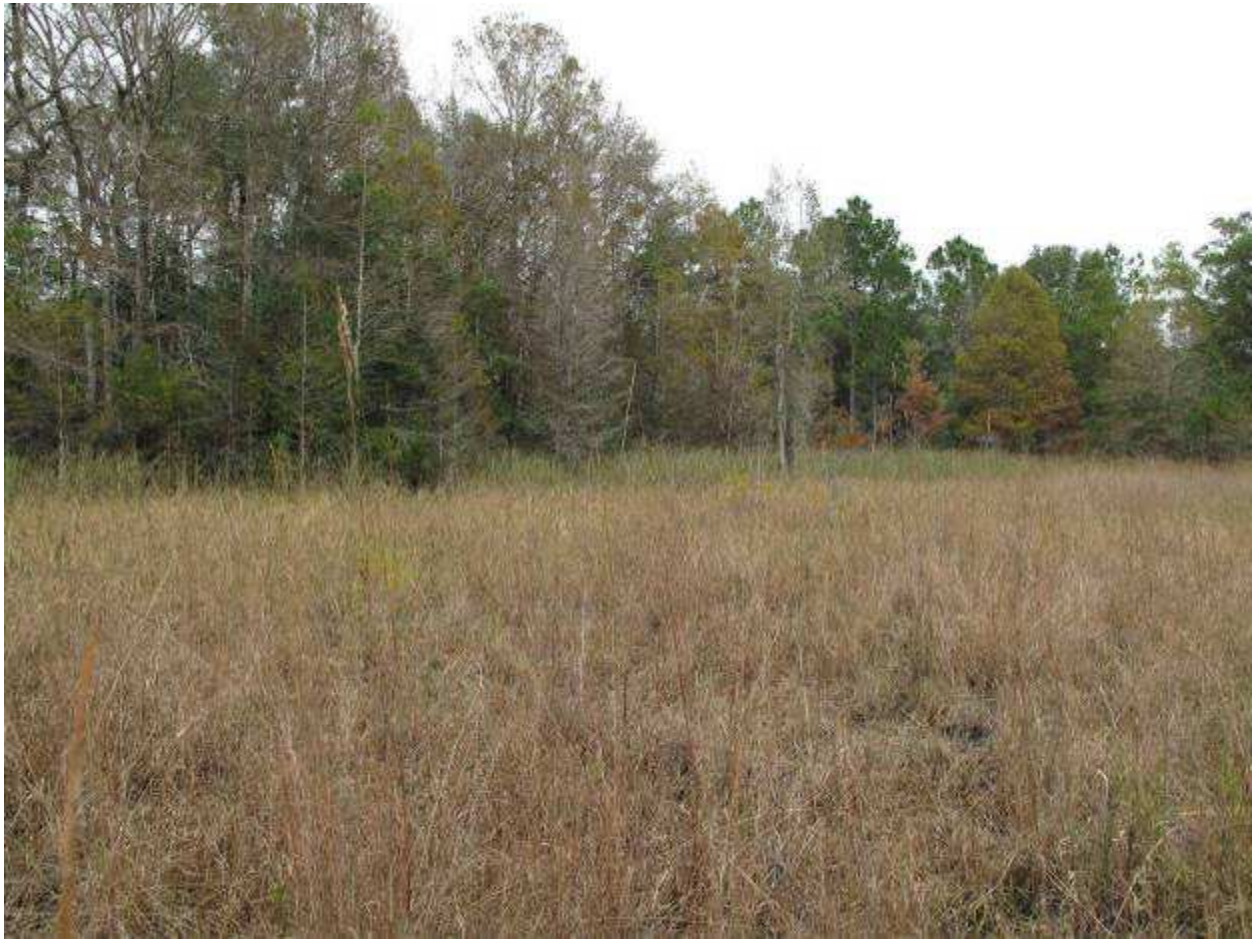
Description: This wetland is a 1.3 ha semi-permanent mix of marsh and forested swamp. The northern half of the wetland is a forested swamp dominated by cypress and gum trees. The southern half of the wetland is herbaceous marsh. The tree canopy covers 25-50% of the entire wetland basin. Holly and wax myrtle dominate the midstory, and cover 25-50% of the wetland. Sedges/grasses, sawgrass, and maidencane grow throughout the wetland, and cover 50-75% of the basin. The swamp portion of the wetland likely formed in a long-term fire shadow created by the hardwood hammock to the north. Pond pine scrubby flatwoods on the south side likely carried fire into the southern part of the wetland with a frequency sufficient to maintain the marsh. This wetland provides a good example of the results of frequent fire and infrequent fire within a single wetland. The adjacent uplands are scrubby flatwoods and hardwood hammock.

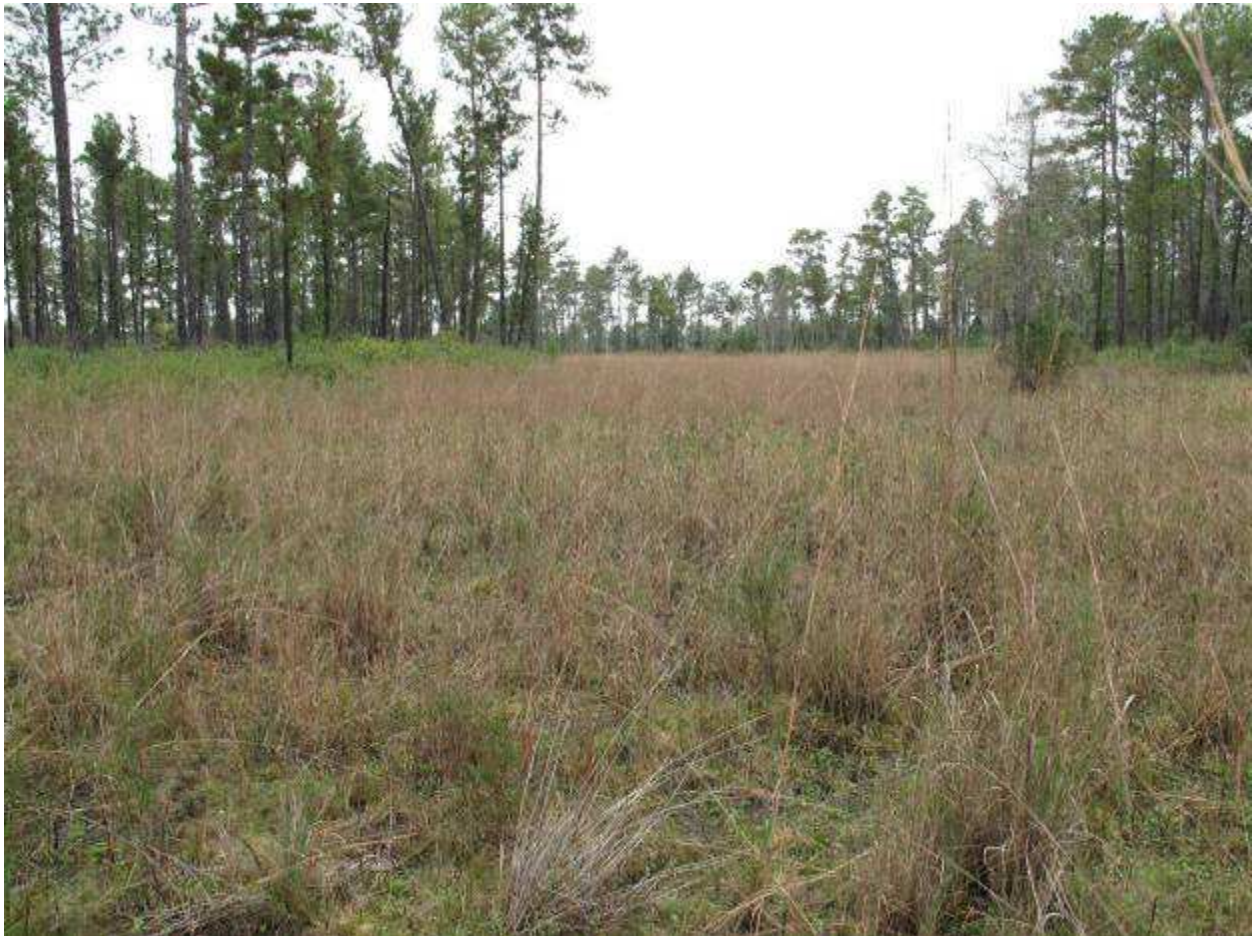
Description: This wetland is a 0.9 ha ephemeral marsh. There is no tree canopy or midstory layer. Sedges/grasses and maidencane grow throughout the wetland, and cover >75% of the basin. Feral hog impacts are old and patchy, in the form of scalloped holes that are growing over with vegetation. The wetland provides a good example of a healthy marsh and is a potential striped newt breeding pond. The adjacent uplands are scrubby and mesic flatwoods.

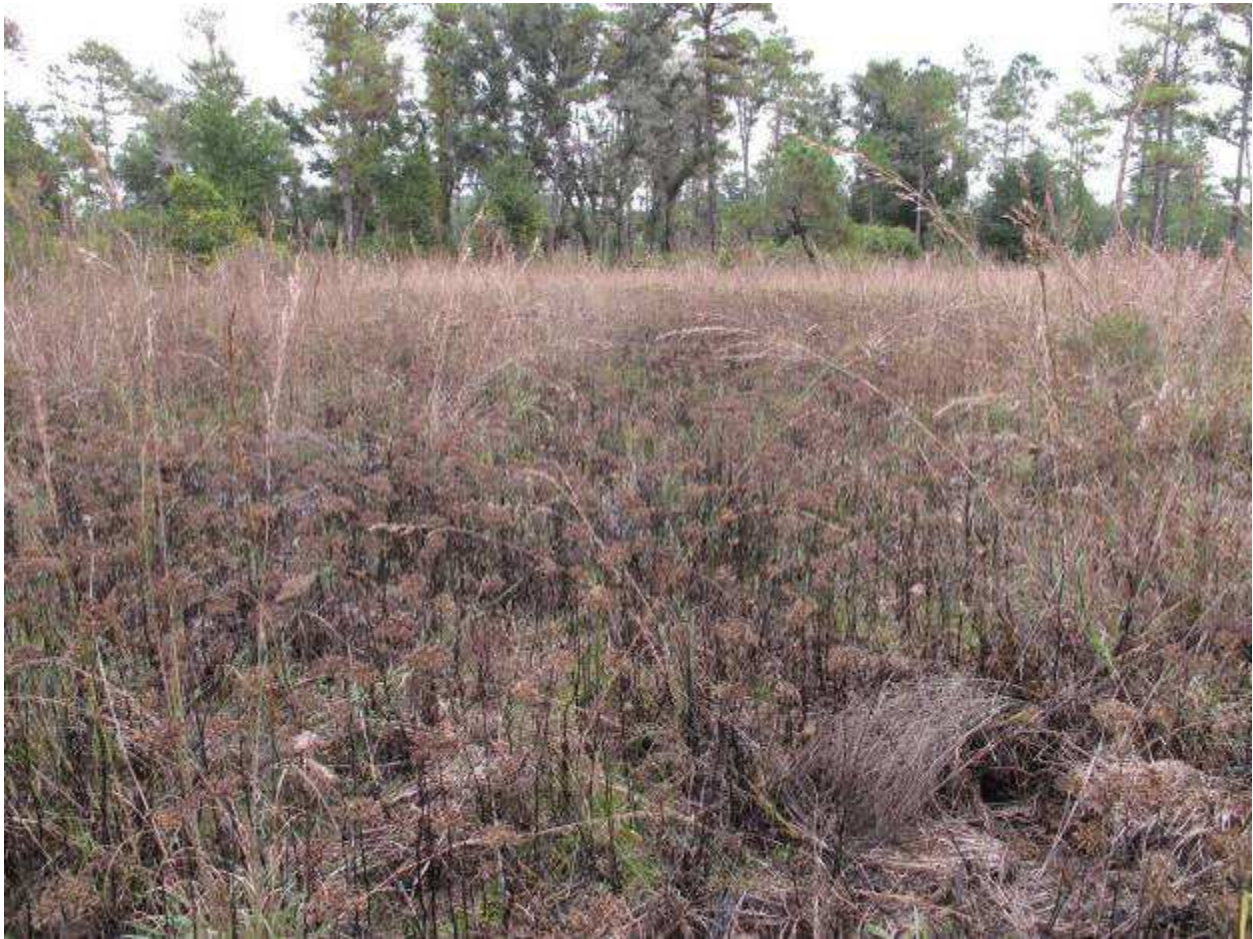
Description: This wetland is a 0.4 ha ephemeral marsh. There is no tree canopy or midstory layer. Sedges/grasses and redroot grow throughout the wetland, and cover >75% of the basin. Extensive, but old, feral hog rooting has grown over with redroot. The wetland is a potential striped newt breeding pond. The adjacent uplands are scrubby and mesic flatwoods.
