Inventory, Assessment, and Restoration Potential of Ephemeral Wetlands on FFWCC Wildlife Management Areas

Half Moon WMA Final Report

Submitted by: Rebecca P.M. Means¹, Ryan C. Means¹, Steven A. Johnson²

¹Coastal Plains Institute

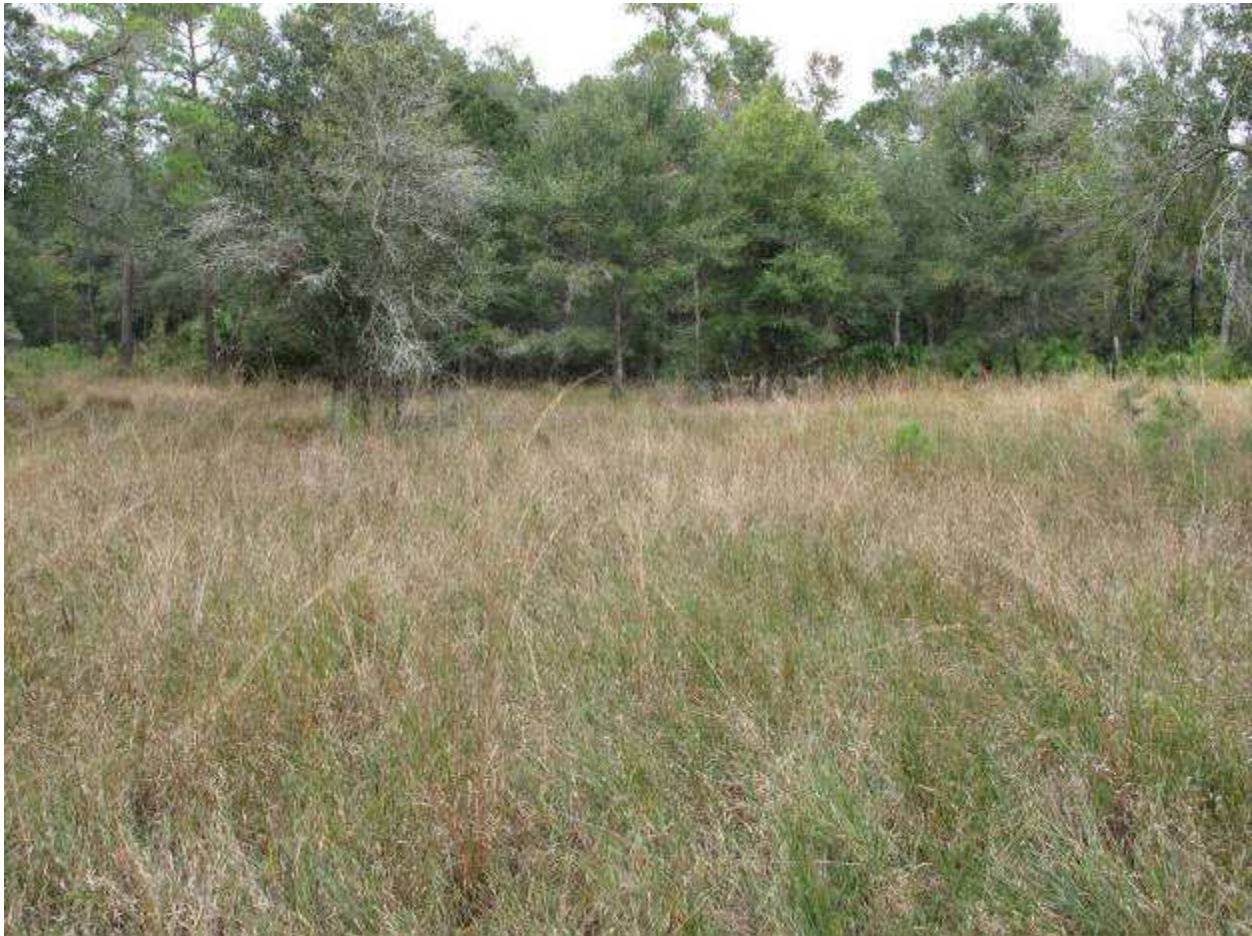
Wetland ID: 50-05

Description: This wetland is a 0.1 ha highly ephemeral marsh. Several laurel oak trees have established on hillocks within the wetland and cover 5-25% of the wetland basin. There is no midstory layer. Maidencane grows throughout the wetland, and covers >75% of the basin. There are 2 vehicular tracks along the south and west edges of the wetland. The adjacent uplands are scrubby and mesic flatwoods.

Wetland Concerns: Vehicular damage

Restoration Action Recommended: Discourage vehicular access to the wetland. Smaller wetlands may need to be flagged to alert users of the existence of the wetland.

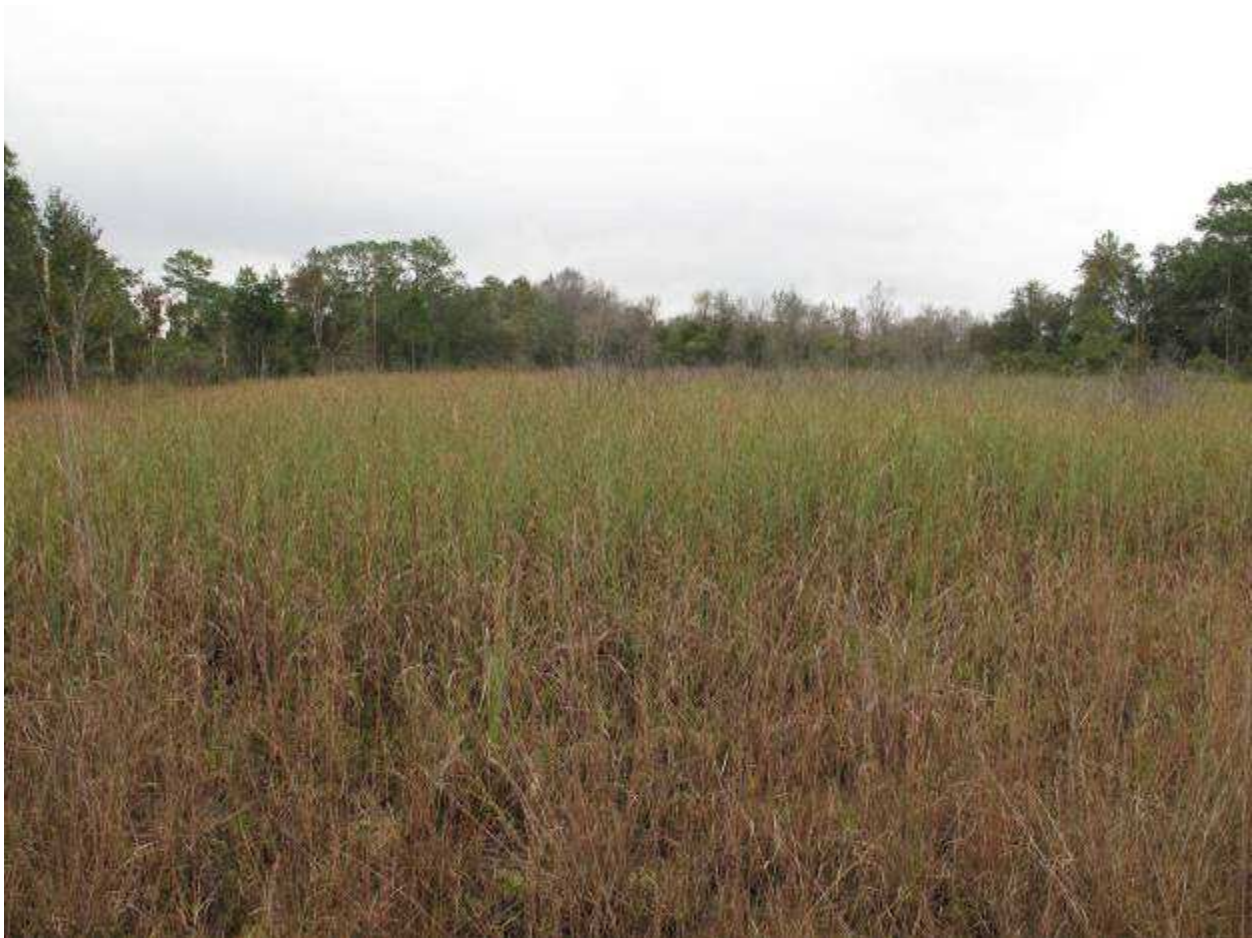
Description: This wetland is a 2.2 ha ephemeral marsh. There is no tree canopy or midstory layer. Sedges/grasses and sawgrass grows throughout the wetland, and covers >75% of the basin. A fireline/private property boundary bisects a small portion of the eastern side of the wetland. This is a potential striped newt breeding pond. The adjacent uplands are scrubby and mesic flatwoods.

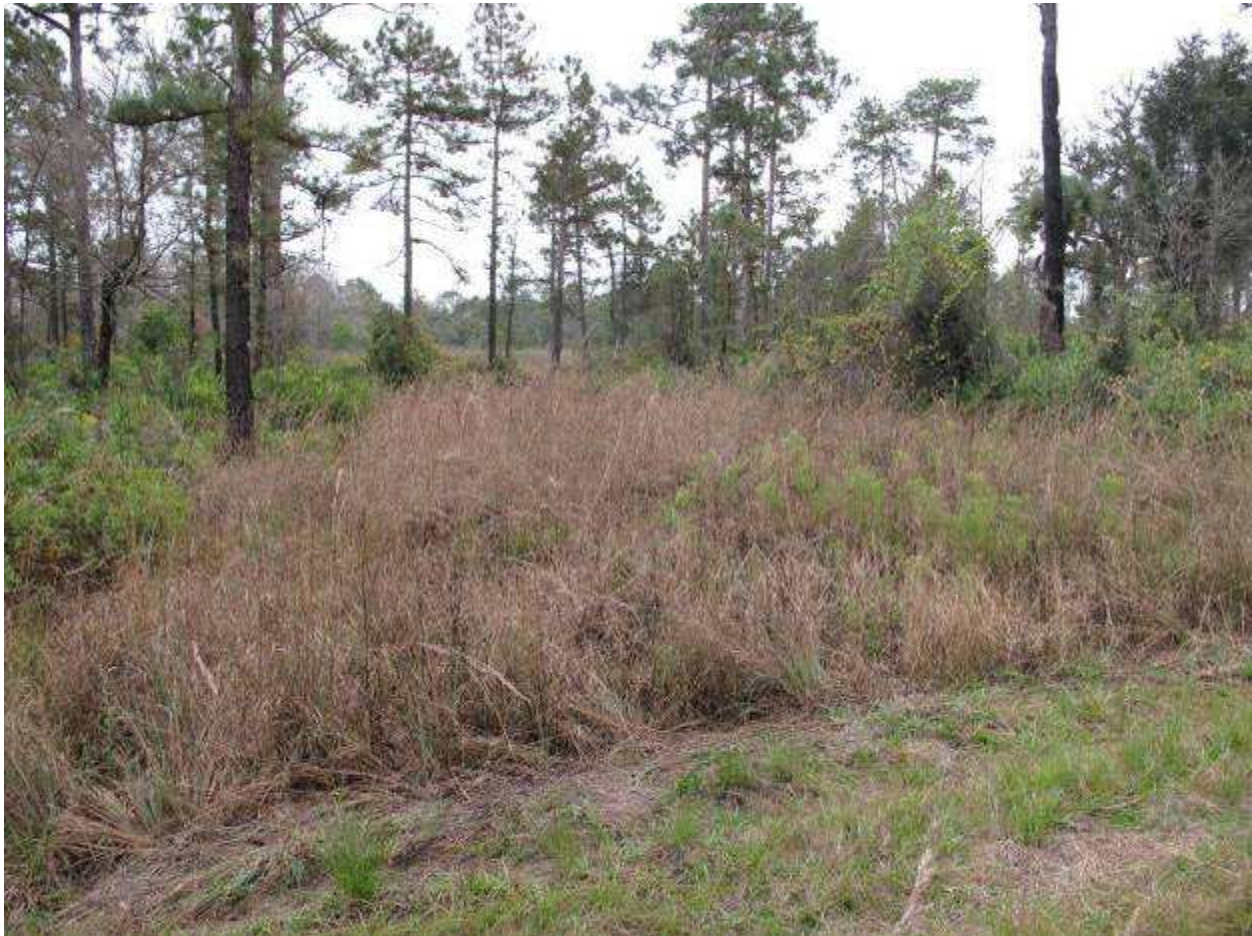
Wetland ID: 50-07

Description: This wetland is a 0.1 ha highly ephemeral marsh. There is no tree canopy or midstory layer. Sedges/grasses and redroot grow throughout the wetland, and cover >75% of the basin. Old feral hog rooting has grown over with vegetation. An access road bisects the wetland. The adjacent uplands are scrubby flatwoods.

Wetland Concerns: Feral hog damage, Road

Restoration Action Recommended: If the access road is necessary, we recommend re-routing it through the thin strip of uplands between 50-03 and 50-07.

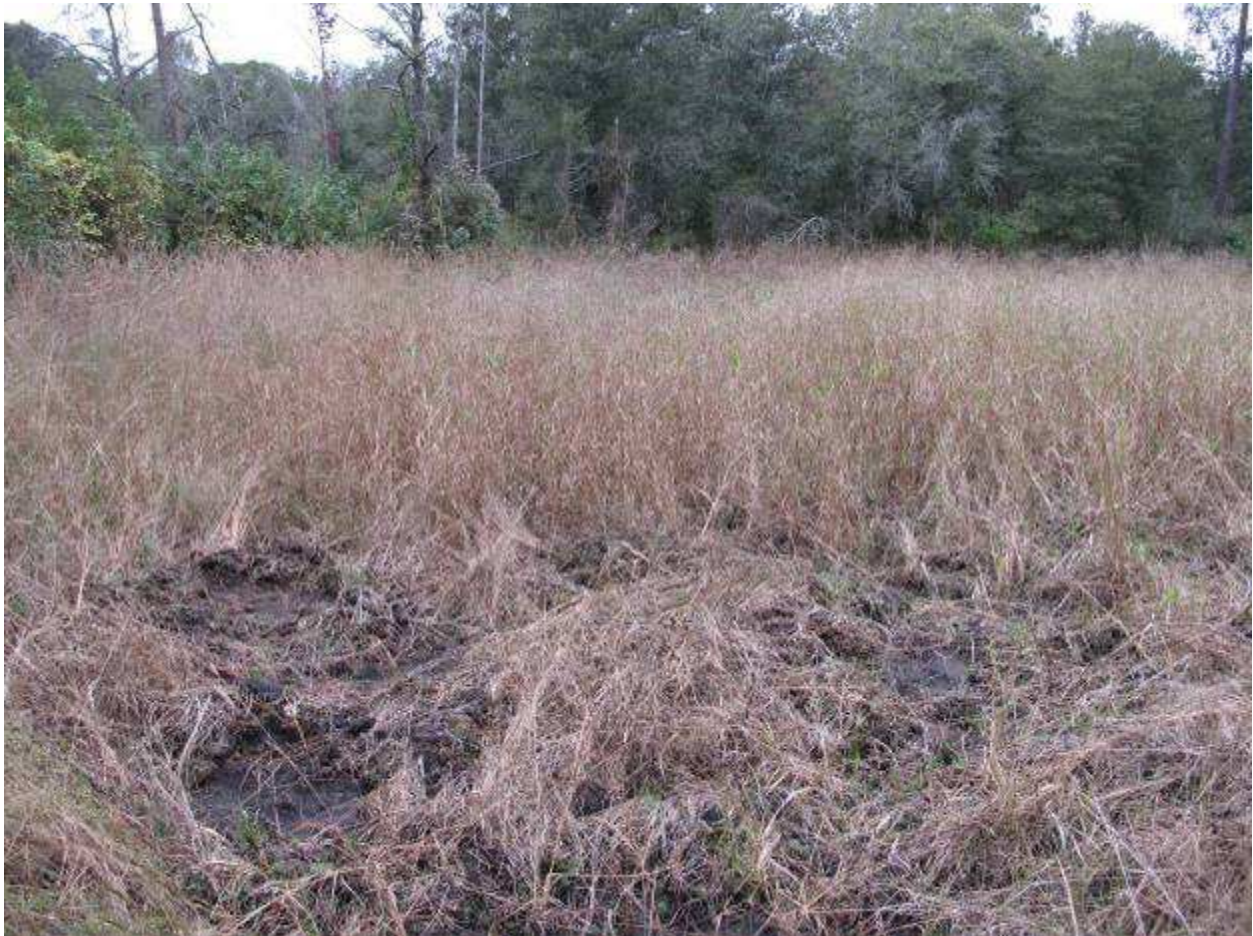
Description: This wetland is a 0.2 ha ephemeral marsh. There is no tree canopy or midstory layer. Sedges/grasses and maidencane grow throughout the wetland, and cover >75% of the basin. Recent feral hog rooting is patchy in the wetland basin. This wetland is a potential striped newt breeding pond. The adjacent uplands are scrubby flatwoods and oak hammock.

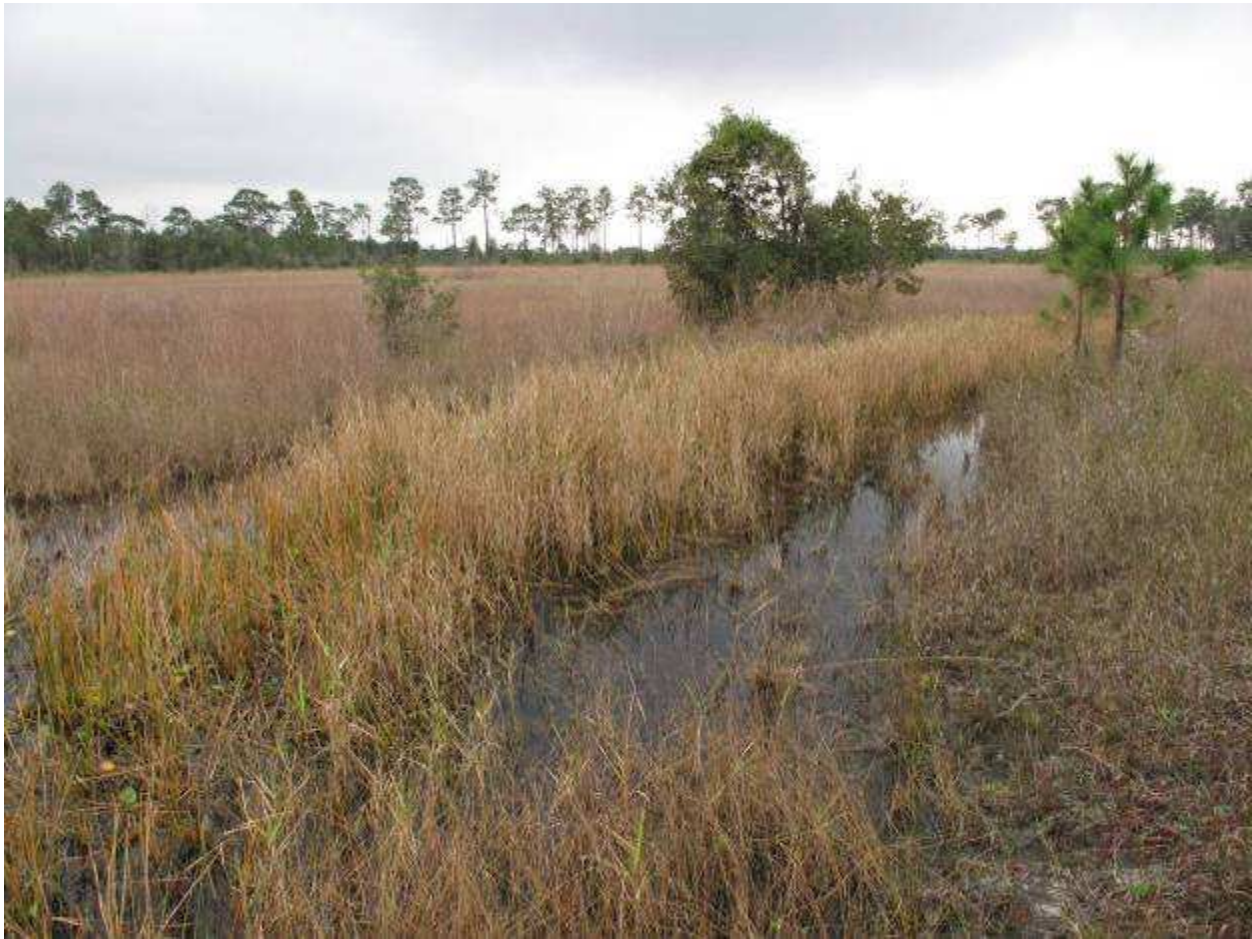
Wetland ID: 50-09

Description: This wetland is a 1.9 ha semi-permanent marsh. Sedges/grasses and maidencane grow throughout the wetland, and cover >75% of the basin. There is an old dug-out on the north side of wetland that is providing refugia for fish. This wetland would be prime potential striped newt breeding pond if the dug-out were filled. A fireline/private property boundary bisects the east side of the wetland. The adjacent uplands are scrubby flatwoods.

Wetland Concerns: Dug-out, Fireline/ private property boundary

Restoration Action Recommended: Fill the dug-out. Contact the private landowner to see if boundary can be moved to encompass the entire wetland. If the boundary cannot be moved, monitor the wetland to ensure fire is not excluded. Maintain the fireline when the wetland is completely dry to prevent ruts from developing.

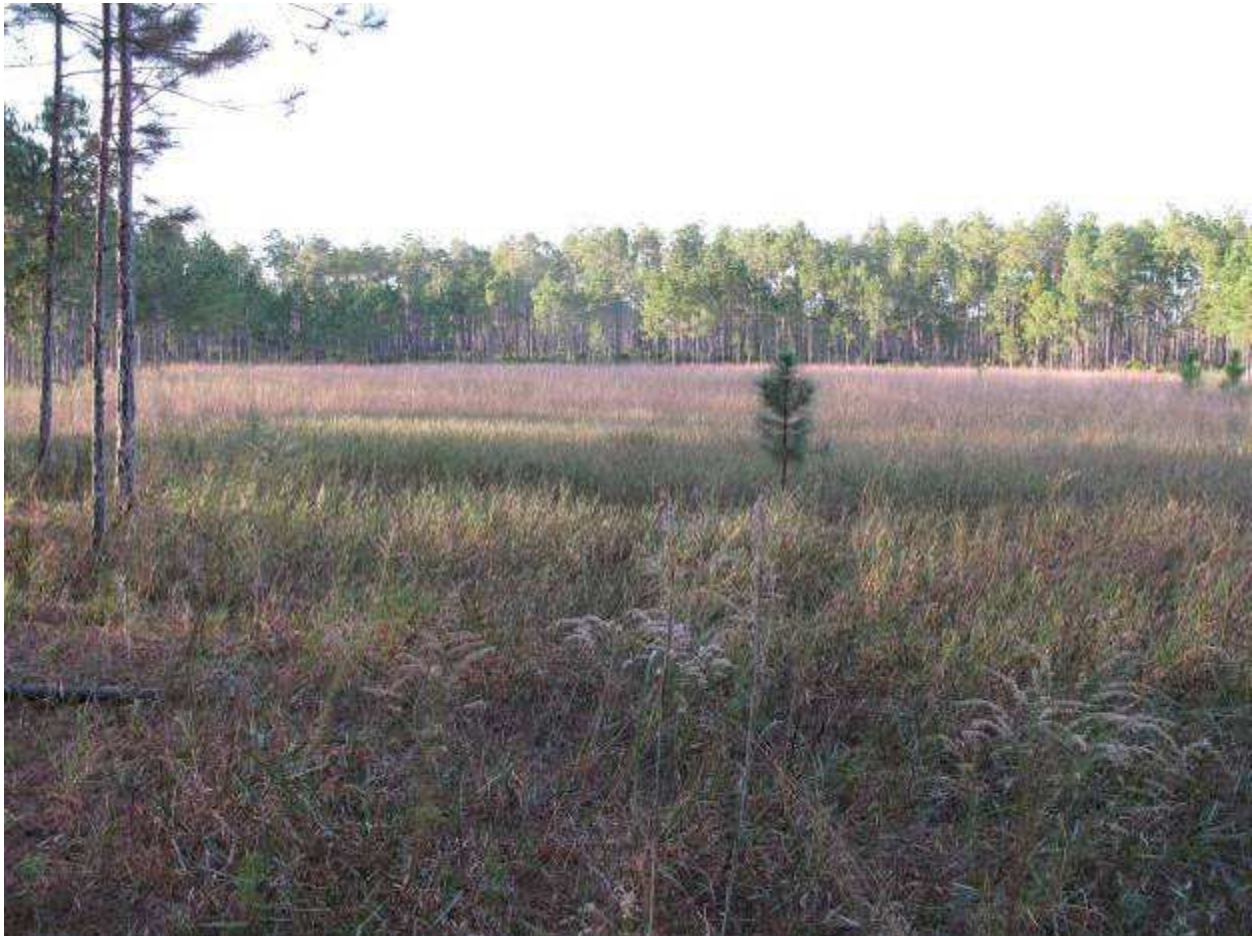
Wetland ID: 52-01

Description: This wetland is a 1.6 ha ephemeral marsh. Pine trees grow in a dense ring around the wetland, and cover 5-25% of the wetland basin. There also are some young pine trees around the edge and in the wetland interior. Thick needle duff covers the wetland floor around the edges. Sedges/grasses and maidencane grow throughout the wetland, and cover >75% of the basin. Feral hog damage is patchy. The adjacent uplands are planted pine forest with dense palmetto understory.

Wetland Concerns: Feral hog damage, Woody encroachment

Restoration Action Recommended: Thin large pine trees around the wetland edge. Encourage periodic fire in the wetland basin. Monitor the wetland to ensure encroaching pine trees are killed with the next fire or inundation. If they become established, the pine trees will need to be removed from the wetland. Alternatively, the small pine trees can be hand-chopped now.

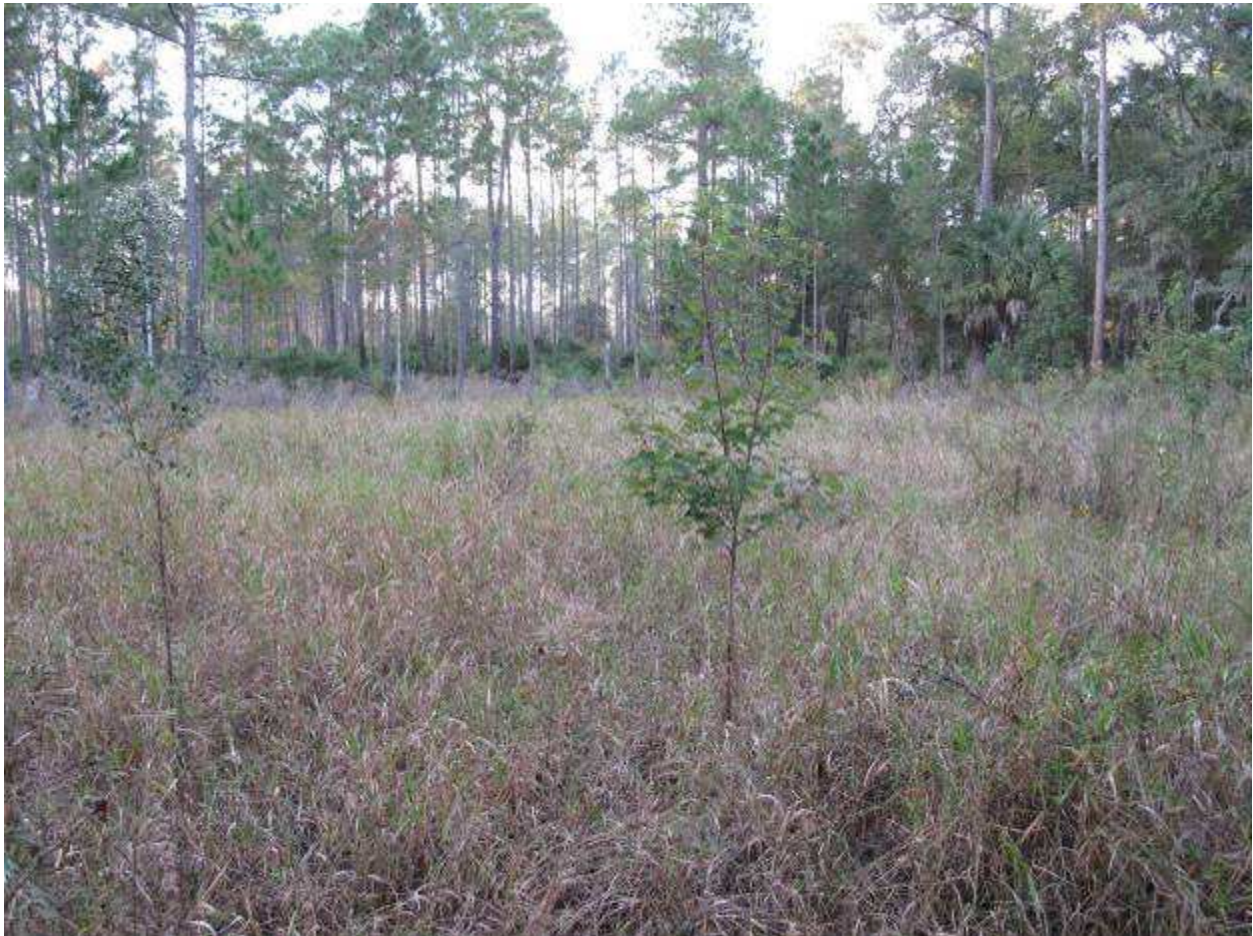
Wetland ID: 52-02

Description: This wetland is a 0.1 ha ephemeral marsh. Several large and small pine trees grow around the wetland edge, and cover 5-25% of the wetland basin. There is no midstory layer. Maidencane grows throughout the wetland, and covers >75% of the basin. The adjacent uplands are planted pine forest with dense palmetto understory.

Wetland Concerns: Woody encroachment (minor)

Restoration Action Recommended: The larger pine trees could be thinned during an upland thinning operation. The small pine trees should be eliminated by the next fire or wetland inundation. The woody encroachment at this wetland is not problem at this time but could become so in the future.

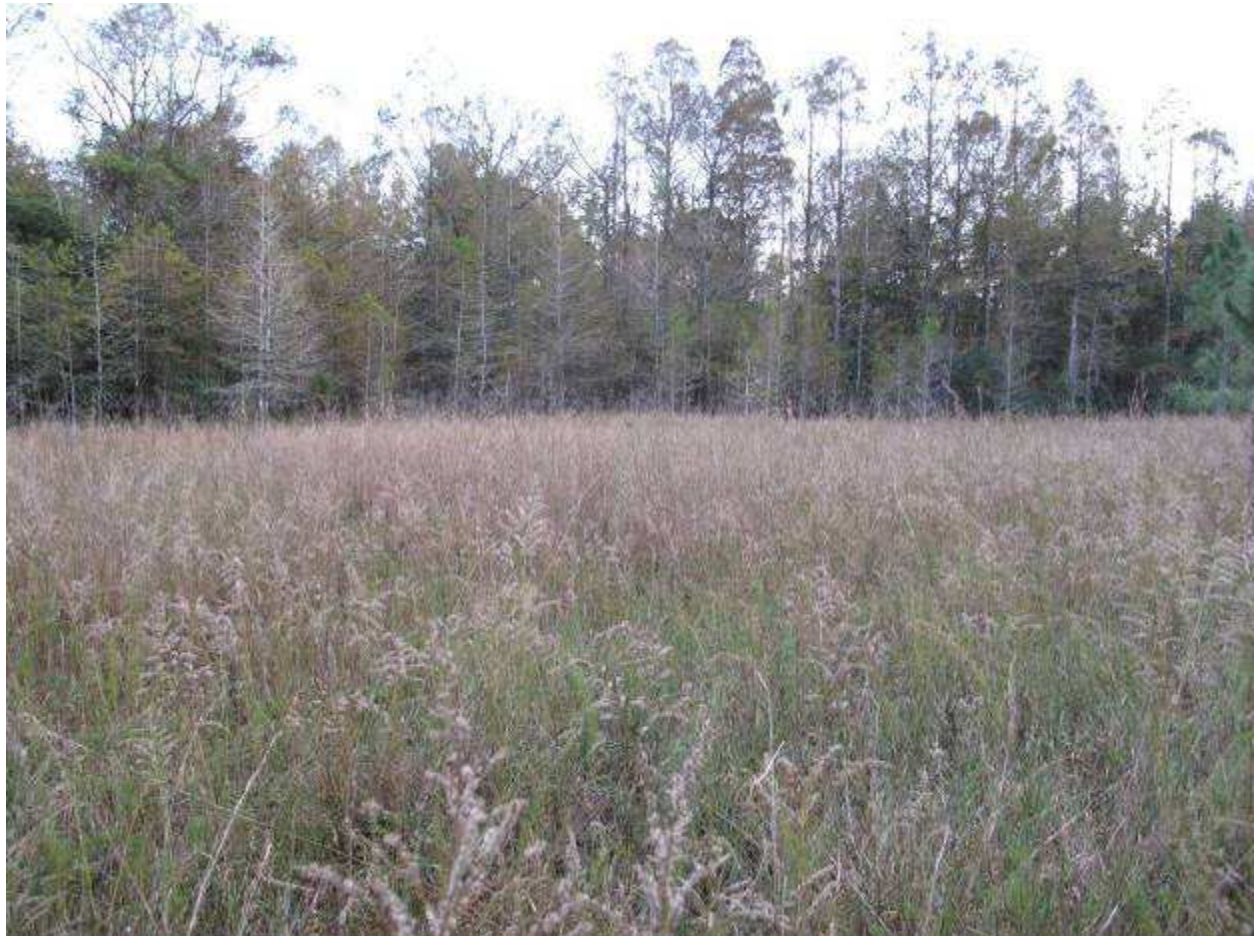
Wetland ID: 52-03

Description: This wetland is a 0.7 ha ephemeral marsh. Cypress trees grow in a strip along the east side of the wetland and pine trees are encroaching from the edge along the west and north sides. The tree canopy covers 5-25% of the wetland basin. The needle duff is not very thick. There is no midstory layer. Sedges/grasses and maidencane grow throughout the wetland, and cover >75% of the basin. The adjacent uplands are planted pine forest with dense palmetto understory.

Wetland Concerns: Woody encroachment

Restoration Action Recommended: Thin large perimeter pine trees. The woody encroachment at this wetland is minor.

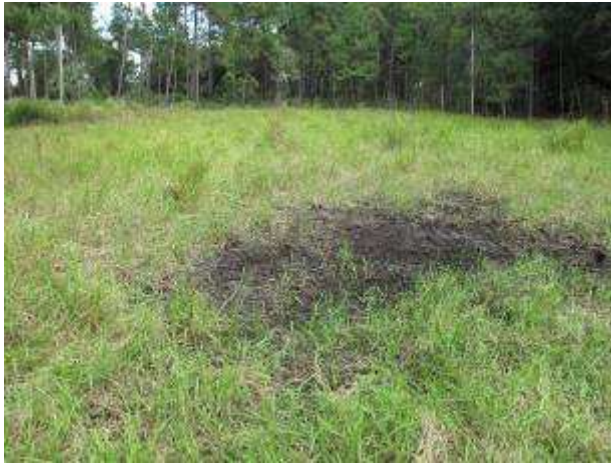
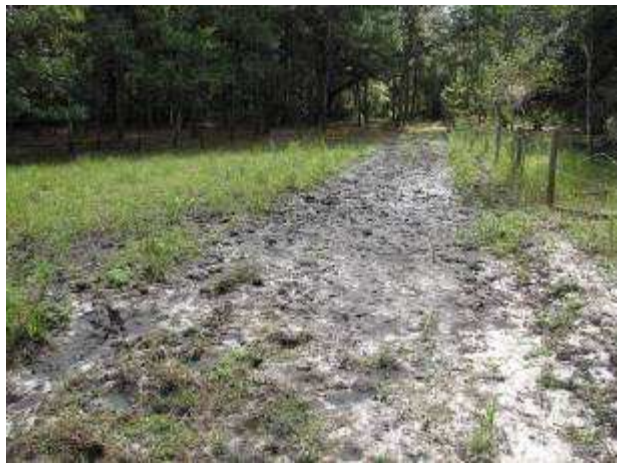
Wetland ID: 54-01

Description: This wetland is a 0.2 ha ephemeral marsh. Pine trees grow around the wetland edge, and cover 5-25% of the wetland basin. There is no midstory layer. Maidencane grows throughout the wetland, and covers >75% of the basin. A fireline/private property boundary bisects the western tip of the wetland. There is evidence of cattle in the wetland. The adjacent uplands are grazed pasture and sandhills.

Wetland Concerns: Cattle, Fireline/private property boundary, Upland condition, Woody encroachment

Restoration Action Recommended: Contact private landowner to see if MU boundary can be moved to encompass the entire wetland. If the boundary cannot be moved, monitor the wetland to ensure fire is not excluded. Maintain the fireline when the wetland is completely dry to prevent ruts from developing. In order to restore the full ecological potential of the wetland, the cattle would need to be removed and the uplands restored. Thin large perimeter pine trees.

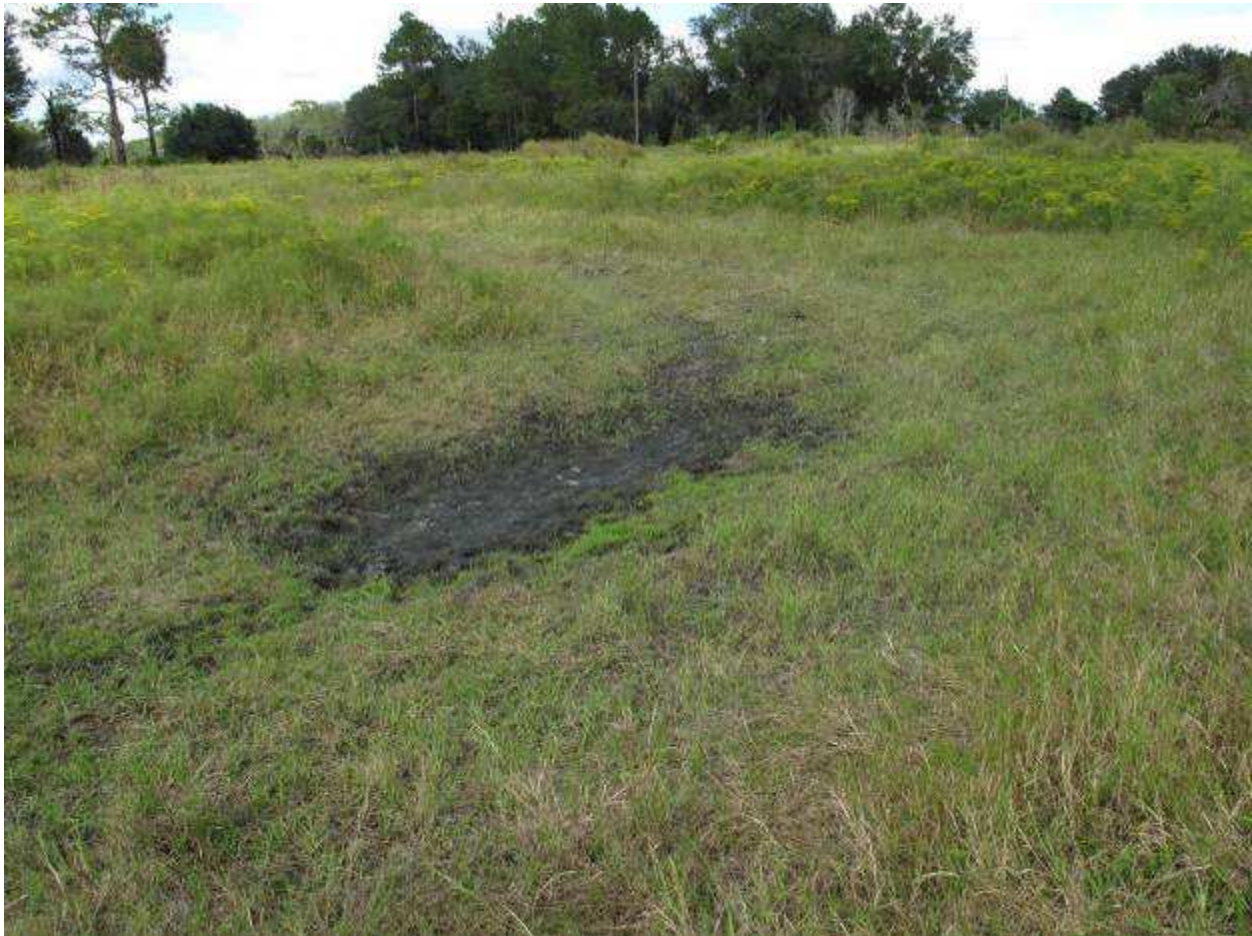
Wetland ID: 54-02

Description: This wetland is a 0.1 ha ephemeral man-made pit/cattle pond. There is no tree canopy or midstory layer. Maidencane grows throughout the wetland, and covers >75% of the basin. This man-made wetland is functioning as an ephemeral marsh. The adjacent uplands are grazed pasture and sandhills.

Wetland Concerns: Cattle, Upland condition

Restoration Action Recommended: While this wetland is man-made, it has the potential to function as an ephemeral wetland if desired. In order to restore the full ecological potential of the wetland, the cattle would need to be removed and the uplands restored.

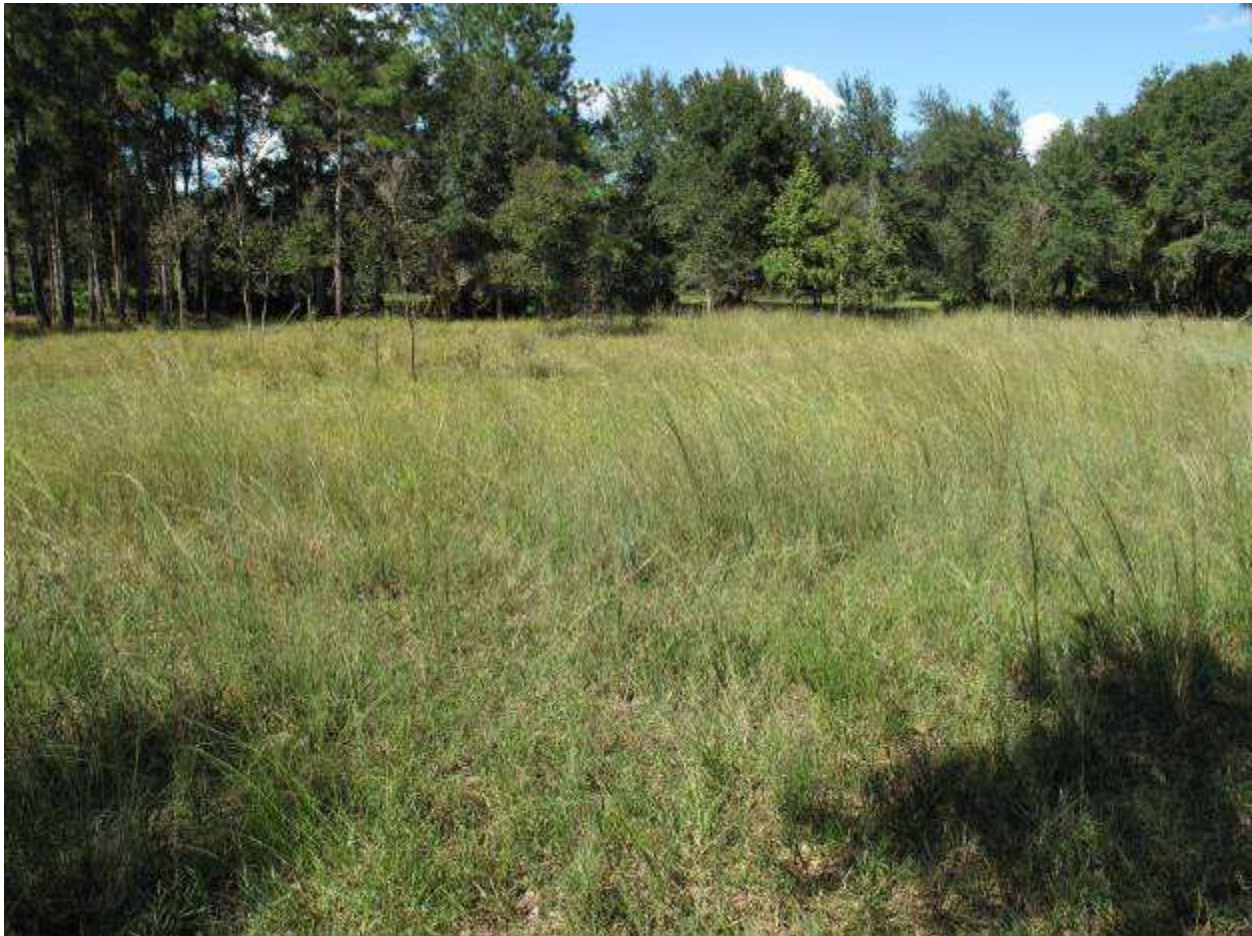
Wetland ID: 54-03

Description: This wetland is a 0.3 ha ephemeral marsh. There is no tree canopy or midstory layer. Sedges/grasses and maidencane grow throughout the wetland, and cover >75% of the basin. A ditch on the north side of the wetland connects to the larger Wetland 54-07. Cattle traffic is light but noticeable. The wetland is surrounded by an oak/palmetto ring and heavily grazed pasture and sandhills.

Wetland Concerns: Cattle, Ditch, Upland condition

Restoration Action Recommended: Fill the ditch to break connectivity with the wetland. Alternatively, the ditch could be plugged and vegetation allowed to regenerate. In order to restore the full ecological potential of the wetland, the cattle would need to be removed and the uplands restored.

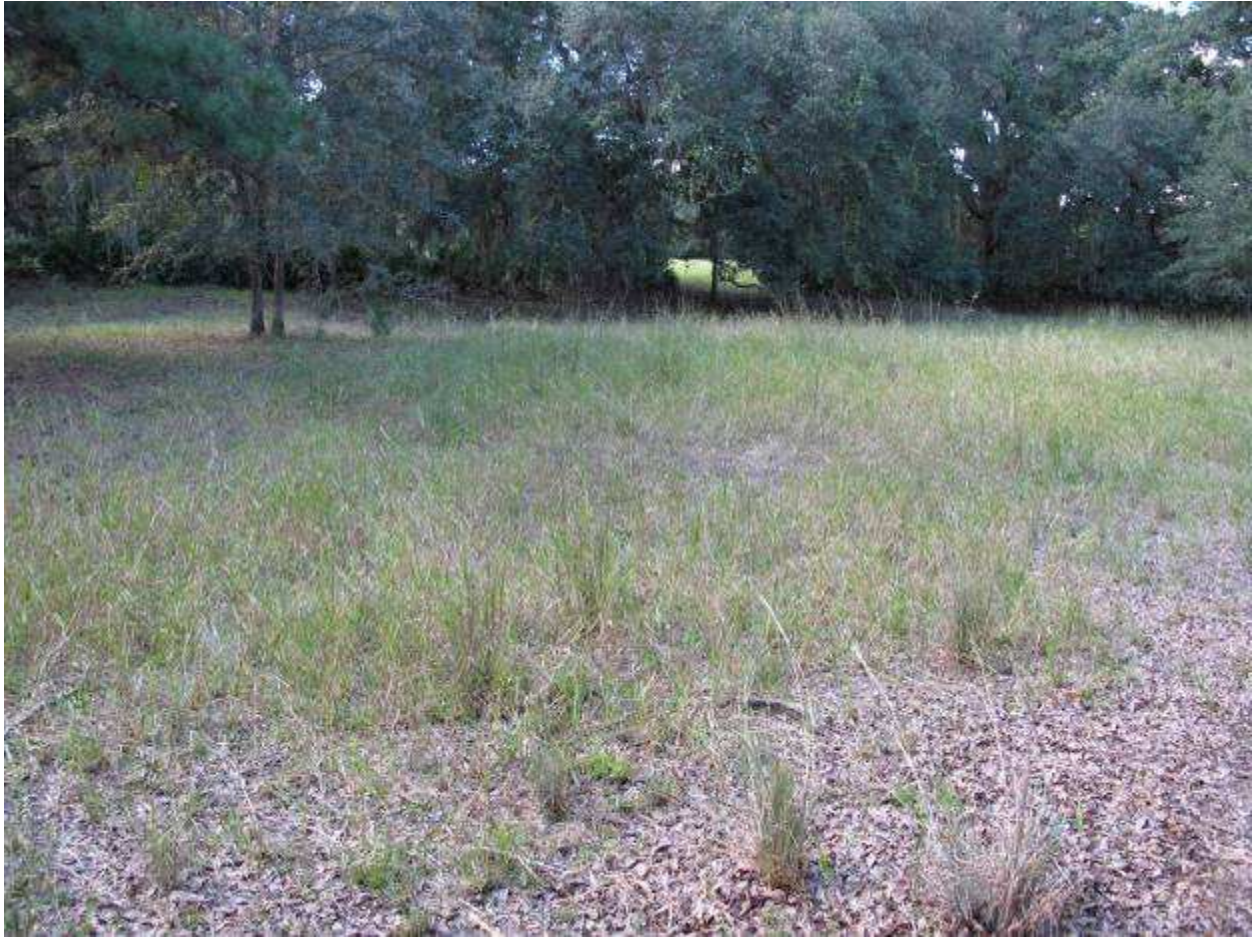
Wetland ID: 54-04

Description: This wetland is a 0.2 ha ephemeral marsh. Oak and pine trees are encroaching from the wetland edge, and cover 5-25% of the wetland basin. There is no midstory layer. Maidencane grows throughout the wetland, and covers >75% of the basin. This wetland appears to be desiccated, possibly due to ditching on the property or to a long dry period. There is cow excrement in the wetland. The wetland is surrounded by a dense, tall oak/palmetto ring and grazed pasture and sandhills.

Wetland Concerns: Cattle, Upland condition, Woody encroachment

Restoration Action Recommended: Thin trees around the wetland edge. In order to restore the full ecological potential of the wetland, the cattle would need to be removed and the uplands restored.

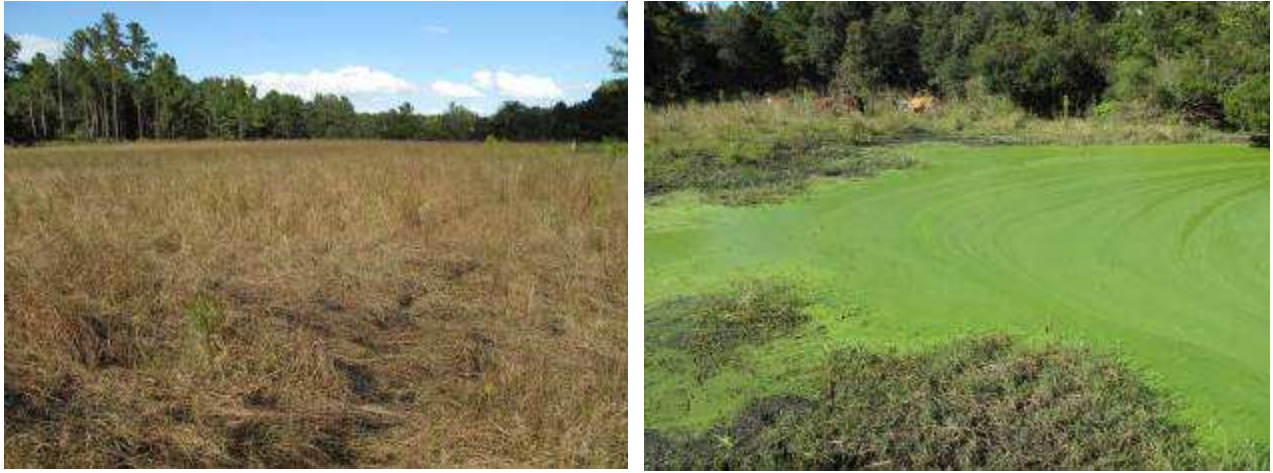
Wetland ID: 54-05

Description: This wetland is a 1.9 ha ephemeral marsh. Large and small pine trees grow around the wetland perimeter. Sedges/grasses and maidencane grow throughout the wetland, and cover >75% of the basin. Cattle traffic is severe in the northeast corner and there is a green film on the water. The wetland may have been mechanically dug to increase the depth. The adjacent uplands are grazed pasture and sandhills.

Wetland Concerns: Cattle, Upland condition, Woody encroachment

Restoration Action Recommended: In order to restore the full ecological potential of the wetland, the cattle would need to be removed and the uplands restored. Thin large perimeter pine trees and remove smaller pine trees.

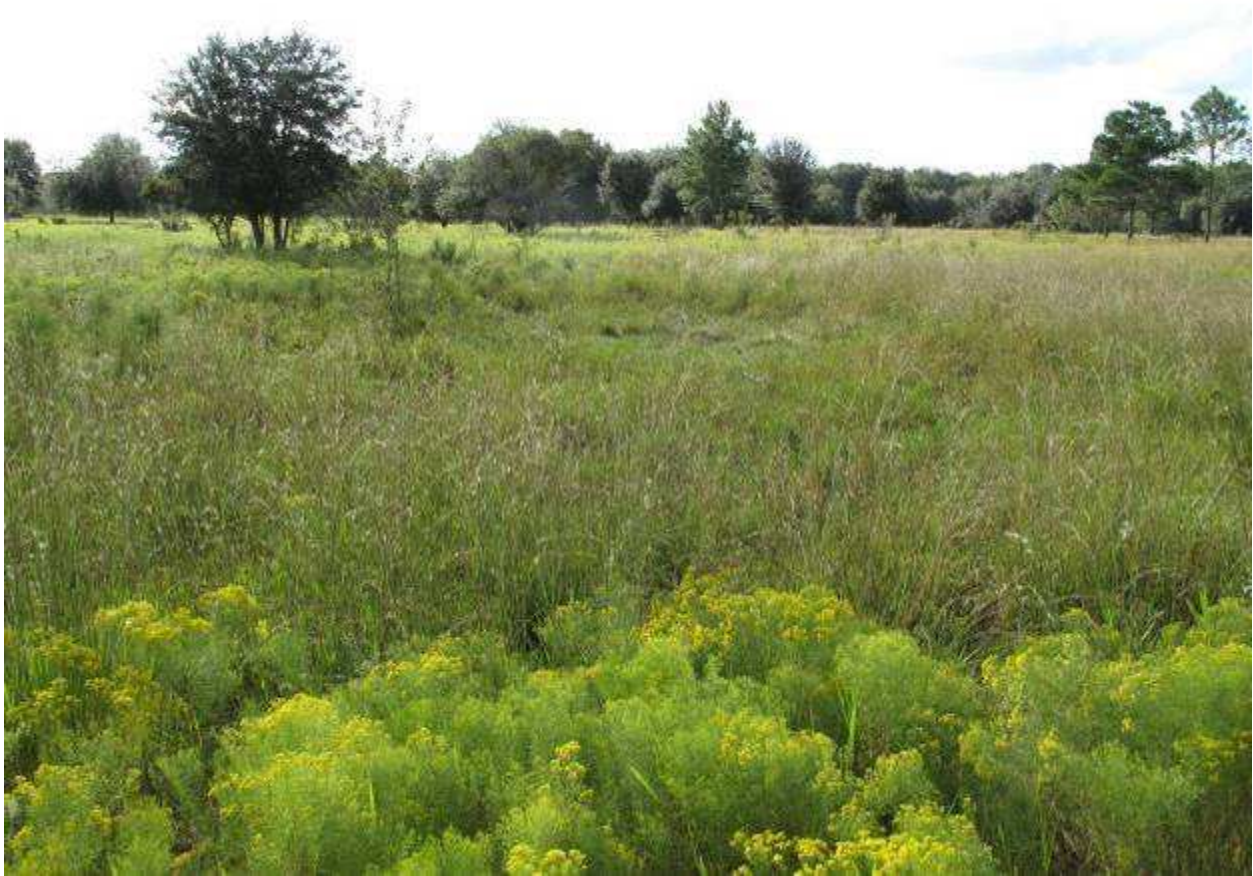
Wetland ID: 54-06

Description: This wetland is a <0.1 ha ephemeral marsh. There is no tree canopy or midstory layer. Maidencane grows throughout the wetland, and covers >75% of the basin. The wetland appears to be healthy despite the presence of cattle. The adjacent uplands are grazed pasture and sandhills.

Wetland Concerns: Cattle, Upland condition

Restoration Action Recommended: In order to restore the full ecological potential of the wetland, the cattle would need to be removed and the uplands restored.

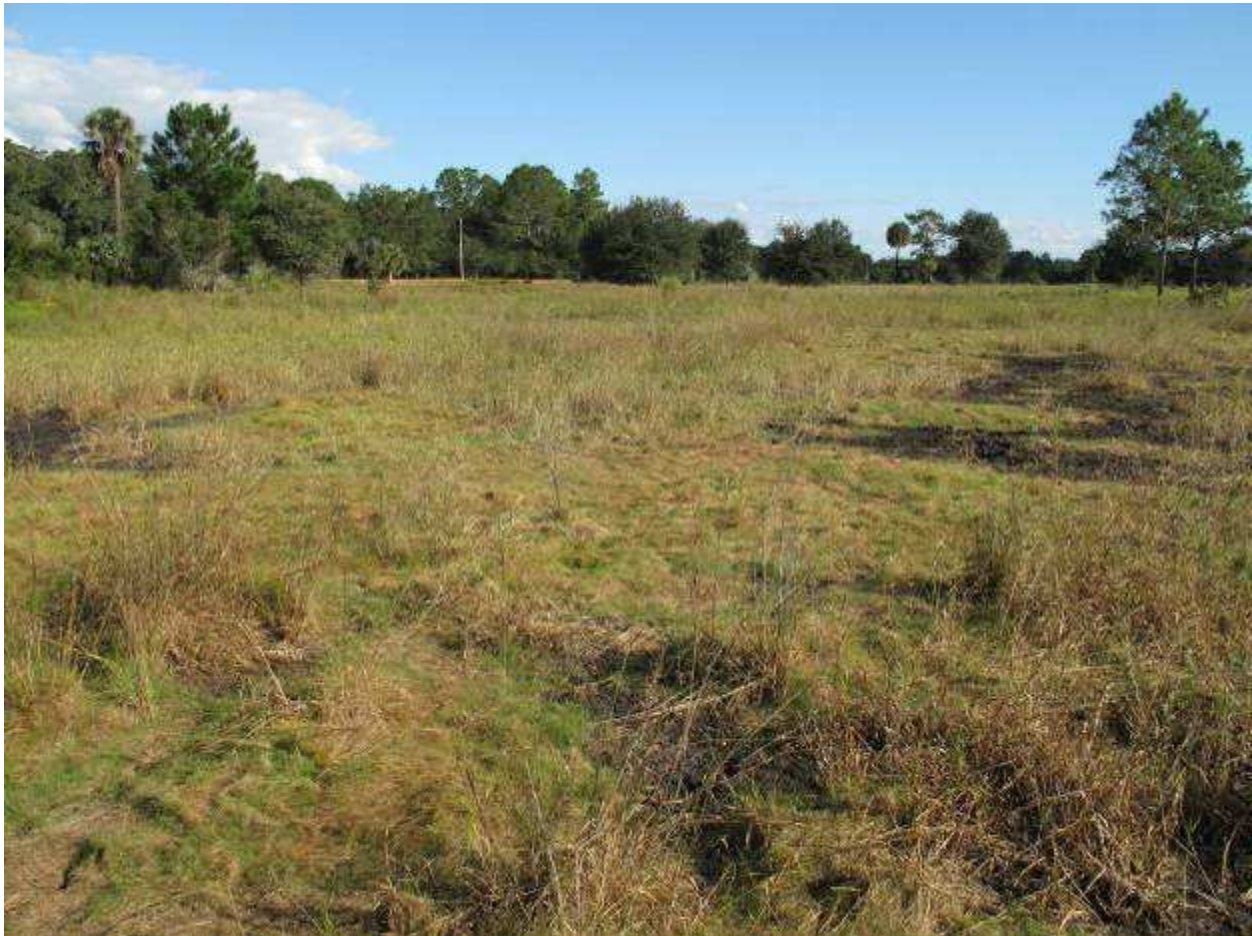
Wetland ID: 54-07

Description: This wetland is a 0.4 ha ephemeral marsh. There is no tree canopy or midstory layer. Sedges/grasses and maidencane grow throughout the wetland, and cover >75% of the basin. There is cattle traffic and a mud wallow area in the center. The adjacent uplands are grazed pasture and sandhills.

Wetland Concerns: Cattle, Upland condition

Restoration Action Recommended: In order to restore the full ecological potential of the wetland, the cattle would need to be removed and the uplands restored.

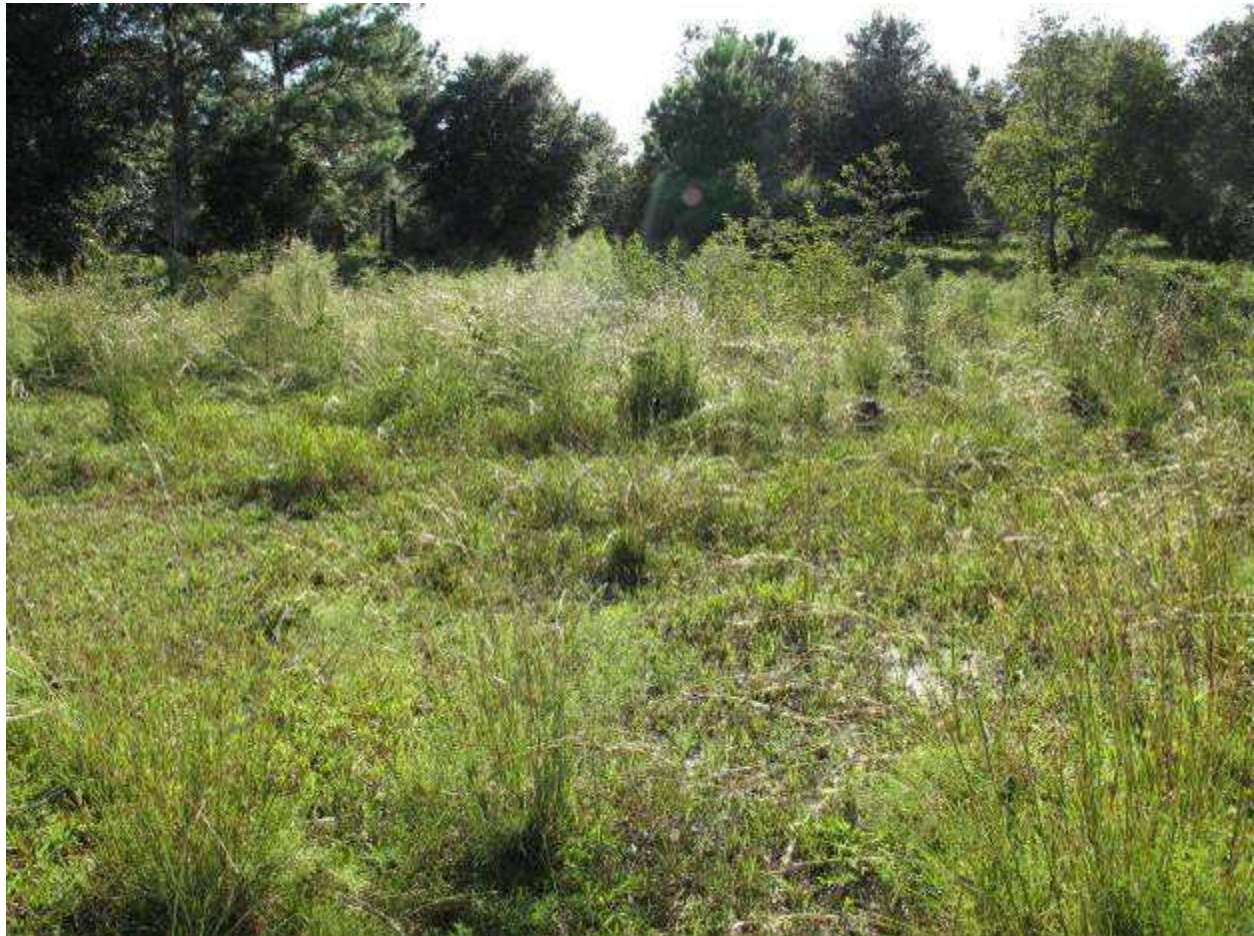
Wetland ID: 54-08

Description: This wetland is a 0.1 ha ephemeral marsh. There is no tree canopy cover. Young persimmon trees cover 5-25% of the wetland basin. Sedges/grasses and maidencane grow throughout the wetland, and cover >75% of the basin. Cattle are using the wetland. The adjacent uplands are grazed pasture and sandhills.

Wetland Concerns: Cattle, Upland condition

Restoration Action Recommended: The next fire or inundation should eliminate the encroaching persimmons. If they become established, the persimmon trees will need to be removed from the wetland. In order to restore the full ecological potential of the wetland, the cattle would need to be removed and the uplands restored.

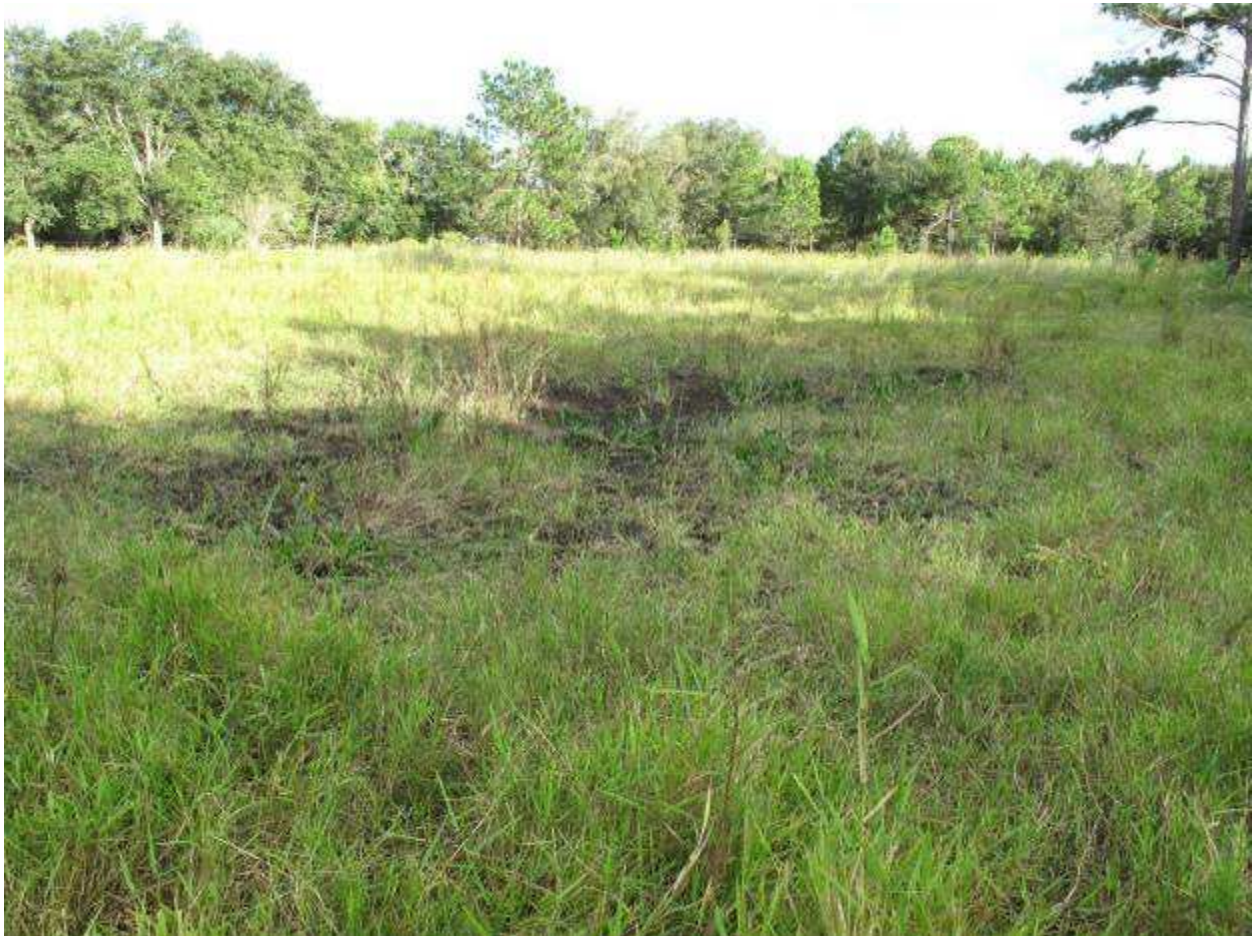
Wetland ID: 54-09

Description: This wetland is a 0.5 ha ephemeral marsh. There is no tree canopy or midstory layer. Maidencane grows throughout the wetland, and covers >75% of the basin. The wetland appears fairly healthy despite the presence of cattle. The adjacent uplands are grazed pasture and sandhills.

Wetland Concerns: Cattle, Upland condition

Restoration Action Recommended: In order to restore the full ecological potential of the wetland, the cattle would need to be removed and the uplands restored.
