Inventory, Assessment, and Restoration Potential of Ephemeral Wetlands on FFWCC Wildlife Management Areas

Half Moon WMA Final Report

Submitted by: Rebecca P.M. Means¹, Ryan C. Means¹, Steven A. Johnson²

¹Coastal Plains Institute

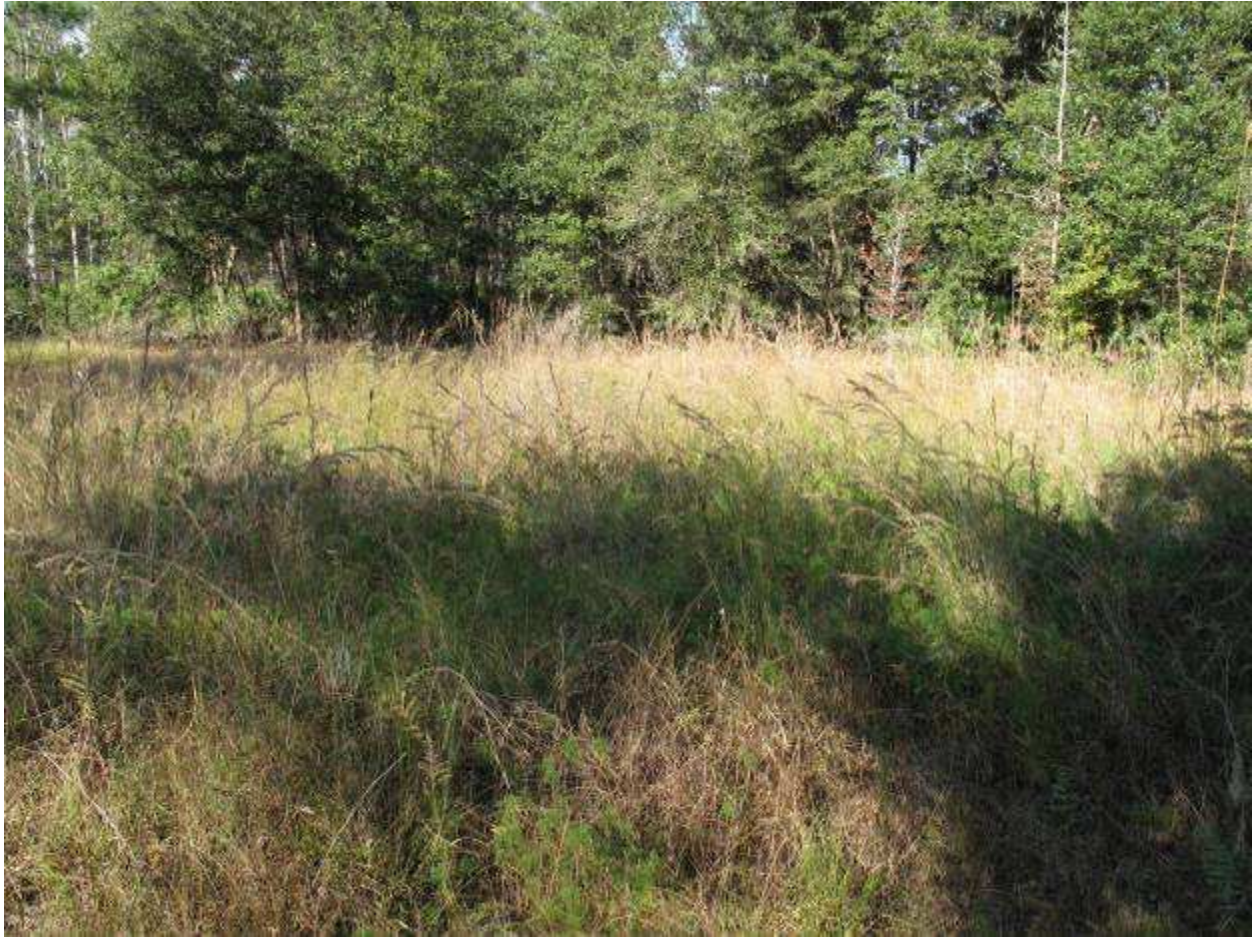
Wetland ID: 55-01

Description: This wetland is a 0.1 ha highly ephemeral marsh. There is no tree canopy or midstory layer. Sedges/grasses grow throughout the wetland, and cover >75% of the basin. The adjacent uplands are pine/oak/palmetto and old field communities.

Wetland Concerns: Upland condition

Restoration Action Recommended: In order to restore the full ecological potential of the wetland, the uplands would have to be restored.

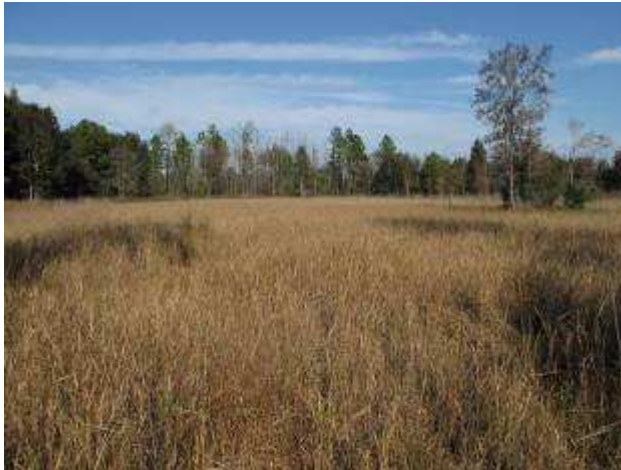
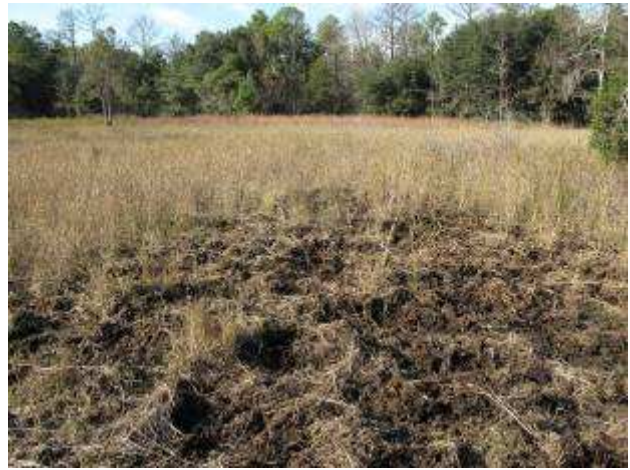
Wetland ID: 55-02

Description: This wetland is a 1.5 ha semi-permanent marsh. There is no tree canopy or midstory cover. Maidencane grows throughout the wetland, and covers >75% of the basin. Feral hog damage is patchy. There is an earthen berm along the east side of the wetland associated with a deep ditch. The berm created 2 wetlands from one large wetland, this wetland on the west side of the berm and a larger wetland to the east that is in MU 47. This marsh would be more ephemeral if the berm and ditch were not present. The adjacent uplands are pine/oak/palmetto and old field communities.

Wetland Concerns: Berm, Ditch, Feral hog damage, Upland condition

Restoration Action Recommended: Remove the berm and fill in the ditch. In order to restore the full ecological potential of the wetland, the uplands would have to be restored.

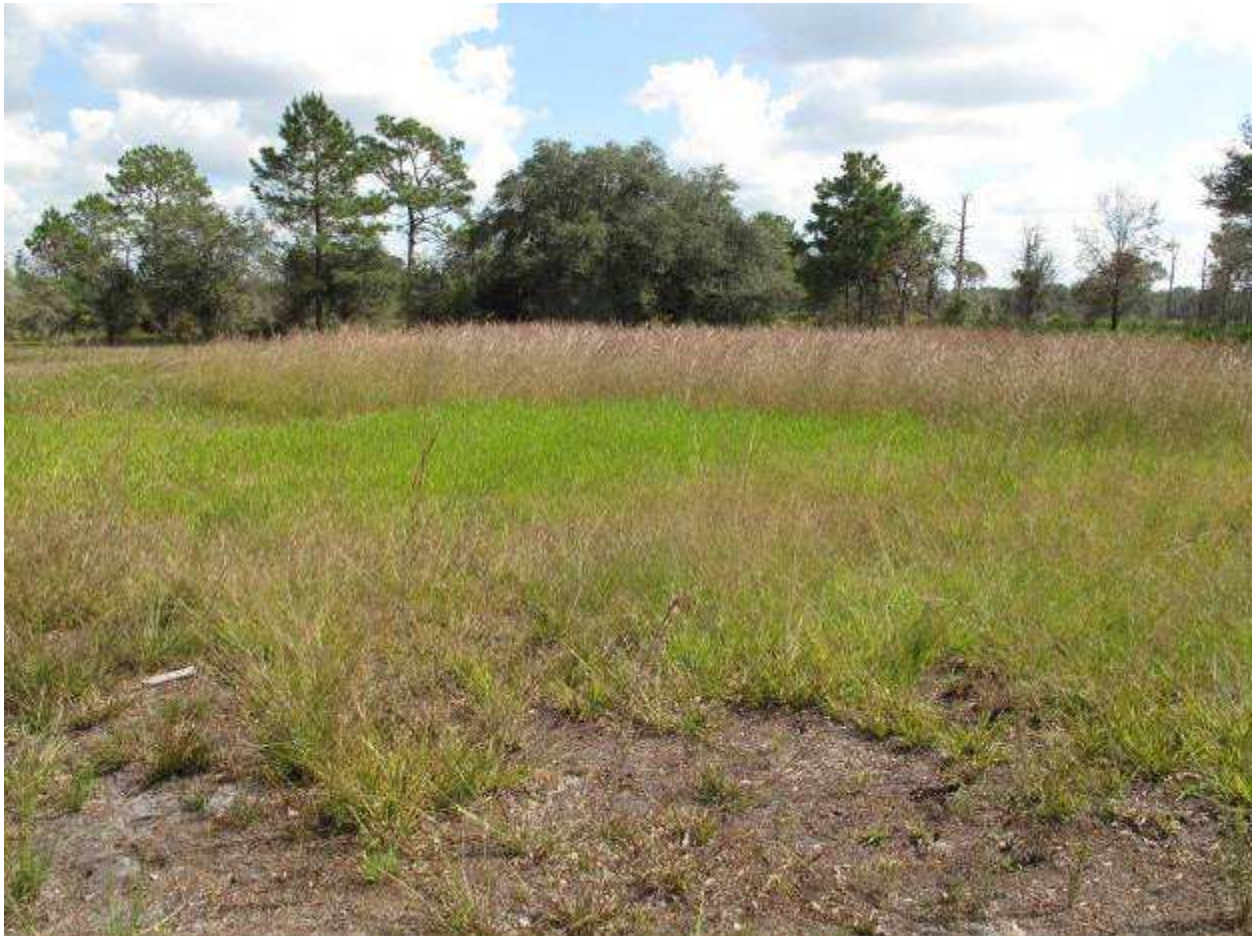
Wetland ID: 56-01

Description: This wetland is a 0.3 ha ephemeral marsh. There is no tree canopy or midstory layer. Sedges/grasses and maidencane grow throughout the wetland, and cover >75% of the basin. This circular marsh is in excellent condition and is a potential striped newt breeding pond. The adjacent uplands are scrubby flatwoods.

Wetland Concerns: None

Restoration Action Recommended: None

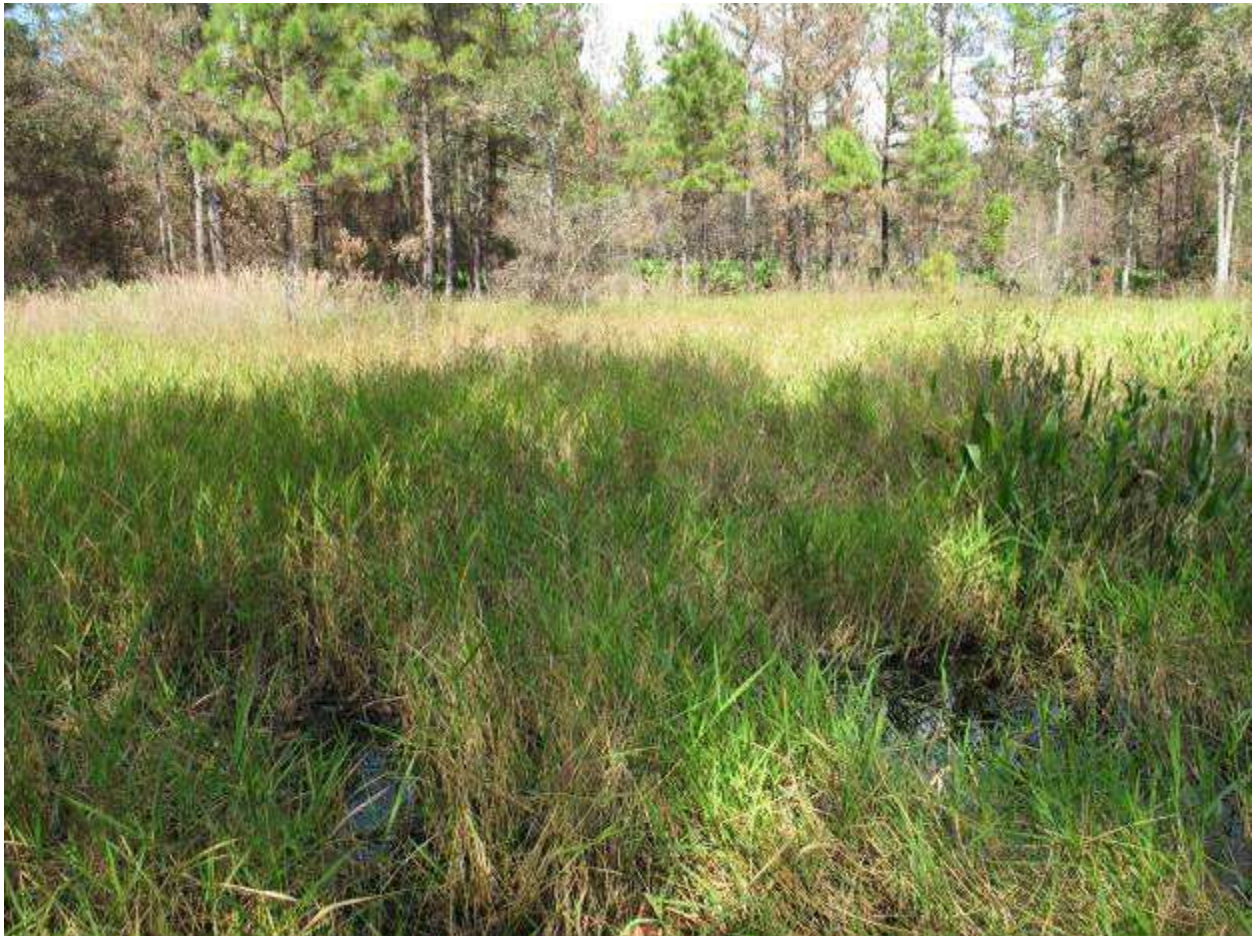
Wetland ID: 56-02

Description: This wetland is a 0.2 ha semi-permanent marsh. There is no tree canopy or midstory layer. Maidencane grows throughout the wetland, and covers >75% of the basin. This wetland, and 56-03 to the southeast, used to be a single wetland. They now are bisected by a 1.5m tall berm and road complex and function as two separate wetlands. This formerly ephemeral wetland was mechanically deepened along the edge it shares with the berm, lengthening the hydroperiod. The adjacent uplands are scrubby flatwoods to the east and pine/oak hammock to the west.

Wetland Concerns: Road

Restoration Action Recommended: The road should be re-routed away from the wetland if feasible. Flatten the berm/road complex and resculpt the wetland floor to allow the 2 wetlands to reconnect.

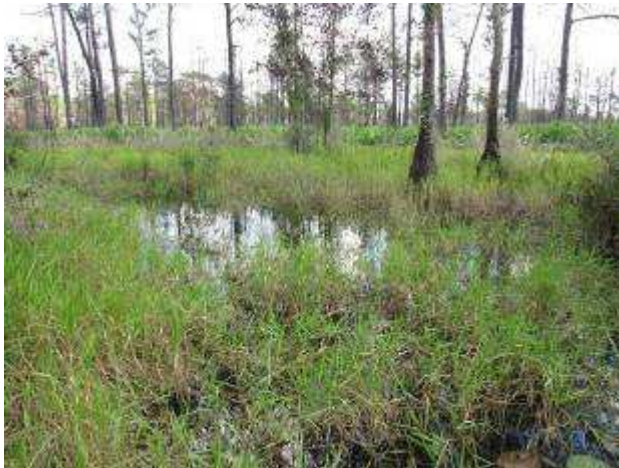
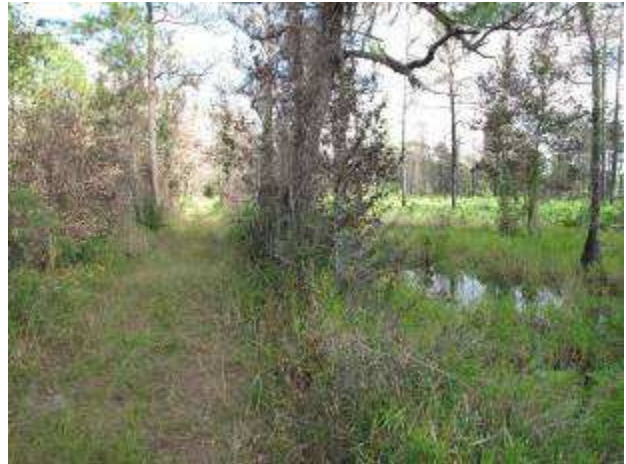
Wetland ID: 56-03

Description: This wetland is a 0.1 ha semi-permanent marsh. There is no tree canopy cover. Buttonbush covers 5-25% of the wetland. Maidencane grows throughout the wetland, and covers >75% of the basin. This wetland, and 56-02 to the northwest, used to be a single wetland. They now are bisected by a 1.5m tall berm and road complex and function as two separate wetlands. This formerly ephemeral wetland was mechanically deepened along the edge it shares with the berm, lengthening the hydroperiod. The adjacent uplands are scrubby flatwoods.

Wetland Concerns: Road

Restoration Action Recommended: The road should be re-routed away from the wetland if feasible. Flatten the berm/road complex and resculpt the wetland floor to allow the 2 wetlands to reconnect.

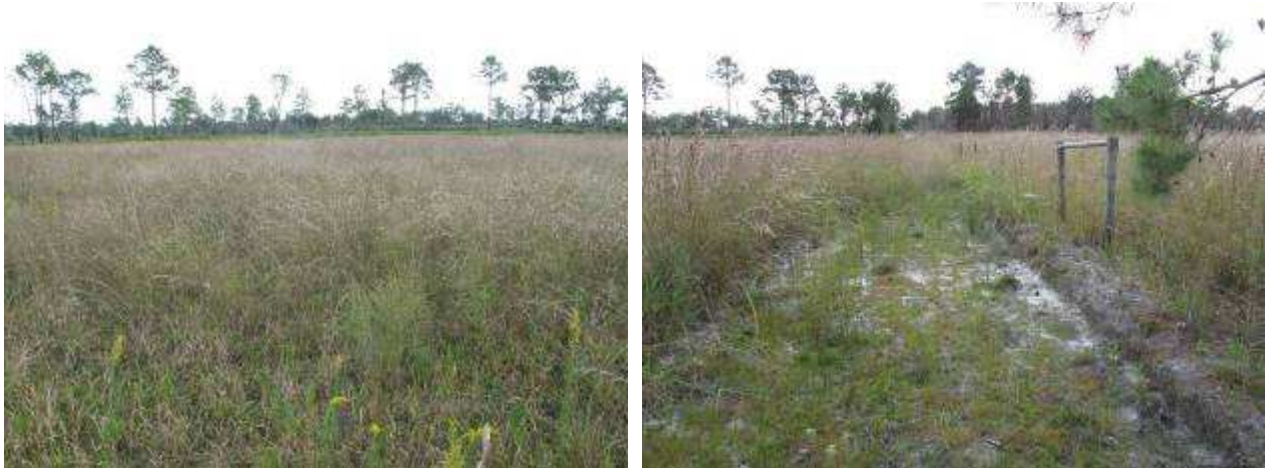
Wetland ID: 56-04

Description: This wetland is a 1.7 ha ephemeral marsh. There is no tree canopy or midstory layer. Maidencane and sedges/grasses grow throughout the wetland, and cover >75% of the basin. A fireline/MU boundary bisects the middle of the wetland. This open marsh is a potential striped newt breeding pond. The adjacent uplands are scrubby flatwoods.

Wetland Concerns: Fireline/MU boundary

Restoration Action Recommended: Re-route the fireline/MU boundary away from the wetland.

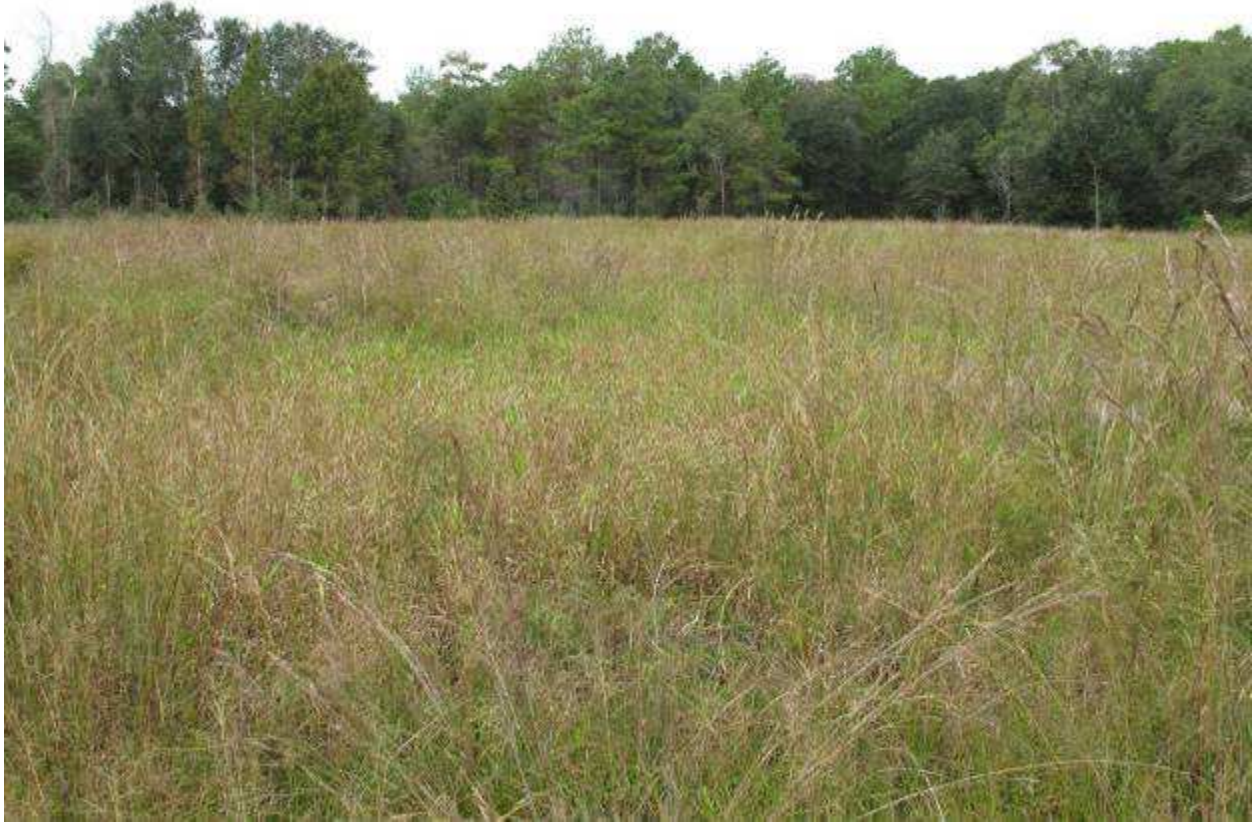
Wetland ID: 57-01

Description: This wetland is a 0.6 ha ephemeral marsh. There is no tree canopy or midstory layer. Maidencane and sedges/grasses grow throughout the wetland, and cover >75% of the basin. The wetland is surrounded by a dense brush/palmetto ring and oldfield with many large and small longleaf pine trees.

Wetland Concerns: Upland condition

Restoration Action Recommended: In order to restore the full ecological potential of the wetland, the uplands would have to be restored.

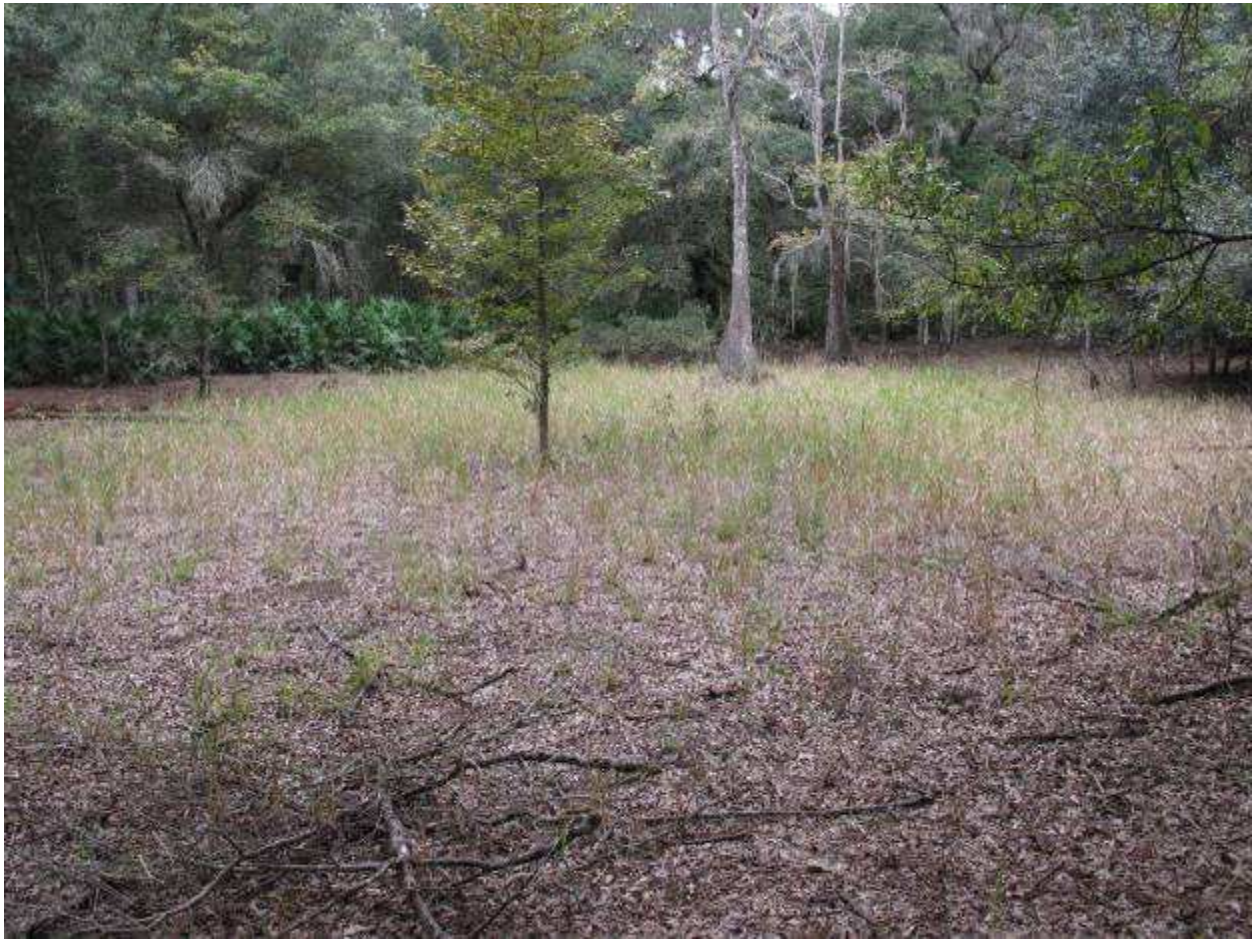
Wetland ID: 57-02

Description: This wetland is a 0.1 ha ephemeral marsh. Large oak trees grow around the wetland edge, and cover 5-25% of the wetland basin. The oaks are established in the upland margin but are leaning over the wetland, shading the littoral zone. There is no midstory layer. Maidencane grows in the wetland center, covering 50-75% of the wetland basin. The adjacent uplands are a dense pine/oak hammock with thick palmetto.

Wetland Concerns: Woody encroachment

Restoration Action Recommended: The perimeter oak trees could be thinned in order to reduce the shading effect and encourage the growth of more herbaceous vegetation. In order to restore the full ecological potential of the wetland, the uplands would have to be restored.

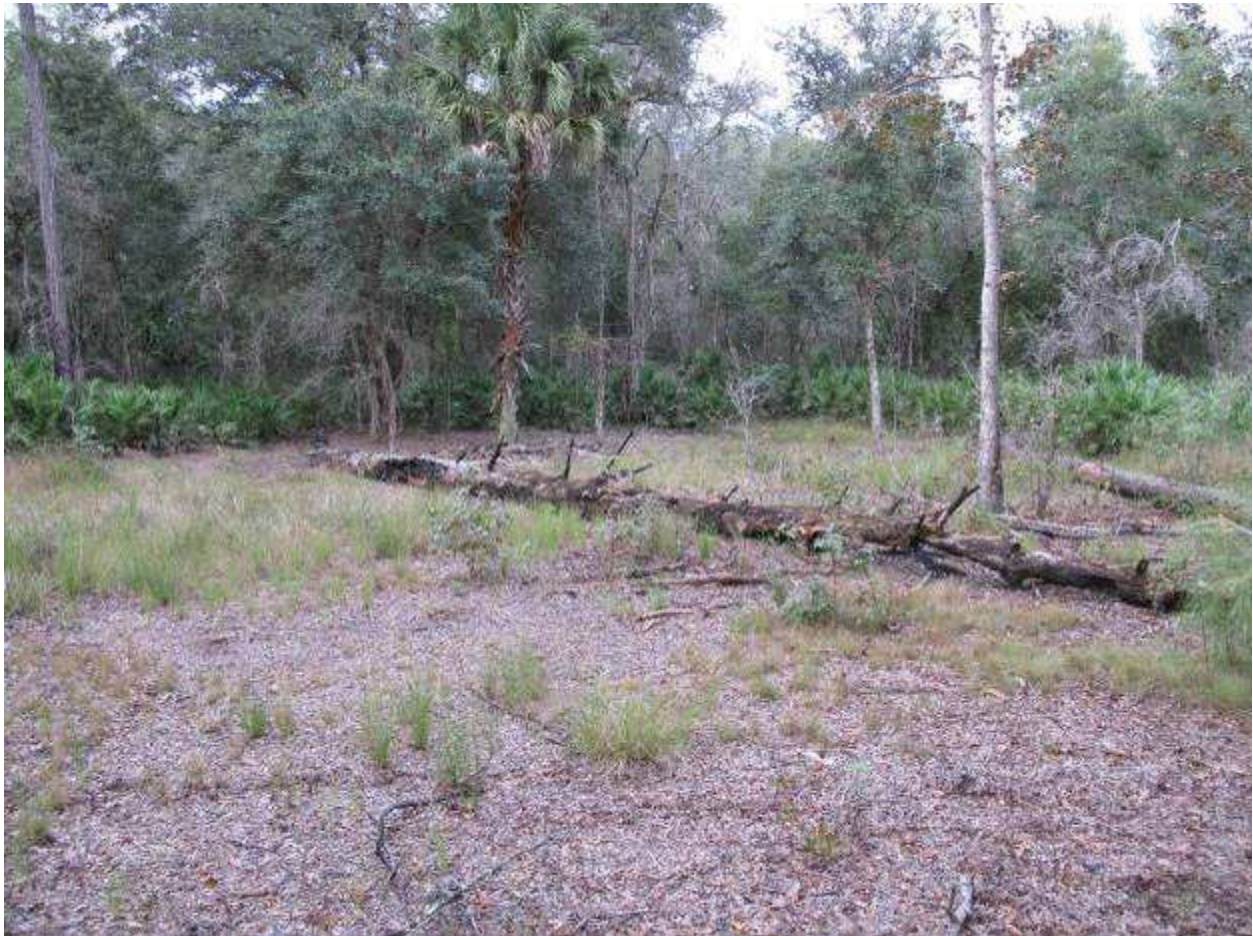
Wetland ID: 57-03

Description: This wetland is a <0.1 ha highly ephemeral marsh. There is no tree canopy or midstory cover. Sedges/grasses grow in scattered patches, and cover 25-50% of the wetland basin. The adjacent uplands are a dense pine/oak hammock with thick palmetto.

Wetland Concerns: None

Restoration Action Recommended: In order to restore the full ecological potential of the wetland, the uplands would have to be restored.

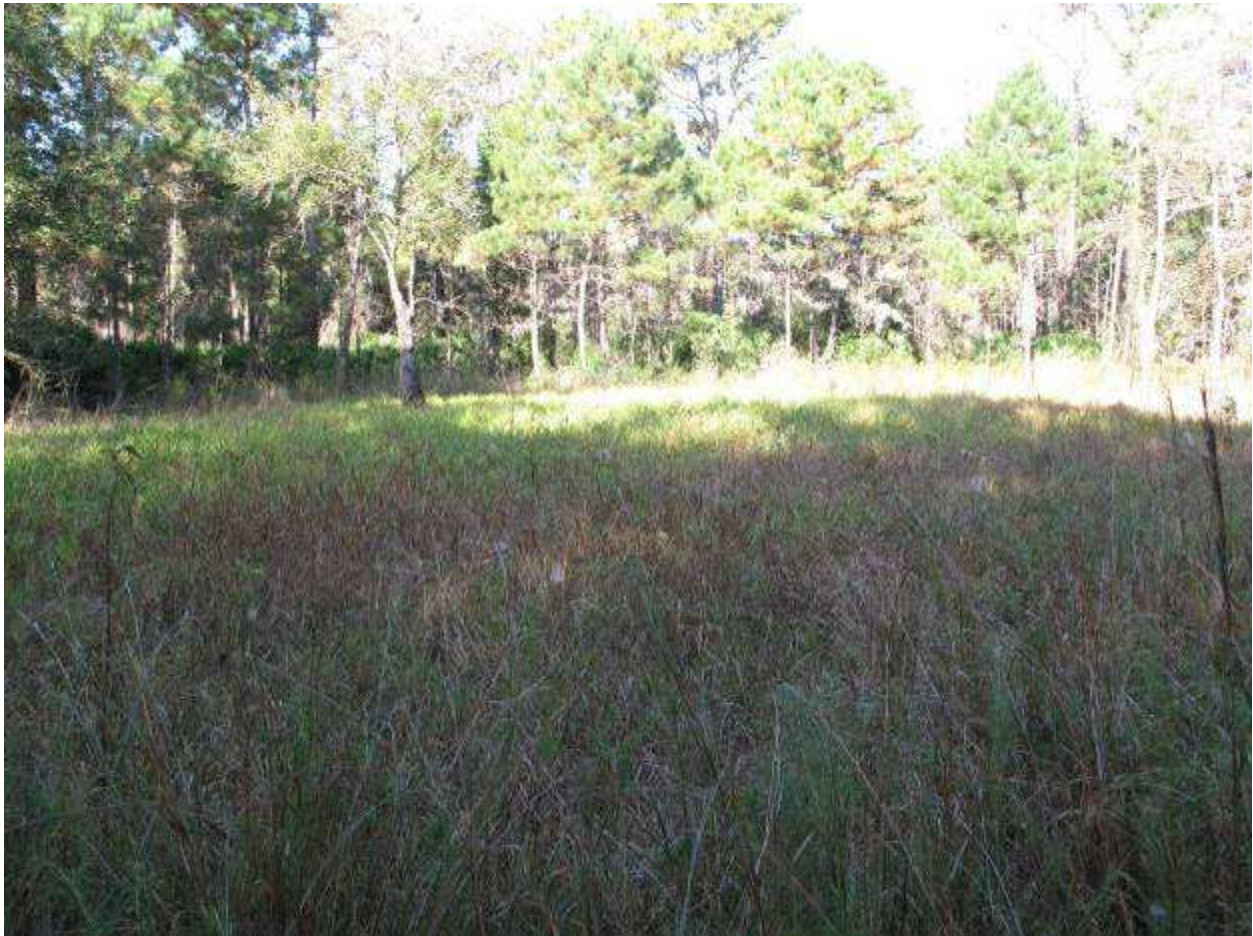
Wetland ID: 57-04

Description: This wetland is a 0.1 ha ephemeral marsh. A few gum trees grow in the wetland, but cover <5% of the wetland basin. A few small pine trees are beginning to encroach from the wetland edge but will be killed with the next fire or inundation. Sedges/grasses and maidencane grow throughout the wetland, and cover >75% of the wetland basin. The wetland is surrounded by a palmetto ring, dense pine/oak hammock with thick palmetto, and oldfield.

Wetland Concerns: Upland condition

Restoration Action Recommended: In order to restore the full ecological potential of the wetland, the uplands would have to be restored.

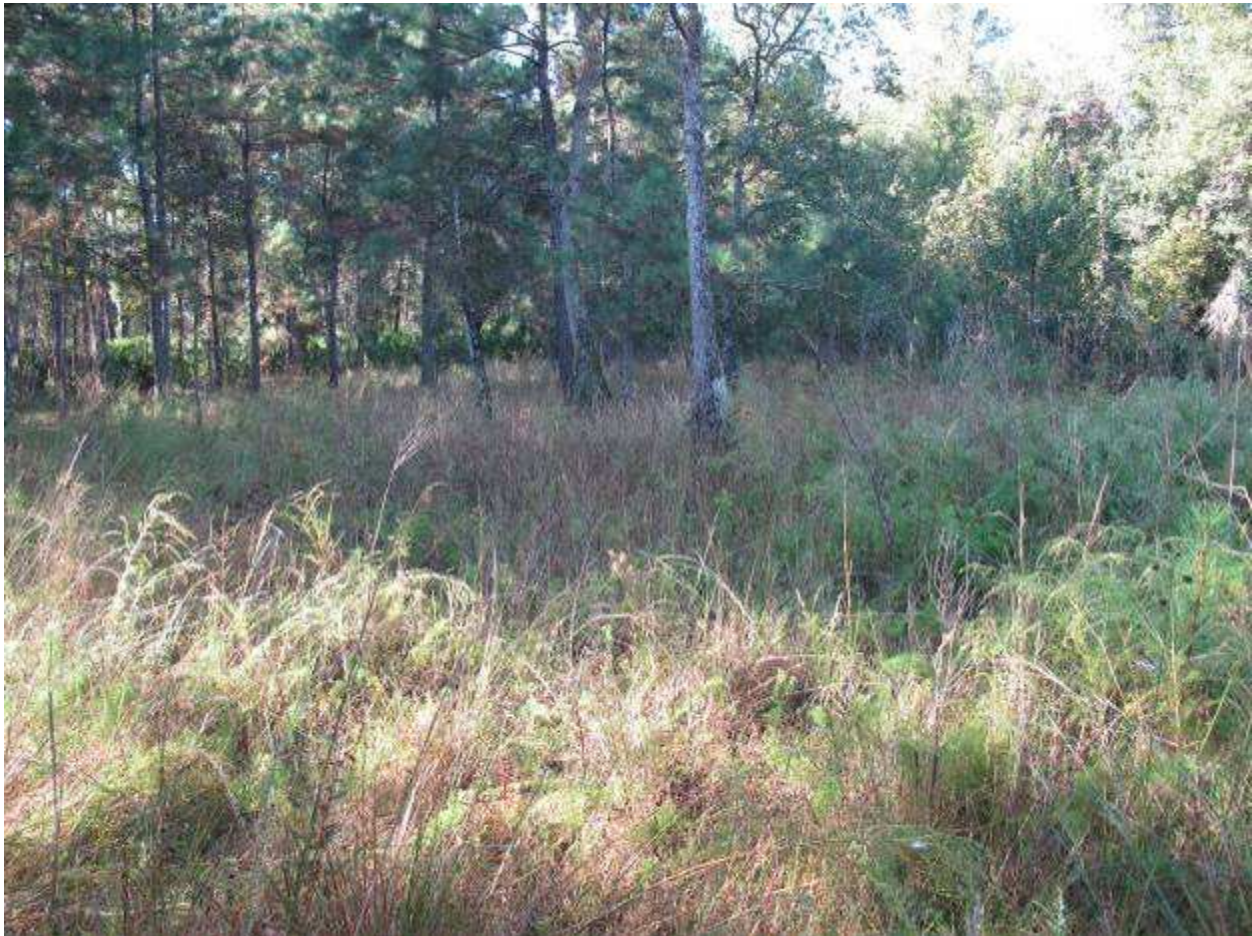
Wetland ID: 57-05

Description: This wetland is a 0.1 ha ephemeral marsh. Pine trees are encroaching into the wetland, and cover 5-25% of the basin. There is no midstory cover. Sedges/grasses and maidencane grow throughout the wetland, and cover >75% of the basin. This wetland, and 57-06 to the northwest, used to be a single wetland. They now are bisected by an earthen berm and function as two separate wetlands. The adjacent uplands are upland pine forest with thick palmetto.

Wetland Concerns: Berm, Woody encroachment

Restoration Action Recommended: Flatten the berm and resculpt the wetland floor to allow the 2 wetlands to reconnect. Remove pine trees from the wetland interior. In order to restore the full ecological potential of the wetland, the uplands would have to be restored.

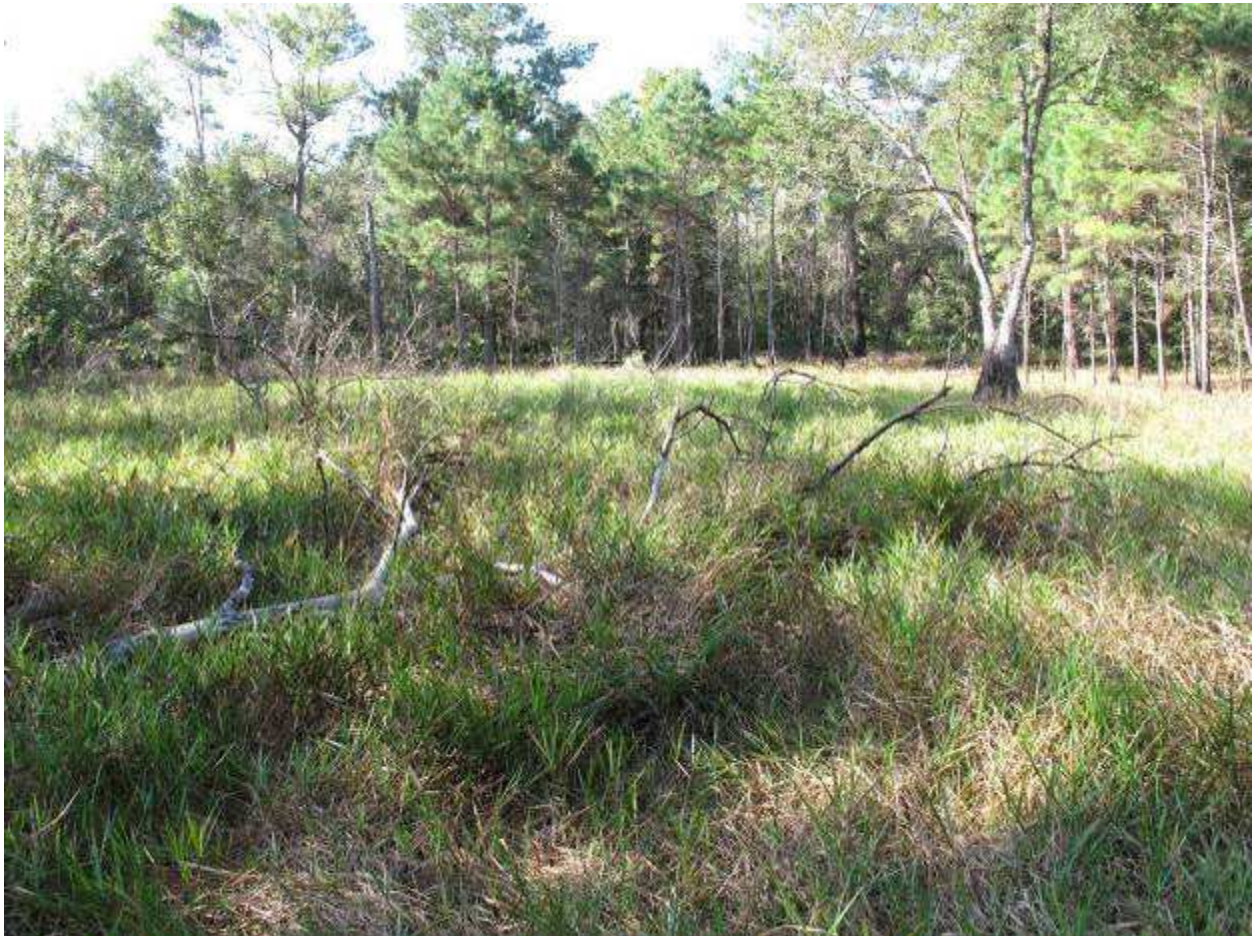
Wetland ID: 57-06

Description: This wetland is a 0.1 ha ephemeral marsh. Pine trees are encroaching from the wetland edge and cover 5-25% of the wetland basin. There is no midstory cover. Maidencane is dense and covers >75% of the wetland basin. This wetland, and 57-05 to the southeast, used to be a single wetland. They now are bisected by an earthen berm and function as two separate wetlands. The adjacent uplands are hardwood hammock with pine.

Wetland Concerns: Berm, Woody encroachment

Restoration Action Recommended: Flatten the berm complex and resculpt the wetland floor to allow the 2 wetlands to reconnect. Encourage periodic fire to reduce the dense maidencane. Remove pine trees from the wetland interior.

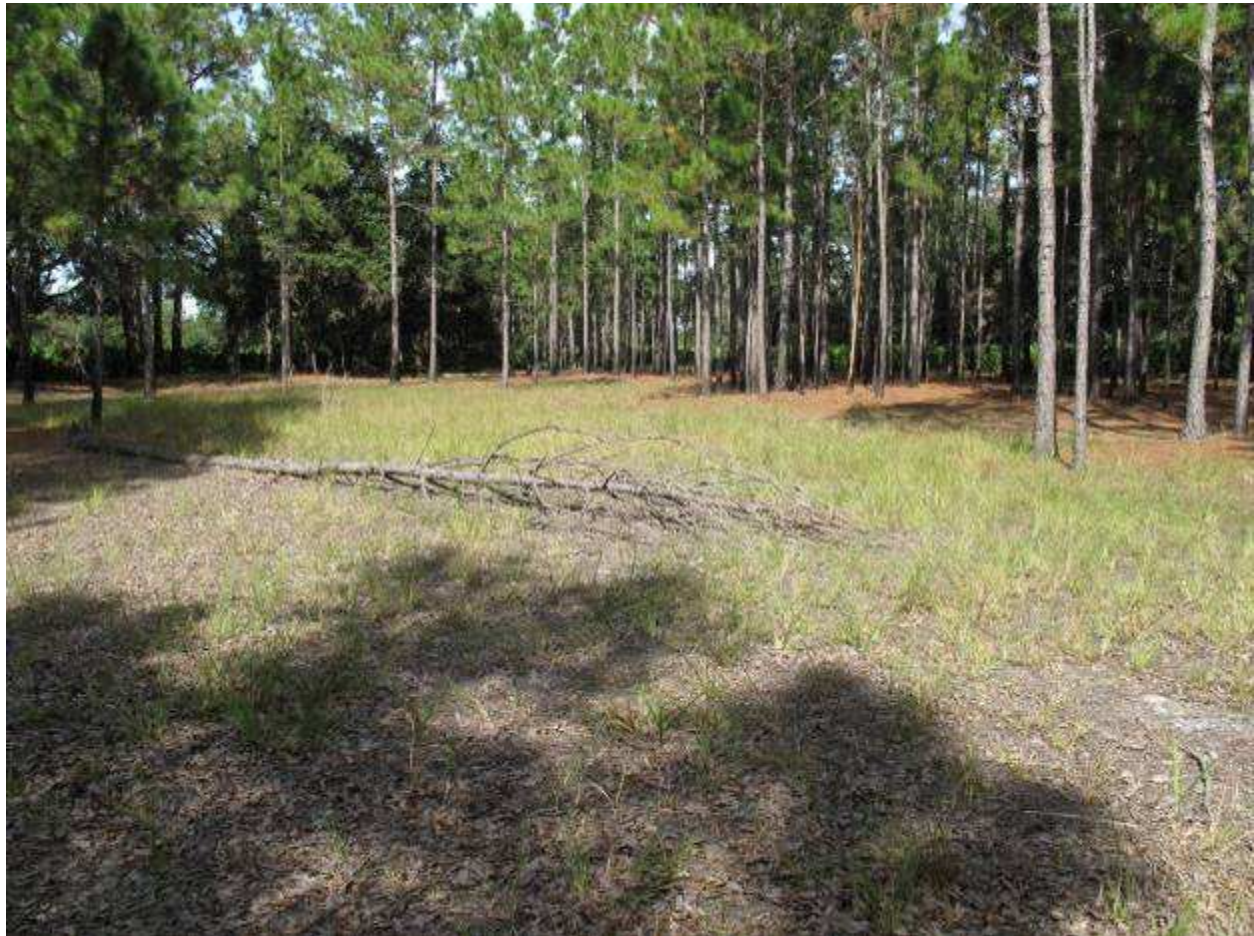
Wetland ID: 58-01

Description: This wetland is a 0.1 ha ephemeral marsh. Pine trees are encroaching from the wetland edge and cover 25-50% of the wetland basin. There is no midstory cover. Pine needles and canopy shading have reduced the herbaceous vegetation. Sedges/grasses grow in the wetland center, and cover 25-50% of the basin. The wetland is surrounded by a dense palmetto ring, oldfield, and planted pine trees.

Wetland Concerns: Upland condition, Woody encroachment

Restoration Action Recommended: Thin perimeter pine trees to reduce the shading effect and encourage the growth of herbaceous vegetation. In order to restore the full ecological potential of the wetland, the uplands would have to be restored.

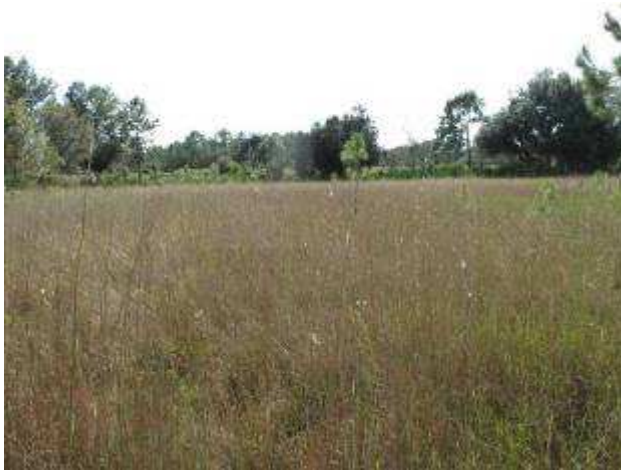
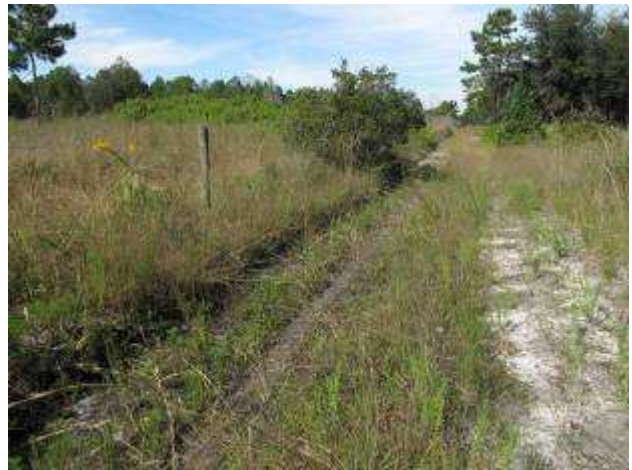
Wetland ID: 58-02

Description: This wetland is a 0.3 ha ephemeral marsh. There is no significant tree canopy or midstory cover. However, a few young pine trees are beginning to encroach from the north side. Sedges/grasses and maidencane grow throughout the wetland, and cover >75% of the basin. A fireline/MU boundary touches the northeast corner of the wetland. The wetland is surrounded by a dense palmetto ring and oldfield.

Wetland Concerns: Fireline/MU boundary, Upland condition

Restoration Action Recommended: Re-route boundary away from this wetland complex. The minor woody encroachment should be suppressed by the next fire or wetland inundation. In order to restore the full ecological potential of the wetland, the uplands would have to be restored.

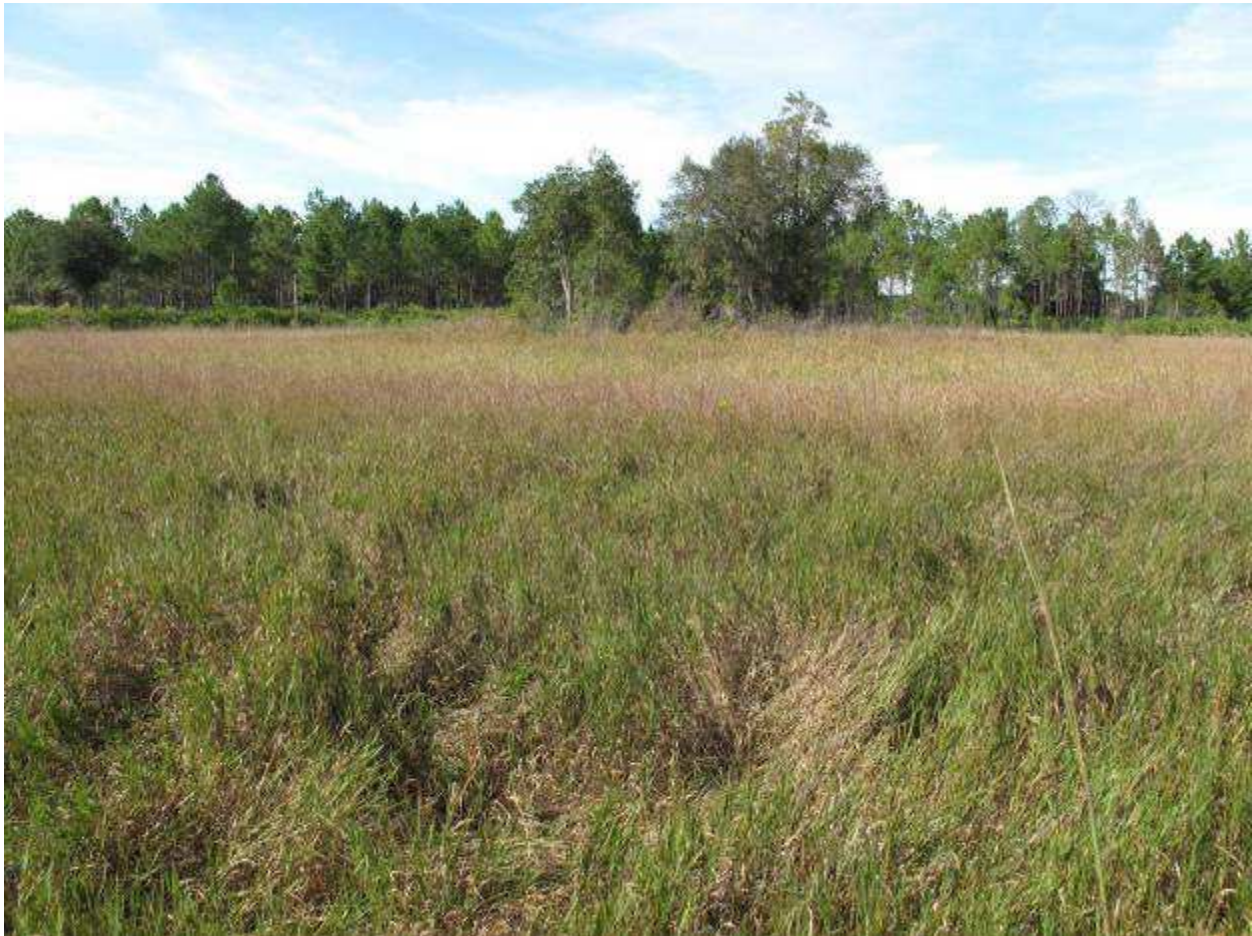
Wetland ID: 58-03

Description: This wetland is a 1.8 ha ephemeral marsh. There is a small island of shrubs and trees in the wetland center and a few small pine trees encroaching in the northwest corner. The woody vegetation covers <5% of the wetland. Maidencane grows throughout the wetland, and covers >75% of the basin. A fireline/MU boundary bisects the eastern side of the wetland. The wetland is surrounded by a dense palmetto ring and oldfield.

Wetland Concerns: Fireline/MU boundary, Upland condition

Restoration Action Recommended: Re-route boundary away from this wetland complex. The island of woody vegetation in the wetland center is natural occurrence and can be left untouched. The minor woody encroachment should be suppressed by the next fire or wetland inundation. In order to restore the full ecological potential of the wetland, the uplands would have to be restored.

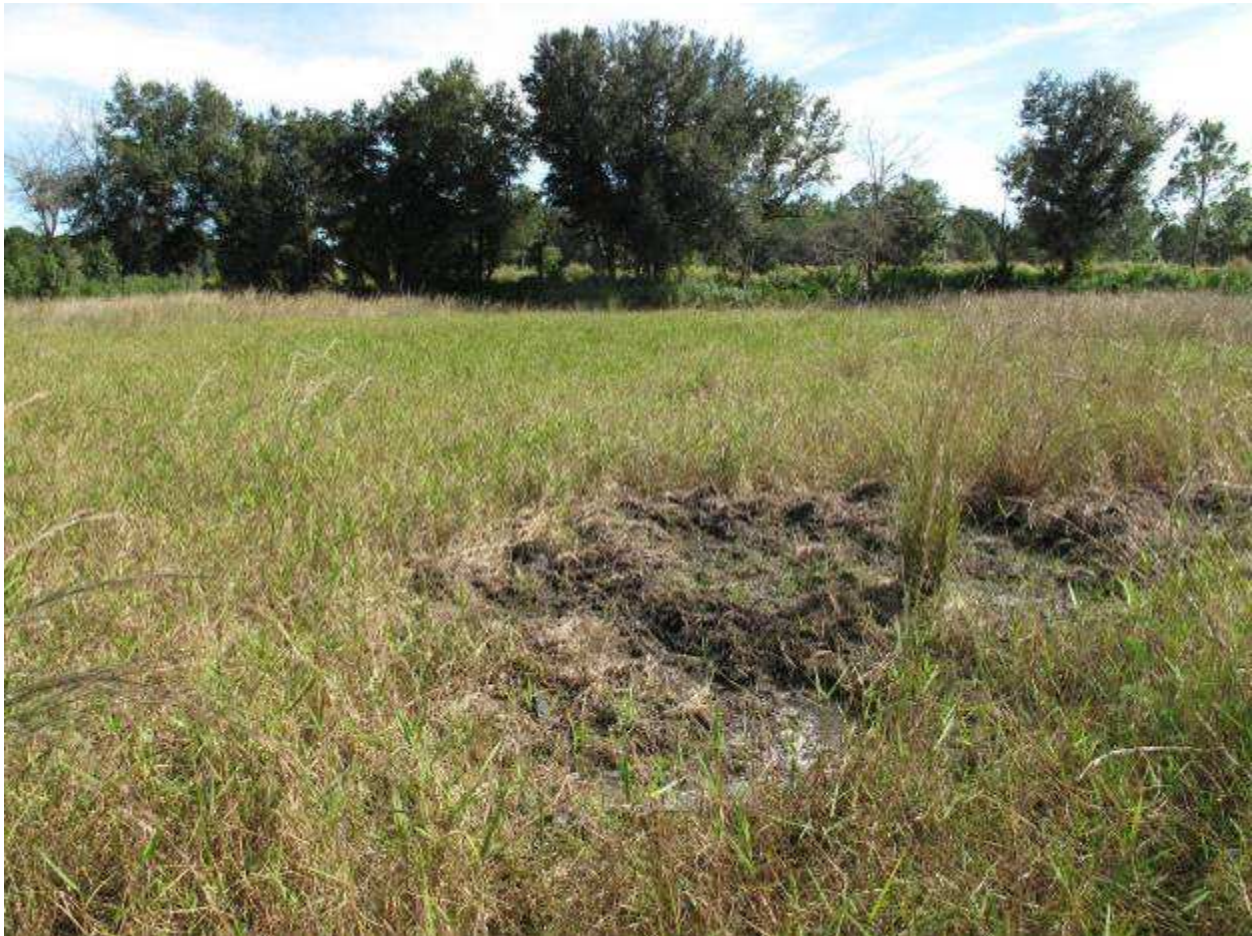
Wetland ID: 58-04

Description: This wetland is a 0.8 ha ephemeral marsh. There is no tree canopy or midstory cover. Sweet gum saplings are beginning to encroach from the northeast side of the wetland, but they likely will be eliminated with the next fire. Sedges/grasses and maidencane grow throughout the wetland, and cover >75% of the basin. There is a patch of feral hog damage in the wetland center. The wetland is surrounded by a dense palmetto ring and oldfield.

Wetland Concerns: Feral hog damage, Upland condition

Restoration Action Recommended: The minor woody encroachment should be suppressed by the next fire or wetland inundation. In order to restore the full ecological potential of the wetland, the uplands would have to be restored.

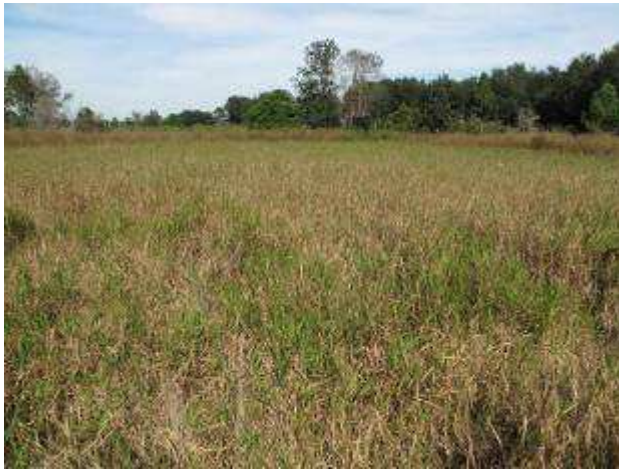
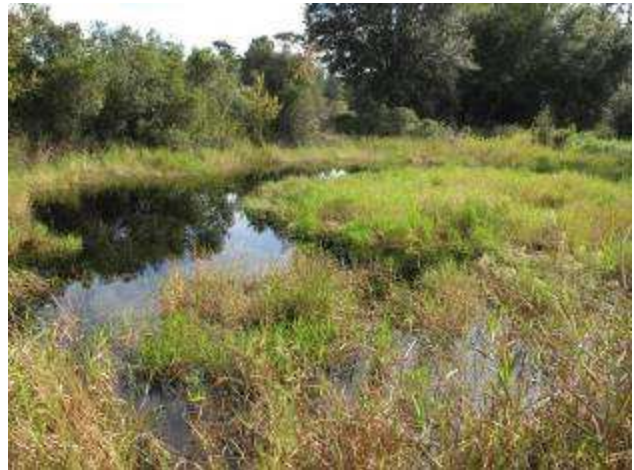
Wetland ID: 58-05

Description: This wetland is a 0.5 ha semi-permanent marsh. There is no tree canopy or midstory cover. Maidencane grows throughout the wetland, and covers >75% of the basin. A deep-water filled pool on the south side of the wetland harbors fish. This feature could be an old dug-out or a result of karst topography. A ditch on the east side of the wetland connects to Wetland 58-10 and a ditch on the south side connects to a larger wetland system. The wetland is surrounded by a dense palmetto ring and a brushy oak/pine/palmetto oldfield.

Wetland Concerns: Ditching, Possible dug-out, Upland condition

Restoration Action Recommended: Fill the ditches to break connectivity with the wetland. Alternatively, the ditches could be plugged and vegetation allowed to regenerate. Fill the deep hole if it is an old dug-out. In order to restore the full ecological potential of the wetland, the uplands would have to be restored.

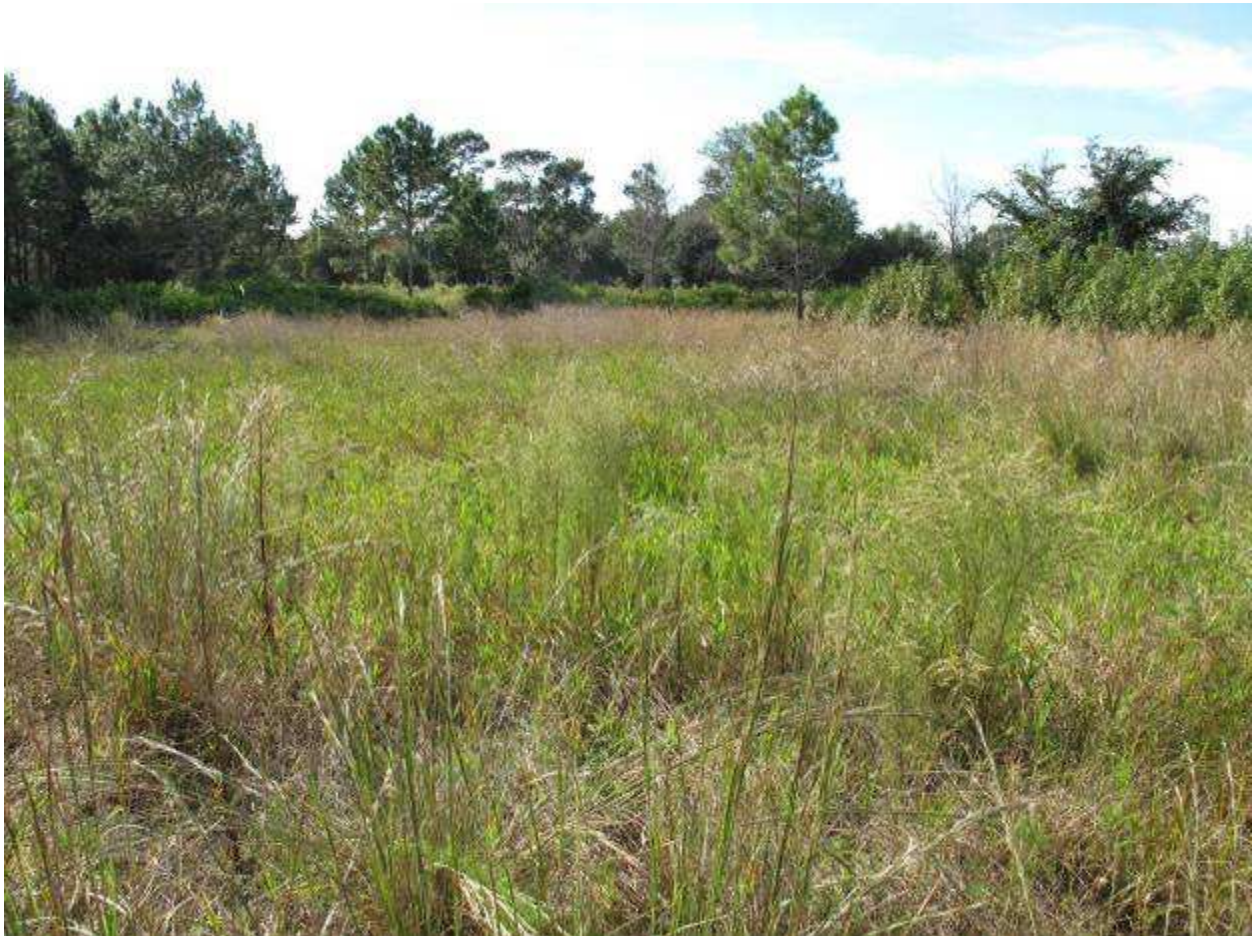
Wetland ID: 58-06

Description: This wetland is a 0.2 ha ephemeral marsh. There is no tree canopy or midstory cover. Maidencane grows throughout the wetland, and covers >75% of the basin. The wetland is surrounded by a dense brush ring, planted pine trees, and oldfield.

Wetland Concerns: Upland condition

Restoration Action Recommended: In order to restore the full ecological potential of the wetland, the uplands would have to be restored.

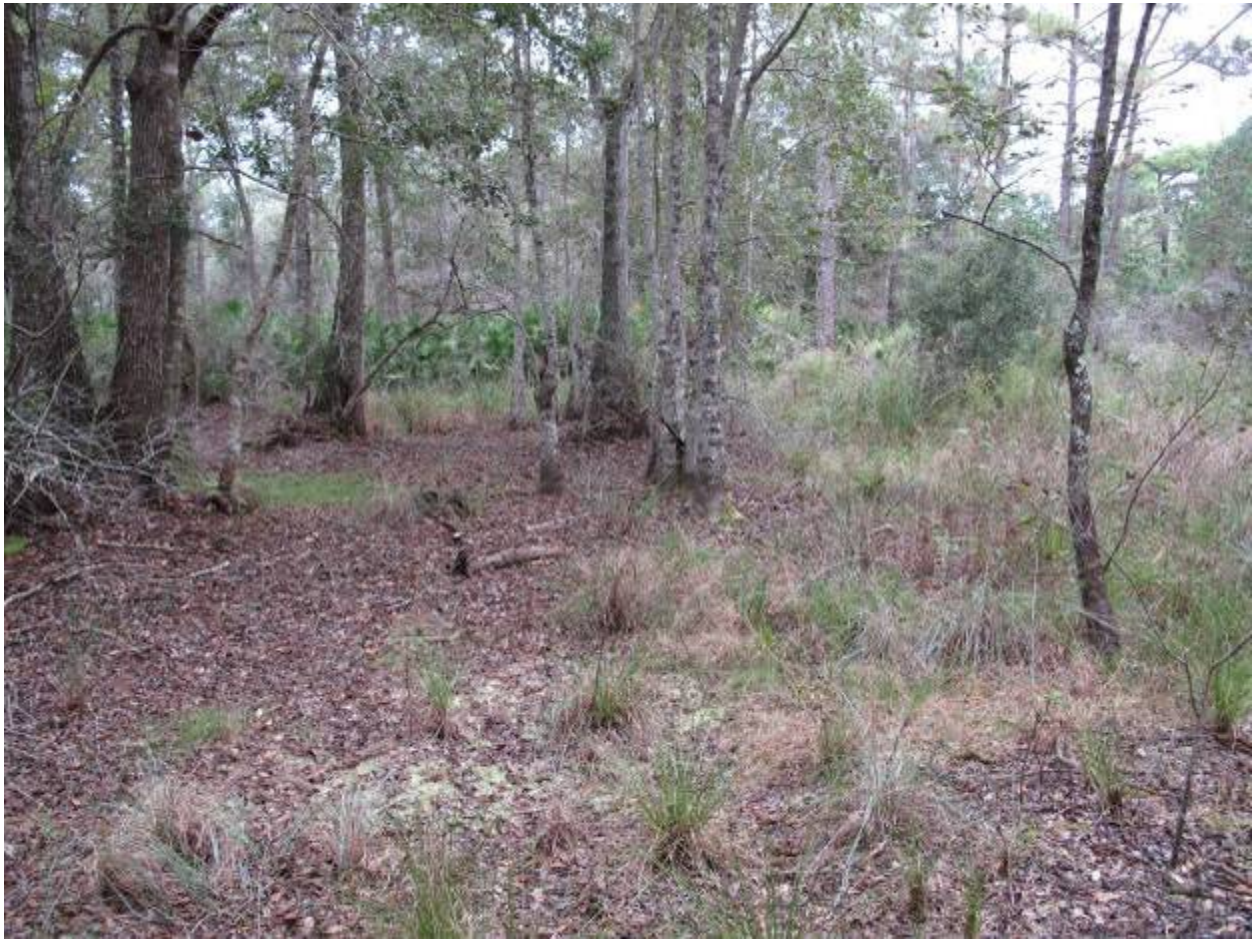
Wetland ID: 58-07

Description: This wetland is a 0.1 ha ephemeral forested swamp. Gum trees dominate the canopy, and cover 50-75% of the wetland basin. There is no midstory layer. Sedges/grasses grow in scattered patches, and cover 25-50% of the wetland basin. The adjacent uplands are a fire-suppressed pine/oak/palmetto hammock.

Wetland Concerns: None

Restoration Action Recommended: In order to restore the full ecological potential of the wetland, the uplands would have to be restored.
